River Otter, Deer Park Hotel, Honiton, Devon

An Advisory Visit by the Wild Trout Trust June 2016

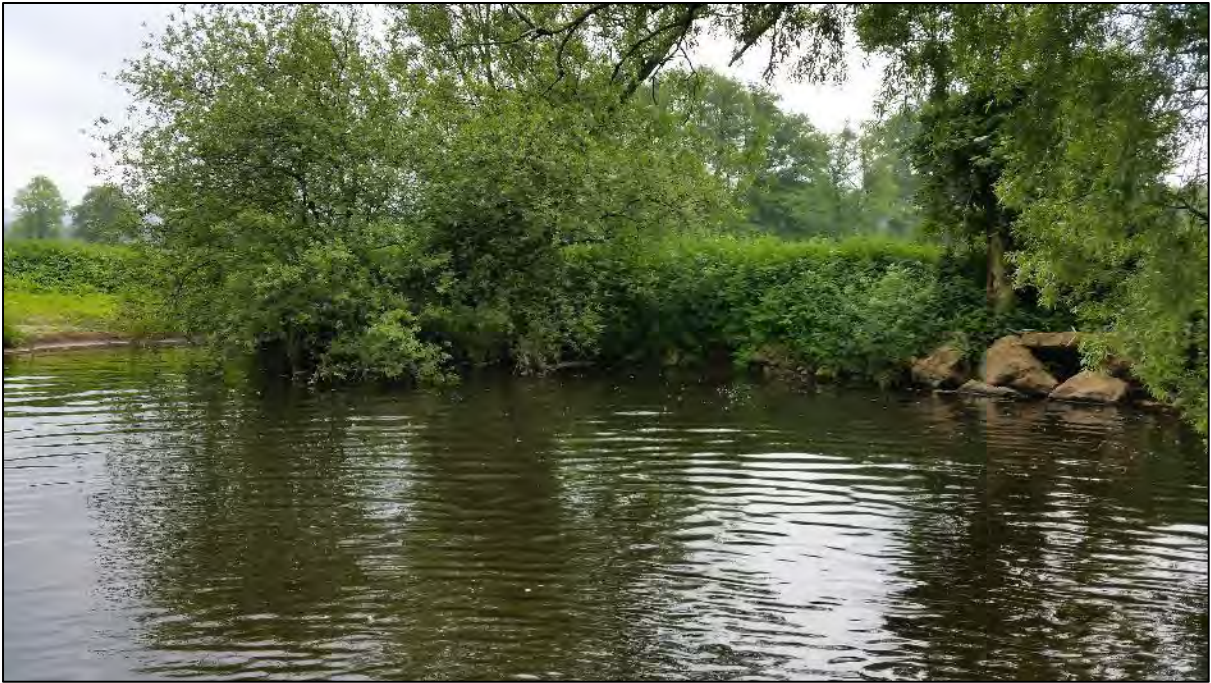
At the upstream extent of the visit, the river forms a deep pool on a tight hairpin meander **known as 'Boulder Pool'**. The remains of a rip-rap (boulder) revetment was observed on the LB (Figure 2), presumably giving the pool its name. Hard-engineered revetments may protect the bank behind them short-term, but at the expense of the bank at the edges of the revetment, or sometimes a section of bank downstream.

At the interface between the hard surface of the rip rap and the soft, friable bank, erosive forces are concentrated, often increasing the rate of erosion around the back of the revetment. Rip-rap bank revetments are remarkably common on the River Otter. In many places the technique has completely denuded the river of marginal habitat and tree cover, creating a general lack of overhead cover and shade. Rip-rap revetments are often installed in an attempt to protect eroding banks. However, in many cases, the increased rate of erosion is a direct result of intensive grazing right up to the top of the bank and the absence of an un-grazed fenced buffer. Riverbanks afforded wide fenced-off livestock exclusion are naturally resistant to erosion as a deep, dense and complex root structure is allowed to establish within the upper bank. Tree saplings are also more readily established in fenced buffers where they are protected from browsing livestock. As well as providing valuable habitat, an established and diverse marginal plant community, complimented by occasional bankside trees such as willows (*Salix* spp.) is, therefore, much more resistant to erosion than banks protected with hard-engineered structures.

Figure 2: The remnants of a rip-rap revetment on the RB (right of image)

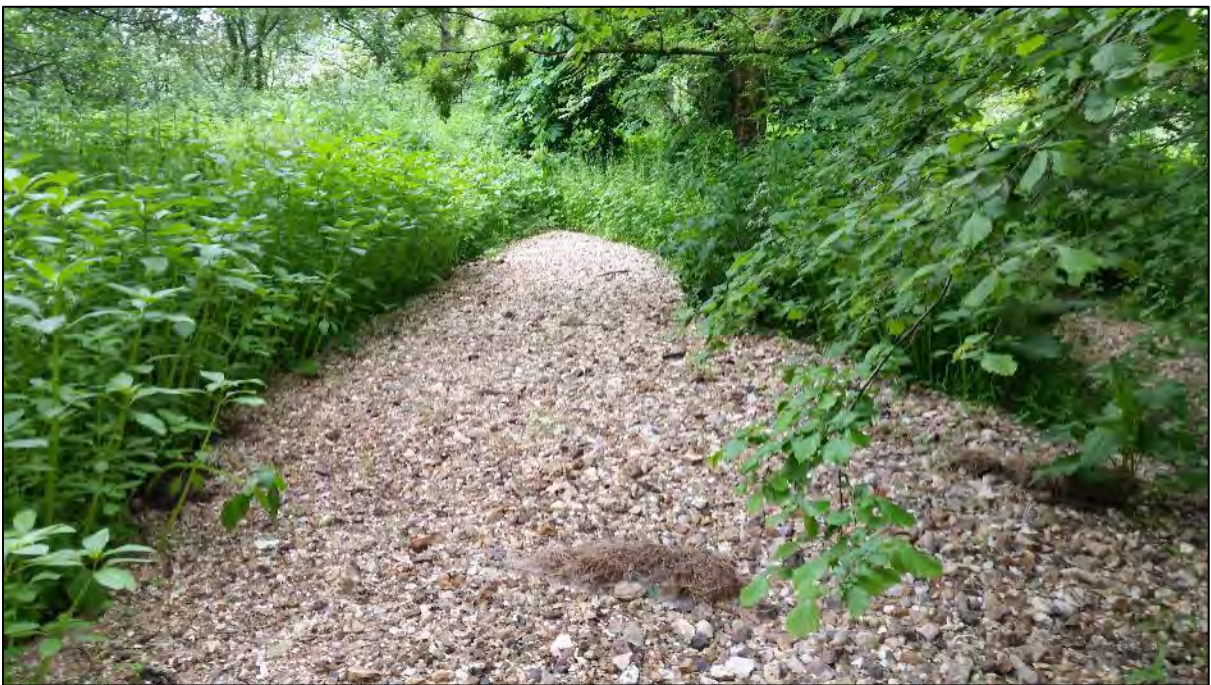
Mid-way through the meander, an enormous volume of river gravels has been deposited during a recent spate event, covering the RB (Figure 3) and forming a gravel bar in the channel (Figure 4). Alongside the bar a mature willow has toppled over and a deep run has been scoured below the exposed root ball. A short distance downstream, a riffle has developed as material scoured out from under the toppled tree has been redeposited.

Figure 3: Several tonnes of gravel have been deposited over the inside of the meander during a spate event

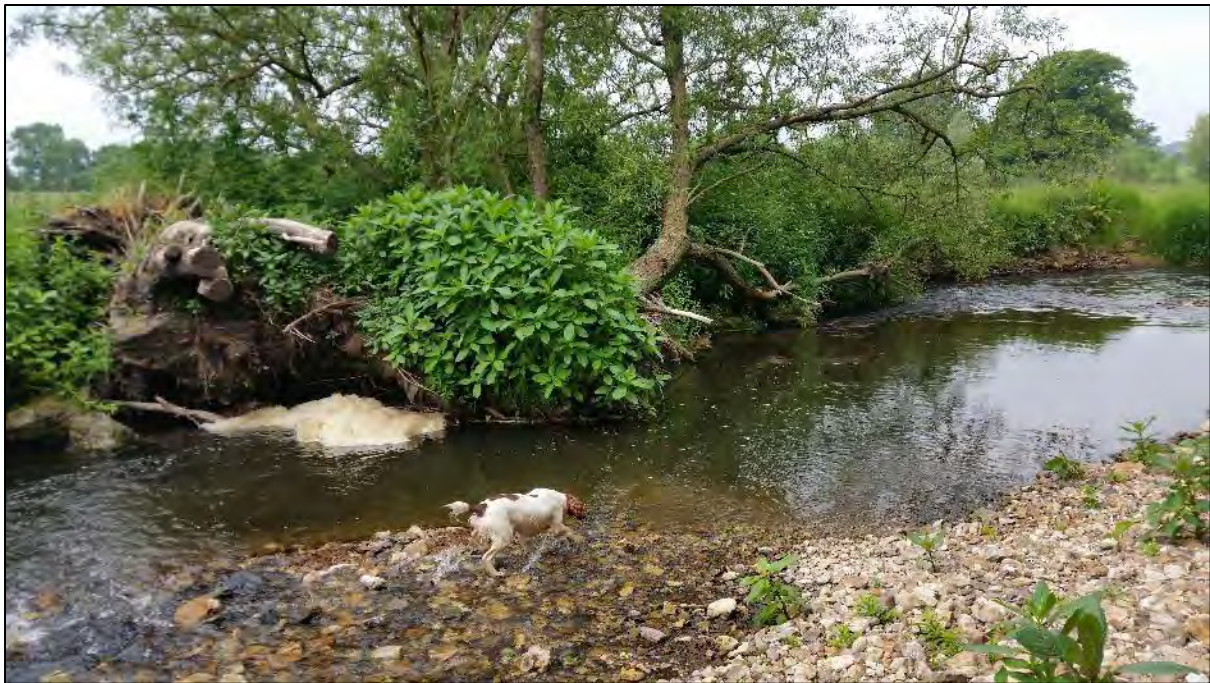
Figure 4: A gravel bar has formed and a mature willow has toppled over

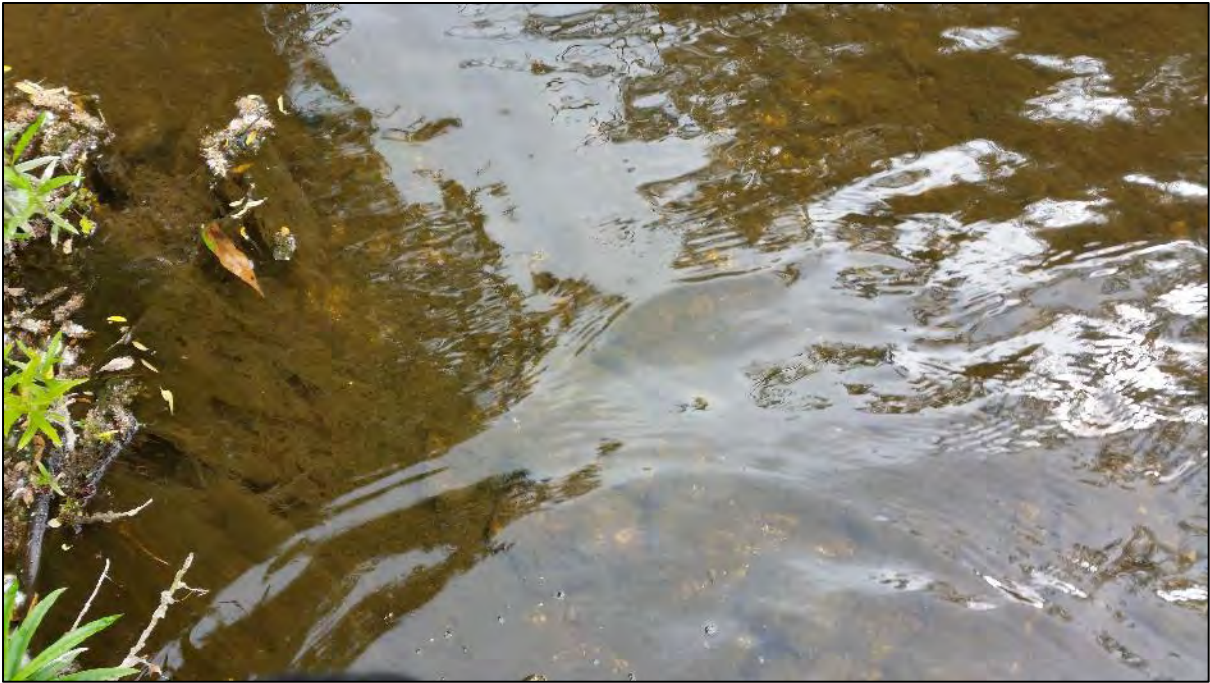
Evidence of a recent algal bloom was also observed (Figure 5), this is a response to excess nutrient input (or nutrient-laden sediment), probably originating from intensive agriculture within the catchment. Algal blooms are often a response to increased levels of phosphates and sometimes nitrates (or both). They are often short-lived, resulting in an abundance of dead organic matter which decays and is broken down by bacterial action. However, the decay process utilises a proportion of the available dissolved oxygen, limiting the abundance of oxygen-sensitive invertebrate species and in extreme cases, suffocating fish.

Figure 5: Dead algae from a recent bloom

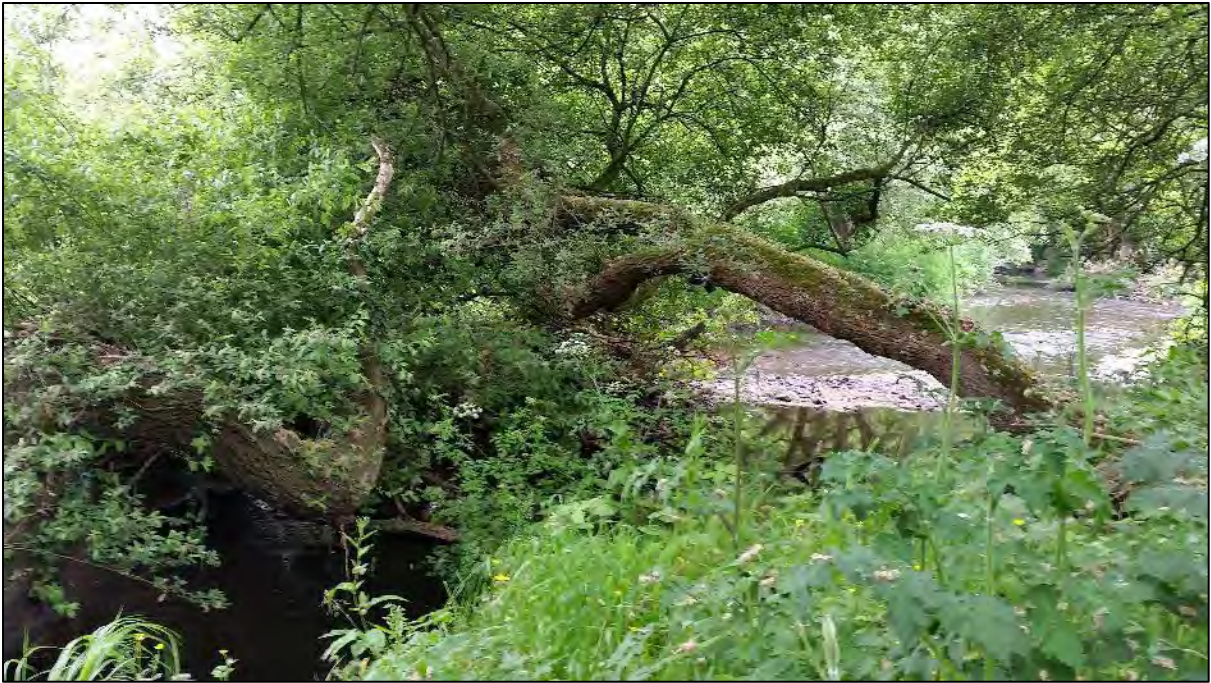
At SY 13511 99909 (Long Reach Pool), a large sallow (round-leaved willow, either goat willow *Salix caprea* or grey willow *Salix cinerea*) has fallen across the river (Figure 6). Sallows are particularly valuable trees for fisheries. They are generally slow-growing and bushy, providing good cover yet requiring minimal maintenance. They also flower early in the year, supporting a range of invertebrates which often become prey for trout.

Figure 6: A fallen willow provides excellent cover habitat

Too often, fallen trees are removed by fishery managers in order to facilitate **casting or access or simply in an attempt to keep the fishery 'tidy'**, at the expense of valuable habitat. In this case, the feature is providing excellent cover and during spate conditions will force flows down underneath it, scouring out a deep pool, sorting the gravel and diversifying habitat downstream as scoured-out sediment is redeposited. This feature should be retained if at all possible.

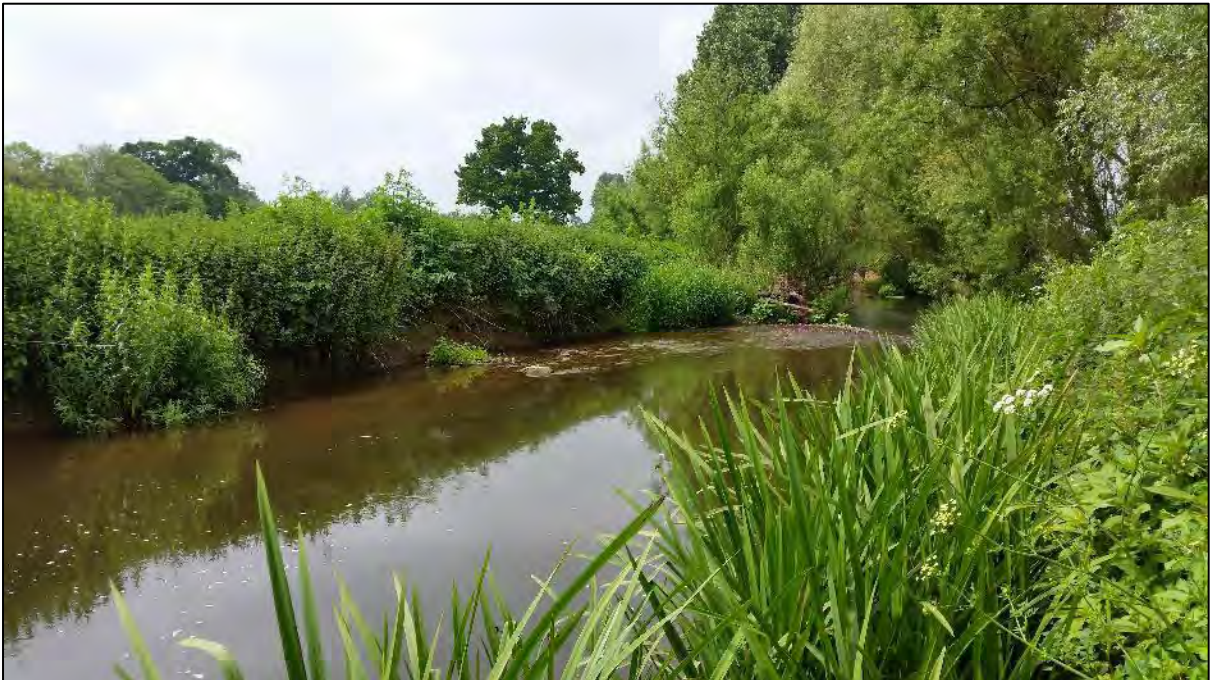
Some long, laminar glides (sections of laminar flow) were observed in the Lazy Run beat (Figure 8). Straight sections of river are often prone to an over-abundance of glide habitat as the uniform nature of the channel evens out flow patterns. However, the glides in the upstream section of the beat are broken up by occasional riffles and natural woody habitat features help maintain a relatively good balance of different habitats. Toward the downstream end of Lazy Run, the river would benefit from some additional woody features to maintain flow deflection and diversify conditions. Simply hinging (cutting partially through and laying downstream) some small bankside trees or large limbs into the river would create conditions similar to those present in the upper section of the beat.

Figure 8: A long glide is broken up by occasional riffles and woody habitat features

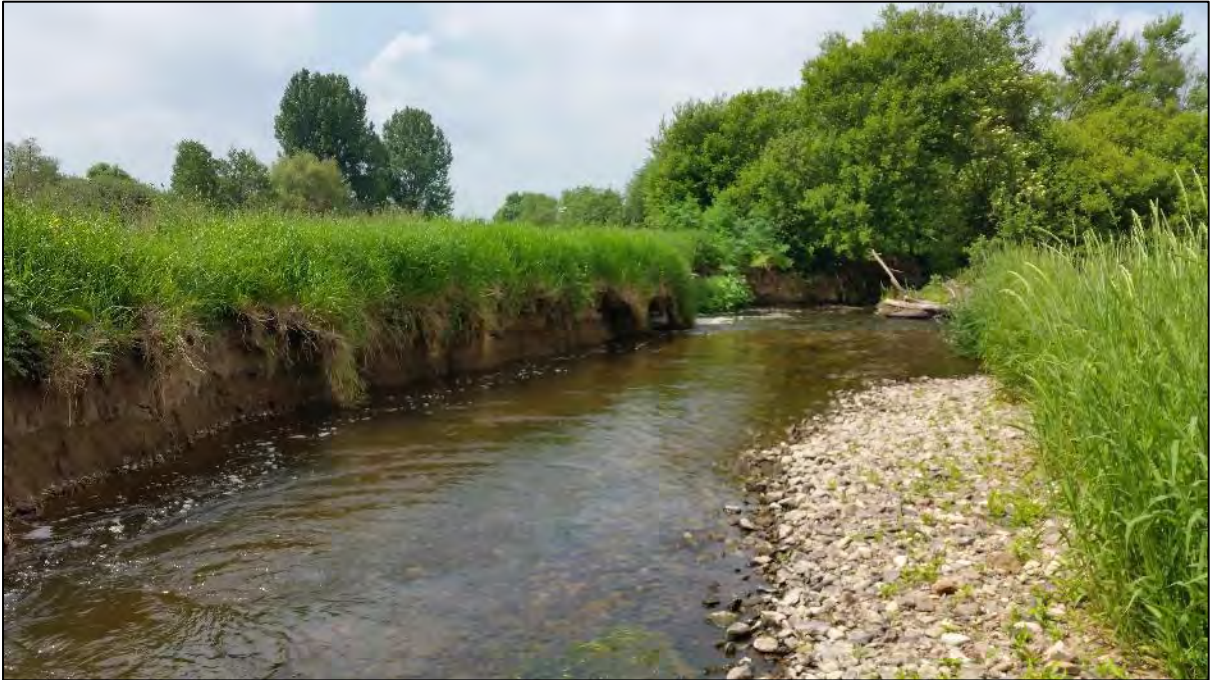
The downstream section of Lazy Run also illustrates the point made earlier with regards to bank erosion. A section of the LB is much less intensively grazed and although bank erosion is occurring, deep root structure is helping to hold the upper bank together (Figure 9). The sandy soil of the Otter Valley is particularly friable, resulting in a naturally incised channel and banks that are prone to cliffing (presenting an almost vertical cliff-like face) on the outside of bends. In general, this is part of the natural character of the river and helps facilitate a naturally active geomorphology that results in a meandering and diverse habitat. The bank erosion also exposes the gravel seam of the floodplain and introduces new gravel into the system. As a spate river with a particularly abundant supply of mobile gravel, flowing through a valley with particularly friable soils, the Otter is prone to abrupt changes in rates of bank erosion. However, the straightening (and therefore shortening), of the river will have increased the energy of flows as the gradient of the river is also increased. The straightening reduces the river's ability to retain substrate, causing bed incision and potentially accelerating the rate of erosion.

Figure 9: The naturally friable soils make banks prone to 'cliffing'. However, a deep root structure helps to control the rate of erosion

In many cases, erosion is not a problem and results in a more diverse habitat. However, where erosion is deemed to be a problem, there are a number of techniques available to protect vulnerable banks that are cheaper, more cost effective and more ecologically sensitive than rip-rap revetments. This can range **from simple tree planting to the creation of 'soft-engineered' revetments**. Examples of such techniques are outlined in the *Recommendations* section of this report.

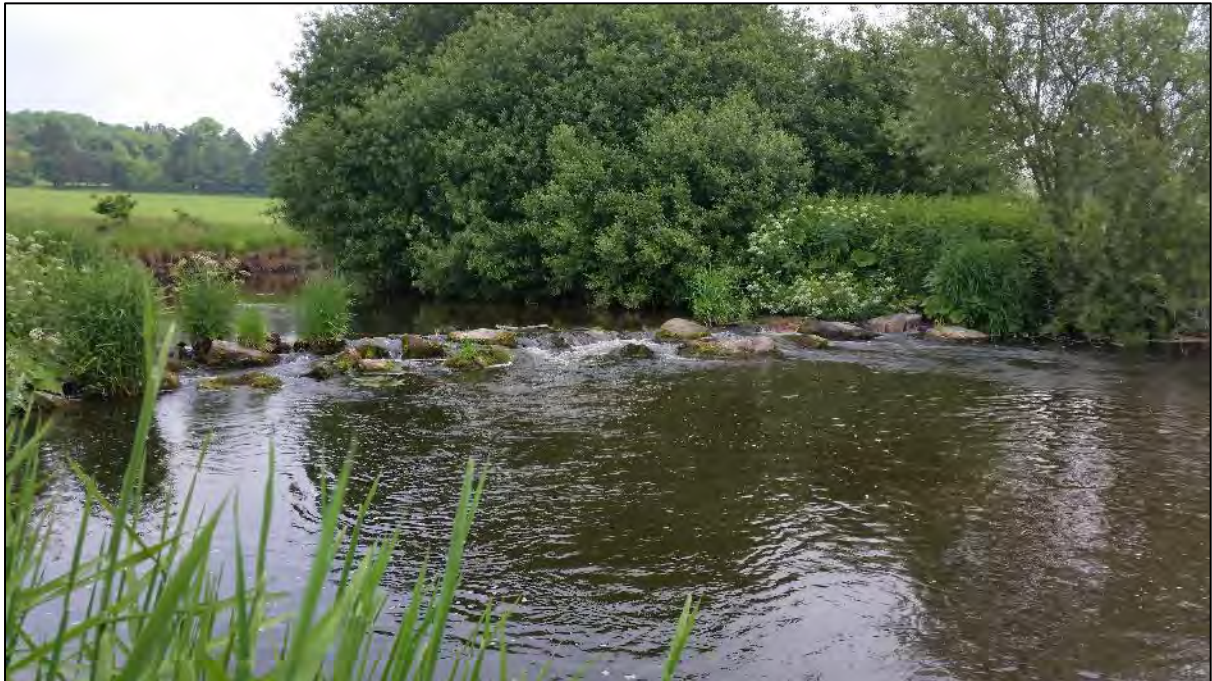
At SY 13202 99769, a boulder weir (High Bank Weir) impounds flow and interrupts natural gravel transport (Figure 10). The structure is not a barrier to fish migration but nonetheless has a detrimental effect on habitat quality and diversity. Weirs such as this have often been **installed as 'summer weirs' in the belief that a depth** of water needs to be held up to mitigate for lower flows in the summer months. However, holding up water causes flows upstream to be slowed, resulting in sediment (along with associated excess nutrients) dropping out of suspension and depositing uniformly across the bed. Weirs also trap sediment, causing the bed to rise and, over time, fill in the pools they were installed to create. The combined action of these two processes results in a uniform and static habitat upstream which is suited to only a limited number of species. Wild trout, being naturally territorial, often defend a small territory from competitors within their line of sight. A wide, uniform deep glide habitat, such as that found above a weir, may sometimes hold bigger fish (able to defend the open territory), but will almost always hold fewer fish than a naturally diverse section of river. The best practice for mitigating against low flows is to work with natural processes and ensure that

A study of maps dating back to 1887 (old-maps.co.uk) show the river significantly straightened. It is possible that weirs at this location were originally installed to deliberately impede sediment transport and maintain the straightness of the channel by suppressing the natural geomorphology.

Figure 10: High Bank Weir is constructed from boulders. The structure creates a uniform habitat upstream and impedes natural sediment transport (and therefore the natural processes that diversify habitat) downstream.

Removing the weirs will allow natural processes to resume and restore habitat diversity. This would also provide a greater number of lies for trout and more opportunity for anglers. Methods for removing these features are explored in the *Recommendations* section of this report.

1. The boulder weirs at Beat 3 and the lower part of Beat 7 should be removed. This should be a relatively easy undertaking provided a suitable size of excavator is used. Engage with the Environment Agency and explore options for weir removal and what is required to obtain the relevant permissions. Depending on available resources, it may be cost-effective to initially remove only half of each weir, alternating the side to be removed on each weir so that a meandering deep trench **or 'thalweg'** is scoured through the bed between them as the river adapts to the new flow regime. This might also maintain some shallow gravelly habitat in the margins, making for easy angler access.

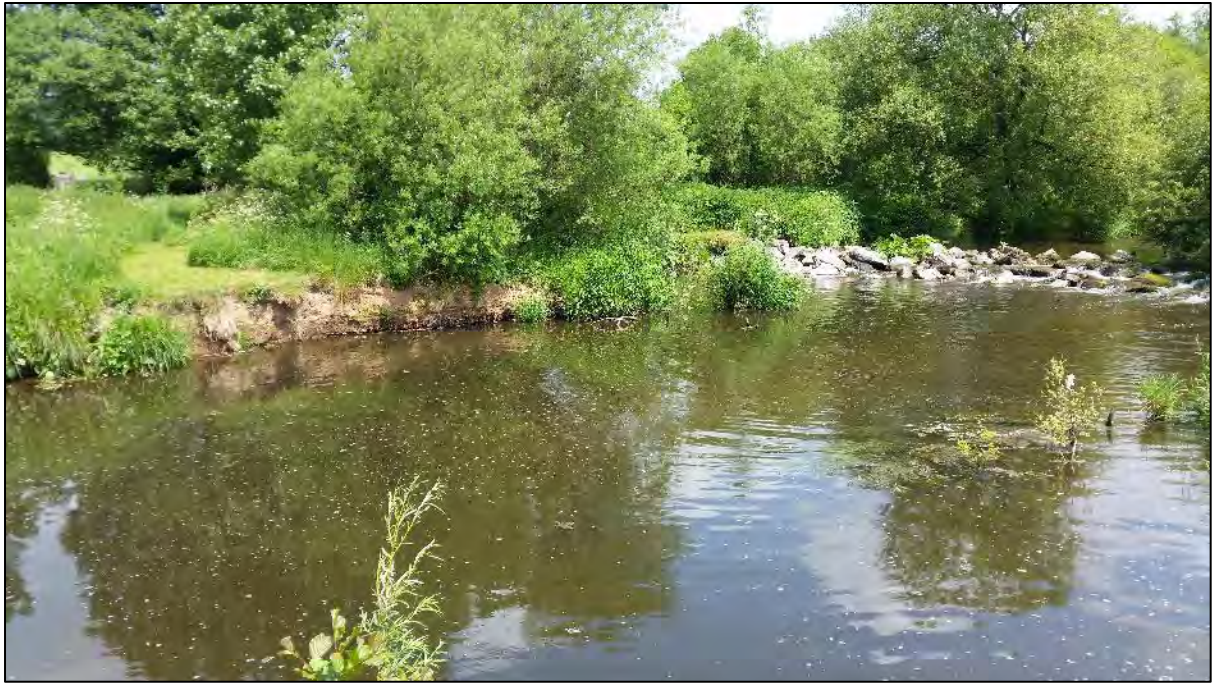
Downstream of the three weirs is a large pool. This has developed as the rate at which gravel is transported away from the section immediately below the weirs is greater than the rate at which it is replaced, essentially resulting in a net loss of gravel from the reach. This has caused the channel to deepen and may be destabilising the banks downstream, causing an increased rate of erosion (Figures 11 and 12).

Figure 11: The RB downstream of the weir (looking upstream)

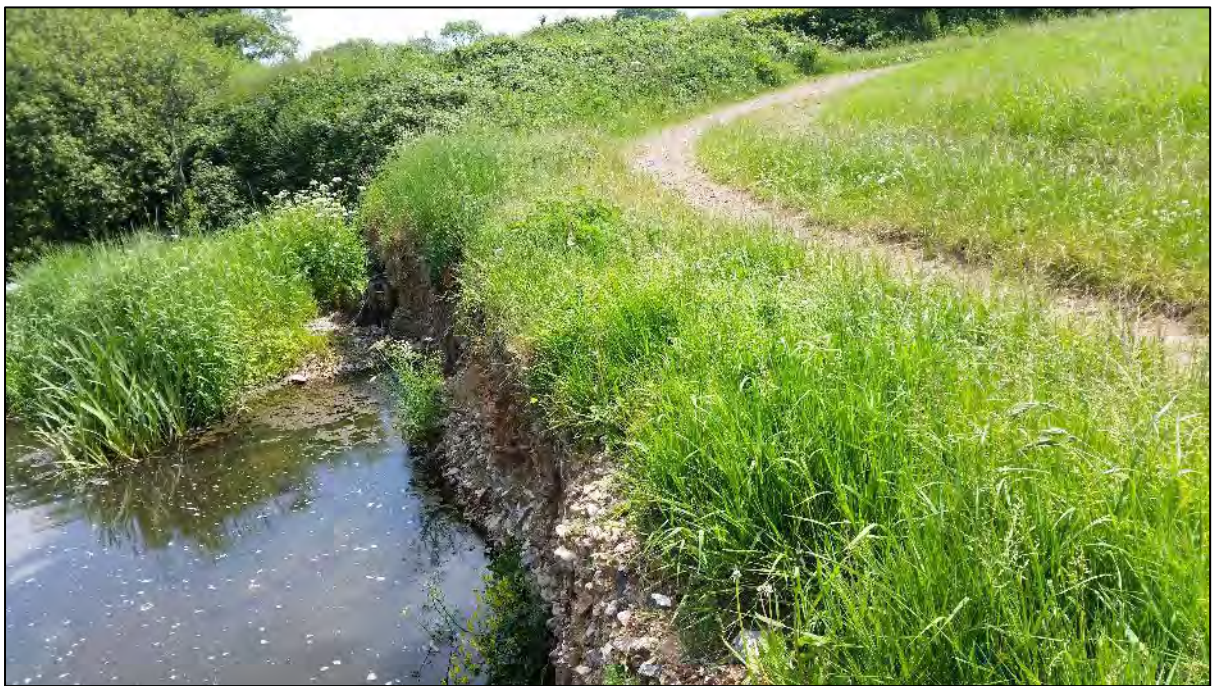
Figure 12: The LB downstream of the weir (looking upstream)

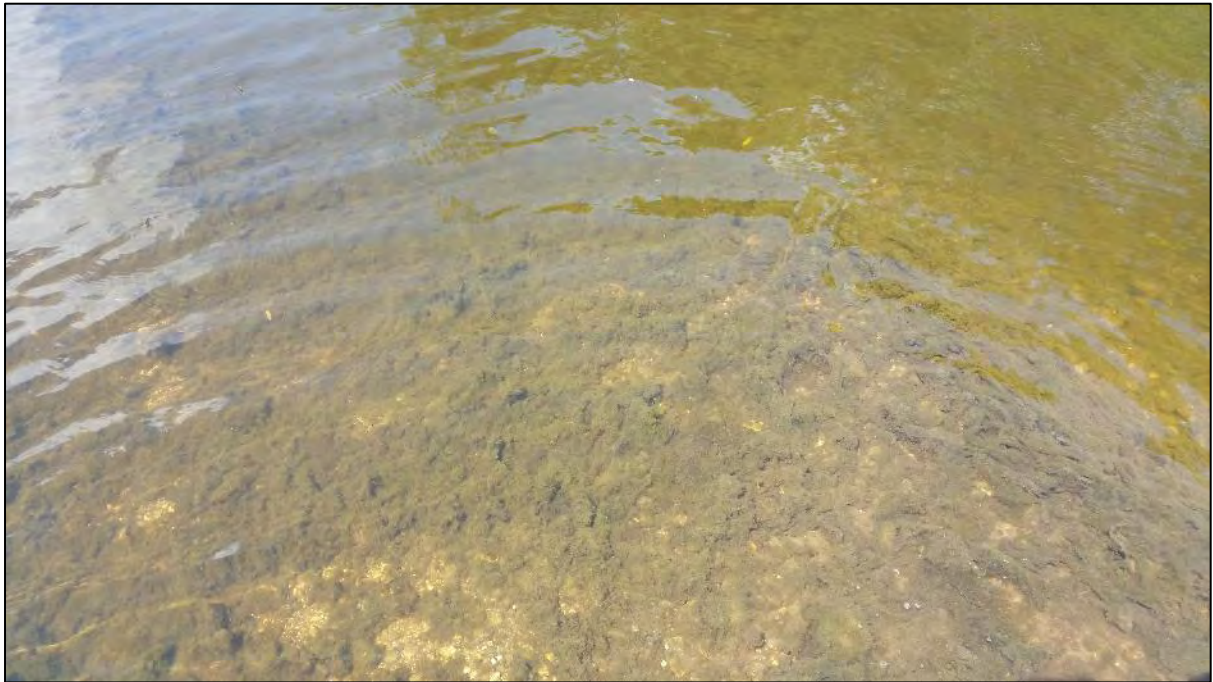
Below the weir pool is a wide riffle and ford. Further evidence of algal blooms, indicating elevated nutrient concentrations were observed (Figure 13). Below the ford the river returns to a more natural condition (Figure 14). From here the river flows through a more densely-wooded section with an abundance of natural woody **features**. The aptly named **'Hanging Bush Pool'** (Figure 15) provides some excellent marginal refuge habitat. Partially submerged live wood is an excellent habitat for juvenile trout. Not only does the tangled assemblage of branches and roots provide good protection from predators such as piscivorous birds, but also enables a large number of juvenile trout to occupy a section of the river margin

Figure 13: Further evidence of excess nutrient in the form of algae smothering a riffle

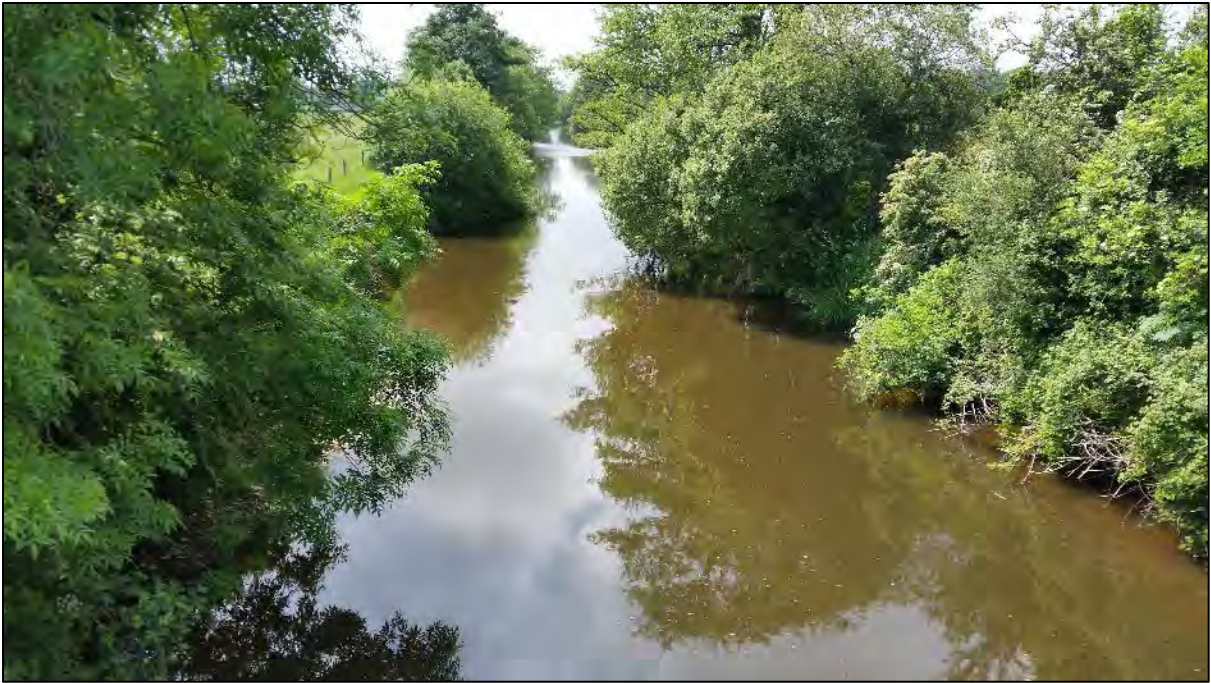
At the downstream extent of the wooded reach, the character of the river changes significantly. The river is significantly straightened and is extremely uniform in width and depth. Some good low cover habitat is present on both banks but tree cover is sparse and the channel is lacking in flow deflection and submerged structure for approximately 300m (Figure 20).

Figure 20: A long straightened section with laminar flow presents a poor quality habitat for wild trout populations

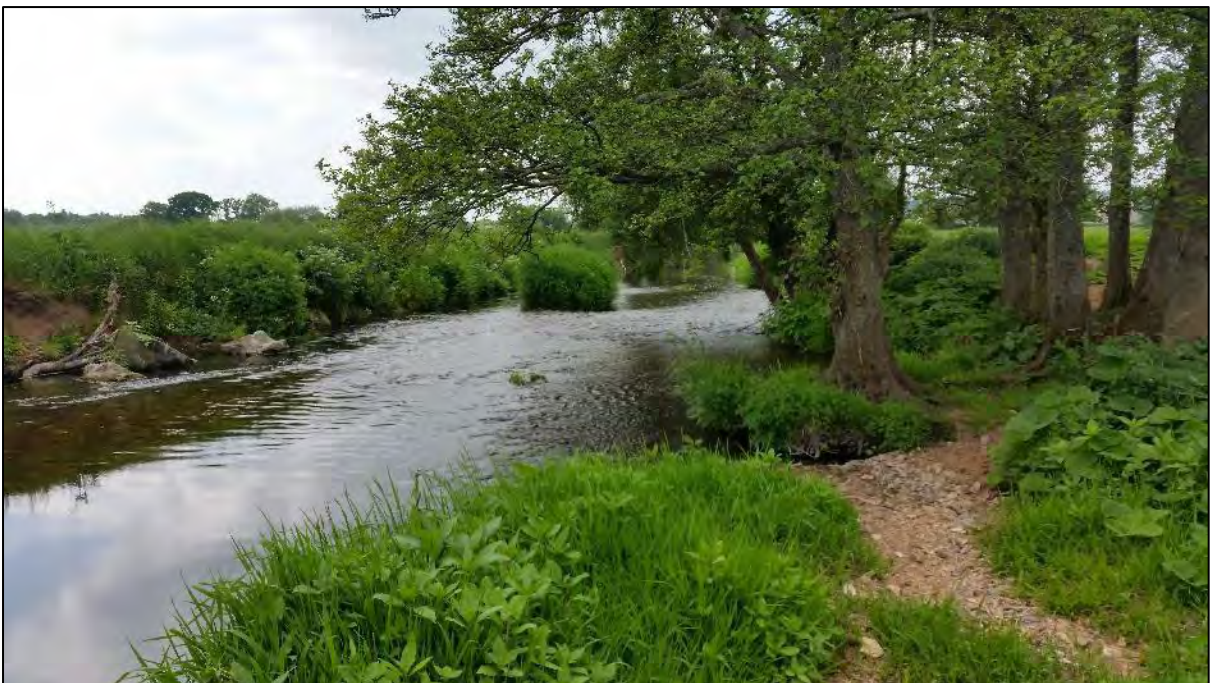
The long uniform reach ends at a riffle at SY 12446 99348 (Figure 21). A sequence of glides and riffles introduce some variation in depth but the reach remains lacking in flow deflection and deep pool habitat.

Figure 21: A riffle introduces some diversity into the straightened section

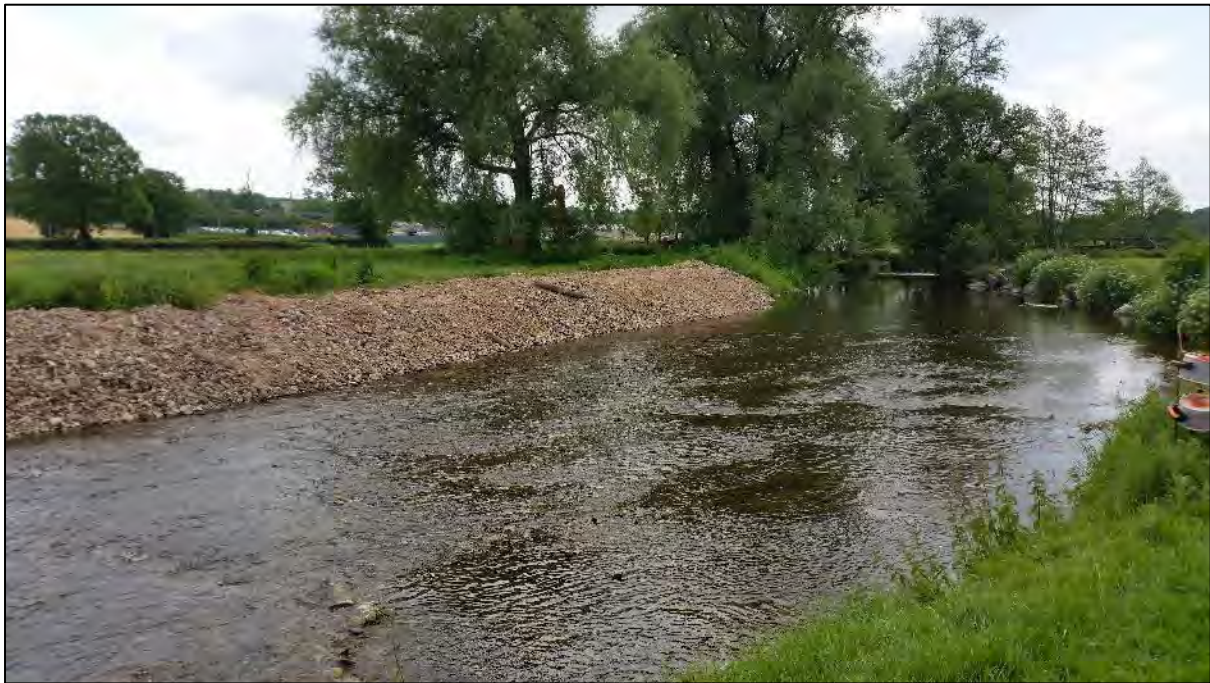
At SY 12148 99292, gravel has been pulled from the channel and piled against the LB (Figure 22). The bank did not appear to be undergoing an accelerated rate of erosion so it was not entirely clear what the motivation for this action was. It is possible that as a bend at the end of a long straightened section, this is the first opportunity for gravel supplied from upstream to settle. It may be that the person

who undertook this action did so out of concern over a gravel bar forming in the channel. However, widening the channel here will almost certainly increase the rate of deposition. This is a potentially very damaging undertaking and is unlikely to have been done with the consent of the Environment Agency (EA). Engaging with the land owner responsible and ascertaining the reason for undertaking such an activity is recommended. Following on from this discussion, it is likely that the Wild Trout Trust or EA will be able to advise on a more ecologically appropriate alternative to whatever it is the person responsible is trying to achieve.

Figure 22: Gravel piled along the LB has been pulled from the river with heavy machinery.

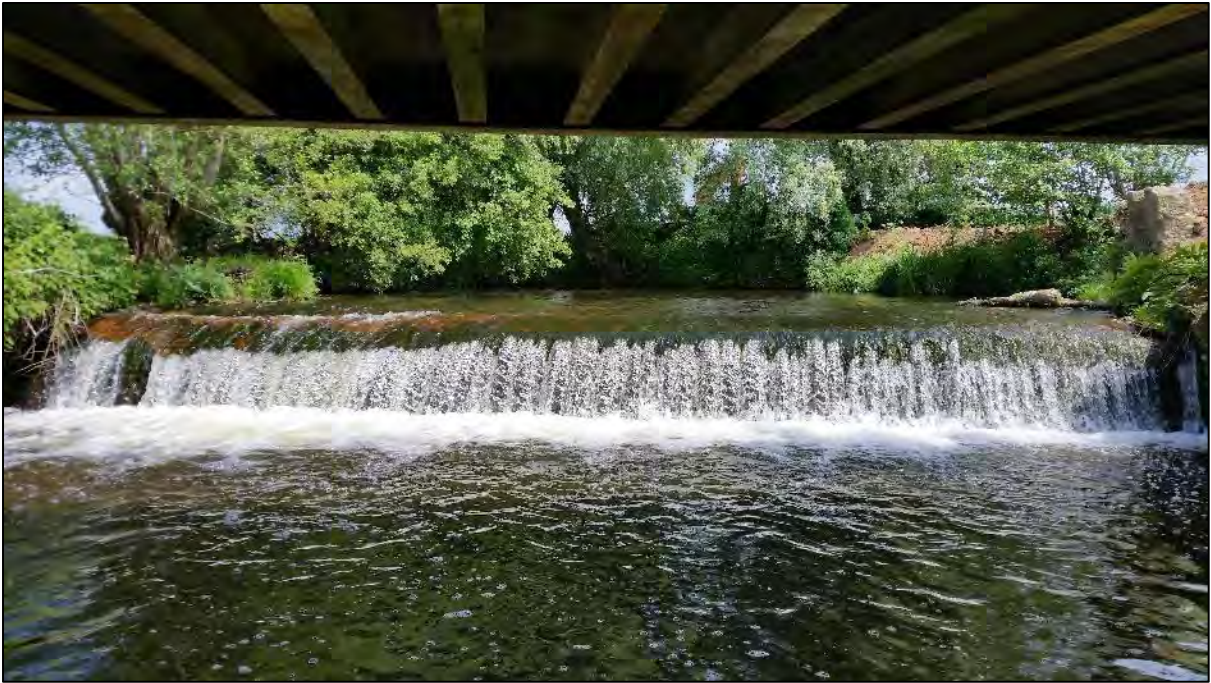
A short distance downstream, the river is impounded by a weir under a bridge (Figure 23). Below the weir is a brick apron which would have been installed to prevent the bed from cutting under the structure. The shallow and fast flows over the apron and the head drop over the weir make it a barrier to fish migration in all but the highest flow conditions. Ideally, this structure should be removed but the presence of the bridge and apron could make this difficult and potentially a major capital project. Engaging with the land owner and EA and exploring options to remove this structure in the medium–long term is recommended. Exploring options to improve fish passage over the structure in the short-medium term may **help to safeguard and enhance the fishery’s wild trout population.**

Figure 23: The brick-built weir and apron under the bridge are a barrier to fish passage

The brick-built weirs should also be addressed. The brick weir at the farmyard (Figure 25) could be removed with an excavator but the weir by

the bridge (Figure 23) may be more challenging. As a stopgap to removing the weir and apron, notched timber baulks could be affixed to the structure to raise water level over the apron and reduce the head loss over the weir. In all cases, the ownership of the weirs will have to be established and owner permission, as well as formal consent from the EA will need to be sought. Engage with the EA **and explore the likelihood of a 'low-cost easement' being installed on the gauging station weir at Fenny Bridges.** This is a tried and tested technique used by the Agency in several locations across the country and usually involves affixing baffles to the sloping face of the weir in an offset pattern to provide a path of slowed and raised water for fish to follow over the feature.

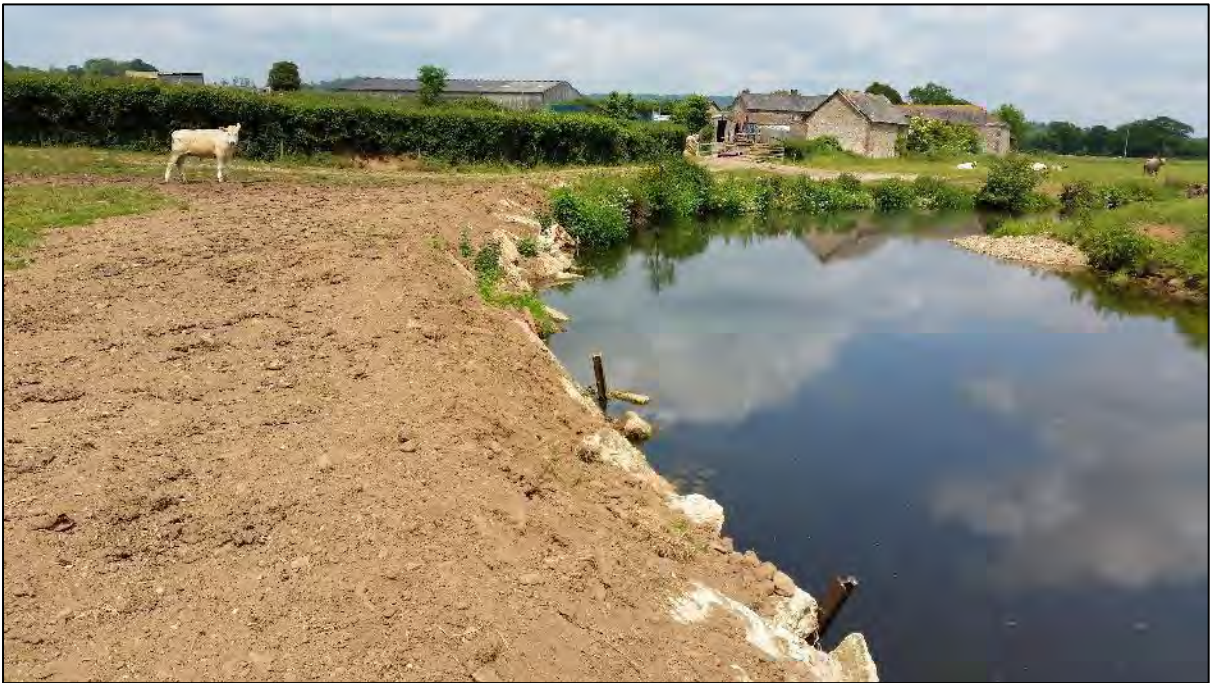
From the bridge downstream, the river flows in a straightened course past a farm yard. On the only bend in the river, a revetment of concrete slabs and iron bars has been installed (Figure 24). Again this is neither the most effective or economical means of protecting banks and the land owner/farmer may benefit from being informed of better practices that will protect the bank whilst also providing the best possible ecological outcomes.

Figure 24: A concrete and steel bank revetment is neither cost-effective nor particularly effective. Soft engineering alternatives are available

4. Encourage the use of soft-engineered techniques such as live willow revetments to protect excessively eroding banks. On sharp bends these structures should be installed to form as smooth a curve as possible so as to limit the occurrences of eddying flows and uneven friction. Live willow brushwood should be aligned in the same direction, ideally with the branched ends pointing downstream to reduce the risk of trapping debris that could pull the structure apart. Finally, the willow should be firmly secured and the upper bank fenced to protect new growth from browsing livestock.

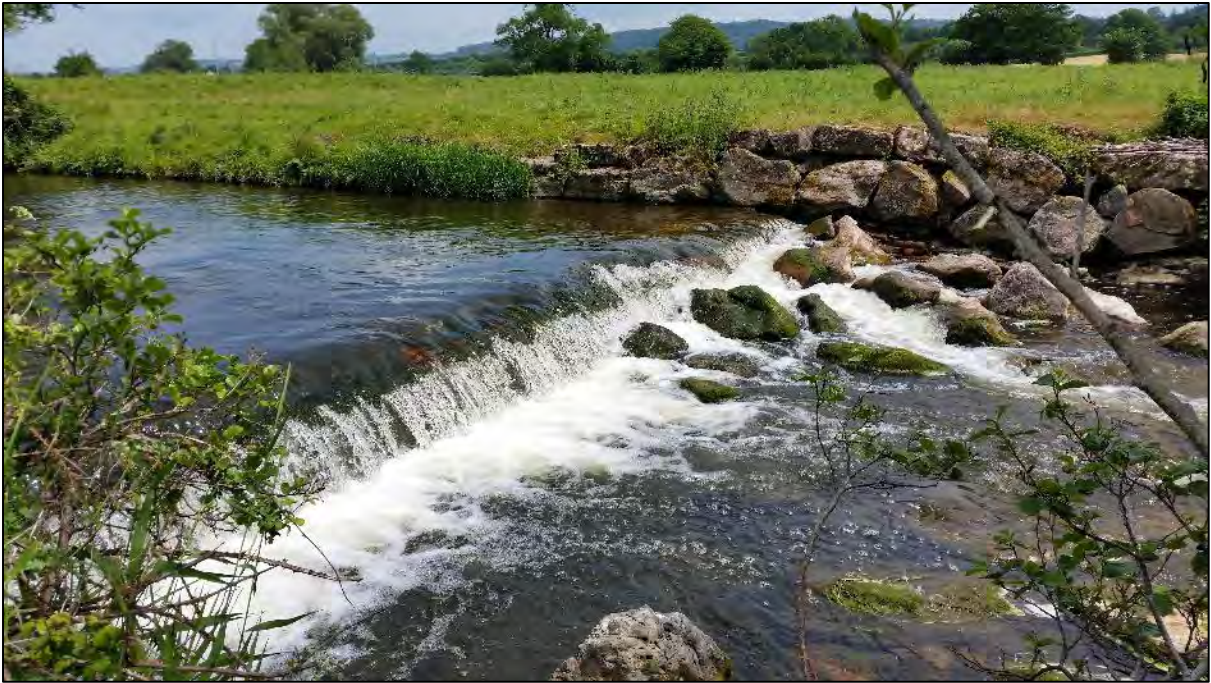
A short distance downstream, another brick-built weir impounds flow and presents a significant obstacle to fish passage (Figure 25). Boulders in the channel near the RB, possibly originating from the adjacent rip-rap revetment, may be helping to ease fish passage by baffling flow and creating conditions similar to those that are often found in natural cascades that trout are well-adapted to overcome.

Figure 25: Another brick-built weir is an obstacle to fish passage, suppresses geomorphology and causes uniform flows

This structure may be relatively easy to remove but because of its unusual construction, further investigation may be required. Below the brick weir, a series of smaller boulder weirs are present (Figures 26 and 27). These are relatively passable but it is worth noting that even structures deemed to be 90% passable can have a significant cumulative effect on the number of trout successfully migrating upstream to spawn (Figure 28).

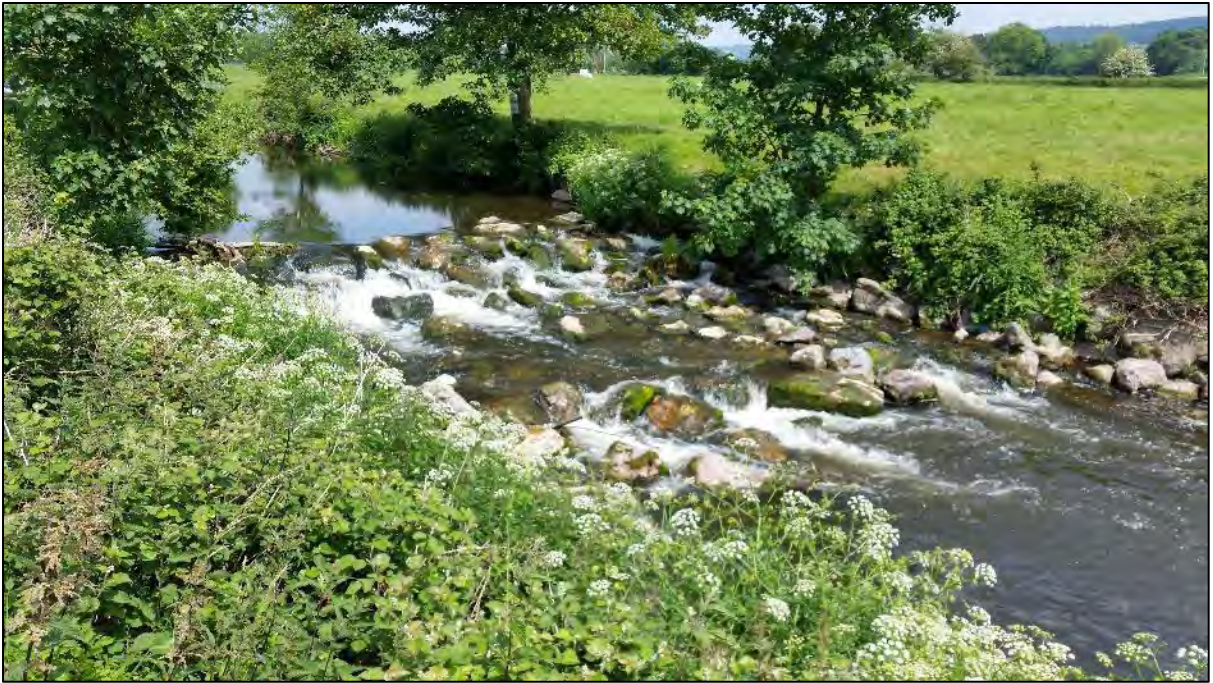
Figure 26: Another boulder weir

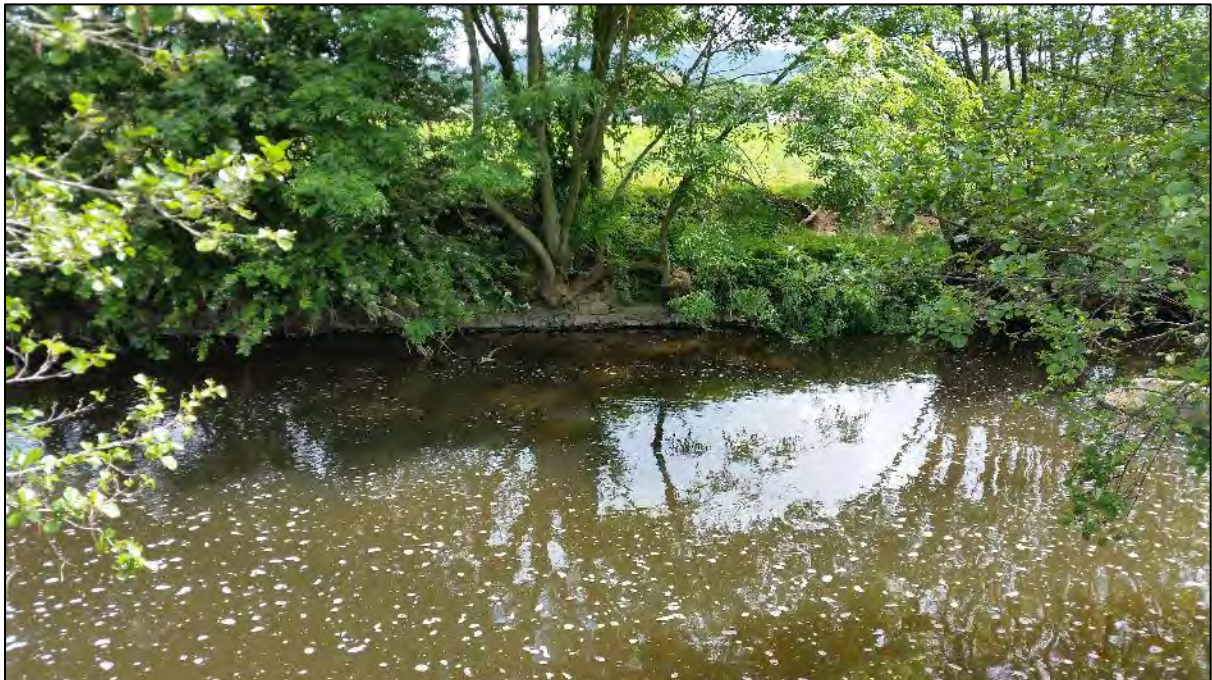
Much of river through this reach is channelised between hard-engineered blockwork banks (Figure 29). This prevents the natural processes that would otherwise diversify habitat from occurring. There is also a paucity of tree cover, resulting in a lack of shade and cover habitat. Planting some occasional trees on both banks throughout Beats 5 – 7 would provide much-needed cover and would also eventually provide woody material that could be used for further habitat enhancement. Ideally, the revetment restraining the river would be removed so that a more natural plan form could develop. However, this would be an expensive operation and would require the full support of the land owner and other stakeholders.

Figure 29: A brick/blockwork wall forms the LB, inhibiting natural geomorphology

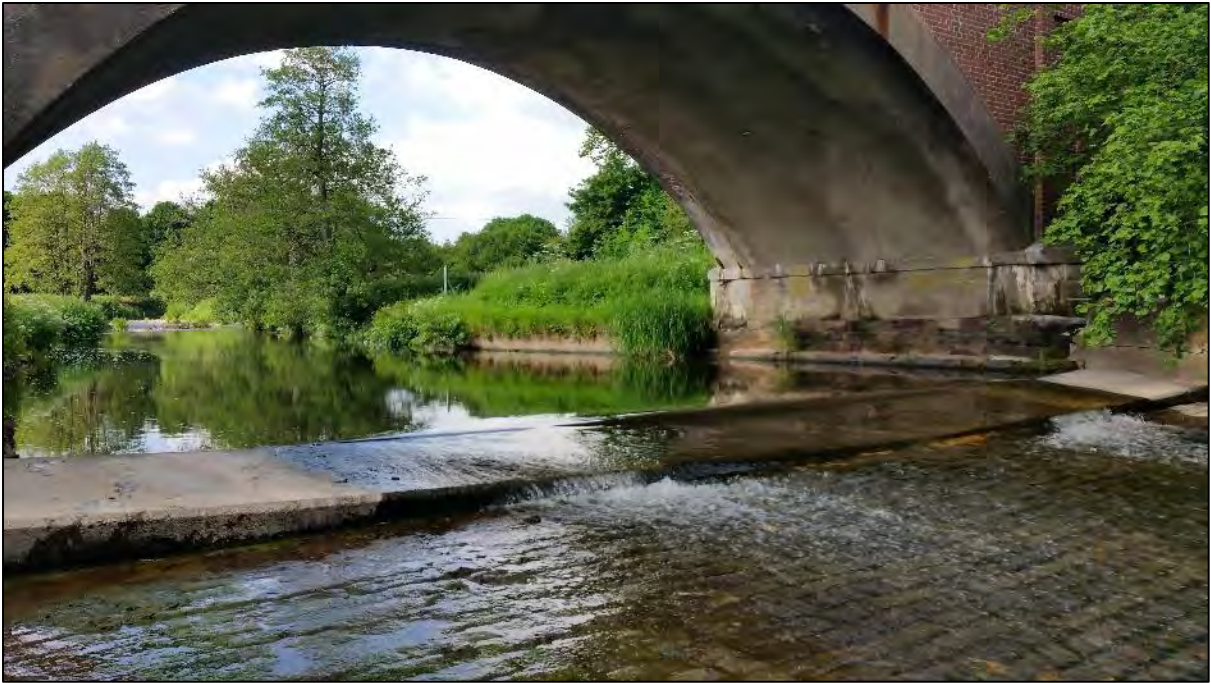
Figure 31: A flat V weir creates uniform, predictable flows. Good for gauging, bad for fish passage.

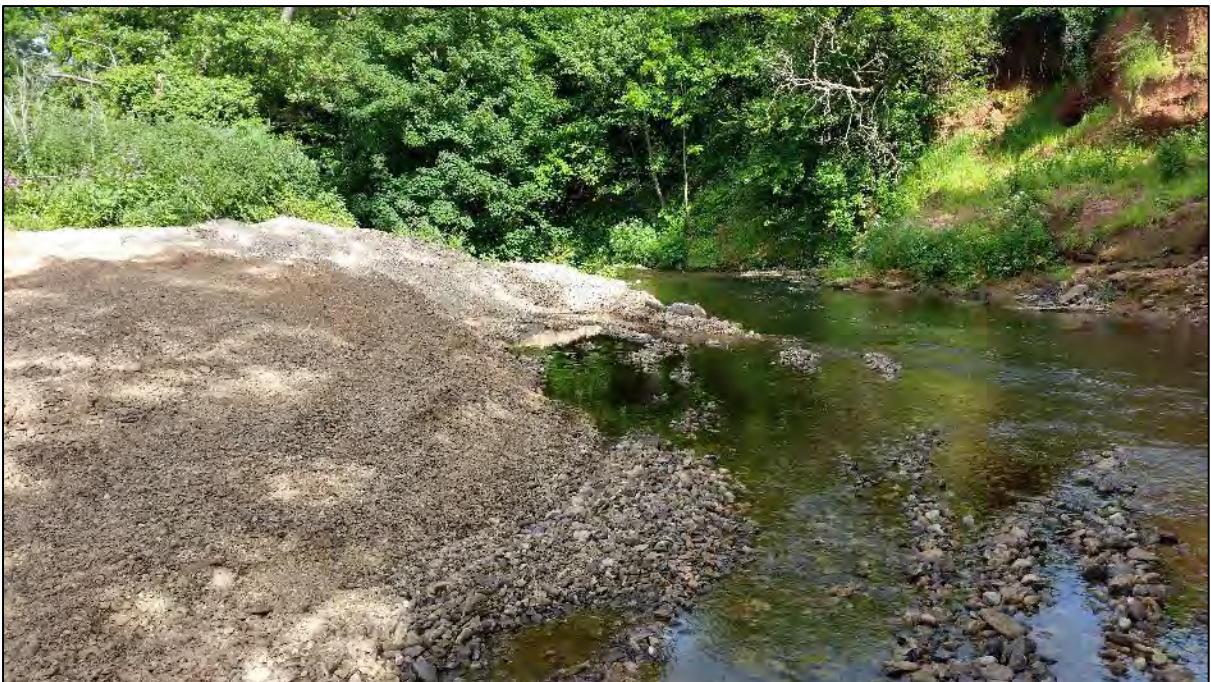
Downstream of the bridge, some good examples of natural woody habitat features were observed deflecting flow and helping create a range of different flow speeds, channel depths and widths. Cover was relatively abundant and there were a number of good feeding lies for trout. At SY 11475 98375 is a tight right hand meander. The acute angle of the meander has caused a large point bar to be deposited on the LB (Figure 32). On the day of the visit it was clear that gravel was being removed from the river at this location on a large scale (Figure 33). The purpose of this operation was not clear and it may be worthwhile enquiring why so much material was being removed and where it was/is going.

Figure 32: A large gravel point bar has accumulated on the inside of the sharp bend
