River Otter, Deer Park Hotel, Honiton, Devon

An Advisory Visit by the Wild Trout Trust June 2016

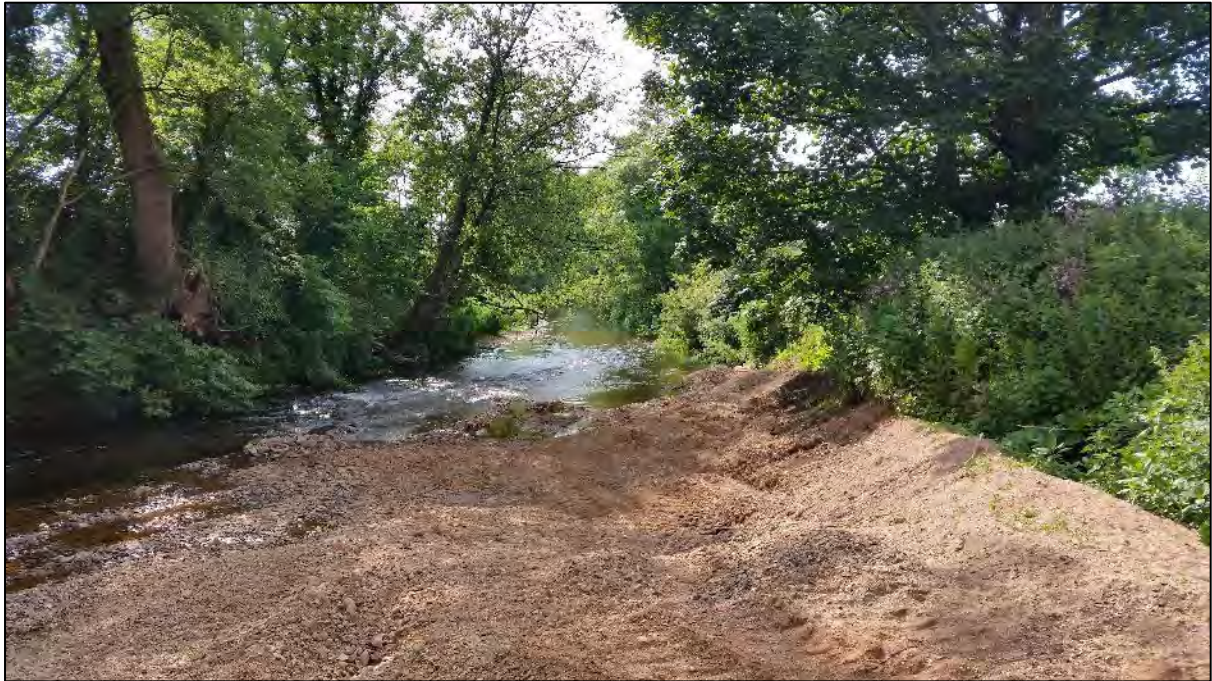
Removing gravel from a river at any location can be detrimental to habitat. A reduced gravel supply is likely to impact on the quality or availability of spawning habitat downstream. It is possible that this activity is not being undertaken legally.

Figure 33: Gravel is being removed and taken away for unknown reasons
