Advisory Visit

Oxfolds and Costa Beck, North Yorkshire

June 10th 2010

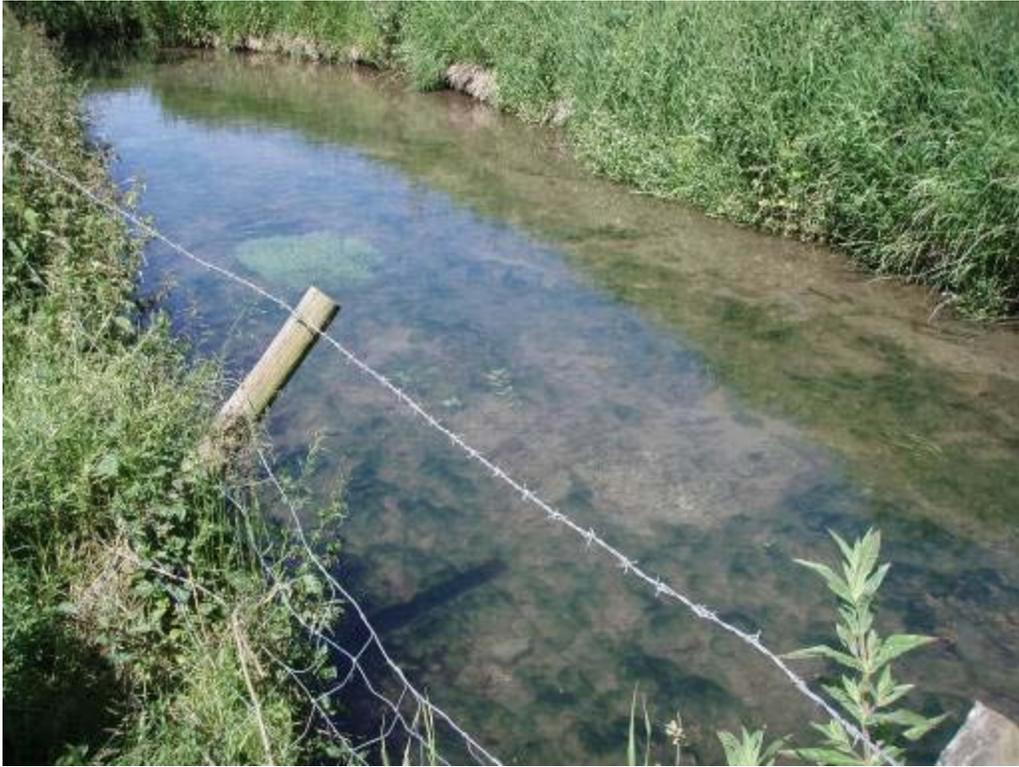
The river was walked in a downstream direction from immediately below the trout farm on the Oxfields Beck. The river bed here is very silty with a heavy growth of green algae. The aquatic flora includes starwort (*Callitriche* sp.), water parsnip (*Berula erecta*) and sparse amounts of water crowfoot (*Ranunculus* sp.).

Photo 1 Oxfolds Beck below the trout farm – heavily silted bed with algae growth

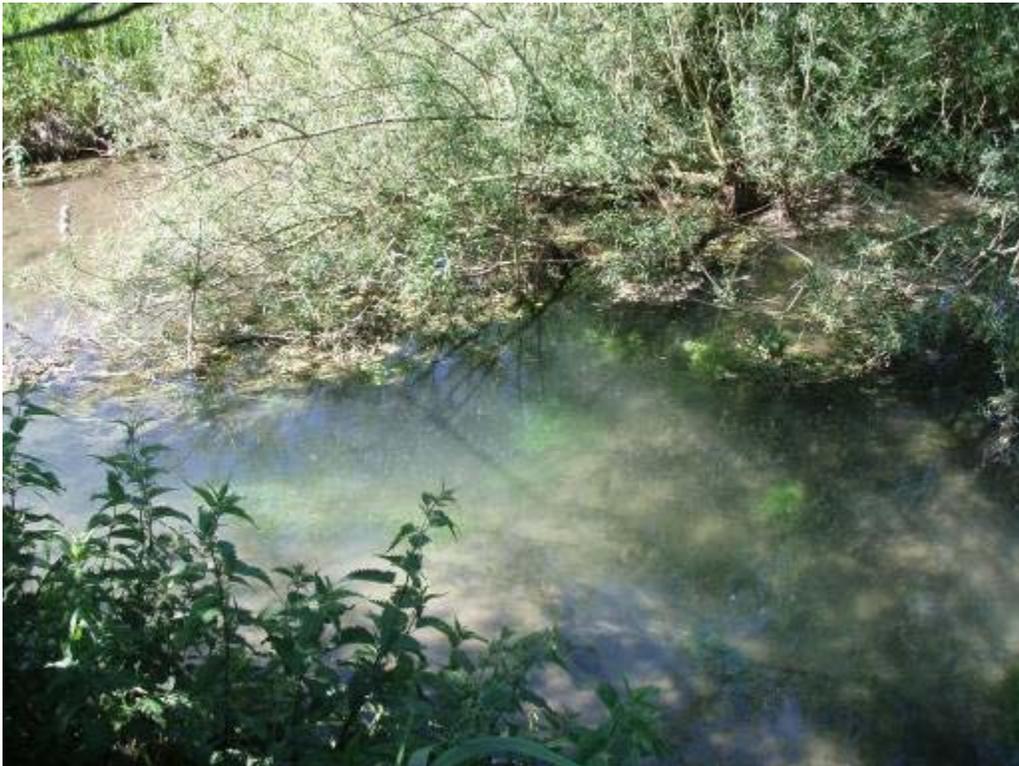
The channel dimensions are relatively uniform with little variation in depth or width, the exception being where deeper holes have been excavated in the river bed. The holes were created by the Environment Agency as areas to trap silt for subsequent removal; despite these areas being emptied infrequently they appear to have maintained some degree of depth.

Photo 2 Excavated silt trap. Combined with the overhead cover this makes good holding habitat for adult fish.

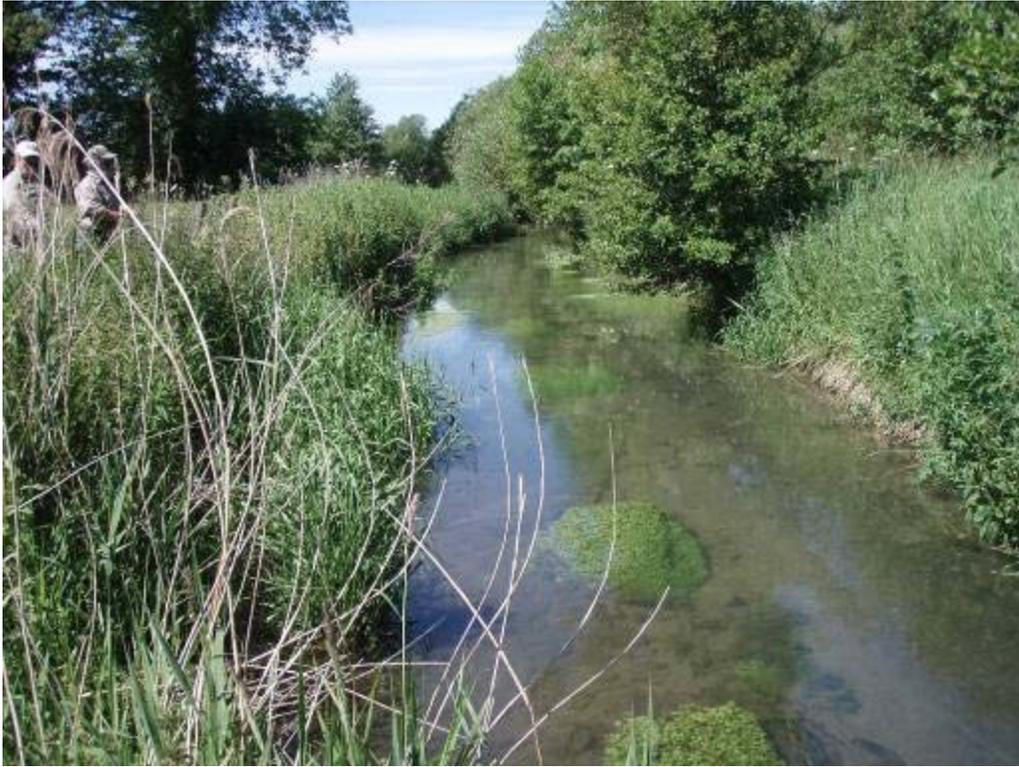
The bankside vegetation alongside the beck is very good, consisting of a dense fringe of reeds, rushes and grasses forming excellent low cover over the margins of the river. The left bank is fenced here alongside a wet meadow and the right bank is an Environment Agency depot.

Photo 3 Good riparian vegetation

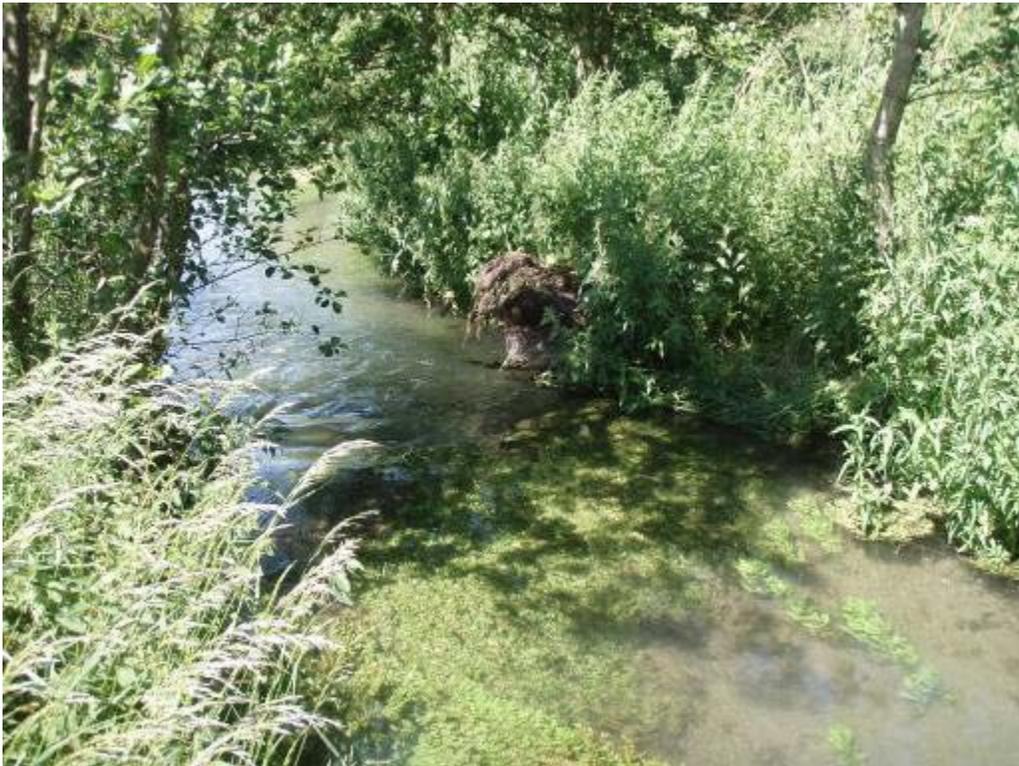
With progress downstream the silty nature of the river bed becomes less evident and some patches of gravel appear in narrower sections of the channel. Some in-stream habitat improvement work was carried out along this section in the 1990s by EA Fisheries Officer Sean McGinty; this includes in-stream structures to deflect flows, narrow the channel and provide marginal cover.

Photo 4 Some in-stream habitat works have been carried out

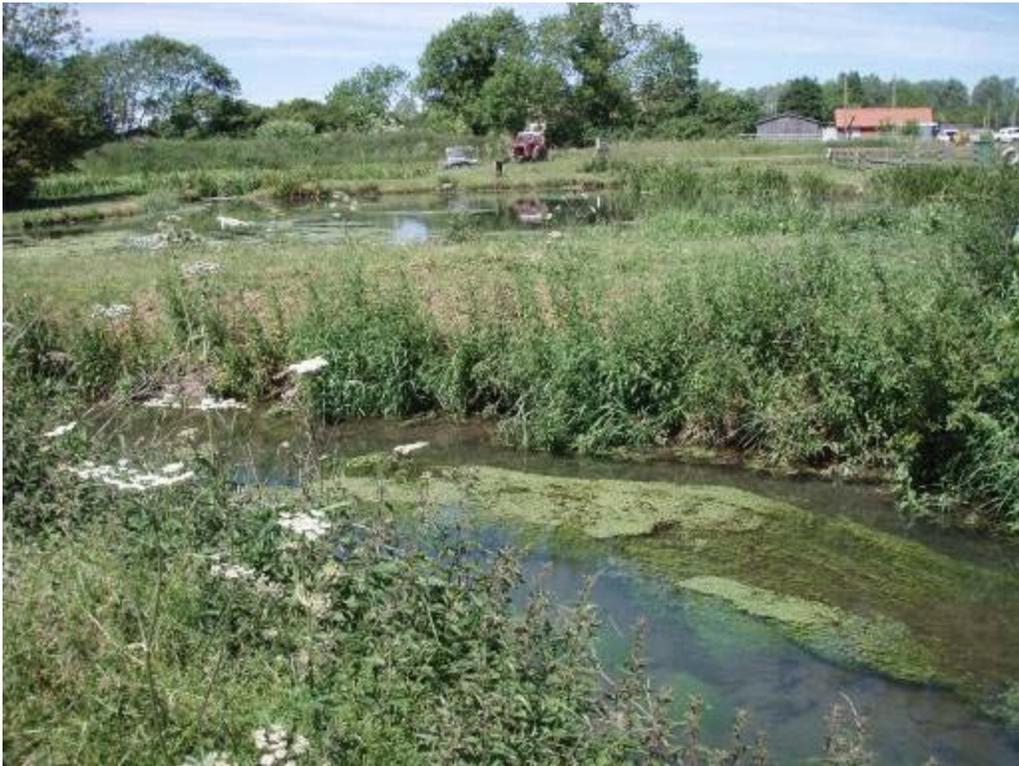
The Costa fish farm site sources its water from the Costa Beck then discharges to the Oxfolds Beck from the right bank. There are two rock groyne in the river here extending from the right bank which were introduced in conjunction with gravel along the left bank to create a fish spawning area. This has not worked as intended and a pool has scoured between the groyne and the gravel has dissipated; the pool is however providing a good holding area for adult trout and grayling. In addition to the above, a large submerged log has been positioned across the channel just upstream of this point.

Photo 5 The beck running alongside Costa fish farm

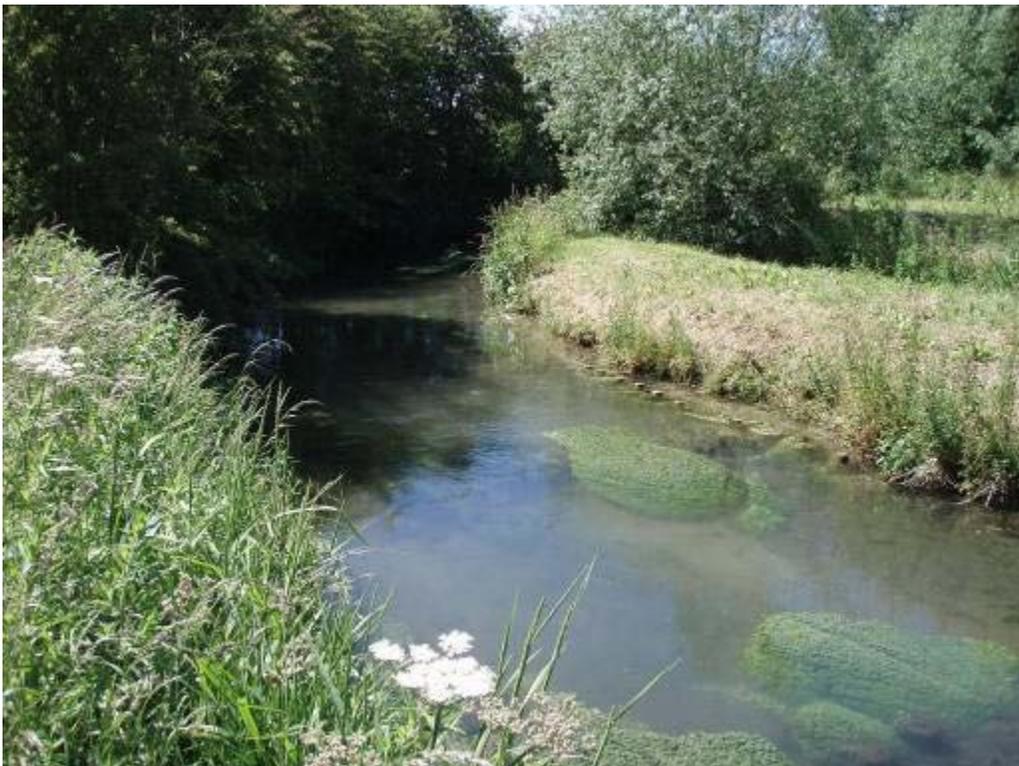
Downstream of the Oxfolds / Costa fish farm confluence the river is faster (increased gradient) with a gravel bed and less silt and more water crowfoot evident. Invertebrate monitoring by PFA (as part of the Riverfly Partnership Anglers' Monitoring Initiative) and Everall (2007) has however indicated organic enrichment at this site.

Photo 6 Just upstream of the confluence of the two channels

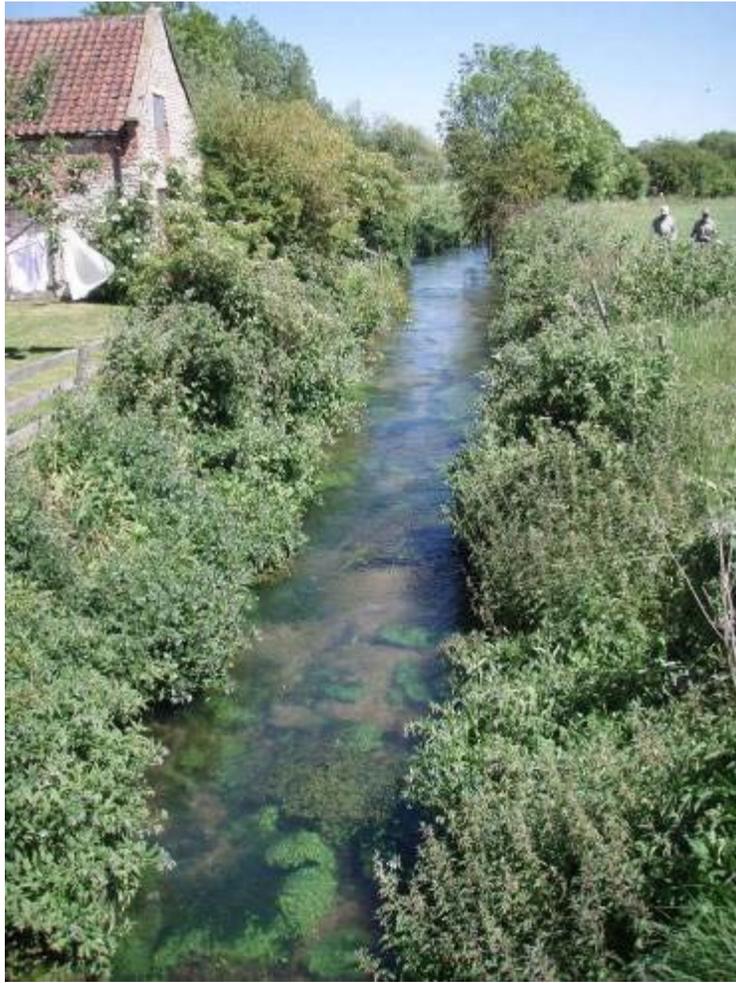
With downstream progress, past the holiday cottages on the right bank to the bridge where Costa Beck joins Oxfolds Beck, down to the Gatehouses flow gauging station, the river has a similar habitat. The channel is straight and the gradient appears slightly higher than other sections; some gravel is evident on the river bed (although this is generally unsorted and not

Photo 7 Alongside the holiday cottages

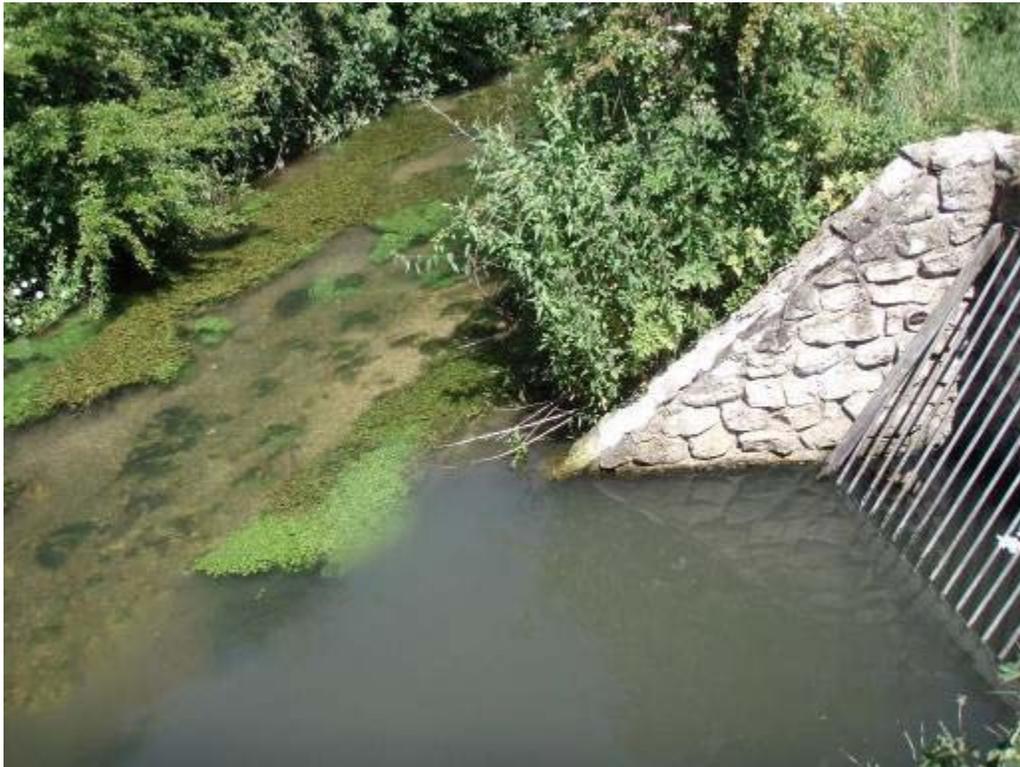
The Pickering sewage treatment works outfall enters the beck from the left bank a short distance upstream of the gauging station. At the time of the visit it was discharging highly coloured effluent despite the recent prolonged dry weather; this was reported as an incident to the Environment Agency hotline.

Photo 8 Sewage works discharge – highly coloured at the time of the visit

The primary consideration for this river is to take action to improve the water quality and prevent continuing polluting inputs. Habitat improvement works will make no difference to the quality of the fishery unless water quality issues are addressed first.

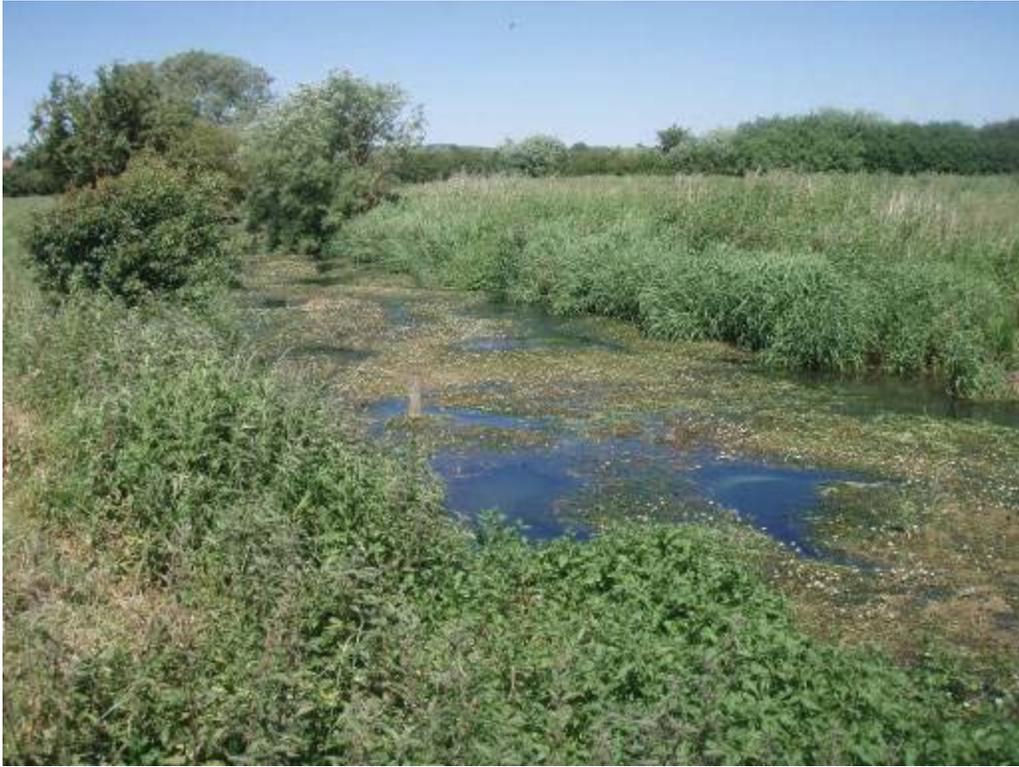
As mentioned in the previous section, the river downstream of the gauging station was dredged around 2001/02. The river here is canalised and has a relatively low gradient. At the time of the visit, submerged plant growth was prolific and holding up water levels.

Photo 9 Downstream of the gauging weir the dredged channel is heavily weeded

The river here has an over-widened channel and lower gradient which promotes the deposition of fine sediment; this in turn leads to prolific weed growth during the summer which chokes the channel. The uniform channel

here requires totally remodelling in order to improve in-stream habitat. The following steps are recommended:

- Channel narrowing to speed up the flow rates. This can be achieved using the methods described in the Chalkstream Habitat Manual (e.g. cut-and-fill to create a two-stage channel). River widths upstream of the gauging station can be used as a guide. (Figures 2,3; Photo 14)

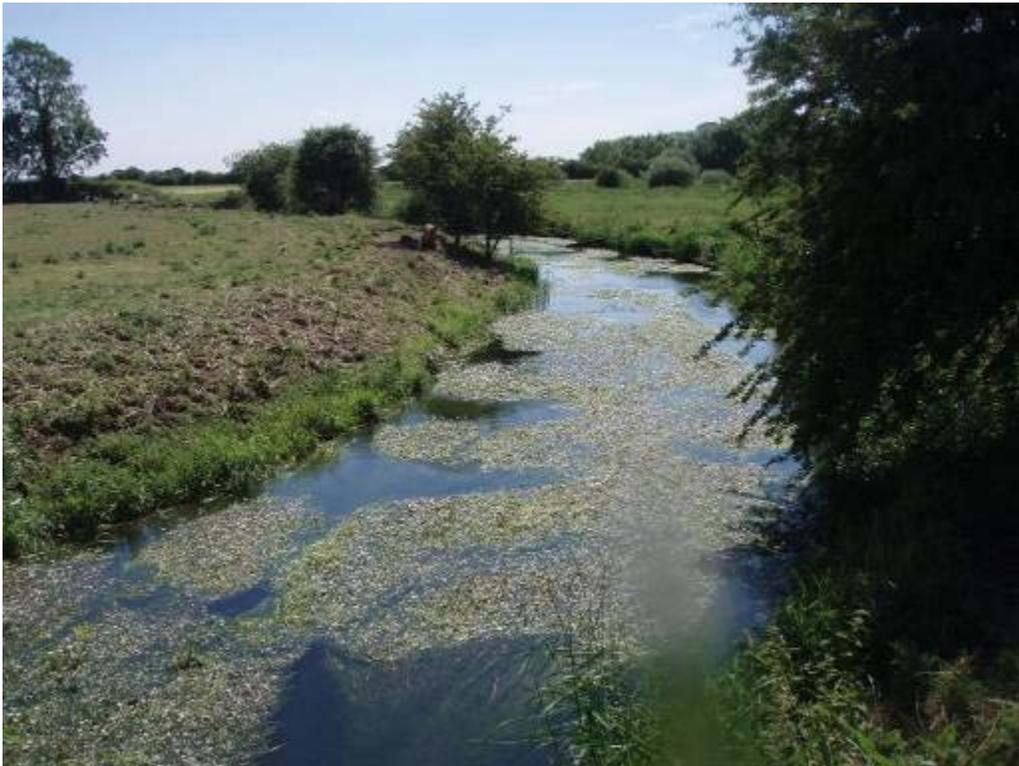
Photographs from Everall (2007) of the same section show the nature of the channel in early spring, without the plant growth. The channel is uniform with little variation in width and depth and has a trapezoidal cross-section. The bed is heavily silted and there is little in the way of cover for fish when submerged weed has died back. Grazing is taking place on both banks and bank poaching and loss of marginal vegetation has occurred in many places.

Photo 10 Livestock have unrestricted access to the banks

- Introduce large woody debris to the river channel to create cover for fish and depth variation through localised scour. This should be done in conjunction with channel remodelling to complement and reinforce those improvements.
- Limit the access of grazing animals to the river banks to encourage the development of a healthy vegetated river margin similar to the ones present on the upstream section of the Beck. Encourage the development of trees along the bank to provide more shade over the channel. Manage the very vigorous types of willow and introduce lower-growing, bushy species (sallows), ash, and alder.

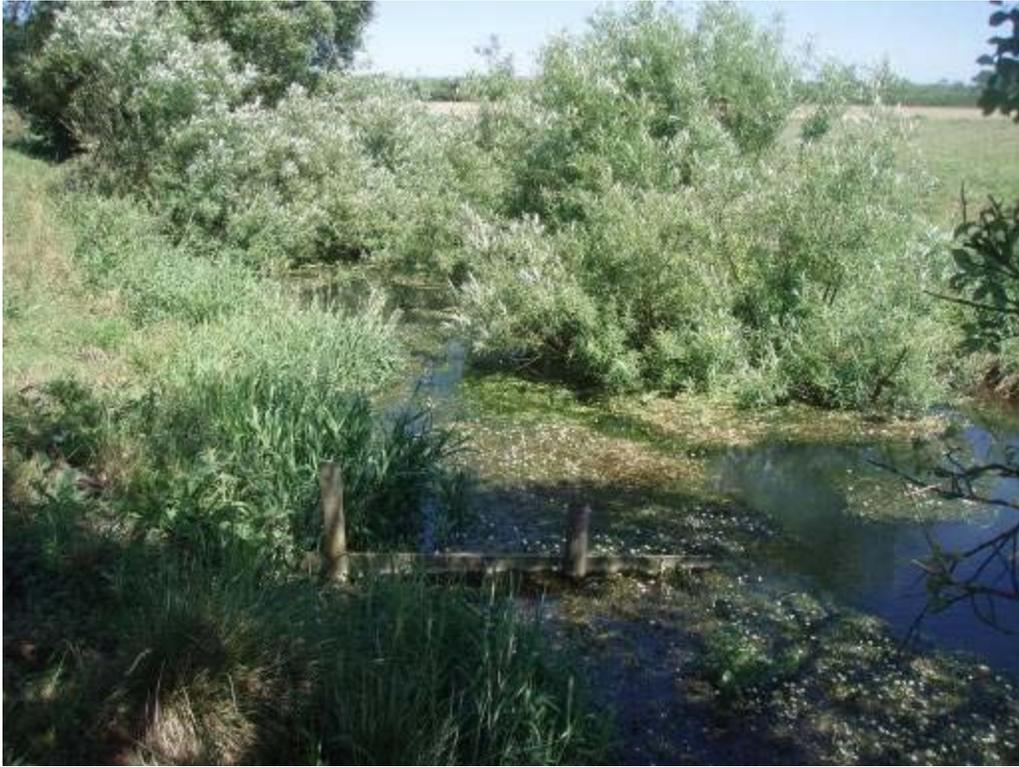
Trees and bushes present along this section include hawthorn and willow. The latter have grown out across the channel in some areas; this provides some good cover for fish, but these are vigorous species and some degree of management is likely to be required. Sallows (*Salix cinerea* and *S. caprea*), such as those seen further upstream, would be more suitable species in this location.

Photo 11 Vigorous willow growth may require management to maintain cover but allow angling access

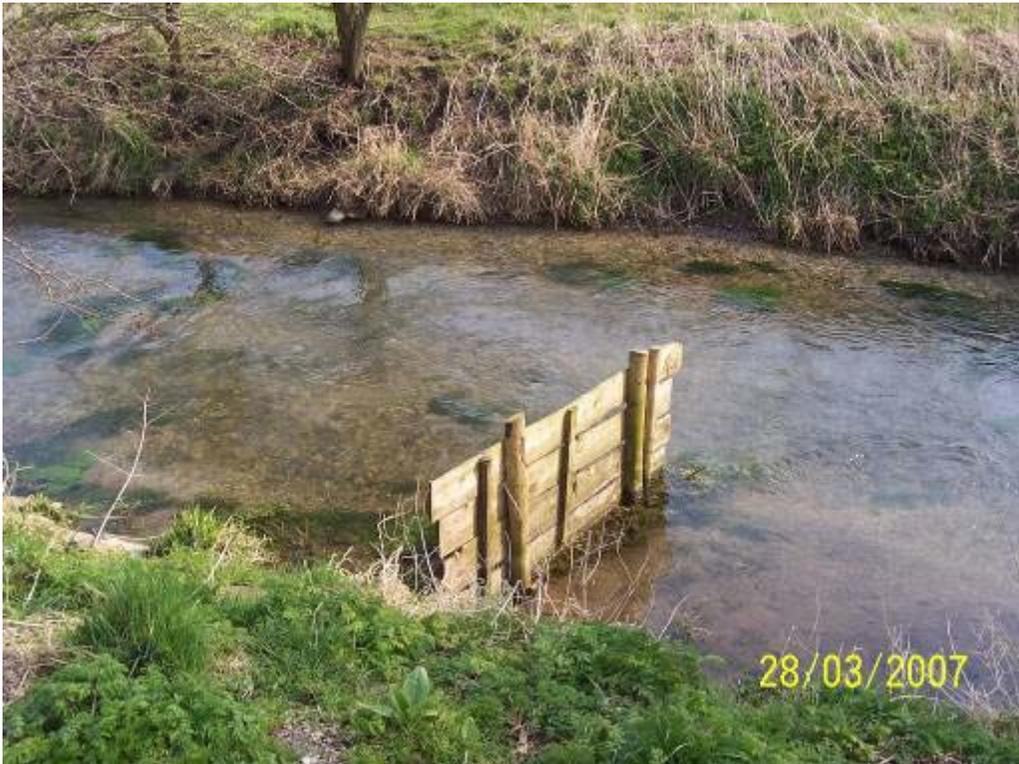
Wooden flow deflectors are positioned along this section at regular intervals. These have not had any discernable effect upon the river channel. Their effectiveness is hampered by the channel being too wide, the low gradient and the prolific weed growth backing up water levels. A much more radical approach is required to improving in-stream habitat along this section involving channel narrowing and remodelling to create variation in the depth profile.

Photo 12 (Everall, 2007) Flow deflectors are ineffective in this overwide channel

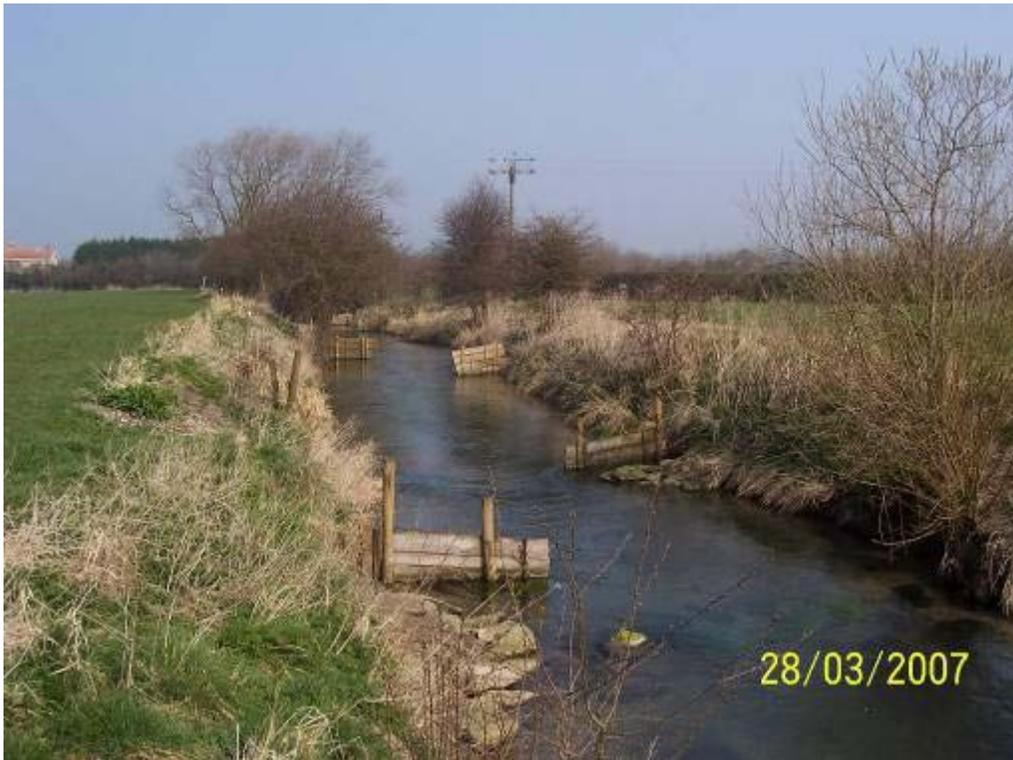
Photo 13 (Everall, 2007) Showing the nature of the channel and deflector positions in the absence of prolific weed growth
