Project Proposal
River Peffrey, Ross and Cromarty
March 2011

This report is the output of a site visit undertaken by Tim Jacklin of the Wild Trout Trust to the River Peffrey on 24-25th March, 2011. Comments in this report are based on observations on the days of the site visit and discussions with Simon McKelvey (Director, Cromarty Firth Fisheries Trust and Conon District Salmon Fisheries Board), Marcus Walters (Moray Firth Sea Trout Project Officer) and Merryl Norris (British Trust for Conservation Volunteers).

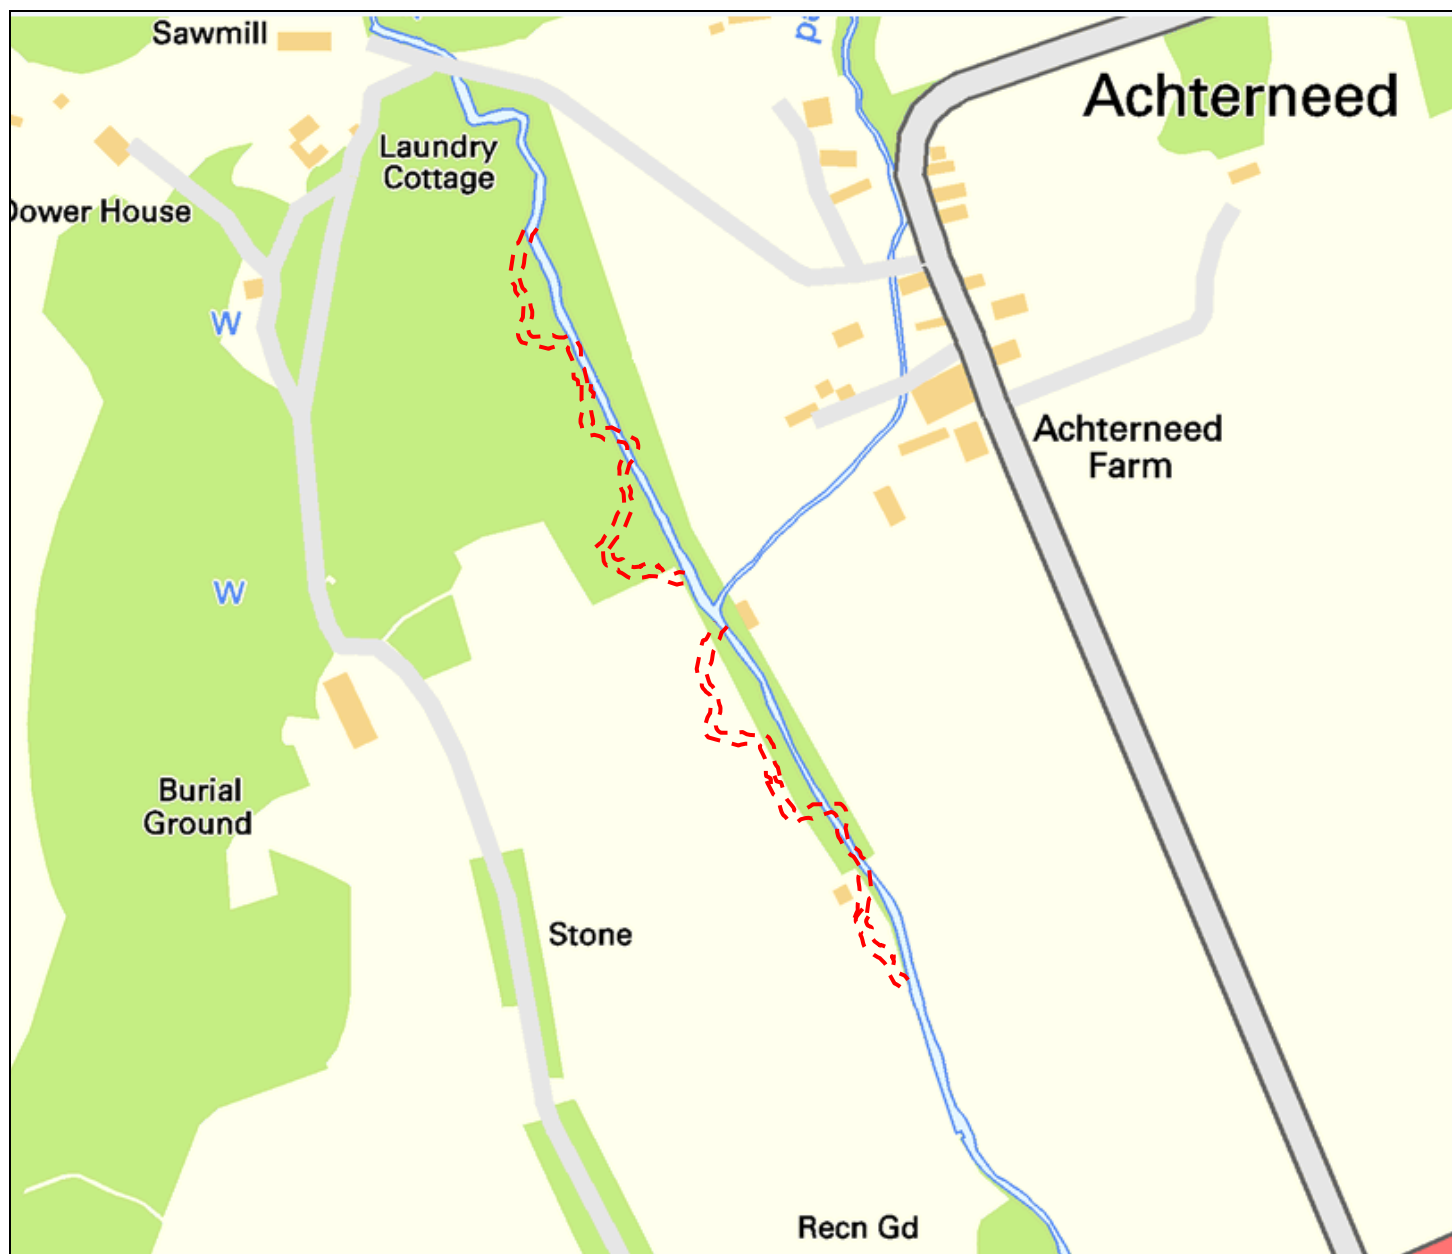
Figure 1 Indication of potential areas for re-naturalising the river channel – for illustrative purposes only. Not to scale.

The RHB upstream of the A834 road is wooded and provides some scope for re-alignment of the river channel and re-modelling of the plan-form (to introduce some sinuosity) over approximately 400 m, without affecting the arable land on the LHB (Photo 1). A project to achieve this would require a survey of levels and design by a fluvial geomorphologist, plus landowner consent. The table below gives an approximate indication of costs of such an option:

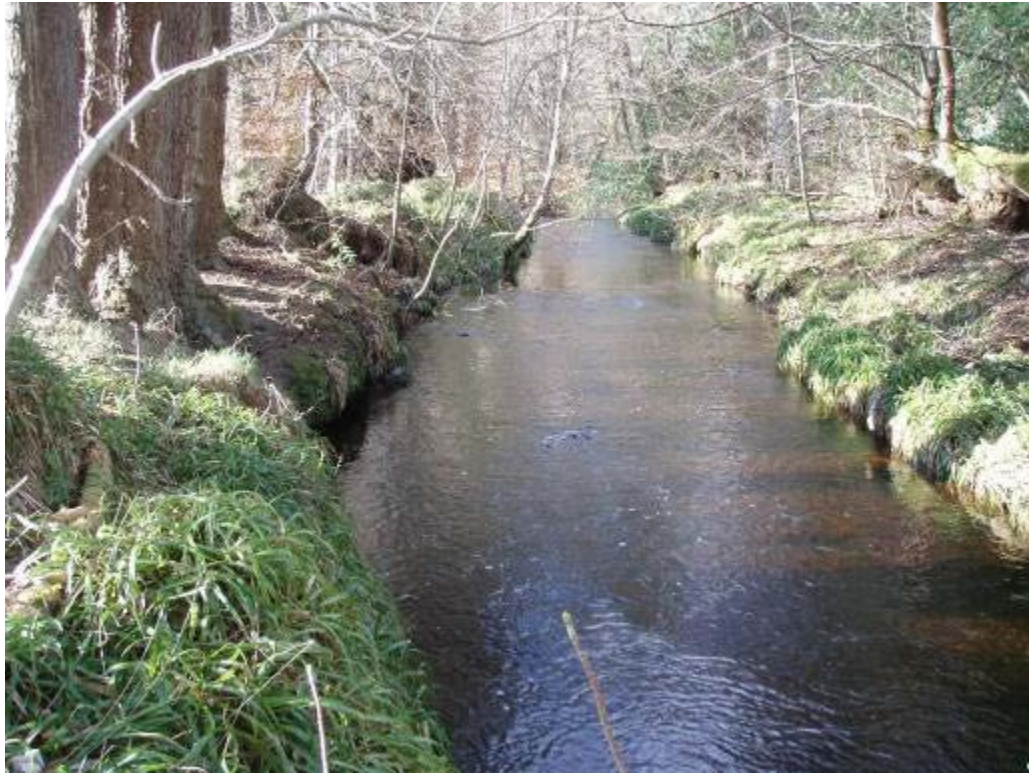
Photo 1 Wooded section of river downstream of the saw mill

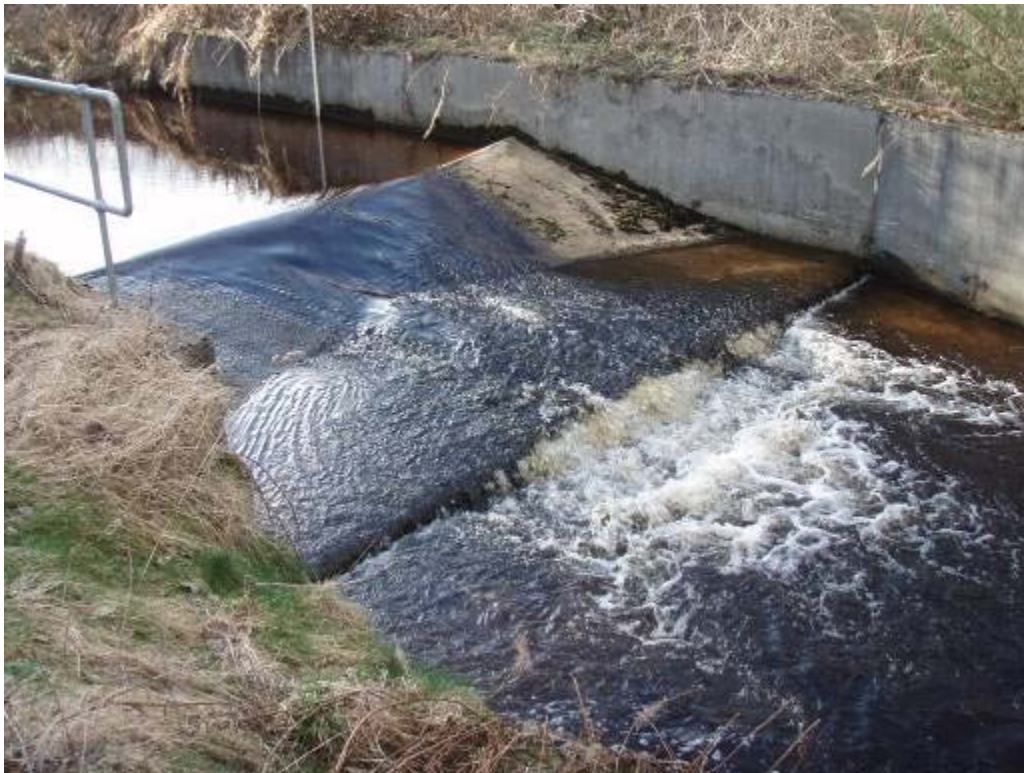
- Improvement of the flat-V gauging station weir for fish passage (Photo 2). This issue was identified in the WTT (2009) report and is being addressed by CFFT, SEPA and Scottish Water (owners of the structure) by building a pre-barrage to raise downstream water levels and drown out the lip which has formed. Further improvement may be possible using Hurn-type baffles or re-designing the gauge according to new ISO (26906:2009) and British Standard designs for compound gauging and fish pass structures. Further details can be found in the Environment Agency Fish Pass Manual³ (pages 147 and 216 respectively).

Photo 2 Gauging weir – currently an obstacle to fish migration

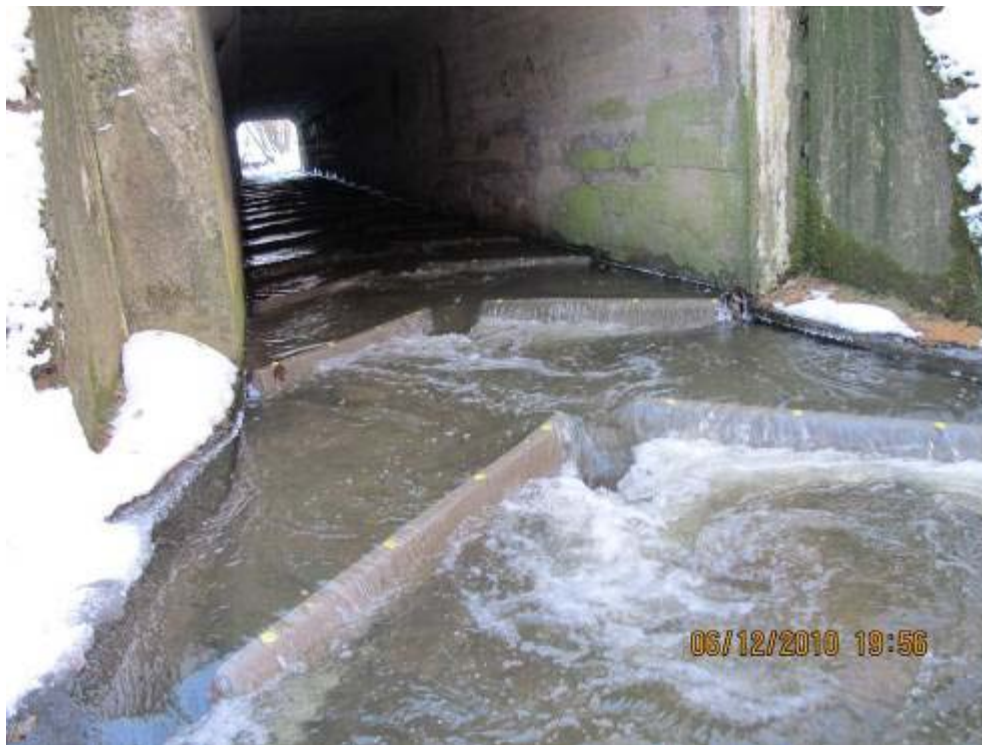
Photo 3 220-mm concrete kerbs thru-bolted to the bed of a culvert to ease fish passage (River Wear tributary, Co. Durham; Photo: Lloyd Atkinson).

- Improvement of fish passage through the culvert under the sewage treatment works track. A lip has developed at the upstream end of the culvert here. Simple baffles fixed to the base of the culvert as described in the WTT (2009) report¹ would be appropriate here. An example of a similar project on a tributary of the River Wear is illustrated below (Photo 3).

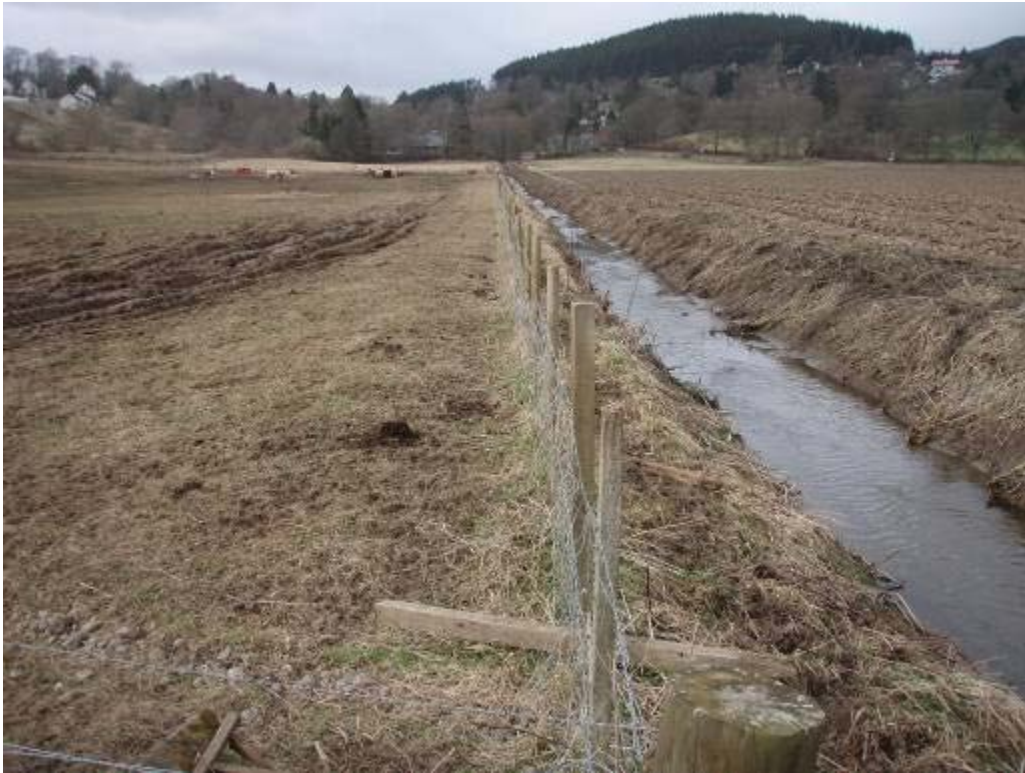
- The ditch entering the river on the RHB immediately upstream of the above culvert is an obvious source of fine sediment (Photo 4) which needs to be addressed. The ditch has been recently cleared out and has arable and livestock agriculture on each bank which is the most likely source of the sediment.

Photo 4 Tributary burn which is a source of fine sediment to the river

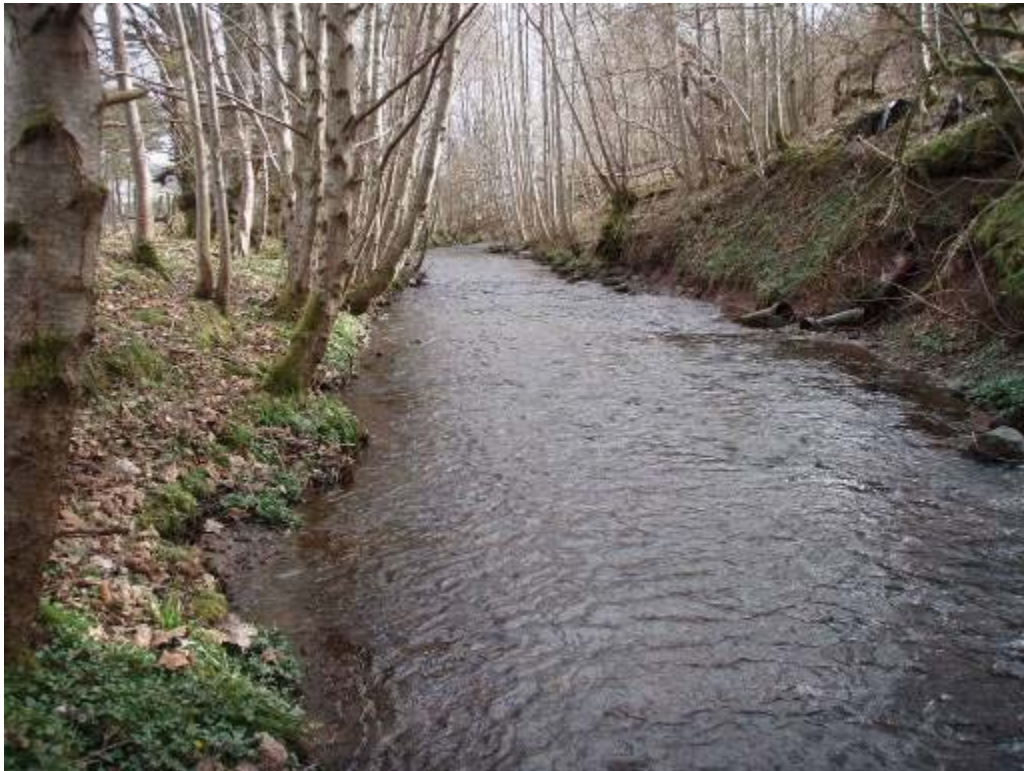
Photo 5

This 700-m (approx.) section has a straight channel with a steeper gradient than the section upstream of the sewage works and a raised embankment on the LHB; the right bank is the steep-sided valley edge. Predominantly this reach is shallow and lack depth variation (Photo 5), although there is some reasonable in-stream habitat, particularly where fallen trees have lodged in the channel creating bed and bank scour.

This section lends itself to the introduction of large woody debris (LWD) because it is in a deep channel and flood risk is therefore low. Cross-channel logs (Appendix 2) plus some less formal structures, such as trees “hinged” into the watercourse would be appropriate here. Twenty in-stream structures could be included in this section, spaced 7 channel width apart.

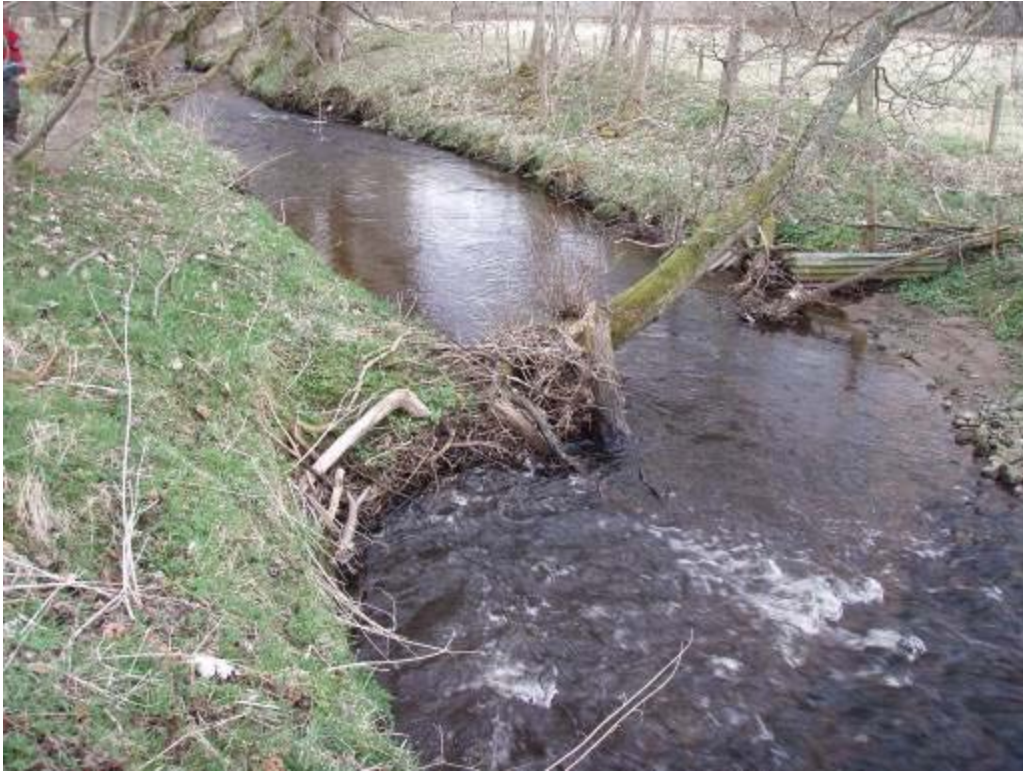
Photo 6 A tree and its root mass has created some flow and depth variation here – good habitat and a good template for the dimensions of introduced structures.

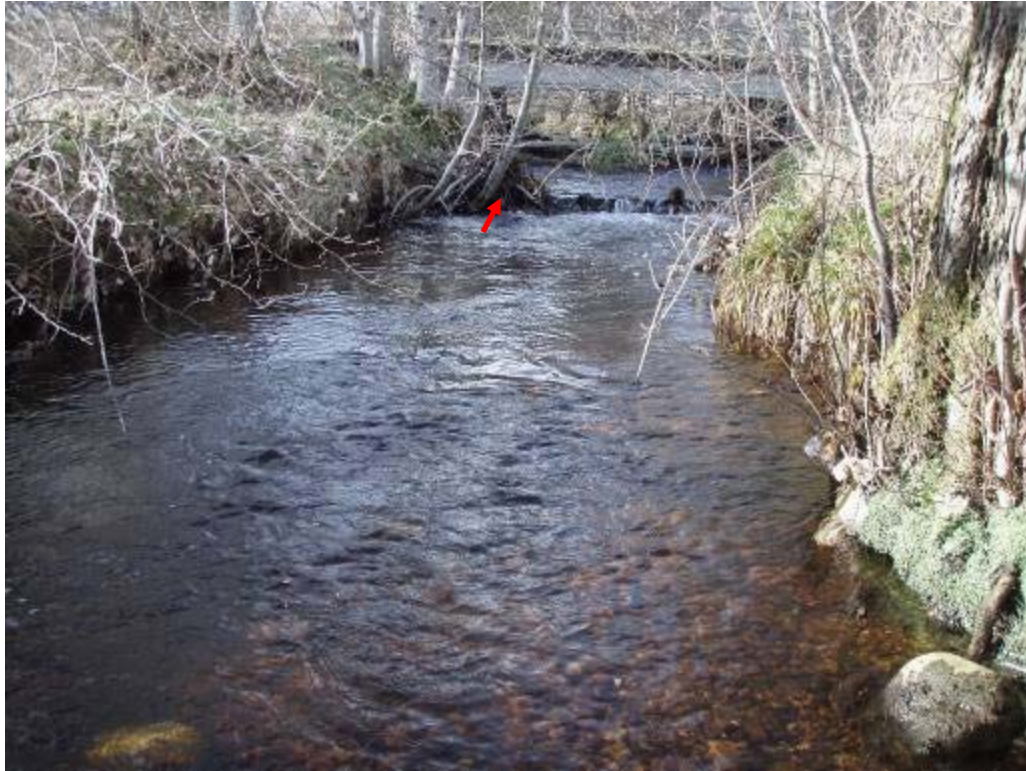
A good natural example was seen on the Peffrey just downstream of the A834 road bridge (above the sewage treatment works) – Photo 7.

Photo 7 Natural cross-channel log creating downstream scour pool and sorted gravel ramp. Note the tree/debris accumulation acting as a “raised end” on the downstream end of the log (arrow).
