Plumpton Mill Stream. Plumpton College

Advisory Visit April 2017

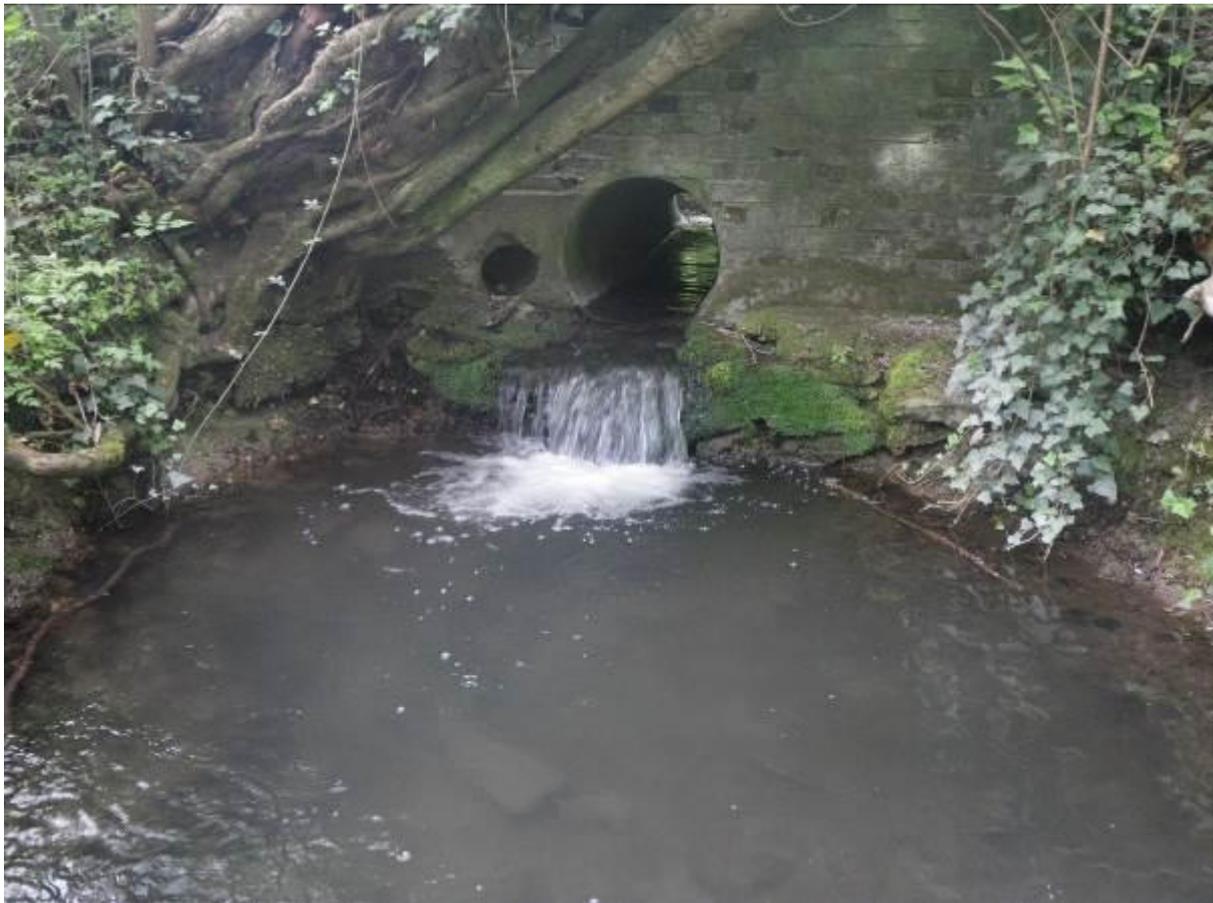
At the upstream boundary the stream flows through a culvert under Streat Lane (cover photo). No assessment of the quality or extent of any fish habitat was made upstream of this road culvert. It is possible that large trout might be able to migrate up and through this culvert under a certain flow conditions. Access under low flow conditions would be problematic, as would any access during high flows, when water velocities emanating from the culvert would be too fast to facilitate free passage. The structure should therefore be classified as an obstruction to free fish migration and dispersal.

A simple easement to improve fish passage opportunities at this site could be implemented. The cost versus benefit of improving fish passage at this location will depend on the extent of habitat availability found upstream of Streat Lane and resolving migration issues downstream.

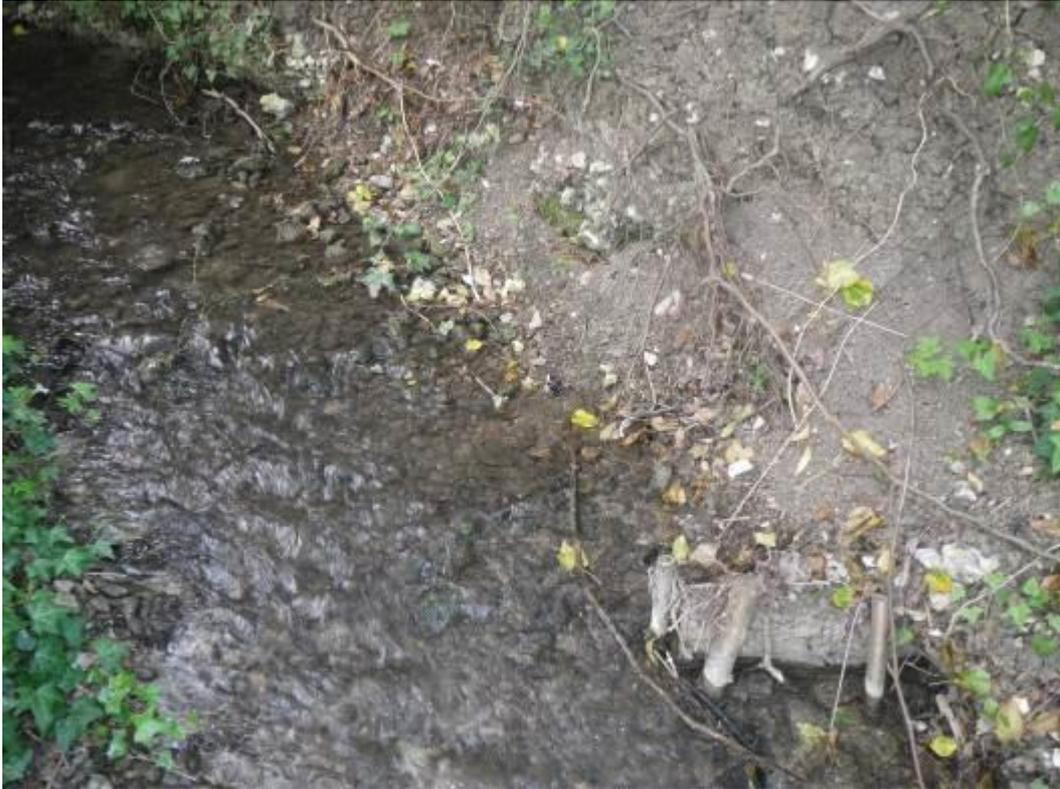
Downstream of the bridge the stream flows in a generally straight channel, which looks to be have been re-aligned, possibly to act as a field boundary or to resolve land management issues. Habitat quality within the channel itself was generally considered to be reasonable, with evidence of occasional shallow pool, riffles and glides, flowing over a comparatively gravel-rich bed. (photo 1).

Some efforts have been made during college tutorials to introduce stub flow deflectors (photo 1) in the hope of creating a more diverse shape to the river bed. For the flow deflectors to be effective, they need to be larger and combined with efforts to loosen the crust of the stream bed, which in many places is heavily armoured with compacted cobbles.

Photo 1. Long sections of the bed and toe of the bank are gravel rich. Note the stub deflector designed to promote bed scour. These need to be considerably larger to be effective.

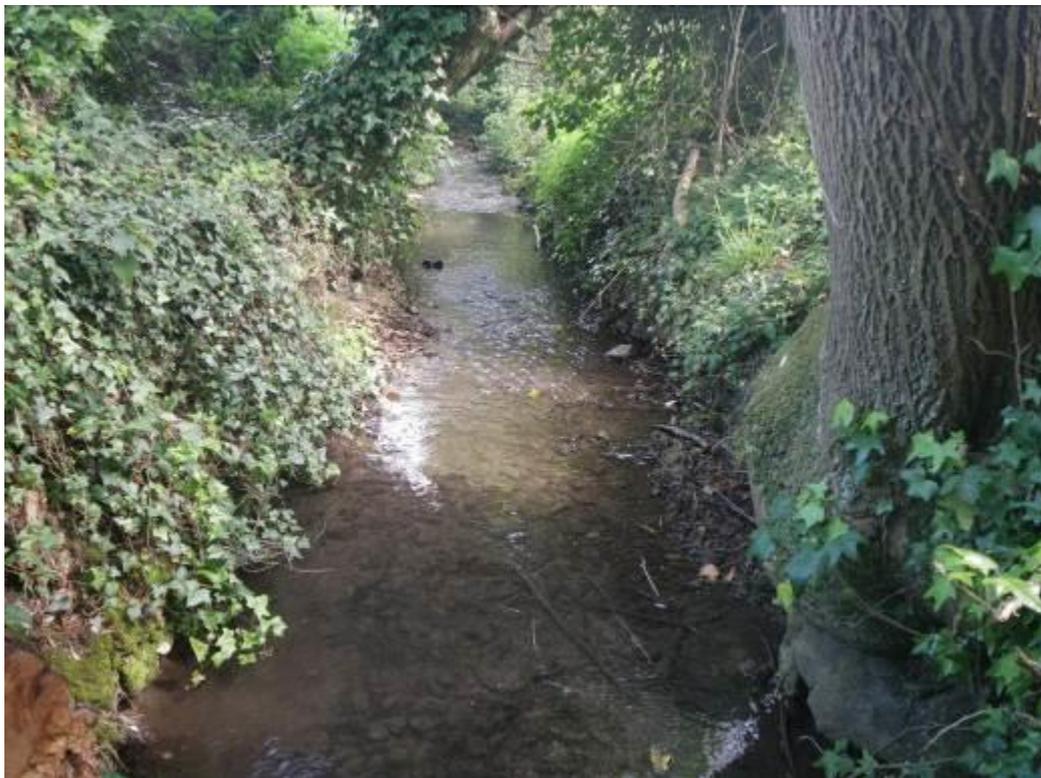
The channel is sandwiched between arable fields but receives some protection via a narrow buffer zone comprised of mature trees (photo 2), as well as a belt of scrub. The banks are steep and the channel is deeply incised, which is a natural characteristic of many Sussex streams. Overall, this section of channel should provide good spawning and nursery opportunities for trout; however, the reach could be improved through the development of additional deeper pool habitat, capable of holding adult fish.

Photo 2. The channel is lined with mature trees and a narrow buffer zone. Note the riffle/glide sequence and dappled light v shade regime.

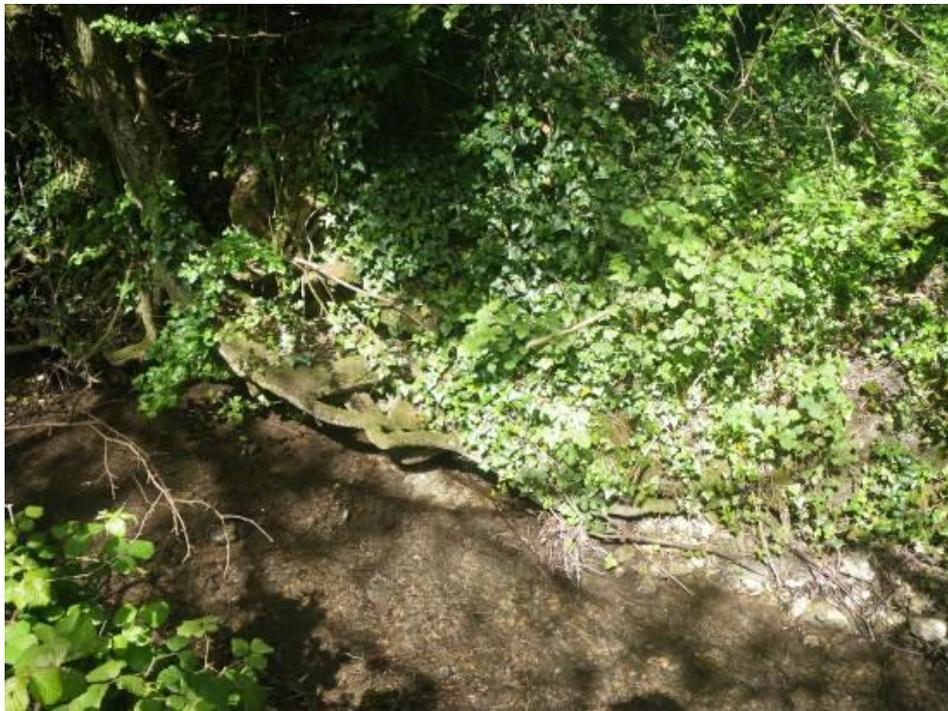
It was apparent that although there was plenty of high-level shade, there was little low-level or trailing in-channel cover from fallen woody material (photo 3). Whether or not the stream has been subjected to a tidy-up or fallen material has been flushed out is not known. The primary food and cover for invertebrates from fallen woody material is critically important, as is the cover provided for small fish. Introducing more woody material either as cover logs, or brushwood shelves would help to reduce predation pressures and ensure that fish take up residence, rather than migrating downstream in search of cover.

Photo 3. The introduction of brushwood via tree hinging would create much improved opportunities for invertebrates and fish.

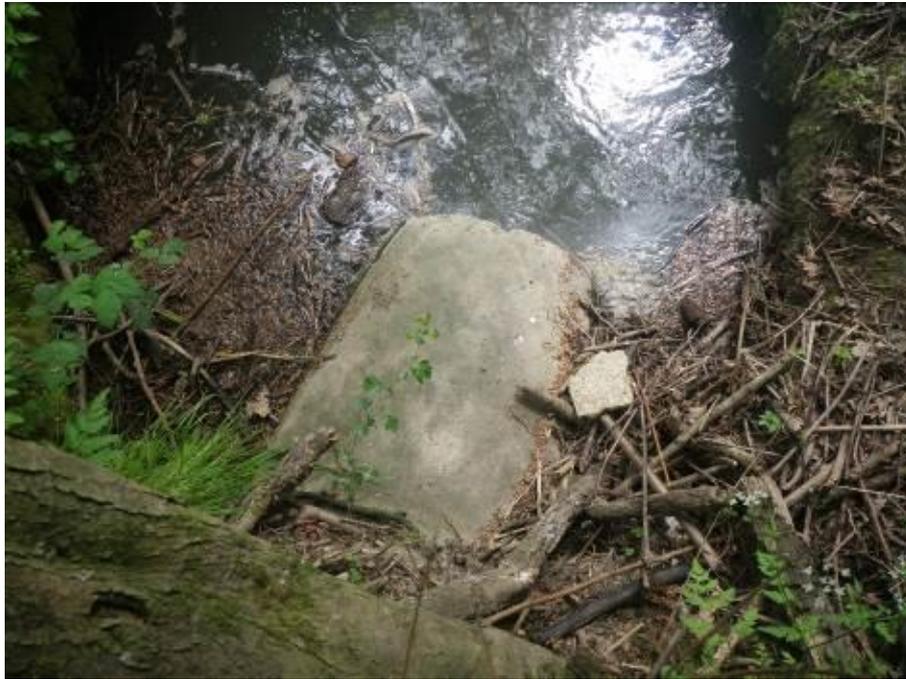
Photo 4. Culverts tubes create huge problems for wildlife.

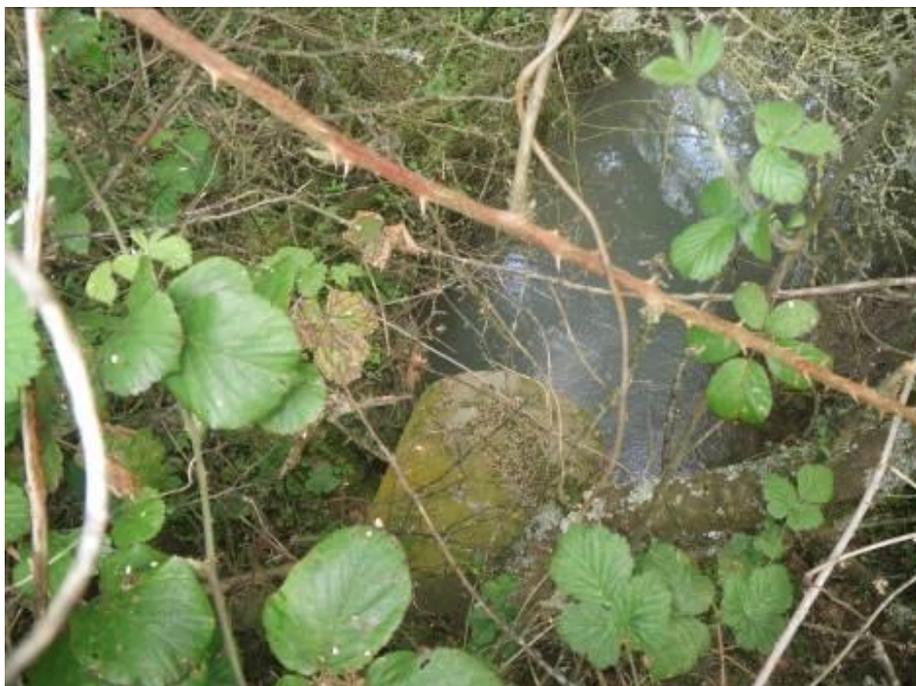
At two separate locations downstream the stream is forced through culverts Photo 5 and 6 to facilitate access for farm machinery. These stream crossings are considered to be of poor design and condition. Although not clear from the photos, the culvert tubes were perched and represent a huge problem for fish migration. Culverts like this are also problematic for eel migration and difficult for mammals such as water vole. Standard best practice for culverts is that they should be designed to be one third over-capacity, with that third sunken below the bed of the watercourse. This allows a natural bed to form within the culvert, improving habitat, assisting fish and sediment movement through the structure and preventing the structure from becoming perched over time. In addition to the environmental problems associated with the structures themselves, the

Photo 5 shows the downstream side of the culvert. The culvert was not sunk into the bed when installed and has now perched above the downstream water levels creating a block for any fish migration.

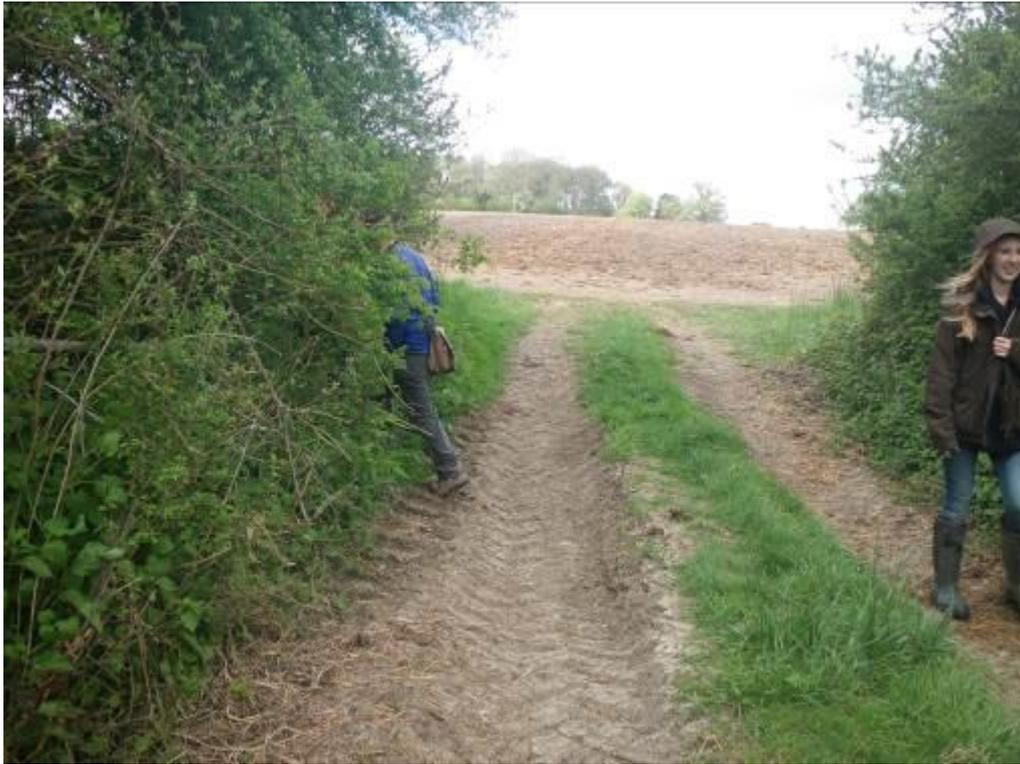
location of the crossings provide a direct pathway for nutrient-rich sediments to run-off the adjacent sloping arable field and bypass any protection given by the narrow field margins (photo 7). This is considered to be poor practice and a major issue for the health of the watercourse.

Photo 6. The culvert runs beneath the track which acts as direct pathway for diffuse pollutants running off the field during heavy rainfall events.

agricultural pollution this stream will not reach its full potential. Wider field margins are required and sediment pathways must be intercepted to increase ground infiltration, rather than surface water run-off. This will require space and possibly more tree planting on slopes and contours, as well as diversion of over-land flow pathways using bunds and soakaways.
