**Advisory Visit**

**Rea Brook, near Shrewsbury**

**November 2015**

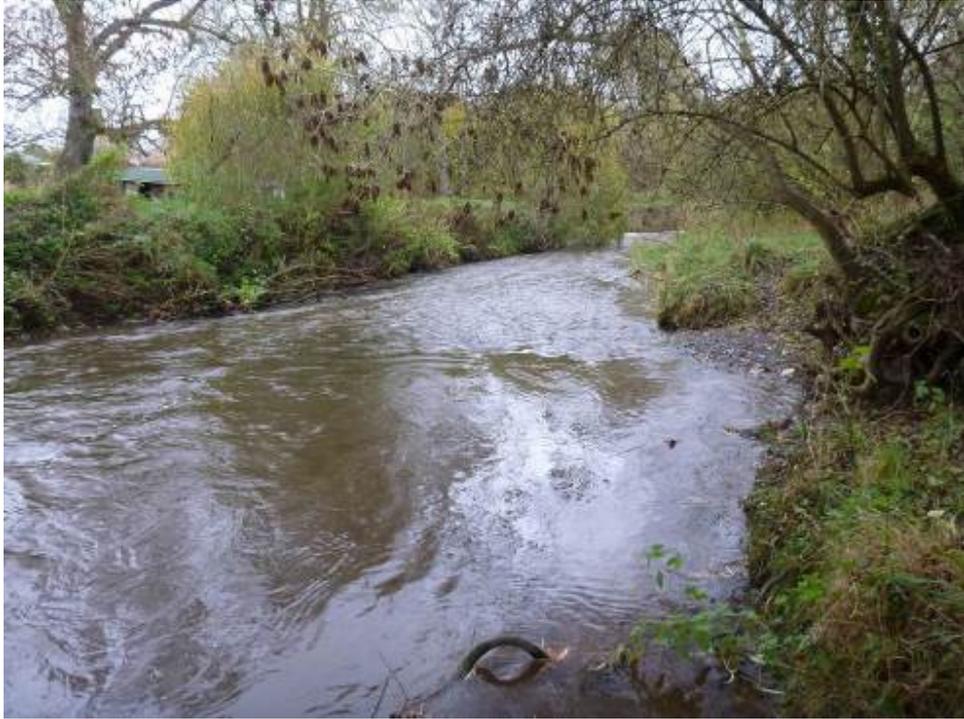
The river was walked in a downstream direction from Hanwood. Alongside the village of Hanwood, the river is bordered on the LHB by houses and gardens and on the RHB by pasture and woodland. The general physical habitat of the river is reasonably good with a meandering plan-form and a pool-riffle sequence (Photo 1). Gravel is present which is of a suitable size for successful trout spawning (Photo 2) and a recent electric fishing survey on a riffle area near the upstream end of this reach produced good numbers of juvenile trout (David Carrington, pers.comm.).

**Photo 1** Good river morphology at the upstream end of the reach – meandering plan-form and a pool-riffle sequence.

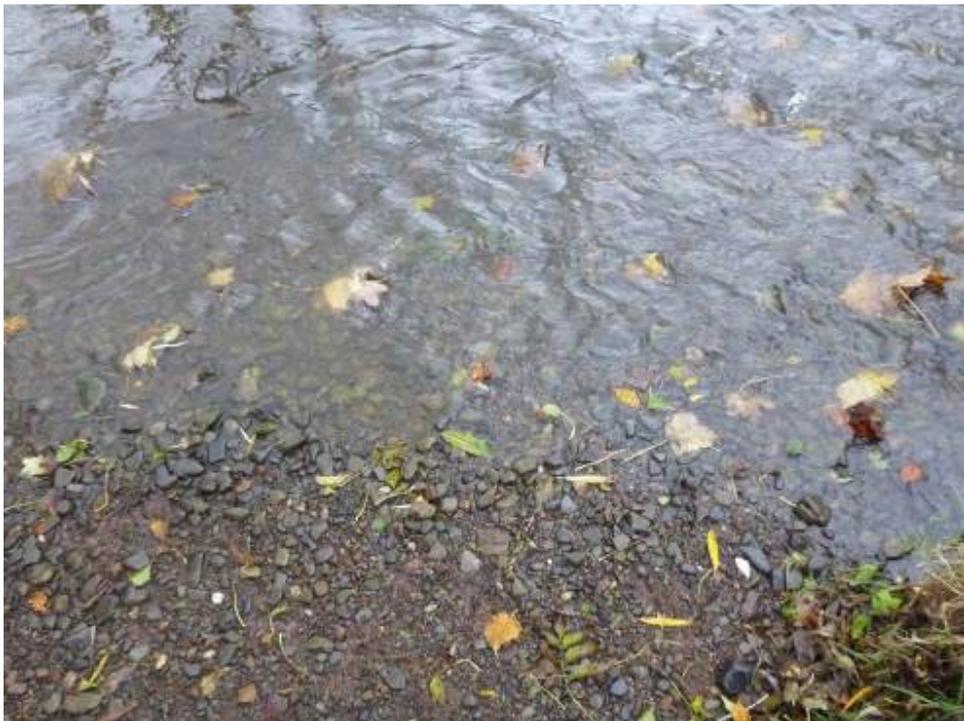
**Photo 2** Gravel suitable for riverine fish (trout, chub, dace) spawning is present on the riffles.

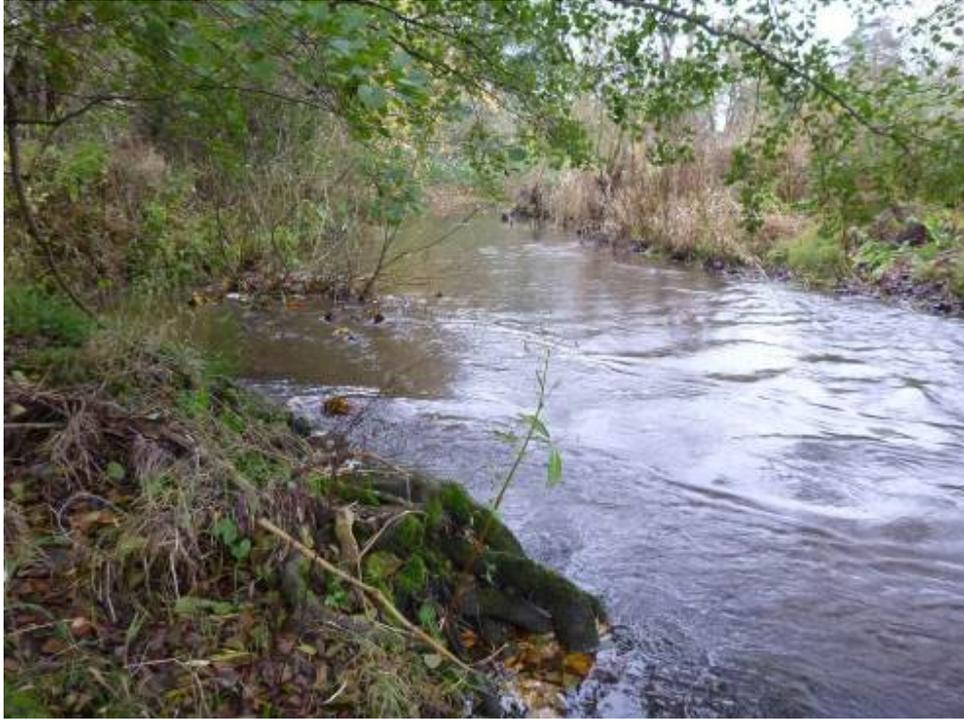
submerged branches and root structures (Photo 3). This is extremely important habitat for fish as it provides refuge areas from predators. Cormorants have been observed on the brook and during the visit, goosanders were seen and otter spraints were found. Having dense cover within the water, which persists throughout the winter, greatly increases the survival rates of fish, particularly young-of-the-year trout. Such cover can be enhanced by partially cutting and laying bankside trees and bushes into the river margins (Photo 4) and by installing brushwood into the margins (see Recommendations).

**Photo 3** Tree roots, overhanging and partially submerged vegetation and shaggy marginal vegetation – all great habitat which should be retained.

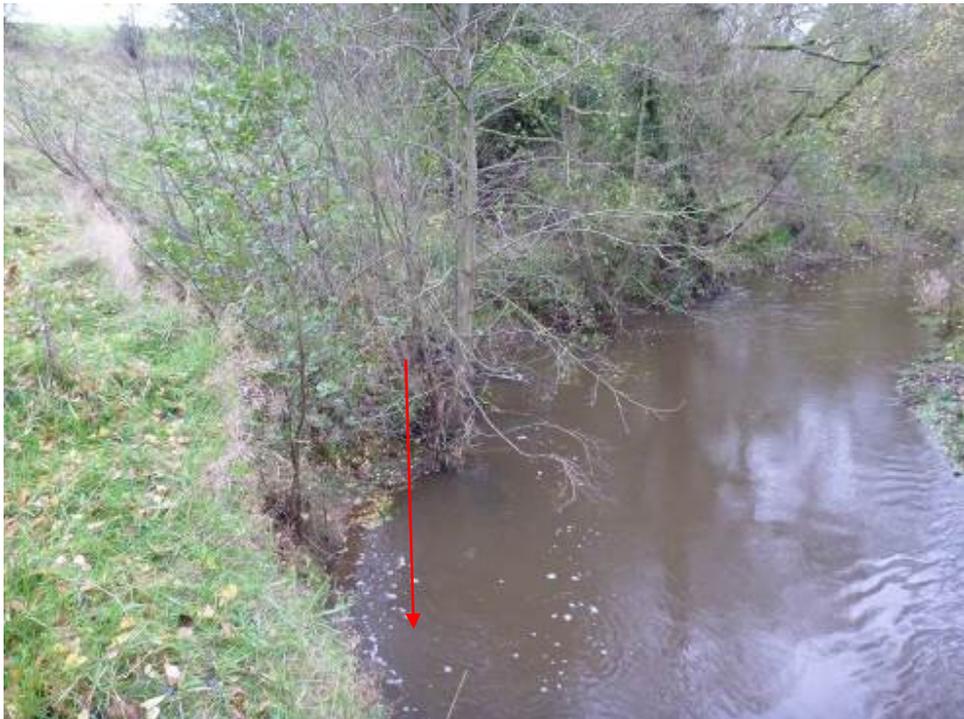
**Photo 4** Example of trees on the true RHB (left of picture) suitable for hinging and laying to improve cover for fish.

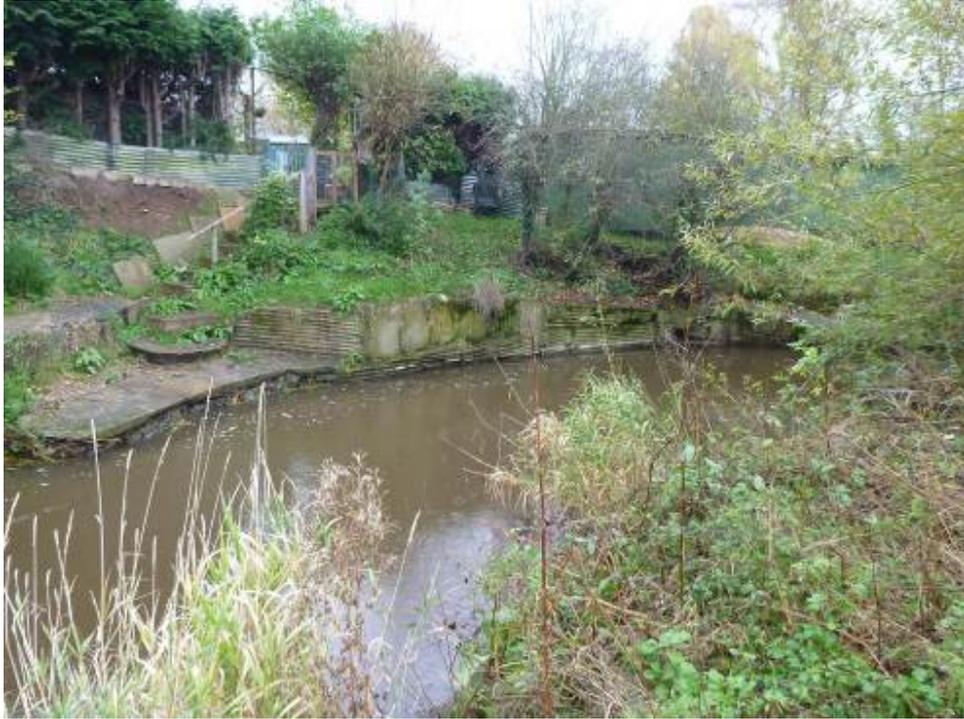
Where the gardens of properties border the river on the LHB, there are generally fewer trees and bushes and less valuable cover. Hard bank revetments are present in a number of locations, which is not good marginal habitat for fish, but changing this would be difficult given the multiple residential ownerships involved (Photo 5). Several examples of garden waste (grass and hedge clippings, soil and rubble) being tipped from gardens onto the LHB were observed (Photo 6). Distribution of an EA warning letter to riparian properties in Hanwood could deter this practice.

**Photo 5 Hard revetment on LHB**

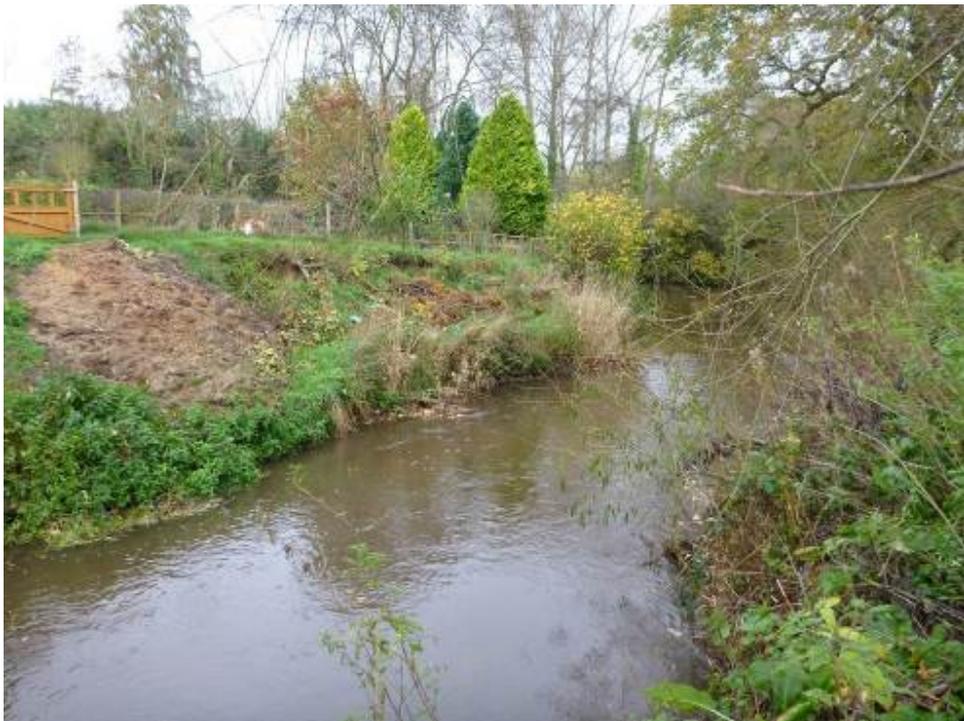
**Photo 6 Tipping of garden waste on the LHB**

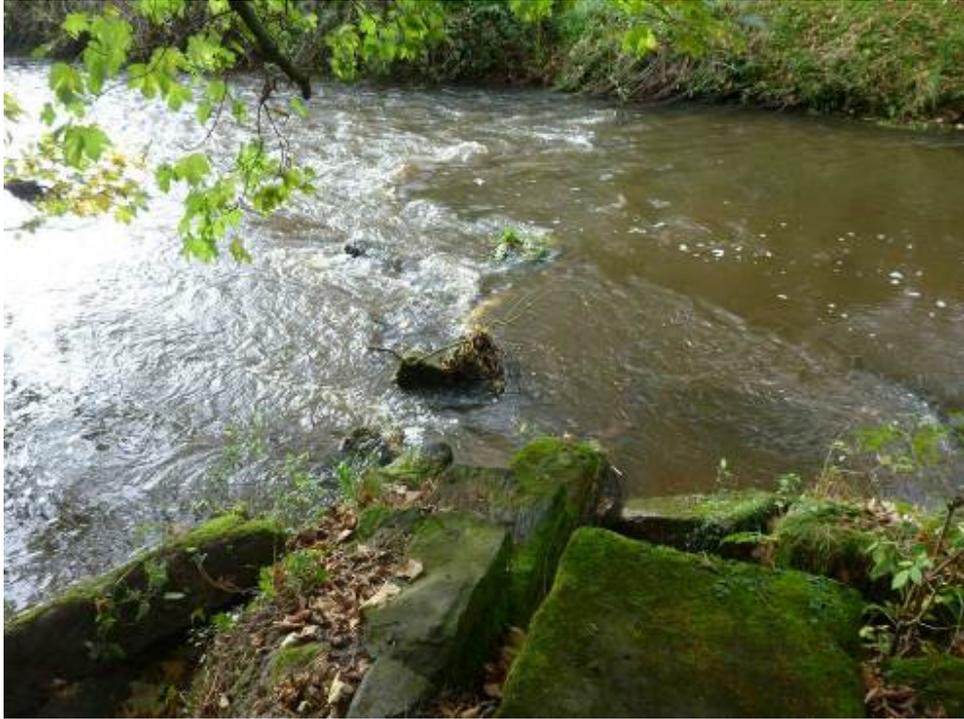
Below the downstream railway bridge, the river enters an area with deciduous woodland on the LHB and grazing on the RHB. At SJ 45869 09644 there are the remains of an old weir (Photo 7), reputedly built with stone removed from Shrewsbury Abbey, which used to divert water down a leat on the LHB to a mill at Hook-a-Gate. The remains of the leat can be seen in the woodland as an overgrown ditch. Only the side walls of the weir remain, the main structure having been removed in the first half of the C20th (Max Canham, pers. comm.). A small bay caused by former bank scour remains on the LHB, although this is gradually silting up. There is no remaining upstream impoundment from the structure (Photo 8).

**Photo 7 Former weir structure.**

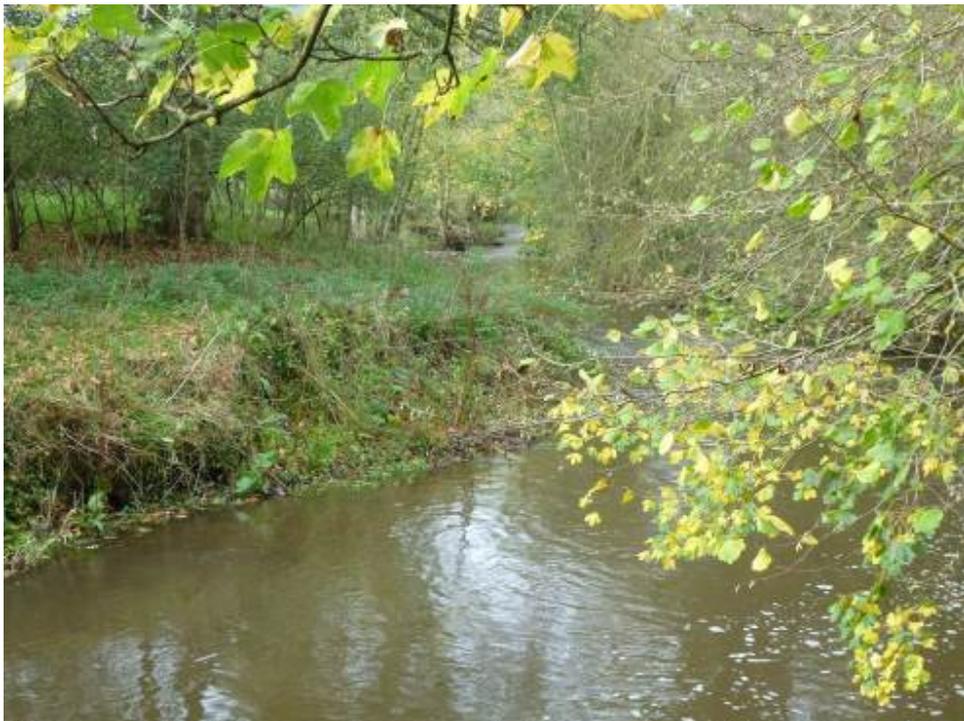
**Photo 8 Good habitat upstream of the former weir.**

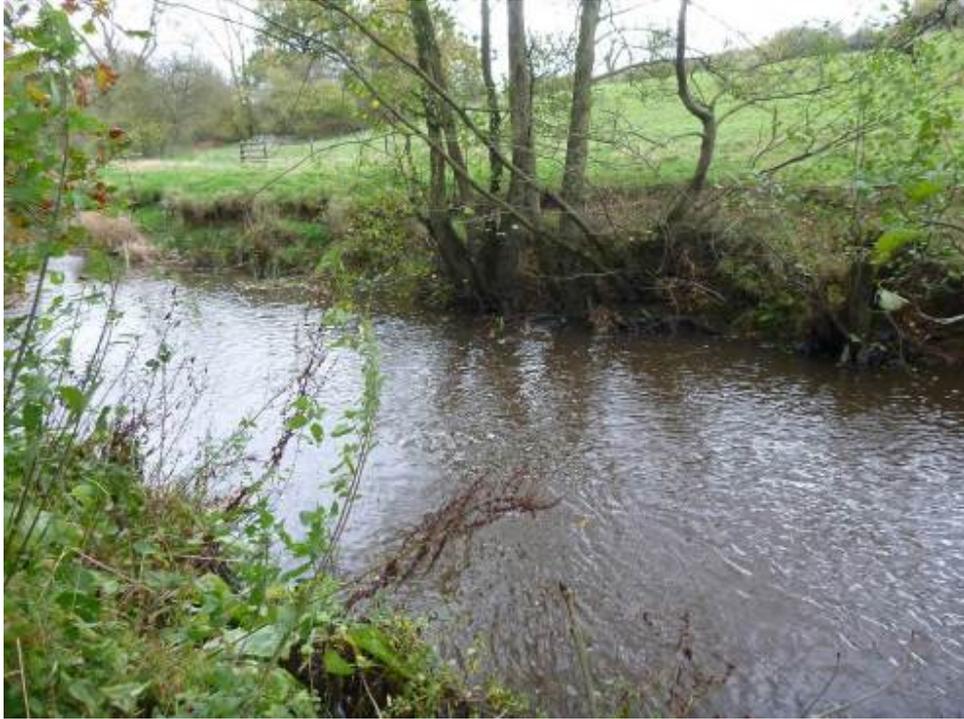
The RHB here is relatively exposed and shows signs of moderate rates of erosion. There are some alders displaying signs of disease (*Phytophthora* sp.) which would benefit from coppicing before they are lost entirely (Photos 9, 10). There are also some smaller trees which could be hinged to provide low cover over the water. Establishing more bankside trees would benefit the habitat and bank stability in this location. A brushwood revetment at the toe of the bank, incorporating live willow would help to kick start this process. Managing grazing pressure with fencing would be required to establish a broader strip of riparian trees.

**Photo 9 Stand of alders affected by disease. These could be coppiced to preserve the root ball within the bank.**

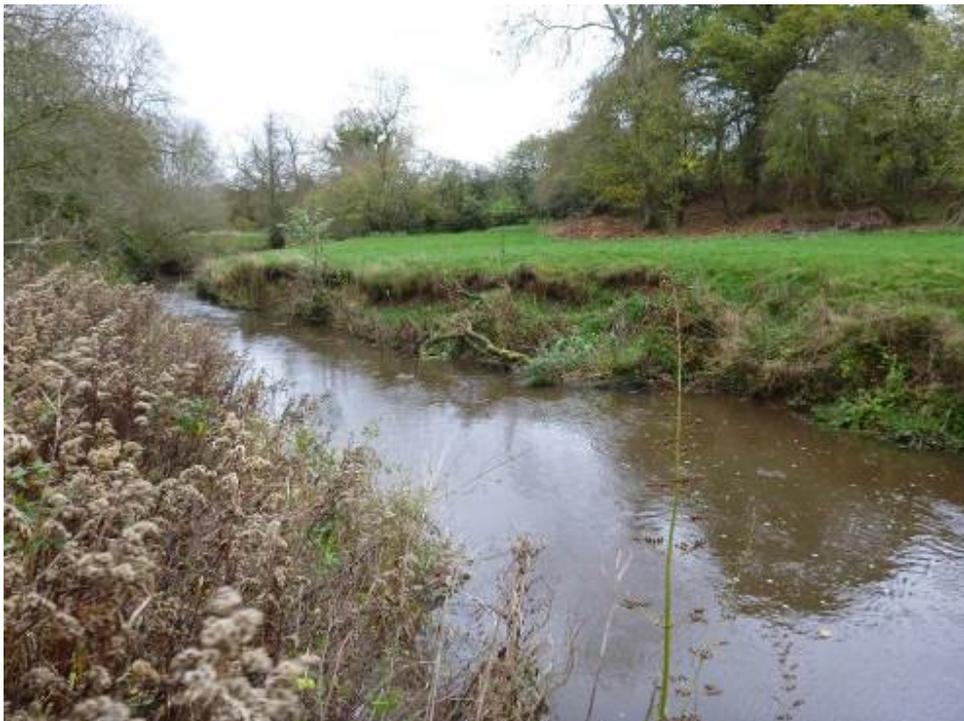
**Photo 10 Relatively bare RHB. Brushwood revetment and tree planting would benefit the marginal habitat here.**

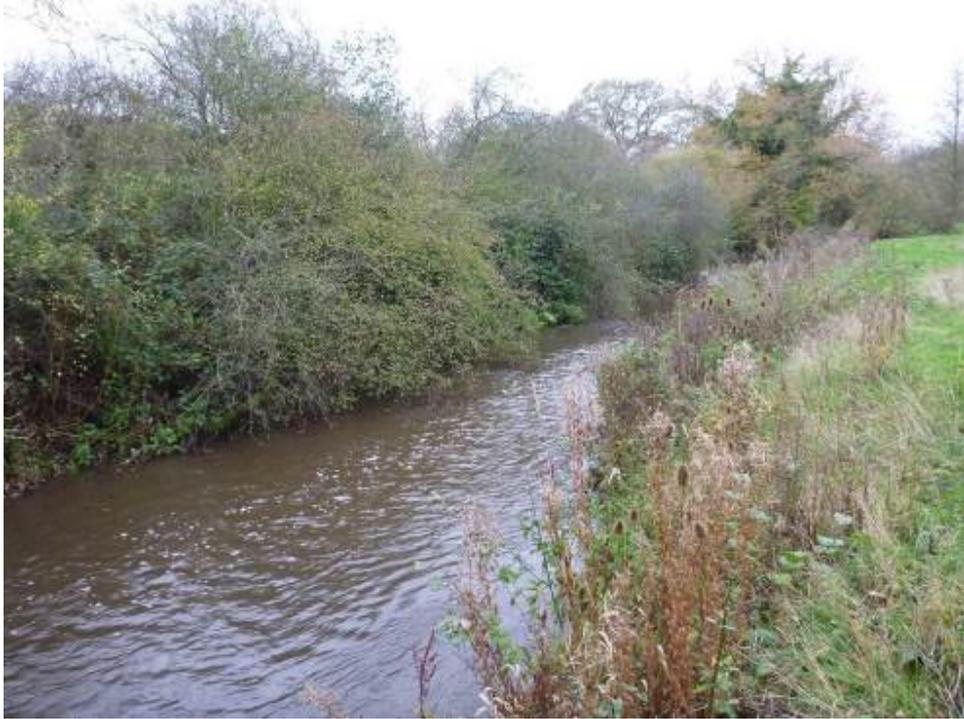
Downstream of this point the river channel is relatively straight, probably as a result of historic channel engineering for milling and/or land drainage purposes (Photo 11). This section has less variation in depth because of the lack of lateral scour associated with straightened channels and could benefit from the introduction of log flow deflectors positioned to promote bed scour (see recommendations).

**Photo 11** Straightened section where log flow deflectors could be installed.

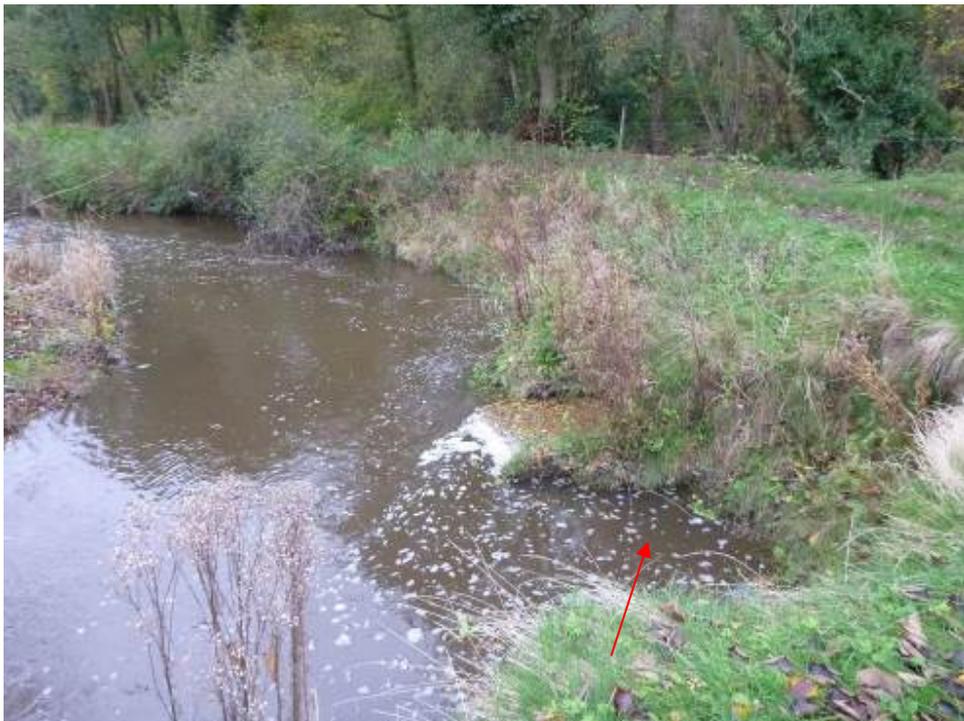
A little further downstream, concern was expressed about bank erosion on the LHB on the outside of a bend. The rate of bank erosion here does not seem excessive, with the toe of the bank appearing to have stabilised and vegetated. There is one scallop out of the bank where a back eddy is causing scour, which could be plugged with brushwood (Photo 12). One of the concerns is vehicle access along the top of the bank here between the river and the woodland. Cutting back some of the trees at the edge of the wood (and using the brush to plug the scour hole) may be a more cost effective solution than bank protection.

**Photo 12** Area of concern for bank erosion. The scallop in the bank in the foreground (arrow) could be filled with brushwood.

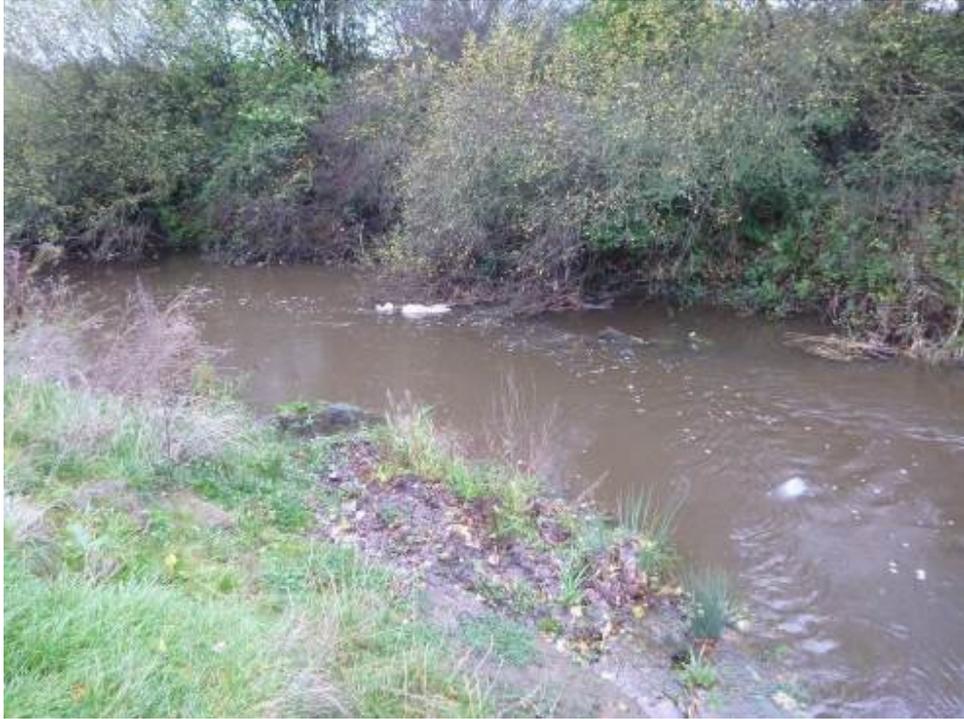
riparian habitat along this reach, with very good low cover over the water provided by overhanging trees and bushes, predominantly on the steeper RHB (Photo 13). This cover provides lies for fish and compensates to some degree for the lack of deeper water in this straightened reach. Carefully positioned log flow deflectors could create deeper areas associated with existing cover to improve adult fish habitat. With progress downstream the flow slows due to the impounding effect of the gauging weir (SJ4657109224); flow deflectors need to be located upstream of this impounded section to be effective in creating bed scour.

**Photo 13** Excellent low cover over / in the water provides numerous lies for fish.

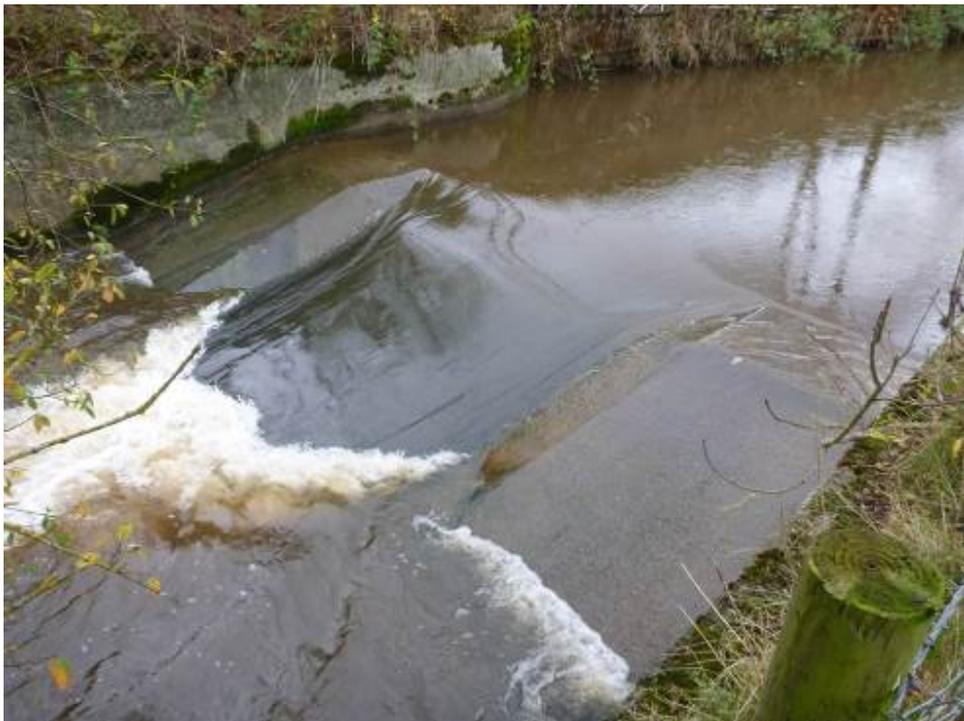
The gauging weir is a compound crump design with a centre channel accommodating lower flows (Photo 14). It presents a barrier to fish passage because of the speed of flow over the face of the weir, particularly for species with weaker swimming abilities (such as coarse fish and grayling) and for smaller salmonids. Improving fish passage at this site would strengthen fish populations in the Rea Brook by linking habitats required by different fish life stages and would facilitate recolonization, in the event of a future fish kill (such as a pollution incident). Low-cost baffle fish passes have been successfully deployed at other gauging weir sites and this weir has been put forward for the EA's programme of fish passage improvements on its own assets. Unfortunately, the compound design of the weir presents some difficulties (currently ISO-approved low-cost baffle designs have been developed only for simple crump weirs). In addition, the Rea Brook is not failing its WFD assessment for fish. These factors combined mean other structures are currently taking priority. A recent survey of the weir revealed some structural problems, so it may be that a replacement, fish-friendly flow gauge is installed in future (Chris Bainger and Chris Grzesiok, pers. comm.).

**Photo 14** Hook-a-Gate flow gauging weir

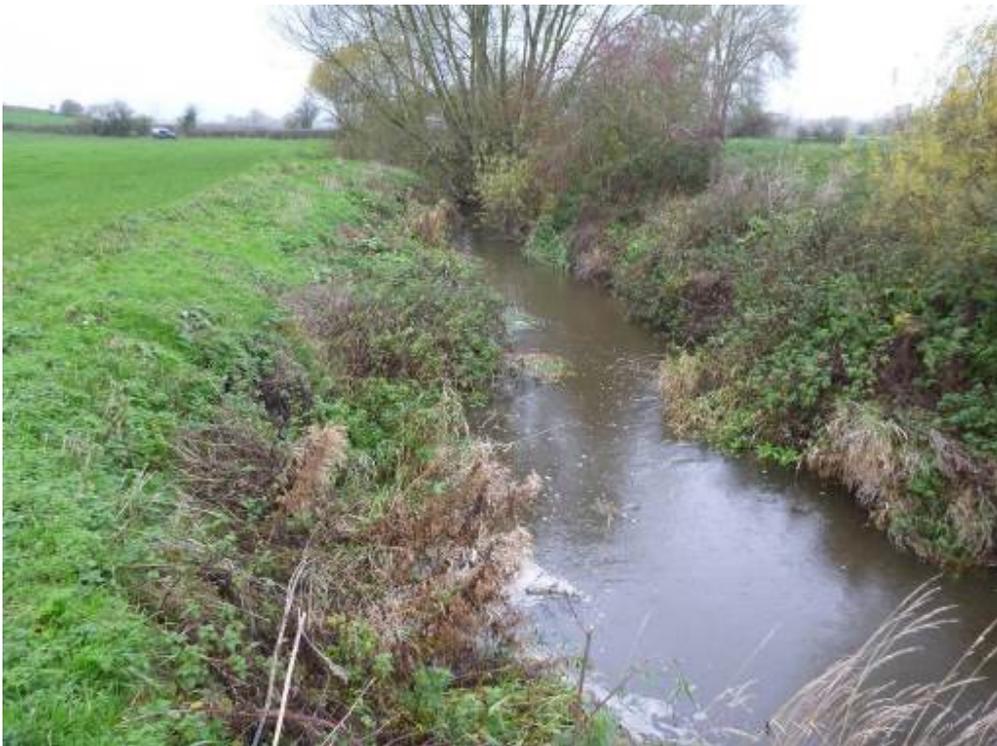
The channel here is deeply incised with steep banks as a result of past river engineering works for land drainage purposes. The channel cross-section is a typical engineered trapezoidal shape, with less variation in depth than would be found in an unaltered channel (Photo 15). The plan-form of the river is less meandering than would be expected, indicating it there has been a degree of channel straightening. This contrasts with the reach downstream of the Pontesford Brook confluence, a short distance downstream which retains a meandering plan-form.

**Photo 15 Trapezoidal cross-section of the channel due to past land drainage engineering.**

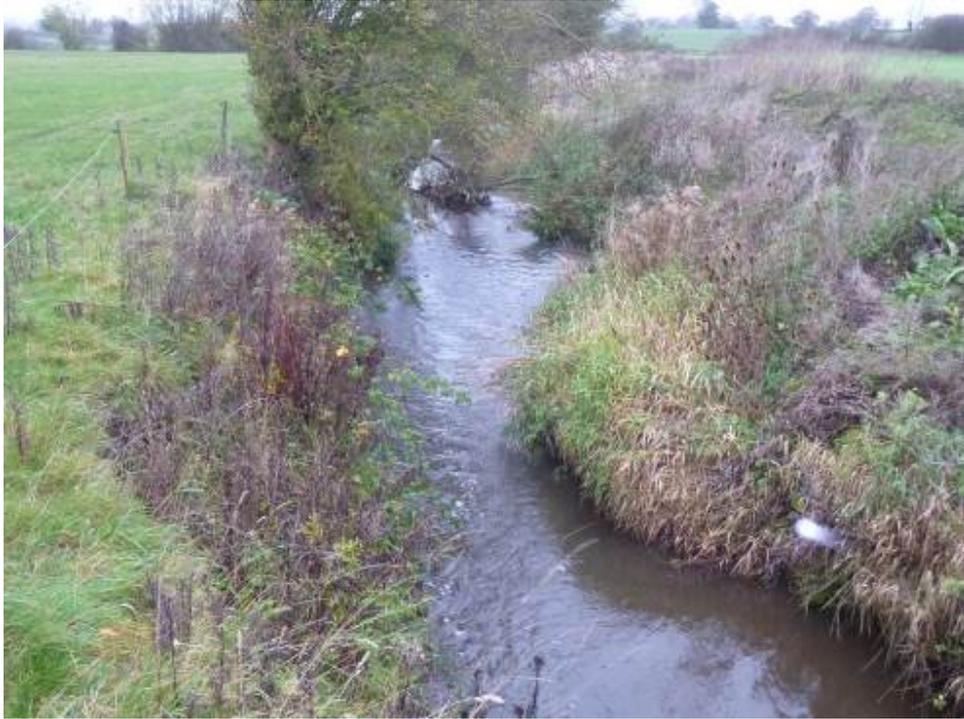
Despite the relatively poor underlying physical habitat resulting from past channel engineering, the river has re-established some pool-and-riffle structure and has developed good riparian habitat in the form of trees, bushes and shaggy vegetation (Photo 16). In some areas, such as the lower end of the reach inspected, previously coppiced crack willows (*Salix fragilis*) have re-grown vigorously (Photo 17) and are in need of management. Coppicing, singling and pollarding on a rotational basis would be ideal here. Replacement of some of these trees with other, slower growing native species is an option to reduce the future maintenance burden.

**Photo 16** Good marginal habitat made possible by the well-maintained fencing along the watercourse. Some re-establishment of a pool-riffle sequence is evident.

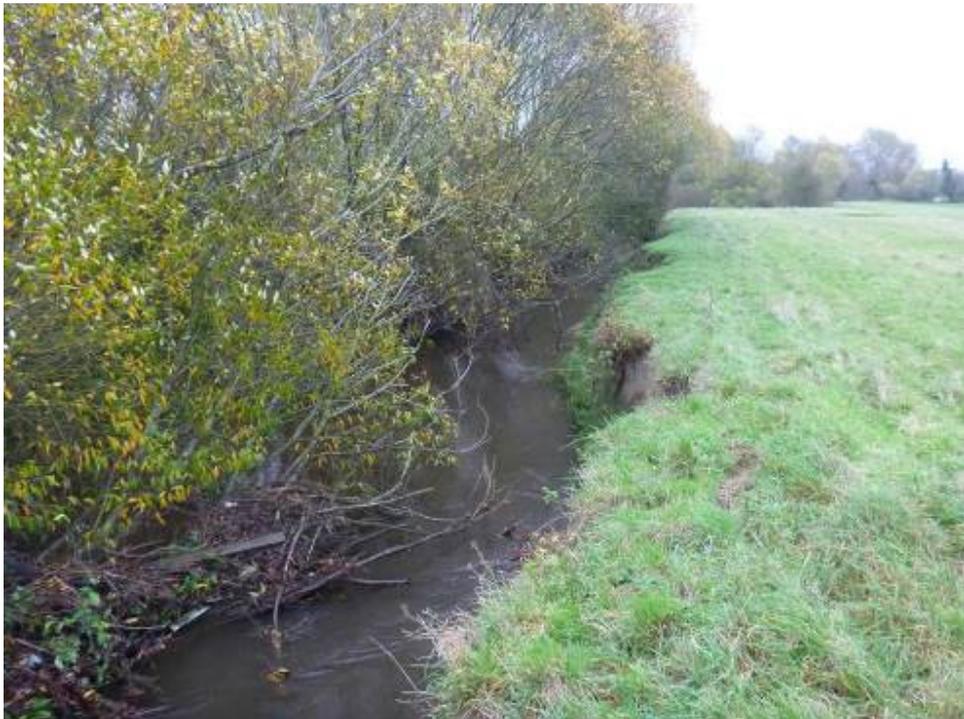
**Photo 17** Re-growth of previously coppiced crack willow encroaching across the channel. These trees need to be managed and the right bank fenced to improve marginal habitat and resistance to erosion.

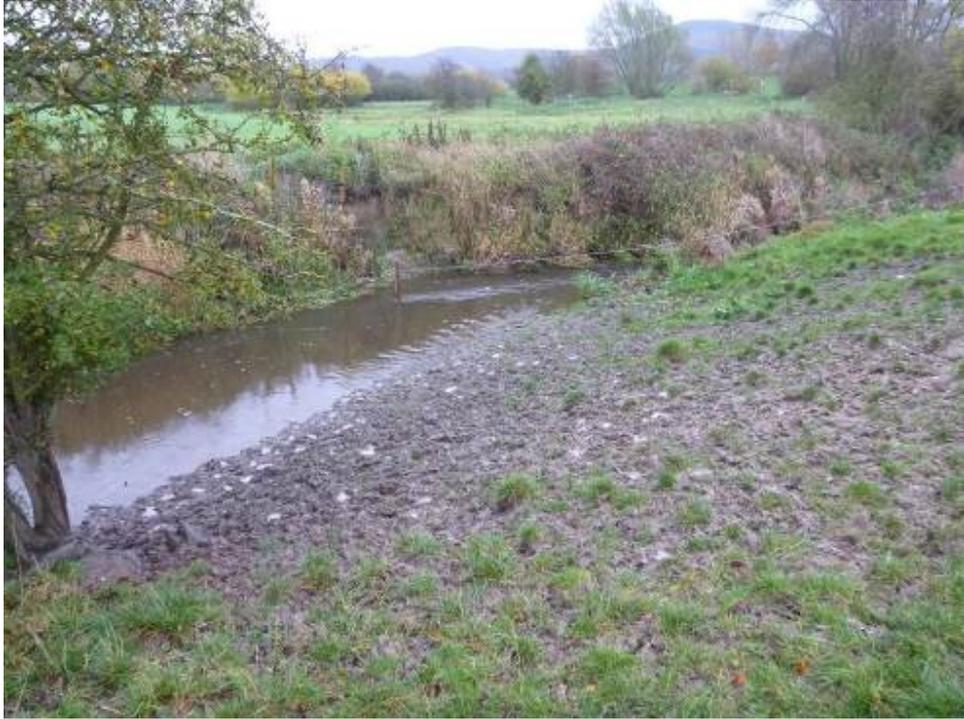
Most of the brook in this section is fenced, either with barbed wire or electric fencing, which has allowed the valuable marginal habitat to develop. Livestock drinking areas are well-defined but could be improved with the installation of some hard standing at the toe of the bank to reduce fine sediment input to the river (Photo 18). A couple of stands of Japanese knotweed (*Fallopia japonica*) are present; this is an invasive, non-native plant which should be eliminated before it spreads (Photo 19). It should not be trimmed or flailed as the individual fragments can propagate. Targeted herbicide use is probably most effective and advice should be sought from the EA regarding the use of herbicide alongside watercourses. A couple of areas were observed where soil or ditch dredgings had been disposed of on the bank close to the river (Photo 20). This risks fine sediment washing into the river and the material would be better spread thinly on the fields.

**Photo 18 Livestock drinking area defined by electric fencing. Some hard standing would lessen the input of fine sediment to the brook.**

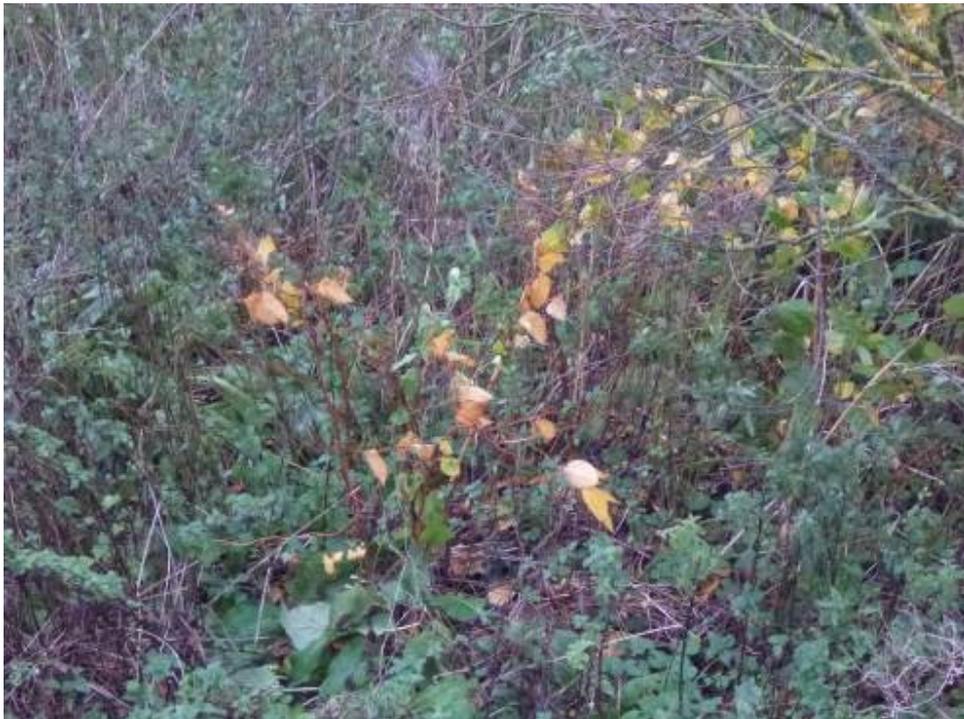
**Photo 19 Japanese knotweed is present in a couple of locations.**

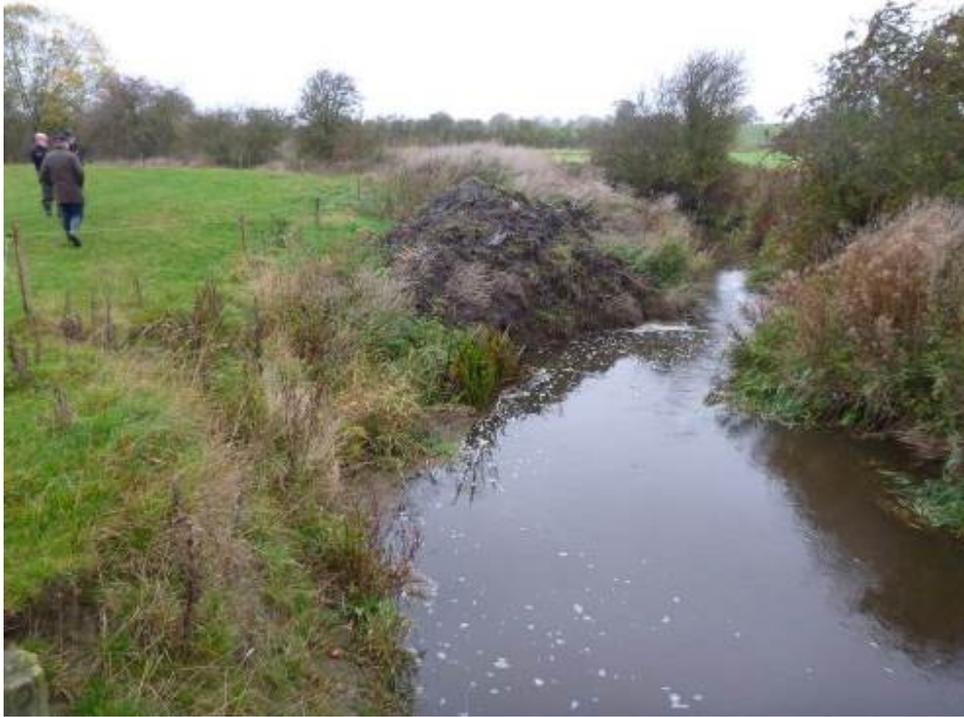
**Photo 20 Spoil disposed of on the river bank**

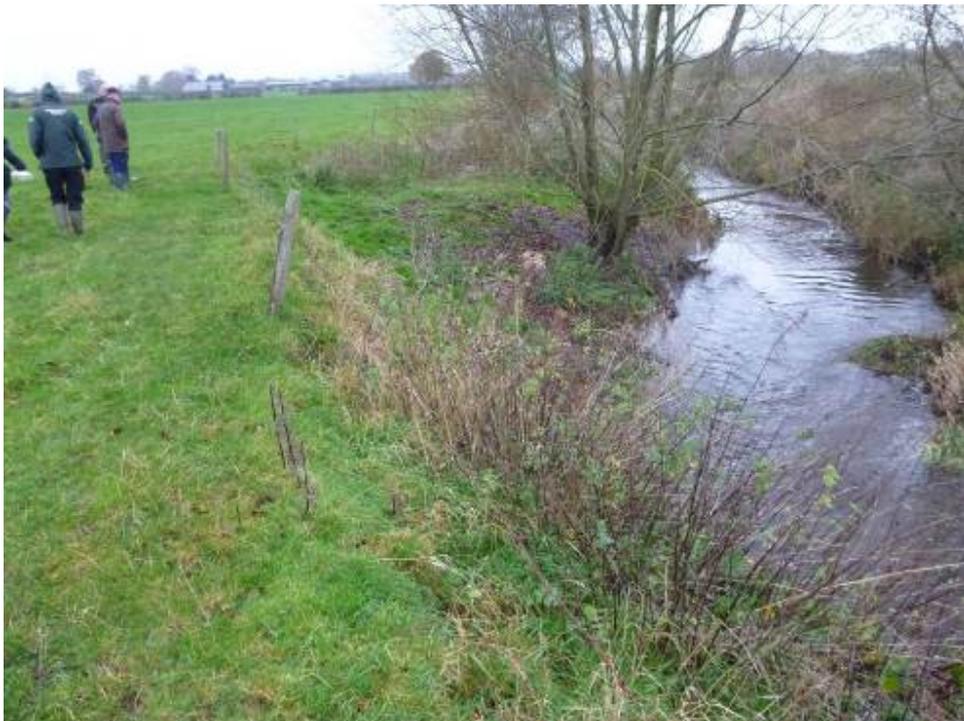
**Photo 21 Lower area of bank**

Some sections of the bank are less steep, where they have slumped and stabilised, creating valuable low shelves alongside the river (Photo 21). Re-

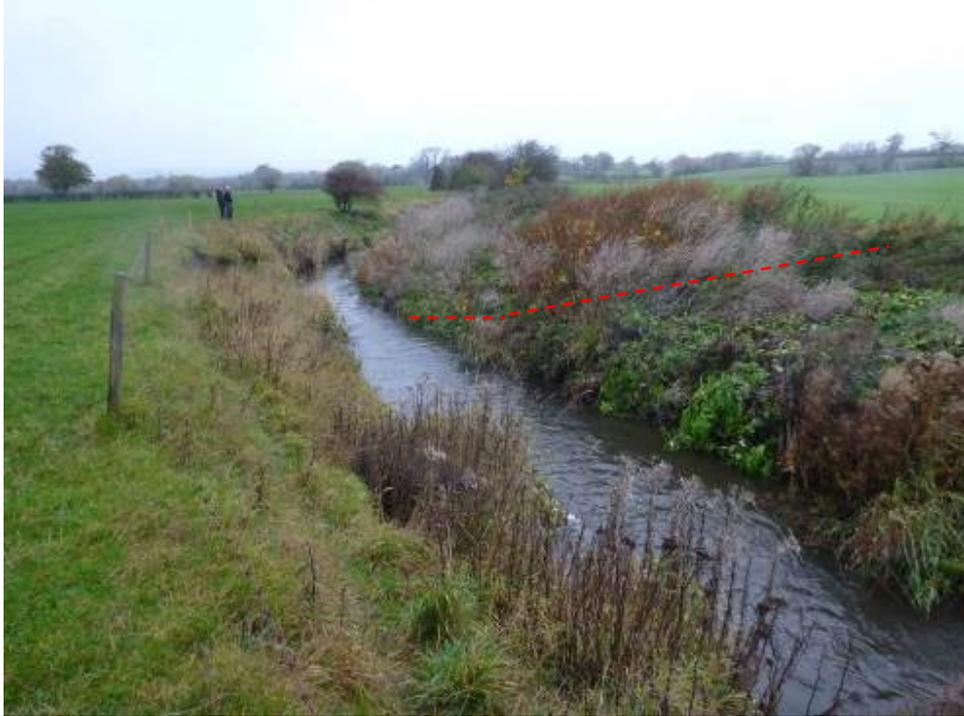
creating these features by deliberately re-profiling the banks would improve the in-stream habitat in this reach (Photo 22). Re-profiling should be targeted on the inside of bends to create an asymmetric cross-sectional profile (see Recommendations).

**Photo 22 Potential area for bank re-profiling on the inside of the bend. This would provide valuable slower, flowing marginal areas at all flow stages.**

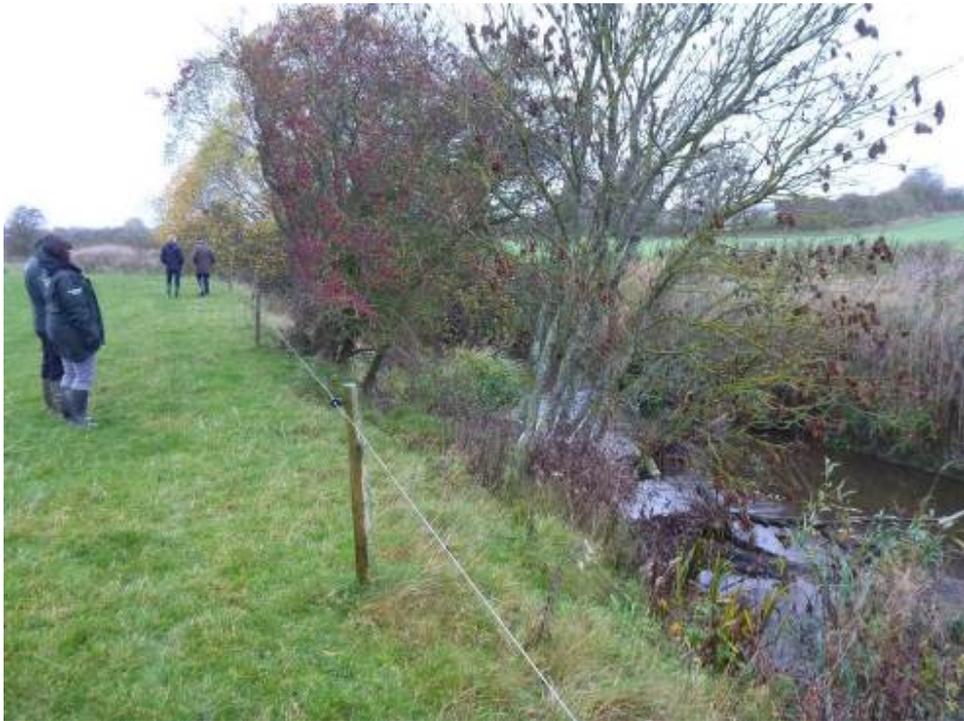
In the straighter glides, where there is little depth variation, log flow deflectors could be installed to promote bed scour. Where suitable bankside trees are located, these could be hinged and laid into the margins to create cover and refuge areas from high flow; this is not recommended for crack willows which will root and grow vigorously, creating an ongoing maintenance requirement (Photo 23).

**Photo 23 Suitable trees could be hinged into the margins to create valuable cover and bed scour.**
