Advisory Visit

River Rea, Shropshire

13th November, 2013

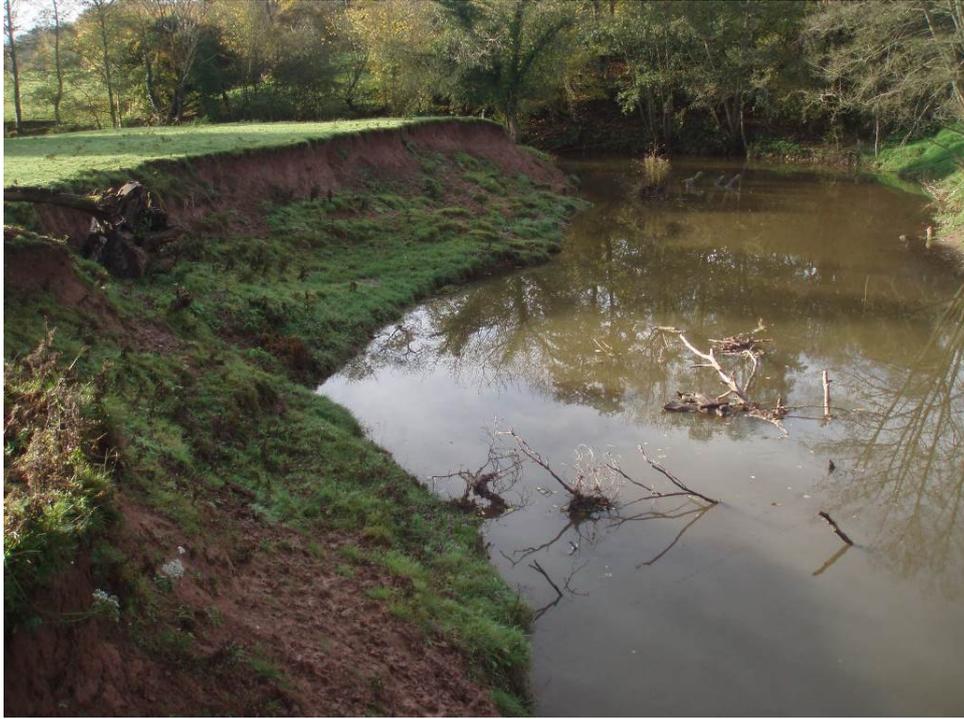
Two areas of erosion were inspected during this visit (Photos 1 and 2). Both areas appear to be affected by rotational failure rather than block failure (see Appendix). The presence of vegetation at the toe of the bank indicates that these areas would probably stabilise if grazing pressure was removed. Poaching of the banks by livestock is significant (Photo 3) and this is

Photo 1 Bank erosion by rotational failure

contributing to accelerated erosion rates. Brushwood revetment is unnecessary here because the banks should become stable once they are fenced and livestock access is prevented; this contrasts with block failure where soft revetment is required to reduce erosion rates whilst fencing and vegetation regenerates. Figure 2 in the appendix shows rotational failure (type d) compared to block failure (types g and h).

Fencing is planned by Severn Rivers Trust and will be required to protect coppice re-growth and allow vegetation regeneration to support the banks. It will be necessary to provide alternative drinking sources for livestock and to have a plan to maintain vegetation between the fence and the river. The latter is particularly relevant given the presence of the invasive non-native Himalayan balsam which could dominate bankside vegetation in the absence of controlled grazing or manual/mechanical cutting.

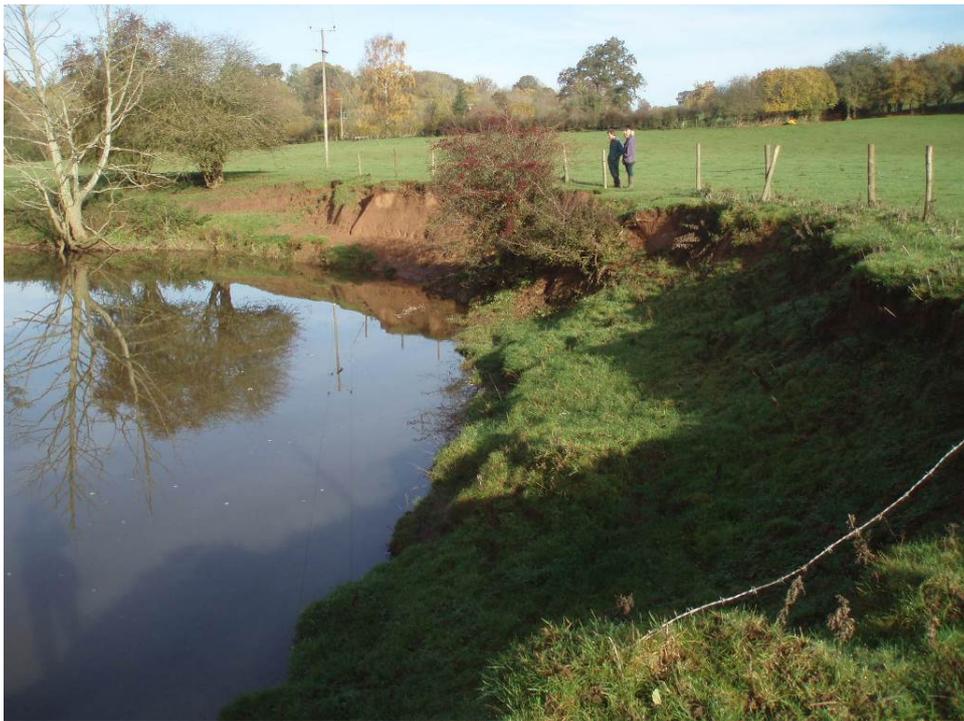
Photo 2 Bank erosion by rotational failure, exacerbated by livestock access.

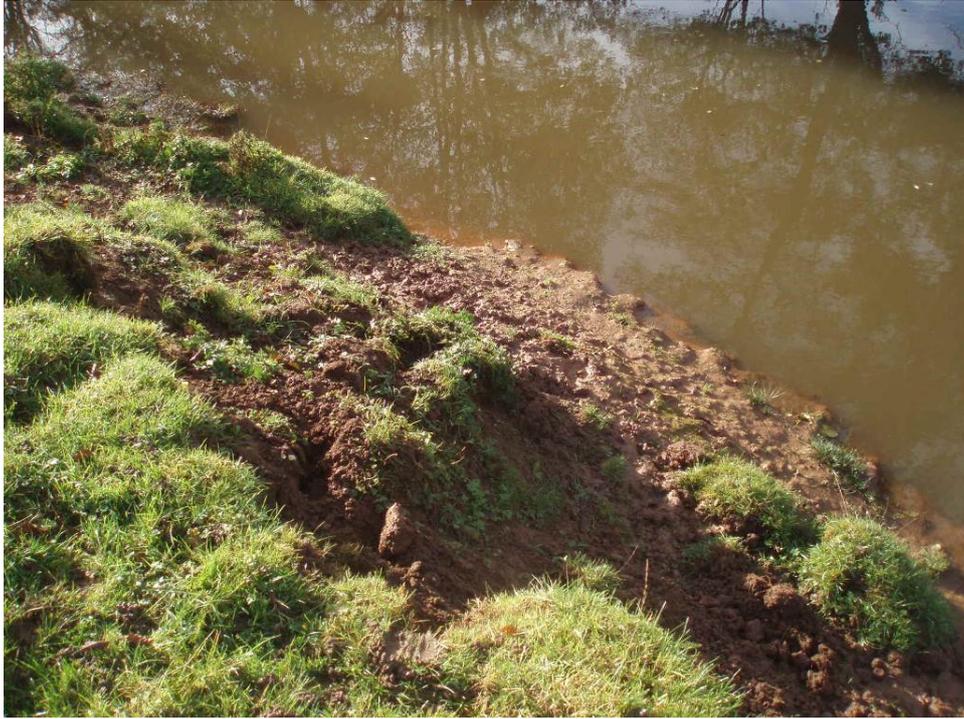
Photo 3 Bank poaching by livestock

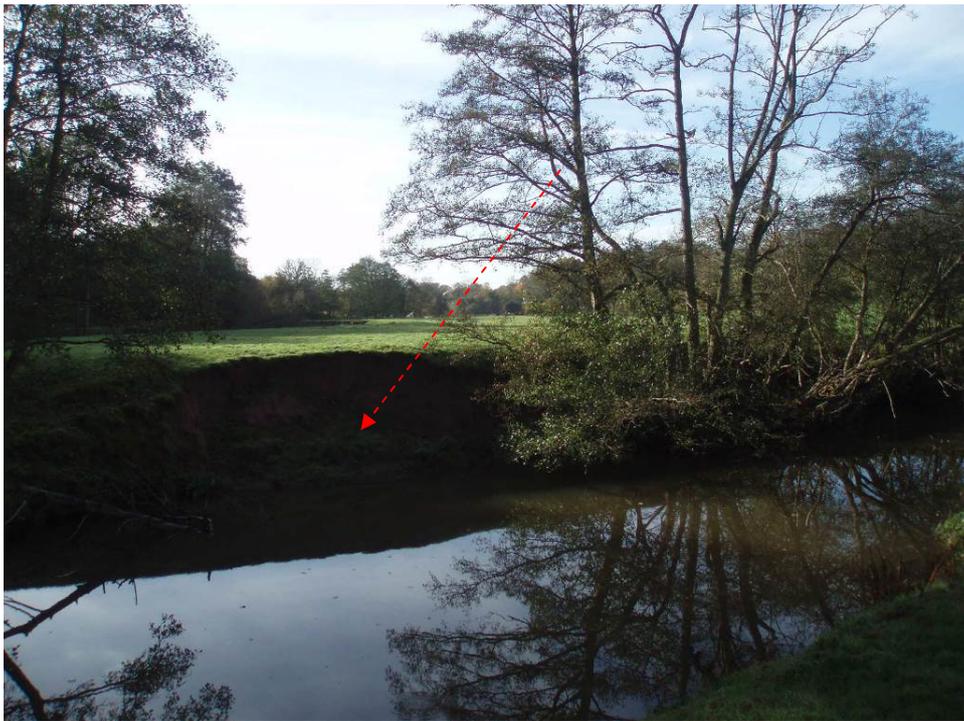
Photo 4 Where suitable trees are positioned next to eroding banks like this, they could be felled and fixed parallel to the bank to protect the bank and restrict livestock access (in the absence of fencing).

In some areas it would be possible to create some features by creative use of bankside trees and bushes. These would improve in-stream habitat whilst protecting vulnerable areas of bank from erosion. Some examples are illustrated in photos 4 and 5. The coppicing contractors could carry out these measures and WTT could provide on-site ideas/training.

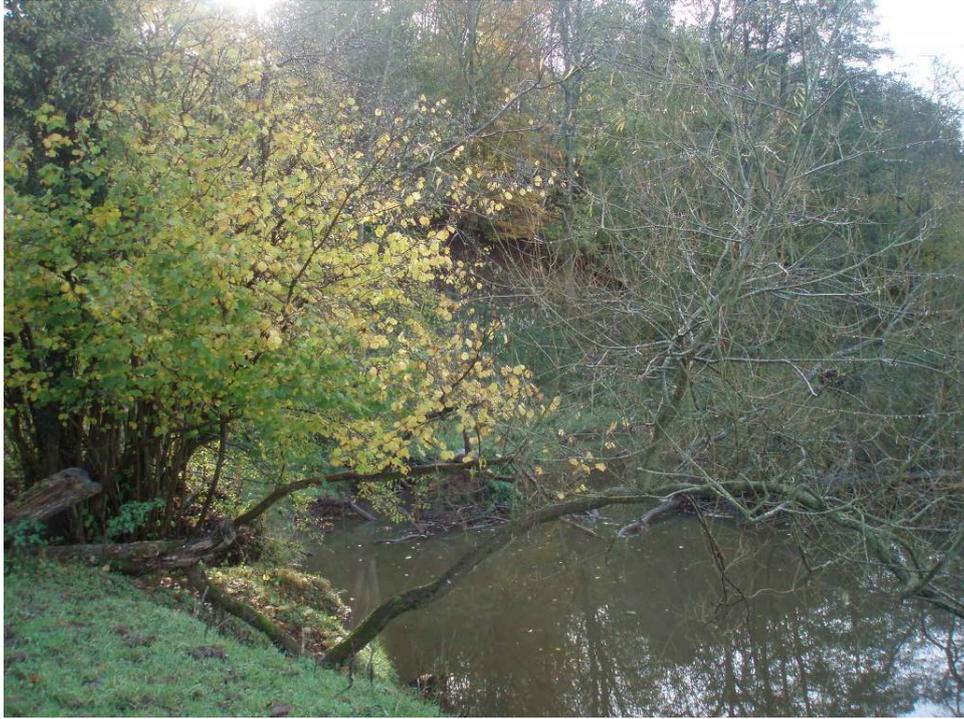
Photo 5 Smaller bankside trees like this hazel and willow could be partially cut and pleached into the river margins (like hedge laying) to create valuable cover for fish and help to protect banks.
