**Walkover Assessment**

**River Rede**

**(Elishaw to Otterburn)**

**06/11/2018**

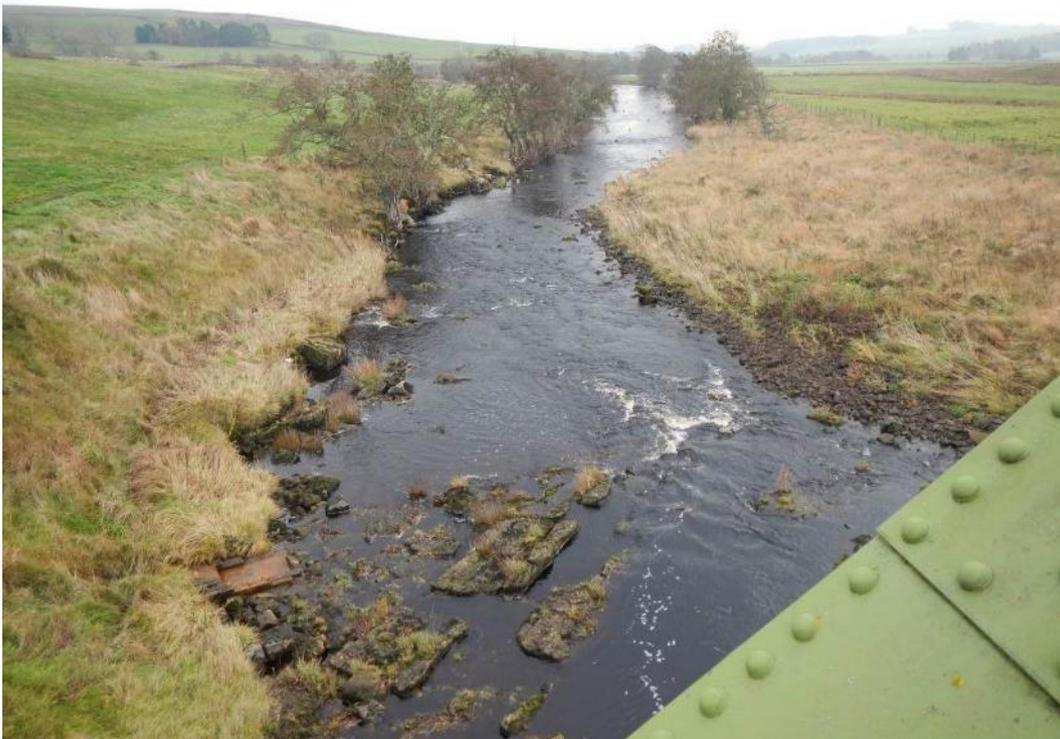
**Photo DSCN4939.** Looking d/s from the A68 road bridge at Elishaw. The RB is effectively buffer fenced with stock netting (NY 85985 95065 - NY 86137 94832). The plain wire fence on the left bank is completely ineffective at excluding livestock (NY 85985 95065 - NY 86152 94866).

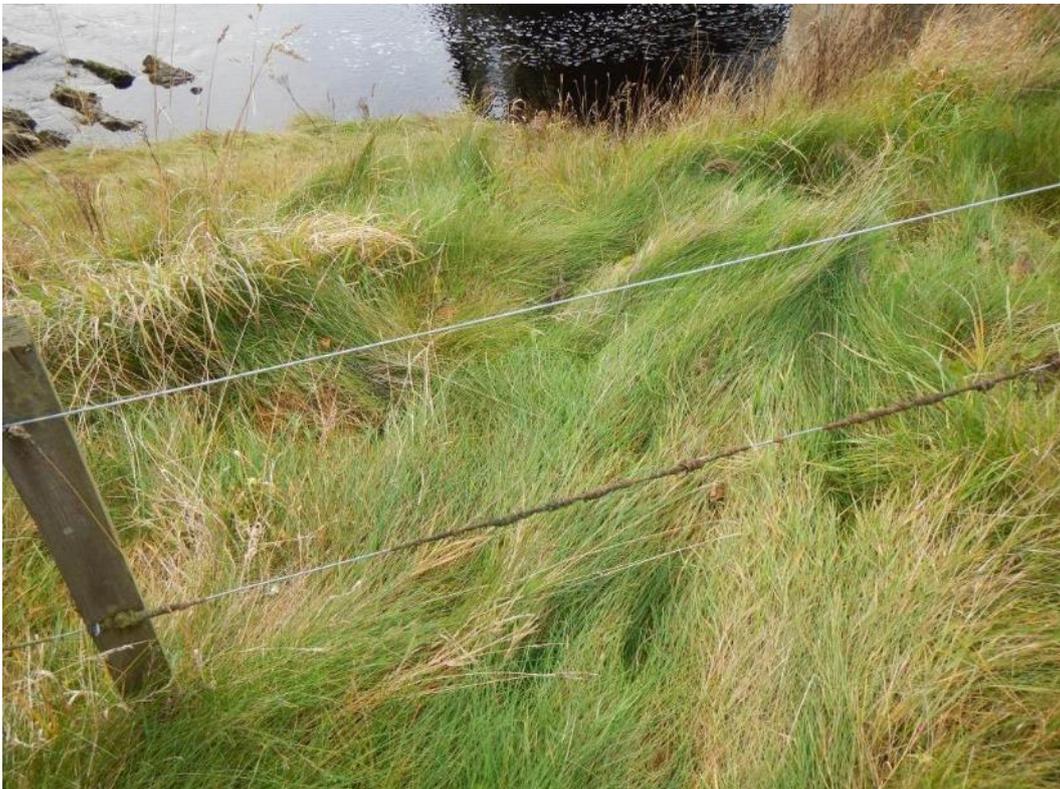
**Photo DSCN4940.** The completely ineffective 2 stand plain wire fence on the LB. Note the significant accumulations of wool from sheep passing freely beneath the bottom wire.

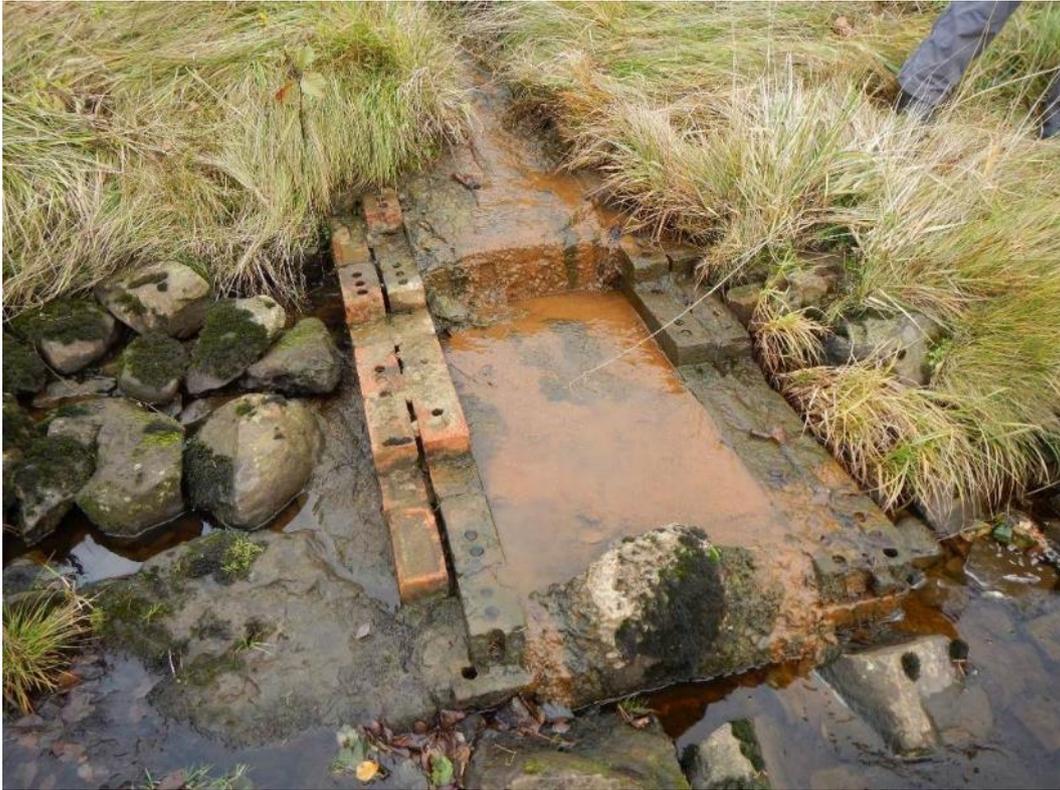
**Photo DSCN4941.** A small, formal outfall on the LB just d/s of the bridge looks striking due to the iron oxide staining but appears to be a low volume and/or iron content (evident by the limited extent of the staining). The dilution factor when this enters the river means it is unlikely to create a negative impact.

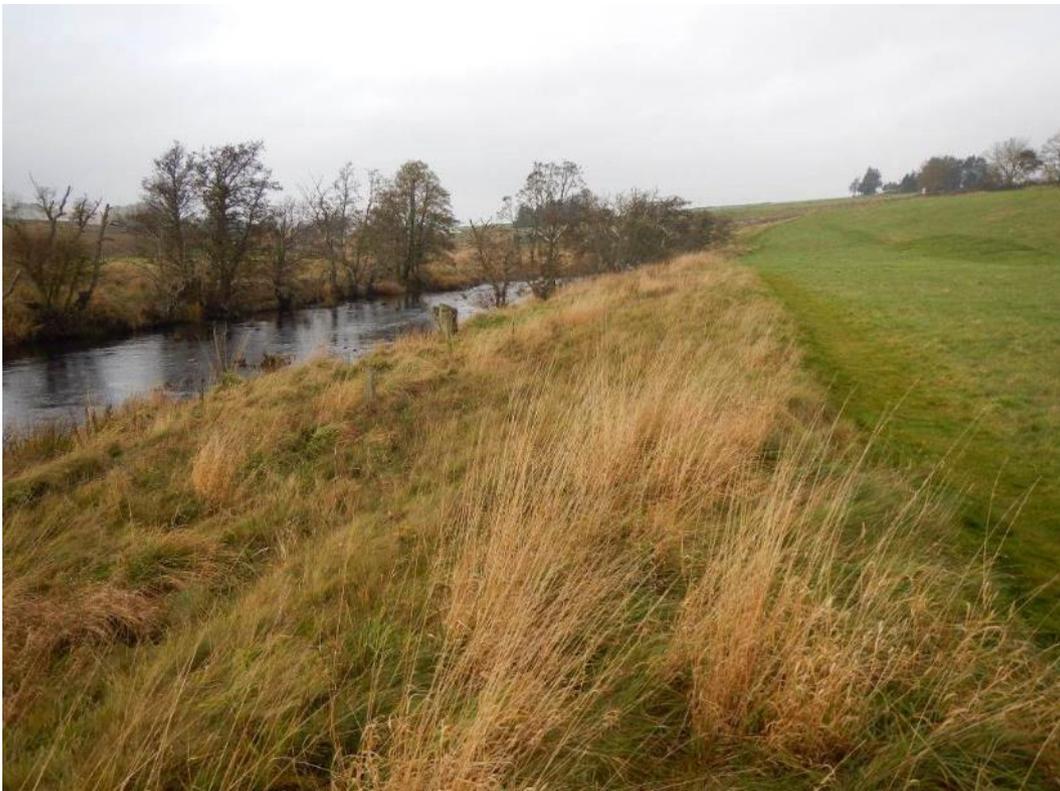
**Photo DSCN4946.** Looking upstream: the first LB field appears to be cut for fodder, then aftermath grazed, with the sheep generally favouring the grass regrowth in the mown areas over the unmown, rank vegetation of the river margin. However, the browsing that is taking place along the riverbank in the absence of an effective fence is sufficient to be preventing natural tree regeneration and suppressing the development of much other than grasses. Sheep will generally preferentially browse saplings over even grass regrowth.

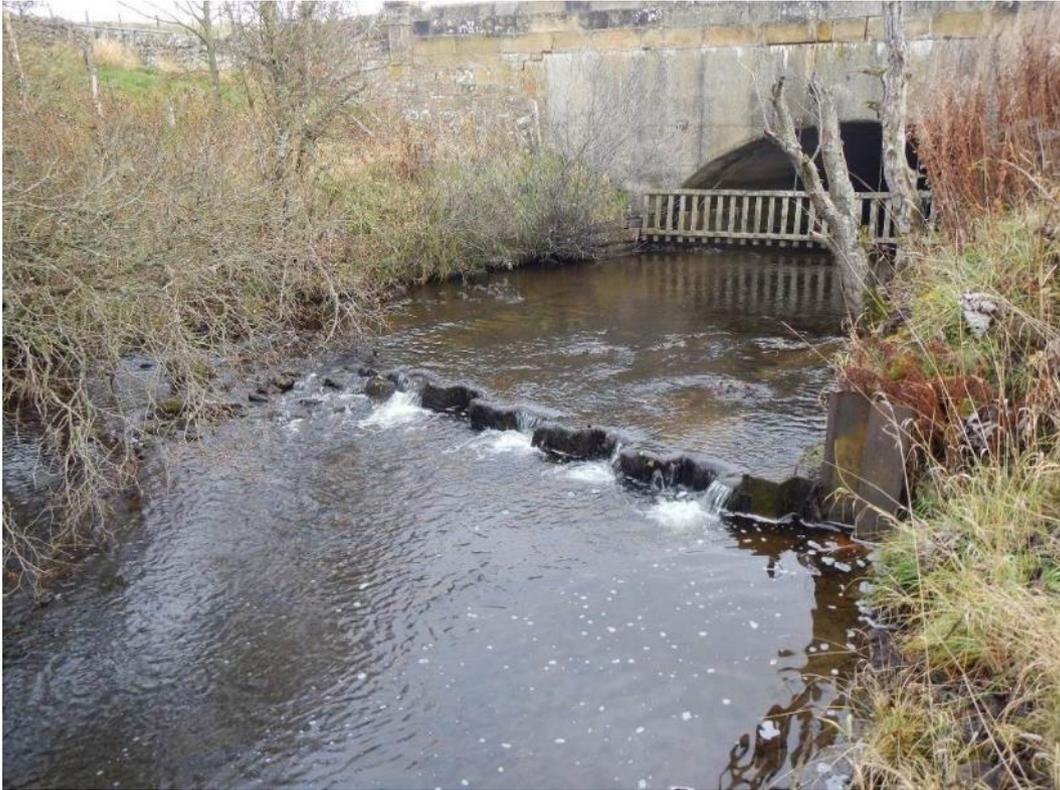
**Photo DSCN4948.** Durtrees Burn joins the Rede at NY 86158 94847. A short distance u/s on the burn, the A696 road bridge footings create small obstruction (NY 86213 94872). The obstacle is reduced by an accumulation of cobble substrate towards the RB, which is acting as a rock ramp easement. However, the shallow water and smooth concrete apron u/s do further reduce the passability of the structure in medium and low flow conditions.

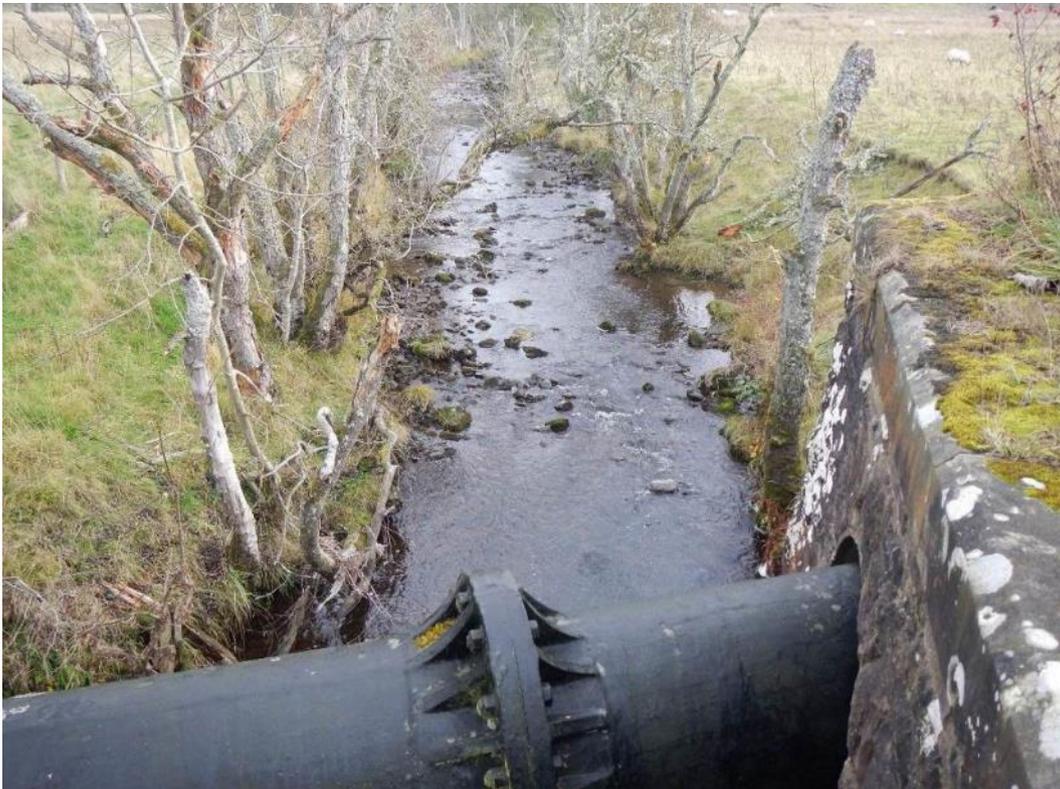
**Photo DSCN4951.** Brief inspection of the Durtrees Burn u/s of the A696 revealed a predominantly cobble substrate that should offer good invertebrate and juvenile salmonid habitat. However, excessive quantities of fine sediment and algal growth appeared to be present on the bed. While this could be a result of a low flow summer, it could also indicate excessive fine sediment and nutrient inputs u/s and so warrants further investigation.

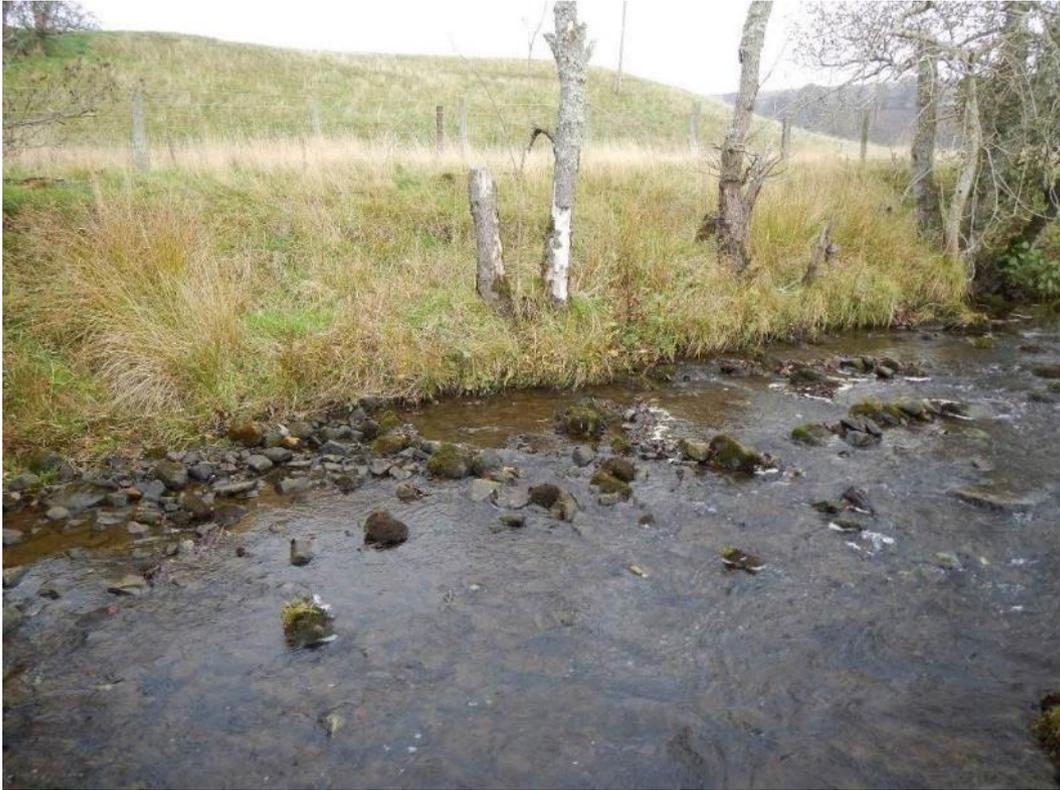
**Photo DSCN4953.** Suspected *Phytophthora alni* (a fungal disease of alder trees) was observed by the numerous dead trees on the burn and on the main River Rede, right from the u/s extent of this walkover.

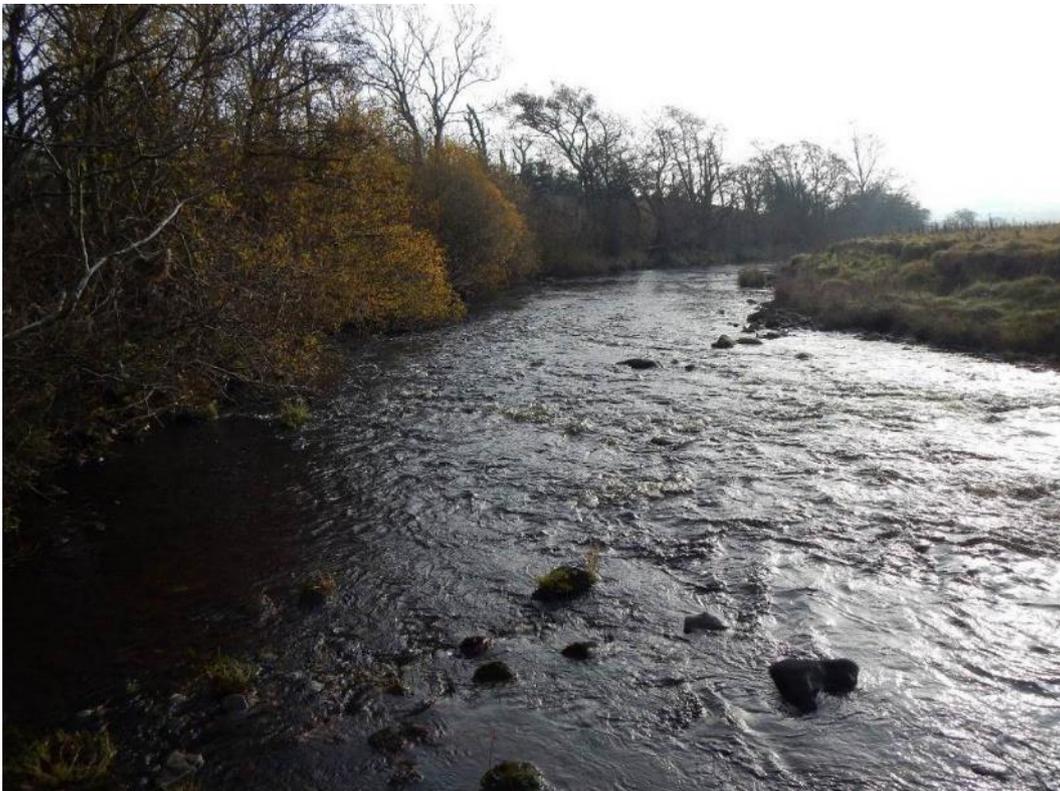
**Photo DSCN4956.** High quality invertebrate and juvenile salmonid habitat was observed in the River Rede, both u/s and d/s of Durtrees Burn. Tree lining of the LB d/s of the burn provides additional habitat diversity and bank protection.

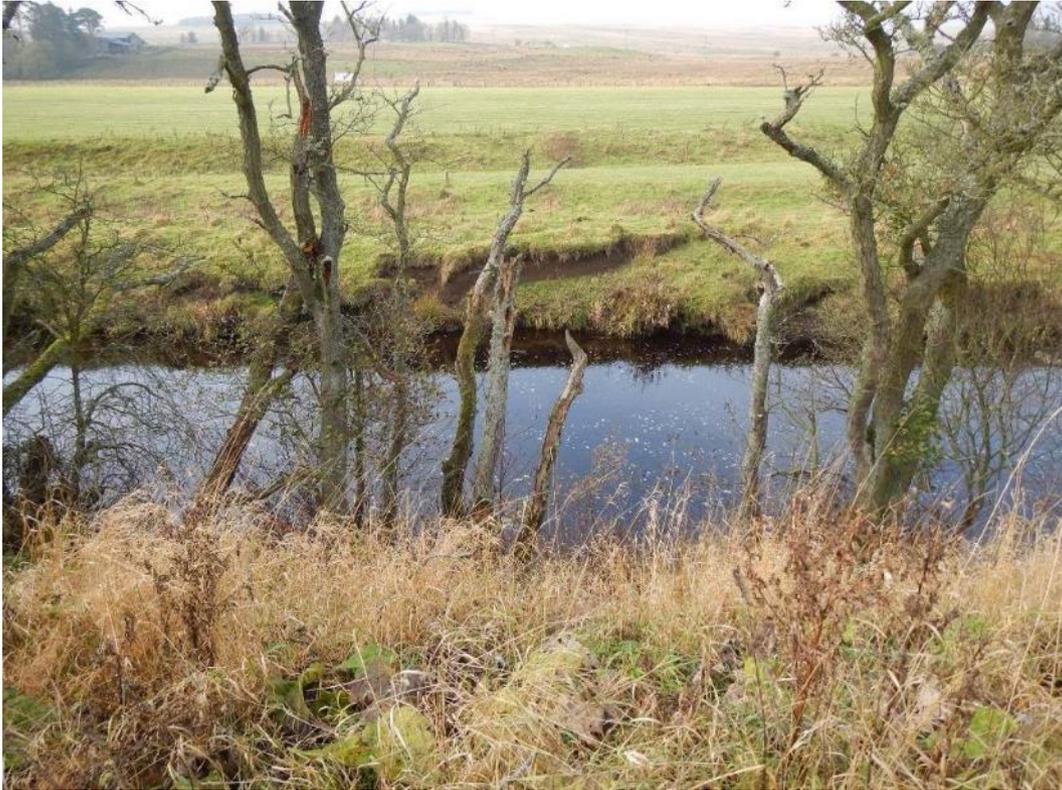
**Photo DSCN4957.** The RB is completely unfenced in the second and third fields d/s of the bridge (NY 86137 94832 - NY 86280 94573). Note the increased bank erosion occurring where there is less vegetation to protect and consolidate the bank. Also note the dead alders in the foreground, but some natural regeneration in the absence of any grazing.

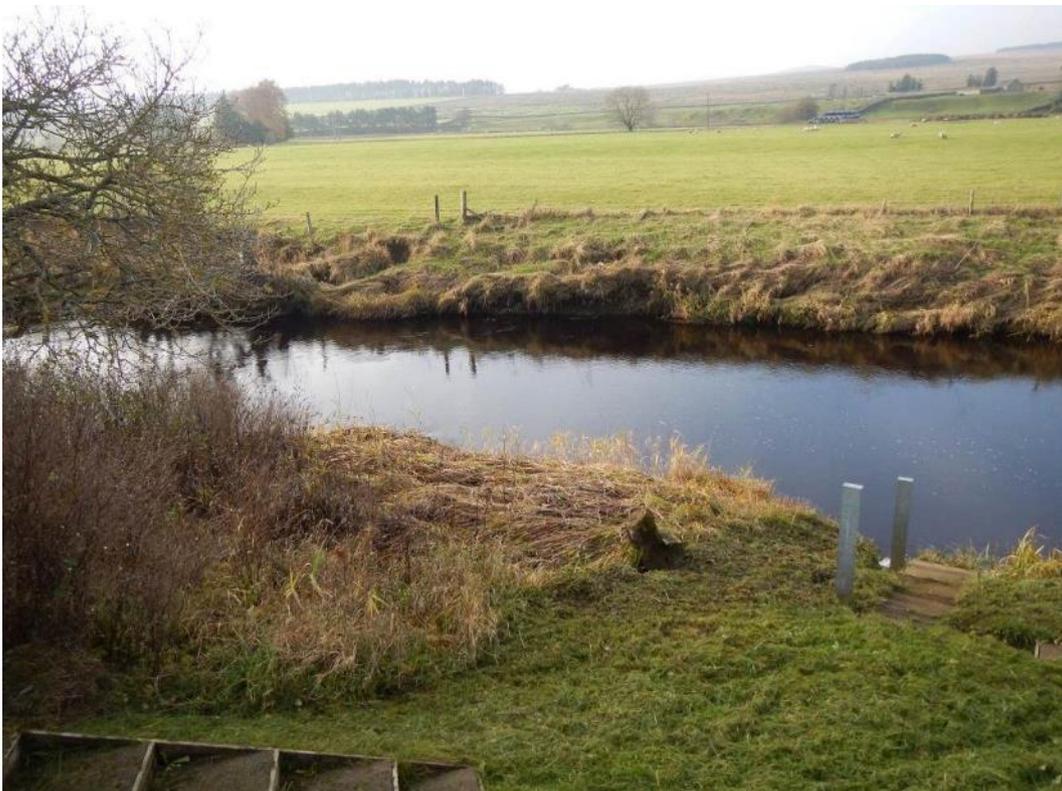
**Photo DSCN4963.** The site of EA Otterburn flow gauging station. A good example of a gauging station with minimal impact upon river ecology. This site is a stark contrast to many stations found elsewhere which employ intrusive weir structures which inhibit sediment transport and fish movement, and generally degrade habitat quality u/s and d/s.

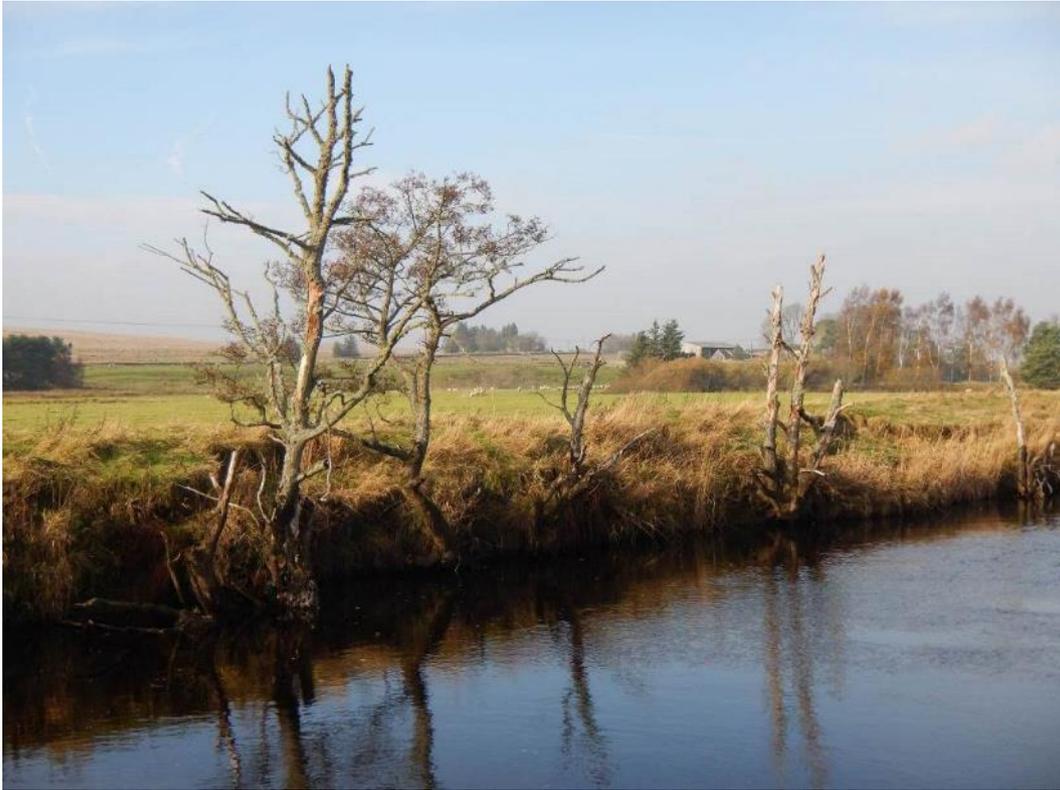
**Photo DSCN4972.** The third RB field is unfenced but appears to be used for fodder production (NY 86280 94573 - NY 86435 93963), then grazing. This again is encouraging preferential grazing in the mown areas; the limited protection to the bank provided by this is also dependent upon low stock density. Note the looming issue of tree loss along the riverbank, likely again in part due to *Phytophthora*, but exacerbated by the long term lack of tree regeneration. This creates an issues through the completely natural die-off of relatively short-lived (~150 years) species like alder.

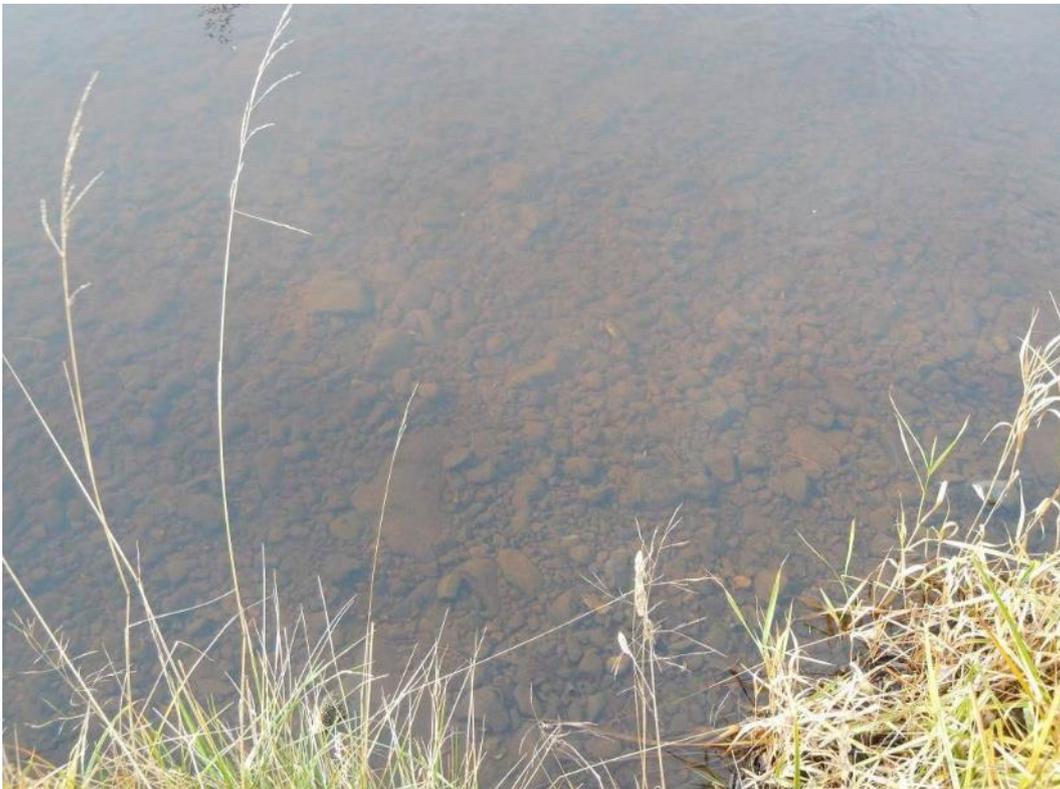
**Photo DSCN4975.** The substrate of the River Rede through much of this section is relatively coarse in nature, even in the slower flowing areas, although they do appear to be accumulating fine sediment in periods of low flow.

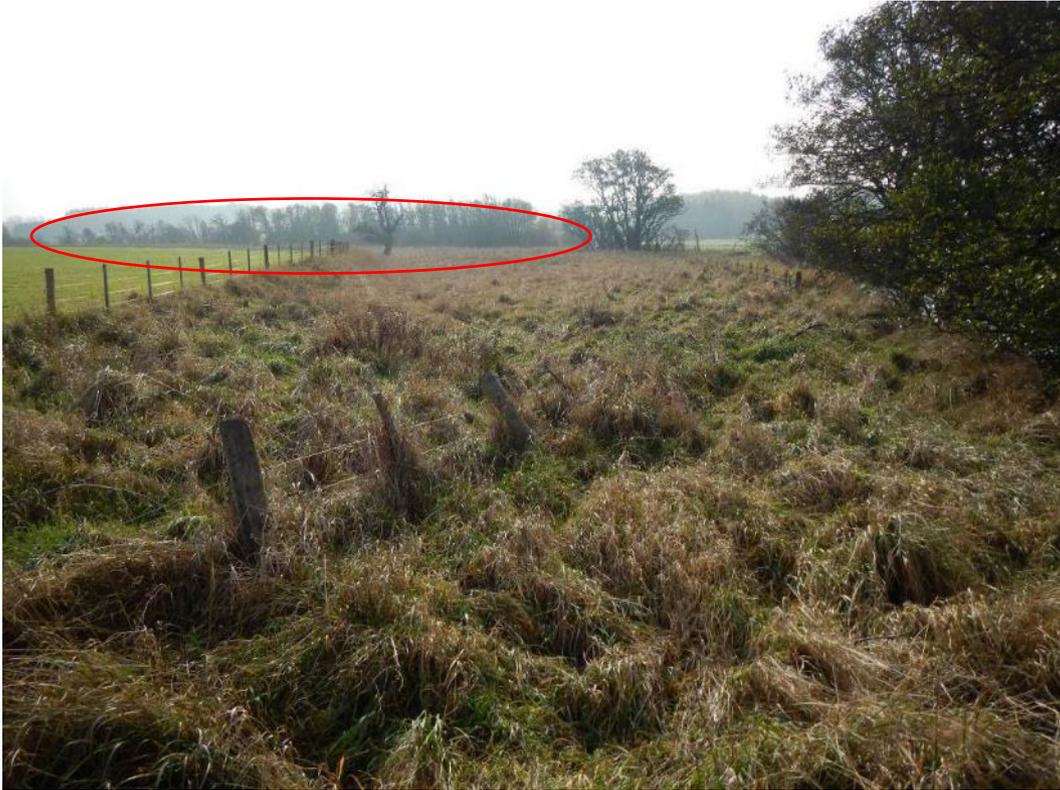
**Photo DSCN4969.** The LB is completely un-grazed along the A696 roadside (NY 86152 94866 - NY 86364 94405), then buffered for an extended (>2.75km) section (NY 86364 94405 - NY 88107 93106: it should be noted that integrity of the fence was not inspected for much of this length). The initial section widens to ~50m in what appears to be a small field that has been relinquished into buffer strip (probably due to flood issues on the low-lying inside bend). This area could offer an excellent opportunity for native deciduous planting to extend an existing small area of riverside woodland (red ellipse).

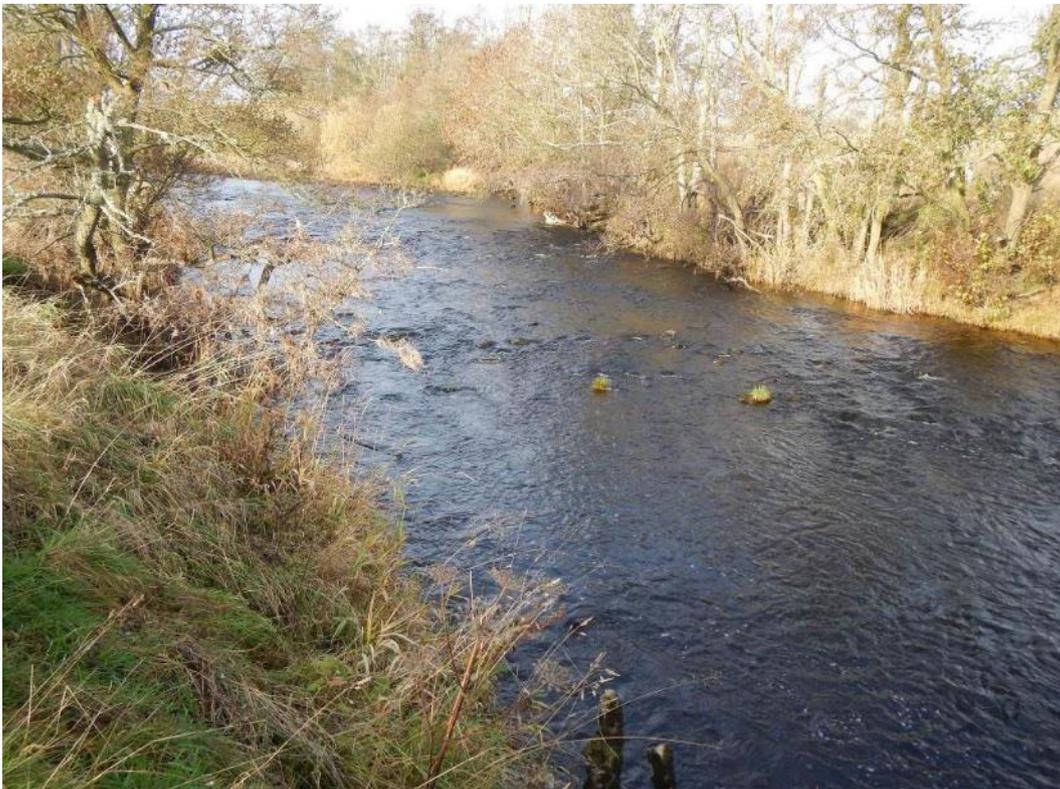
**Photo DSCN4981.** High quality riffle habitat with gravel and cobble substrate – ideal for juvenile salmonids and the invertebrate communities upon which they feed. The areas of smaller, mobile substrate also offer potential for salmonid spawning.

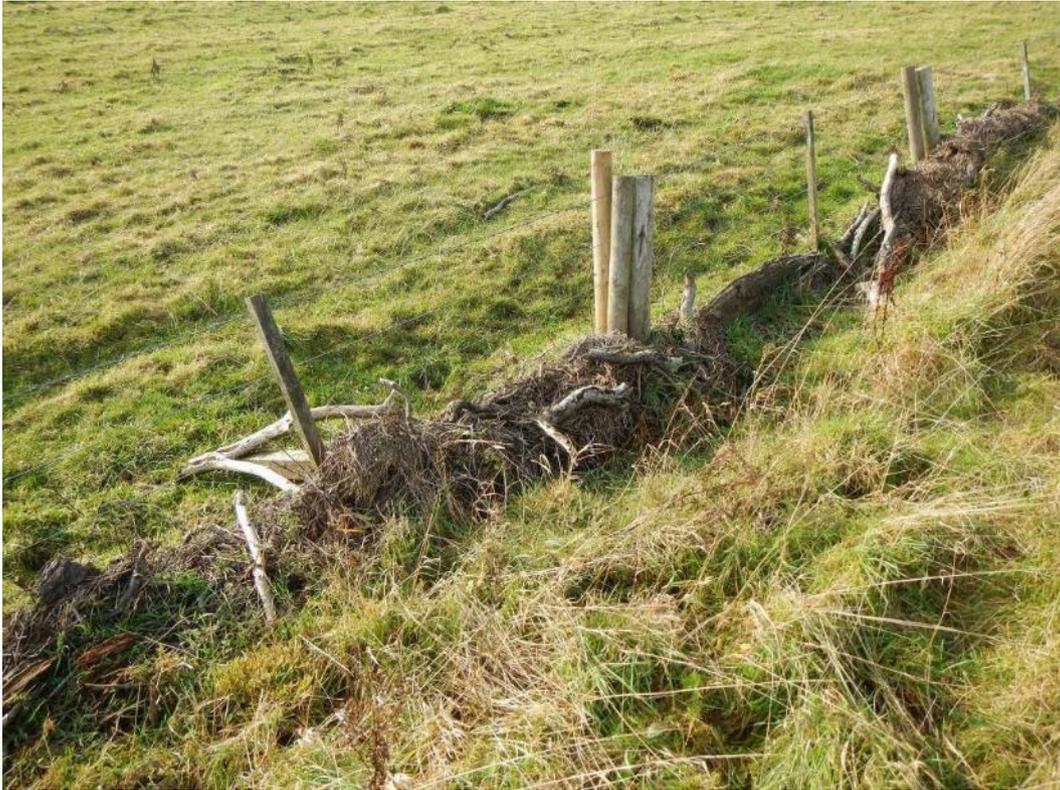
**Photo DSCN4983.** Between NY 86435 93963 and NY 87145 93536, the right bank is buffer fenced with five strand wire fencing (4 plain and 1 barbed), which is a minimum standard to be sheep-proof and may be ineffective at excluding lambs. Seven strand plain (+ 2 additional barbed on top if cattle are present) is usually recommended. Efforts have been made to maintain the fence, as evident by replacement posts, but this area appears to be flood-prone and post and rail fencing may be more appropriate (as has been used in other areas).

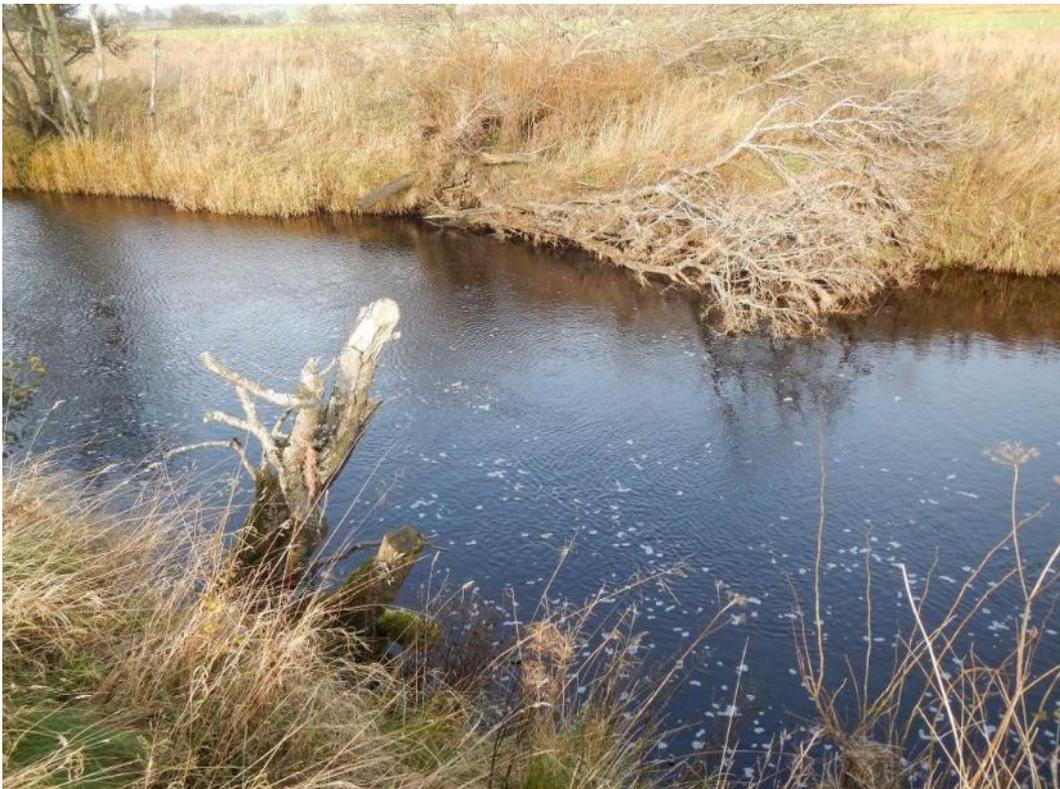
**Photo DSCN4984.** Generally scarce in-channel habitat provided by a toppled, but still living tree. This type of high quality habitat structure provides shade and cover in which fish can shelter from high flow and evade predators.

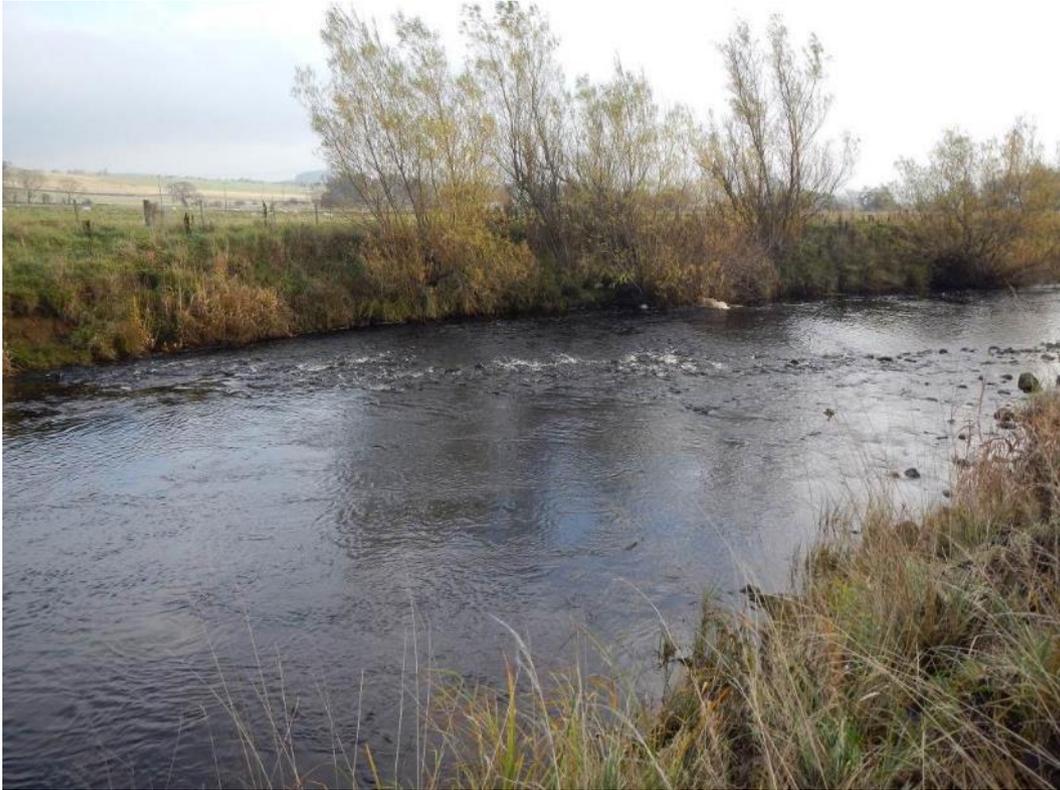
**Photo DSCN4990.** Good quality in-channel habitat, enhanced by willow trees along the LB which help to consolidate and protect the bank, driving erosive forces into the bed to maintain deeper pool habitat (background). Most of the trees present on the LB are relatively young, suggesting that it may have been unfenced for long periods previously and from which the trees are now recovering. Even so, they are generally only present along the bankline, with a lack of trees further back in the buffer.

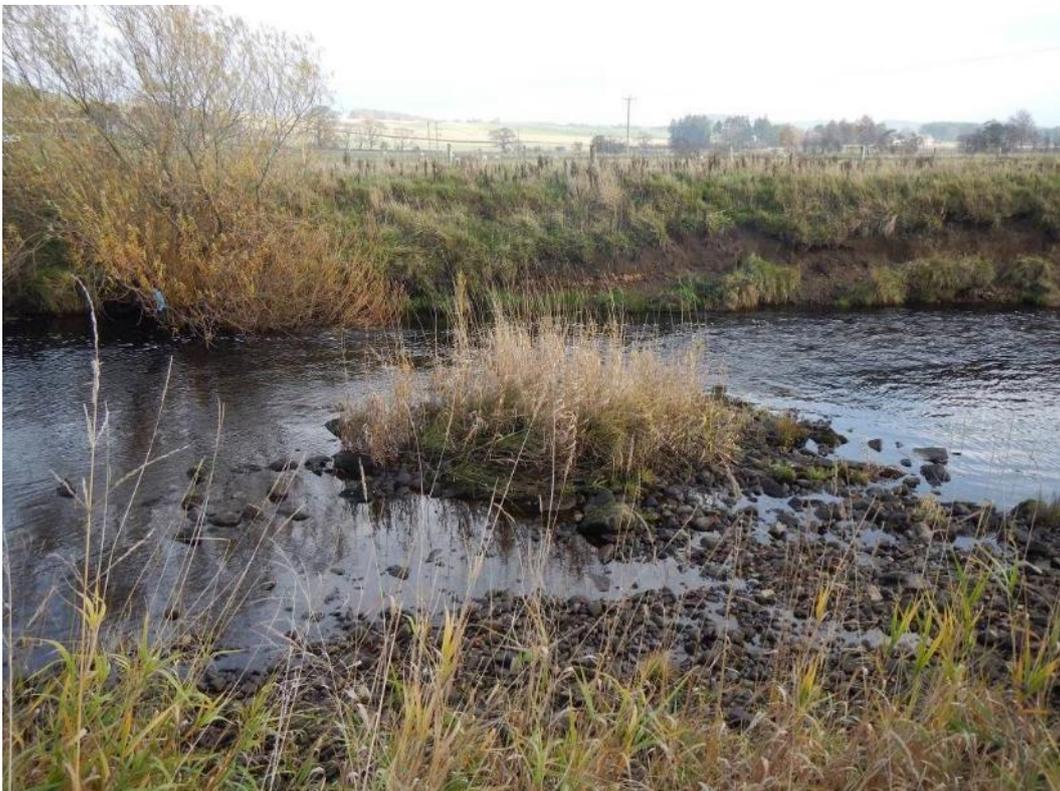
**Photo DSCN4991.** Bank erosion, almost certainly exacerbated by the installation of rock to the channel a short distance d/s, which has increased back-eddying and scouring at the toe of the bank. A flood bank, set back from the bank top will also promote greater flow energy within the channel during floods which is also likely to increase erosion.

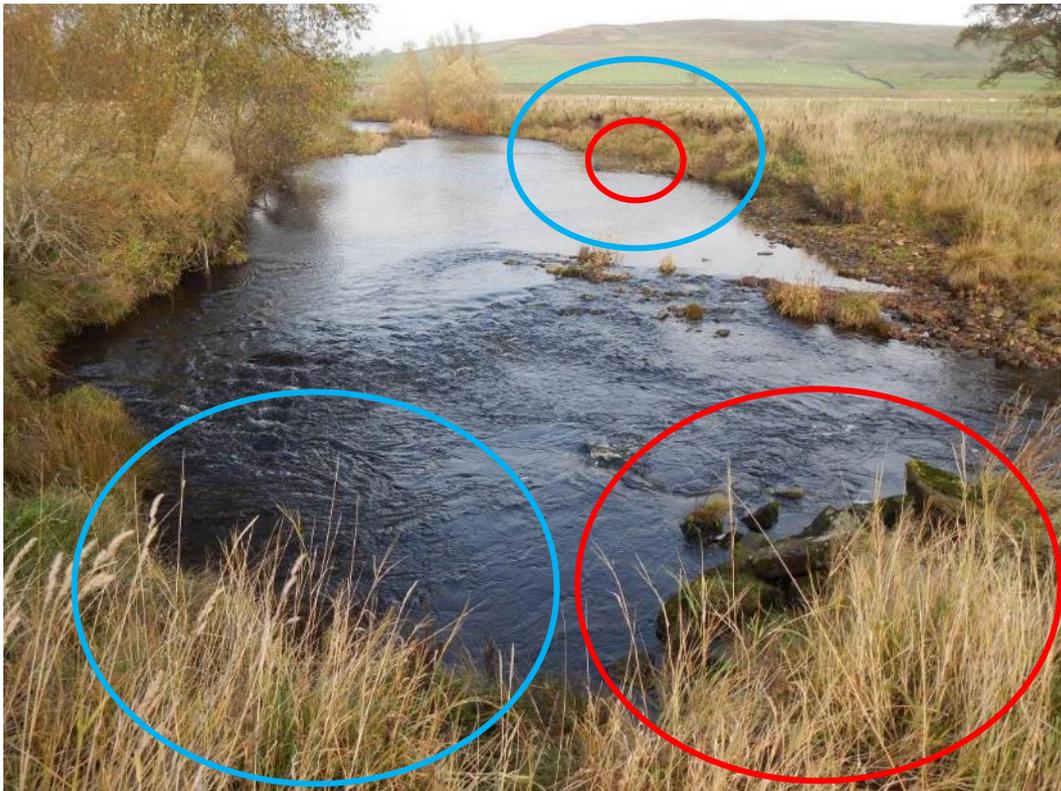
**Photo DSCN4998.** Around NY 86733 93783, what are suspected to be inappropriate cobble and boulder groynes (but could be the remains of attempts to protect the banks with rock) have been installed (red circles), which are greatly contributing to bank erosion and bank slumping (blue circles). The impact of the rocks in the foreground can be seen from an alternative angle in Photo DSCN4997.

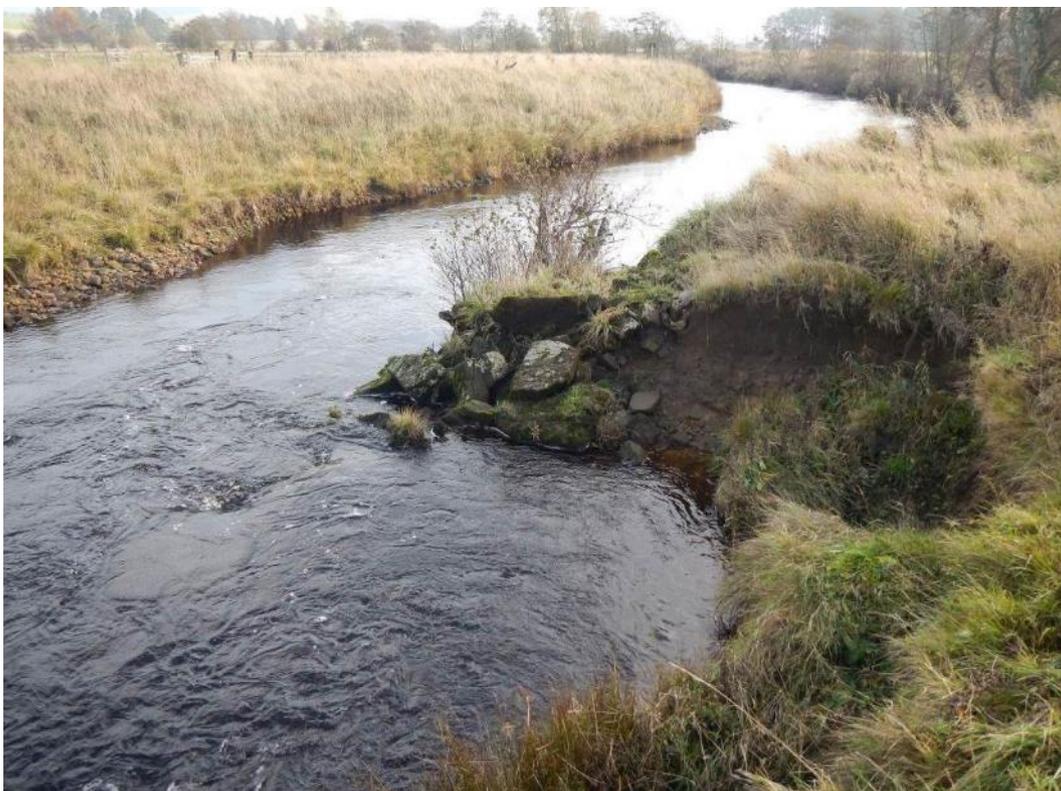
**Photo DSCN4997.** While the erosion created by the rocks is relatively localised, and creates some additional channel sinuosity and habitat diversity (so creates no significant detriment to the reach as a whole), more sympathetic, green habitat improvements that replicate more natural features could have created a far better end result.

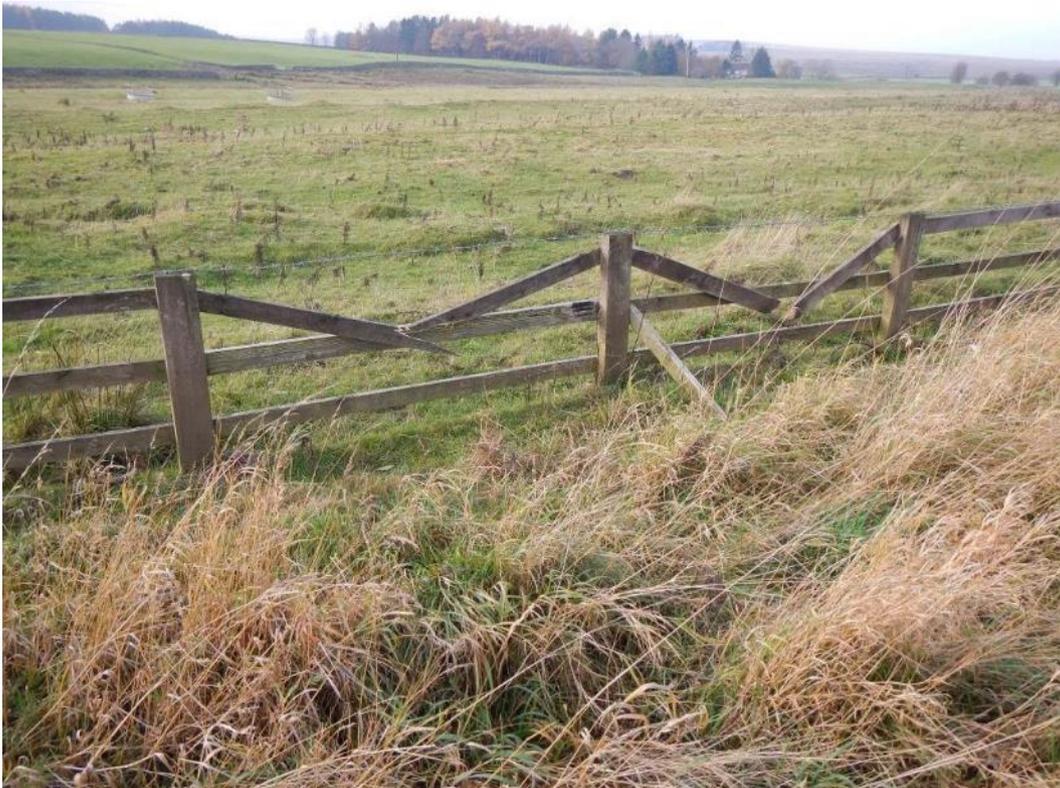
**Photo DSCN4995.** In many areas, sections of post and rail fencing have been installed (instead of the more generally used post and wire) to protect susceptible areas from flood damage. These appear to have worked but are now well into their effective lifespan and the top rails appear unable to withstand pressure from cattle, which were not observed during the visit but almost certainly caused the damage.

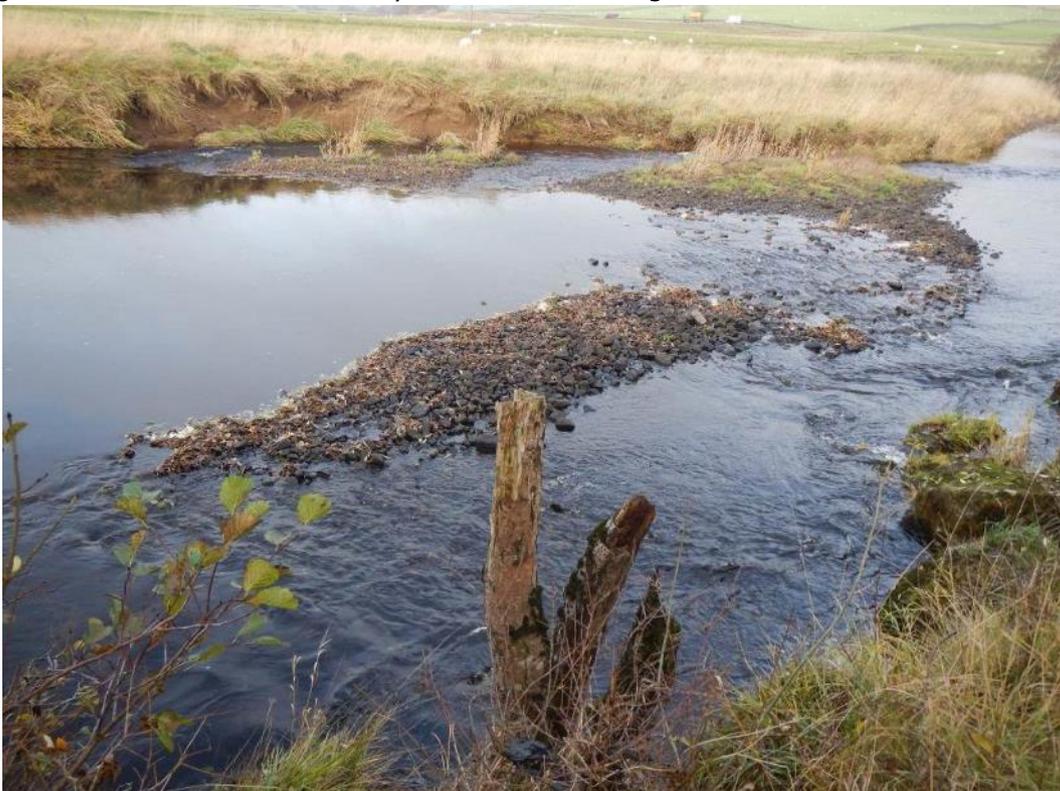
**Photo DSCN5009.** A potential spawning site, provided by the characteristic lift at the tail of the pool that salmonids favour. The range of graded substrate sizes here 10-60+mm is ideal for a range of fish sizes, from <0.5kg upwards. Note the lack of trees along the far (LB), both along the bankline and further back from the river. Additional overhanging and trailing cover would greatly enhance the spawning habitat (and habitat in general).

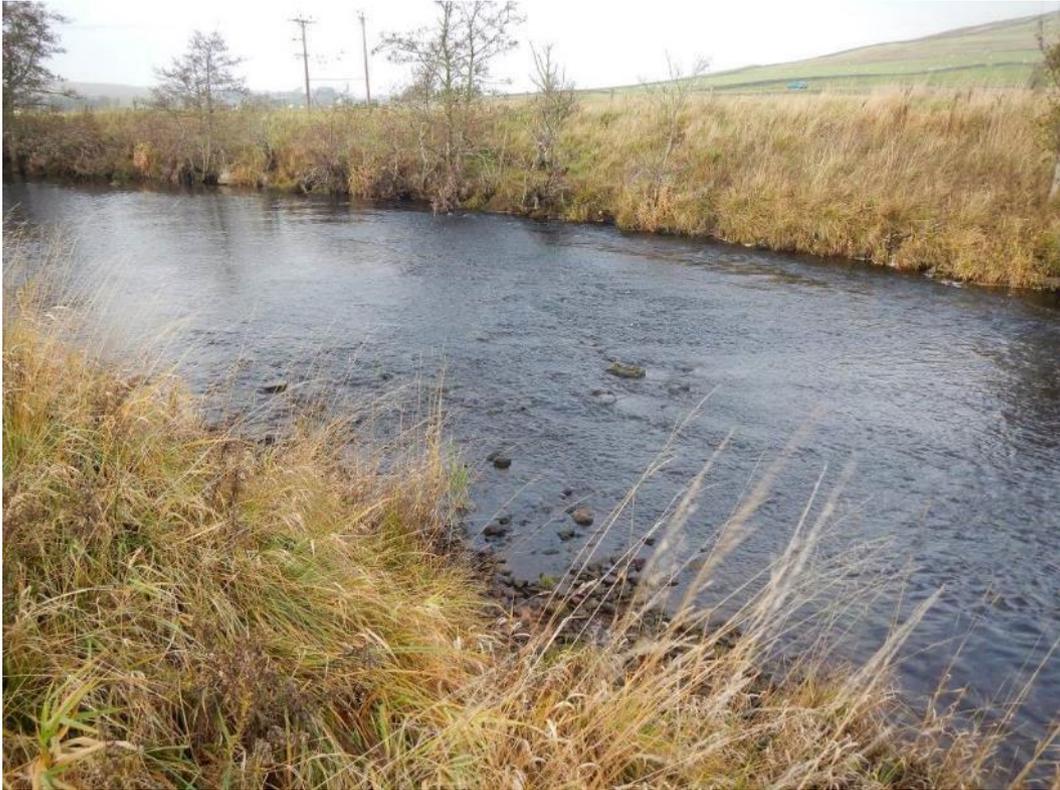
**Photo DSCN5013.** More valuable cobble riffle habitat: this area being suited to larger migratory fish - some of which were observed at the site.

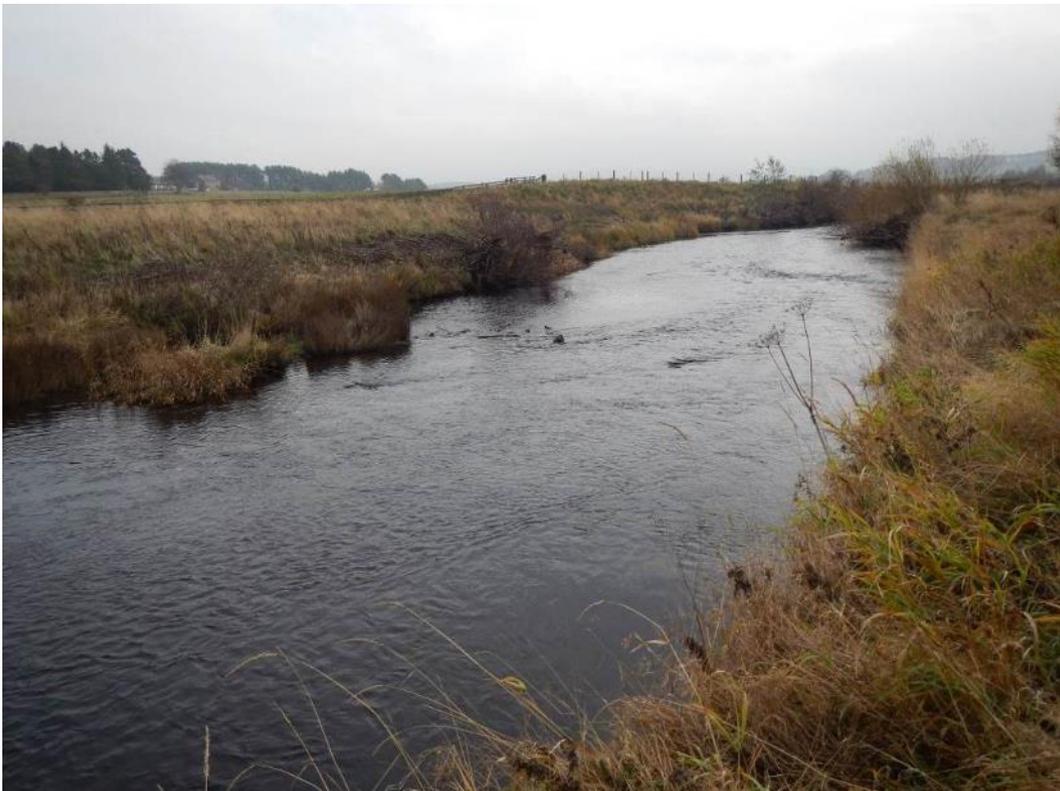
**Photo DSCN5020.** Continuing around the bends in this more sinuous section of channel, valuable pools, riffles and glides provide a range of recovering, high quality juvenile and adult salmonid habitat.
