**Walkover Assessment**

**River Rede**

**(Elishaw to Otterburn)**

**06/11/2018**

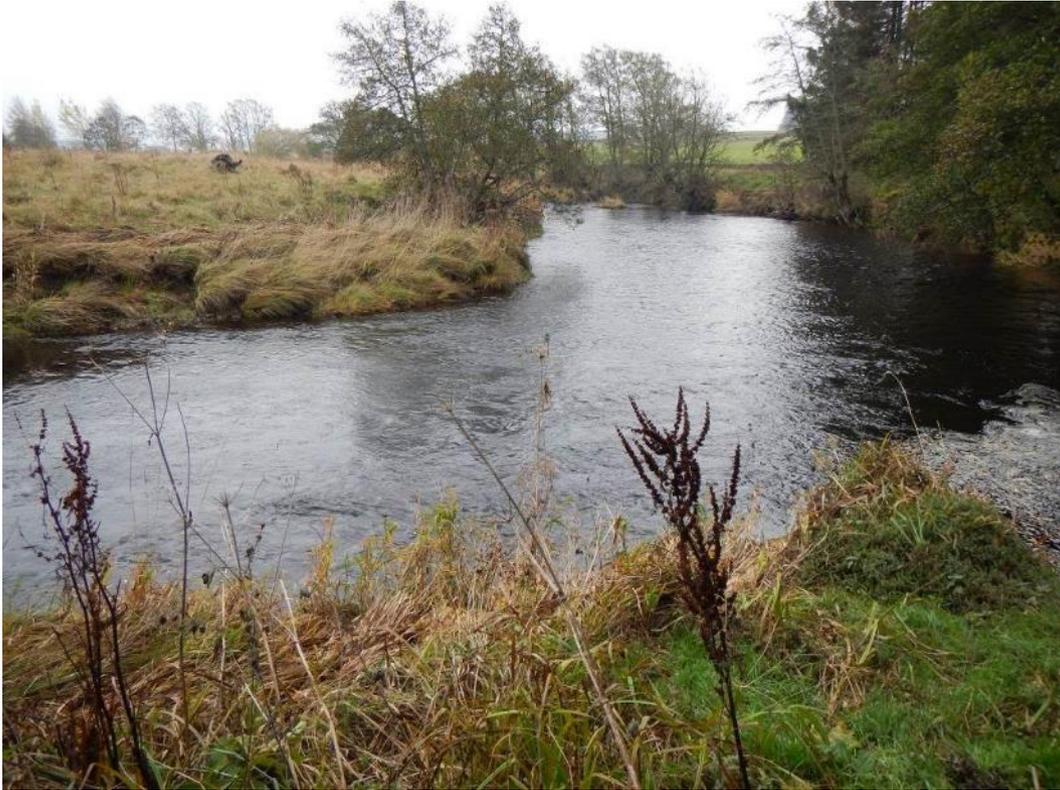
**Photo DSCN5032.** For a short section, the river flows alongside a small coniferous plantation, where longer term exclusion of livestock has allowed recolonisation by a broader range of vegetation. Some deciduous trees have also established (or been retained) along the river's edge, which are helping to limit bank erosion (even though it is a relatively tight outside bend) to a natural rate and driving scour into the bed to create a deep holding pool for larger migratory fish.

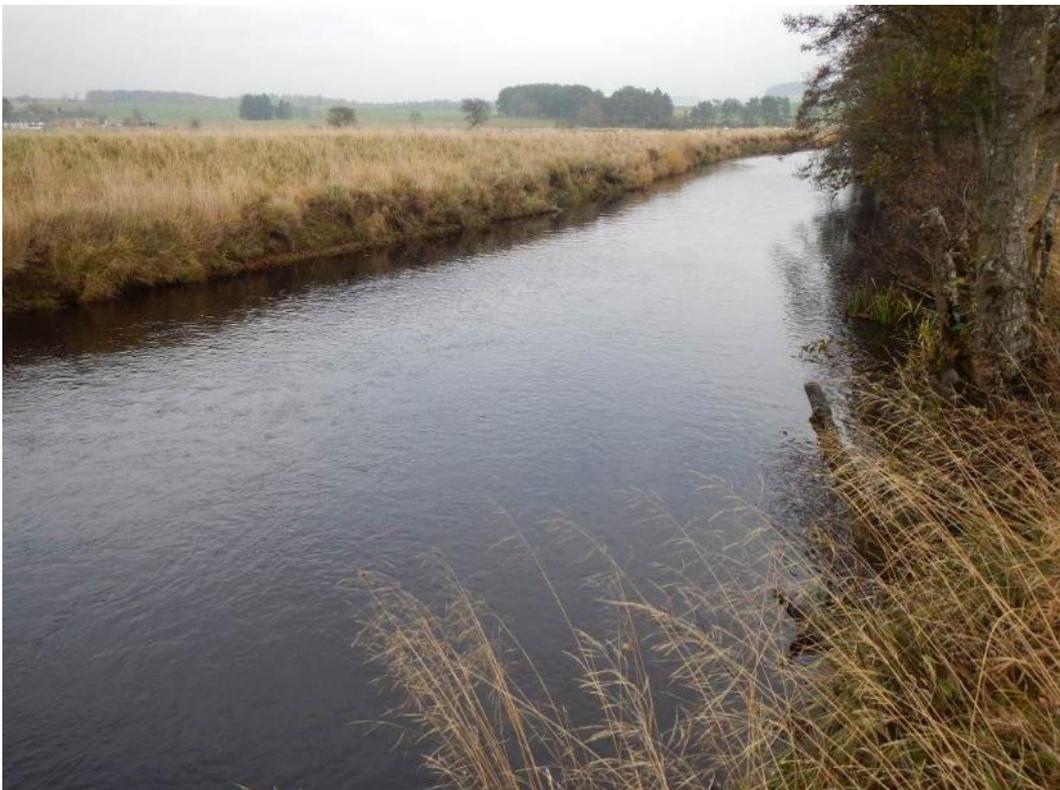
**Photo DSCN5039.** The section d/s of the wood appears very uniform and over capacity. This may be associated with past dredging of the channel and what appeared to be a raised embankment along the LB. Again, note the lack of trees along the LB.

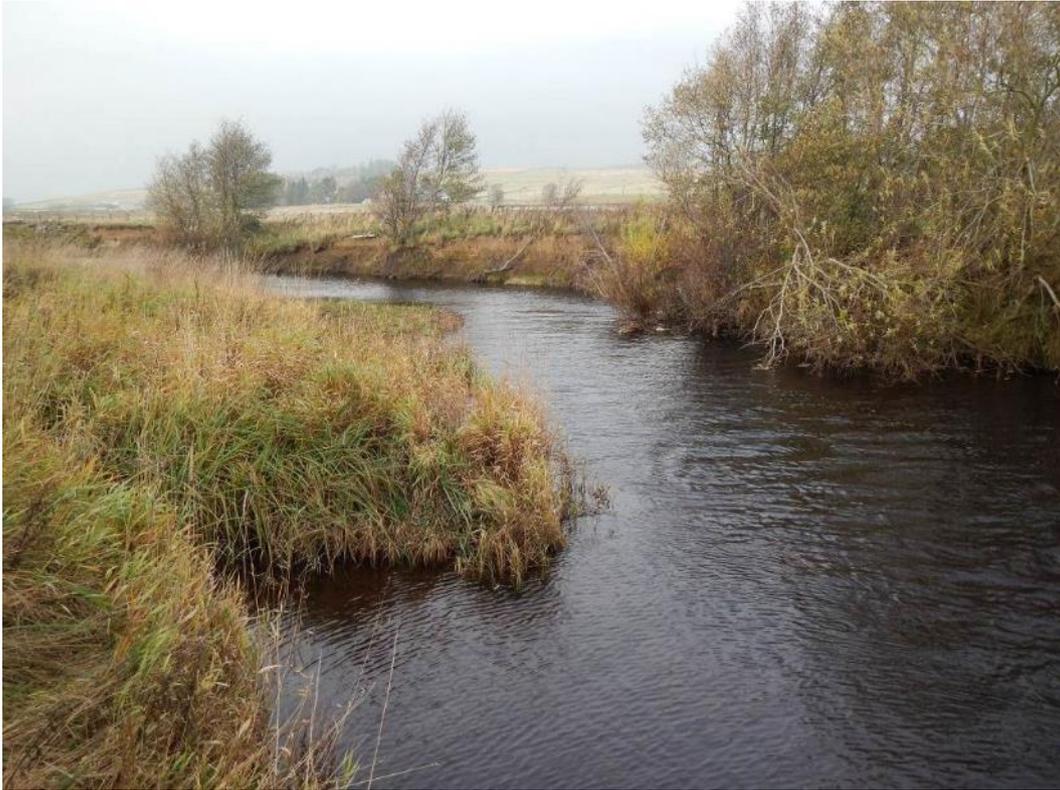
**Photo DSCN5047.** Trees at the bend d/s of the section provide good in-channel structure and help consolidate the bank, but many are now precariously close to being lost. The deep slow pool u/s is likely to interrupt sediment supply to this section which would certainly contribute to the erosion. If, as suspected, the pool was dredged historically, that rapid loss of sediment transport and interruption of d/s supply may have initiated the erosion, even though some sediment transport is now occurring (possibly on very high flows).

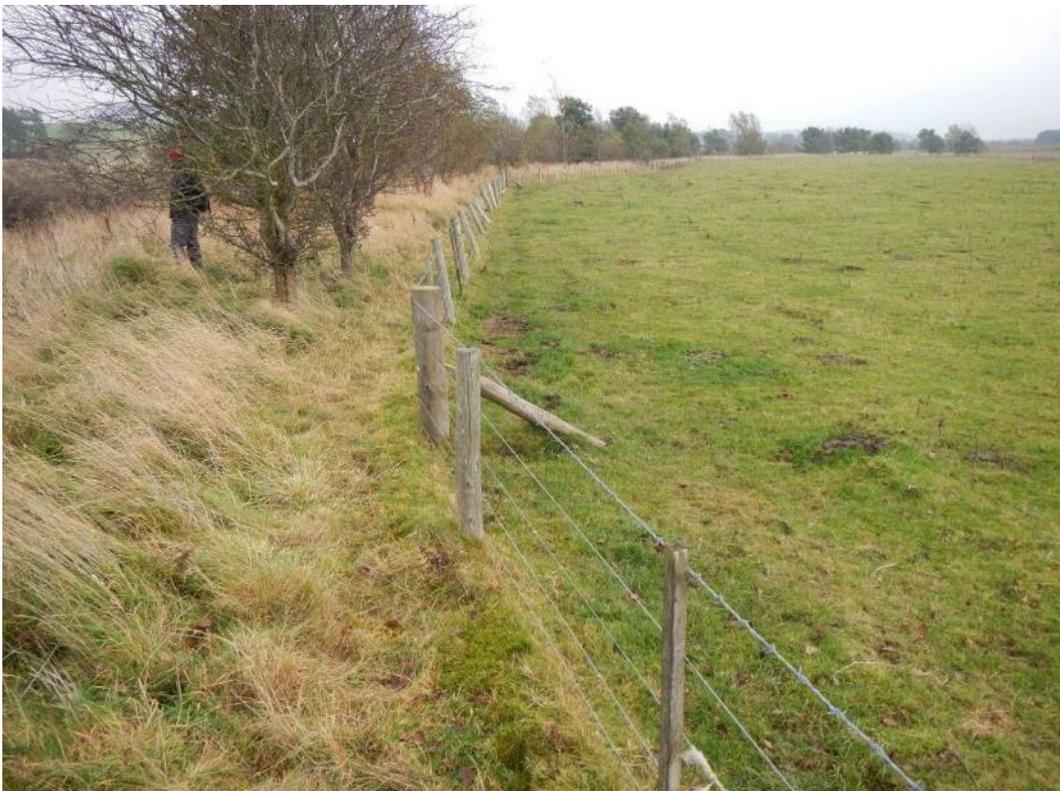
**Photo DSCN5045.** Fencing on the RB in the field d/s of the plantation is old and no longer stock-proof, with many posts now rotten and leaning (NY 87172 93348 - NY 87641 93245). Stock may be accessing the d/s end of the plantation from this field. Additional wire strands and/or stock netting (where appropriate) would better protect the buffer strip.

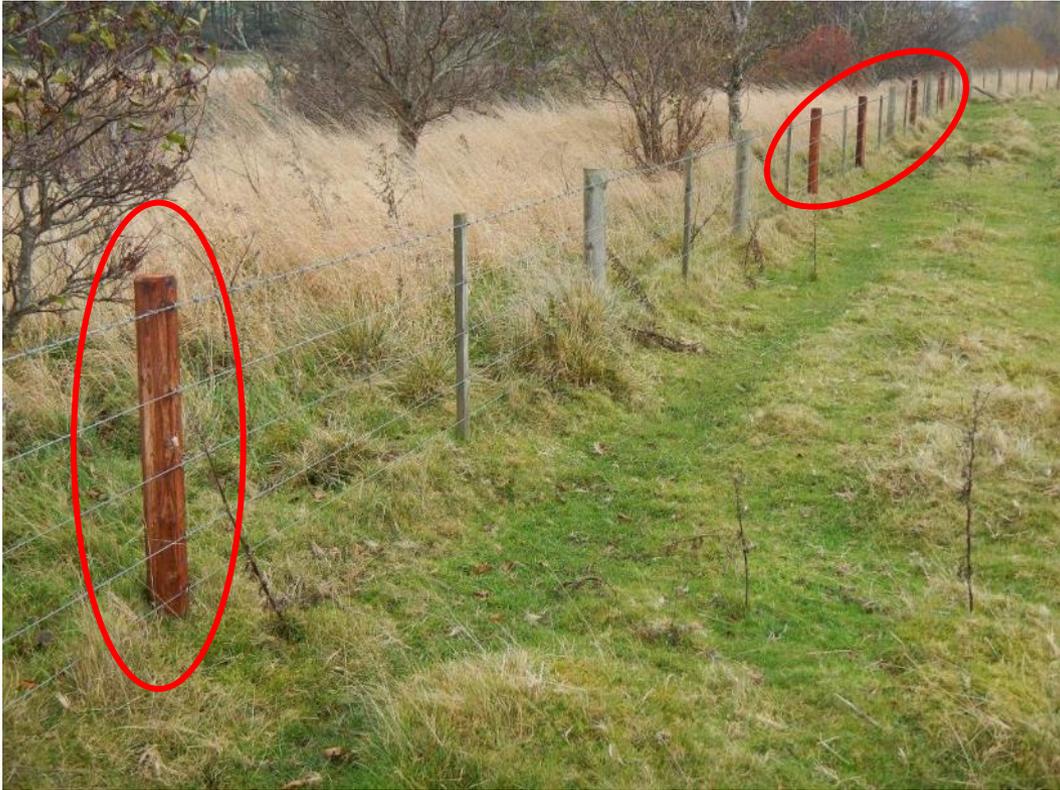
**Photo DSCN5055.** The fence in the next field d/s (NY 87668 93225 - NY 88143 92949) appears to have been in a similar state but has relatively recently been renovated with the replacement of many posts (red ellipses) although some rotten posts did appear to have been missed.

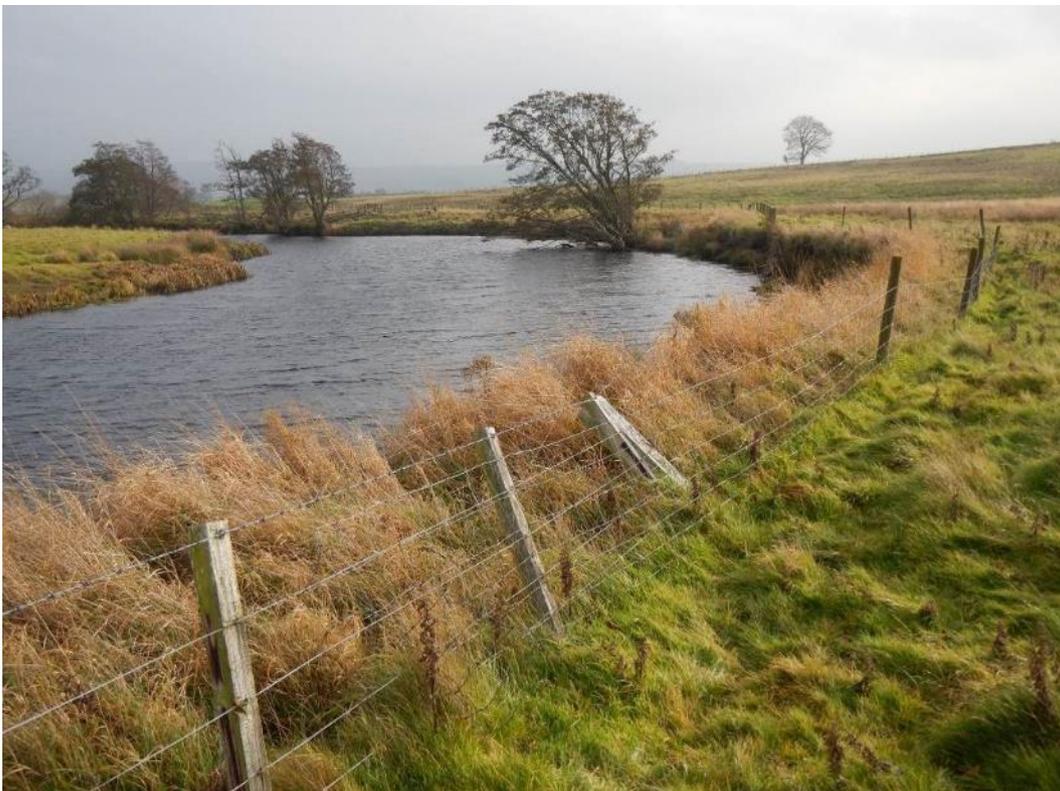
**Photo DSCN5070.** The fence in the next section d/s on the RB is in need of repair, ideally replacement (NY 88143 92949 - NY 88333 92714), and is falling over in several areas. The river has eroded laterally and undermined the fence, which has been replaced with a temporary section. By this point, the river is already impounded by Otterburn Mill weir and in-channel habitat is severely degraded for the river's native flow-loving species.

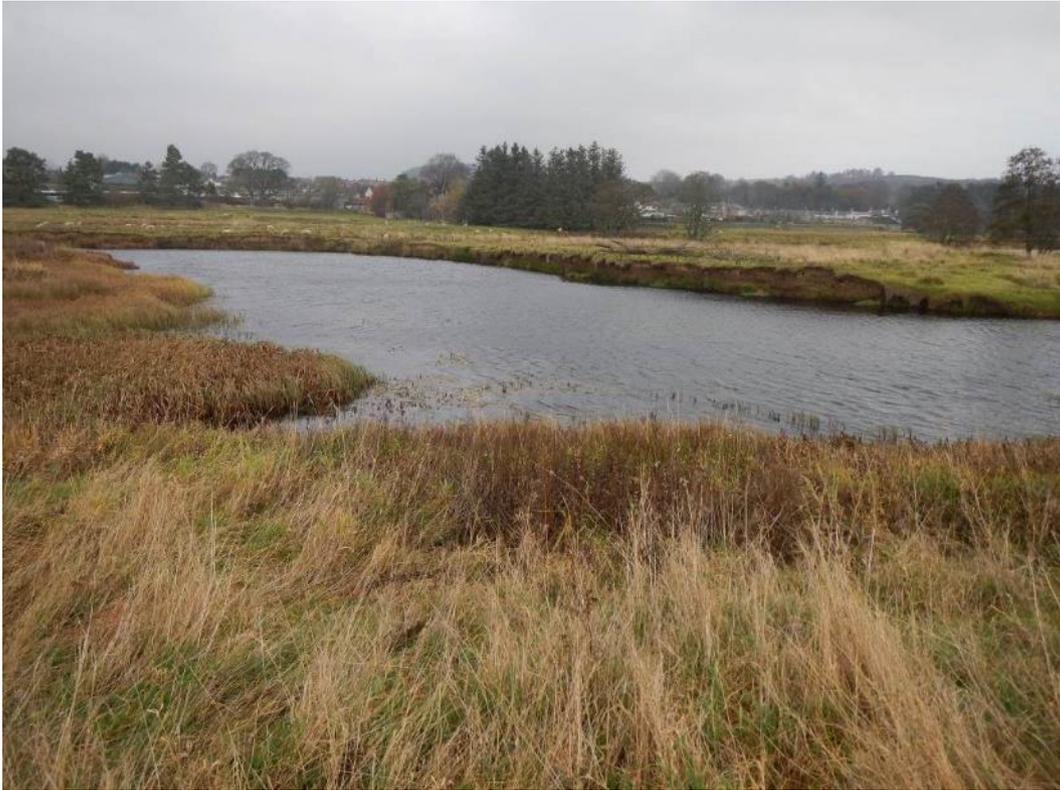
**Photo DSCN5066.** The LB is unfenced which is further exacerbating erosion issues (NY 88107 93106 - NY 88500 92965).

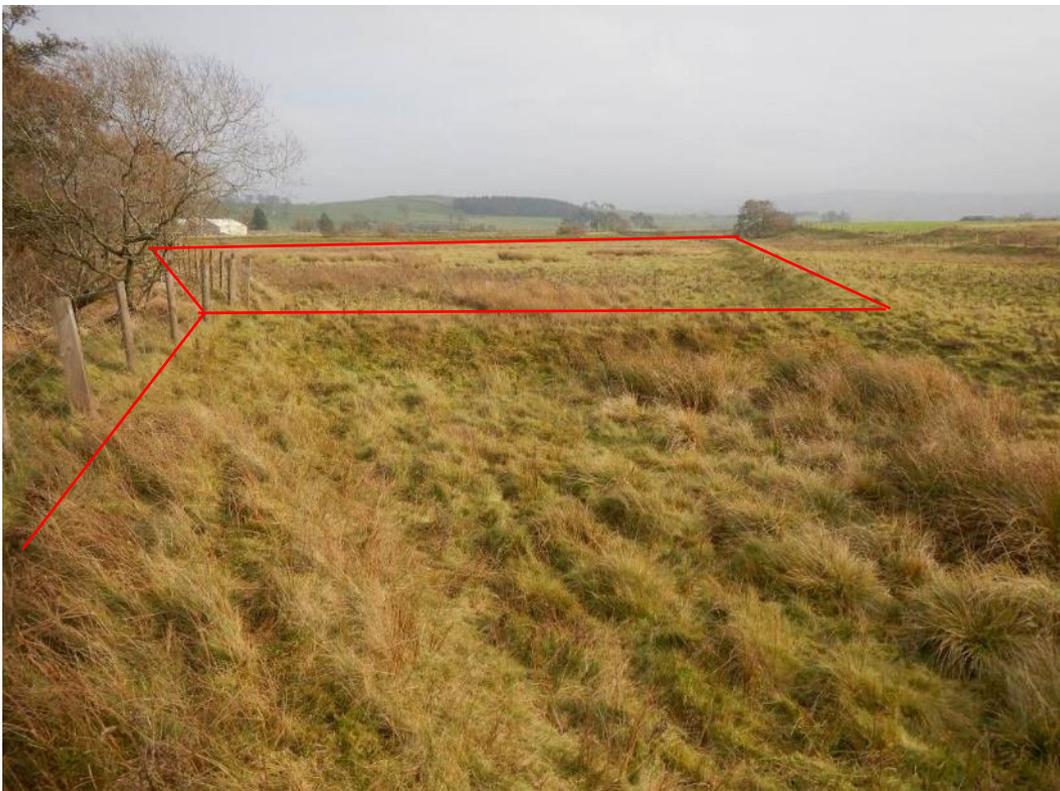
**Photo DSCN5076.** The field alongside Otterburn Mill Weir is encompassed by floodbanks (red line), suggesting an additional impact from the weir upon flooding. The first ~260m of the field is fenced but the majority d/s to the B6320 road bridge (NY 88333 92714 - NY 88841 92658) is unfenced, with the riverbanks suffering from severe erosion and slumping in many areas d/s of the weir.

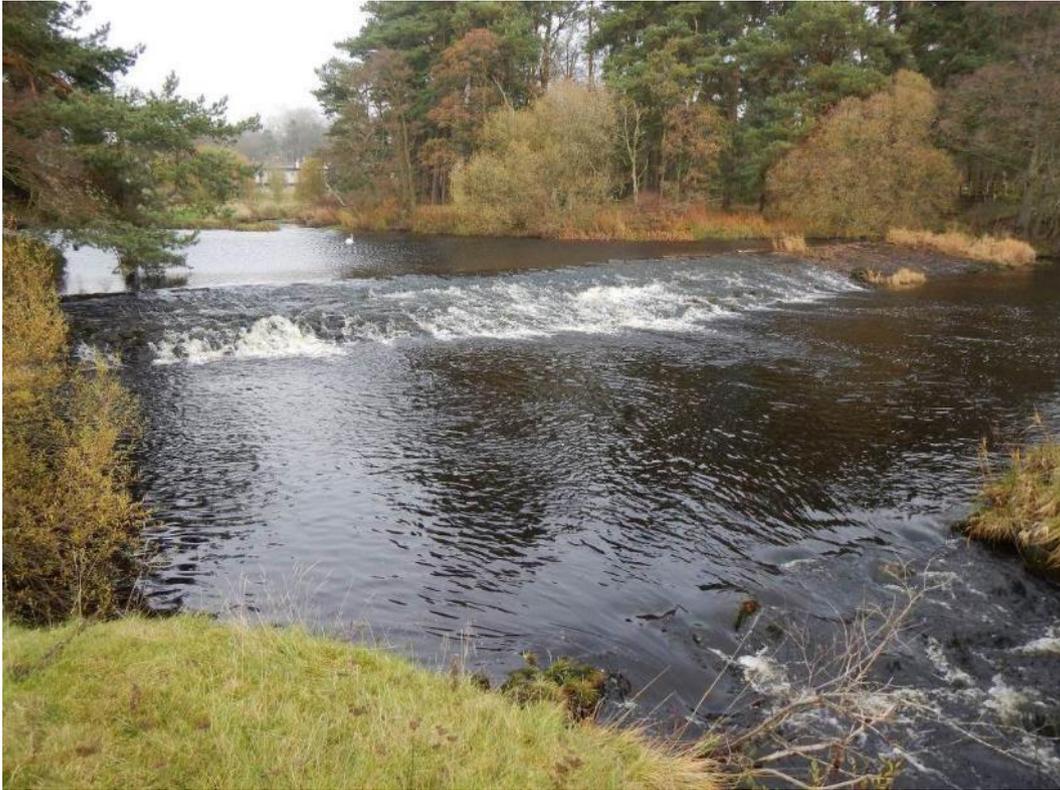
**Photo DSCN5080.** Otterburn Mill Weir (NY 88575 92884) is a >1m stone sett obstruction that limits the timing and ability of fish to pass u/s and d/s. The impoundment degrades over 1.5km of habitat u/s and interrupts the river's natural sediment supply, contributing to channel incision and erosion d/s. This is particularly pertinent with reduced sediment supply and transport, as highlighted in various previous reports for the River Rede.

1	NY 88575 92884	Options to remove both weirs at this location should be fully investigated, to allow natural fish movement and alleviate the degradation of >1.5km of river habitat u/s (and any impact d/s).

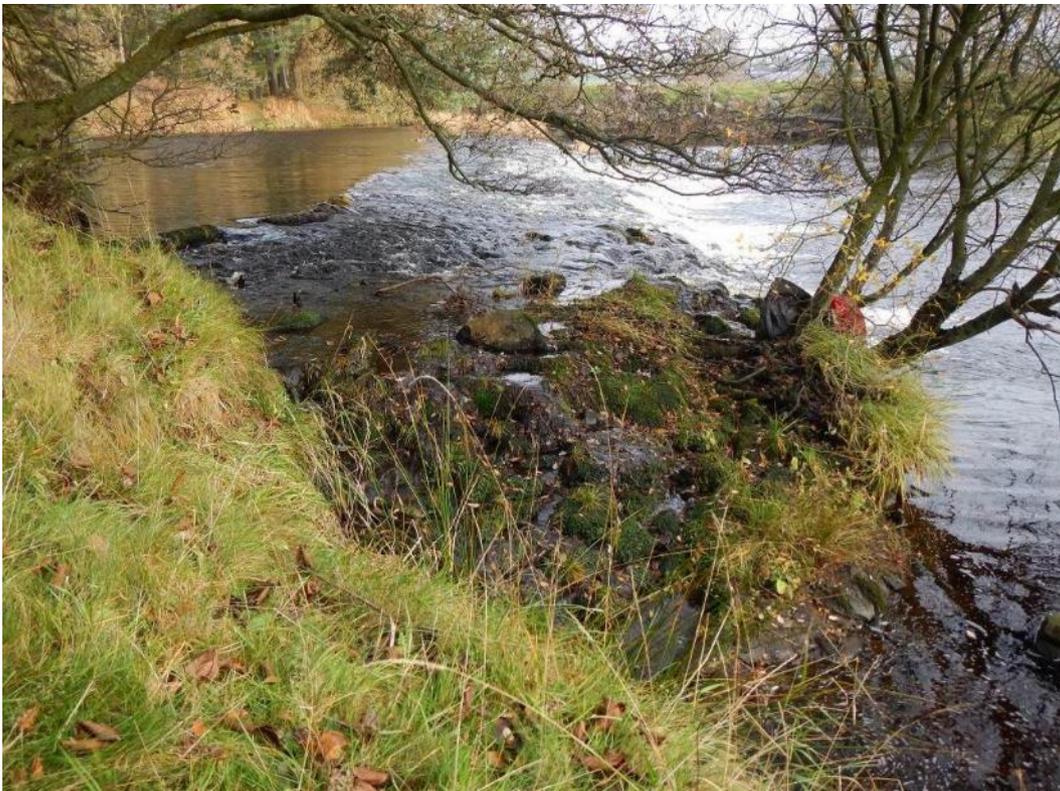
**Photo DSCN5078.** While not being a complete barrier to all fish, the weir is an obstacle to most fish, under the majority of flow conditions. As well as the impacts upon u/s fish migration and dispersal, numerous studies show that artificially impounded reaches can result in up to 80% mortality of emigrating smolts. This is aside from the general increased fish mortality experienced in the vicinity of any obstruction.

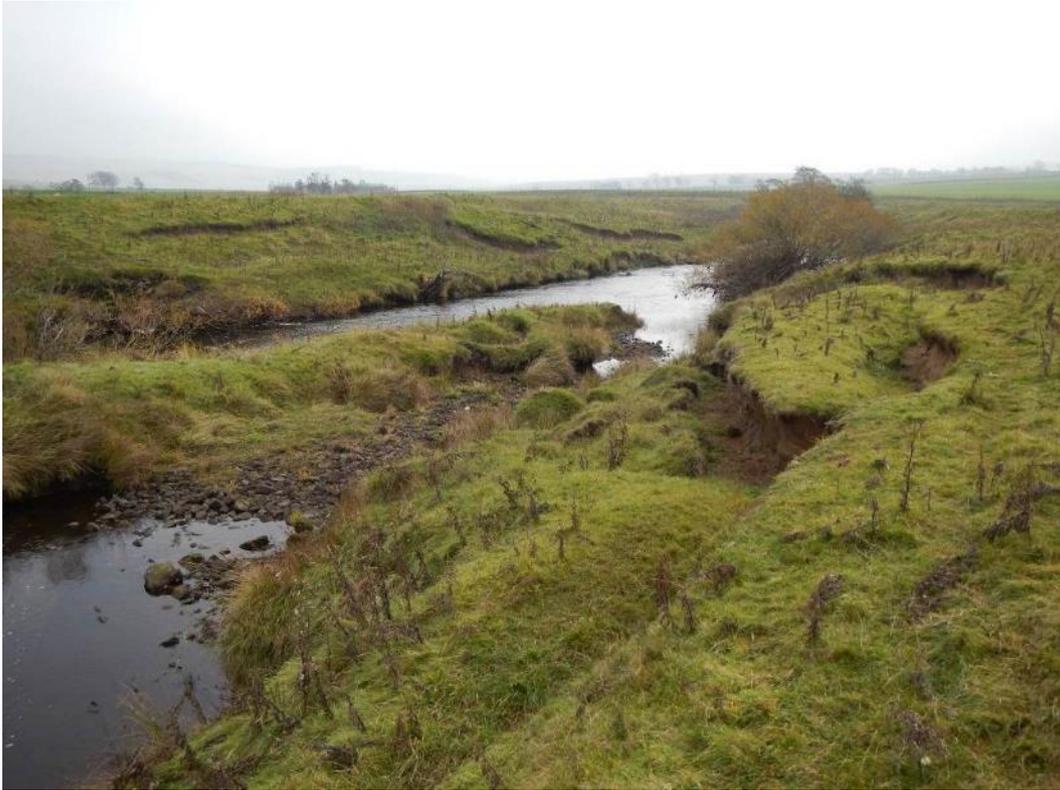
**Photo DSCN5081.** Channel incision, bank slumping and erosion d/s of the weir which is exacerbated by interrupted sediment supply through the impounded reach, coupled with livestock trampling and excessive grazing pressure. Note the sheep scarring not only weakens the bank but is preventing them from adequately re-vegetating, consolidating and re-grading.

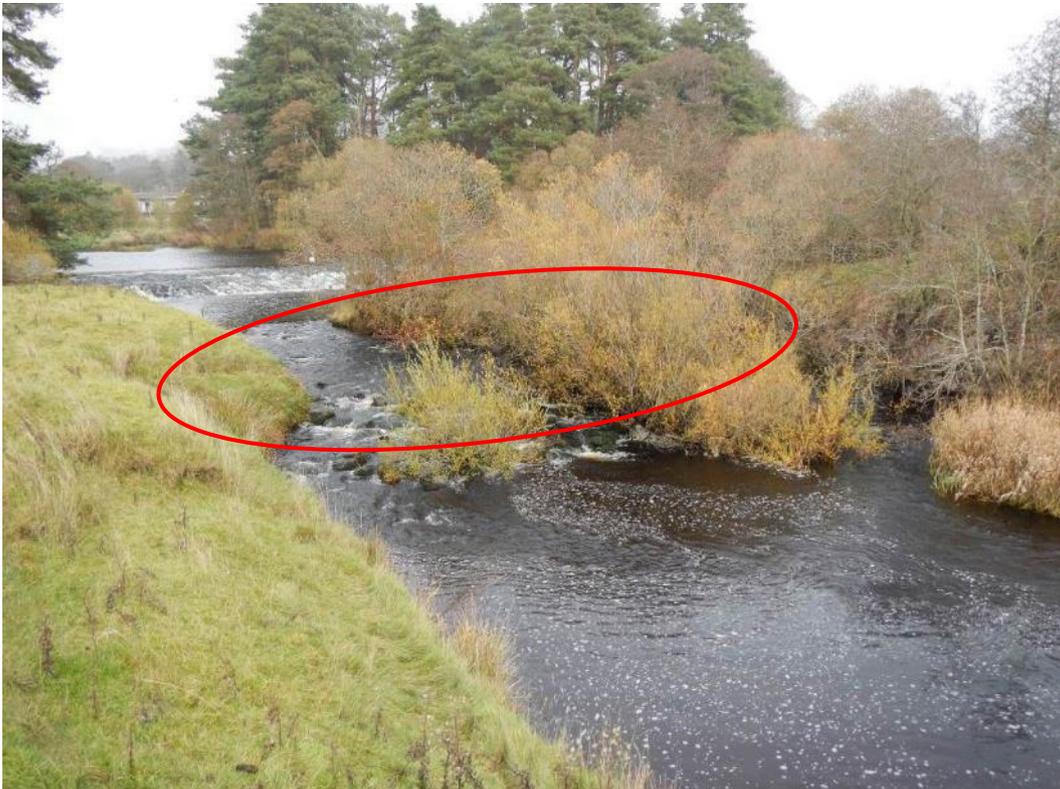
**Photo DSCN5083.** A smaller weir, immediately d/s of the larger weir creates less of an issue and does ease access over the larger weir; however, with current understanding of the major detriment weirs create to riverine ecosystems and hydromorphology, all man-made obstacles should be removed from river channels wherever possible. However, it will be important to ensure that the main weir is removed first.

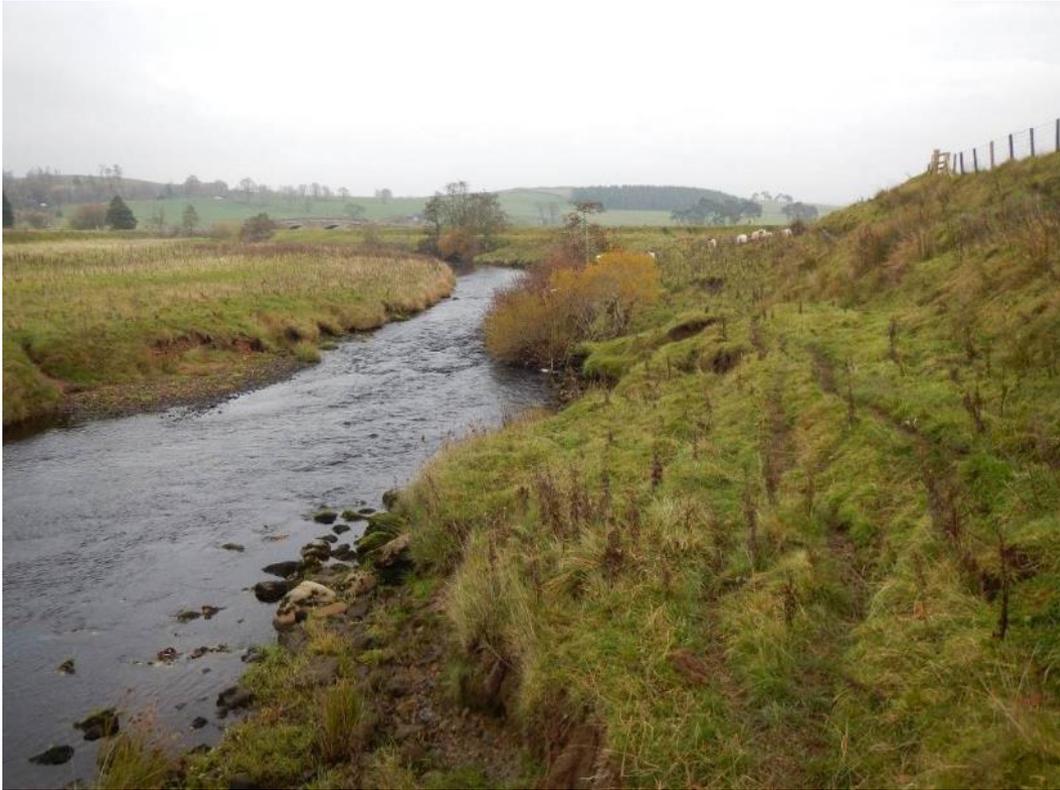
**Photo DSCN.** The LB is also unfenced d/s of the weir, to the B6320 road bridge (NY 88617 92886 - NY 88841 92658). The channel in this area provides some habitat variability but the river margins are severely degraded when compared to the buffer fenced sections upstream. Occasional trees provide better quality habitat locally but the area is notable underperforming, with excessive bank erosion and a lack of regeneration ultimately threatening the few trees that do remain.

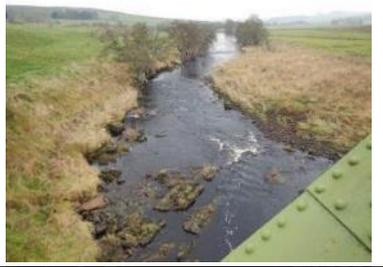
Observation	Photo (If required)	Priority (1-3)	Location	Proposed action
Suitable stock fencing (RB).

3	NY 85985 95065 - NY 86137 94832	Ensure fencing is maintained.
Completely ineffective stock fencing (LB).		2	NY 85985 95065 - NY 86152 94866	Install appropriate buffer fencing to exclude livestock from the riverbank.
Lack of buffer fencing (RB).

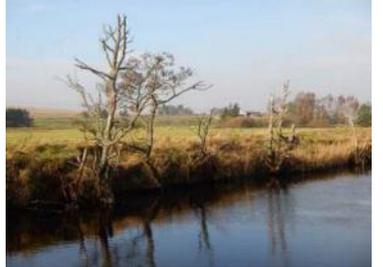
1	NY 86137 94832 - NY 86280 94573	Install appropriate buffer fencing to exclude livestock from the riverbank.
Lack of buffer fencing (RB).

2	NY 86280 94573 - NY 86435 93963	Install appropriate buffer fencing to exclude livestock from the riverbank.

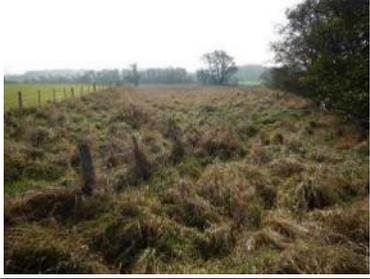
<p>Long &gt;2.7km section of buffer fenced riverbank (LB).</p>

<p>2</p>	<p>NY 86364 94405 - NY 88107 93106</p>	<p>Ensure fencing is maintained. Much of this section was not inspected due to the walkover being conducted from the other bank in this area. It should be ensured that the fence is stock-proof.</p>
<p>Old poorly stock-proof buffer fence (RB).</p>

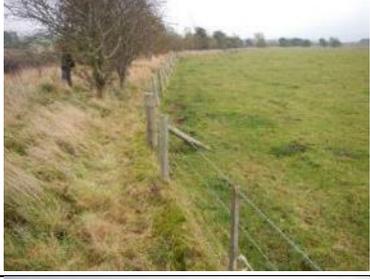
<p>2</p>	<p>NY 86435 93963 and NY 87145 93536</p>	<p>Ensure fencing is maintained stock-proof and ideally replaced.</p>
<p>Old poorly stock-proof buffer fence (RB).</p>

<p>2</p>	<p>NY 87172 93348 - NY 87641 93245</p>	<p>Ensure fencing is maintained stock-proof and ideally replaced.</p>
<p>Old poorly stock-proof buffer fence (RB).</p>

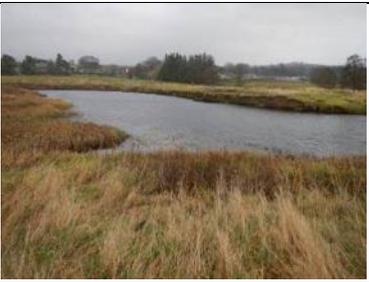
Lack of buffer fencing (LB).

2	NY 88107 93106 - NY 88500 92965	Install appropriate buffer fencing to exclude livestock from the riverbank.
Lack of buffer fencing (RB).

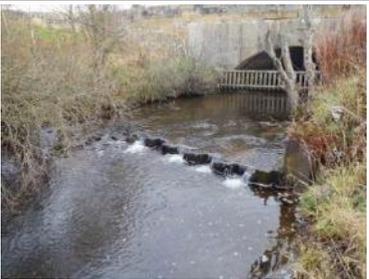
Observation	Photo (If required)	Priority (1-3)	Location	Proposed action
Obstacle to fish movement.

2	NY 86213 94872	This is a low priority as obstructions go, owing to the limited impact; however, improvements could easily be made with the installation of baffles to increase the water depth over the footings and focus attraction flow.

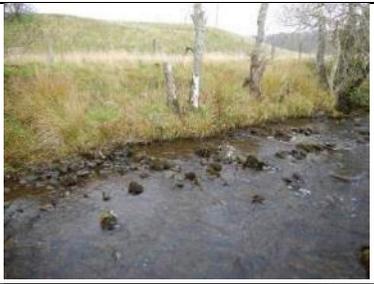
Suspected fine sediment input on Durtrees Burn.

2	NY 86158 94847	Further investigation of the waterbody u/s.
Significant potential for planting (LB).

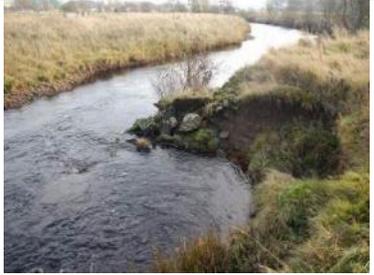
2	NY 86364 94405 - NY 88107 93106	The >2.7km long section of buffer fence area offers an opportunity for tree planting, with additional potential in the particularly wide section (NY 86372 94251 - NY 86654 93907) if the landowner is amenable.
Inappropriate in-channel structures/rocks.

2	NY 86733 93783	Ideally, these structures should be removed, although the erosion created means that they may well disintegrate if left alone. In-channel structures and/or bank protection should not be installed without seeking appropriate advice.
Major obstruction to fish movement.
