Advisory Visit
Afon Rhiw, Powys
September 2012

Introduction

This report is the output of a site visit undertaken by Tim Jacklin of the Wild Trout Trust to the Afon Rhiw / River Rhiew, at Lower House, near Berriew, Powys on 6th September, 2012. Comments in this report are based on observations on the day of the site visit and discussions with Mr. Woodruff (landowner), Mike Morris (Senior Projects Manager, Severn Rivers Trust) and Jason Jones (Fisheries Officer, Environment Agency Wales).

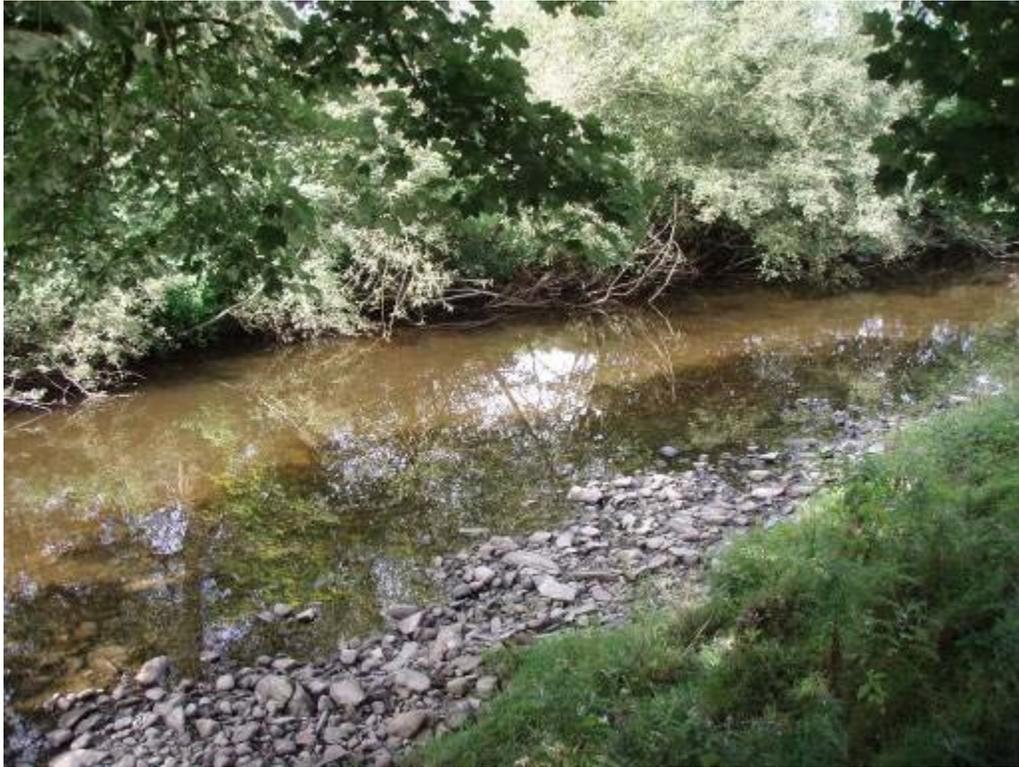
The section was walked in a downstream direction. The Rhiw has a moderately steep gradient of approximately 1 in 280 or 0.36% over the section inspected. The bed substrate is predominantly coarse sediment (cobble and gravel) and in-stream habitat is largely shallow glides and riffles (Photos 1, 3, 5), with a dearth of deeper pools (only three noted over the whole section).

Photo 1 Glide indicating how base flow water levels are reported to be much lower than 30 years ago; typically they would have covered all the exposed bed substrate. Very good low cover is present over the water on the far bank.

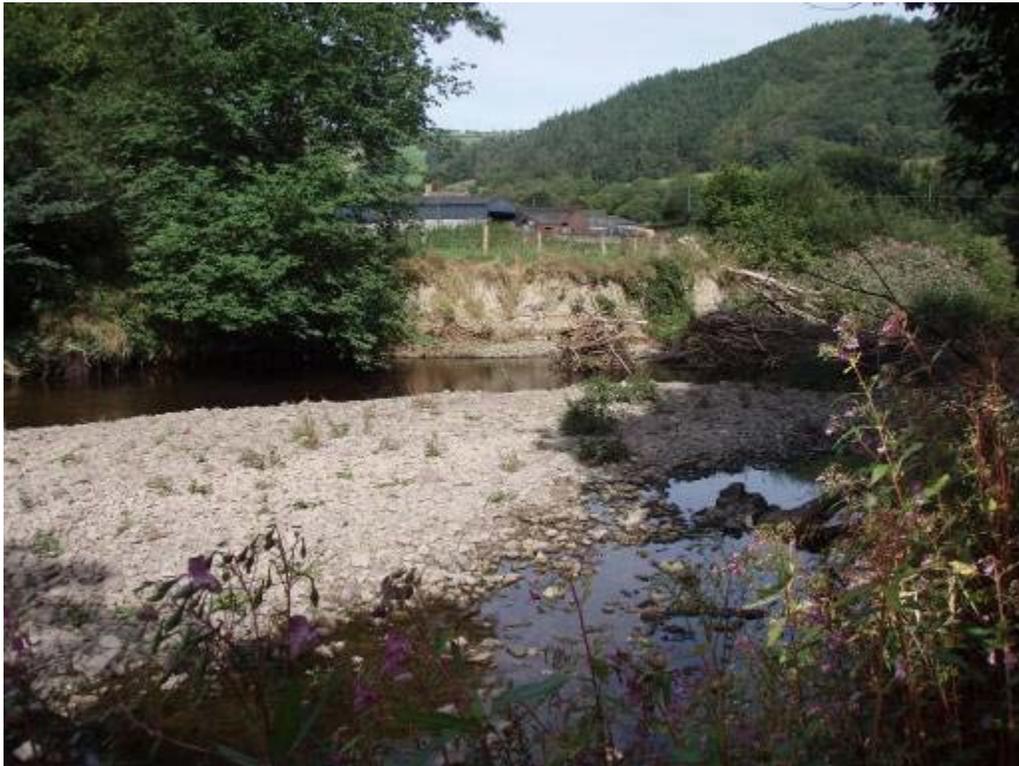
In contrast to other parts of the river (as observed on the day and on aerial photography), considerable lengths of the section inspected had a much wider river channel (bank-full width) and contained large gravel bars and islands, comprising coarse gravel (Photos 2-5). In these areas, active bank erosion was taking place.

Photo 2 Former deep pool area now filled with large quantities of coarse sediment. Bank erosion and tree loss occurring on the outside bank.

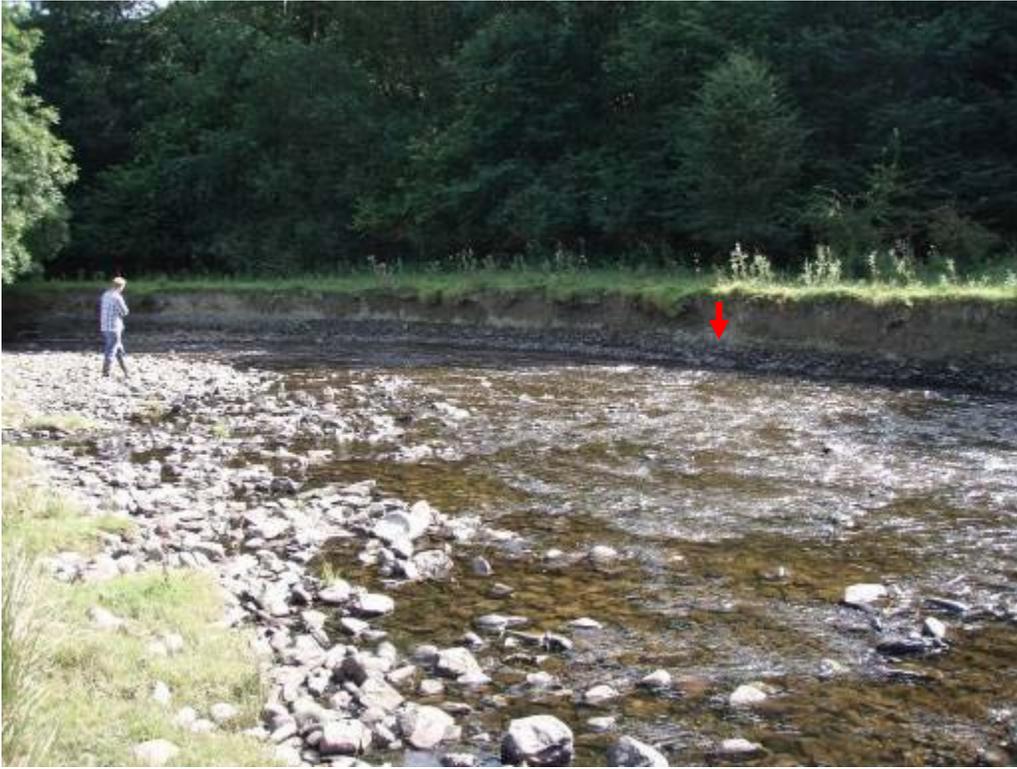
Photo 3 Top of the gravel seam (arrow) indicates the former bed level of the river and that down-cutting and subsequent lateral erosion may have occurred as a result of changed hydrology and/or channel shortening (meander cut-off).

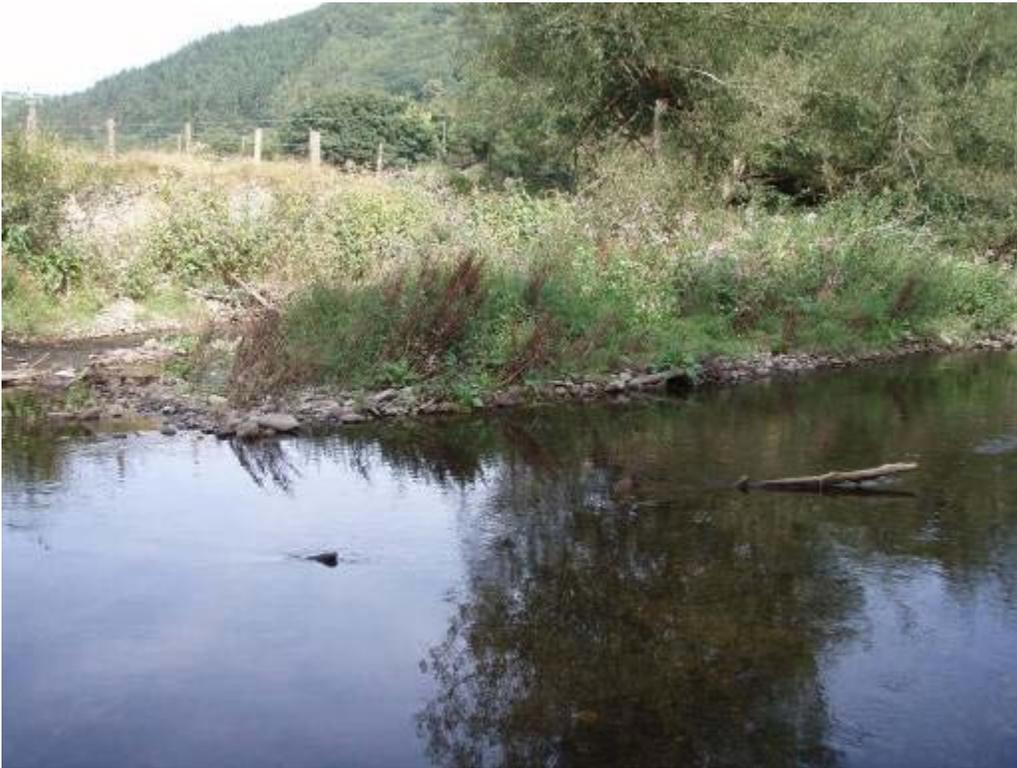
Photo 4 Vegetated gravel island

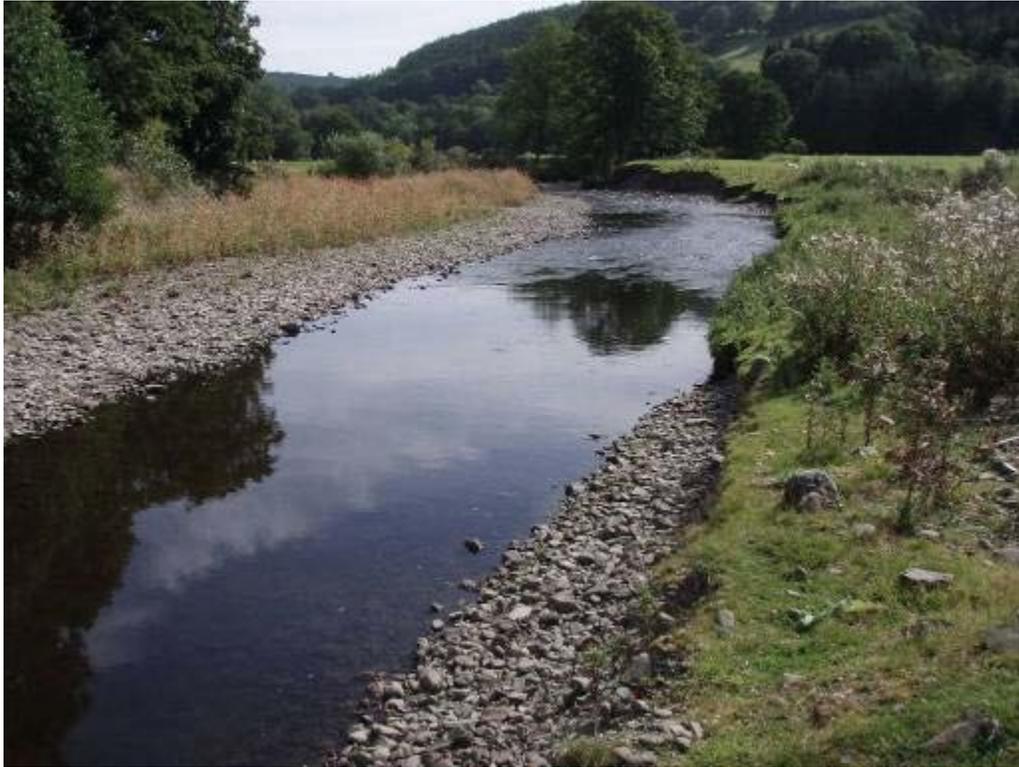
Photo 5 Over-wide, shallow channel with coarse sediment deposition and bank erosion. Lack of cover and depth makes this a poor habitat for salmonids.

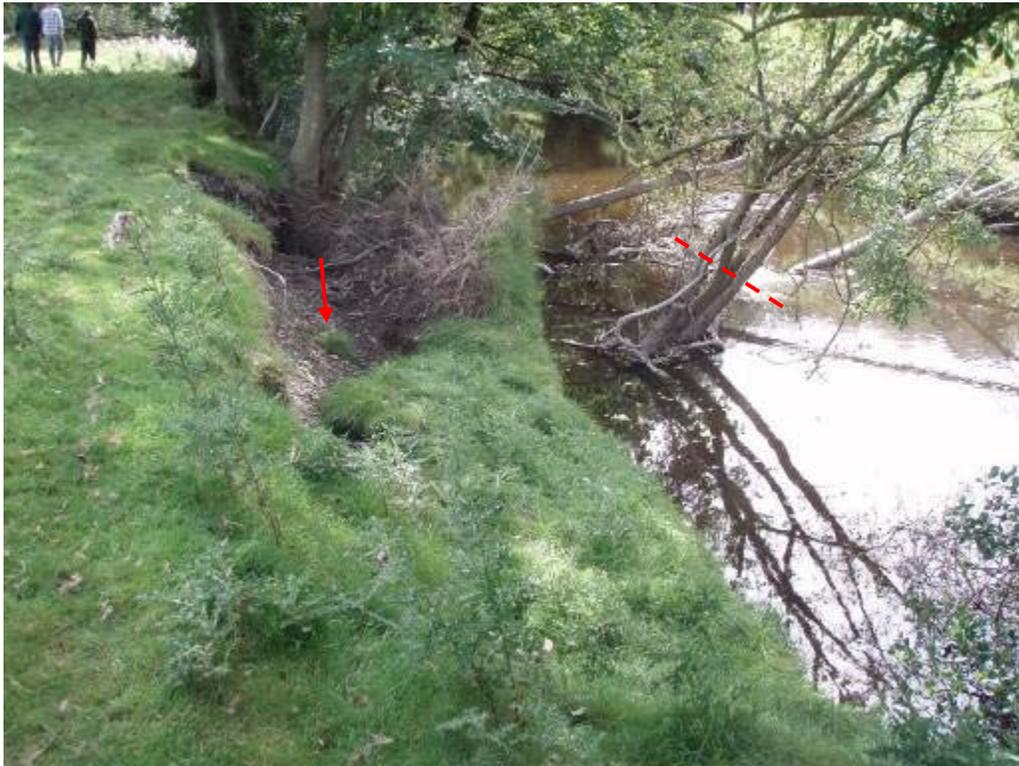
Photo 6 Slumping banks and loss of trees and bank stability – ultimately this will lead to channel widening and a scenario similar to Photo 5. Retention of submerged woody debris (below dashed line) and packing of bank (arrow) with the remainder (plus bay-leaved willow bundles) will help to retain stability (if protected from grazing).

There were a number of examples of leaning and collapsed trees (Photo 6) where the down-cutting and lateral erosion described above is undermining the root systems. If left unchecked, the loss of trees will greatly reduce the bank's resistance to erosion leading to channel widening and shallowing, like the areas in Photo 5. In these open sections of river, the shallow, exposed water provides poor trout habitat and will hold few fish of any life-stage. It is therefore important to try and prevent the loss of trees (see recommendations); where this has already occurred it is recommended that soft revetment techniques are used to stabilise the banks and provide some dense marginal cover for juvenile trout and salmon. These areas must be subsequently fenced to exclude livestock (including sheep) and trees encouraged to establish; this is vital if long-term bank stability is to be achieved.

Stabilise areas where trees may be lost. Trim the collapsed trees (Photo 6) and pack the bank behind the root mass with woody debris and willow bundles. Coppice leaning trees and use to make tree kickers (see appendix).

- Six tree kickers
- Six log flow deflectors
- Bank revetment associated with Photo 6

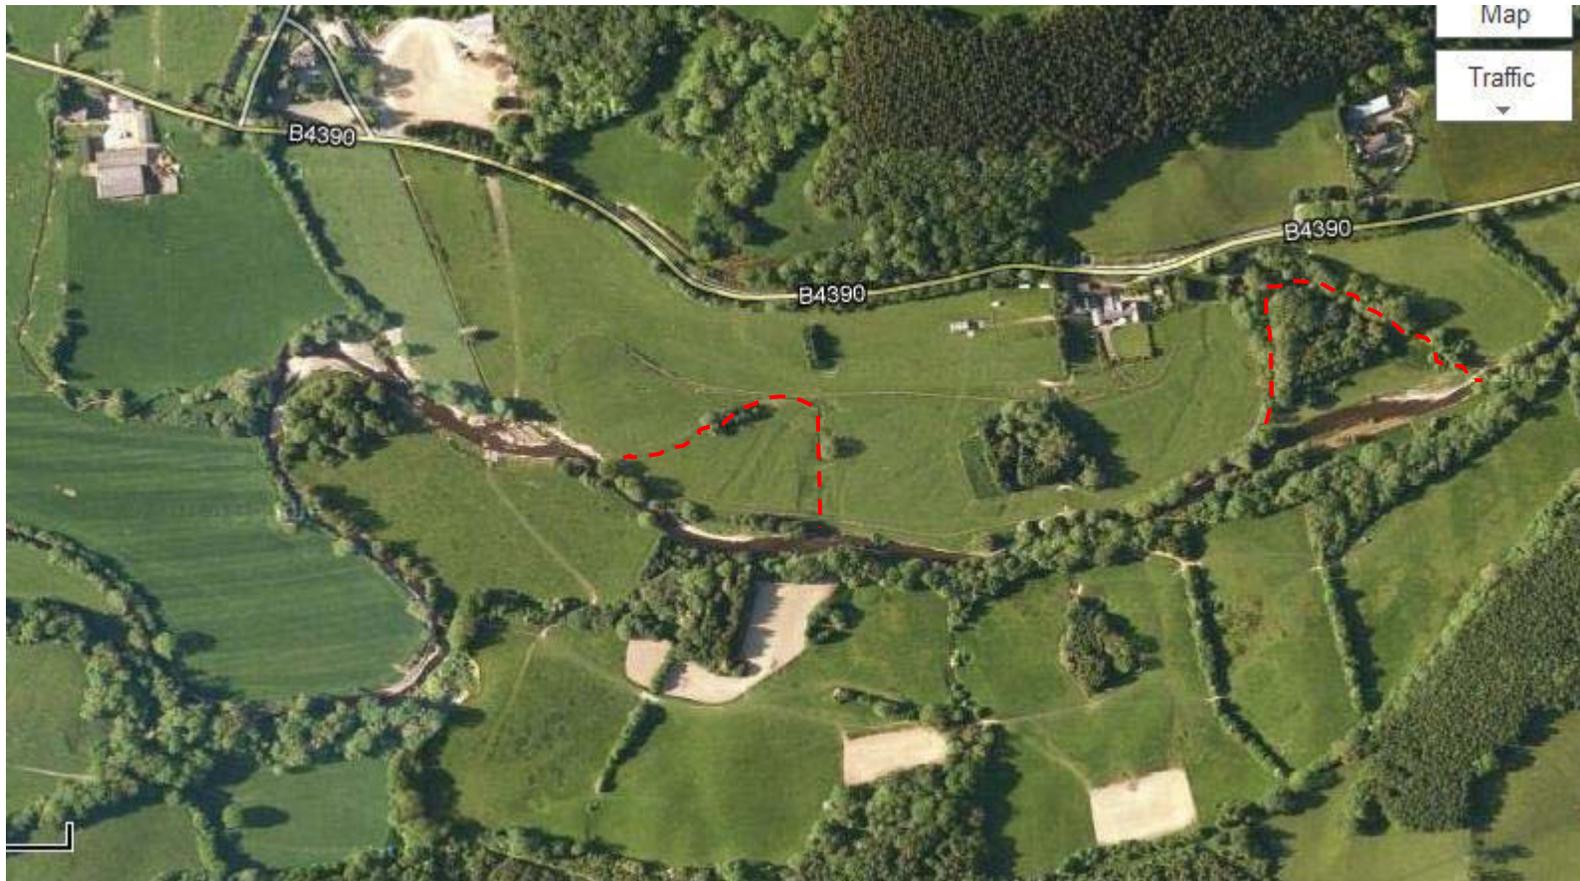
Inspection of aerial photography (Google Earth) suggests that channel changes in the immediate vicinity may also be a contributory factor. There are two areas on this section where meanders have been cut-off thus shortening and steepening the river channel (Fig 1). This can often cause rivers to cut downwards and there is some evidence of this here, where the former river bed level is evident in eroding banks. Following down-cutting, the river can then erode laterally (to form a new floodplain level), possibly undermining trees and reducing bank stability, and leading to an over-wide channel prone to coarse sediment deposition.

Figure 1 Aerial view of the reach showing sections of former meander (dashed lines); the left meander is shown as cut-off on an 1886 map, whereas the right meander is still shown as river channel on a 1984 map. The lighter areas indicate the extent of coarse substrate deposition and contrast with the narrower, tree-lined sections typical of much of the rest of the catchment.

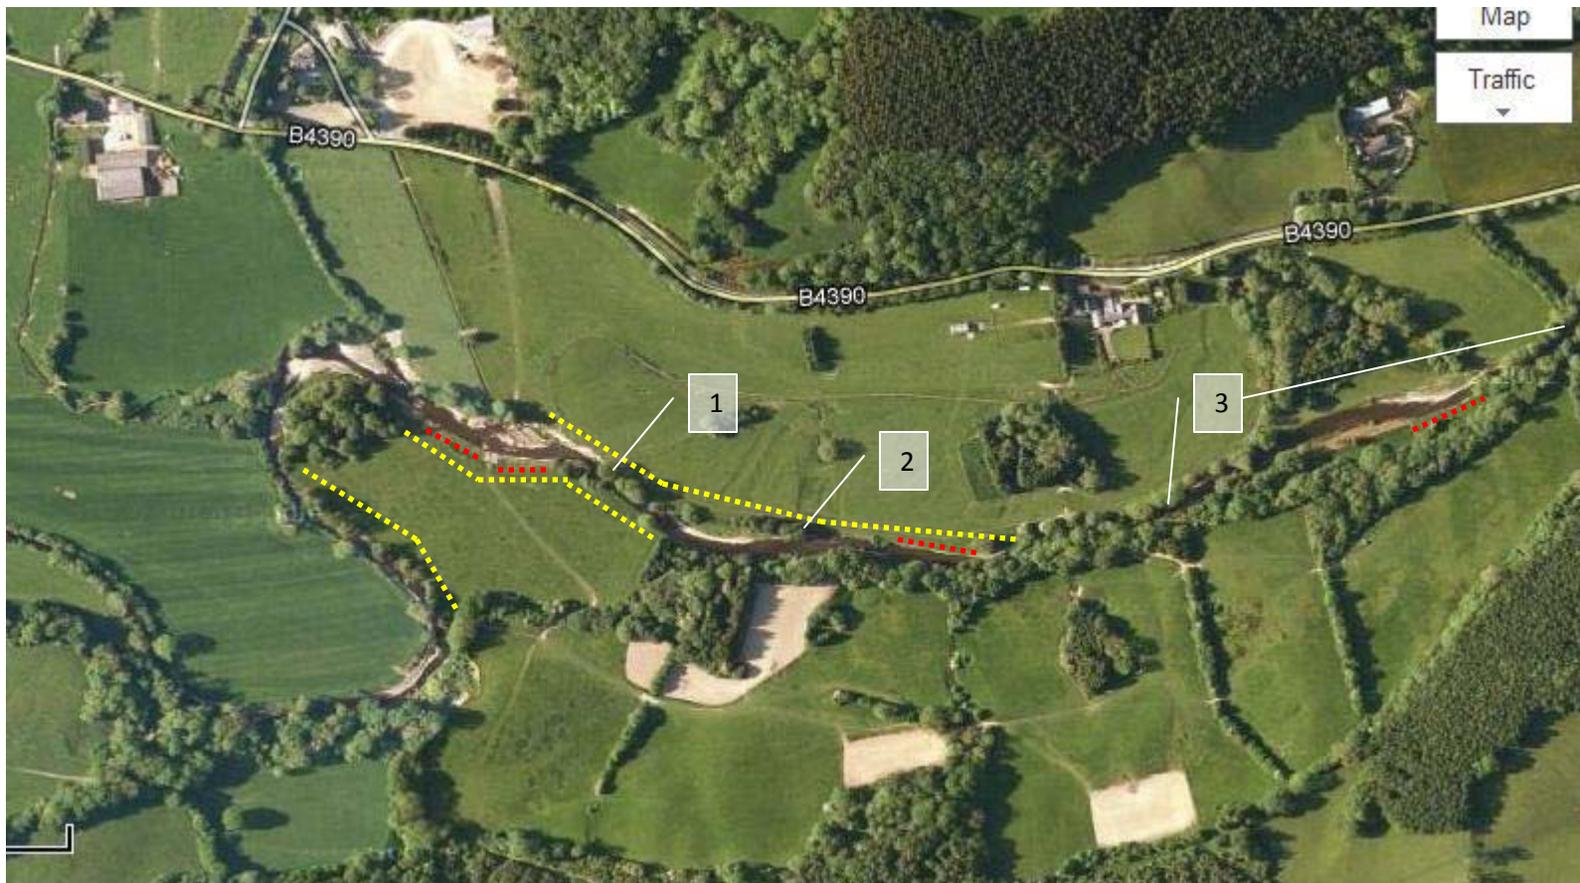
Figure 2 Red lines = soft revetment; yellow lines = fencing; 1 = Photo 6; 2 = tree kickers; 3 = log deflectors and tree kickers

Use soft revetment (see appendix) against the eroding banks indicated in areas in Figure 2.

Fence the river banks to create a generous margin between the river and agricultural land; this should be sufficiently wide (10m) to allow trees to regenerate. The fence should exclude all livestock including sheep (see appendix).

Install log flow deflectors and tree kickers on shallow glide sections to increase flow and depth diversity (see appendix).
