Advisory Visit

River Avon

Stirlingshire

Undertaken by Gareth Pedley

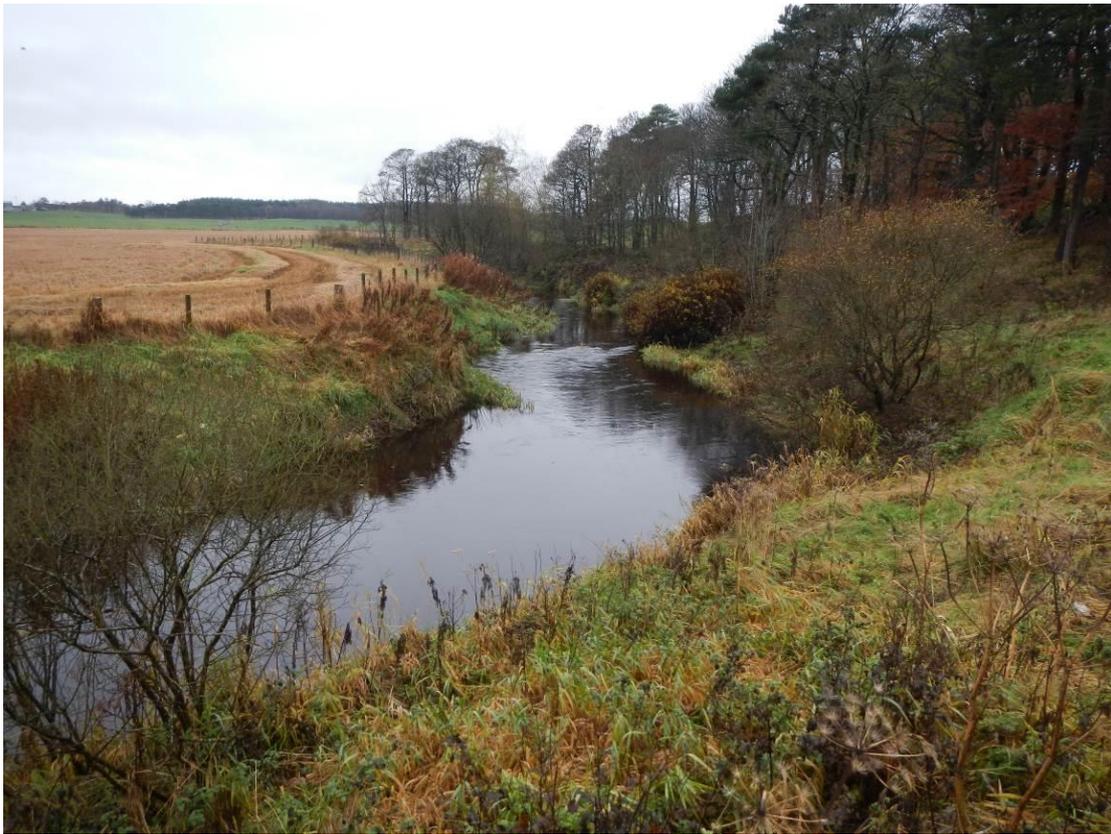
Upstream of the B803, the river is uniformly deep and narrow for the upper reaches of a river. One of the few sharper bends (Fig. 1) does provide some deeper pool habitat but dredging of this area creates an overcapacity channel that will be subject to greatly increased deposition. Further u/s, the lack of discrete wider, shallower areas and gravel bars creates a paucity of pool and riffle habitat and suggests a history of extensive dredging. This interpretation is supported by the local knowledge of FFT staff members accompanying the visit who confirm both historical and recent (ongoing) dredging. The consequent altered channel form and function inevitably reduces habitat quality for fish and invertebrates. Furthermore, the bed lowering and interruption of natural sediment supply d/s resulting from dredging often perpetuates channel incision, leaving areas of higher, unprotected banks, at far greater risk of erosion.

Figure 1. An area where material has been removed from the channel and placed upon the far bank (RB). In a natural scenario, the inside and outside of bends are actively maintained by erosion and deposition according to the flow energy and material supplied from u/s; widening or deepening a channel simply result in increased deposition locally.

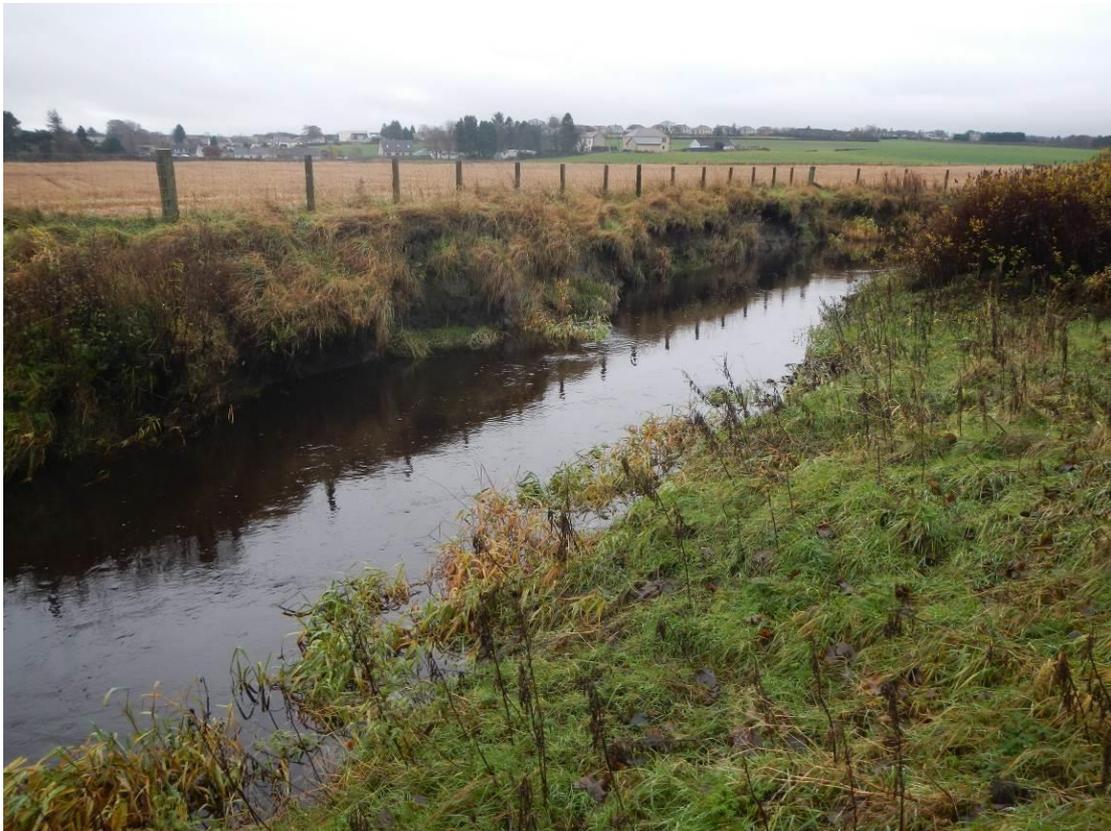
Figure 2. At the very next bend u/s of the dredging, bank destabilisation is clearly evident. It is likely that the removal of bed material downstream has accelerated the transport of bed material from this section to fill the void d/s - that bed lowering and destabilisation inevitably leaves the banks here more susceptible to undercutting.

The area of erosion in Fig. 2 was highlighted for possible brash bank protection work. While brash work is often undertaken to protect vital assets or infrastructure and limit the input of fine sediment, the value of undertaking such work in that location is limited, from an ecological perspective. Again, the greatest detriment from the erosion is the loss of land to the land manager, yet it is the channel dredging and limited buffer with a lack of trees that is exacerbating the erosion issues. Ceasing dredging and moving the buffer fence back away from the river to allow tree planting is therefore in the interests of the land manager who should be seeking to undertake that work voluntarily. The site also appears difficult to work in, owing to the depth of water in which any bank protection would have to be installed, so the time and effort involved may well be better spent on more influential habitat improvements elsewhere.

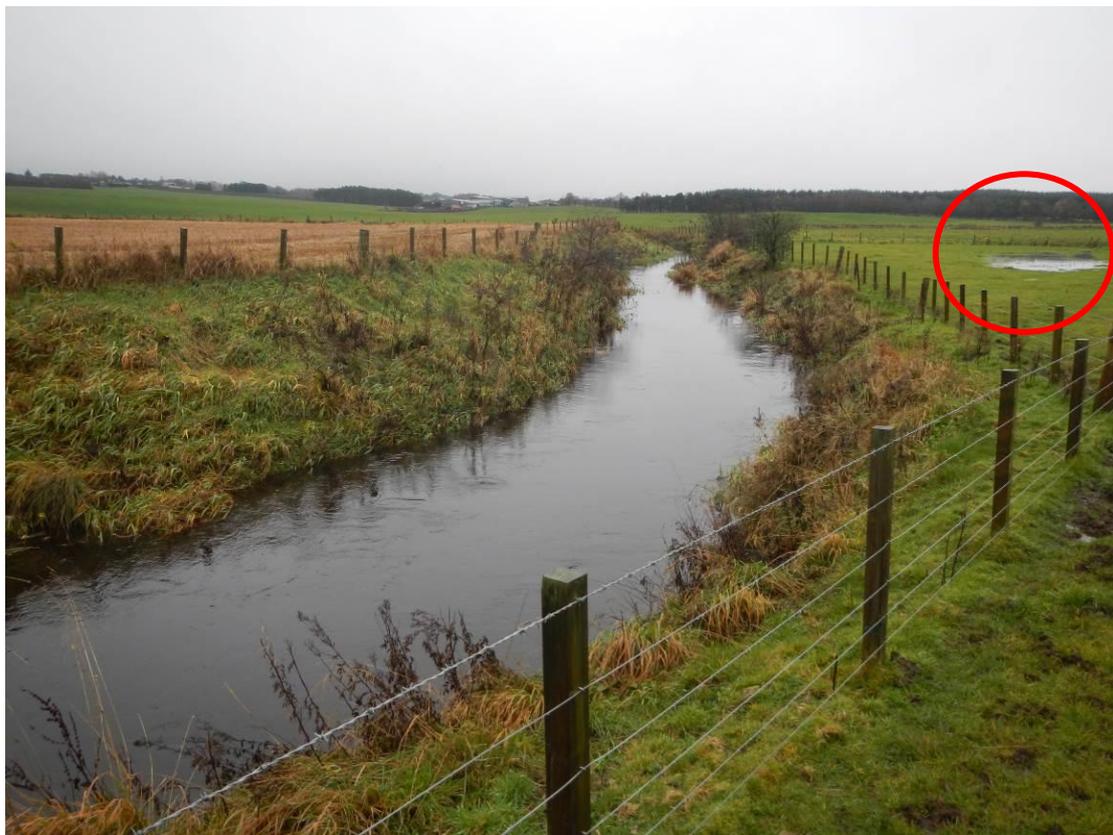
Figure 3. A relatively featureless channel section, lacking bends and discrete pool and riffle features. Although being stable naturally limits the supply of very fine sediment it also limits the supply of the important and lacking coarser substrate (gravel, cobble etc.) and the uniform channel provides poor fish and invertebrate habitat. Note the standing water in the adjacent field (red circle), this may be evidence of the rivers past course.

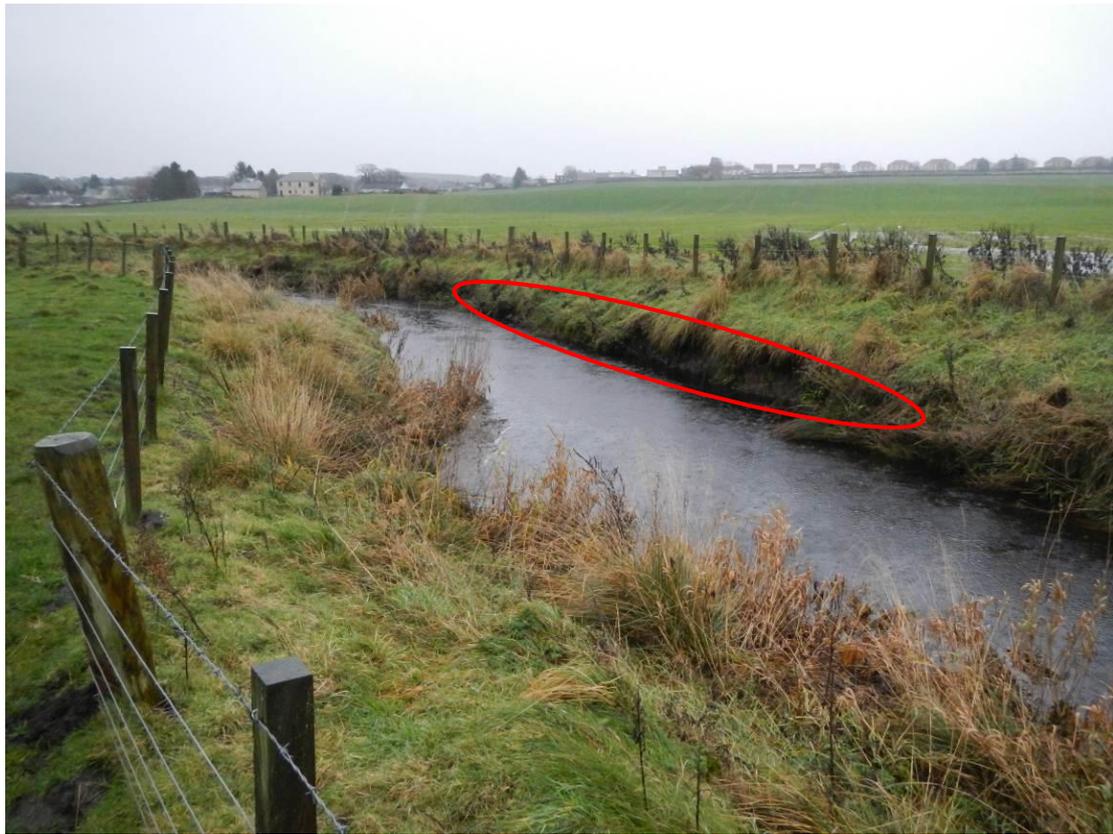
Areas further u/s are eroding (Fig. 4), which is inevitable over an extended reach where dredging has occurred, owing to the lowering of the bed and interruption of sediment transport. In addition to sharper bends, where some natural erosion would be expected, erosion is occurring on the straighter, narrow sections (likely to be maintained or created narrow by dredging/lowering the bed). The erosion appears to be a natural reaction of the higher flow energy being constrained within the incised channel which is consequently adjusting to those flows - the lowered bed will not be so quick to recover, particularly if the gravel supply is limited, as suspected.

Figure 4. A straight and narrow section where the increased flow energy will be contributing to erosion (red ellipse). Dredging occurring at the location, u/s or d/s is also likely to be contributing.

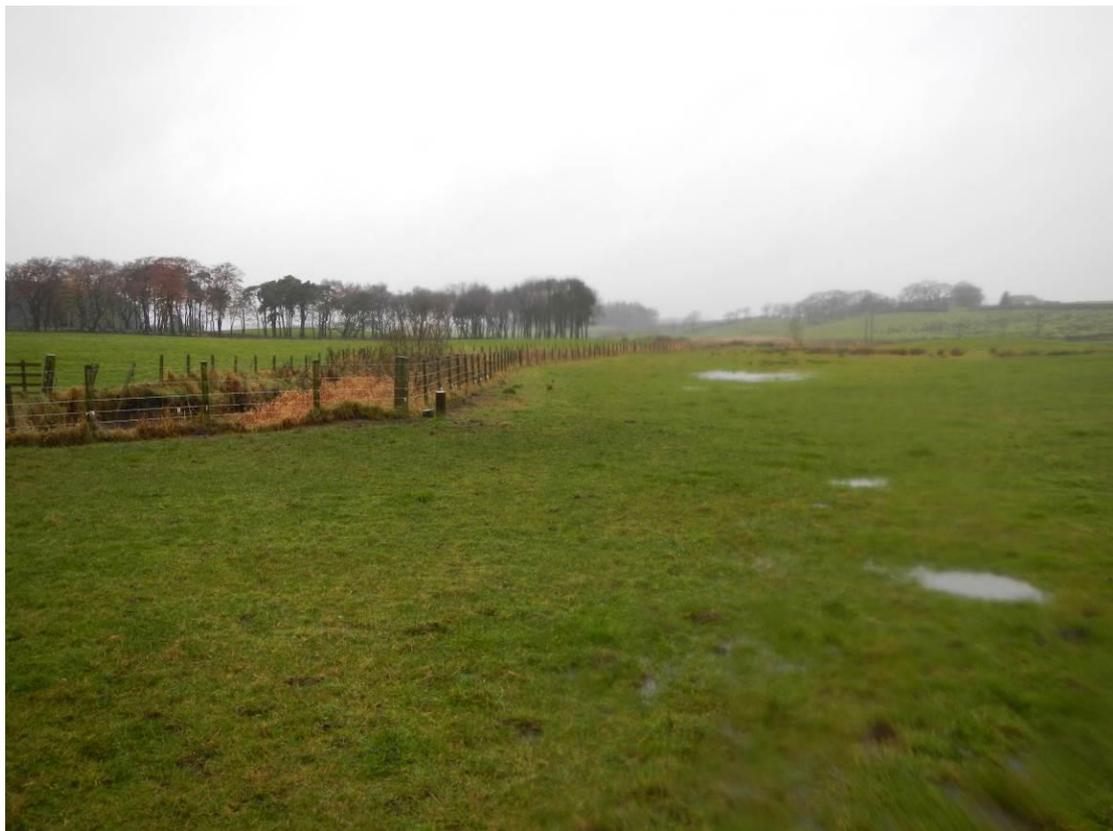
Past channel courses (paleo-channels) were observed within the floodplain. These often remain as low points within a floodplain, occasionally after natural channel adjustment but often after artificial straightening (Fig. 5). These areas can continue to accumulate sub-surface flow which re-surfaces or prevents infiltration in wet conditions. Watercourse straightening therefore rarely delivers the intended benefits for land drainage, usually leading to an increased wetted area within the floodplain in wet conditions.

Figure 5. Wet areas with the adjacent fields may hint at the river's past courses.

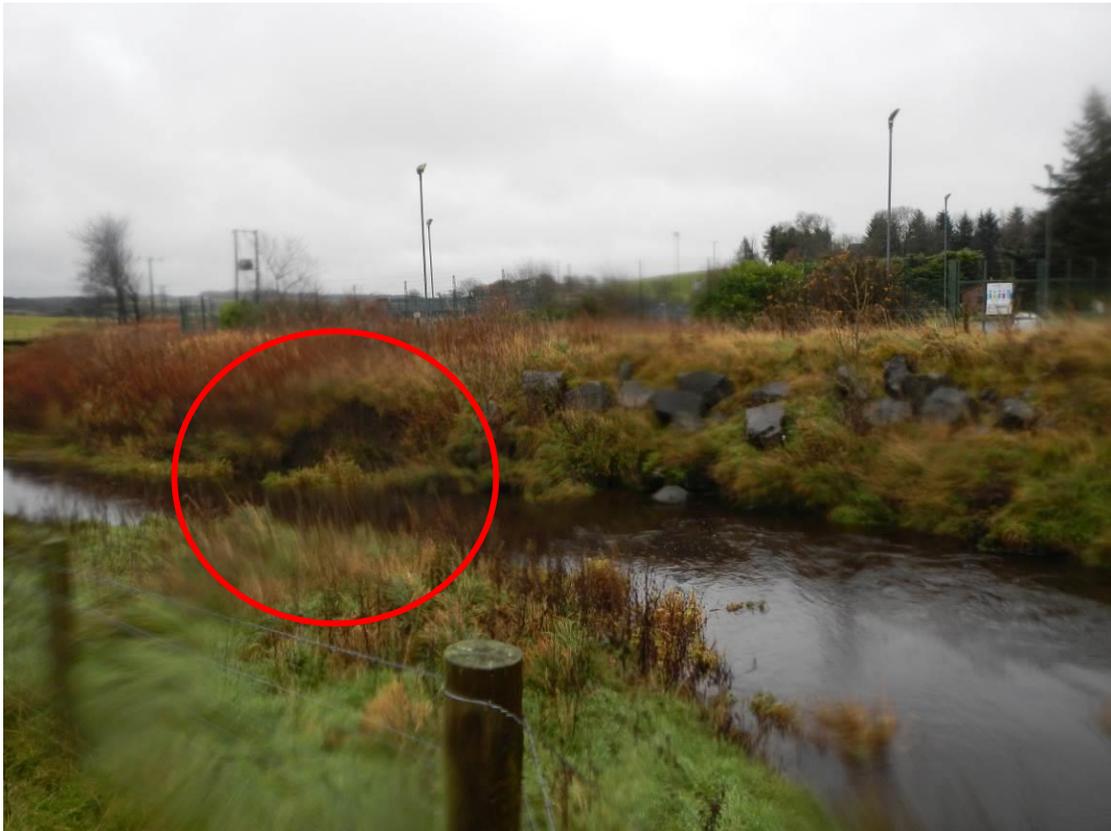
The channel d/s of the B803 suffers many of the same impacts as u/s, with the addition of rock armouring along the sewage treatment works bank. As invariably occurs, the intended hard revetment with stone rip rap has provided some short-term protection, in one area, but at the expense of the area immediately d/s, where erosion is accelerated (Fig. 6).

Figure 6. Hard, rip rap armouring of the river bank, resulting in accelerated erosion immediately d/s (red circle).

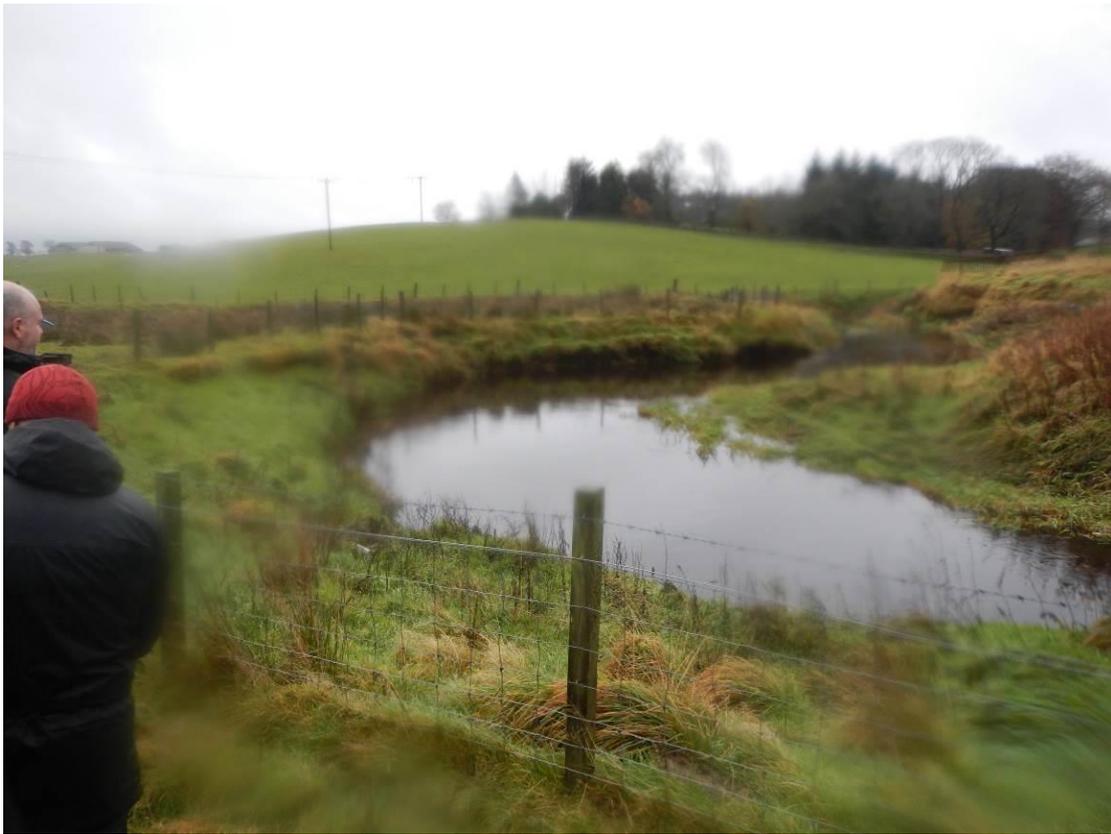
Figure 7. Just d/s of the sewage works is a rare (for this river section), sharp meander. Planting of the LB could help preserve this feature. Sadly, the history of dredging and inhibition of sediment supply is inhibiting the reformation of high quality natural riffle features even d/s of this area.

Downstream of the sewage works is a short, more naturally sinuous area that, despite comprising two sharp bends, has relatively stable banks and hints at the river's natural planform (Fig. 7). Planting of the banks in this area (particularly the LB) would be beneficial to help consolidate the bank further and protect one of the few naturally sinuous sections and improve the riparian cover. Further d/s, the channel is clearly straightened with a lowered (dredged) bed (Fig. 8). This realignment continues for a long distance past the extent of the site visited (Figs 9 & 10).

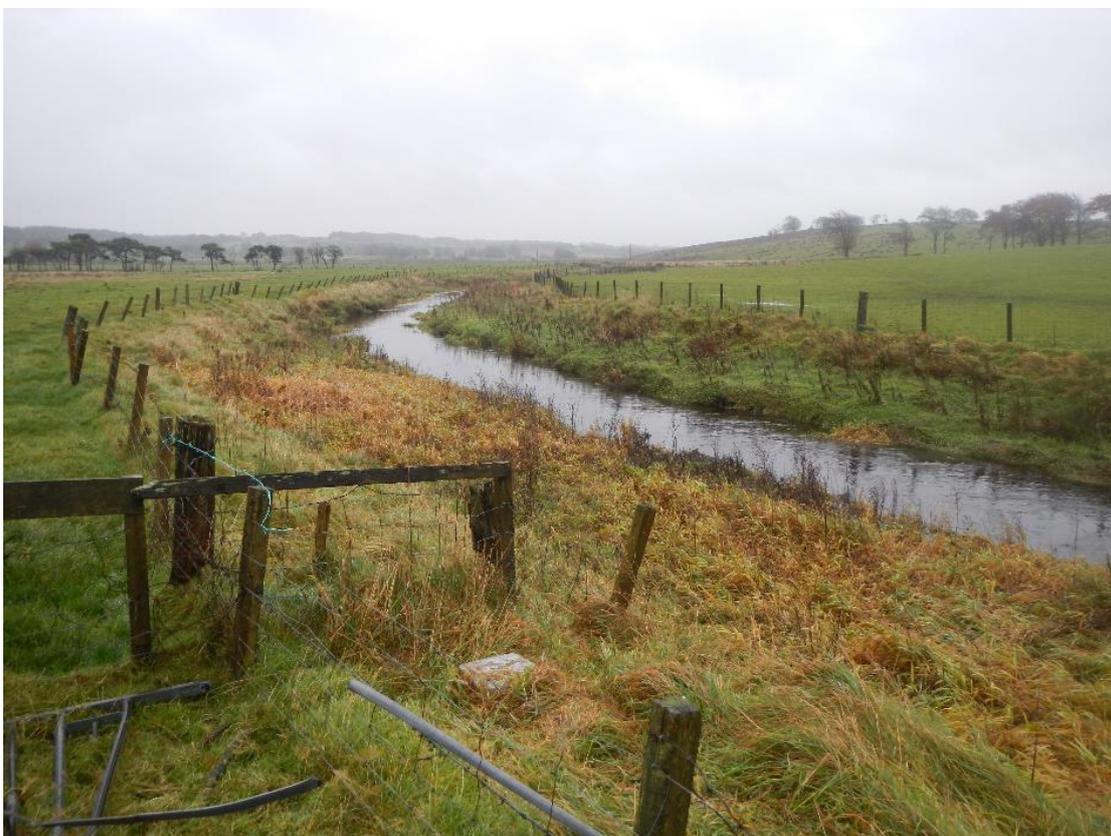
Figure 8. Although the channel is not completely straight d/s of the meanders, it has clearly been severely realigned and straightened to gradual, sweeping bends.

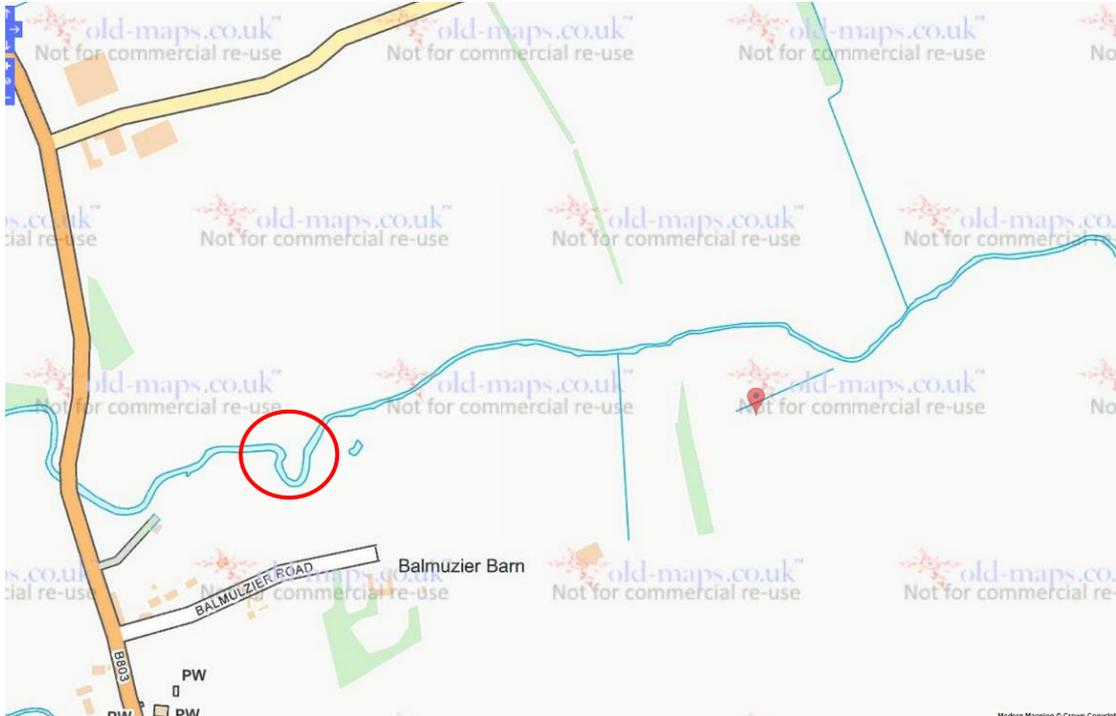
Figure 9. The approximate current position of the River Avon as visited and shown on current maps/aerial photography (www.old-maps.co.uk). The red circle identifies the only existing remnants of a more natural planform.

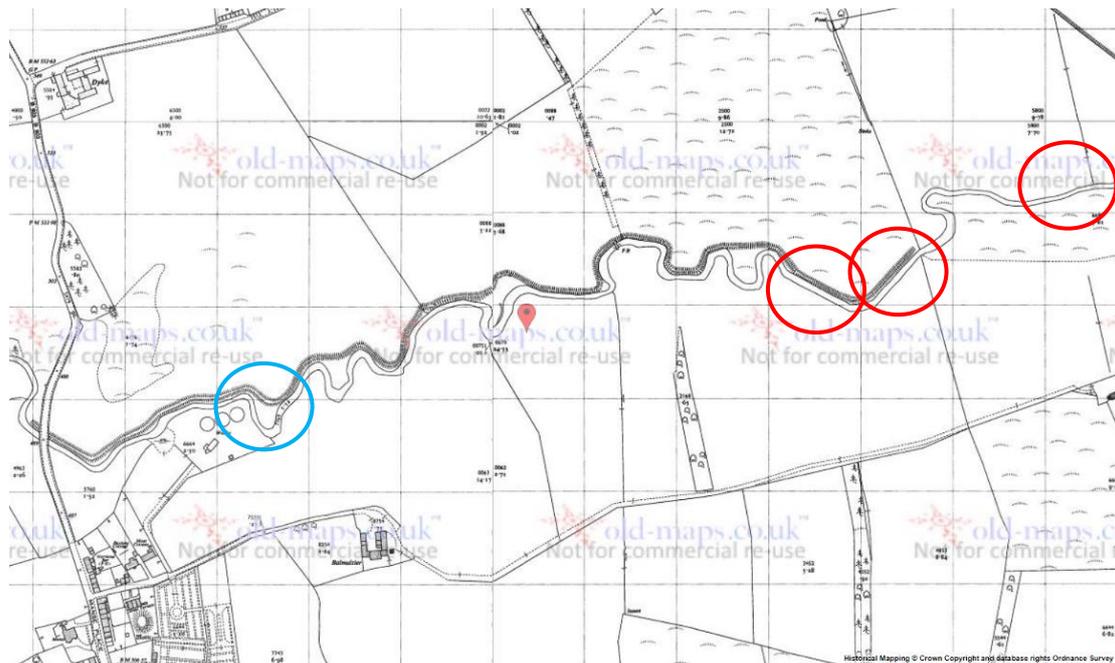
Figure 10. OS Plan 1962 - (taken from the 1:2500 scale map - www.old-maps.co.uk). From the available maps, the channel appears to have followed this approximate course until sometime between 1967 and 1990 (which fits with the timeframe reported on the SAPA website). Note how the sinuous section identified d/s of the sewage works (blue circle) is actually the only near-natural planform remaining. Even there (as far back as the 1897 map), the river is flanked along its LB by a floodbank. Such banks were often created and / or added to with material dredged out of the river. Also note that even in the 1962 map there are already sections that appear straightened (red circles).

Before any major work is undertaken d/s of the B803, it is recommended that further investigation of the site is undertaken to ascertain the river's natural course and alignment as even the more natural course identified in Fig. 10 may have already been altered. Obtaining LiDAR data for the site would be highly beneficial in understanding the topography of the land and what may be beneficial or even possible at the site. While the LiDAR data may not be definitive and past channels may be masked by backfilling and natural channel migration, it could certainly help improve understanding of the site and what a river restoration/improvement scheme might potentially look like. The land owner could then be approached with a range of proposals (an inclination to consider river restoration was previously expressed). If agreement to proceed with a scheme is given, it would then be worthwhile procuring a geomorphologist to produce detailed designs.
