Pont and Blyth Investigation
River Blyth – from Ogle Burn to River Pont
(Waterbody ID - GB103022076910)
Dates – 12/04/12

1.0 Introduction

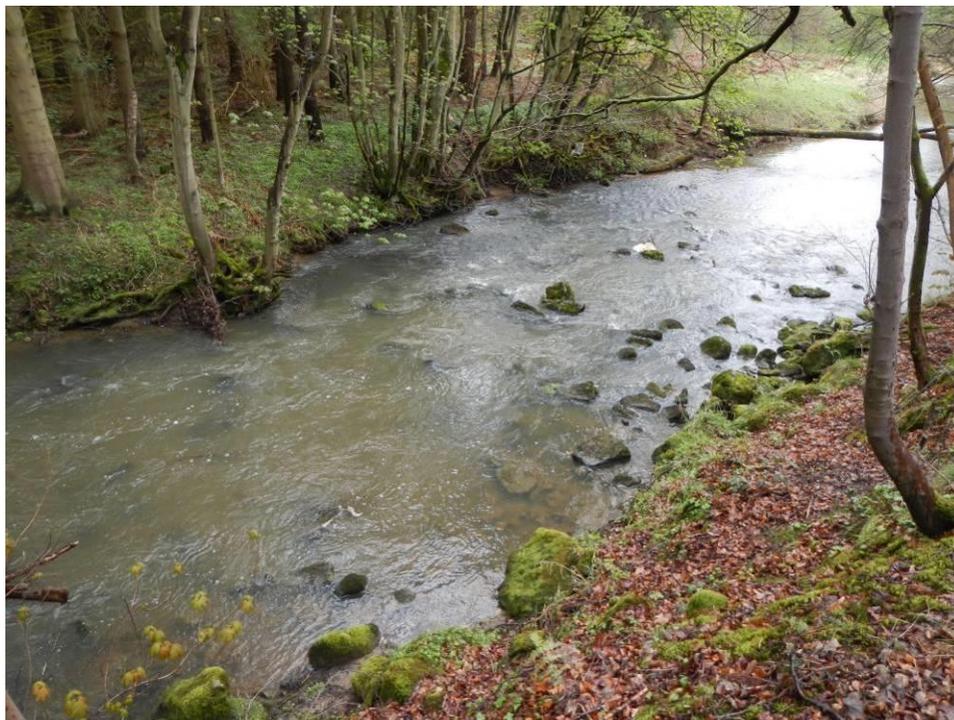
The upper section of this waterbody flows within a shallow gorge and exhibits a range of high quality habitat, with a natural pool and riffle sequence supporting a balance of substrate size and type (Picture 1). The river channel ranged in width, from around 4-8 metres, usually in the 5-6 metre range.

Picture 1. Good juvenile salmonid habitat, provided by shallower water over gravel and cobble substrate. The wider channel in this section is in major contrast to the over deep and narrow, dredged sections, with a lack of natural substrate range at the lower end of this waterbody.

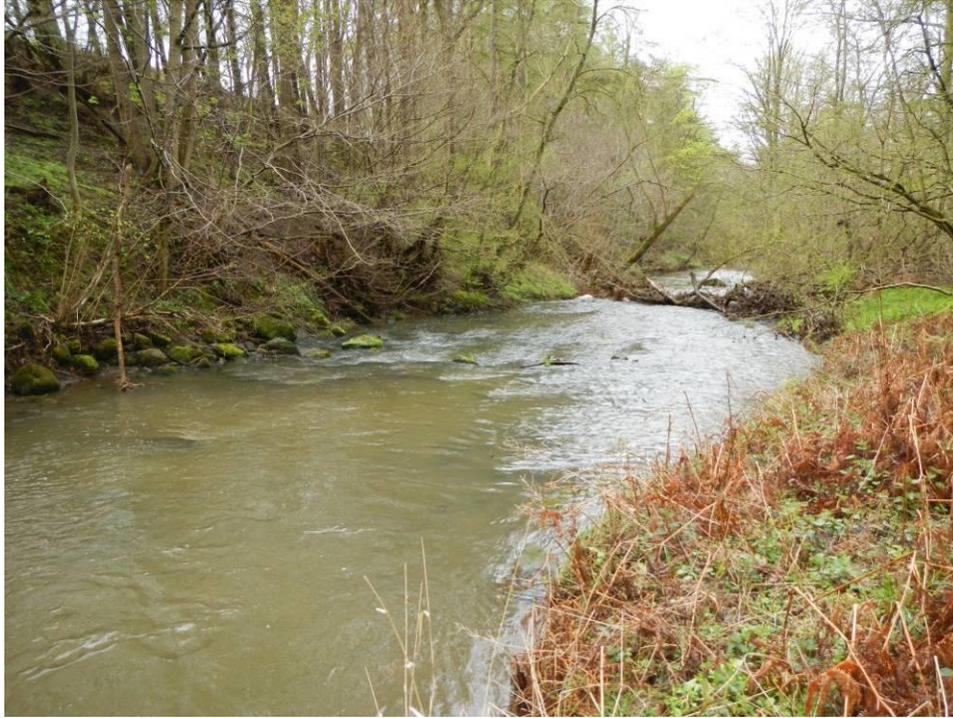
In most areas the river flows through or alongside woodland, where a natural deciduous tree cover provides a balance of light and shade, structure within the channel, and a readily available source of woody material to the watercourse (Picture 2).

Picture 2. The tail of a pool, flowing into riffle (c.6-7m wide), with beneficial LWD dam in the background. The dam is providing flow diversity, cover and scouring of the river bed.

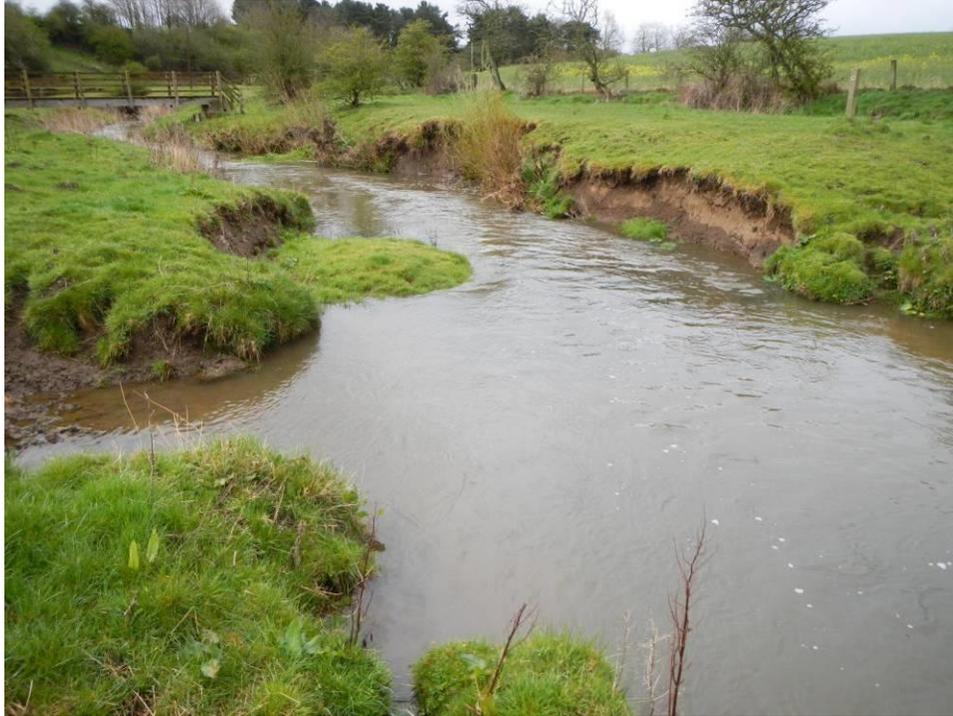
Although the upper section of this waterbody was generally in good condition, some issues were encountered. There were obvious erosion problems resulting from unrestricted stock access to the riverbank at the upstream limit. The problem also continues upstream into the adjacent waterbody (Picture 3). This is leading to a loss of land and increased siltation of the watercourse. Some attempts appear to have been made to inhibit the rate of erosion by planting willows in the areas worst affected. Again, stock access and grazing/browsing is likely to reduce the efficacy of any living bank protection.

Picture 3. Erosion in the field at the upper limit of this waterbody. Willow in the centre of shot appears to have been planted as bank protection and is providing some benefit, but suffering from grazing. Buffer fencing would greatly improve the situation here.

Other than stock access and erosion issues the channel was in reasonably good condition, particularly for this catchment, with no obvious signs of dredging and a limited, natural level of incision within the banks. Major improvements could still be achieved by simply excluding livestock from the riverbank around the upper limit with a buffer fence. Once installed, further benefit could be gained through additional planting of native shrubs, particularly willow/sallow (*Salix* spp.) whips. These can be pushed straight into the eroding areas of bank, to increase cover and bank protection.

Buffer fencing would be beneficial in all areas where stock have access to the riverbank. This is primarily an issue in the first field, at the upstream limit of the waterbody, and at the fields at the downstream end of the lower section.

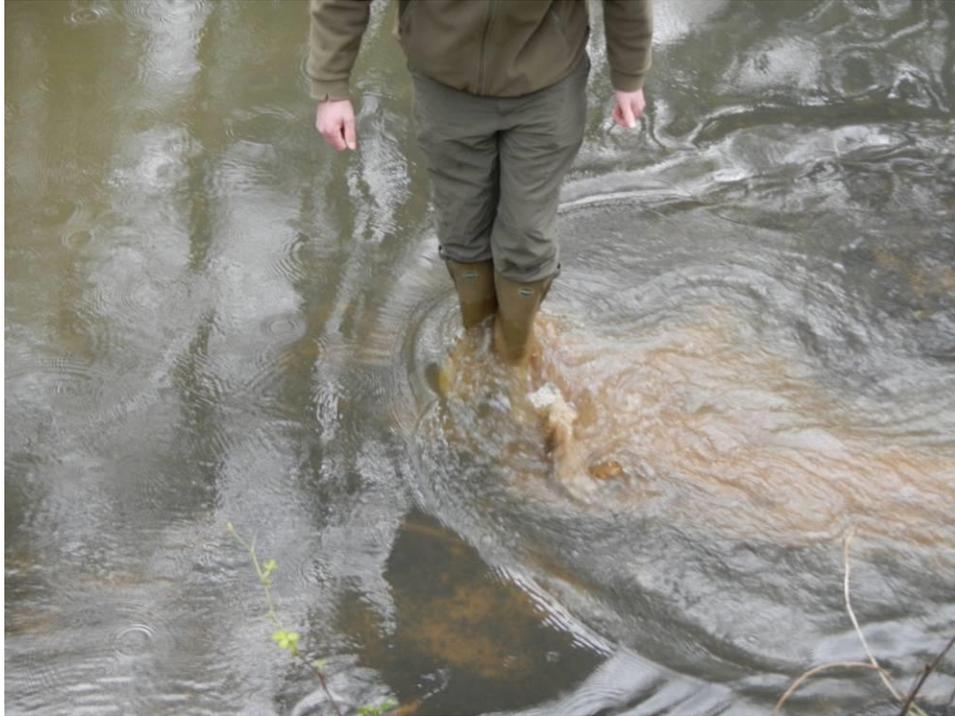
The erosion issues highlighted, and other sources of sedimentation further upstream producing the high levels of turbidity on the day, are contributing to a degradation of the substrate quality throughout. Even in areas of high flow velocity and shallow water depth the substrate contained a high silt loading (Picture 4). Consequently, in many areas where salmonid spawning substrate was present it was compromised, and likely to yield poor fry emergence.

Picture 4. Heavily silted gravels, as demonstrated by the silt plume liberated from the riverbed by shuffling. This action also revealed that the bed was compacted and not easy to move through the fine sediment, further reducing its suitability as salmonid spawning substrate.

The first issue that has to be addressed before any serious improvements can be made to wild salmonid production on this waterbody is sedimentation, particularly from sources upstream. It is understood that such issues are being tackled in conjunction with the Northumberland Rural Diffuse Partnership, and this will be pivotal to future improvements on the river, particularly for improvements to substrate quality.

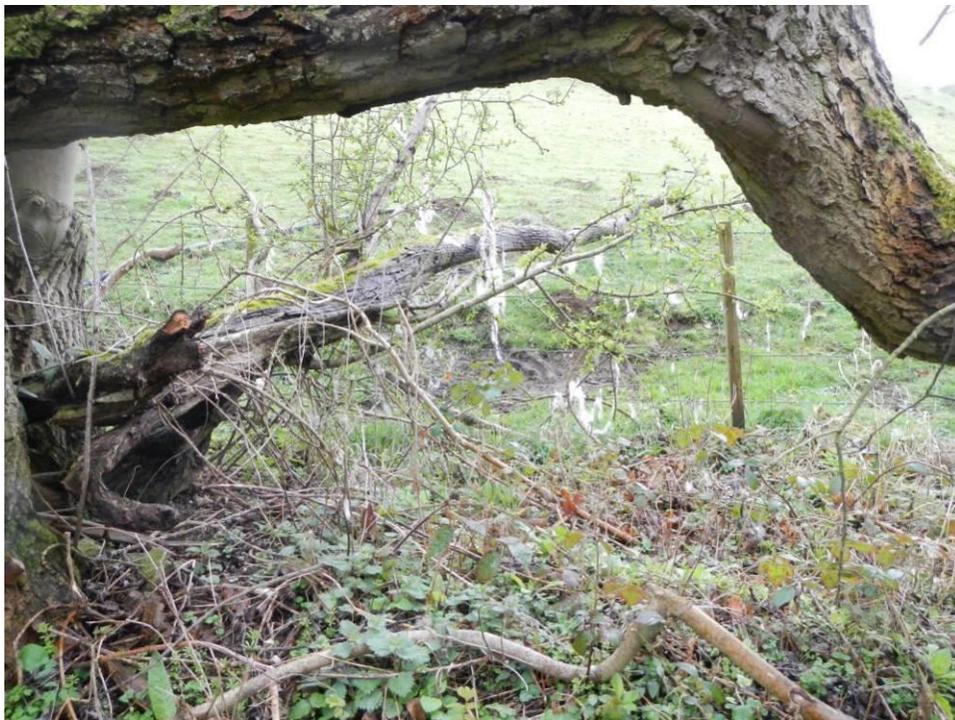
Although most areas were buffer fenced there were areas in which the fence has fallen into disrepair. If these fences can be maintained, the healthy bank-side vegetation and bank stability can be protected (Picture 5).

Picture 5. An area of unmaintained fence where sheep appeared to be escaping. Wool attached to vegetation outside of the fence appeared to confirm this issue.

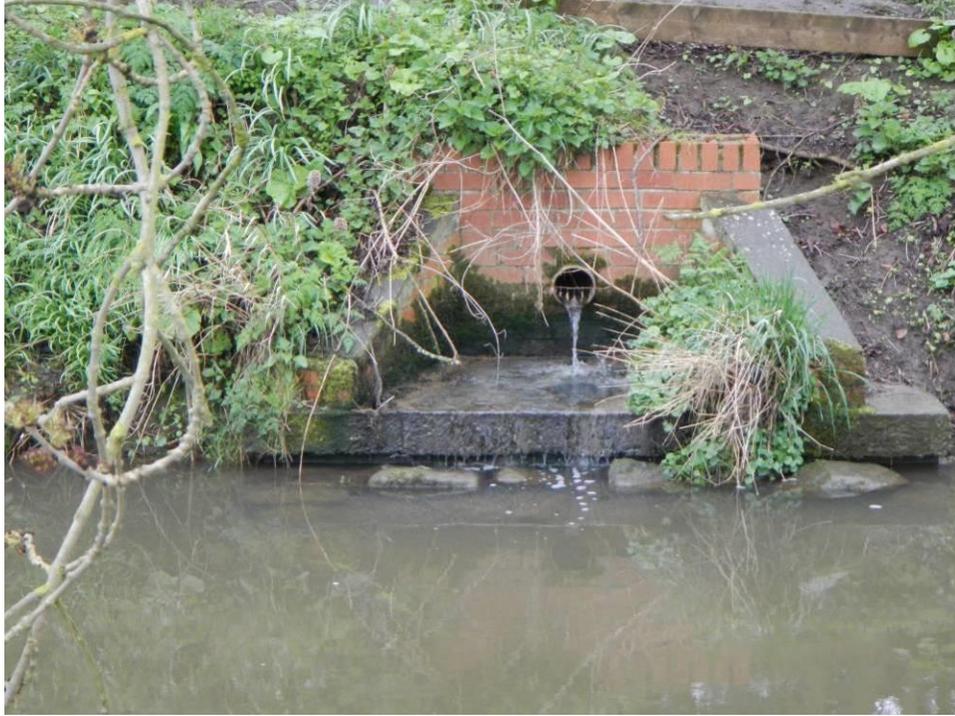
One potentially significant discharge was identified within the upper section in the area of Kirkley Hall College. It is advised that the quality of this discharge should be investigated, as it appeared to have a high organic component, with a strong sewage odour (Picture 6).

Picture 6. Discharge to the river that appeared to have a high organic content and was producing a significant 'sewage odour'.

It is advised that the discharge around Kirkley Hall College (NZ1515577459) should be investigated as it appeared to be of a high organic content and a distinct sewage smell was apparent in the area of the pipe. This issue could be leading to negative enrichment of the watercourse downstream.

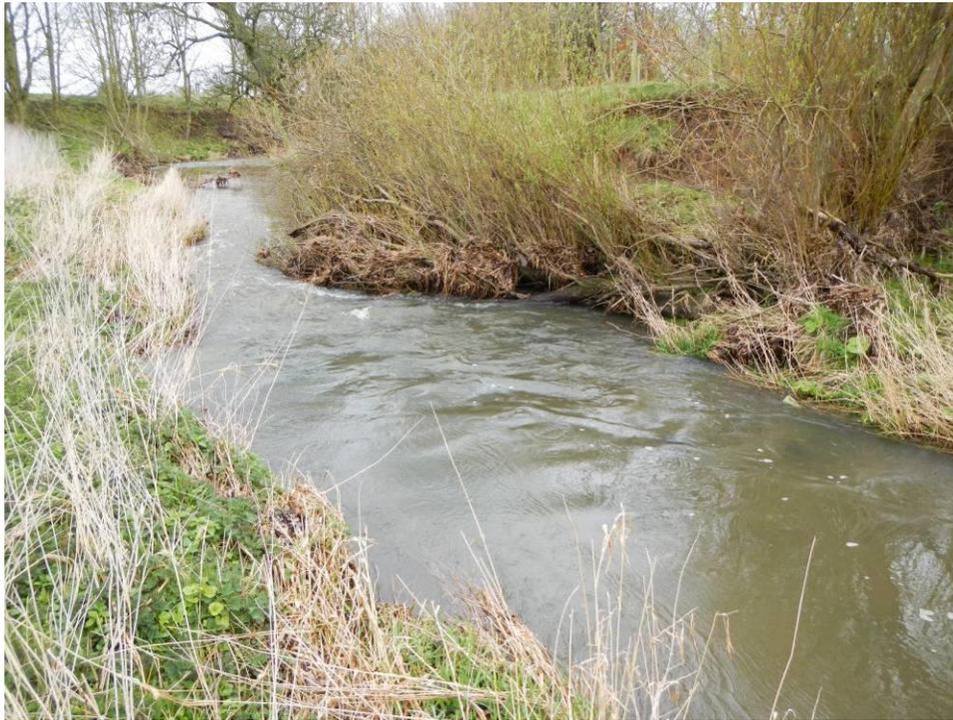
Buffer strips were in place for much of the upper two thirds of this section, which hosted a range of rough vegetation and beneficial habitat features, including shade, cover, and flow diversity/turbulence. The vegetation provided significant bank protection, with erosion generally limited to the sharpest bends. Some areas of bank side trees were present, predominantly willow shrubs and alder (*Alnus glutinosa*), also providing valuable habitat and bank protection (Picture 7).

Picture 7. Willow on the far bank, providing flow diversity, cover and bank protection.

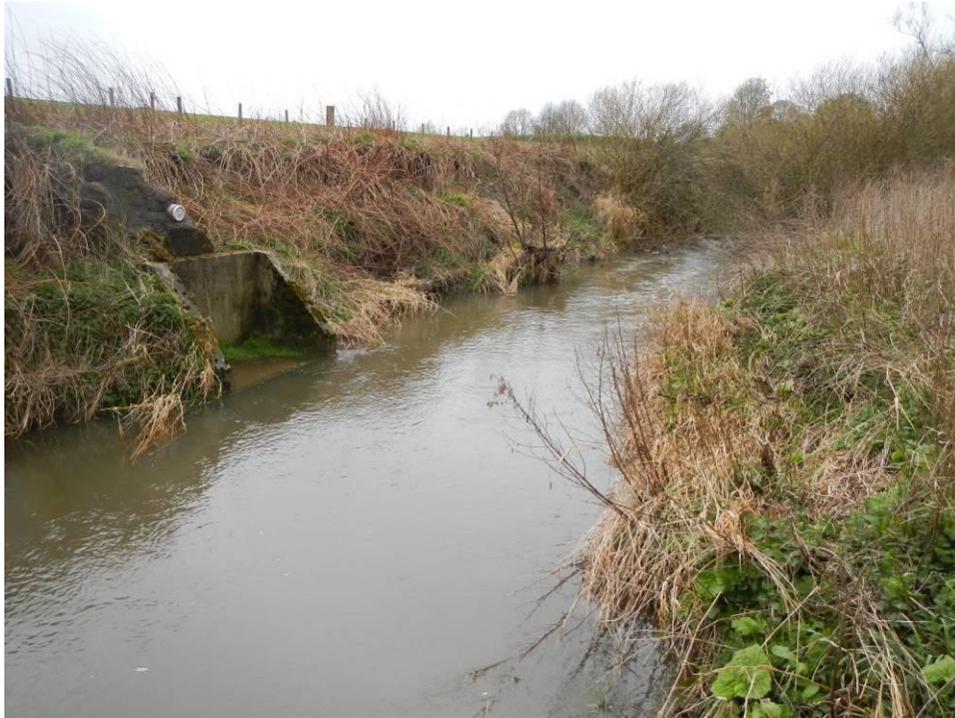
Much of the river below Thorneyford Road Bridge has been dredged, incising the channel within its banks (Picture 8). The river has also been straightened in several areas, particularly around NZ1640177583, and the bottom field of the reach around the Pont confluence (NZ1784977692, Picture 9). This has reduced the prevalence of natural channel features and the range of substrate expected, somewhat limiting the availability of fine gravel.

Picture 8. The first area in which the river channel was significantly incised. Dredging spoil was evident at the top of the LB.

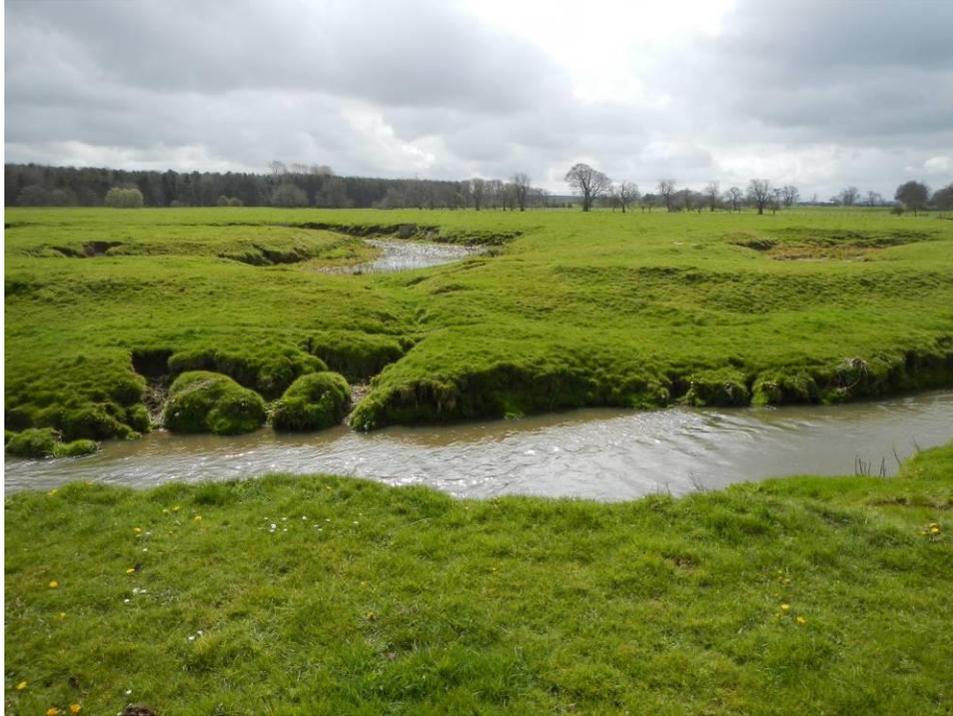
Picture 9. The current, straightened river channel is visible in the foreground (flowing right to left). To the right of shot (in the background) is the upstream end of what was originally a meander, that would have joined the relict channel to the left of shot (in the background), probably via a short section of the current channel (centre shot foreground).

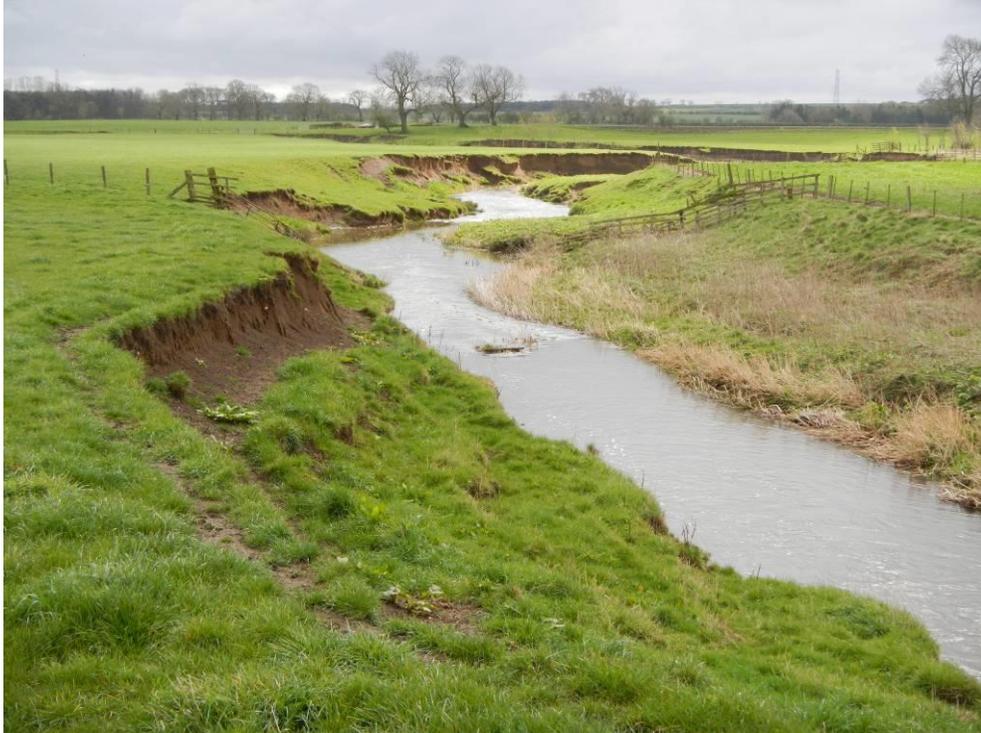
The other significant issue encountered in this section was overgrazing and poaching by livestock, as can be seen in pictures 10-12. This was encountered in the lower section of the river, from NZ1651177685 on the RB, and NZ1666877912 on the LB, from which point buffer livestock had access to the river. The impact was immediate and the level of erosion went from a low level, predominantly on the outside of sharp bends where natural adjustment was occurring, to major erosion and sedimentation for long sections of river (Picture 10 & 11).

Picture 10. Little or no erosion on the un-grazed RB where healthy levels of vegetation are present (right of shot). Serious erosion is occurring in the un-fenced fields (foreground and background).

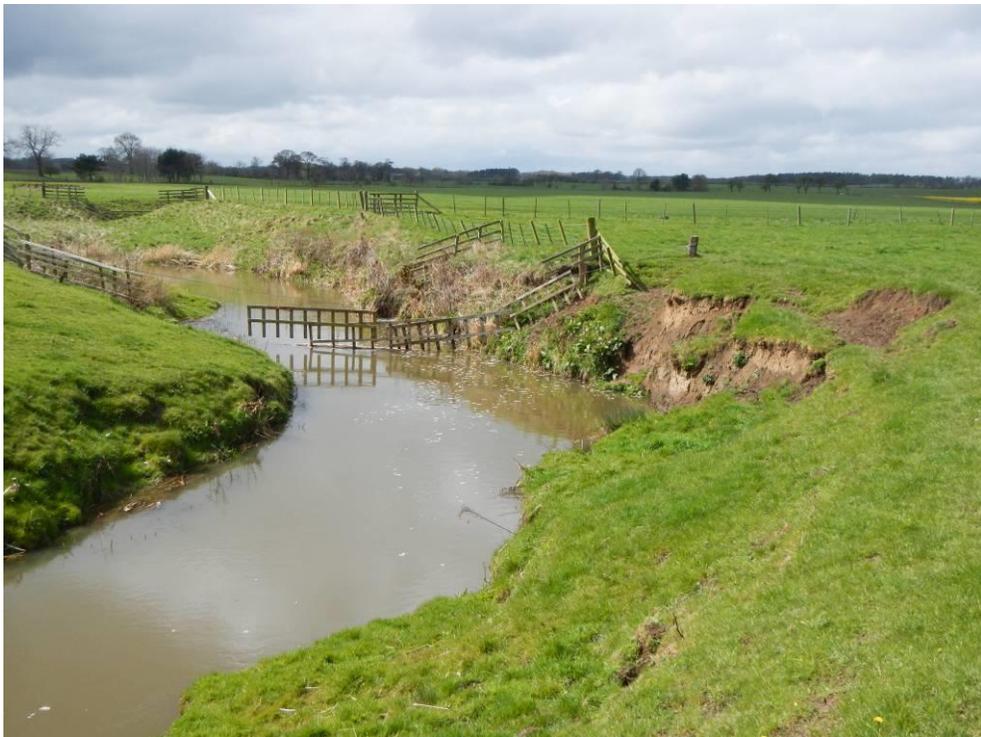
Picture 11. Again, very little erosion is occurring in the background where the river is buffer fenced, but immediately outside the fence major erosion is occurring due to over-grazing and livestock poaching (foreground, right).

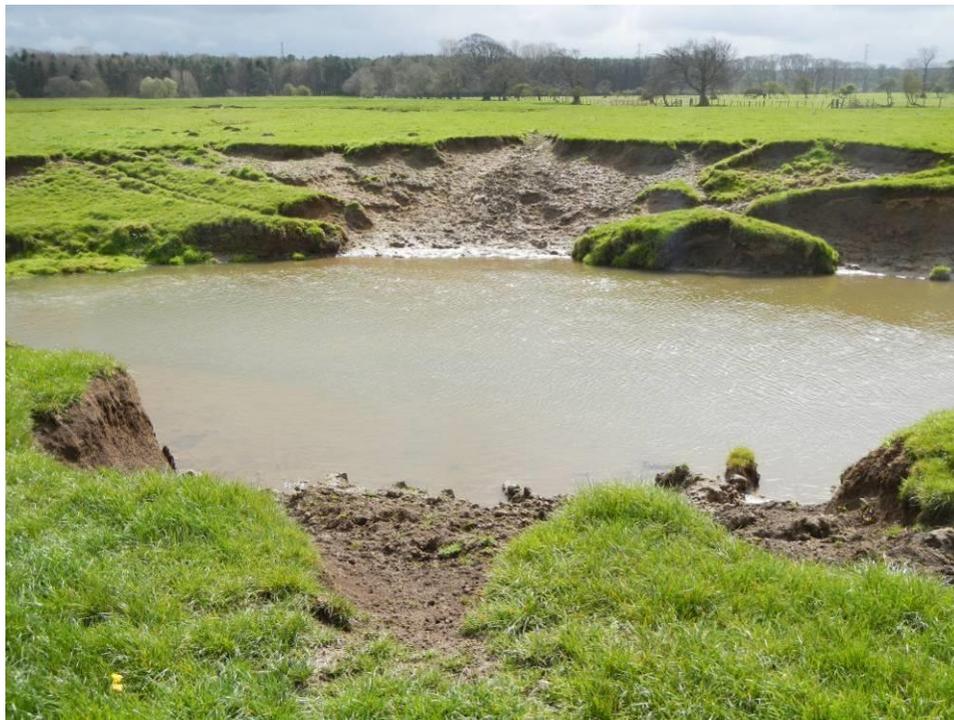
Cattle crossing areas and watering points are causing major erosion and siltation issues (Picture 12). If stock access to the river could be restricted to one area of the riverbank per field, where formal drinking areas could be provided, the river bank would be much less susceptible to erosion. This would be a vast improvement on the current scenario where stock have unrestricted access and are accessing the river in multiple areas of each field. It is important to note that the damage is not restricted to the side of the river in which the buffer fencing is absent, as cattle are clearly crossing the river to exploit grazing within the fence on the other side (Picture 13).

Picture 12. Cattle crossing point that is facilitating increased erosion of the river bank. The bare earth, here and disturbed ground will also be increasing the rate at which sediment is washed into the river during wet conditions.

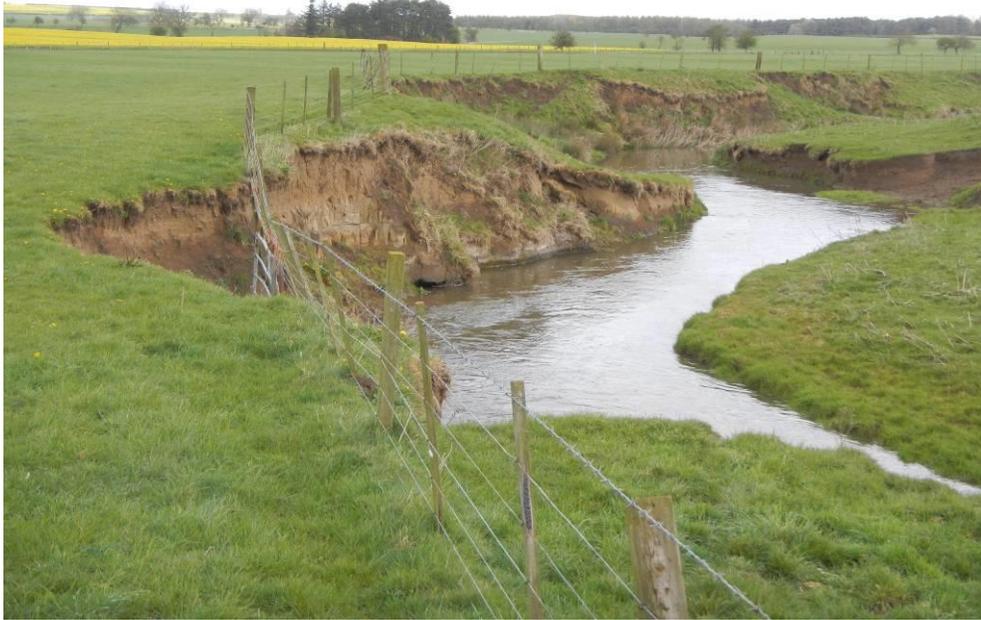
Where soils are light and friable, as is the case here, simply the prior loss of varied species vegetation and the associated root mass can be enough to allow erosion to start. When this is coupled with damage from cattle poaching the problem is vastly exacerbated and large areas of land can be lost in a short period (Picture 13).

Picture 13. Erosion that has been seriously exacerbated by grazing from livestock that have crossed the river from the unfenced bank. The buffer fence is restricting access from one bank, but not the other.

The knock-on benefit of double bank buffer fencing would be enhancement of habitat that the vegetation and marginal cover would provide, allowing the channel to adjust to a more natural width. Without grazing pressure self-set shrubs and seedlings are also likely to become established over time, and the potential would also be created for additional planting within the buffer strips.

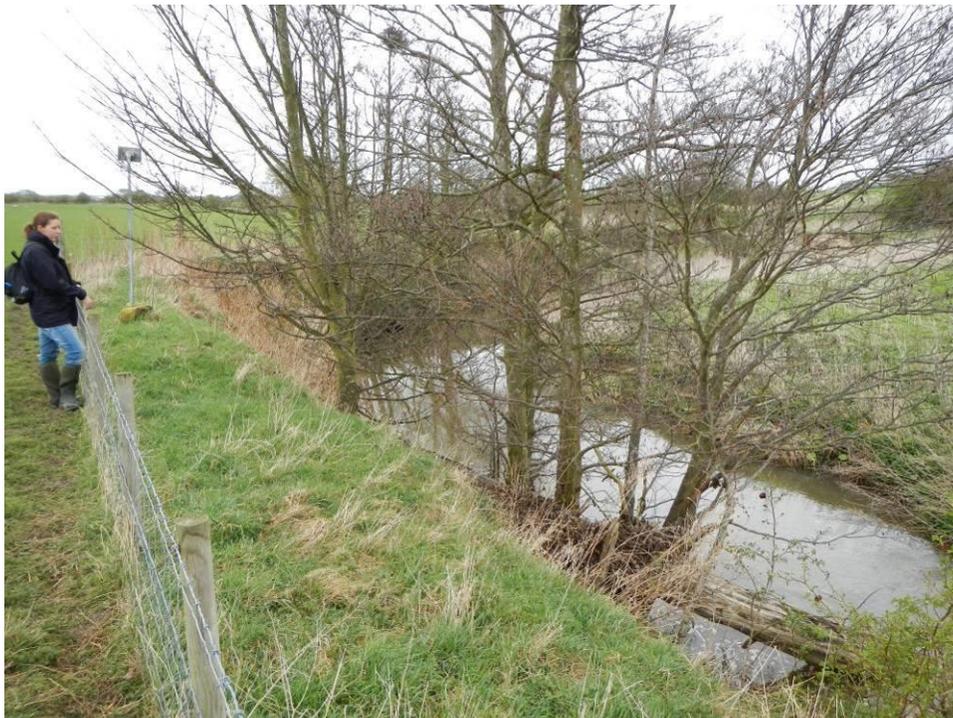
Picture 14. A group of alder trees representing a prime opportunity for coppicing and installing tree kickers to increase low level cover and structure within the dredged channel.

This would lead to the more beneficial scenarios seen in pictures 14 and 15, where established trees provide a wide range of habitats and bank protection. Some land management within the buffer strips would still be required to reduce the risks posed by invasive species, and to prevent the development of a vegetation monoculture. This may be achieved by very low intensity periodic grazing, but this is unlikely to be required for at least 3-5 years, to allow establishment of the beneficial shrubs and herbage.

It is important that this is not done to excess, and coppicing one trunk out of a group of four or more, would be sufficient to encourage some low re-growth and provide a large log that could be anchored to the stump or jammed between the remaining trees as a kicker.

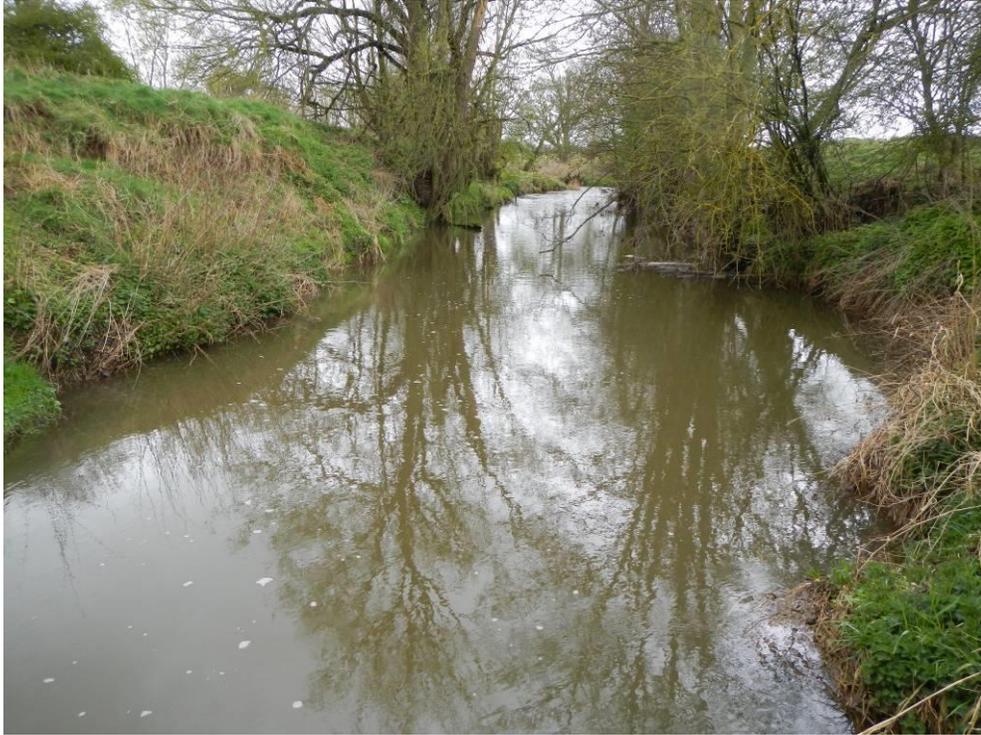
Picture 15. Bank side willows and hawthorn on a dredged and straightened reach that could be employed to greatly increase in-channel structure and low level cover by hinging some trunks into the channel.

The further management option of hinging is available, where young supple tree species are present. This method involves partially cutting the trunk of the tree/shrub and then pushing it down over, or into the watercourse. By leaving the trunk attached to the stump, the tree will be retained in place and will remain alive, providing even greater cover through continued growth, in a similar way to laying a hedge.
