Advisory Visit
River Eden and Scandal Beck
01/05/2015

1.0 Introduction

This report is the output of a site visit to Kirkby Stephen and District Angling Association's (KSDAA) water on the River Eden, undertaken by Gareth Pedley and Jon Grey of the Wild Trout Trust. Several KSDAA members attended the visit (including Alan Swann who along with Colin Edney, requested the visit). Daniel Brazier (Eden Rivers Trust) and John Garner (Natural England) also attended. This report covers observations and discussions made on the day of the visit.

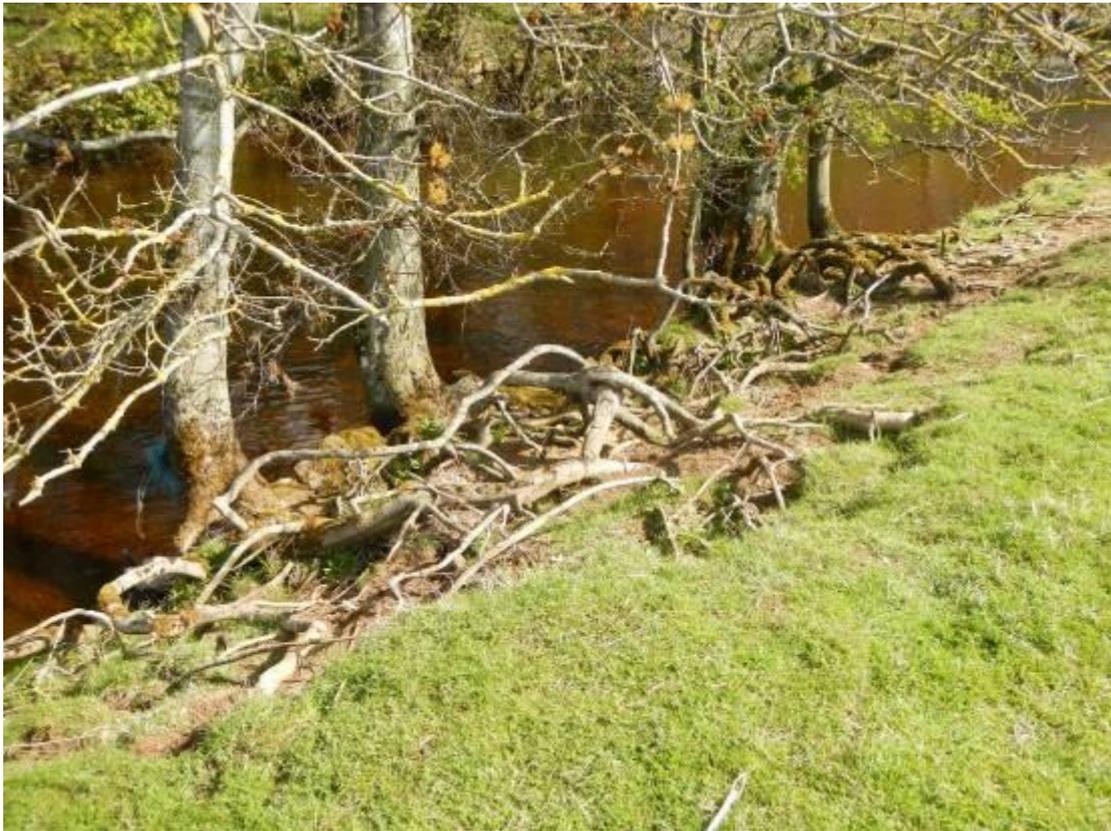
In the fields upstream of Eastfield Bridge the impact of sheep grazing was immediately apparent (Figure 1). Sheep grazing maintains grass closely cropped to the ground and ensures that other herbaceous vegetation cannot establish (grasses regrow from their base and withstand continual grazing pressure far better than other plants). The impact of this land management has notable implications for the local ecology and riverbank stability.

As only a small amount of vegetation is present above the ground, direct protection of the soil (via interception of precipitation and diffusion of high flows) is limited. In addition, as the grass expends much of its energy replacing the grazed material above the ground it has less energy to place into root growth below the ground. This means that there is less root structure under the ground and the structure is much less diverse than if multiple species with varying root systems (some deep, some extending laterally) were present. Uniformly shallow root systems do very little to reinforce earth banks against erosion. These combined factors make grazed turf highly susceptible to erosion, as evident by the exposed tree roots where areas of topsoil have been lost (Figure 1). This is further compounded by both trampling by livestock and associated washout of material at high flows. (See example in Figure 2 of the root system below a diversely vegetated bank on another river where the roots extend >50cm into the ground, rather than c.15cm with grazing)

Figure 1. Closely cropped grass that provides very little protection and a lack of root structure to support bank stability. Consequently, sheep trampling and high flows have resulted in significant erosion around the trees.

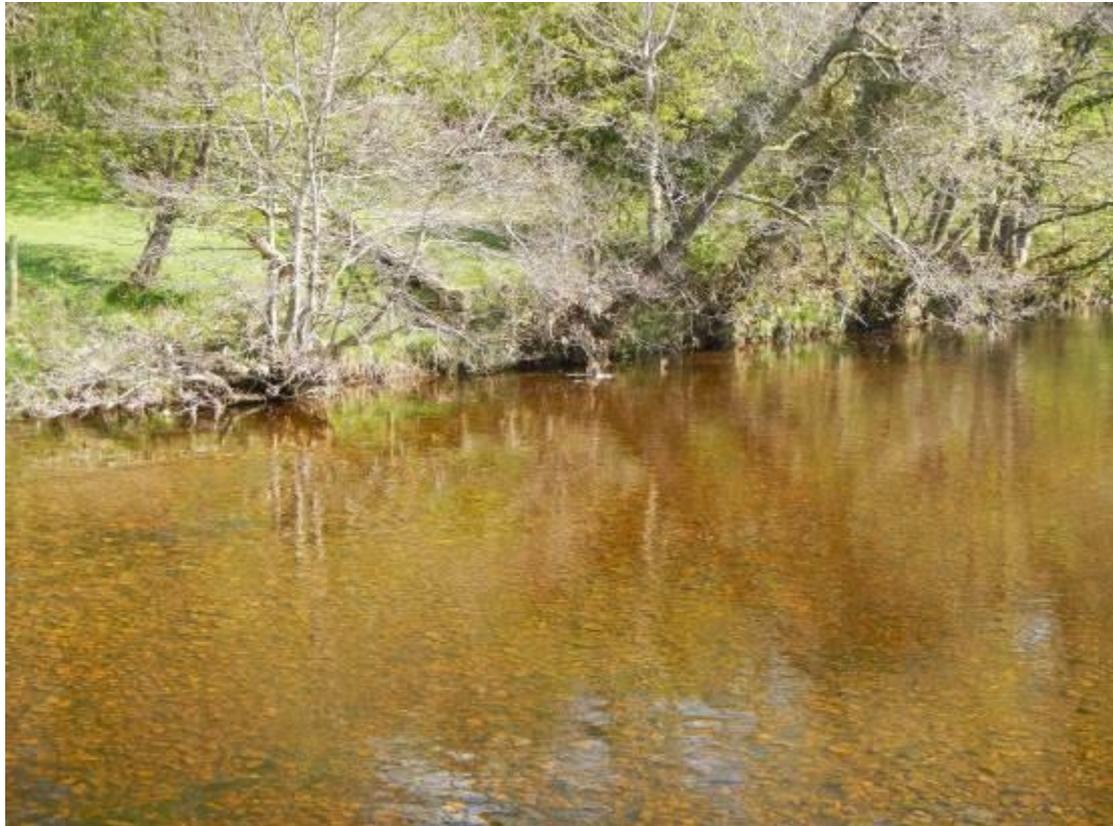
Throughout much of the section upstream of Eastfield Bridge the channel has been modified, with notable areas of bank revetment and steep, tree-lined banks; this, in conjunction with areas of bedrock, often maintains an overly uniform channel width and correspondingly uniform bed profile (Figure 6).

Figure 6. Uniformly wide channel section with a correspondingly uniform bed profile. Some good low-level cover is provided by the overhanging trees on the far bank (RB), but increased structure in the LB margin could increase sediment retention that would focus flows down the RB and increase water depth around the fish lies.

In most areas, at least one bank provides good low-level and trailing tree cover, supporting lies for parr and adult trout; however, the steep, formal nature of the banks appears to be preventing natural narrowing. High flows, contained within the banks and unable to escape onto the floodplain, are likely to mobilise much of the sediment deposited at lower flows. This is another good reason to promote diverse structure within the river margins (LWD and trailing branches) as it will facilitate greater retention of substrate that will, in turn, create greater variation in flows and river bed profile.

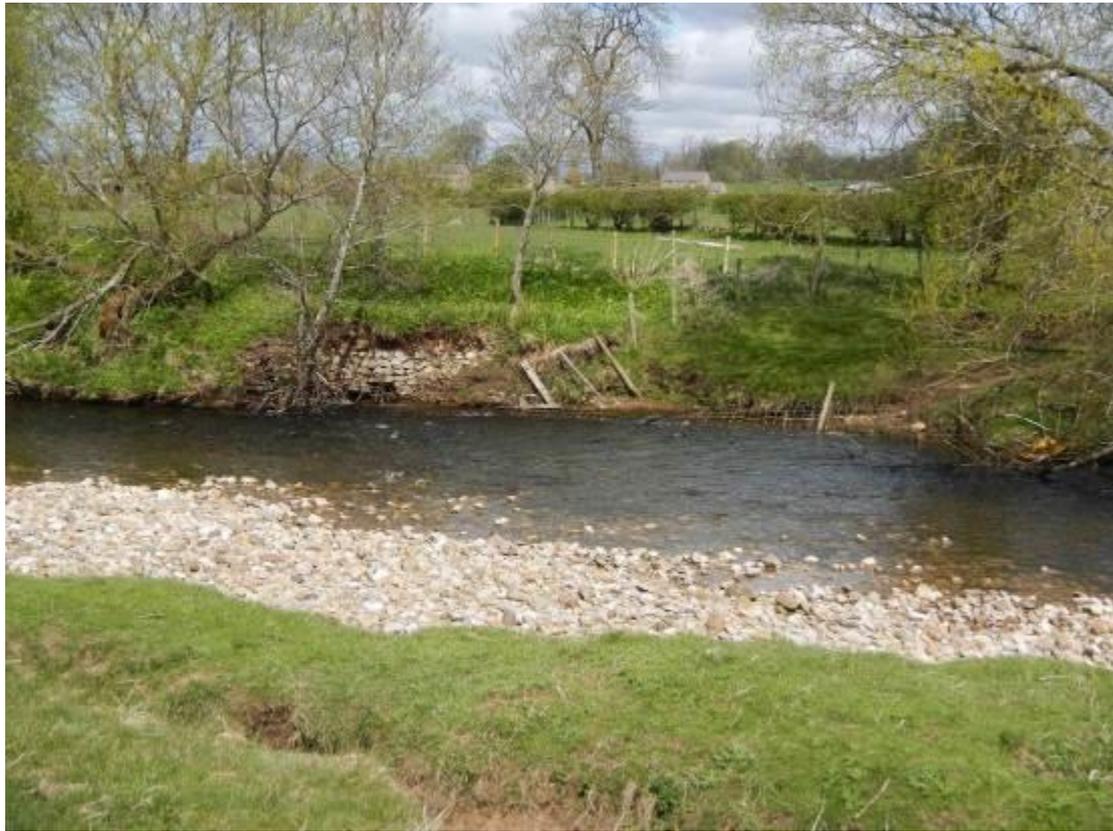
In areas, the river is already beginning to narrow naturally within its channel, particularly immediately upstream of the bridge (Figures 7 & 8). However, sheep grazing on both banks is impacting on the process. Grazing of vegetation on the gravel bar on the LB is inhibiting consolidation and stabilisation of the bar (Figure 8) and a watering point on the RB is accelerating erosion and land loss (Figure 7).

Figure 7. Gravel deposition in the near (LB) margin and erosion around a livestock watering point along the far bank.

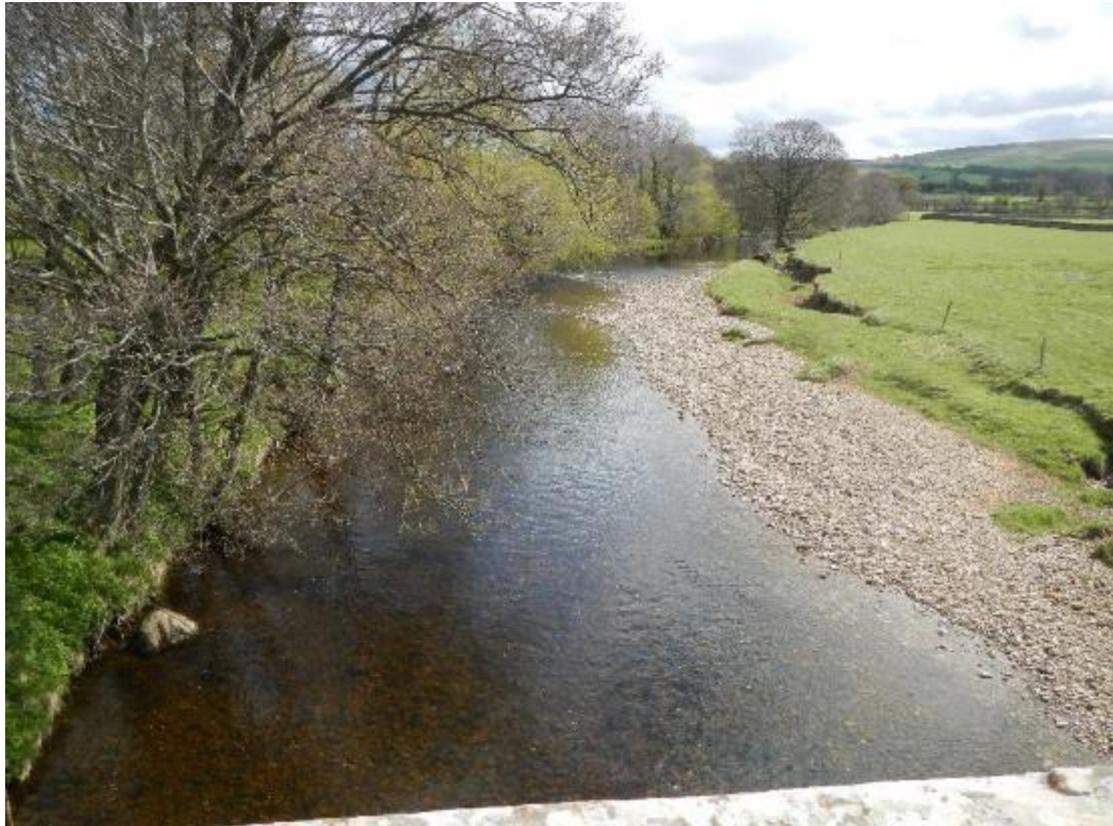
Figure 8. Looking upstream from Eastfield Bridge, gravel deposition on the true LB (right of shot) is providing some beneficial narrowing. However, heavy sheep grazing is preventing much of the bar from becoming vegetated and increasing the area of the front edge that remains mobile. This prevents further, beneficial narrowing that would otherwise help to maintain greater water depth under the trees along the right bank.

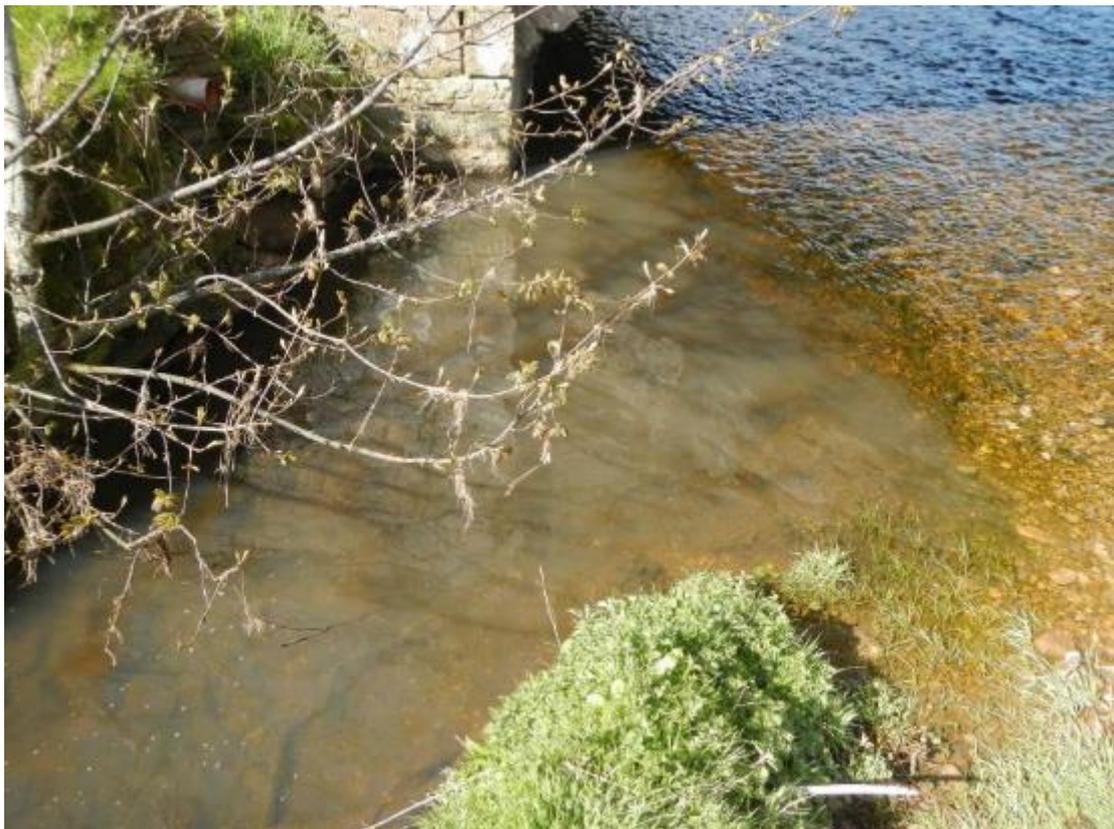
At the upstream side of Eastfield Bridge footings, an outlet from the sewage treatment works was noted. It appeared to be discharging water of a poorer quality than the river; something that would be worth investigating as, although colour and odour are no clear indicator of an issue, they may suggest that the discharge is not meeting the conditions of its consent. In addition, anecdotal evidence from KSDAA members during the site visit suggest that river fly sampling in that area has revealed impoverished invertebrate communities. This is another reason to request that the Environment Agency assesses the discharge.

Figure 9. Water discolouration and odour were noted at the sewage works discharge u/s of Eastfield Bridge. This may indicate an issue with the quality of water being discharged to the river.

It is recommended that the sewage treatment works discharge at Eastfield Bridge is investigated as it appeared to be particularly discoloured and odorous (Figure 9), possibly indicating an issue.

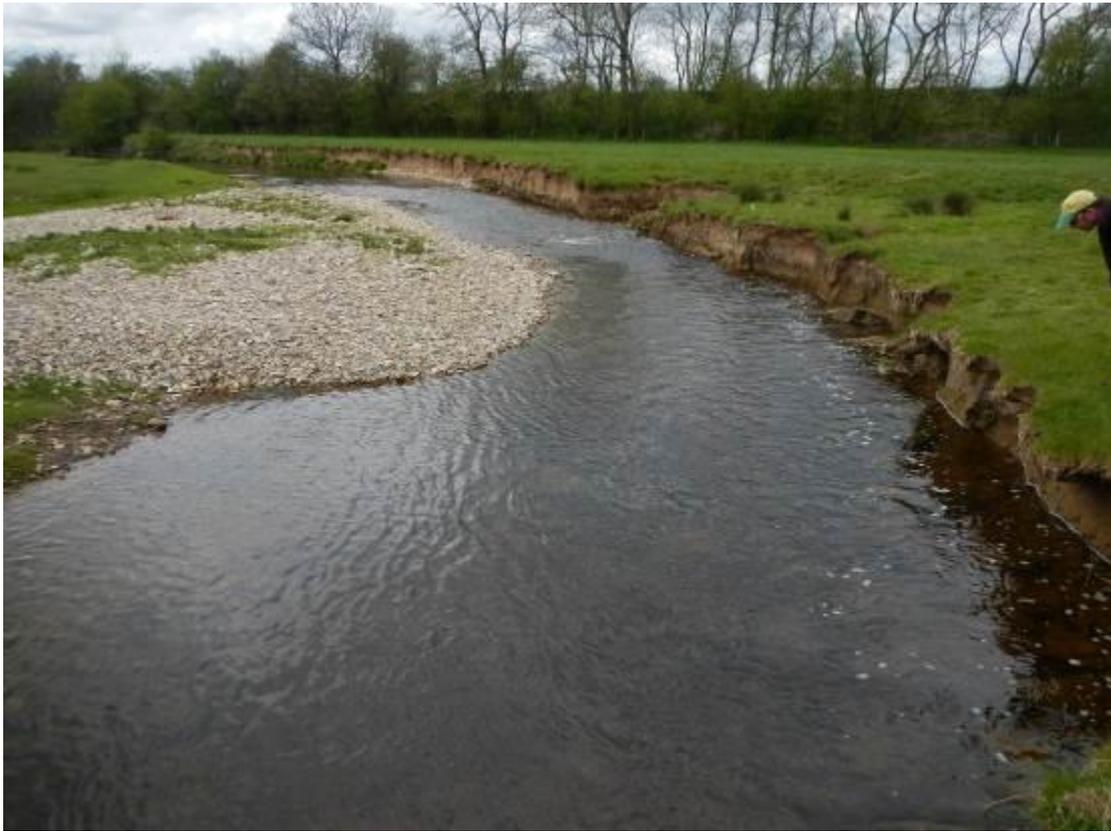
Scandal Beck was walked from its confluence with the Eden to an upstream limit near the railway crossing. In this area obvious signs of channel realignment were noted, likely in part, due to the railway line, but also as part of the historic channel maintenance undertaken throughout the catchment to create larger, less fragmented grazing areas. It is apparent this treatment has not really had the desired effect as the river has reinstated a more natural, meandering course (Figures 11 & 12); something that has happened more actively due to grazing of the river banks. The initial erosion and movement of the channel to a more, sinuous course is positive, but it is now at a stage where stabilising the banks in its current course would be beneficial.

Figure 11. A long section of erosion occurring where the beck has eroded the banks to reinstate a more sinuous channel course. Fencing is now required to exclude livestock to increase vegetation cover, allow tree regeneration and stabilise the banks to reduce the significant sediment input. If fenced, it may then be worth installing soft bank revetment

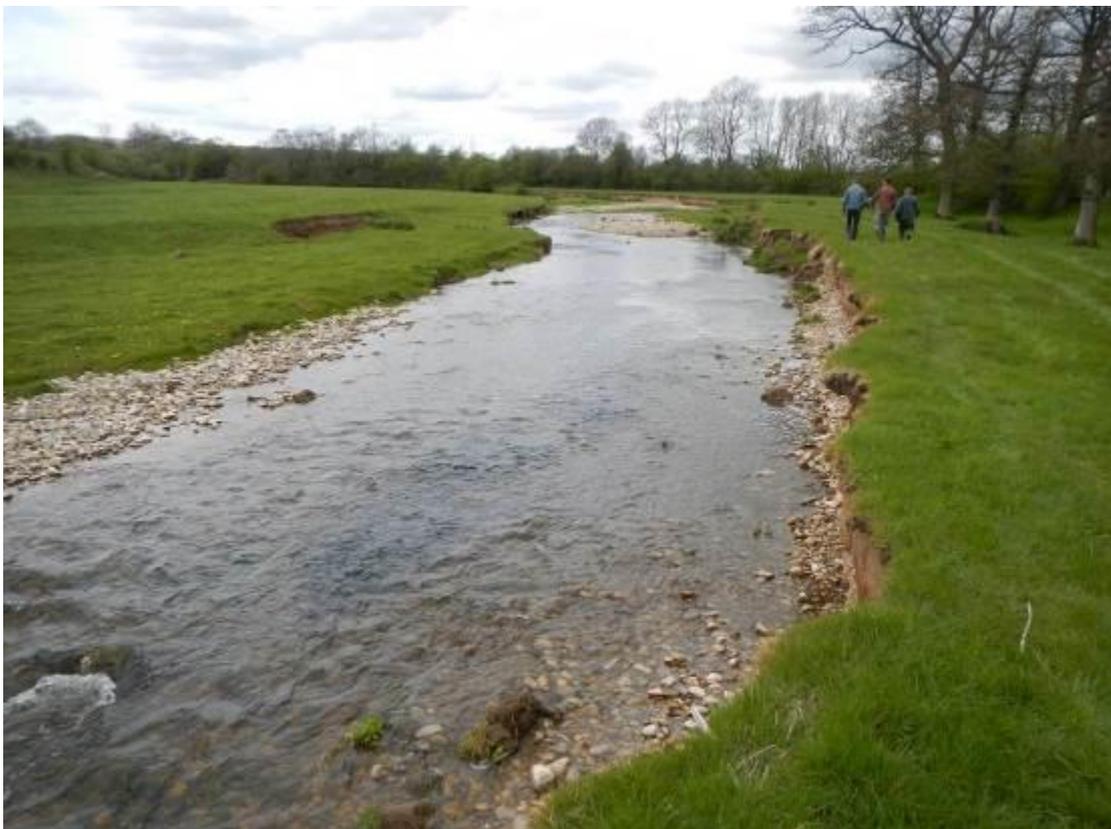
In many sections, the Beck is becoming over-wide, leading to shallowing (Figures 12 & 14) and there is a notable lack of trees, shrubs and herbaceous vegetation in the grazed sections. The monoculture of grasses and shallow root structure along the bank also means that as the banks slump, due to erosion undercutting, much of the material is washed away, rather than remaining in place to form a consolidated, re-graded bank (Figures 12 & 13).

Figure 12. Over-widening and shallowing due to erosion. Note the significant lack of trees or bankside vegetation/cover.

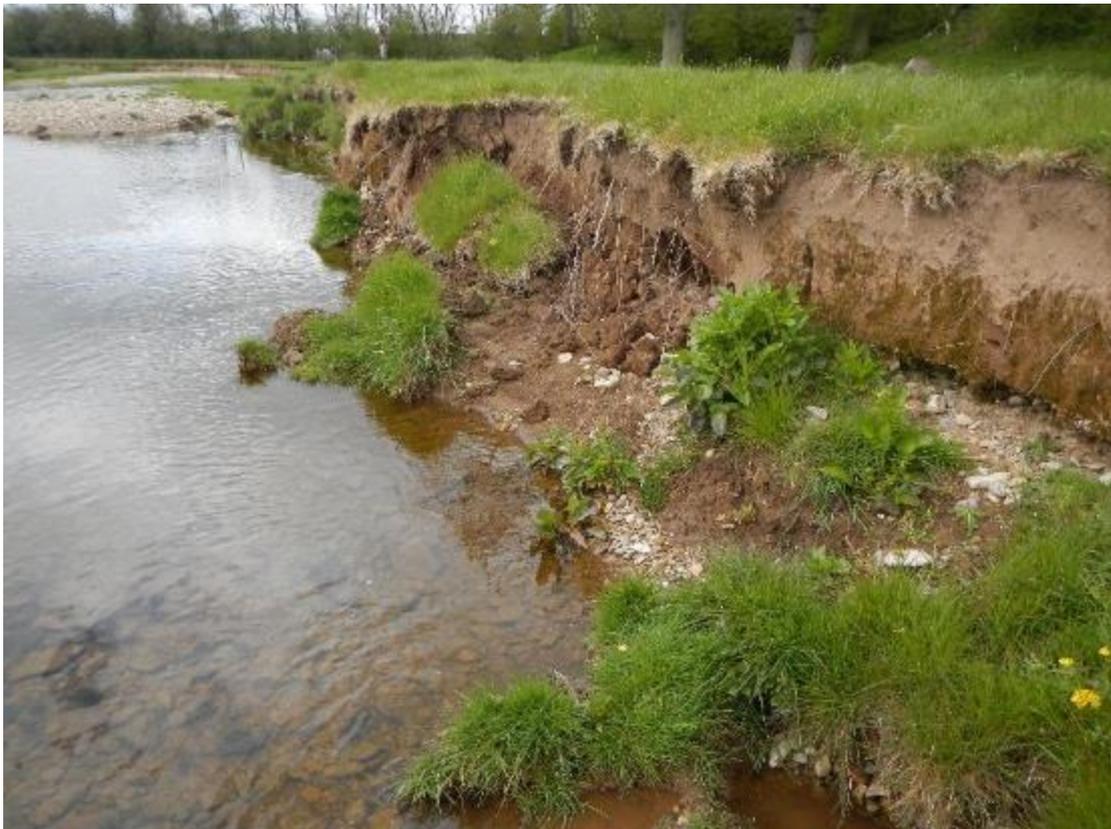
Figure 13. A lack of root structure within sandy, friable banks is reducing the potential for bank stabilisation and natural re-grading as much of the earth will be washed out in high flows. The roots visible within the subsoil are from the trees in the background, rather than the turf and topsoil. Buffer fencing to allow a greater diversity of grasses and herbaceous vegetation would greatly assist in stabilising the upper and mid soil layers.

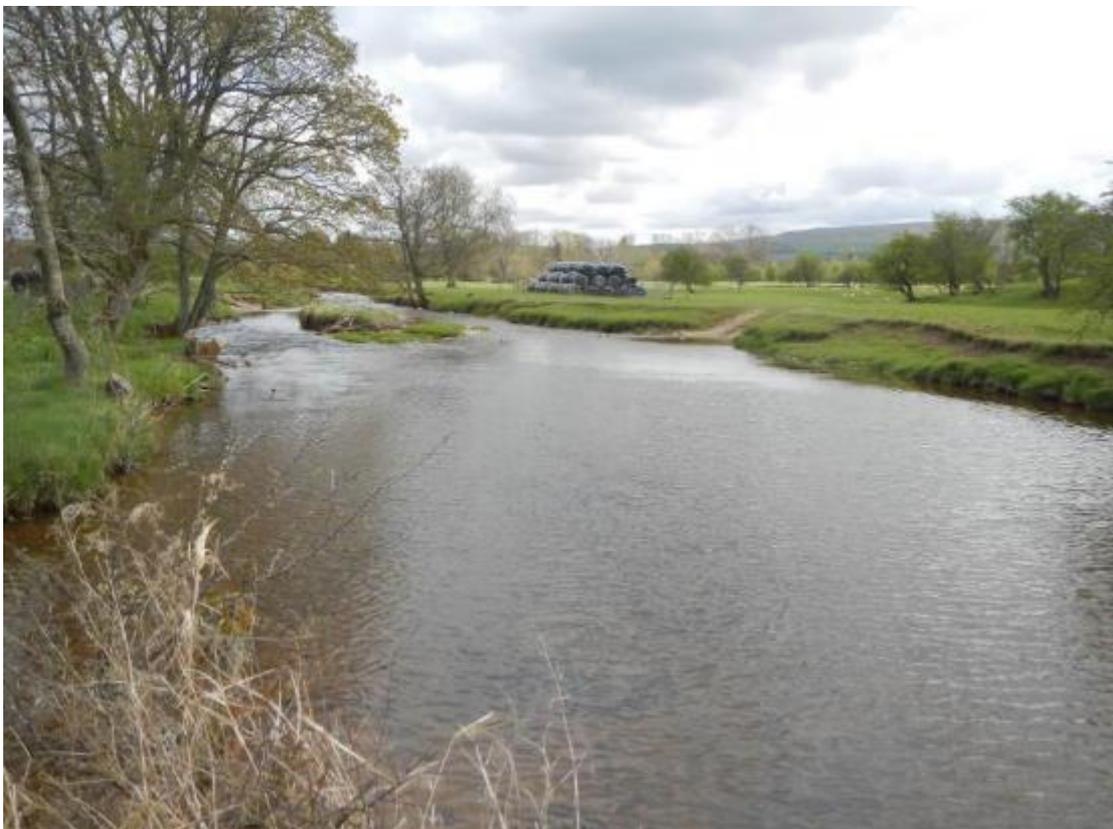
Figure 14. Significantly over wide section of the Beck where grazing and a fording point have destabilised the banks and exacerbated erosion.

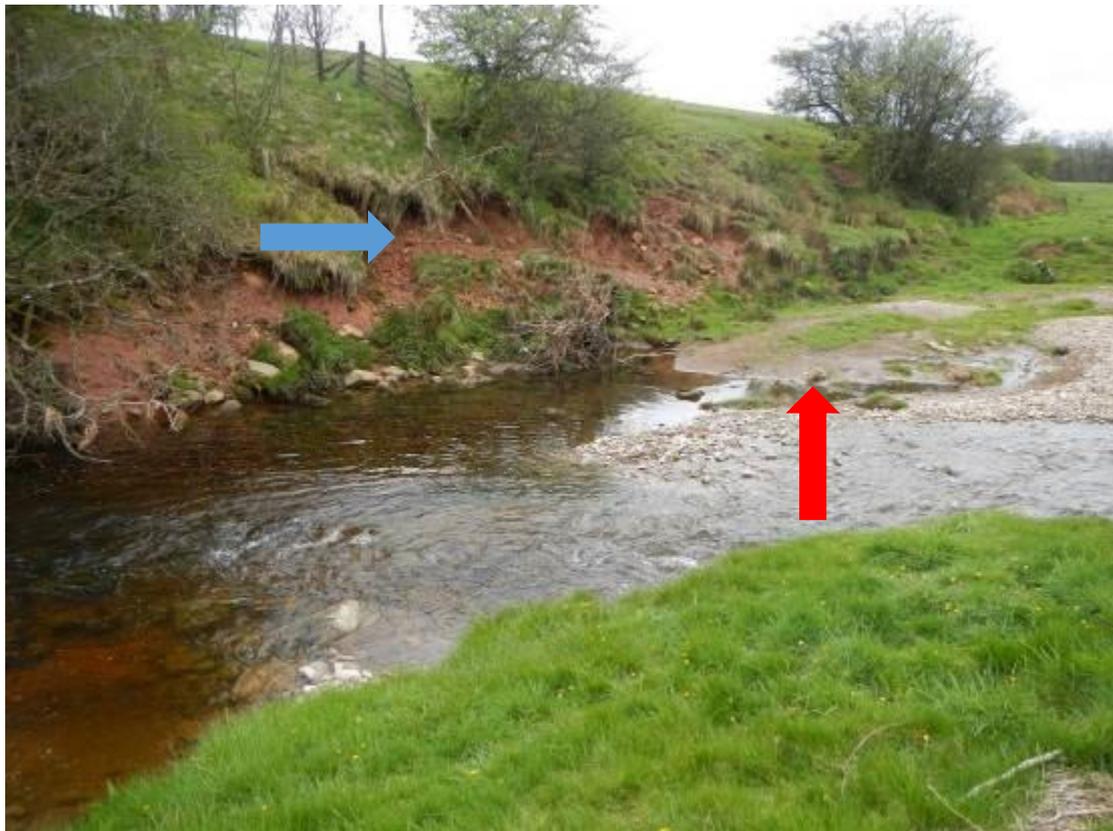
Figure 15. Further erosion issues (blue arrow) where livestock are trampling/poaching the bank within the field around the end of a poorly maintained fence. Also note the large accumulation of fine sediment in the backwater area (red arrow).

Increased sedimentation, as a result of bank erosion (among other issues), can be seen in Figure 15, as can trampling and poaching of the ground around the end of a poorly maintained fence. Maintaining existing fences and installing new riverside buffer fencing to exclude livestock from the watercourse will allow more diverse vegetation and trees to become established which will greatly reduce erosion rates and improve habitat along the reach.

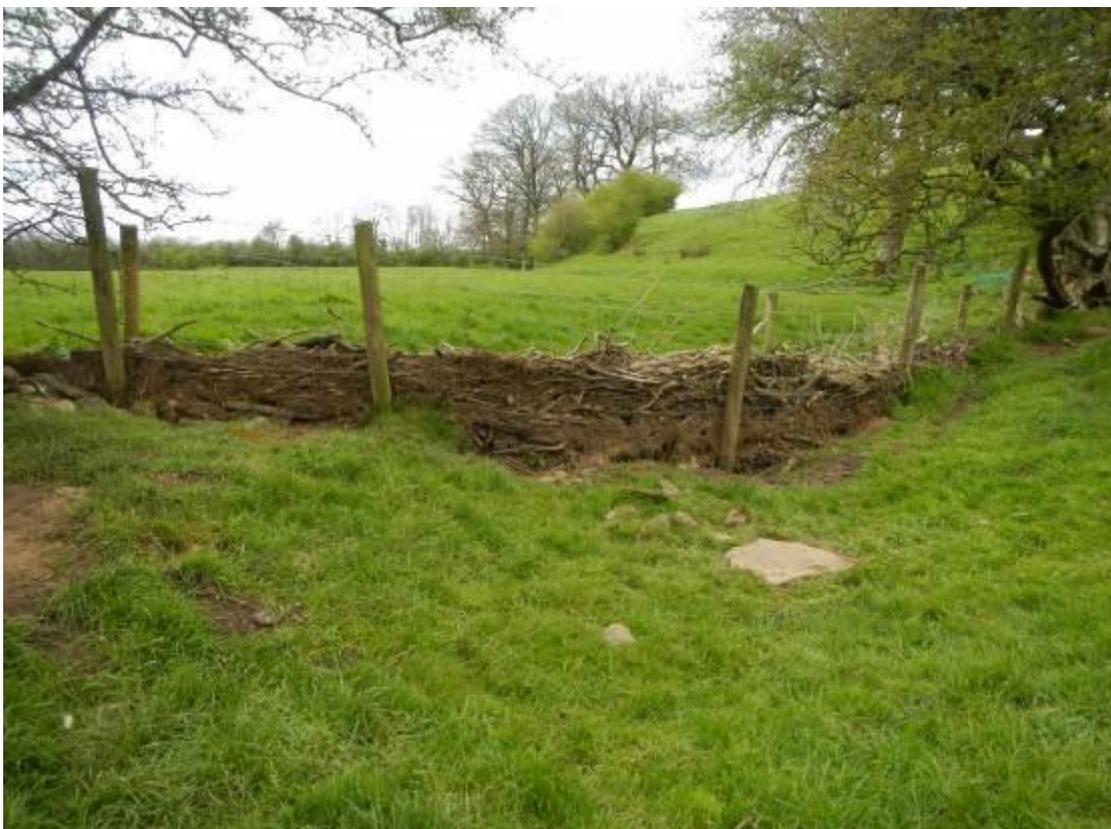
A fence in the adjacent field also shows how high (out of bank) flows often find the old (paleo) channels in the adjacent fields, as evident by the flood debris. This is something that the farmer should be encouraged to maintain to prevent the fence being washed out.

Figure 17. A fence crossing one of the rivers old channel courses in the adjacent field demonstrates a high water pathway where debris has accumulated against the fence. This highlights the fact that buffer fences may need to be designed to accommodate high flows and prevent them being washed out.

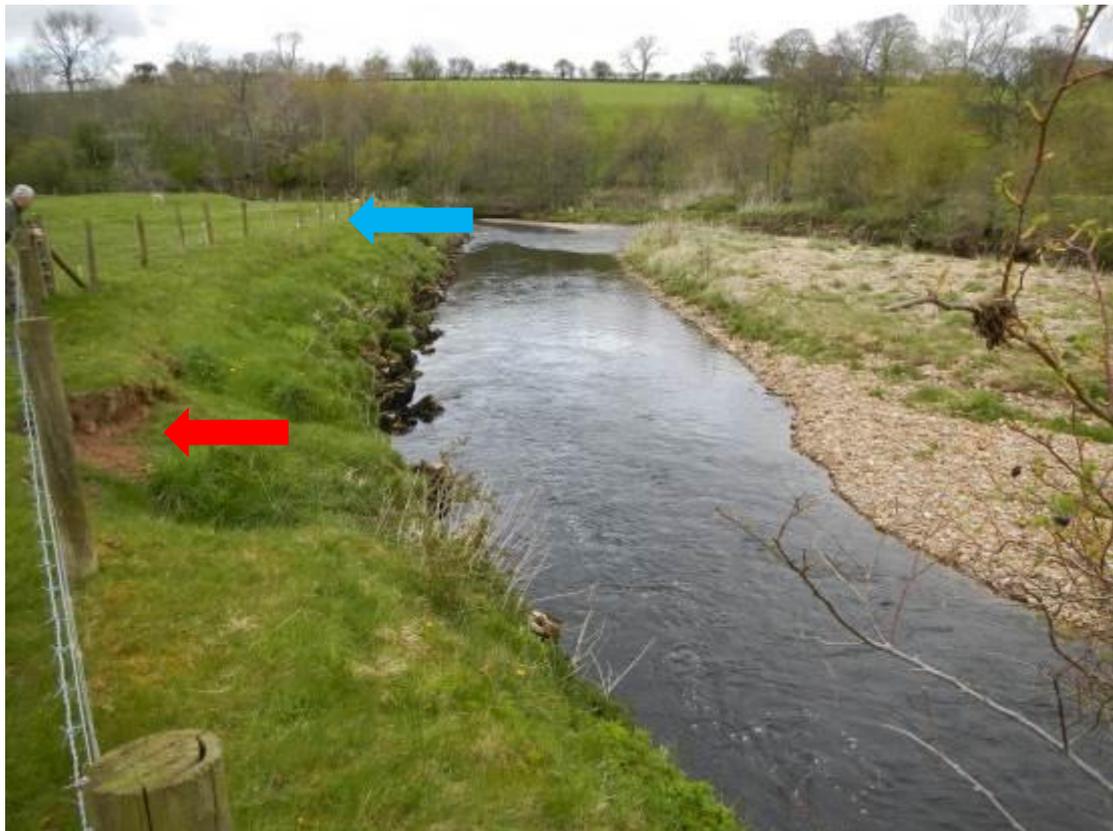
The upstream limit inspected on the Ploughlands beat was at the large vegetated island in the River Eden. At this point it became immediately apparent that, although the river was buffer fenced, sheep were still gaining access as evident by the short grass within the fence, wool on the fence wires and sheep erosion scars on the bank (Figure 18). As already detailed, even at low numbers, sheep on the river bank are likely to inhibit self-set shrubs and more lush herbaceous vegetation from becoming established, which will greatly limit the development of valuable riparian habitat.

Figure 18. Obvious signs of sheep access into the buffer strip. Wool on the wire (blue arrow); no difference in grass length or vegetation structure either side of the fence, apart from the lower less accessible area; sheep scarring of the ground (red arrow). The rock armour within the bank and along the toe does force a deeper pool area but also inhibits valuable tree and vegetation cover along the river's edge.

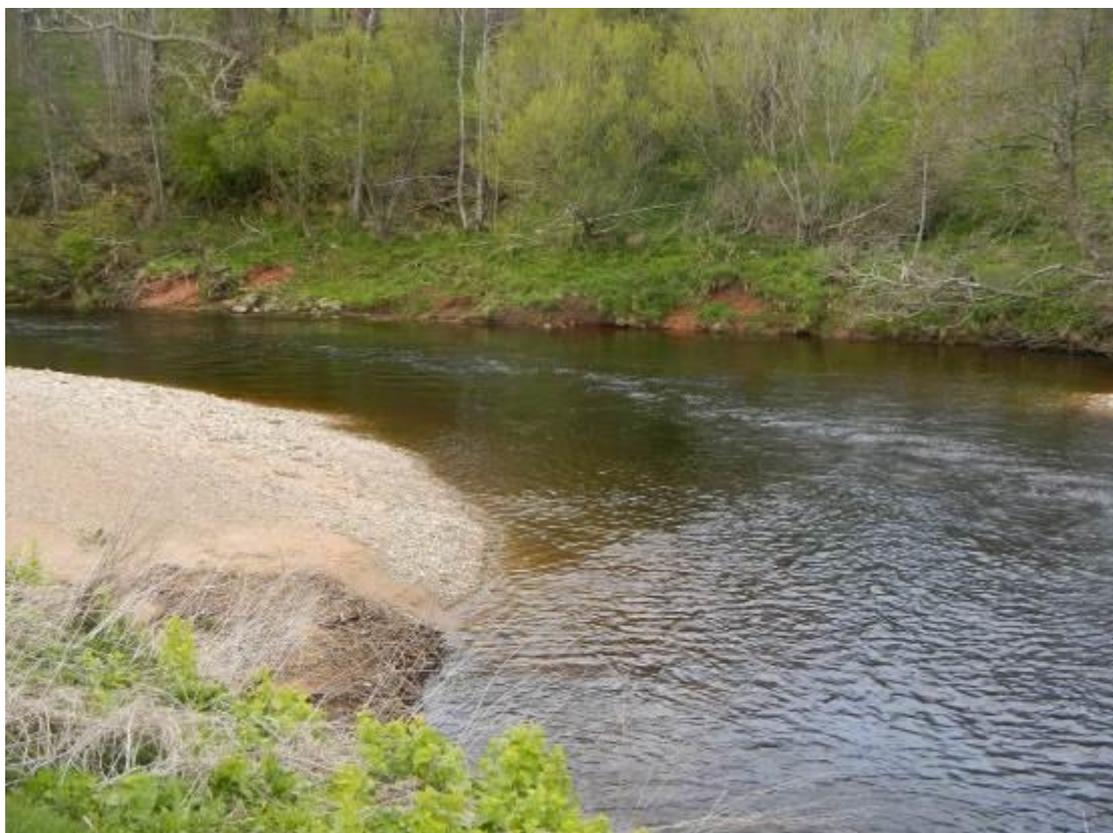
In the pool downstream, clay within the RB performs a similar function, with the cohesive material deflecting flows downstream and into the bed to scour another pool (Figure 19). Some of the vegetation and turf/topsoil has been lost along the waterline, probably where a layer of water has become trapped between the turf and soil causing it to slip. Planting willow whips along this bank would reduce the occurrence of bank slipping and provide great, low-level, fish-holding cover along the run.

Figure 19. Clay within the RB naturally creates a pool feature. It appears that water trapped between the turf and the clay has led to bank slippage. Greater tree coverage along the lower bank would reduce slippage and greatly improve the fish-holding capacity.

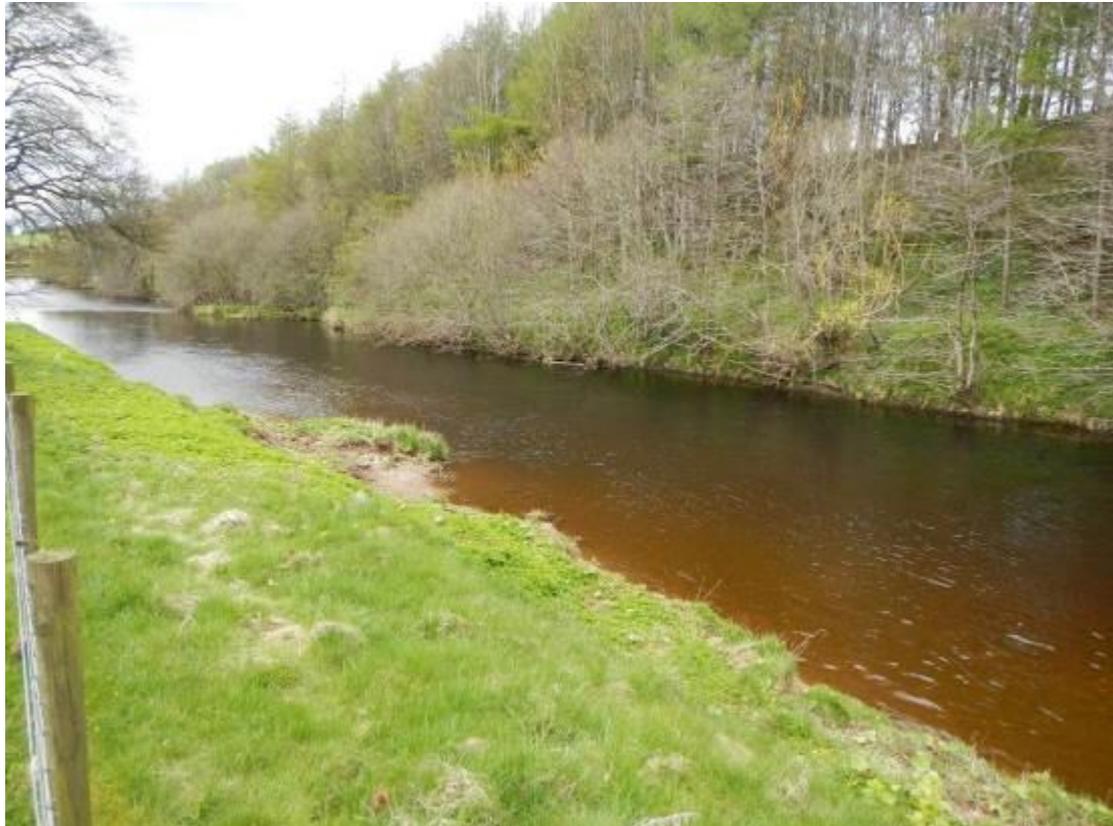
Large areas of the channel downstream of the pool appear to have been dredged and re-sectioned, leaving an over-capacity channel that is quite deeply incised (Figures 20, 21 and 22) and compromising areas that would otherwise be good spawning habitat for salmon and grayling (Figure 21). However, if stock can be kept off the river bank, natural narrowing will occur as sediment deposits within the river margin and becomes consolidated by vegetation, as is starting to occur (Figure 20). More willows along the bankside and within the river margin would be very valuable in trapping sediment and assisting the natural narrowing process (Figures 20 & 21).

Figure 20. Straight, likely re-sectioned channel. Low trees on the RB provide good cover for adult trout. Sediment depositions in the LB margin will consolidate and remain in place to provide valuable channel narrowing if sheep access is prevented. Planting a few trees (particularly willow for hinging in future) along this bank is advised to promote narrowing.

Where trees are available along the bank, habitat improvements can be easily achieved by laying the trunks, or selected branches down into the watercourse to increase low cover and in-channel structure. The method is usually limited to willow, elm, hazel, hawthorn and small alder, but some others can be laid carefully. Laying willows into over-wide sections, where available (Figure 22), or once they have been established on the open, wide sections (Ploughlands – around Figures 20-21) will be greatly beneficial.

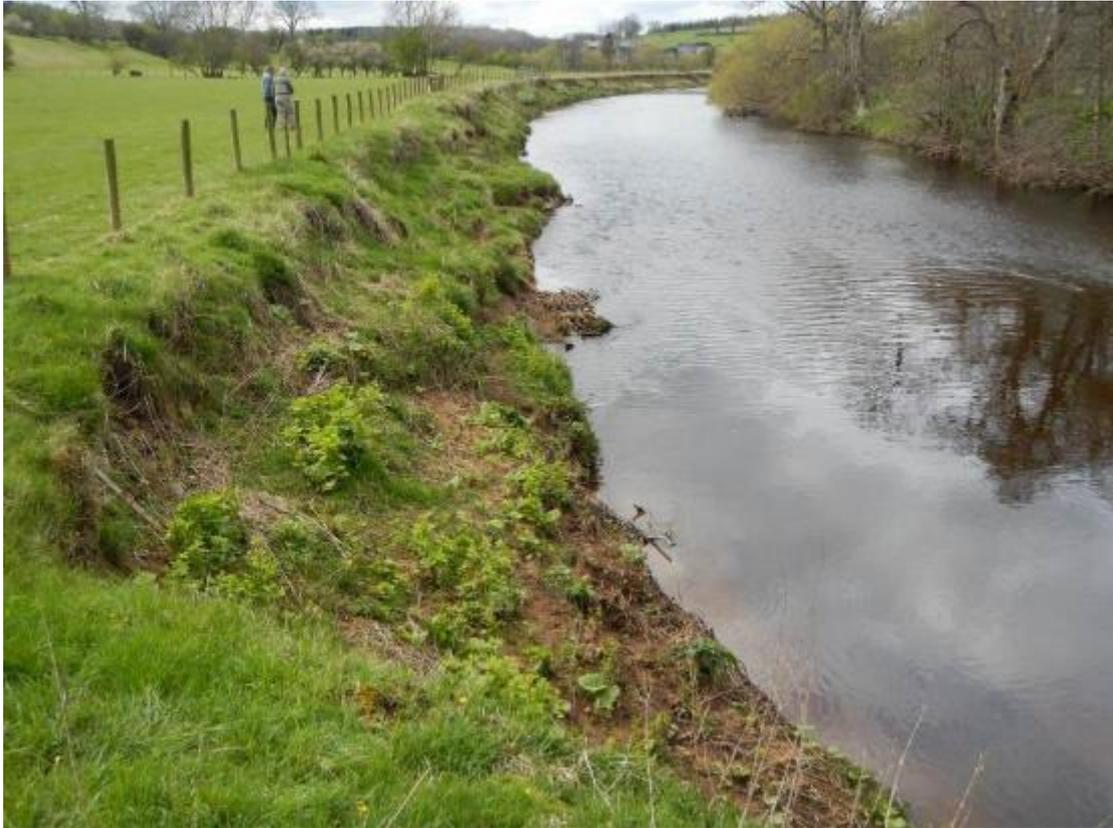
The poorly vegetated area in the foreground of Figure 21 is a result of a stand of Himalayan balsam (Figure 23) which shades out other species during the growing season, then dies back to leave no root protection within the bank over winter. This should be dealt with to prevent its spread and even greater erosion issues.

Figure 21. Over capacity channel where potential spawning habitat, particularly for salmon and grayling, is compromised by sedimentation. Owing to the large size of Eden trout, they too may use the area if sedimentation could be reduced. The poorly vegetated area in the foreground is a result of Himalayan balsam that should be dealt with.

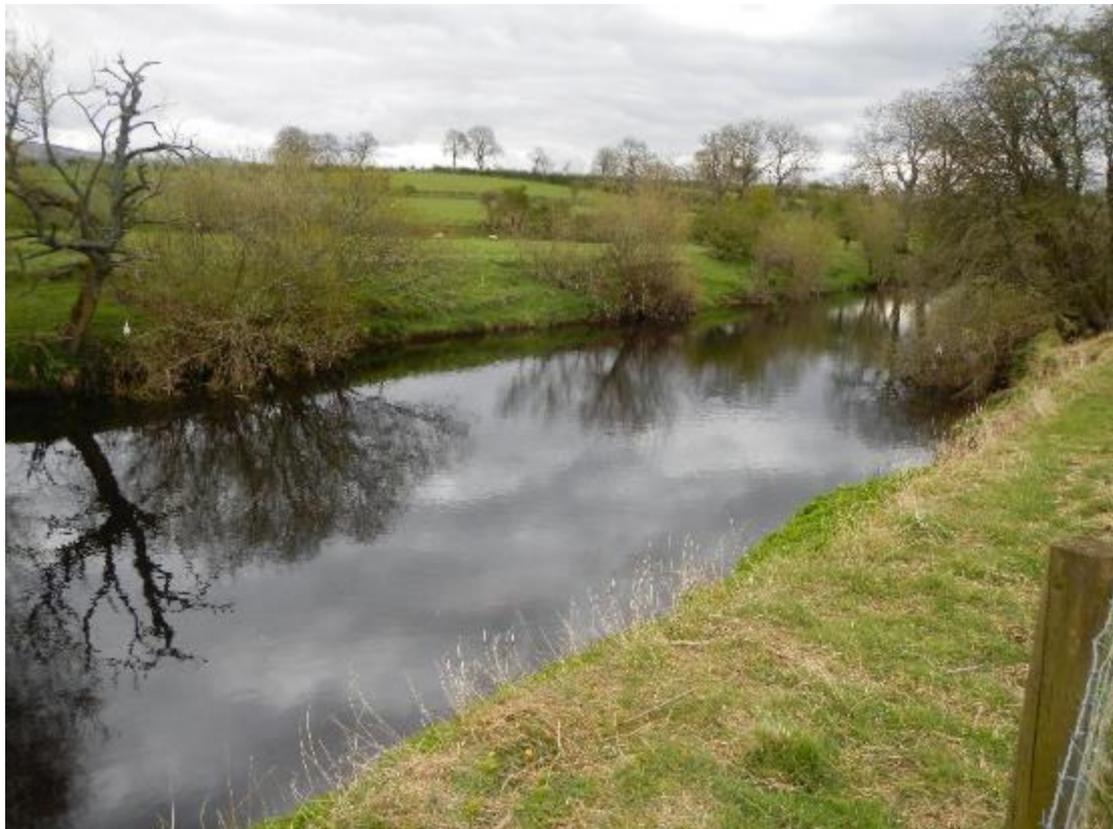
Encouraging willow trees into the channel, as is already occurring in places, is of significant benefit to the deeper section (Figure 22). Increased structure within the channel provides cover in which fish can evade predators, narrowing and flow diversity, and the structure will also help to retain substrate where it touches the river bed.

Figure 22. Over-deep and wide section, where trailing trees provide vital cover in which fish can evade predators. They also increase the fish holding capacity by providing lies within what is otherwise poor habitat. As they fall into the river, the willows should help sediment to accumulate in the margin and, over time, start the channel narrowing process.

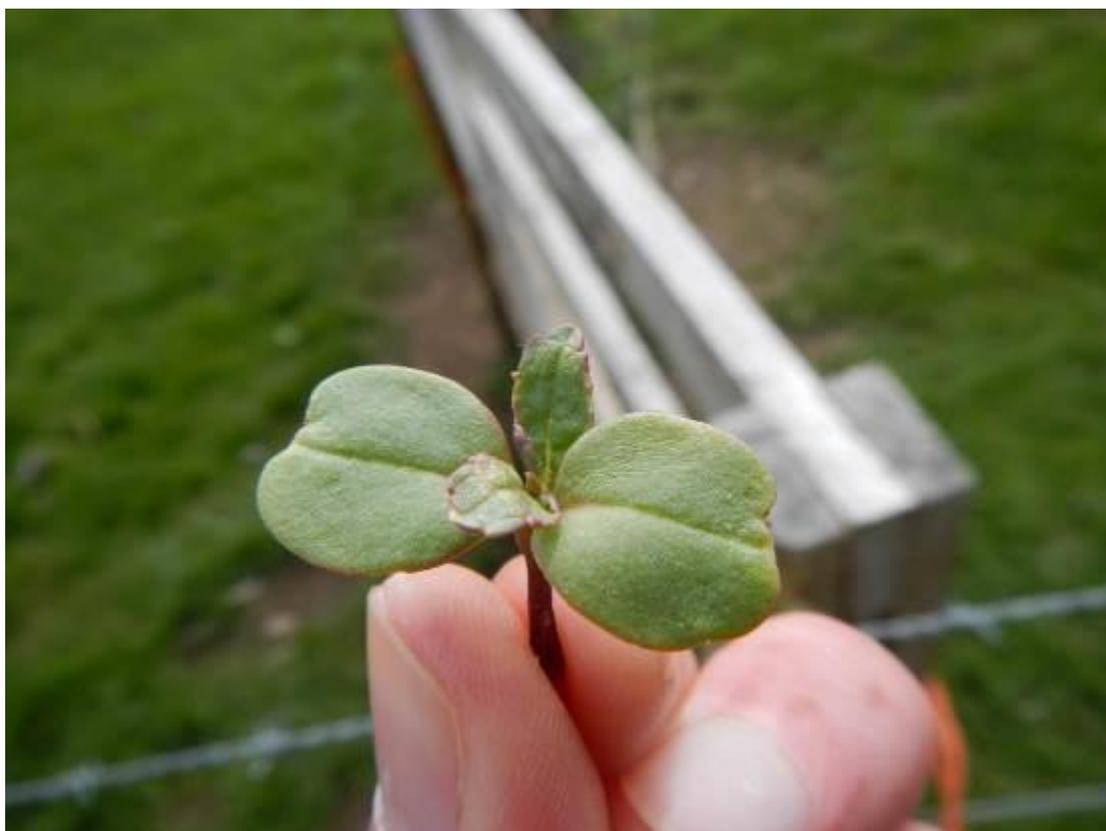
Figure 23. A young Himalayan balsam shoot found on the LB (in Figure 21).

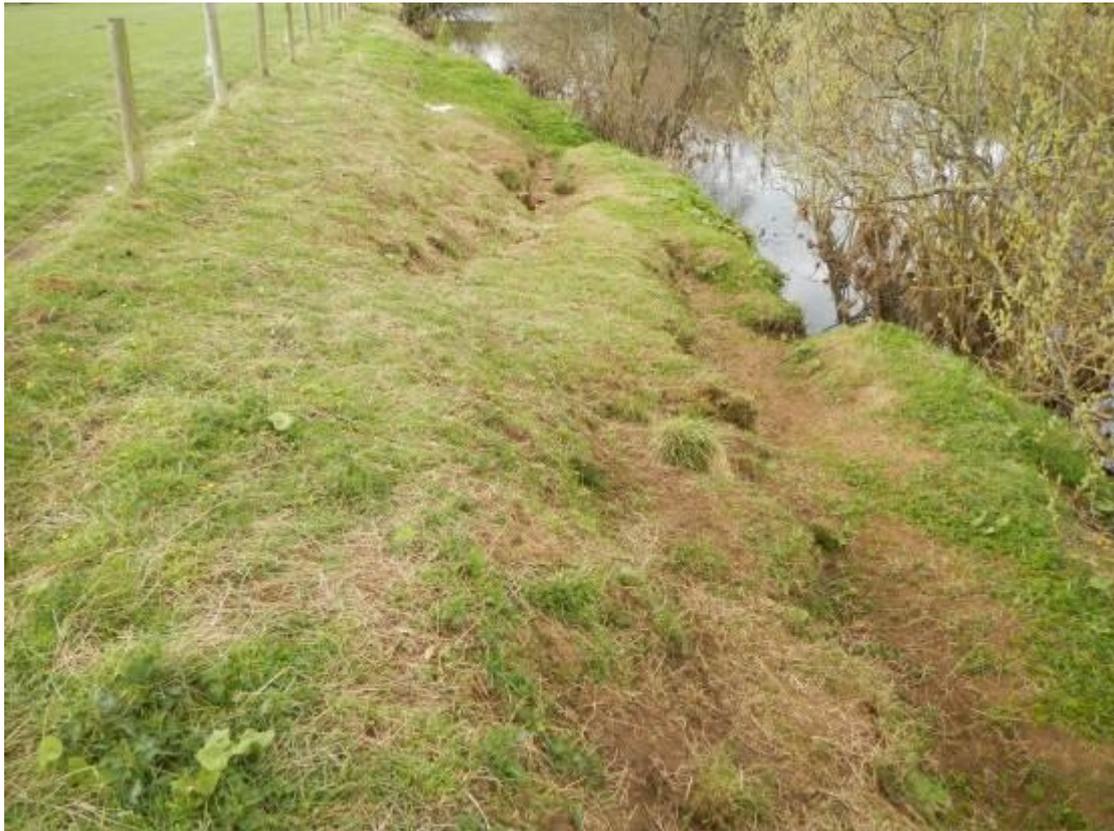
Further downstream, the effect of sheep ingress to the buffer zone is even more significant (Figure 24), with the sheep erosion scarring and grazing pressure plain to see. Although the buffer is continuous, the adjacent fields are separated, and the lower field appears to be grazed more heavily than the upper one, which is encouraging sheep to enter the better vegetated buffer strip through the slack wires.

Figure 24. Towards the downstream end of the buffer strip, poor tension of the wiring and greater stock densities allows results in increased access and grazing within the buffer (probably mostly lambs), and erosion is again evident.

For this reason, it is very important to maintain the tension of the plain strand fencing wire with the tensioners that are located at the straining posts (Figure 25) to keep the lambs, and ultimately, sheep out. It might be worth contacting the farmer to offer to do this for him, as it may lead to better maintenance. In addition to being an issue for the retention of a well vegetated strip, it is also an inconvenience for farmers when the sheep go through the fence and have to be retrieved, so it may be in their interest to let KSDAA undertake occasional maintenance.

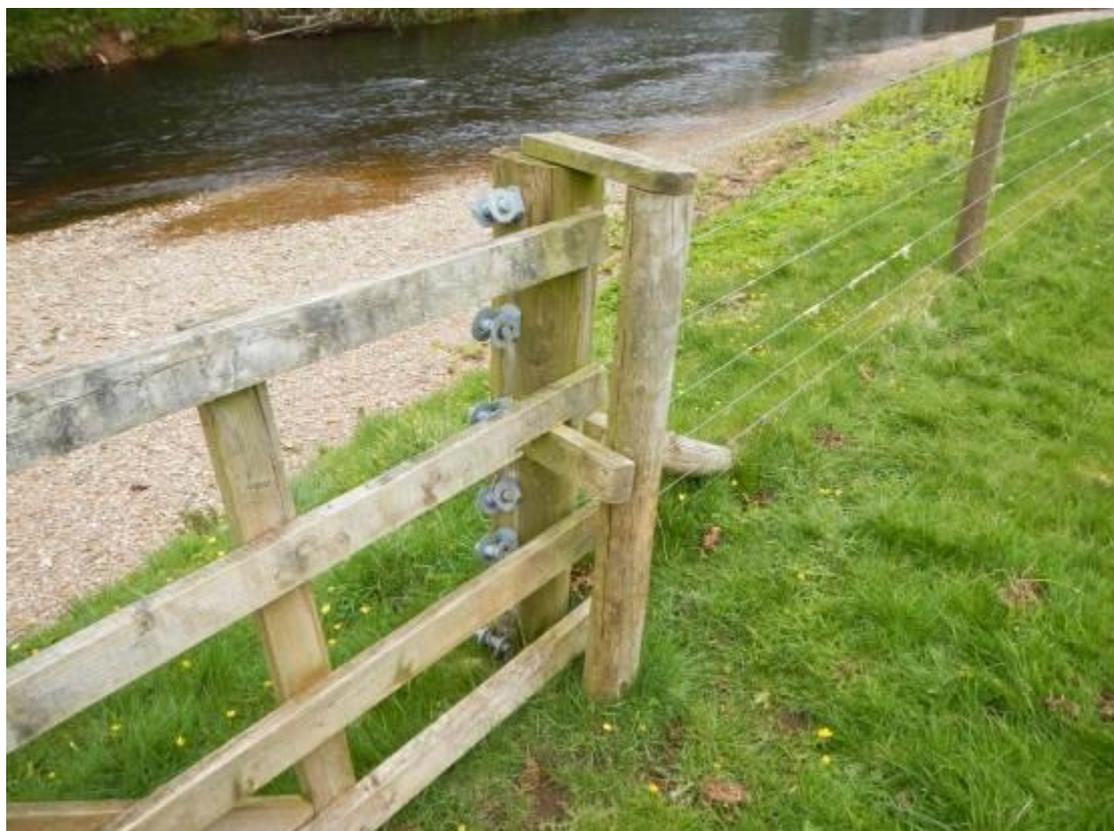
Figure 25. The buffer fence is equipped with tensioners, which means that the wires can be tightened to improve its stockproofing. Note the gravel bar in the background with is the rivers way of naturally narrowing; at least part of this is likely to become vegetated if stock can be kept out.
