Advisory Visit
River Eden and Scandal Beck
01/05/2015

1.0 Introduction

This report is the output of a site visit to Kirkby Stephen and District Angling Association's (KSDAA) water on the River Eden, undertaken by Gareth Pedley and Jon Grey of the Wild Trout Trust. Several KSDAA members attended the visit (including Alan Swann who along with Colin Edney, requested the visit). Daniel Brazier (Eden Rivers Trust) and John Garner (Natural England) also attended. This report covers observations and discussions made on the day of the visit.

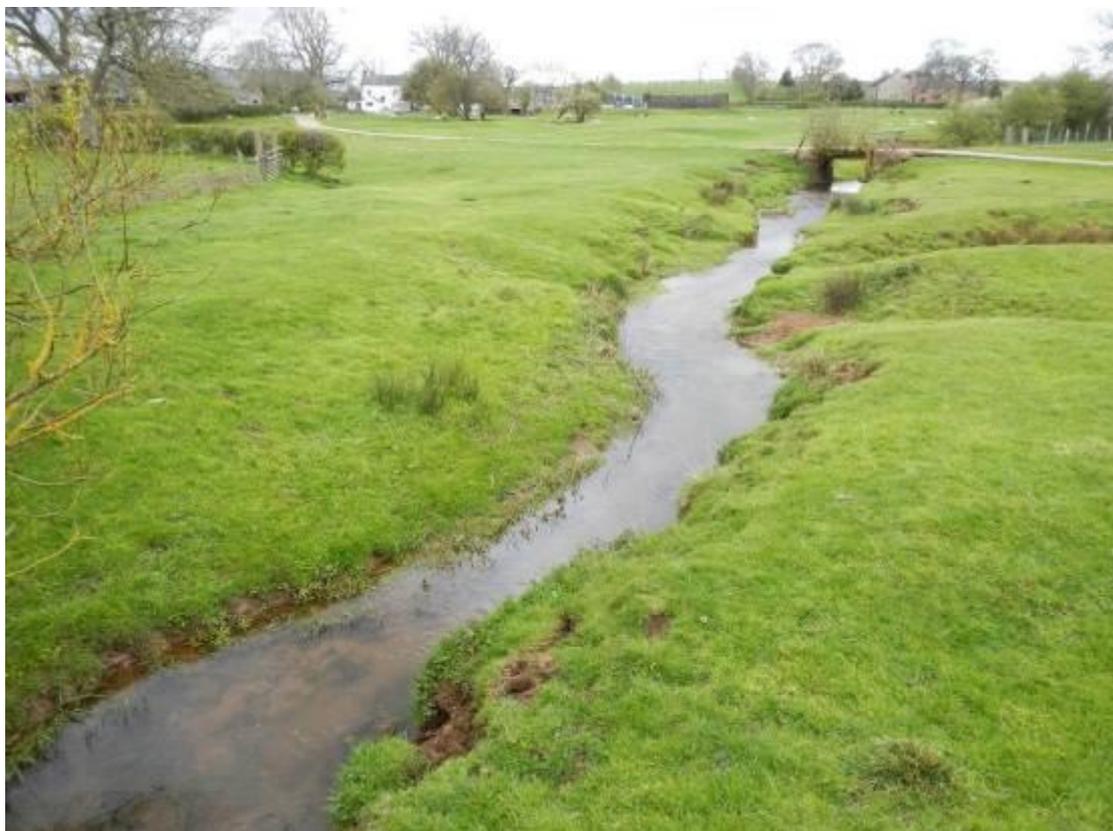
A small tributary (Blind Beck) enters the Ploughlands beat (Figure 26). This is exactly the size and type of tributary that KSDAA should be focussing on as spawning and juvenile areas for trout that will populate the Association waters. However, despite having the basic characteristics (suitably sized gravels and flow characteristics), the Beck is in a poor state at present, with significant sedimentation that greatly reduces its potential to support fish stocks on the main river (Figure 28).

Figure 26. Blind Burn supports many of the characteristics required for a valuable spawning tributary in terms of gradient, basic substrate, depth and flow, but is compromised by sedimentation and grazing.

Land management upstream and grazing of the banks are major contributors to the sedimentation, but also affect the physical habitat. If the Beck can be buffer fenced to reduce erosion and allow natural narrowing that will scour the bed clean, and the other sediment inputs associated with farming practice upstream can be addressed, the Beck could be transformed. Buffer fencing would also allow the establishment of shaggy marginal vegetation that will support good fry habitat; with the associated, more stable banks, it may also be beneficial to install some small pieces of woody debris to further accentuate flows and scour/sort spawning gravel areas. This would serve as an excellent demonstration project to show the positive impact of the fencing and habitat improvement on a small scale, where anglers fishing the beat will be able to see it develop over time.

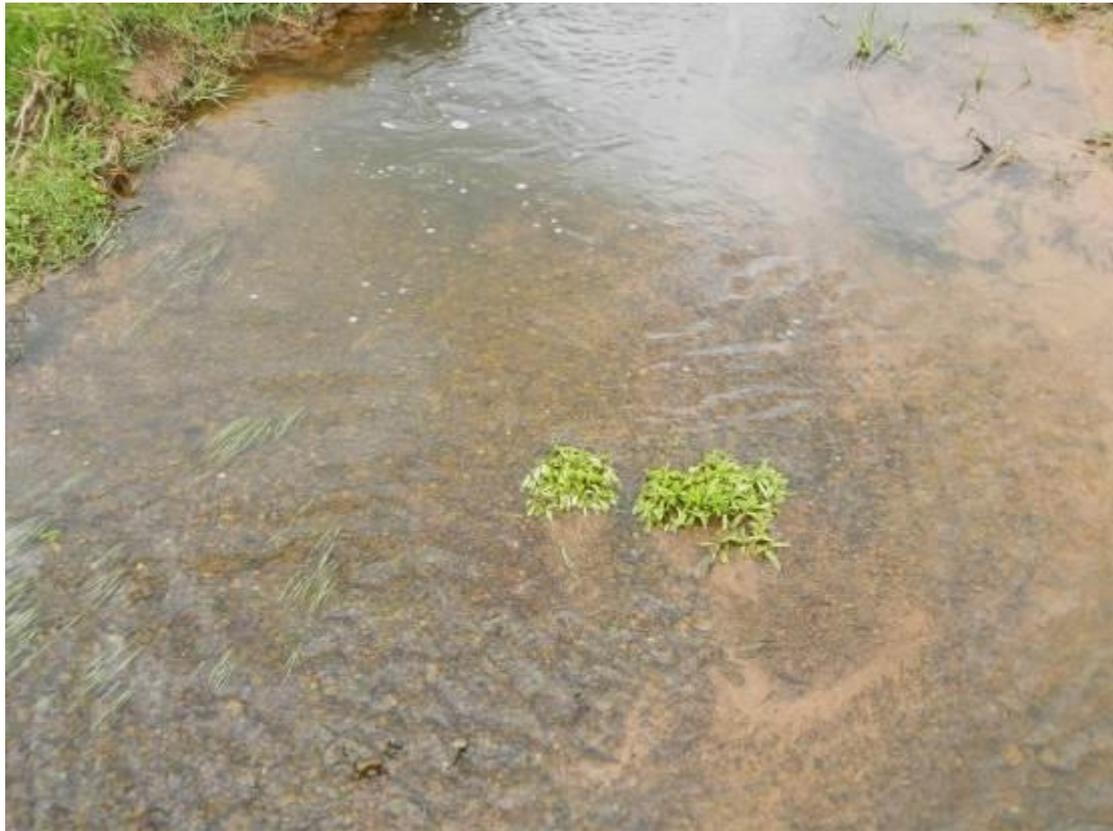
Figure 28. Substrate on the Blind Beck. The basic, natural substrate here should be ideal for trout spawning, but note the significant loading of fine material that renders it almost completely useless for salmonid spawning. Addressing the sediment inputs and fencing the beck could greatly improve natural trout production in the area.
