Advisory Visit
River Enler, Newtownards
Northern Ireland
5th April 2016

1.0 Introduction

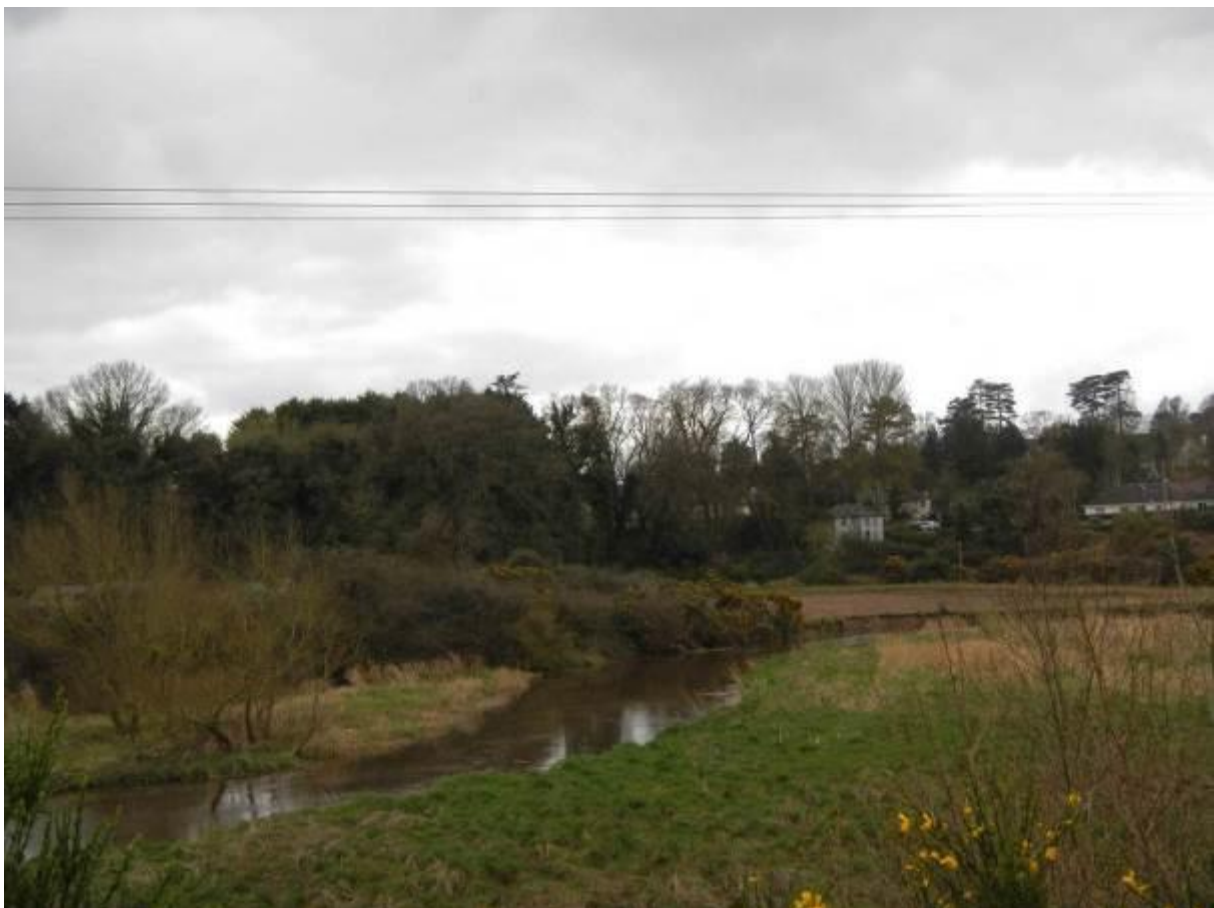
Figure 1. Bankside trees and vegetation provide important cover and flow diversity in the ever changing tidal reach. The wide floodplain of this reach limits the likely impact of such structure on river levels u/s.

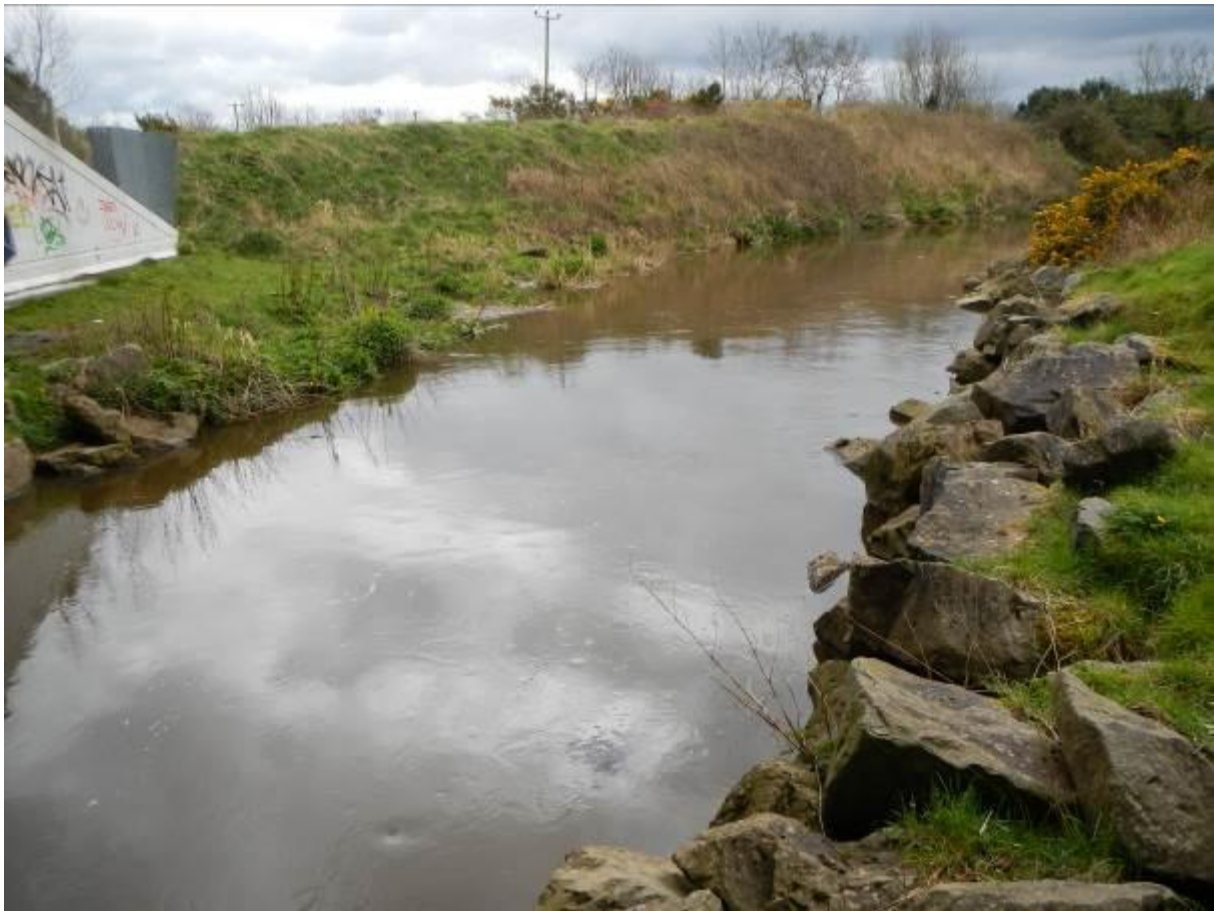
At lower flows, the impounded reaches u/s of a weir also create an easy hunting ground for predators and poachers, undoubtedly increasing losses to the fish population, particularly of juvenile fish (including smolts) on their d/s migrations. These sections act as an ideal spot where fish-eating birds could easily corral fish.

Figure 2. Even seemingly surmountable weirs and barriers can have an impact upon fish stocks and limit the overall success of a population. The weir in this picture is drowned out by the high tide but how many fish become stuck above or below it on lower flows and lower tides?

Removal of weirs and other obstructing structures within the channel should be a primary goal for improvement works for the river. Removing the rock weirs within the Middle and Lower town sections could not only improve habitat, and fish and substrate movement within those sections, but it could also potentially lower flood risk. The reduced flood risk could also increase the potential for allowing a more diverse tree and vegetation structure to develop within those areas.

A great initial step would be to investigate the potential to notch the weirs and remove at least a portion of them down to bed level. The location of the notch should be dictated by where deepening and the main river flow would be beneficial and with the hard engineering of the banks in many places it may even be possible to encourage some variation in the flow path (as described for the upper section) within the town. Where this is seen as too high a risk to the riverbanks or adjacent infrastructure, notches could simply be restricted to the centre of the channel.

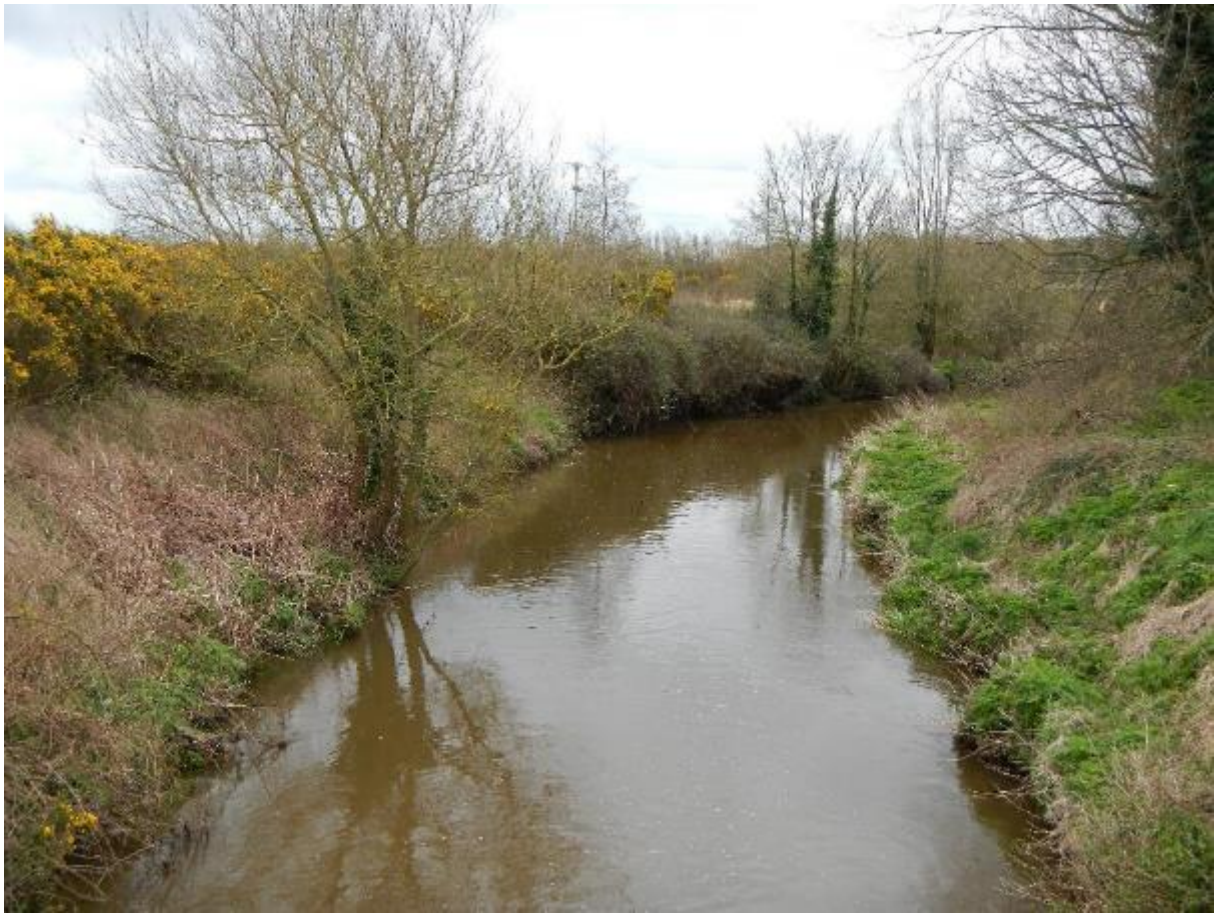
U/s of the weir, the wide, uniform channel appears relatively featureless, barring the occasional tree and overhanging bush, likely subjected to past dredging activity. Increasing the amount of cover and, ideally, trailing/in-channel structure would be beneficial to retain resident fish and providing improved holding water for migratory fish (Fig. 3).

Figure 3. There is a general lack of cover in many areas of the Lower Section.

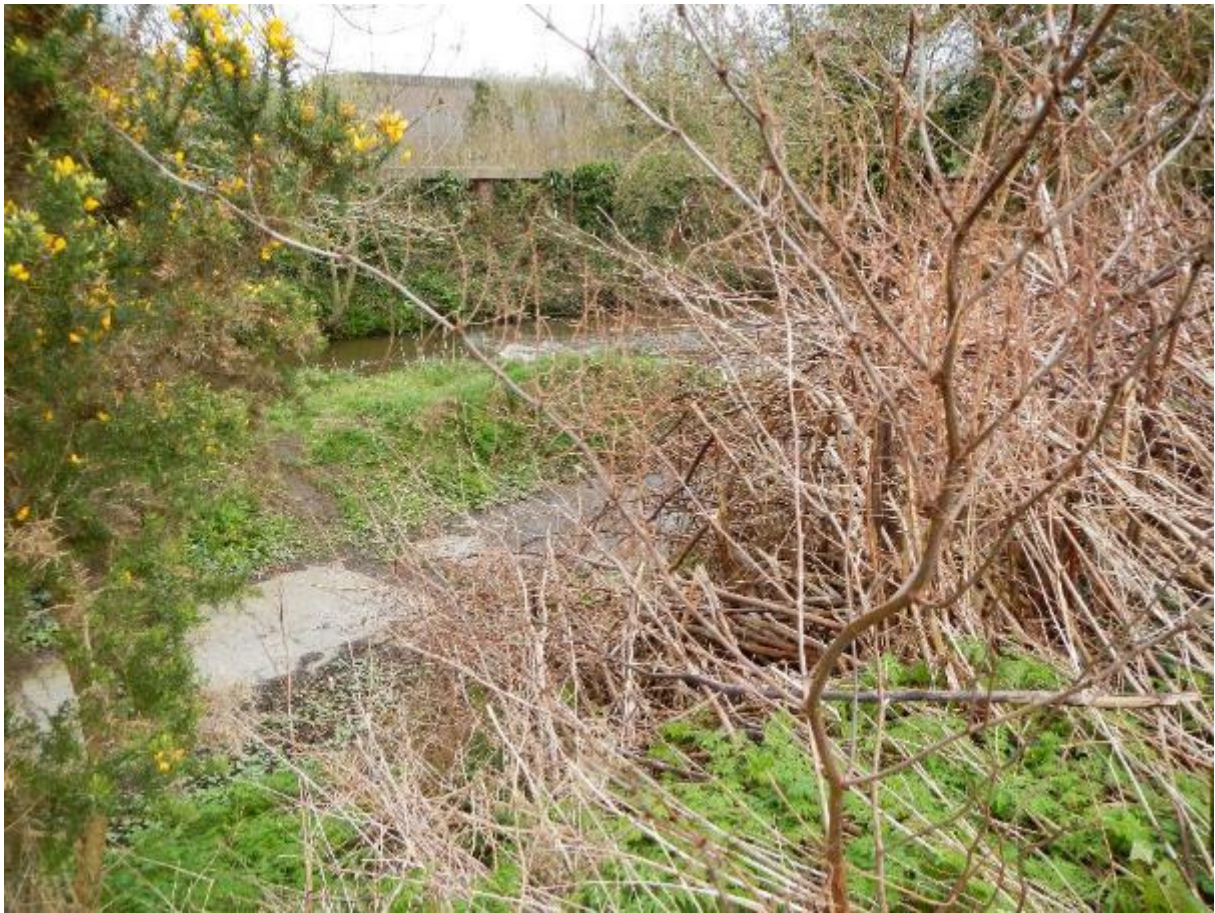
At the u/s end of Comber Park (NW 58205 23603), what is thought to be the u/s limit of Japanese knotweed (*Fallopia japonica*) was observed (Fig. 4). This is a highly invasive and destructive non-native invasive species that out-competes and over-shades native plant species, leaving poorly vegetated banks that are susceptible to erosion. It is important that such potentially damaging infestations are treated before they can take over.

Figure 4. The suspected source of Japanese knotweed (brown canes in foreground) on the river.

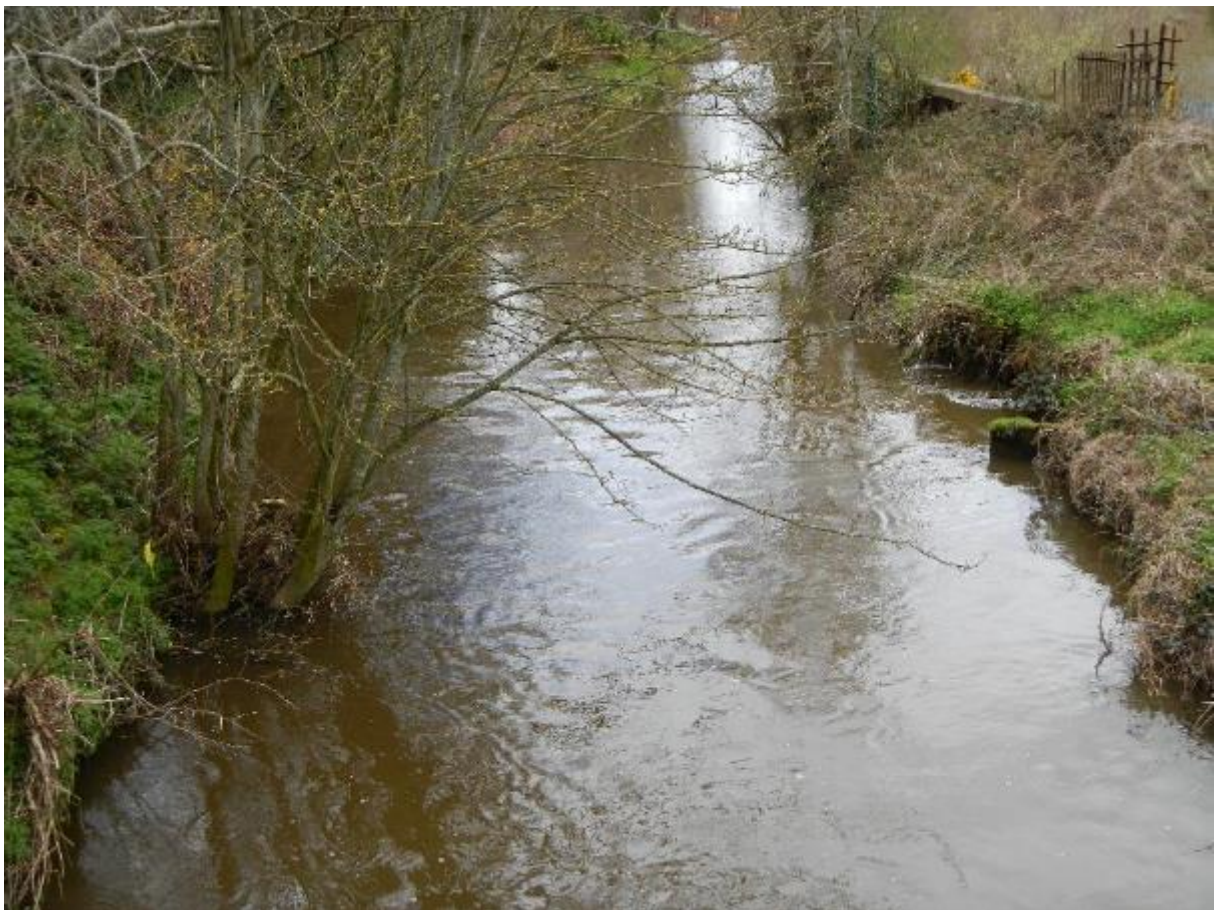
U/s of the knotweed, further signs of past channel maintenance and realignment are evident by the significantly straightened and uniform channel. In most areas, the bankside cover is too high above the water level to provide significant fish-holding potential (Fig. 5).

Figure 5. Cover and in-channel structure provides some enhancement of the artificial channel but much of the cover is above the optimal height above water level.

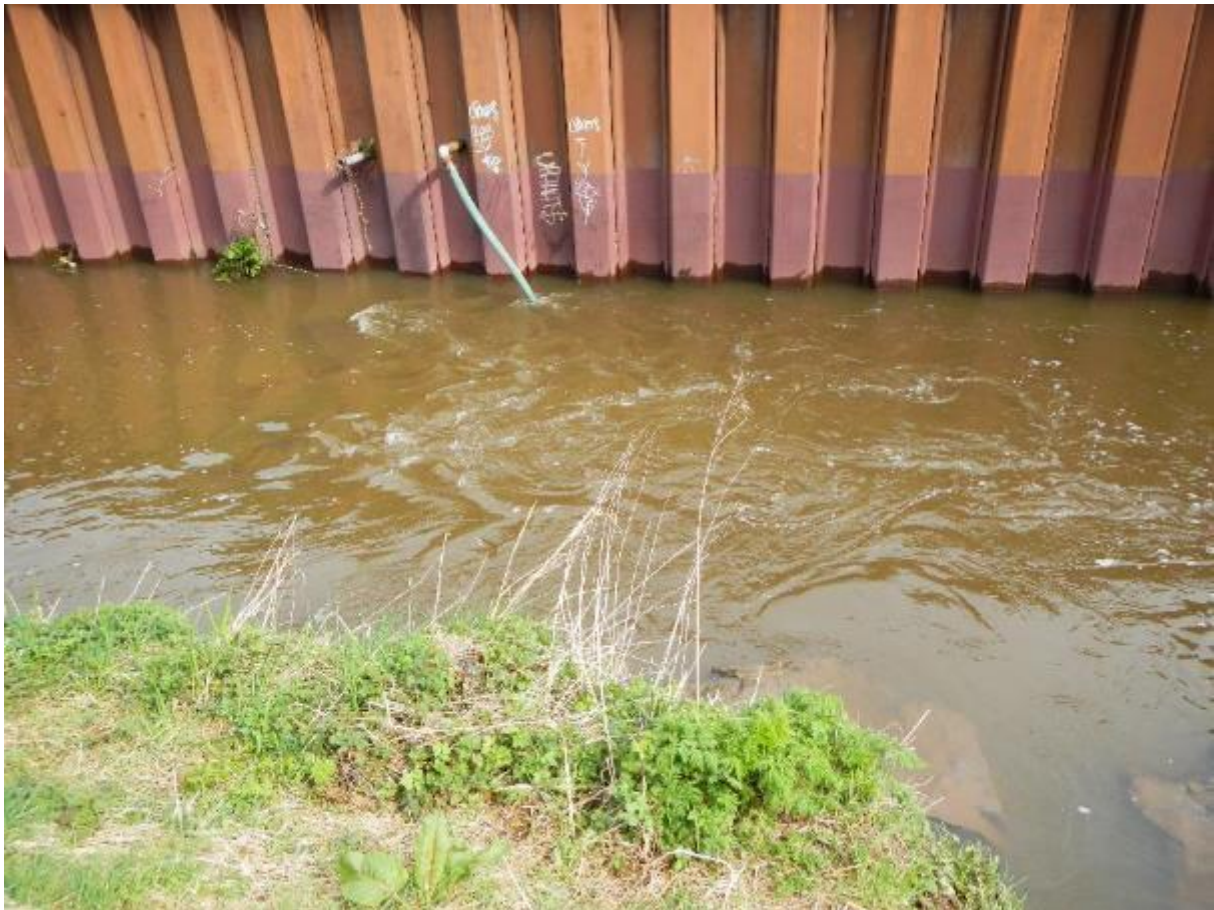
In addition to the straightening, much of the riverbank through Comber has been artificially revetted, often with sheet piling but also with rock armouring. This appears in part to be to keep the river within its artificial alignment but also to increase flood protection for the surrounding infrastructure. The sheet piling creates a barren edge to the river with little cover or sanctuary for fish and another submerged weir poses a barrier and potentially delays fish within this sub-optimal habitat where they are susceptible to predation, stress and poaching, particularly at low flows (fig. 6).

Figure 6. Sheet piled river margins provide no cover or refuge and another rock weir poses another potential obstacle that could delay fish within the sub-optimal habitat.

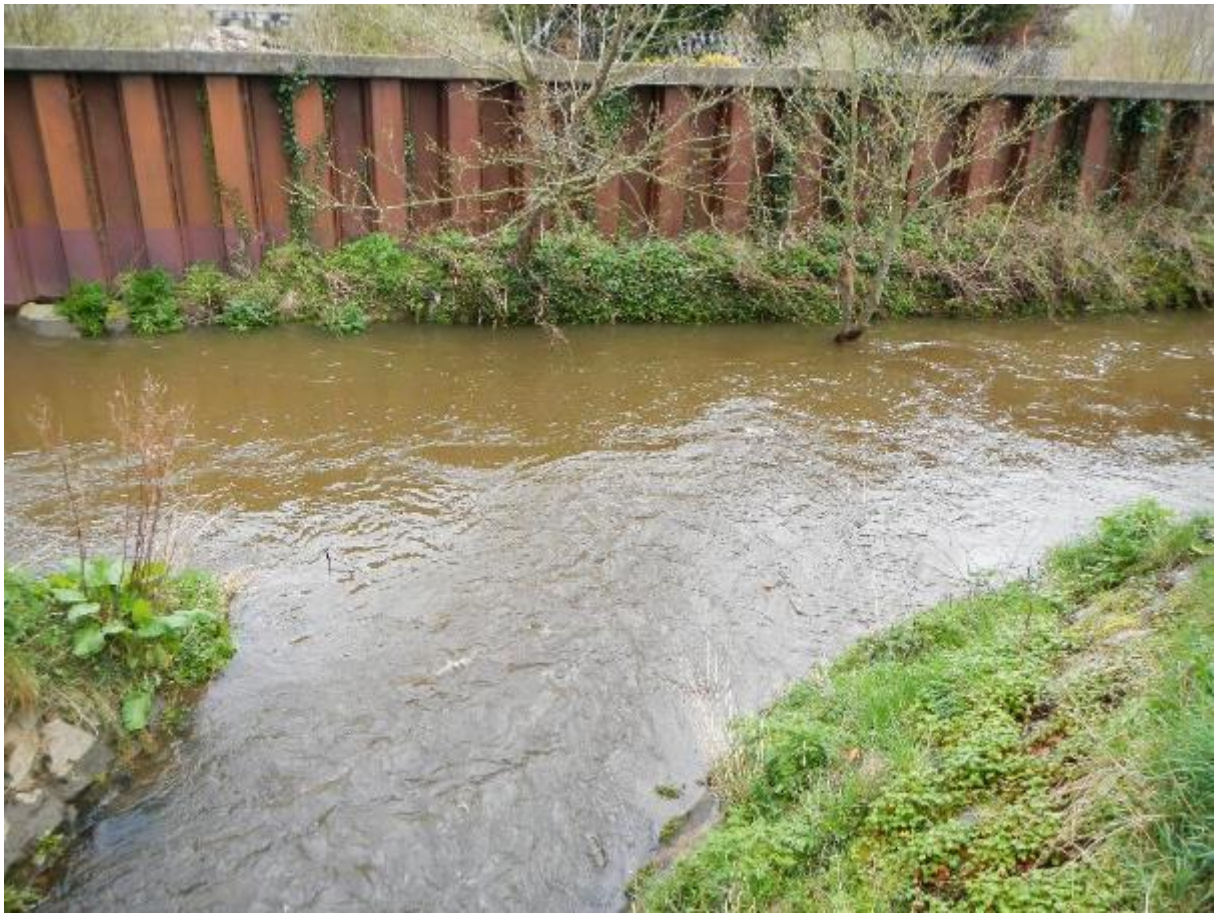
Figure 7. Where shrubs become established and pose no flood risk they should be retained at all cost as they will help to provide some of the vital cover that is lacking. Pruning the low branches will only improve angler access to areas that fish used to inhabit!

Owing to the lack of cover within the town area, it is therefore important to retain and encourage small shrubs and vegetation anywhere they can grow without adversely affecting flood risk (Fig. 7). In many places that such shrubs have established, it appears that the low branches have been removed. This may be to reduce perceived flood risk but it is more likely that it was simply to ease angler access. The temptation to prune low trees and branches for access should always be resisted as the action will simply remove the feature that held the fish anyway leaving no cover and no fish.

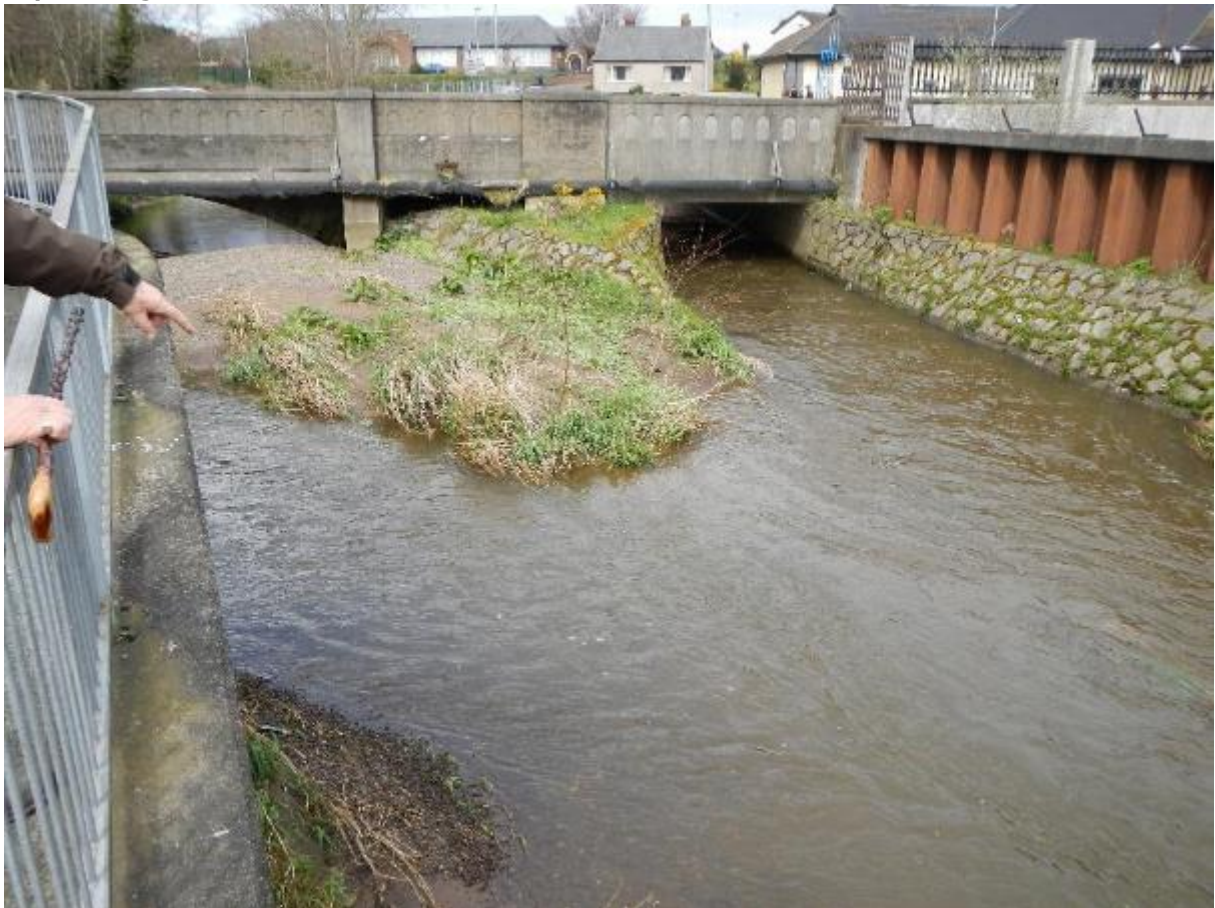
At Newtownards Road Bridge, the overwide channel has caused sediment deposition, partially blocking one arch (Fig. 8). Removing the sediment here will only facilitate further deposition as it is the loss of energy within the over-wide channel that is causing the material to be deposited.

Figure 9. Deposition around the Newtownards Bridge. Removing this will simply reinstate the over-wide channel and result in more deposition. This work may be undertaken by the council to maintain capacity but would be of no real benefit to angling as it may even remove spawning gravels.

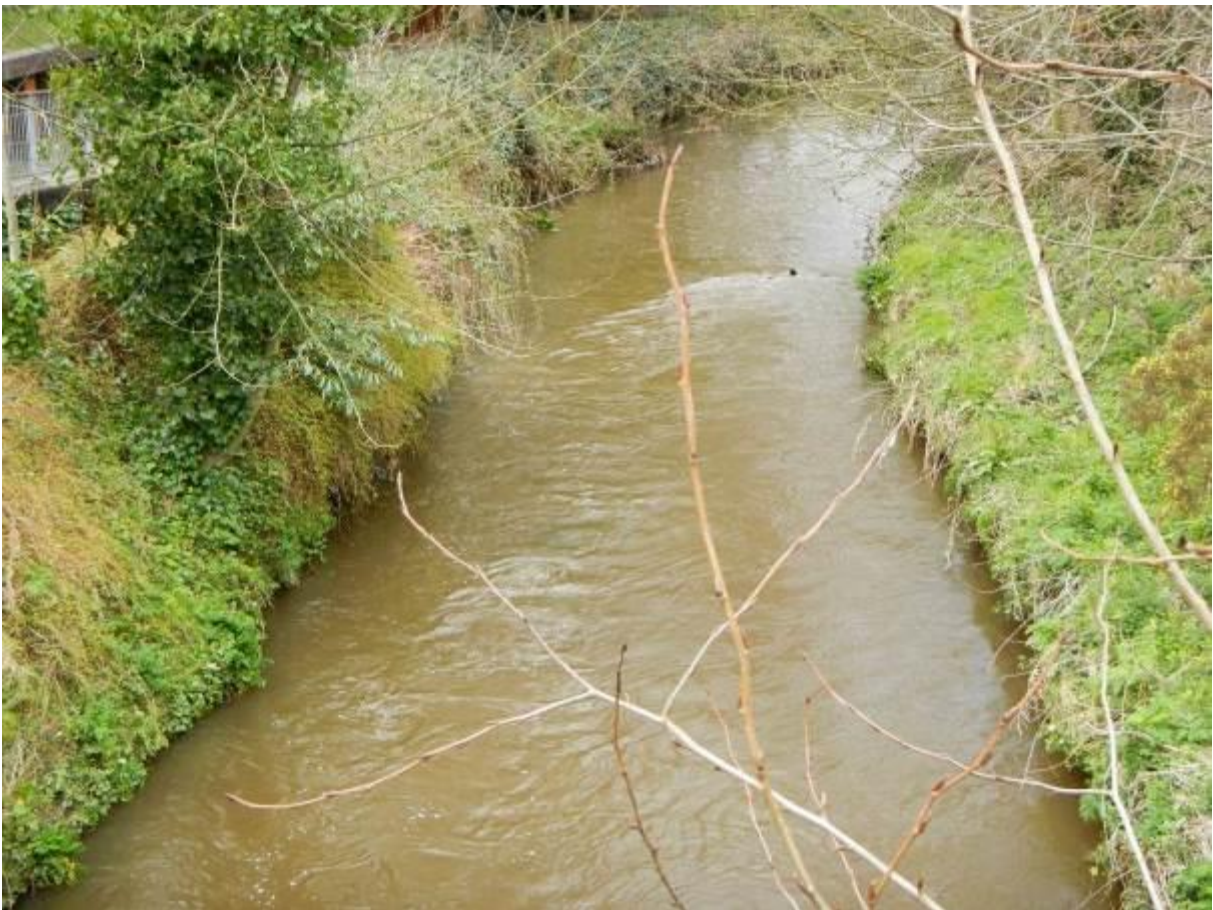
The channel u/s of the road bridge remains a uniform width and is of low sinuosity. This will greatly limit the natural variability of substrate sizes that should occur within the channel as areas of wider channel (as under the bridge) are required to facilitate deposition of finer gravels, although the exact extent of this was difficult to ascertain on the day, owing to the coloured water (Fig. 10). In addition to the obvious impacts upon reduction of potential fish spawning, the lack of substrate diversity and sorting degrades its habitat quality for many beneficial native invertebrates. The lack of low/trailing cover and in-channel structure also reduces fish holding features within the channel and limits the number and size of fish that it can support.

Figure 10. U/s of Newtownards Bridge the channel remains uniform and lacking cover/in-channel structure.

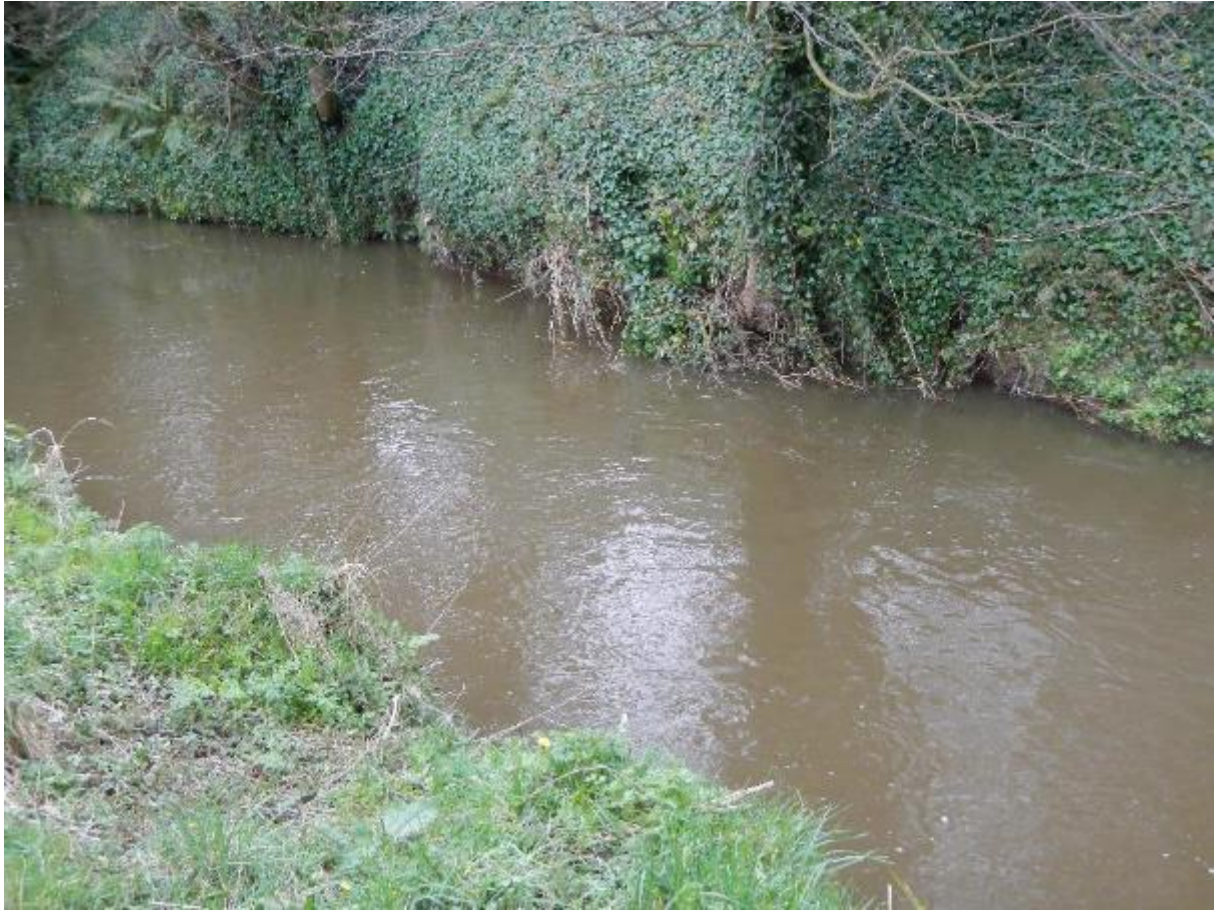
Some areas of low/trailing cover are present, and should definitely be retained (Fig. 11). These are the obvious locations that resident fish will chose to hold and form likely lies from which to catch resting migratory fish. However, there is again a general lack of this type of cover through the Middle Section. Planting the occasional small, shrub willow species (*Salix* spp.), particularly goat willow (*S. caprea*) that do not grow too large or rapidly and provide valuable low, bushy cover will greatly increase the fish-holding potential of the section (Fig. 12).

Figure 11. Owing to the general lack of overhanging and trailing vegetation, it is vital to retain whatever cover is available.

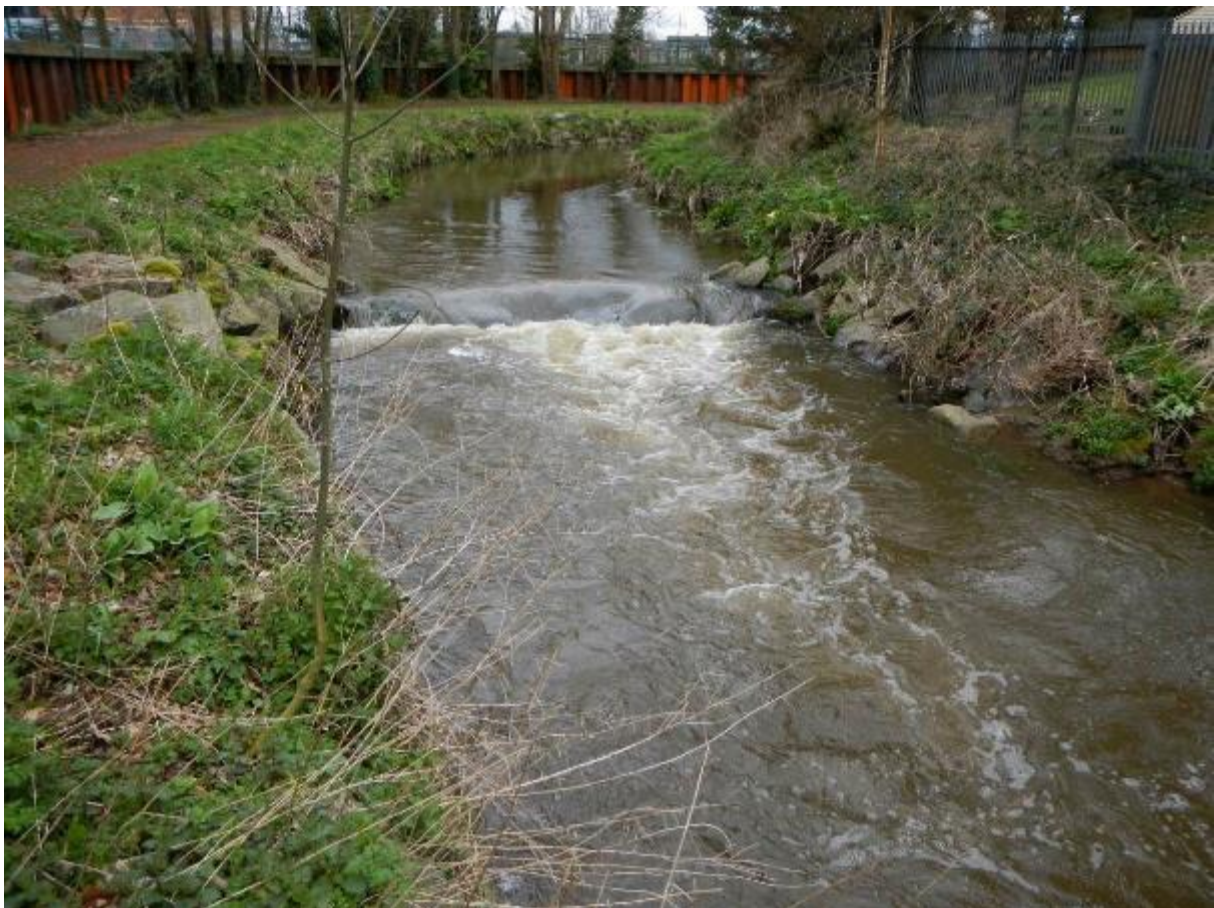
Throughout the Middle Section numerous weirs are present, fragmenting habitat within the river, interrupting fish and sediment movement and impounding flows (Fig. 13 & 14). Although once thought to create good habitat and fishing pools, it is now recognised that weirs form little more than sediment traps on a river and the associated deposition leads to shallowing of the pools over time. For this, and the reasons mentioned previously, weirs should be removed from rivers wherever possible. Where habitat features are required, bankside and trailing trees perform many of the same beneficial functions without the negative implications.

Figure 13. A potential barrier to fish movement which impounds the river u/s and interrupts sediment transport through the river.

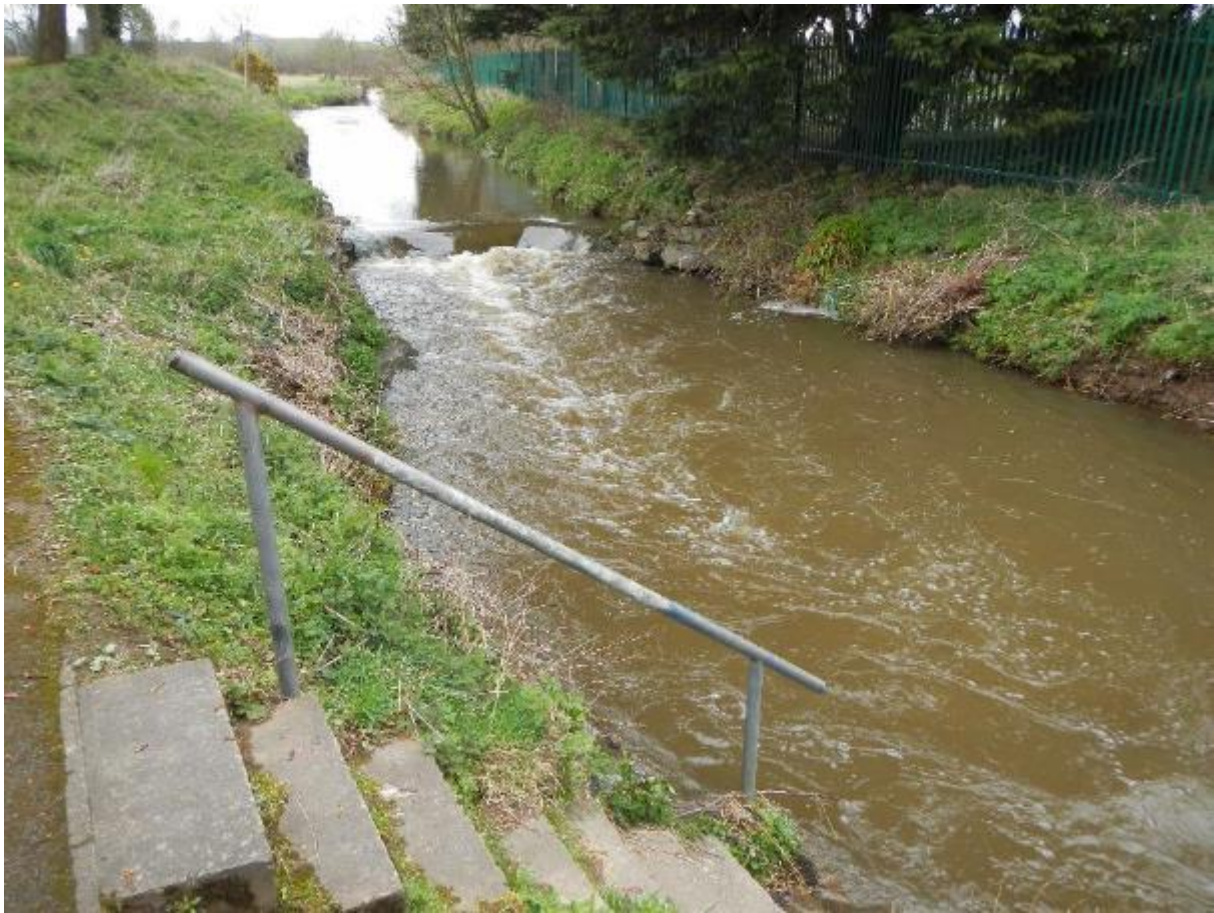
Figure 14. Another of the numerous rock weirs throughout the Middle Section that pose issues to fish and substrate movement.

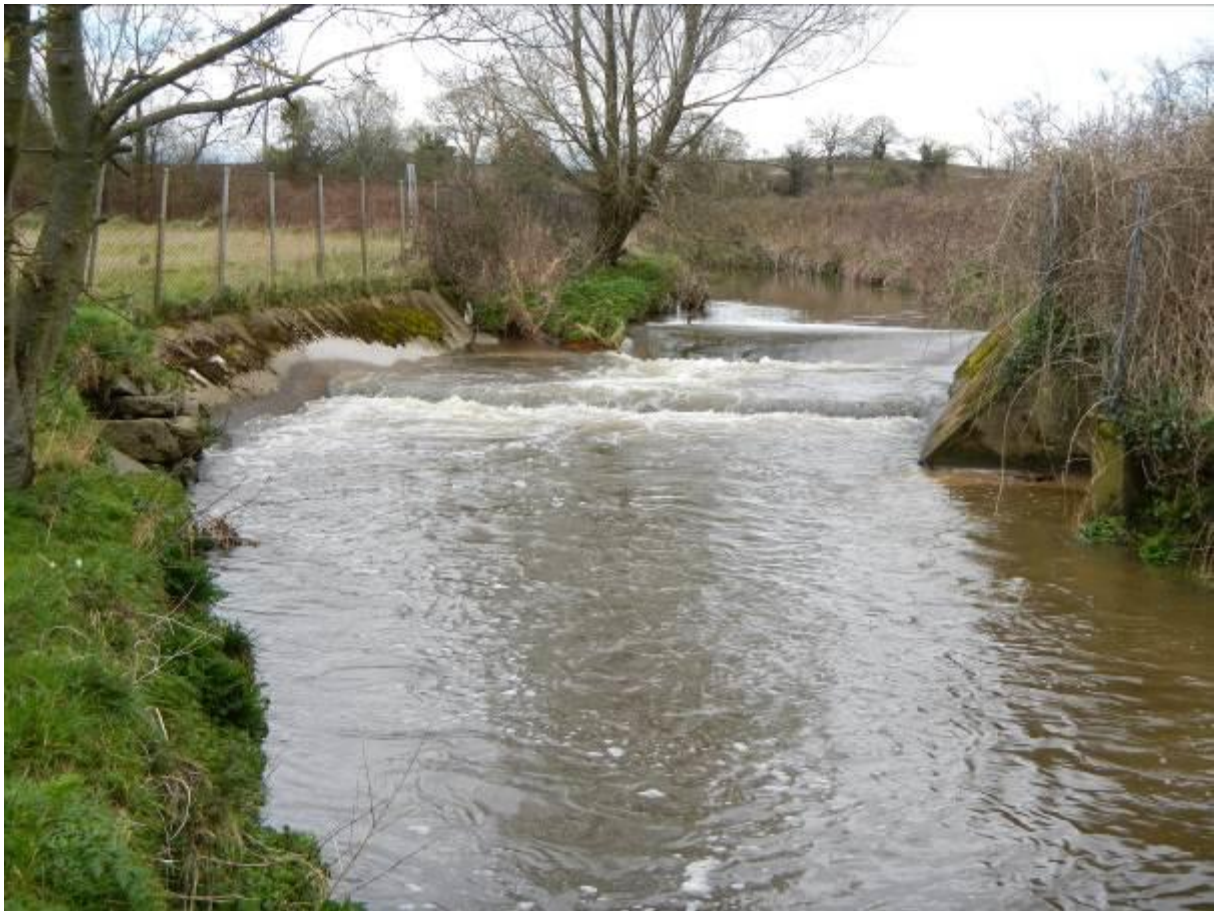
The largest weir with potentially the poorest passability observed on the river is the flat-V flow-gauging weir (NW 5790424165, Figs. 15 & 16). This undoubtedly forms some barrier to all fish, although it is likely that larger fish will ascend it more easily than smaller ones, particularly in higher flows as it drowns out more and increased turbidity provides some cover.

While at the site, and as if on cue, a small trout (c.200mm) attempted to ascend the weir and failed. This highlights not only the issue with fish passage but that fish passage is required throughout the year, not just in the period immediately preceding spawning, and for all fish sizes. All trout, including 'resident' fish and juveniles require the ability to move freely, both u/s and d/s, to make optimal use of available habitats. Consider that the best habitats for one life stage may be quite different from another and that those habitats could be u/s or d/s of their current residence. Again, the behavioural barriers that discourage fish movement due to water depth, temperature or exposure can be as detrimental as physically impassable ones and a combination of all factors amplifies the impact. This is a major reason that the potential impact of barriers is so often underestimated.

Figure 15. Looking u/s at the flat-V flow gauging weir – a notable barrier to fish passage.

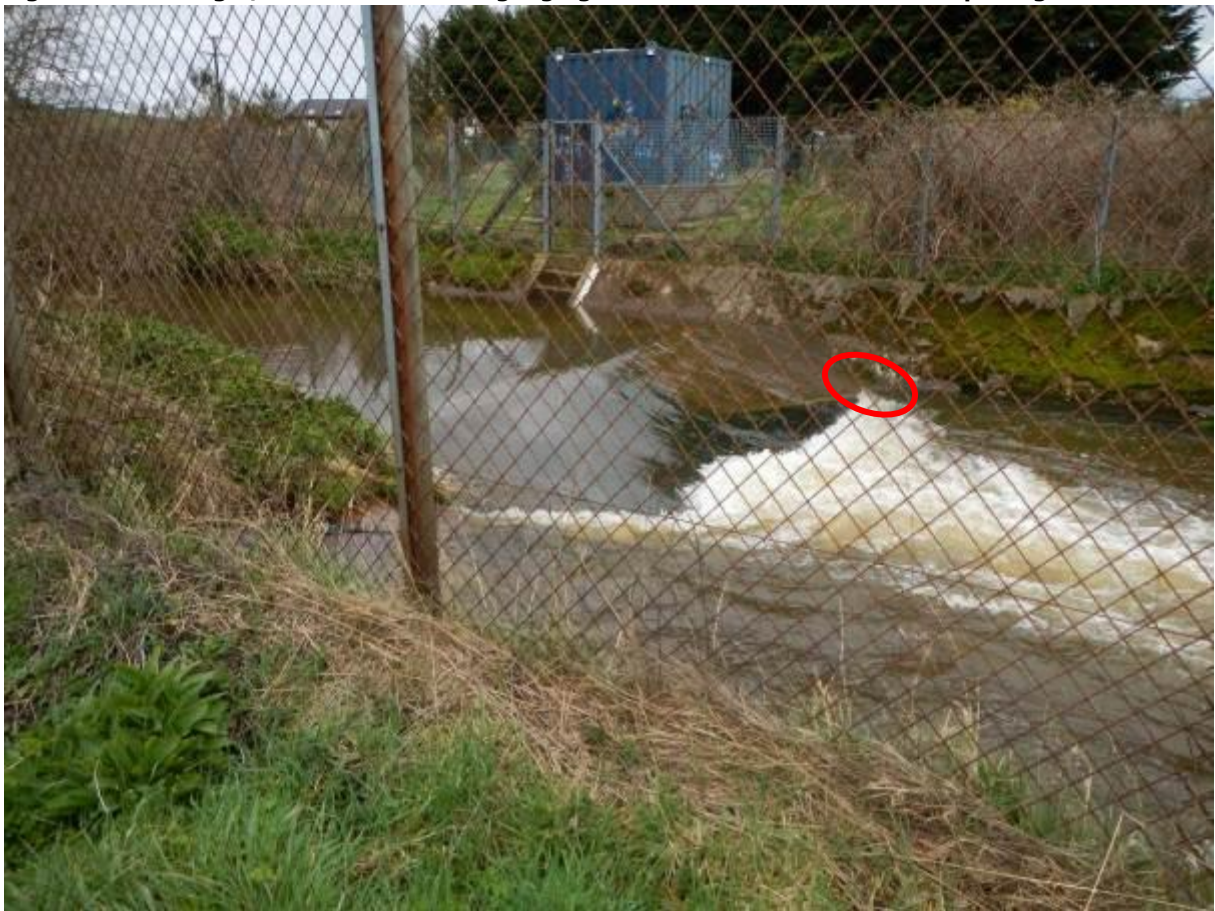
Figure 16 provides a better perspective of the fast shallow flows that fish will find so difficult to ascend. As the water depth increases to that which would be more passable, so will the velocities, exchanging one issue for another.

Figure 16. Side view of the flat-V gauging weir, where shallow, high velocity flows provide a physical and behavioural barrier to fish passage. Increased flow and depth that would ordinarily make an area more passable are likely to significantly inhibit fish passage through greatly increased flow velocities. The small trout was observed failing to ascend the weir in the area highlighted in red – it is probable that this was the only area with low enough velocities for the fish to even attempt the ascent.

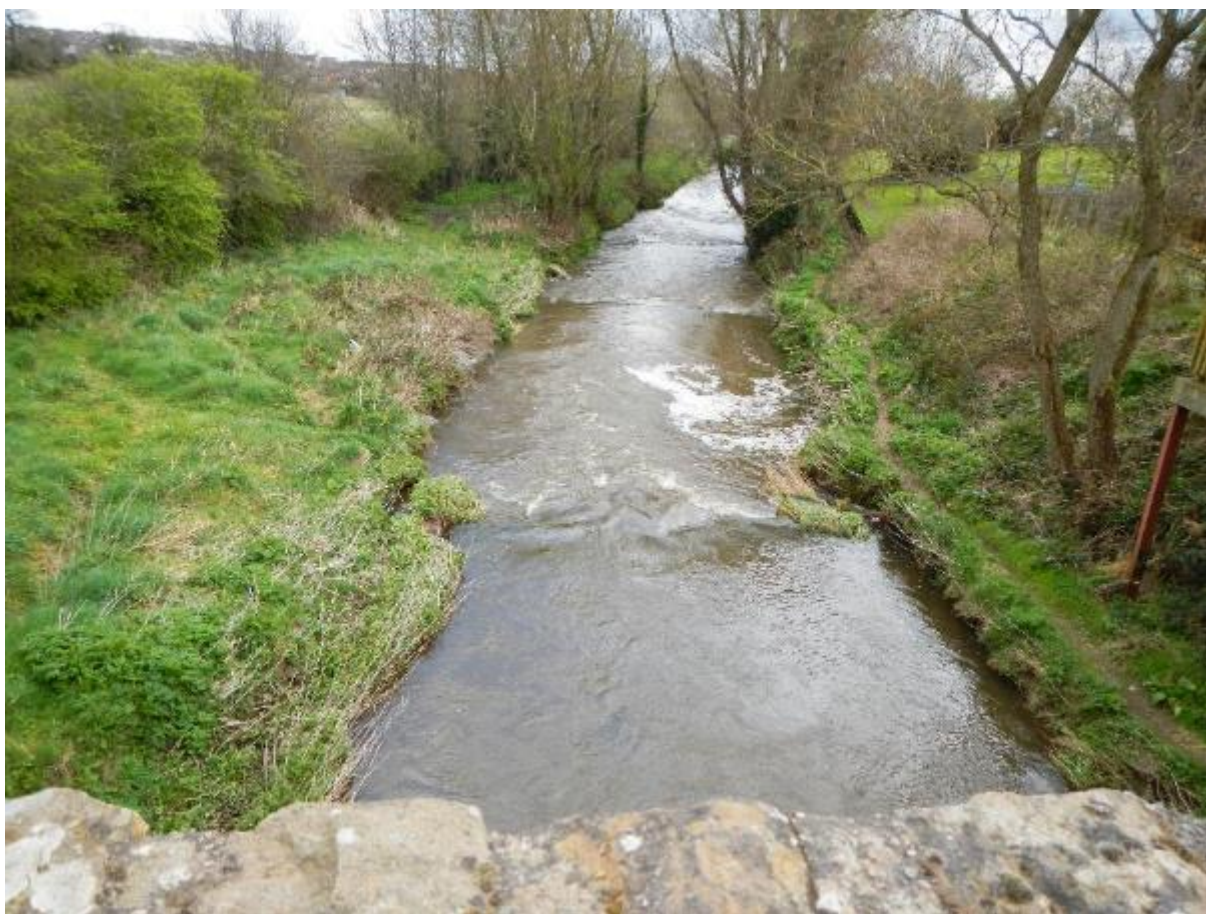
The gauging weir impoundment extends for c.60m u/s through what is reasonable habitat (good tree and bankside cover) but severely degraded by the uniformity of flows. The final stretch of the Middle Section, up to the bridge, is again straight, shallow and lacking low and in-channel cover (Fig. 17). Planting trees along the bankline could greatly improve this habitat by providing cover and diversifying flows to increase bed scour and deposition. The weirs in this section also further prevent flow diversification as each weir effectively resets the flows by spreading the water and energy across the full channel width. Removal of the weirs or at least creating offset notches to encourage a more meandering flow path (one side of the channel to the other) would be greatly beneficial.

Figure 17. Straight, shallow, uniform section that would benefit from increased in-channel cover.

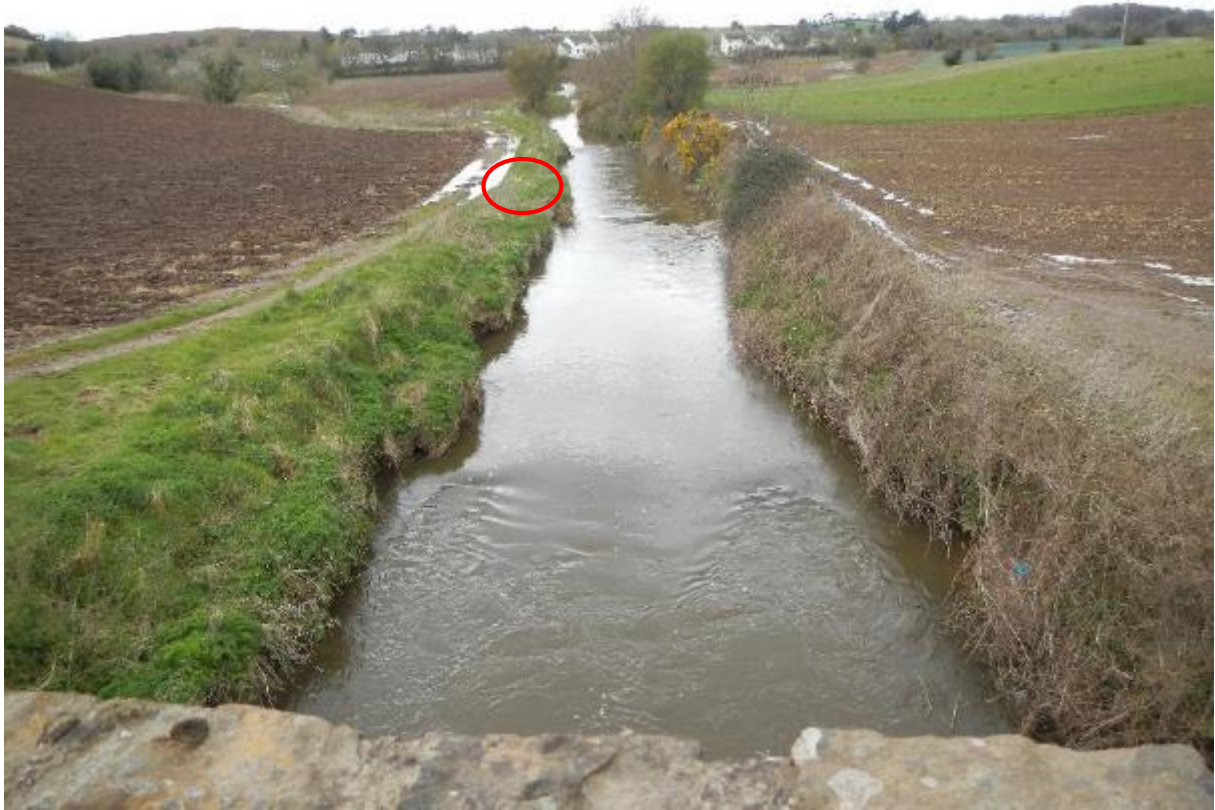
The banks are less revetted in the Upper Section but the channel remains heavily modified, being notably straightened and of uniform. The close proximity of access tracks and worked land to the river is also leading to additional sediment inputs where gutters are cut through the banks to drain the track, as do the field drains (Figs. 18 & 19). Areas of trees, shrubs and rank vegetation provide some cover and shelter within the channel but a lack of in-channel cover and structure remains - this limits the fish carrying capacity and of the area and leaves them susceptible to predation.

Figure 18. Looking u/s of Kennel Bridge, the channel is significantly straightened and uniform offering little refuge from predators. Drainage points from low-lying areas of track and puddles drain silt laden water directly to the river (red circle).

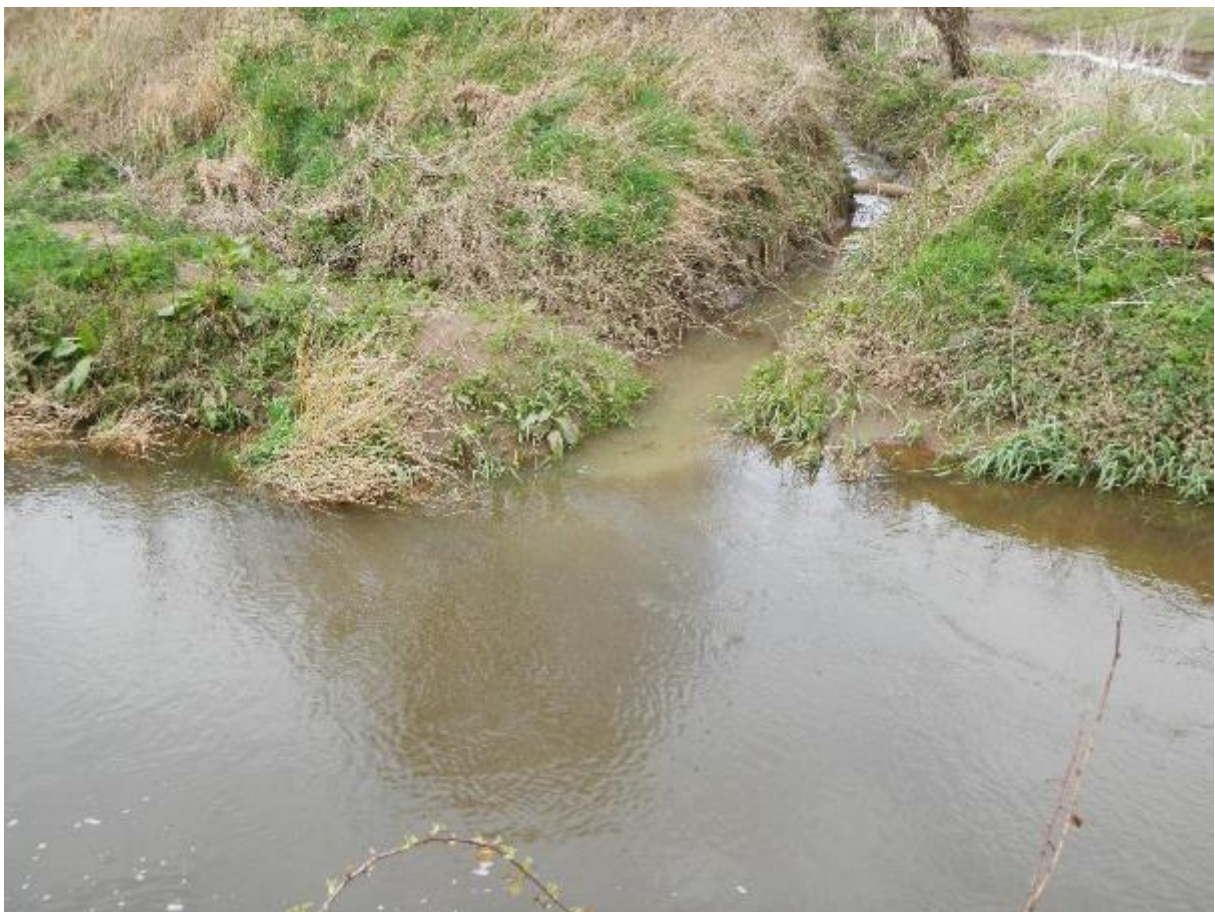
Figure 19. Field drains provide additional detrimental fine sediment input to the river.
