Advisory Visit
River Enler, Newtownards
Northern Ireland
5th April 2016

1.0 Introduction

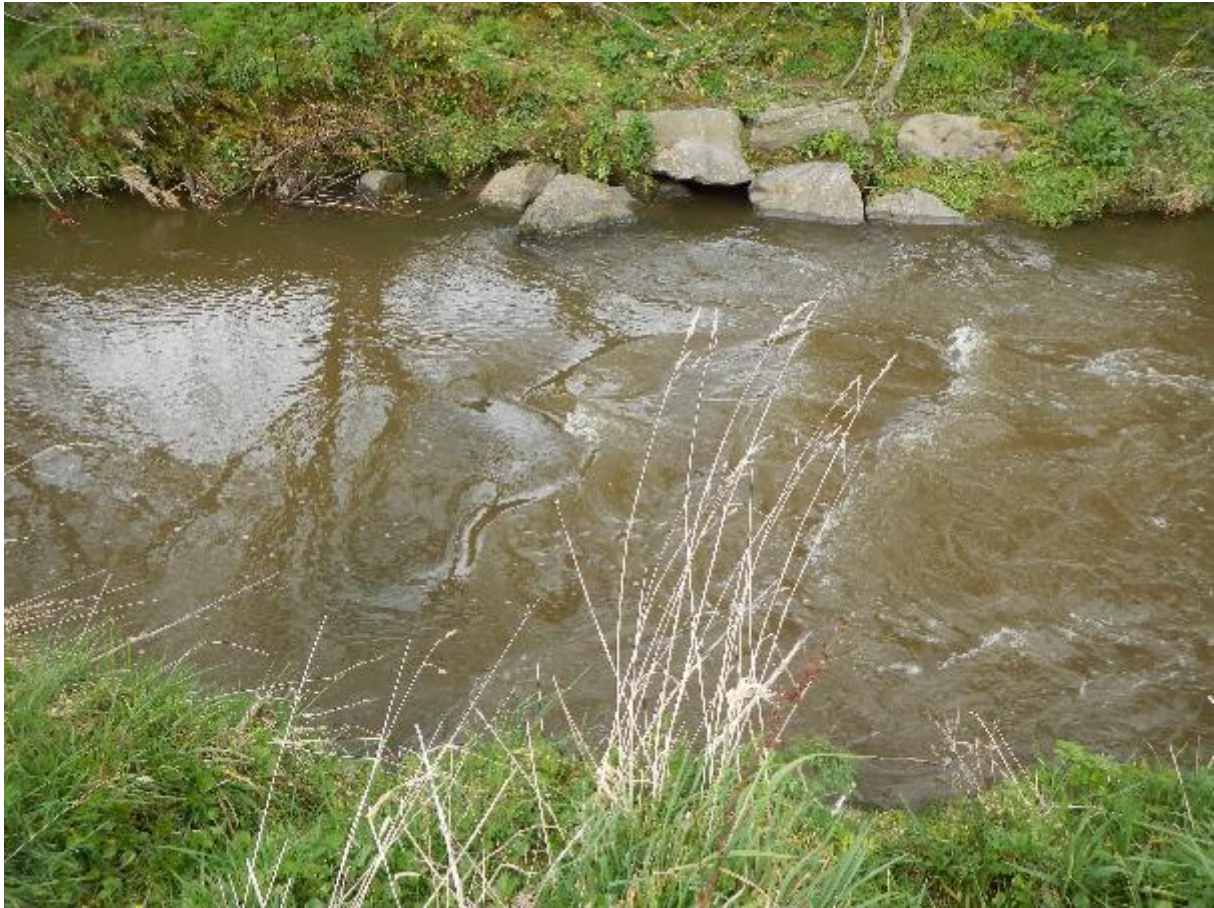
Low-level weirs again de-energise the river flow, interrupt sediment transport and inhibit the natural development of a more natural channel morphology in many areas (Fig. 20). The impoundment created also inhibits the natural scouring and sorting at pool tail u/s where such action is required to maintain high quality invertebrate and spawning habitat free from fine sediment.

Figure 20. One of many low-level weirs in the Upper Section that impound the river and inhibit the development of a more natural channel.

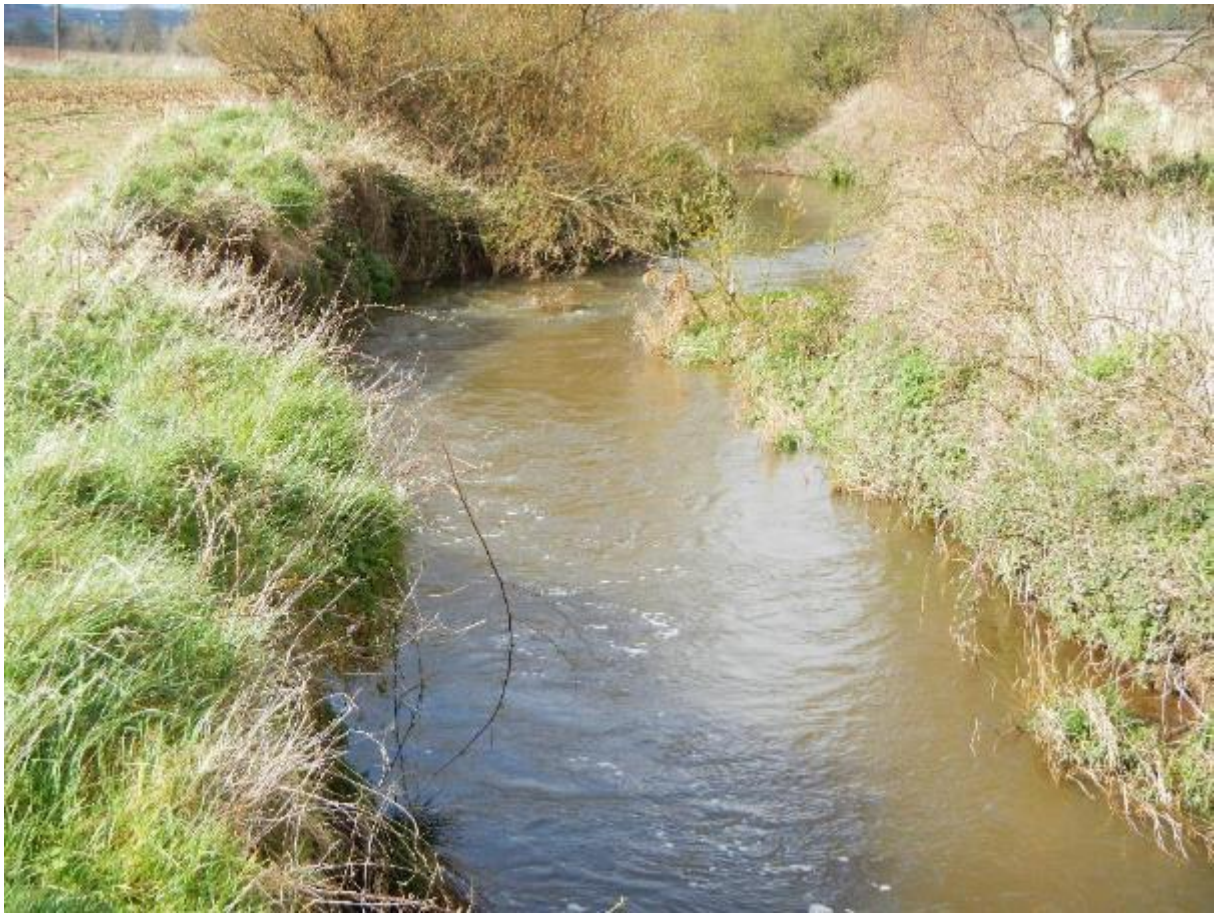
Areas of bank slumping and regrading have allowed beneficial widening of the channel, with a corresponding increase in the availability of finer gravel substrate providing valuable potential invertebrate and salmonid spawning and juvenile habitat (Fig. 22). Willow planting will help to consolidate the regraded bank and provide a valuable increase in lacking cover.

Figure 21. Gravel bar (right of shot) that is forming a vegetated berm and greatly diversifying the channel structure. This effect has occurred in several areas where weirs have become outflanked but will also occur as more in-channel structure (trailing trees) becomes established and diverts flows within the channel. Such gravel formations are greatly inhibited by weirs interrupting gravel supply.

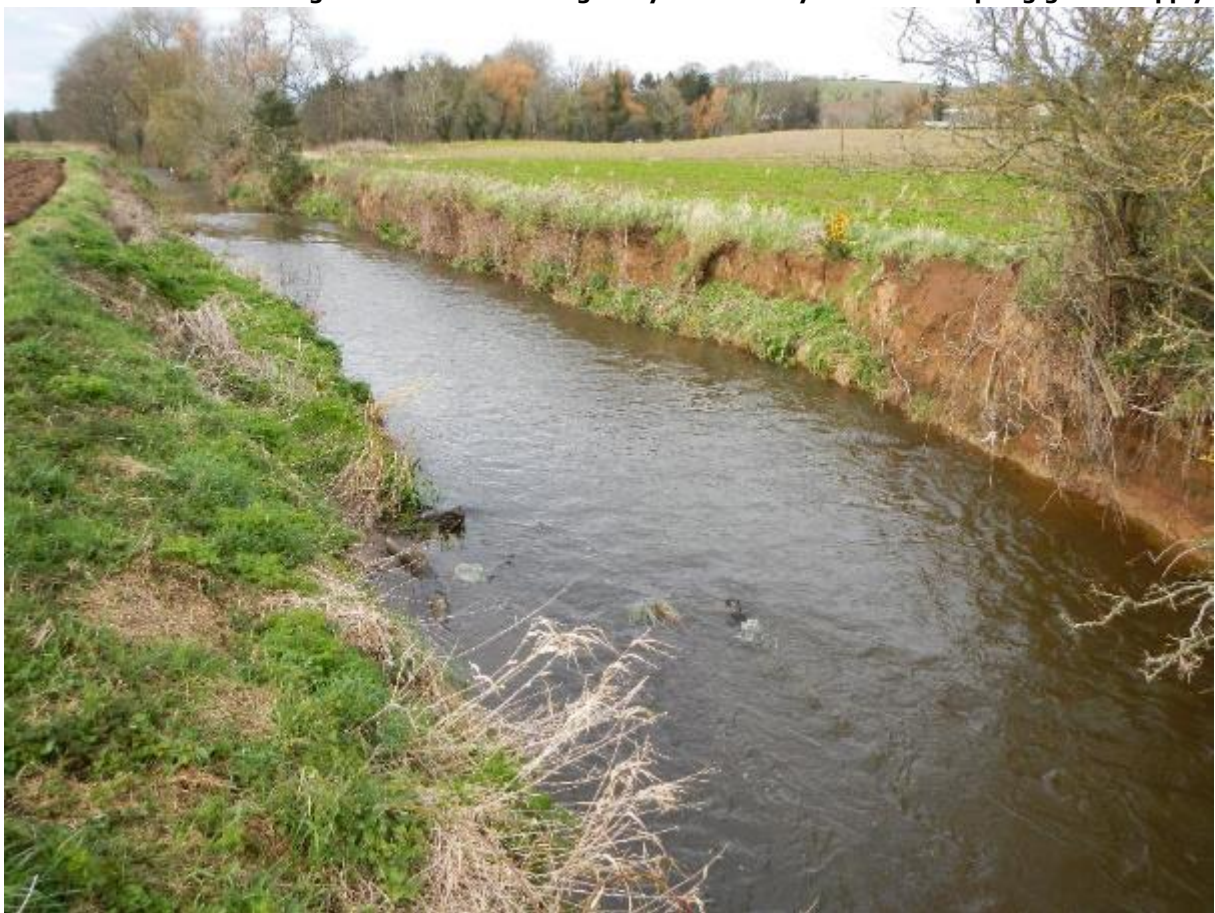
Figure 22. Bank slumping (providing width variation) and natural regrading assisted through stabilisation by bankside vegetation improves this section; however, more cover is required.

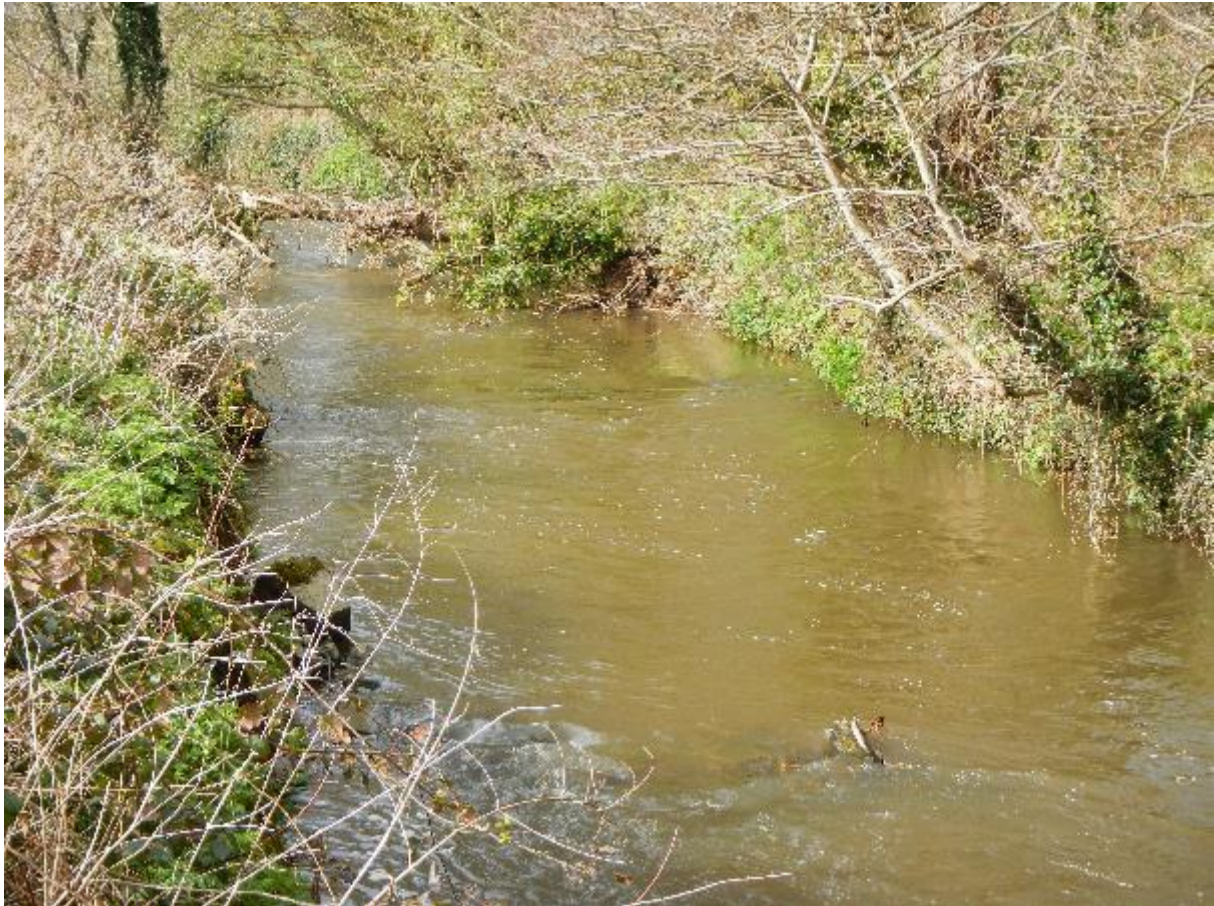
The u/s end of this section becomes wooded on the LB and with the additional trees, benefits from inputs of woody material that also provide cover and flow diversity, greatly enhancing the section (Fig. 23). However, the channel is still very uniform in width and with the bank revetments on the RB and naturally stable, tree-lined banks on the other side, along with a lack of in-channel structure, it has little ability to change to a more natural, meandering shape.

Figure 23. Higher quality habitat provided by adjacent trees and vegetation which, through the additional bank protection, offers an opportunity to drive bed scour and create deeper holding water along those banks.

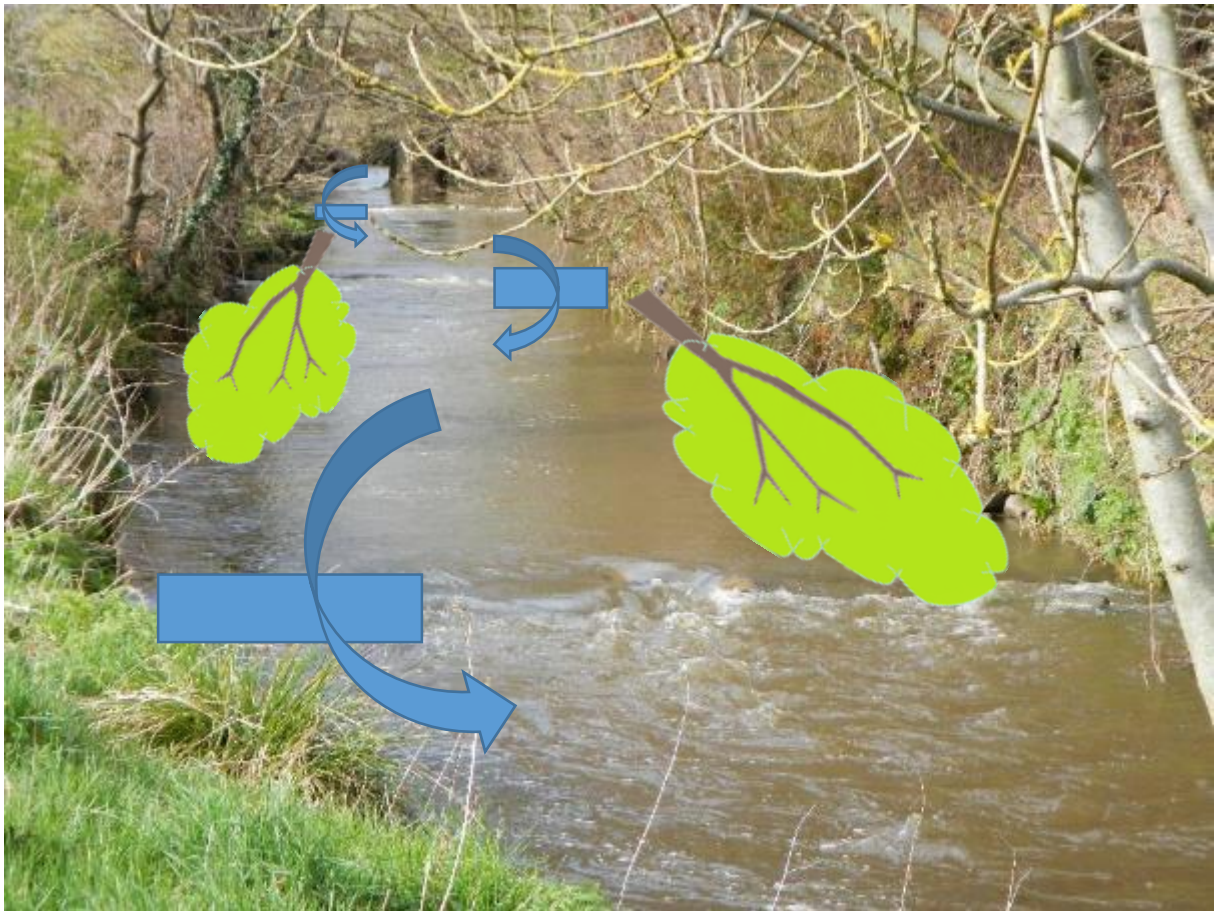
The high, natural stability of the LB through tree roots and vegetation offers an ideal opportunity to develop the channel structure. Flows can be directed along the LB side of the channel where, unable to erode outwards into the stable bank, they will scour downwards to develop deeper, self-maintaining pool areas and sort bed materials. Removing (initially) a small section of the weirs at the side where bed scour is required will be the first step (Fig. 24). This can be further assisted through the installation of additional, strategically placed large woody material to create pinch points but also areas of slower flow to increase deposition and substrate retention. Once the channel is naturally recovering it may then be beneficial to remove the remaining weir material, if it is not simply consumed within the new channel shape.

Figure 24. Strategically removing small sections of the weirs (indicated by blue blocks and arrows) could start to reinstate a more diverse flow regime. In addition, diffuse woody material (tree canopies) pinned u/s of the weirs and around the areas of deposition would further focus flows through the gaps while facilitating deposition along the opposite bank areas.

This technique would work well alongside notching weirs in the Upper section at alternating sides (see Fig. 24). Sediment can then be allowed to accumulate, consolidate and form new, vegetated in-channel bars or even encouraged by planting with willow whips. A further step could be to employ living willow tree kickers that then also have the potential to take root into any fine sediment that accumulates around their canopy in exactly the same way that laid willows will often strike root from their branches and start to grow back into the ground.

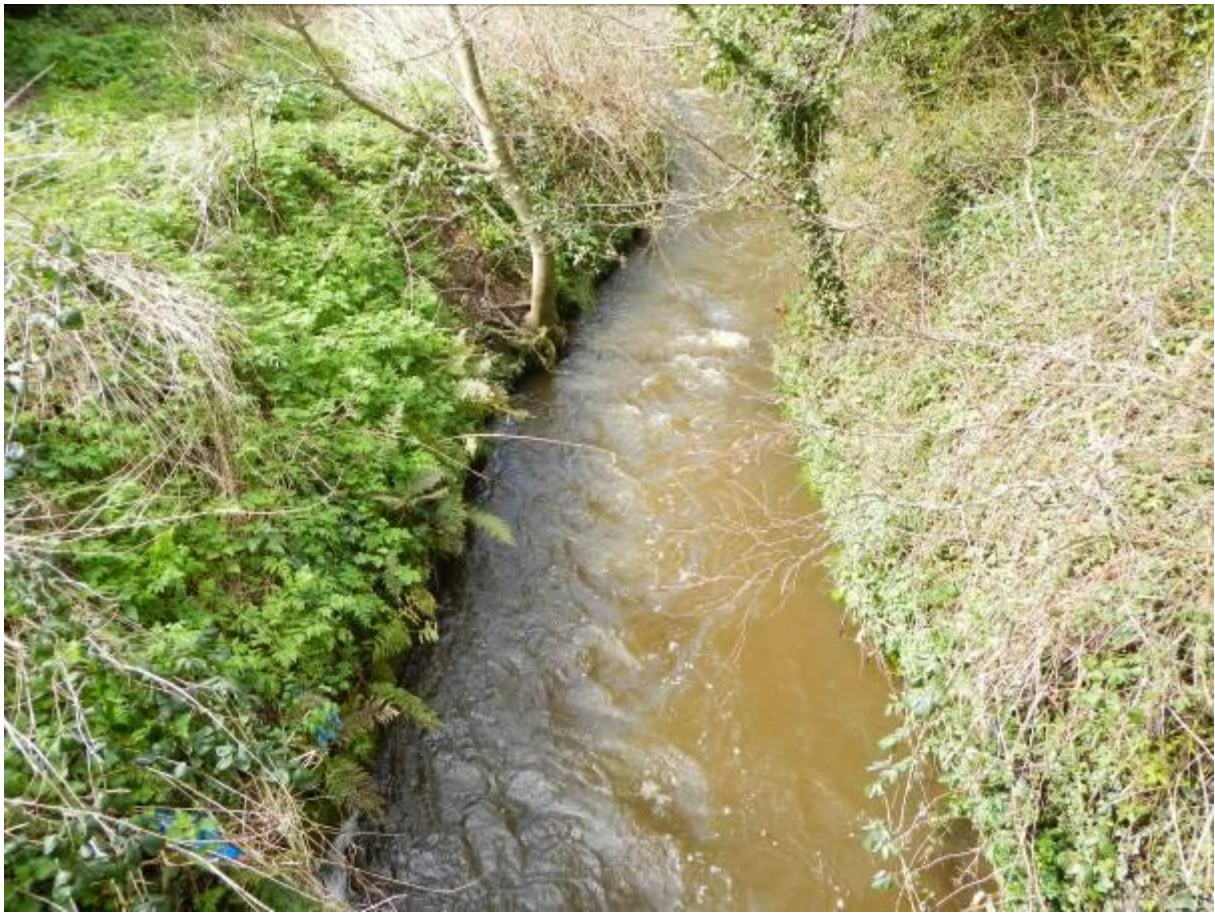
Figure 25. One of the tributaries which joins in the town. Some habitat potential but a notably degraded channel course and dimensions.

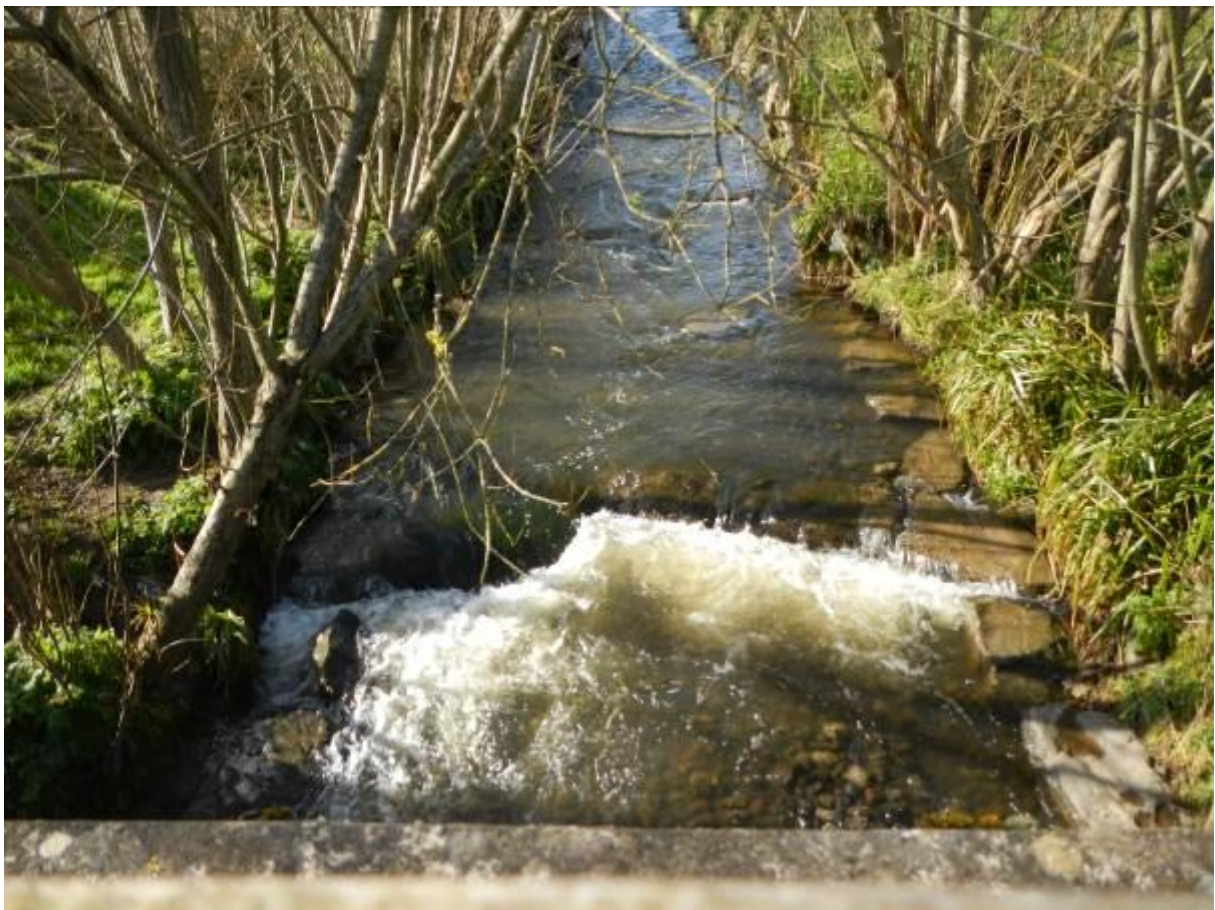
The upper Enler was spot checked, where it flows past the Billy Neil Soccer School of Excellence, and it appears similarly degraded by straightening and hard engineering as the lower sections (Fig. 26) but again, is likely to provide some spawning and juvenile habitat. The potentially lower flood risk and larger riverside buffer strips in this area may allow more extensive in-channel improvements to be undertaken. Bankside willows could be thinned to allow greater light penetration to the channel, with some limbs laid into the channel to provide low cover and develop the channel morphology.

Figure 26. The upper Enler, near the Billy Neil Soccer School. Heavy armouring constrains the channel but there is potential to let more light in and increase the low/trailing cover. Again, completely removing at least a portion of the weir would be beneficial.

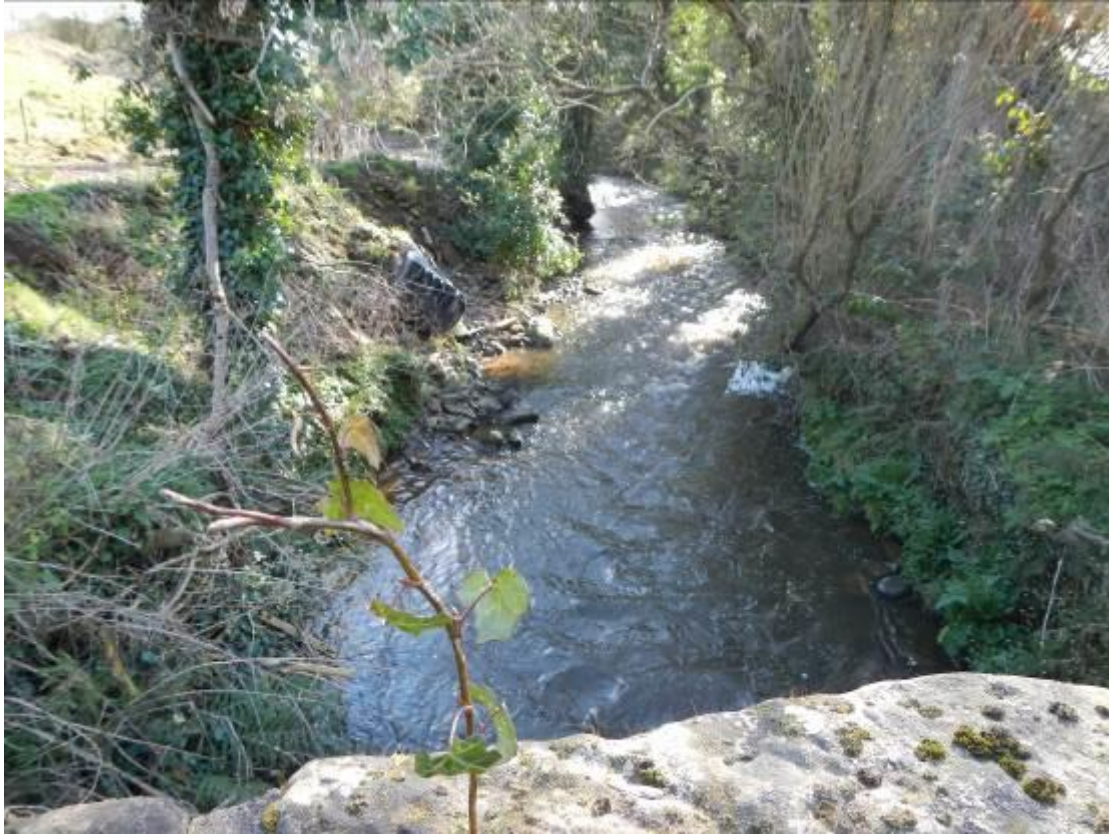
An upper section of the main tributary, referred to as the Gransha River, was also inspected via a spot check looking u/s and d/s of the Glen Road Bridge (Figs. 27 & 28). The channel here is far more natural, with a good diversity of bankside cover and river substrate. The conditions appeared to provide high quality spawning and juvenile salmonid habitat.

Figure 27. A more natural, if possibly straightened, section u/s of the Glen Road Bridge.

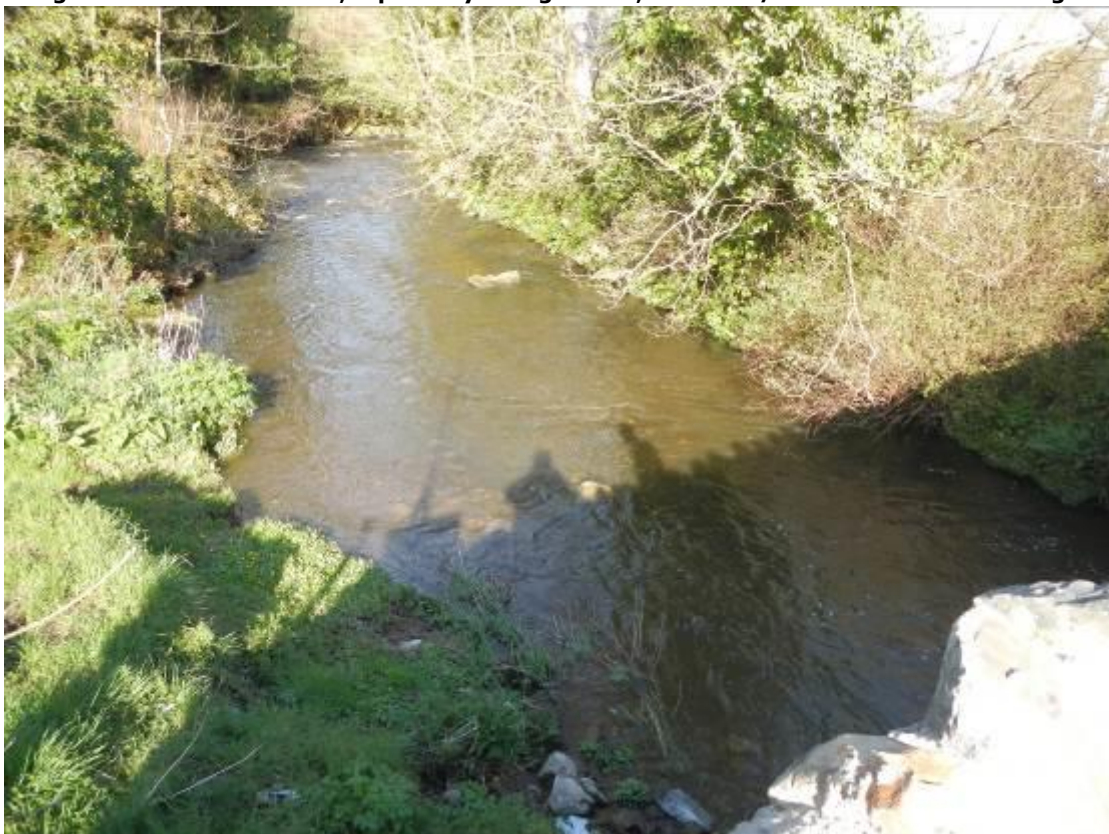
Figure 28. More natural channel dimensions and bankside vegetation d/s of the Glen Road Bridge.
