**Advisory Visit for the North Yorkshire Moors National Park and
Glaisdale Angling Club**

River Esk, North Yorkshire

13th June 2013

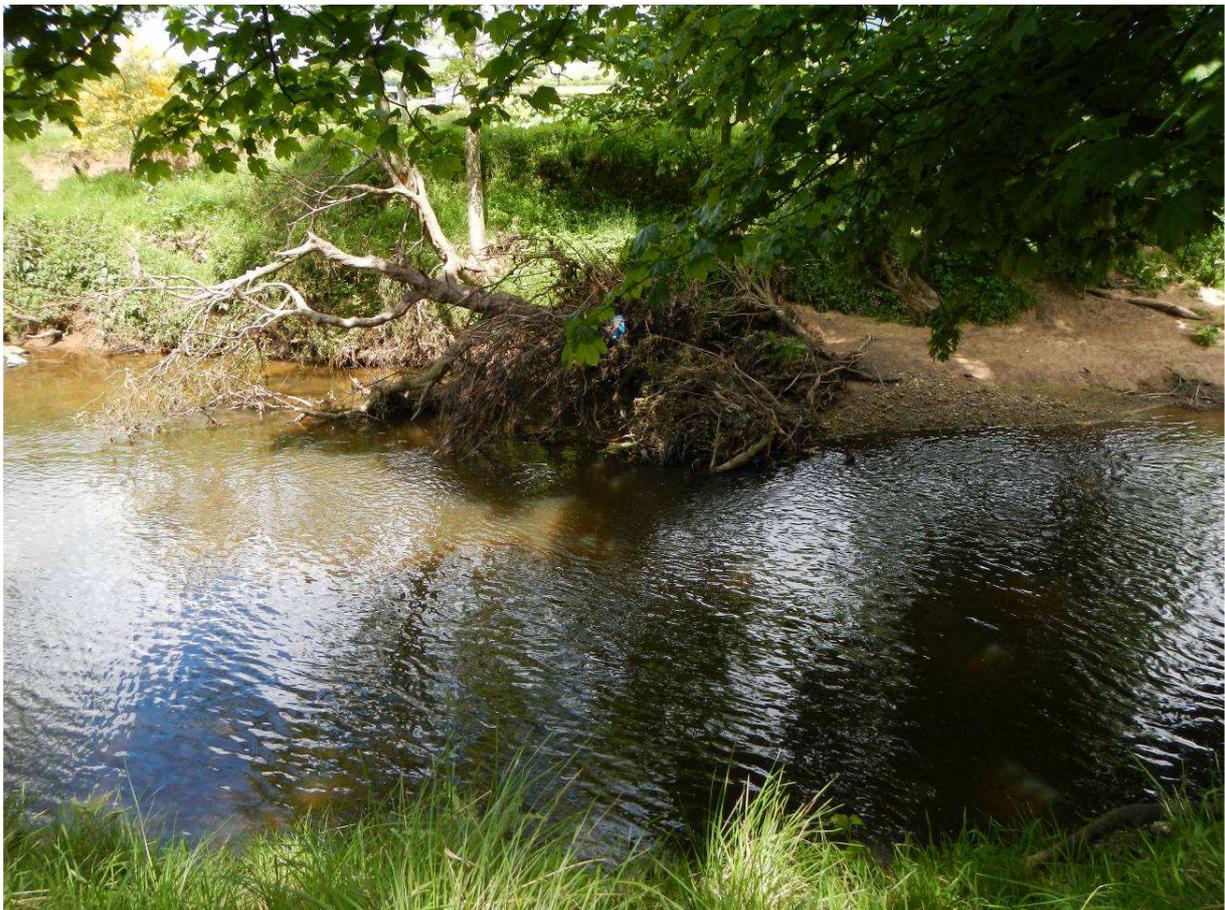
Figure 1. Highly-beneficial large woody debris that has been washed out of the bank and become lodged towards the tail of a pool. Note the significant accumulation of bed material upstream, providing valuable storage, and the area of protection from higher flows provided downstream.

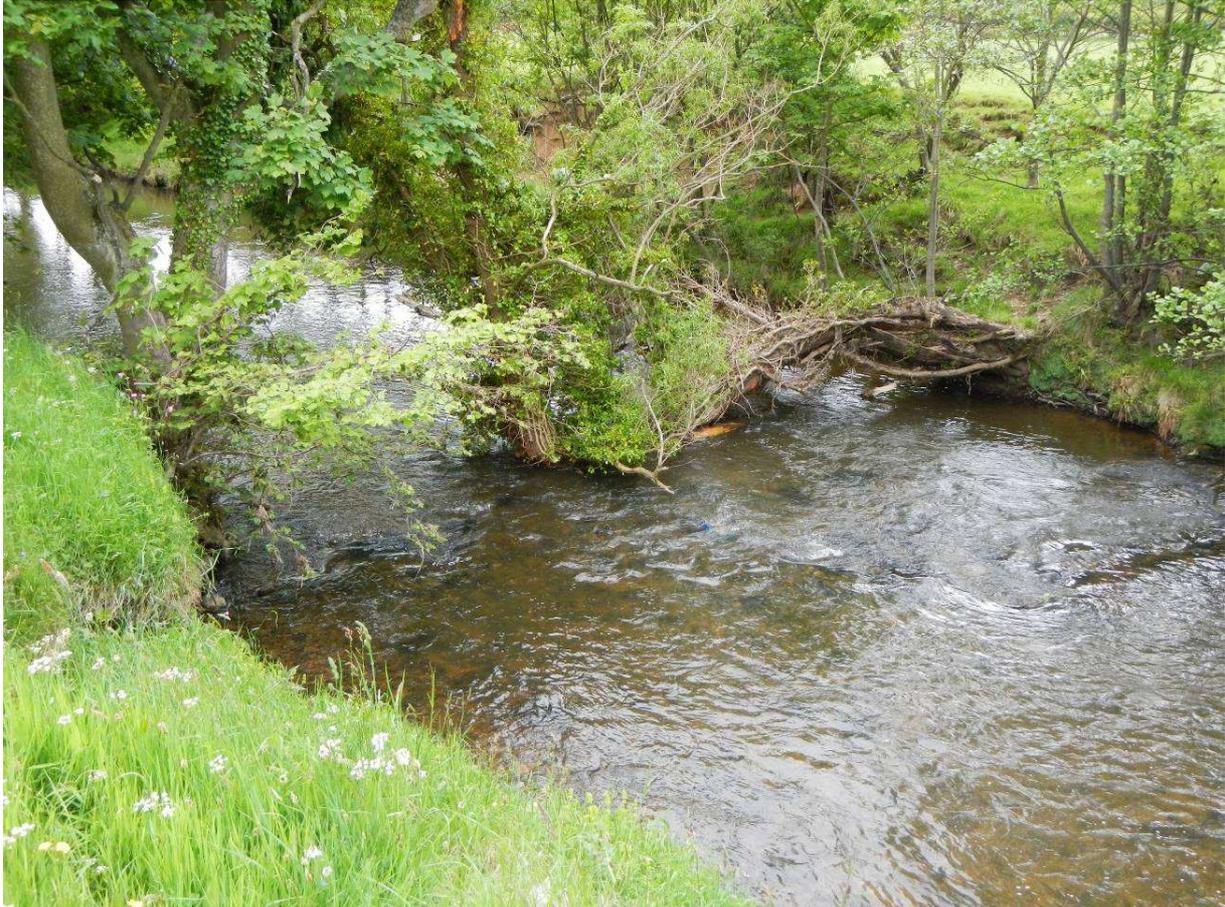
Figure 2. Another excellent example of Large Woody Debris (LWD) that is providing great cover for trout and down-scouring of the bed that will help create and maintain deeper areas with clean substrate.

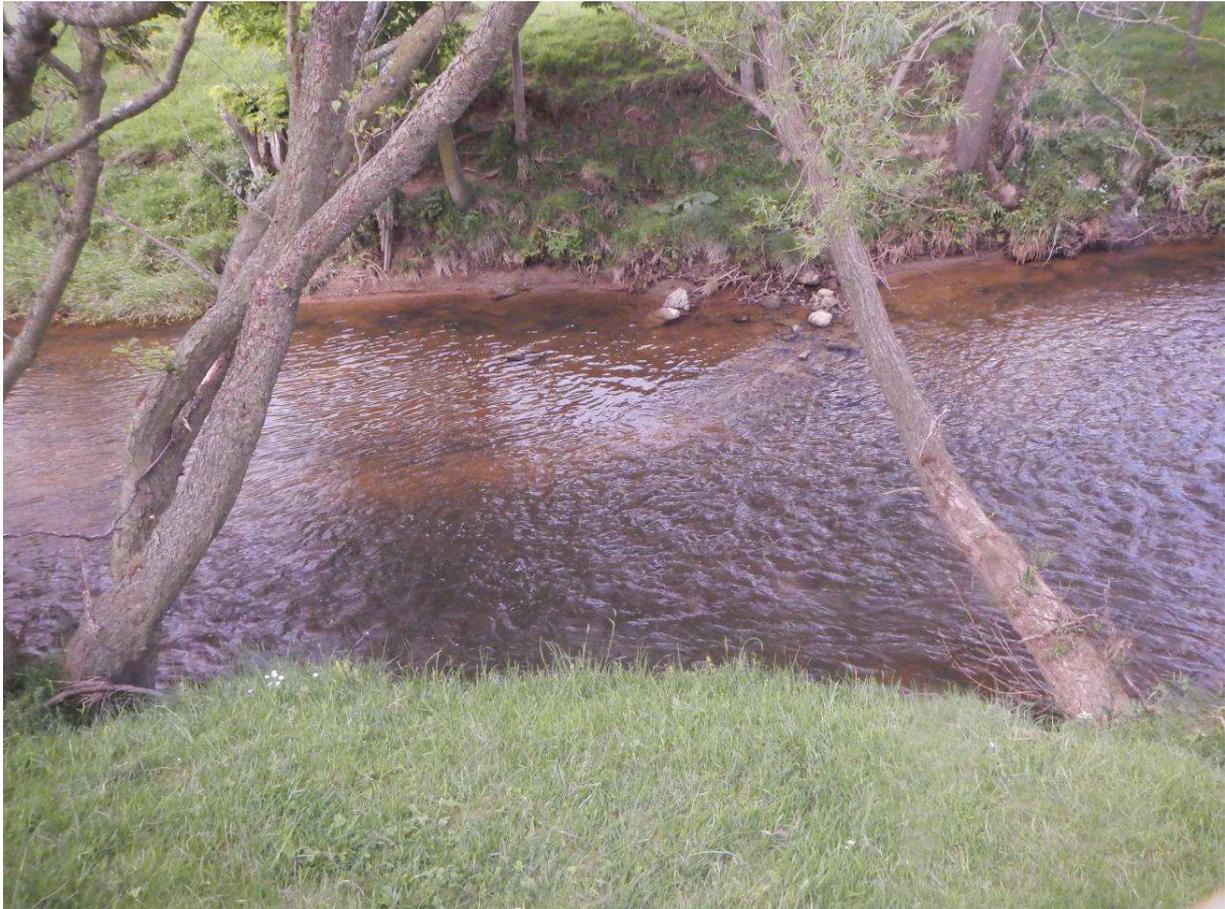
For most of the reach inspected the river bed lies well below the bank top, within an incised channel. As there are no obvious signs of dredging, it is likely that this is a product of the light sandy soils and relatively high-energy river system causing erosion and incision. Correspondingly, there was a significant over supply of sediment within the reach, and into the reach from upstream that is likely to be significantly compromising spawning habitat for smaller salmonids such as resident trout. It is possible, however, that the higher flows over the larger gravels and cobbles on which migratory salmonids spawn are more capable of transporting the sandy sediments that appear to be compromising the trout-sized spawning gravels. These conditions favouring larger fish may be contributing to the suspected reduction in resident trout populations. Figure 3 demonstrates the issue quite clearly, with significant fine sediment deposits in the far (RB) margin, and cleaner, darker substrate in the deeper, higher energy flows.

Figure 3. Obvious signs of over supply of fine sediment in any areas of slower flow.

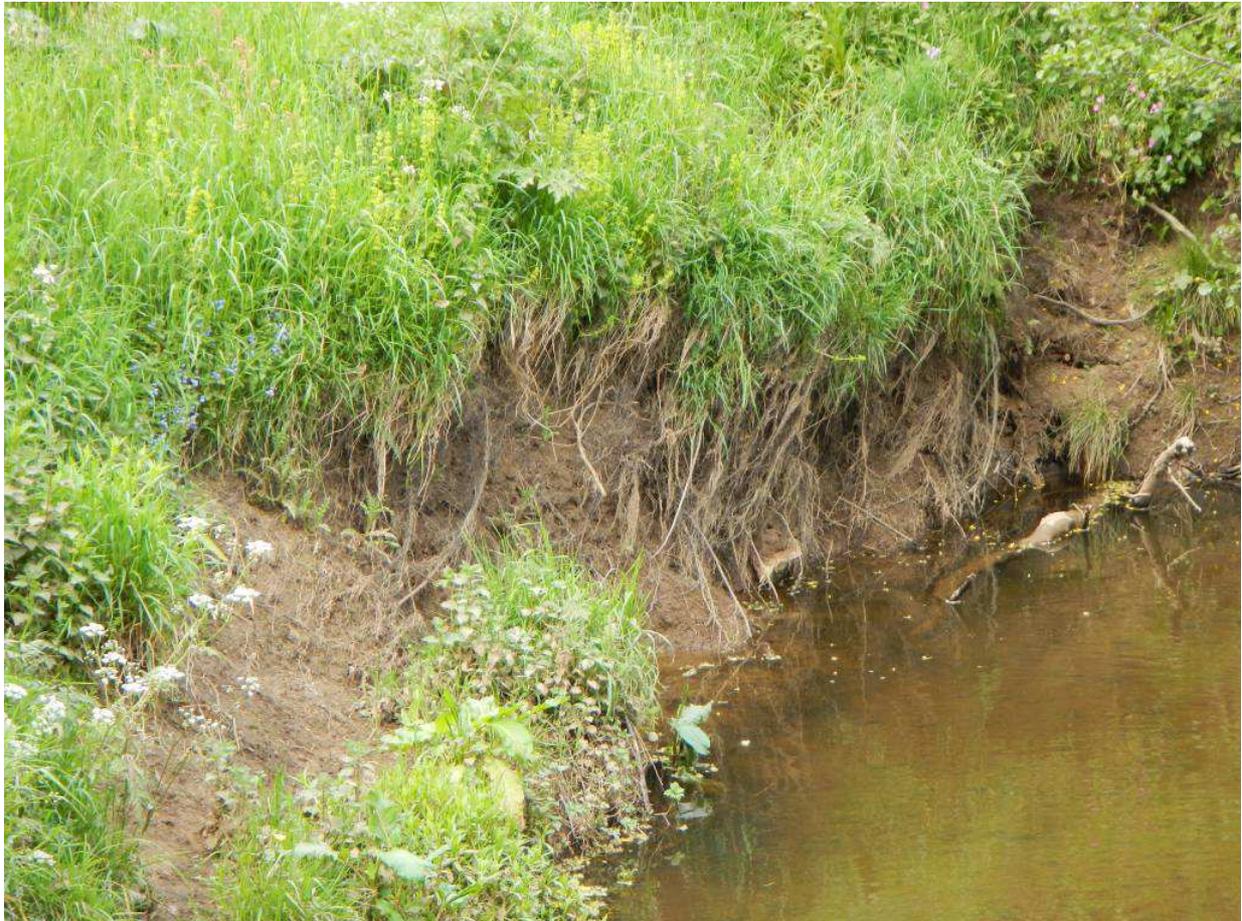
Compare the difference in cover and root structure between the ungrazed, diversely-vegetated section of more stable bank (Figure 4), and that of the heavily grazed bank downstream, where serious erosion issues are occurring (Figure 5). Some erosion is occurring in the first example (Figure 3), but at a much slower more natural rate, and it is much more likely to become consolidated over time than the second example (Figure 4), where the next large flood is likely to wash out large volumes of the unprotected earth.

Figure 4. Ungrazed-bank where some erosion is occurring, but at a relatively slow, natural rate, due to the positive effect of vegetation.

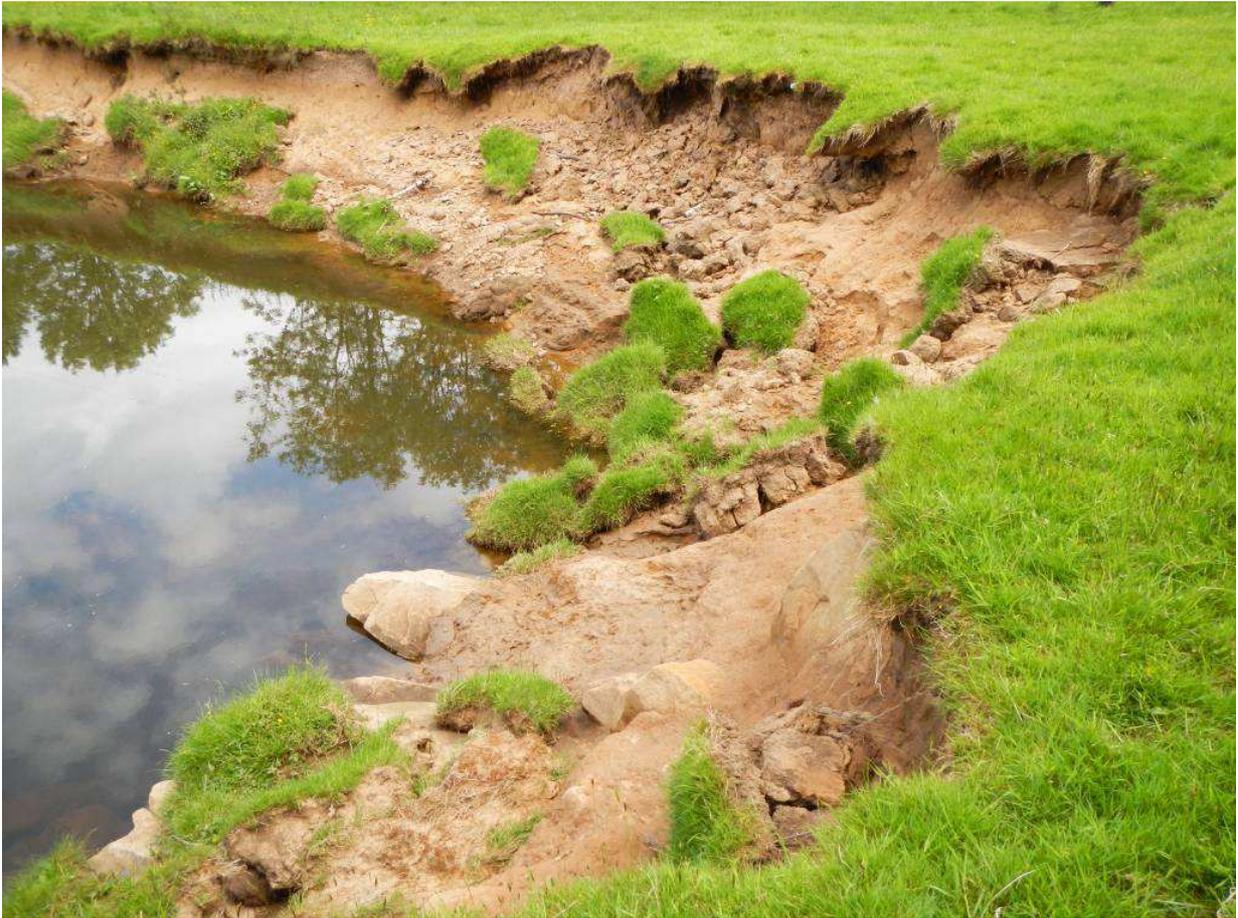
Figure 5. Bank erosion, significantly exacerbated by livestock access to the river bank.

In addition to the general erosion issues, and the major erosion at the downstream end of the section inspected (Figure 5), there was also another significant area of erosion where springs within the bank, possibly exacerbated by field drains, are saturating the high bank, leading to mass failure. Over time this has also led to the loss of many of the bankside trees that would ordinarily protect the bank toe (Figure 6: NZ 78073 06314). Stock poaching and grazing are further exacerbating the issue.

The area shown in Figures 5 & 10 would benefit greatly from stock exclusion, well back from the bank top, to allow more diverse vegetation structure to develop and natural bank consolidation to occur. While this may not be the entire solution, it would be an ideal, low-cost, first step to promoting consolidation of the bank, which has already re-graded to a more stable angle. It is worth raking the bare earth and planting it with a natural local seed mix to kick-start the vegetation. The issue can then be assessed later in the year, and soft bank revetments undertaken with willow, if required.

With stock excluded from the river banks, planting additional trees within the buffer strips will be particularly beneficial (Figures 5 & 10). Planting willow from whips and saplings of local provenance, particularly smaller shrub species (*Salix pentandra*, *S. phyllicifolia*, *S. cinerea* & *S. caprea*), will increase bank stability and provide good cover. The smaller shrub species are best for this as they require less maintenance and provide good dense cover at a low level.

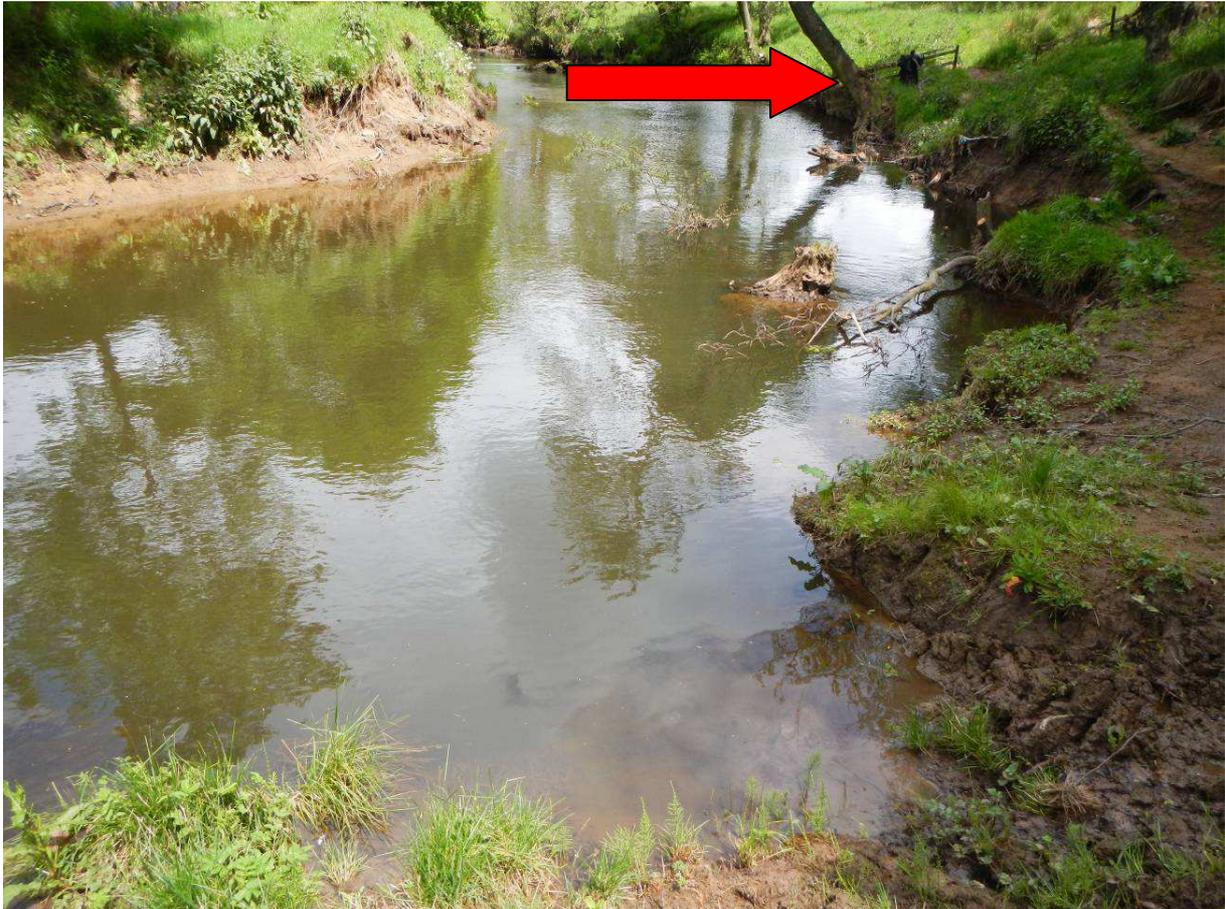
Figure 6. The toe of mass failing section of bank where several trees have been lost previously. Coppicing the tree in the background (red arrow) should promote more low level cover through re-growth and reduce the leverage that will, at present, ultimately pull the tree over.

The area of mass failing bank shown in Figure 6 is a prime location for fencing, as stock exclusion should promote regeneration of the understory within the wood, and help consolidate the land. It may also be worth considering brash type soft revetment around the toe of the bank, either by anchoring tree tops on the bank, to trail into the river, or by wiring brash along the river margin and lower bank to baffle flows (as demonstrated in Appendix B). The requirement for this can be reassessed in the autumn.

Coppicing is a great way of increasing low-level re-growth where tree canopy has lifted. This treatment was not considered necessary in most areas, but coppicing of the tree highlighted in Figure 6 could reduce the leverage acting against its roots and prolong its time *in situ*. A demonstration of coppicing can be seen in Appendix D, where a whole run of trees have been coppiced; however, better results can be achieved by only coppicing selected trees, to prevent short term loss of habitat diversity.

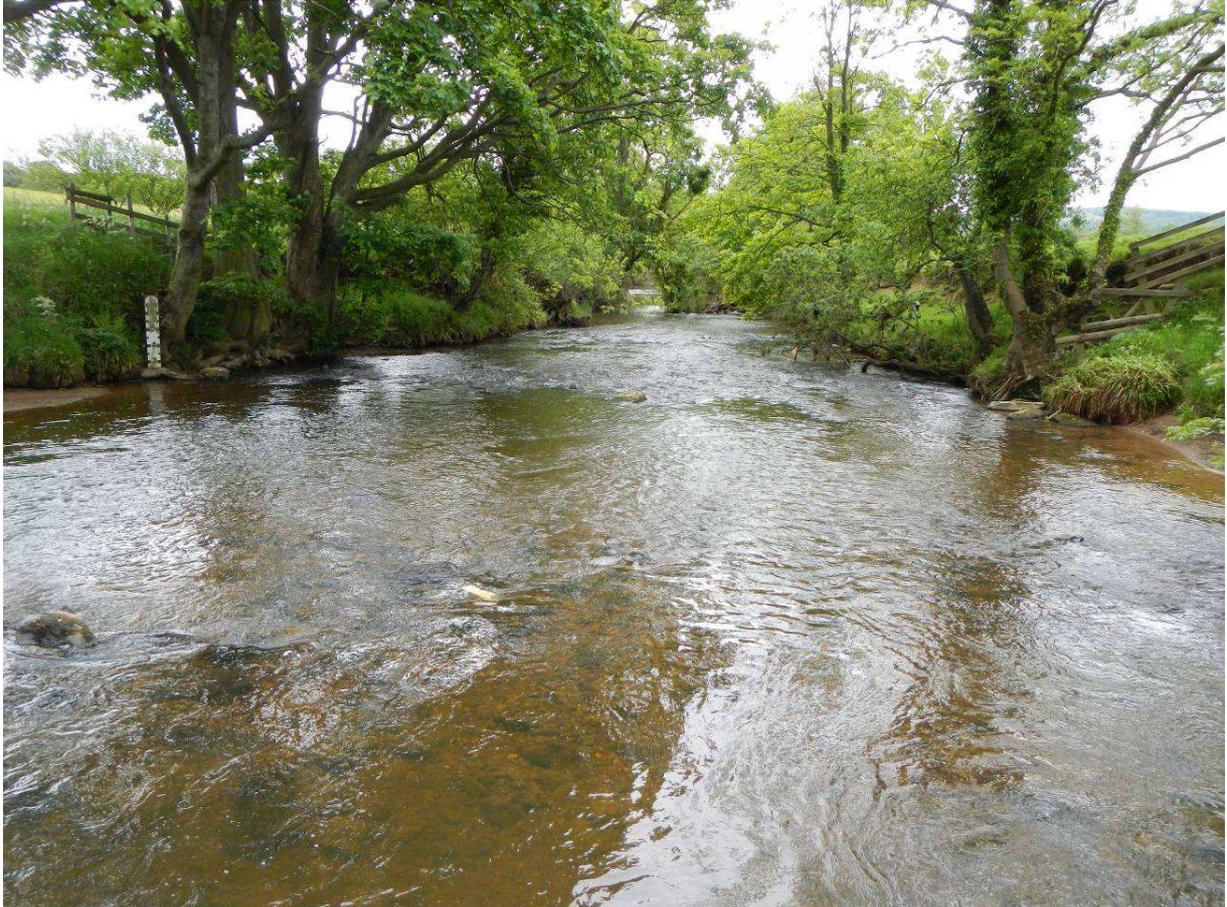
Despite the ubiquitous problems with sediment input, areas of reasonable quality habitat were observed for most salmonid life stages. Shallow riffles with good flow diversity and marginal structure provide quality habitat for juvenile trout and salmon (Figure 7). The section depicted in Figure 7 was apparently heavily cleared on the RB, with many of the trees and low branches cut back. This type of action seriously denudes vital aerial and trailing cover along the river bank that is vital fish holding habitat. It was not surprising, therefore, to hear that anglers observed a decline in trout catches in this section subsequently. Now the cover has regenerated, the habitat is much more capable of holding fish, increasing the potential carrying capacity of the river. This serves as a warning that tree management should only be undertaken very sparingly to avoid negative consequences.

Figure 7. Good juvenile salmonid habitat, with reasonable aerial cover and some potential for spawning, although the substrate is somewhat compromised for smaller species by excessive sedimentation.

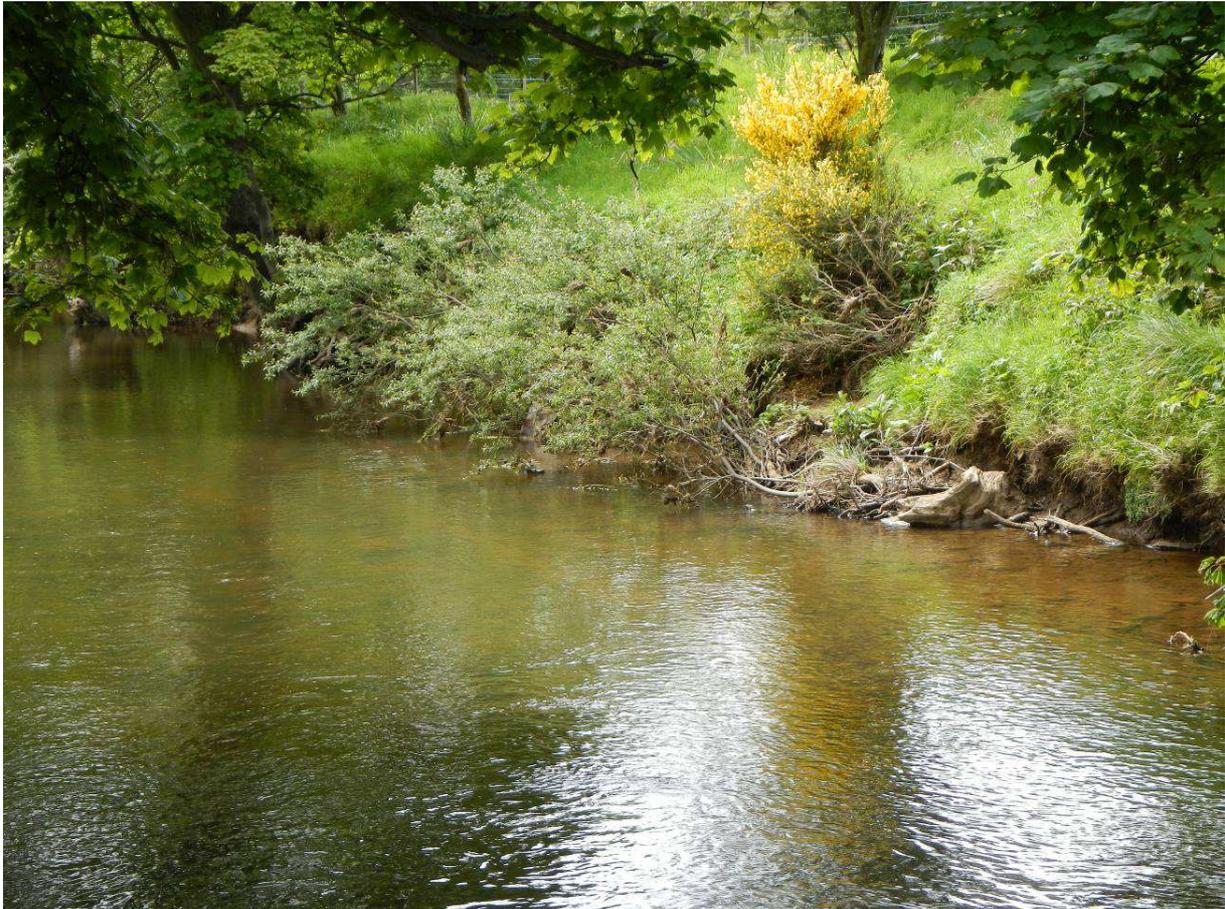
In some areas self-set willows also provide good trailing and aerial cover, and undoubtedly increase the number of fish that the river can hold, while also stabilising the toe of the banks (Figure 8). A further benefit of these natural, “hydrologically-rough” structures along the river banks is that rather than deflecting flows, as hard structures like rock armouring or groynes would, they actually slow and diffuse the flows, dissipating the energy along the river bank, causing sediment deposition where it is beneficial and encouraging formation of more river bank. They still, however, provide channel narrowing, increasing local flow velocities and diversity within the channel that is highly beneficial for rheophilic species such as salmonids.

Figure 8. Bank side willow along the waterline that will increase beneficial deposition and consolidate the bank toe, while providing valuable cover and shade for adult fish, and protection from flows and predation for juveniles.

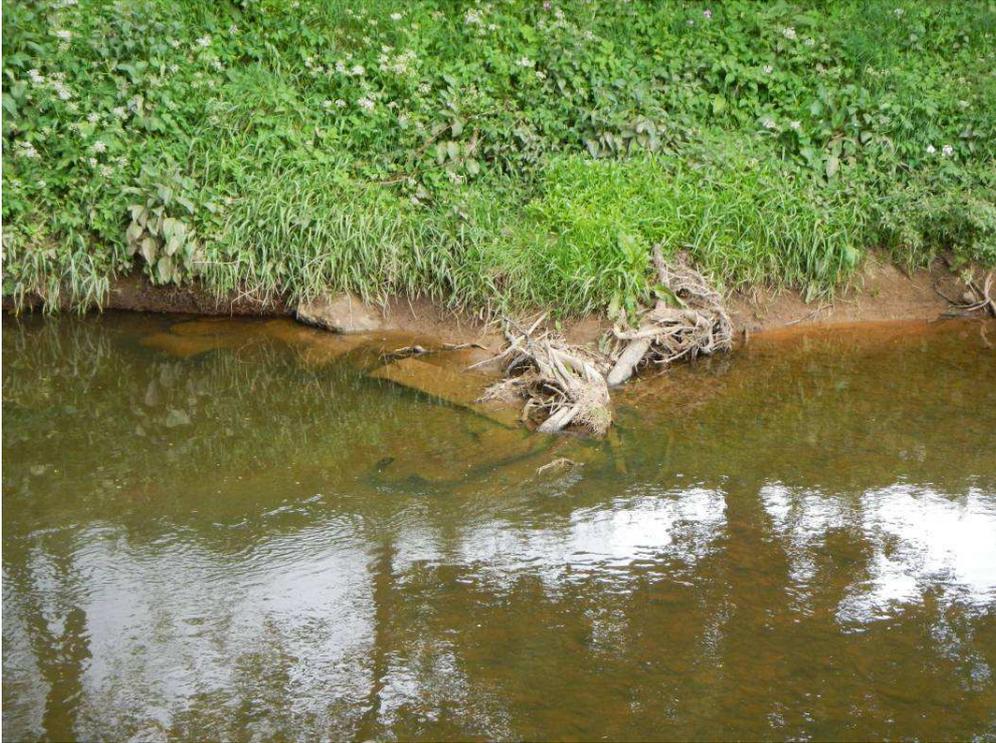
The remains of several small rock weirs, groynes and hard bank protection were also observed throughout the section inspected. For the most part these are in a poor state of repair and relatively innocuous. However, some of the groynes and solid structures are making the banks susceptible to erosion by diverting higher flows into the bank (Figures 9 & 10). One of the weirs is also a potential issue, being fully intact and impounding flows upstream. This is exacerbating issues with sedimentation of the pool upstream and also increasing the depth over what would otherwise probably form a spawning riffle (Figure 11: NZ 77809 06205).

Figure 9. One of the old groynes that could lead to increased bank erosion.

Either of the methods described would be beneficial in areas where groynes are already present in the river margins (as Figure 9). As the willow grows, it will consolidate the deposited material around the groynes, with the

diffuse structure of the shrubs slowing the detrimental erosive flows around the groynes - while still providing beneficial channel narrowing.

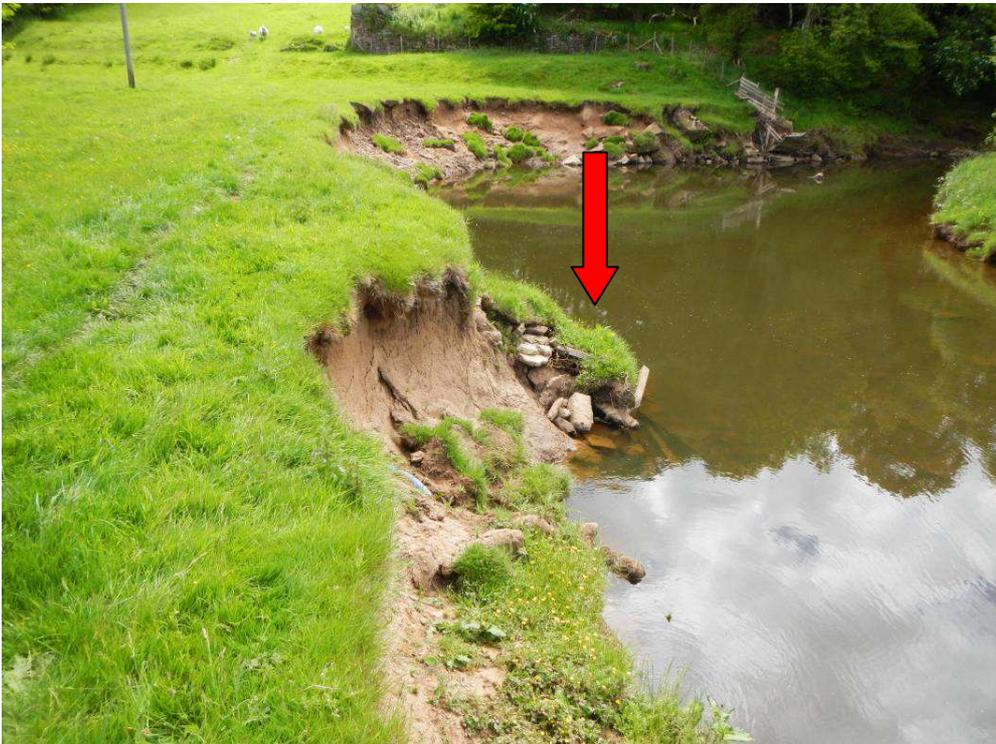
Figure 10. Scouring and exacerbated erosion up and downstream of previous attempts at hard bank protection.

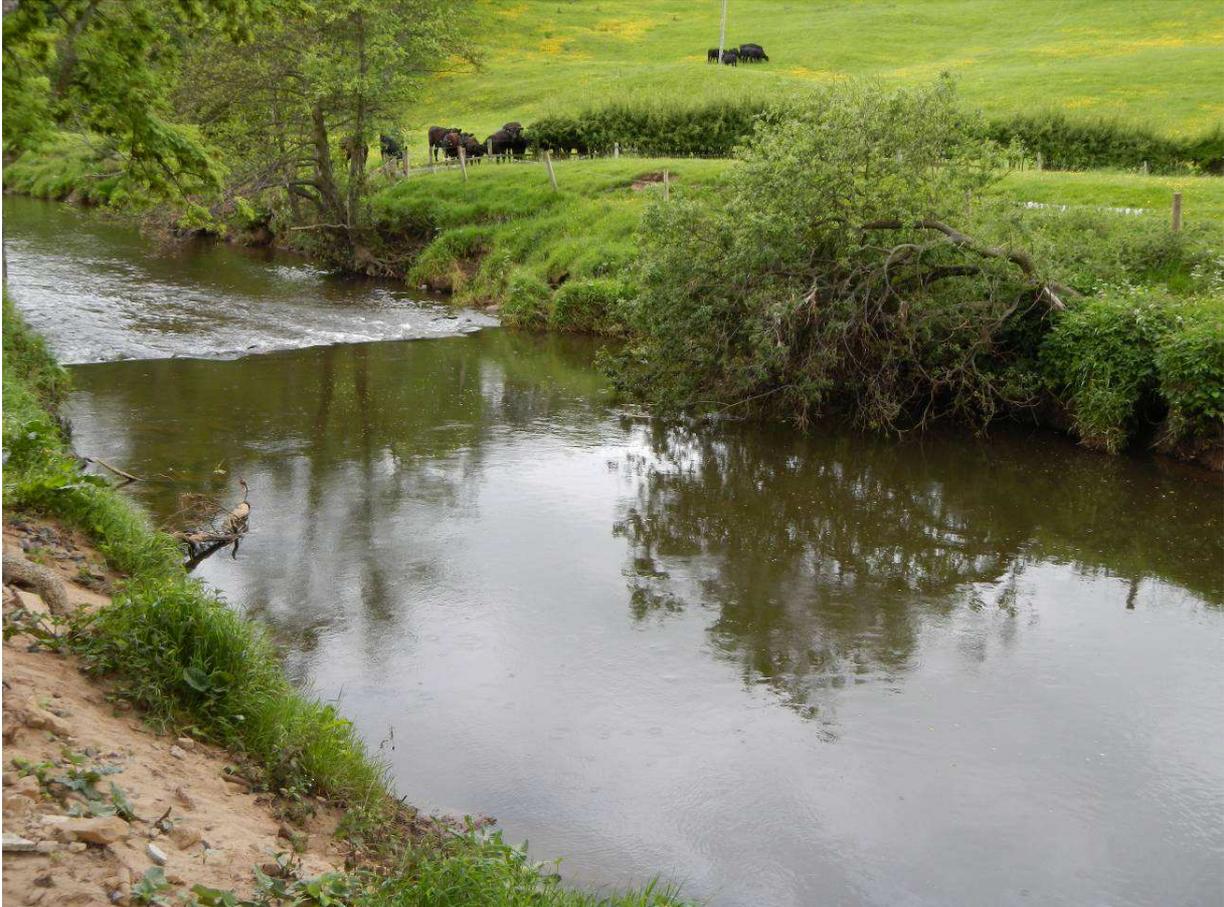
Figure 11. Stone weir which is causing impoundment of flows upstream, increasing sedimentation and degrading the lift at the tail of the pool that would otherwise provide spawning habitat.

It is strongly recommended that the central section (ideally 1/3 of the total width) of the weir downstream of the railway bridge (Figure 11) is removed. This will restore beneficial flow to the pool upstream, allow formation of a spawning area at the tail of the pool upstream and restore some degree of bed-load-transport through the section.
