Walkover Assessment

River Gaunless – Tributary of the River Wear

County Durham

Date – 21/01/15

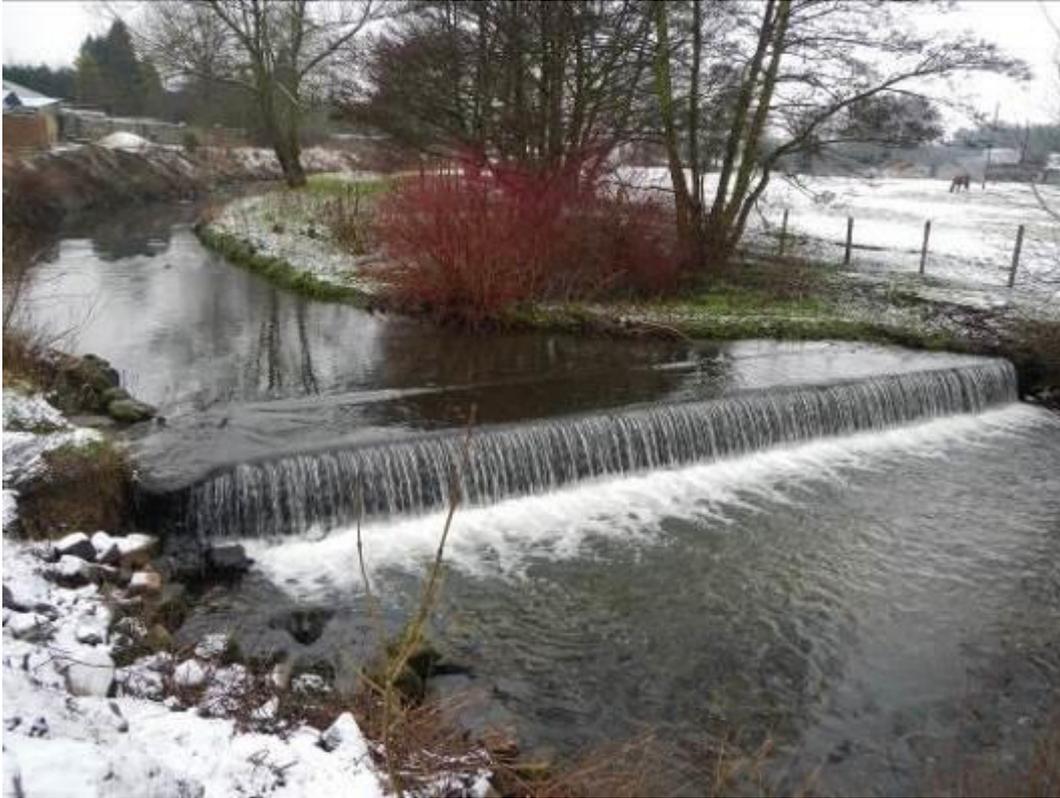
At the upstream limit of the section inspected, between West Auckland and St Helen Auckland, the channel is realigned and impounded by a medium-sized weir (c. 450mm) (Fig. 1). This weir may be passable in higher flows but the vertical fall and shallow water over the weir make it a significant obstacle to most fish in normal flows. The impounded reach upstream has largely filled in with substrate supplied from upstream and so presents only a small impact to sediment supply downstream. However, the straightened nature and uniform width of the channel (increased gradient/lack of flow diversity) in this area reduces the localised scour and deposition processes found in unmodified, meandering channels. For these reasons, finer gravel substrate suitable for salmonid spawning and deeper pool features are lacking for some distance (Fig. 2).

Figure 1. Weir at upstream end of the reach inspected which poses an obstacle to fish passage.

Ideally, the weir in West Auckland should be removed, to reinstate connectivity for fish passage and sediment transport through the river, however, some local residents are against removal as it once supplied a mill. This should not necessarily be a deterrent as often with discussion and explanation of the issues posed by a weir, stakeholders can be convinced that removal is the appropriate option.

If further determined negotiations for removal of the weir are not successful, a rock-ramp easement could be employed to *aid* fish migration. This could be installed on the downstream side of the weir, or at either side as a bypass channel. It must be conceded, however, that an easement will not fully mitigate the weir's impact and an ongoing maintenance issue of the weir and easement will remain.

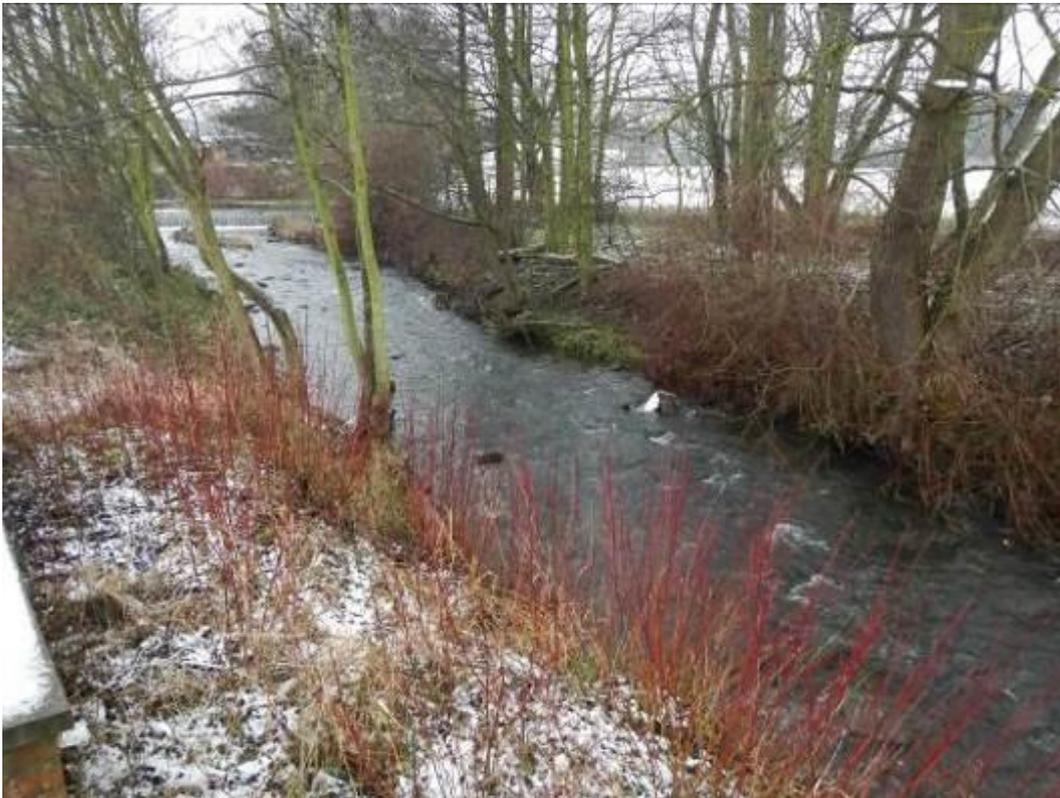
Figure 2. Straightened section of river with little diversity of water depth and coarse (large cobble) substrate.

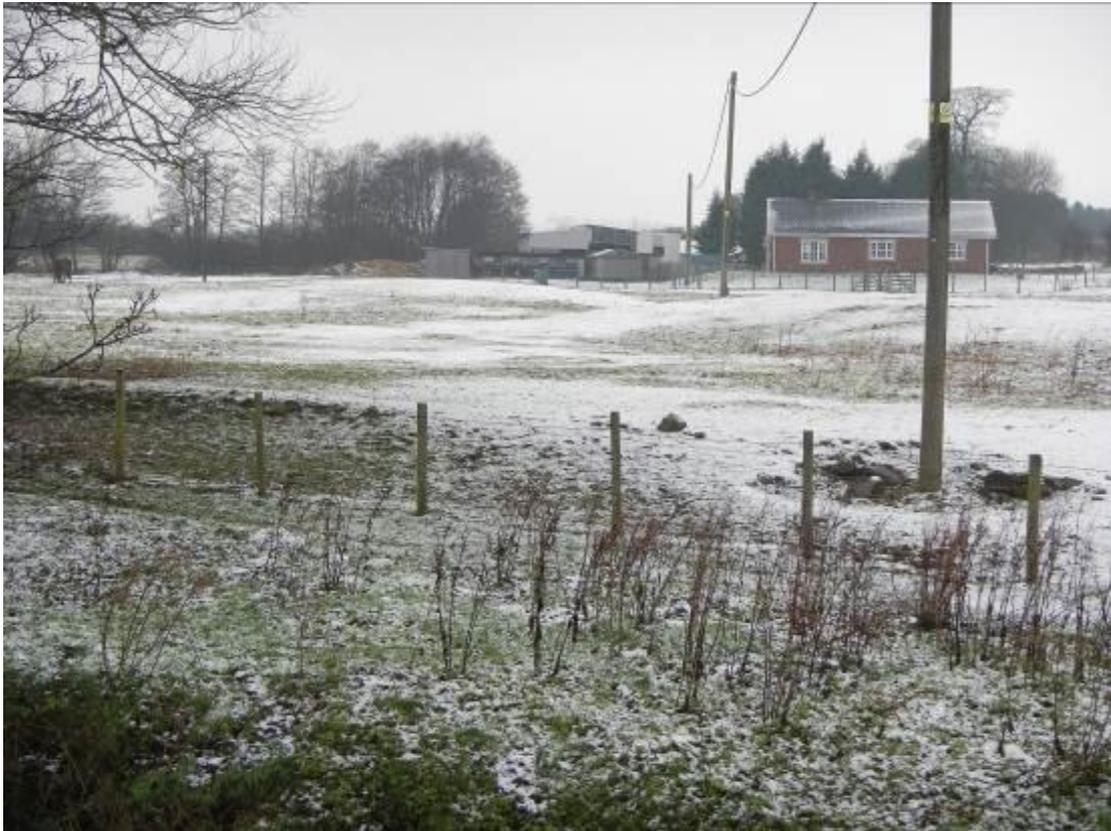
Figure 3. Evidence of a previous sinuous paleo-channel.

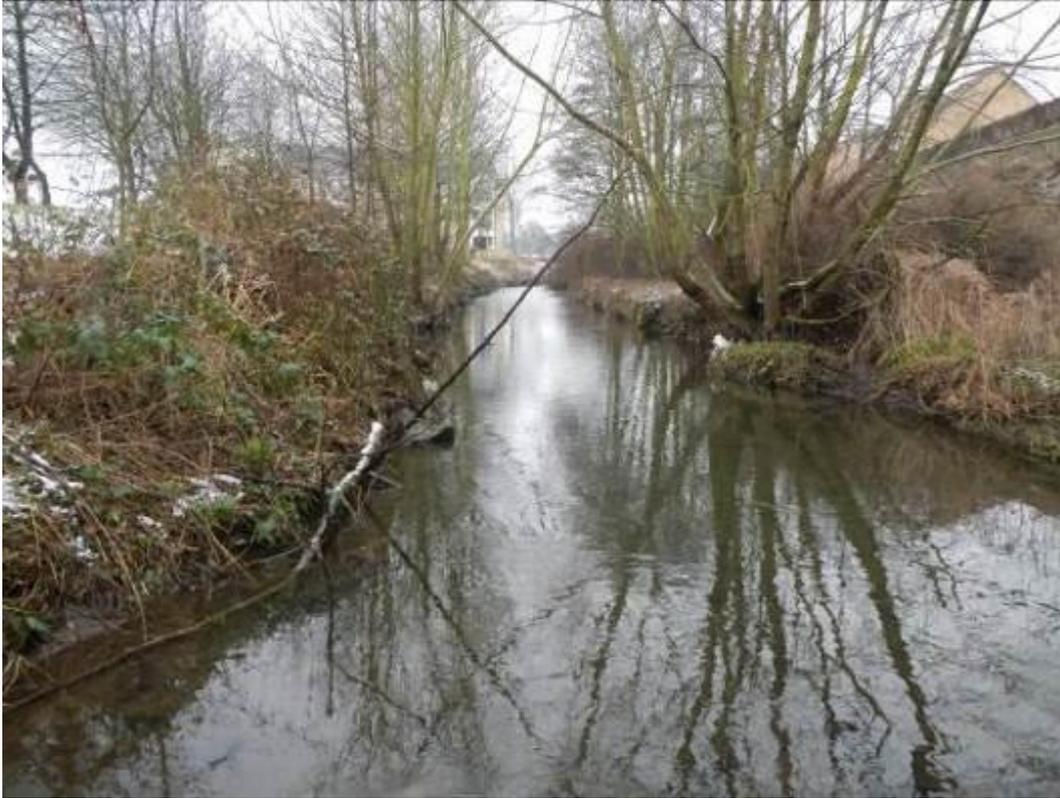
Realignment of the channel continues downstream into St Helen Auckland, where a lack of low level cover in areas suggests historic channel maintenance for land drainage (Fig. 4 & 5). Some small bankside shrubs were present, presumably established since the last maintenance, but in general the area has a lack of marginal cover and structure (low/trailing branches).

Figure 4. Straightened river section lacking low-level and in-channel/trailing cover.

Location	Action			NGR
	Hinging	Coppicing	Planting whips	
West Auckland (Figs. 4 & 5)	LB	LB		NZ 18323 26622 & NZ1843126608
West Auckland		LB		NZ 18528 26547

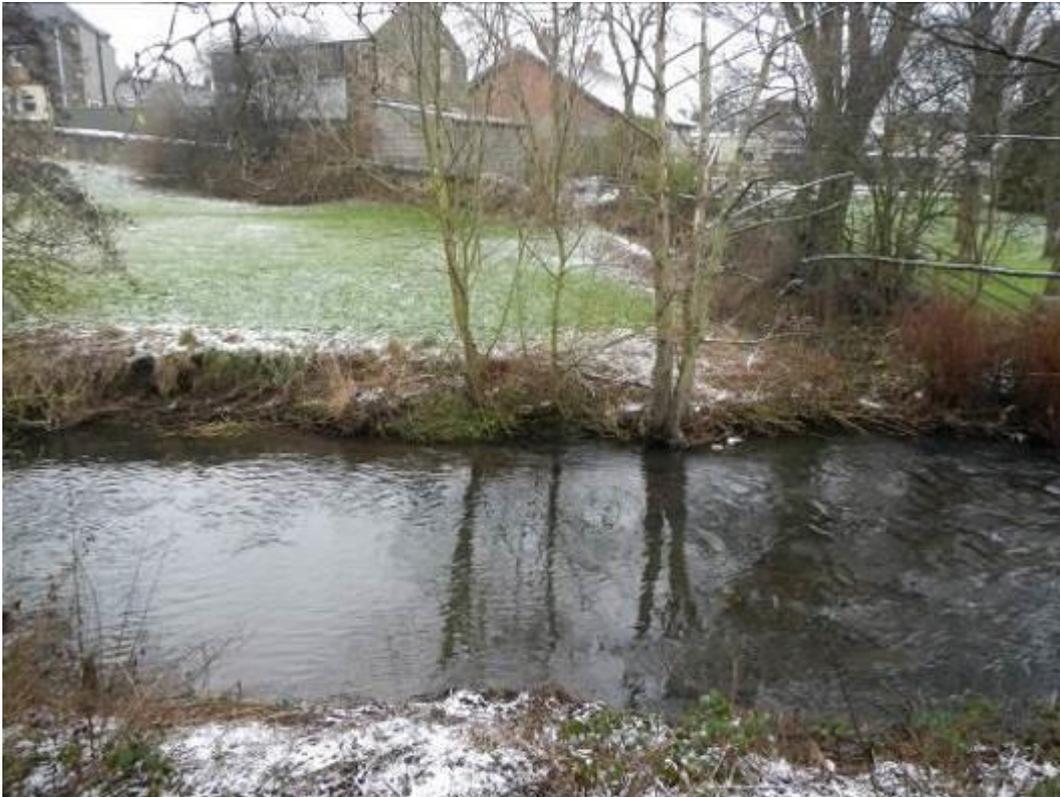
Figure 5. Bankside trees present but a general lack of low cover.

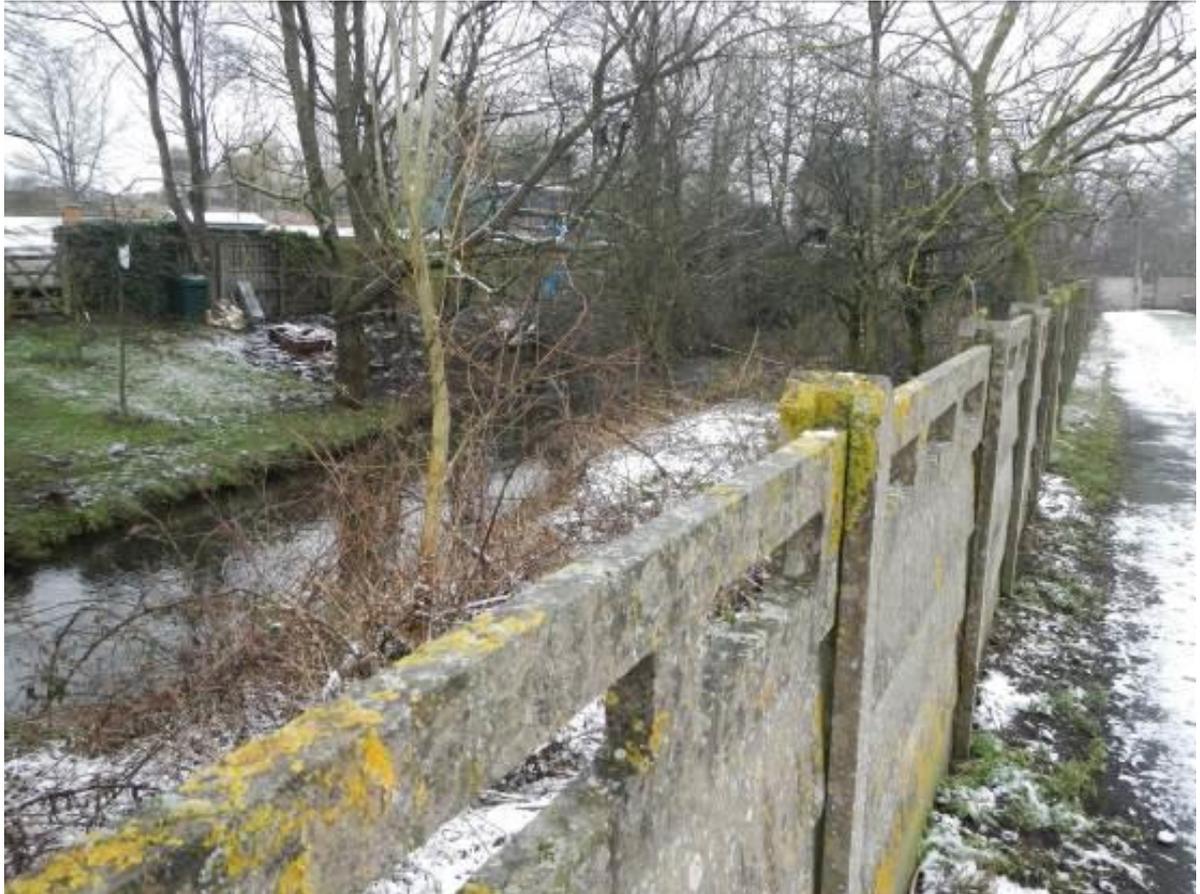
Through the housing estate, access to the river is impeded by an unsightly concrete fence (Fig. 6), seemingly for no reason. It is possible that promotion of the river's value as an asset to the local community and removal of the fence could better engage local residents with the river. There is, however, a risk that increased access could lead to abuse of the water course currently protected by the fence, so the community engagement aspect would be required.

Figure 6. Concrete fence shielding the river from sight of the houses on the RB.

Second field D/S A6070 Road bridge (Figs. 27 & 28)	RB	RB	NZ 20784 26779	NZ 20939 27305
Area around (Figs. 30 & 31)	LB	RB	NZ 20762 27290	NZ 20842 27354
(Figs. 32, 35 & 36)	Both banks for the lower 2km	RB Top section	NZ 20939 27305	NZ 21032 27832
As described in the assessment, it may also be beneficial to remove the concrete fence (Fig. 6) and promote the river as an asset to the local residents, rather than the degraded feature it historically represents and that has to be shielded from sight.

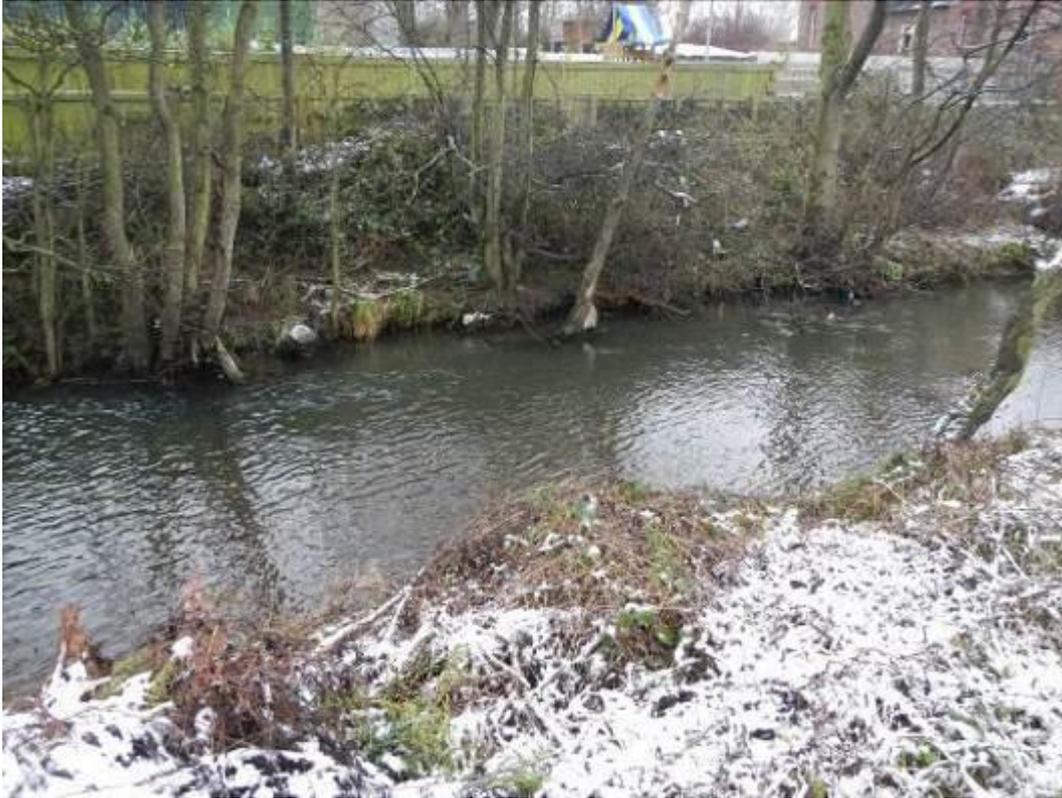
Areas of bank protection afforded by mature alder trees have focussed bed scouring and developed deeper pool habitat, although the lack of low/trailing branches is still very apparent (Fig 7). A low pipe crossing significantly restricts channel capacity (Fig. 8); a fact that may support the case for increasing low-level and in-channel structure in the area, as the pipe is likely to be the over-riding restriction in terms of channel flood conveyance. Downstream of the pipe the channel widens slightly, facilitating the retention of a finer gravel (likely liberated by bed scour below the pipe). The gravel bar formed provides an important potential salmonid spawning area. Collapsed crack willow (*Salix fragilis*) alongside the bar represents the natural occurrence of a type of habitat that could be replicated in other areas to increase low cover with minimal impact upon flood conveyance.

Figure 7. Deeper pool habitat created where root protection along the bank has facilitated some bed scour.

(Fig. 7)				
Fields downstream of West Auckland (Fig. 14)	RB			NZ 19074 26381
Downstream of A688 (Fig. 16)	LB			NZ1928626365
High eroding bank near failed fencing (Fig 18)			Both banks	NZ 19408 26201
Downstream of A6072 (Fig. 23)	LB	LB		NZ 20531 26798

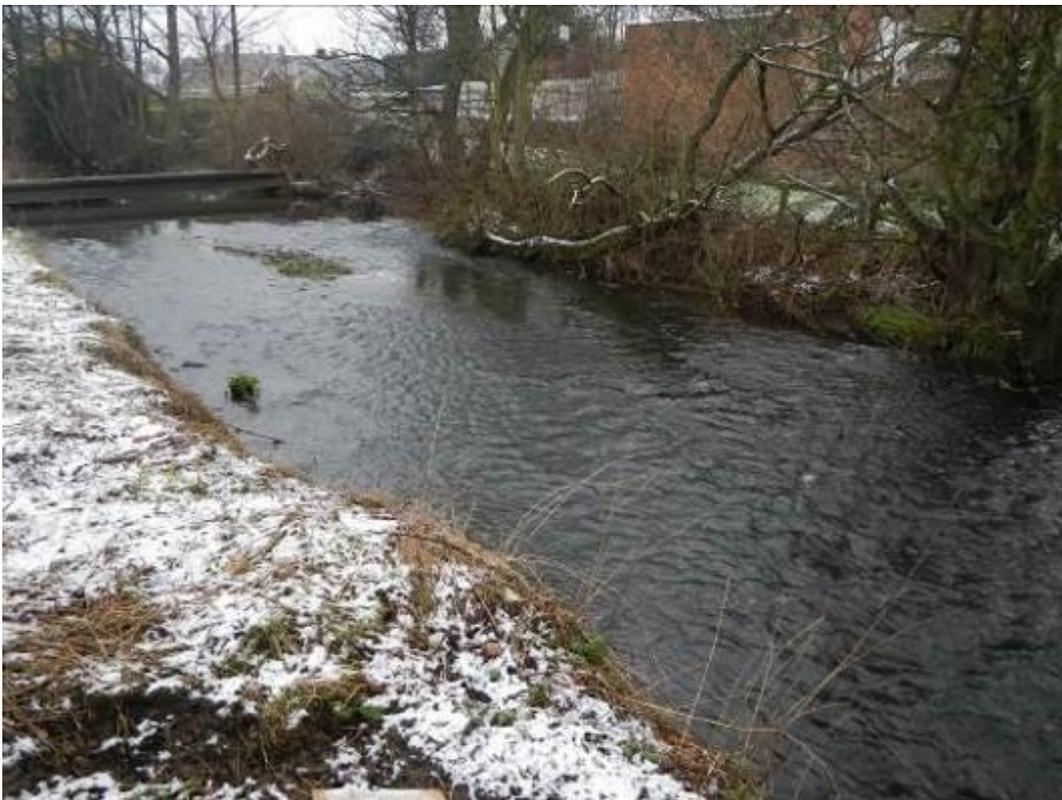
Figure 8. Wider channel facilitating retention of finer gravels (potential salmonids spawning habitat), with a fallen willow alongside.

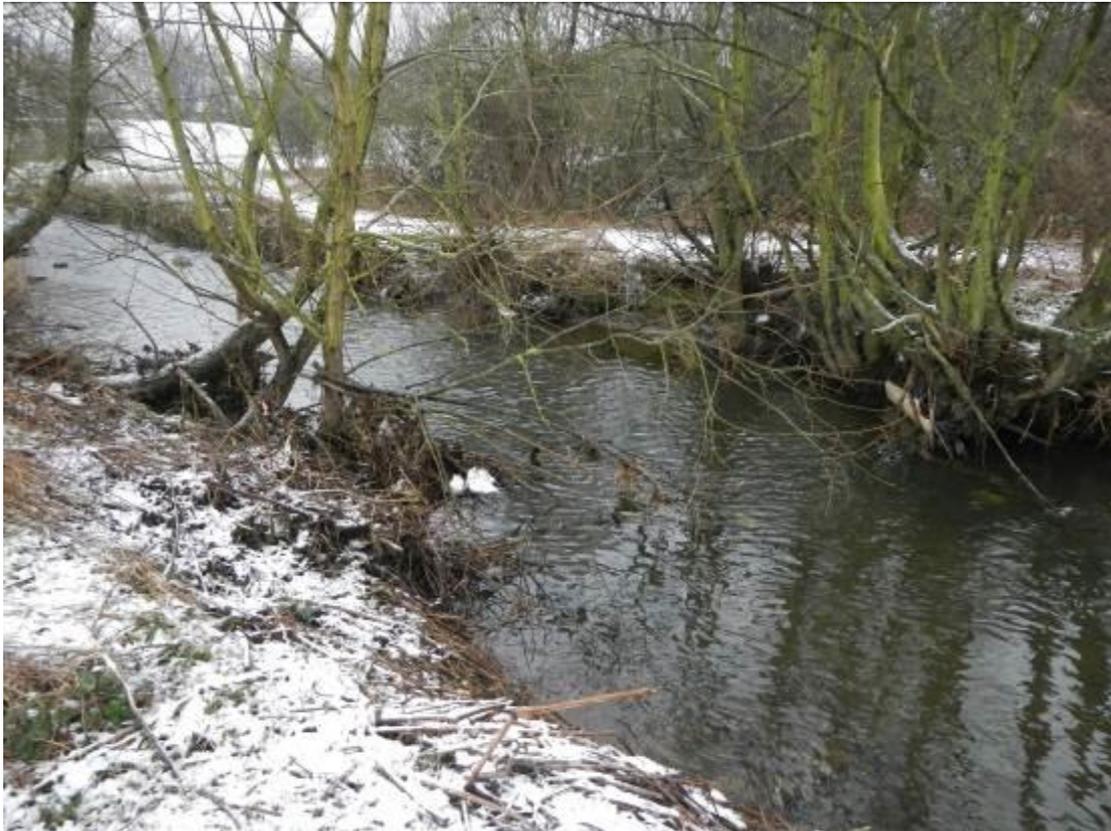
Moving downstream, out of the conurbation of St Helen Auckland, a short section of relatively high quality in-channel structure is present, along with associated scour pools and healthy flow diversity (Fig 9).

Figure 9. Good tree cover along a more diverse channel.

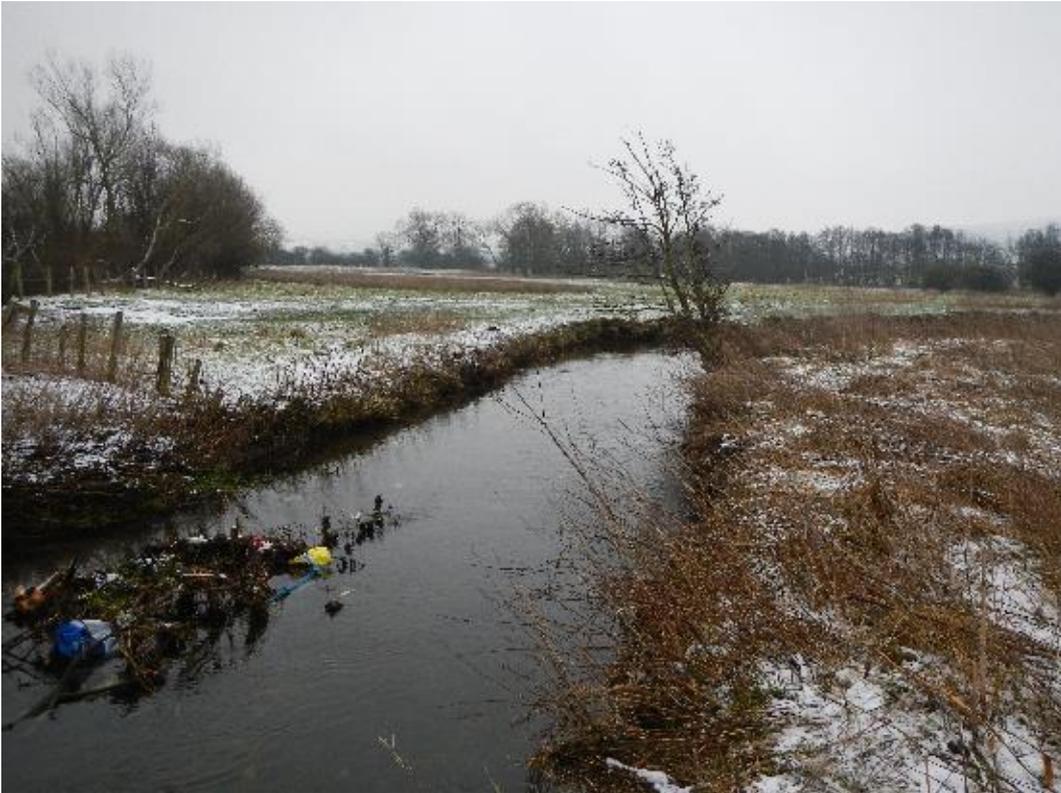
A short distance downstream, grazing becomes an impact along both banks, particularly the left (Figs. 10 & 11) and is a significant factor in the lack of trees and low cover in many areas, as the grazing prevents natural regeneration. With a lack of vegetation and tree root structure the banks are much more susceptible to high flows and notable erosion was present, sometimes on both banks (Fig. 11).

Figure 10. The start of grazing d/s of St Helen Auckland.

Location	Action		NGR	
	Installation	Repair	U/S	D/S
D/S St Helen Auckland (Fig. 10)	Most of both Banks	LB at D/S limit	NZ 18782 26482	NZ 19204 26371
D/S A688 (Fig. 17)		LB	NZ1936826272	NZ1936826272
Water gates and fence (Figs. 18 & 19)		Both banks	NZ 19408 26201	NZ 19506 26208
(Fig. 20)	Exclude livestock from area of boggy ground		NZ 19463 26129	
(Fig. 22) Section not walked	Both banks		NZ 19639 26208	NZ 20445 26835

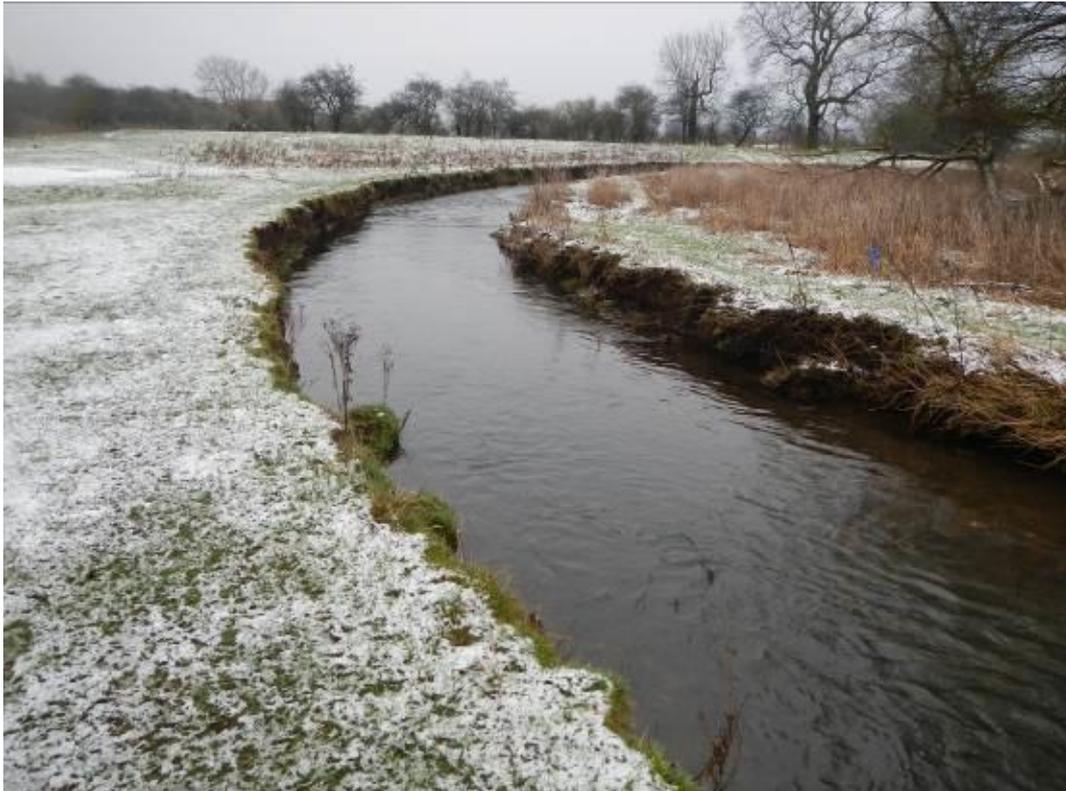
Figure 11. Significant grazing and lack of trees and herbaceous vegetation, leading to destabilization of both banks.

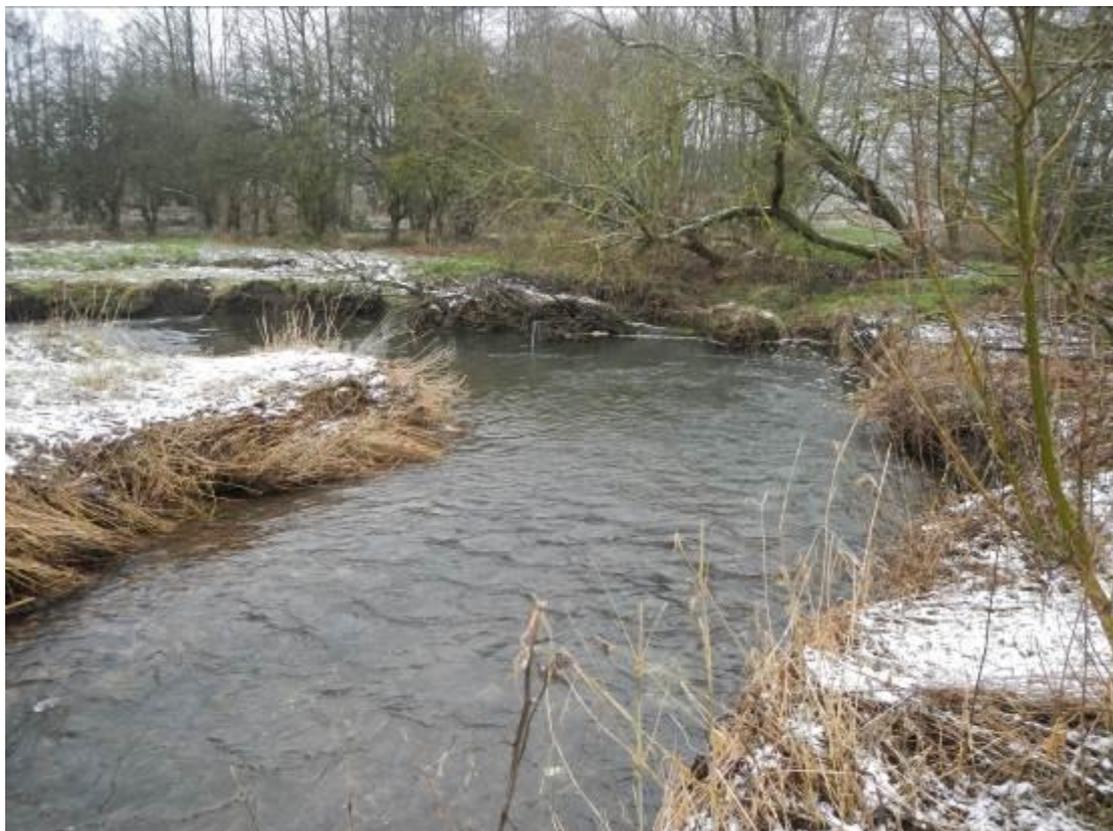
The impact of channel maintenance and realignment reduces significantly through this section and a more natural, meandering planform is present (Fig. 12). There is some evidence of straightening but this is most likely due to historic management of land boundaries and land drainage. In general, the river is actively recovering a more natural planform. With the more sinuous planform and reduced gradient a greater diversity of mobile substrate was present, providing high quality salmonid spawning habitat. Although limited,

Figure 12. A more sinuous planform facilitates beneficial scour, creating pool habitat and reworking the substrate to greatly improve spawning habitat.

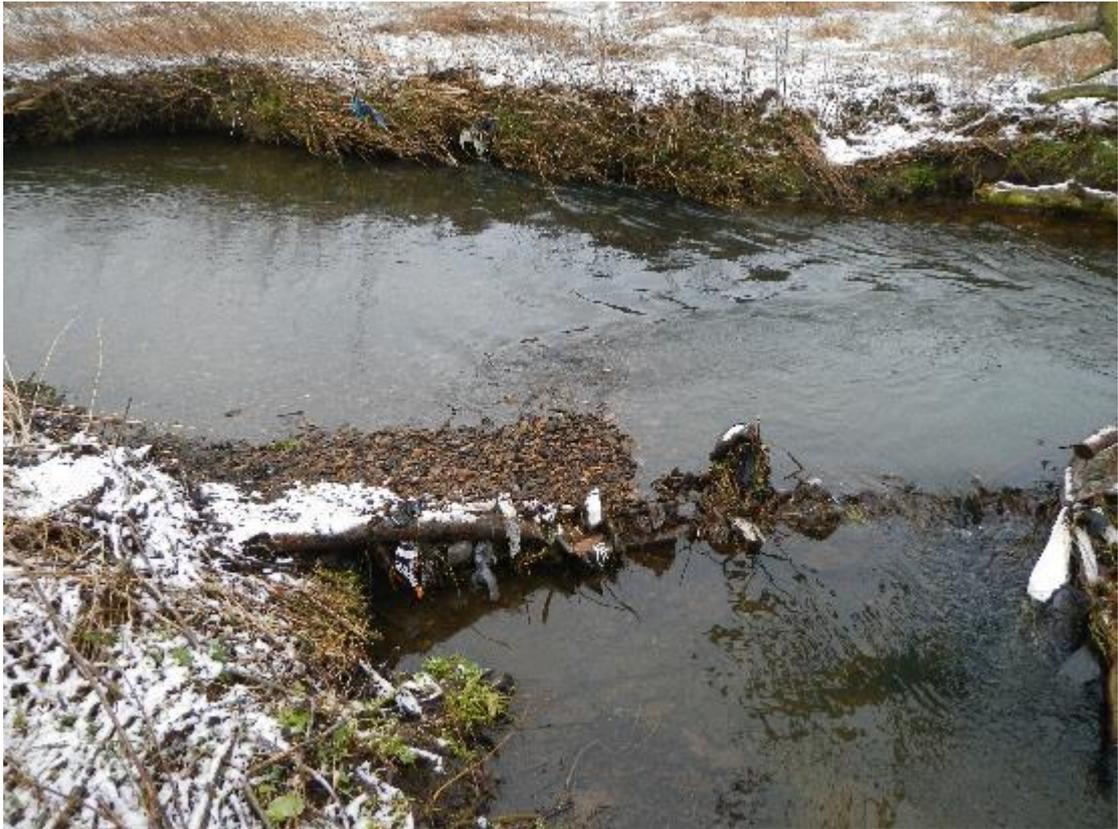
in areas large woody debris (LWD) retains the mobile substrate and further enhances spawning habitat (Fig. 13).

Figure 13. LWD retaining gravel and enhancing spawning habitat.

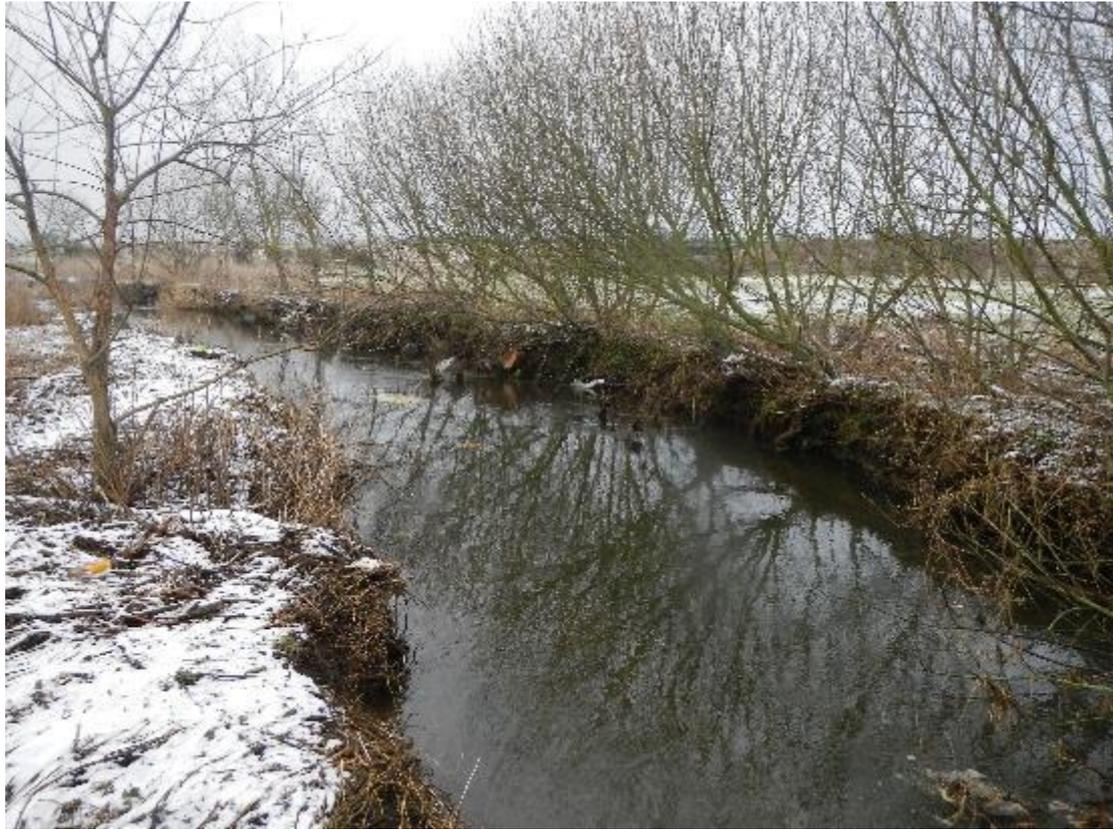
A reasonably successful attempt at bank protection appears to have been made with a line of willows around one outside bend, providing bank stability and habitat enhancement (Fig 14).

Figure 14. Planted willows provide bank protection and habitat. The habitat could be further enhanced by laying some willows into the channel.

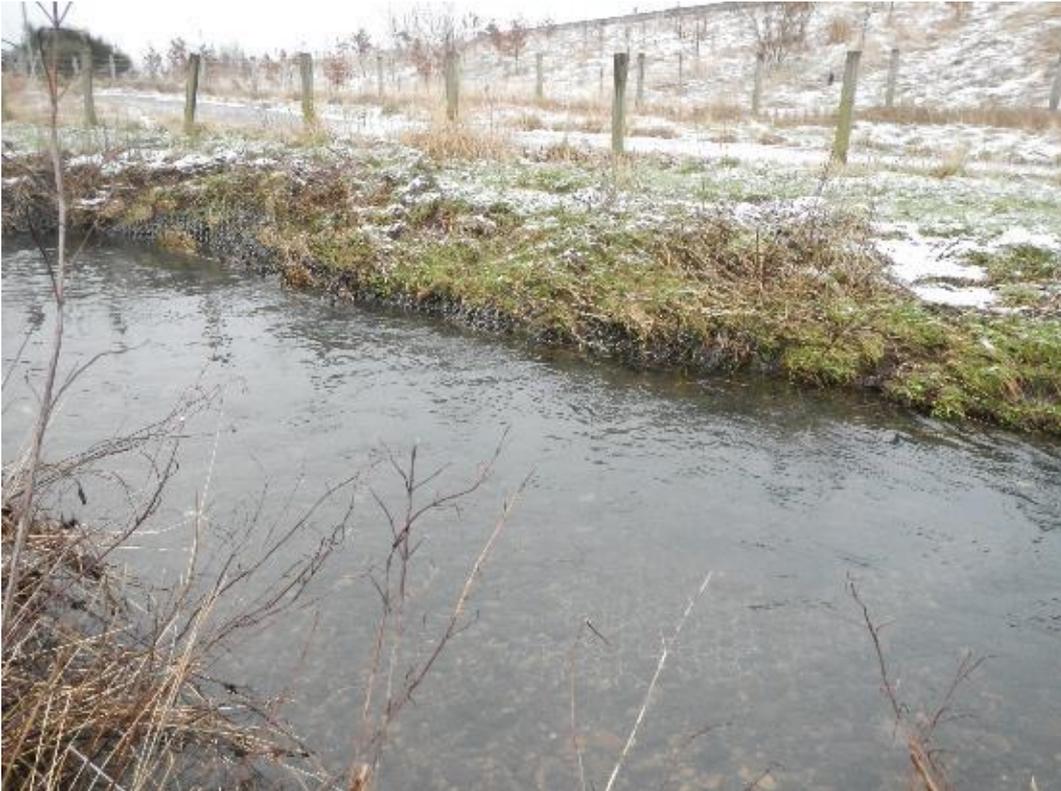
In stark contrast to the soft willow protection, hard armouring has been employed on the river bed and banks in the area around the A688 Road Bridge, with the whole channel constrained within rock netting (Fig. 15). Natural substrate is retained over the top in most places, however, and some semblance of in-channel/bed features exist.

Figure 15. An appalling use of hard engineering, with the entire bed and banks constrained within rock netting.

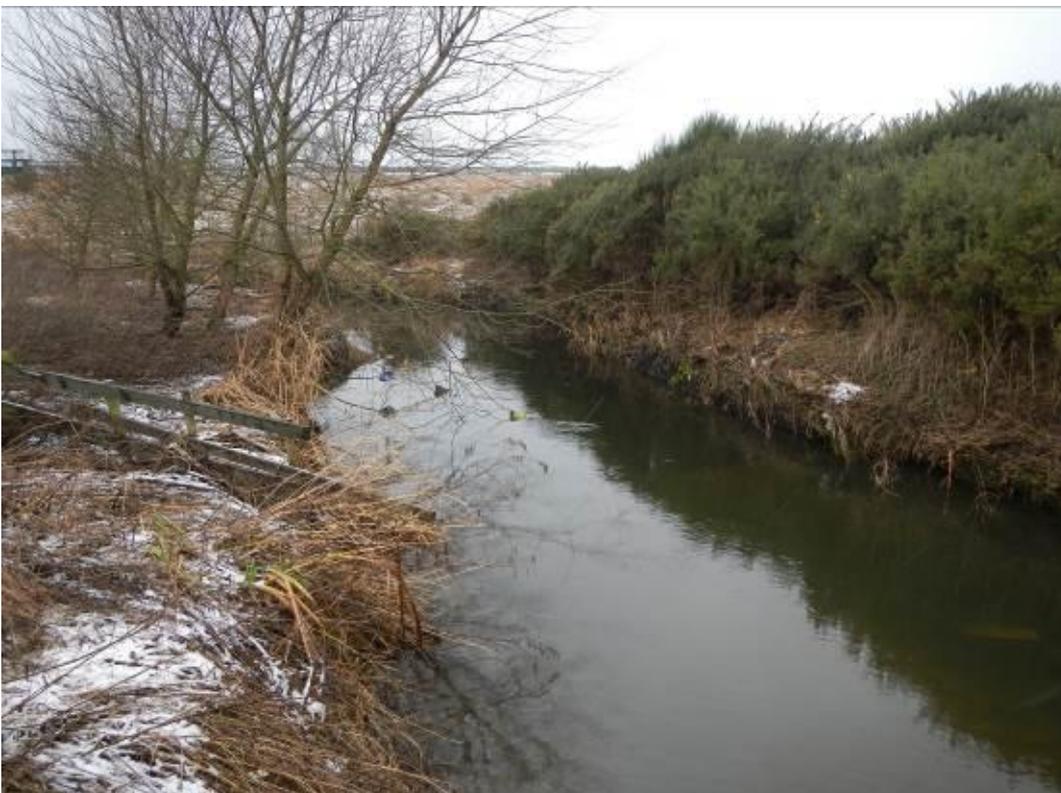
Figure 16. Stock excluded allowing improved vegetation cover, but some signs of dredging. Hinging the tree into the channel would greatly enhance in-channel habitat.

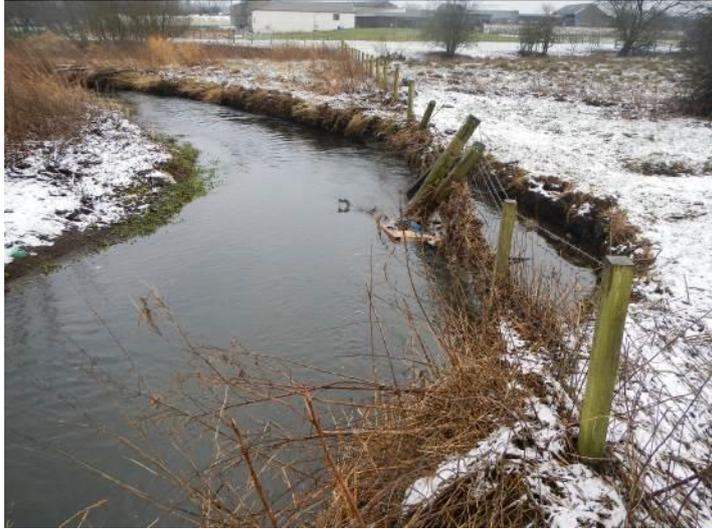
Figure 17. Area of erosion requiring fence repair/relocation.

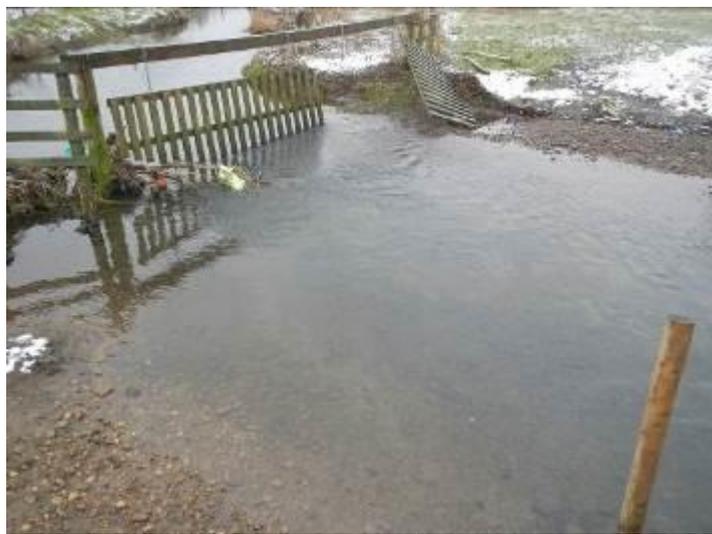
Figure 18. Ford and water gate requiring repair.

Willow can also be employed effectively to stabilise areas of eroding bank (eventually achieving a similar effect to that shown in Figure 14). This is achieved by driving whips into the ground at 400-800mm spacing throughout areas of unstable bank. Areas that could particularly benefit from this treatment include the eroding bank face in Figure 18, and other locations around that area.

In areas where fencing has been undertaken and where bank erosion is a particular issue wired brash revetment could also be installed to help protect the bank while it becomes vegetated (This method works very well in conjunction with planting of willow whips). The method involves the creation of a brash mattress, over-wired and secured with posts (see Figs. 42 & 43) which acts as a diffuse barrier to flows, protecting the bank and increasing deposition of fine sediment which then assists the colonisation of vegetation. This method would be ideally suited to the area of erosion in Figure 18. In deeper areas, larger overlapping brash/tree kickers along the bank toe can help.

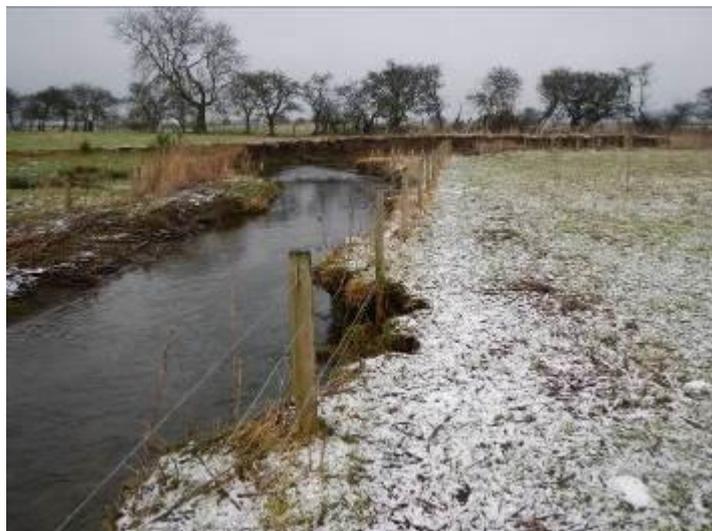
Figure 19. Erosion requiring fence repair and relocation (possibly due to poor fence maintenance and stock accessing/grazing the bank).

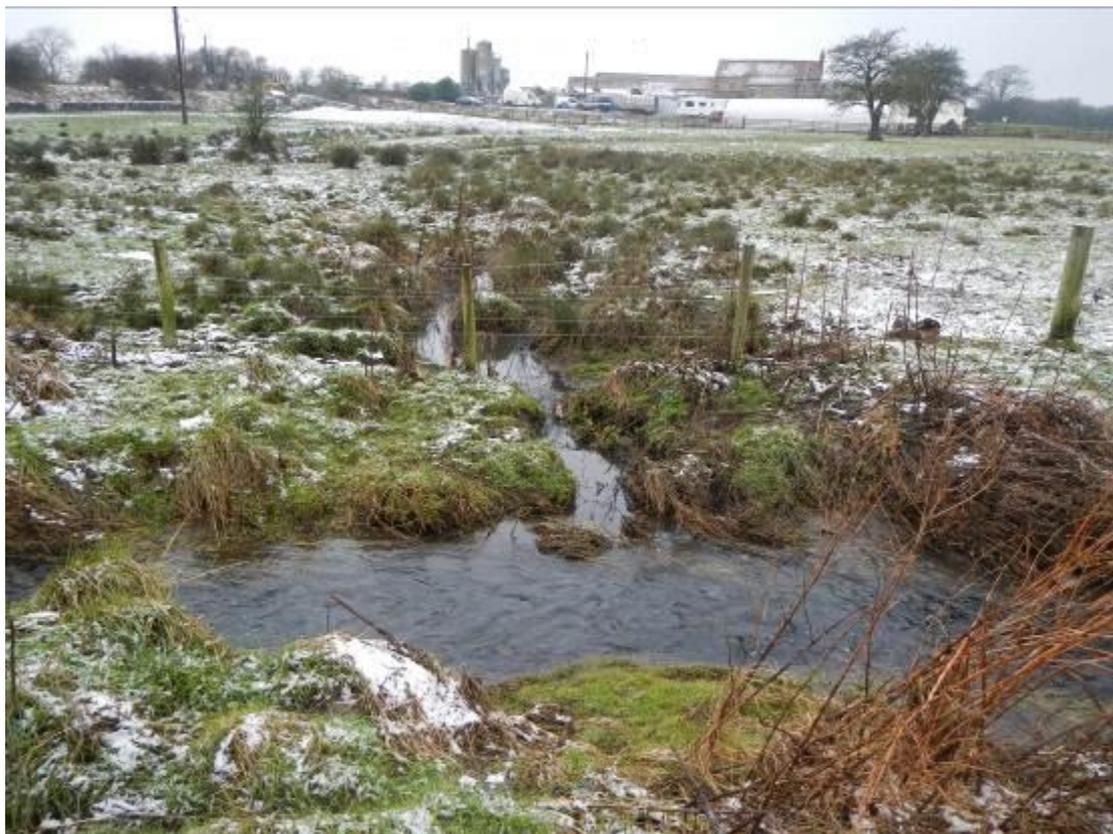
Towards the downstream end of this section Hummer Beck confluences with the Gaunless (d/s limit of the WFD waterbody) and provides a notable sediment input to the river. A short distance upstream of the confluence on the Beck an obvious point source for fine sediment was noted (Fig. 20), but inspection further upstream revealed that the Beck is already carrying a high sediment load by that point. Observation of the bed showed the Beck to comprise a significant portion of silt and sand.

Figure 20. A boggy spring area in the field (background) which creates a source of sediment to the river.

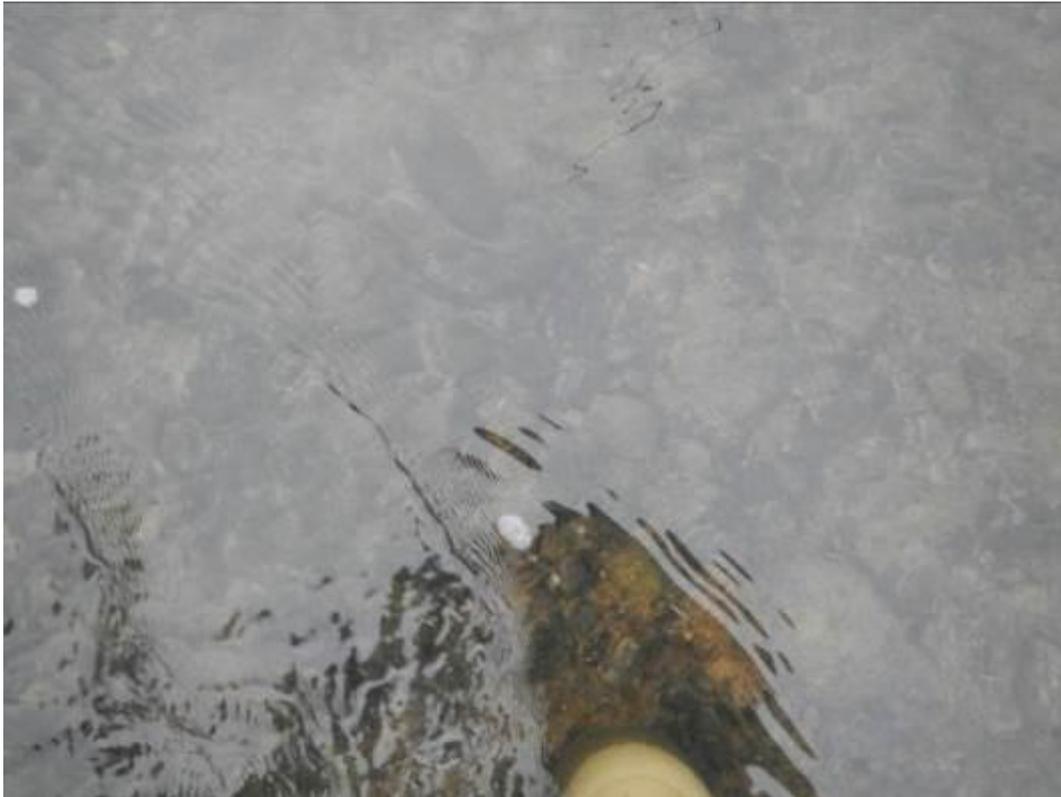
Figure 21. Heavily silted bed of the Hummer Beck.

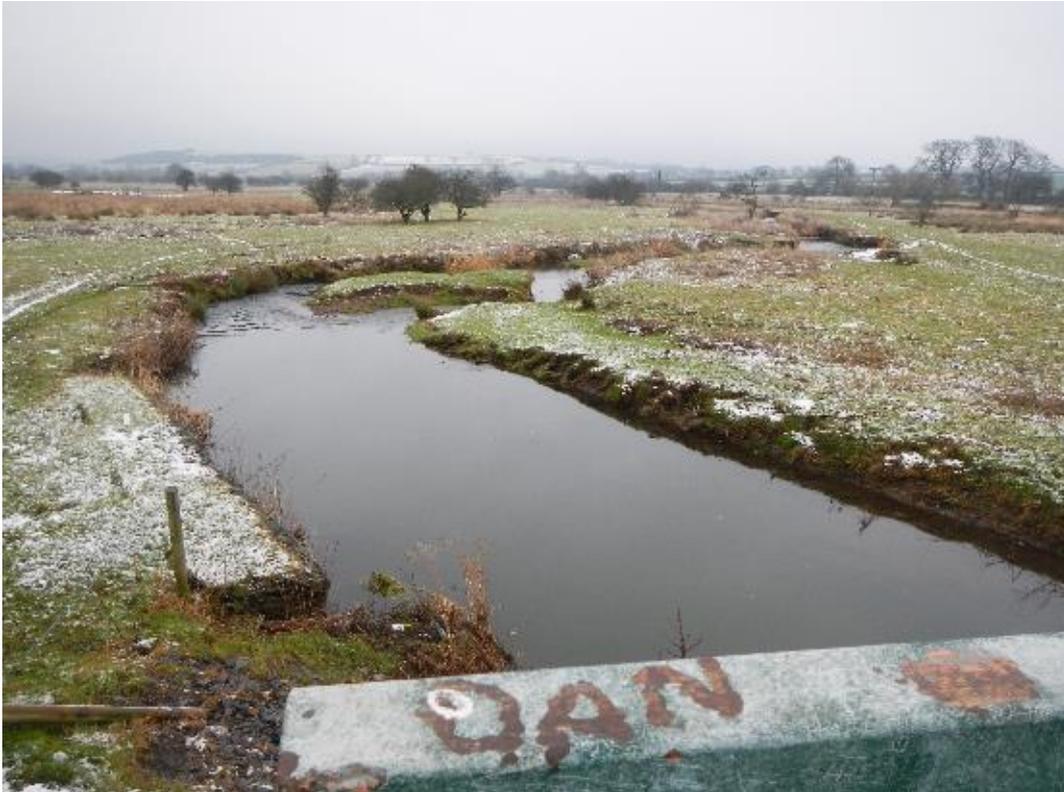
Similarly, the section downstream of the bridge that wasn't walked would also greatly benefit from fencing, which, if given a large enough buffer, would probably allow the section to recover naturally into high quality salmonid habitat.

Figure 22. The middle section (not walked) where a generous buffer strip would facilitate natural recovery.

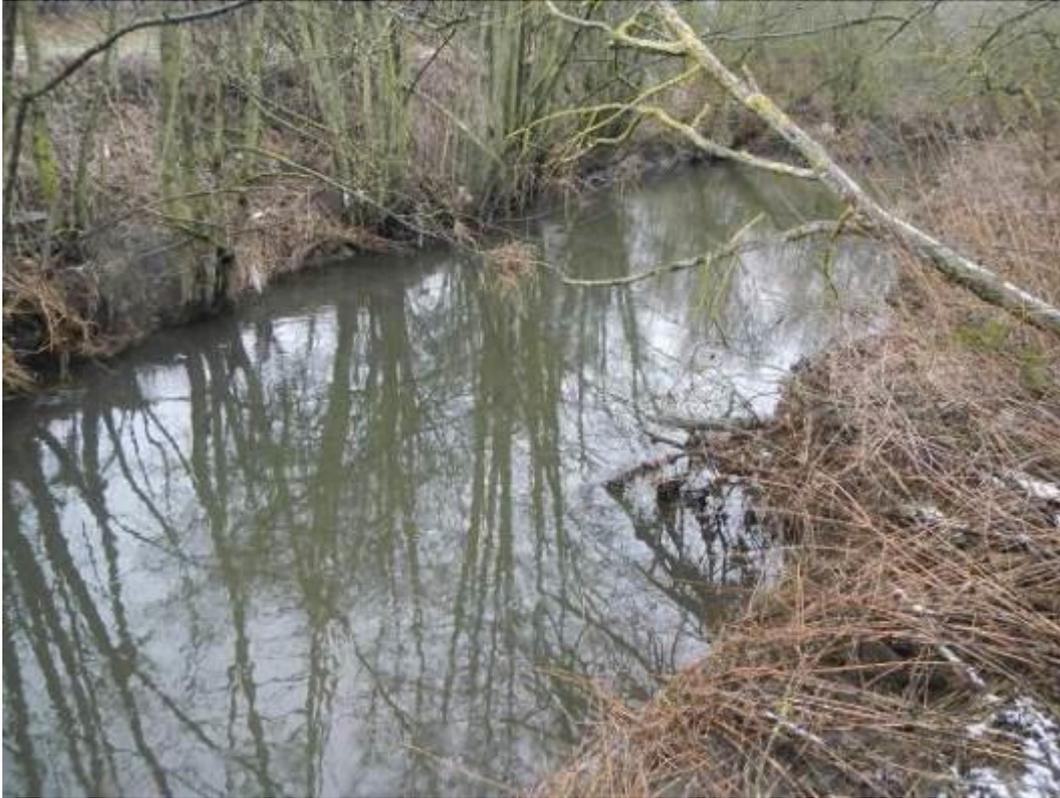
Downstream of the A6072 the river is very much more incised, flowing between deep banks and with a relatively uniform bed profile (generally deep and lacking riffles) (Fig. 23). The banks open out in areas (Fig. 24), but even in these areas a lack of shallow gravel and spawning habitat prevails. Adult and larger juvenile trout habitat is of a reasonable quality through these areas due to the deep water in conjunction with a relative abundance of bankside trees and rank vegetation.

Figure 23. Deep water in an incised channel with high banks d/s of the A6072 with a lack of shallow riffle areas. Also note the water discoloration.

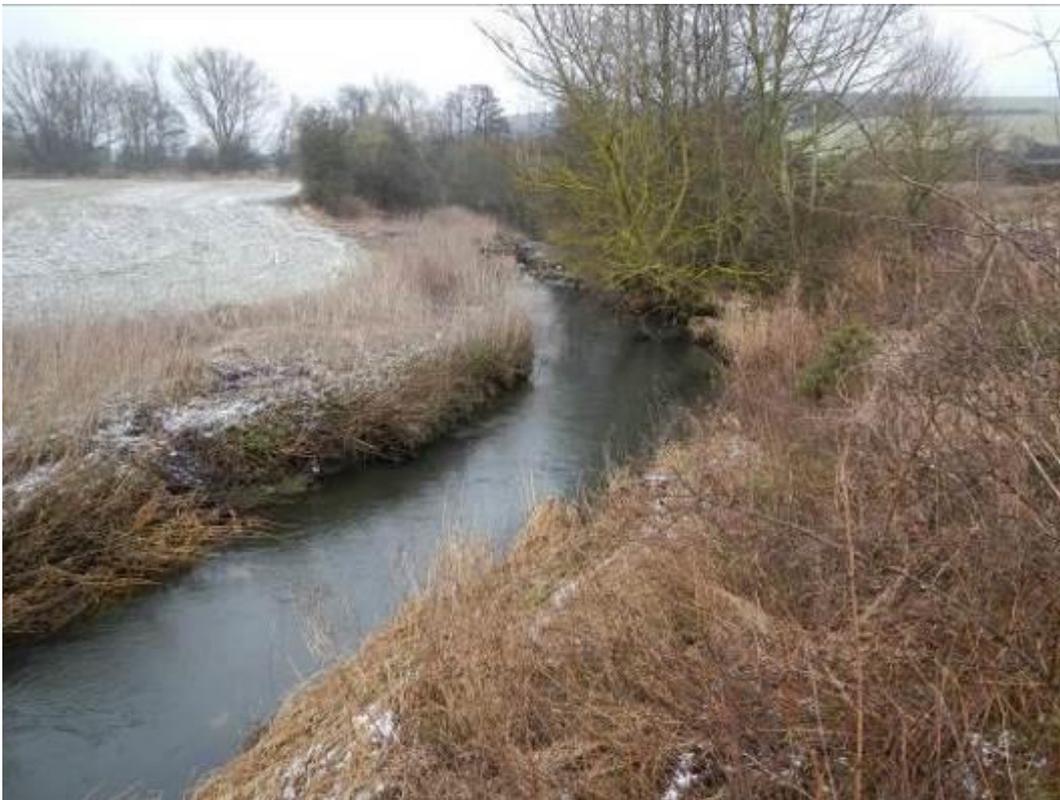
Figure 24. An area of more open banks, but the lack of shallow water and gravel bars remains.
