Walkover Assessment

River Gaunless – Tributary of the River Wear

County Durham

Date – 21/01/15

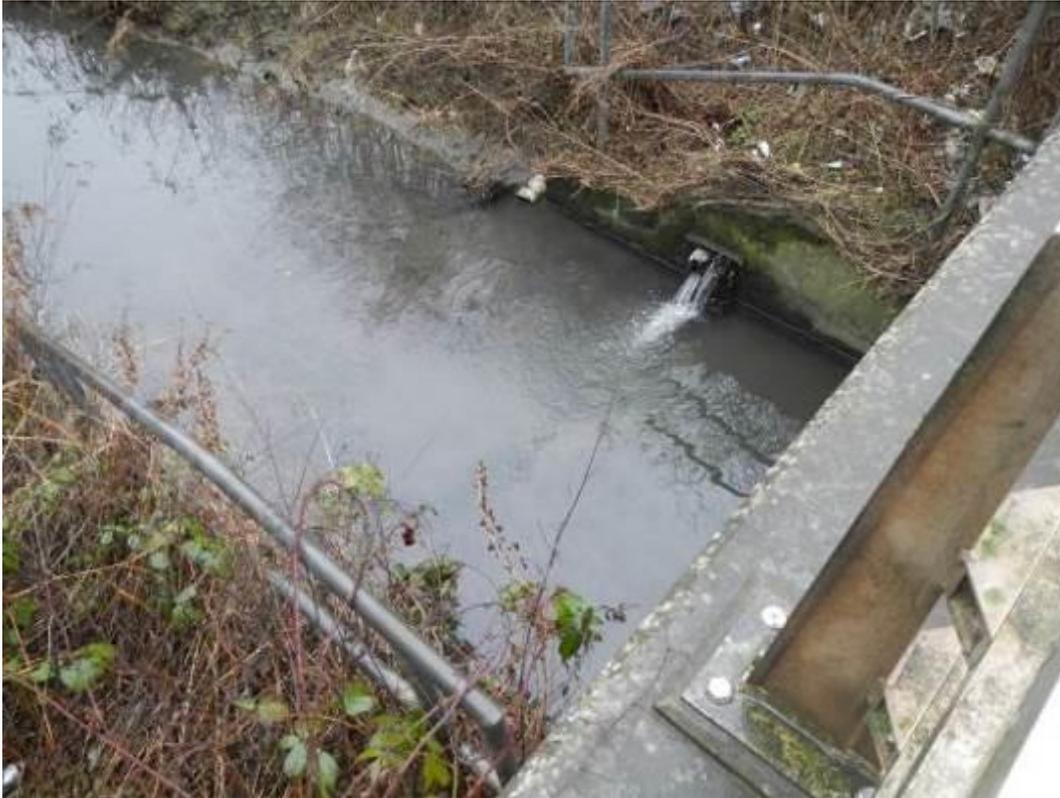
A small tributary joins the Gaunless just downstream of the road which carries sediment-laden water from both field and road drainage (Fig. 25). Further downstream another field drain also enters the river and appears to be supplying ochreous water via a large soak away area/outflow area (Fig. 26). This is, in fact, likely to be greatly reducing the impact of the outfall as the large area and slow transition is likely to be allowing oxidisation to occur (causing the colouring) before it enters the Gaunless, at least at low flow. It may, however, be worth investigating the chemical impact on the river in low flows (particular pH). A brief investigation of old maps identifies the location of a disused colliery on the hill above, which is almost certainly the source.

Figure 25. Small tributary/drain supplying further sediment laden water.

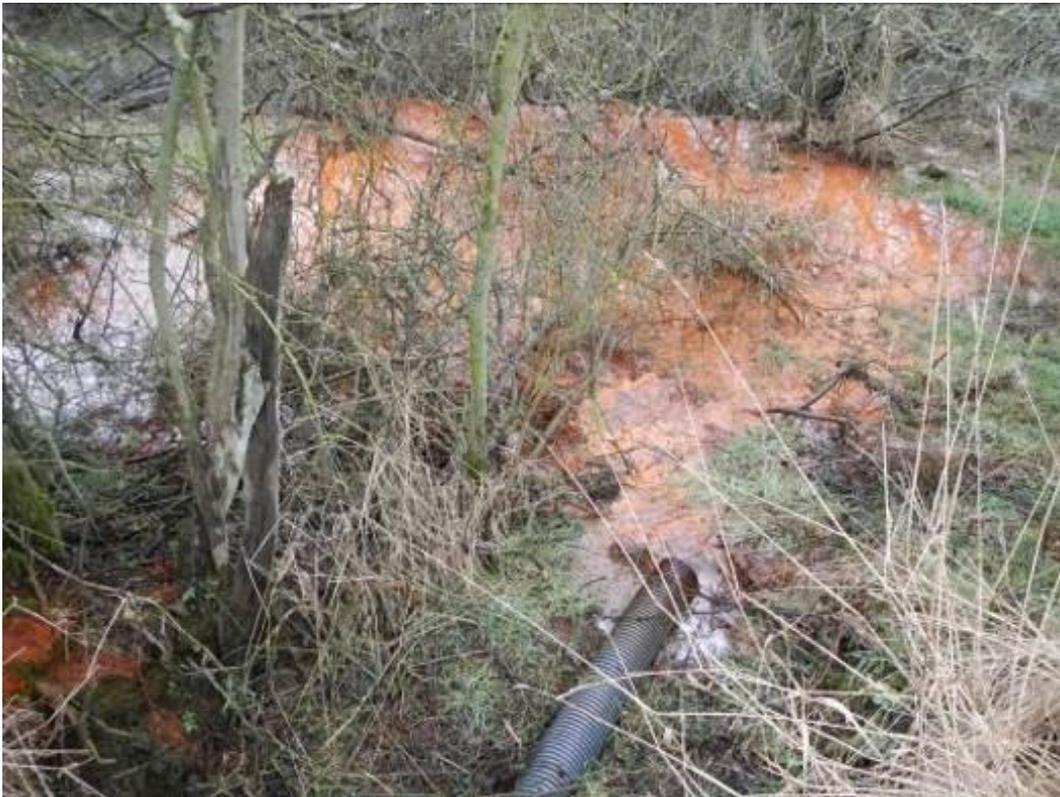
Figure 26. Large area of ochreous discharge that is very likely draining the old mine workings further up the hill.

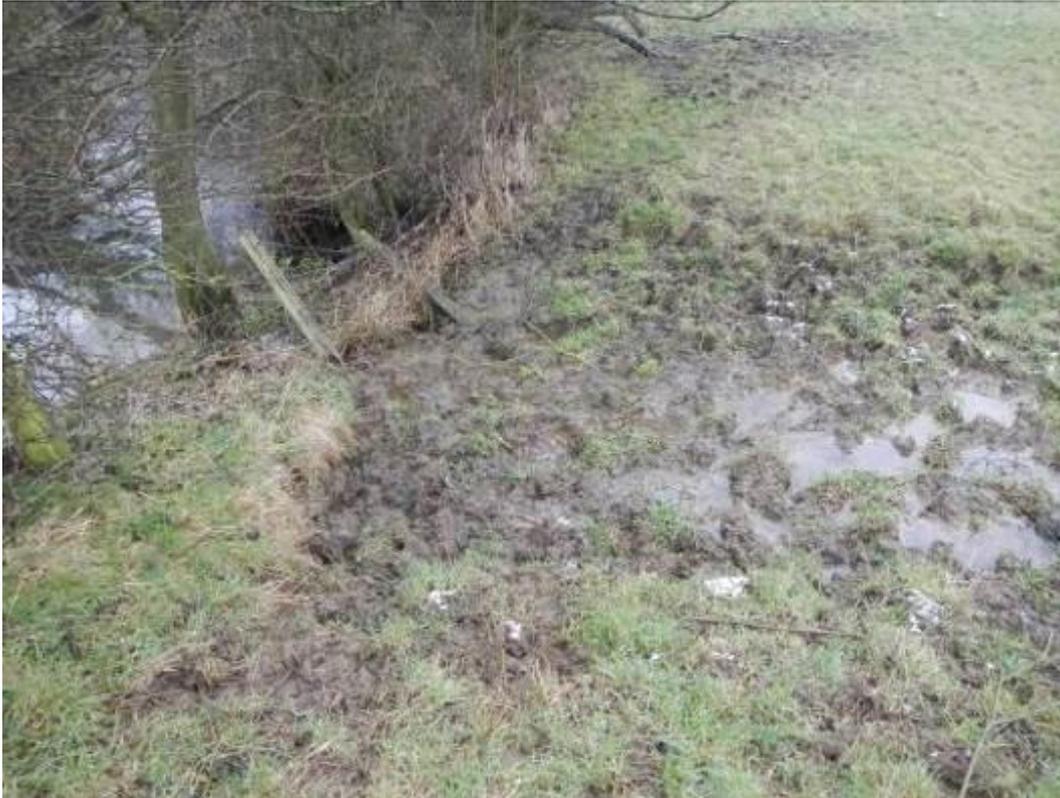
Further downstream two areas of boggy land around natural springs also create sediment inputs to the river. The impact of these are greatly exacerbated by livestock poaching of the area (Fig. 27).

Figure 27. Boggy, poached area in field creating a sediment source.

Second field D/S A6070 Road bridge (Figs. 27 & 28)	RB	RB	NZ 20784 26779	NZ 20939 27305
Area around (Figs. 30 & 31)	LB	RB	NZ 20762 27290	NZ 20842 27354
(Figs. 32, 35 & 36)	Both banks for the lower 2km	RB Top section	NZ 20939 27305	NZ 21032 27832
As described in the assessment, it may also be beneficial to remove the concrete fence (Fig. 6) and promote the river as an asset to the local residents, rather than the degraded feature it historically represents and that has to be shielded from sight.

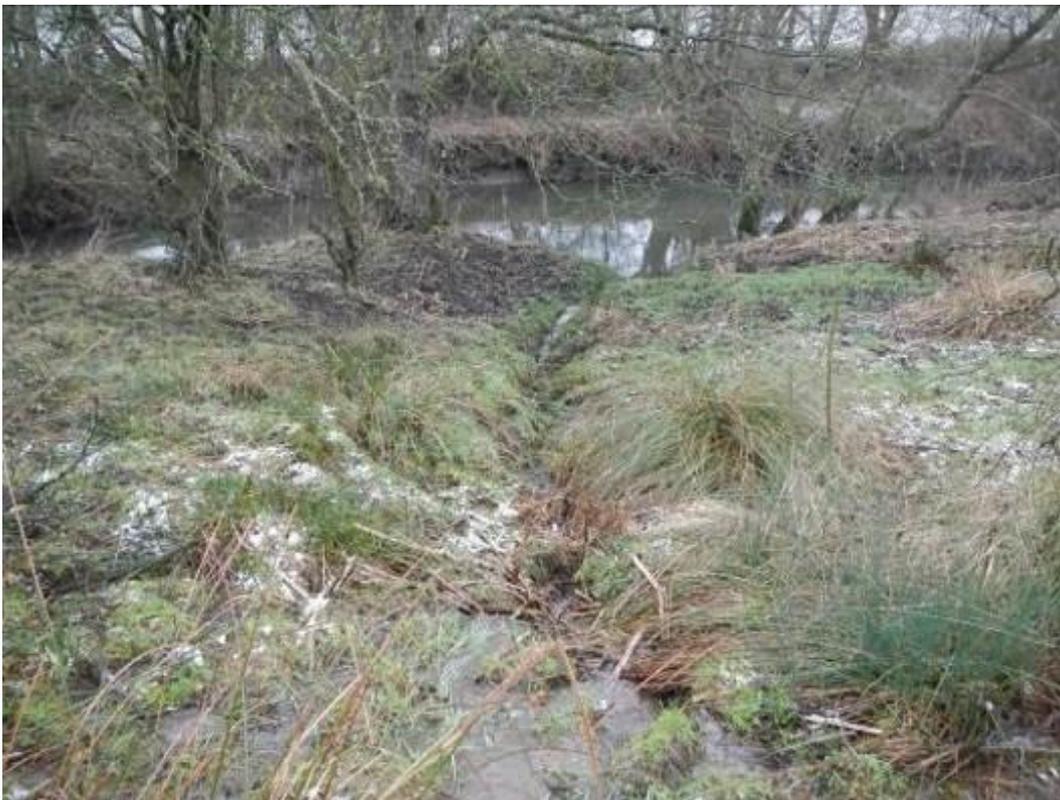
Figure 28. Natural spring and boggy area creating a sediment source.

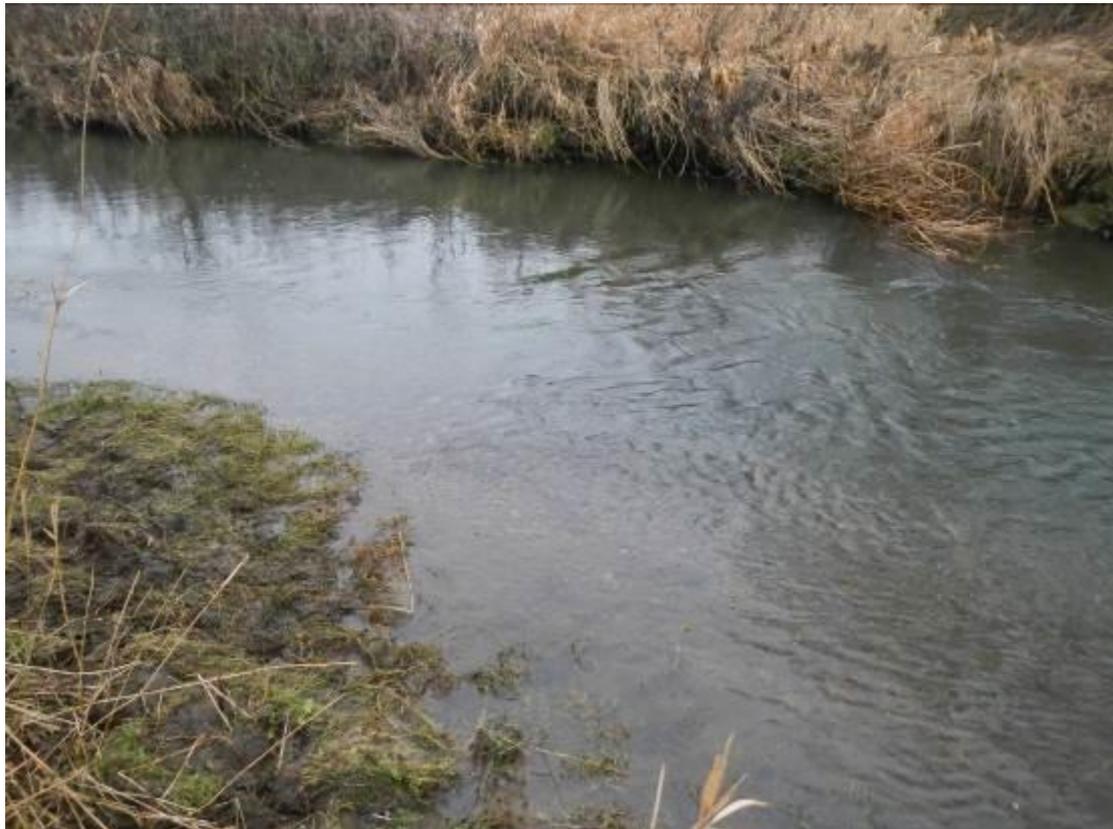
Approximately 1km downstream of the bridge the valley opens up and the character of the river changes. With high flows able to spill onto the floodplain a greater portion of finer substrate is retained and gravel bars and riffles are again present (Fig. 29).

While the substrate is relatively mobile and of a suitable size for salmonid spawning it is significantly compromised by a high fine sediment content. This greatly reduces its attraction for spawning salmonids and will significantly lower the survival rate of any eggs deposited within it. The issue is further exacerbated by increased livestock access from this area onwards, downstream. Horse access to both banks, apparently via the LB, and associated heavy grazing is inhibiting anything but a sparse covering of grass from becoming established and significantly contributing to bank erosion (Fig. 30). In the same field there is also a very poorly located outfall that is likely to result in erosion and may also be supplying silt laden water to the river (Fig. 31).

Figure 29. Wider, shallower channel downstream of the high banked, incised section. Gravels are present in this area but are significantly compromised by high sediment loading.

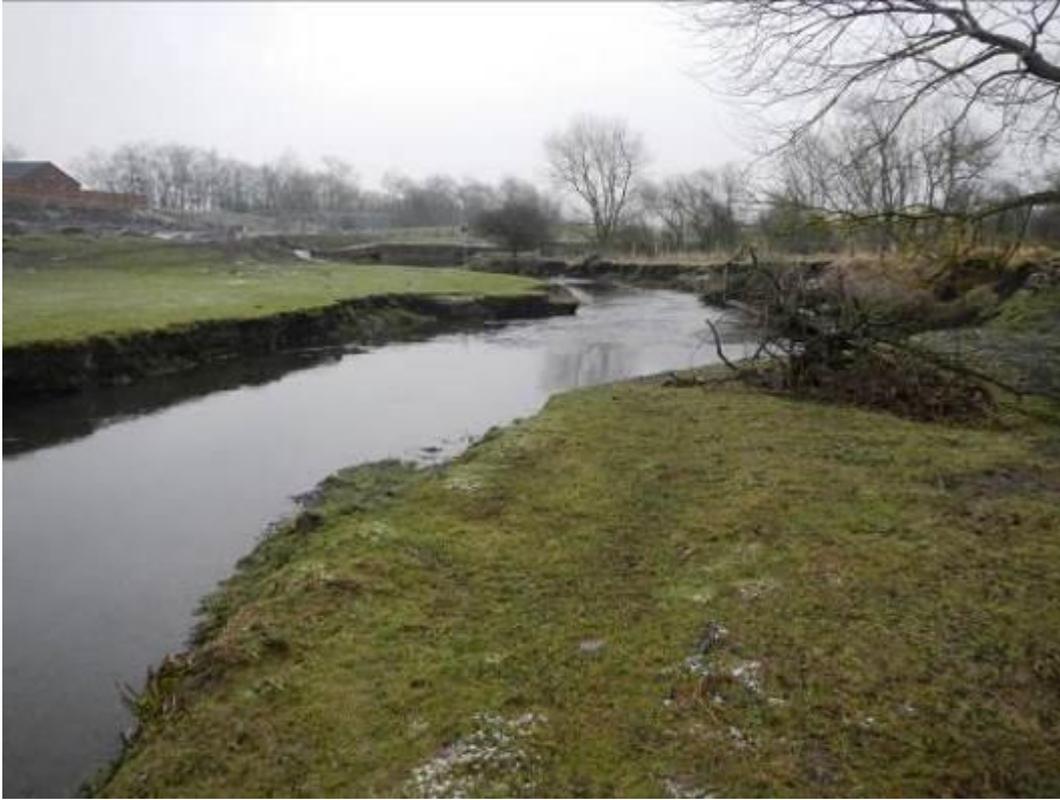
Figure 30. Significant bank erosion, primarily due to horse grazing.

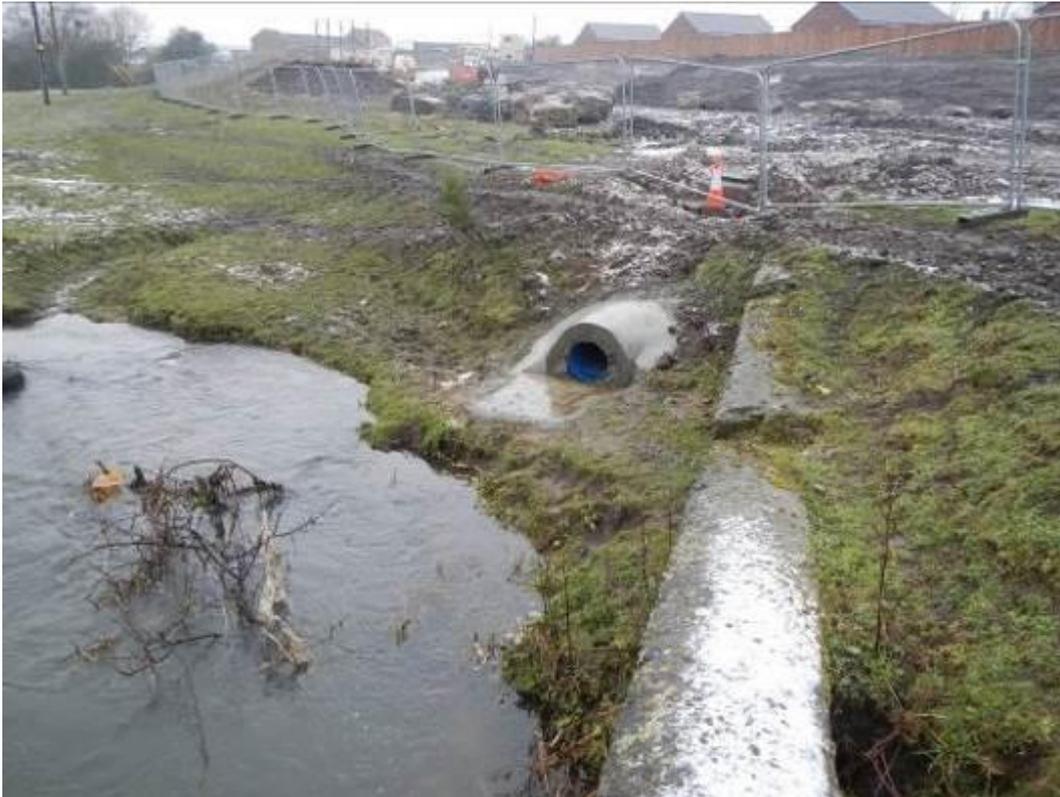
Figure 31. Poorly located outfall.

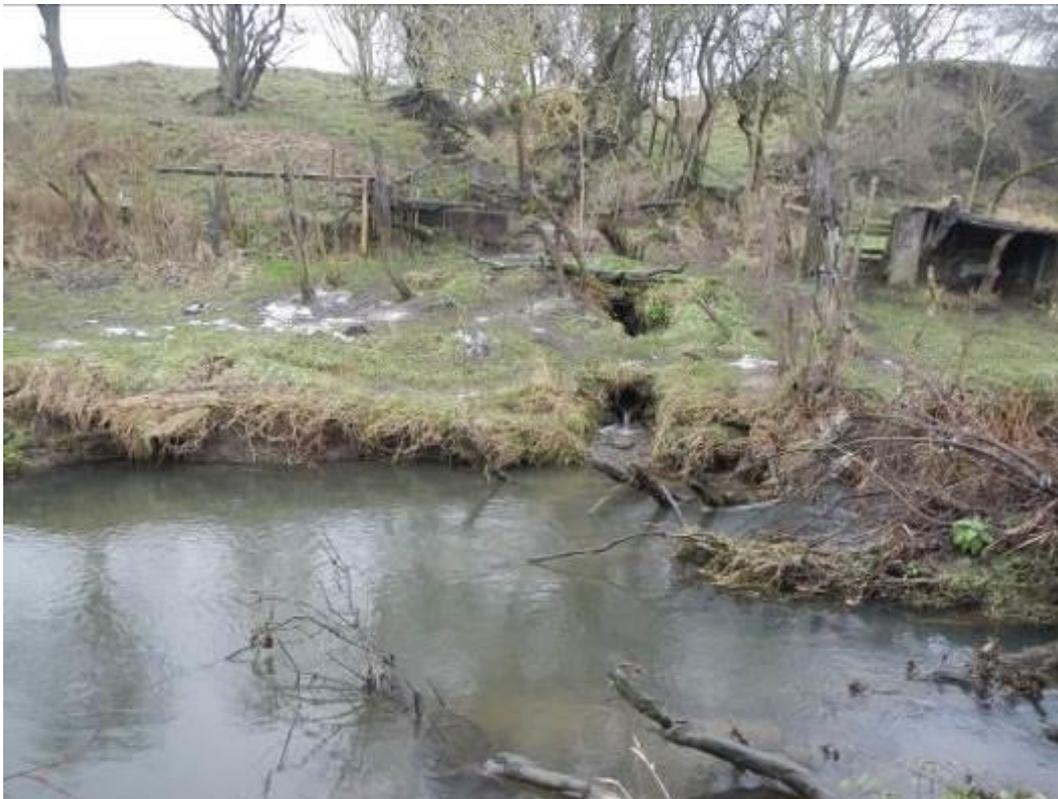
On the right bank, where another field drain discharges to the river, grazing and poaching result in another sediment input to the river (Fig. 32). The presence of good marginal cover and in-channel structure provided by trees does, however, provide some aspects of good adult trout (*Salmo trutta*) habitat (Figs. 32 & 33).

Figure 32. Field drain sediment source in an area with good in-channel structure. The bed is, however, smothered with a significant sediment burden.

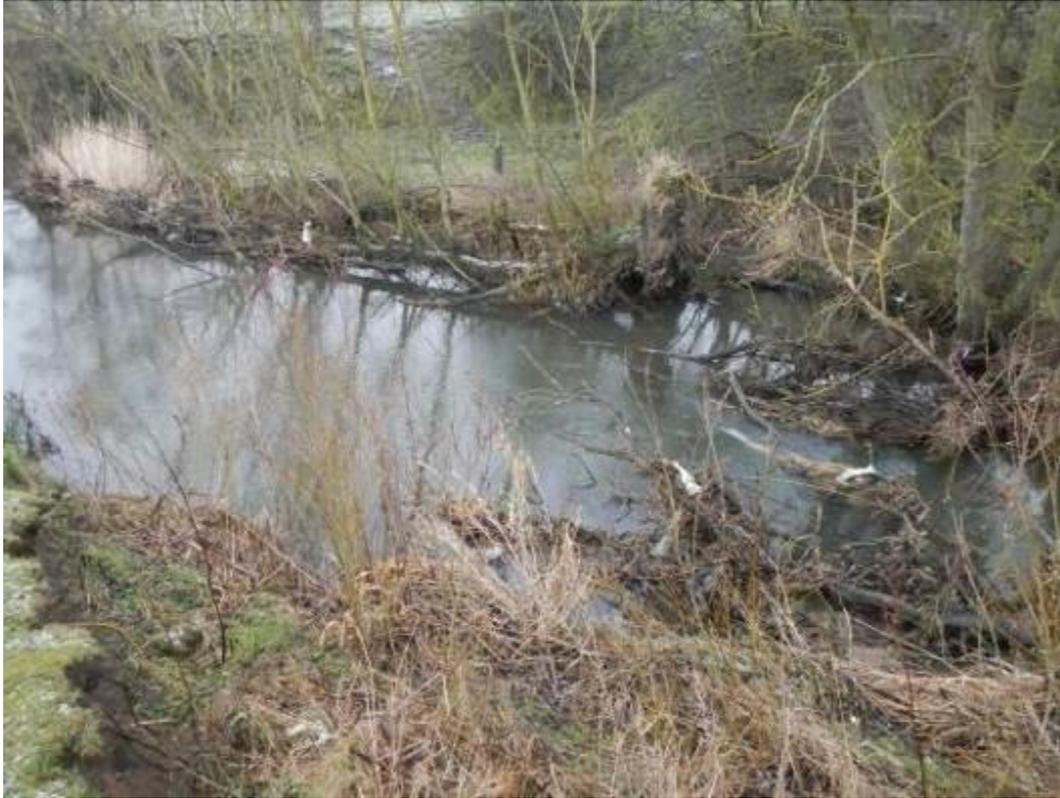
Figure 33. High quality pool and in-channel structure habitat in an otherwise degraded river section.

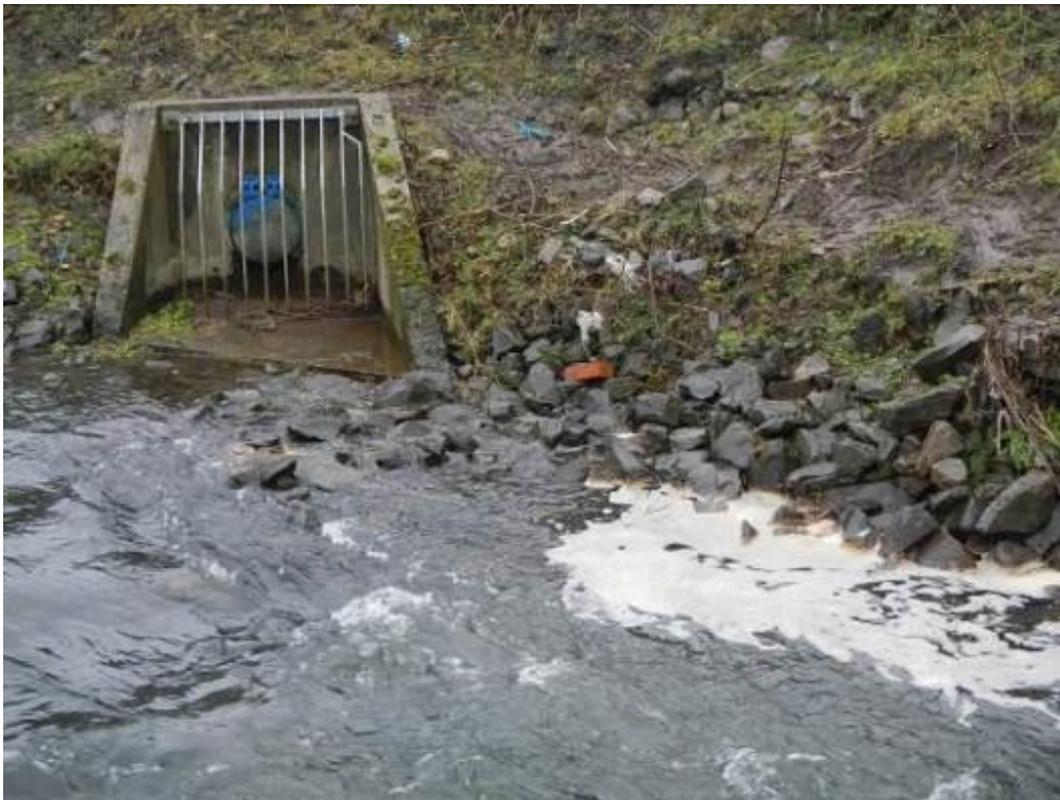
Further downstream, discoloured water and foam associated with a flap valve outfall suggest another potential pollution source (Fig. 34), although the exact content and therefore impact could not be ascertained.

Figure 34. Potential pollution and likely sediment source.

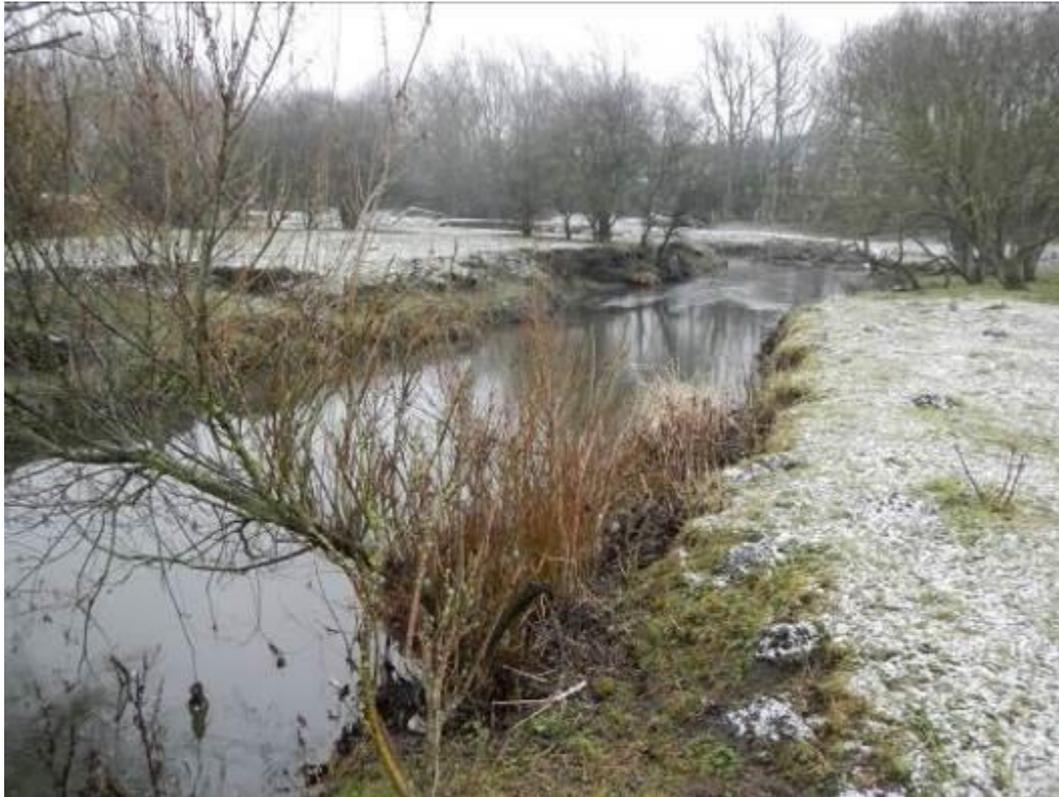
Excessive grazing remains a problem for the remainder of the river section walked, with an obvious impact on not only the pasture land but also the bankside trees, as evident by the heavily browsed willow branches (Fig. 35). Aside from the grazing issues and sedimentation, the actual river morphology through most of this section is of a relatively high quality, with pools, riffles and meanders (Fig. 36). However, the hydromorphology of the lower 350m is significantly impacted by realignment to a significantly straightened course (Figs. 37 & 38) and by being constrained within a geotextile lined and rock armoured channel.

Figure 35. Evidence of heavy grazing pressure, with horses having to resort to browsing the willows.

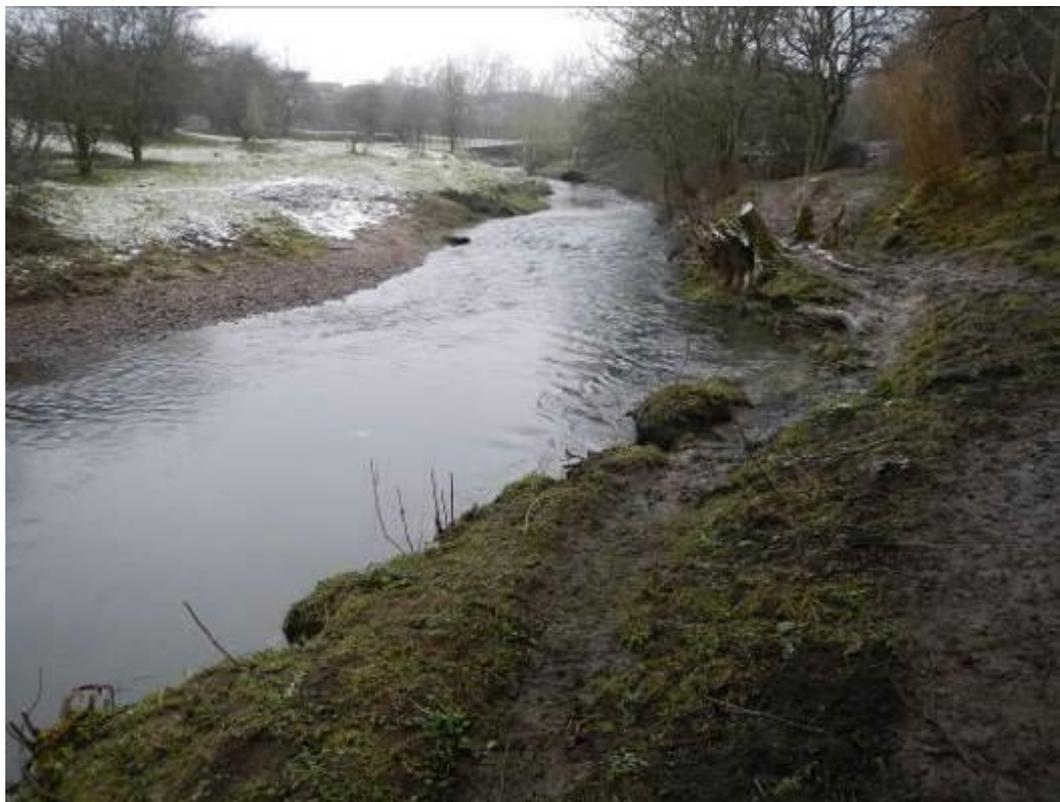
Figure 36. Area of relatively natural channel morphology, but still compromised by grazing/erosion.

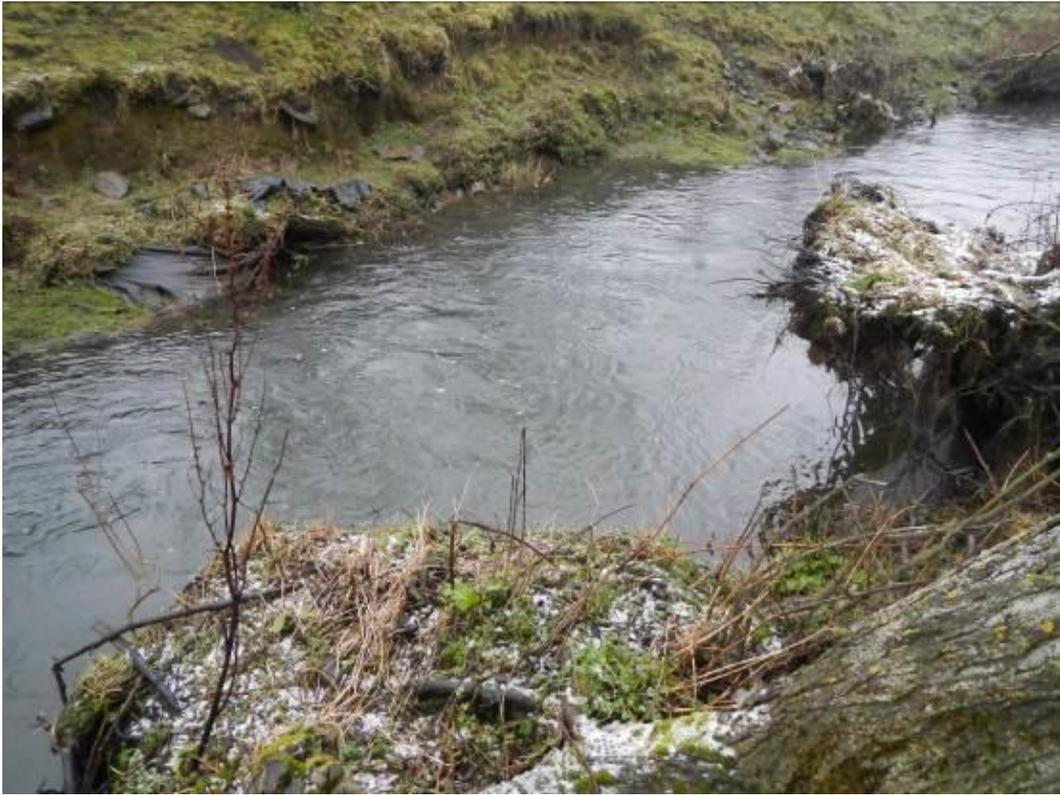
Figure 37. Signs of the past channel realignment, with the geotextile channel lining evident on both banks.

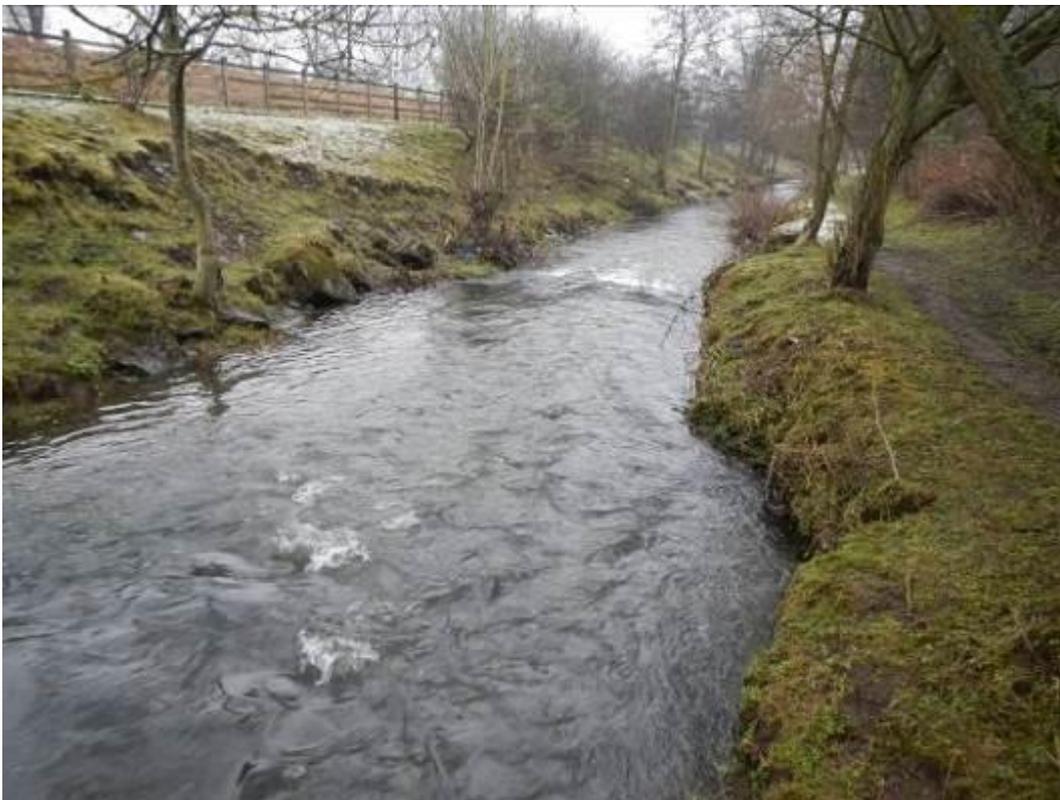
Figure 38. Straight uniform, armoured channel with little habitat diversity and coarse substrate.

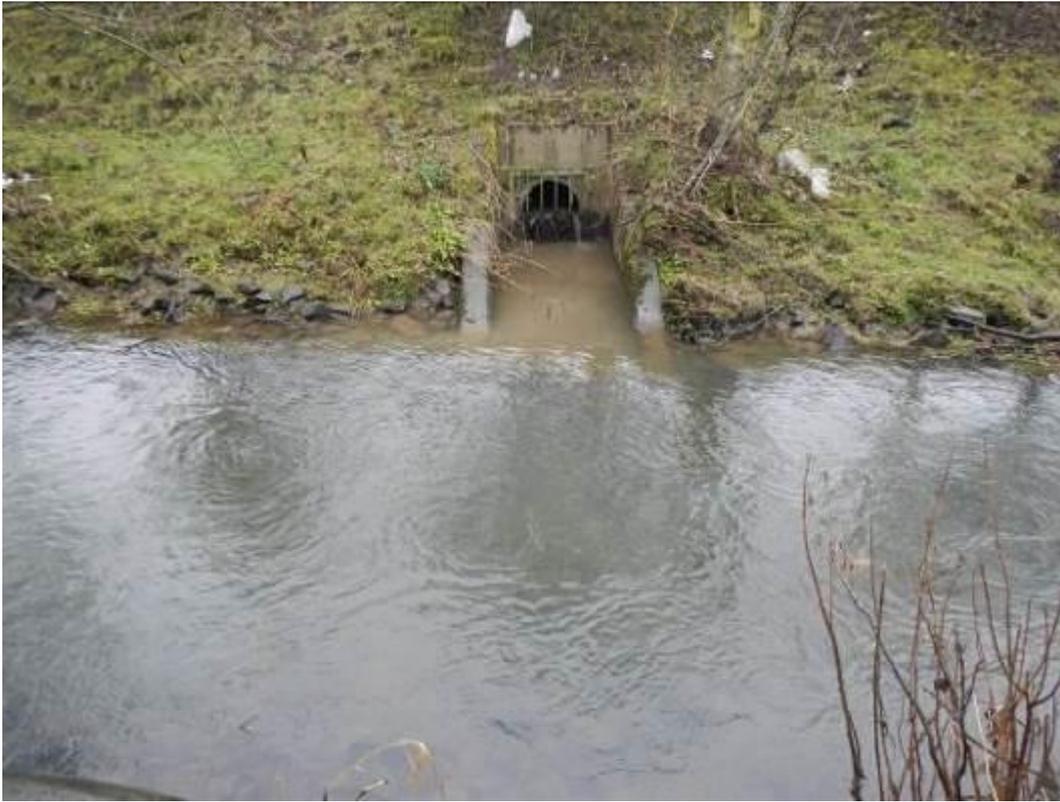
One more outfall enters the river through this straightened section and as with the others upstream, supplies sediment laden water (Fig. 39). Owing to the location of the outfall, alongside the A68, the outfall may be from a road drain.

Figure 39. The farthest downstream outfall, which delivers yet more sediment to the Gaunless.
