River Meon – Titchfield

An Advisory Visit by the Wild Trout Trust, June 2017

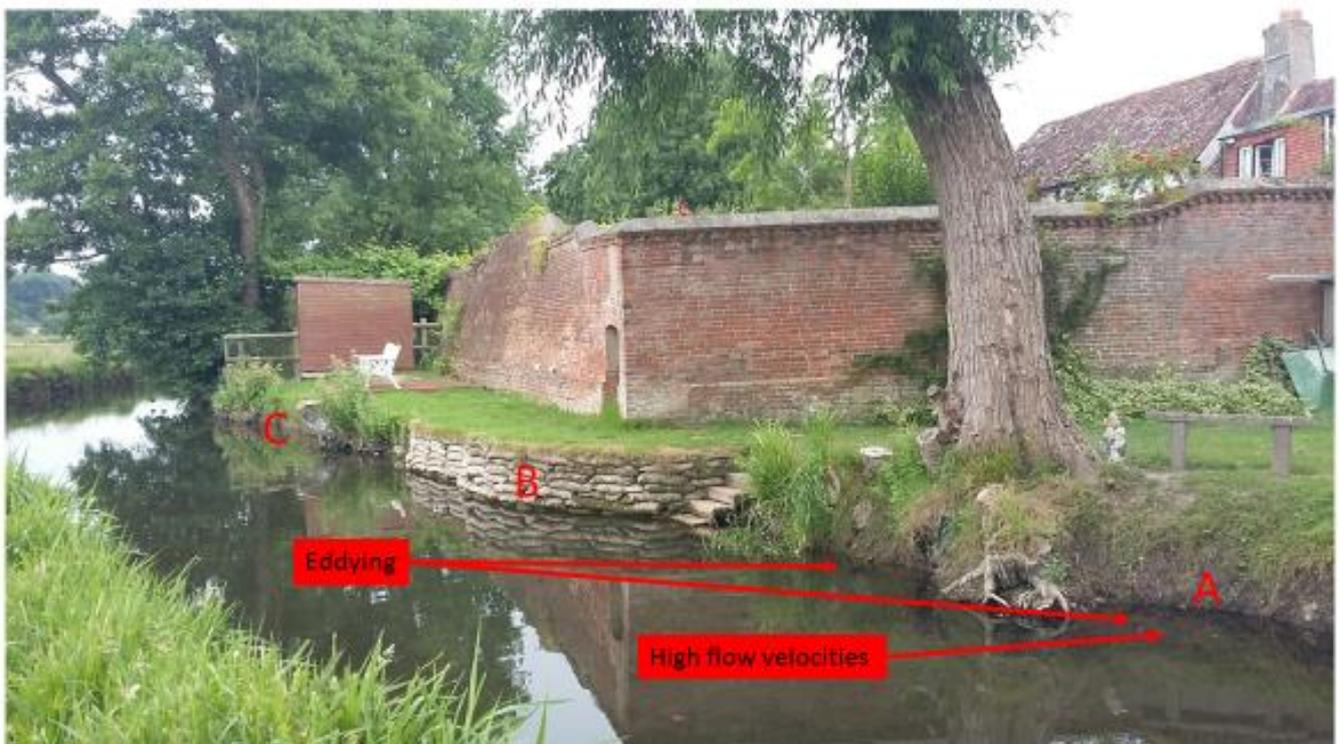
Following the inspection of the banks at both properties, it would appear that the banks adjacent to the upstream property (photo 1) are potentially more at risk from a block bank failure than the banks adjacent to the downstream property. This is simply because the bank here is on the outside tail of a sweeping bend. Potentially, any high flow velocities will sweep down the outside of the bend adjacent to the well defended (tree lined) bank next to the Fisherman's Rest car park before barreling into the vertical bank upstream of the large willow tree (marked A).

Photo 1 Bank adjacent to the upstream property

The large willow tree will undoubtedly have a network of strong roots that will help to bind the bank together. This extensive root system is providing bank

protection in the vulnerable area marked A. It will be important to keep this tree healthy to maintain optimum bank protection. Crack and white willow have a tendency to split and fall, rather than upending with root plate attached. Pollarding tall trees to take the weight of the top of the tree will often increase the lifespan of large willow trees, however expert arboriculture advice is required before contemplating any work.

Without an extensive root system, the bank marked A would be extremely vulnerable due to its vertical configuration and undefended top soils (managed lawn). Ordinary lawn grass is very shallow rooted and does not provide any significant support for the top or face of the bank and therefore leaves the bank vulnerable to erosion. The vertical "cliff" face is also a hostile environment for any plants to grow and therefore there is no complex root matrix available to help bind the soils. Battering back the bank to a sloping angle would enable some planting to become established but would involve a loss of garden and leave the willow vulnerable. The best option here is to establish a new toe to the existing bank and plant up with energy-absorbing aquatic emergent plants. This is discussed further in the recommendations section.

The bag work bank protection highlighted at B in photo1 and also shown in photo 2 has obviously been installed to provide critically important protection for the ancient wall behind. This will undoubtedly protect the wall immediately behind the bag work from any bank failure but it will lead to increased erosion pressures on the downstream end of the bag work, where flow will eddy off the hard promontory created by the bag work and nibble away at any soft, vertical surfaces downstream.

Sections of the bank adjacent to the upstream property of Place House Cottages are vulnerable to failure due to a combination of the vertical nature of the bank face and the configuration of the bank in relation to the upstream bend. The short section of hard bagwork defences in the central section of the bank-line exacerbate the risks of bank erosion immediately downstream, especially where there is the possibility of voids developing where a dead tree root mass is rotting back. There was no evidence of a high density of vole burrows in this location although it must be accepted that burrowing animals will only make the bank weaker.

Effective protection against bank failure adjacent to the upstream property can be achieved by building out a new low-level toe to the existing bank. A narrow gutter of at least 150mm between any new bank toe and the existing bank toe must be retained to avoid blocking any low-level vole burrows, which would be illegal. The gutter can be plugged at the upstream end of the gutter in an area which is known to be absent of any vole burrows. This will help to avoid any heavy erosive flows from funneling down between the existing bank line and the inside line of any newly created bank toe.

The outline of the new bank toe should be constructed from two lines of soft revetment (300mm diameter faggot bundles secured behind driven untreated chestnut stakes) or coir rolls secured in the same manner, to form an envelope of approximately 1m in width. The approximate 400mm void between the two lines of revetment to be lined with a biodegradable geotextile, made from coir or jute and the pocket created filled with a gravel/soil mix to within a few centimeters of mean winter water level. It is essential to then plant up the new bank toe with a range of emergent aquatic plants. Sedge is highly recommended as a tough plant, that will not grow as tall as burr reed and has well-developed root systems. Photo 5 depicts the use of faggot revetment with new planting to create a new bank-line in front of a vertical brick lined bank on the River Meon at Meonstoke.

The new bank toe should be constructed to form a nice smooth arc around the existing bank and promontory and should be keyed back into the existing bank line just short of the adjacent tree lined sections that form the property boundaries. Creating any planted toe to the existing bank beneath existing tree shading will fail.

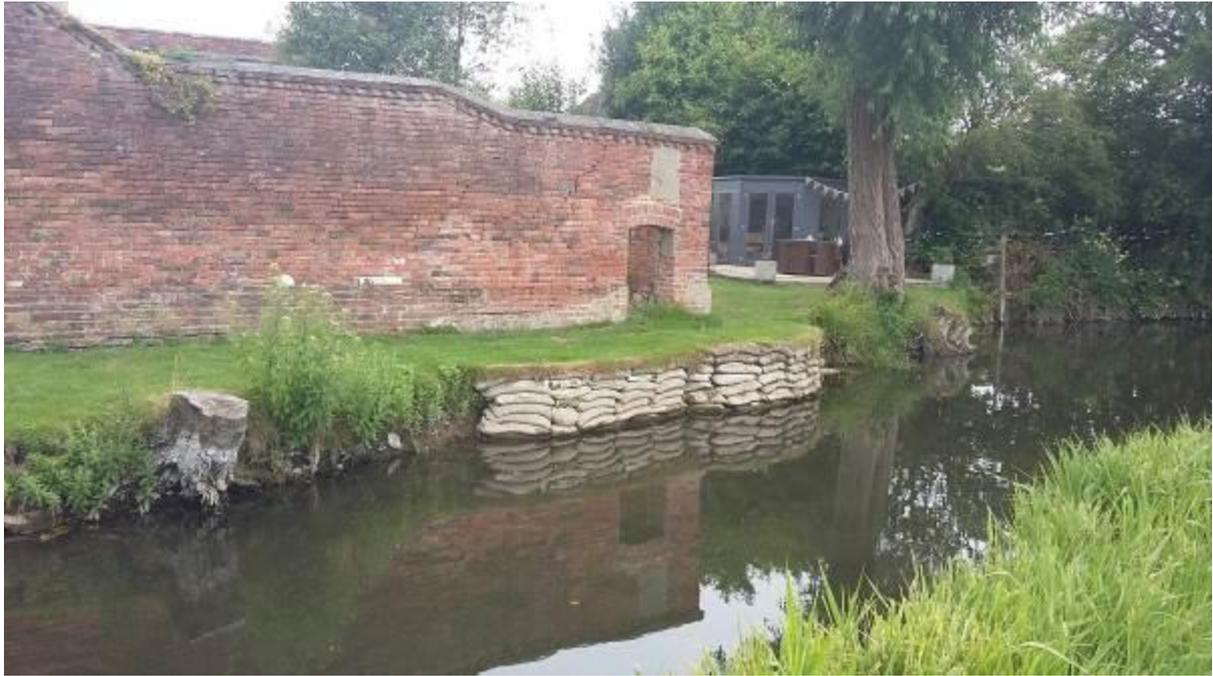
The dead tree stump (photo 2) located a short distance downstream of the bagwork is also of concern as the network of large roots will be slowly rotting away to leave substantial voids that would be far larger than any colony of voles could ever create. Again a new planted toe to the bank is required but should extend out from the apex of the bag work to run downstream in a smooth arc and knit back into the bank just downstream of where the shed is located. A smooth arc of energy absorbing aquatic emergent plants will help to avoid excessive flow eddying.

Photo 2. Highlighting the area of vulnerable bank immediately downstream of the bagwork.

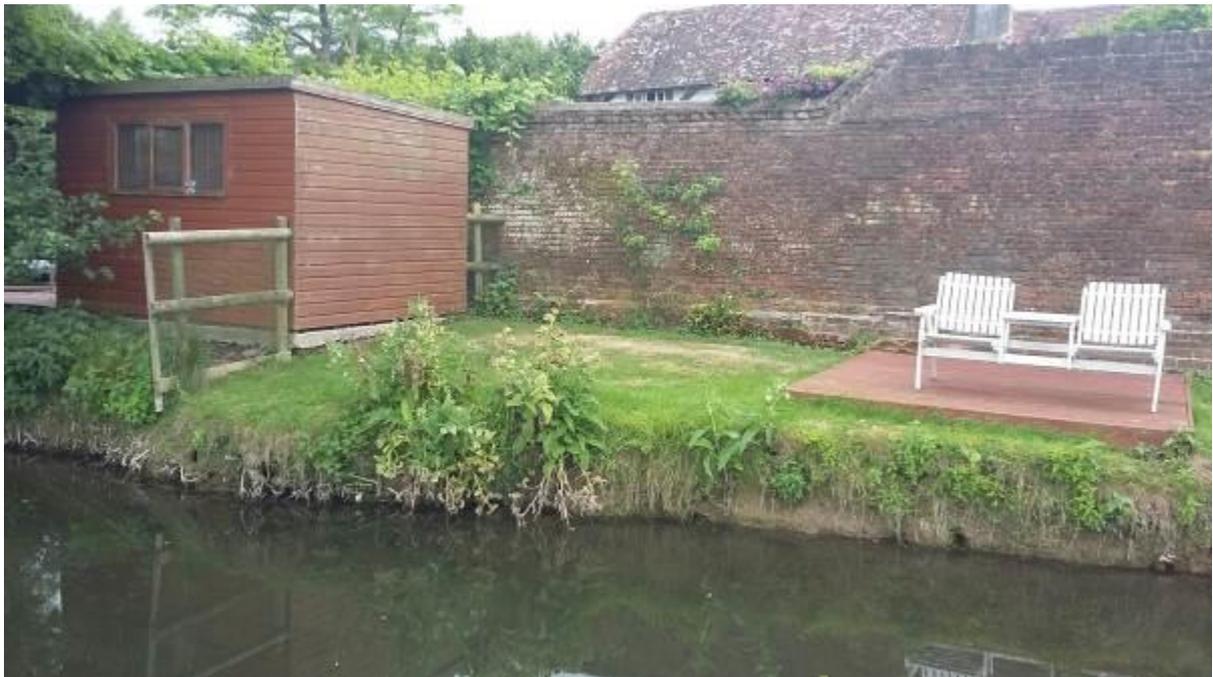
Photo 3. The vertical nature of the bank leaves it more susceptible to failure. Planting up a low, energy absorbing toe to the existing bank would create effective and attractive bank defences.

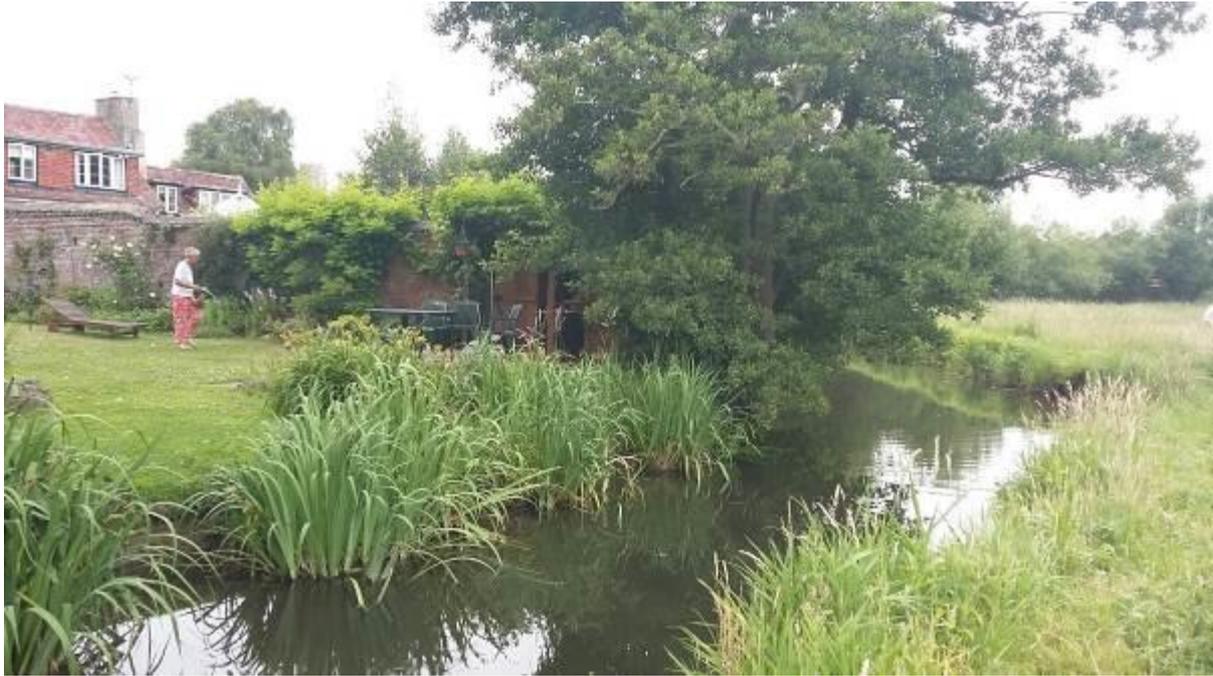
The bank adjacent to the downstream property (photo 3 and 4) is far less vulnerable to any bank failure because it is located on the downstream and inside of a slight right hand bend. As a result, the river will be the naturally depositing on this side of the channel.

Photo 3. The bank adjacent to the downstream property sits on the inside of the bend and is situated in a natural area of sediment deposition. River-related erosion is highly unlikely to occur in this location.

The section of bank located adjacent to the downstream property is highly unlikely to fail due to any river erosion pressures. Plugging the small gaps between existing clumps of emergent plants is all that is required to ensure full bank protection.

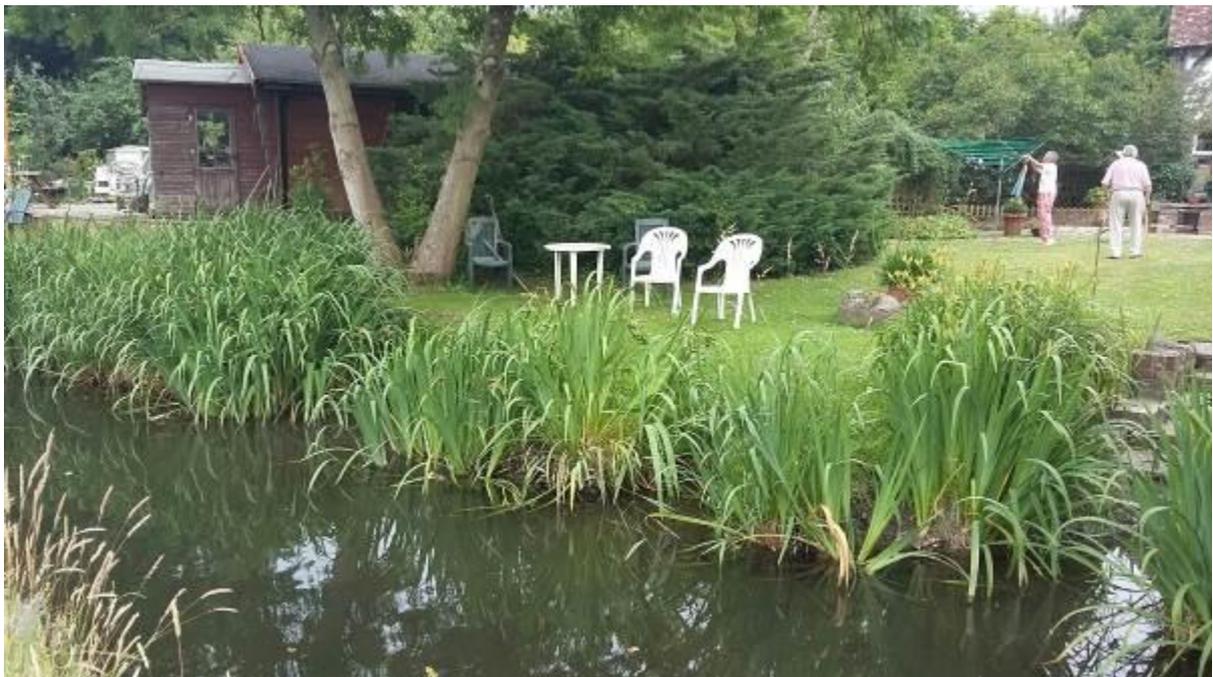
Gaps between the existing clumps of emergent burr reed may act as attractive thoroughfares for water fowl to exit and enter the river, potentially damaging soft banks and leaving them vulnerable to erosion. Burr reed (*Sparganium* spp.) dies back during the winter months and is not considered to be as durable as some species of emergent sedge (*Carex* spp.) for bank protection purposes.

Photo 4. undefended gaps in the stands of burr reed could be vulnerable to erosion via bank trampling by large water fowl.

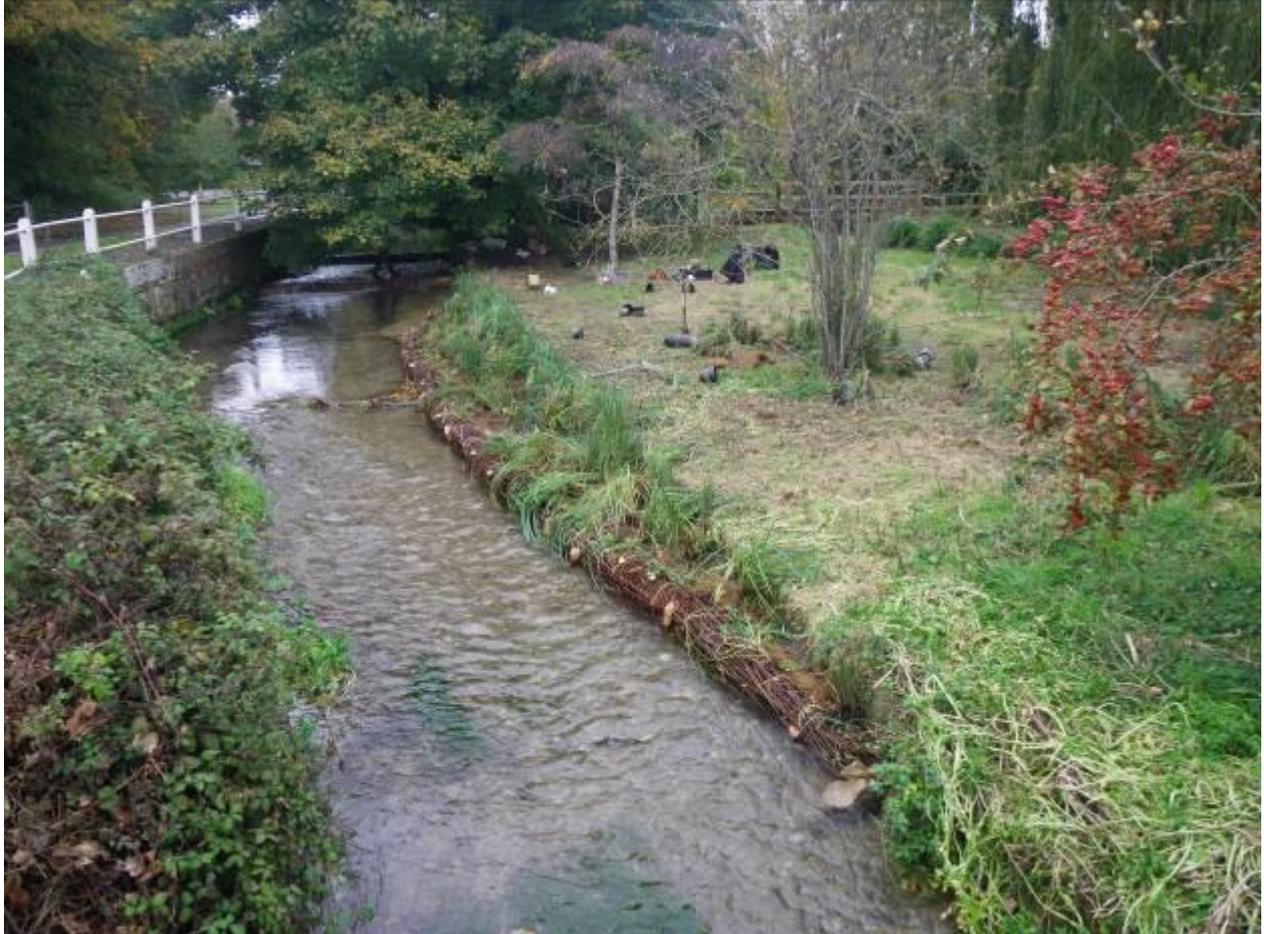
Photo 5. A new bank toe created using faggot bundles plus a gravel in-fill and planted with aquatic emergent plants. If properly constructed, a bank like this is hugely resilient and will protect the foundations of the existing hard wall (now obscured from view). The new toe also creates a valuable new habitat.
