Pont and Blyth Investigation
River Pont – from Fenwick Burn to Med Burn
(Waterbody ID - GB103022076840)
Date 19/12/11

1.0 Introduction

This report is the output of a site visit undertaken by Gareth Pedley of the Wild Trout Trust to the River Pont, on 19 December 2011. Comments in this report are based on observations on the day of the site visit.

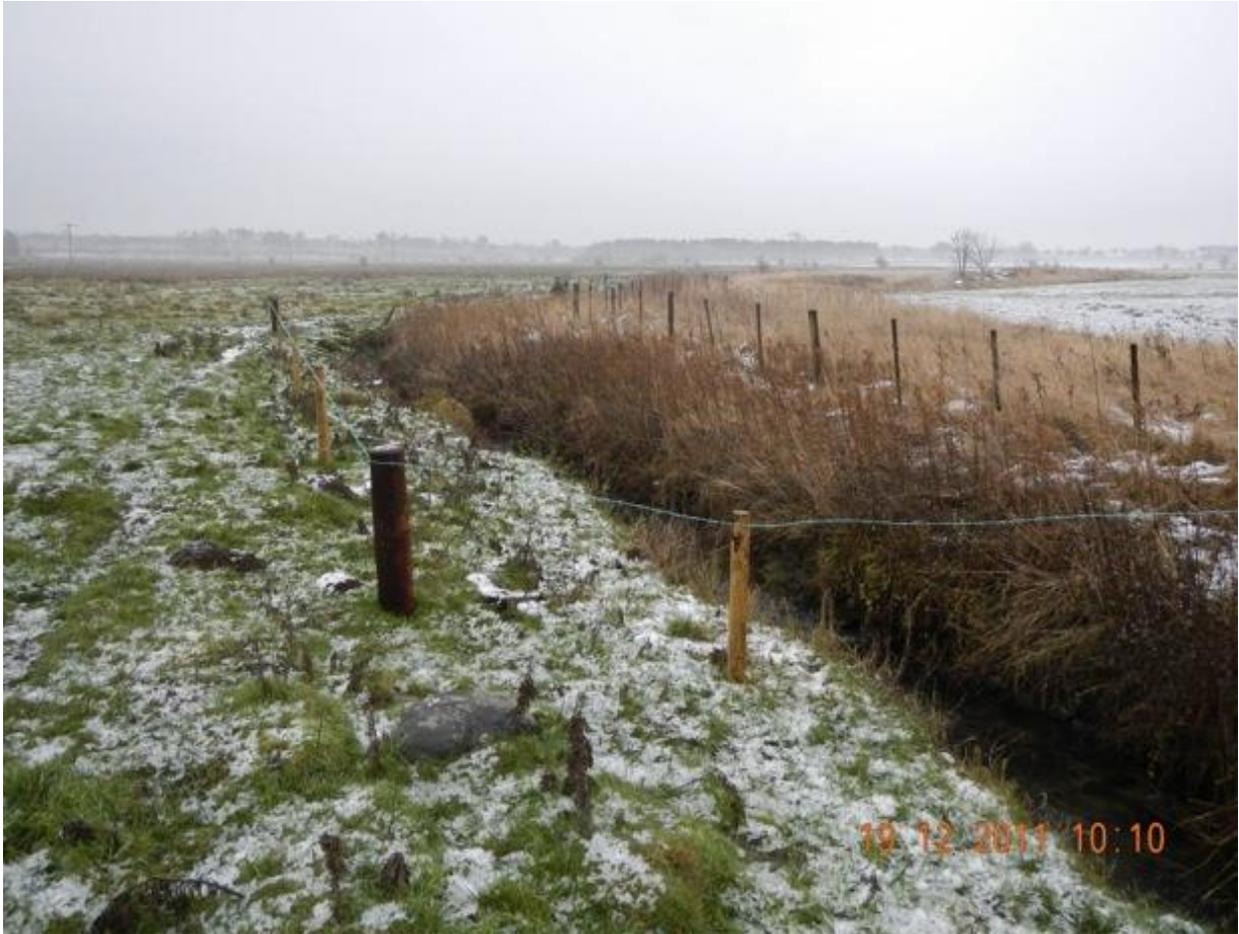
It was immediately apparent that the Fenwick Burn was subject to significant dredging and straightening which has left a uniform clay/earth channel with little natural stream bed material present. This greatly limits the potential of the tributary for spawning due to an absence of suitable substrate. The habitat of the Burn is also compromised for juvenile and adult trout by the uniformity of the channel and flow, and general lack of aerial cover.

The Burn was buffer fenced downstream of the bridge with single breast barbed wire that would prevent cattle access to the LHB in all but a drinking area (Picture 1). However the fence was not suitable to exclude sheep. Grazing in the field appears to have prevented beneficial riparian vegetation from becoming established (this may have occurred before the fence was erected). The RHB is protected by a buffer strip which separates it from arable land use.

Picture 1. Fenwick Burn. The channel is straightened and uniform, with little cover on the LHB. Some cover is provided on the RHB where livestock are excluded.

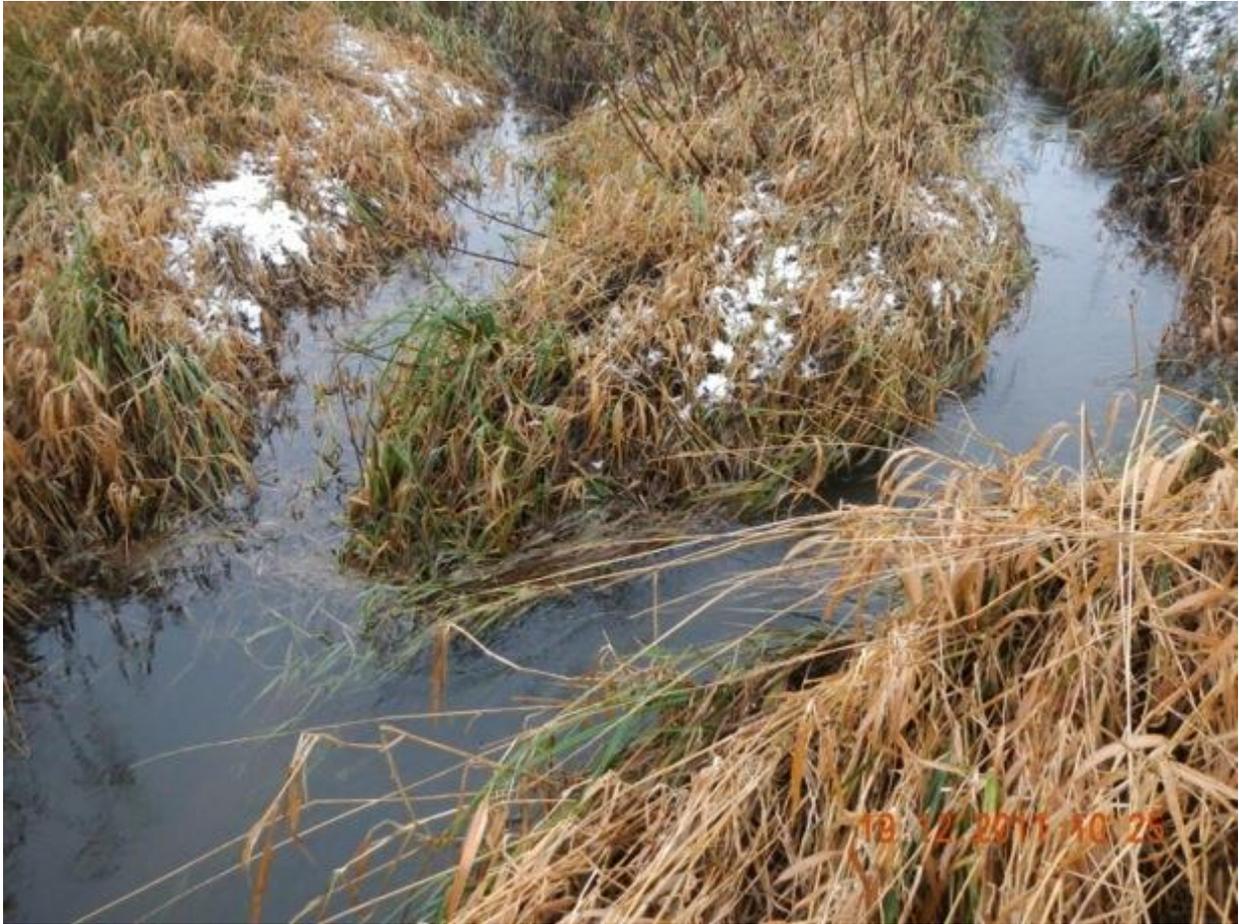
On the day of the walkover the Fenwick Burn appeared to be the main constituent of the waterbody, providing more water than either the upper River Pont or adjacent Burn. The size of the River Pont catchment and size of the river upstream would suggest that it should be the largest of the three. Abstraction is known to occur in the upstream waterbody on the Pont and with this in mind it is suggested that the level of abstraction and compensation flow be investigated.

Picture 2 (NZ0634372139). River Pont on the left. The main channel to the right is the Fenwick Burn, and the adjacent Burn enters on the right about half way up the picture.

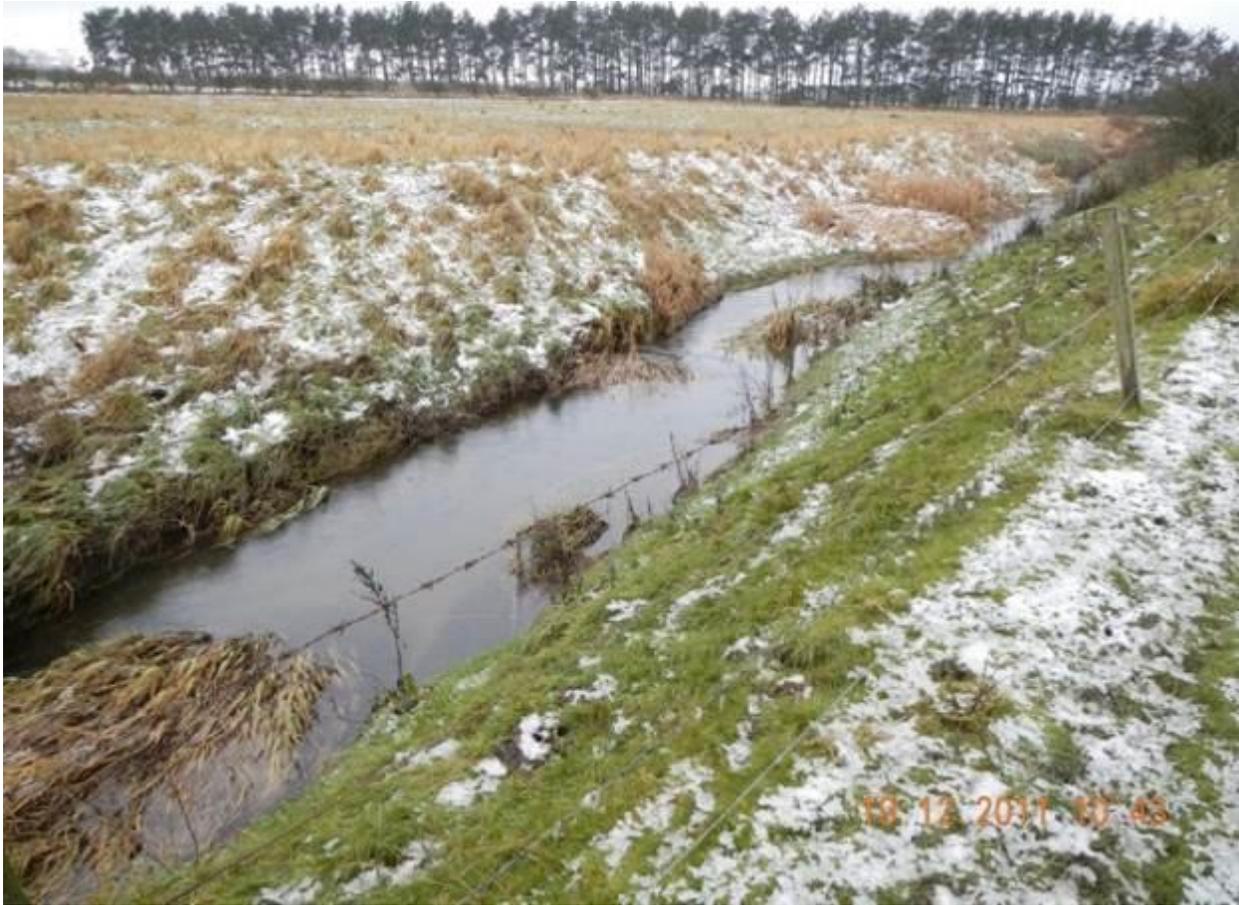
Where present, and maintained, buffer fencing offered protection to riparian vegetation. This vegetation provided cover and flow diversity, narrowing the channel to <1m and slightly increasing sinuosity within the straightened channel. In the narrowed sections bed material was relatively clean and although not suitable size for spawning should provide beneficial invertebrate habitat. In many areas the buffer fence had fallen into disrepair (Picture 3) and was not completely stock-proof limiting the protection it provided. The section would greatly benefit from maintenance of the fence to exclude stock fully and allow further establishment of riparian vegetation.

Picture 3. Increased channel sinuosity from encroaching marginal vegetation within buffer fenced areas (NZ0680972227). Fence in need of repair to allow vegetation to establish as on far bank.

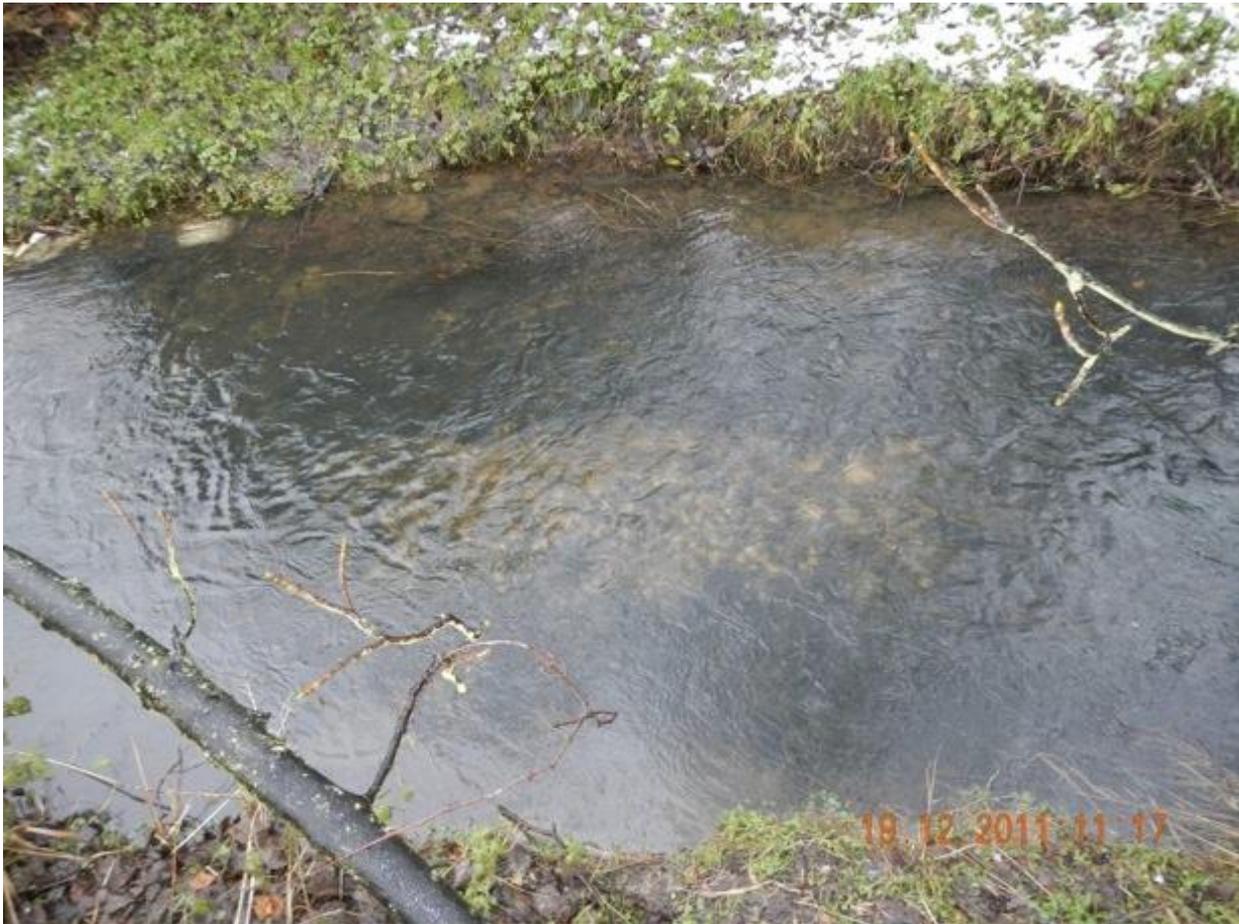
Shallower riffle sections through the village were the first areas where healthy *Ranunculus* beds were observed within the waterbody and where habitat and substrate were suitable, trout had attempted to spawn. There was evidence of several attempted redds and one definite redd of a size that would suggest sea trout spawning (approx 100cm).

Picture 4. Large trout spawning redd in Stamfordham (NZ0787371883).

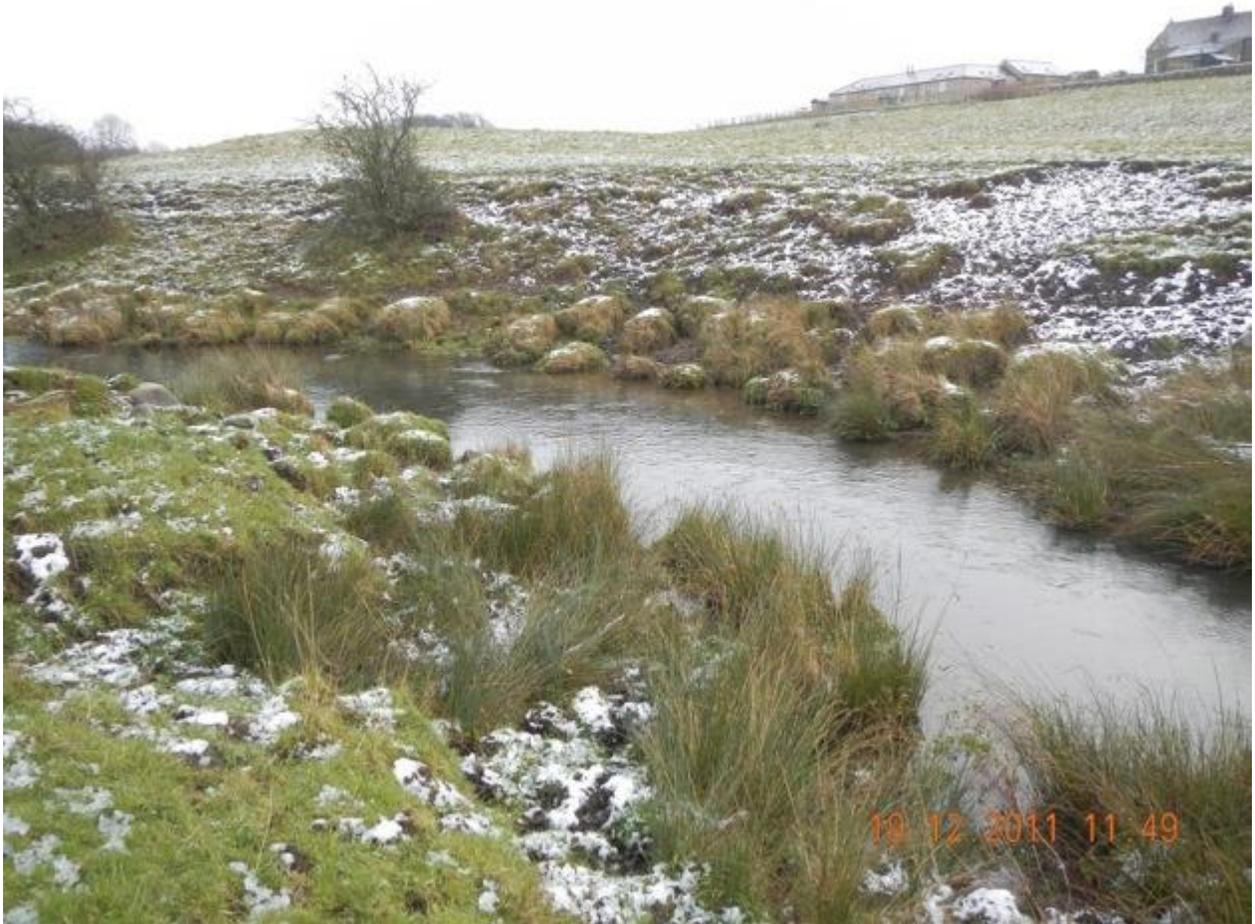
From the gauging station down, the LHB was heavily grazed, providing little habitat and a potential sediment source to the river. The RHB had a healthy buffer fenced strip and stable bank. This situation, as with the dredging, extends downstream through the section to a point below the Stamfordham sewage works outlet. From here down, both banks suffer from over grazing but there is a notable bend where a reduction in dredging means that habitat could be greatly improved (Picture 5). Buffer fencing would be beneficial wherever stock has access to the river but through this section the lack of dredging and suitable natural bed characteristics may allow spawning and juvenile habitat to establish if both banks are fenced. This would allow the channel to naturalise through marginal encroachment that would provide cover and increase velocity.

Picture 5. Potential for significant habitat improvement through buffer fencing (NZ0851171780).

With the inclusion of fencing, several areas identified in the report could possibly improve naturally to a state where they provide spawning and juvenile habitat (Pictures 5, 12, 15 and 19) and remediate the river towards good status.

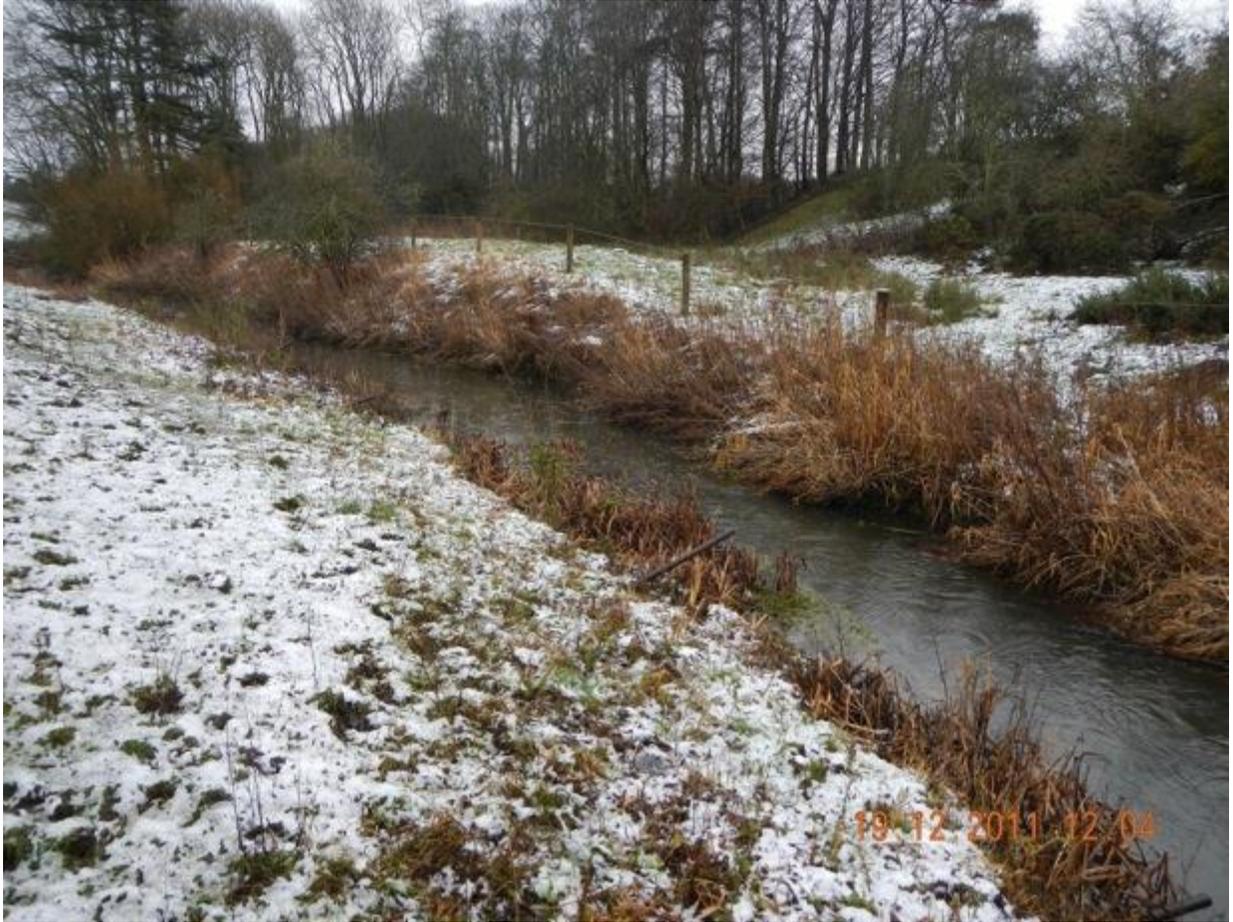
Further downstream the channel is again dredged and exhibits the same issues described on upstream sections. Similarly, where livestock have been excluded marginal vegetation encroachment and the associated natural channel narrowing have benefitted the river but there is little of the natural gravel substrate present. The increased depth means that although the channel is relatively narrow (down to 1m in places), it is still mostly too uniform in width, with a lack of flow diversity and gradient. In this section another suspected area of channel realignment was also visible (Picture 6).

Picture 6. The course of the old channel can be seen as a low lying area on the right of the picture. Emergent species extending up the LHB also show how bed material has been dredged from the channel (NZ0874471674).

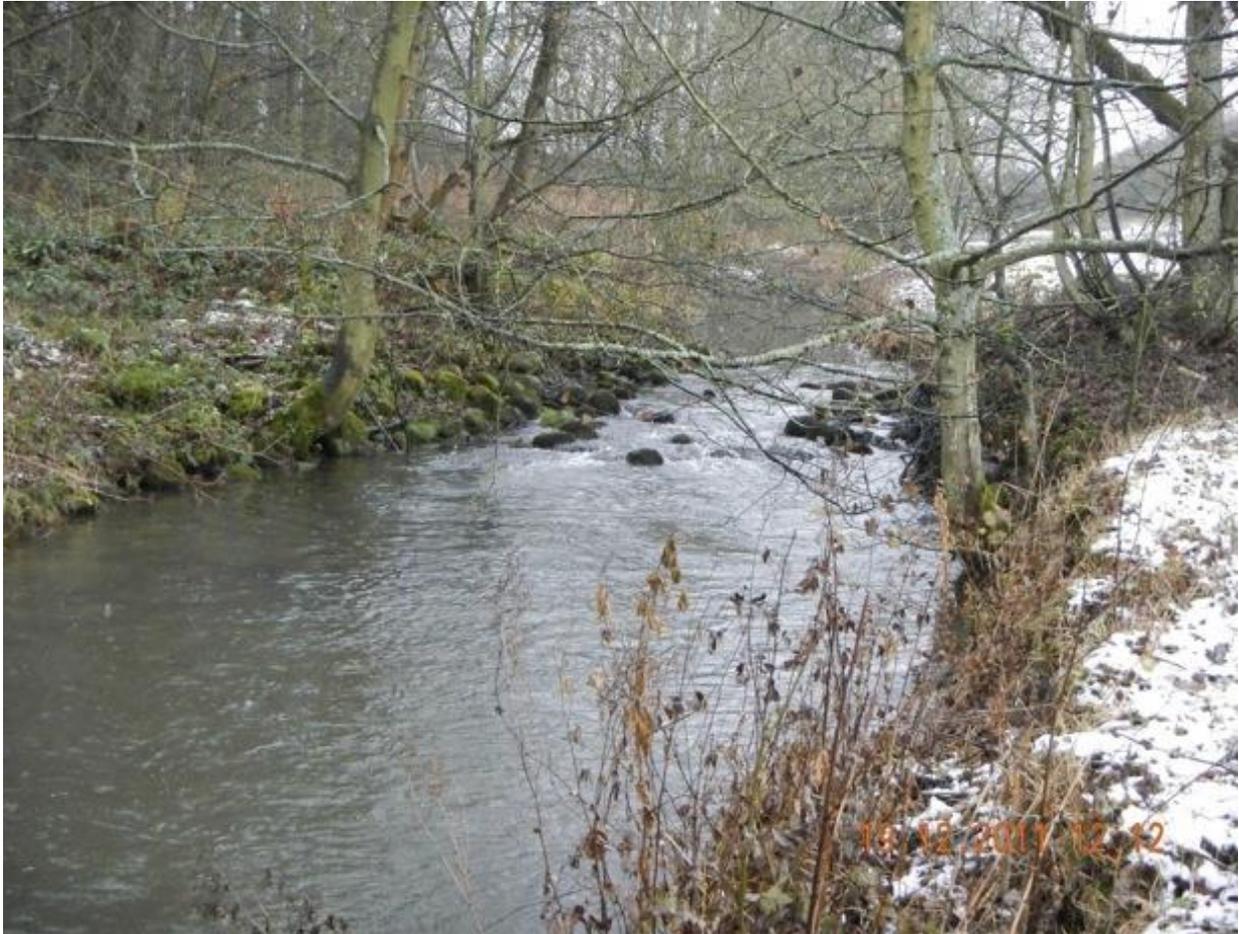
A short distance further downstream the first notable weir in the waterbody was encountered (picture 7). Contours in the adjacent field suggest that the purpose of the weir was originally to provide water to Mill House. This point also marks a change in the channel characteristic as from here down to the bottom of the section (Mill House Bridge) the bed is slightly improved exhibiting cobble and some gravel substrate.

Picture 7. Mill House weir, causing water to be impounded upstream (NZ0894771603).

The weir is in a dilapidated state and poses no real issue to fish passage; however, the impounded section upstream drowns the natural channel characteristics and compromises potential spawning habitat.

In most cases, removal of the middle third of each weir may be sufficient. This would retain a degree of channel narrowing, increasing scour and pool formation and improving habitat within the altered sections.

This remediation is of relevance to the weirs above Mill House Bridge (Pictures 7 & 17), and all weirs downstream of Mill House Bridge (Picture in Appendix A).

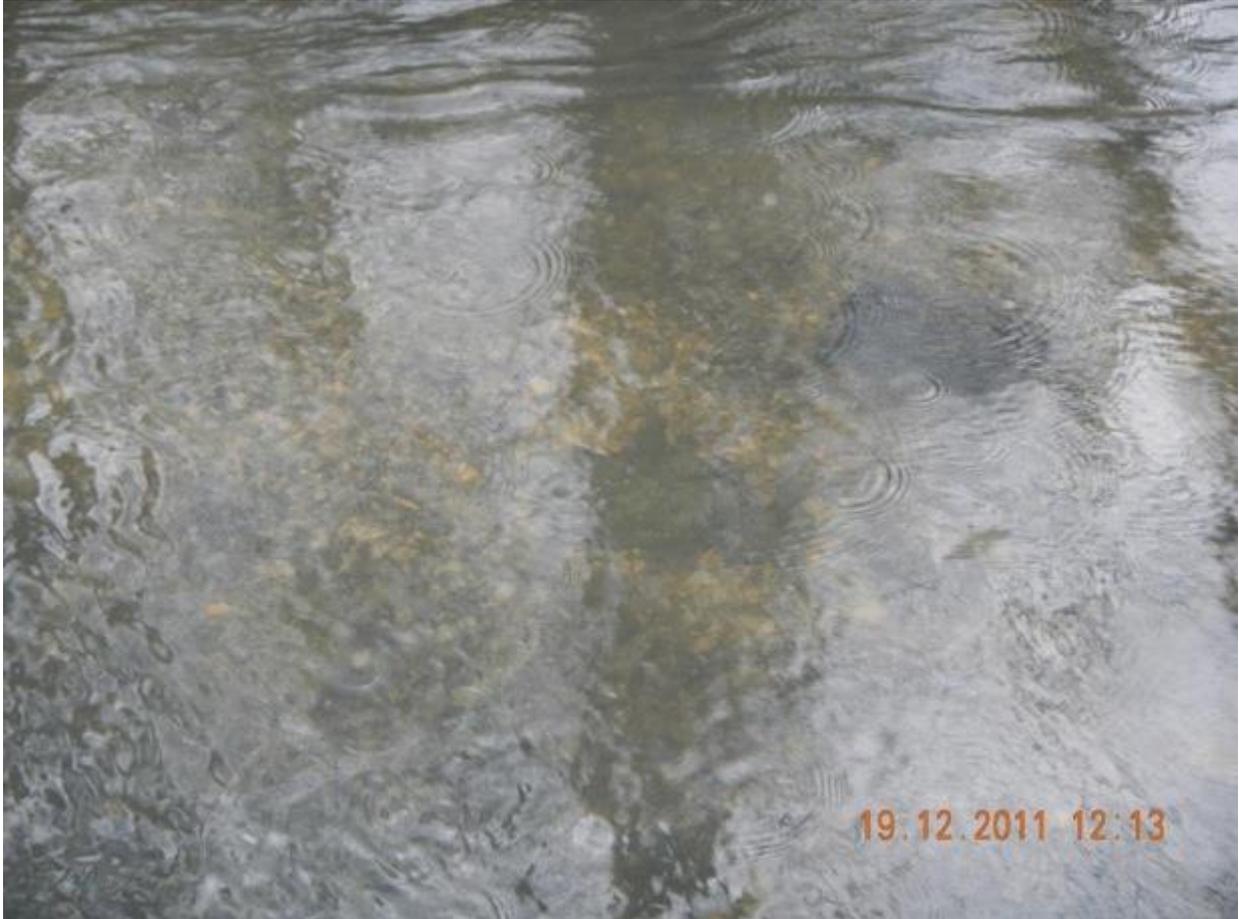
At the tail of Mill House weir pool, fish have attempted to cut redds but hit bedrock through the shallow gravel layer (picture 8). This highlights the scarcity of spawning habitat in the area and increases the importance of removing barriers that compromise the habitat that is available.

Picture 8. Attempted spawning redd just downstream of Mill House weir. The dark areas are bedrock.

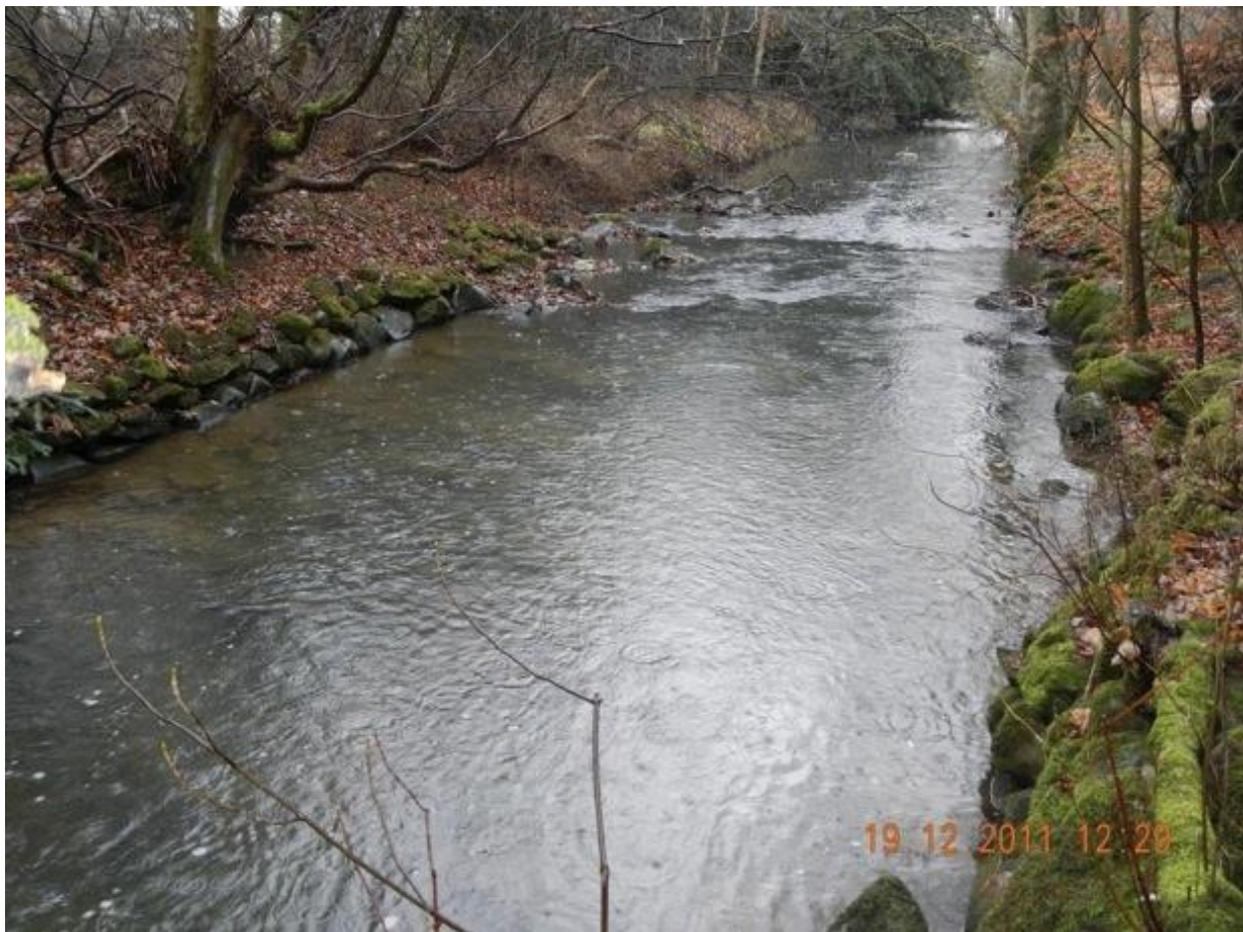
Below Mill House Bridge, the channel continues to be constrained and consequently remains straight for long sections, with a regular width of around 5-6 metres (Picture 9). This results in a lack of pools and gravel bars but the greater gradient and bed level in this area, the presence of natural bed material (boulder to gravel), and the more natural flow characteristics mean that habitat in this area is generally of a higher quality for salmonids. This is particularly true with regards to spawning and juvenile habitat supported by the observation that wherever suitable size range for trout spawning were present, redds had been attempted.

Picture 9. Straightened channel constrained by revetment (NZ0926171578).

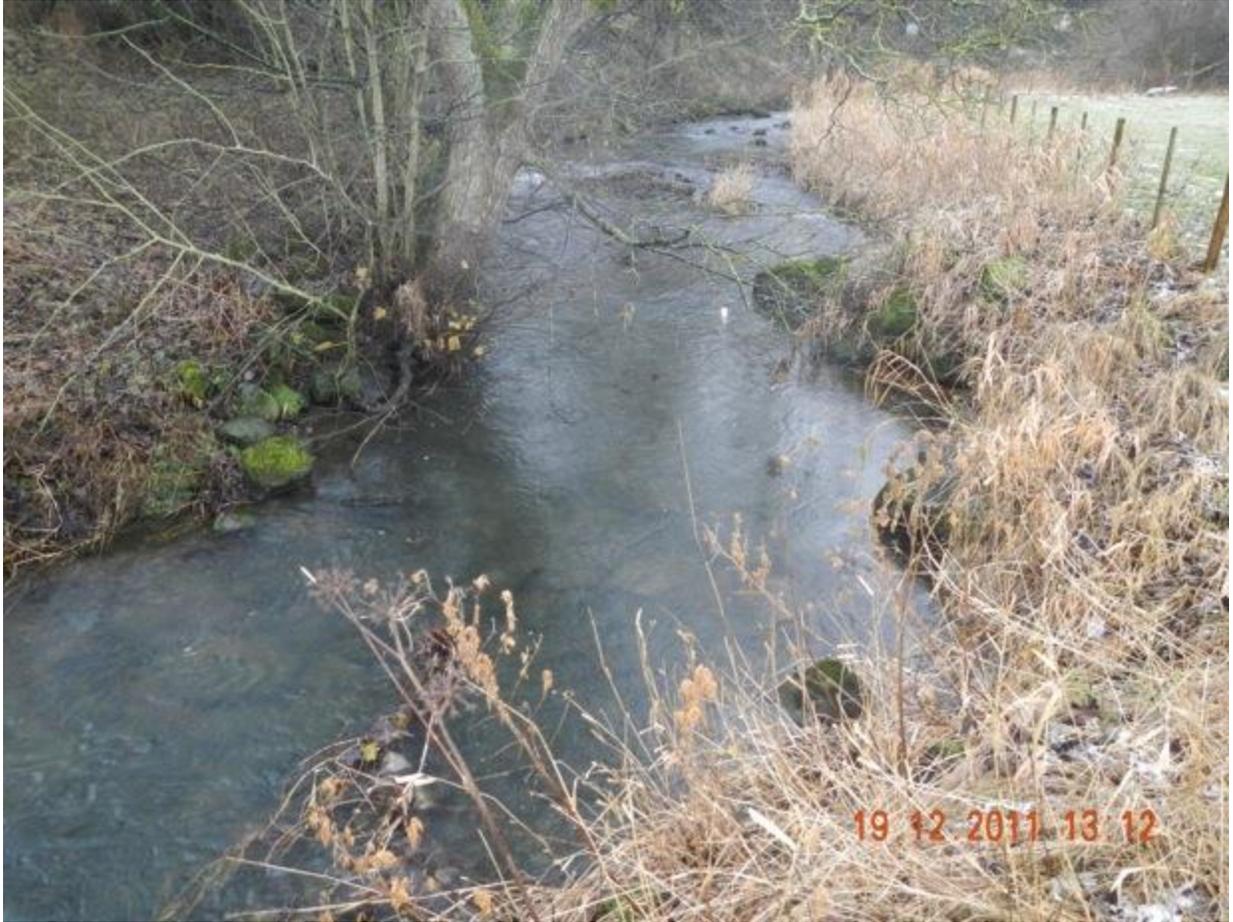
Most of the river bank through this section had stone revetment which had in places washed out. Constraining the river within stone walled channels is not conducive to good habitat, limiting the potential for the creation of natural channel features such undercut banks and overhanging cover. However, the walls had obviously been in place for a long time and the river has naturalised to an extent within the channel. The lack of dredging in most parts and natural gradient creates a reasonably healthy pool and riffle habitat (Picture 10).

Picture 10. Typical habitat for much of the section between Mill House Bridge and Dalton. The habitat is generally more natural, but with stone revetment in sections on both banks.

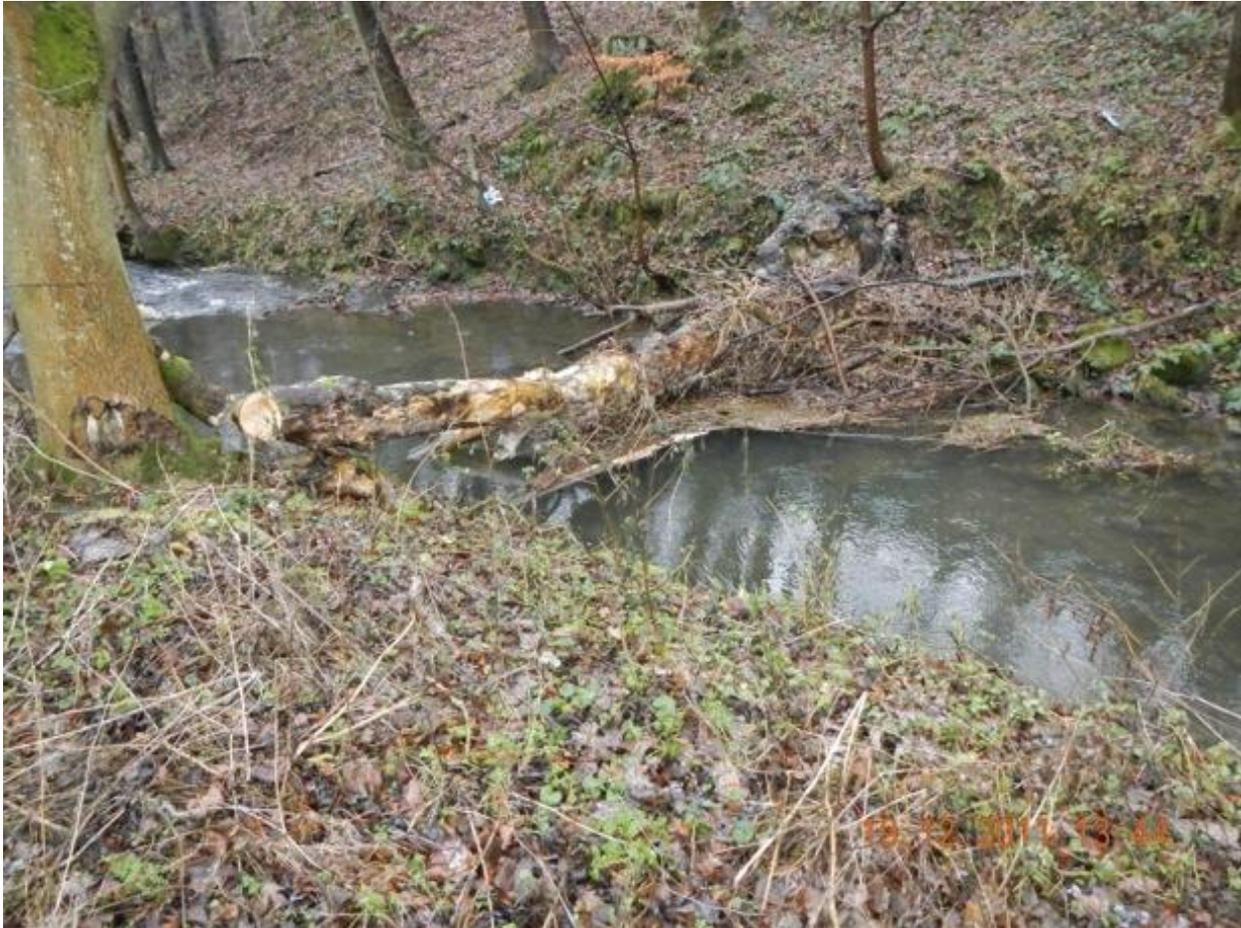
At the upstream edge of Dalton the river passes through a series of gardens where it is further constrained by high walls for approximately 200m. It then passes into deciduous woodland at which point several trout were observed, ranging from 15-25cm. They were congregated in a pool with good cover provided by woody debris within the channel (Picture 12). This demonstrates the value of woody debris-type habitat which can greatly improve the fish-holding capacity of a pool.

Unfortunately, the log providing the cover had been cut, presumably to allow it to wash out in a flood. The level of elevation of the houses above the river means that that the log is unlikely to have caused flooding and so it would have been beneficial to retain the structure for habitat.

Picture 12. Woody debris within the channel. This greatly improves the holding capacity of the pool but is likely to be lost in the next flood.

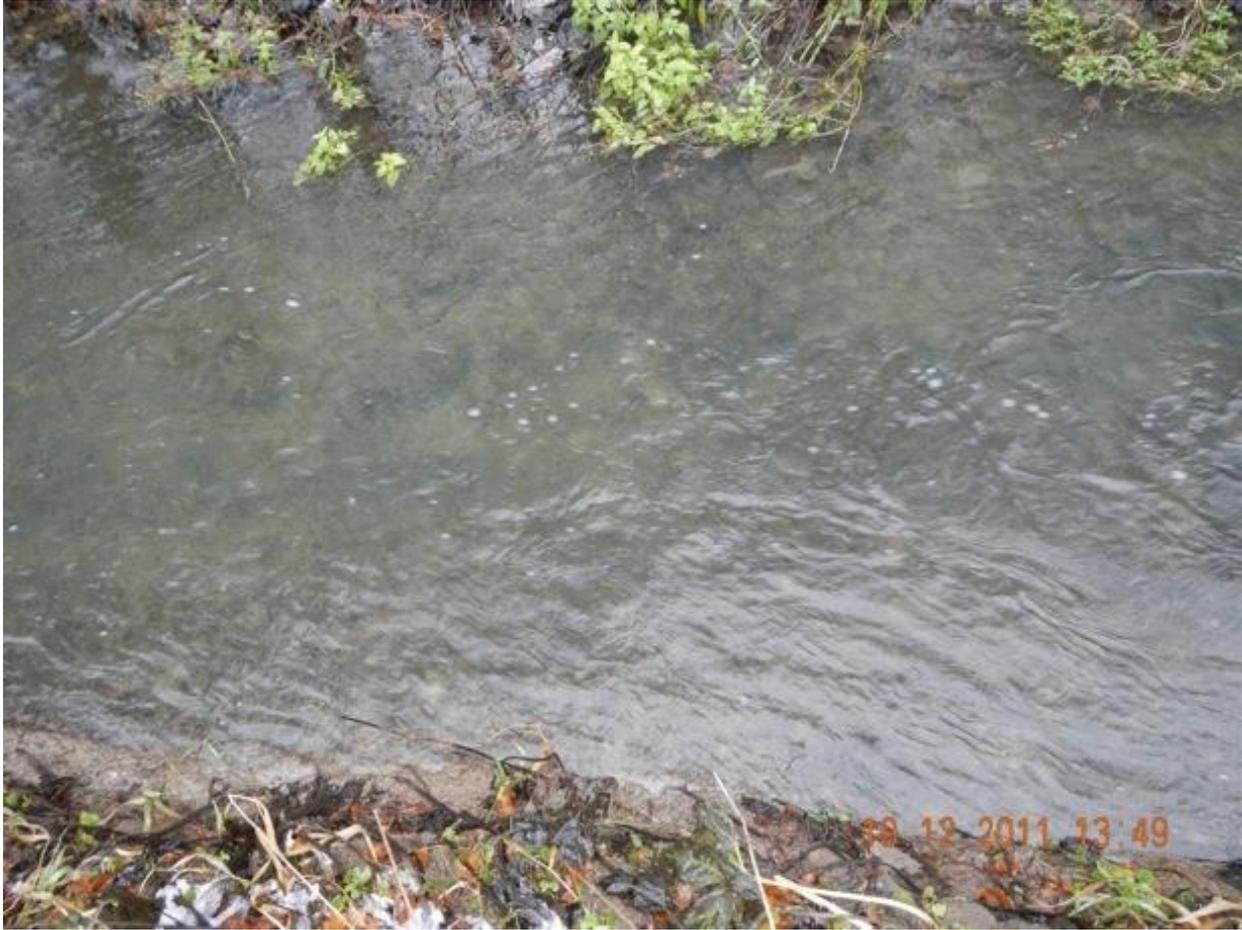
Shortly below this point the river bed became very grey with what appeared to be sewage fungus (Picture 11). This is usually associated with an elevated nutrient loading, possibly indicating chronic sewage pollution in the area. Correspondingly, no fish were observed for over 100m downstream.

Due to the rural location of the buildings it is quite possible that they are operating septic tanks. Leaking tanks are certainly a possible cause of the observed issues which should be investigated further.

Picture 11. Greyish coating on river bed (NZ1120671887), approximately 150m downstream of Mill Bank House.

As an initial measure the suspected pollution occurring around Dalton should be investigated. It is possible that this is an intermittent or low level chronic discharge so a detailed site investigation may be required. Diatom sampling in the area and samples of the grey coating on the bed would also be beneficial. This factor alone could be rendering a long section of the river unsuitable for aquatic life.

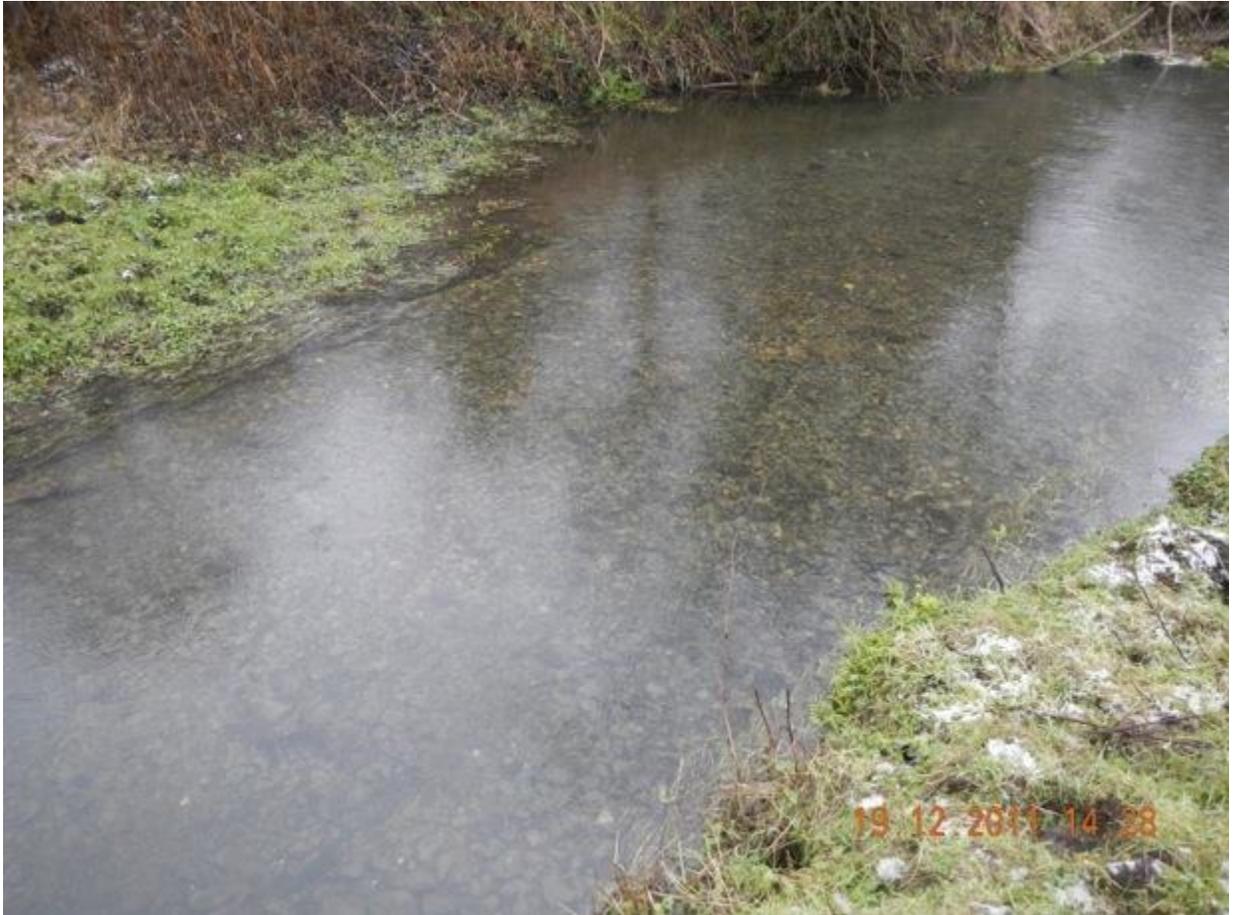
Much of the river bed from this point down to Eachwick Bridge exhibited a grey or brown coating, again suggesting excessive nutrient loading. Algal growth, even in the well tree lined areas, was elevated well above that observed in upstream sections, even when compared to areas with better light penetration through the canopy.

Picture 12. Gravel with uncharacteristic grey film still evident much further downstream (NZ1203371175). The substrate appeared to be suitable for spawning but had not been used, unlike similar gravel upstream. Buffer fencing in this area would allow natural vegetation encroachment into the channel increasing flow velocity and improving the habitat as a potential spawning area.

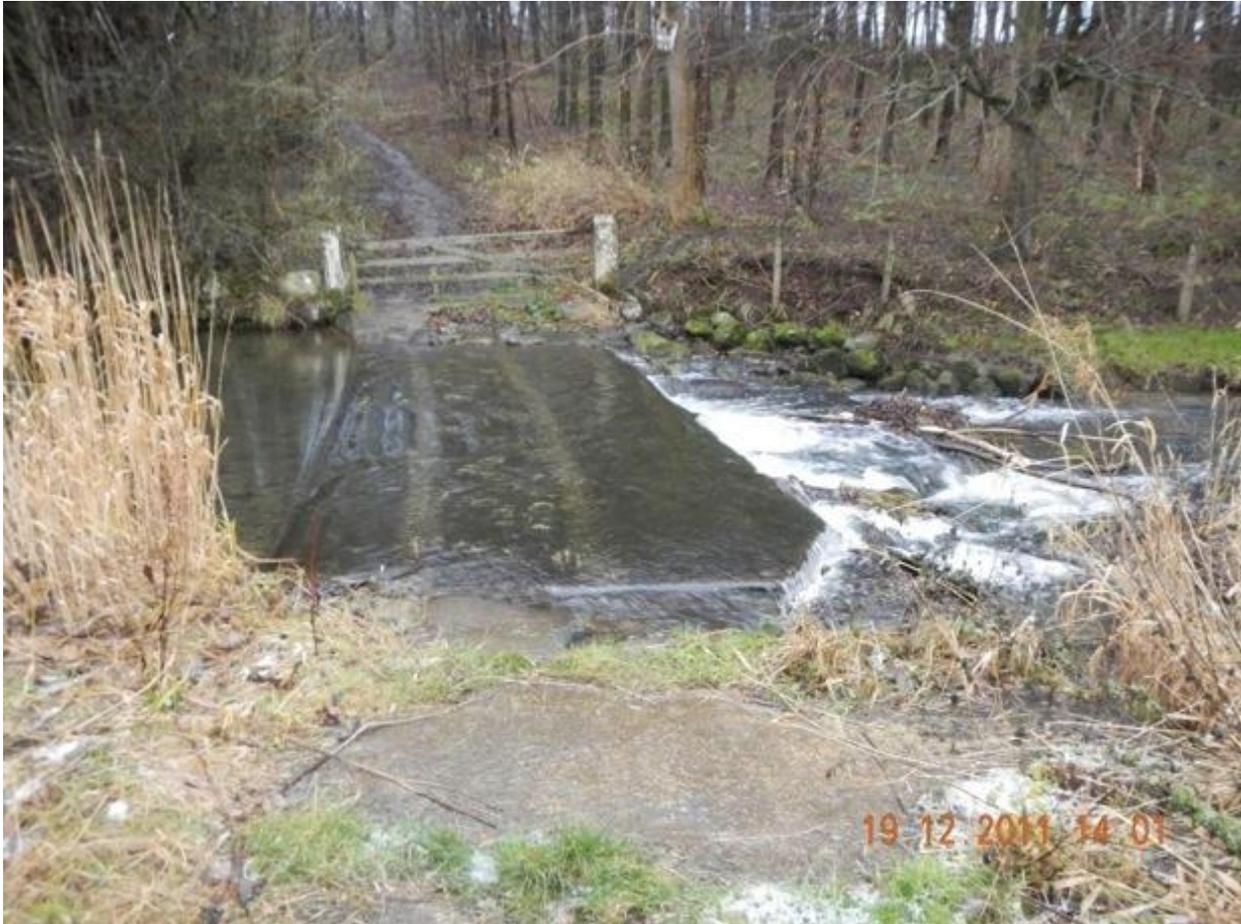
At the point where the river emerges from the wood an old concrete ford poses a barrier to fish migration (Picture 13). This is unlikely to pose an obstacle to larger fish in medium or higher flows, but is likely to limit fish passage at lower flows due to the shallow water depth and uniform the bed. This type of structure is also likely to be significant a barrier to juvenile fish, preventing their exploitation of upstream habitats. It was obvious from recent tyre tracks that the ford is still in use.

Picture 13. Concrete ford which poses a barrier to juvenile fish migration, and adult fish migration at low flows (NZ1148571797).

Excluding the weirs, which should be removed or notched as previously described, there was only one structure that posed an obstacle to fish passage. This was the ford in the Dalton to Eachwick Bridge reach, at NZ1148571797 (Picture 13). It was ascertained that the structure is still in use so removal is likely to be infeasible.

The optimal solution for this structure would be to create an additional rock ramp, graduating the ford bed down to the river bed level. If this incorporated a lower channel or pools, fish would be assisted, at least to the level of the ford. There would still be an issue caused by the shallow water over the ford but this would be a lesser obstacle than currently exists. Any measure to deepen water over the ford would render it less efficient and so are impractical, but a shallow notch through the ford bed could be beneficial in creating increased depth and would assist fish movement.

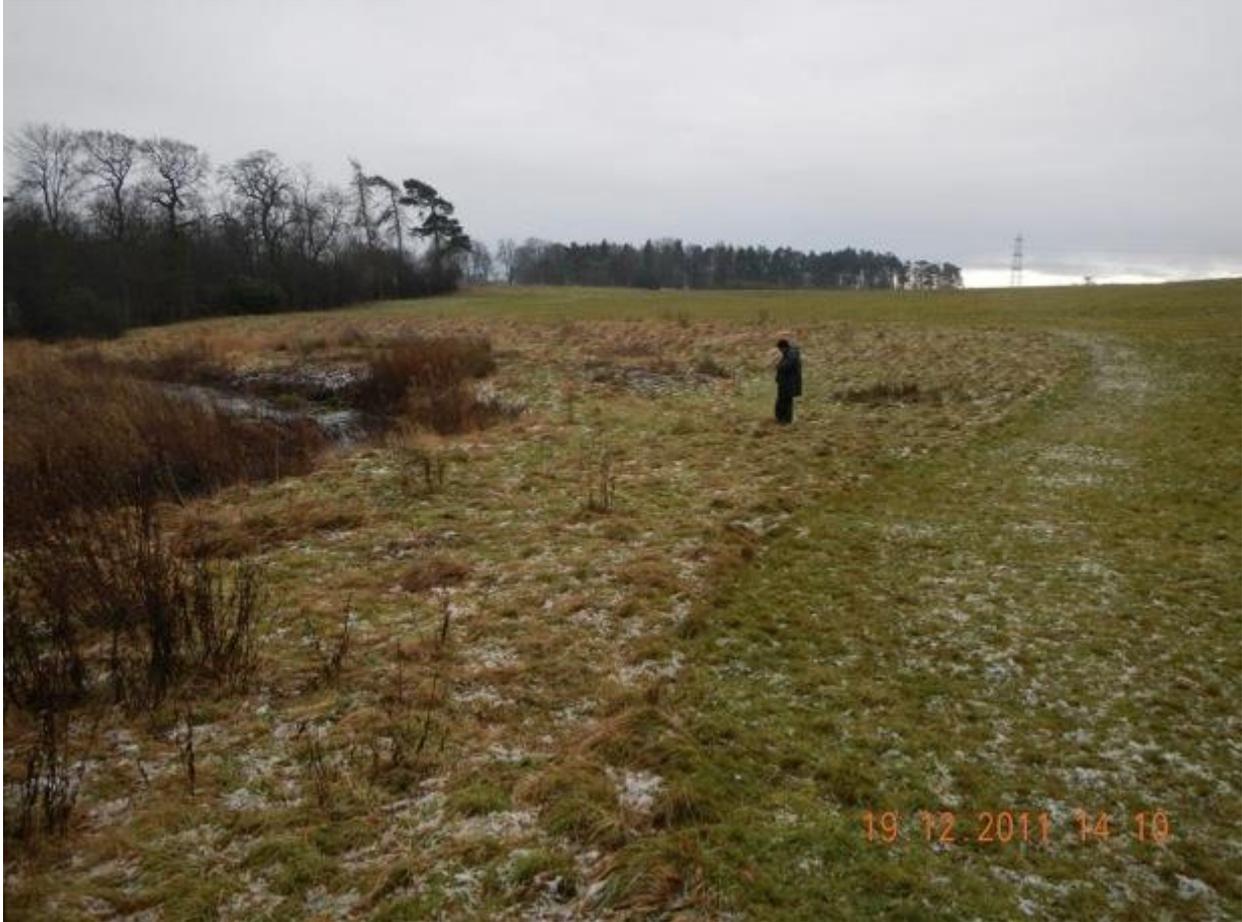
The bank in this area appeared to have been previously protected either by a fence, or by a buffer being left between the river and any mowing (Picture 14). Correspondingly, the marginal vegetation was abundant and healthy, providing good cover and bank protection.

Picture 14. Buffer strip between field and river bank (NZ1156471693).

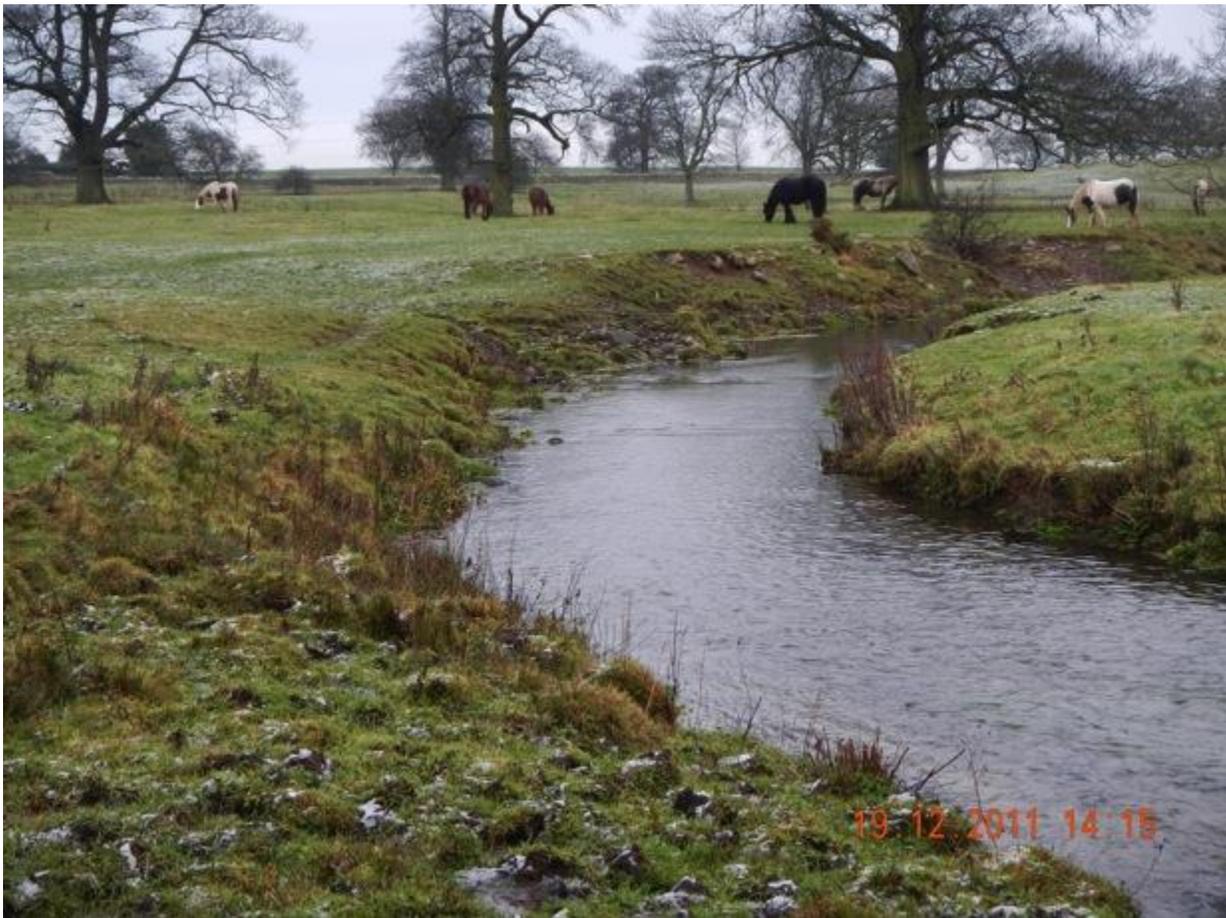
A short distance downstream the river enters an area of horse grazing on both banks. From here down to Eachwick Bridge, most of the banks are heavily grazed with little or no marginal cover and livestock poaching evident (Pictures 15 & 16). The habitat in this area was noticeably degraded; the livestock poaching is likely to input a significant sediment load to the river.

The majority of habitat was provided by flow diversity and bed substrate as the gradient was significant to create a pool and riffle sequence. Where the banks were wooded and stock did not have access, habitat was improved by aerial cover from overhanging tree bows. The channel in this section was generally wide and excessively silty, but had a natural range of substrate size incorporating suitable spawning substrate. This suitable substrate was seriously compromised by smothering from sediment, algae and other organic growth.

Picture 15. Over grazed banks and potential excess sediment source. Habitat is sub optimal due to the channel being wide, with an absence of aerial cover and marginal vegetation (NZ1168371539).

Buffer fencing here would allow much more dense marginal vegetation to establish, increasing bank stability and liberating less sediment to the watercourse. The vegetation would also encroach into the watercourse causing natural narrowing which would increase flow velocity and gravel cleaning. Much of this section would also benefit from an increased level of aerial tree cover but this is unlikely to be possible without fencing.
