Pont and Blyth Investigation
River Pont – from Fenwick Burn to Med Burn
(Waterbody ID - GB103022076840)
Date 19/12/11

1.0 Introduction

This report is the output of a site visit undertaken by Gareth Pedley of the Wild Trout Trust to the River Pont, on 19 December 2011. Comments in this report are based on observations on the day of the site visit.

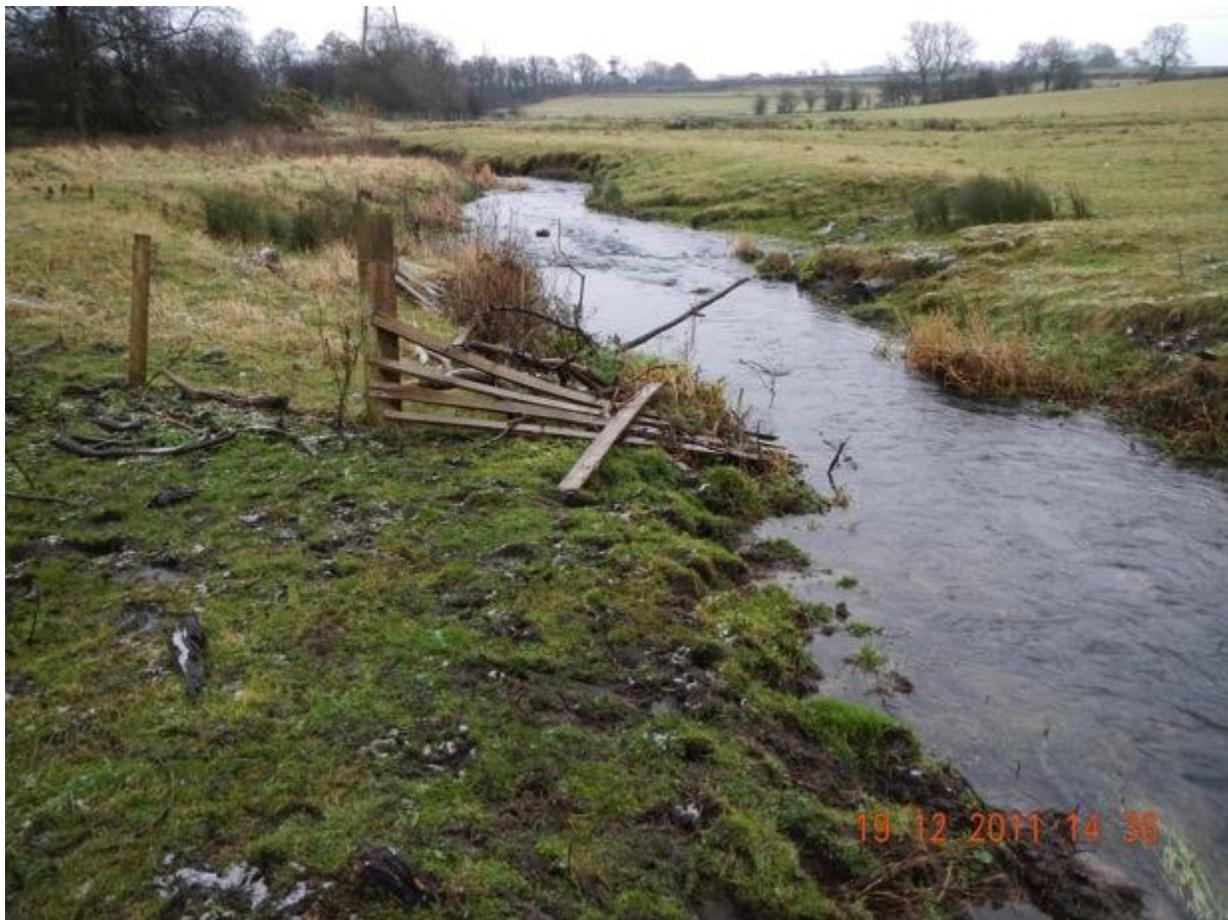
The first field below Eachwick Bridge (NZ1204171073) is subject to the same management as the fields above and as such suffers from the same lack of vegetation, and sedimentation issues due to over grazing. From the second field, down to Dissington Bridge (NZ1254870933) both banks were subject to less grazing pressure and a slightly healthier range of vegetation was observed (Picture 16 the far ground). Buffer fencing here would still be advisable where livestock have access as this would provide better bank stabilisation and potentially allow some self-set trees to become established. If a fence were installed, planting within the fence would also be beneficial.

Picture 16. Intensive horse grazing in foreground, less intensive, presumed sheep grazing in far-ground behind the broken fence (NZ1244570903).

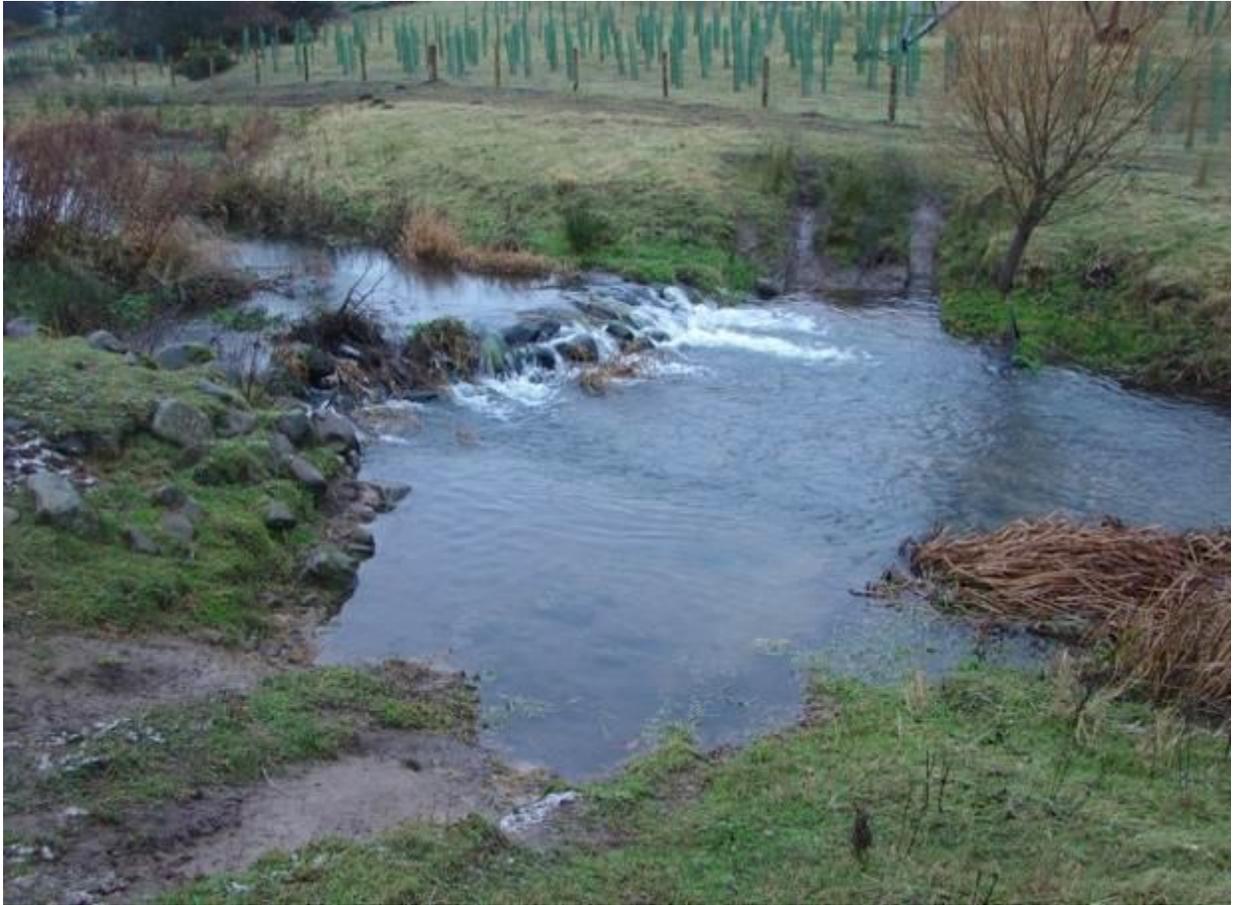
There was another significant weir in this section which is unlikely to be an issue for adult fish but may cause a behavioural barrier and an obstruction to juvenile fish. It also impounds the river for some way upstream (Picture 17).

Picture 17. Small weir causing an impoundment to the river (NZ1247470894).

In most cases, removal of the middle third of each weir may be sufficient. This would retain a degree of channel narrowing, increasing scour and pool formation and improving habitat within the altered sections.

This remediation is of relevance to the weirs above Mill House Bridge (Pictures 7 & 17), and all weirs downstream of Mill House Bridge (Picture in Appendix A).

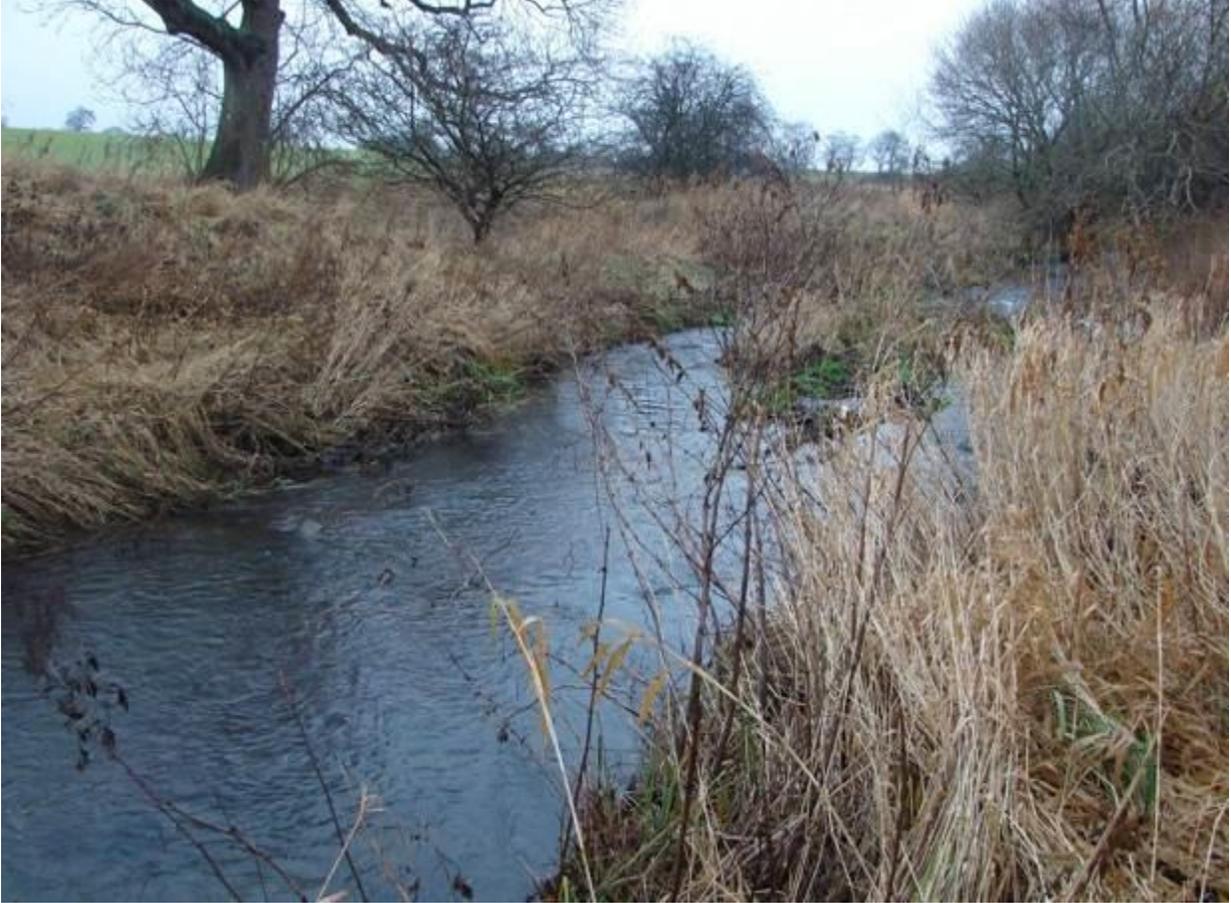
Although re-sectioned for much of its length, the area directly downstream Dissington Bridge had much better habitat due to an absence of grazing pressure. This has allowed beneficial bankside trees to become established which provide a suitable balance of light and shade. The channel was incised through most of this section but appeared to have naturalised to an extent with natural bed material and some sinuosity provided by marginal vegetation encroachment (Picture 18).

Picture 18. Well vegetated banks below the second bridge (NZ1272371167).

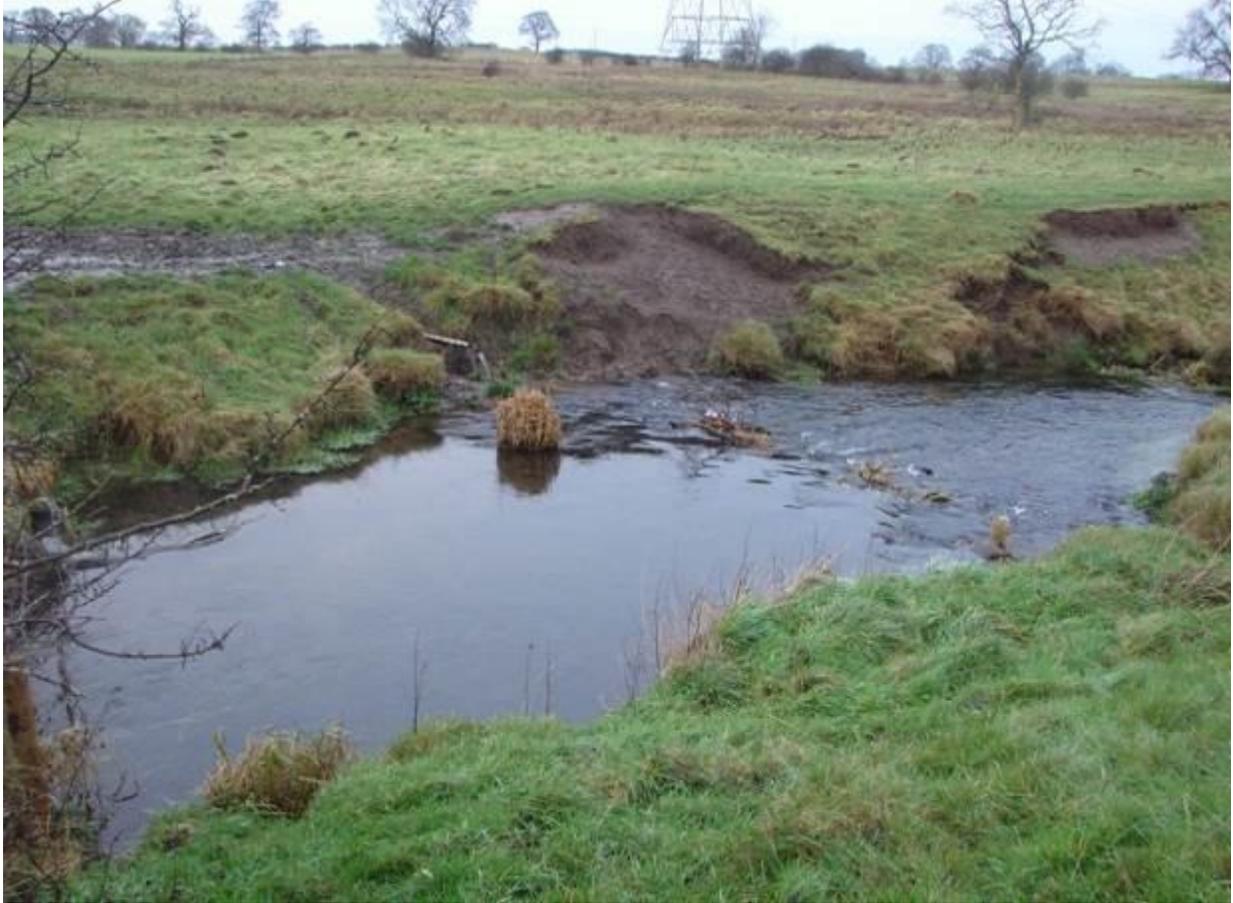
The bottom field of this section down to the Med Burn confluence was heavily grazed on the LHB. This has led to bank erosion and increased sedimentation of the watercourse (Picture 19). As with other such sections this would greatly benefit from buffer fencing to create a more naturalised channel with marginal vegetation.

Picture 19. Overgrazed field that would benefit from stock exclusion through buffer fencing (NZ1276371305).

With the inclusion of fencing, several areas identified in the report could possibly improve naturally to a state where they provide spawning and juvenile habitat (Pictures 5, 12, 15 and 19) and remediate the river towards good status.
