Pont and Blyth Investigation

River Pont – from Med Burn to Small Burn

Date – 25/10/12

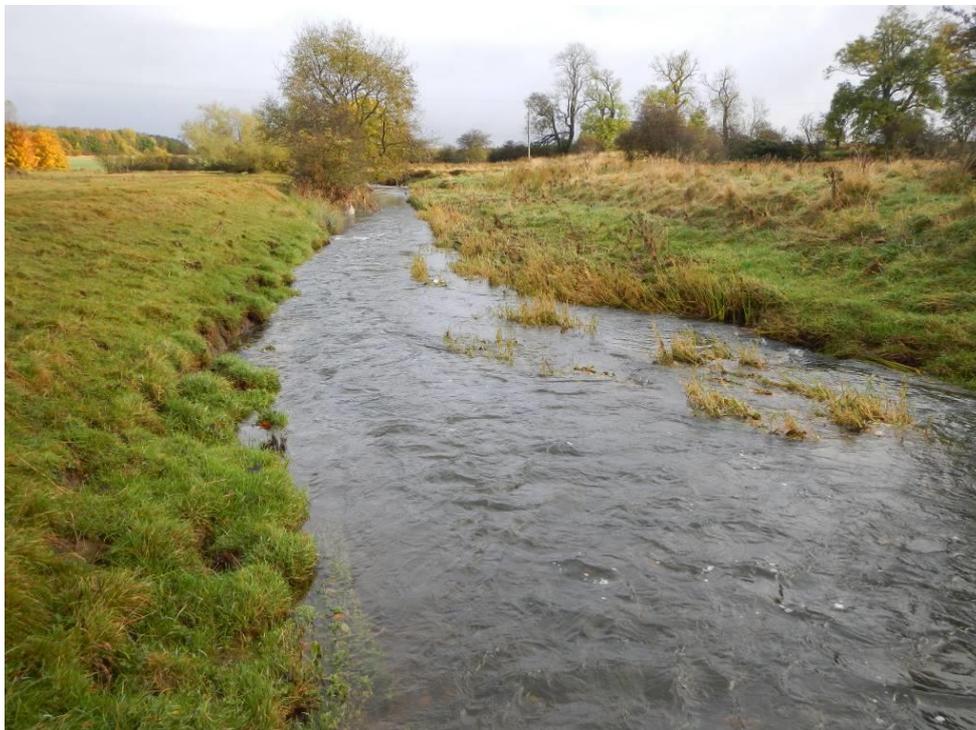
As with most areas in this catchment with stock access to the river bank, marginal vegetation is limited, reducing cover and leading to poaching and increased bank erosion. Some trees were present, predominantly hawthorn (*Crataegus monogyna*), but buffer fencing to increase marginal vegetation, cover/shelter and allow tree planting would be very beneficial.

Picture 1. Straightened river section with limited bank-side vegetation and some riffle habitat. Note the greater level of vegetation and reduced erosion on the RB, where stock access is restricted. If areas of channel could be widened more spawning substrate may be retained.

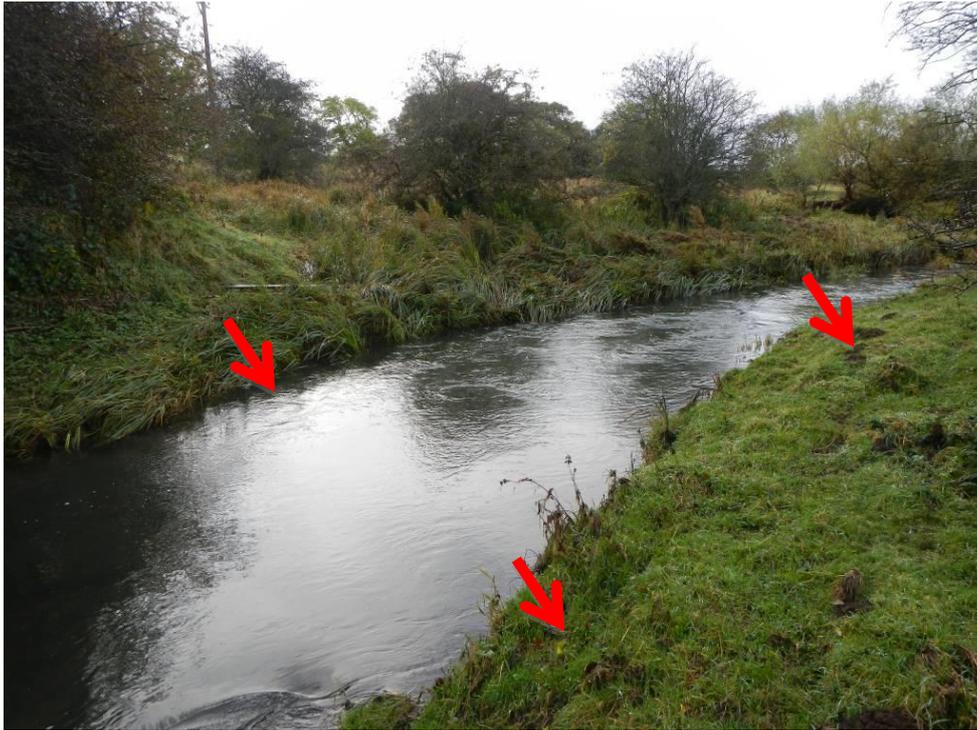
Towards the bottom end of the 1st field the river exhibits some increase in sinuosity, and with this the availability of deeper pool habitat increases (vital for older year classes of fish), particularly around obstructions. Planting of goat willow or sallow (*Salix caprea* and *S. cinerea*) whips into the river bank along the deeper pool areas would greatly increase their habitat quality (particularly cover) and ability to hold larger adult trout (example Picture 2).

Picture 2. Possible locations for tree planting, particularly willow/sallow whips (these would require protection from livestock and should ideally be within buffer zones).

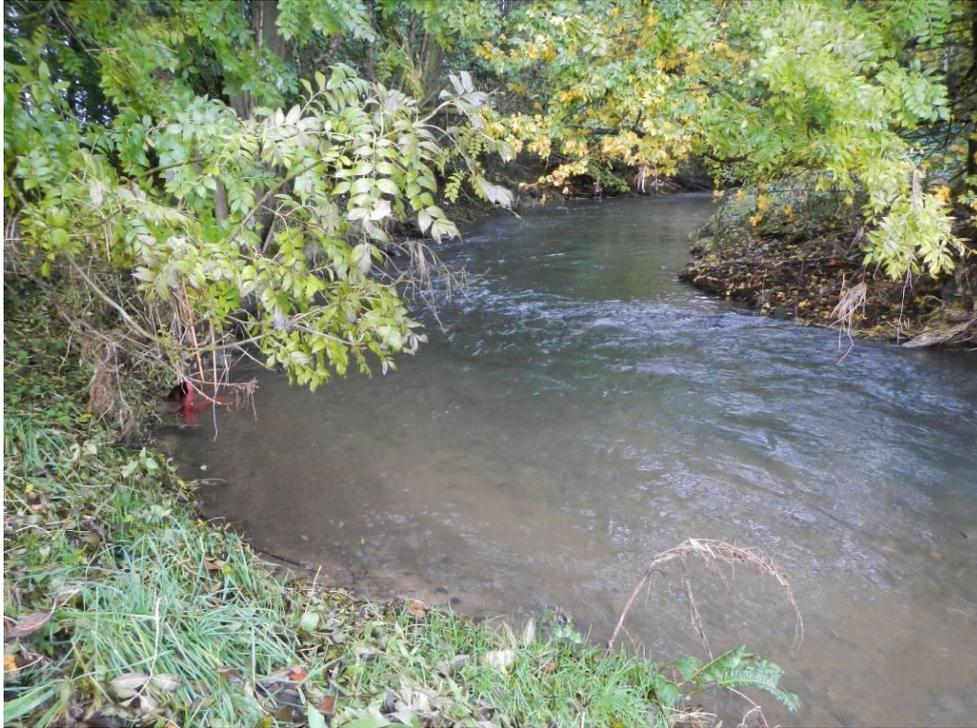
The river then enters a wooded section (NZ1319471715), where the sinuosity of the channel increases further. Bank-side trees provide in-channel diversity through their root systems, which along with branches and woody debris provide the low level cover that is lacking in other areas of the river. Correspondingly, the habitat is of much higher quality (Picture 3). There is still a general lack of smaller substrate suitable for spawning (10-50mm), but a more varied channel cross-section and profile has allowed small areas to accumulate. A small tributary joins the River within the wood, and as with many of the smaller tributaries, appears to be a source of increased sediment (Appendix A; Picture 1).

Picture 3. Improved habitat through the wooded section, where stock are excluded and less dredging has been undertaken.

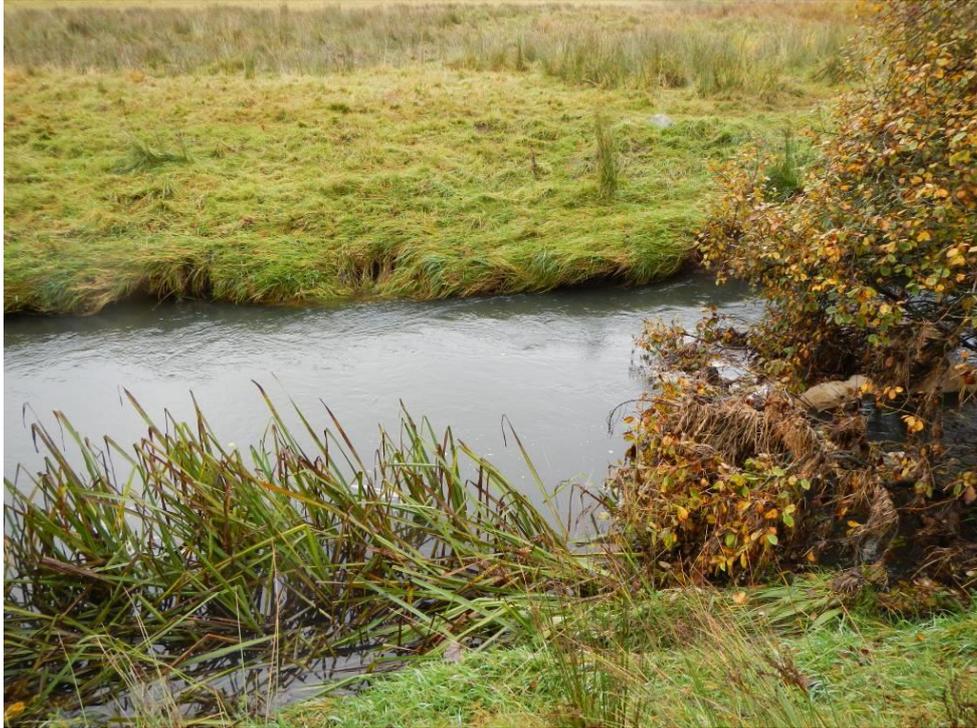
Downstream of the wood, grazing again becomes an issue, predominantly on the LB, but even the lighter grazing on the RB is suppressing marginal vegetation. Buffer fencing of both banks would be beneficial. Significant realignment has taken place here, moving the River to a straightened, deepened course along the edge of the floodplain. This has left a long section of channel with an incised bed, lacking in shallower riffle sections, with little juvenile habitat. Where trees are present to provide cover and constrict the flow, pool type habitat is of a reasonable quality for adult fish (Picture 4).

Picture 4. Improved adult trout habitat provided by a tree encroaching into the river channel. This provides increased flow diversity and cover to an over deepened channel. The addition of buffer fencing would further enhance habitat by increasing bank-side cover and protecting the banks.

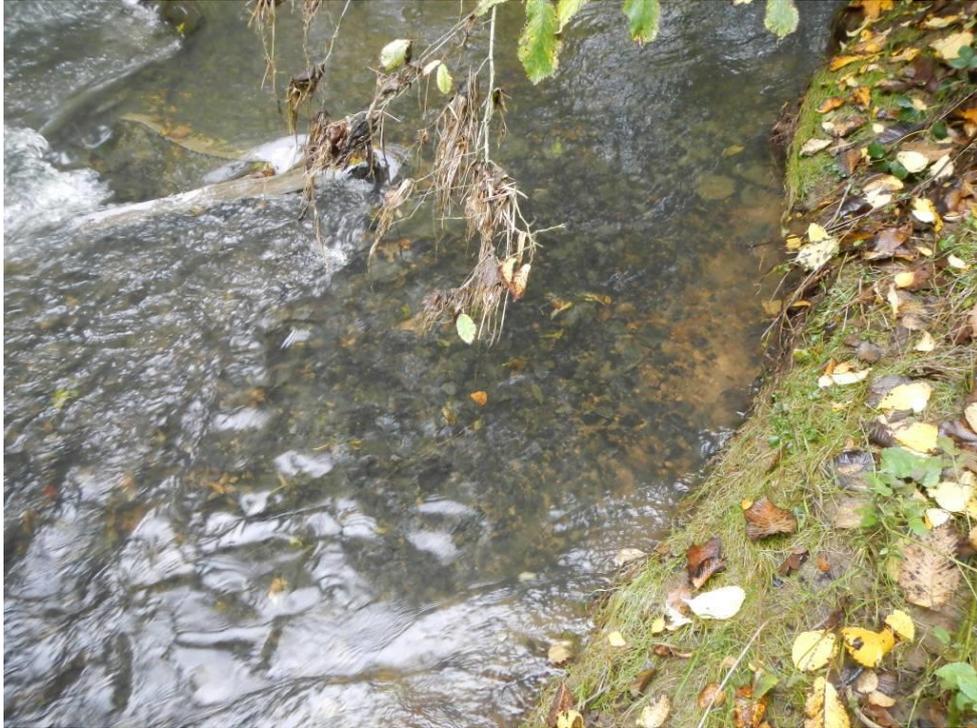
Downstream the river enters another wooded section, where again the sinuosity increases slightly and the extent of dredging/channel deepening is lessened. However, the channel still appeared to have been subjected to realignment from its natural course. In this area smaller substrate was again evident, but not in the volumes to provide significant spawning benefit, as much of it is compacted with fine sediment and much larger gravel/cobbles (Picture 5).

Woody debris was present within the channel, providing beneficial cover and flow diversity, as were falling/trailing marginal trees. Where these protruded far enough into the channel to facilitate some bed scouring/sorting gravel lifts had been created, but again, only with limited potential for spawning due to the high sediment content and lack of 10-50mm gravel.

Picture 5. Typical example of the smaller substrate to be found within the reach, which is of limited use for spawning.

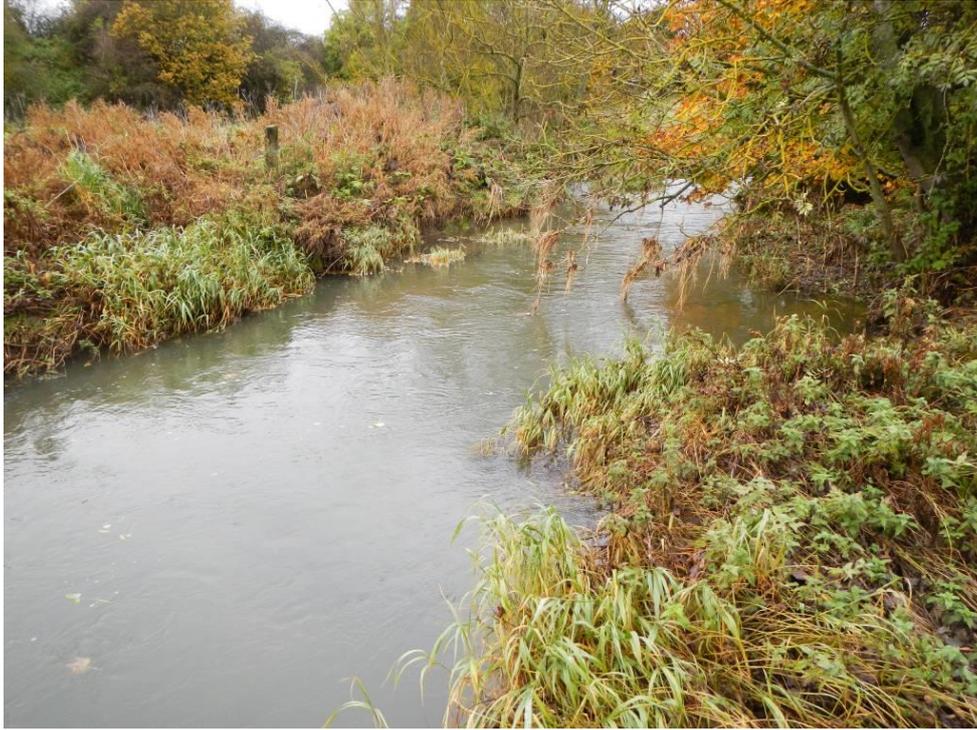
Picture 6. A good example of the healthy herbaceous vegetation that would benefit all sections of the river and wildlife throughout the river corridor.

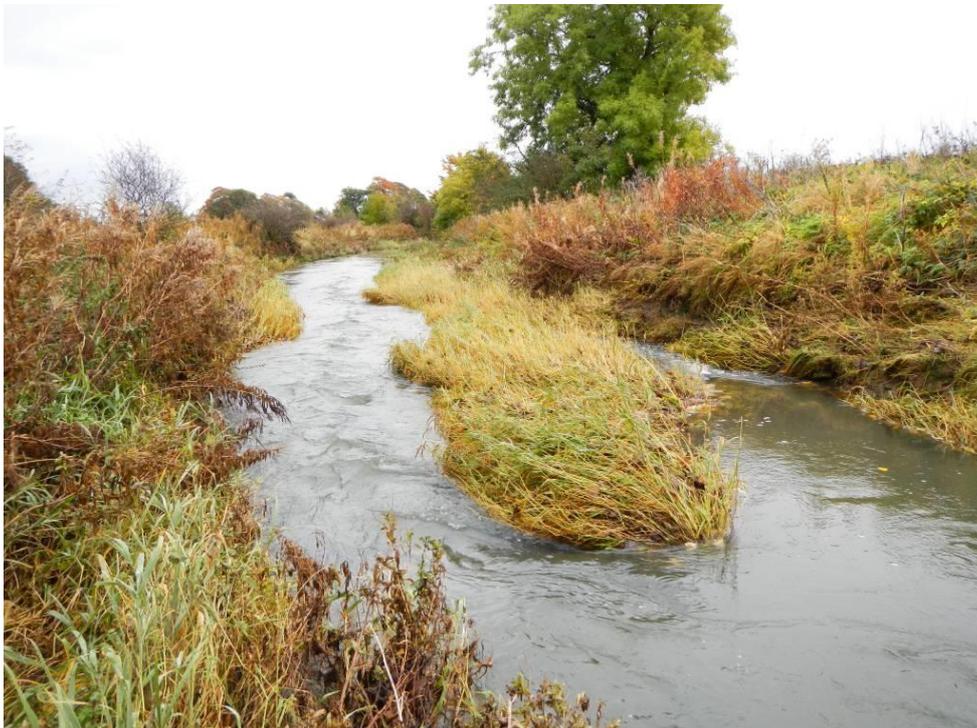
Picture 7. Some natural in-channel features starting to develop.

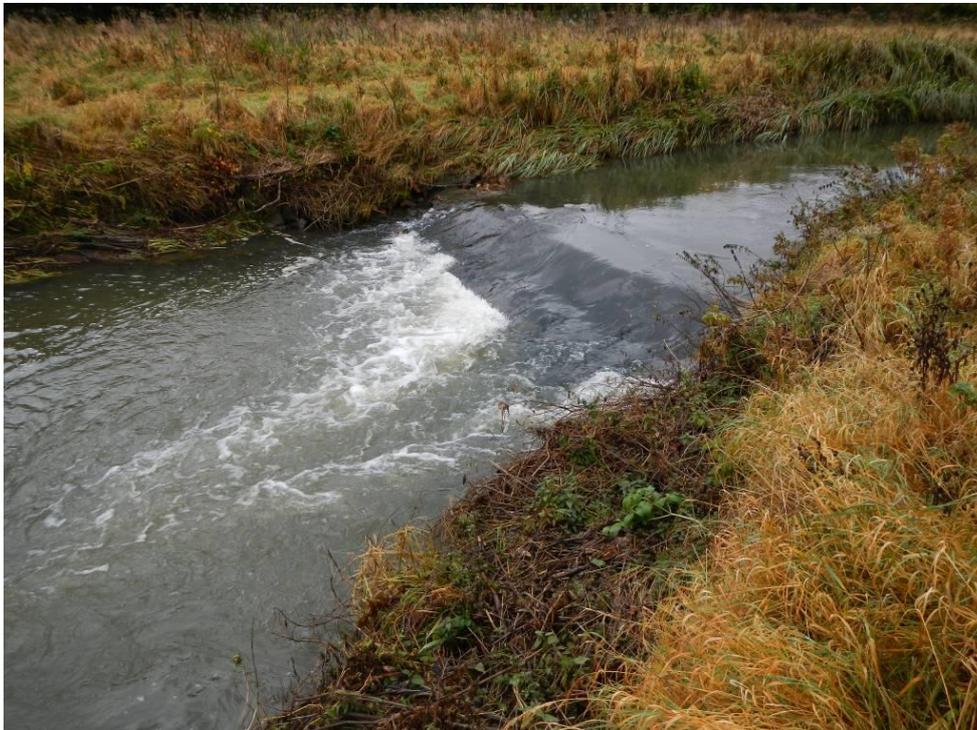
As would be expected there was a recurring issue of land use throughout the gardens, with most lawns mowed down to the rivers edge, leaving no marginal fringe. A more significant issue, however, was the vast array of weirs that have been created throughout most of this section. These weirs range from small barriers that pose issues for small fish species, juveniles fish and sediment transport, through to large-scale structures that are likely to be impassable to a large percentage of the River's fish population for most of the time (Appendix B). Pictures 9 & 10 show examples of two of the worst obstructions.

Picture 9. Significant weir (c. 60cm high), likely to be impassable to a large percentage of the Pont's fish stocks at most flows (also Appendix B; Picture 3).

Due to the lack of natural bed features, over-deep, incised channel and low gradient, the weirs present create a significant issue to the river, impounding flow, interrupting sediment transport and forming barriers to fish migration (Appendix B). It is recommended that all of these impoundments are removed down to river bed level.

Notching of a portion of the weir would be another option (significantly poorer option than removal), but if undertaken, this should be a wide enough notch to prevent over-accelerated flows that could also cause an obstruction and cause accelerated scour/erosion. It should also be ensured that the notch extends right down to bed level, thereby completely removing the obstruction to both fish and substrate migration.

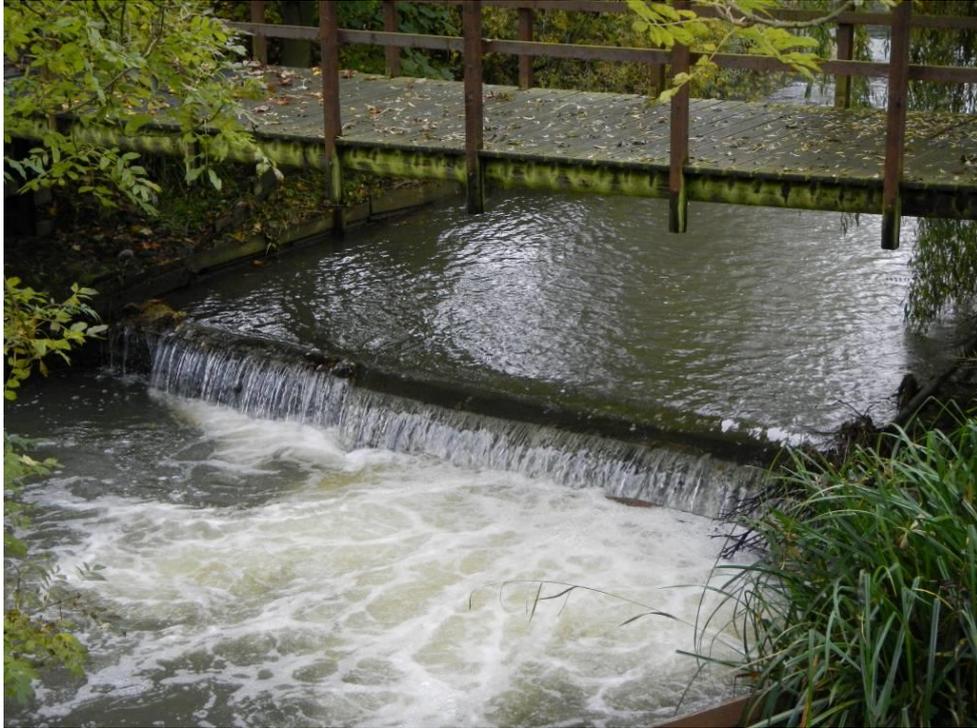
Picture 10. Another significant barrier to juvenile fish stocks c.45cm high (also Appendix B; Picture 10).

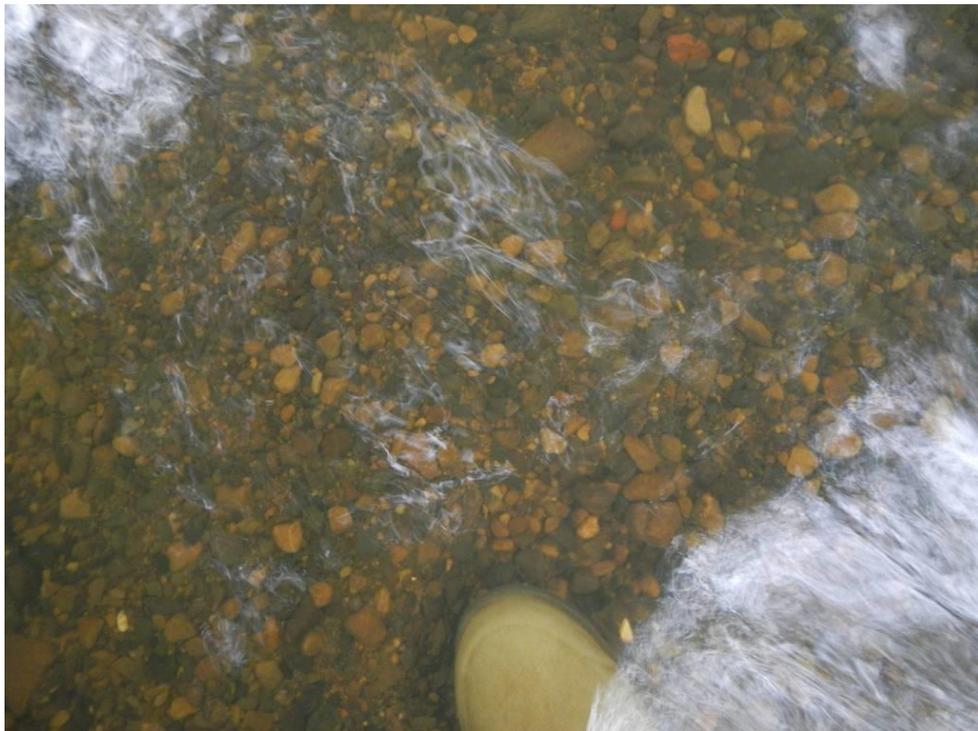
downstream of the gardens (upstream (u/s) and downstream (d/s) of Fox Covert Lane) and through Ponteland Park provides some of the best spawning substrate on the entire Pont system, for both trout and grayling (Picture 11). The obstacle to upstream migration from here for all fish life-stages created by the weirs, and the potential impact on fish stocks should not be underestimated.

Picture 11. A good example of the improved substrate (10-50mm) for salmonid spawning in the section of river between the downstream limit of the gardens in Darras Hall and the downstream limit of Ponteland Park.

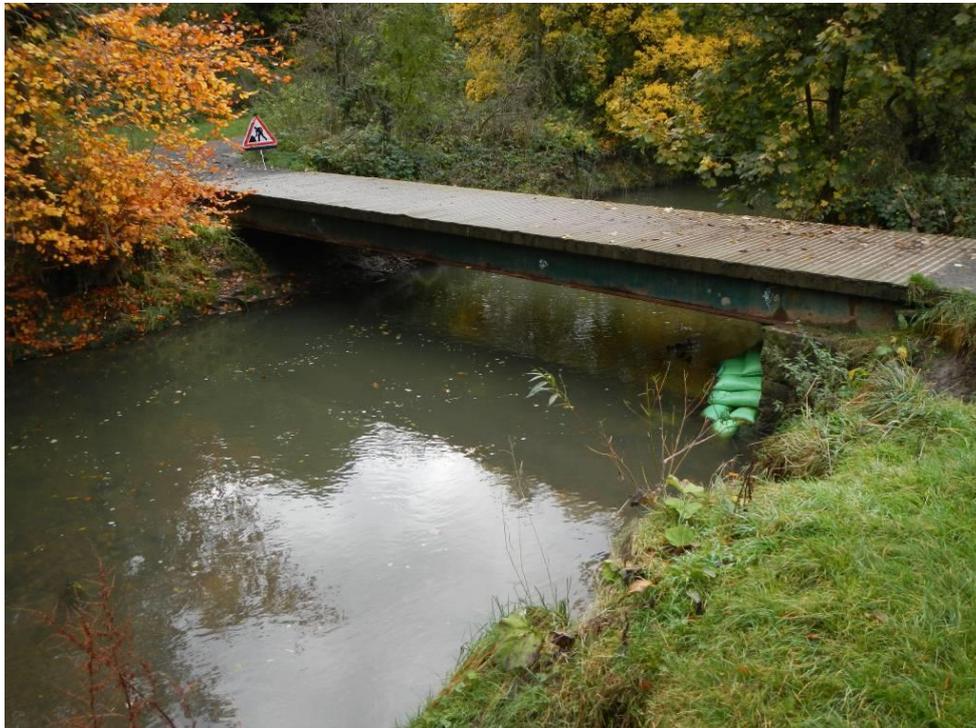
floodplain in the park, all the valuable low level, overhanging branch habitat was being removed (Picture 12) – despite the section being bracketed by two bridges whose hydrological limit are likely to make such vegetation clearance redundant for reduction of flood risk.

Picture 12. One of two bridges that create a significant constriction through the Park and restrict flows to a much greater degree than would be created by retention of low branches along the river margin.

management with the requirements of natural habitat and performance under the Water Framework Directive. As highlighted in pictures 12 and 13, although causing some increase in channel roughness, the structures adversely affecting flood risk through Ponteland are unlikely to be the small overhanging and trailing vegetation that is so valuable for habitat. Where in-channel material absolutely has to be removed, it is recommended that permanent, substitute fish cover be installed, such as tethered tree kickers. Good, positive publicity could be gained with the local residents if the reasons for these actions were explained on interpretation boards.

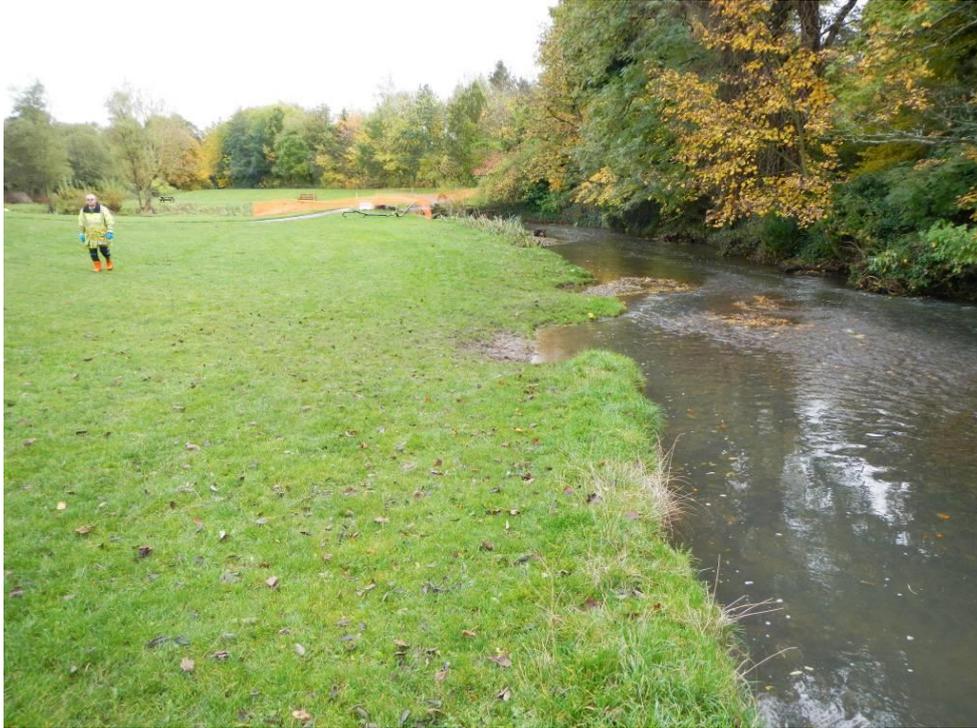
Picture 13. The widest floodplain profile throughout Ponteland Park, between two low bridges, yet all of the low level branches have been removed along the RB to create a tunnel cut effect, leaving no low level or in-channel cover habitat.

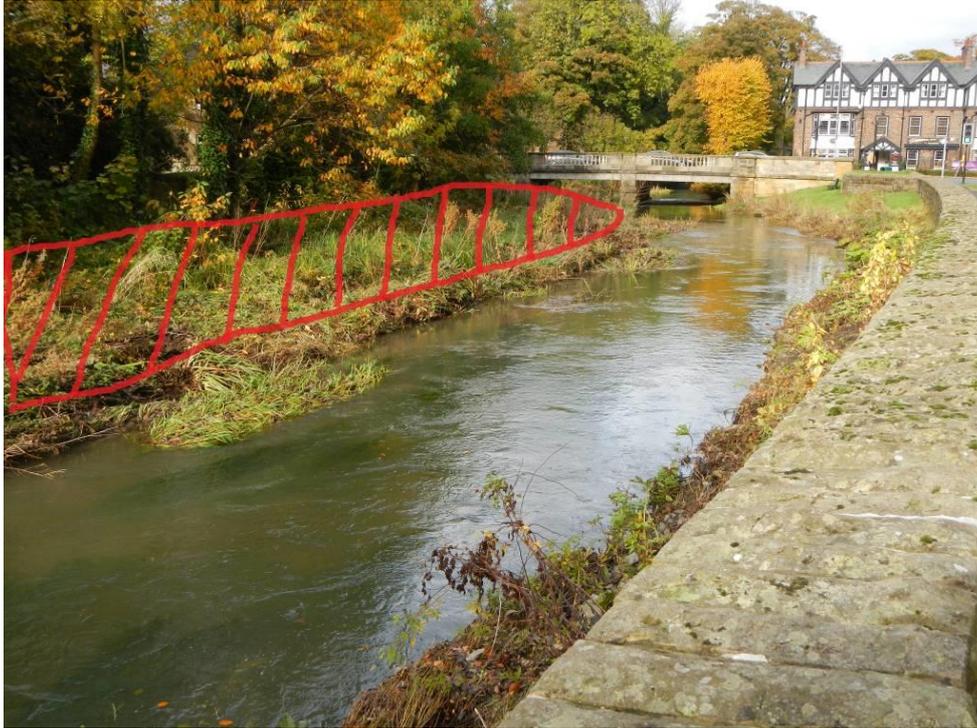
Downstream of the Park, upstream of the A696 road bridge, is another area where significant levels of channel maintenance are carried out. The wide, straight area directly above the A696 bridge accumulates gravel after high flows, as is to be expected where an over-wide channel is maintained. With this in mind it is suggested that options are investigated for increasing flood capacity through development of a two-stage channel, rather than the intrusive maintenance dredging that currently occurs. If the large area of unused land on the LB, upstream of the bridge were lowered and graded to increase flood capacity, the wetted river channel and margins could be left un-dredged. Once naturalised, this should improve conveyance of bed material within the river channel at most flows, while providing high flow capacity in the second stage of the channel (Picture 14).

Picture 14. Upstream of the A696 road bridge, where it may be possible to reduce dredging by lowering the LB (hatched red) to increase flood capacity. This would allow the river channel to naturalise and remove the ongoing impact of dredging on the river.

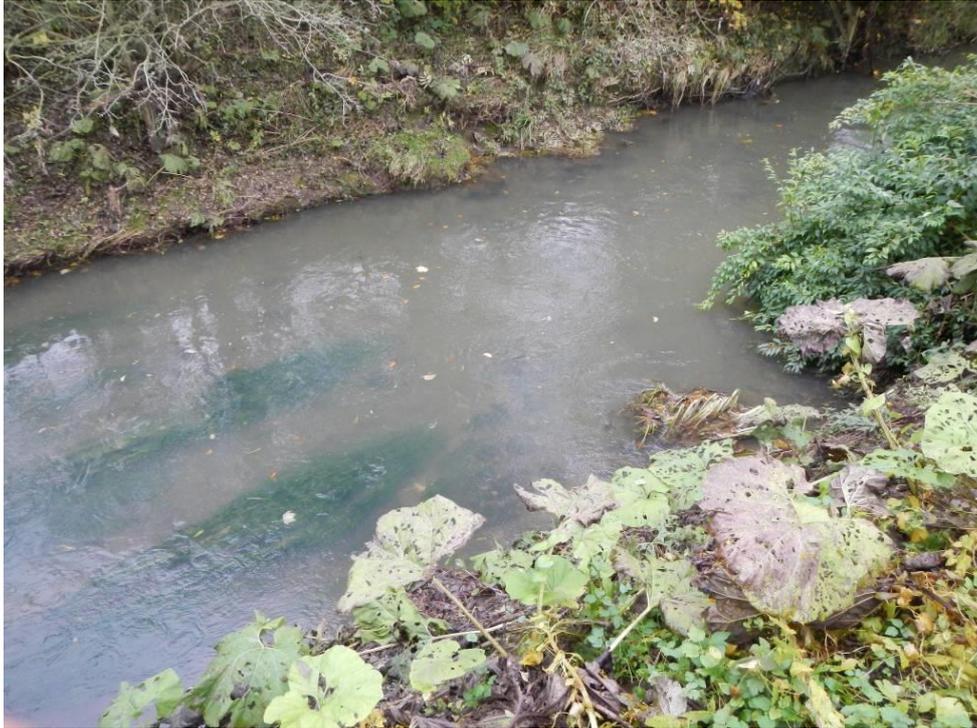
Downstream of the road bridge the River is again heavily straightened, but where deeper pools occur, with good cover and in-channel structure, habitat quality improved (Picture 15). Correspondingly, several fish were observed taking insects from the river surface in this section.

Picture 15. Straightened channel, but with sufficient depth, cover and in-channel features to provide reasonable trout habitat.

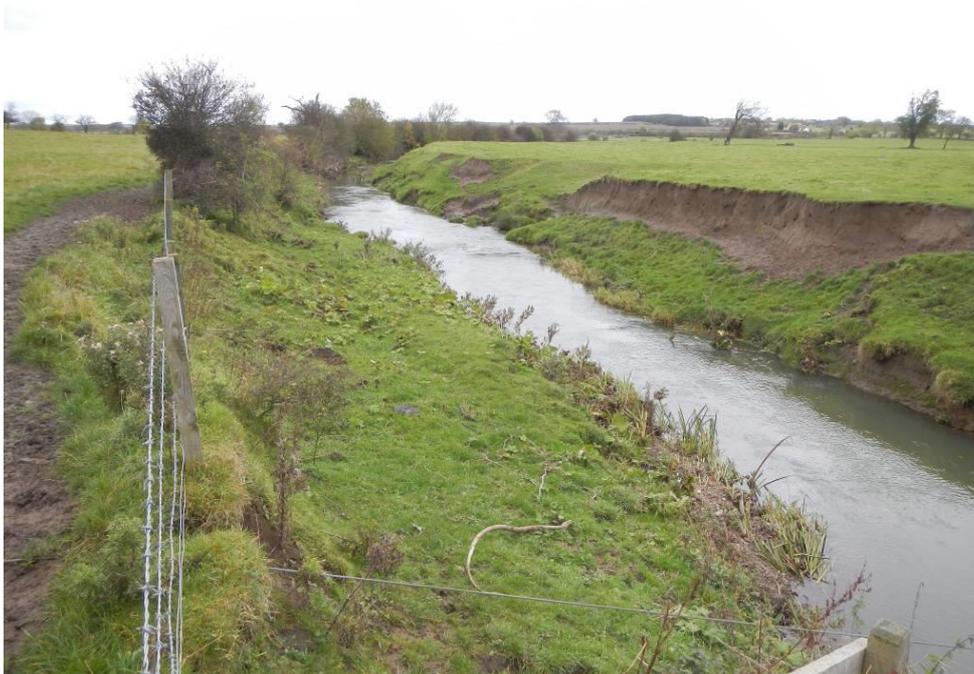
Picture 16. Erosion and livestock scarring on an area of naturally re-grading slumped bank. Note the obvious grazing pressure within the buffer zone that must be occurring from livestock crossing the river.

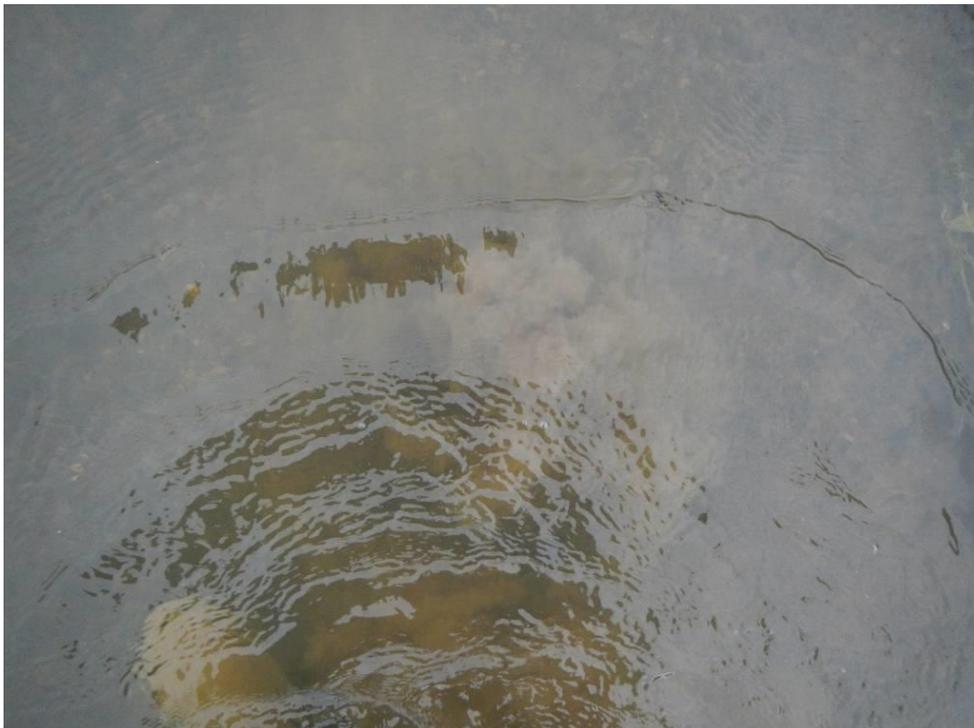
Further downstream the channel remains heavily straightened and dredged and livestock have access to the river bank. This further increases issues on the watercourse, with greatly increased bank erosion and sedimentation occurring. There is a short section of buffer fencing on the left bank where improved cover was present, but below this open stock access to the river occurs, with stock crossing over from the opposite bank in sections where only one bank is fenced. Continued grazing pressure/trampling is also inhibiting recolonisation of vegetation in areas of slumped banks where natural re-grading is occurring (Picture 16). The substrate in this area is severely compromised by the resulting heavy sediment loading (Picture 17).

Picture 17. Evidence of heavy sedimentation of the river substrate, with a large silt plume liberated by shuffling on the bed.

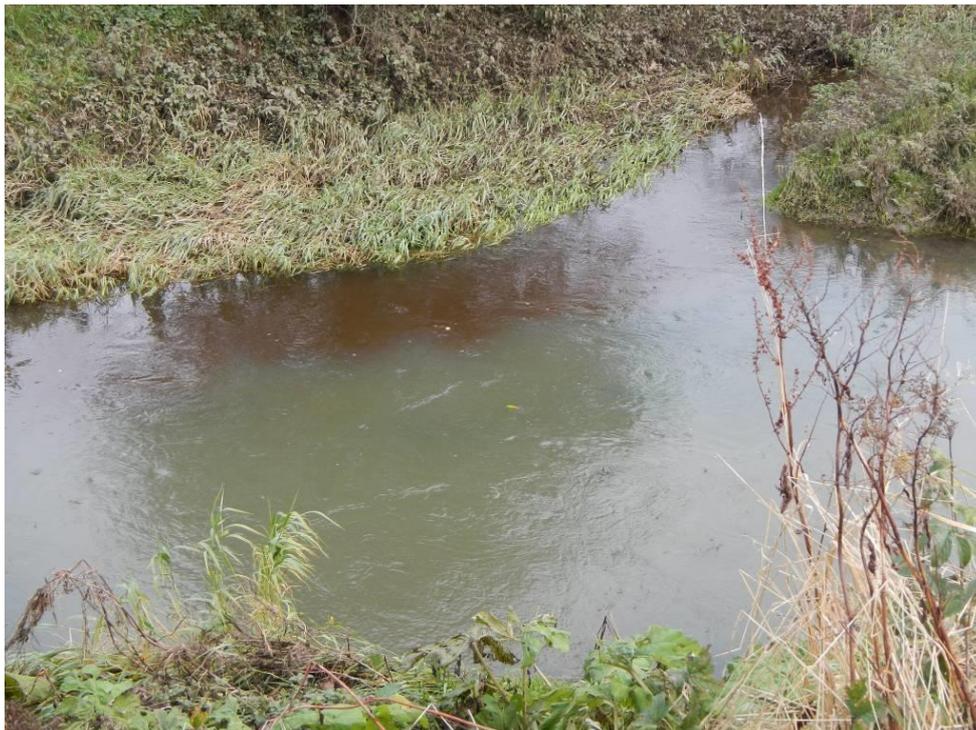
One other significant feature of this lower section was the input from a tributary of a different type of turbidity to the river (Picture 19). Unlike the seemingly clay-based inorganic type inputs from most tributaries and field drains encountered, this tributary appeared to be discharging much darker water, with a higher organic content. Further investigation on Google maps revealed that the tributary drains Prestwick Carr (Picture 20), which is likely to explain the humic stain and organic content.

Picture 19. The dark brown component along the far bank is the discharge from Prestwick Carr.

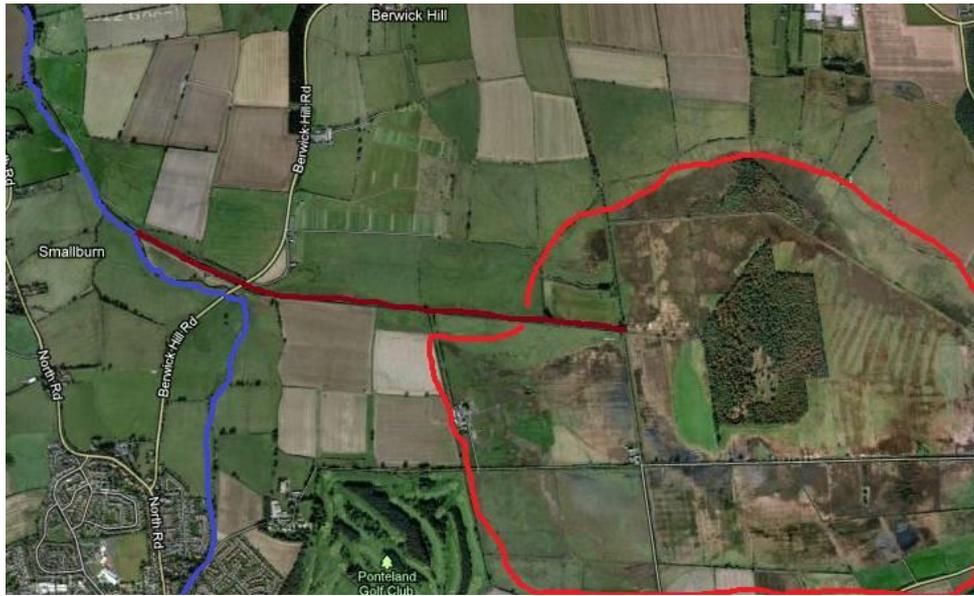
Picture 20. The indigo line represents the River Pont, the brown line represents the tributary draining Prestwick Carr and the red perimeter outlines Prestwick Carr. The difference in the soil type around the Carr can be clearly seen.

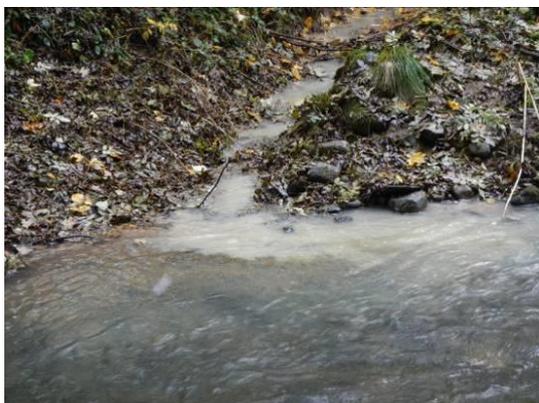
Picture 1. Sedimentation from a small tributary in wood (NZ1319871880)

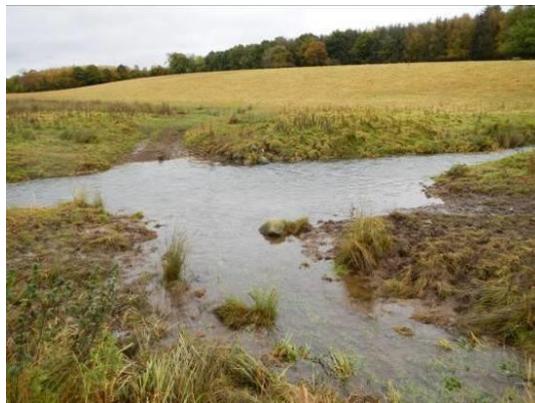
Picture 2. Fording point downstream of wood. Poaching and erosion issues continued u/s & d/s in this field (NZ1309572053)

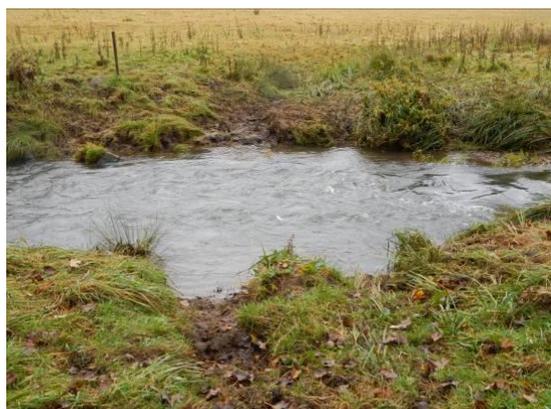
Picture 3. Cattle fording point (NZ1325672163)

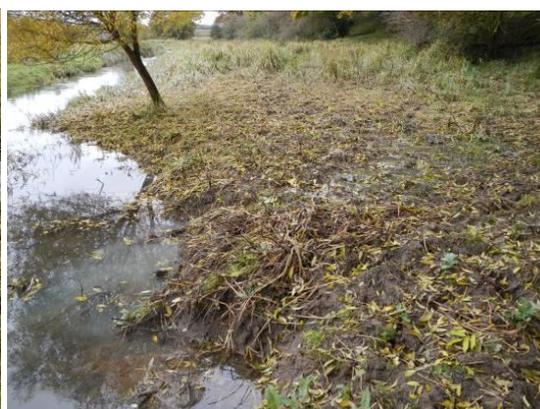
Picture 4. Poached boggy ground leaching sediment (NZ1343872194)

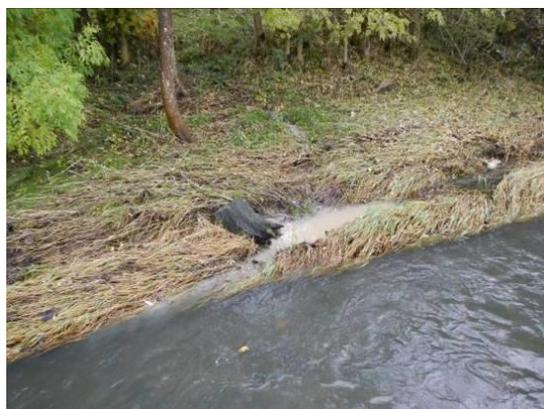
Picture 5. Field drain on RB u/s culvert (NZ1366172217)

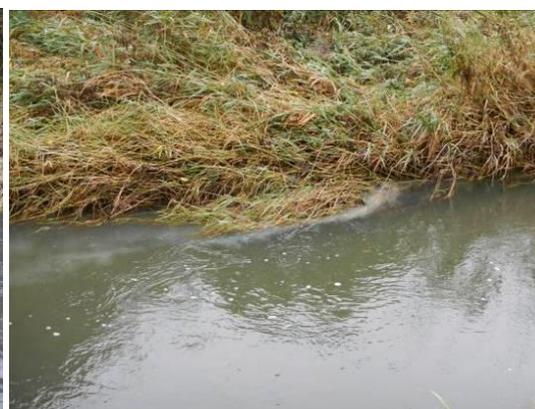
Picture 6. Field drain on RB u/s culvert (NZ1368872251)

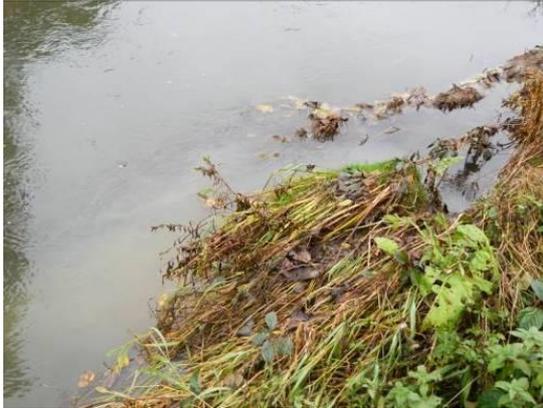
Picture 7. Field drain on LB u/s culvert (NZ1369472252)

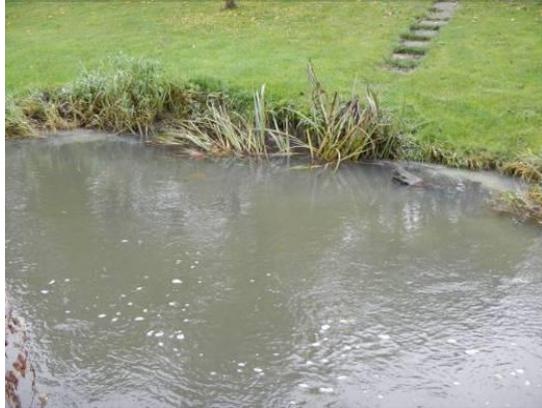
Picture 8. Two land/garden drains on far bank (RB) in first Darras Hall garden (NZ1414572288)

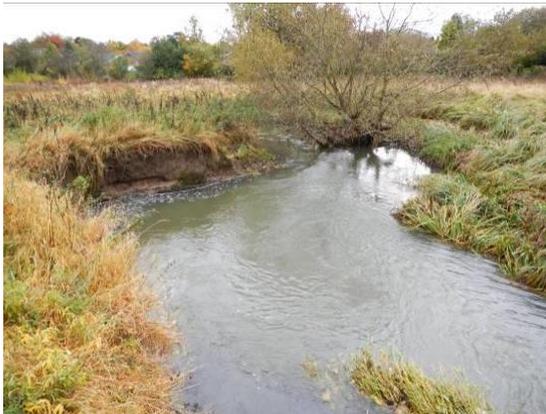
Picture 9. Bank erosion (NZ1452872086)

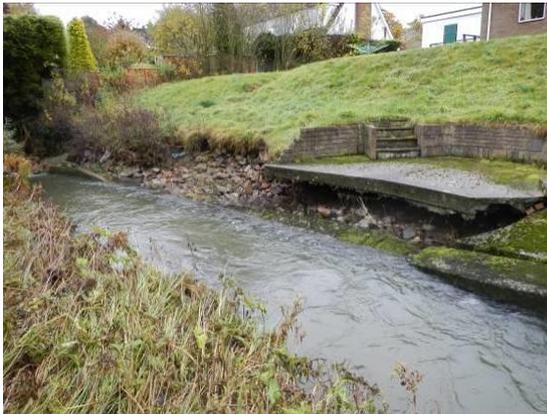
Picture 10. Bank erosion and slumping in garden (NZ1464971978)

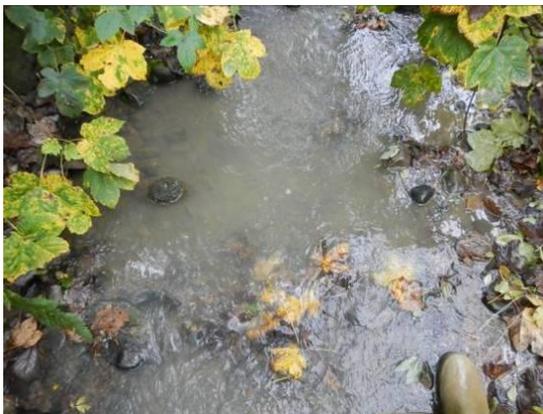
Picture 11. Light sedimentation from tributary (NZ1514772185)

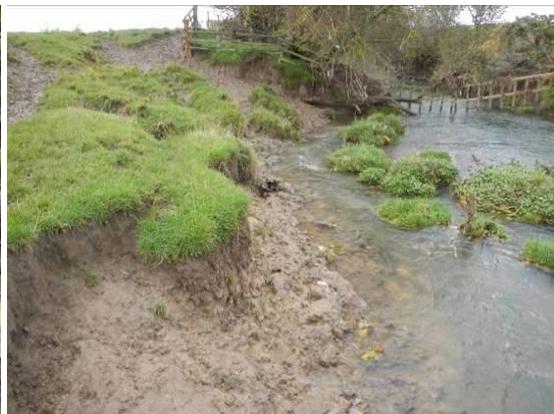
Picture 12. Major cattle poaching and erosion around drinking point (NZ1675773473)

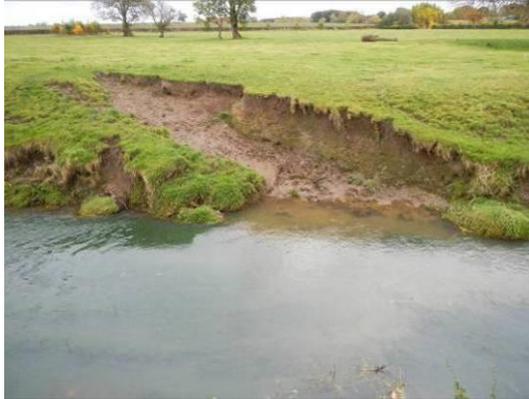
Picture 13. Cattle poaching and erosion around access point (NZ1679873945). Another similar issue was present in the same field

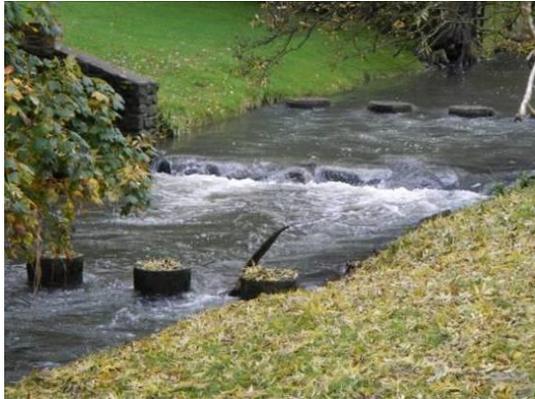
Picture 1. Small weir causing an obstacle to small fish, with some impact on transport of bed material (NZ1423672280)

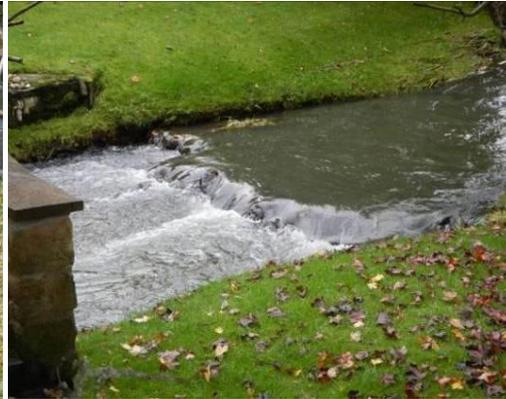
Picture 2. Small weir causing an obstacle to small fish, with some impact on transport of bed material (NZ1437672235)

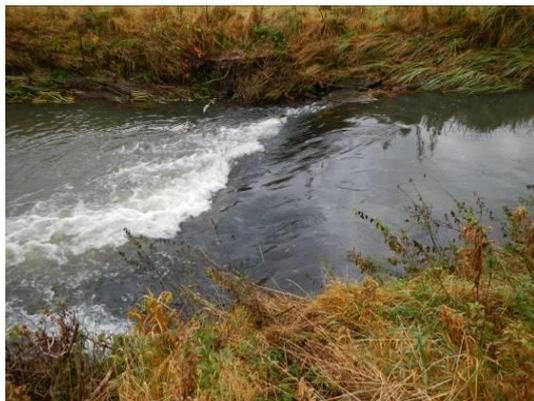
Picture 3. Significant barrier to most fish in most flows, significantly inhibiting transport of bed material (NZ1453772076)

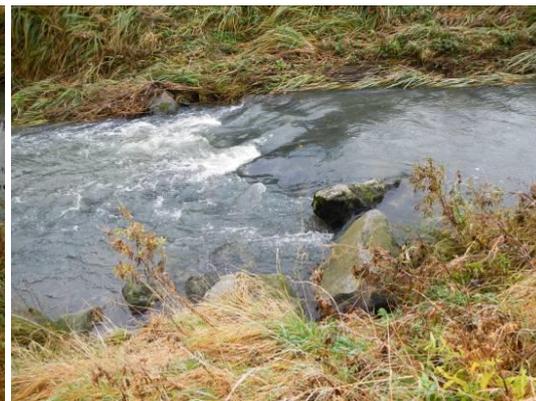
Picture 4. Small weir causing an obstacle to small fish, with some impact on transport of bed material (NZ1458572026)

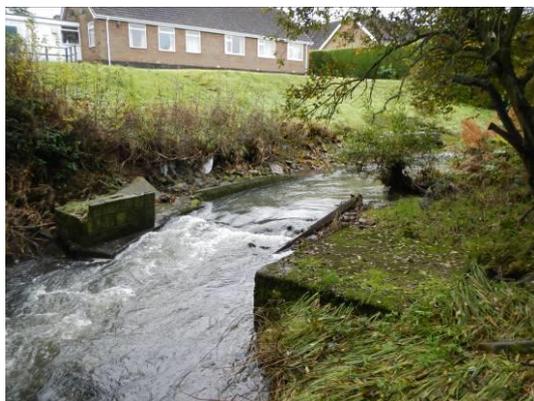
Picture 5. Small weir causing an obstacle to small fish, with some impact on transport of bed material (NZ1468171964)

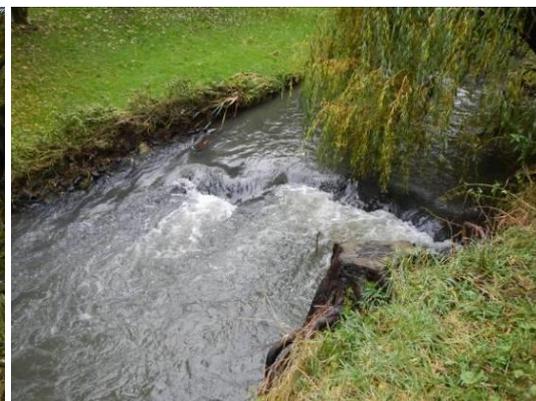
Picture 6. Small weir causing an obstacle to small fish, with some impact on transport of bed material (NZ1474071987)

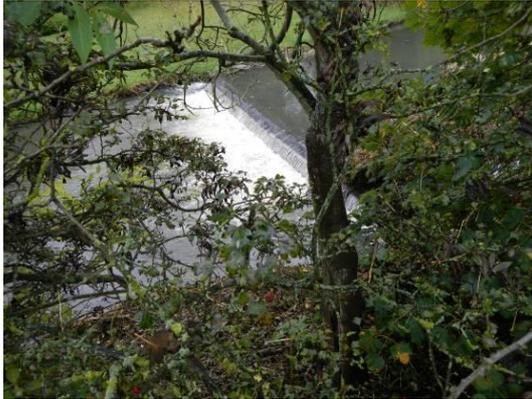
Picture 7. Medium sized weir that is an issue for smaller fish and transport of bed material (NZ1493572026)

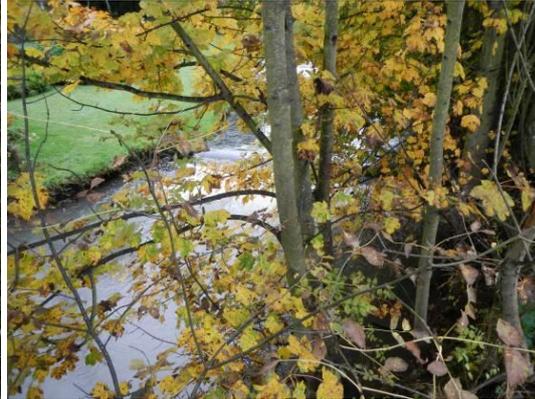
Picture 8. Medium sized weir that is an issue for most fish at low/medium flows, and for transport of bed material (NZ1495172035)

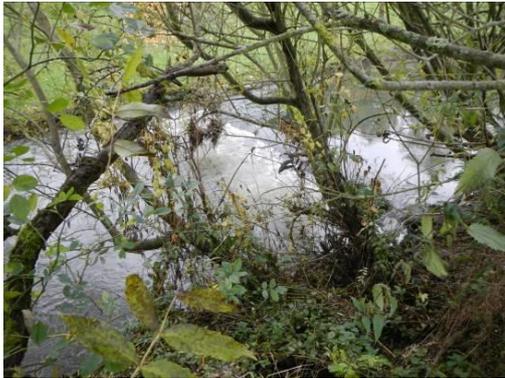
Picture 9. Medium sized weir that is an issue for smaller fish and transport of bed material (NZ1499272040)

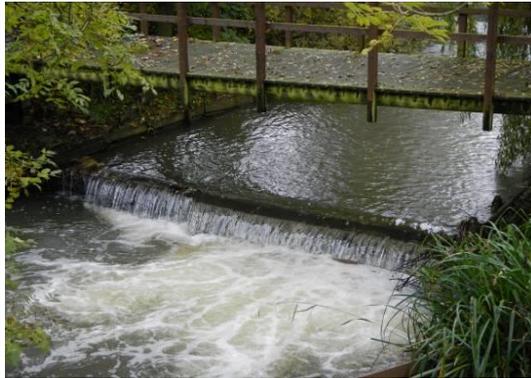
Picture 10. Medium weir causing an obstacle to small fish, with some impact on transport of bed material (NZ1500372107)

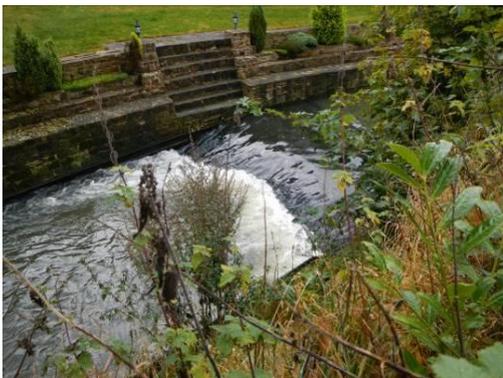
Picture 11. Significant barrier to most fish in most flows, significantly inhibiting transport of bed material (NZ1529572247)

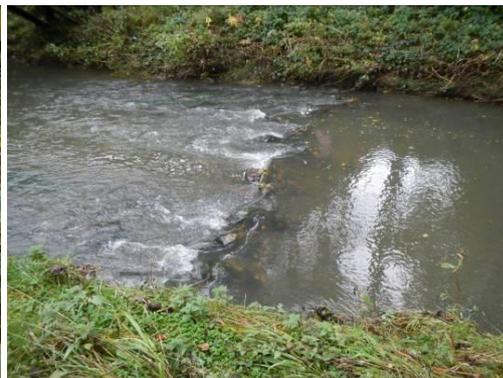
Picture 12. Small weir causing an obstacle to small fish, with some impact on transport of bed material (NZ1552172418)

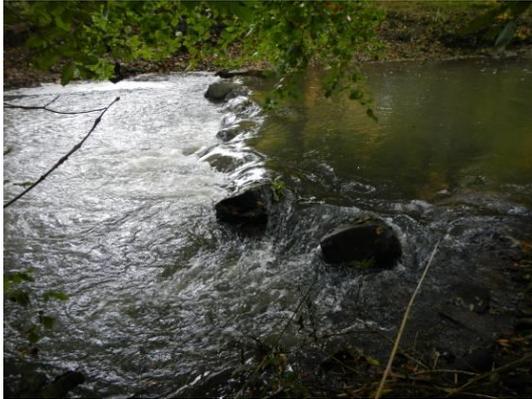
Picture 13. Small weir causing a minor obstacle to small fish, with some impact on transport of bed material (NZ1560772455)

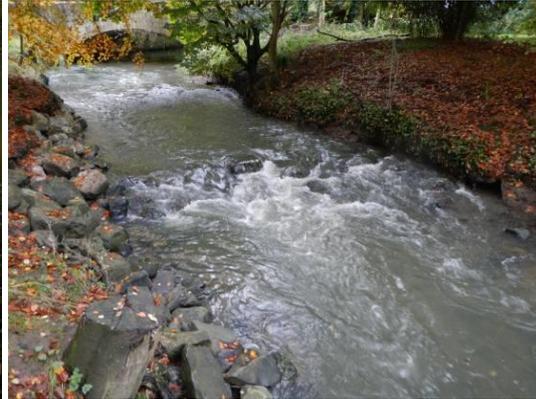
Picture 14. Small weir causing an obstacle to small fish, with some impact on transport of bed material (NZ1583172503)

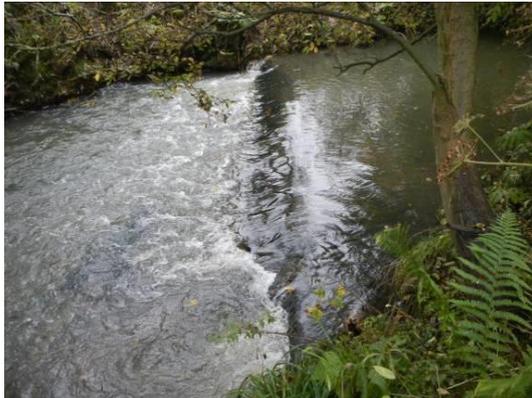
Picture 15. Small weir causing an obstacle to juvenile fish and some impact on transport of bed material (NZ1671373182). By the look of this obstruction it may be a pipe crossing so may require an easement, rather than removal.

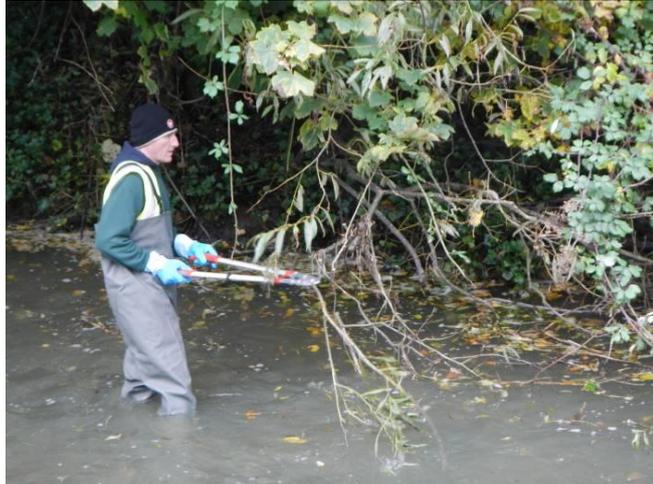
Before

Beneficial low-level cover that provides shade and security, particularly for adult fish.
