Pont and Blyth Investigation

River Pont – from Med Burn to Small Burn

Date – 25/10/12

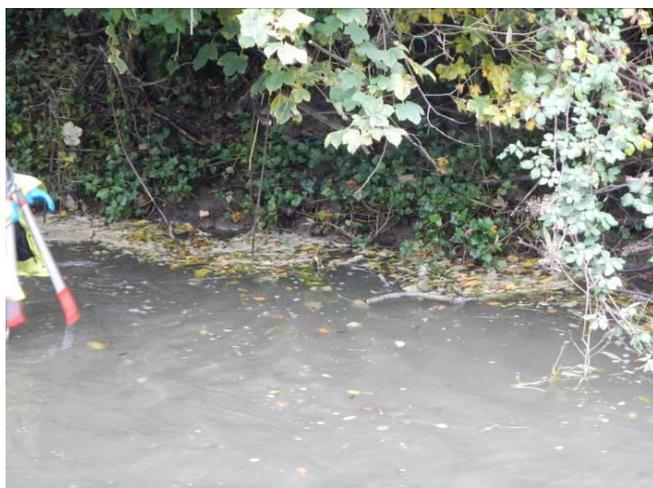
After

All of the beneficial aerial cover has been removed. This prescription was carried out throughout Ponteland and upstream towards Darras Hall, removing almost all of this type of habitat for an extended section of river.
