Pont and Blyth Investigation

River Pont – from Small Burn to Bellasis

(Waterbody ID - GB103022077050)

Dates – 09/02/12

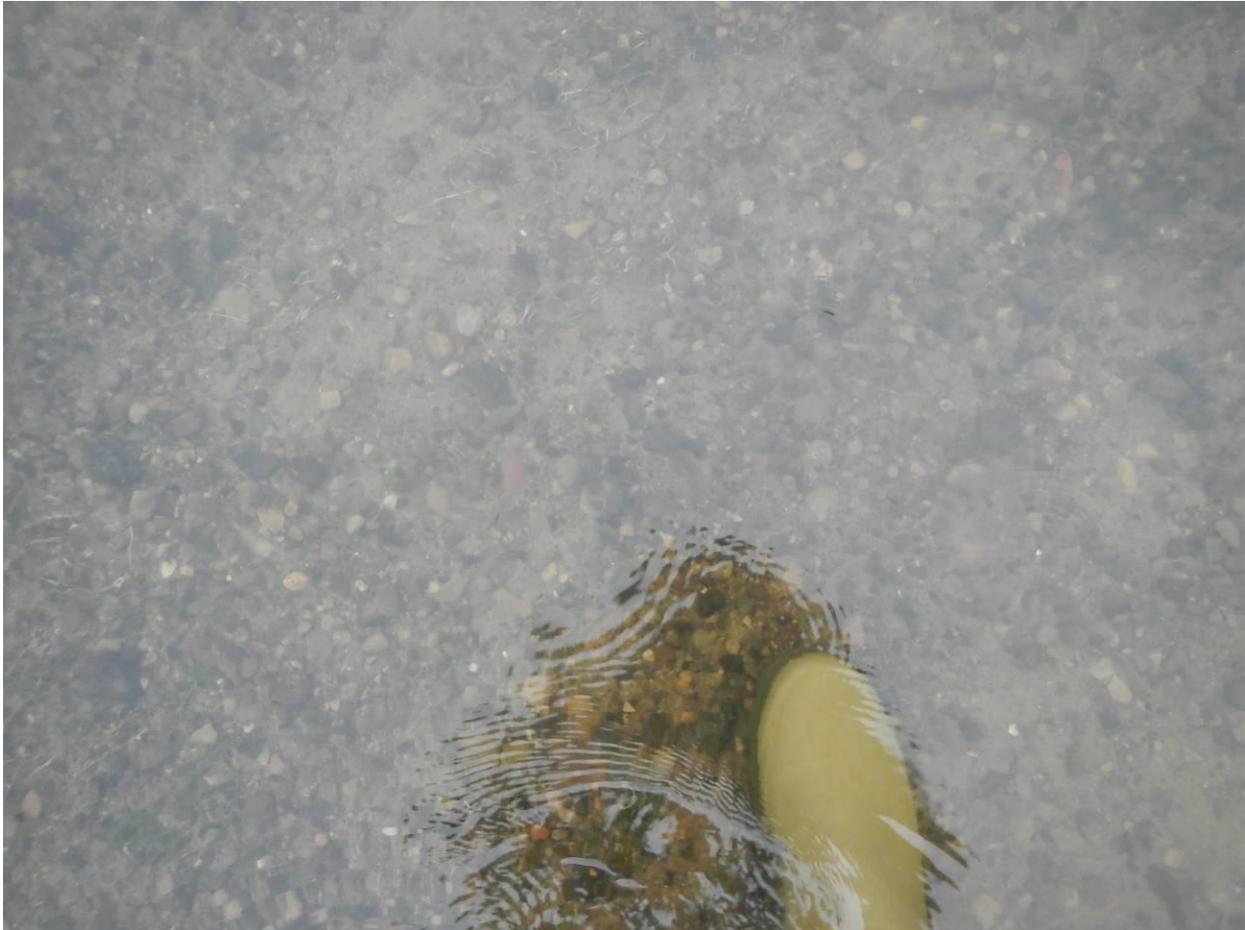
It is important to note that the gravels are heavily silted and of minimal use for salmonid spawning (Picture 1). This indicates that there is a significant sediment input to the River upstream, as described in areas on the Pont and Small Burn upstream. These issues must be addressed before significant improvements can be made to the in-channel habitat.

Picture 1. Gravel of a suitable size for salmonid spawning, but seriously compromised by high sediment loading (NZ1631274624).

The first issue that has to be addressed before any serious improvements can be made to wild fish production is sedimentation of the watercourse. It is understood that this is being tackled in conjunction with the Northumberland Rural Diffuse Partnership, which will be pivotal to any future improvements to the river.

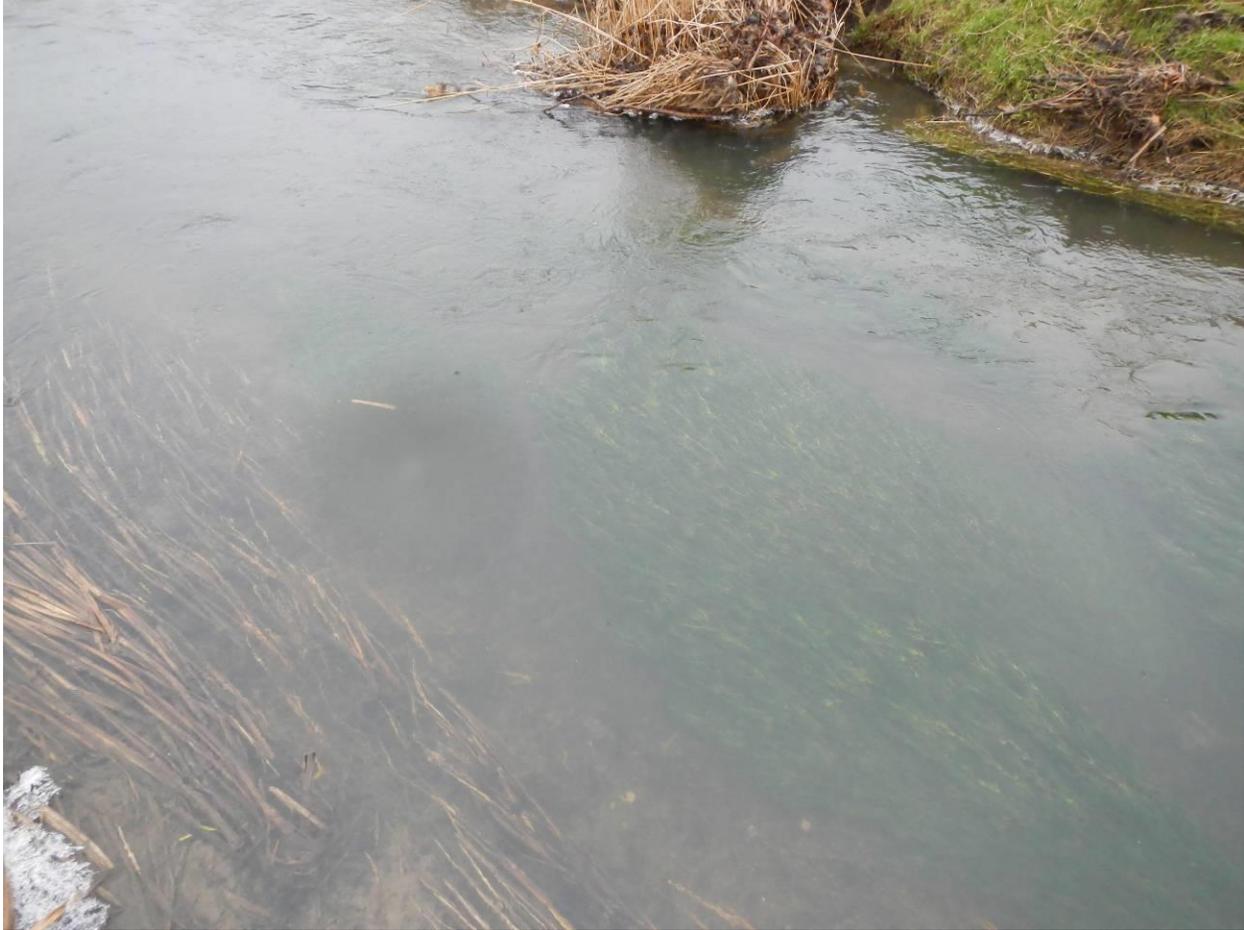
Habitat improves slightly downstream where the River is buffer fenced on both banks (NZ1619774839). Prevention of stock access has allowed areas of slumped bank to consolidate and re-grade. It has also allowed the river to begin naturally narrowing, through underwater sediment berms deposited along the margins (Picture 2). This increases the flow rate and has enabled water crowfoot to establish, which also takes up channel capacity and further accelerates the flow. These berms could be planted with willow whip cuttings to increase consolidation and assist channel narrowing.

Picture 2. Naturally narrowing channel with a sub-surface berm (left of the picture) that is being consolidated by emergent vegetation. The increased flow has benefitted the water crowfoot.

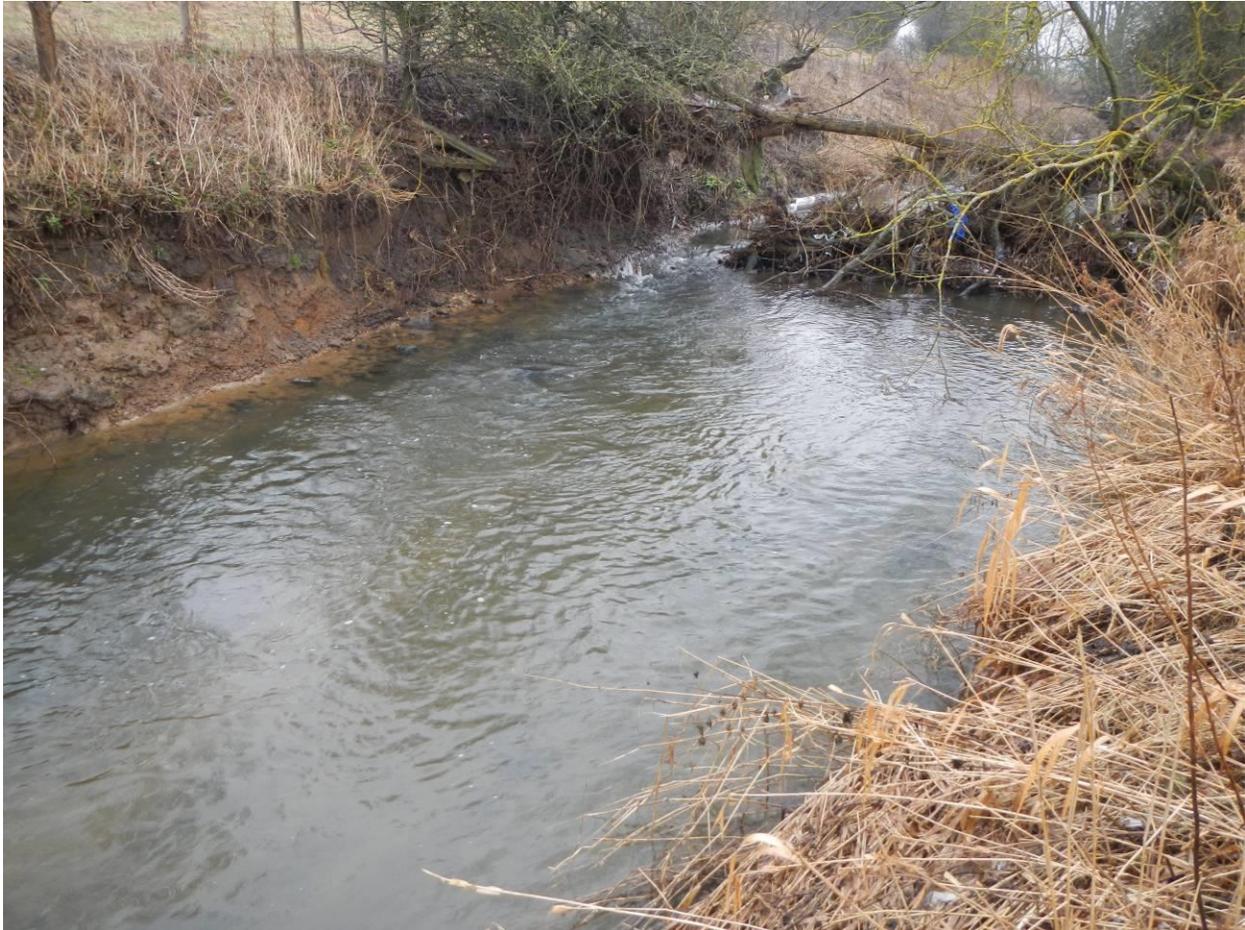
In the area around the Coldcotes Burn the buffer zone is larger and longer established, supporting a wider diversity of vegetation, including mature alder (*Alnus glutinosa*) and willow (*Salix sp.*). These not only provide valuable aerial and trailing cover within the channel, but also a good source of large woody debris (LWD) (Picture 3). This type of in-channel structure is likely to be removed in other areas of the system to reduce flood risk, but should be retained wherever possible to create flow diversity, scouring and gravel sorting.

Picture 3. Beneficial LWD, but is causing erosion due to the steep bank. While the flow created is beneficial, the situation could be improved by anchoring the butts of the branches to the bank and allowing them to slew round and rest along the bank. Willow whips could then be planted along the erosion scar.

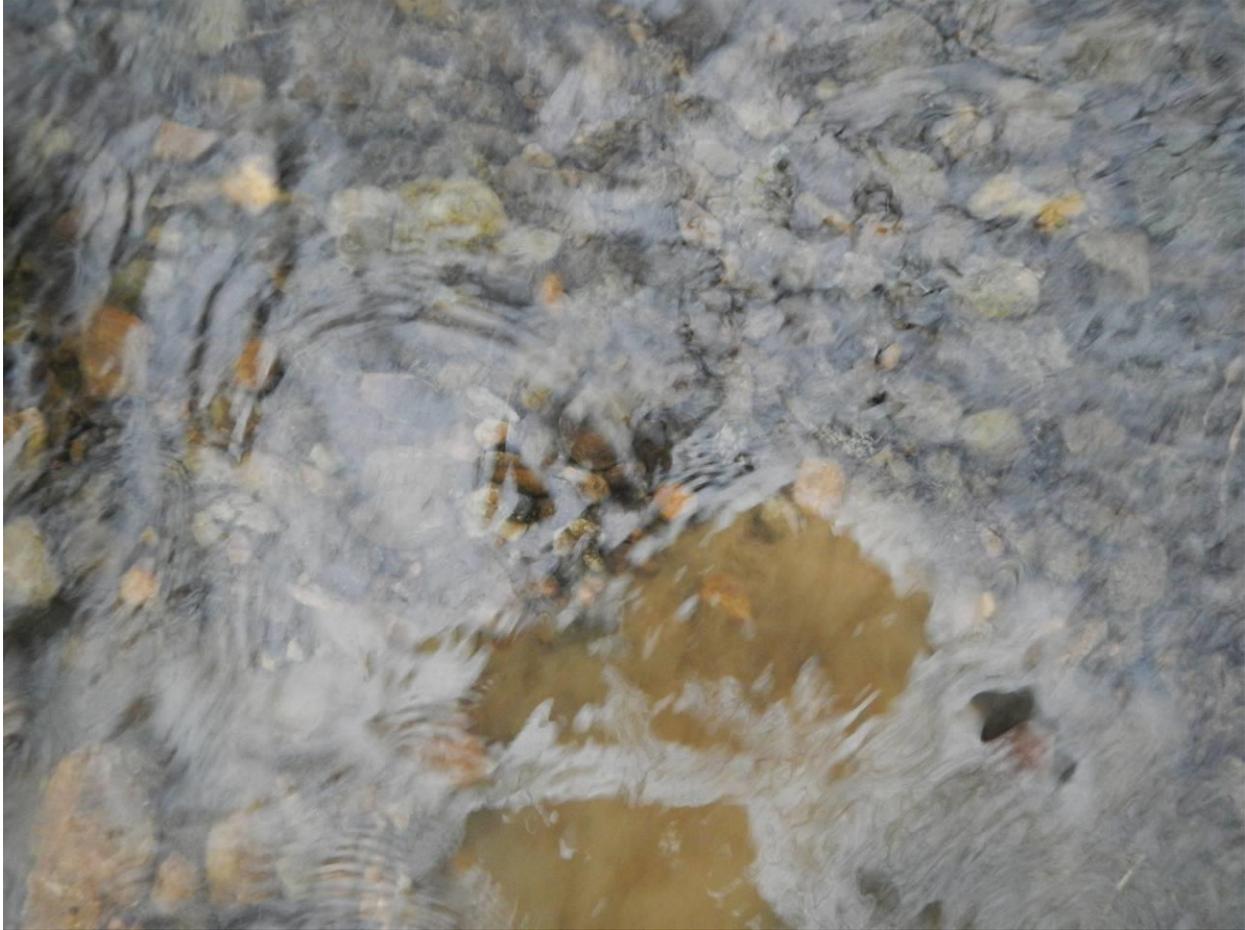
As with the main channel, the Burn bed had a high sediment component which needs to be addressed. If the sediment inputs can be reduced, the Burn appeared to have a real potential for partially mitigating the lack of spawning habitat in the area.

Picture 4. The bed of the Coldcotes Burn, just upstream of the Pont. The substrate was of a suitable size for spawning, but overly silty, as can be seen by the brown plume.

The Small Burn is covered in a separate report, but it is recommended that the Coldcotes Burn (NZ1598775188) is investigated further. The Burn appeared to have significant potential as a spawning tributary, but the quality of the gravel was compromised by high sediment loading.

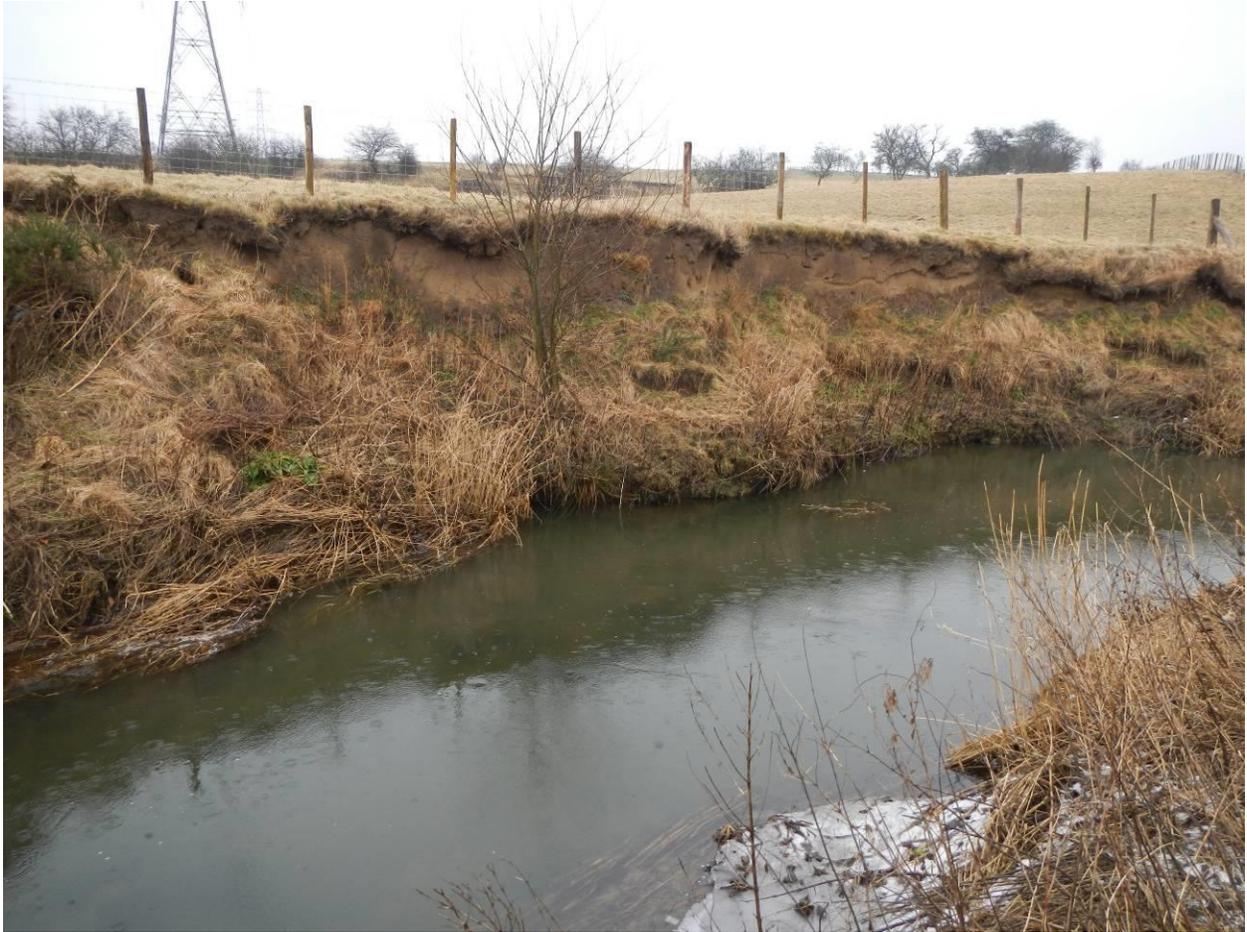
Due to the extent of past dredging work on the Pont, and depth of channel incision, many areas of the riverbank were subject to slumping (Picture 5). This is the natural way that the river will re-profile the bank to a more natural gradient, but without suitable vegetation and tree cover to provide a good root system this effect can be lost. In fenced areas with good vegetation cover the bank has a good chance of stabilising before it is washed away.

Picture 5. Slumping bank that is naturally starting to consolidate.

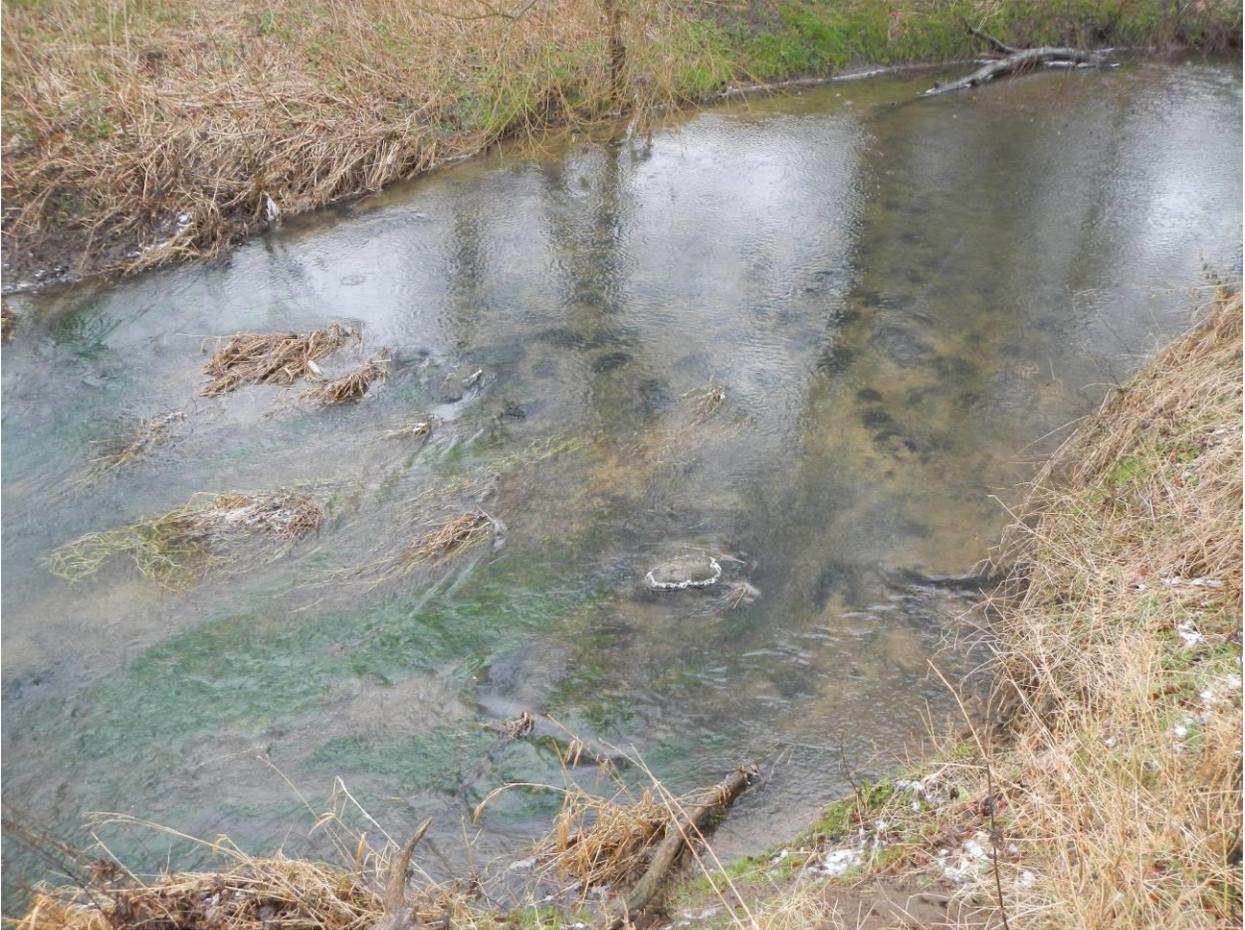
In this area the spoils of dredging were evident along the banktop, but some parts of the riverbed retained more-natural substrate. The habitat of this area could be greatly improved with the installation of a gravel riffle, but again, until the sediment input issues are tackled the benefit is likely to be inhibited (Picture 6).

Picture 6. Possible site for gravel riffle re-instatement. Note that even though the channel is relatively shallow, with a fast flow, there is still excessive sedimentation of the bed (NZ1630374655).

- NZ1630374655 - NZ1630374655 (numerous locations along straightened section)
- NZ1630374655 – Picture 6

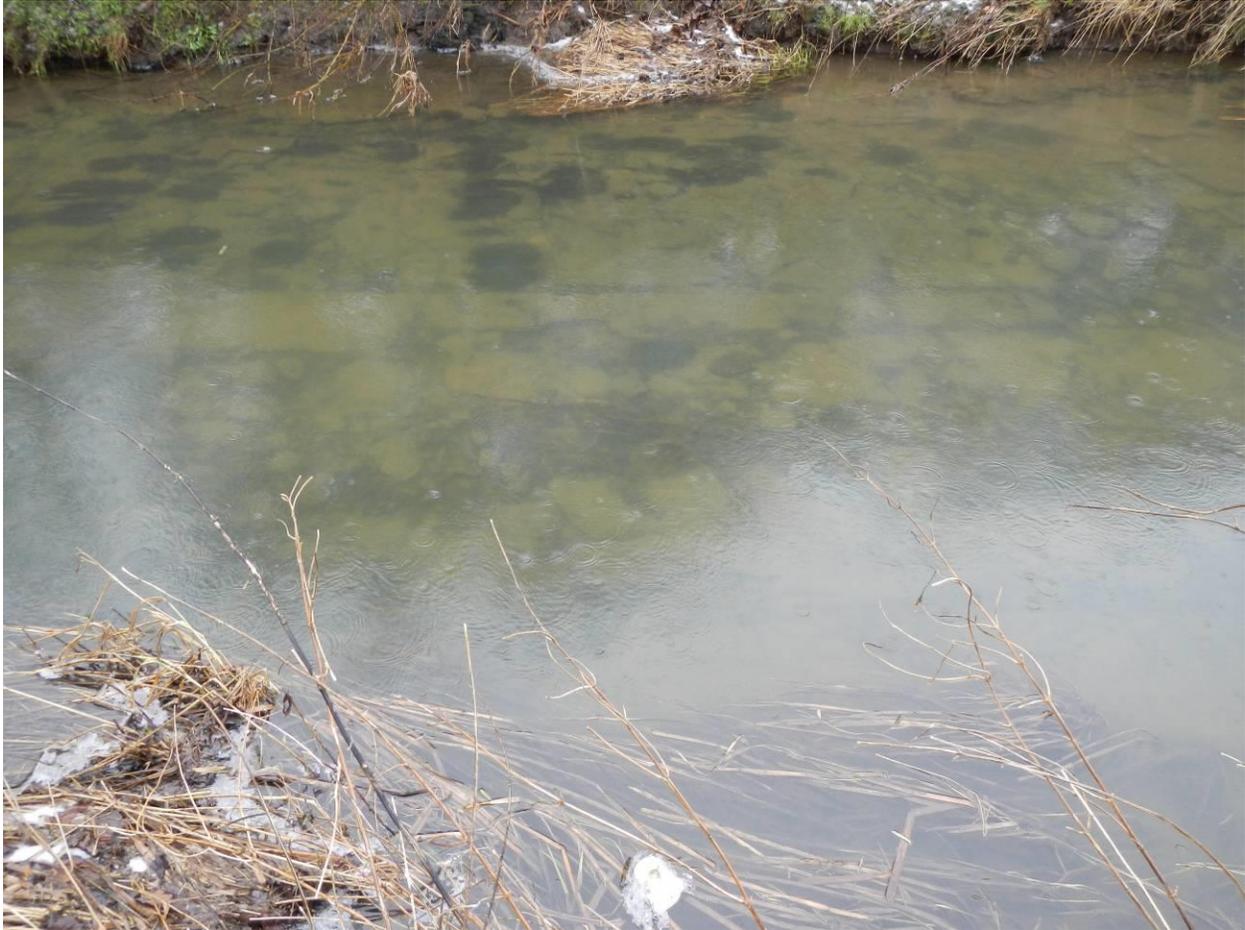
From this point downstream, the level of dredging and incision varies, but is significant, until a point where bedrock becomes evident (NZ1603775742), which will have prevented further dredging for a short section (Picture 7). This area would also benefit from gravel introduction.

Picture 7. Exposed bedrock on the river bed.

- NZ1630374655 – Steep section of straightened river, but has sufficient gradient to create salmonid spawning redds
- NZ1594775646
- NZ1603775742 – Area around exposed bedrock (Picture 7)
- NZ 16296 76436 – Horse field u/s picture 10.

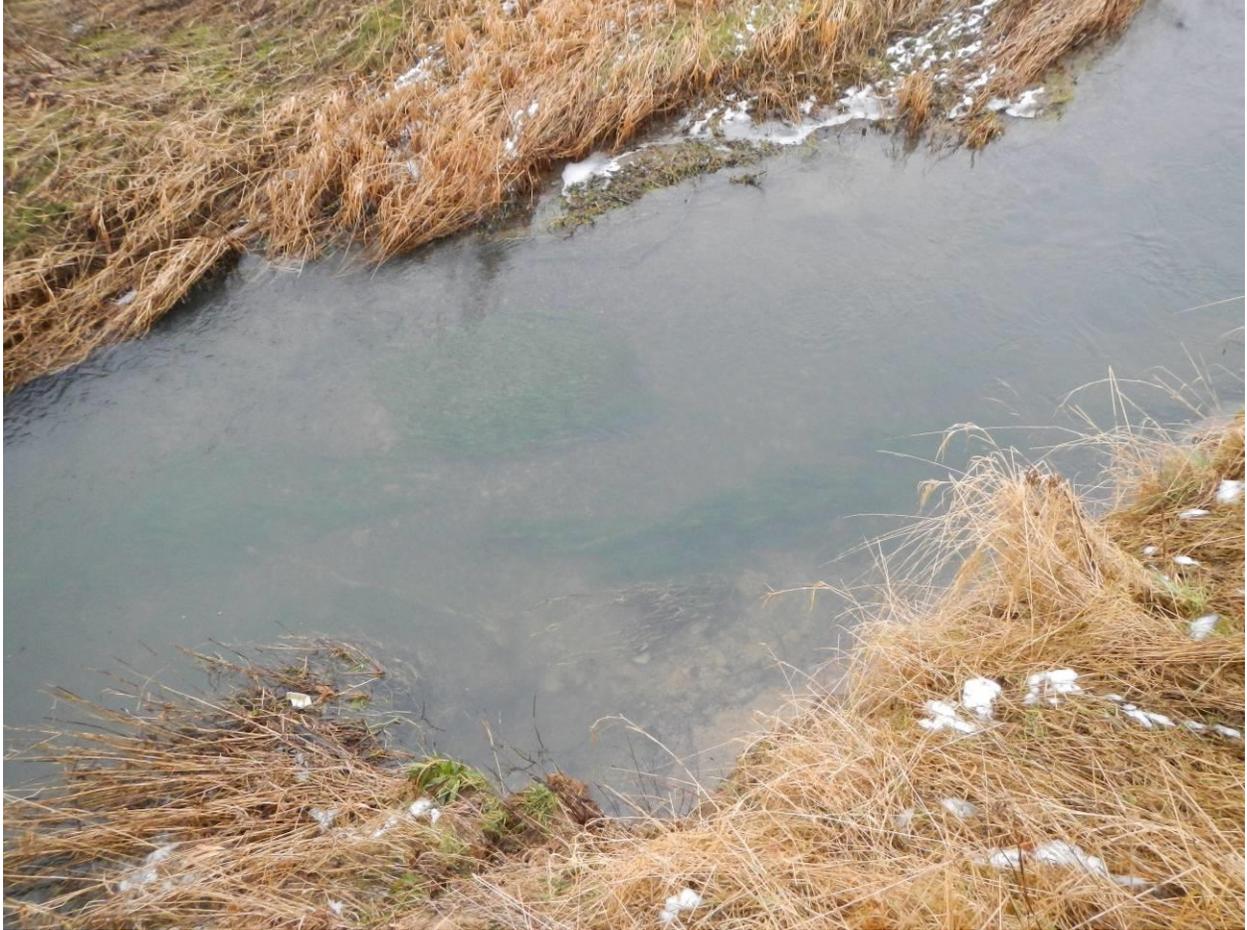
Much of the Pont at in this area remains subject to intermittent, deep dredging, but where the dredging is reduced and some sinuosity remains to the channel, the habitat improved. In these areas water crowfoot and some cleaner gravel was observed (Picture 8).

Picture 8. Healthy beds of water crowfoot and some gravels, where the dredging is less extensive.

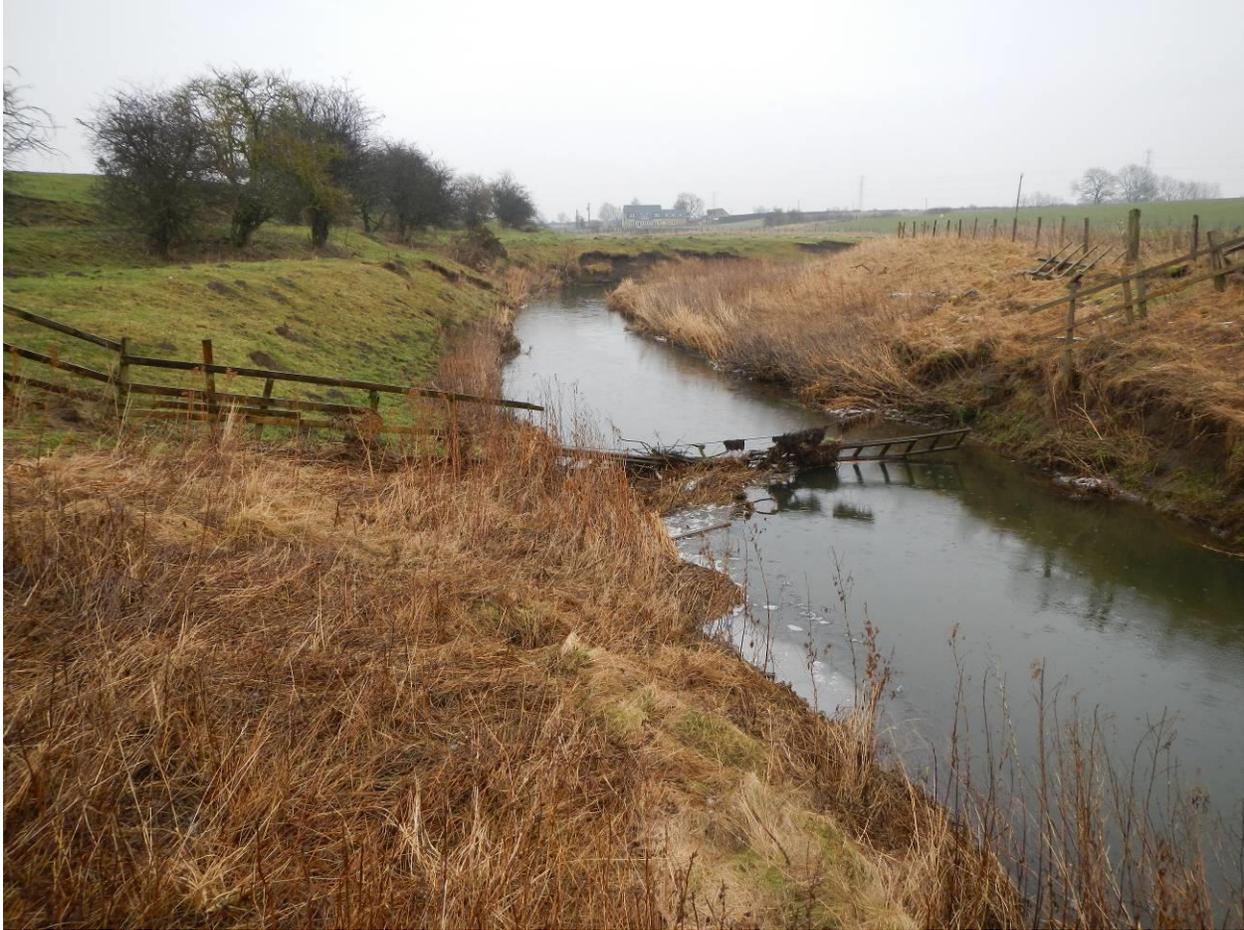
Below this section the RB continues to be fenced, but fencing on the LB ceases at a watergate. From this point, stock access begins and the effect is immediately evident (Picture 9, NZ1632276439). The level of marginal vegetation diminishes and the level of bank erosion greatly increases.

Picture 9. Contrast between the well vegetated foreground and RB, and grazed, eroding LB. The reduced root mass of the grazed land provides less stabilisation for slumped areas, which are likely to wash away before they can become consolidated. (Compare with picture 5 where greater vegetation cover exists and consolidation is occurring) The apparent terraced area in the top left of shot comprised of river dredgings.

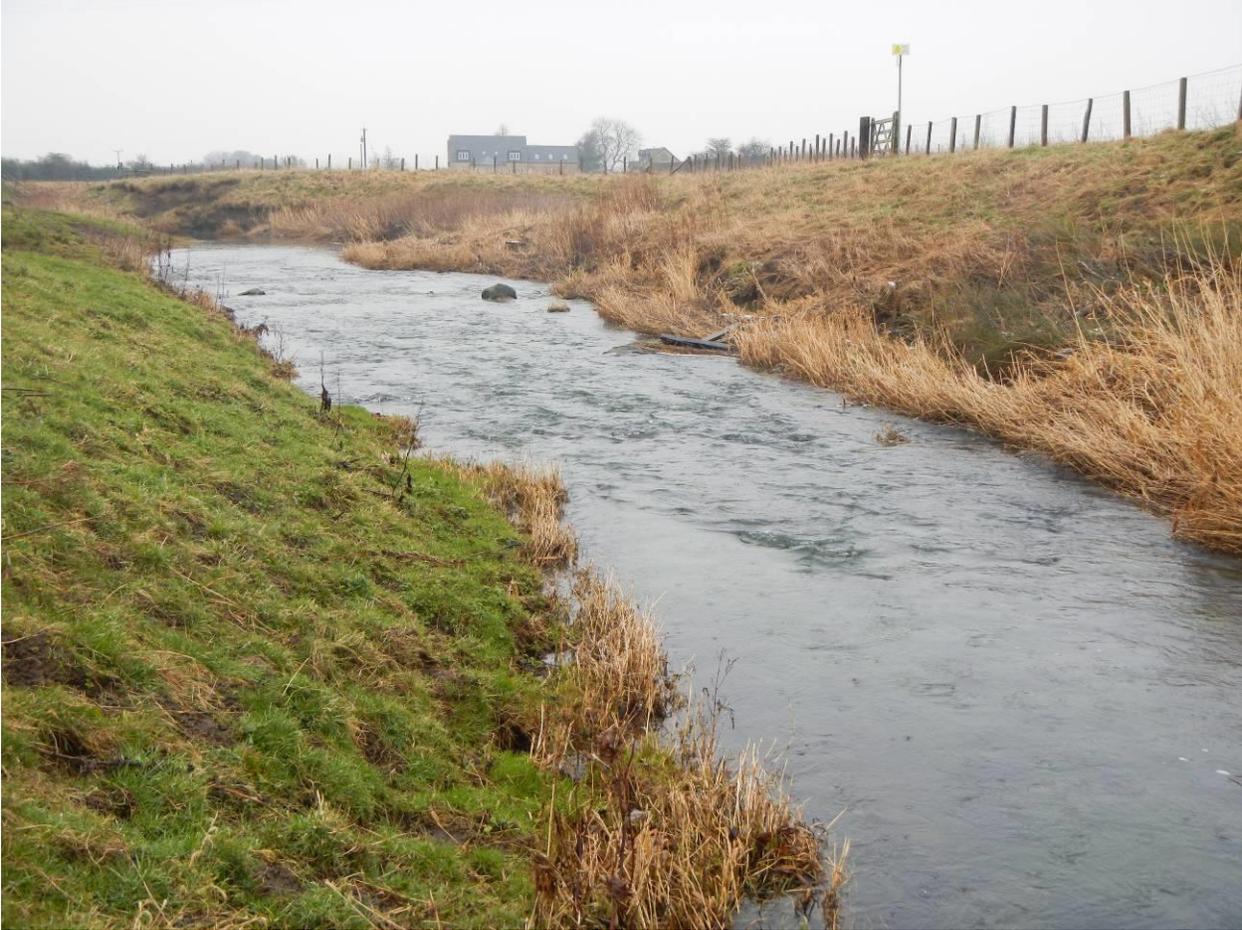
Approximately 150 metres further downstream of the watergate, the level of dredging appears to decrease and the level of incision decreases. Consequently the bed increases in diversity, with gravel bars producing riffles and areas of faster water (Picture 10, NZ1634476450). If livestock could be fenced out of this area the habitat would greatly improve naturally to an extent where the bed may provide some potential for salmonid spawning.

Picture 10. Area of channel with grazed bank that could be greatly improved through stock exclusion. This would allow encroachment of marginal vegetation as is occurring on the fenced RB, naturally narrowing the channel and aiding gravel cleaning/sorting.

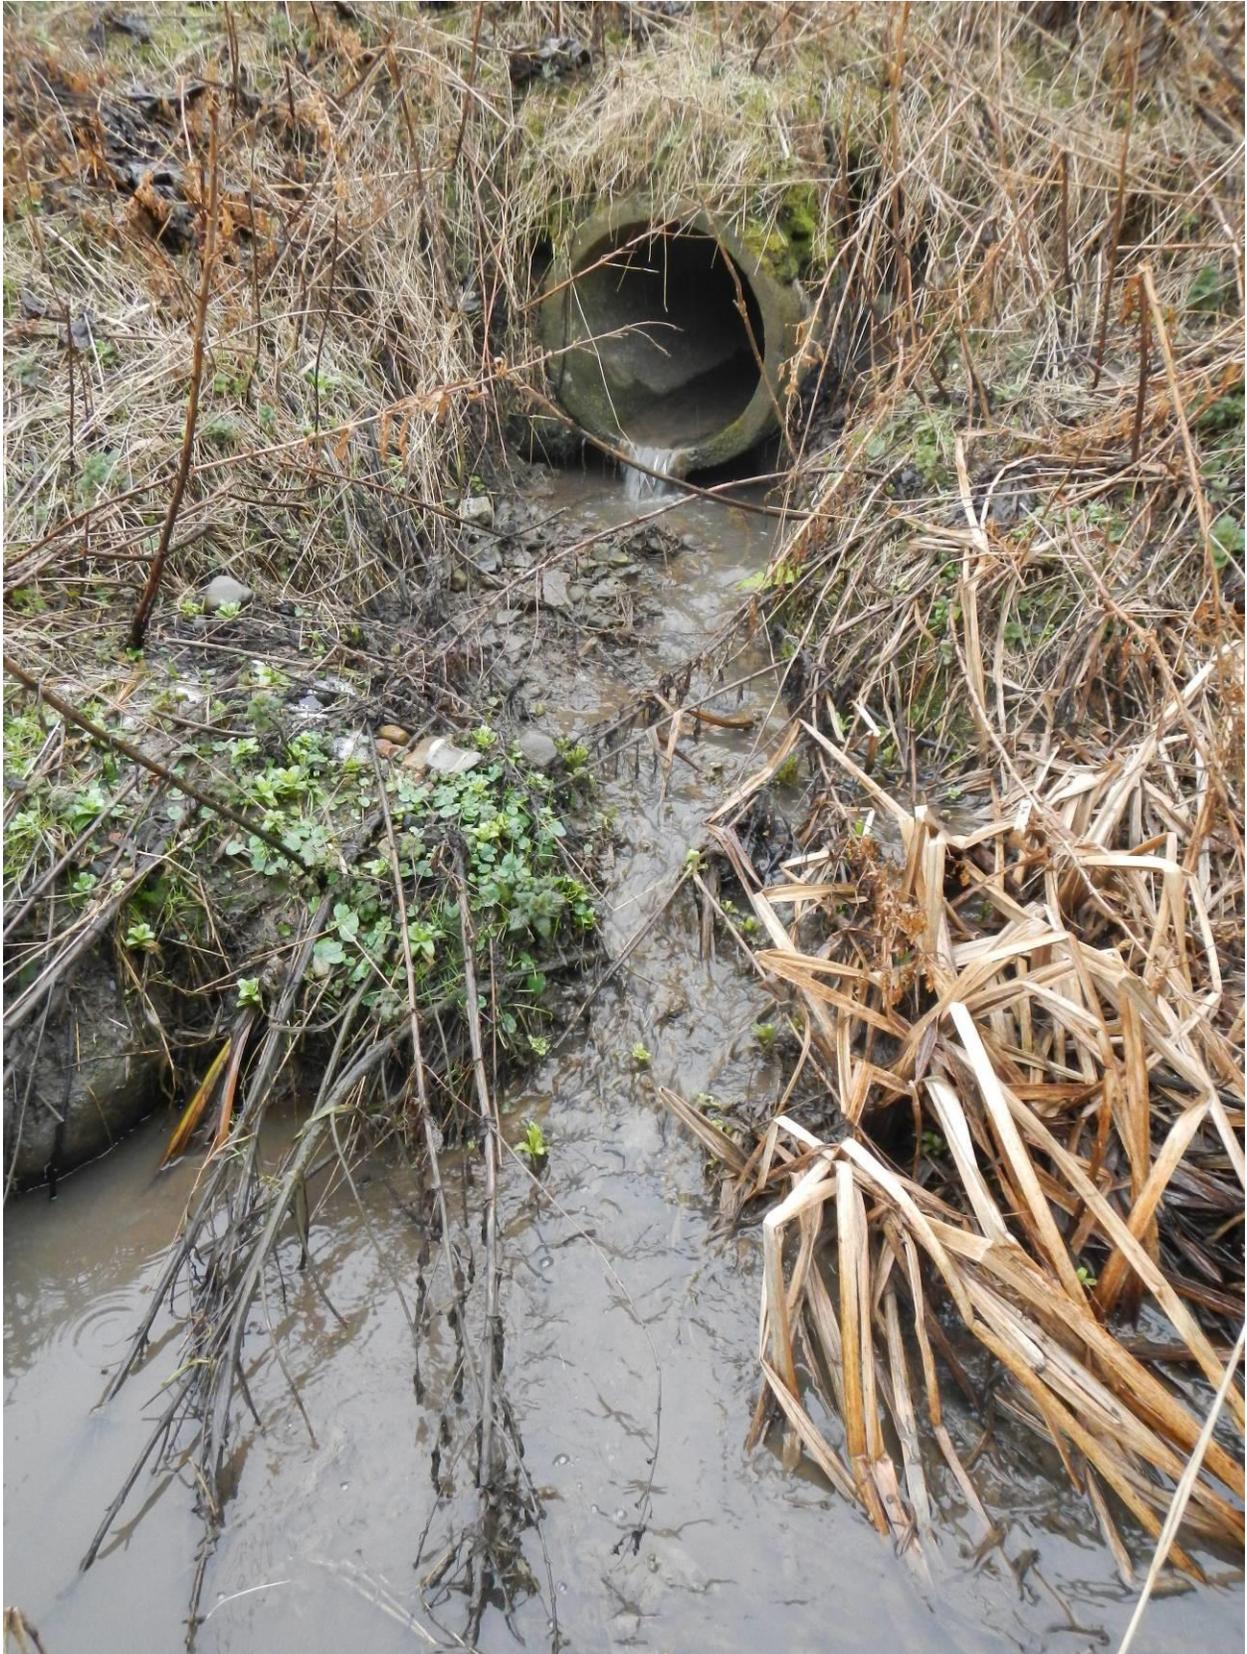
Downstream of this point, to Kirkley Mill Bridge, the channel was more heavily dredged and the habitat reverted to a much poorer quality. At the upstream side of the bridge there was a notable pollution source. A small pipe was discharging a grey plume into the river, with a localised proliferation of sewage fungus on the bed and vegetation (Picture 11, NZ1661476629). This obviously warrants further investigation with mitigation if appropriate.

Picture 11. Discharge to the river with notable odour and sewage fungus.

The discharge at Kirkley Mill (NZ1661476629) should be investigated as it appeared to be of a high organic content and was supporting a significant accumulation of sewage fungus.

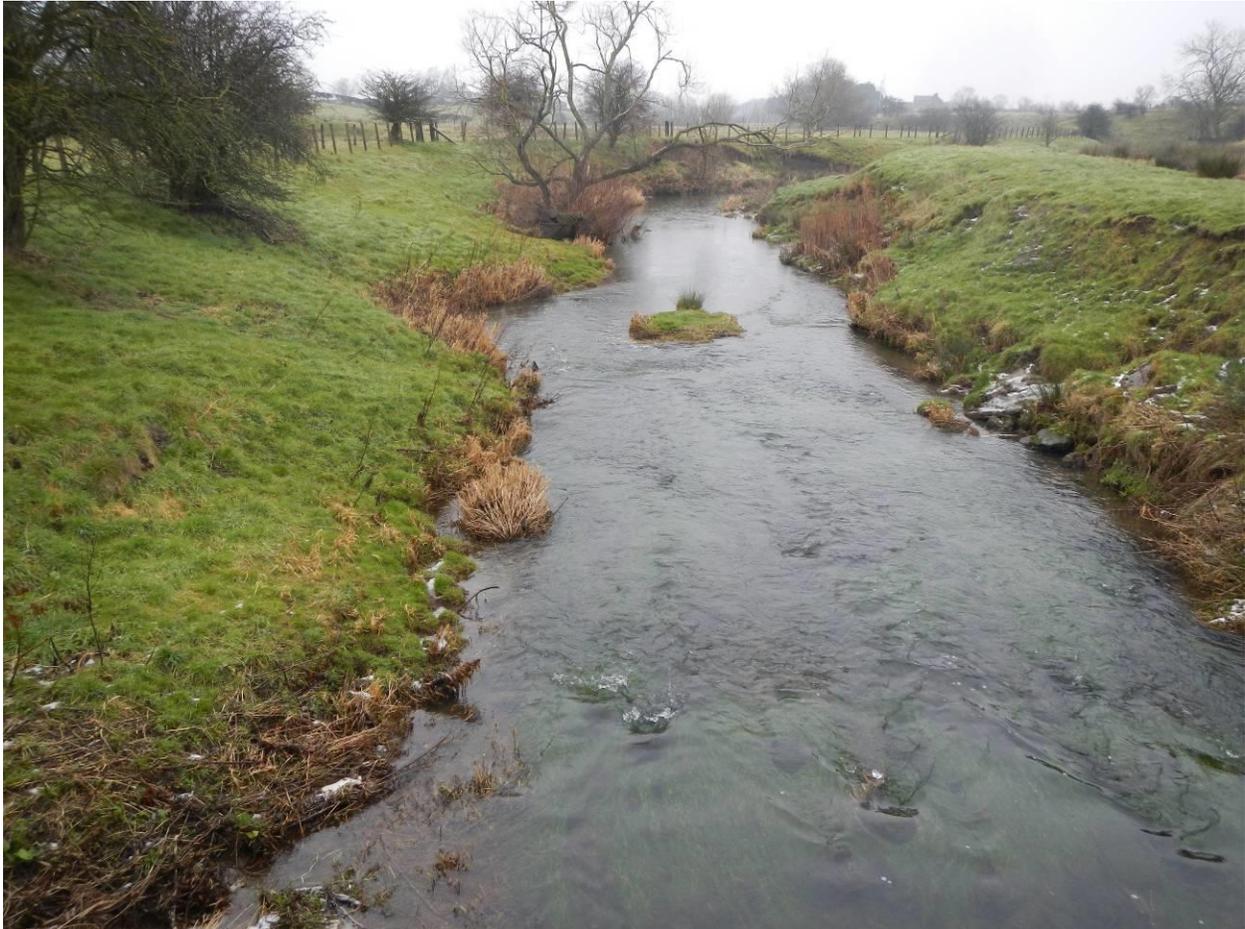
Below the bridge the fencing regime changed, with the LB being fenced and the RB not. The lack of vegetation on the LB suggests that stock from the RB are crossing the river and grazing the LB, giving increased importance to stock exclusion from the RB (Picture 12).

Picture 12. Evidence of grazing on both banks, although the LB is buffer fenced.
