Pont and Blyth Investigation

River Pont - from source to Fenwick Burn

(Waterbody ID - GB103022076850)

Date 07/03/12

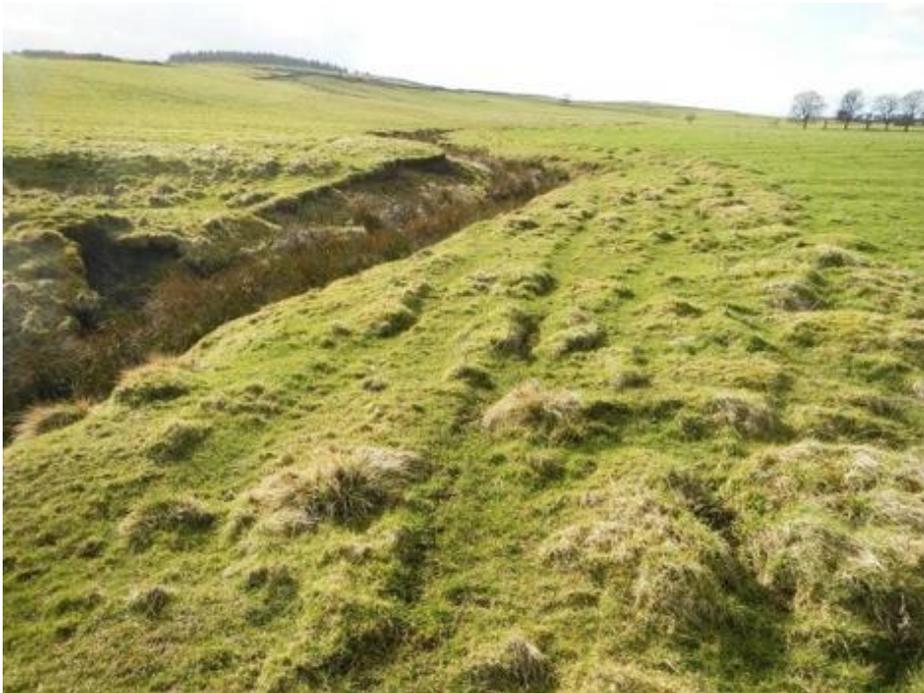
Picture 1. Dredged, straightened and incised river channel, with a lack in tree cover and the bank protection they provide. Erosion scarring from sheep can also be seen, with the bare earth further contributing to sedimentation of the watercourse.

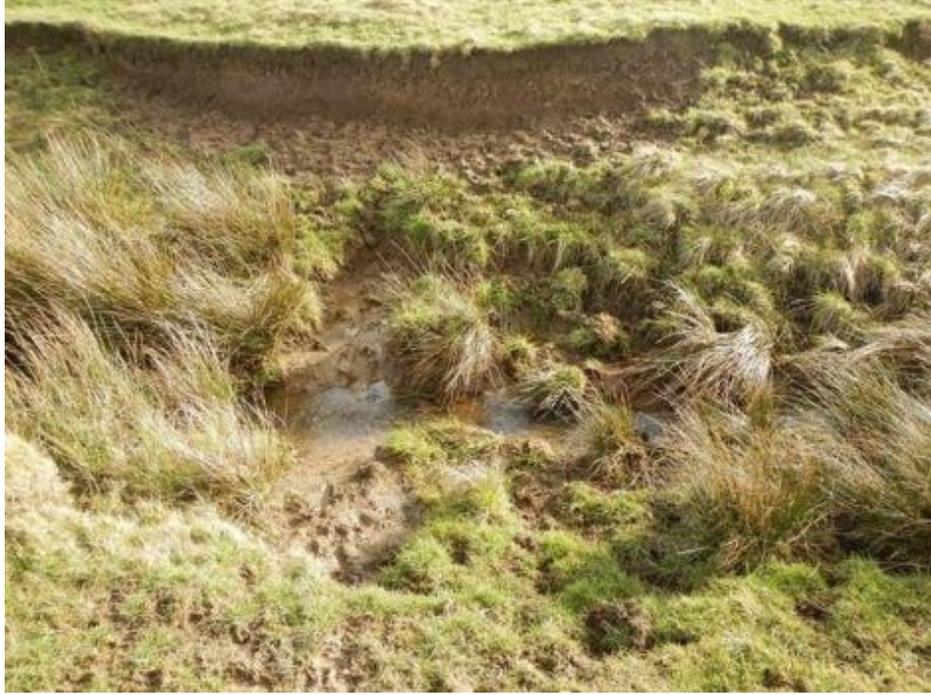
The unrestrained livestock access to the water is also resulting in multiple crossing points, which also vastly increase the sources of sediment (Picture 2). Buffer fencing would greatly reduce the sediment input from this area, although some would still be inevitable, due to the dredged, earth bed.

Picture 2. Livestock crossing point and sheep erosion scarring (NY9841769500).

- NY9841769500 - Picture 2, and fields upstream
- NZ0049269488 – Picture 13, large area of poaching around drinking pond
- NZ0138670320 - Picture 19
- NZ0183270796 – Picture 24 & 25
- NZ0076471030 – Next field u/s of picture 27
- NZ0091470969 – Picture 27
- NZ0229571031 - Picture 29

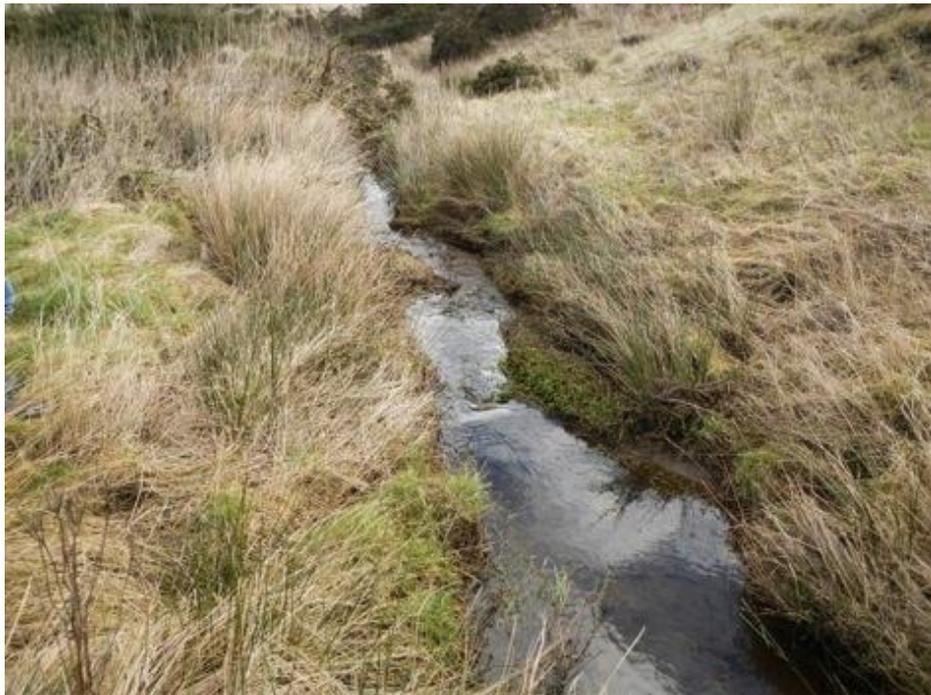
Picture 3. Typical of the habitat between the A68 and the gorge c.250m downstream.

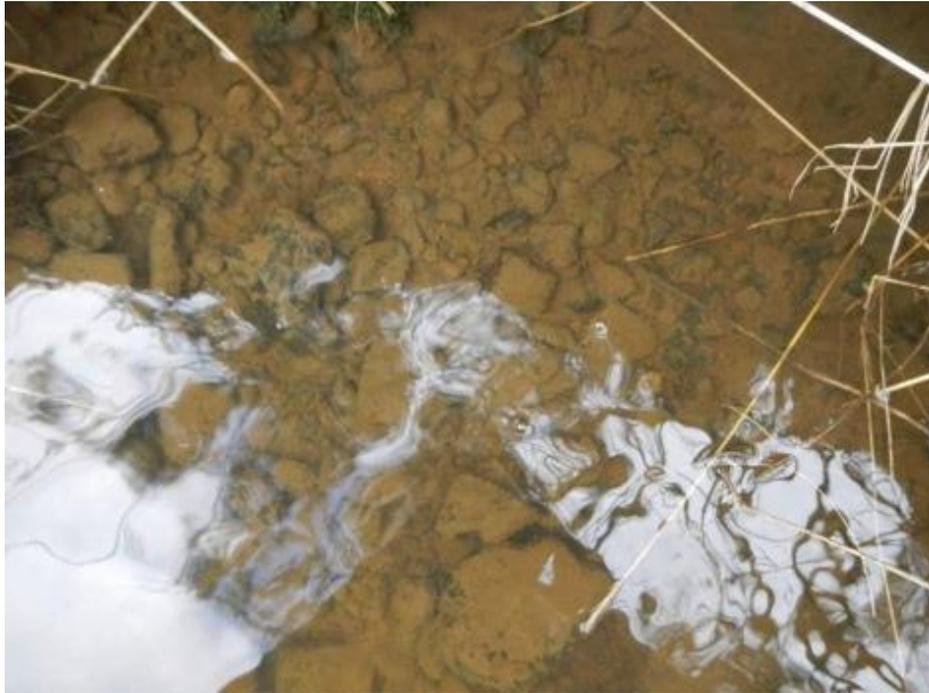
Picture 4. Heavily silted gravel and cobble substrate, as was common throughout most of this waterbody.

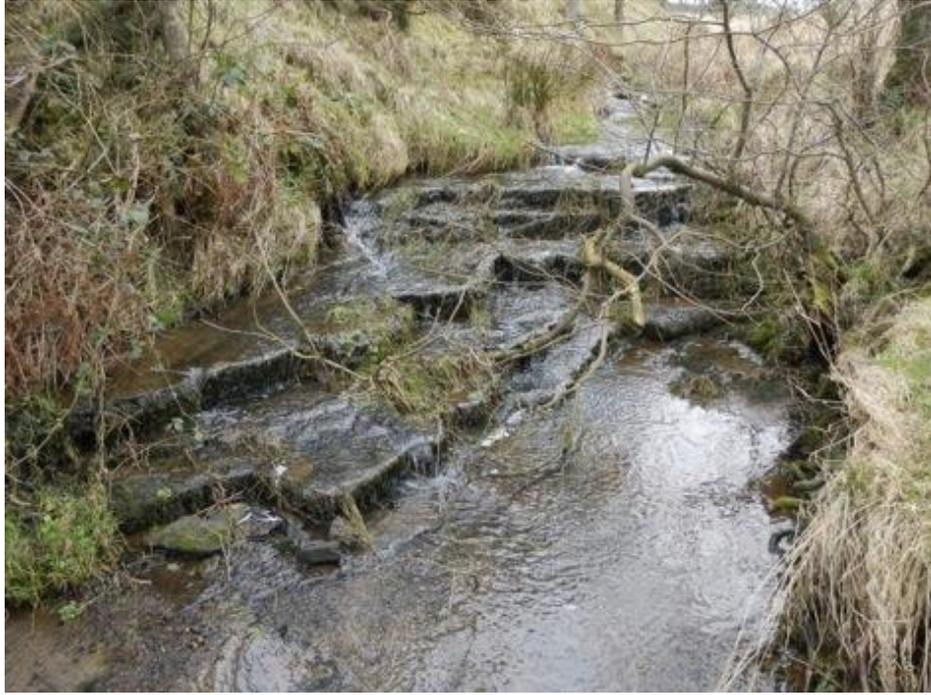
c.250m downstream of the A68 the river enters a deep, steep sided, wooded gorge, flowing over bedrock shelves (Picture 5). While these shelves were not impassable to salmonids they would be a significant behavioural barrier, only passable in certain flows.

Picture 5. One of several bedrock steps within the gorge.

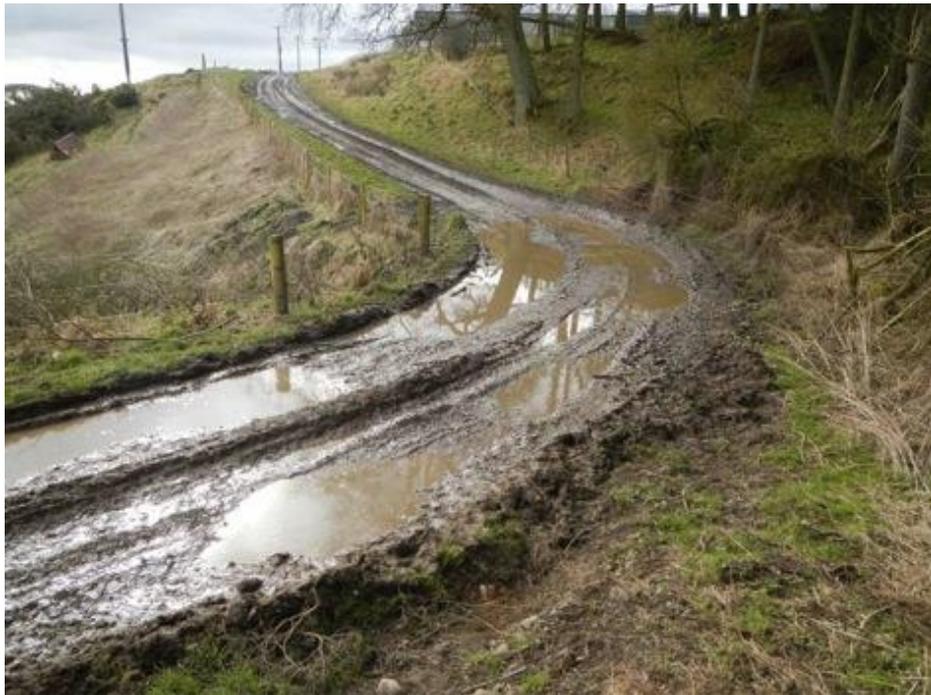
The gorge opens out into unimproved pasture at the downstream end, where a farm access track crosses the River. This is also a significant sediment source in wet conditions (Picture 6).

Picture 6. Farm access track over the River, which provides significant sediment input (NY9903269621).

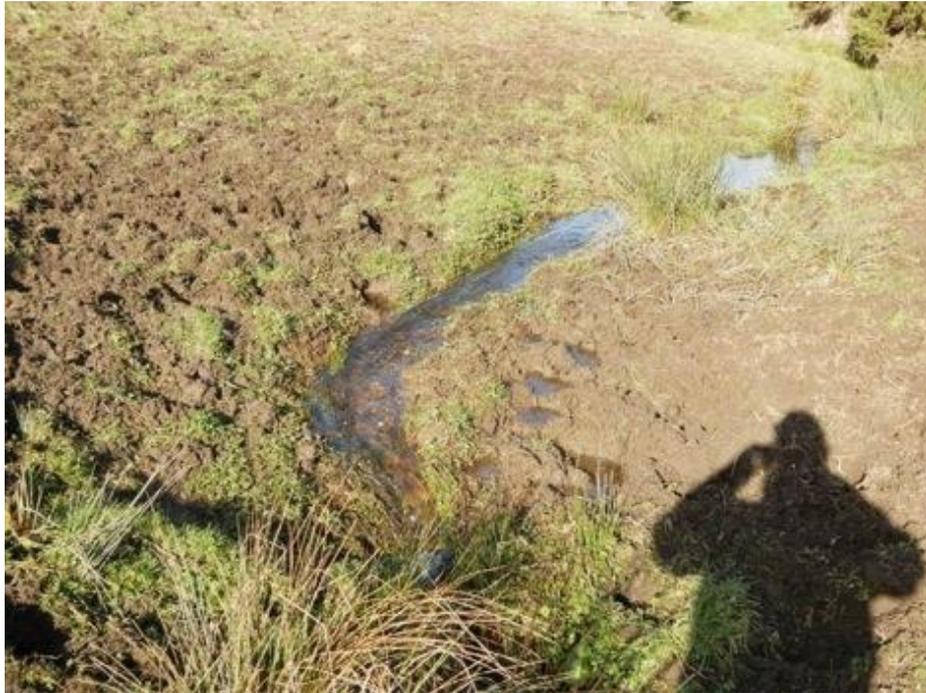
The first two fields below the gorge were grazed by horses, which had unrestrained access to the watercourse in many areas, although gorse bushes along the bank did provide some protection. Where they did have access heavy poaching and sedimentation of the watercourse were observed (Picture 7). Various cased caddis

Picture 7. Poaching and sedimentation through horse access to the watercourse.

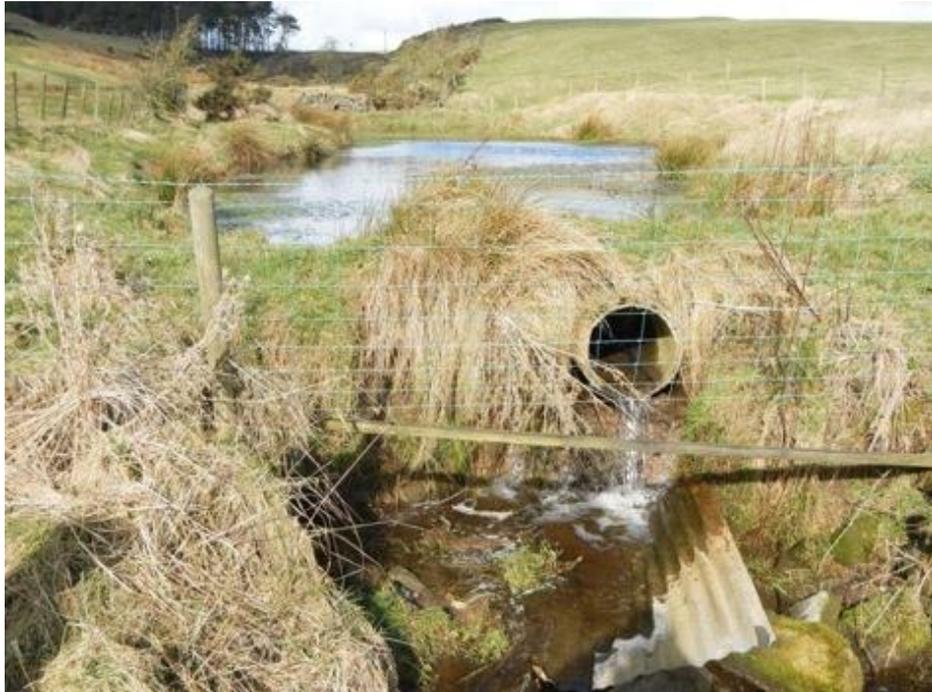
At this point (NY9933469377) the first of two major barriers were observed, a large ponded area of the River, created by a pipe dam (Picture 9). This creates a vertical drop of c.60cm, with no depth below, making it impassable to all fish species. A short distance below this was a second sluice structure, which is no longer in operation, but is also likely to have created a barrier to fish passage (Picture 10).

Picture 9. Pipe dam (c.60cm) creating a complete obstruction to fish passage. The downstream end of the wooded gorge can be seen in the background.

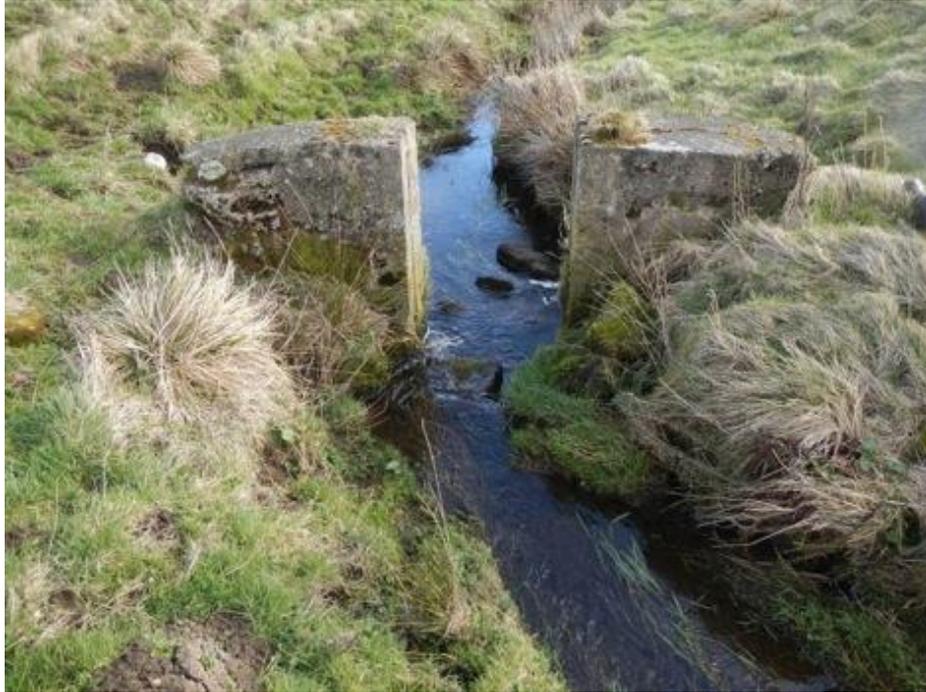
Picture 10. The remains of an old sluice, the walls of which were >120cm and is likely to have created a barrier to fish passage when in operation.

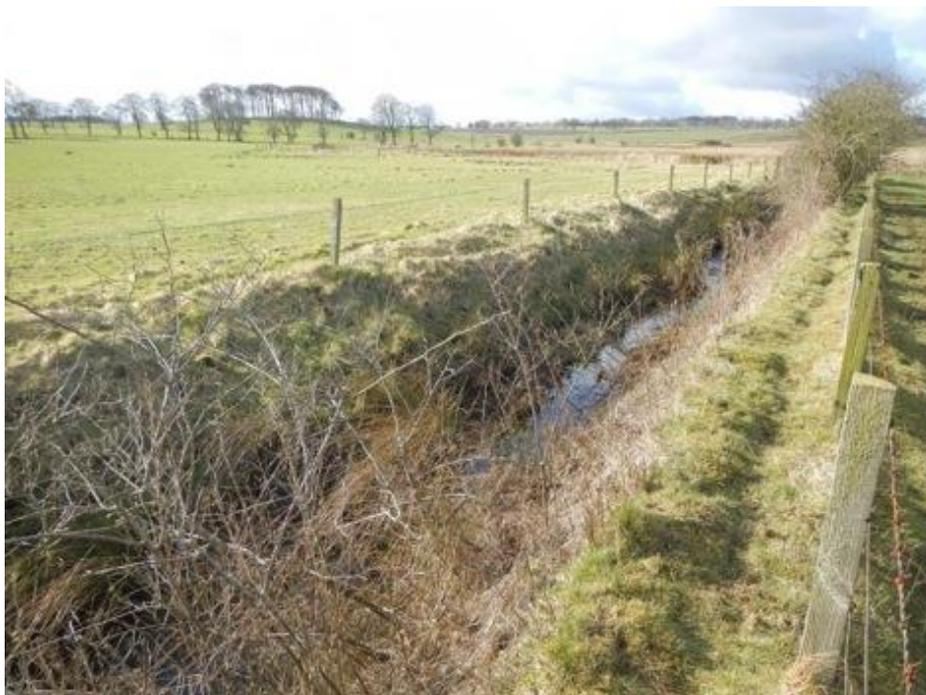
Picture 12. Typically straightened and dredged channel.

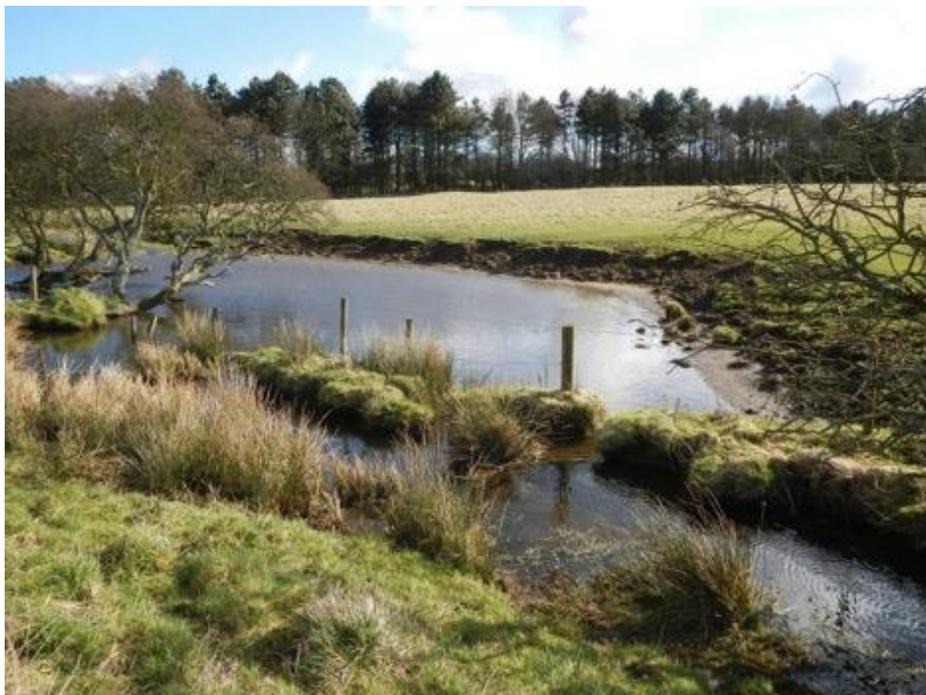
This was further demonstrated in a large pool, presumably created for cattle watering, where large volumes of sediment had accumulated. This could be beneficial in lower flows, trapping silt and suspended solids, and preventing their transportation downstream. However, poaching around the pool will also be contributing to the problem and there may also be issues in high flows, when greater flows entering the pool could re-mobilise large volumes of silt, and heavily silted areas were observed downstream (Picture 15).

Picture 13. Large pool that is acting as a silt trap.

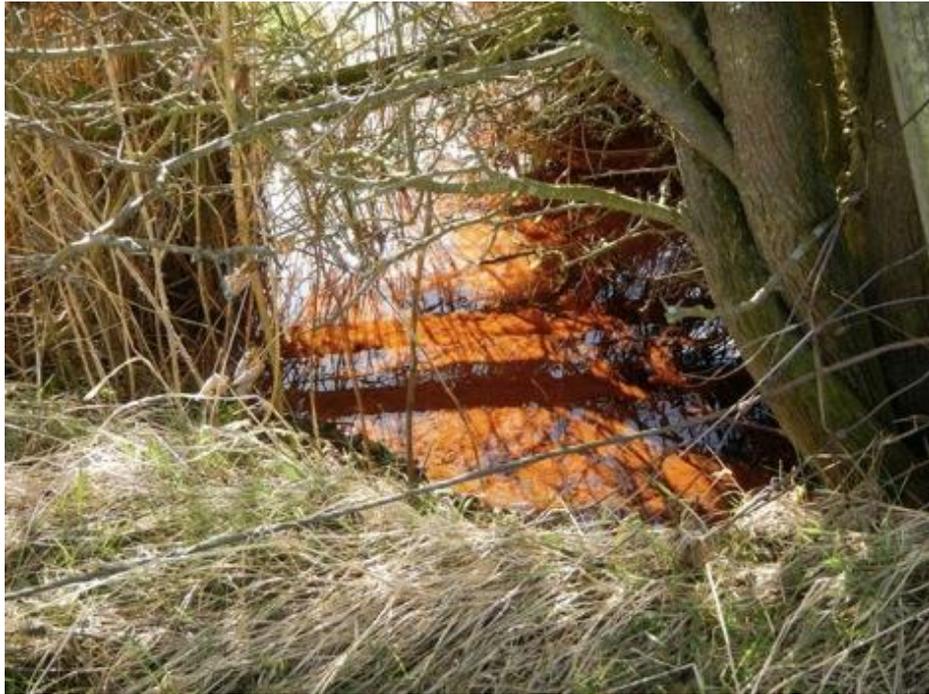
Along the LB of the pool an ochreous discharge was noted (NZ0053969516). The size of area affected and the volume being discharged to the river did not appear to be having an affect on the watercourse, but the area affected was quite noticeable (Picture 14).

Picture 14. Ochreous discharge entering the river.

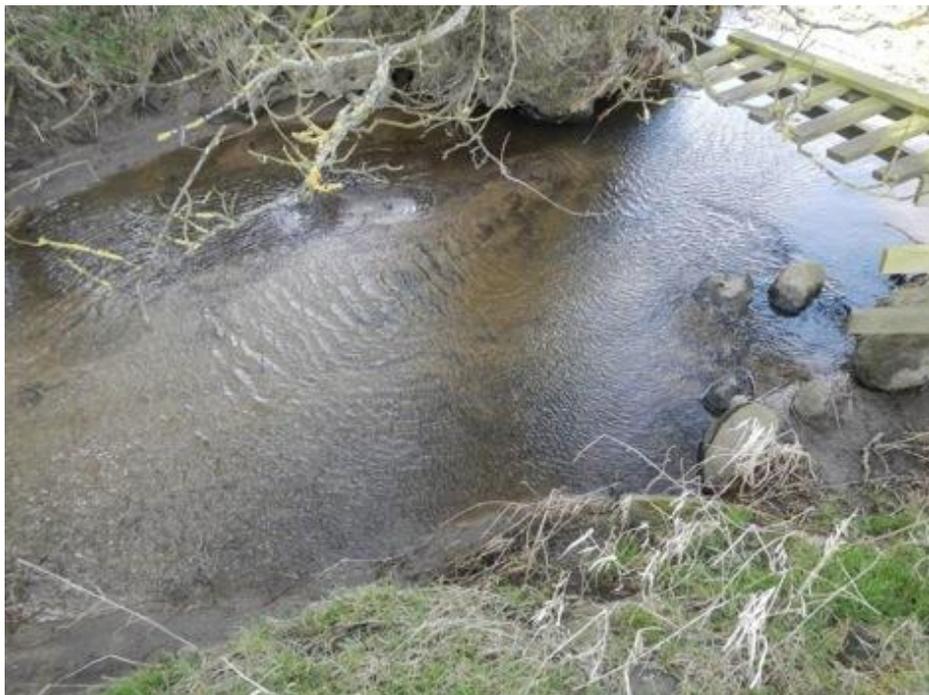
Picture 15. Heavily silted area, with no natural coarse substrate visible on the bed.

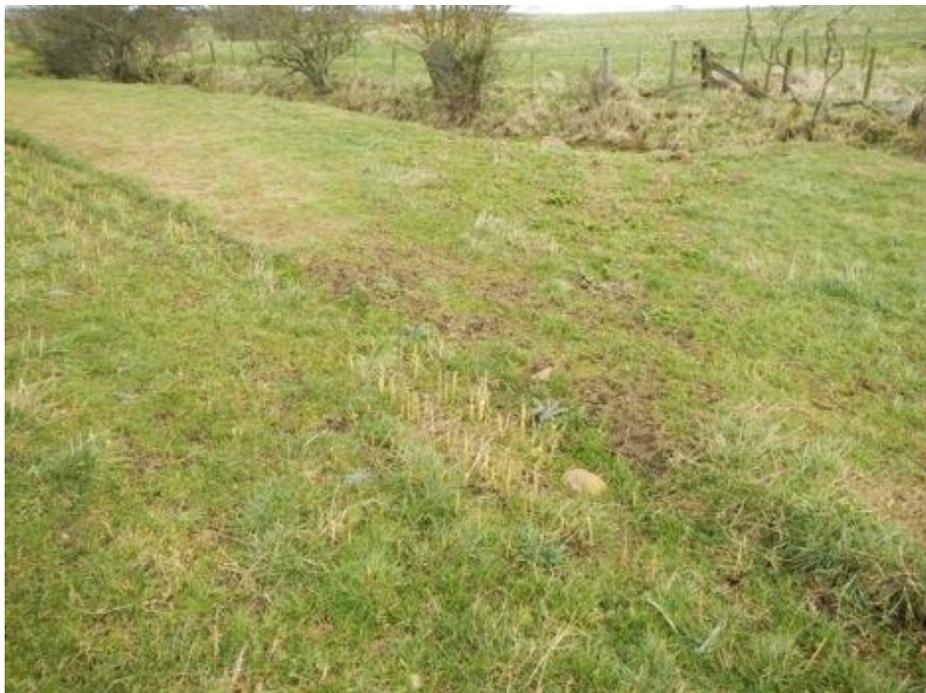
A short distance downstream on the LB was an arable field where a filed margin gutter appeared to have been connected directly to the river via a sub surface drain (Picture 17, NZ0107270026).

Picture 17. Probable sub surface field drain.

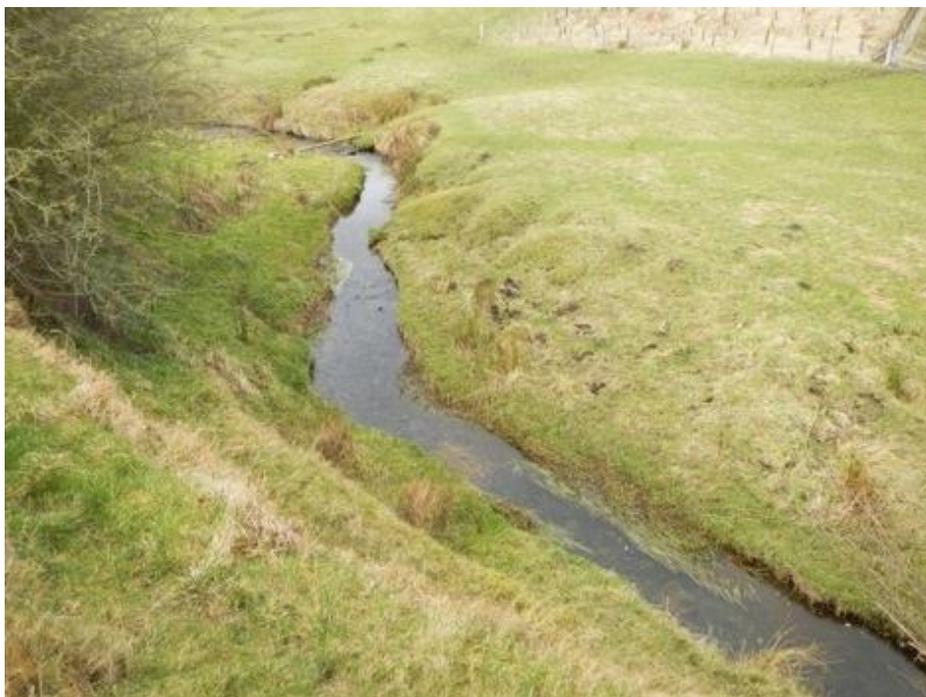
Whittington Mill was heavily grazed and here exclusion of livestock from the river would be beneficial (Picture 19, NZ0138670320).

Picture 19. Well-grazed area upstream of Whittington Mill.

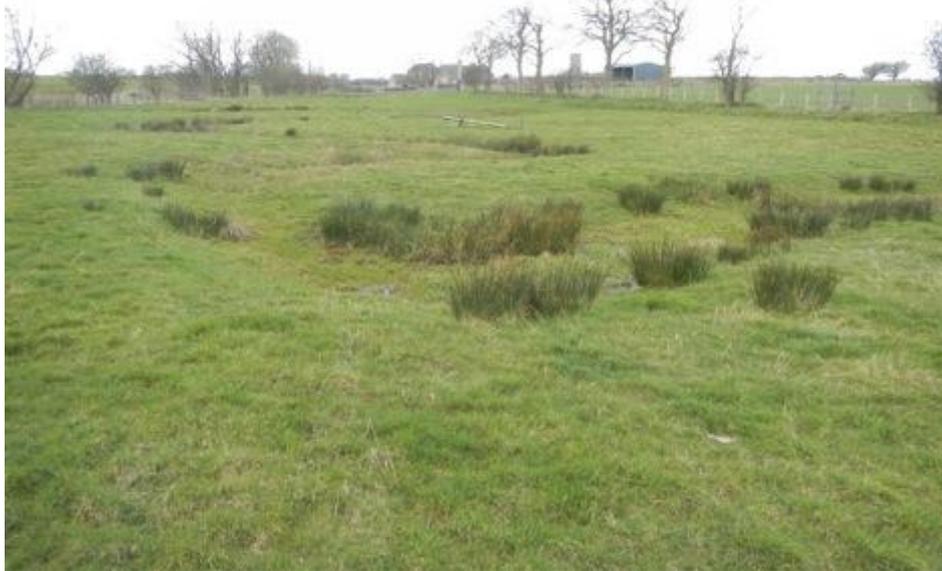
Downstream of Whittington Mill the River was again seriously realigned, with the sinuous natural channel clearly visible through the LB field (Picture 20, NZ0162570409) (also visible on Google maps). This could be the ideal site for a river re-alignment project.

Picture 20. Low-lying ground that represents the old river course.

The reach downstream of Whittington Mill NZ0162570409 (Picture 20) would also greatly benefit from re-meandering. Here the River could be easily returned to its old course relatively, as the relic channel is still visible in the field on the LB.

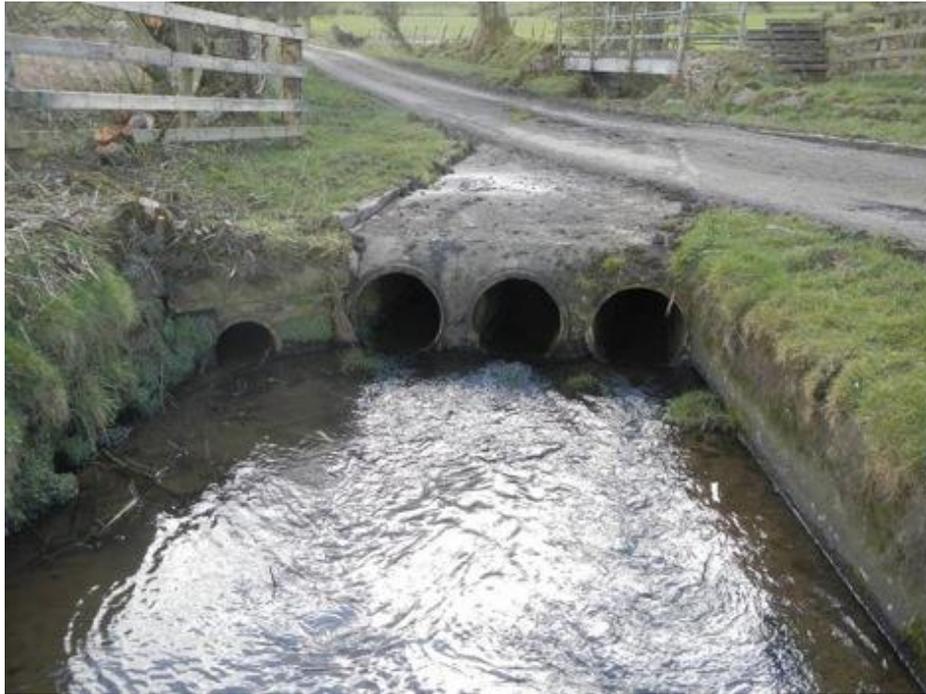
At the downstream end of that field the river passed under a road, through a piped culvert, which poses a small barrier to fish passage that would be more easily passable to smaller rather than larger fish at low flows. Fluming is also likely to occur at higher flows, limiting fish passage and restricting access to medium-low flows (Picture 21).

Picture 21. Pipe culvert which poses a small barrier to fish passage (NZ0192070863).

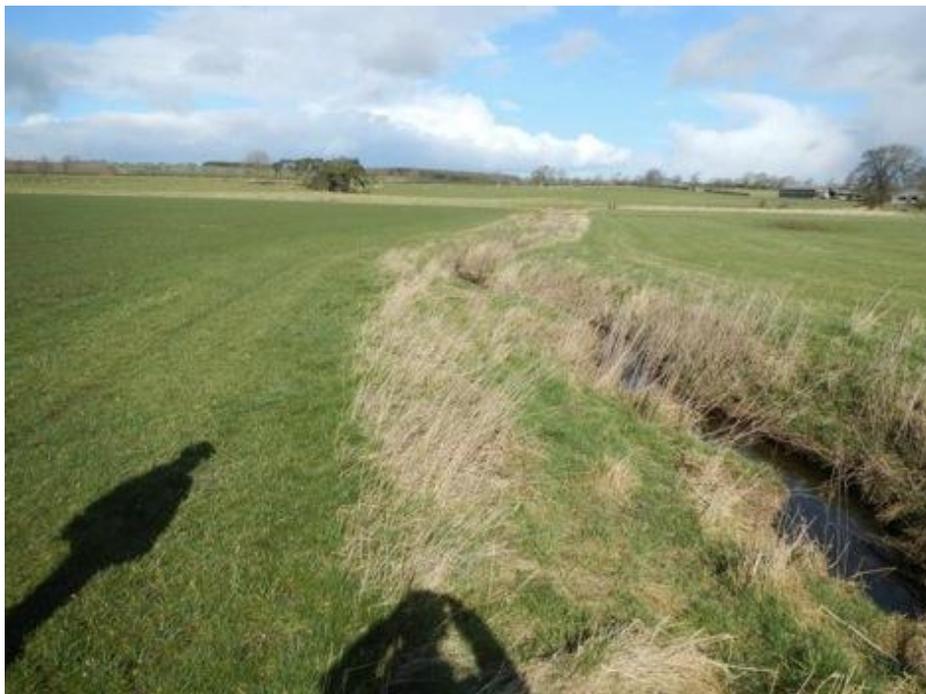
Channel re-alignment continued through the two fields downstream of the culvert, with a straightened, narrow channel resulting (Picture 22). This prevents the formation of deeper pools and wider shallow riffles required to form the fine, clean gravels for spawning. Some natural substrate remains, but the high sediment content, unnatural width, and profile provide poor habitat (Picture 23).

Picture 22. Realigned channel downstream of Whittington Mill access track culvert.

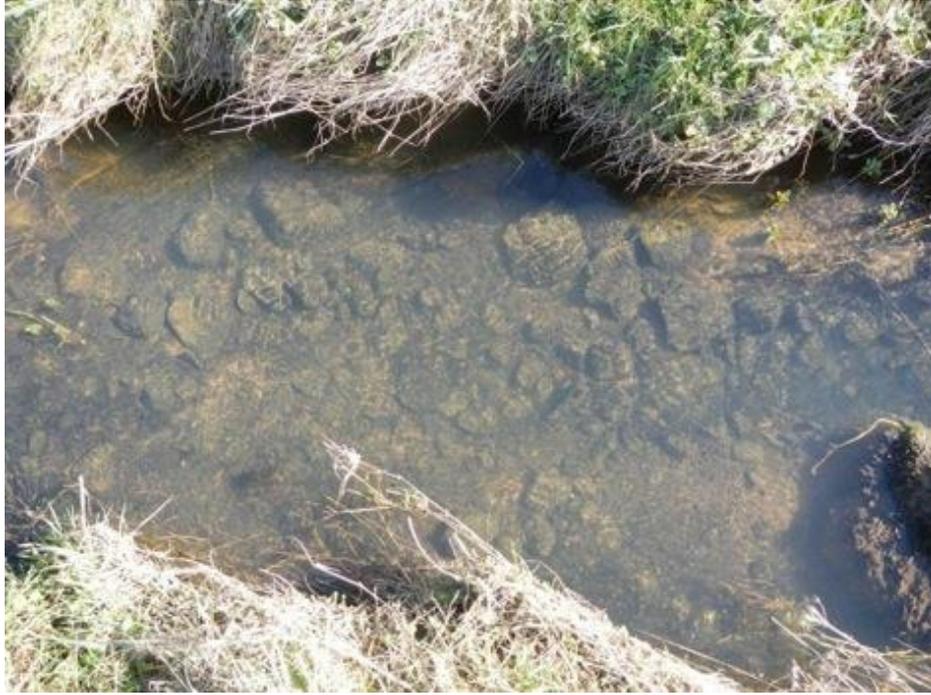
Picture 23. Range of substrate size, although the 5-50mm required for salmonid spawning is limited.

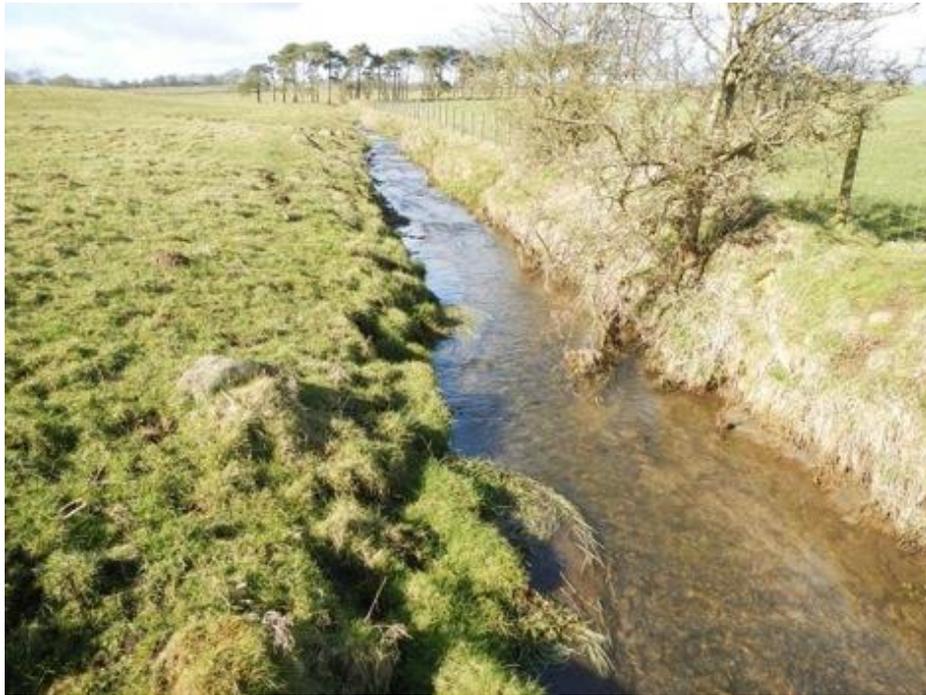
Picture 25. Straightened tributary with similar issues to the Pont (NZ0189570863).

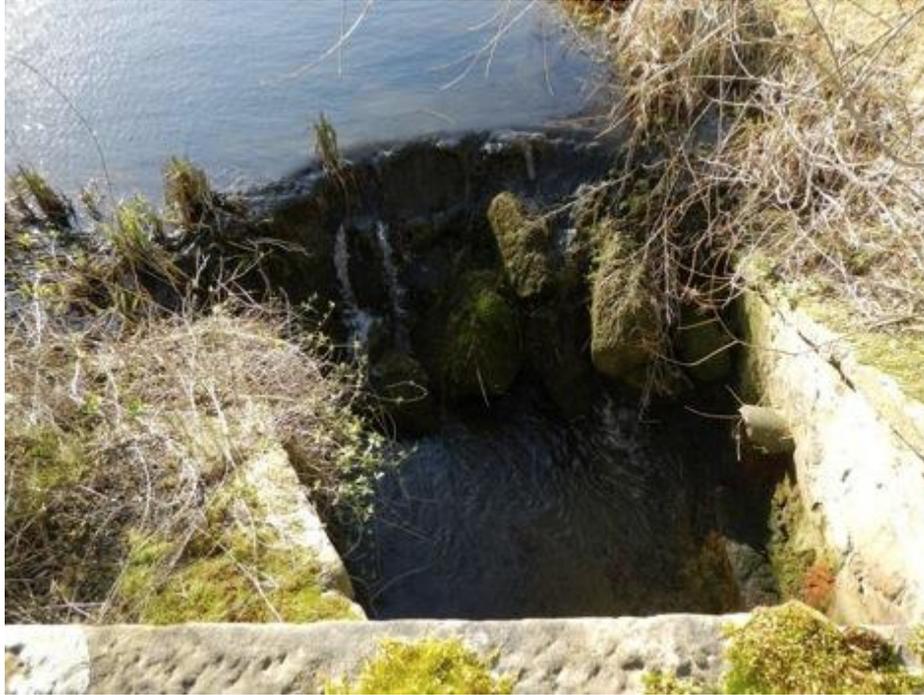
Spot checks carried out on the tributary upstream revealed unfenced, grazed fields contributing to sediment issues, an impassable barrier at NZ0035170406 (Picture 26), and notable sediment issues at NZ0076471030 and NZ0091470969 (Picture 27).

Picture 26. Impassable Barrier upstream of the road bridge to the South of Great Whittington. Directly downstream of the Bridge was a drinking point with high sediment input.

As with the Pont, fencing would allow some naturalisation of the tributary. However, without major re-meandering and possibly gravel reinstatement the habitat for salmonids will remain compromised, with limited spawning potential and a lack of suitable habitat for all life stages.

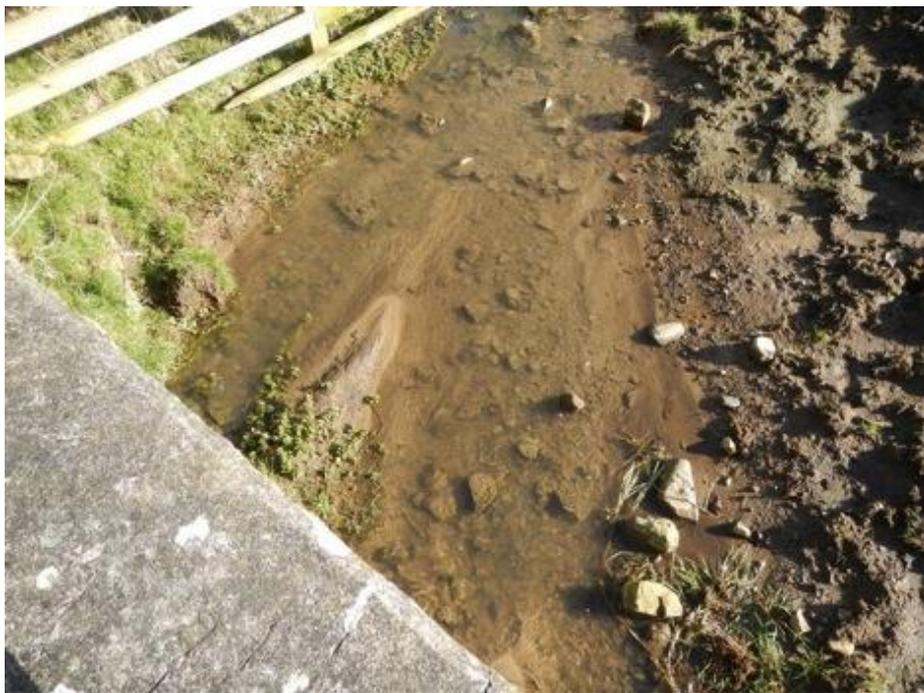
Picture 27. Sedimentation issues at a drinking point, directly downstream of the Matfen to Great Whittington Road. Sediment is also accumulating here from upstream, as can be seen by the bar, to the left of shot. This was also the case at the next crossing point upstream.

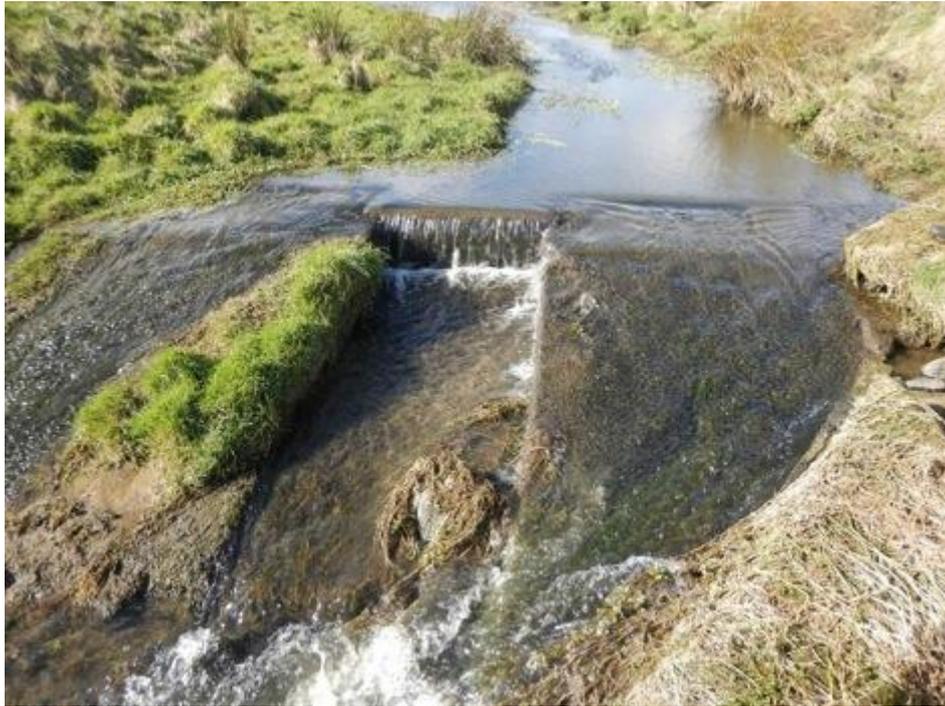
A short distance downstream of the tributary there is an old sluice structure on the Pont, which appears to serve no purpose (Picture 28). If the sluice boards were removed, passability of the structure for fish would greatly improve, but ideally the structure should be

removed to allow natural fluvial processes and complete fish passage.

Picture 28. Small concrete structure posing an obstacle to fish passage (NZ0192070863).

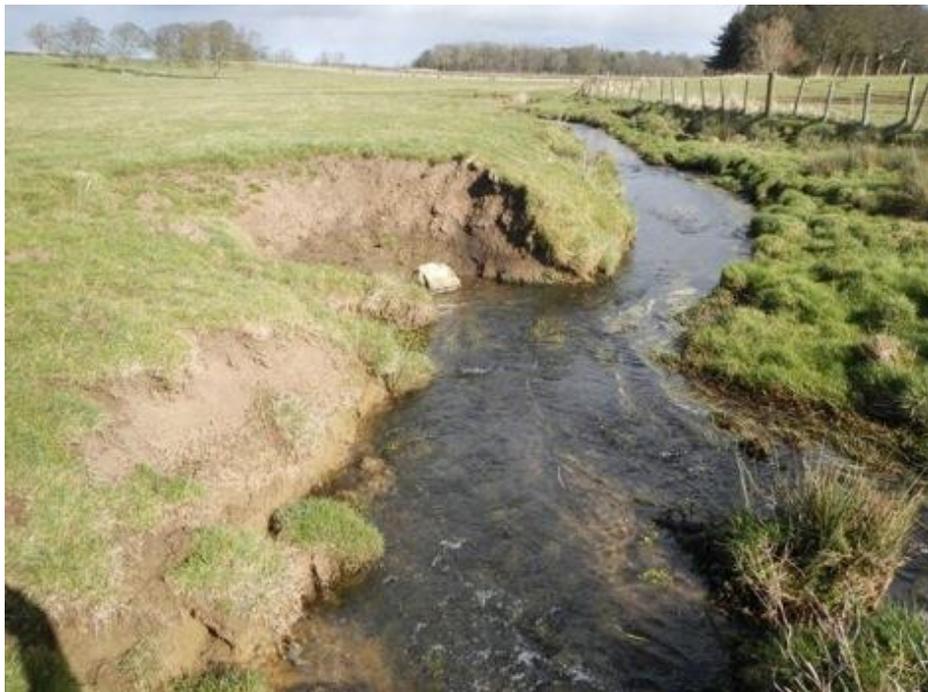
Picture 29. Erosion issues from stock access to the riverbank (NZ0229571031).

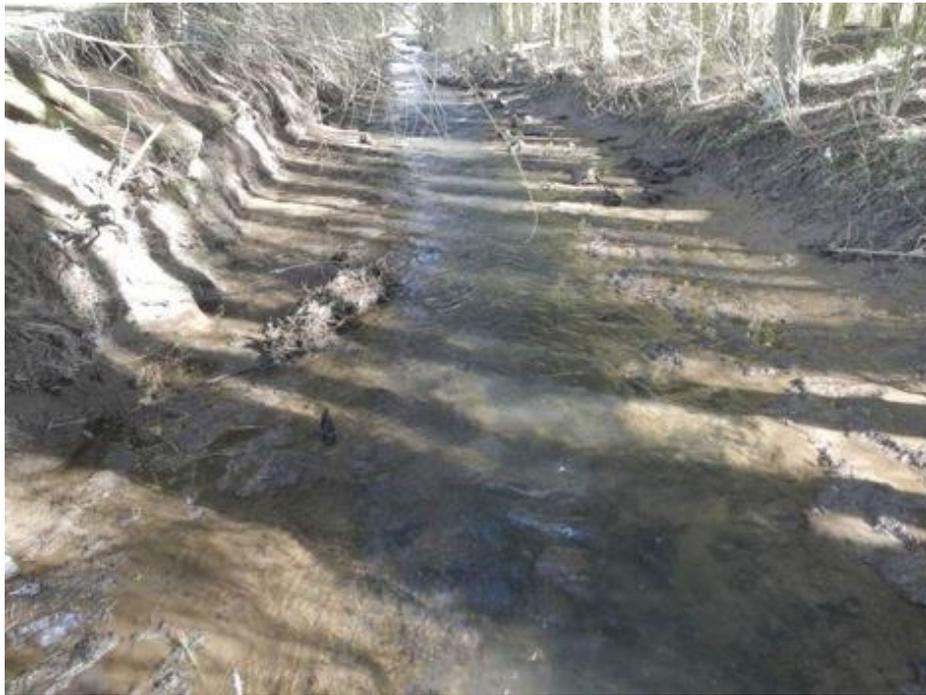
The land use then changes in the field upstream of Matfen Golf Course, where the river becomes further constrained within a boulder clay channel, through a coniferous plantation (Picture 30). Here, the River flows through a heavily shaded, 60cm wide trench, within a boulder clay two stage channel, that is likely to be a constant source of very fine sediment and provides very poor habitat for fish and invertebrates.

Picture 30. Two stage boulder clay channel (NZ0249971151).

Fine sediment issues were also identified in the plantation upstream of Matfen Golf Course, where the river is incised within a boulder clay trench. This increases the input of very fine sediment to the River, as no vegetation can grow on the clay. This is a difficult issue, but the ideal solution would be to re-meander the watercourse, outside of the plantation.

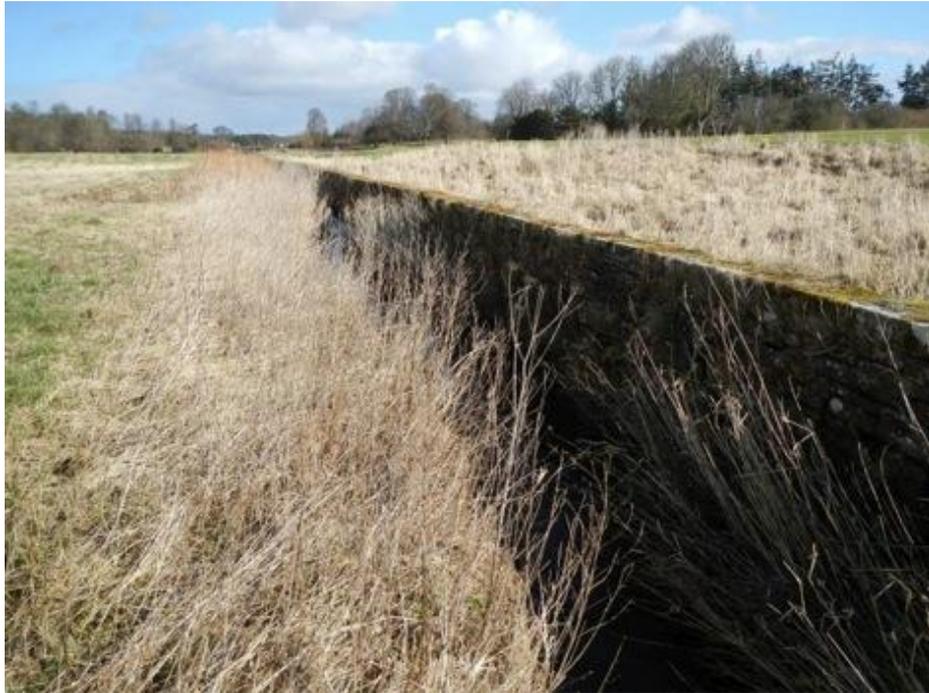
Downstream of the plantation, the river enters the Golf Course and becomes constrained by a stone wall revetment, that will prevent any natural channel adjustment (Picture 31).

Picture 31. Walled bank revetment, present in many areas through the Golf Course.

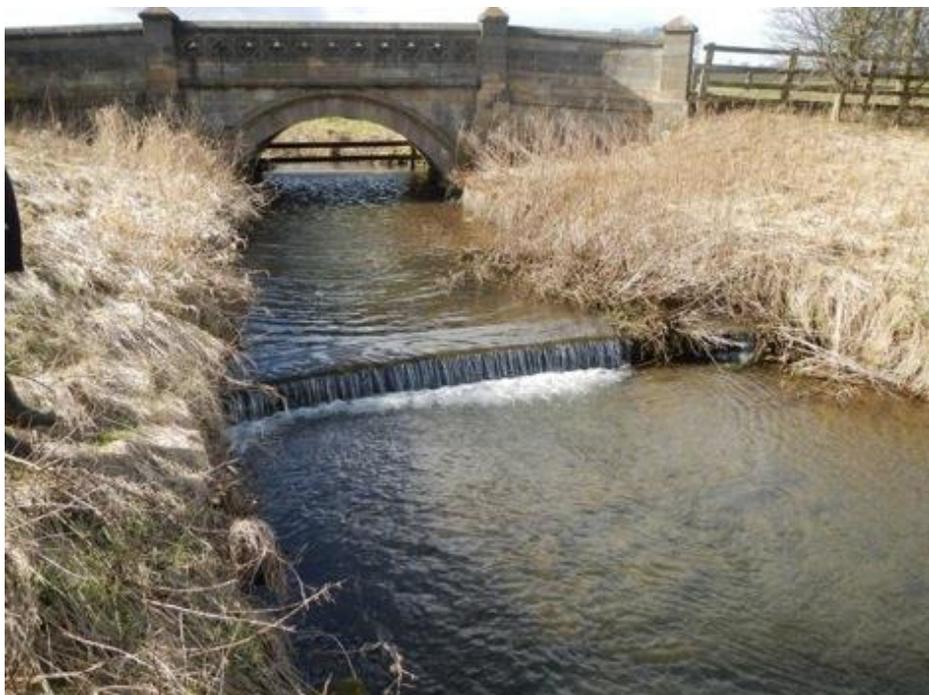
Picture 32. Small weir (c.25cm) that poses a barrier to juvenile fish, grayling and minor species, limiting their exploitation of upstream habitat. The shallow apron on the downstream side exacerbates the problem. Two valuable shrubs on either bank, downstream of the weir have also been recently coppiced, removing the valuable cover they would provide. This appeared to be an on-going maintenance issue, probably for minimal aesthetic benefit and should be stopped.

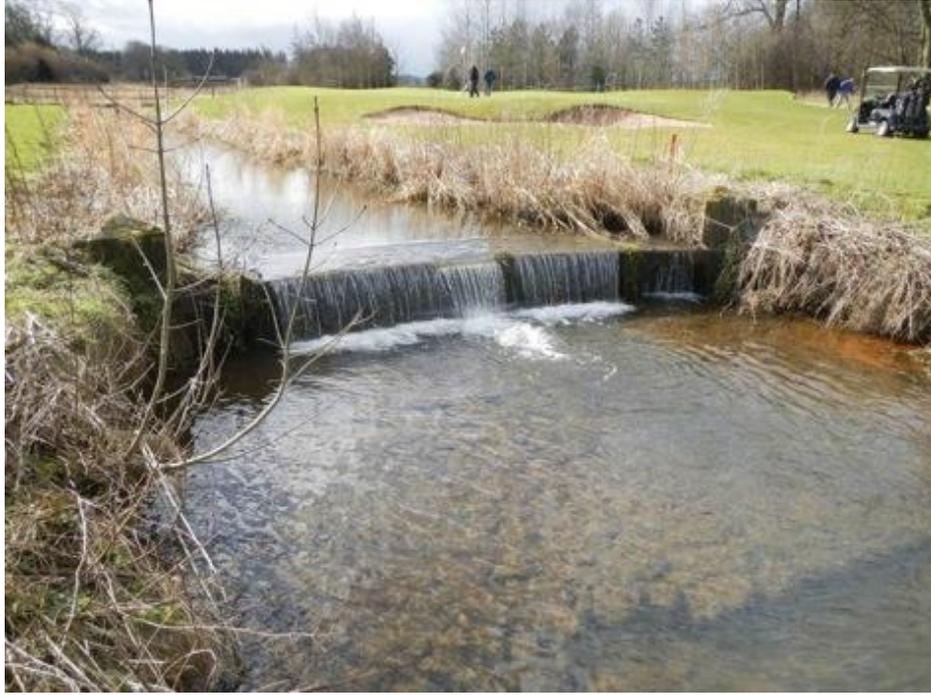
Picture 33. c.50cm weir that poses a more significant barrier to fish passage. The height of the jump alone is a significant issue for juvenile fish, grayling and minor species, but with the shallow water on the downstream side, created by the weir apron, the weir becomes impassable for all fish at low and medium flows.

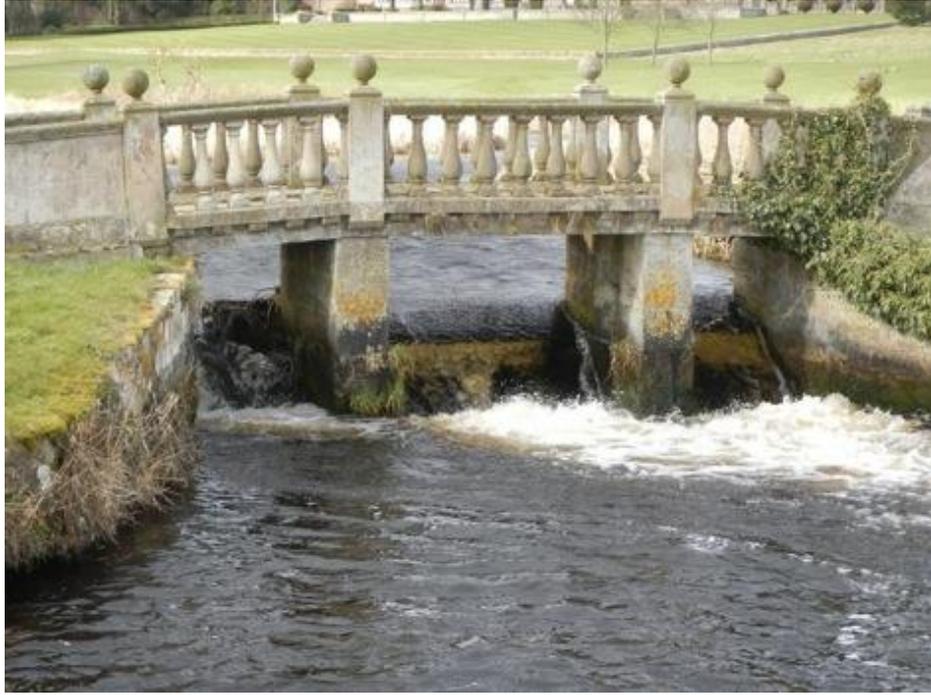
Picture 35. The largest weir in the Golf Course (>60cm). This is likely to pose little barrier to large salmonids, as there was good depth below and they are likely to swim straight through. In contrast, the weir is likely to pose a significant barrier to smaller fish, and grayling, impassable to juveniles due to the high velocity, chute flow over the weir.

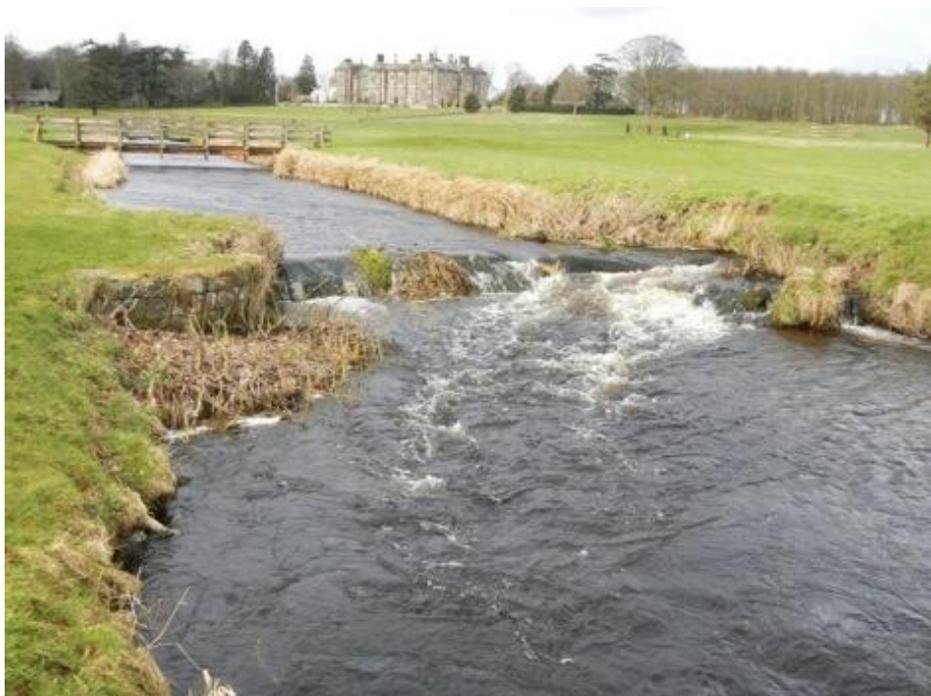
Picture 36. Derelict weir that should be passable to most fish, larger than fry. Notching or removal would still benefit the river by allowing better substrate transport downstream and reducing the impoundment upstream.

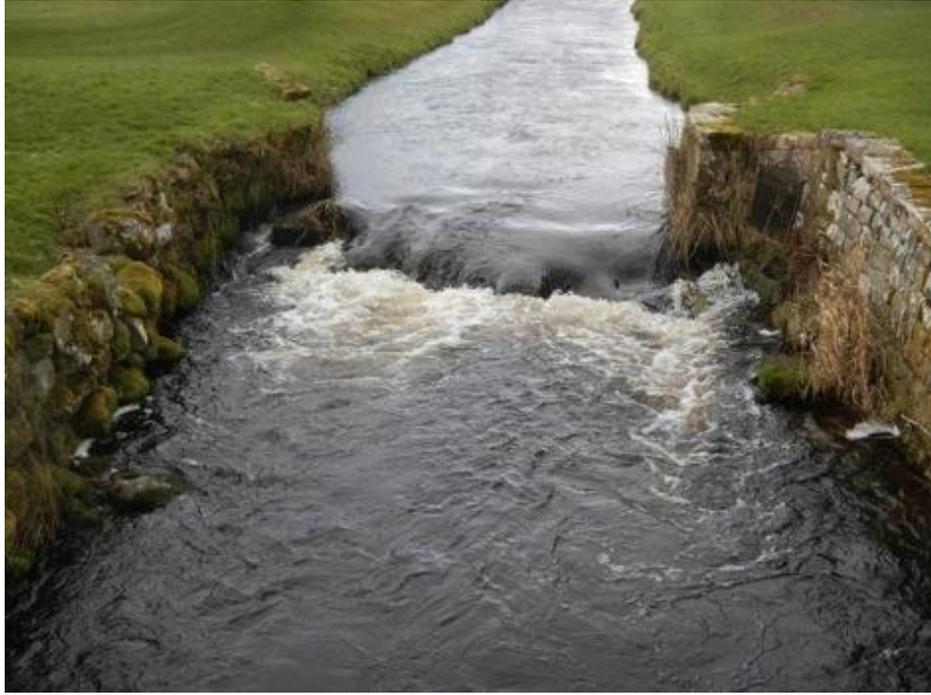
Picture 37. Another small weir that is only likely to be an issue for small and juvenile fish, but limits sediment transport and causes impoundment of the river.
