Pont and Blyth Investigation

River Pont - from source to Fenwick Burn

(Waterbody ID - GB103022076850)

Date 07/03/12

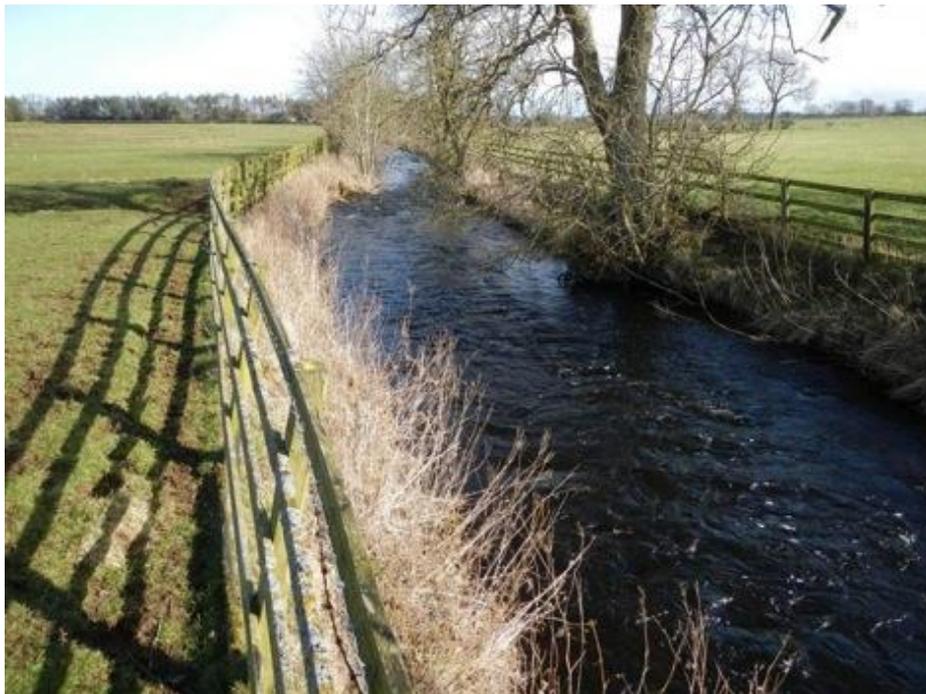
Picture 40. Fast flowing, straight section, with few in-channel features, that will fail to fulfil its potential fish holding capacity due to a lack of resting areas.

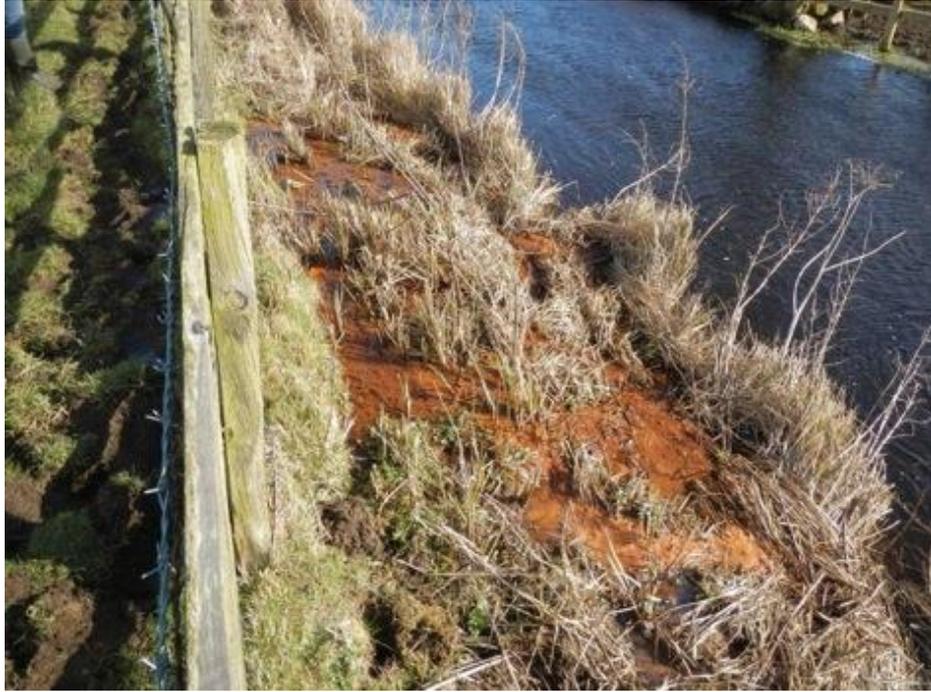
Within this section another ochreous discharge was identified (Picture 41, NZ0430471543). As with the previous, it was not considered to be of a significant volume to be detrimental to the river, but is worth noting in case the volume increased. A small weir was also present, which posed little obstacle, but removal of the central third would be beneficial (NZ0423871522).

Picture 41. The second ochreous discharge observed on this waterbody.

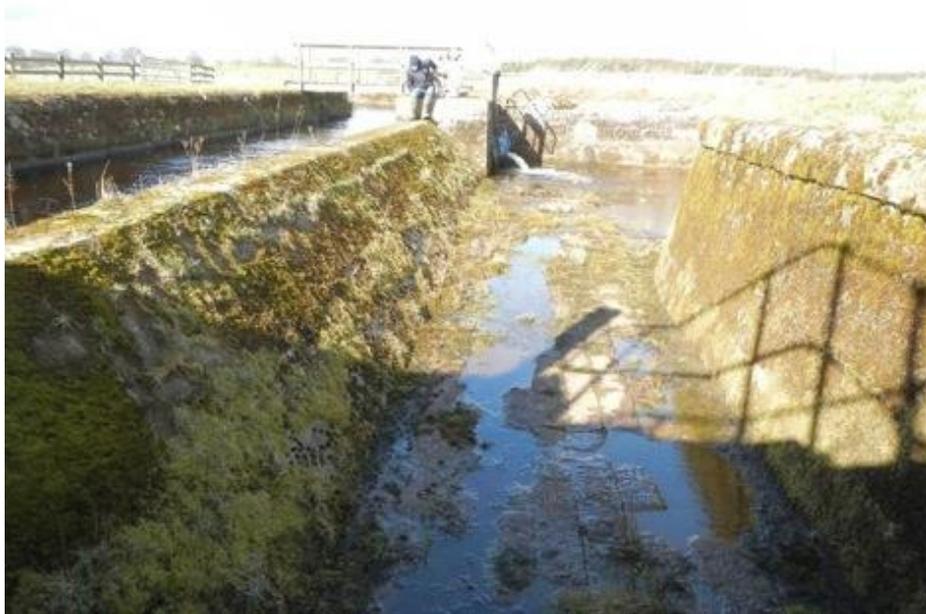
Further downstream at NZ0533971347, was one of the single most significant negative impacts on the whole Pont/Blyth system. This is the point at which the water for the River Pont is supplied from the transfer channel. This structure is completely impassable to fish in almost all flows and completely disconnects the River Pont from its upper catchment. In ecological terms, with the upper River Pont actually feeds the Whittle Burn system, barring a very low volume that feeds the Pont via a c.15cm pipe, running around ½ bore (Picture 45 & 46). Additional water would be supplied via the overspill (Picture 45), when a significantly higher amount of water is flowing down the transfer channel. The benefit of this to the river is limited, as it still fails to provide connectivity for fish passage or substrate transport.

The implications of this are massive; effectively the flow within the River Pont is flat-lined at greatly reduced volume from that point downstream, in most flows, until an instant increase occurs as overflowing occurs. This creates issues through flushing, without a significant ramping effect, as would be expected with natural flows.

The other, and equally crucial issue, is the prevention of fish passage up or downstream between the two parts of the River Pont. This not only prevents exploitation of the habitats by many organisms from above to below, and vice versa, but also prevents

re-colonisation following pollution incidents and fish kills, which are a regular occurrence on the Pont. Consequently, the benefits that could be gained from the improved substrate and flow within the transfer channel are mostly lost, leaving only the negatives. This is a major issue for the River Pont system and needs to be addressed.

Picture 45. Side view of the water supply to the Pont downstream of the transfer channel, showing the high flow overspill in the foreground.

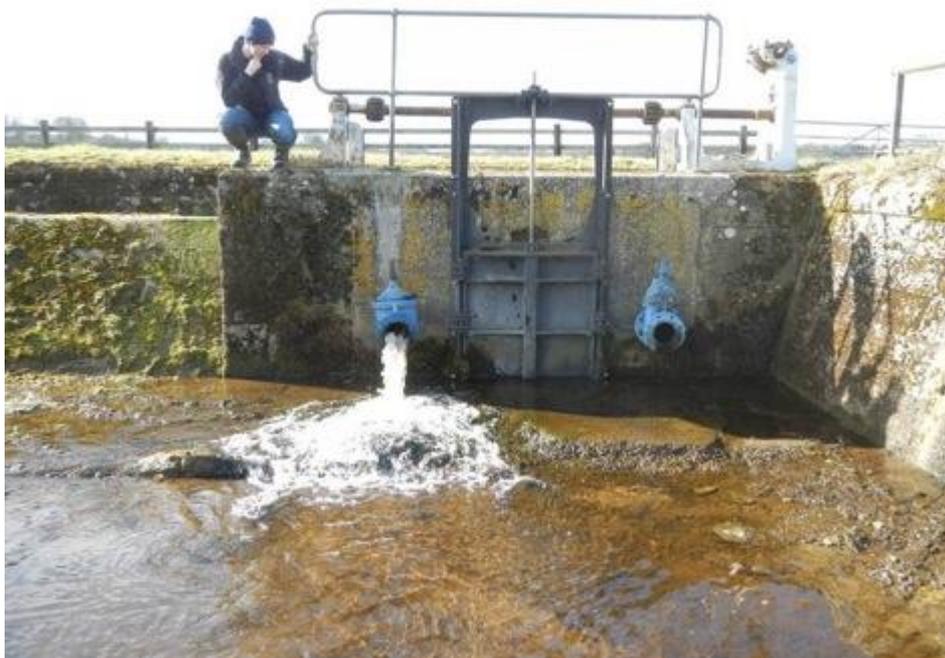
Picture 46. The entirety of the Rover Pont, as supplied from the transfer channel.

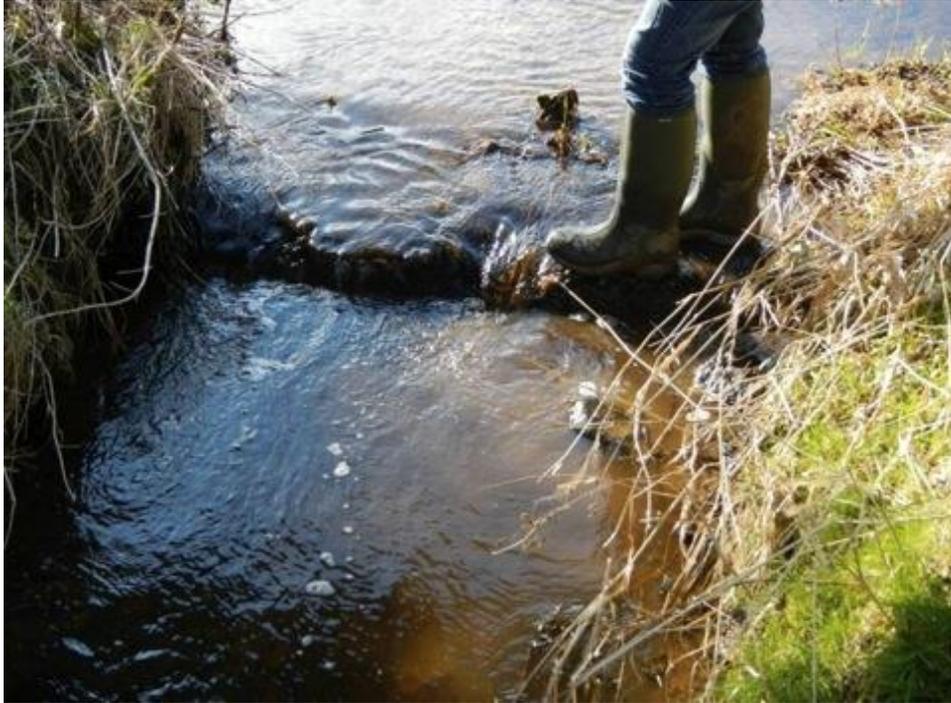
The scale of the issue can be observed at the point the River passes over the downstream limit of the apron (Picture 47). The flow here can be directly compared to the volume of water present in the River Pont at the weirs above the input of water from Hallington Reservoir, in pictures 32 and 33.

Picture 47. The outflow from the apron of the supply to the River Pont.

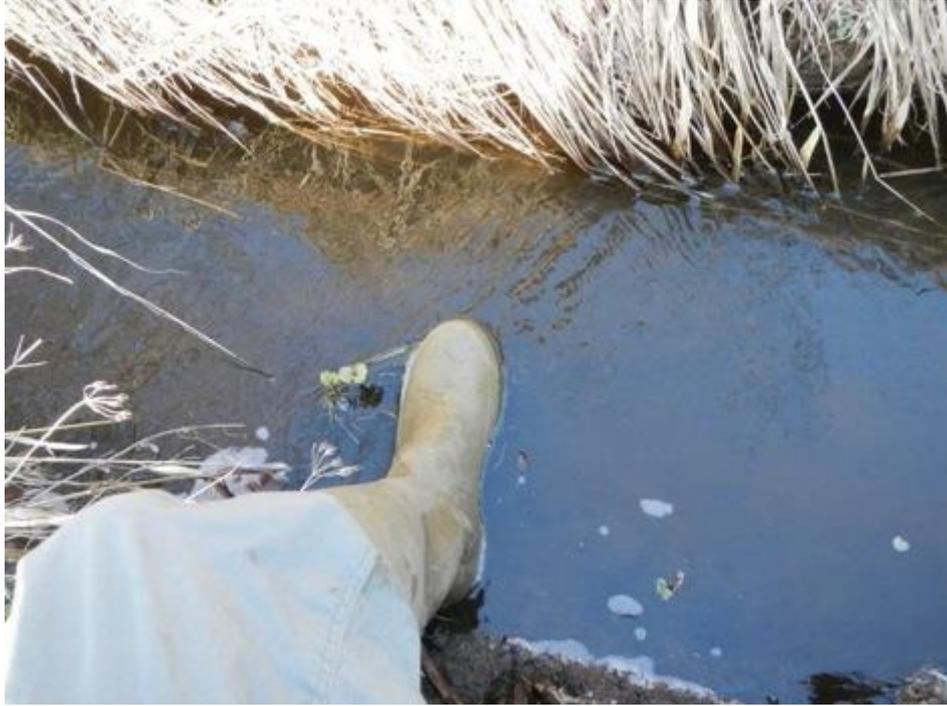
It can also be seen that the River reverts to a significantly incised and straightened channel, with little in-stream structure or riparian tree cover. As with other similar sections upstream, there was a lack of natural substrate and little, if any, potential for spawning.

Picture 48. The River Pont below the transfer system, at around 60cm, or two feet wide, with very little flow.

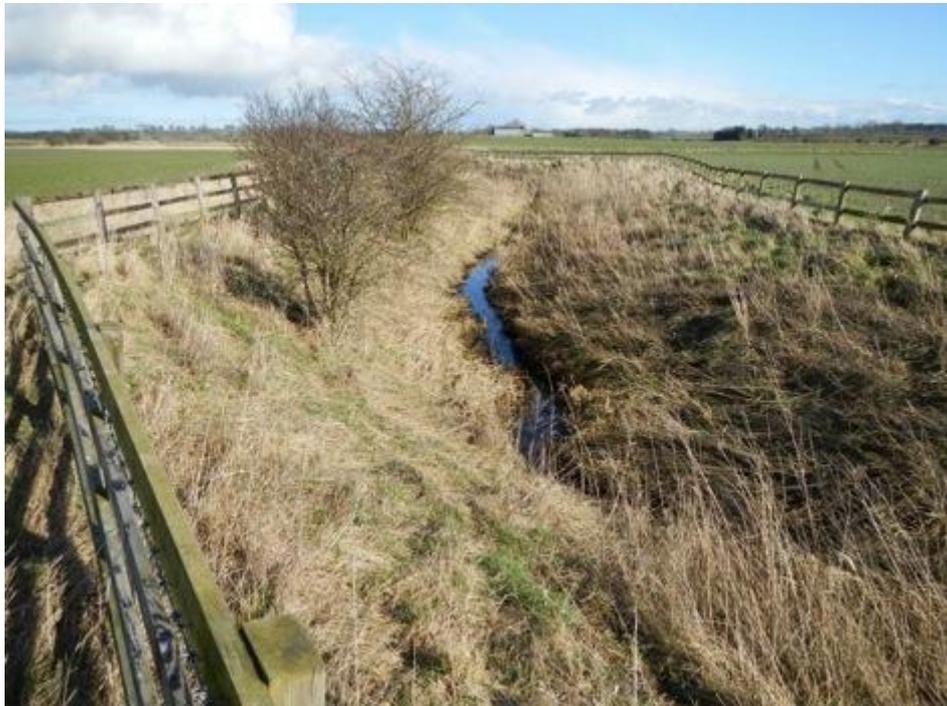
Picture 49. River Pont below the transfer, at a small proportion of its volume upstream of the transfer.

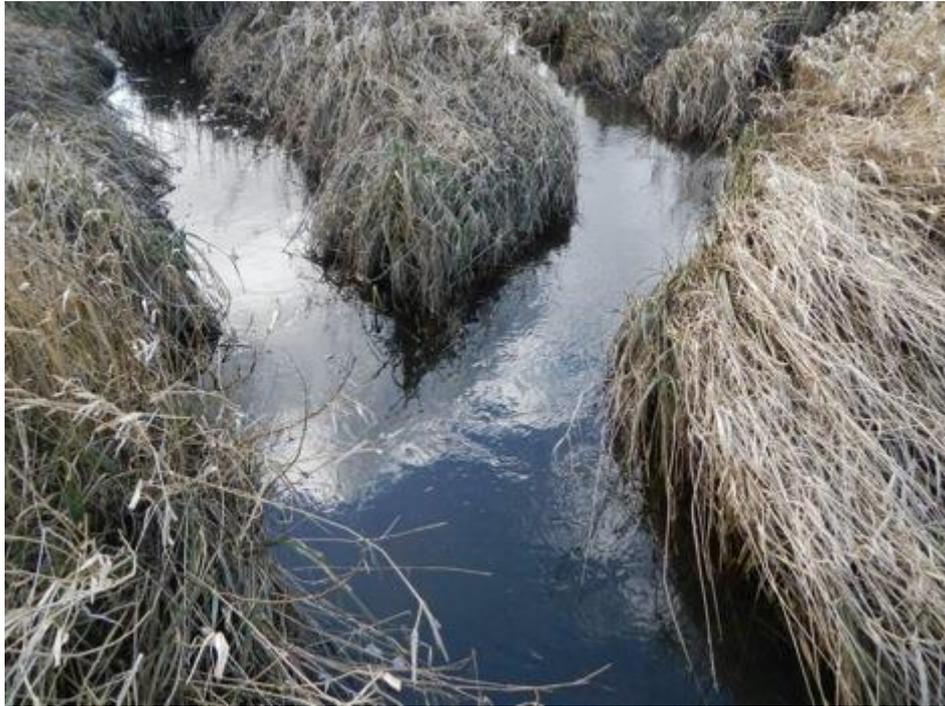
providing a much lower than expected proportion of the flow (Picture 51).

Picture 51. The downstream limit of the waterbody at the confluence of the River Pont and Fenwick burn. The River Pont is left of shot, the Fenwick Burn right.
