Advisory Visit

River Bure, Blickling Estate, Norfolk

December 2017

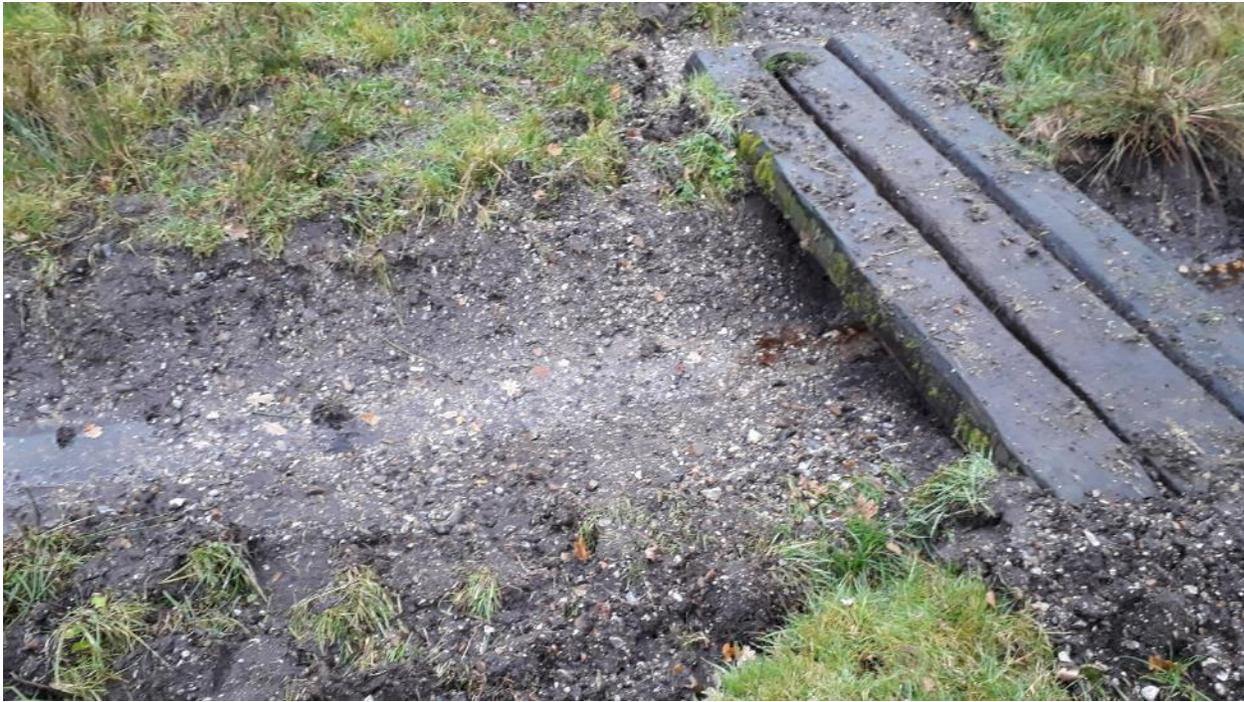
Picture 1 – Recent ditching work has revealed valley peat, alluvium and fractured chalk and flint. It is doubtful that any gravel could be from within the site.

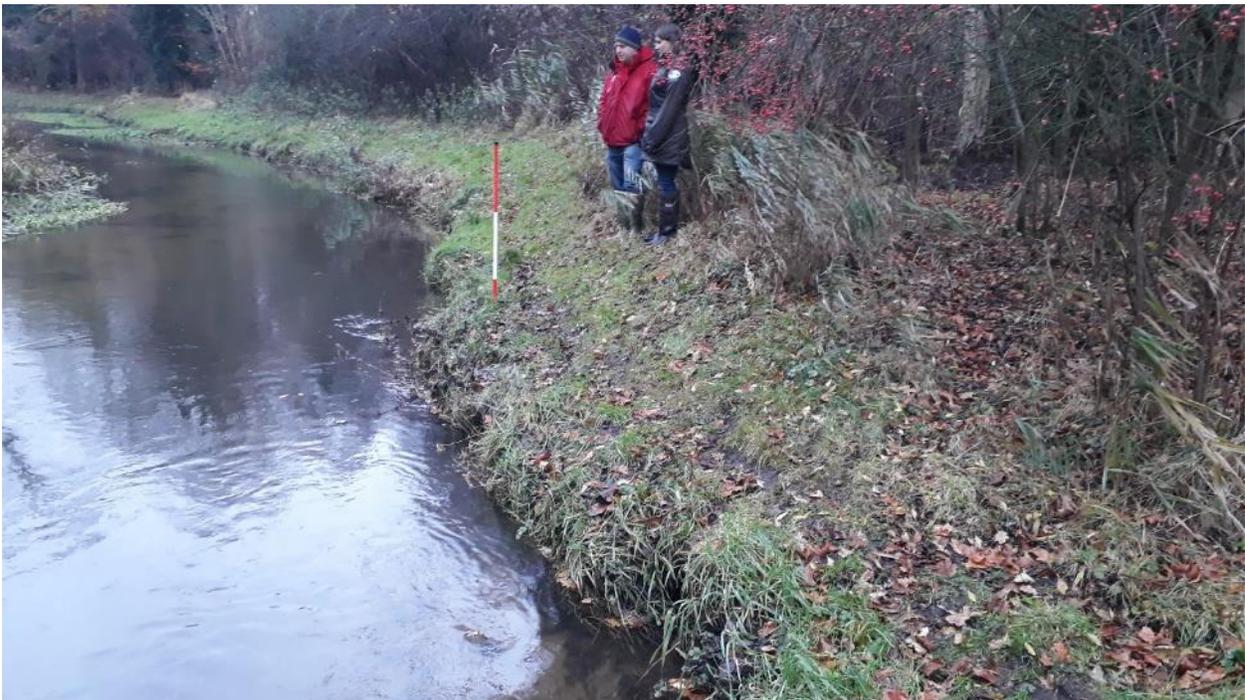
- Signal crayfish burrow into the alluvial banks.

- The burrow network extended back >75cm and creates a 'honeycomb' network beneath the anglers' path.
- The burrow network collapses under the weight of anglers.
- Slab failure occurs resulting in large sections of bank collapsing into the river.
- The bank material is then washed downstream resulting in a widening of the channel.
- The material is then deposited within slower reaches of the river leading to a smothering of the river bed with silt and sand.
- The widened channel then has less energy to scour away fine sediments, thus turning a gravel dominated river into one which is fine sediment dominated.

Picture 2 – Note how the ranging pole has been sunk into the bank, it had been pushed through a network of crayfish burrows.

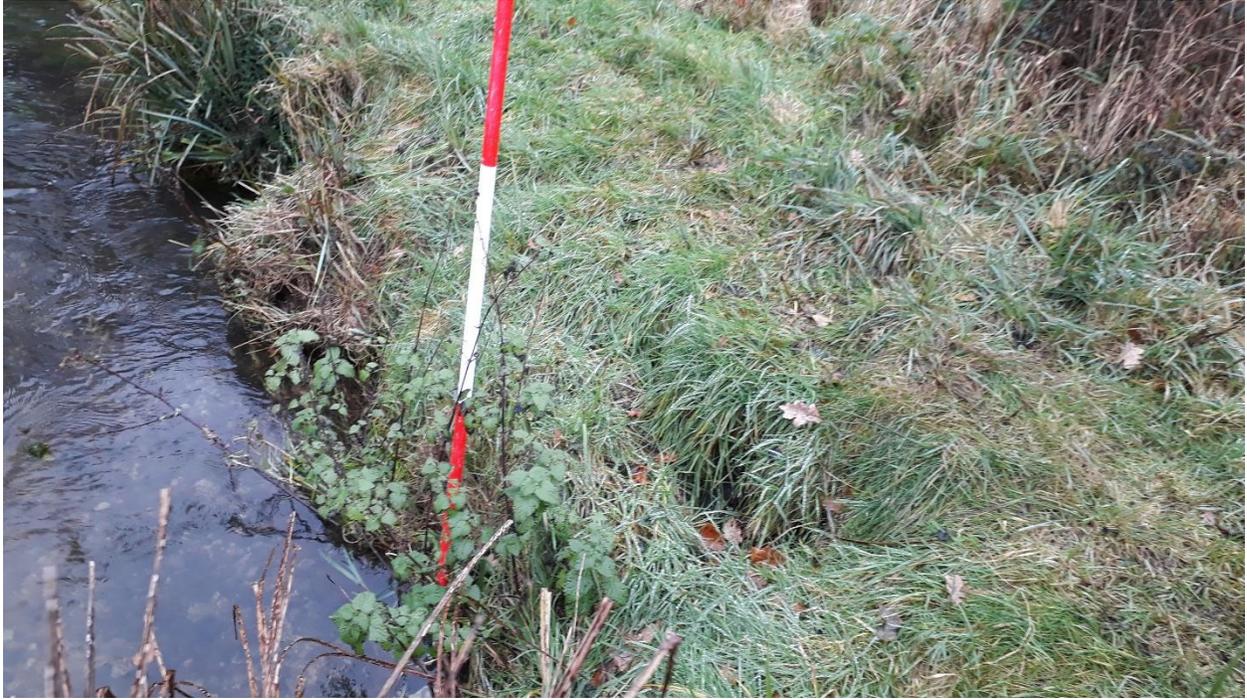
Picture 3 – Note the slab failure collapse that is happening to this area of bank as crayfish burrows cause it to become weakened.

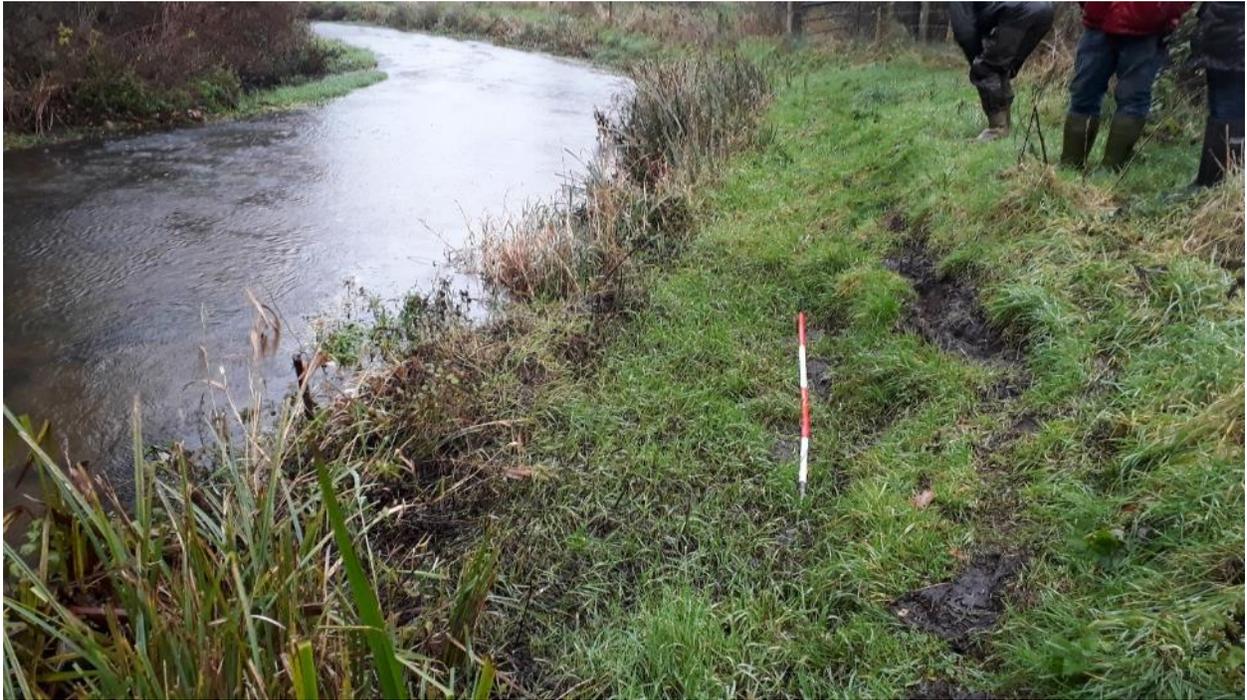
Picture 4 – Note how the bank (the anglers' path) has slumped down as crayfish burrows have reduced its structural integrity.

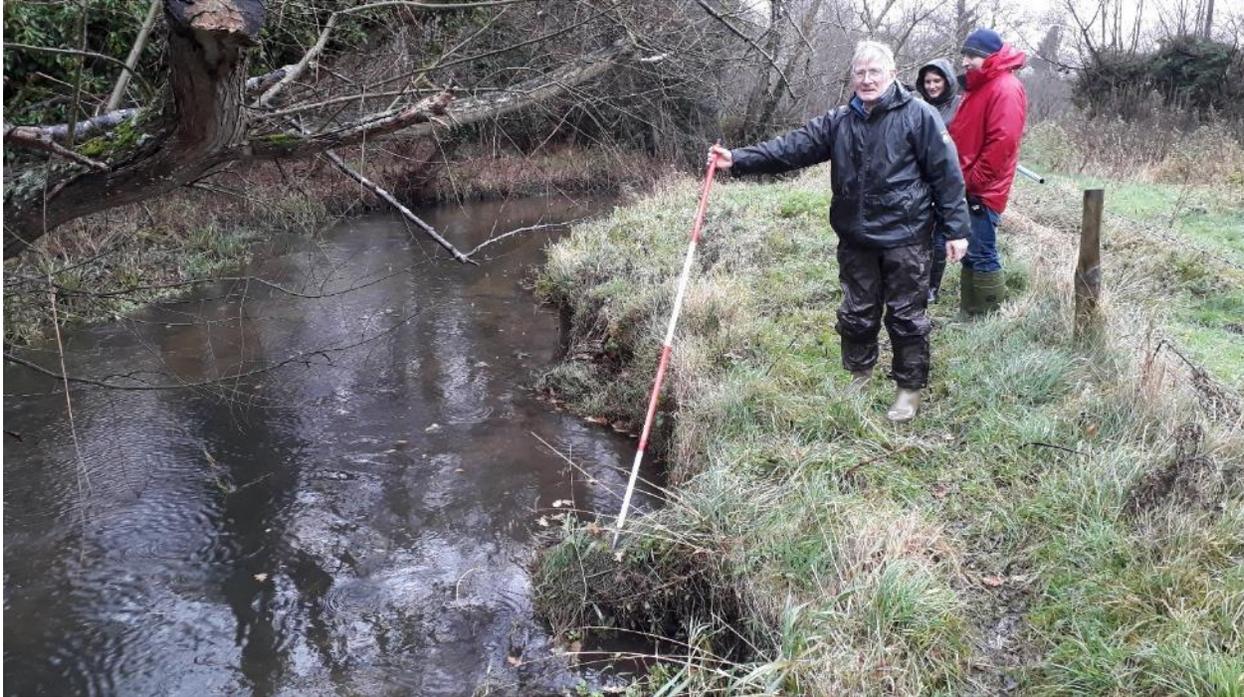
Picture 5 – Note how large chunks of the alluvial bank have been lost due to the burrowing action of crayfish.

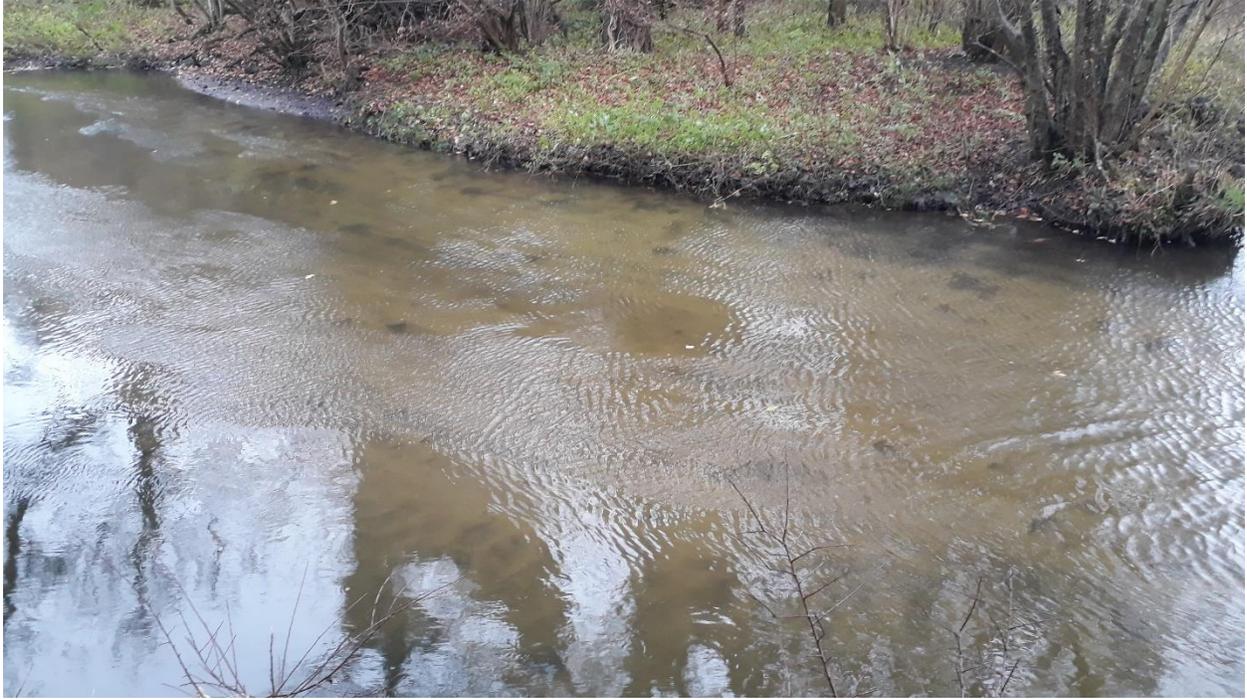
Picture 6 – Note the extensive sand deposition which is smothering the river bed and moving downstream in bars.

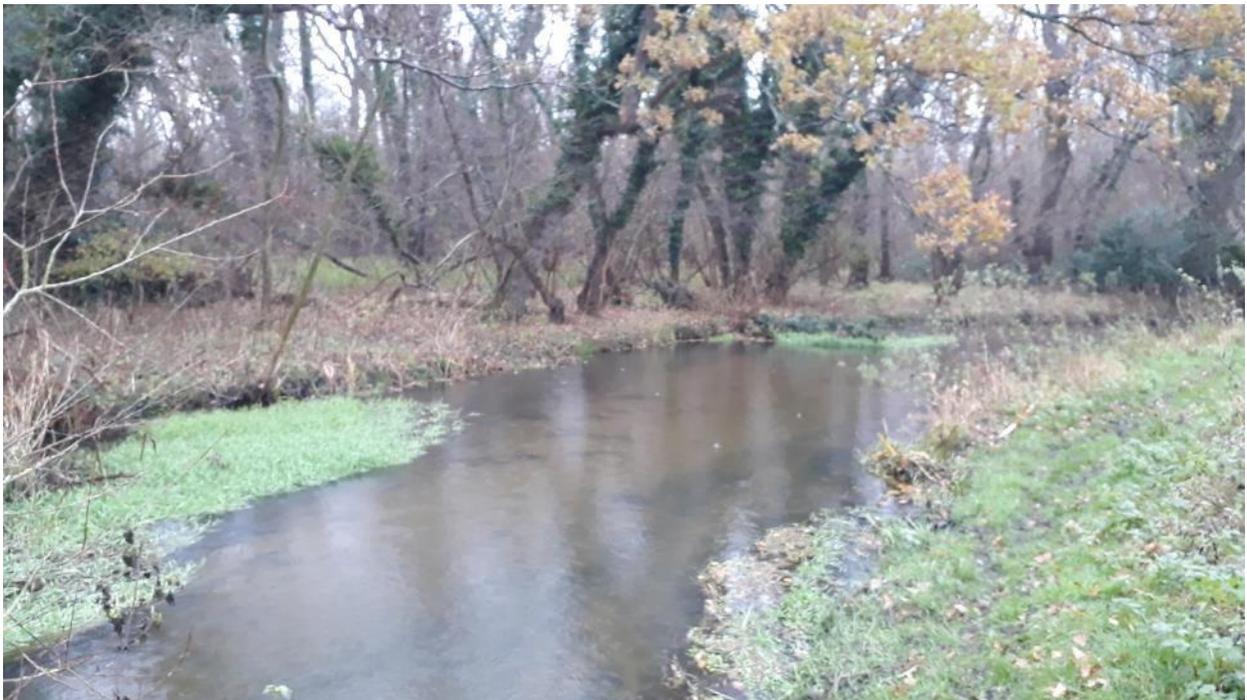
Picture 7 – Again, note the extensive sand deposition which is smothering the river bed and moving downstream in bars.

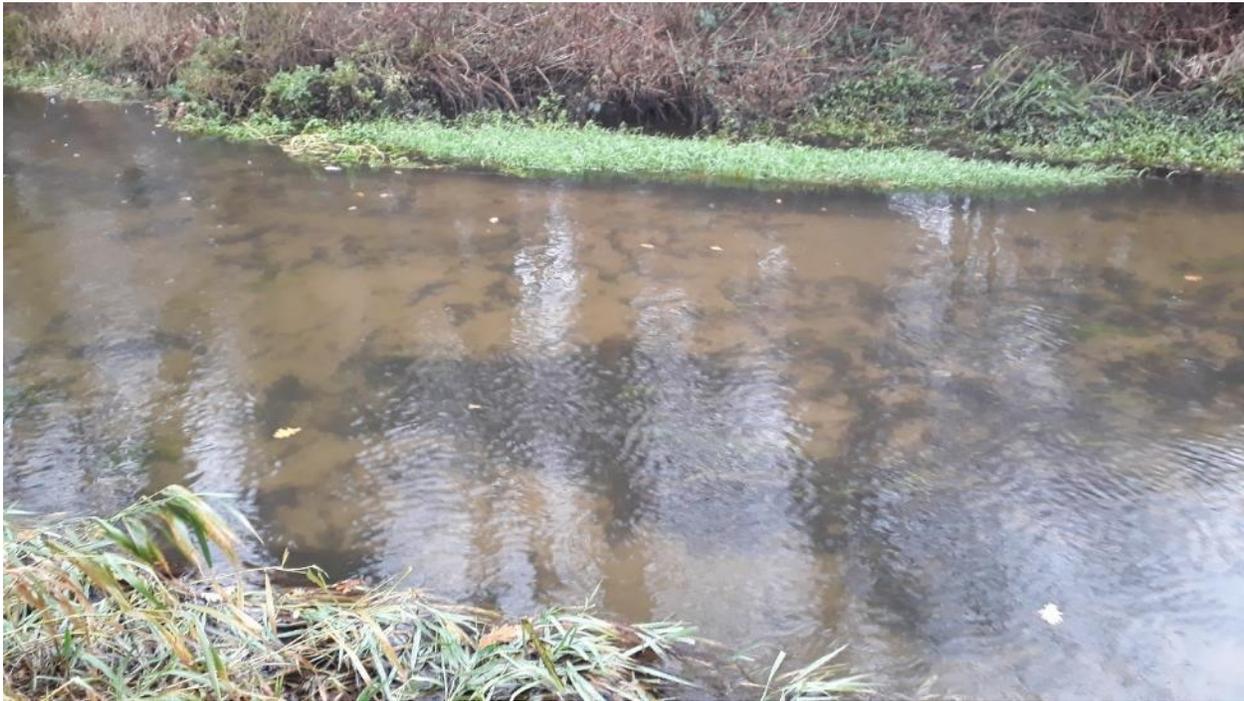
Picture 8 – Note the extensive sand deposition which is smothering the river bed and moving downstream in bars. This problem occurred throughout the reach inspected.

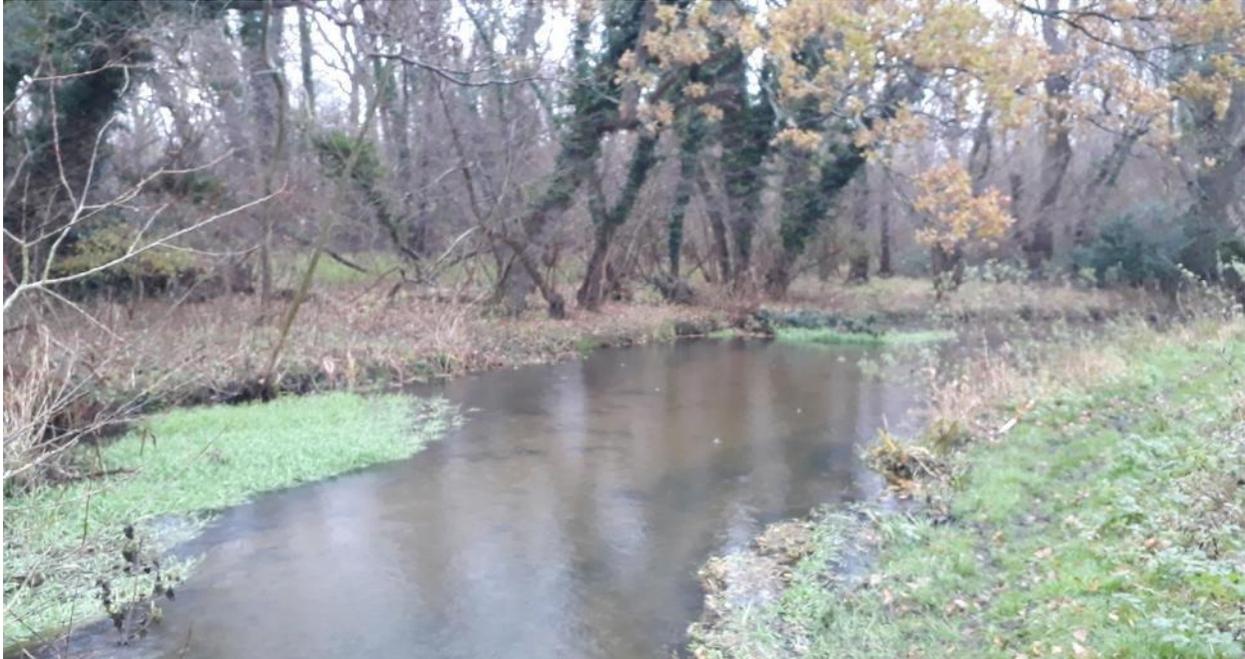
Picture 9 – The effect of shade cast by riparian trees is starting to restrict marginal growth. Note the gap in the reed sweet grass which is believed to be in response the shade cast by the oak tree.

Tree management is considered necessary as it is evident that some trees are now casting shade which is reducing marginal growth. Additionally, if banks are left bare they are prone to erosion and can become sources of sand and silt input. Tree management should be combined with the

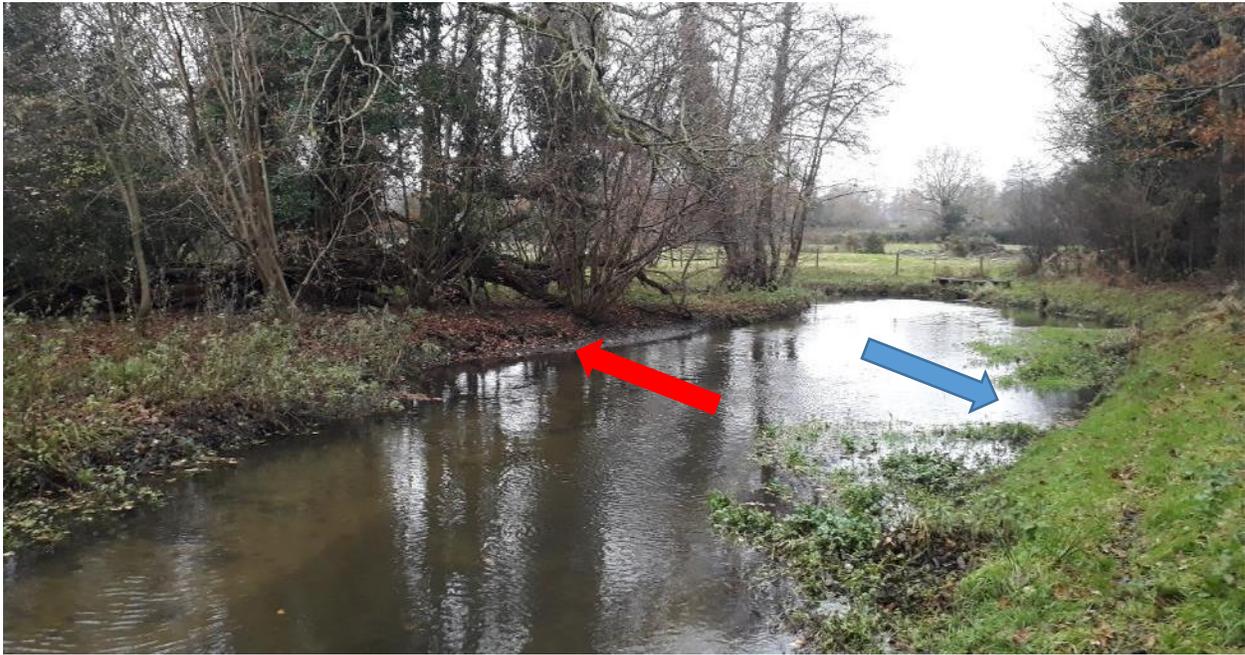
Picture 10 – The effect of shade cast by riparian trees is also visible in this picture. Note the gap of vegetation which would have otherwise been growing beneath the hazel (red arrow) and upon the opposite bank (blue arrow). Additionally the growth on the LHB is mainly nettles. There is a minimal fringe on the RHB. In an unshaded environment one would expect significant marginal growth to extend out from the LHB and to be forcing the flow against the RHB as flow is drawn though this reach between two large meanders. This problem occurred on many of the reach's meanders.

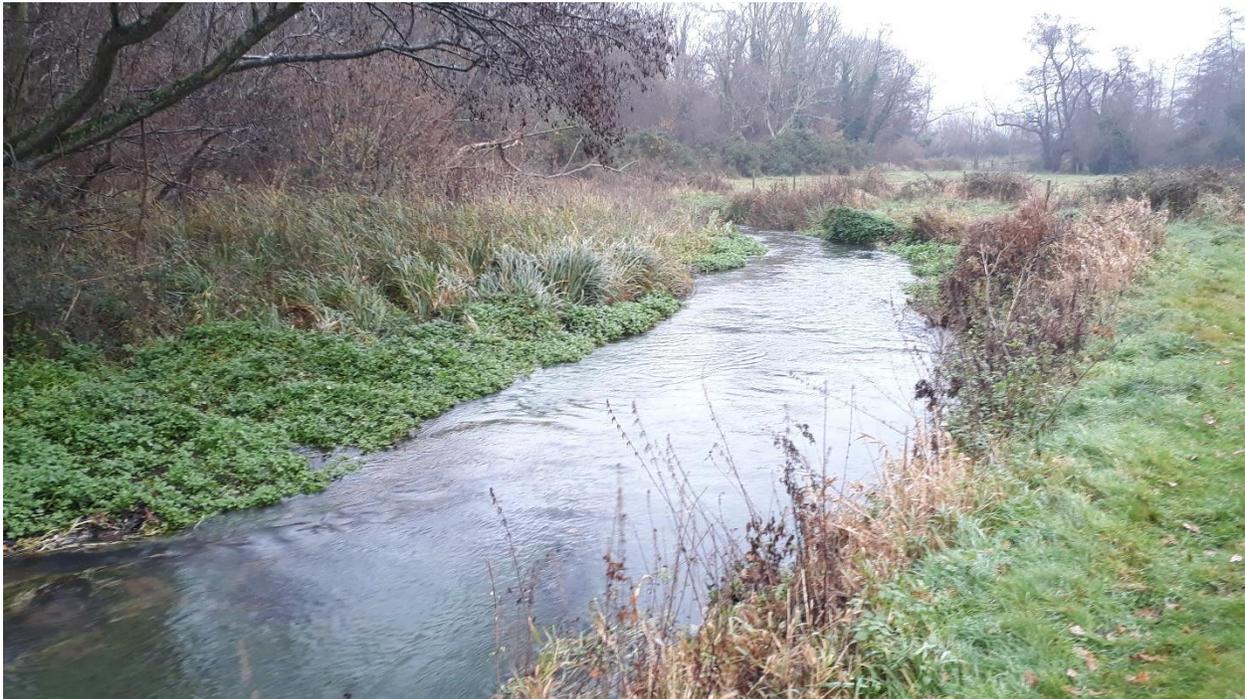
Picture 11 – Good marginal vegetation occurred where the channel receives direct sunlight. The marginal plants are able to narrow the channel resulting in a cleansing flow with the ability to transport sand and silt.

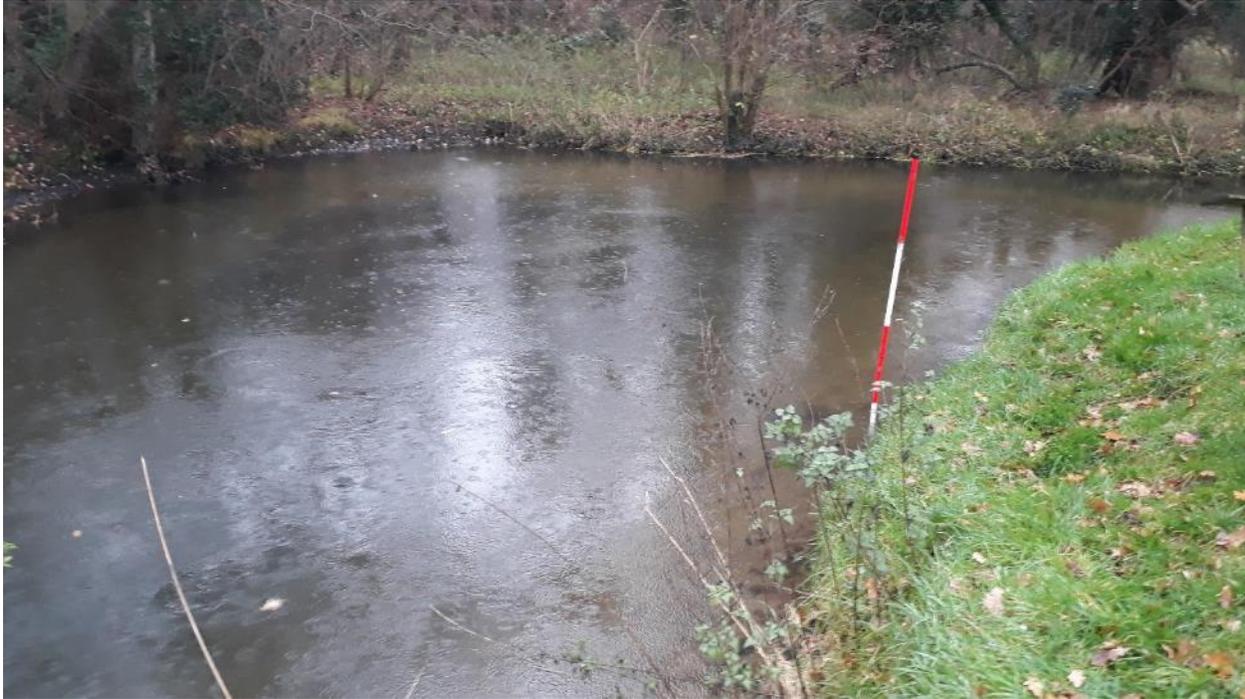
Picture 12 – Note the lack of a vegetated meander point bar (where the ranging pole is). A vegetated bar is normally present on the inside of meanders. In addition to narrowing the channel and forcing a cleansing flow against the outside bend, it would also act to entrain fine sediments as they are transported downstream.

The river is overwide in many locations. Channel narrowing using brush berms to re-align the flow within the existing channel would be beneficial. This could form the basis of a significant restoration project on this reach which would see tree thinning used to provide a source of woody material used for the benefit of the river.

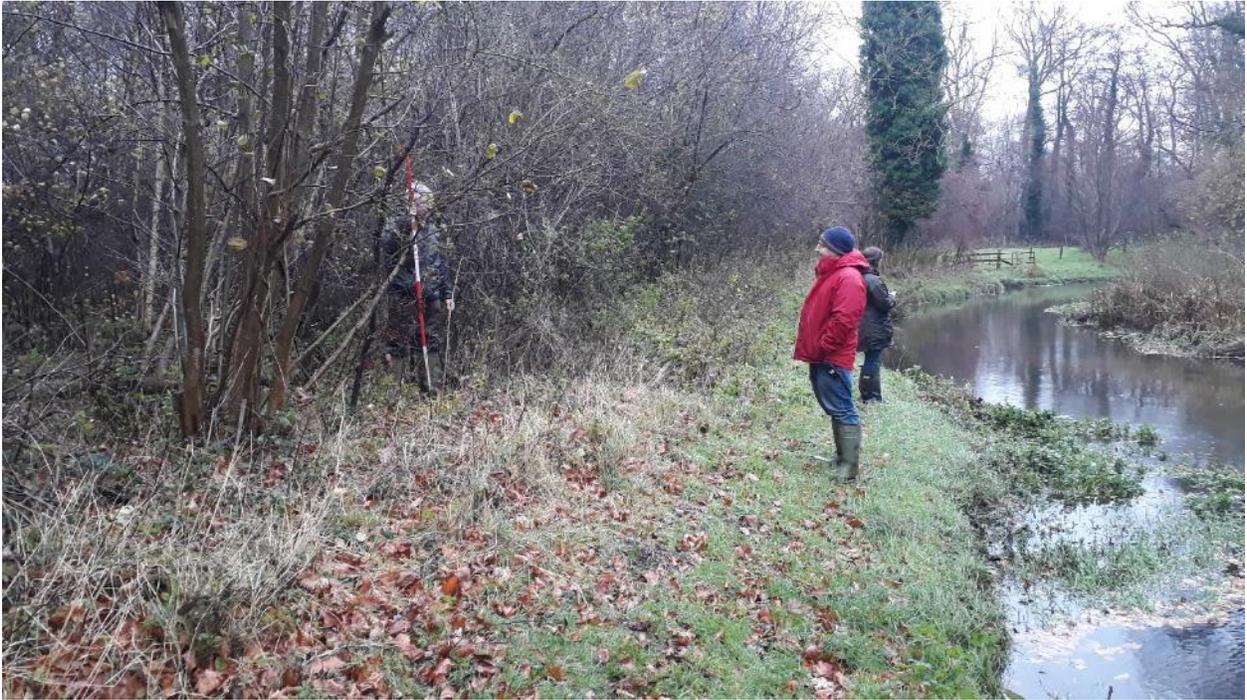
The river had been dredged in the past as levees of dumped material were present with semi-mature trees growing upon them (see over for picture 13).

Picture 13 – Note the raised levee which the ranging pole is being held on. If the dredged material has a high gravel content it might be suitable for re-use within the river. But removing many semi-mature trees to source it might not be desirable or cost effective.

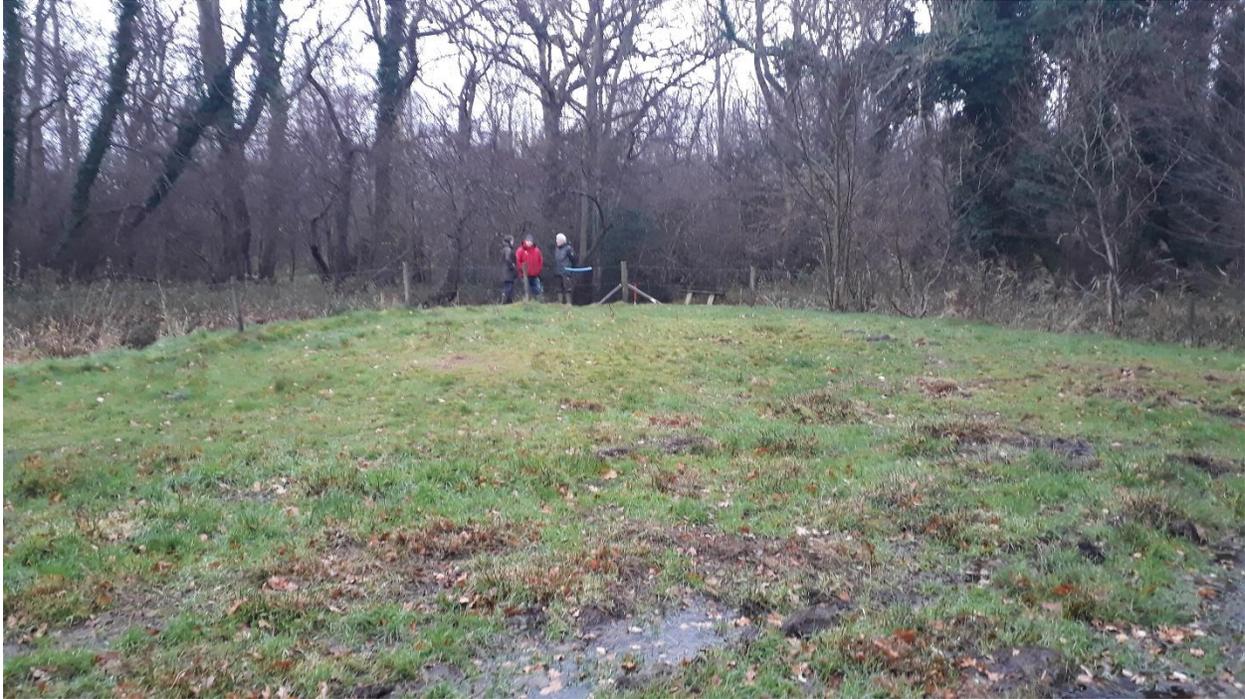
Picture 14 – Note the raised ground as a view back to the river is taken. Raised features such as this could (subject to an environmental permit) be pushed back in to the river to aid the process of meander point bar development and geomorphic processes such as meander scour and sediment transport.

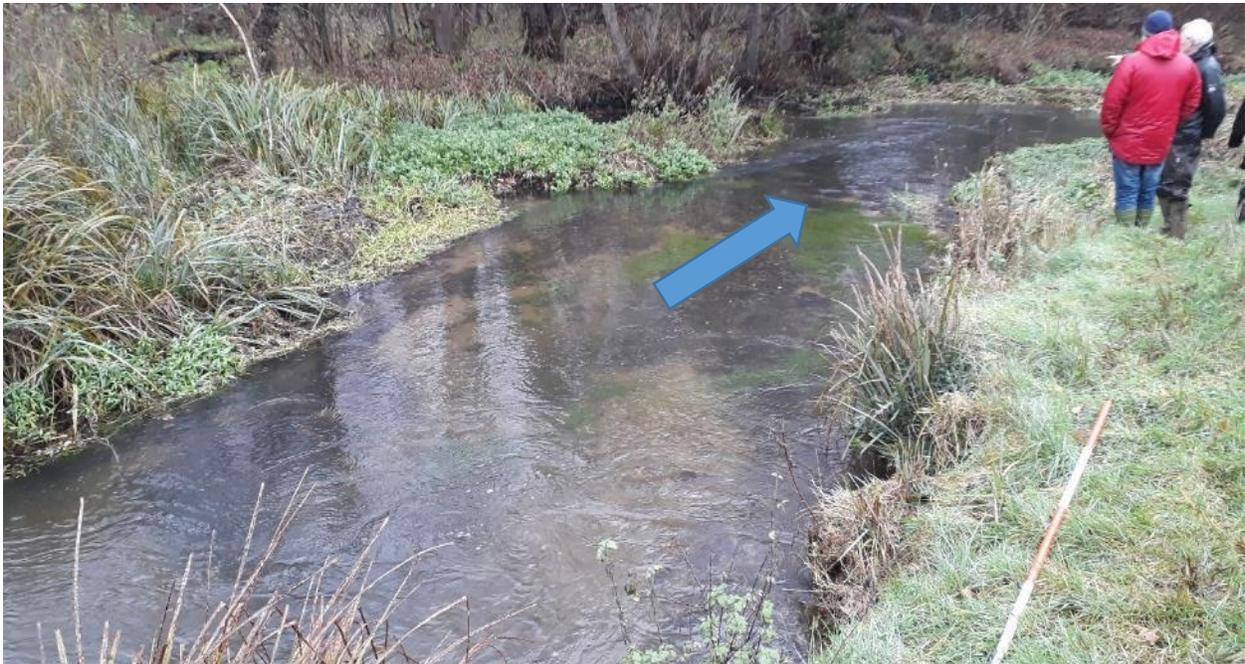
Picture 15 – Note the short riffle (blue arrow) as a result of local scour which occurred after a meander. This location also had a well-established marginal fringe which was maintaining a channel width of ~5m with subsequent diversity of flow (instead of smooth laminar flow which was observed in many over-wide locations).

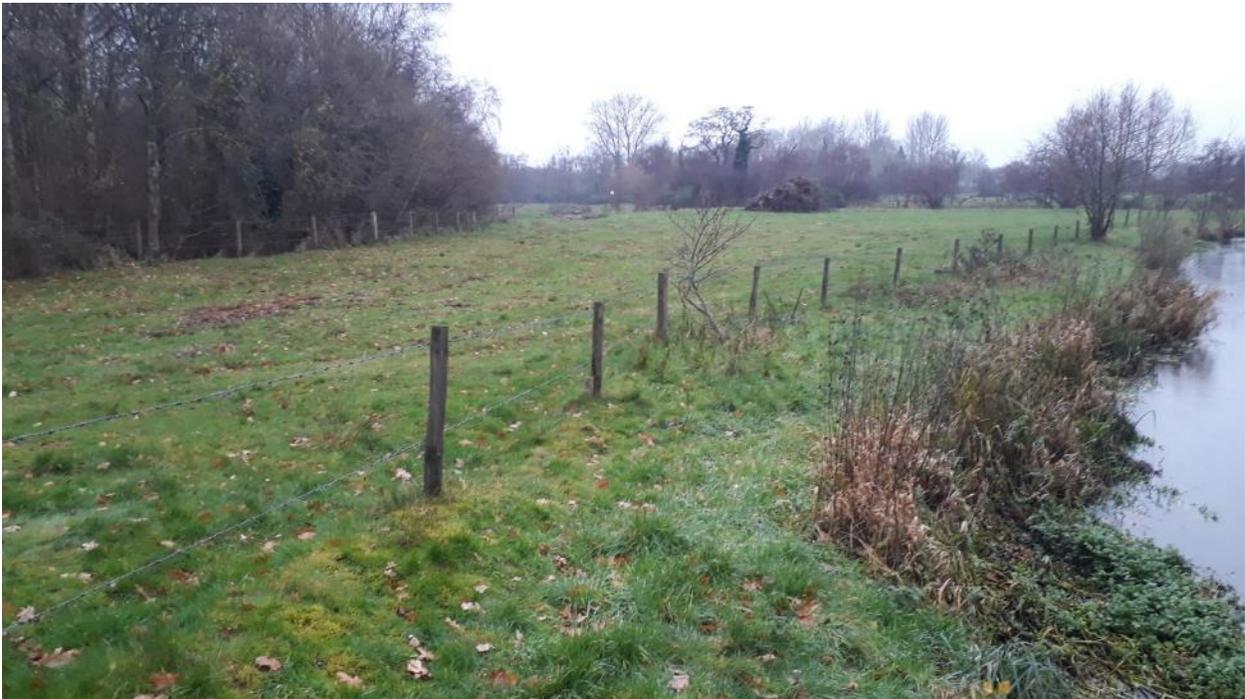
Picture 16 – Note the relatively low ground level of the adjacent pasture land. The river has the ability to connect to its flood plain relatively easily in most locations.

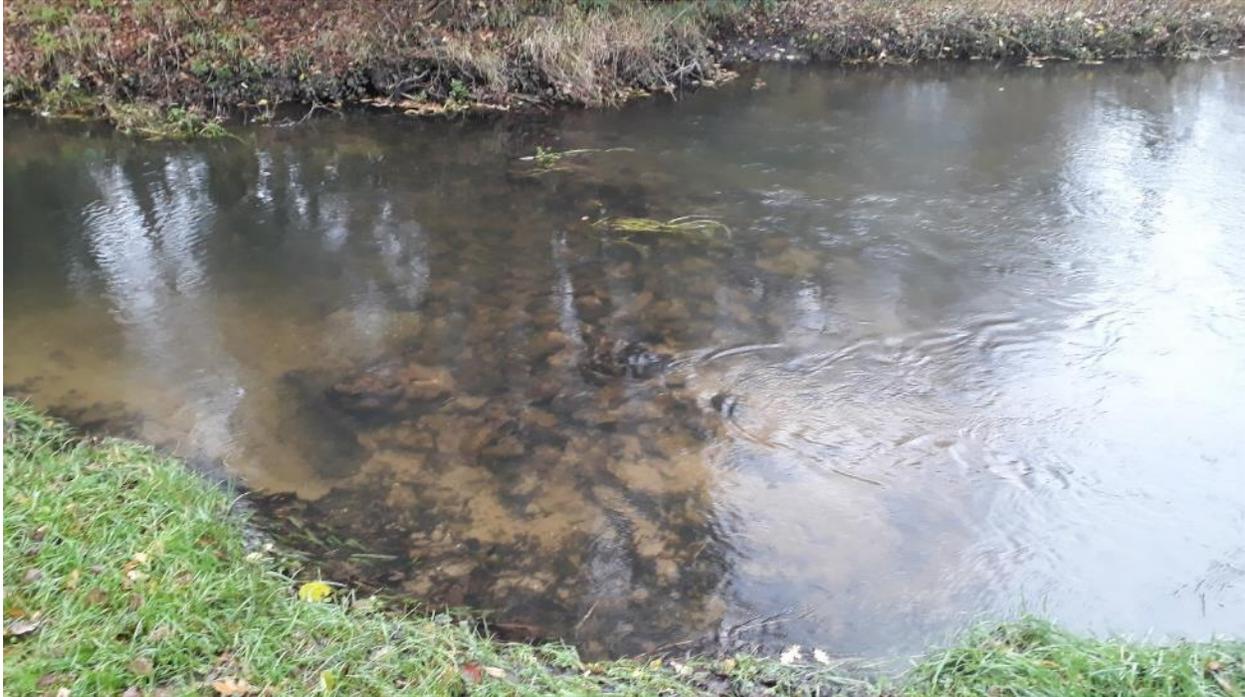
There was one low stone weir (see over for picture 17). This feature had been constructed many years ago and its purpose was to funnel low flows, and to create a local area of broken water. This feature is not considered beneficial to the river as it is hindering sediment transfer (especially of coarser material). In low flow periods, the weir may create an area of broken water immediately downstream of it, but it will be impounding a section immediately above. The benefit of local scour associated with a weir is almost invariably negated by the degraded (impounded) habitat above it.

Picture 17 – A low stone weir constructed from large flint stones. Note how the feature is covered by fine sediment and retains a “head” of sand upstream where additional fine sediments are deposited. This structure will also be providing adult crayfish habitat. This structure should be taken out or at the minimum have its central third removed so that the stones act as a throttle point to flow rather than impeding it and sediment transfer.

The low stone weir should be removed, or at the very least, have its central third removed. Removal will enable the meander pool above it to experience higher flow velocities with a consequential increase in the river's ability to transport and sort its load. If channel narrowing is required at this location then consideration should be given to the use of brush berms, LWM flow deflectors or bank realignment (combined with anti-crayfish measures). At present the large stones will be providing excellent cover for adult crayfish.

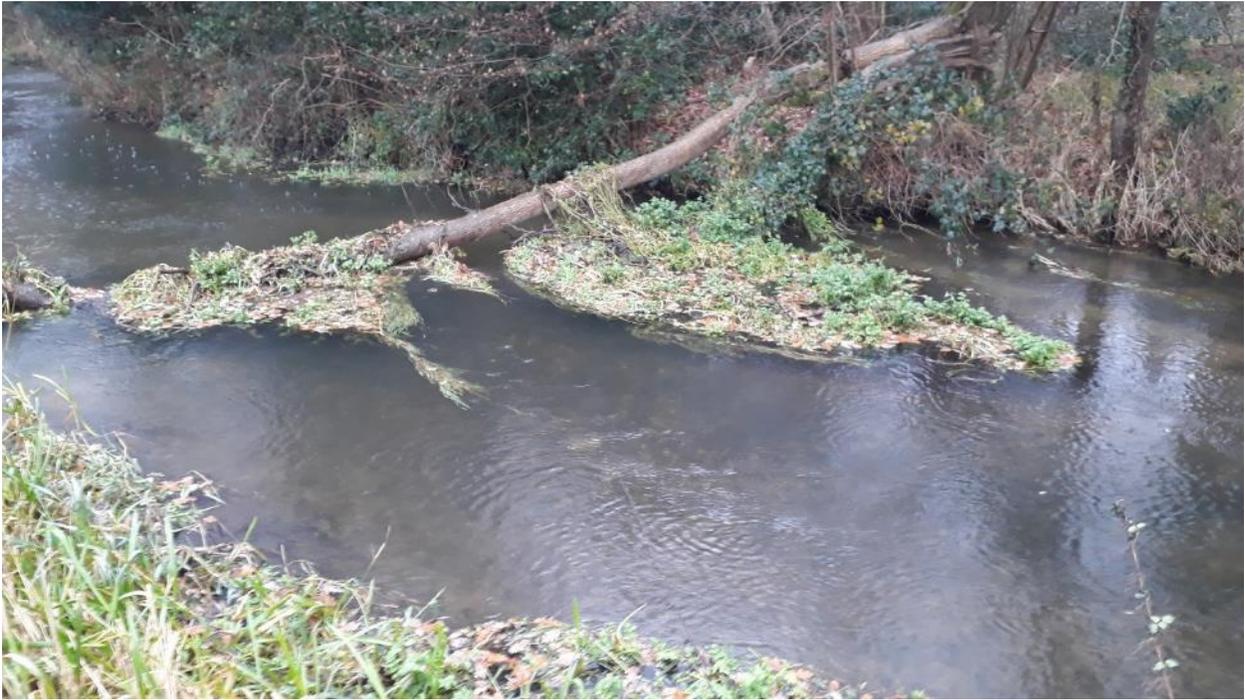
Picture 18 – Large woody material has fallen into the channel. It has then collected floating matter which is turn will be harbouring invertebrates and provides overhead cover for trout.

The presence of LWM within the channel should be welcomed, seen as valuable habitat and be positively managed. There were a number of fallen tree limbs which were gathering plant matter against them. These natural habitat enhancements can be secured using posts and wire, and do not require the consent of the Environment Agency if one is reducing the flood risk posed by such occurrences.

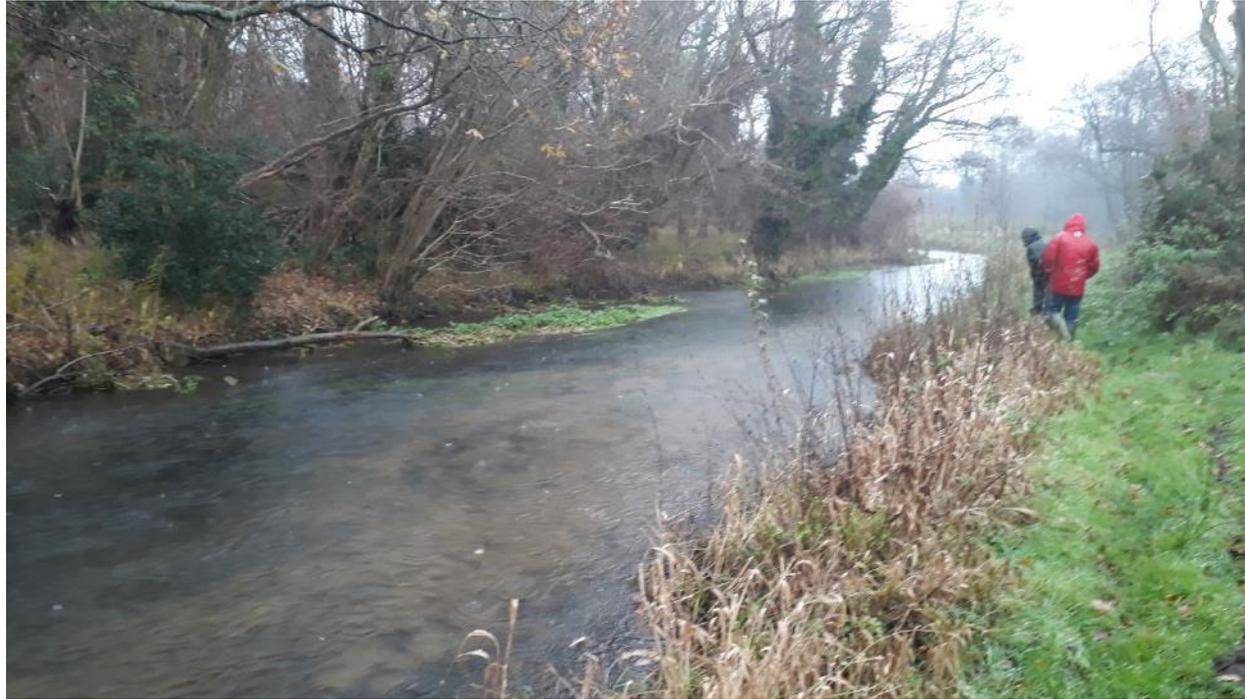
Picture 19 – Large woody material has fallen into the channel and has collected further floating matter. This natural occurrence can be easily replicated by the technique of tree laying (or hinging) to increase the trout holding capacity of the river.

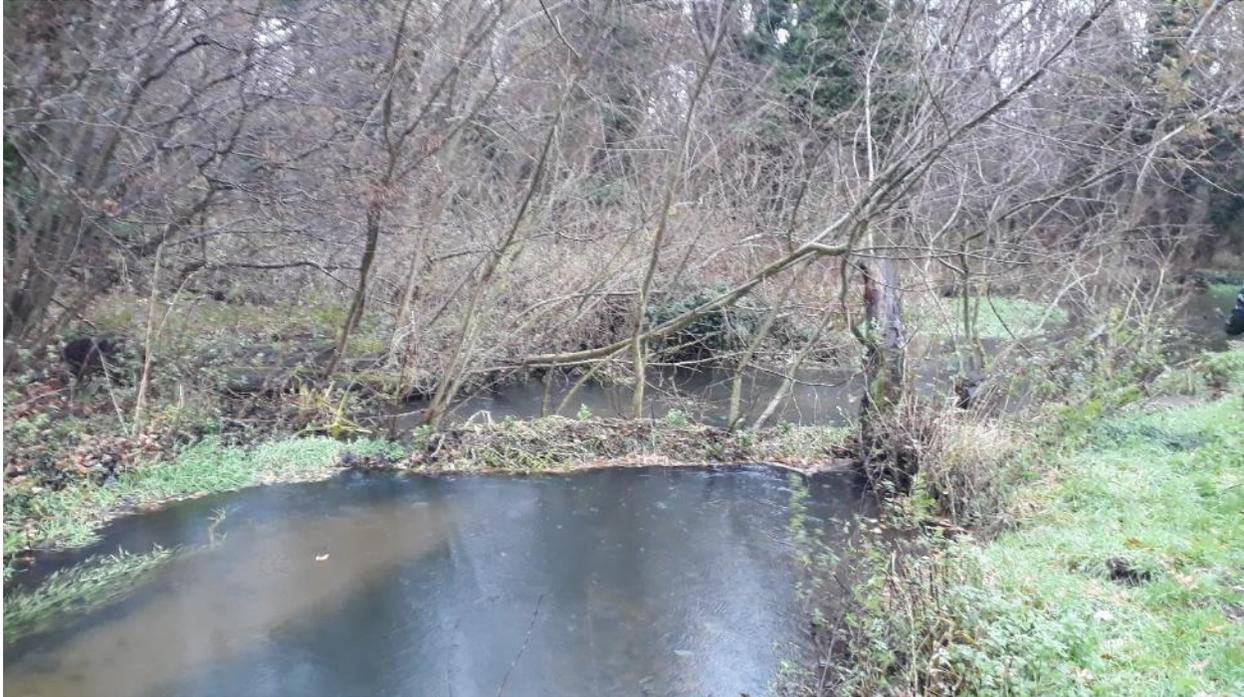
Picture 20 – At this location live woody material has caused debris to build-up against it. In addition to the benefits listed above this material will be forcing the flow of water downwards as it moves past it, thus increasing bed scour.

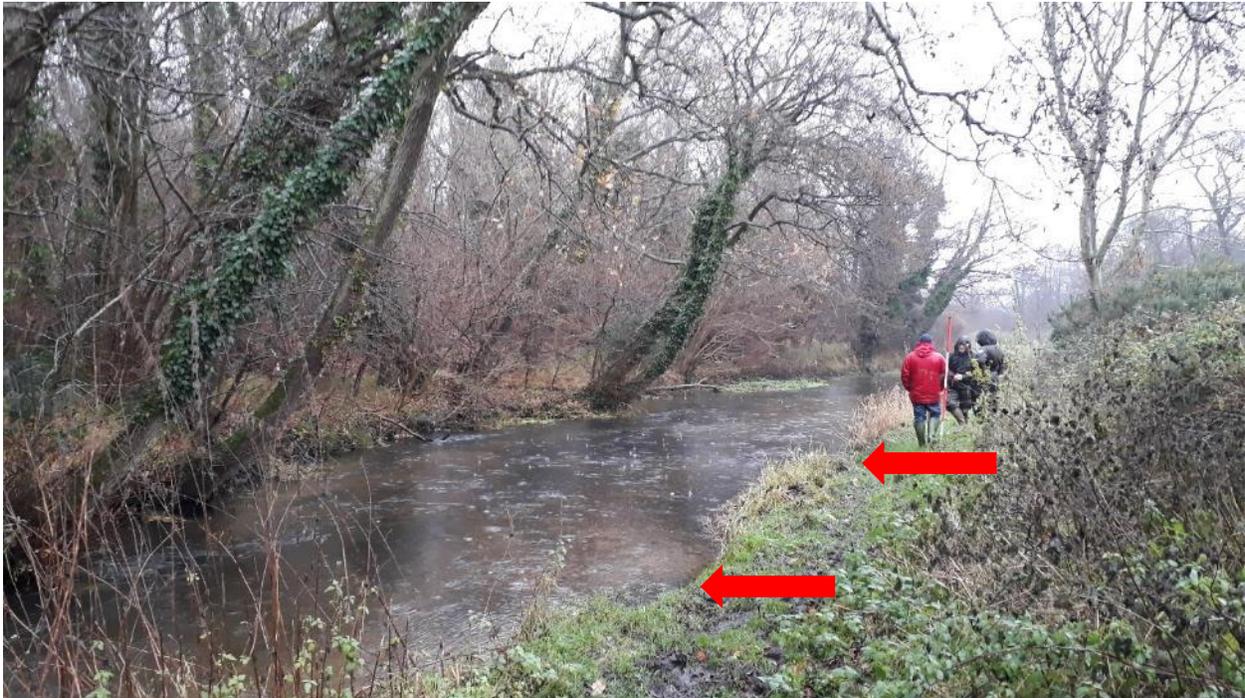
Picture 25 – Trees with much potential to be hinged, thus providing instant overhead cover and flow deflection whilst reducing marginal shade. Note the missing marginal vegetation where the tree canopy casts shade (red arrows).

technique of tree hinging. This technique sees trees (large or small) cut to produce an effect similar to hedging laying, but in this instance the trees are laid so as to provide instant overhead cover for fish. Many riparian trees and shrubs were viewed as suitable during.
