Advisory Visit
River Fynn, Suffolk
May 2019

Key findings

1.0 Introduction

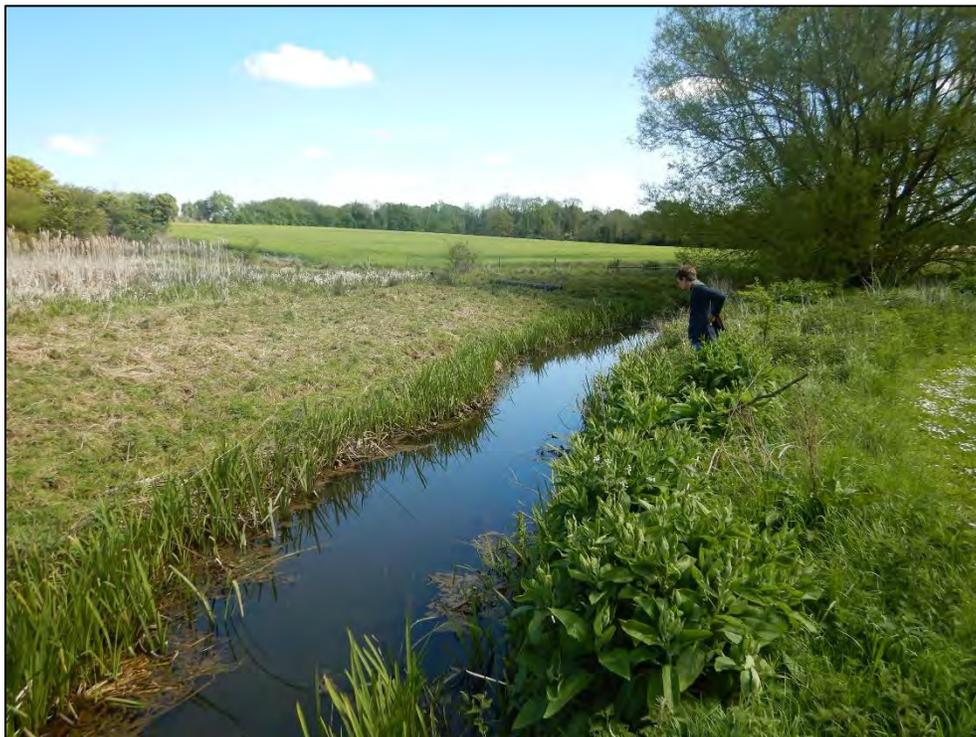
The visit started at the downstream end of the reach alongside Playford Mere. The Fynn was little more than 3m wide for most of its length with incised banks. The river had clearly been subject to extensive dredging and realignment in the past, resulting in a straightened channel with no visible coarse sediment deposits, consequently there was a complete absence of riverine features such as riffles, glides and gravel bars (pic 1).

Pic 1 – The River Fynn showing an impoverished channel.

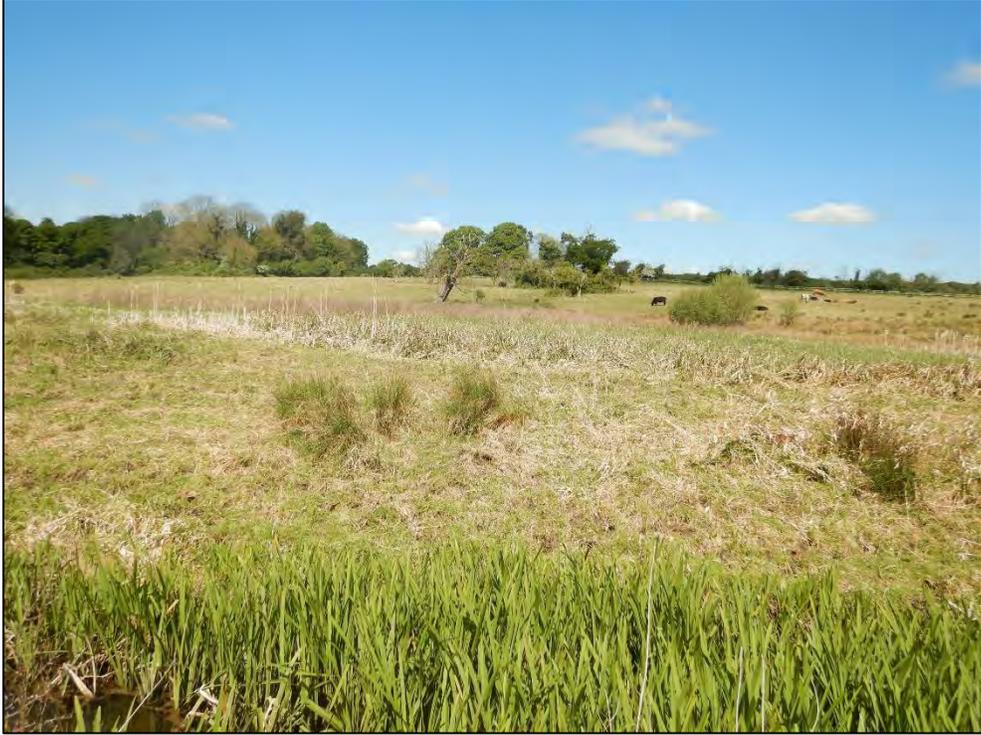
Land use **on the river's LB was rough grazing** and the land rose up from the floodplain (pic 3).

Pic 3 – The land use of the left bank was rough grazing.

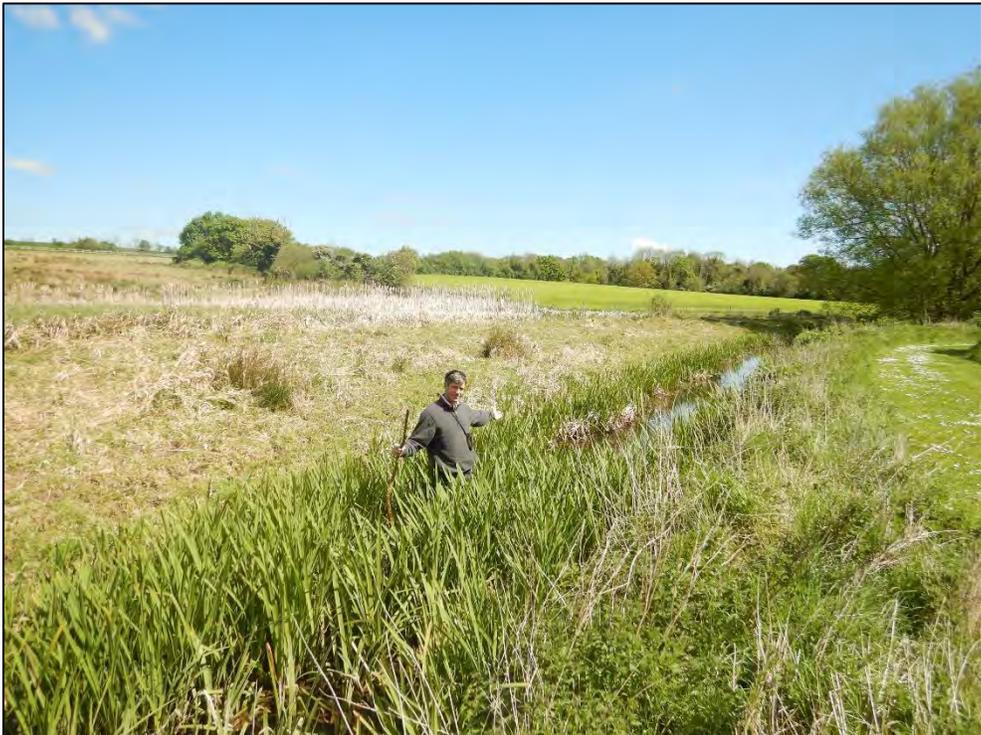
The river was choked with branched bur reed. In places the bur reed was dense enough to hold the weight of a person (pic 4). This was an interesting observation, as the bur reed had clearly been in place for many years and was acting as a trap of fine sediment which had consolidated, almost mimicking the way in which riffles would form. After the stand of bur reed, the channel deepened to provide a pseudo pool habitat. The presence of dense stands of bur reed, together with consolidated fine sediment, is indicative of the current lack of dredging or desilting to this reach, and the river is seeking to restore natural features (riffles) in the absence of a supply of coarse sediment.

Pic 4 – Bur reed had consolidated fine sediment almost mimicking the form of a riffle.

If access were possible for excavators and dumpers, it would be very interesting to introduce coarse sediment to the sites of consolidated bur reed and to allow the river to redistribute the material according to flow dynamics.

- The lower river should be allowed to evolve through natural processes unless it were possible to import coarse sediment (10-40mm gravel) in which case it would be worth placing the material upon, and in the general vicinity of, the consolidated stands of branched bur reed.

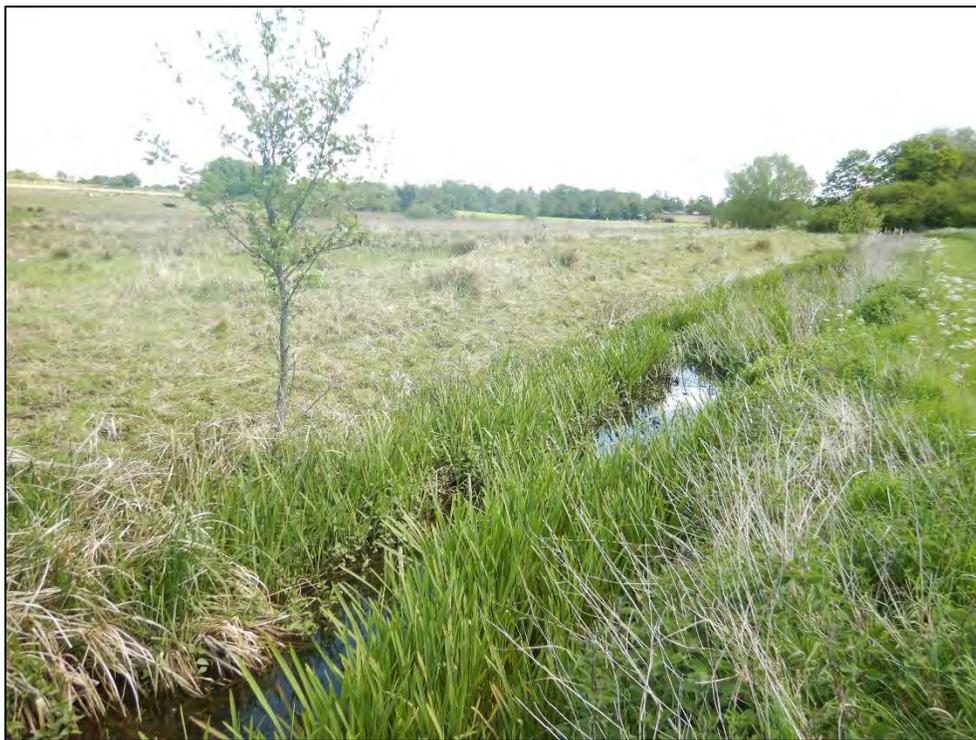
However, flow was pushing through the bur reed where the river had energy and it had maintained a small pathway of ~0.75m width through the reed (pic 5). The presence of a sinuous channel through the reed was encouraging as **it showed the river's intention to re-meander** across its floodplain. But any extensive meandering is very unlikely given the lack of gradient, low-flow and non-eroding margins. Furthermore, the close proximity of the mere, together with land rising on the left bank, significantly restricts the potential for realignment of the river to restore a more natural channel planform. Sadly, **the river appears to be caught in a "geological straight jacket"**.

Pic 5 – The river was able to cut a sinuous path through the branched bur reed.

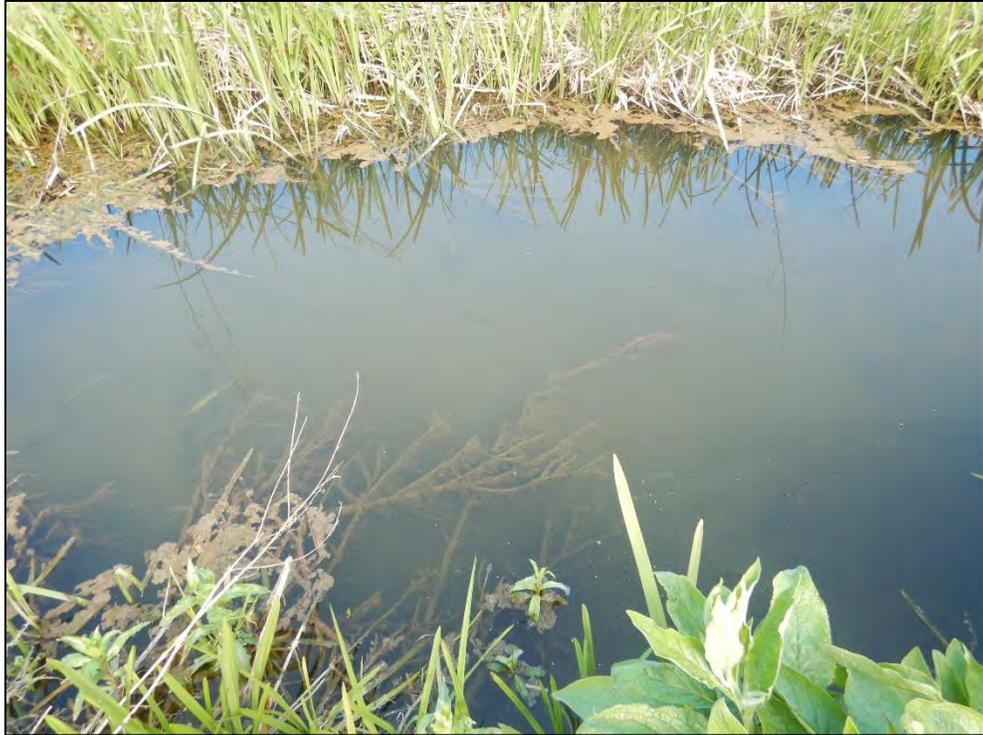
Numerous small fish were seen in the deeper "pool" habitats. Most were believed to be a stickleback species. There were also many mussels present, with many considered to be alive amongst the extensive silt that covered the bed (pic 6). Dense silt upon the riverbed is generally undesirable as it smothers aquatic habitats, limiting the available niches for invertebrates, resulting in an impoverished aquatic community. This results in less prey (food) items for fish.

Pic 6 – The riverbed was covered in fine sediment.

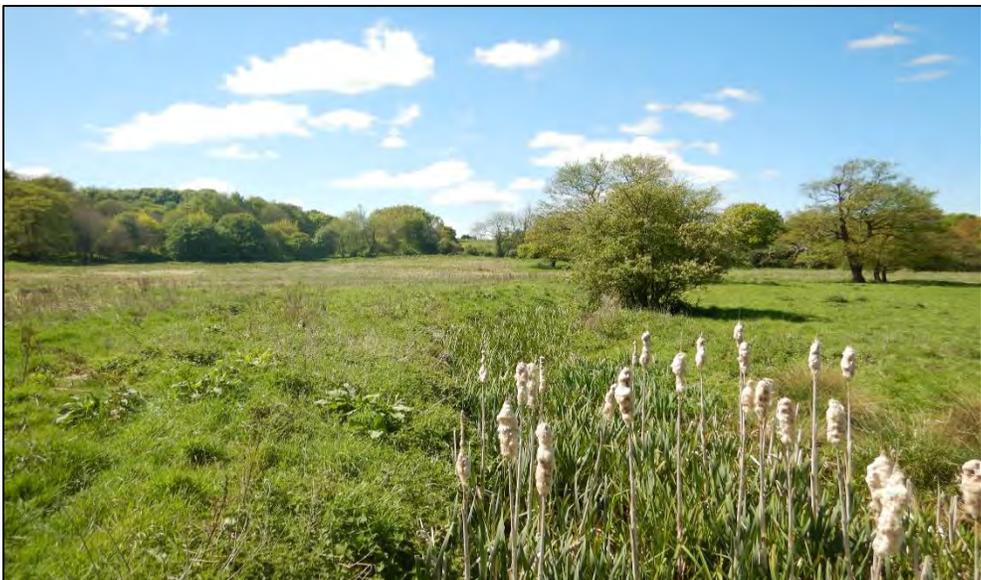
Towards the upper reach of the visit a number of very dense stands of reedmace were noted. They had grown to dominate the channel and diffused **the river's** flow, with water unable to define a clear pathway through. In places the channel was very overgrown (pic 8). Algae and organic matter was building-up against the reedmace, reinforcing the appearance of the degraded channel.

Pic 8 – Reedmace dominated the channel in places.

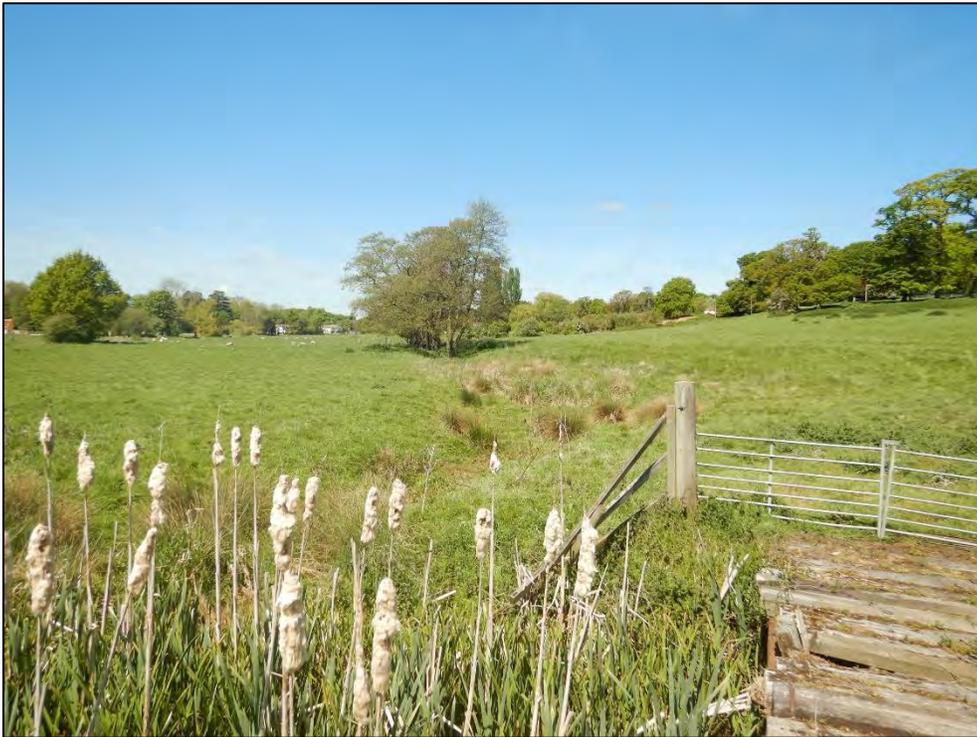
A dry tributary ditch (presumably once a small stream) entered the Fynn just above a sleeper bridge (pic 9). The ditch had no restoration potential.

Pic 9 – A small tributary ditch met the Fynn.

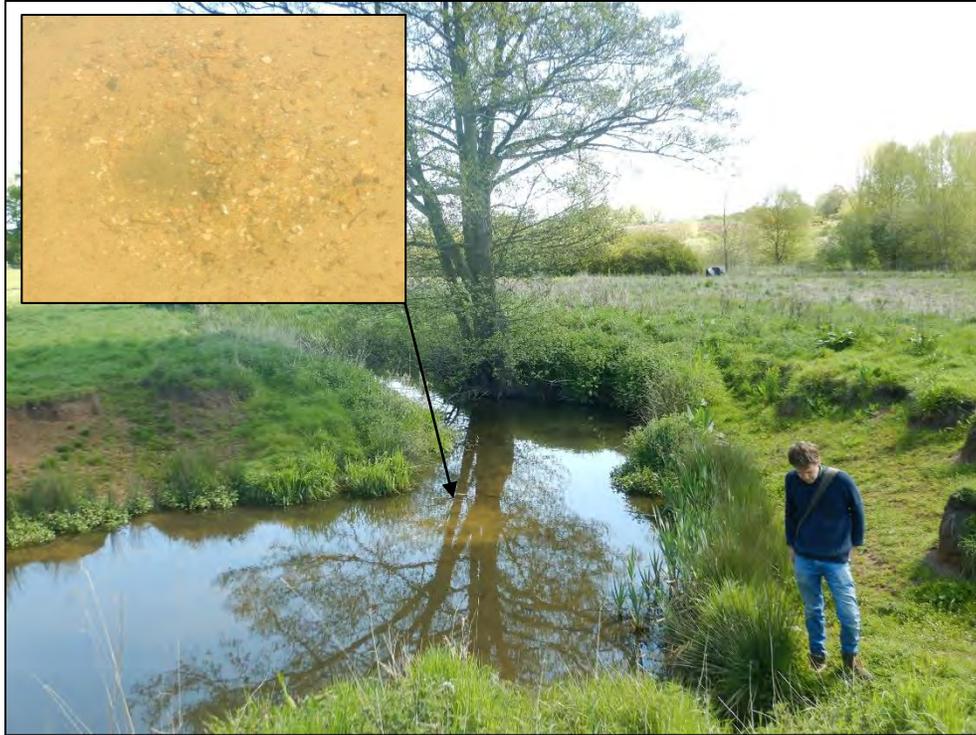
Above the **bridge the river's form** subtly, but importantly, changed. The channel was more sinuous and the bed profile was more variable. Adjacent to a mature common alder tree, a deep pool was present (pic 10). This part of the river did not appear to have been subject to the extensive dredging and realignment evident on the lower river.

Even more encouraging was the occurrence of coarse bed sediment in the form of a shallow gravel bar following a pool. The shallow water habitat was being utilised by a small shoal of dace. Disturbance of the riverbed by foot revealed the gravel to be quite extensive, but poorly sorted and containing a high proportion of sand.

Pic 10 – The river exhibited features such as meanders, bed variation and deeper pool habitats. A gravel bar was present (inset) a short distance upstream of a mature alder.

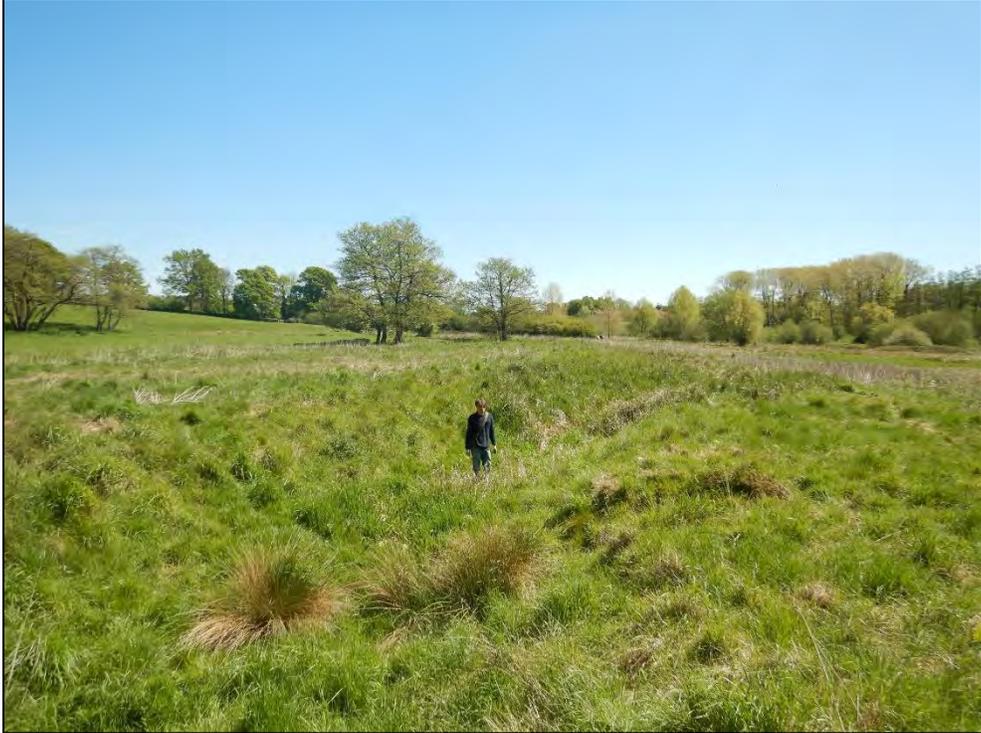
Within the floodplain there was a redundant channel that once formed a mill stream (pic 11). The channel was no longer connected to the river and did not **hold water. Investigation of the channel's bed did not** reveal any gravel deposits. Restoration of the river to the redundant channel is not considered to be worthy at present due to its poor channel form, multiple landownership and flood risk to the mill house.

Pic 11 – The course of the redundant channel leading from the former mill.

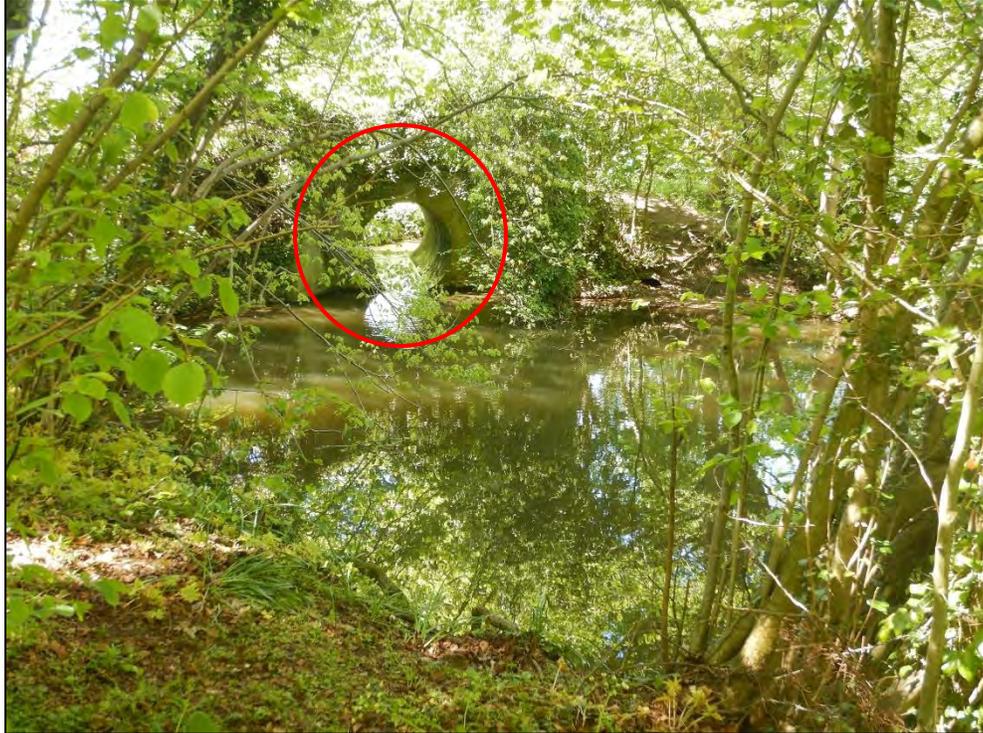
Most encouraging of the entire visit was to observe a brown trout rising in a large pool (pic 15). The pool had flow variation, tree cover, depth cover, an exposed gravel bar and a shallow gravel riffle as water exited it. The only drawback was that the pool appeared to have been created by a culvert at its head which carried a track above. In flood **periods the water's energy is** focussed through the culvert maximising scour of the pool, but it is very likely a barrier to fish movement due to shallow depth (at low flows) and elevated flow velocity (at high flows). This culvert may be one of the known barriers identified by the EA in **assessing the river's status under WFD.**

Pic 14 – A large pool created by water flowing through a culvert (red circle). A brown trout was observed rising.

- The culvert in the upper river may present a barrier to fish movement at high and low flows. All fish species need to migrate along rivers, especially brown trout. The installation of simple baffles to the culvert would be likely to increase the culvert's **passability** for a range of fish species.

- The EA should be contacted to see if they are aware of the culvert presenting a barrier to fish movement, and whether there are plans to address it.
