**Advisory Visit**  
**River Granta, Babraham, Cambridgeshire**  
**October 2019**

**Rob Mungovan**  
[rmungovan@wildtrout.org](mailto:rmungovan@wildtrout.org)

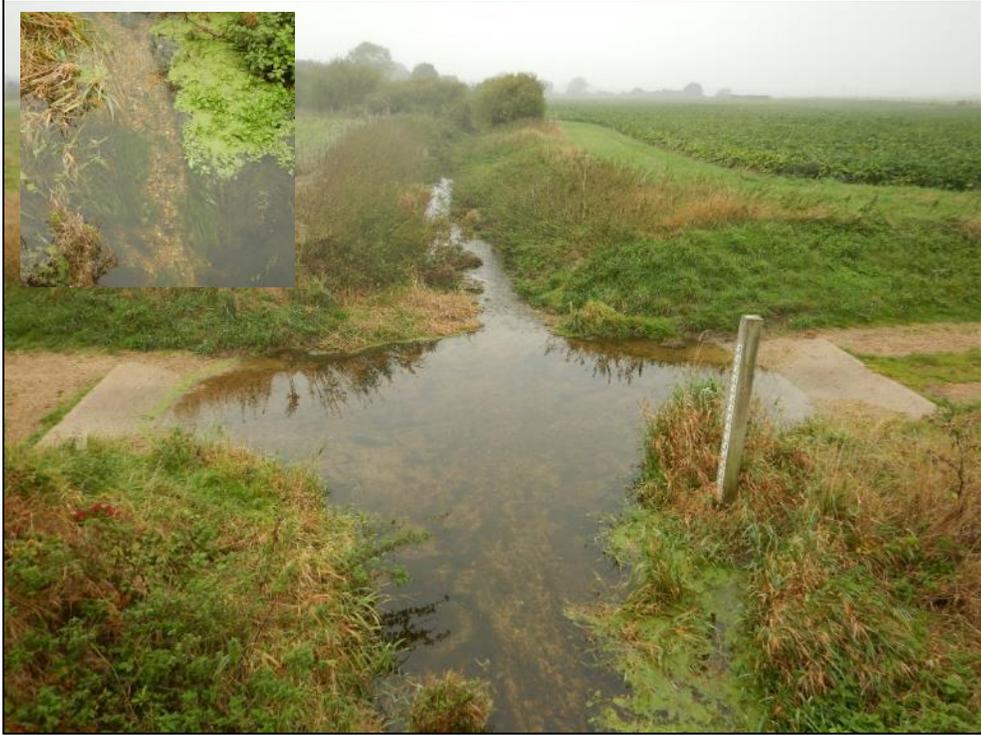
Pic 1 (TL 49526 51416) – The lower limit of the visit, the ford environs provide good marginal cover and a gravel bed suitable for trout to spawn upon (when stronger flow returns).

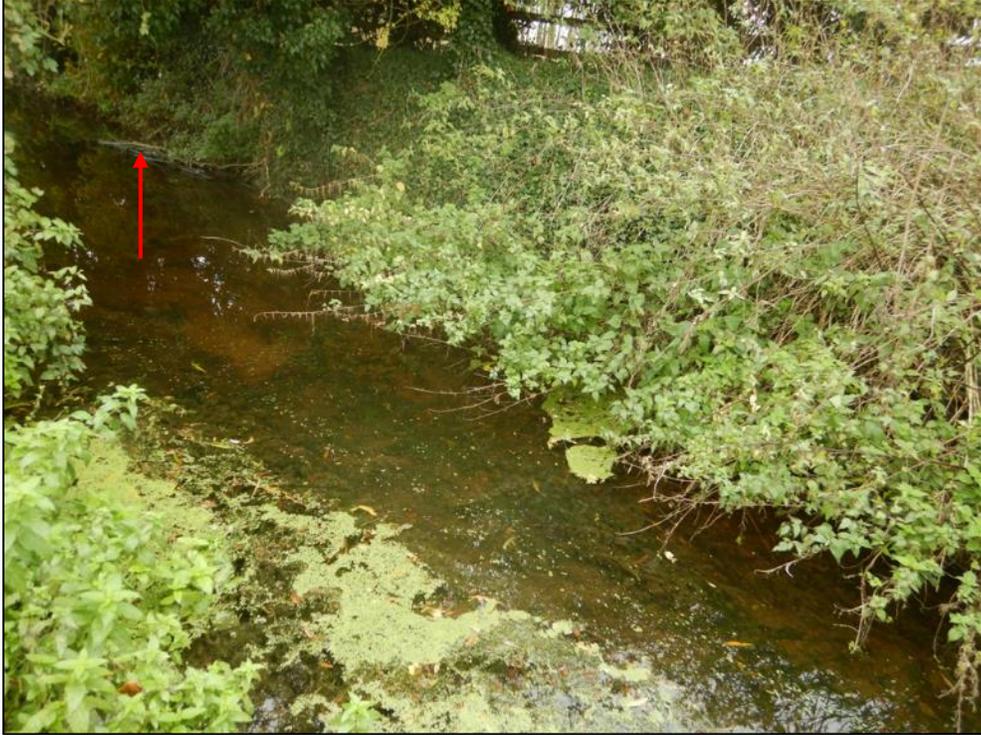
Above the ford, the river was canalised. Its width was largely uniform at ~3m with steep banks, little sinuosity and few marginal plants. The bed was covered in fine silt which smothered the gravel. The lack of scouring flow allowed Canadian pondweed and algae to dominate the open water (pic 2).

Pic 2 (TL 49547 51427) – The river has poor flow diversity, lacks sinuosity and has impoverished habitat. Note the faggot constructed flow deflector (red arrow).

flow deflector had not had any significant effect on bed scour due to it being constructed from faggot bundles which were allowing flow through the woody material as opposed to concentrating the entire flow around, and over, the structure. Furthermore, the deflector should have been extended further out into the channel to achieve a greater effect.

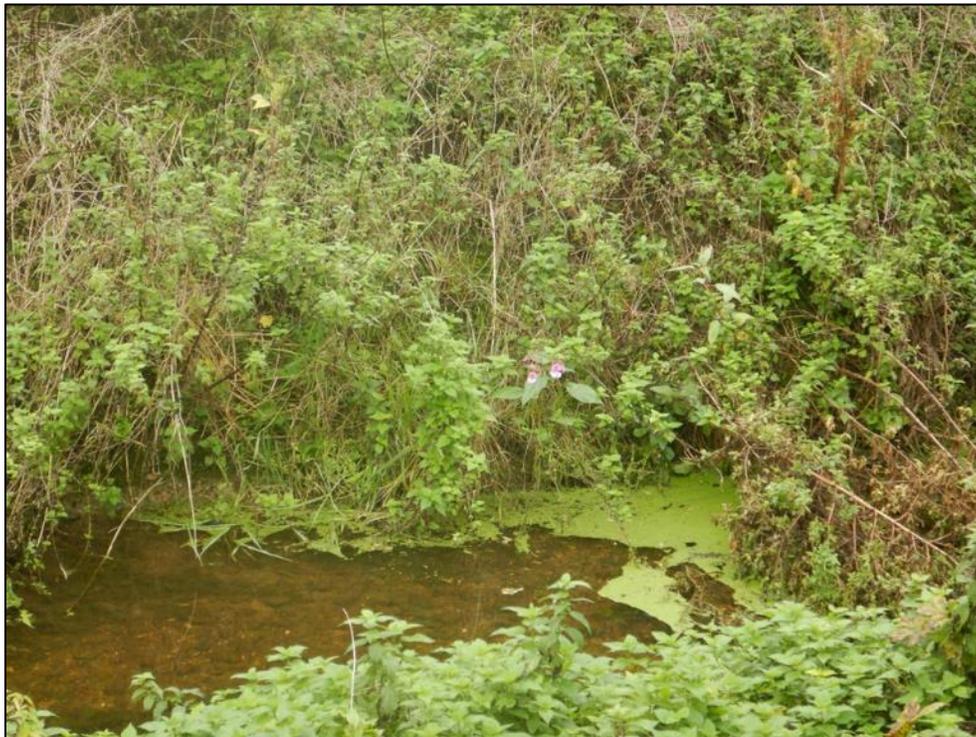
Pic 3 (TL 49609 51386) – Nettles continued to dominate the bankside flora with occasional Himalayan balsam plants present. Note the lack of marginal vegetation.

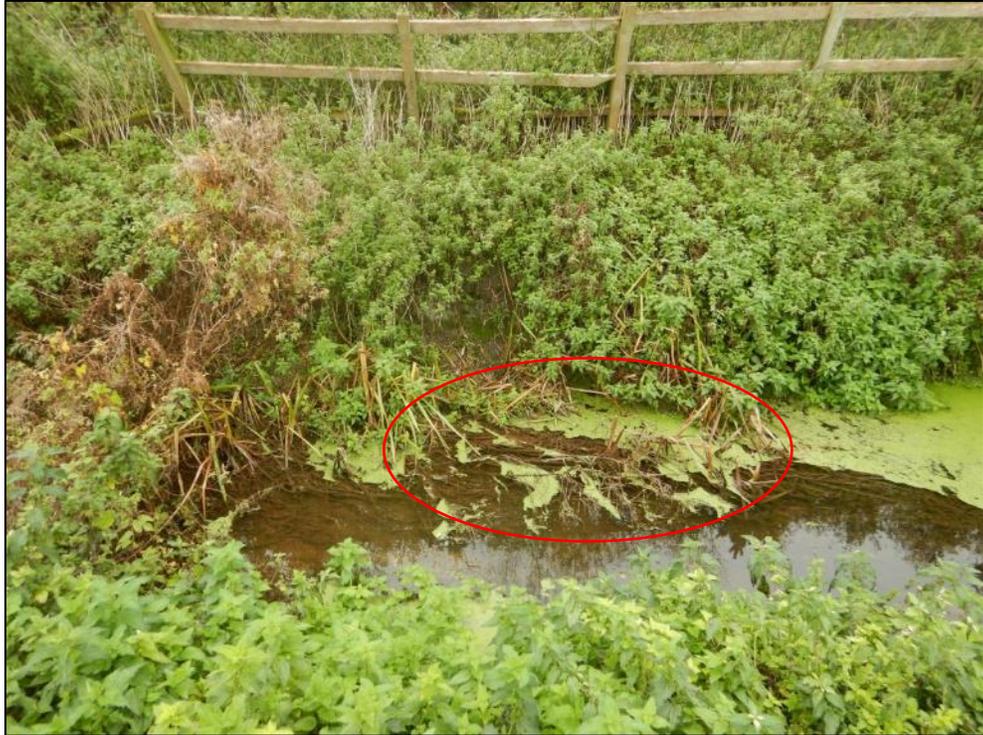
The tree dominance reduced at TL 49653 51391, and the river became unshaded. However, the lack of marginal vegetation was surprising. The EA herbicide control programme was considered to be the cause. Remnants of dying vegetation were observed, together with some yellow discolouration of nettle leaves (pics 4 & 5). The water colour had a brown tint consistent with rotting organic matter (pic 6). The use of herbicide by the EA on the Granta is not considered to provide any significant level of flood protection, yet the removal of marginal plants will negatively impact upon bank stability, fine sediment input and biodiversity. Herbicide causes the decomposition of a plant *in situ* (pic 7), consuming oxygen from the water, placing a further unnecessary stress upon the diminished flows of the river. The repeated use of herbicide is thought to be the reason for the reduced occurrence of marginal plants in the Granta.

Pic 4 (TL 49653 51391) – A stand of dying vegetation (red oval) and discoloration of nettle leaves as a result of herbicide drift.

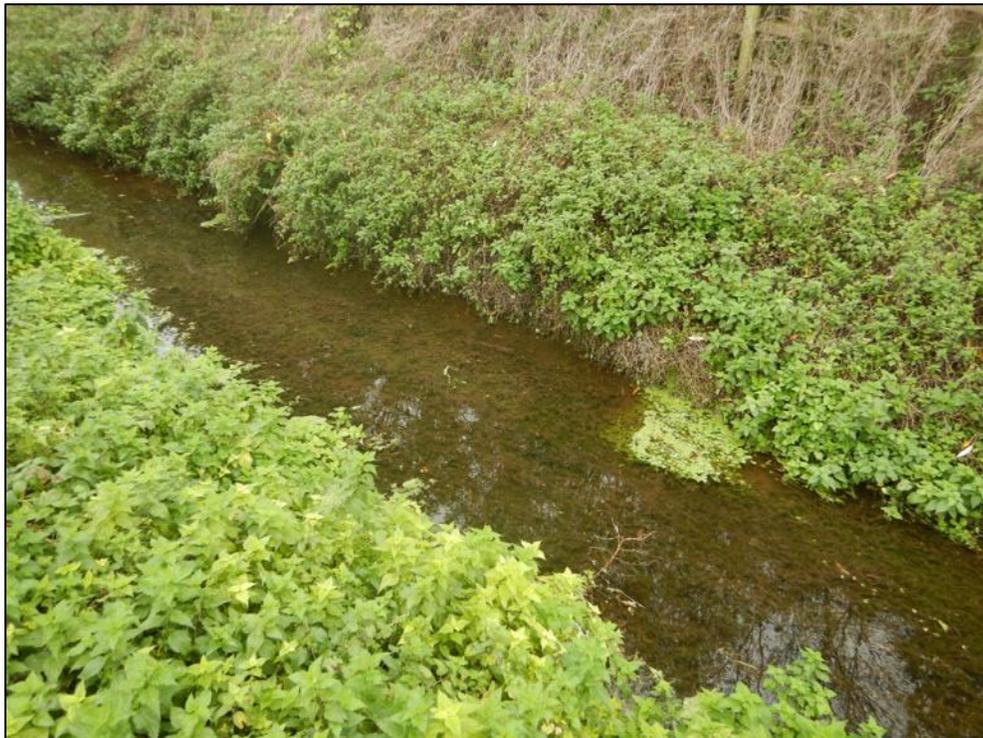
Pic 5 (TL 49681 51395) – Note the yellowing of the nettle leaves, a river choked with pond weed and algae, and poor-quality habitat.

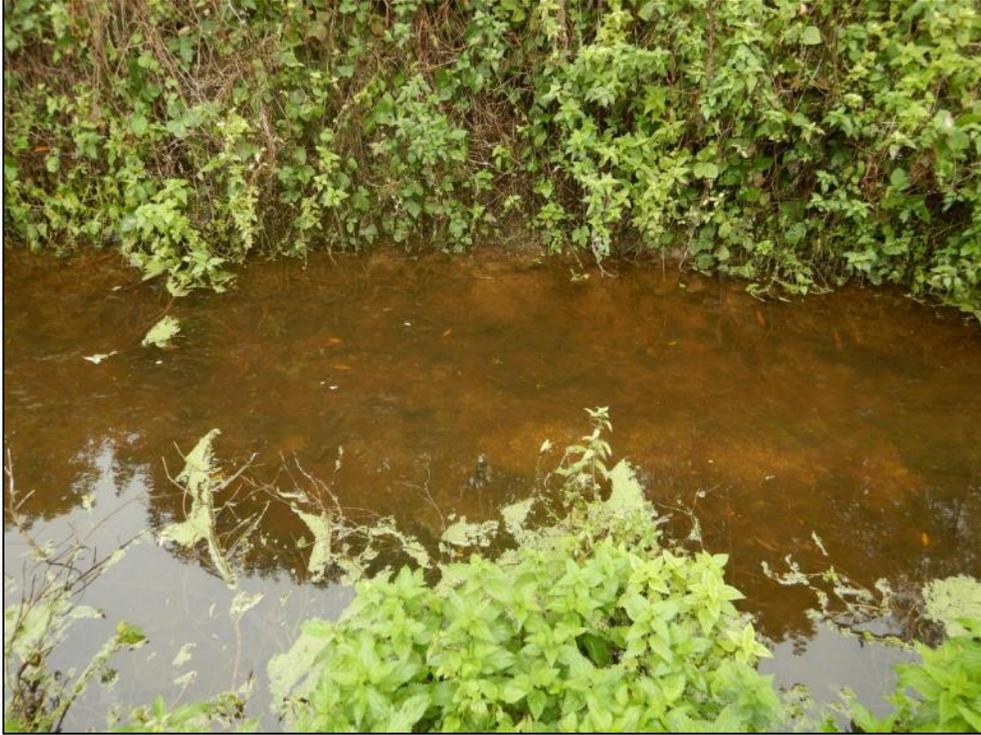
Pic 6 (TL 49701 51392) – Note the brown tint to the water, believed to be from organic matter rotting down.

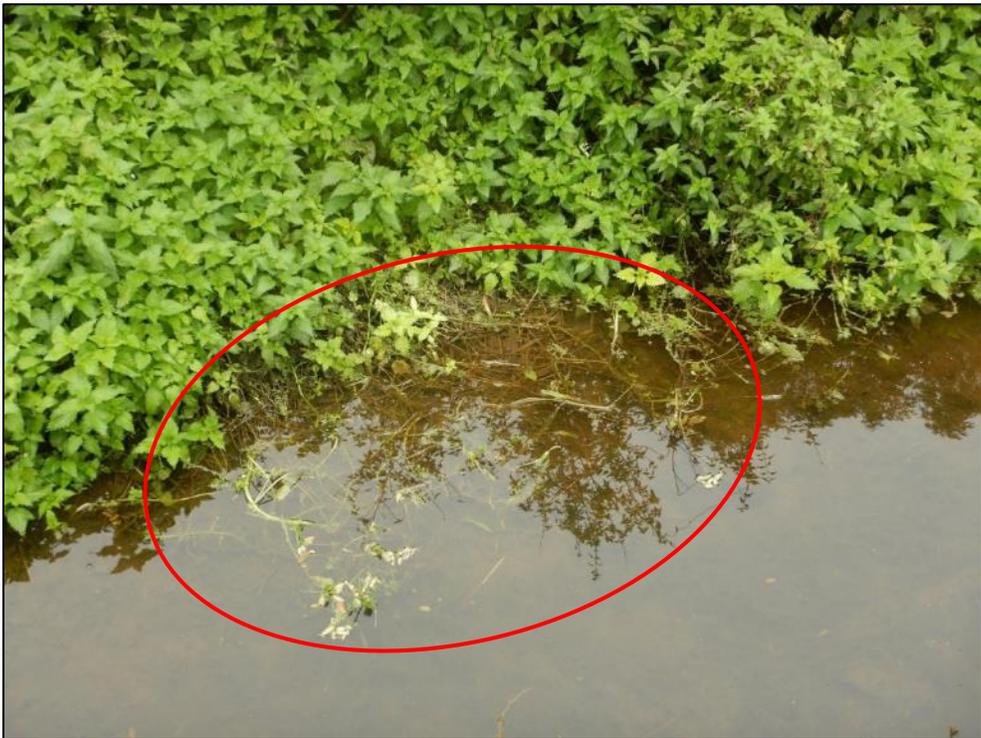
Pic 7 (TL 49714 51394) – The remains of a stand of watercress (red oval) killed-off by herbicide and now almost entirely rotted away.

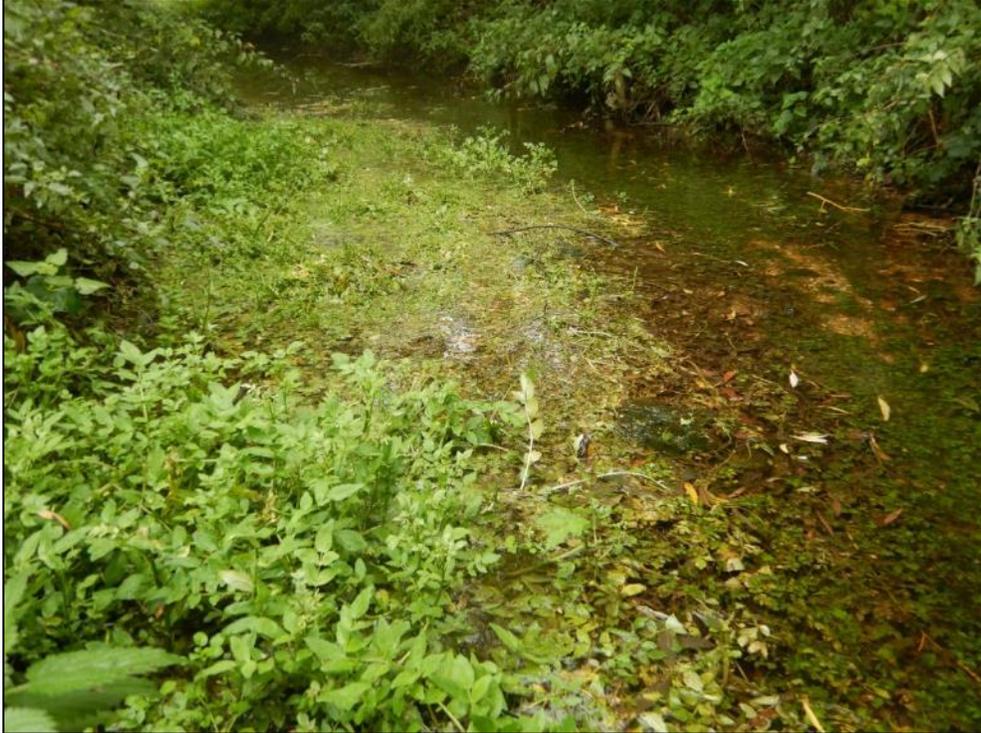
The river widened out to  $\sim 5\text{m}$  with a gravel bar present. The shallow margins were colonised by lesser water-parsnip, but unfortunately the majority of the stand was dying, assumed due to herbicide application (pic 9). The Granta is in a poor a state of management up to this point.

Pic 9 (TL 49743 51381)- Herbicide has been applied to this stand of lesser water-parsnip.

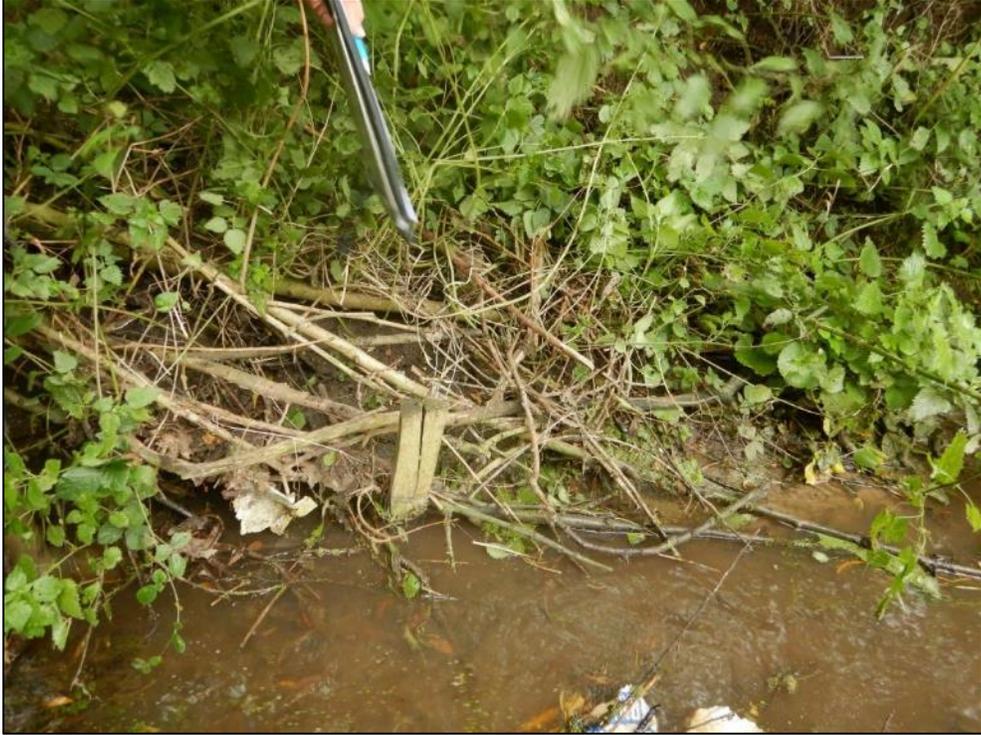
Pic 10 (TL 49743 51738) – The remnants of a brushwood structure that has entrained fine sediment and become partially colonised by vegetation.

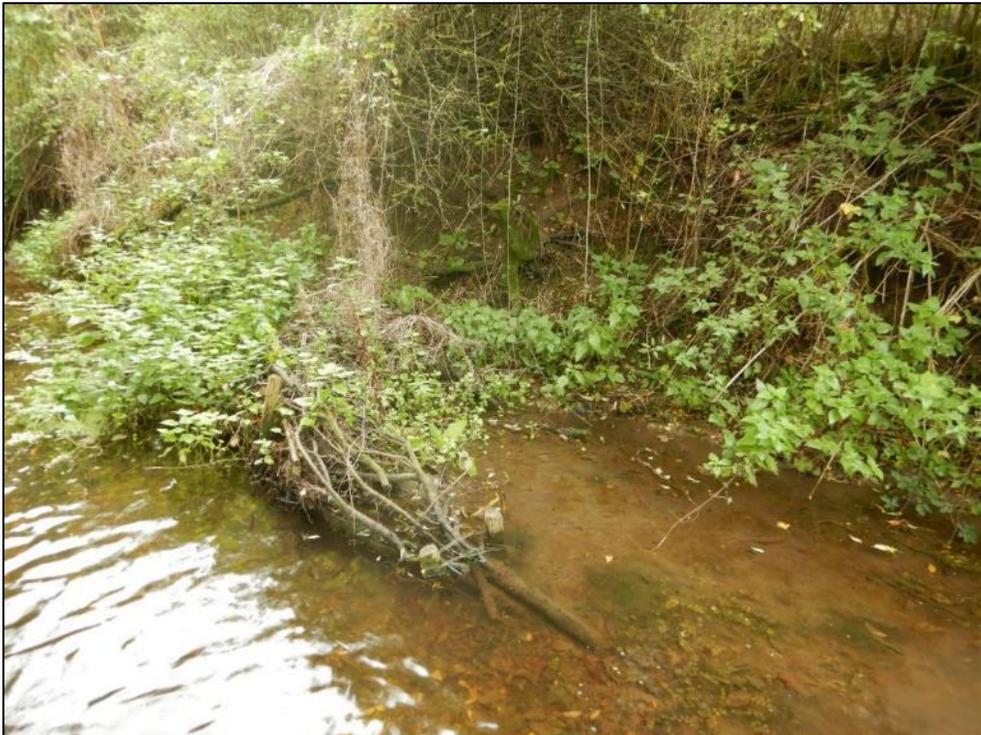
The occurrence of fallen sticks, branches and tree limbs, together with the organic matter that they collect, may look unsightly to some but the presence of such material is of great importance within rivers. Collectively such material is referred to as Large Woody Material (LWM). LWM leads to an increase in the surface area on to which a biofilm (algae, bacteria and other microbes) can grow. In turn, the biofilm may become a source of food for invertebrates, increasing the total biomass that a river can support. LWM also provides underwater cover, offering protection for fish against otters or fish-eating birds. LWM can also provide natural flow deflection which may locally increase a river’s velocity assisting cleansing of the gravel bed, but correspondingly slowing it elsewhere around the structure. Where LWM presents no flood risk it should be retained as it improves hydraulic roughness within the channel. Where possible, fallen trees should be secured in the river margins to provide habitat cover. There was scope for this where the cross-sectional area was greater and banks were lower. The only LWM present was that placed by the EA ~5 years ago with much of it now in a state of degradation, soon to be lost (pic 13).

Pic 13 (TL 49807 51357) – A flow deflector was the only LWM present in this reach of river.

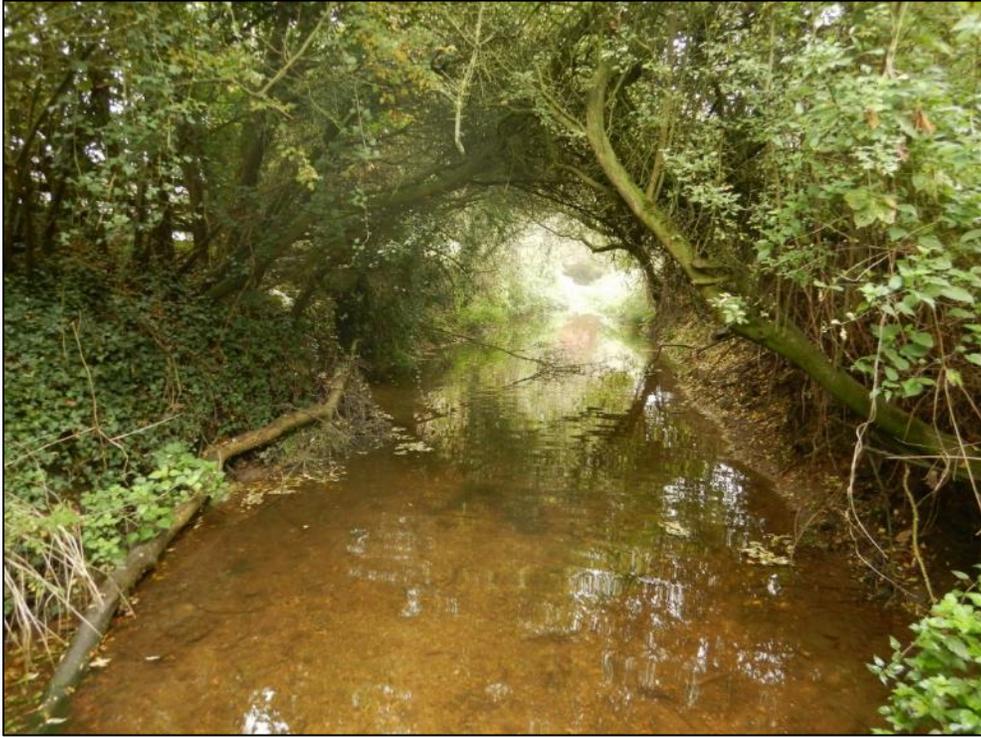
~50m long presents a degraded habitat beneath it (pic 14). Only 2 trailing branches provide any degree of habitat cover. The flow beneath the shrubs lacks diversity resulting in poor sediment sorting and a uniform bedform.

Pic 14 (TL 49817 51353) – Only 2 trailing branches provide habitat. This reach is significantly over-shaded and too wide for the flow normally conveyed.

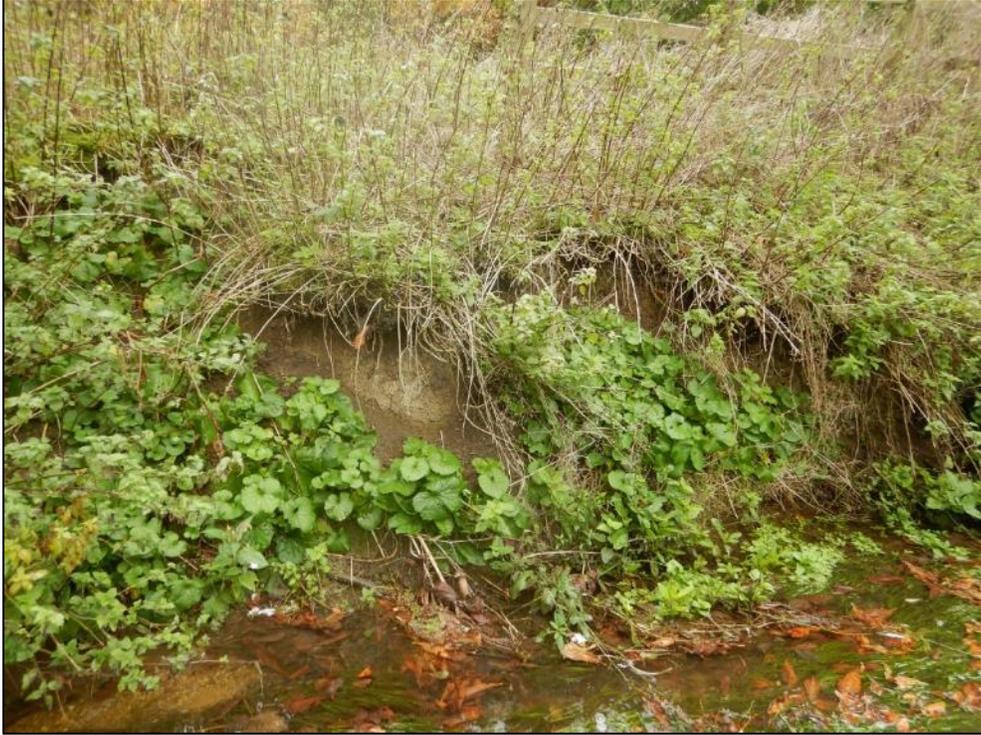
Above the discharge pipe the LB became steep to the point where it was unstable, resulting in an earth exposure (pic 15). Eroding banks inputting fine sediment are not necessarily desirable, but the exposed bankface provides a potential kingfisher nest site and should be retained. Minor habitat work to expose further bare earth could increase the chances of kingfisher nesting at the site, as would the installation of artificial kingfisher nest chambers. In the relatively flat Cambridgeshire landscape the occurrence of suitable nest sites is known to be a limiting factor to kingfisher distribution.

Pic 15 (TL 49859 51339) – Eroding banks may be used by nesting kingfisher.

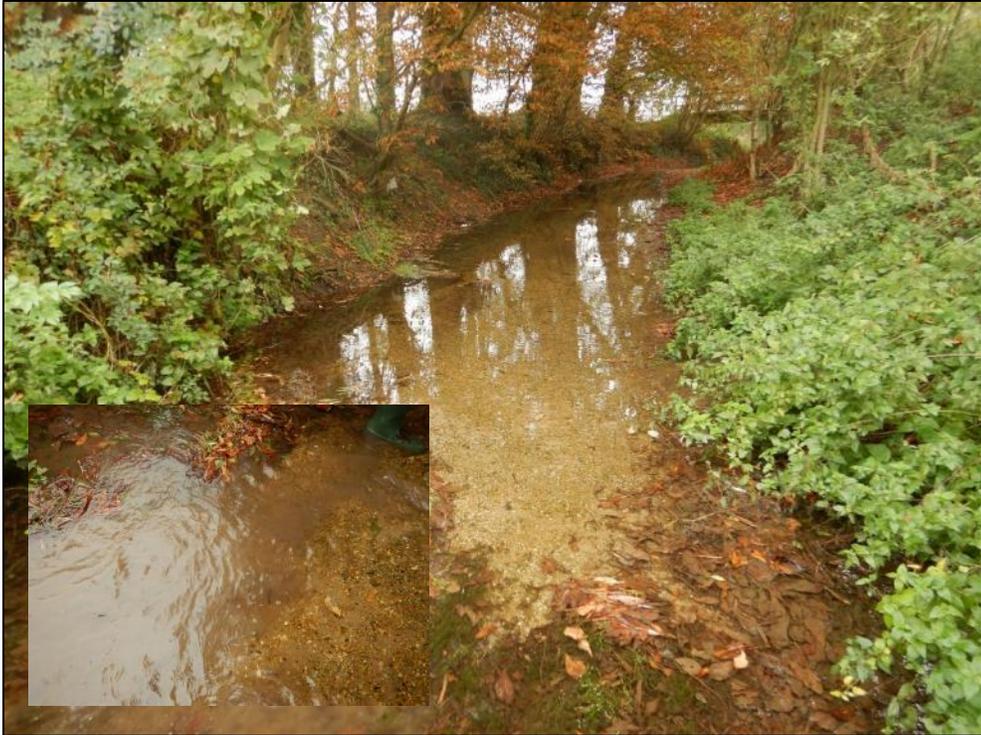
A “clean” gravel glide was observed beneath a stand of horse chestnut trees (pic 16). Upon closer inspection by using one’s foot to dislodge the sediment (inset pic), it became apparent that the gravel was poorly sorted and contained a high proportion of fine sediment. At present, this area represents poor spawning habitat.

Pic 16 (TL 49870 51340) – The gravel bed contains a high proportion of fine sediment and is unsuitable for trout to spawn upon.

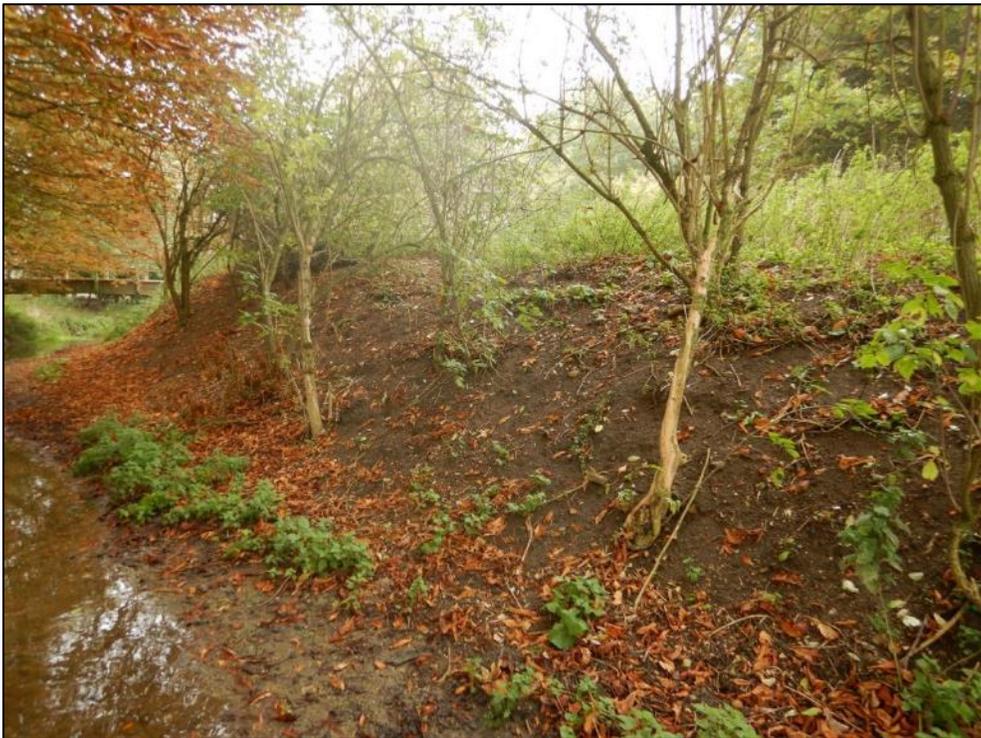
The horse chestnut trees cast much shade which suppressed understory vegetation on both banks (except for some elder bushes opposite). Consequently the banks were bare and a source of fine sediment input (pic 17). Removal of the elders would allow more light to the river which may initiate marginal growth, aiding bank stability. Furthermore, using an excavator the toe of the bank could be pushed down and out in order to create a narrowed-down low-flow channel with a wider cross-sectional area to convey flood flows.

Pic 17 (TL 49882 51337) – The elder growth should be removed leaving the bank to be re-graded to create an enhanced a low-flow channel.

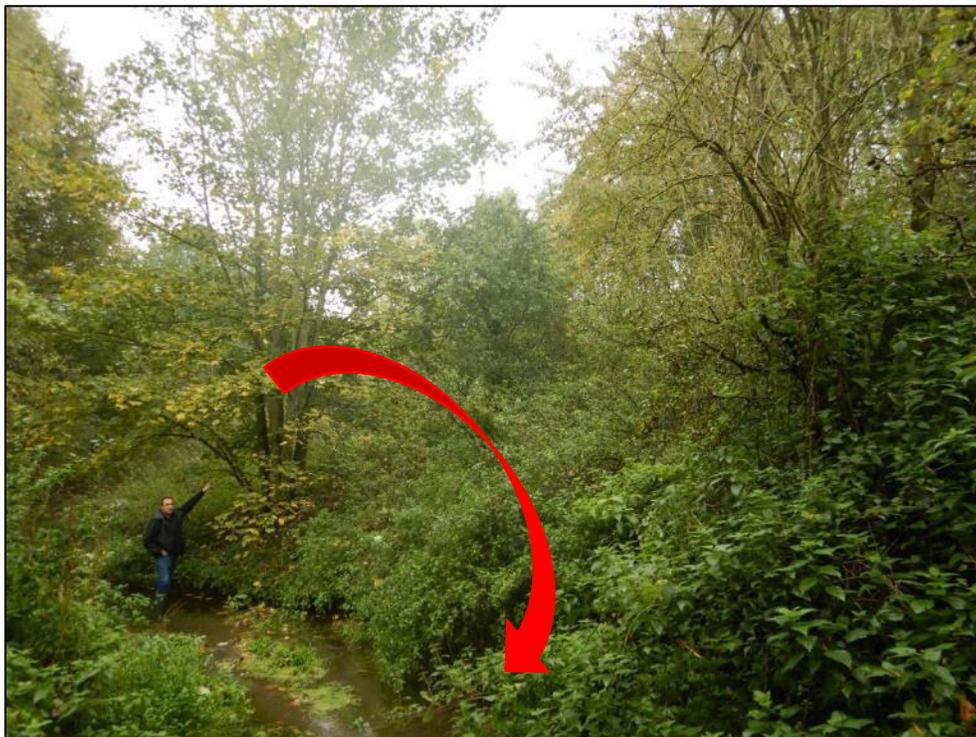
The river flowed through a mix of open and closed canopy, with a few medium sized sycamore trees present (pic 18). The sycamores are suitable for tree-hinging which would reduce the effect of shade, provide immediate overhead cover at water level and enhance flow diversity.

Pic 18 (TL 49908 51310) – A sycamore tree suitable for hinge-cutting to provide immediate cover and flow diversity.

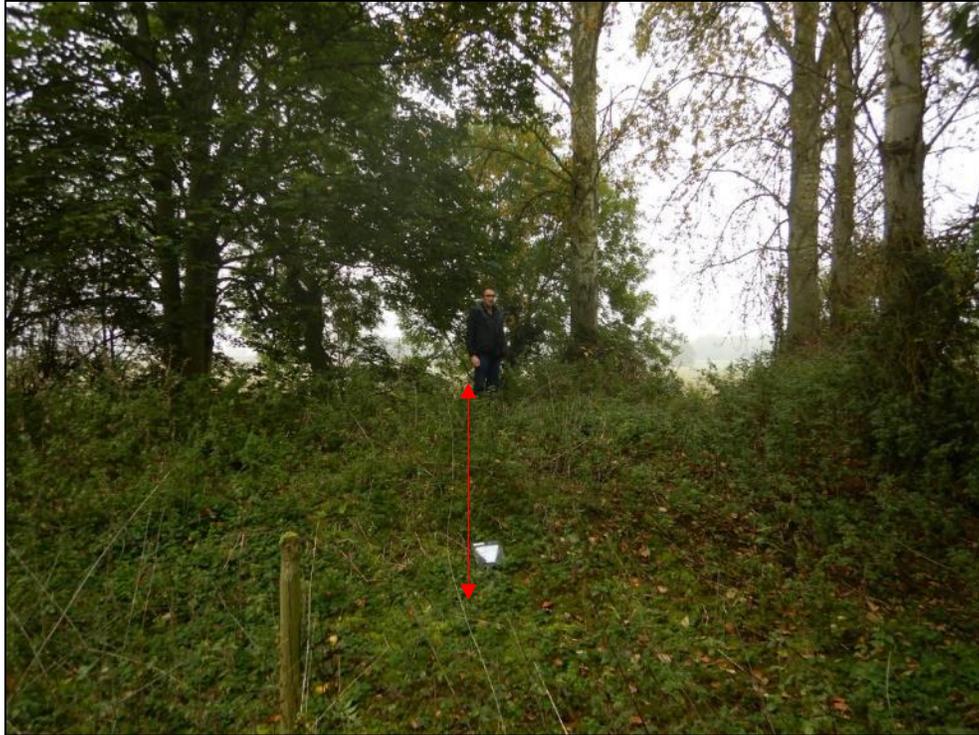
Walking through the adjacent woodland (established within the last 20 years), evidence of extensive dredging became apparent with large piles of gravel-rich spoil placed along the LB forming very significant levees to 1.5m high (pic 19). By removing material that was once beneath water and placing it above water (on the floodplain) the capacity of the floodplain has been reduced by the corresponding volume of spoil excavated from the river. Levees prevent rivers from connecting with their floodplains and stop water flowing back to a river. It may be possible to utilise the spoil levees to create new marginal

Pic 19 (TL 49918 51281) – Very large spoil levees (red arrow) are present along parts of the river and showed the extent of previous dredging activity. Removal and re-use of the spoil levees would allow floodplain reconnection.

features. Some spoil may even contain enough gravel to enable the restoration of features such as riffles. When scoping any habitat enhancement or restoration, the removal and/or use of the spoil levees should be considered to achieve floodplain re-connection.

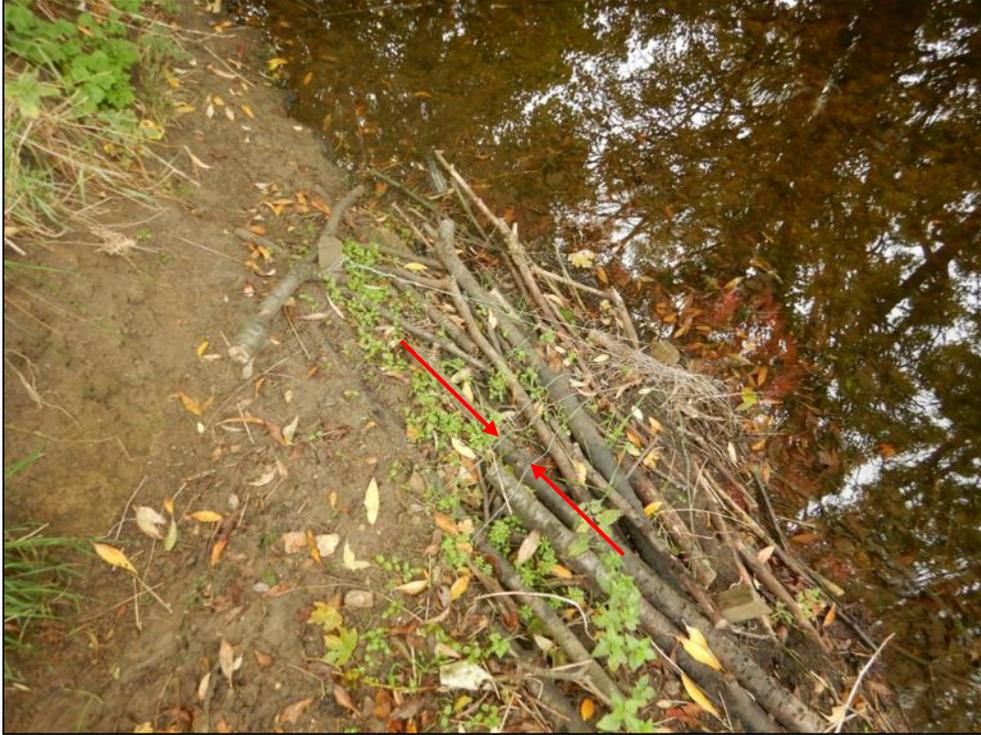
A location was reached that was clearly a popular spot for people to enjoy the river. Consequently, the banks were eroded by dogs and people, creating a source of damaging fine sediment input. It would be possible to address the bank erosion with carefully placed logs and faggot bundles to sensitively reinforce the bank, and to close-off some evolving slides. Of note was some brushwood held by long lengths of wire which had become loose and presented a hazard to people and their dogs (pic 20). The WTT can demonstrate ways to fix structures in place which minimise risk to river users.

Pic 20 (TL 50748 50907) – This faggot bundle has been effective in stopping bank erosion, but the fixing wire (red arrows) has become slack and poses a hazard.

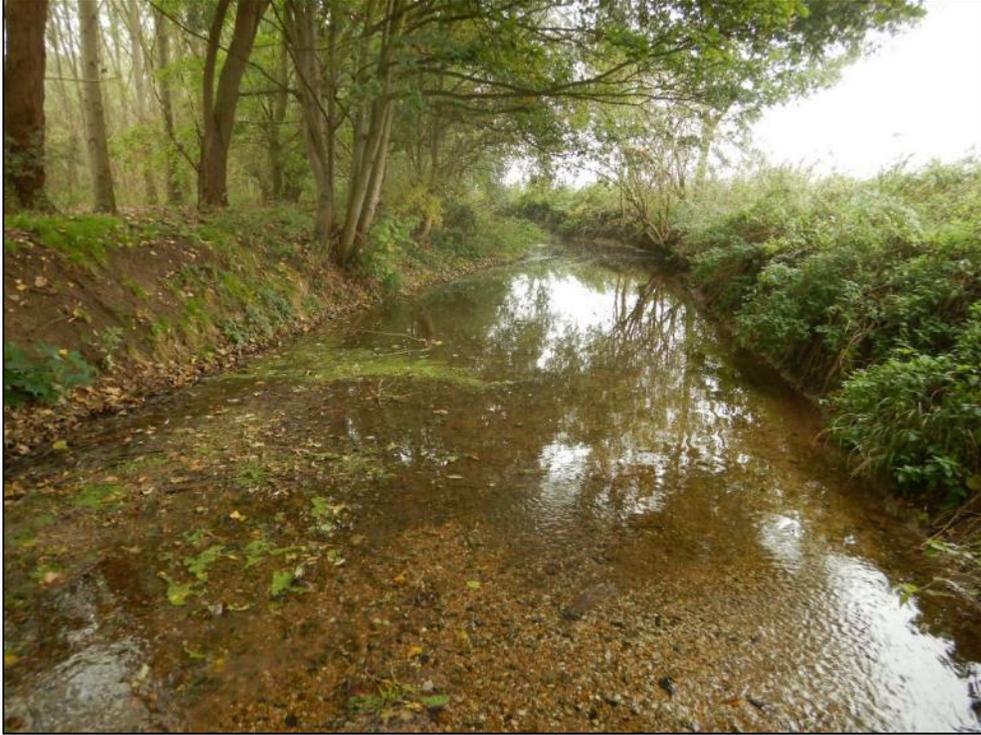
Interestingly, a point was reached where the width was  $\sim 5.5\text{m}$  with trees casting shade. Consequently, the in-channel flora was limited (pic 23). That view contrasted starkly with the view immediately above it (pic 24), where light reached the river and vegetation grew resulting in abundant marginal cover.

Pic 23 (TL 50289 51217) – A stark channel with no cover; a consequence of shade and LWM removal.

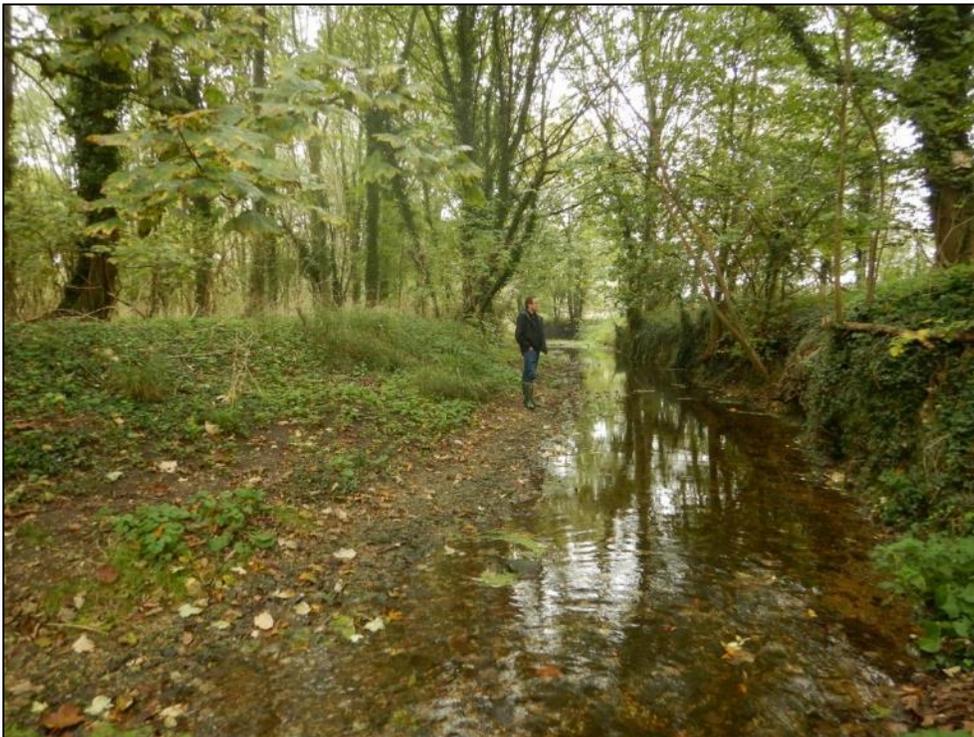
The tree cover increased again and suppressed marginal vegetation (pic 25). The RB retained a near vertical angle which has provided a nesting site for kingfishers. Clearance of vegetation from the bank-face could make it more suitable. Alternatively, bank scour could be initiated by tethering a felled tree on the LB to create scour on the RB. The felled tree could be positioned to create bed scour as well. The cross-sectional area of the river at this location was relatively wide so flood flow should not be impounded by any structure positioned across the channel. Furthermore, out-of-bank flow would move through the adjacent woodland due to the relatively low LB.

Pic 25 (TL 50510 51159) – The cross-sectional area of the channel was wide at this point which makes it suitable for in-channel structures without adversely affecting flow conveyance.

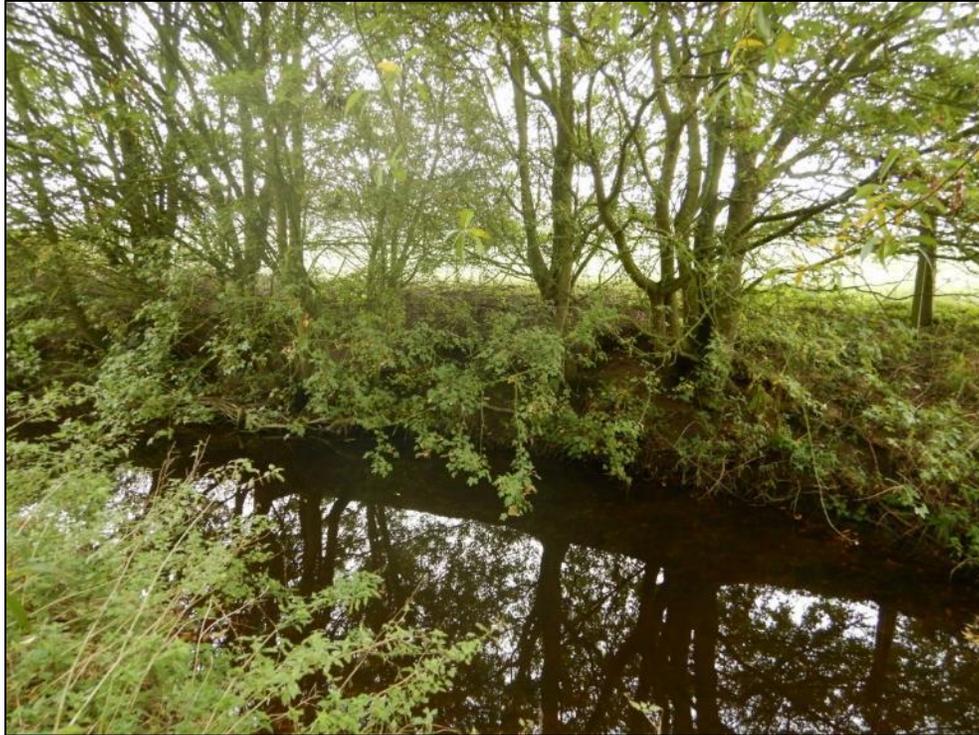
The tree cover over deeper pools was desirable, especially a stand of field maple (pic 27), which in addition to providing cover, provides bank strength and habitat amongst the root network. The general approach should be to retain shade and cover over pool habitats, and to allow riffles and glides to be open so that marginal and aquatic vegetation can grow in the shallow water environments. The branches of the field maple which extend over the river should not be taken-off. If a greater degree of in-river cover is needed, then it would be possible to hinge-cut some branches to provide underwater cover.

Pic 27 (TL 50776 50876) – Field maples provide overhead cover and shade to a pool habitat.

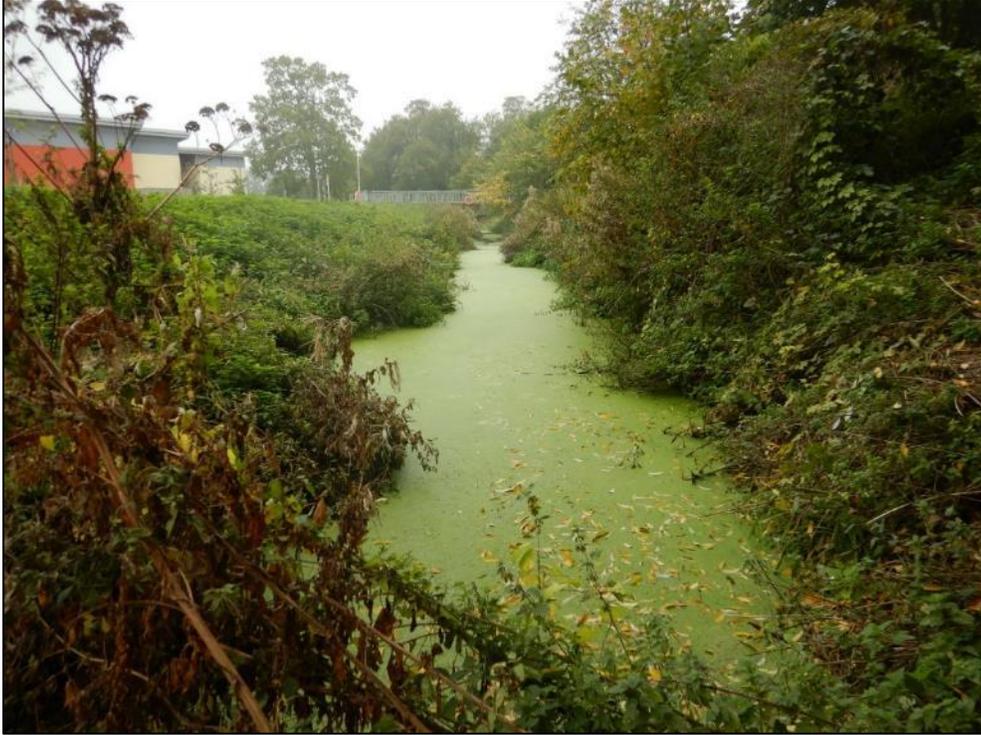
The reach of river immediately above and below the site bridge was entirely covered by duckweed (pic 28). The plant had been covering the river above the weir but had been moved downstream *en masse* following river clearance by BRC staff in the vicinity of the weir. This is indicative of the exceptional low-flow and nutrient enrichment. The plant could be washed further downstream but that is simply moving the problem on, compounding it as the plume of duckweed becomes greater. The plant should be left to be dispersed by flow and die-back from frost.

Pic 28 (TL 50784 50812) – Duckweed smothering the river due to exceptionally low flow.

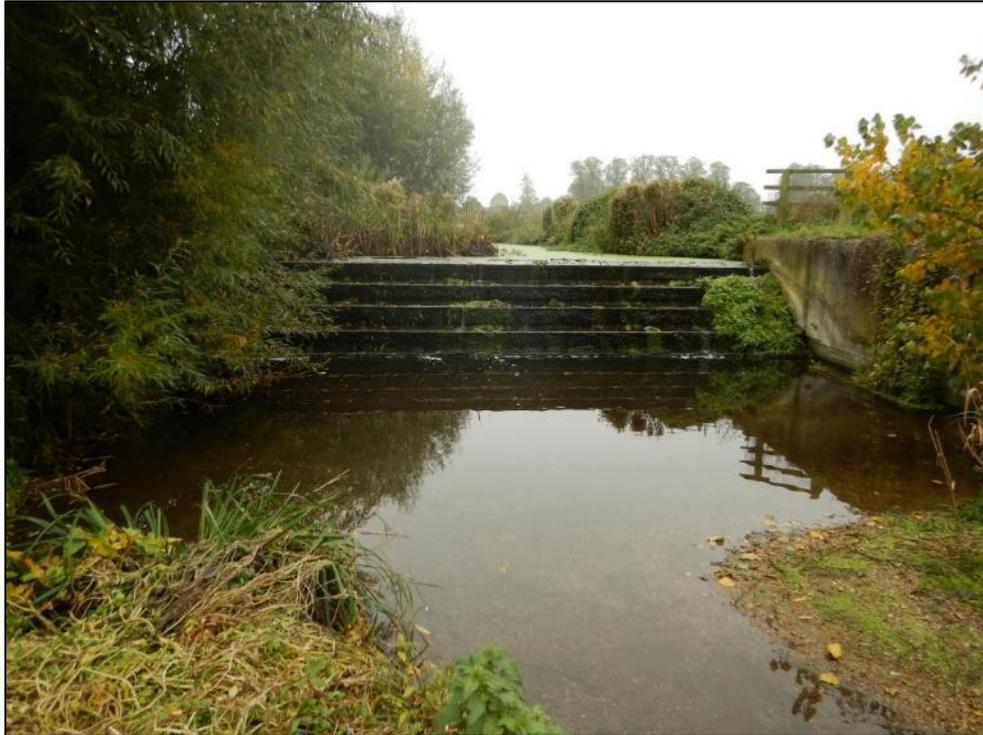
The weir at TL50795 50612 was the upstream limit of the visit (pic 30). It retains a head of water  $\sim 1.2\text{m}$  and represents a barrier to the migration of all fish species over a wide range of flow conditions. The occurrence of steps down the weir limits the effect of bed scour, consequently there was no significant scour pool below the weir (except for one discrete area). The weir pool had been entirely covered by fool's watercress until its recent removal by BRC staff (releasing the duckweed which collected downstream). A shoal of dace ( $\sim 5$  up to  $20\text{cm}$ ) was observed in the weir pool, suggesting that the dominance of fool's watercress may not have been the problem that it appeared to be.

Weirs disrupt the natural process of sediment transfer along a river, acting as traps for coarse sediment (refer to illustrations 2 & 3 below). With a paucity of coarse gravel supply, the riverbed below a weir is prone to down-cutting (or incision) as bed material is washed downstream without a regular supply from upstream.

Pic 30 (TL50795 50612) – The weir: a total barrier to fish migration and a flood risk.

The weir should be removed or partially cut through (notched) as it is a barrier to fish movement, prevents natural river processes and represents a very significant flood risk to the BRC. Removal of the weir would have huge beneficial effects for the river (leaving the EA gauging station  $310\text{m}$  upstream as the next barrier to be addressed). If the historic setting of Babraham Hall is important then it would be possible to remove the weir and retain similar

water level by raising the bed extensively throughout 310m reach. Detailed investigation would need to be undertaken.
