Advisory Visit

River Granta, Cambridgeshire

August 2019

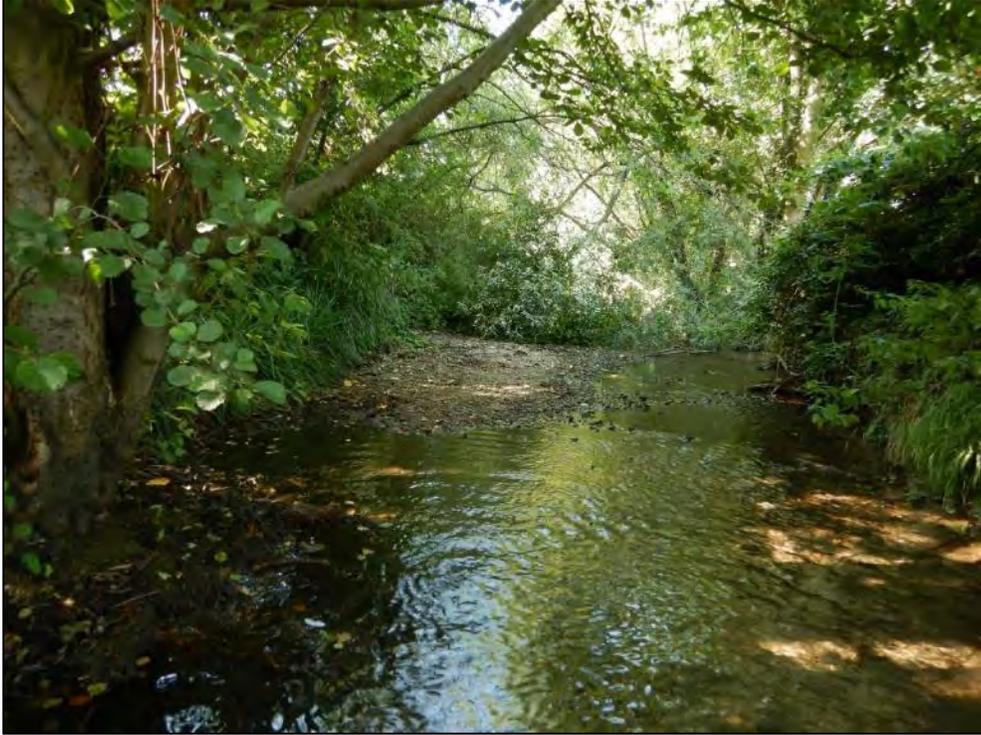
The visit started at the lowest end of the village recreation ground where the river flows within a ~3m deep by ~3.5m wide channel. Water depth during the visit was seriously affected by the low-flow and ranged from ~0.03m over gravel riffles (pic 1) to ~0.5m in natural pool habitats. A pool and riffle sequence is important in a river as it naturally diversifies the flow and provides habitat for juvenile trout (within the shallow riffles) which keeps them from competing with (or from being eaten by) adult trout found in the pools.

Pic 1 – The Granta at the lowest end of the visit had a distinct pool and riffle sequence but flow was significantly depleted.

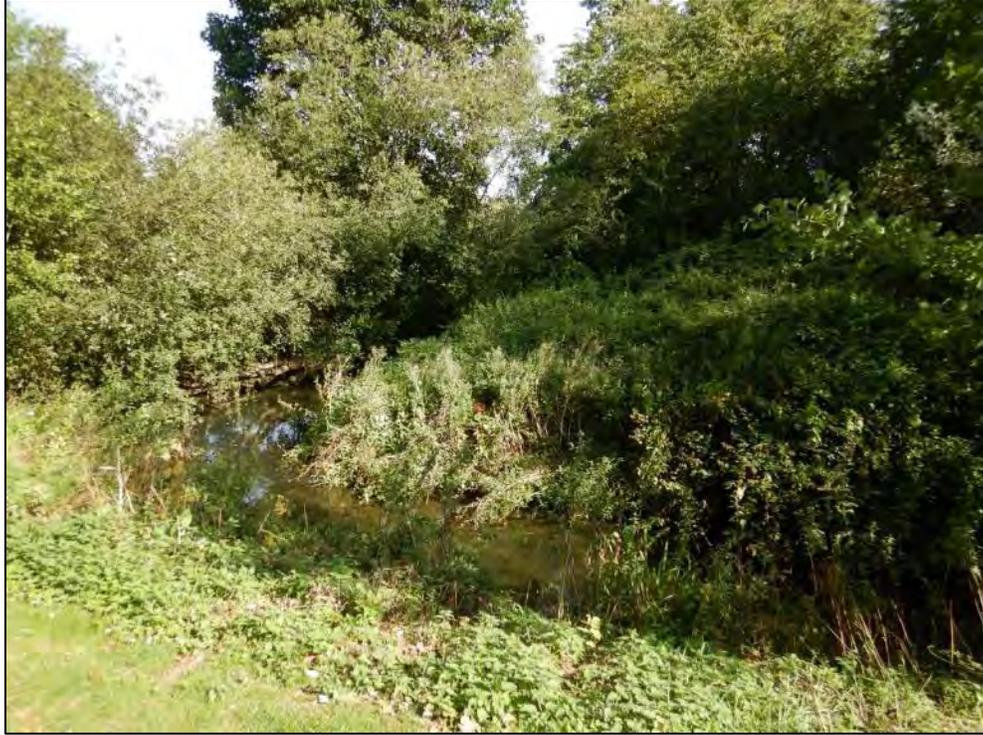
At one sharp meander, a prominent pool had developed. That pool provided depth, with cooler water almost certainly present given the shade of riparian trees. In 2013, the author (whilst in a different role) had been consulted regarding the stability of the bank. So, to monitor the rate of erosion, a stake was driven into the bank. That stake has remained relatively flush with the bankface, suggesting only limited erosion since. The meander had previously been reinforced with semi-rigid posts and wire netting. That revetment has entirely failed (pic 2). A scheme had previously been discussed to deliver sensitive bank protection and habitat creation over the length of the meander (that original concept is presented in the appendix) and it is still considered to be a worthy project which **could be delivered under the EA's Exempt Flood Risk**

Pic 2 – This meander could be enhanced to provide greater habitat cover and scour control to protect the nearby footpath.

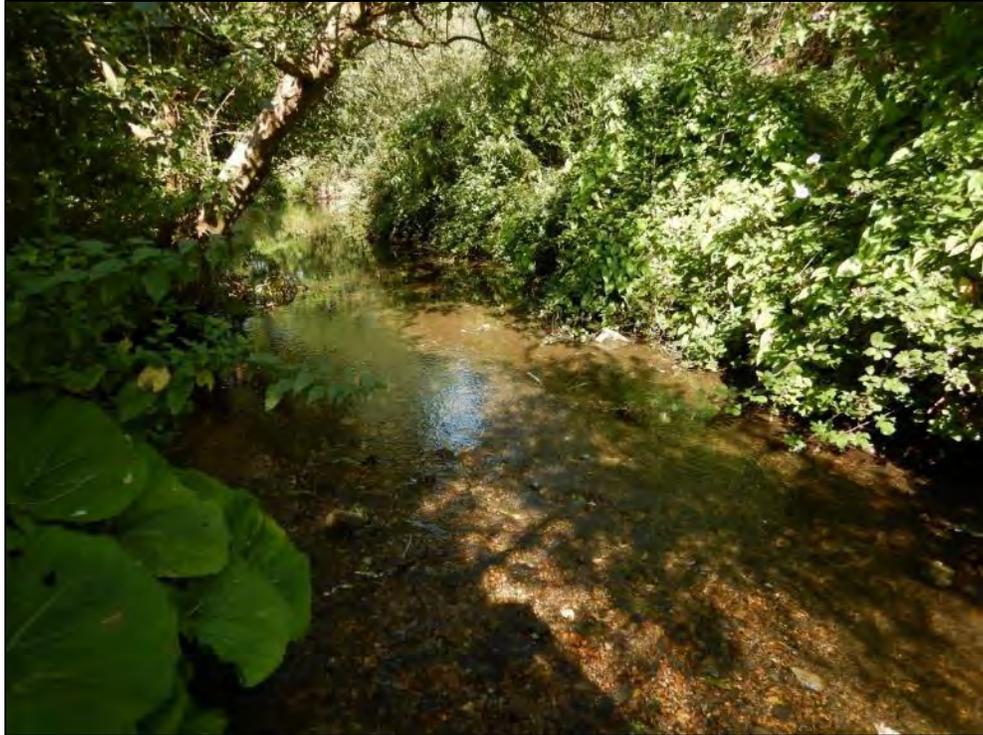
Of note in the shallows was the general lack of marginal plants such as reed canary grass, pendulous sedge or great willowherb (pic 3). It is possible that the shade of the tree canopy was limiting their growth. Where the river was more open great willowherb lined the channel and provided important marginal cover, interspersed with pendulous sedge.

Pic 3 – Shade from the tree canopy appeared to be suppressing marginal growth on shallow riffles.

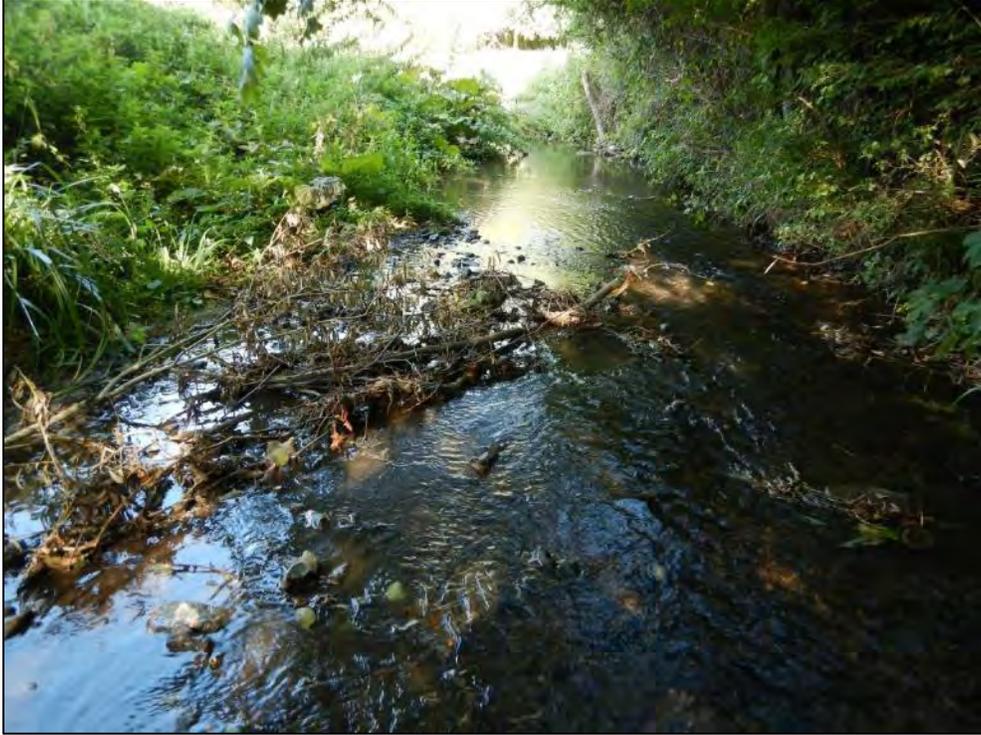
A small branch was observed in the river (pic 4). Whilst the branch may look unsightly to some, the presence of such material is of great importance within rivers and is often referred to as large woody material (LWM). The structure creates an increase in the surface area on to which a biofilm (algae, bacteria and other microbes) can grow, thus initiating nutrient cycling. In turn, the biofilm may become a source of food for invertebrates, increasing the total biomass that a river can support. LWM also provides underwater cover, offering protection for fish against otters or fish-eating birds. Importantly in this instance, the branch was providing a small degree of flow deflection which accelerated **the river's flow over the riffle**, assisting cleansing of the gravel bed. Where LWM presents no flood risk it should be retained.

Pic 4 – Fallen LWM should be retained within the river where it poses no flood risk.

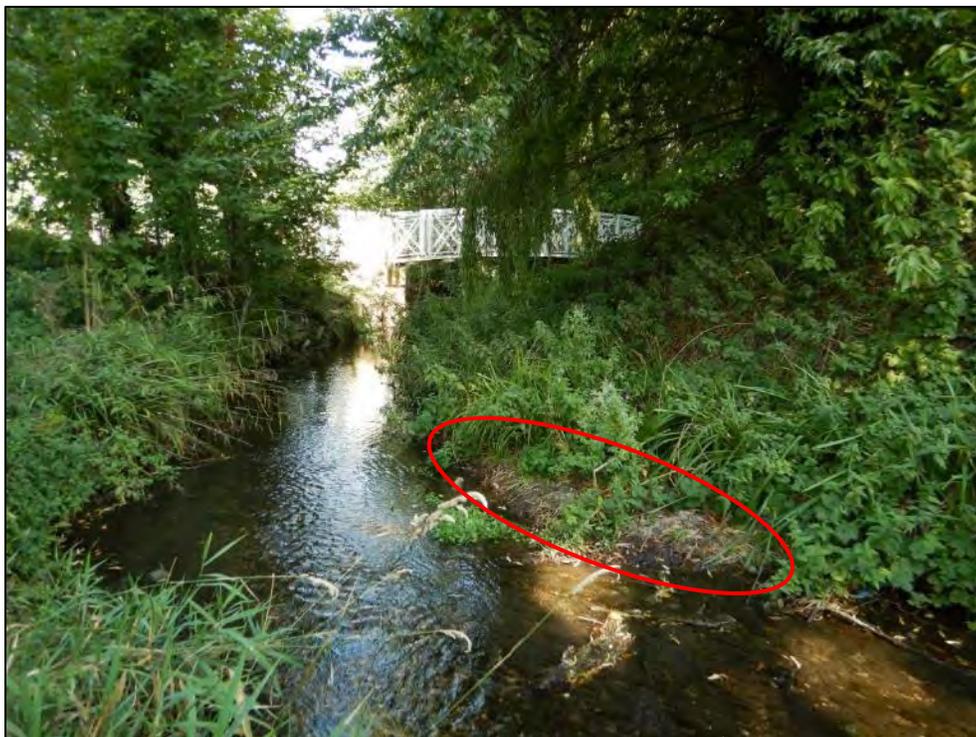
A white metal footbridge crosses the river almost half-way along the recreation ground, a short distance above the bridge was a sparsely vegetated berm (pic 5). That berm was subject to herbicide application in 2011 (reported to be the EA). In the subsequent eight years, the berm has only just become re-vegetated but not to the extent that it previously was. Vegetated berms provide important storage points for fine sediment. Without vegetation fixing sediment, it may be deposited on the riverbed where it can degrade invertebrate and fish spawning habitat, or in pools, causing them to shallow. Vegetated berms also provide natural channel narrowing that is in balance **with the flow of the river (as it has been created through the river's processes**

The use of herbicide by the EA on the Granta at Linton (acknowledged in **correspondence with EA's FCRM function**) is not considered to provide any significant level of flood protection, yet the removal of marginal plants is likely to negatively impact upon bank stability, fine sediment input and biodiversity. Herbicide acts by causing the breakdown of a plant in situ, and as the plants rots it will take oxygen from the water column. In combination with the hot weather and low-flow, the wide use of herbicide places an unnecessary stress **upon the river's diminished form**. A return visit to the river in early September confirmed that watercress immediately downstream of the recreation ground had been killed-off by herbicide. Its use was also observed at a number of locations further downstream. The repeated use of herbicide is thought to be a reason for the diminishing occurrence of marginal plants downstream of Linton.

Pic 5 – The red oval is the remains of a previously established vegetated berm which was lost through the application of herbicide.

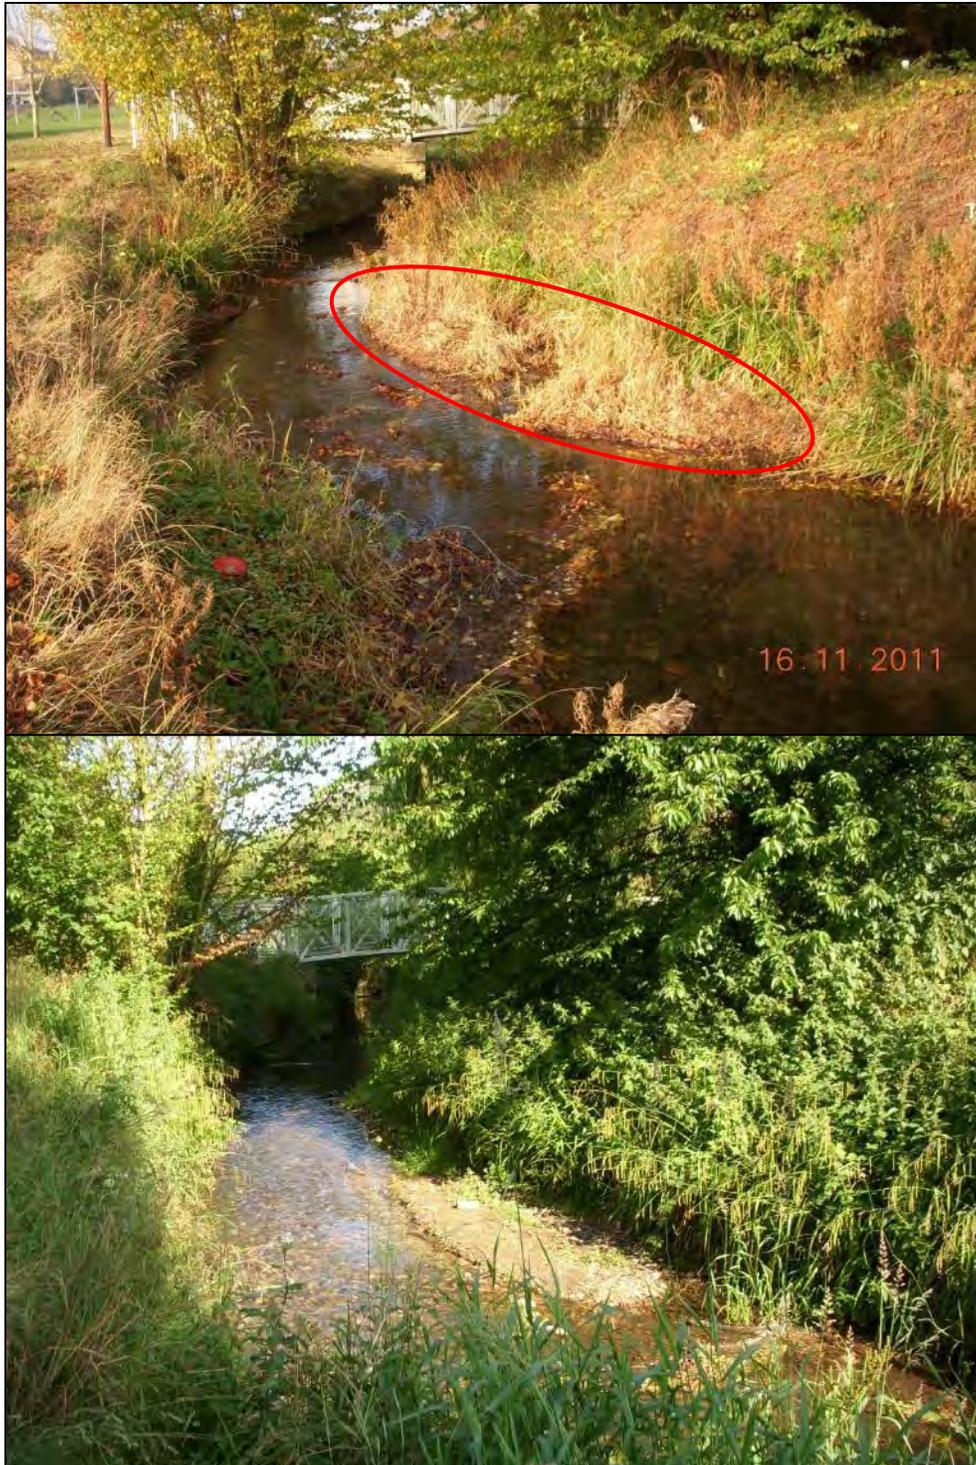
Pic 6 – Top picture shows the same location as pic 5 after herbicide application to the reed canary grass (red oval) in 2011. The bottom picture was taken in July 2013, the emergent vegetation had not recovered, fine sediment and gravel was exposed. Removal of the berm will not occur as **the river's natural** processes dictate that sediment deposition must occur on the inside of a meander.

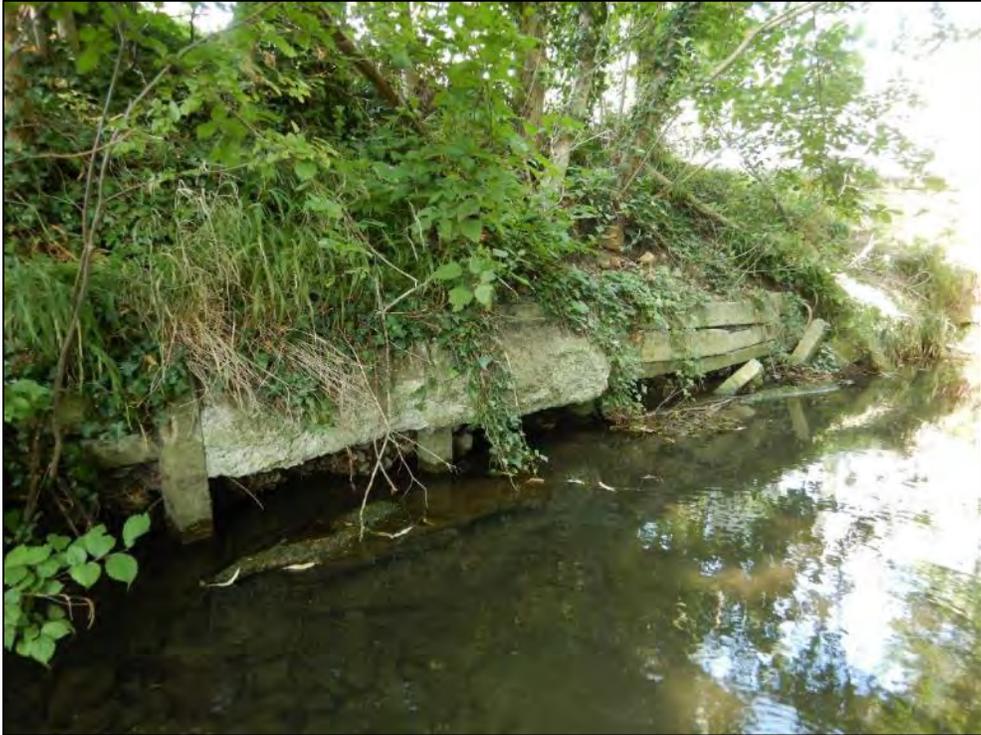
A short length of dilapidated hard bank revetment was observed (pic 7). Hard revetments are not appropriate in a natural river setting as they provide minimal habitat gain, can be costly to replace and simply move erosive forces downstream. Where bank erosion is leading to bank collapse the underlying cause of the instability should be investigated. In this instance it will be a combination of factors, but the most pressing one is the occurrence of a weir ~20m upstream (pic 8).

Pic 7 – Concrete slabs had been used to support the bank and were starting to collapse.

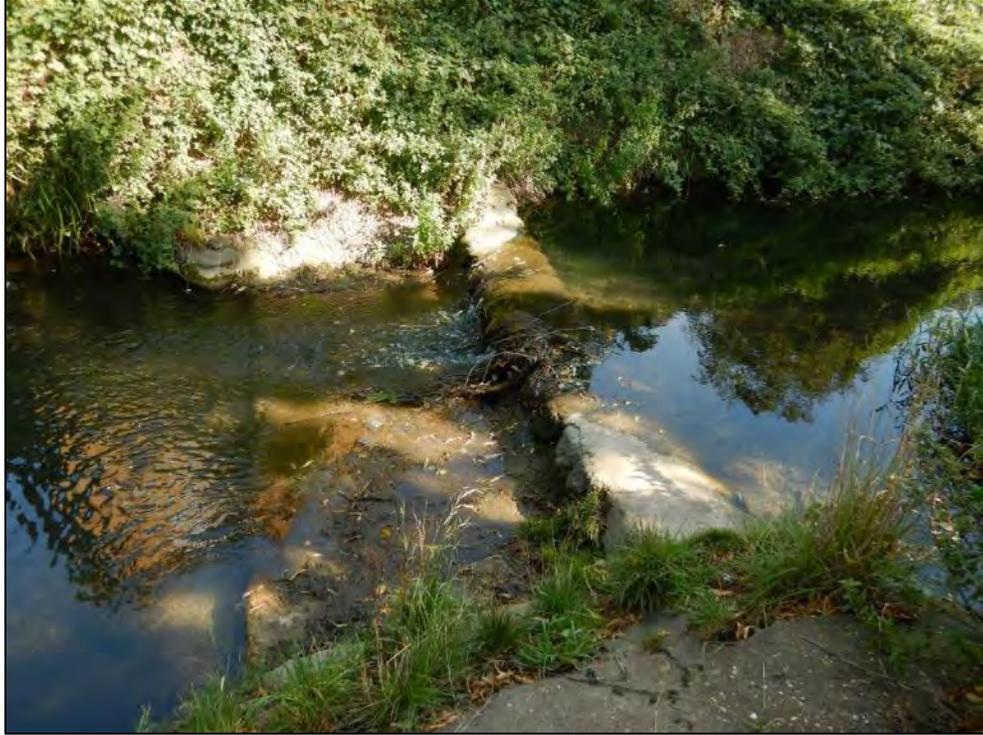
Pic 8 – A low-weir within the recreation ground, degrading the river habitat.

Weirs disrupt the natural process of sediment transfer along a river, acting as traps for coarse sediment (refer to illustrations 2 & 3). With a paucity of coarse gravel supply, the riverbed is prone to down-cutting (or incision) as bed material is washed downstream without a regular supply from upstream. Down-cutting can lead to an incised channel with a consequential loss of bank stability and floodplain connectivity. This problem is likely to have been magnified by historic river dredging. Eventually, the pool habitat originally present upstream of a weir is also lost as it fills with sediment. That was the case at all 3 of the weirs observed downstream of the Dog and Duck pub.

The purpose of the lowest 3 weirs is unknown. If they were not installed to **reduce the river's energy, they may have been for amenity purposes.** It was estimated that the 3 weirs cumulatively hold back a head of water of ~0.9m.

The removal, or partial notching, of the weirs (excluding the gauging station weir) should be undertaken to allow free flow, fish passage and sediment transfer. It will also increase flood protection by allowing early flood water to move downstream without water backing-up within the channel behind the weirs. The lowest weir in the recreation ground could be worked upon first due to it being in a state of partial collapse with water leaking around it.

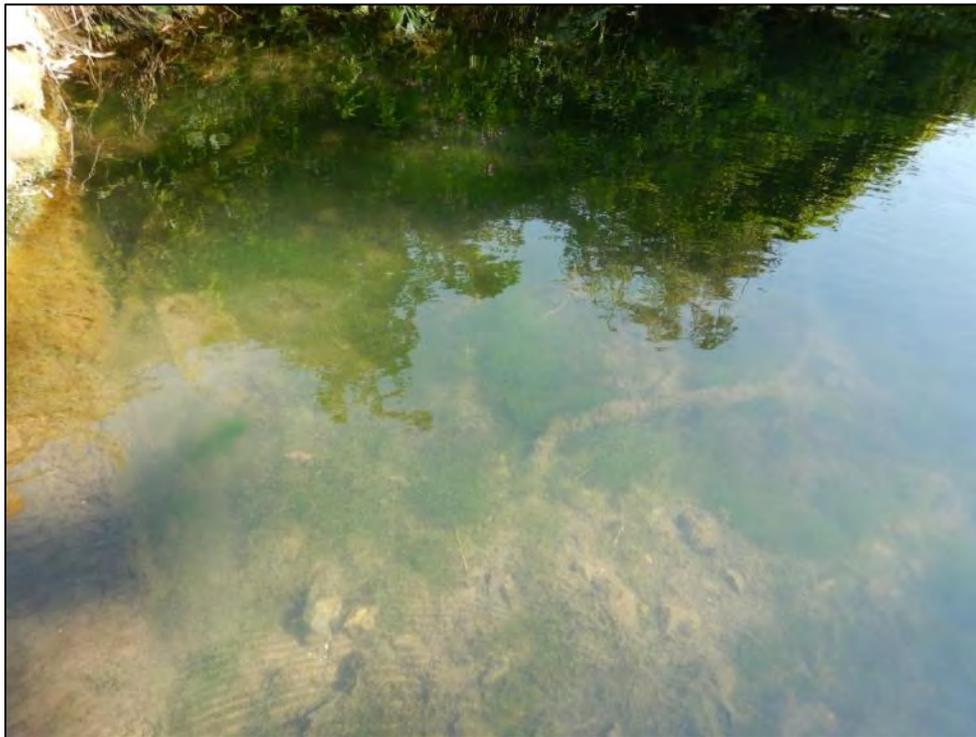
It was concerning that no brown trout were observed in the recreation ground reach, their distribution probably being controlled by water temperature and dissolved oxygen content. It was noticeable that above the weir, the water was affected by filamentous algae which filled the water column as it grew in response to the bright sunlight (pic 9) and warming water temperature. Casual investigation of the river for aquatic invertebrates revealed the species expected for the downstream riffle habitat (freshwater sponge, cased and caseless caddis larvae, mayfly larvae and freshwater shrimp). However, upstream of the weir the invertebrate community was severely impoverished, with only occasional flat worms and pond snails (both species that can tolerate low oxygen levels).

Pic 9 – The river above the weir presented a degraded habitat of silt and algae.

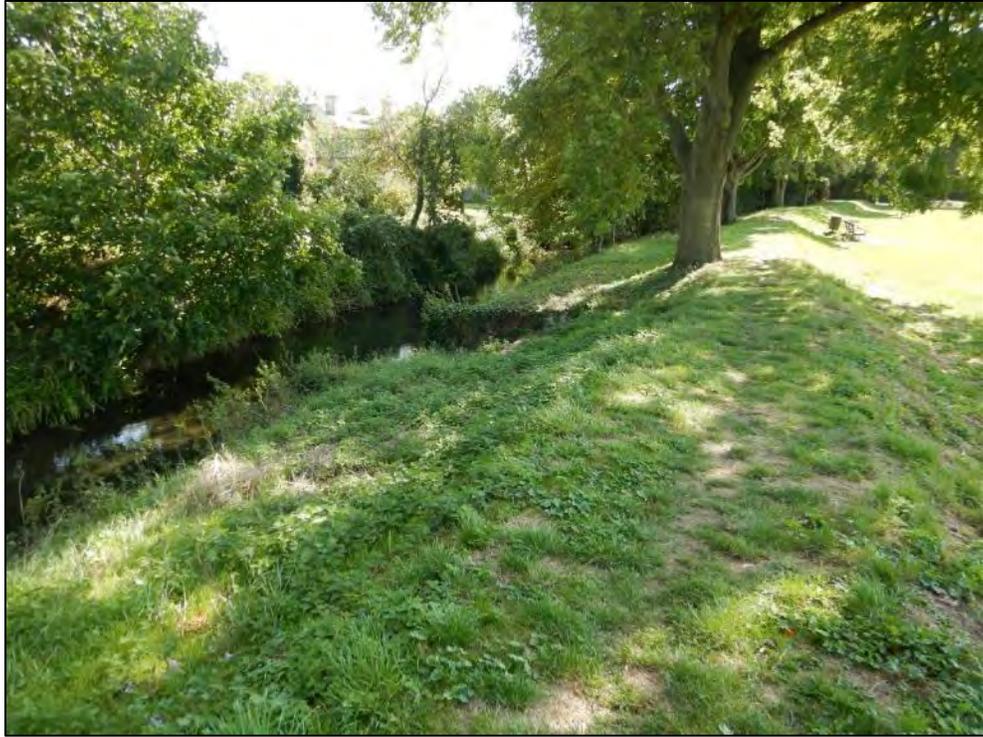
Gardens led down to the river on the RB, with many being supported by revetments to prevent their collapse into the river. The recreation ground was then dominated by the cricket ground on the LB. At this point the river has been embanked (pic 10). The embankment may increase flood risk to upstream properties by preventing water from spilling on to its floodplain.

Pic 10 – The embanked river adjacent to the cricket ground.

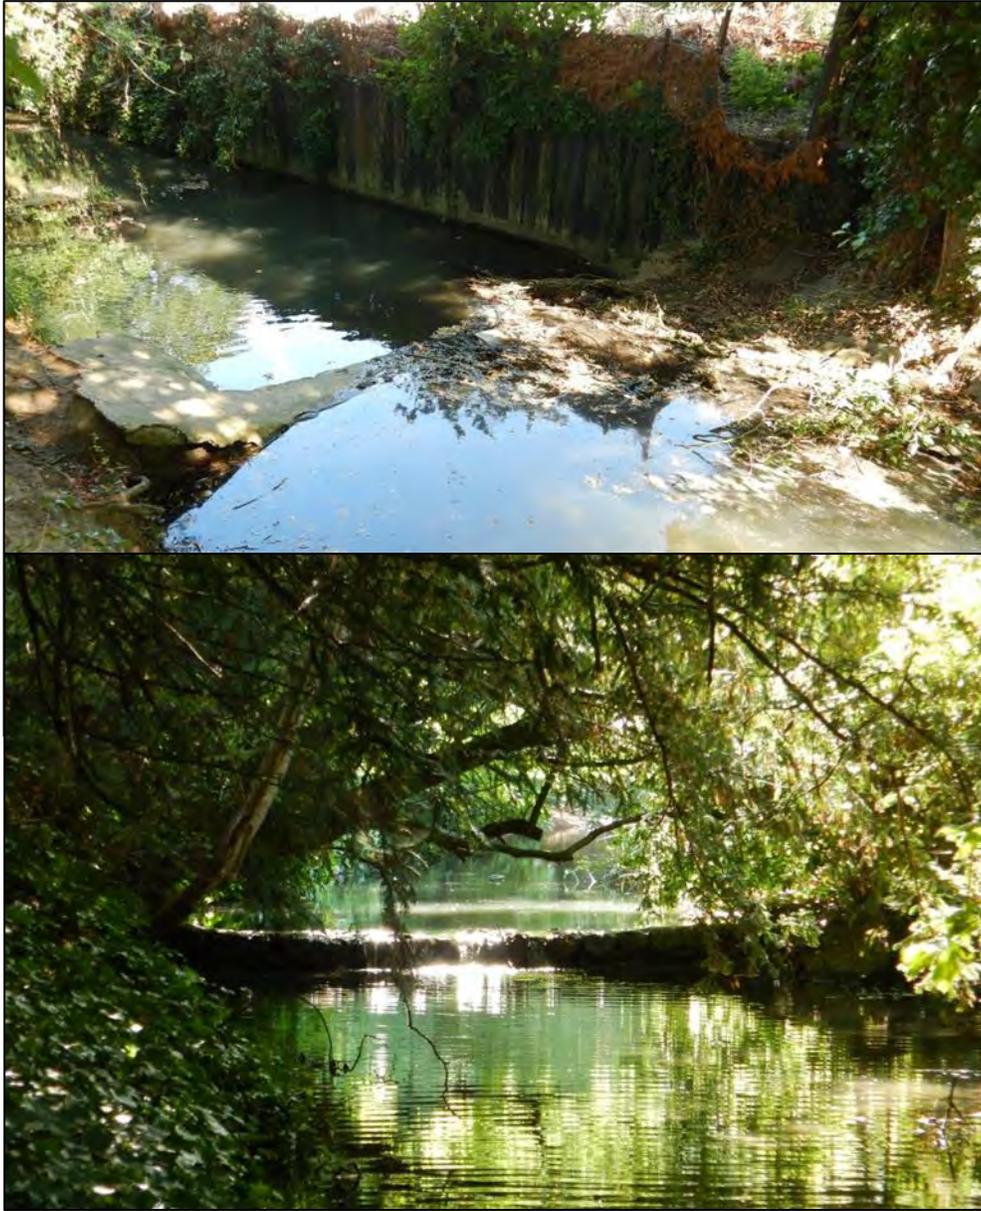
The river ran parallel to the recreation ground in an incised channel which was impounded by two further weirs (Pic 11). In this section, there is little flow variation even though some gravel bars had become exposed due to the low water levels. The river was suffering from siltation, excessive algal growth and excessive shade (pic 12).

Pic 11 – Two further weirs were observed, one alongside the recreation ground and another immediately downstream of the Dog and Duck pub.

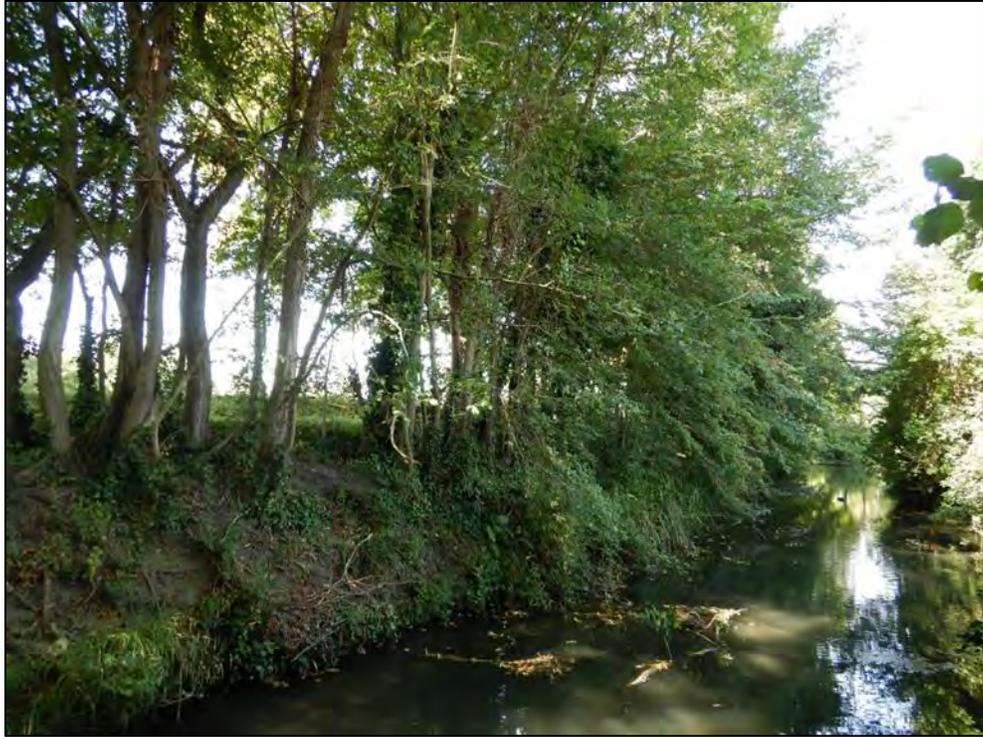
The management of shade requires careful consideration. In hot periods, as previously mentioned, the shade can bring benefit, but when excessive, it limits the growth of marginal plants which are important for retaining bank strength and controlling fine sediment input. The trees present interesting opportunities for habitat management to address the lack of flow diversity and the balance of shade versus open habitat. Open reaches tended to be dominated by pendulous sedge growth (pic 13); no aquatic plants were observed and the channel was dominated by algae. A technique favoured by the Wild Trout Trust for delivering instant woody cover at water level is tree-hinging. Trees (large or small) are cut to produce an effect similar to hedge laying. Species such as willow and hazel respond particularly well. Laying retains a living hinge that secures the cut stem to the tree stump so structural strength is retained. With the tree-top laid at water level, it provides excellent over-head cover, flow deflection and, if beneath the surface, increased habitat for aquatic invertebrates and cover for fish against predators.

Pic 12 – Tall riparian trees cast excessive shade preventing marginal growth.

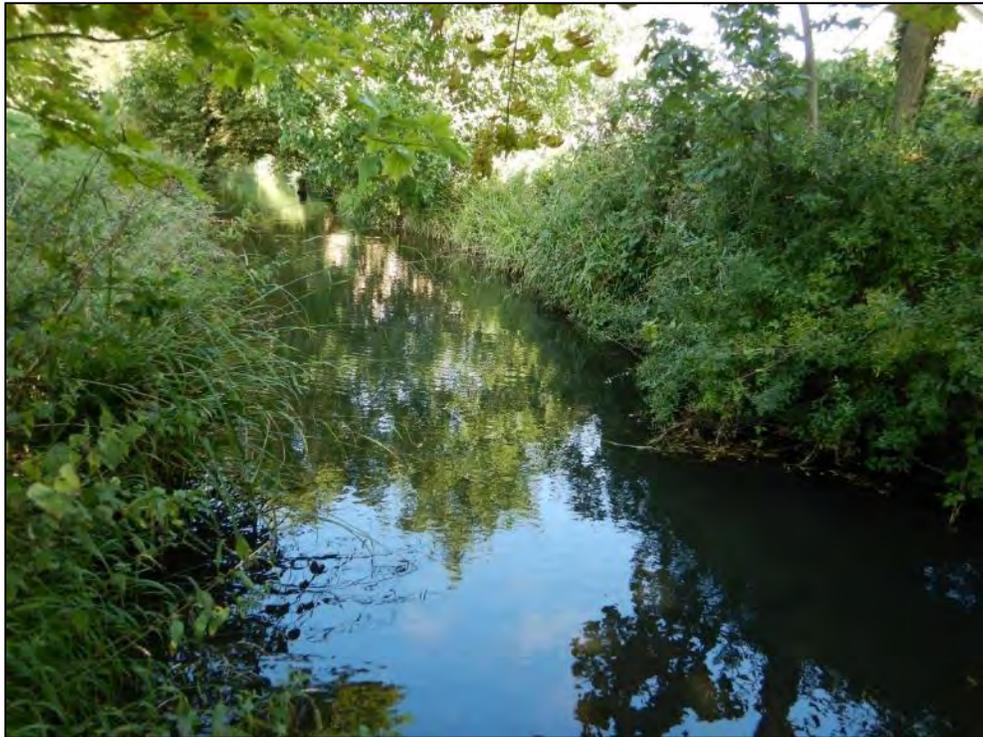
Pic 13 – Marginal vegetation growth was limited in terms of its true emergent species. Most plants trailed down into the water. This may be indicative of previous herbicide control which had removed the few emergent plants present.

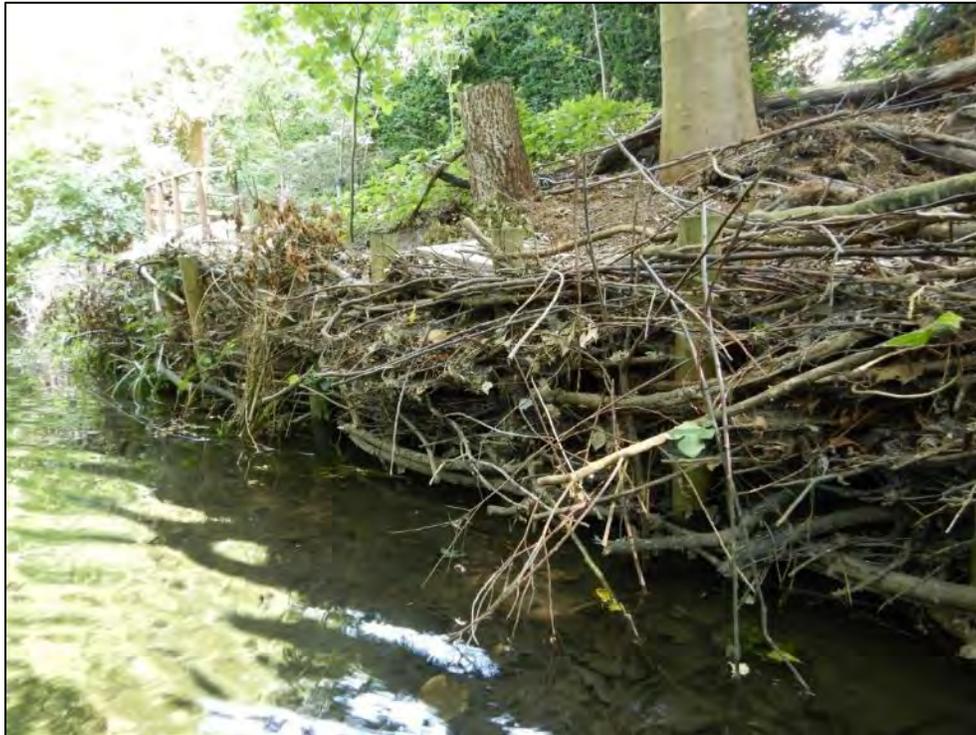
One garden property was using a more sensitive bank revetment approach: a brushwood retaining wall. That type of feature is beneficial for the river in that it provides invertebrate habitat, looks natural to the setting and creates channel roughness, **acting to slow the river's flow through the reach** (adopting the philosophy of *Slowing the Flow* see <http://slowtheflow.net/the-science/>). If this approach was promoted more widely along the river, it could bring flood management benefit (pic 14).

Pic 14 – A brushwood retaining wall provided a complementary habitat to the river.

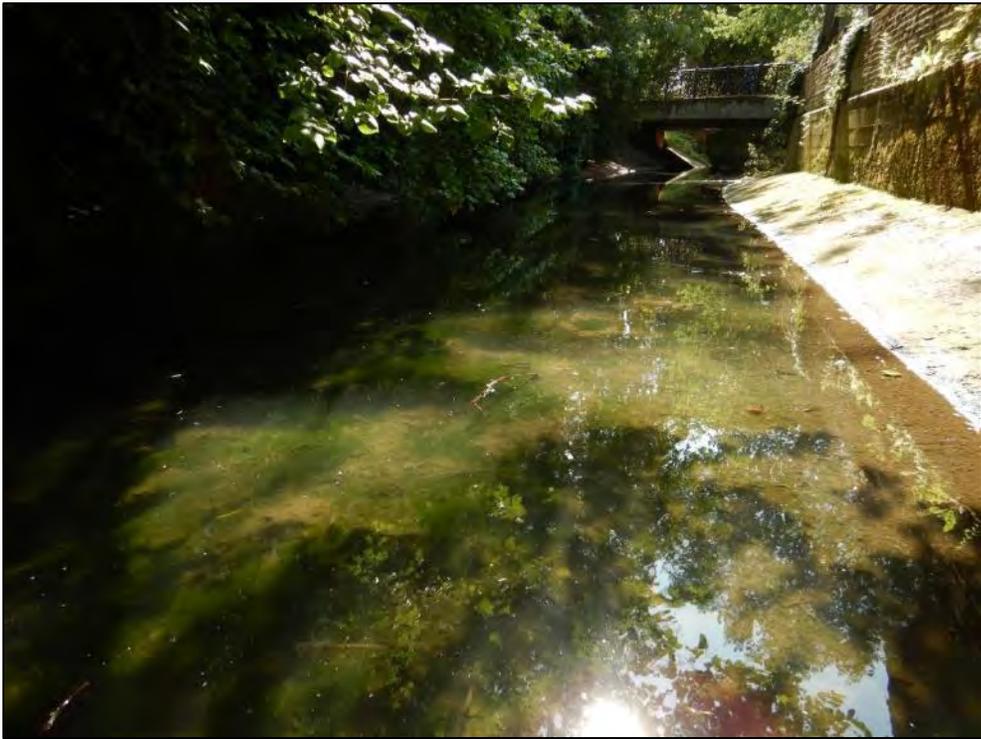
Alongside and upstream of the Dog and Duck pub, the riverbed was ~5m and concrete-lined (pic 15), offering minimal habitat other than very shallow deposits of gravel in a few places. The concrete was covered by ~30cm of water and was densely covered in algae. The river had no flow diversity and did not provide an **attractive frontage to the pub's garden**. The water level was governed by the weir immediately downstream.

Pic 15 – The concrete-lined River Granta in the centre of Linton.

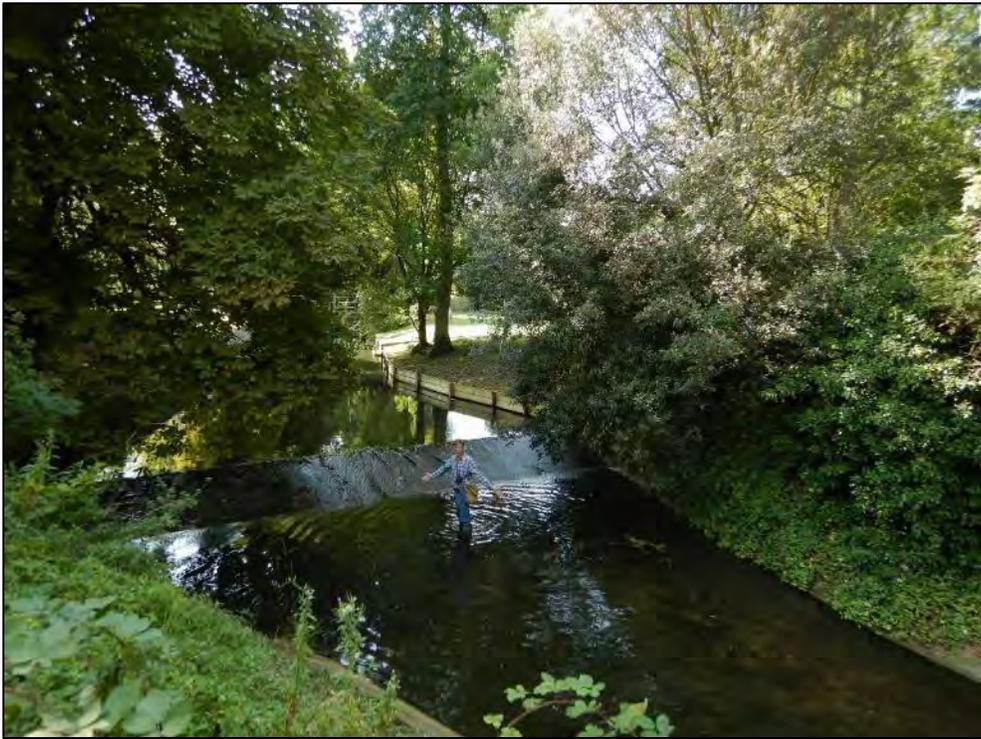
A short distance upstream of the High Street bridge was another, ~10m wide weir (pic 16) that retained a ~0.9m head of water and had a very smooth concrete spillway. There was no scour pool downstream and the weir significantly degraded the river, presenting a barrier to fish movement over a wide range of flow conditions.

Pic 16 – The weir in the centre of the Linton increases flood risk, prevents sediment transfer and degrades the river habitat.

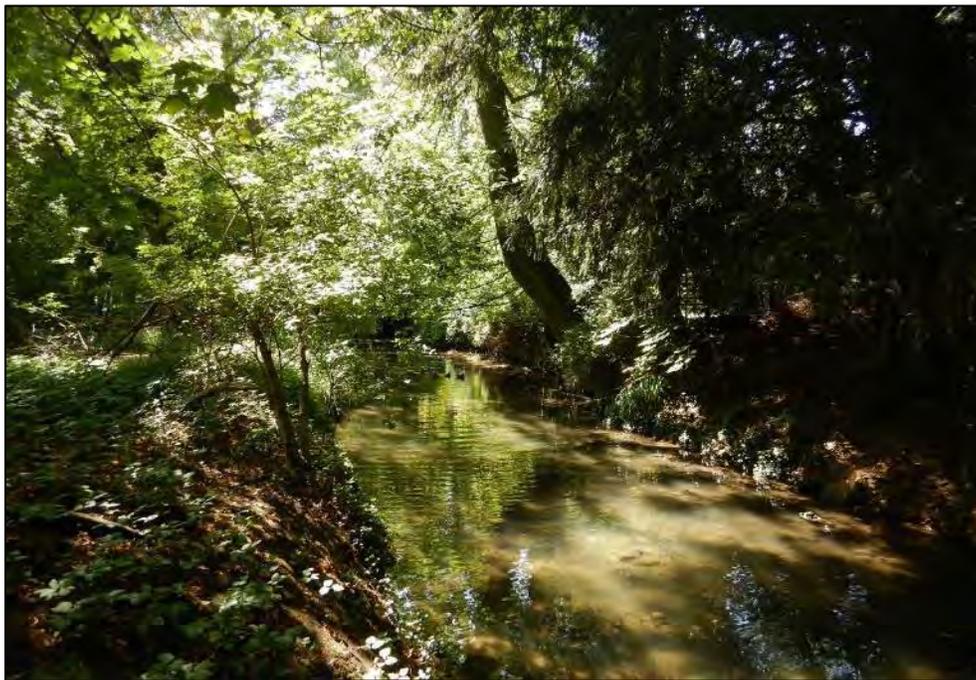
Pic 17 – Upstream of Horn Lane the river was shaded and over-wide with little flow diversity.

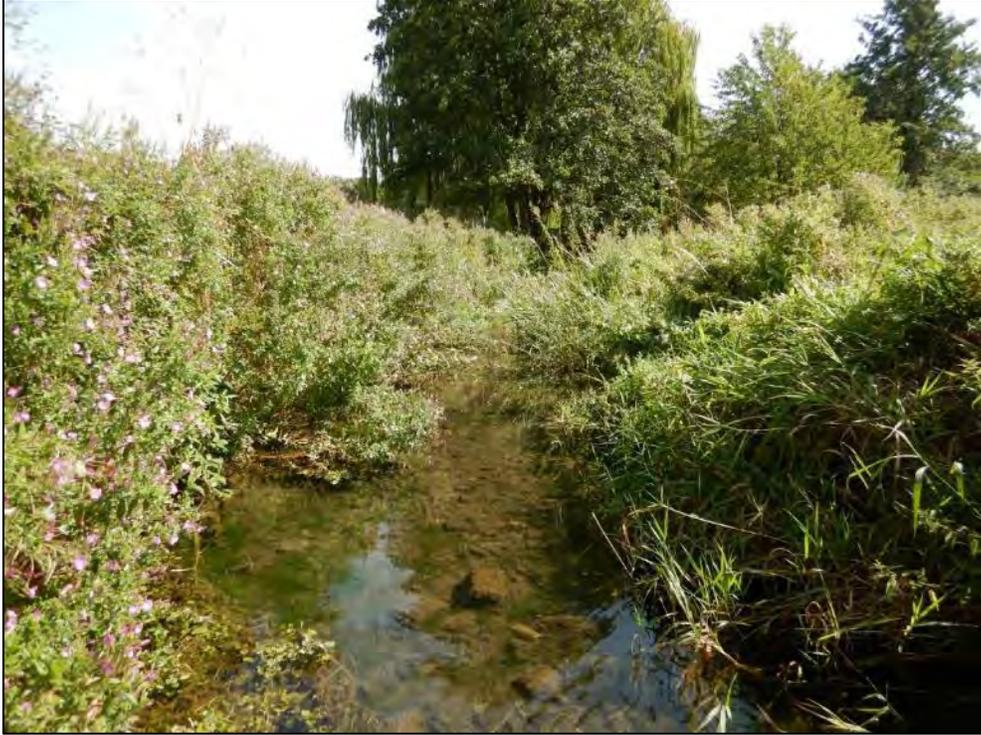
Pic 18 – Upstream of the village the river was lined with lush emergent vegetation.

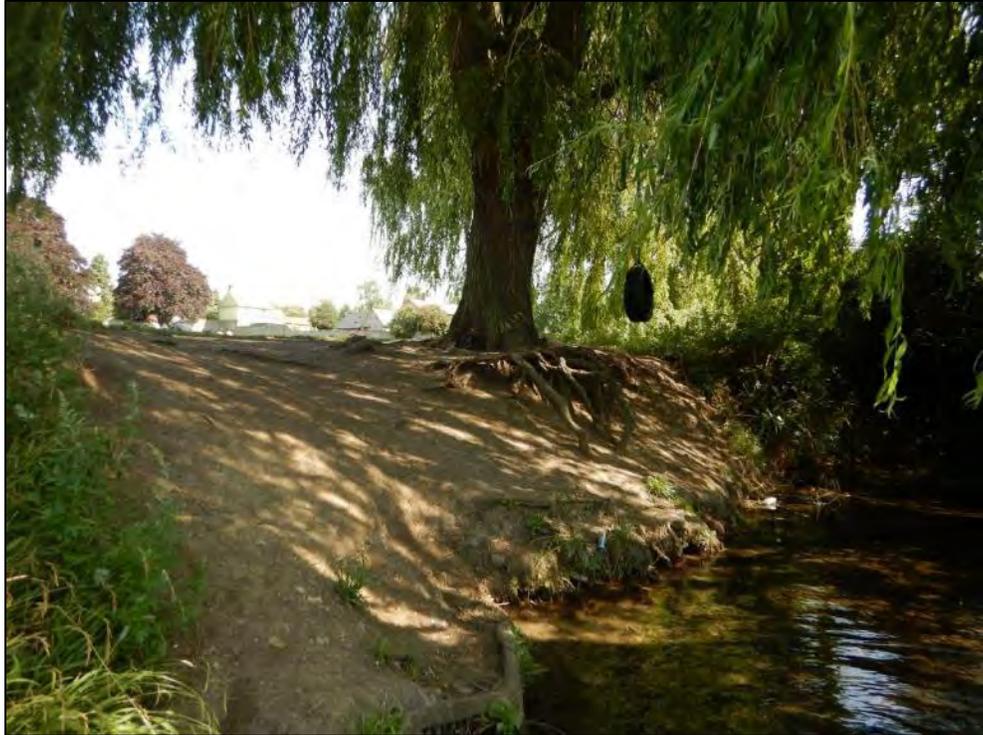
At the rear of Camping Close (open meadows) there was a limited area of bank erosion associated with a rope swing (Pic 19). The trade-off between young people enjoying the river and an area of slight bank erosion is considered acceptable. However, it might be prudent to monitor the eroding bank and undertake strengthening work if, and when, considered necessary.

Pic 19 – Bank erosion associated with a rope swing.

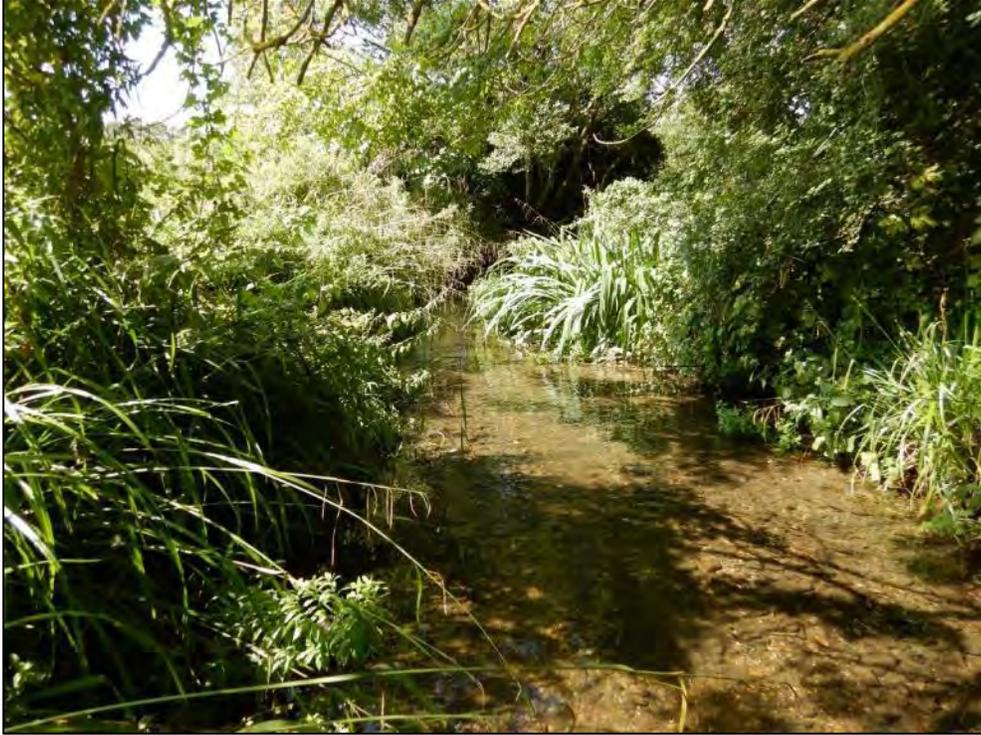
Pic 20 – The river had an attractive appearance of a chalk stream as is expected for the River Granta.

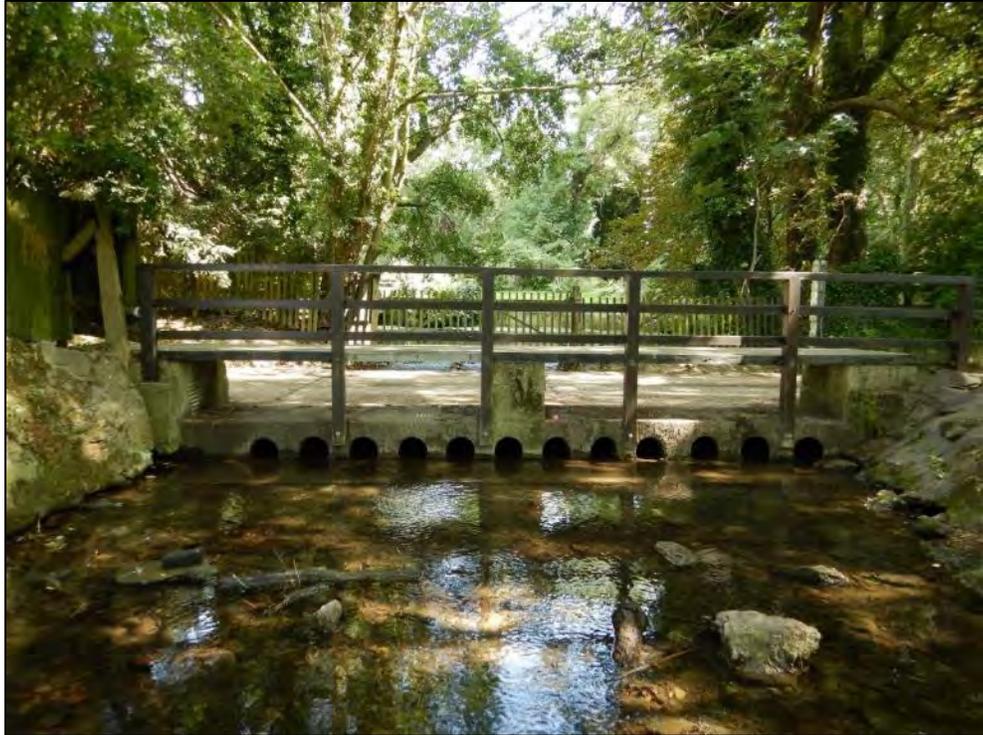
The mill pool was observed from the road. It was providing a deeper water reserve for a range of aquatic species in the low-flow period. However, the very presence of the mill and its associated water control structures has resulted in an artificial regulation of the river levels, and a barrier to the movement of a range of fish species.

Pic 21 – The Mill Lane bridge/ford combination – a barrier to fish movement.

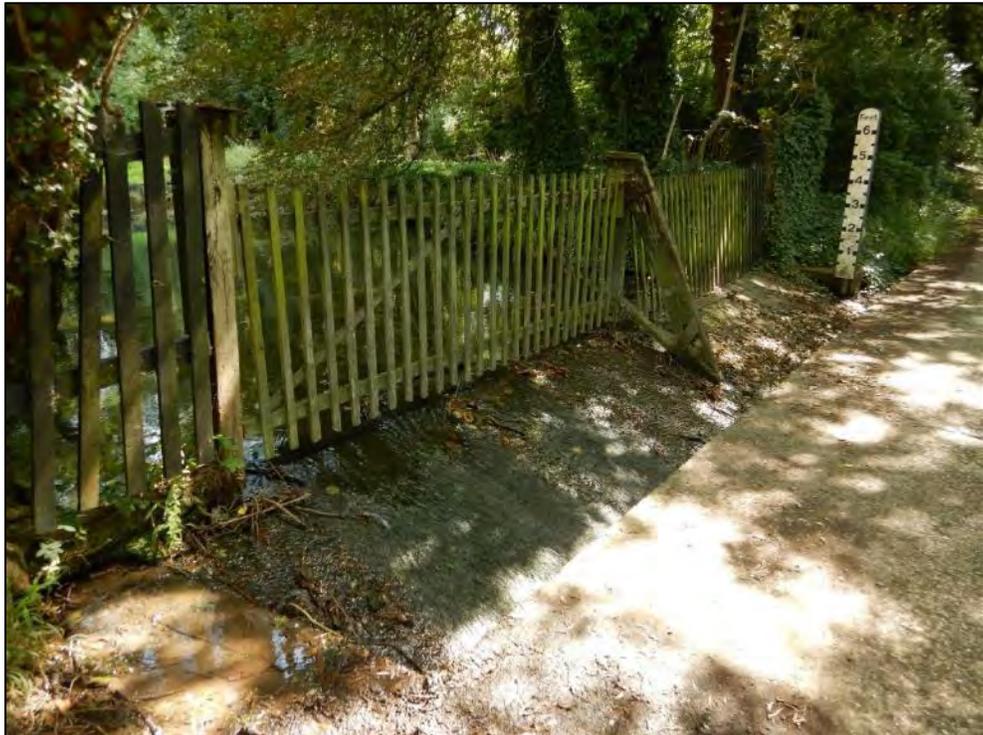
Pic 22 – The river emerges from beneath the fence to flow through pipes which ran beneath the road. The pipes must be prone to blockages given their narrow size.

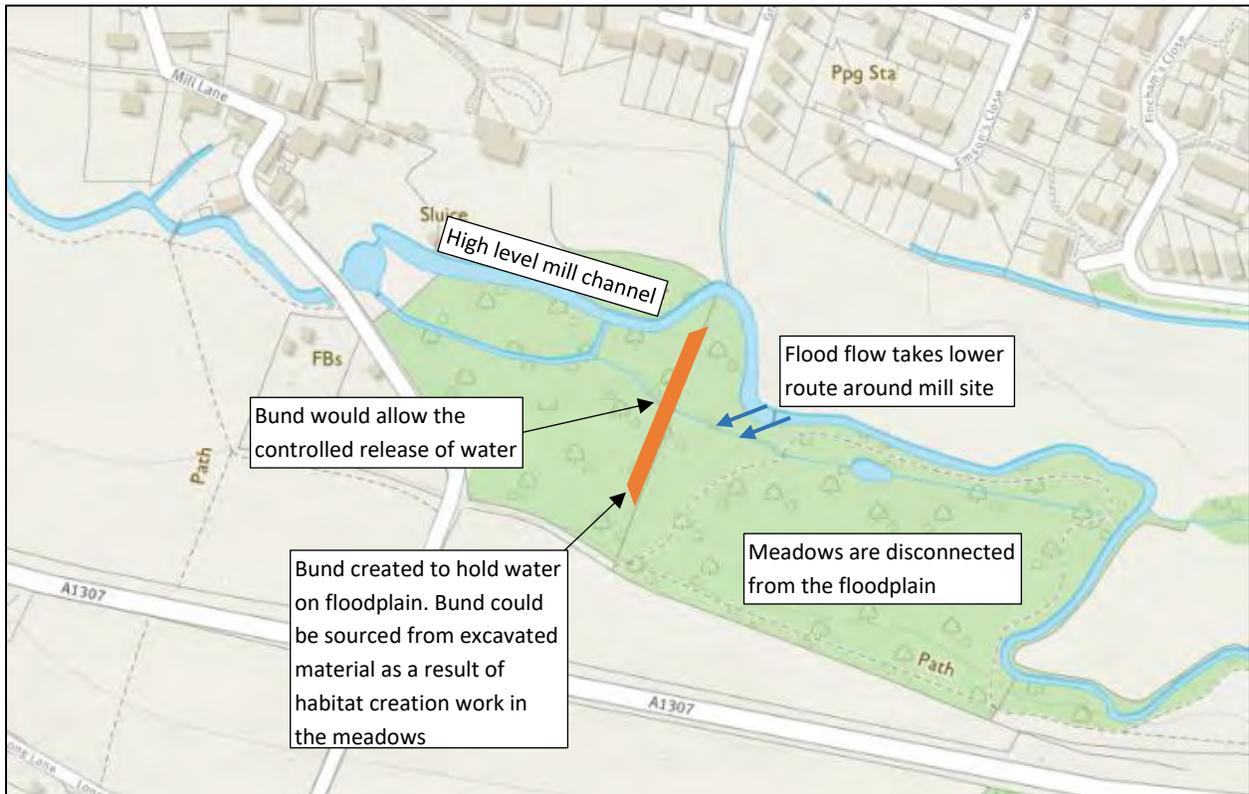
Through previous involvement on environmental matters locally, the author is aware that during significant flood, flows can by-pass the mill. The flood water then moves on to inundate land including some properties. However, the riverside meadows upstream of Leadwell Meadows do not receive full inundation as the river is disconnected from its floodplain. Previous investigations have looked at means of increasing floodplain storage. It is still considered appropriate to investigate the potential for creating a bund at the lowest part of the meadows in order to retain floodwater and to prevent it by-passing the mill. The suggested location for a bund is illustrated on map 3.

Map 3 – The possible location of a flood relief bund to hold water on Leadwell Meadows.

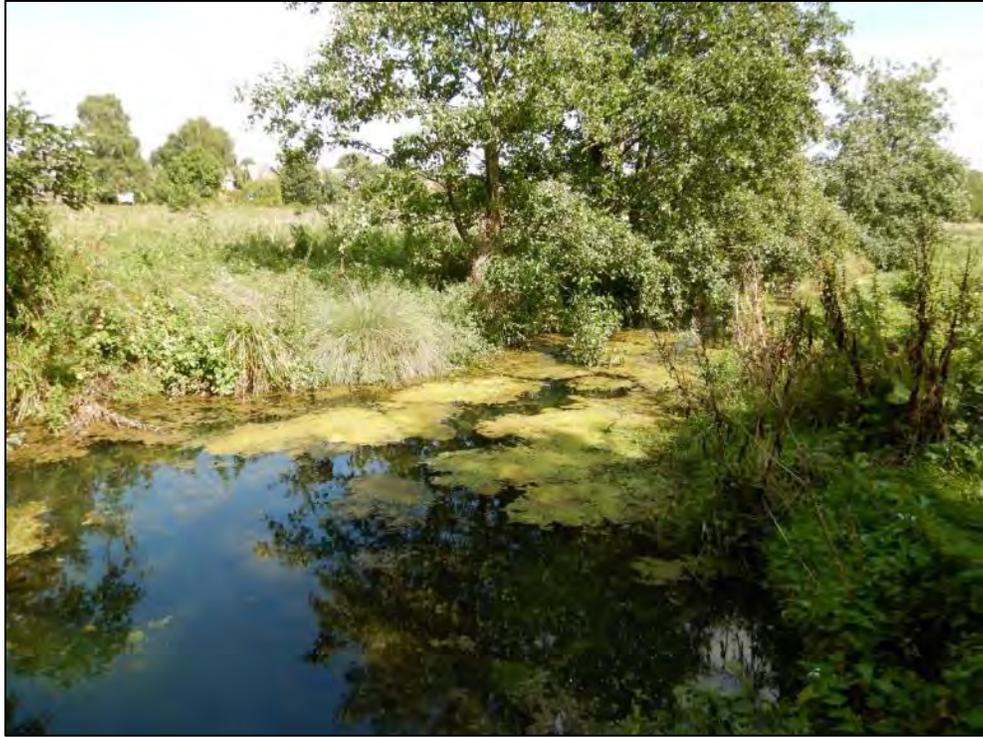
Once in Leadwell Meadows, the impounding effect of the mill became apparent with depths in excess of 1.2m and the slow-flowing water covered with algae (pic 23). Whilst the algae can look unsightly it does keep the water beneath cool from the sun and it should be tolerated. The algae is growing due to the impoundment, bright sunlight and high nutrient content of the groundwater.

Pic 23 – The effect of the mill impoundment was noticeable.
