Advisory Visit

River Granta, Cambridgeshire

August 2019

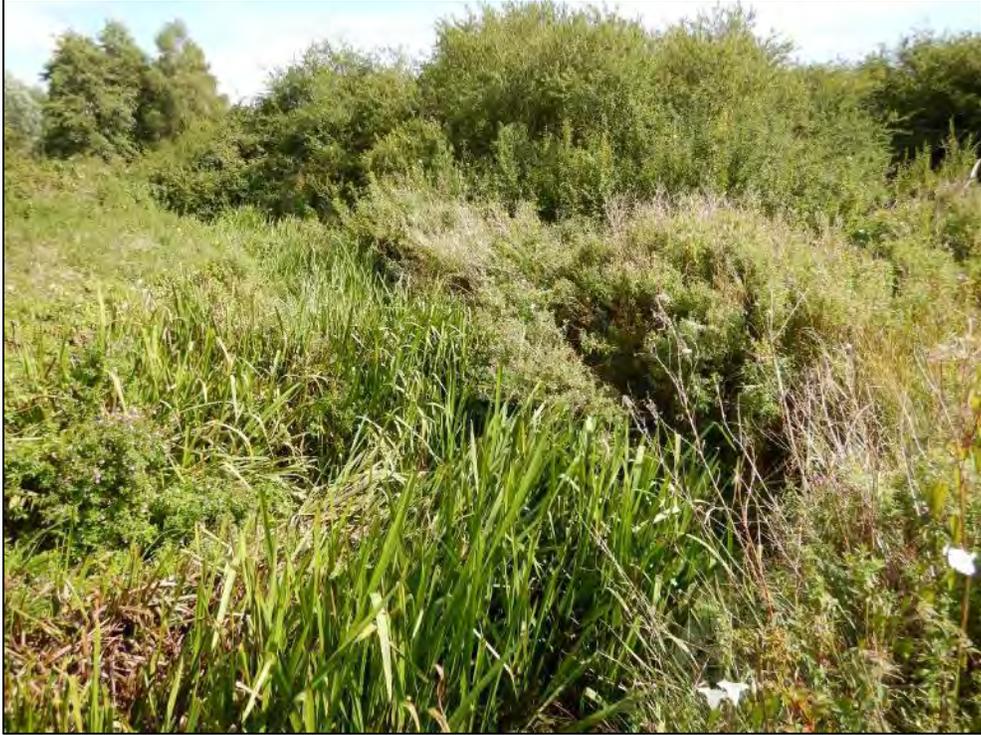
The dense vegetation offered excellent water vole habitat, and two brown trout (up to 20cm) were seen in clearer areas. Evidence of signal crayfish burrows was apparent amongst the alluvium-rich banks, and in places the banks were collapsing leaving fence posts hanging. Bank failures as a result of crayfish burrowing can be a significant problem and an input of fine sediment to a river.

Pic 24 – The river was over-grown with emergent vegetation, but it still conveyed its flow through the vegetation.

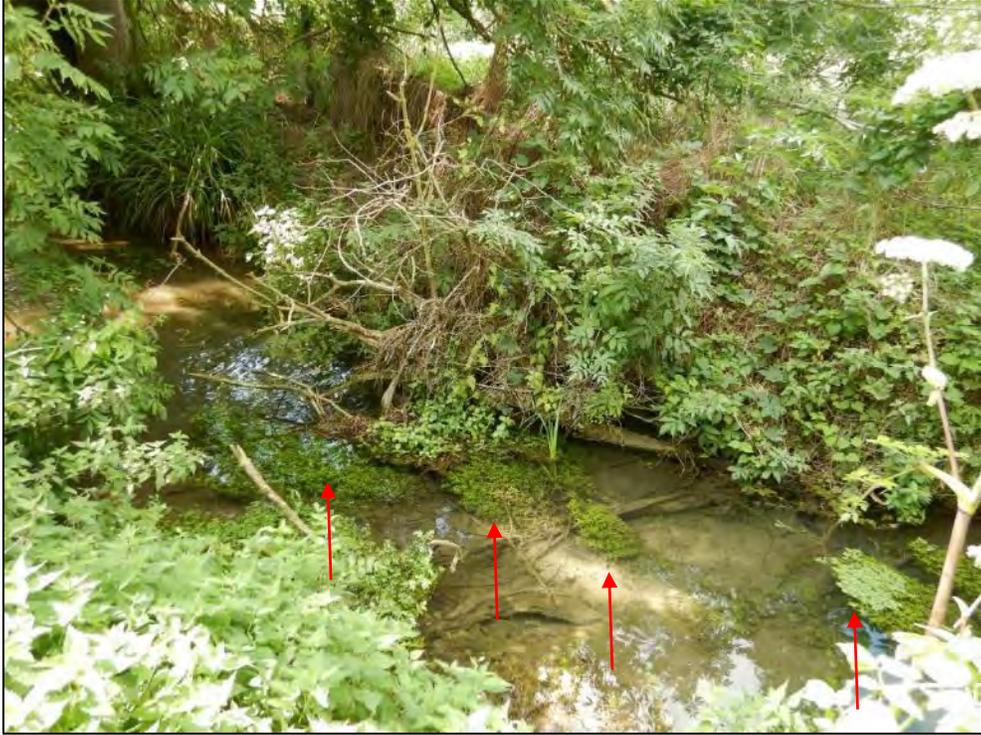
The river had stands of water starwort (pic 25), a plant typical of chalk rivers and able to sustain its growth in slower conditions than water crowfoot (another typical chalk river plant that was not observed). Where the river ran shallow, habitat was improved where flow was funnelled between dense stands of lesser water-parsnip (another typical chalk river plant, pic 26). It should be noted that the typical chalk river plants are occurring where the **river's water temperature is coolest**, where they are not smothered by algal growth and not disturbed by ducks dabbling nor dogs entering the river.

Pic 25 – The clear water sustained water starwort growth (red arrows).

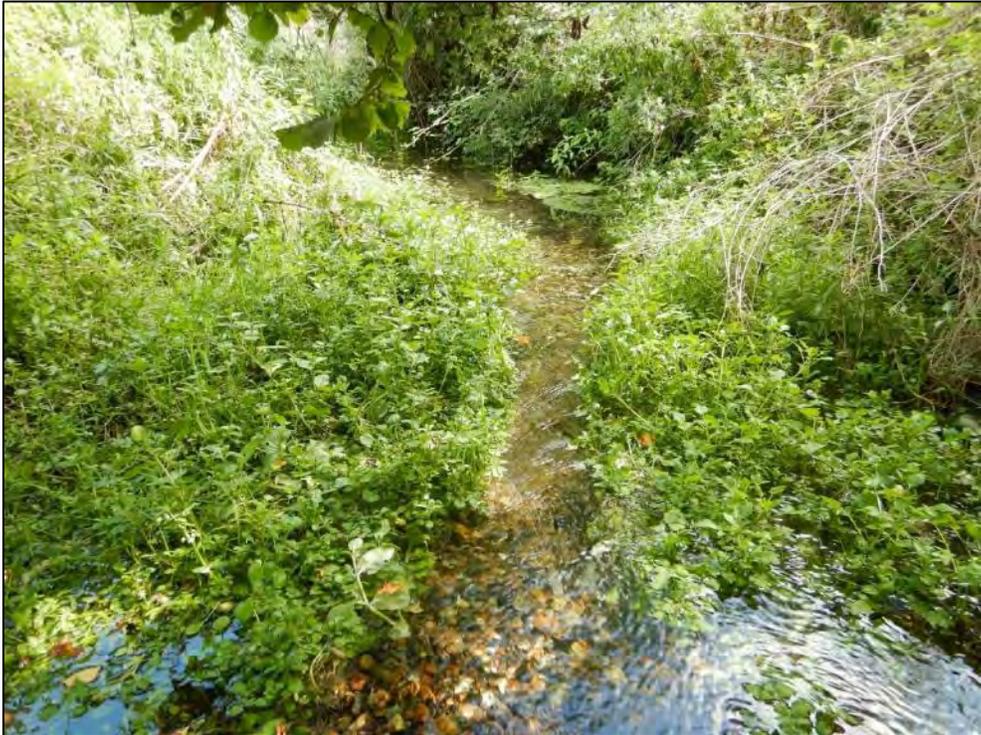
Pic 26 – Stands of lesser water-parsnip narrowed the channel maintaining flow velocity and a clean gravel bed. This "micro-channel" could still sustain juvenile brown trout and other fish species.

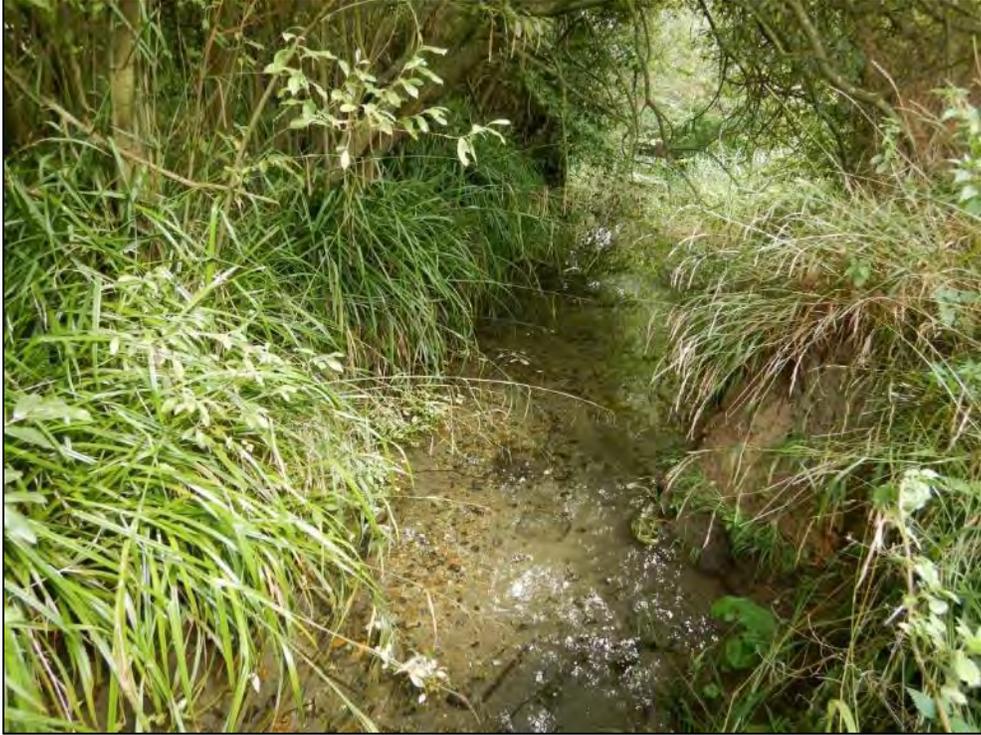
At a few locations, the tree cover was dense and reduced the growth of aquatic plants. Sedge species tended to dominate in the semi-shade. The open water habitat of the shaded areas provided a valuable **"pool" habitat** in contrast to the more choked open reaches (pic 27). The tree coverage could be manipulated to provide more cover at water-level, but it is considered important to also retain overhead cover in an otherwise largely open reach.

Pic 27 – The limited amount of shade in the upper reaches provided important open water in an otherwise vegetation choked channel. Adult trout would be able to utilise such areas.

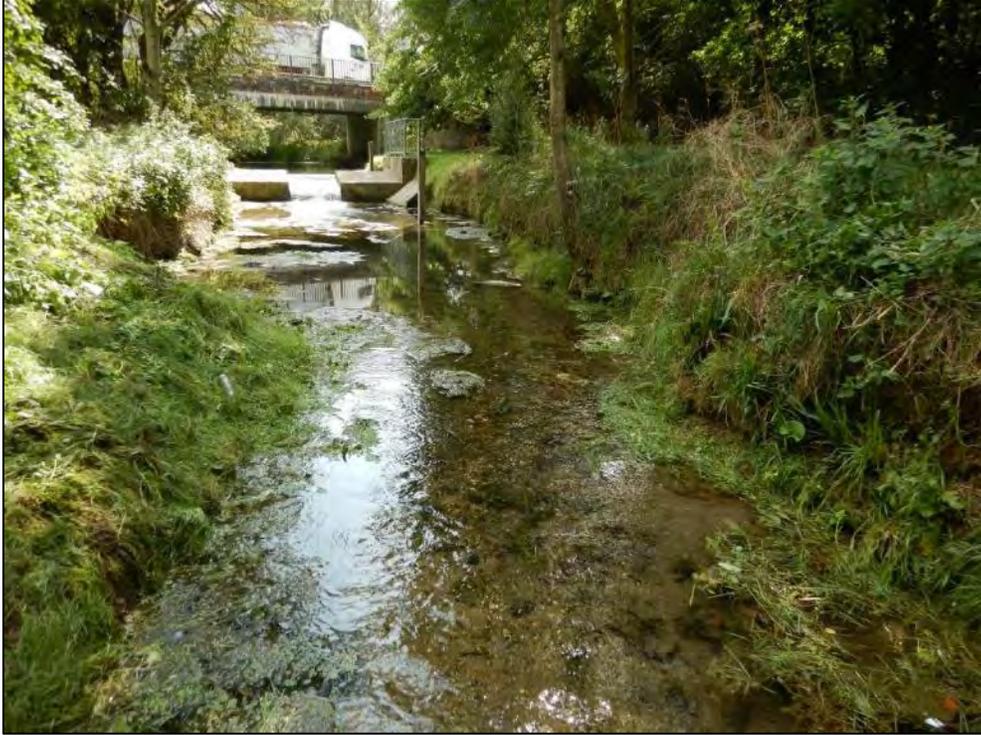
At the upper most reach of Leadwell Meadows, the vegetation had been strimmed (pic 28) in order to prevent the dominance of woody vegetation **which could affect the EA’s gauging station**. Whilst this is not desirable in terms **of the river’s marginal habitats, its impact** is relatively insignificant given the dense marginal vegetation found elsewhere in the reach.

Pic 28 – The river downstream of the gauging station is regularly maintained by the EA to keep it clear of woody vegetation which could affect its operation.

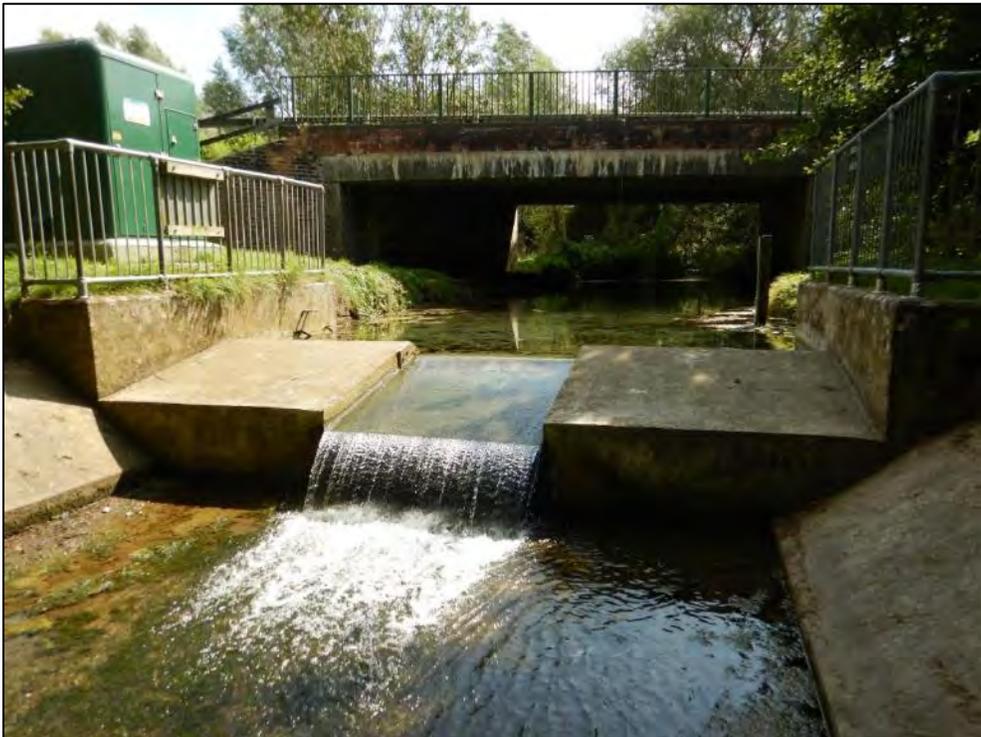
Pic 29 – The EA's gauging station presents a barrier to the movement of fish.

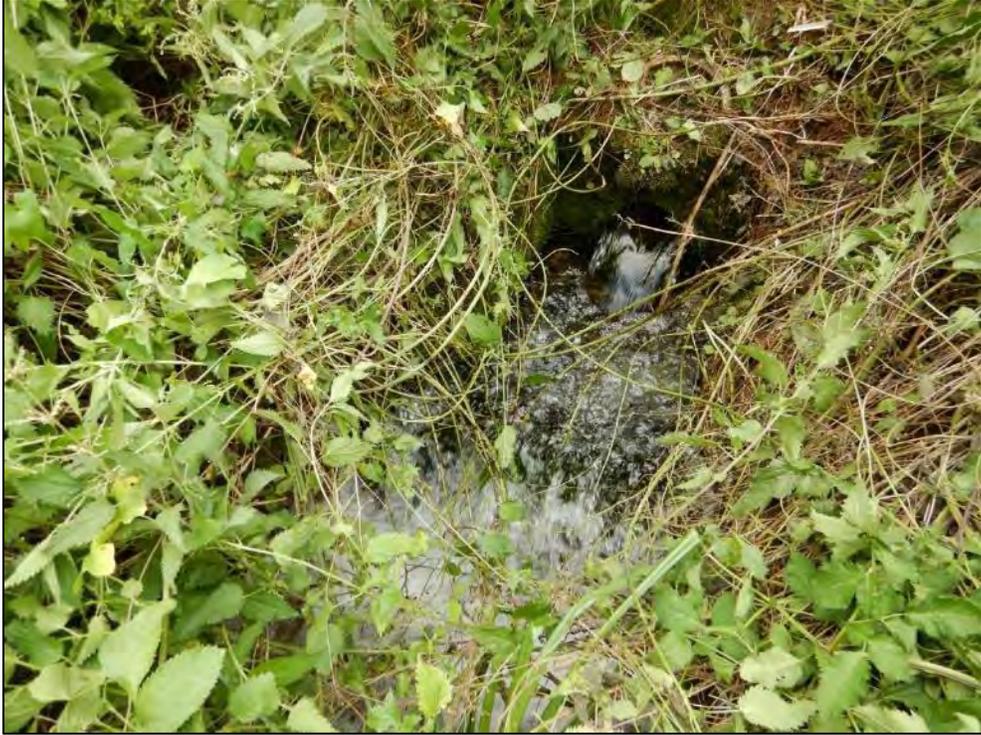
~20m above the A1307 bridge, **the EA’s compensatory borehole outflow was** located on the LB (pic 30). At the time of the visit, it was considered to be the main source of the river.

Pic 30 – The EA’s compensation borehole outflow, the current source of the river.
