Advisory Visit

River Roden, Shropshire

June 2019

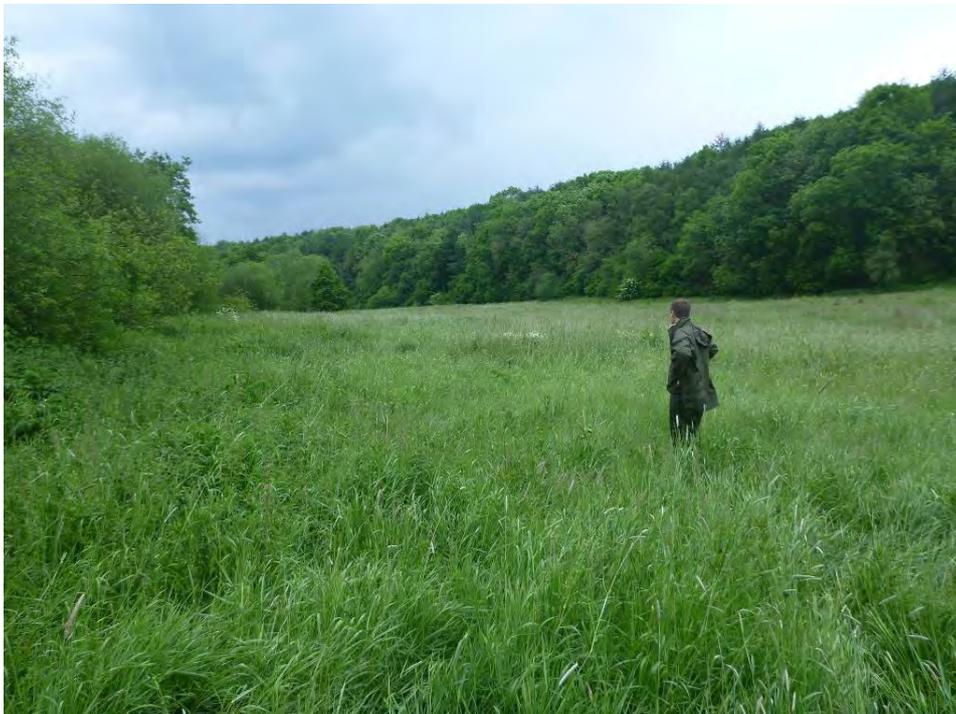
Photo 1 Wide floodplain area adjacent to Preston Springs. The river channel is to the left of the picture (downstream view), beyond the raised embankment of dredged material and trees.

It is difficult to say if the channel has been realigned here. It appears to follow the edge of the floodplain, suggesting it has been moved to maximise the extent of the valley floor for farming, but there is no evidence of former channels on the floodplain from LiDAR data (Appendix 1). Further investigation is recommended to see if the river has been straightened and whether re-meandering is an option here. Even if the river remains in its

present course, there is scope for re-profiling the right bank, creating an inset floodplain and reinstating a naturally varied channel width; any gravel present in the spoil bund could be re-introduced to the river.

- Investigate the feasibility of river restoration in the floodplain areas alongside Preston Springs and between the A49 and Harcourt Mill.

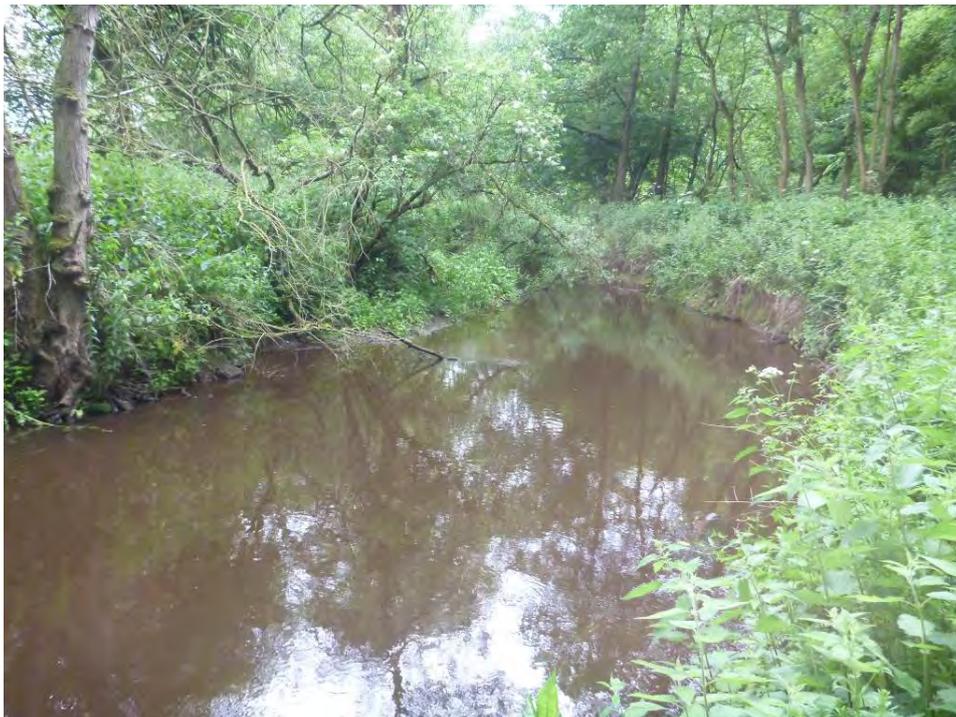
The re-sectioning of the river channel has left it over-wide, incised and disconnected from its floodplain. Where the river is shaded, the channel remains wide (Photo 2), in contrast to more open areas where marginal plants have colonised and trapped silt, gradually narrowing the channel (Photo 3). In the heavily-shaded sections, some trees could be felled to allow more light to reach the channel, with the woody material generated secured in the river margins to provide a matrix for the settling silt, colonisation of vegetation and narrowing of the channel (see Recommendations).

Photo 2 Over-wide, incised channel as a result of past dredging. Shaded areas like this have not recovered a natural channel width.

- If restoration of the natural form of the channel is not possible, various techniques could be used to improve habitat within the existing channel. Where the river channel is over-wide and shaded, hinging and laying trees and creating brushwood shelves (Photo 22, Figure 4) will introduce more variety to the river channel shape and encourage growth of aquatic plants. Where the river channel is deeply incised, bank re-profiling with an excavator could be used to create an inset floodplain and introduce more variety to the channel.

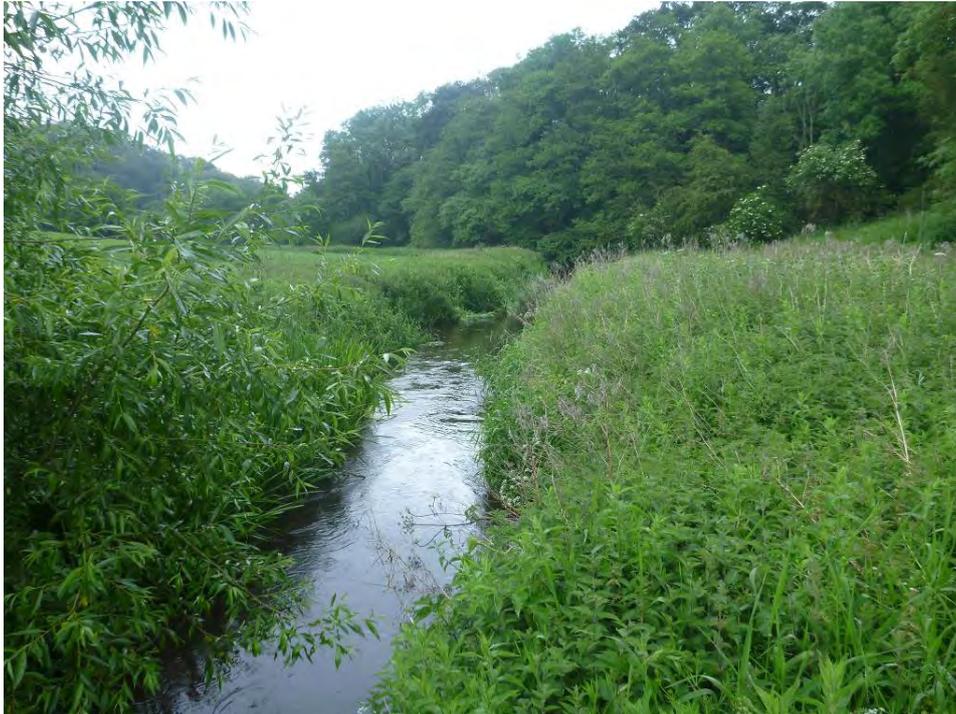
Photo 3 Less shaded areas have narrowed through colonisation by emergent vegetation. This may not persist in the winter months when the vegetation dies back.

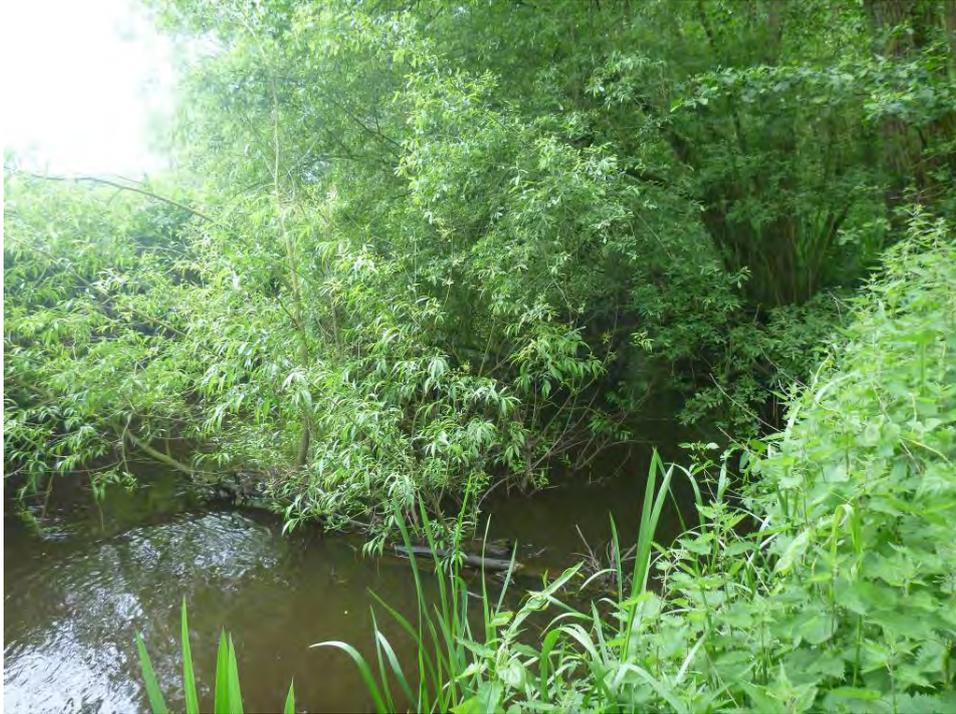
In many areas, riparian trees have grown entirely across the channel (Photo 4); some are the dense re-growth of previous coppices. Low cover over (and extending into) the water is very important for retaining trout and other fish species, but in this section there is definitely a case for thinning out the branches. The aim should be to achieve diversity, with the retention of some 'impenetrable' areas, coppicing and singling of others, and hinging and laying others (see Recommendations).

Photo 4 Dense growth of willow across the channel from a previously coppiced tree. This is valuable cover for trout and some should be retained, but some management is required in this reach in conjunction with the recommended channel improvements.

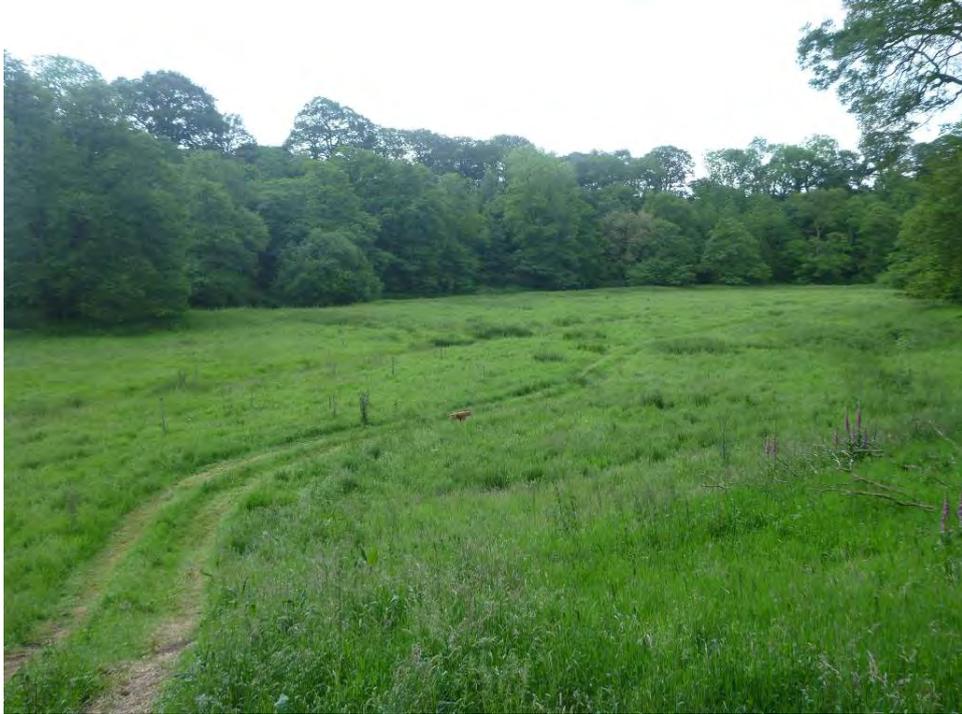
Downstream of the A49, the river describes a broad S-bend down to Papermill Bank. The flat valley floor lies between steep bluffs (Photo 5) and the river channel flows close against the eastern and then western edge of the floodplain. The position and lack of meanders in the channel here indicates it has been re-aligned to the edge of the floodplain in the past, possibly for agriculture or milling (Appendix 1). The former papermill downstream is described as being in ruins by 1750 (*Paper making in Shropshire*, L.C. Lloyd, Trans. Shrops. Arch. Soc. 1937-38), so the river could have been modified centuries ago. The channel has certainly been re-sectioned, indicated by the poor in-stream habitat (Photo 6) and spoil bund on the right bank.

Photo 5 View of the valley from Castle Rough. The river channel is under the tree line, behind the bund of dredging spoil.

This area warrants a more detailed investigation into the feasibility of re-naturalising the river, by re-meandering, restoration of a pool-and-riffle sequence and restoring connectivity with the floodplain. Examples of similar projects are given in Appendix 2.

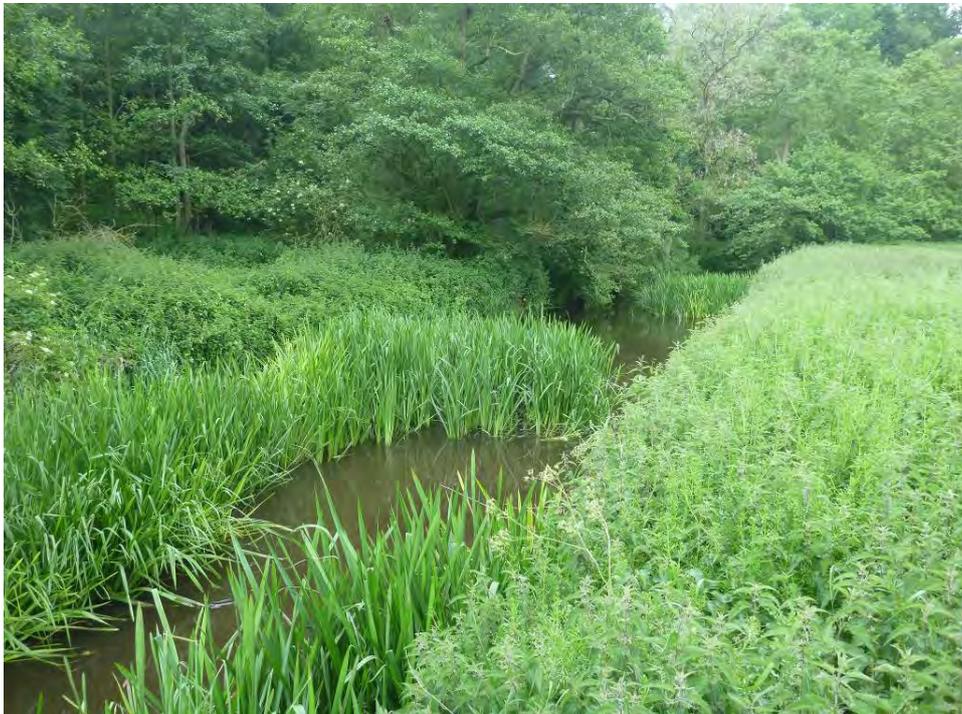
Photo 6 The river channel in the same location as Photo 5. An over-wide, trapezoidal cross-section with a bund of spoil on the right bank (nettles). Emergent vegetation signifies slow flow and silt deposition.

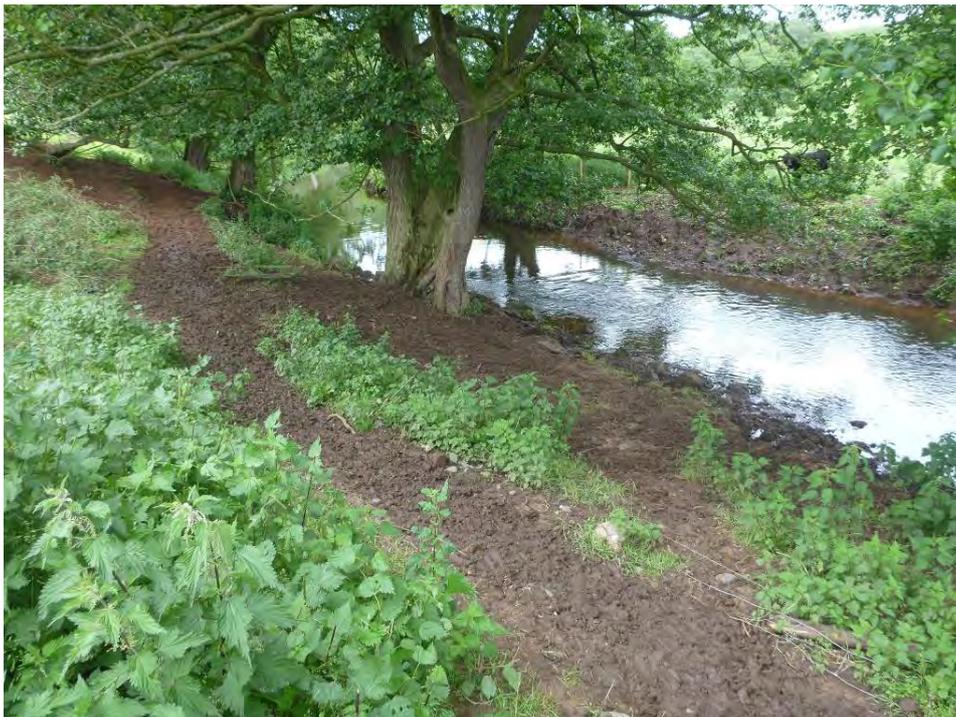
Immediately upstream of Papermill Bank, the valley broadens and there is a short section of river with better habitat, being more meandering and closer to a natural level below its floodplain level (Photo 8); possibly an indication of limited (or no) past dredging activity in the vicinity of the old stone bridge carrying the track to Papermill Bank. Cattle were present in the field upstream of the bridge at the time of the visit and bank poaching was damaging the riparian habitat, creating a source of fine sediment entering the river (Photo 7). There were the remains of a fence here indicating stock access has been controlled in the past; this should be reinstated to protect the river.

Photo 7 Cattle poaching of the banks upstream of Papermill bridge.

- Address the issues where agricultural land use is impacting upon the watercourse, for example by fencing livestock out of the watercourse and preventing run-off from arable fields from carrying sediments and nutrients into the river.

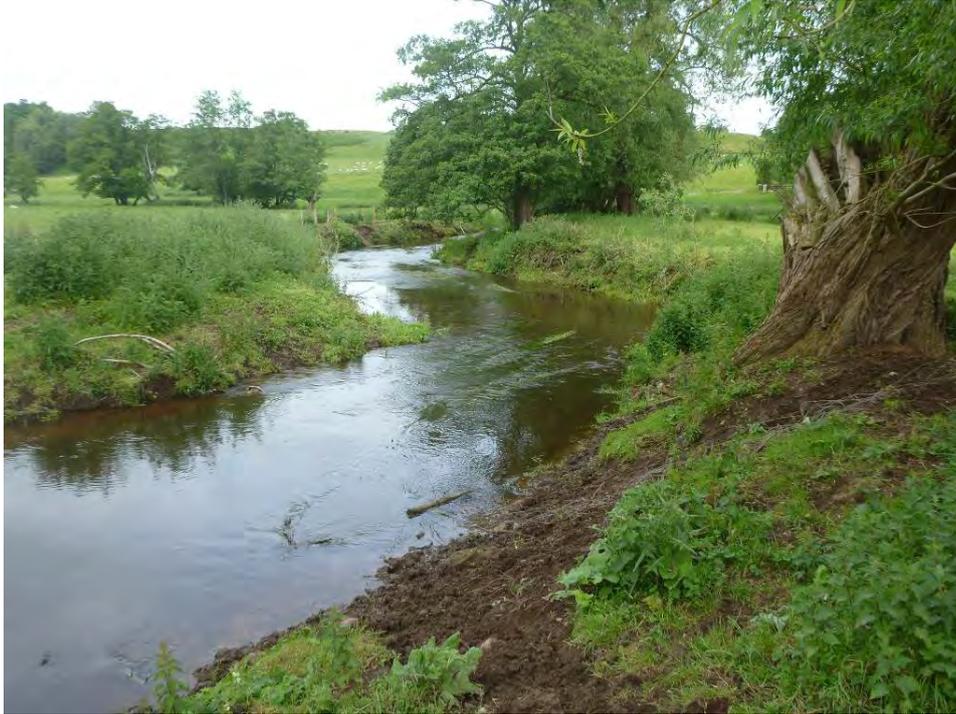
Photo 8 Better potential in-stream habitat upstream of Papermill bridge, notwithstanding the cattle access.

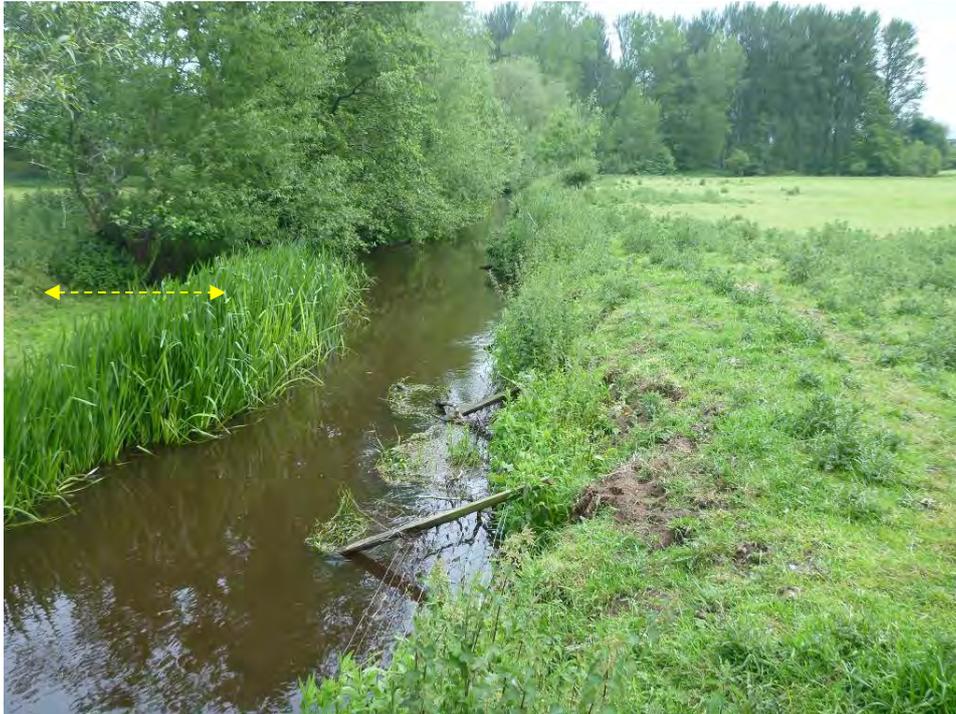
Downstream of Papermill Bank, the valley floor remains broad and wet and is utilised for grazing. Cattle were present and had free access to the river as the fence is in disrepair. The channel here has been re-sectioned in the past, but it appears that trampling by livestock has pushed the banks down in places, narrowing the channel. In the short term, livestock access should be restricted to improve riparian habitat.

Photo 9 Downstream of Papermill Bridge, livestock trampling has narrowed the overwide channel (a good thing) as indicated by the arrow, but the grazing is limiting the quality of riparian habitat and fencing should be reinstated.

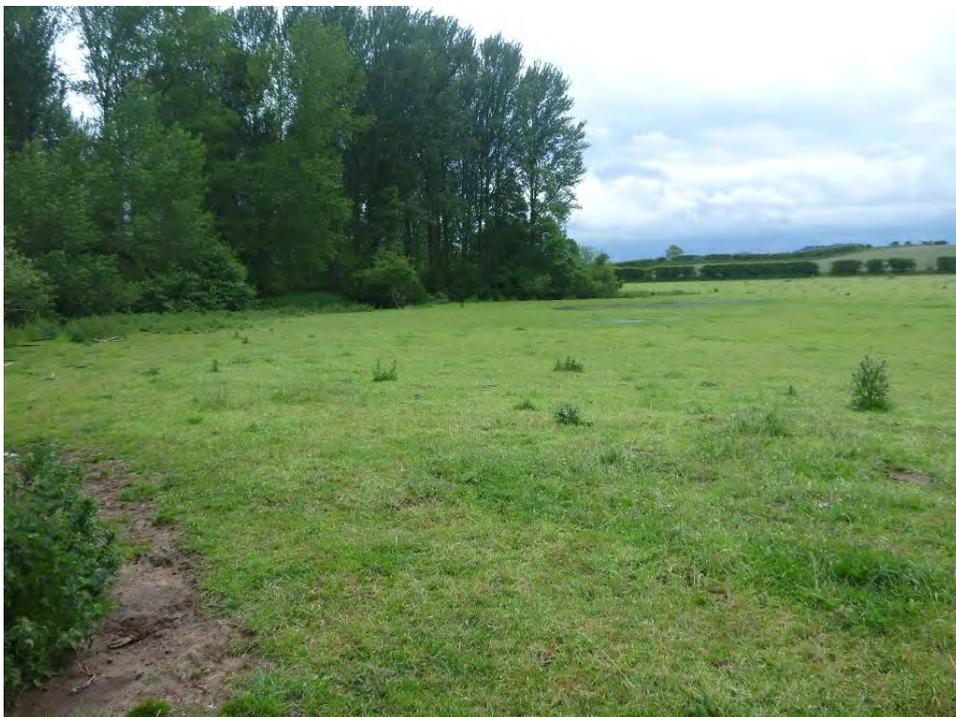
Photo 10 Broad, wet valley floor on the RHB, 'The Bog' on the LHB (planted with poplar).

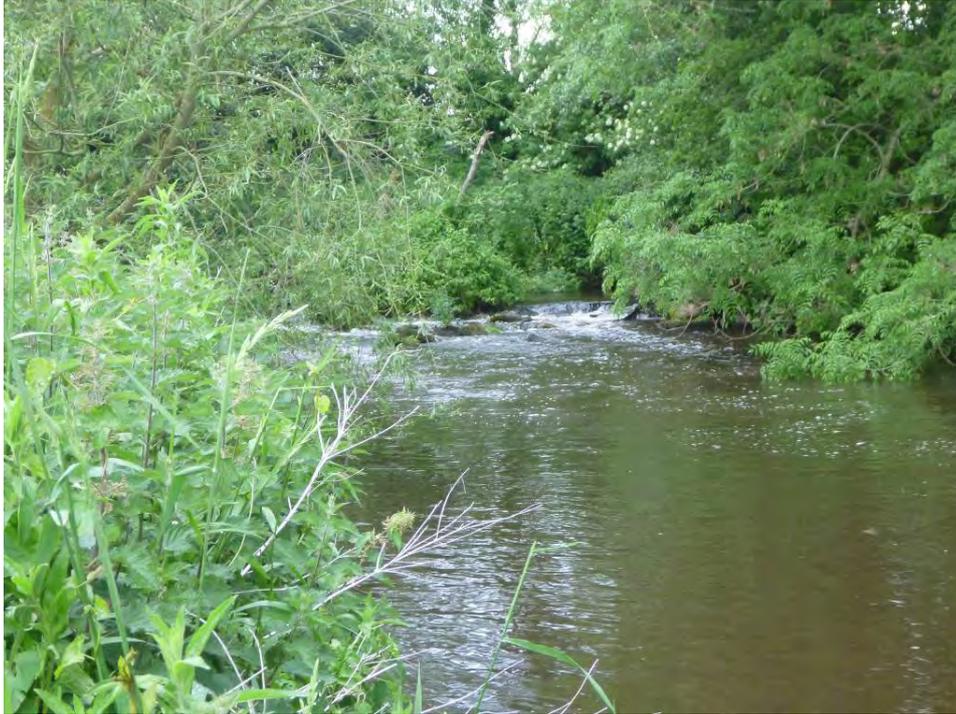
Weir remains at grid reference SJ5563225183 (Photo 11) highlight the head of what was probably once a leat (now dry) leading to Harcourt Mill. Upstream of the weir, the field below Papermill Bridge is wet and low-lying, as is the area on the LHB opposite, marked on Ordnance Survey maps as 'The Bog'. These areas may have formerly been a mill pond when Harcourt Mill was operational (it appears defunct on the 1880 OS map, in contrast to Stanton and Moreton Mills downstream).

Photo 11 Remains of the weir at SJ5563225183.

This area should be included within any feasibility study for river restoration work, looking at what might be possible utilising the gain in riverbed gradient if the weir were removed or bypassed.

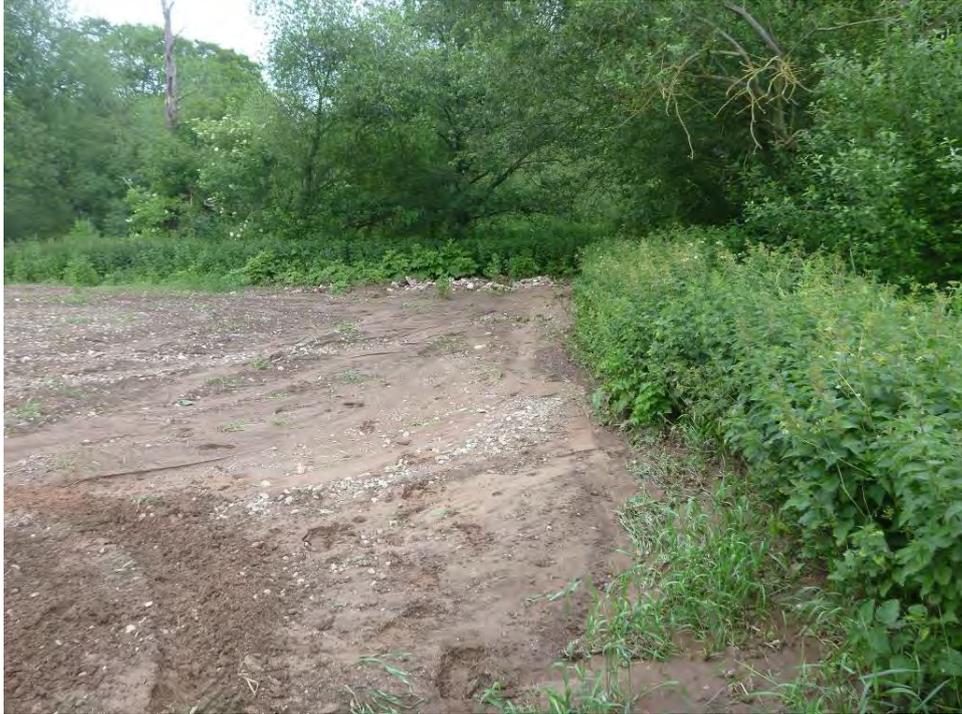
Fine sediment ingress to the river is occurring in the field on the RHB immediately upstream of the weir, currently being cultivated for onions (Photo 12). Surface water run-off pathways were evident in the low corner of the field adjacent to the Besford Brook confluence and further upstream alongside an irrigation pump. The recent wet weather had washed soil across the field margins and directly into the river. Fine sediment degrades invertebrate habitat and reduces the survival of trout eggs which incubate within the gravel over winter, both potentially leading to fewer trout in the river. The sediment also carries nutrients which will be directly contributing to the abovementioned WFD failure for excessive phosphate levels. Wider margins and/or no cultivation of vulnerable areas should be implemented to prevent this problem.

Photo 12 Surface water run-off from an arable field corner entering the river (background) and brook (immediately beyond the nettles, right of picture).

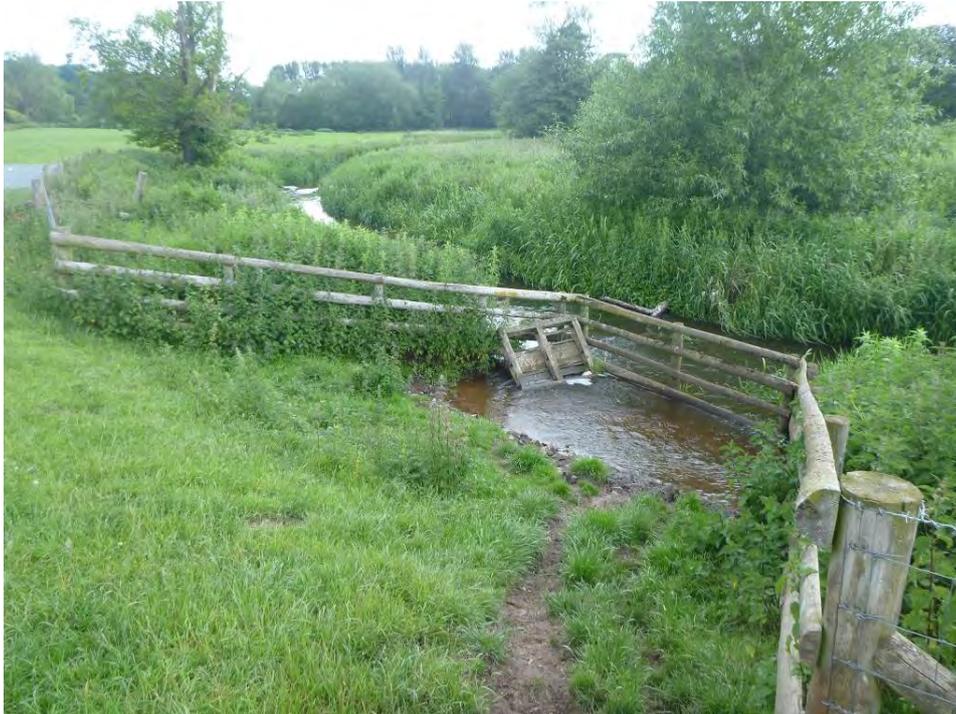
Downstream of the weir to Harcourt Mill, the river is fenced off on both banks with hard-standing livestock drinking bays. This has produced a good riparian zone which has allowed the channel to narrow, prevents bank erosion and fine sediment ingress, provides cover for fish and a range of habitats for invertebrates. The fencing should be maintained to exclude livestock. Angler access could be provided by either strimming a narrow path, or access points for fishing by wading.

Photo 13 Riparian fencing and drinking points allow a much better marginal habitat to develop, compared with the situation in Photo 7 - Photo 10 .

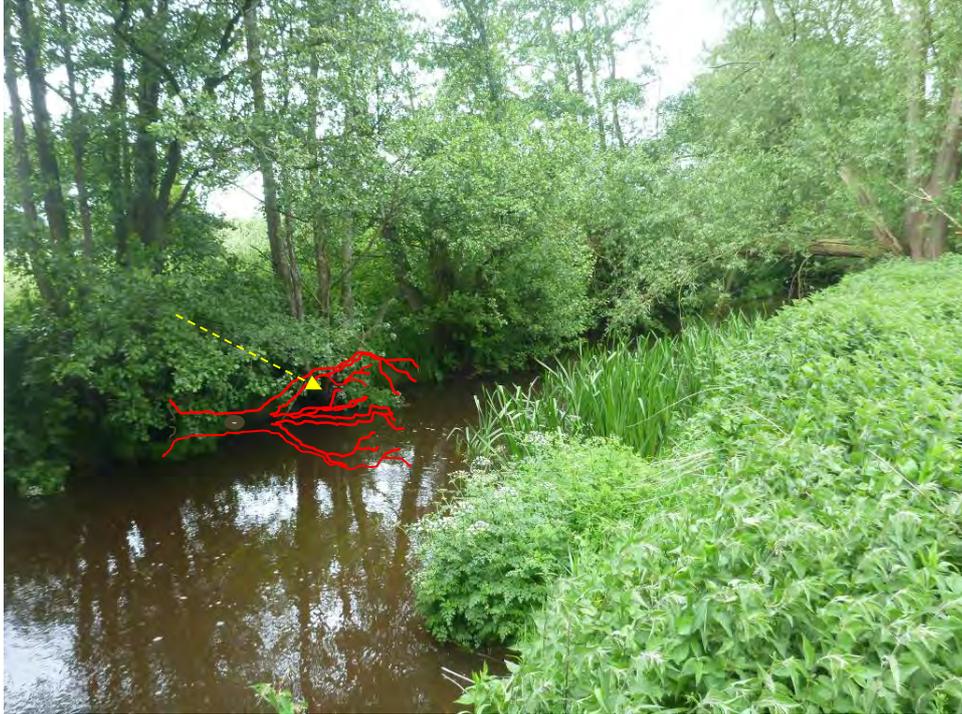
This reach has a meandering plan-form and although the river has probably been re-sectioned in the past, there is a variety of good in-stream habitat (Photo 14 - Photo 18). In some areas, the channel is well-shaded by trees, often previously coppiced alders (Photo 14, Photo 16); there is scope to coppice selected trees and lay them into the channel along the margins. This would provide cover and encourage the narrowing of the over-wide channel in over-shaded areas.

Photo 14 Areas with plenty of previously coppiced alders have scope for laying trunks into the river channel to provide cover.

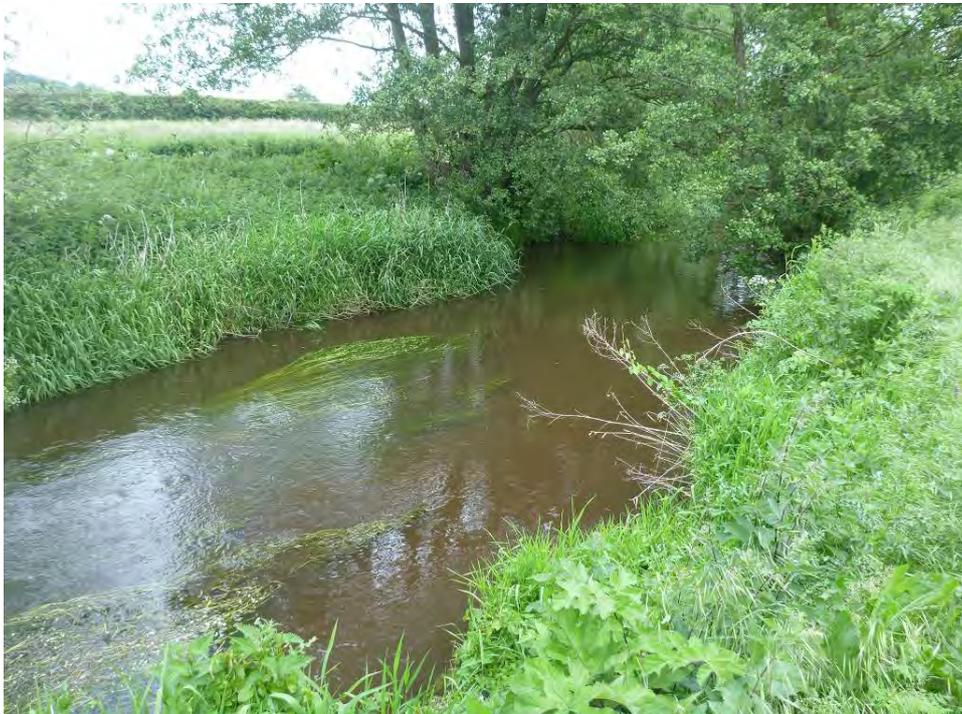
In more open areas, the channel has narrowed itself and in shallower sections water crowfoot occurs, providing cover and invertebrate habitat (Photo 15, Photo 17). Although not inspected on this visit, the EA walkover highlights an impoundment and barrier to fish migration at Moreton Mill, a short distance below the downstream boundary.

Photo 15 More open areas support water crowfoot.

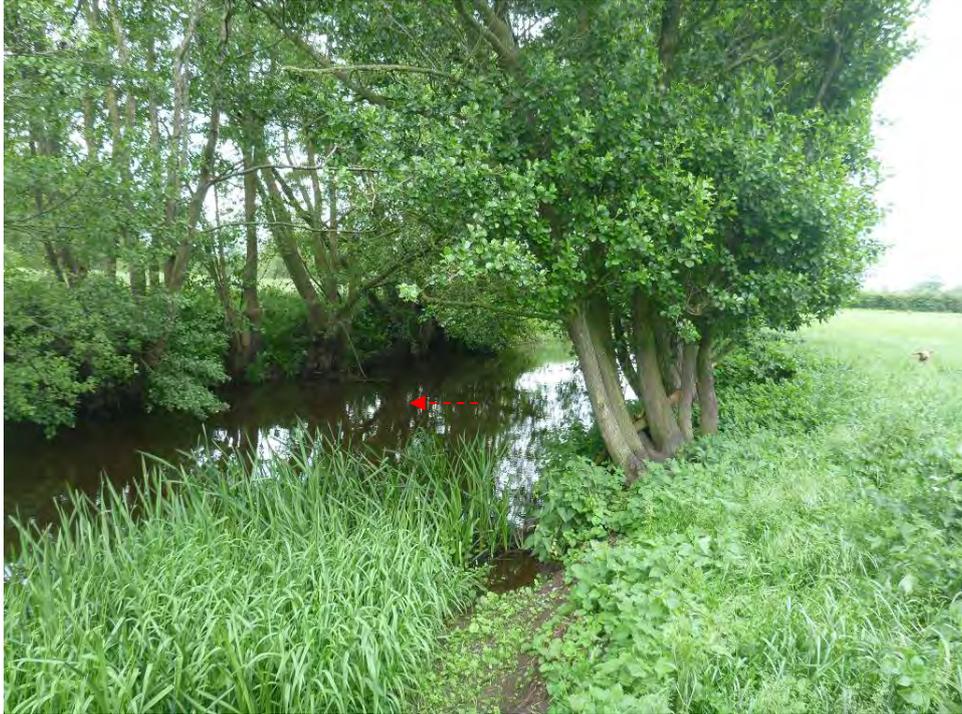
Photo 16 Trees on both banks shade the channel and inhibit narrowing by emergent vegetation. Laying trees into the margins here would improve in-stream habitat, letting more light in and providing additional in-channel structure.

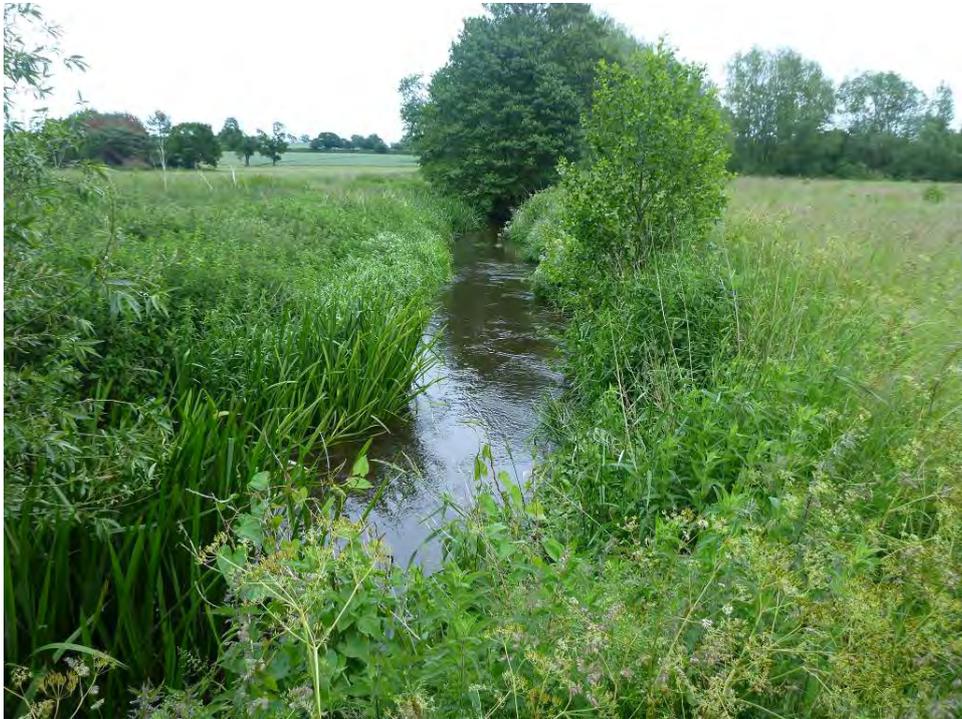
Photo 17 A more open area where the channel has naturally narrowed.

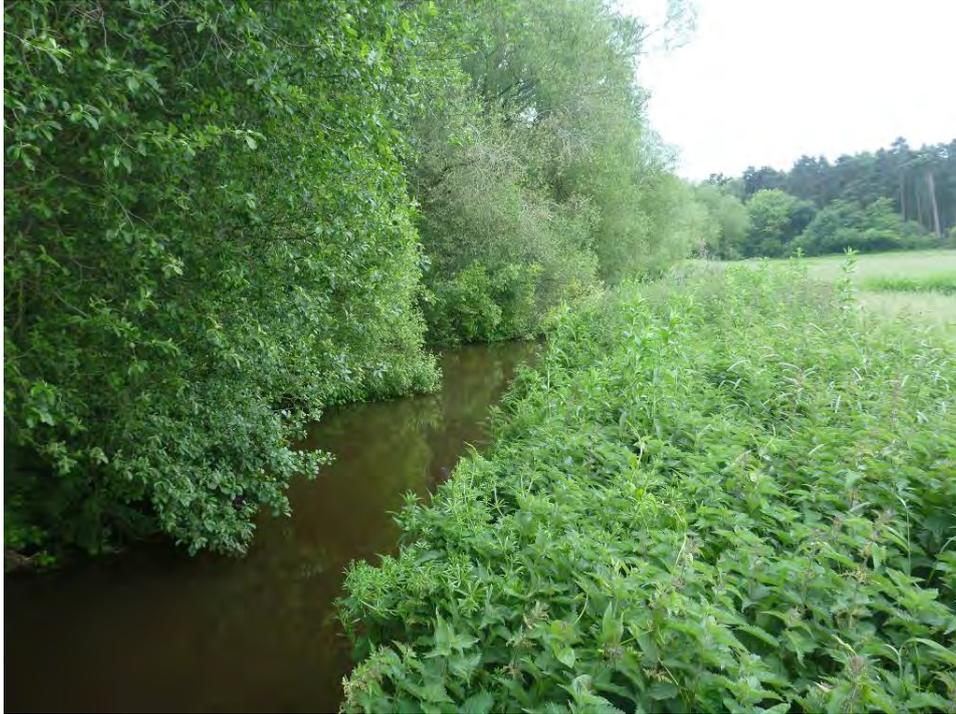
Photo 18 The river looking downstream to Forge Coppice. Excellent low cover over the water from the LHB bushes.

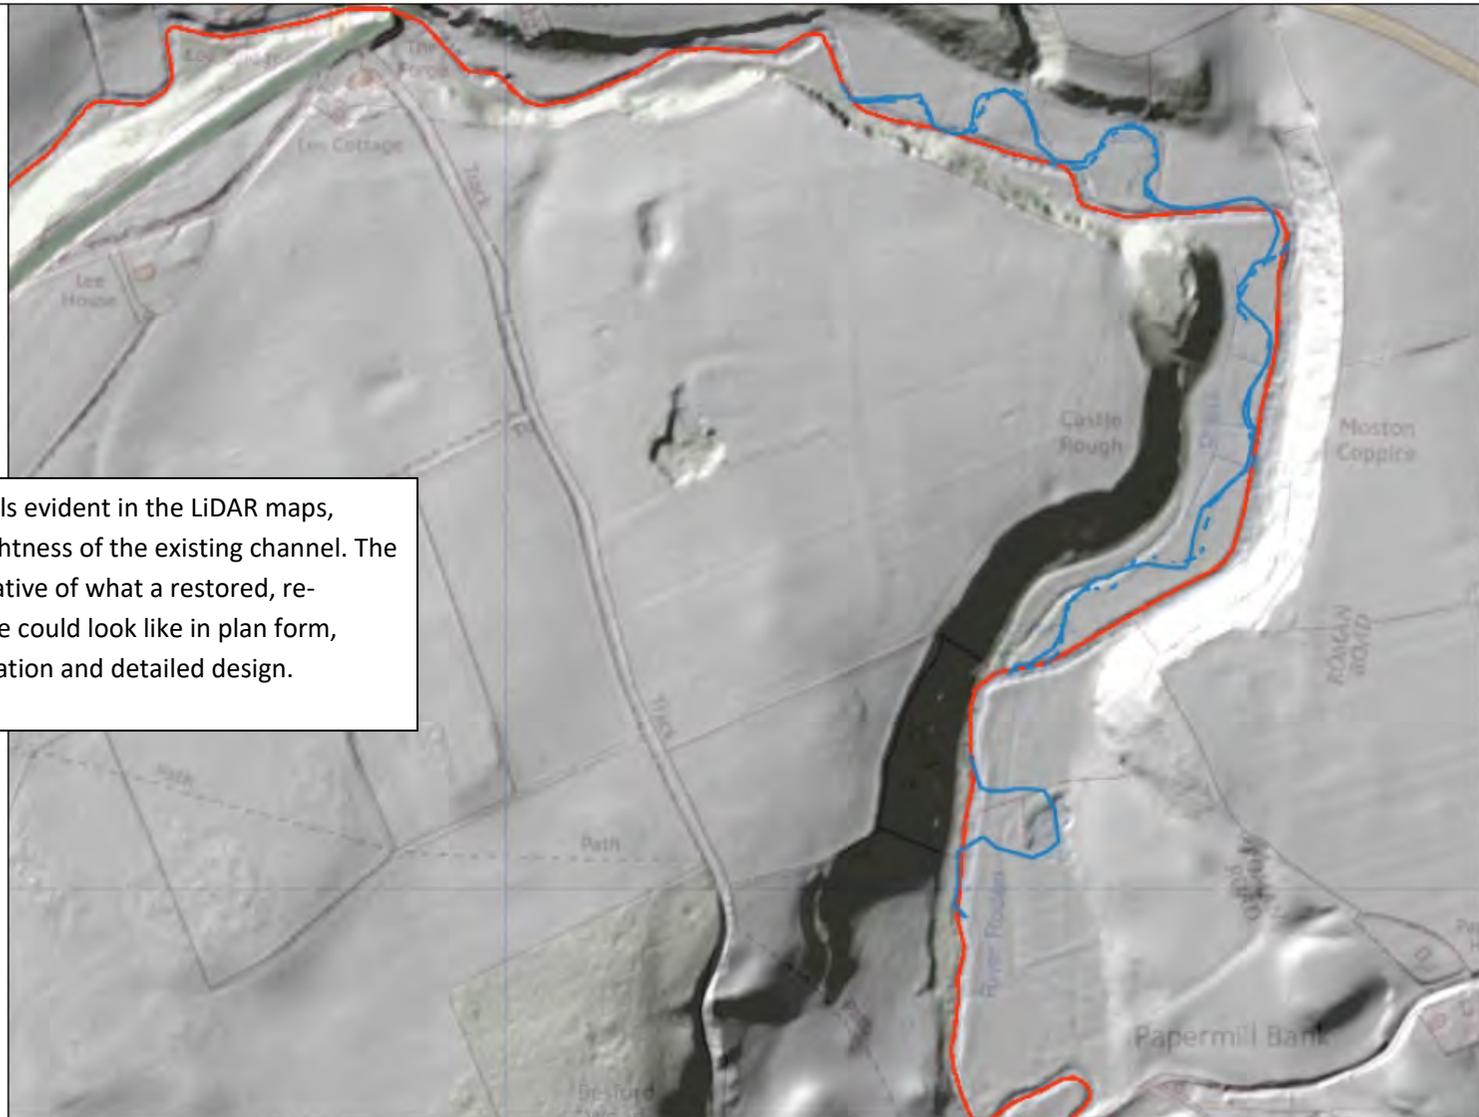
R Roden, The Forge to Papermill Bdg

There are no relict channels evident in the LiDAR maps, despite the artificial straightness of the existing channel. The blue lines are purely indicative of what a restored, re-meandered channel course could look like in plan form, subject to further investigation and detailed design.

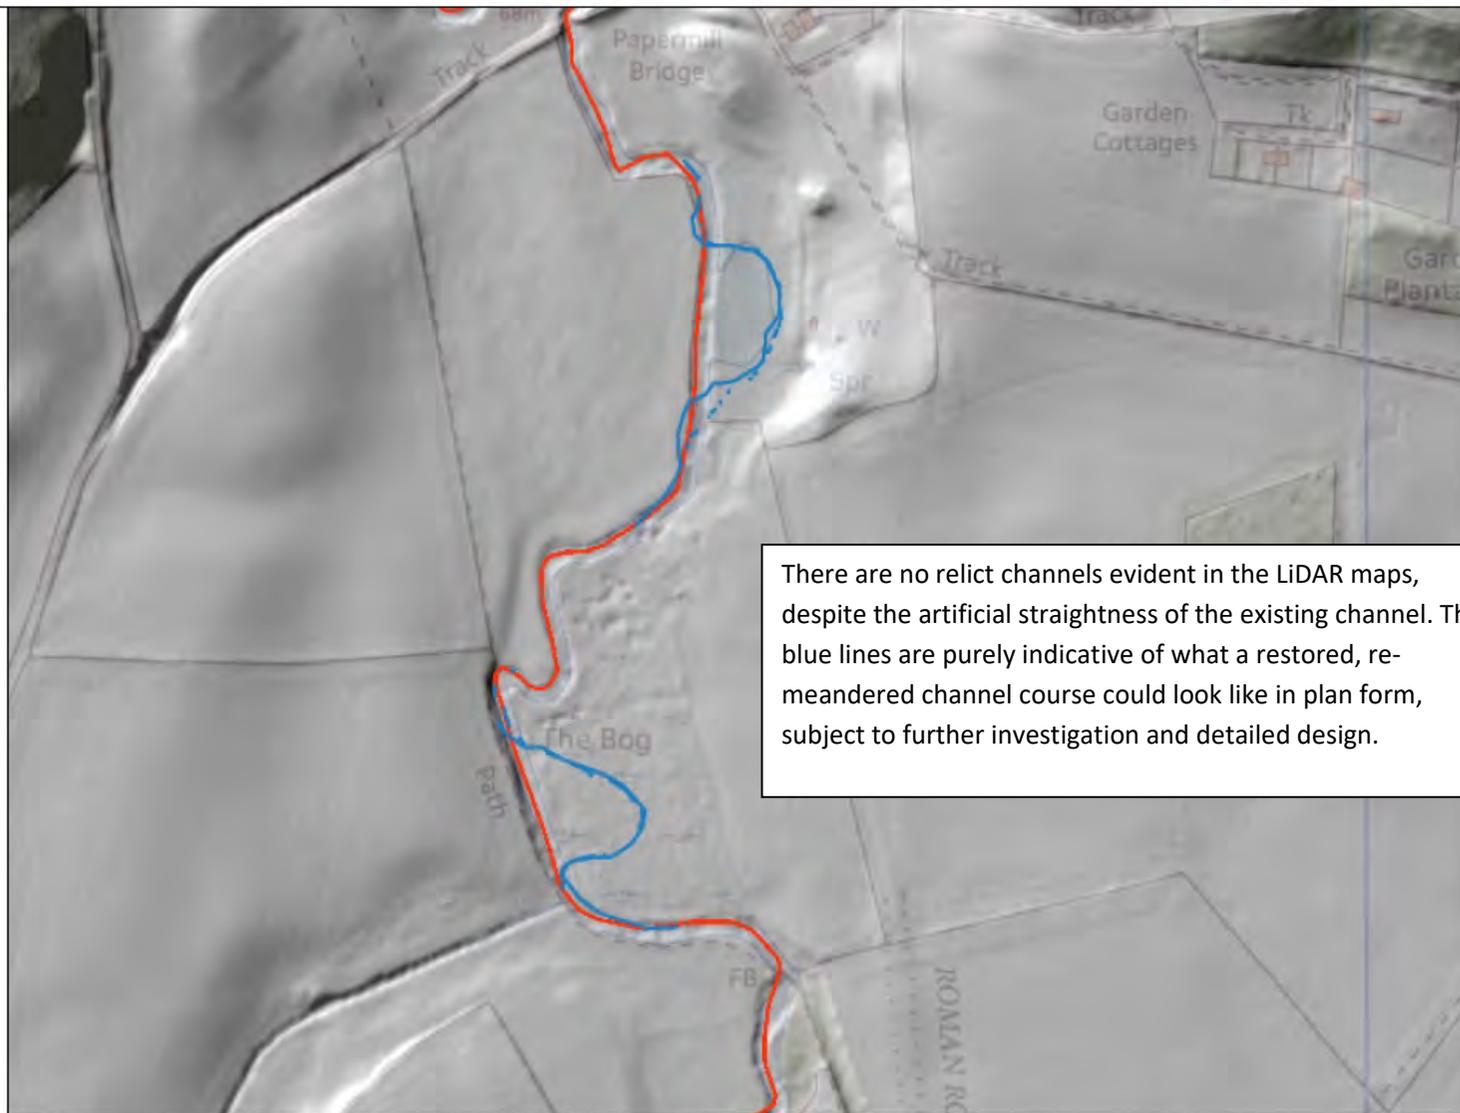
R Roden, Papermill Bdg to The Bog

There are no relict channels evident in the LiDAR maps, despite the artificial straightness of the existing channel. The blue lines are purely indicative of what a restored, re-meandered channel course could look like in plan form, subject to further investigation and detailed design.
