River Rother - Empshott

A advisory visit by the Wild Trout Trust – October 2013

1. Introduction

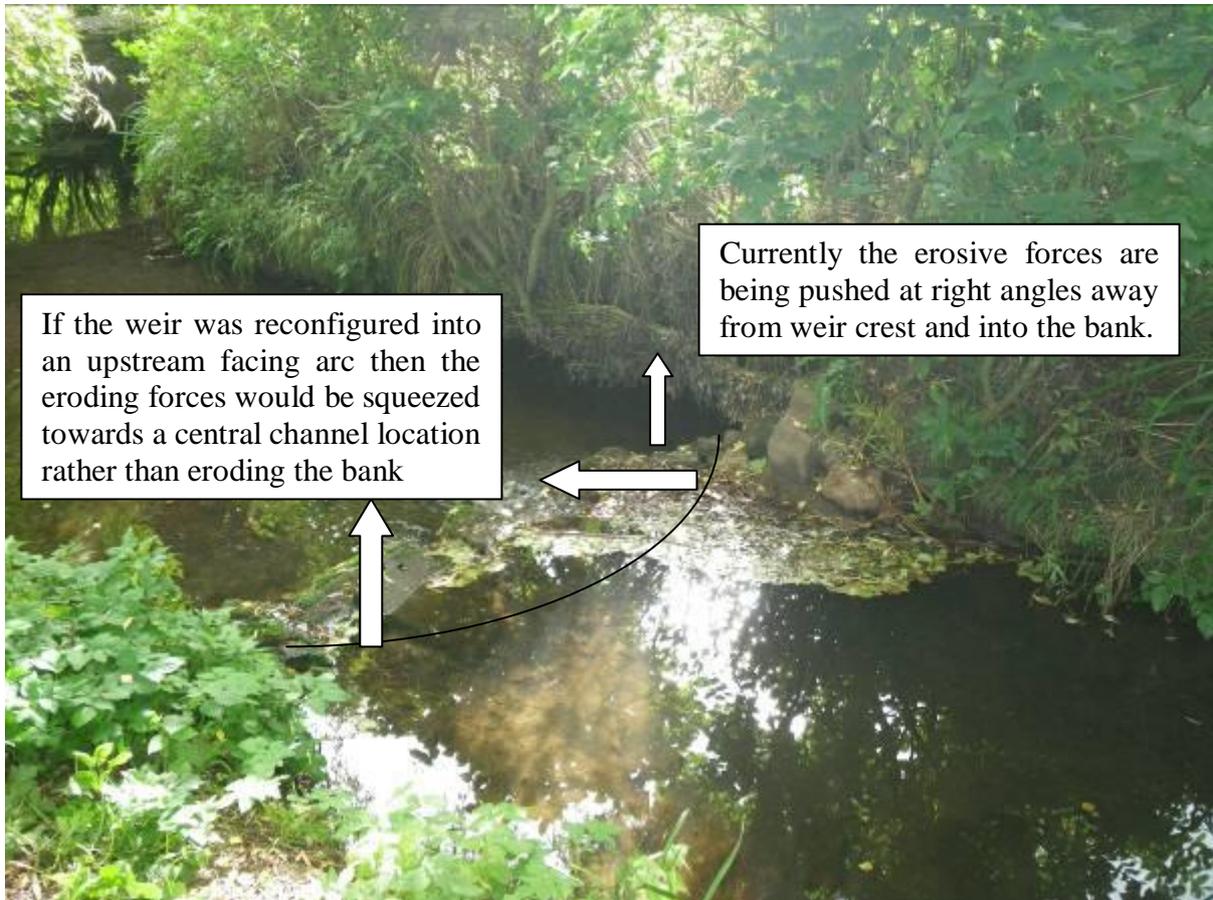
Photo 1 Weir at Bulls Brook cottage

Towards the bottom boundary, the river is slightly impounded by a small stone weir (photo 1). Some concerns have been raised over bank erosion on the RB, where the river flow is being squirted towards the margins and as a result is nibbling the bank away. The garden staff have made some valiant attempts to slow down the rate of erosion by planting willow spilling. This will undoubtedly help to protect the bank but heavy shading via a large weeping willow located on the opposite bank may restrict how well this material strikes.

Erosion pressures on the bank at this location are mainly due to the configuration of the stone weir structure. Currently the weir forms a gentle downstream facing arc and under spate conditions it is thought that high velocity water is being forced out and into the margins, rather than being funneled into central channel locations.

The weir was installed at least 20 years ago, presumably to hold up water levels in the reach adjacent to the property gardens. This increased water depth is slowly but surely disappearing as the river bed has started to accrete sediments and is slowly rising, causing a distinct step in the river bed.

The property owners value the sound of the water as it tumbles over the stones but unfortunately this feature is having an adverse impact on the streams morphology and ecology, as well as being responsible for the bank erosion on the downstream side of the structure.

Reconfiguring the weir to construct two upstream facing stub groynes will resolve the erosion issues. Leaving a free gap between the groynes will also enable the river bed to erode back the settled sediment that has deposited in the

section upstream of the weir. The groynes, or flow deflectors could be constructed from the existing stones, or be fabricated from tree trunks. Under most flow conditions this alternative design should still be audible as water will bubble over the top of the stub groynes.

Replacing the stones to form two upstream facing flow deflectors and removing the central section of the weir all together is the best option. This will initially lower the water levels upstream and pull the water through much faster and lower. Initially the river will look very unattractive in the reach immediately upstream of the structures because the deposited bed material will be exposed. The increased flow velocities generated by pulling out the central section will some help to clean the bed and will soon become a much healthier environment for invertebrates and fish, especially if coupled with exposure to slightly more direct sun light. The principle of driving the river bed down by encouraging swift water velocities, rather than impounding the level with a full channel width weir will provide a high quality stream environment for gravel spawning fish species such as trout and bullheads (*Cottus gobio*).

Removing the existing structure and replacing it with upstream facing stub groynes will reduce bank erosion pressures and create improved habitat upstream.

The use of planted live willow in the area adjacent to the bank erosion is recommended. Willow spilling works best where the whips can be pushed down into the toe of the bank at water level and where there is sufficient light to promote vigorous growth.
