Walkover Habitat Survey
Ruskington Beck, Lincolnshire
November 2016

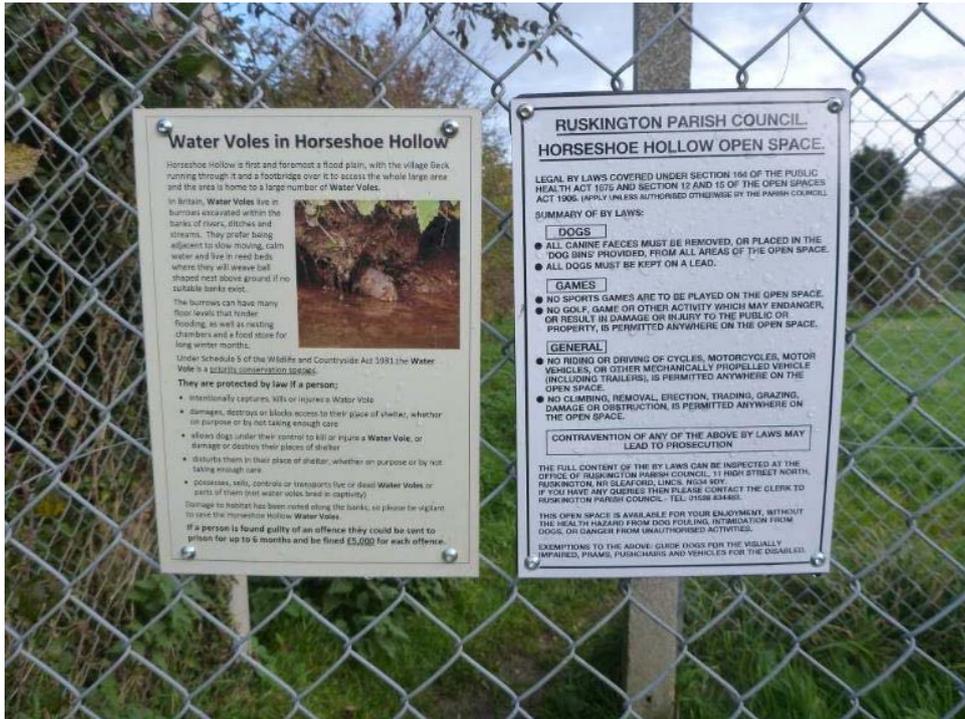
Photo 1 Information sign regarding water voles in Horseshoe Hollow.

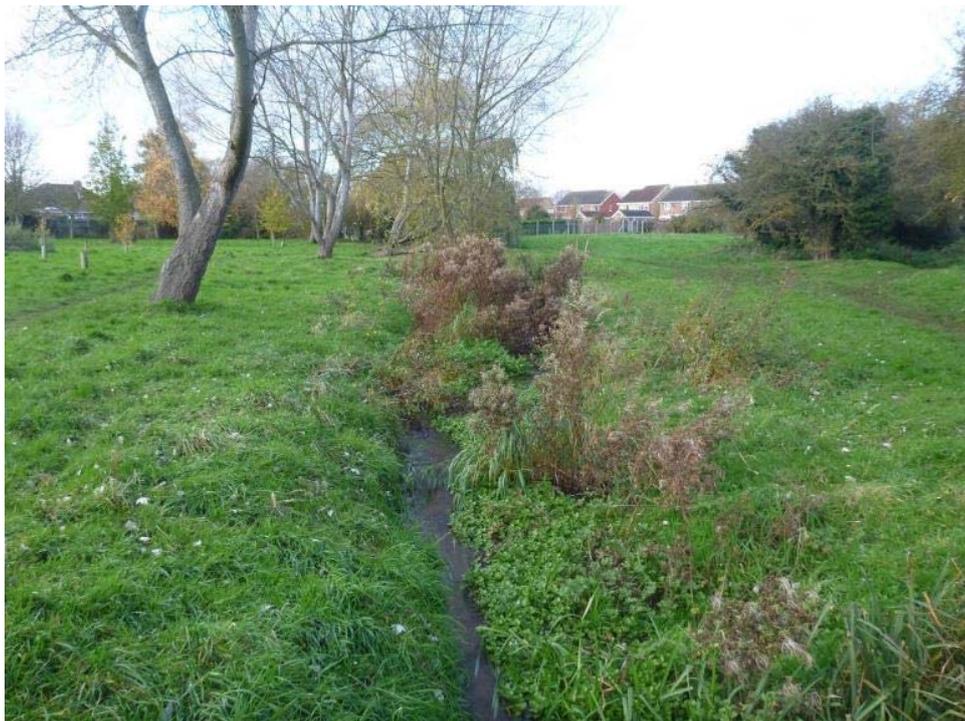
A short section (200 m) of the Beck runs through Horseshoe Hollow public open space between Lincoln Road and Manor Road (TF0772751256). This reach has few bends suggesting it has been straightened in the past, but it has natural banks which are low and with good connection to the adjacent floodplain. There is a population of water voles (*Arvicola amphibious*) in this area (Photo 1). The inspiration for "Ratty" in *Wind in the Willows*, the Water Vole is Britain's fastest declining wild mammal and has disappeared from many parts of the country where it was once common. It is threatened by habitat loss, but has suffered particularly from predation by the introduced American Mink. There may be opportunities on Ruskington Beck to improve and link habitats, increasing the range and resilience of the vole population and contributing to its national conservation.

Photo 2 Low, natural banks within Horseshoe Hollow.

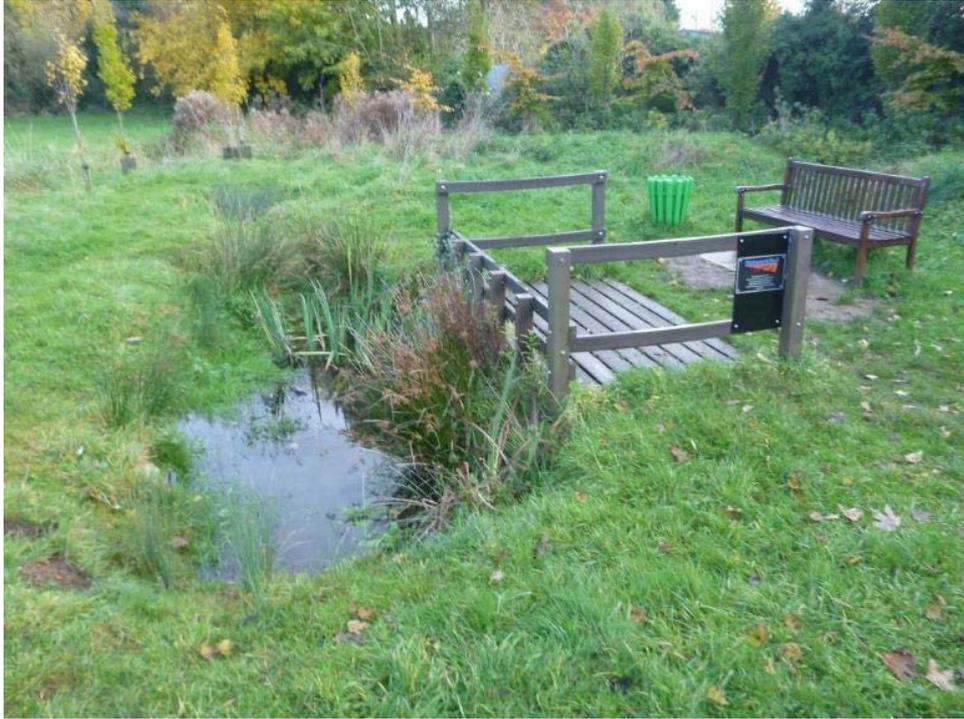
There is a pond dipping area created in 2015 as part of a project undertaken by Network Rail and the GNGE Alliance in partnership with Ruskington Parish Council (mitigation for disruption caused by upgrading the East Coast Main line).

Photo 3 Pond dipping area created by Network Rail / Parish Council project.

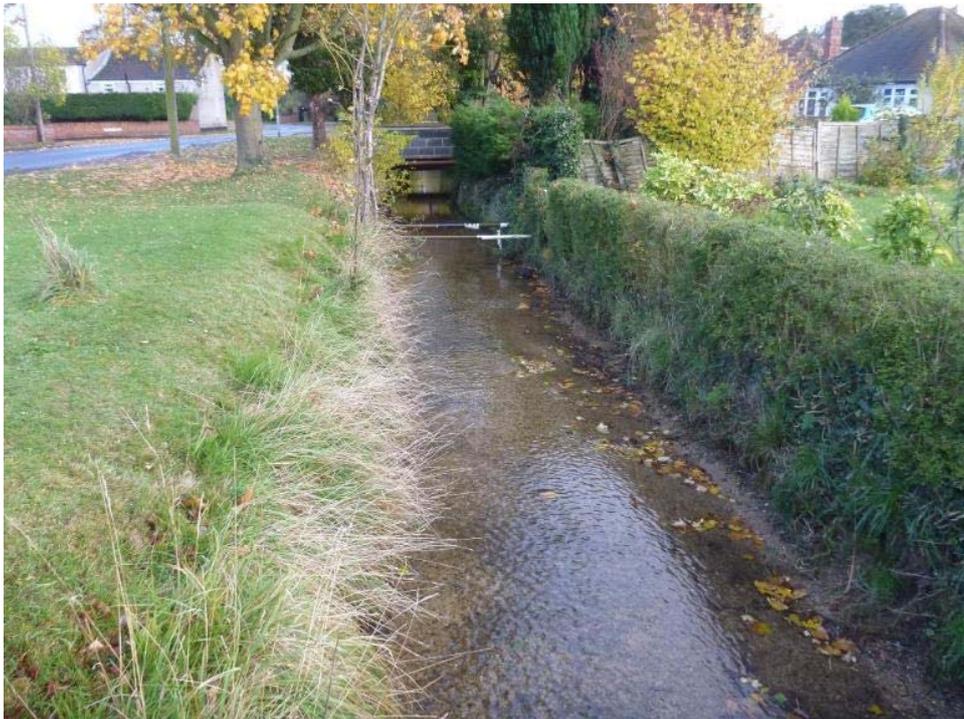
Downstream of Horseshoe Hollow, the Beck enters a very heavily modified channel alongside Manor Street (Photo 4), then through the grounds of private residences (Photo 5), and alongside Chapel Street (Photo 6) into the village centre where it is flanked by High Street North and South (Photos 7 - 8). Throughout this section the channel is artificially wide, shallow and bordered by vertical walls of concrete, brick or stone; habitat value throughout is extremely poor.

Photo 4 Highly modified, artificial channel alongside Manor Road.

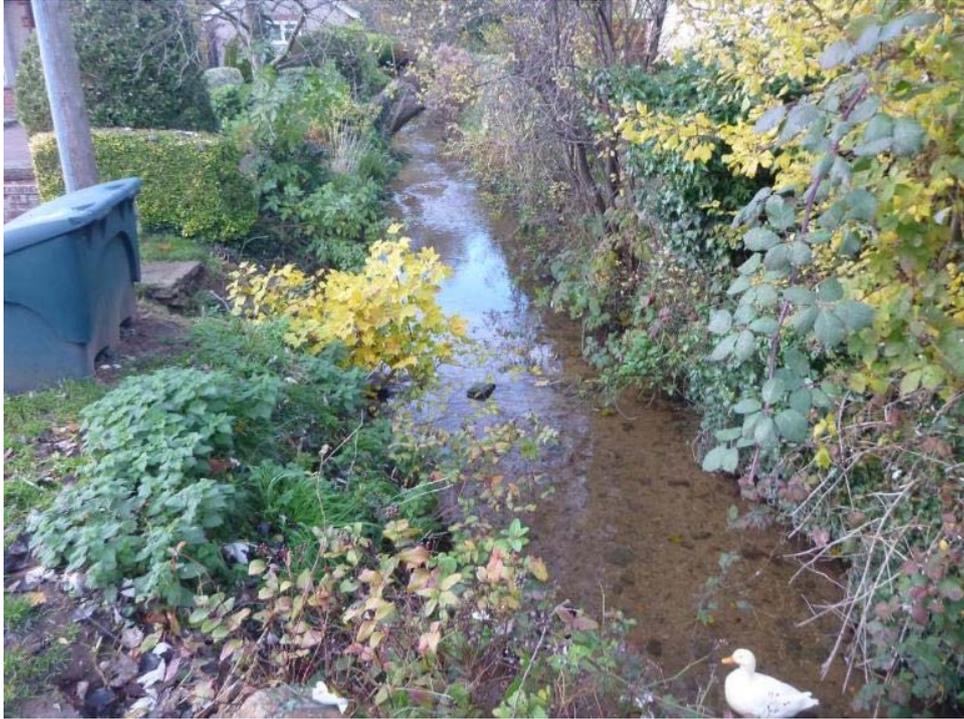
Photo 5 View upstream from Chapel Street of section flanked by private residences.

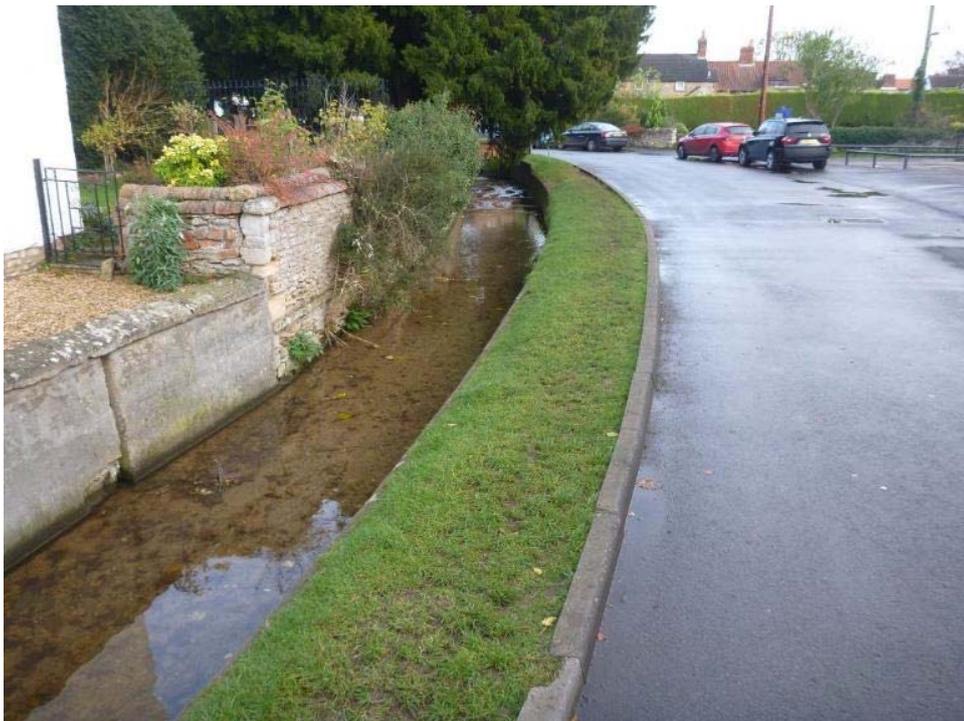
Photo 6 Highly modified, artificial channel alongside Chapel Street.

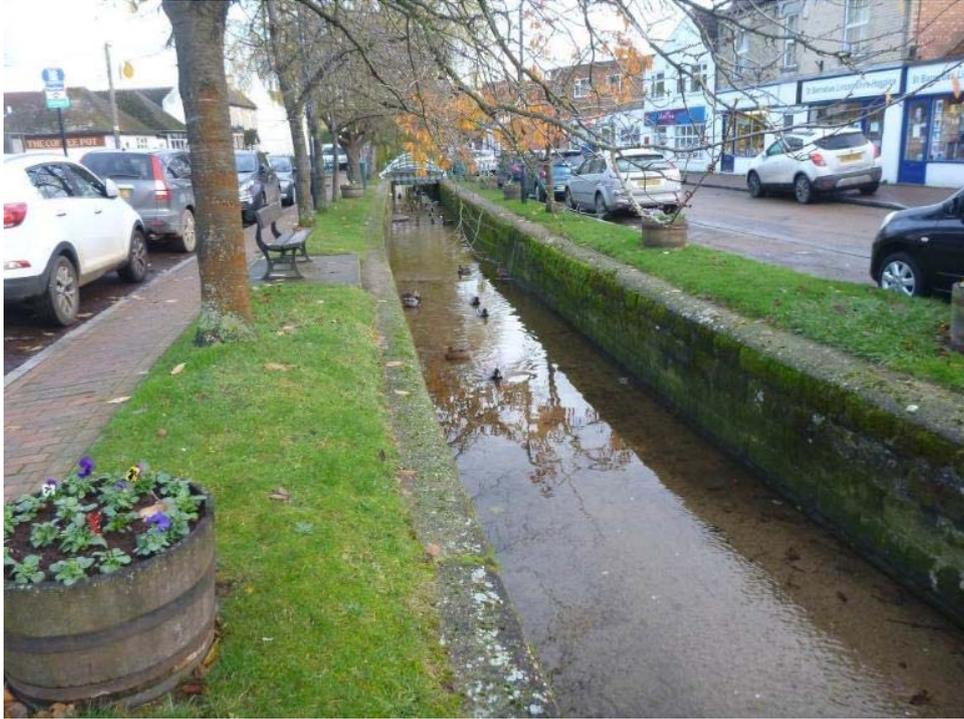
Photo 7 Highly modified, artificial channel alongside between High Streets North and South.

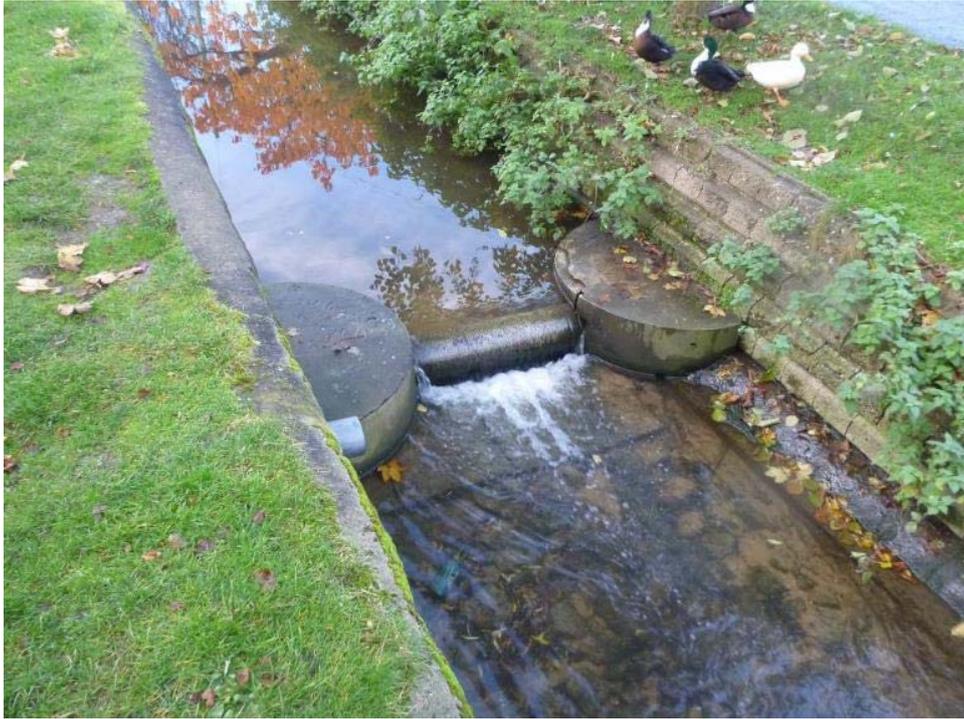
Photo 8 Small weir on the High Street section

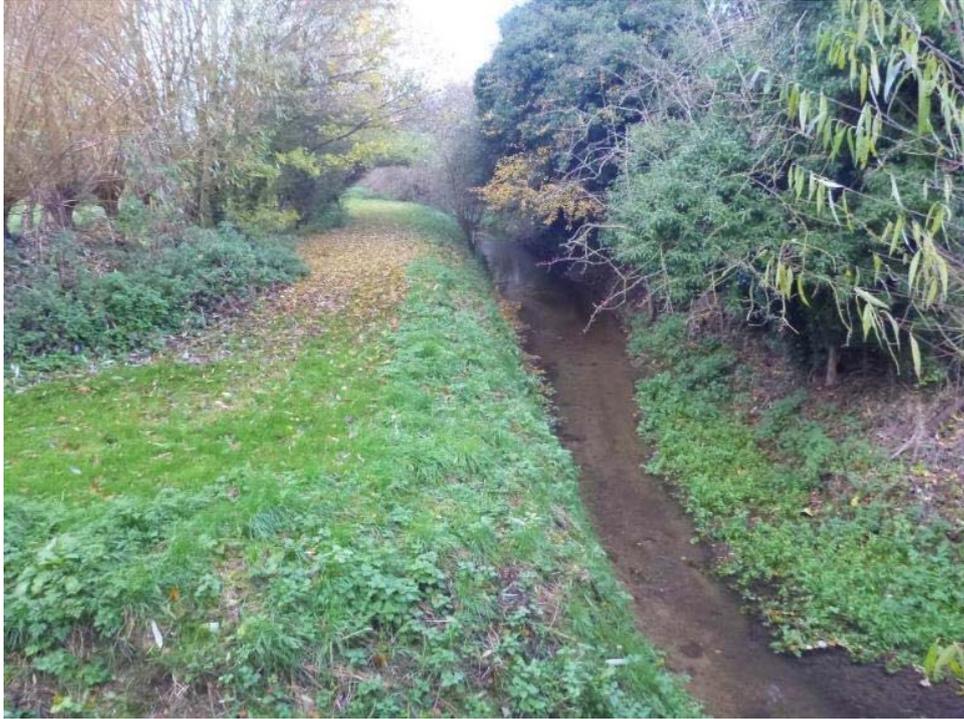
Photo 9 View upstream from the road alongside the sewage works.

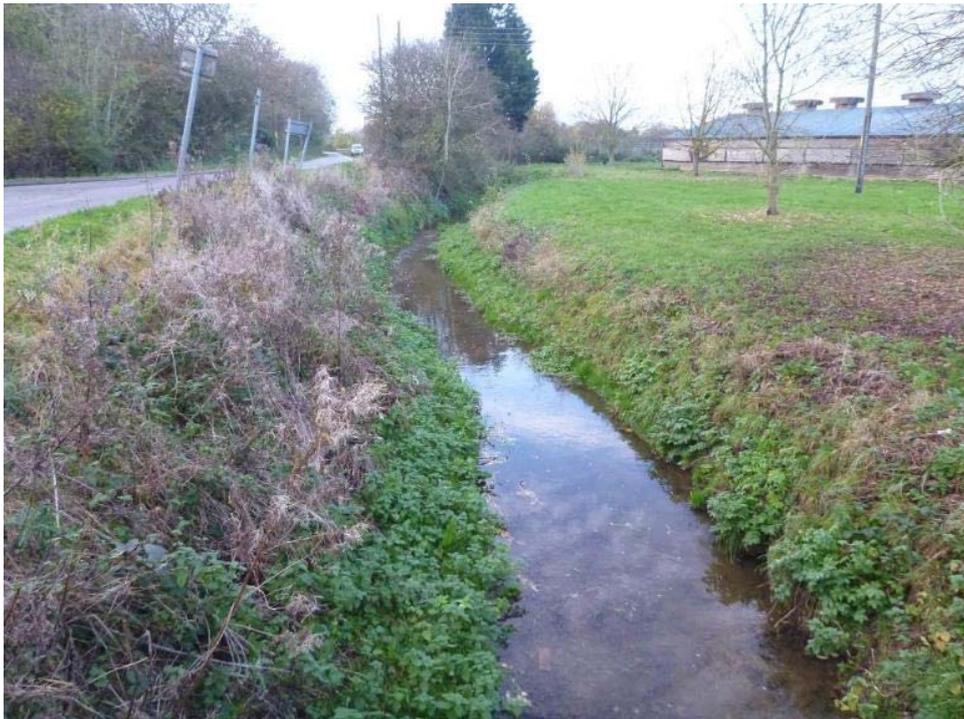
Downstream of the sewage works on Priory Road the Beck follows the Spires and Steeples Trail to its confluence with the River Slea. Apart from short sections at the upstream end (Photos 10 -11), the Beck is effectively a land drain with uniformly poor habitat. Regular maintenance occurs here and the banks had recently been cut and aquatic vegetation removed (Photo 12). There may be opportunities for habitat improvement along this reach with the aim of improving connectivity with the River Slea and interpretation for users of the trail. Liaison and working in synergy with the landowners and authorities currently maintaining the watercourse (possibly Environment Agency Operations Delivery team) would be vital.

Photo 10 View upstream from TF0915950389.

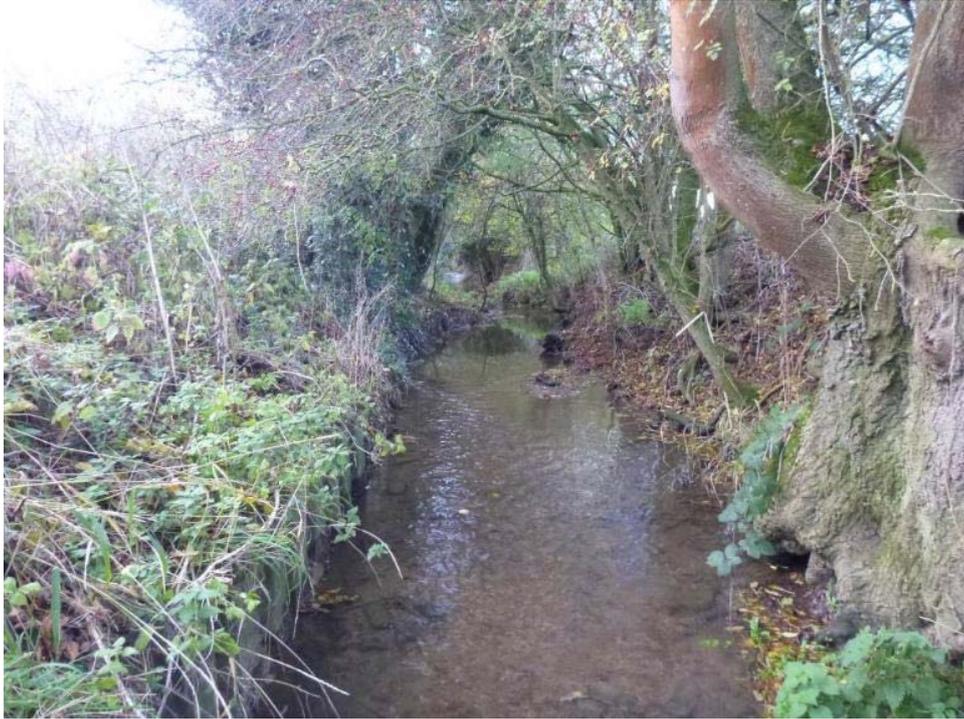
Photo 11 Shaded section alongside the track next to Lakeview.

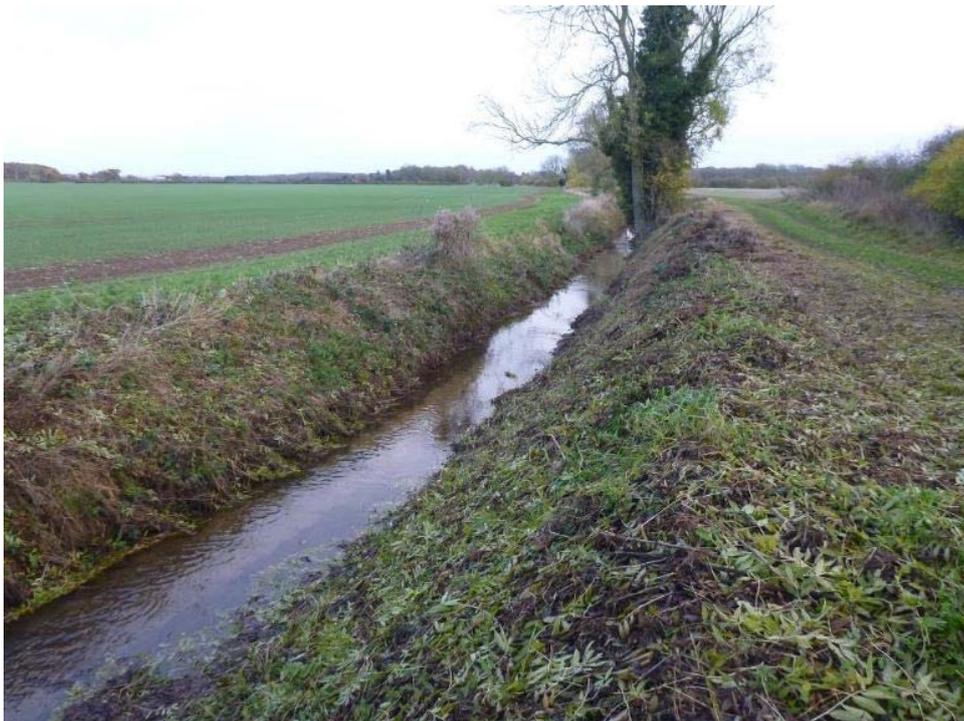
Photo 12 Beck alongside track at TF 09458 50191. The channel is straightened, deepened and maintained for drainage. The bankside and instream vegetation had recently been cut.
