Advisory Visit

Sandybeck (Tributary of the River Cocker, Cumbria)

26/07/2016

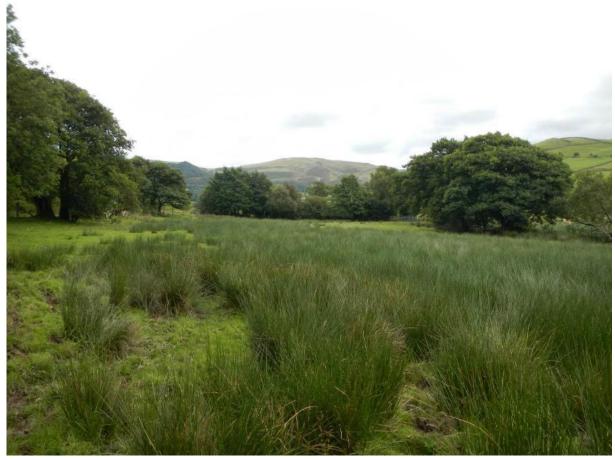
Immediately u/s of Sandybeck Bridge, issues associated with relocating a watercourse to higher ground are apparent. The fields to the RB (downhill) side of Sandybeck, between the current elevated course and the valley bottom remain wet and are dominated by rushes (Fig. 1). This is almost certainly exacerbated by water seeping downhill through the bed and RB bank from the current, perched watercourse towards the much lower land at the natural valley bottom. This is one of many reasons that relocating a watercourse from its natural channel not only negatively impacts on the function and health of the watercourse but also creates issues for land management and / or drainage.

Figure 1. Looking d/s at the natural slope (left to right) between the now perched, current Sandybeck Channel (just out of sight to the left of shot) and the low point of the valley (right of shot). The land on the slope inbetween will be receive sub-surface seepage from the current watercourse and so remains wet and dominated by rushes (centre of shot).

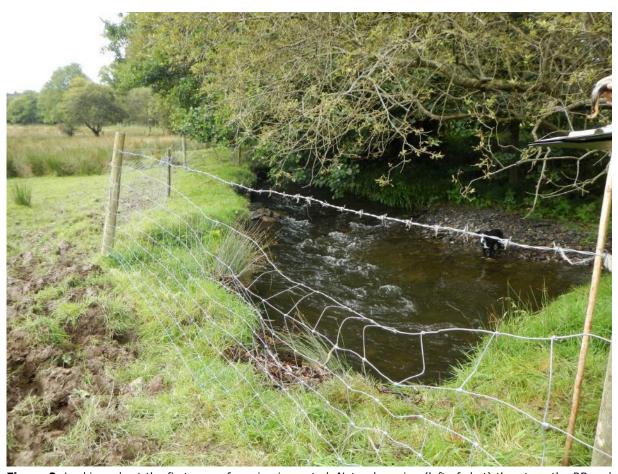
Livestock grazing is denuding the banks of diverse vegetation and causing physical damage through poaching and this, along with the deterioration of the hard bank revetments allowing increased natural scour and deposition, is leading to areas of the RB (downhill side) becoming eroded. The adjacent areas of the floodbank now also threatened. Figure 2 shows the first erosion area encountered, where the damage from livestock is clearly evident and introductions of stone along the RB are also altering flows and sediment transport, further contributing to the issue. Inspection of the area around the stone also revealed the remnants of old bank protection boards. These are facing diagonally d/s across what is now the current channel and acting as a flow deflector, turning flow towards the RB (Fig. 3).

Figure 2. Looking u/s at the first area of erosion inspected. Natural erosion (left of shot) threatens the RB and raised floodbank (note the ground sloping away to the left) which retains the watercourse in its perched location. Cattle poaching can be observed to the left of shot, further destabilising the bank and the lack of vegetation within the fence along the bankside show that the ground is still being grazed. Gravel deposition (right of shot) is now also occurring as a natural consequence of deposition the widened channel.

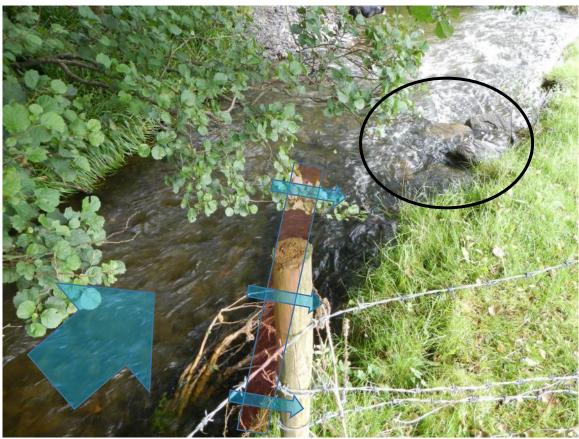
Figure 3. The remains of bank protection boards (red shaded block) acts as a sub-surface d/s flow deflector directing flow more acutely into the bank. This may be why the stone was introduced d/s (black circle). However, the stone increases turbulence and will add to the erosion issues at certain flows. The structure also diverts/interrupts the transport of substrate along RB line, potentially increasing erosion and undercutting d/s.

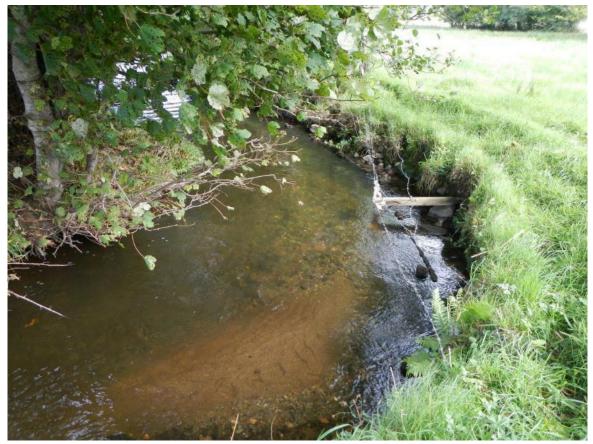
At the next erosion site u/s, the bank protection boards remain as a bank toe but the lack of trees and vegetation on the bankside and top leave it highly susceptible to erosion (Fig. 4). A similar situation is evident in figures 5 & 6 but there, the beck appears to have already completely outflanked the bank protection there and begun to undercut the bank.

Figure 4. Looking d/s; a lack of vegetation on the bank leaving it susceptible to erosion. The remains of the bank protection boards are still evident but the fence has long since ceased to provide any protection. The valley slopes away to the right of shot. As with the other areas of lateral erosion, this is one of the few pools (deeper water) and better quality fish-holding and spawning habitat.

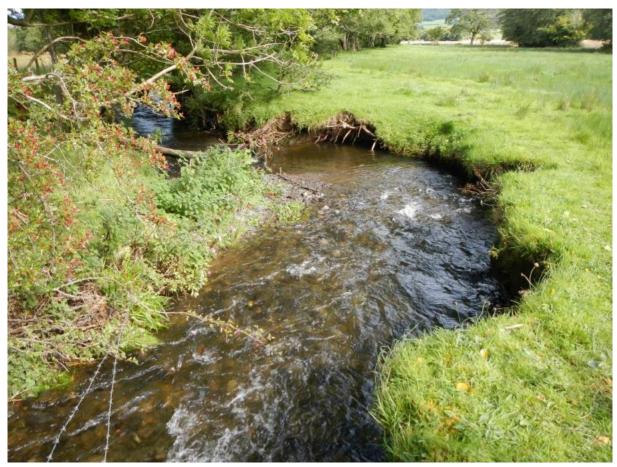
Figure 5. Looking d/s; minimal bankside vegetation and a lack of root matrices has allowed the RB to become undermined through lateral erosion. Note the slower, deeper water associated with the bend. The valley slopes away to the right of shot. The land to the left of shot is likely to have been created through deposition as the channel became over-wide by migrating though the RB (right of shot).

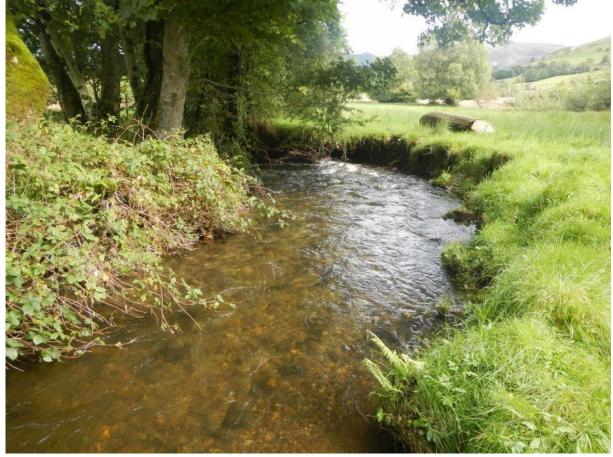
Figure 6. Looking d/s; this location is a similar situation to that shown in Figure 5, with the early signs of bank undercutting evident. The valley slopes away to the right of shot.
