Scampston Beck Catchment Walkover

North Yorkshire

04/08/2015

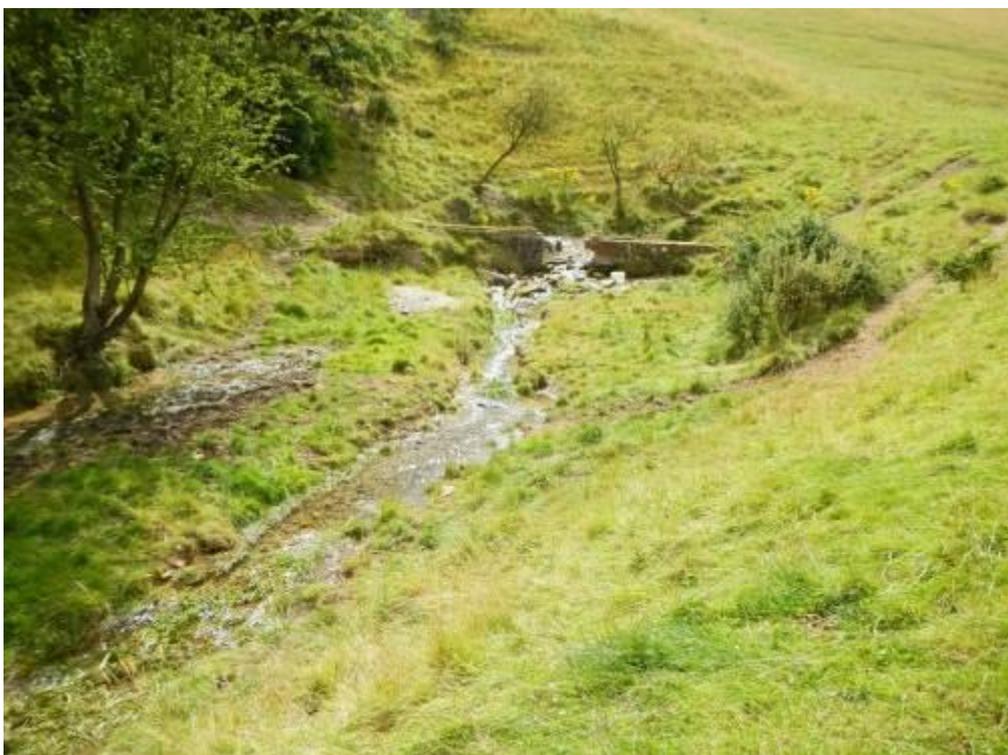
Newton Beck emerges from the Wolds as the main tributary of Scampston Beck, where the remains of a water off-take (now defunct) are still clearly evident. Immediately, the impact of grazing upon the sediment and nutrient input to the Beck are apparent. Bankside vegetation is relatively closely cropped and poached ground with animal faeces drain straight into the Beck (Fig. 1). However, the physical characteristics of the Beck do provide potential for salmonid spawning and juvenile habitat, with the bed comprising loose, 10-40mm sized gravels.

Figure 1. Source of Newton Beck, immediately subject to impact from livestock.

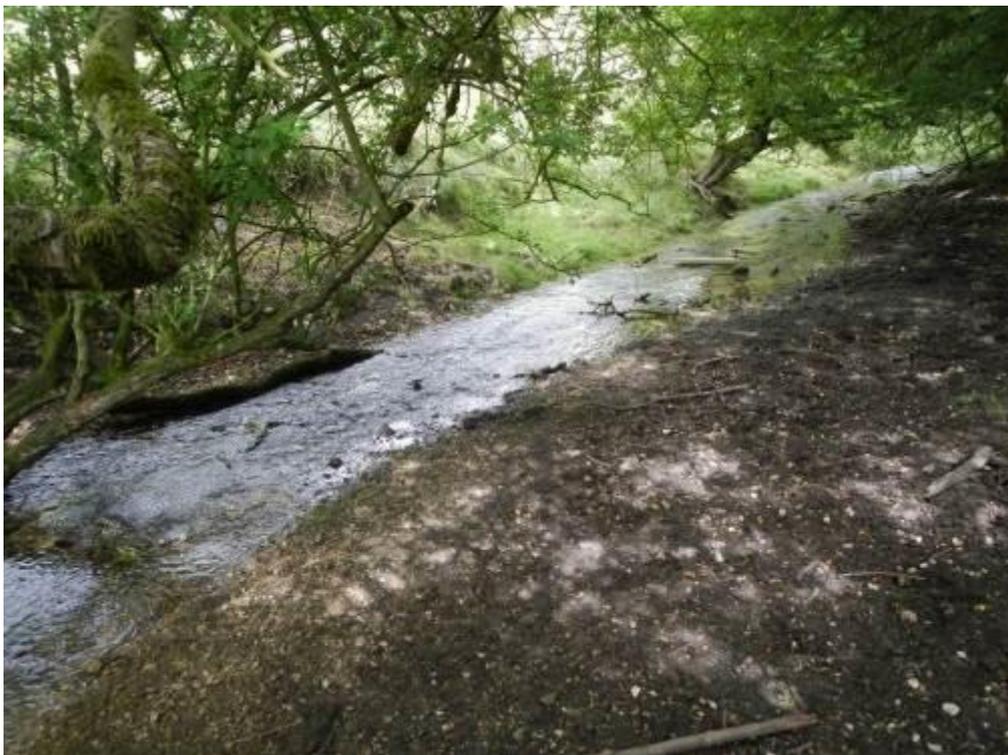
Where trees/shrubs are present (predominantly hawthorn *Crataegus monogyna*), shading inhibits the growth of grass and other vegetation and increases the susceptibility of the ground to poaching and surface runoff (Fig. 2).

Figure 2. Bare earth under hawthorn shading, also subject to cattle poaching.

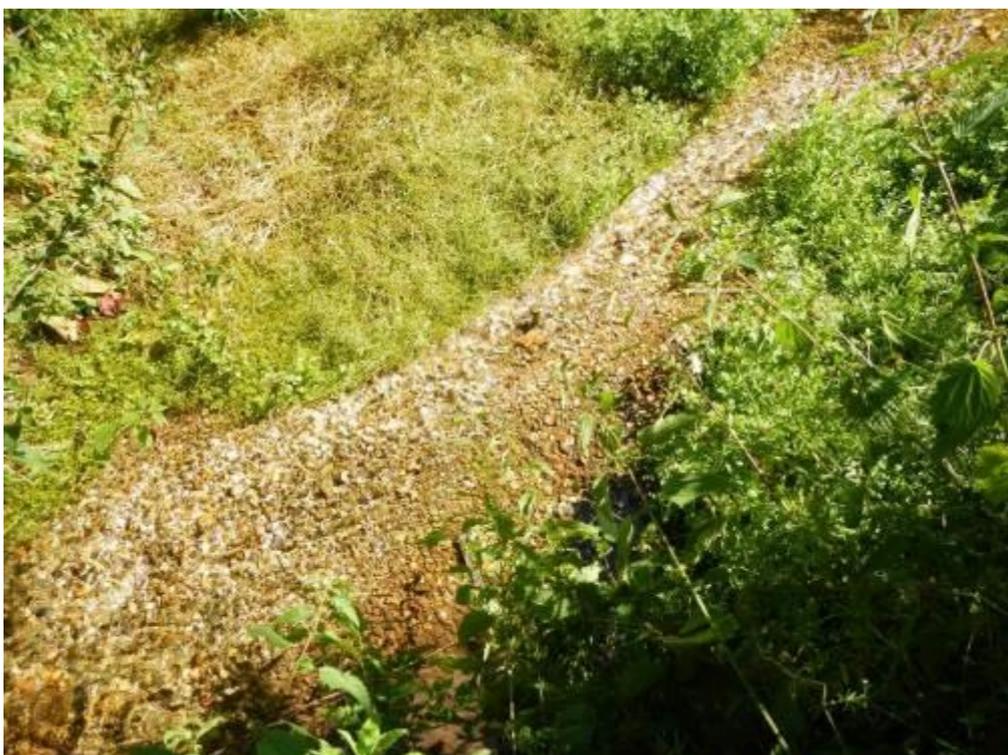
Figure 3. High quality trout spawning and fry habitat.

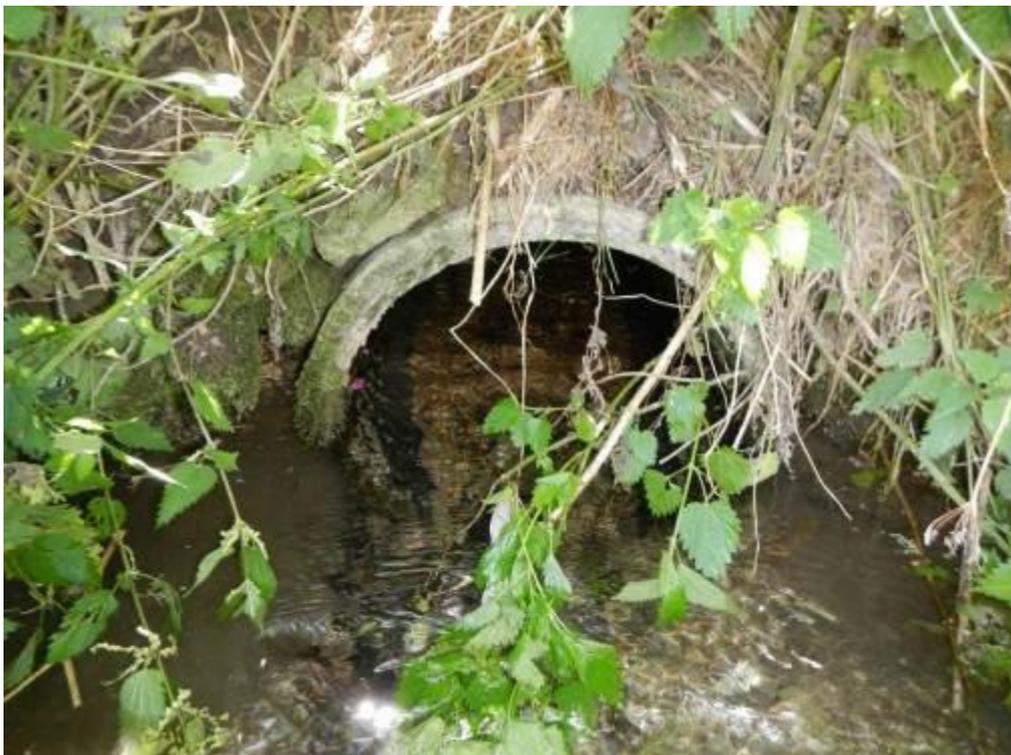
The first potential obstacle observed was a c.50cm diameter culvert under one of the estate access tracks (Fig. 4). This did not pose a barrier to fish movement at the time of the visit as a bed of natural substrate has developed within the pipe, suggesting at least some sediment transport. However, the pipe is relatively low diameter and has the potential to block easily with debris from u/s. In high flows, velocities within the pipe may also render it more of a barrier to fish. Ideally, the pipe should be at least double the diameter and sunk at least 1/3 below the bed level to reduce the potential for blockages and prevent potential issues with fish passage.

Figure 4. Undersized culvert with a potential for blockage (SE 88621 71294).

The track itself is a potential source of fine sediment to the watercourse; something that could be mitigated by creating drain points from the track that would discharge to soakaways (shallow scrapes in the ground) in areas of rough vegetation well away from any watercourse, rather than draining directly to the Beck.

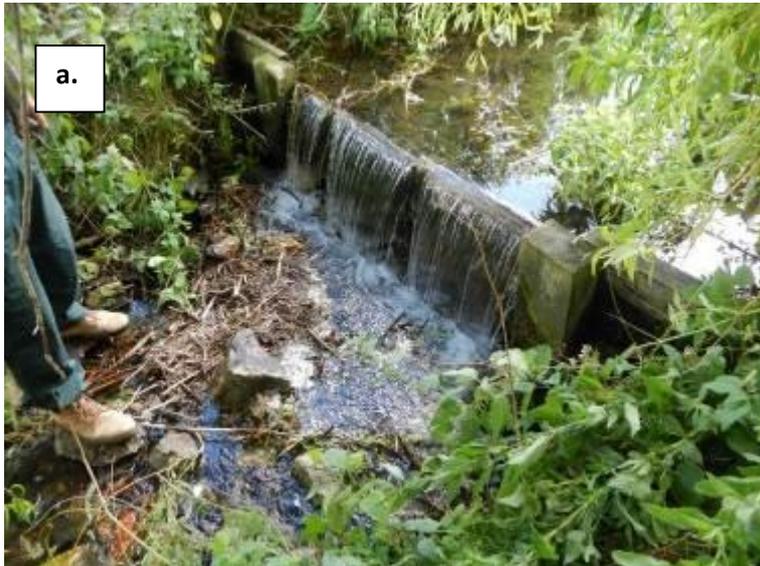
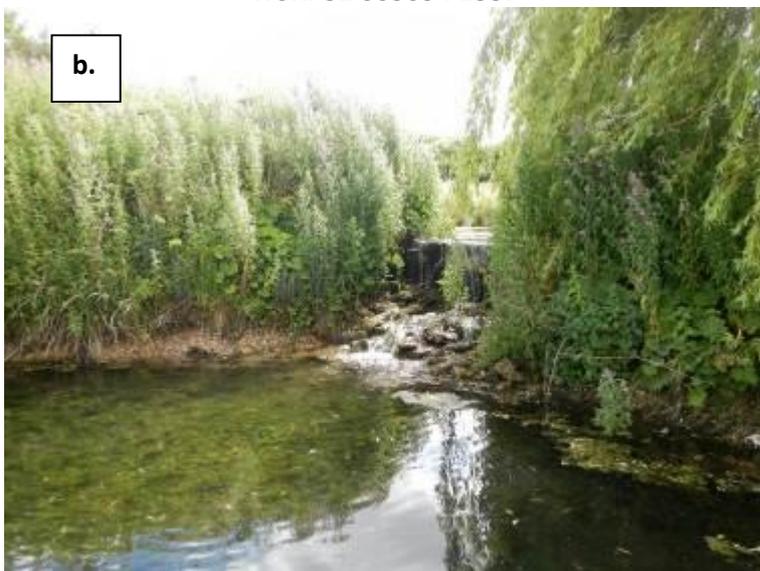
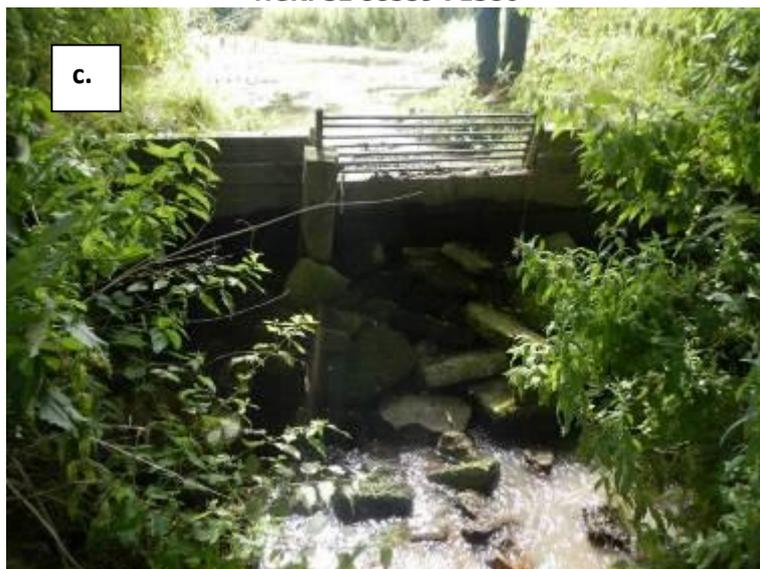
Downstream of the culvert, the Beck is impounded by a series of 3 disused duck flighting ponds. Such features are common place on sporting estates and, in this case particularly, cause almost complete barriers to fish movement u/s and d/s (Figs. 5a-c). While these do provide some deeper water for adult trout, restoring a natural planform and un-impounded channel would be of much greater benefit, allowing wild fish stocks to populate the Beck.

Figures 5a-c. A series of impoundments creating, now disused, duck flighting ponds. These create impassable barriers to fish and, combined with the ponds, inhibit sediment transport.

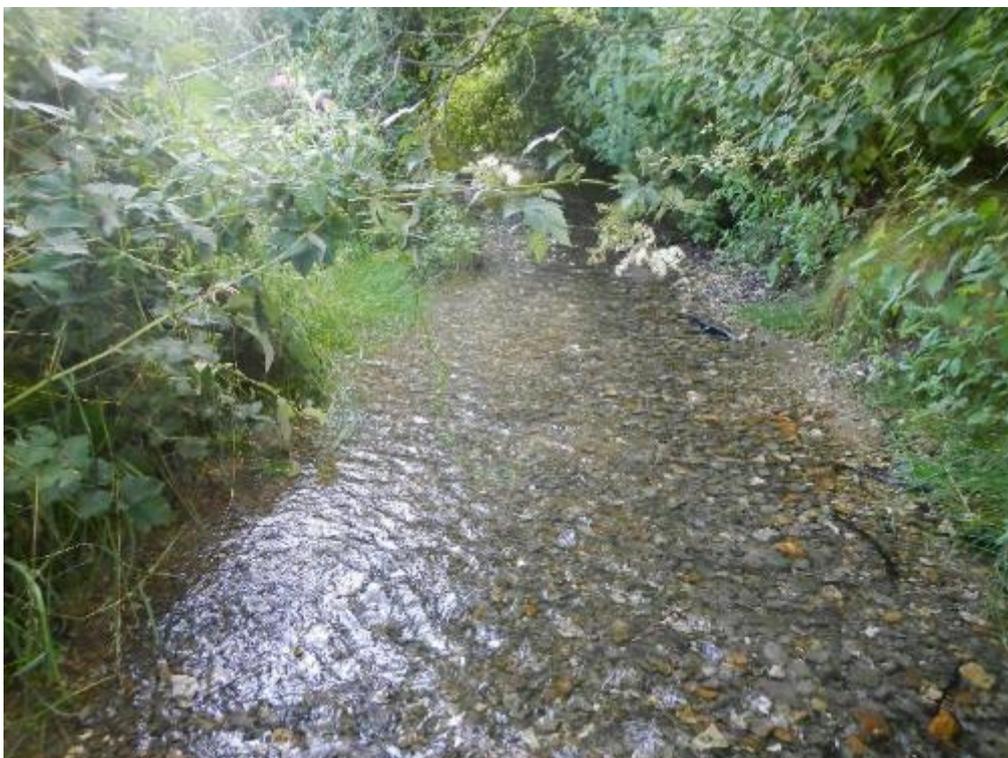
Downstream of the ponds, through a lightly tree-lined section, the channel and habitat quality improves, although lack of sinuosity or structure to scour and maintain deeper areas means that it remains relatively shallow and uniform.

Figure 6. Good basic components (flow and substrate), but a lack of natural channel morphology.

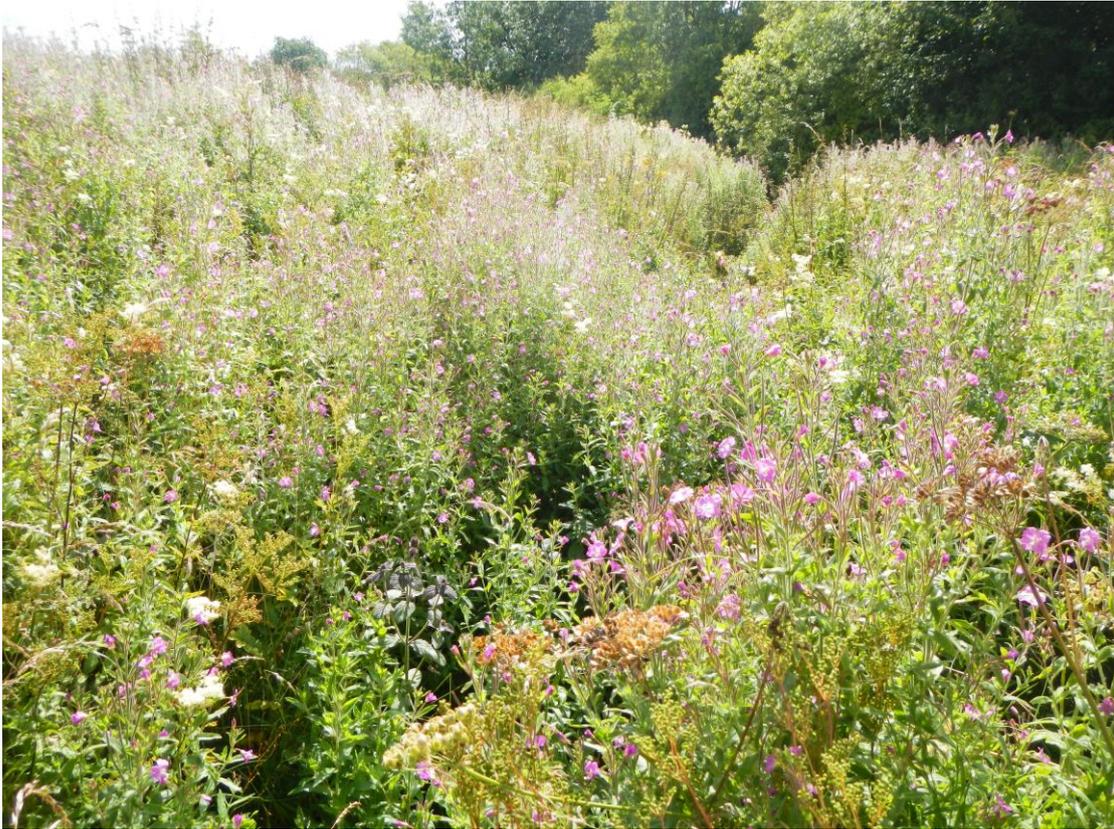
As the bank-side canopy opens out and trees become less of an influence, the marginal vegetation begins to take over and, while not actually encroaching far into the channel, starts to over shade the narrow cross-section channel (Fig 7). The issue is exacerbated by the past channel realignment (and lowering of the bed) which confines the Beck within a straighter, uniform width channel that is set further below the bank top.

Figure 7. Vegetation beginning to over-shade the straightened, uniform width channel.

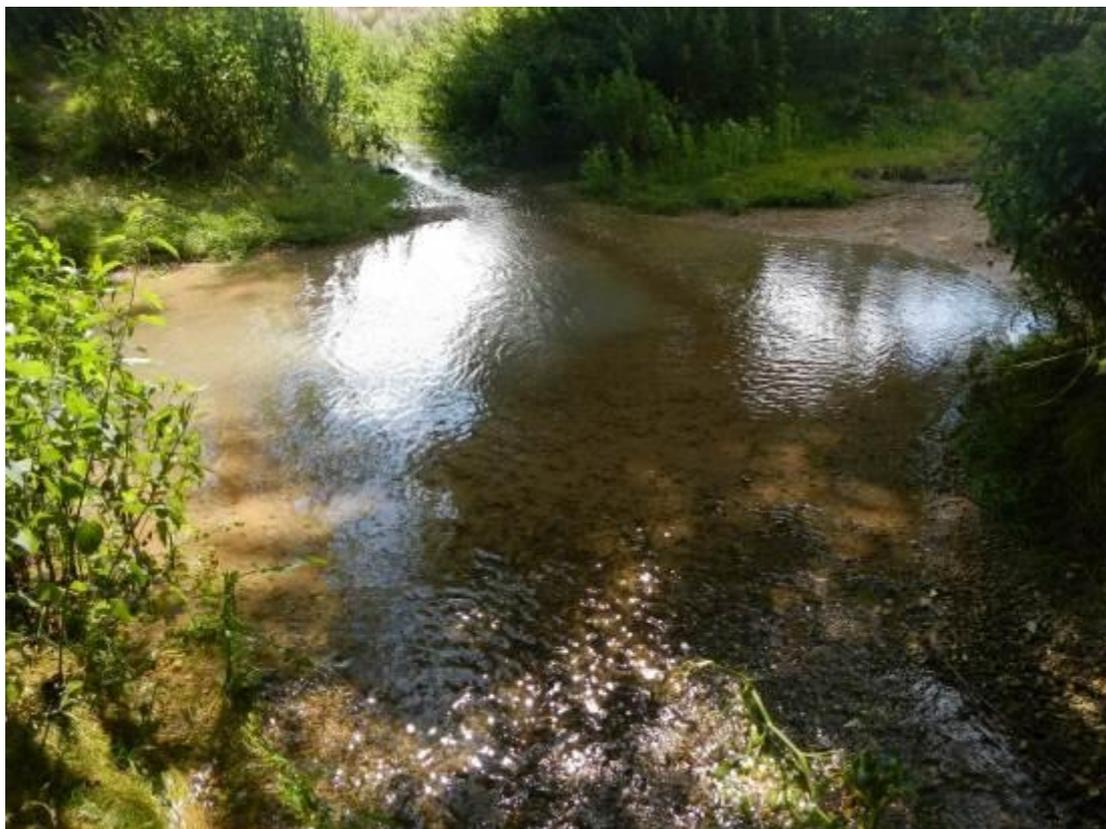
At the u/s extent of the plantation, an access track crosses the Beck and creates a significant sediment input (Fig. 8). The track acts as a conduit for surface runoff and the physical disturbance of the bed mobilises fine sediment that can be observed to be deposited along the channel d/s.

Figure 8. Ford and access track (NGR: SE 88315 71725) that pose significant sediment inputs to the Beck which can also be observed as an impact in Figure 9.

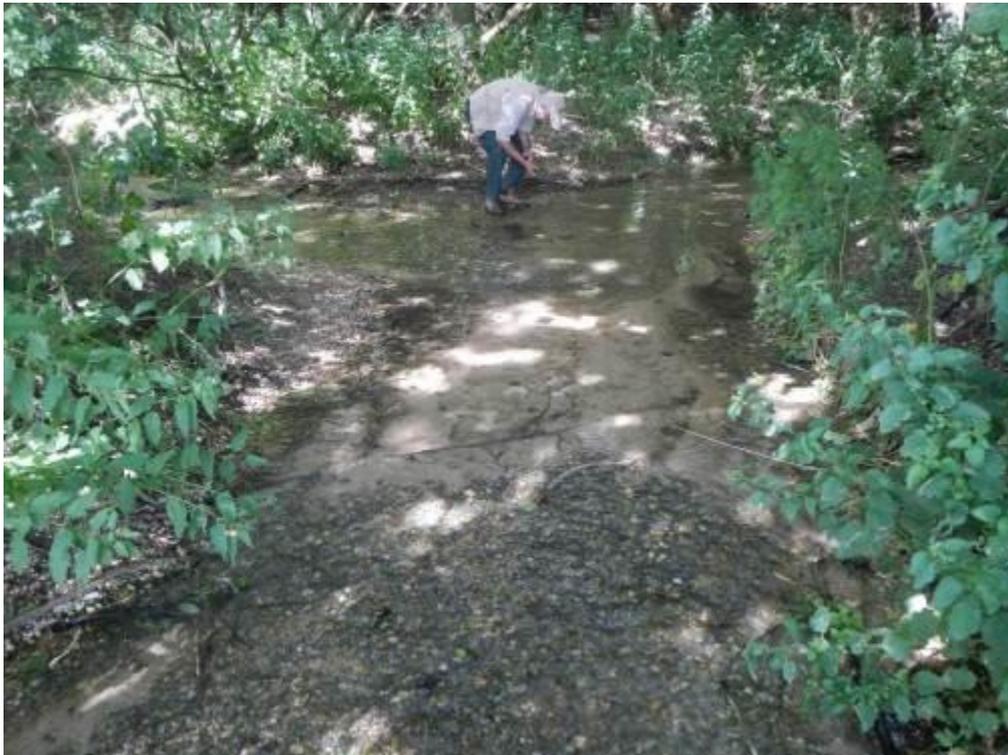
Figure 9. Small tributary entering the Beck (NGR: SE 88293 71742). Note the sediment (centre shot) emanating from the ford just upstream.

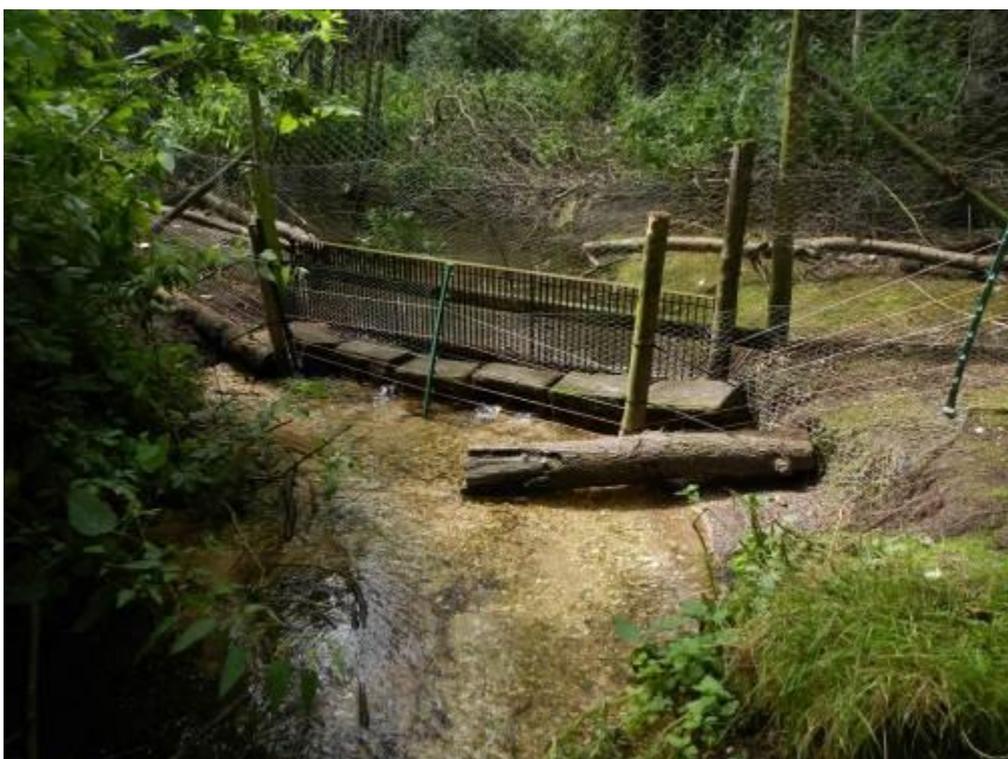
A short distance into the plantation, a tributary joins the Beck (Fig. 9). A pheasant release pen approximately 20m u/s on the tributary poses a complete barrier to fish passage and renders it unusable by fish as a spawning tributary (Fig. 10). The solution here should be to completely remove the obstruction from the watercourse as soon as the pheasants have been released from the pen and not reinstate it each year until the pheasants are put out to the pens, thereby limiting the obstruction to a short period over the summer. This would also prevent the potential issue of debris building up against the pen in higher flows and causing damage. Ideally, a small gap should be maintained (e.g. 1 breezeblock wide, centre channel; see Fig. 10) at all times.

Figure 10. A pheasant release pen on the tributary poses a complete barrier to fish passage (SE 88288 71735).

The u/s side of the pen was not assessed but it is assumed that a similar setup exists there, and so the same operating procedure should be adopted.

Description	Figure No.	Solution	Location
Barriers	Pheasant release pen d/s and possibly u/s end	10	Maintain a free-gap of at least 1 breezeblock wide at all times and remove all blocks and metal grates as soon as the pheasants have left the pen.	SE 88288 71735
Sediment inputs	Access track ford	8 & 9	<ol style="list-style-type: none"> 1. Ideally the ford should be replaced with a clear-span bridge or oversized, sunken culvert similar to that in Fig 14; however, a cheaper solution could be to line the bed with coarse stone that is less susceptible to erosion. 2. It should also be ensured that the track has drainage points that discharge to soak-away areas in rough vegetation, rather than directly to the watercourse. 	SE 88315 71725
	Forestry drain	11	Ideally a buffer of deciduous trees should be provided along any watercourse (as per Forestry Commission best practice guidelines). Thinning along the watercourse would be beneficial to allow light penetration and promote bankside vegetation, and	SE 88299 71765

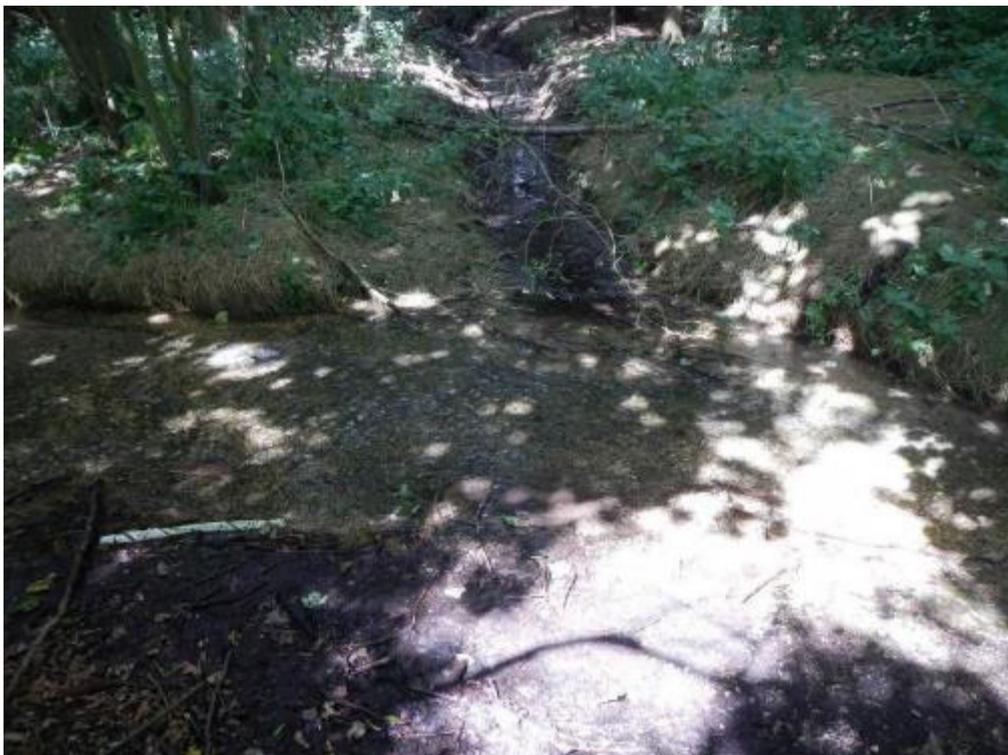
A short distance d/s of the tributary, a forest drain enters the Beck, a potential source of additional sediment in wet conditions (Fig 11). A few metres further d/s another ford presents similar issues to that of the ford u/s (Fig. 12), with sediment impact evident immediately d/s from the disturbance.

Figure 11. Forestry drain (SE 88299 71765).

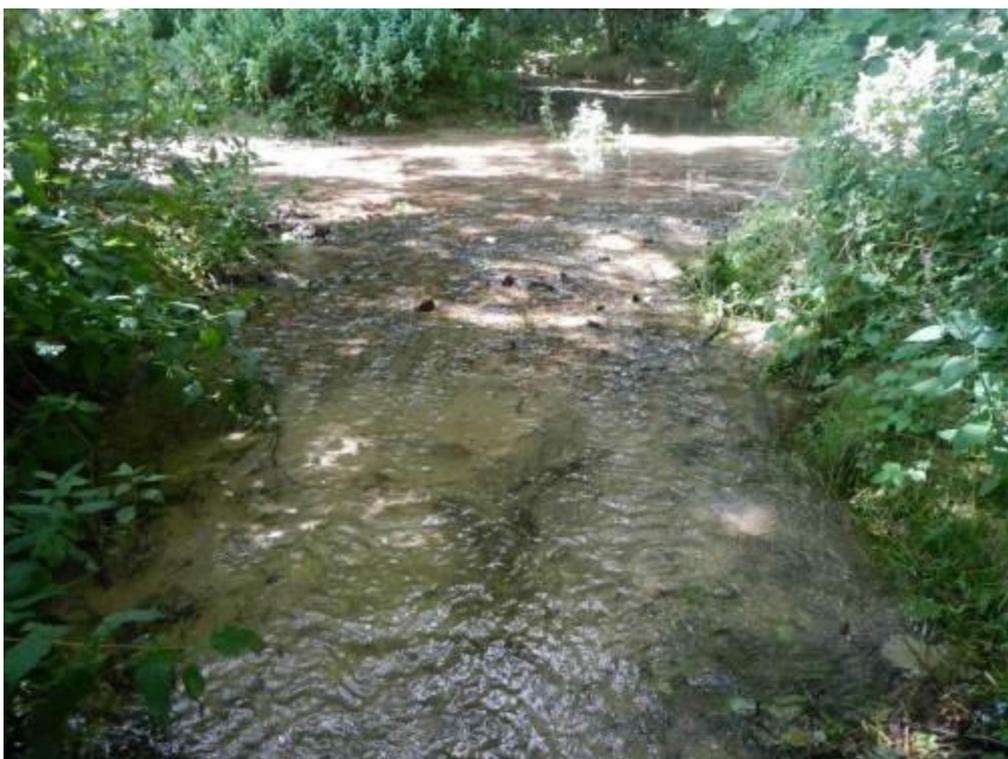
Figure 12. Second ford (NGR: SE 88317 71765), creating similar sediment issues as the first.

woody branch structure introduced to the channel to slow flows and reduce erosion.	
	Access track ford	12	Ideally the crossing should be replaced with a clear-span bridge/culvert like Fig 14. It appears that some hard-core has been introduced to improve the track and, at the very least, this should be added to.	SE 88317 71765

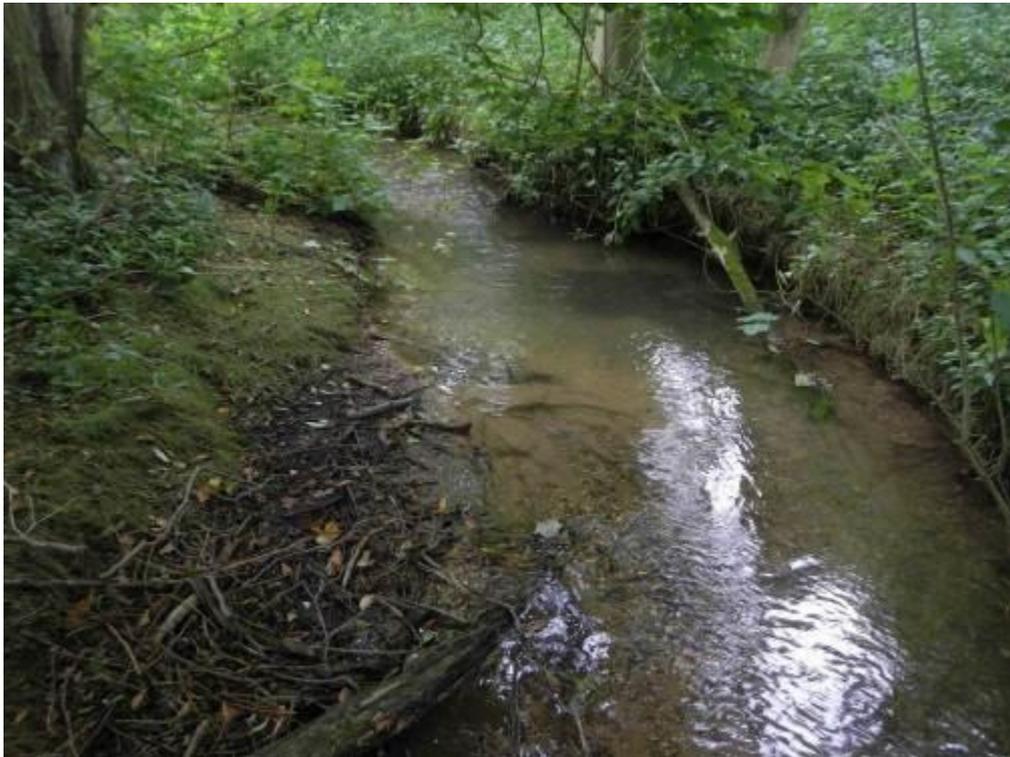
In areas where the channel has developed greater sinuosity and woody material is available, bed morphology is more diverse, and as a consequence there is more deep water and higher quality adult trout habitat (Fig. 13). As a bare minimum, increasing woody material within the channel that will encourage greater scour and deposition would be highly beneficial.

Figure 13. Greater channel sinuosity and LWD creating scour, deposition and more varied channel morphology.

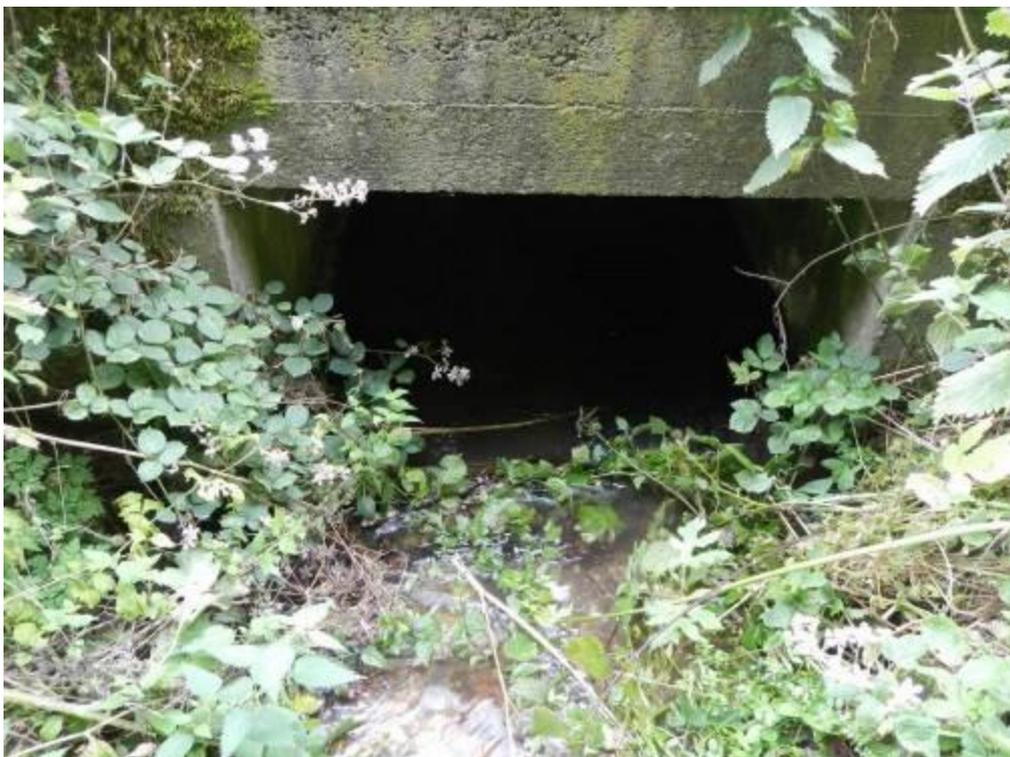
Approximately mid-point down the plantation, a culvert carries another track over the Beck. This culvert is of a more appropriate size and shape, posing no major obstacle to fish movement or sediment transport. It was, however, partially blocked at bed level, highlighting the potential for issues with all fixed apertures on watercourses.

Figure 14. A more suitable sized culvert – larger still would be better to reduce the chances of blockage (NGR: SE 88507 72070).

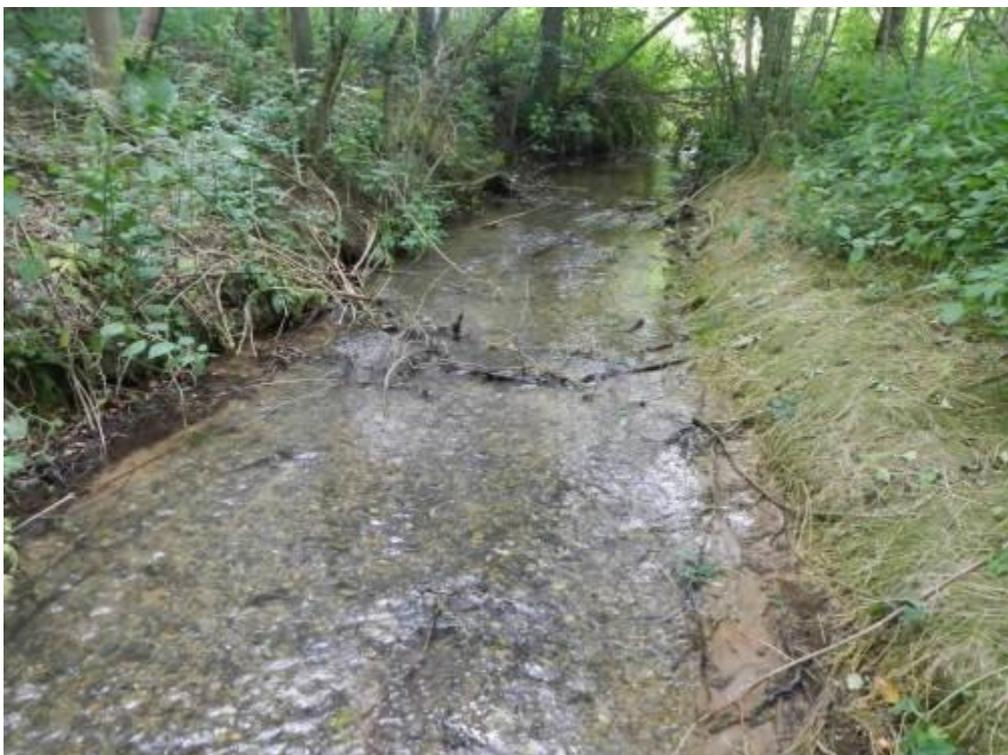
The channel remains relatively straight and the uniform cross-section is easily observed d/s of the culvert (Fig. 15). Where LWD has accumulated in the channel, the bed is more varied in profile as the substrate is sorted by scour and flow diversity (Fig. 16).

Figure 15. Straight, uniformly-wide channel.

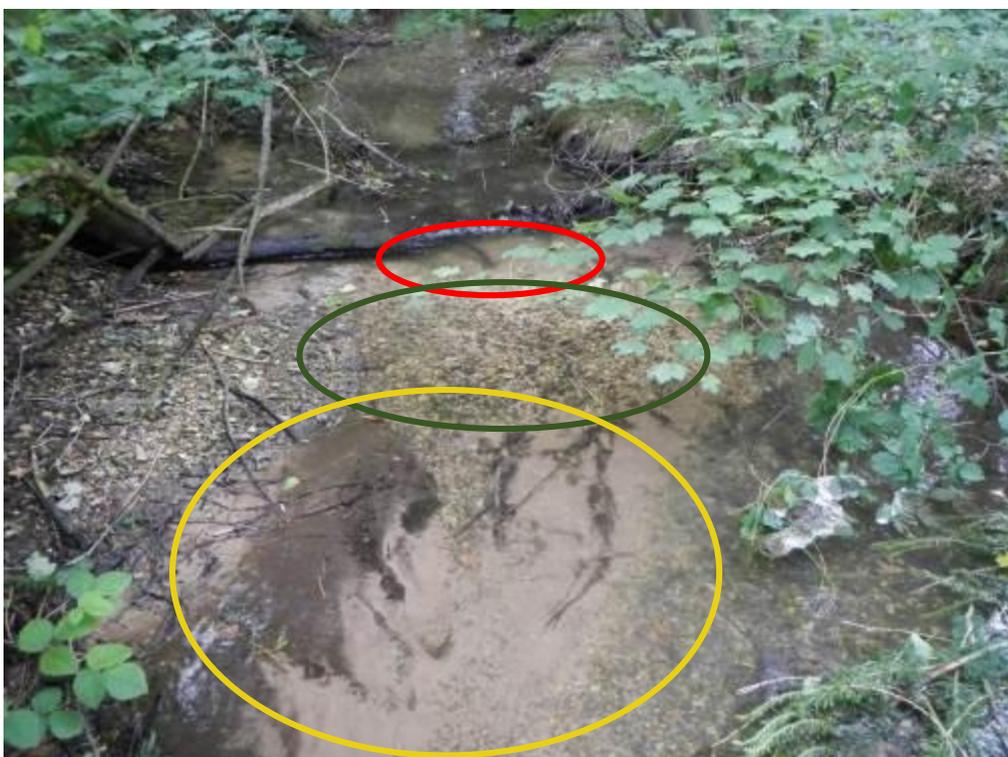
Figure 16. Woody material across the channel that has scoured and sorted the substrate, creating a plunge pool (red oval). Note how the heavier, coarse substrate remains at the upstream end (green oval), with the finest material carried furthest and deposited downstream (orange oval).

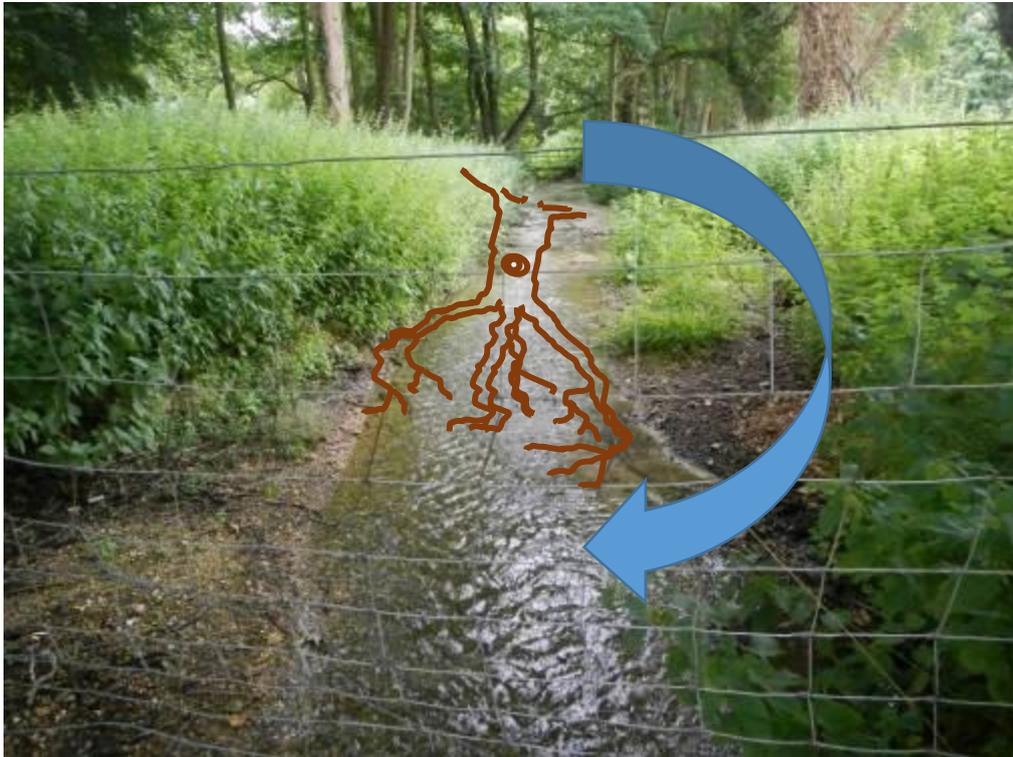
At the d/s end of the plantation, a wider, less incised section with depositional features provides a good example of how, even with a simple, low-cost intervention, some sinuosity could be returned to the Beck with the use of LWD (Fig. 17).

Figure 17. Some sinuosity could be returned to this area (blue arrow) by using LWD (brown) to divert flows around the vegetated berm (right of shot).

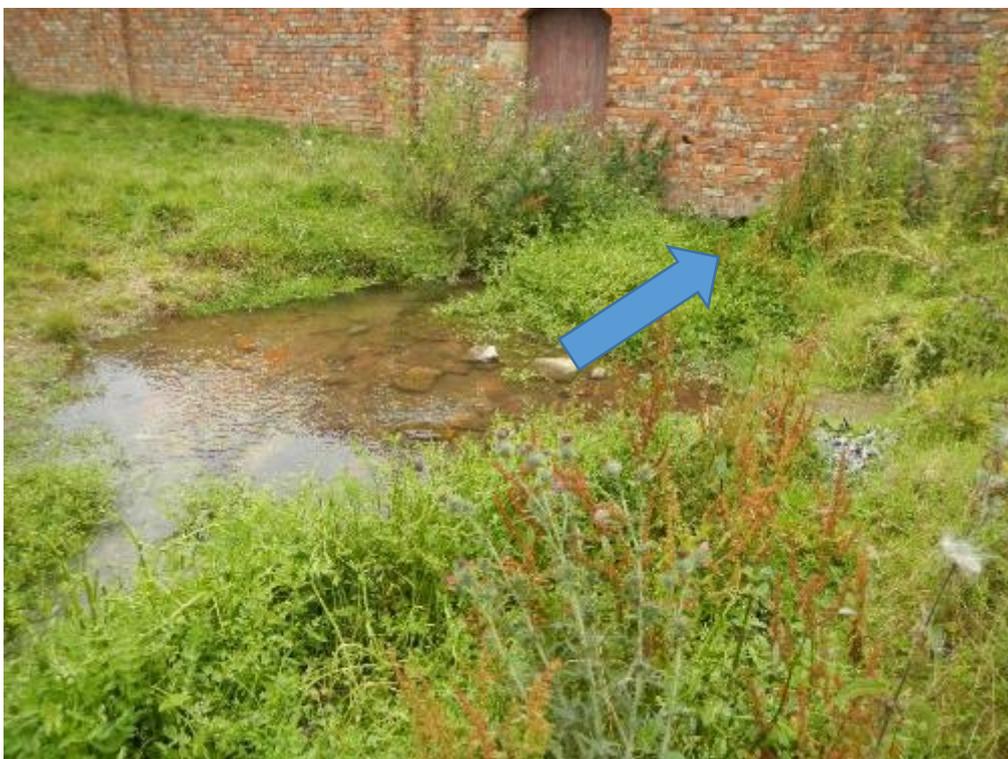
The Beck enters a walled garden at the edge of the estate, flowing through a small, foals watercress (*Apium nodiflorum*) choked culvert (Fig. 18).

Figure 18. Culvert into walled garden (blue arrow)(NGR: SE 88689 72431).

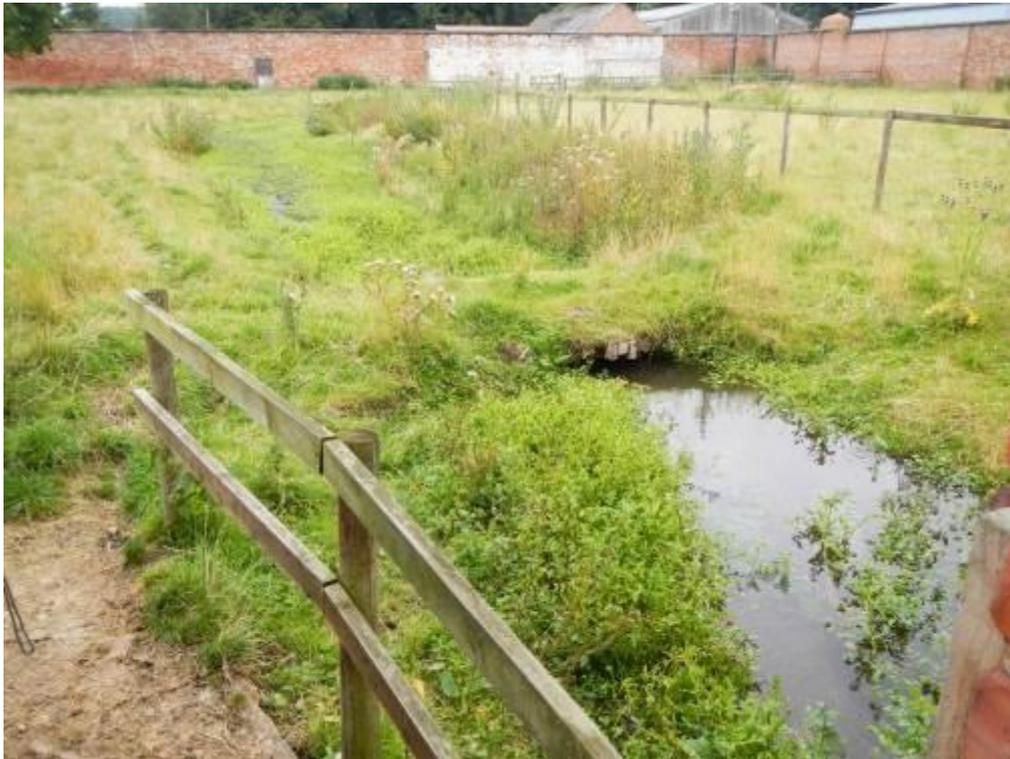
The wide nature of the channel d/s of a second culvert within the walled garden (Fig. 19), and the low gradient in the area, reduce flow velocities. This has allowed aquatic vegetation to establish across the majority of the channel width in most places, which then impounds the flow (Fig. 19). D/s, the Beck then disappears down a third culvert which takes it under the main buildings and farm yard (Fig. 20); the bottle neck at this point also results in some back-up of flow due to vegetation accumulation.

Figure 19. A second small culvert in the walled garden is of little consequence to the Beck (NGR: SE 88692 72438)

Re-meandering the Beck through the walled garden section (within its current over-wide channel) would create more sinuosity and narrowing to focus flow energy and maintain a low-flow channel free from vegetation. This would also result in cleaner, better-sorted gravels, of a higher quality habitat to wildlife.

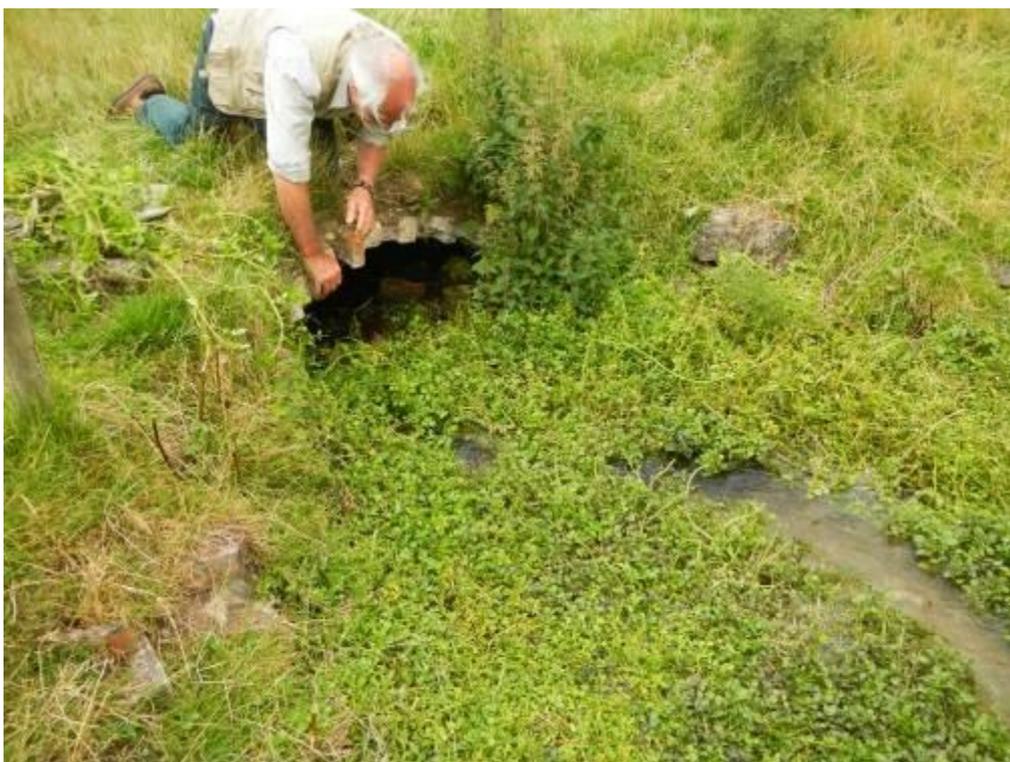
Figure 20. The third culvert that takes the Beck under the farm buildings and farm yard, and causes a slight bottleneck/impoundment (NGR: SE 88707 72475).

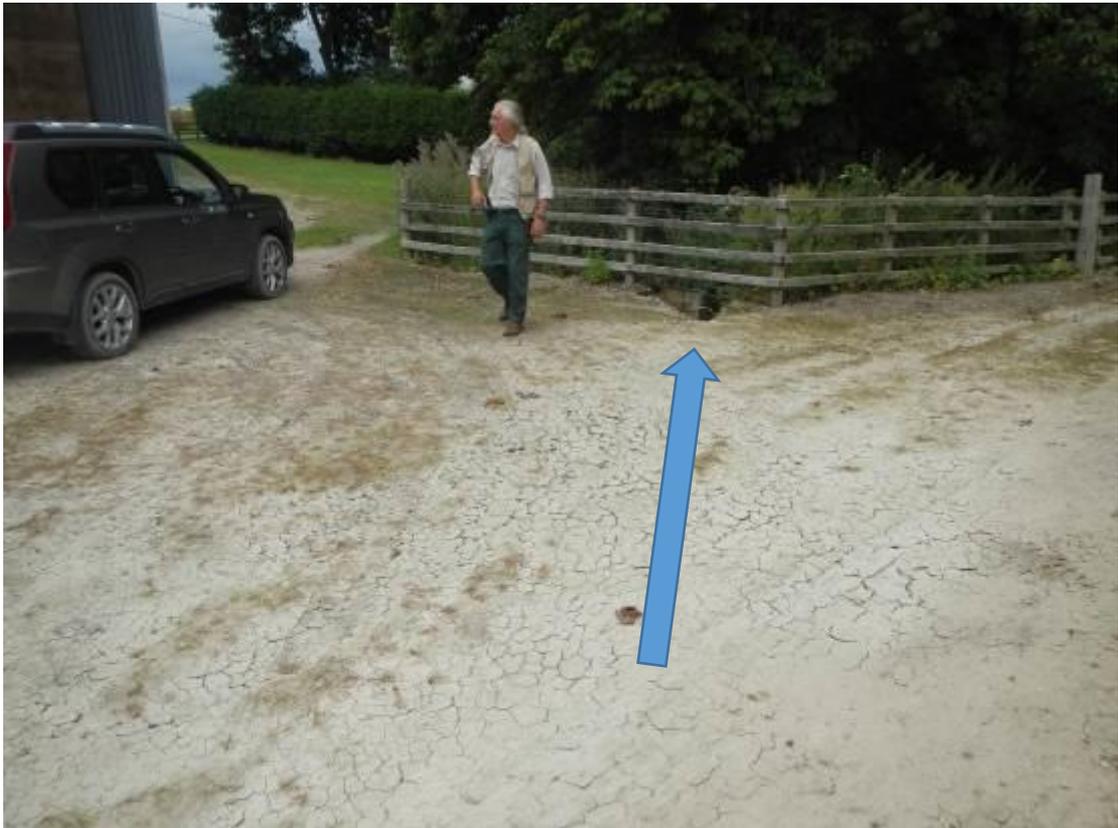
Where the Beck emerges from under the yard, there was an obvious gutter along which much of the surface water from the yard (including the contents of disconnected roof drains; Fig. 22) could enter the Beck (Fig. 21). This is likely to be a significant source of sediment (and other pollutant) ingress.

Figure 21. A notable sediment input to the Beck where surface water from the farm yard enters (NGR: SE 88734 72549).

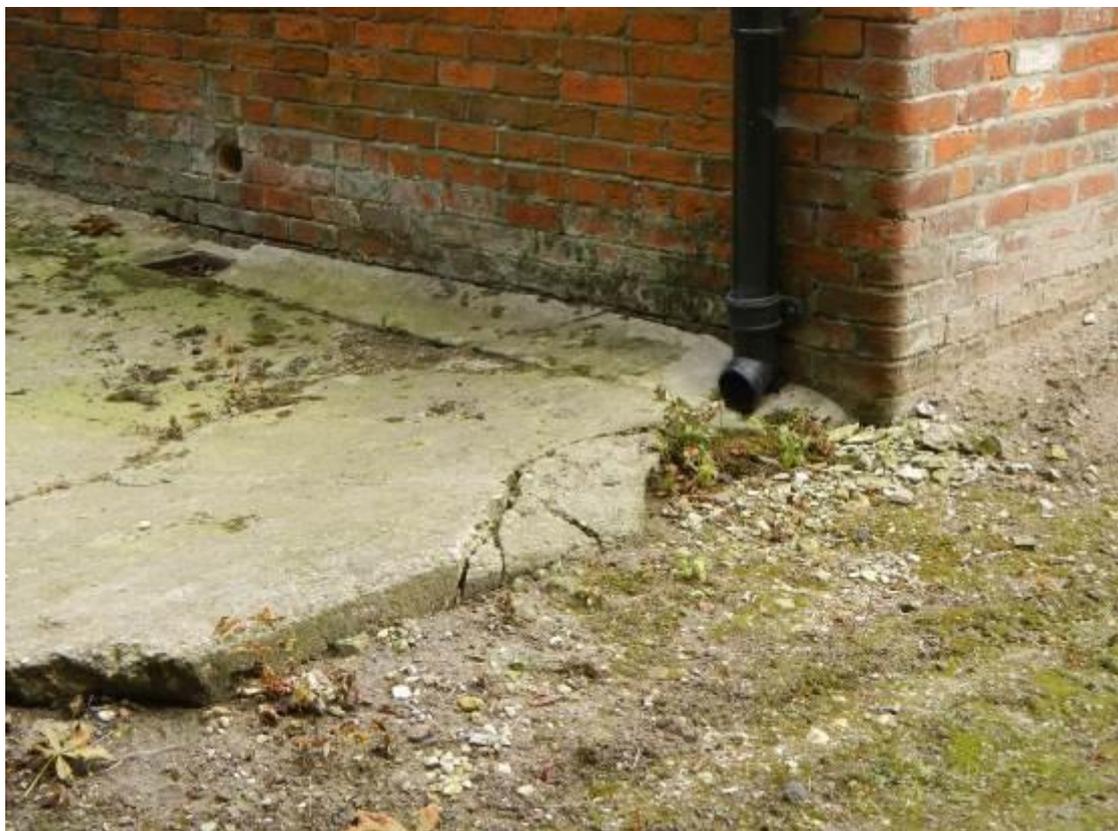
Figure 22. Roof drain discharging straight onto the yard/track.

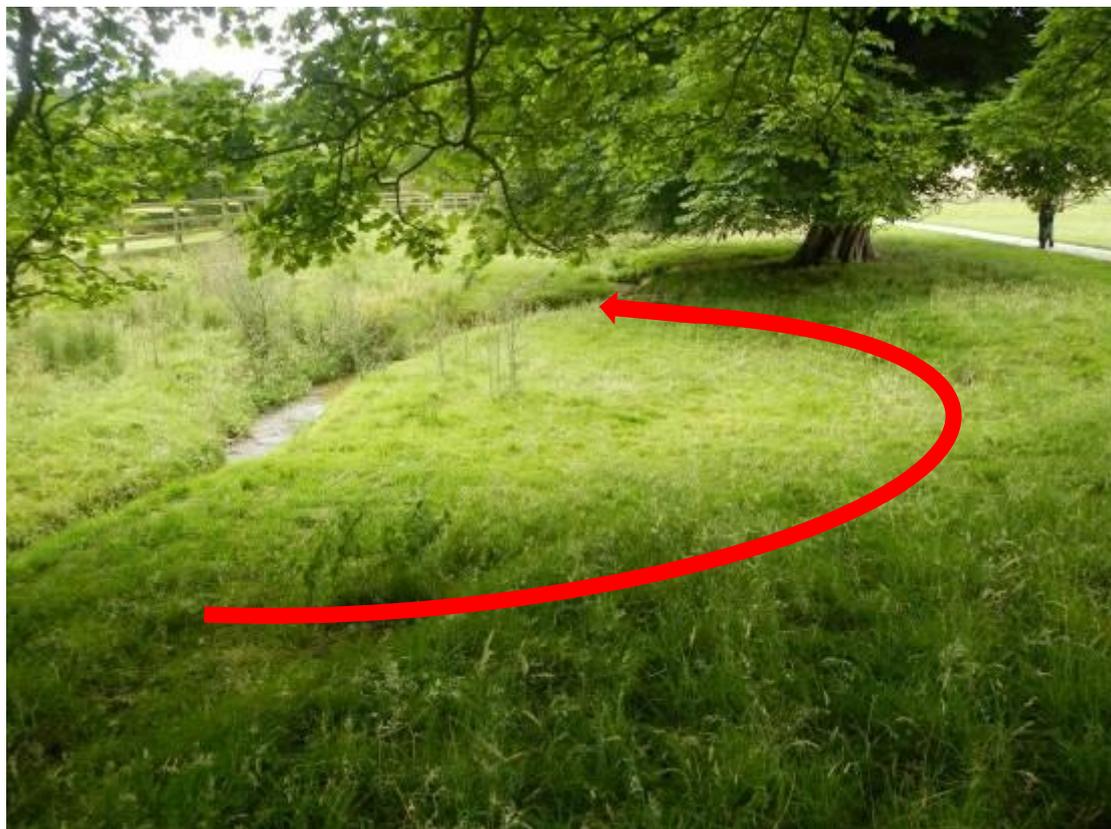
D/s of the yard, the Beck flows through a small section of parkland, and while the livestock appear to be maintained at a low density, a long history of grazing is apparent by the lack of herbaceous vegetation and natural tree regeneration (saplings/young trees; Fig. 23).

Figure 23. Grazing of the parkland maintains a predominantly grassy bank line with no natural tree regeneration or herbaceous vegetation. Channel straightening has also been undertaken, as evident by the paleo-channel (red outline).

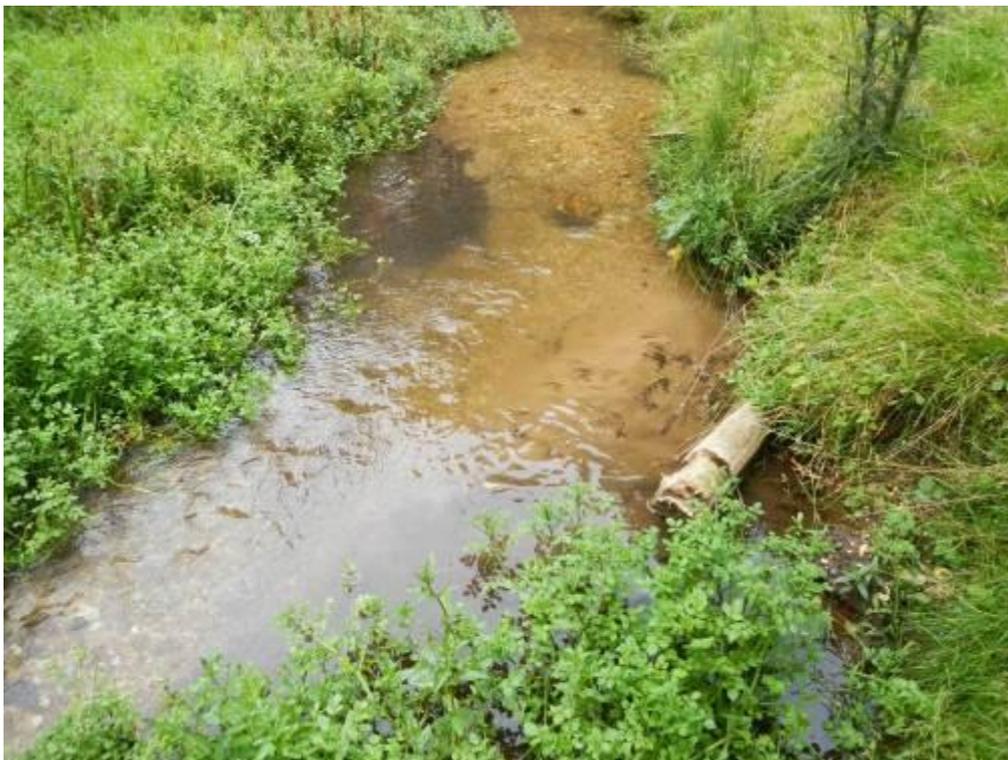
By this point, the sediment loading is notable anywhere the channel becomes wider or deeper and the lower water velocities allow deposition, but in faster flowing areas the bed remains relatively clear of fine sediment (Fig. 24).

Figure 24. Areas of faster flow maintain a sediment free bed; however, in the slower, deeper areas the impact of sediment inputs from upstream are evident.
