Scampston Beck Catchment Walkover

North Yorkshire

04/08/2015

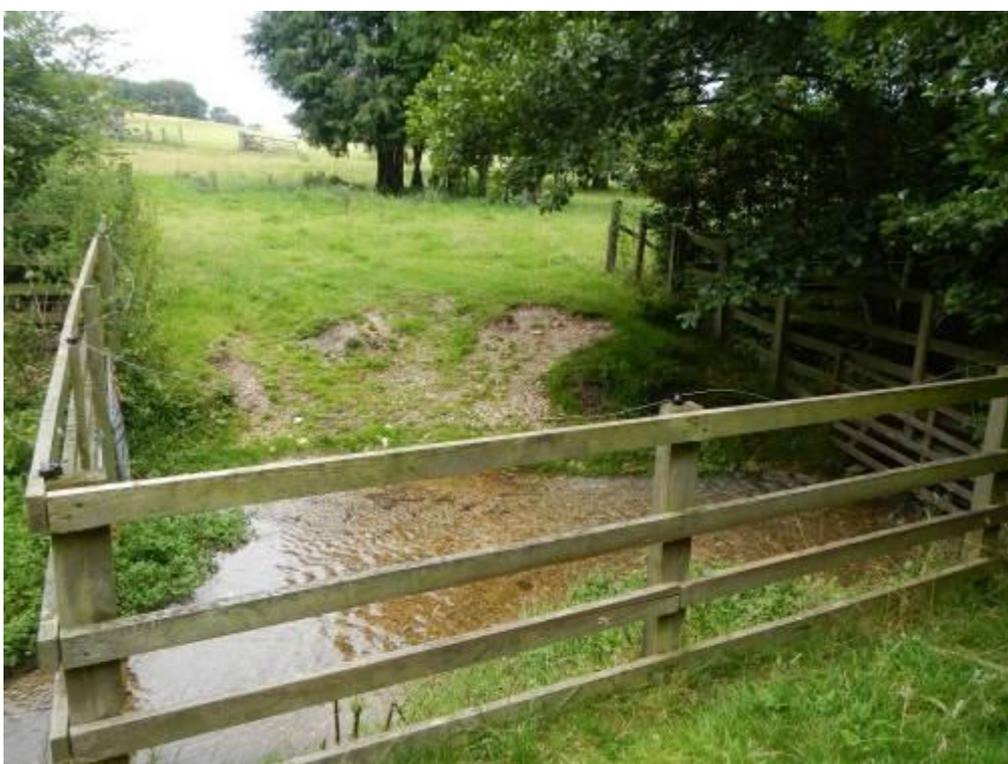
The potential impact, even from light grazing, is apparent throughout this section, where localised livestock activity around the drinking point (Fig. 25) and around a small bend in the Beck (Fig. 26) results in increased erosion rates. It is likely that erosion similar to that occurring in Figure 26 is the reason for the Beck originally having been straightened through here. Although relatively stable when well vegetated, even small bends can suffer accelerated erosion where grazing and trampling/poaching occur.

Figure 25. Erosion and over-widening at a livestock drinking point (NGR: SE 88763 72607).

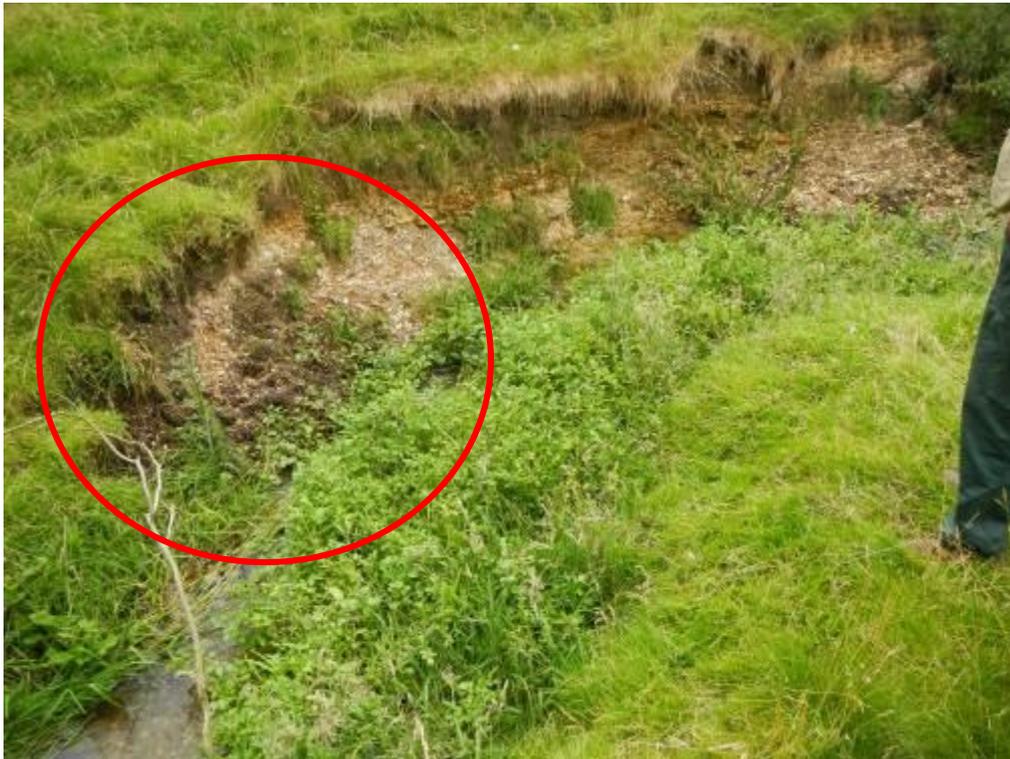
Figure 26. Erosion on a relatively sedate bend. This issue is resulting from trampling/poaching (red circle) that occurs even at low livestock density.

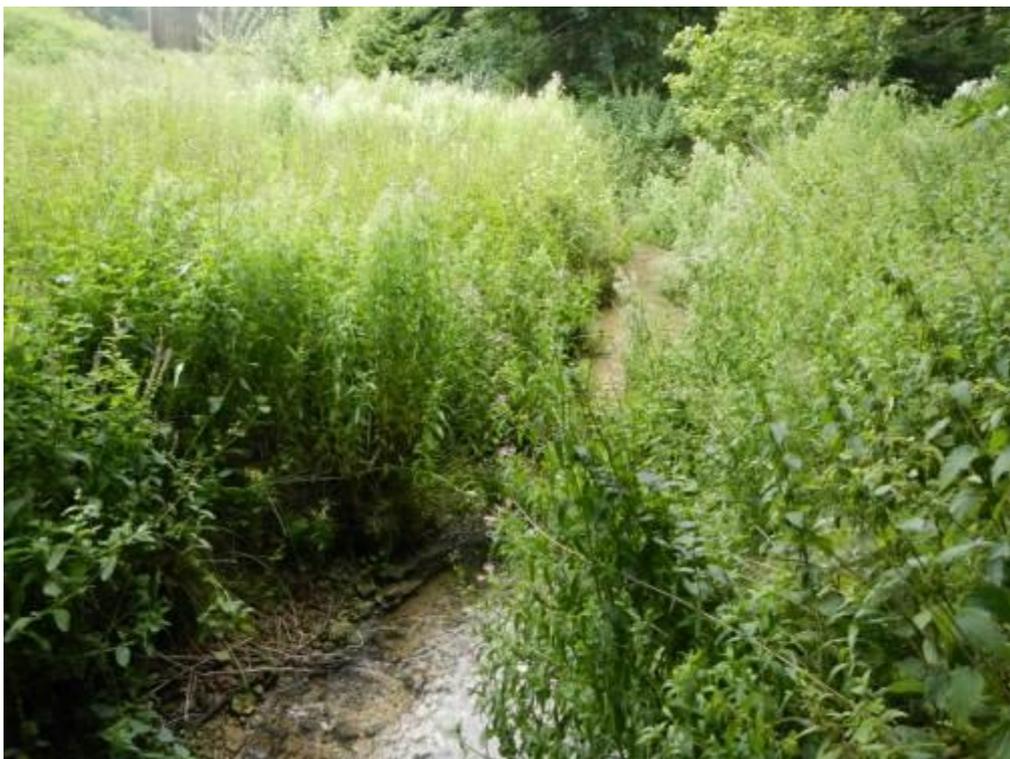
D/s of the park, the Beck enters an on-line pond, although it is bypassed prior to dredging. The bypass provides fish passage and true riverine habitat along the Beck; it would be greatly beneficial to retain this feature permanently, and maintain only a 'sweetening flow' to the pond. This would maintain fish passage and greatly reduce the rate of sedimentation within the pond, reducing the requirement for dredging.

Figure 27. Bypass channel around the drained pond.

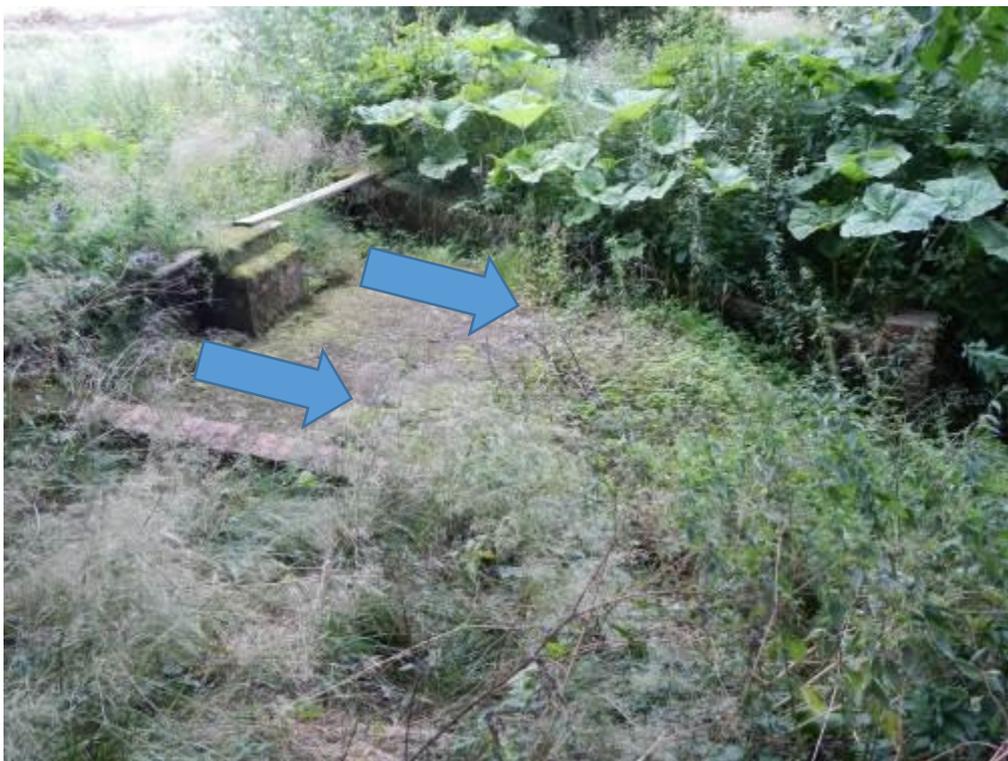
Ordinarily, the >1.5m high, pitched stone outflow would represent an impassable barrier to fish migration u/s (Fig. 28), and the pond itself would inhibit downstream passage and sediment transport.

Figure 28. The currently dry outflow to the pond (NGR: SE 88577 72945).

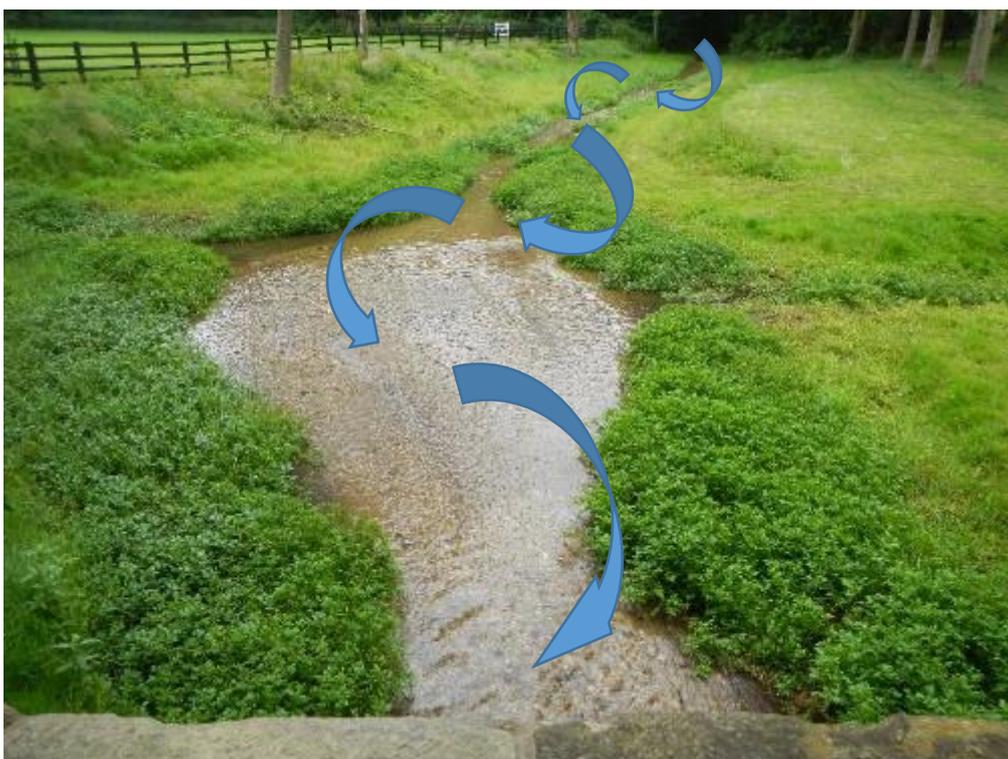
D/s of the pond, a straightened, two-stage channel presents a great opportunity to initiate re-meandering and create a self-maintaining channel with high quality habitat (as shown by a blue line in Fig. 29).

Figure 29. An ideal opportunity for localised re-meandering of the channel.

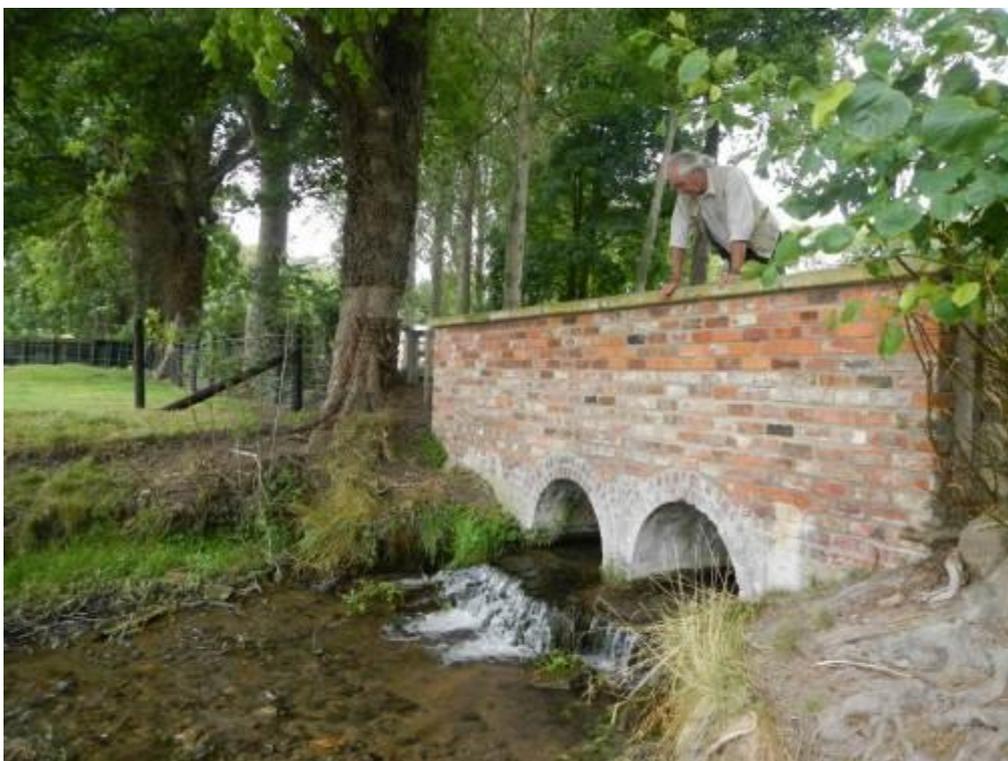
The road crossing and culvert immediately u/s of Manor House Farm creates a barrier to fish movement in most flows. The stepped entrance creates a difficult jump onto shallow water through the culvert. The width restriction caused by the culvert, and associated fluming of flows means that accelerated velocities will further inhibit fish passage at higher flows.

Figure 30. A stepped invert/base and shallow water make the track crossing culvert an issue for fish passage (NGR: SE 88458 73009).

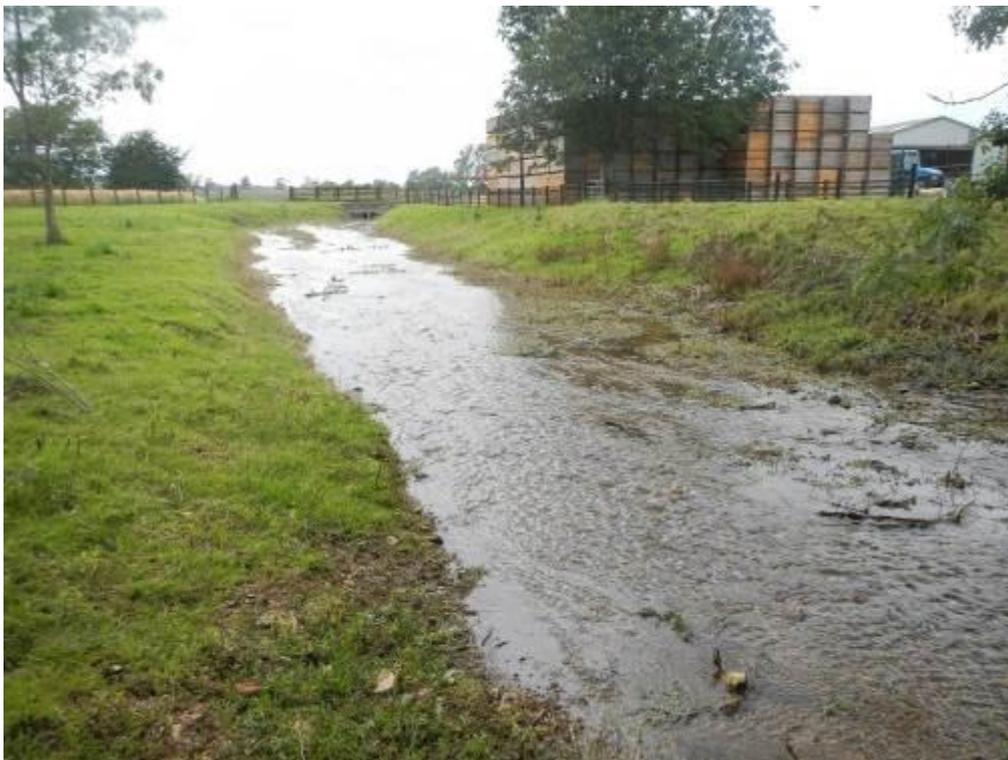
D/s of the culvert, the impact of heavier grazing can be seen, with the channel being significantly and uniformly wider, creating very shallow water. It also appeared that the 'weed' species (docks *Rumex* spp. and thistles etc.) had been sprayed with herbicide, right along the water's edge. This is potentially damaging to aquatic life: Glyphosate-based herbicides, in particular, are de-activated quickly by contact with soil – but remain toxic for longer in water (with birth-defects in amphibians among their undesirable impacts). Due to the associated risks, a specific licence is required for the use of herbicides by a watercourse.

At the d/s extent of the sprayed field, another pipe culvert poses similar issues to the one immediately u/s, owing to the flow being split between two small pipes, although it is less perched above the river bed. Ideally, the pipes would be replaced to create one large orifice that would more easily pass debris, sediment and wildlife (including fish).

Figure 31. Dead plants along the RB suggest that herbicide has been used along the watercourse. In the background another culvert creates another potential obstruction (NGR: SE 88379 73036).

A very similar prescription, coupled with fencing out the livestock and ceasing spraying the vegetation along the watercourse is also recommended for the field d/s of the road (Fig. 31). Re-meandering there would be very easy as the grazing and spraying have left an over-wide channel that could be easily manipulated with brash and / or woody material to create structure in the channel and deflect flows.

The culvert d/s, in the background of Figure 31 (SE 88379 73036) should, ideally, be replaced with a larger capacity, single culvert.

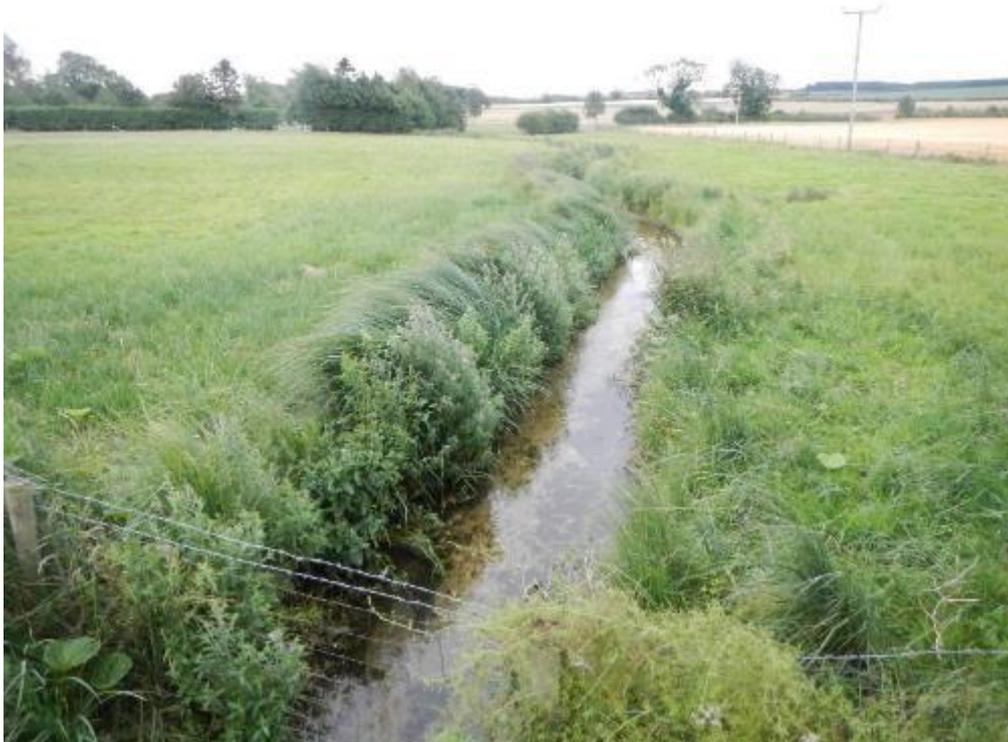
Figure 32. Straightened, channelised section upstream of Millennium Pond.

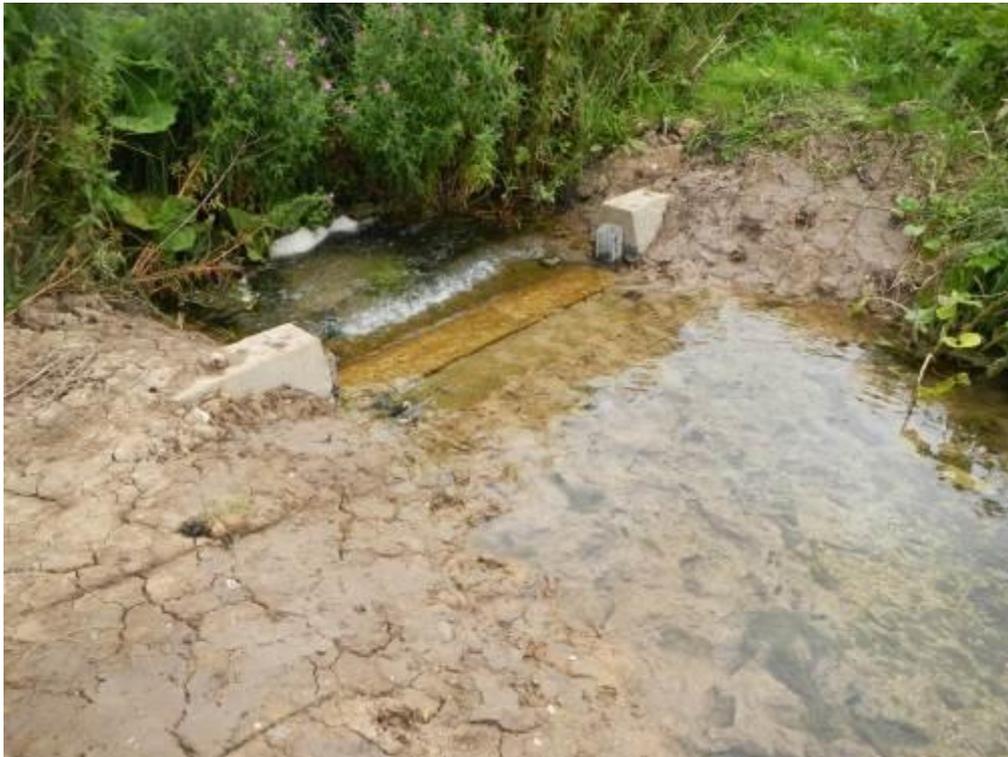
Figure 33. Fixed cross section/board weir (Millennium Pond - NGR: SE 87822 73308).

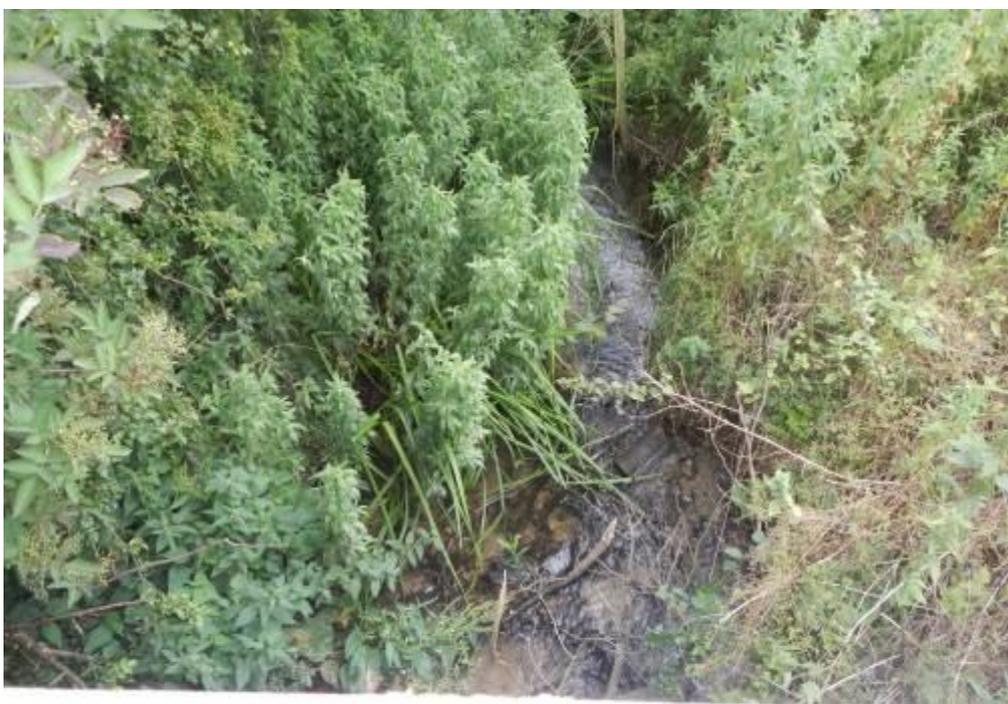
D/s of the pond, the Beck is well protected by buffer strips with dense herbaceous vegetation which appears to extend all the way to Willow Garth Plantation (as observed via Google Earth).

Figure 34. Dense vegetation provided by a generous buffer strip. This situation appears to extend as far as the Willow Garth Plantation.

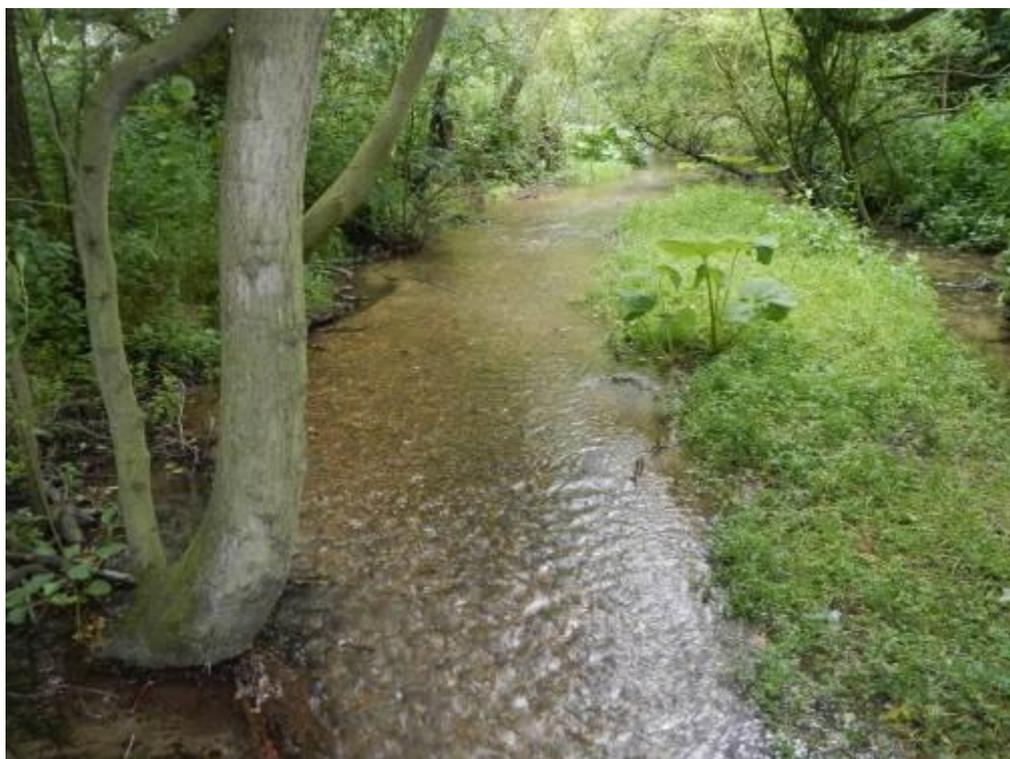
Figure 35. Straightened channel that is beginning to recover through natural deposition. Greater in-channel structure would assist the process by diversifying the channel width.

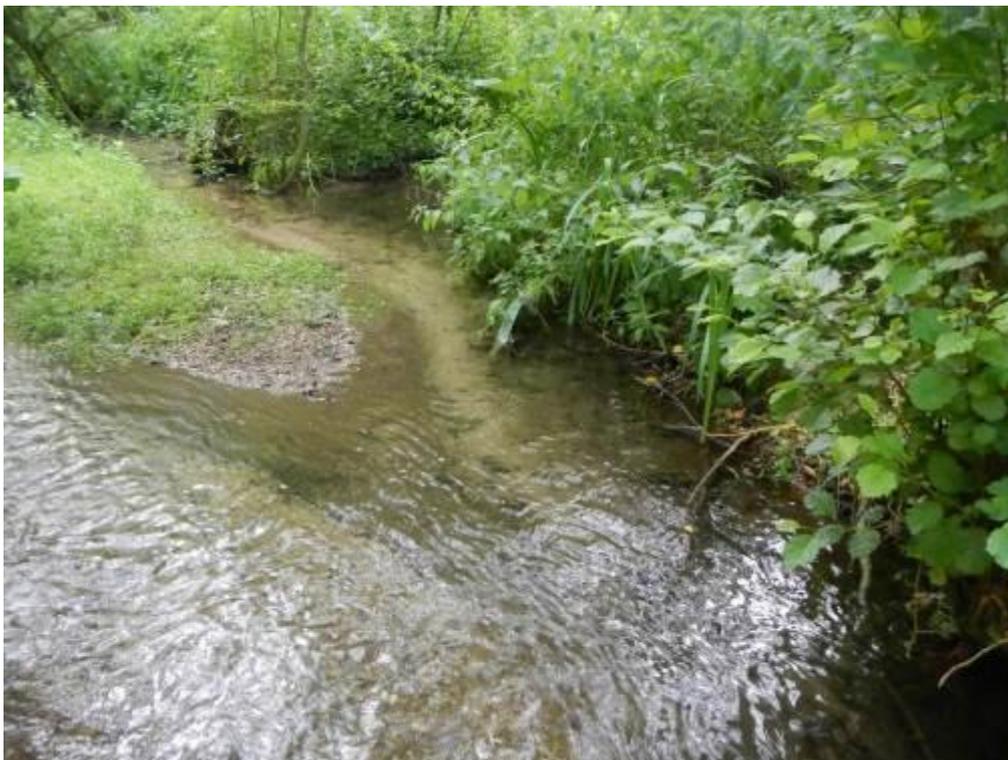
Figure 35. Immediate impact of sediment input from a small land drain (NGR: SE 87240 73969)

The issue of sediment input from the field drains (Figs. 35 & 39; SE 87240 73969 & SE 87201 74075) should also be addressed, ensuring that maintenance of the drains is limited to reduce the mobilisation of sediment. One option to reduce the impact could be to create a large sump area in the drain to act as a sediment trap, well upstream from the Beck. This could then be emptied periodically during future maintenance, as it becomes full. The leaky water trough located by the upper field drain (Fig. 36; SE 87101 73702) should be repaired and relocated to a location where the inevitable ground poaching around it will not result in sediment reaching any watercourses.

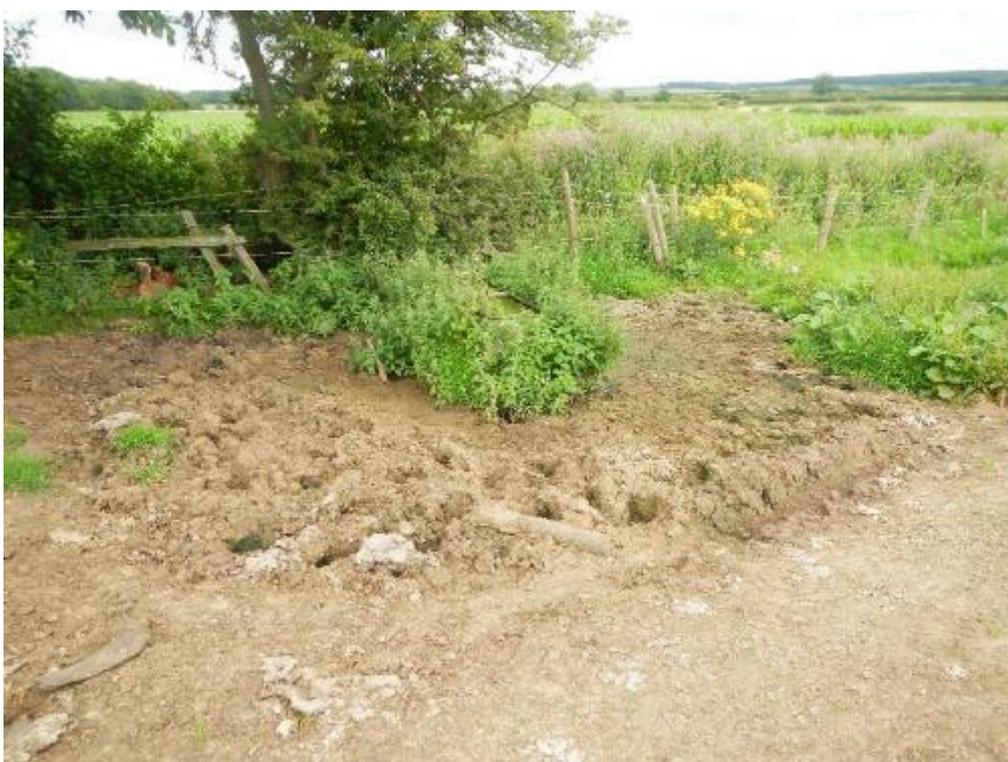
A brief inspection of the drain revealed that, although it dried up c.300m u/s, a poorly located, leaking cattle drinking trough surrounded by poaching appeared to be a major sediment source (Fig. 36). Relocating the trough away from the drain would greatly reduce the issue.

Figure 36. Major sediment input to a field drain resulting from poaching around a leaking water trough (NGR: poaching SE 87101 73702).

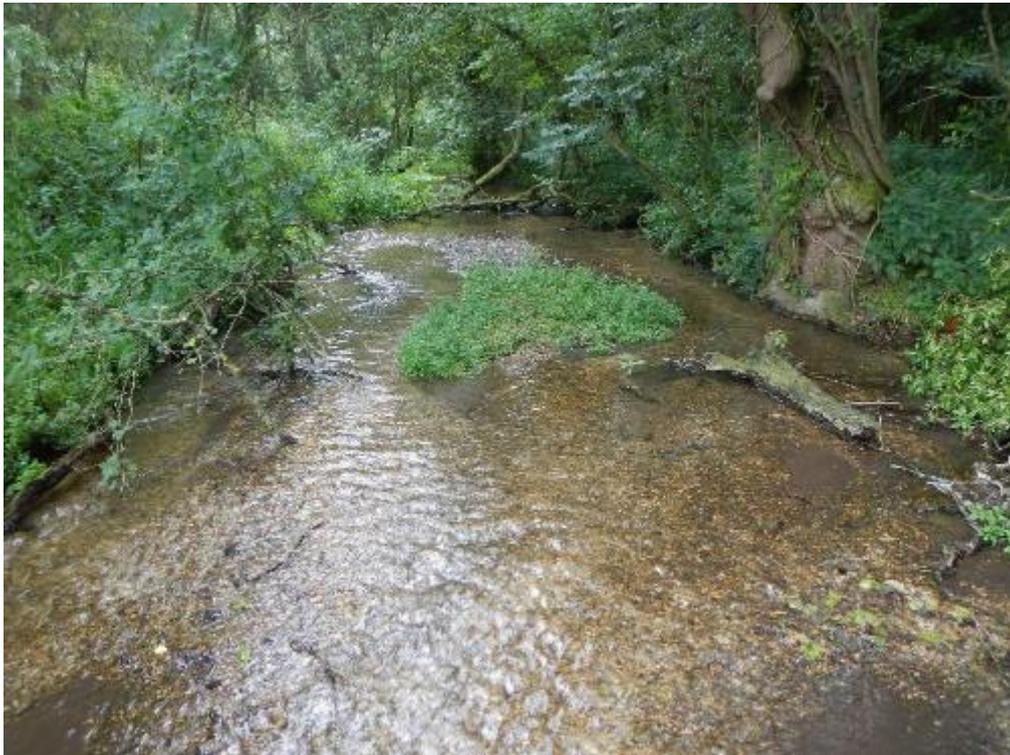
Accumulations of fine sediment in all slower flowing areas were noted across the Beck bed d/s of the drain input. LWD in the channel helps to create areas where the fine sediment can accumulate, while also creating faster areas and scouring flows to sort the substrate but the impact of fine sediment is still very apparent (Fig. 37).

Figure 37. Sediment accumulations wherever flow velocities are reduced.

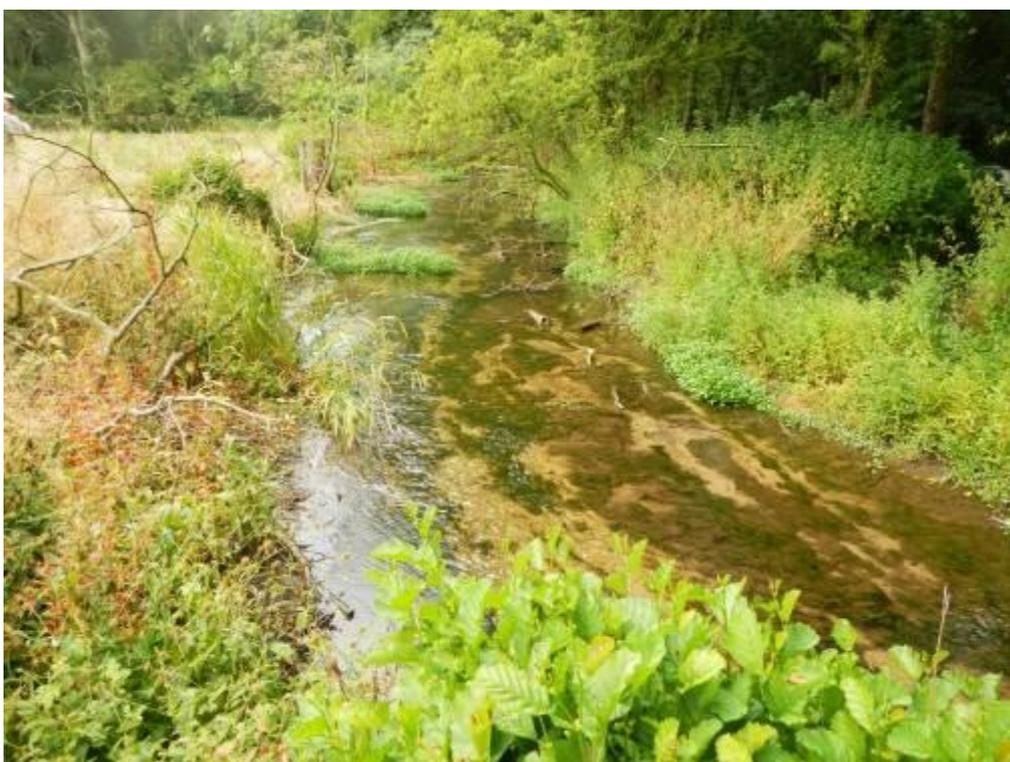
Figure 38. Algae and sediment smother the bed upstream of the sluice impoundment.

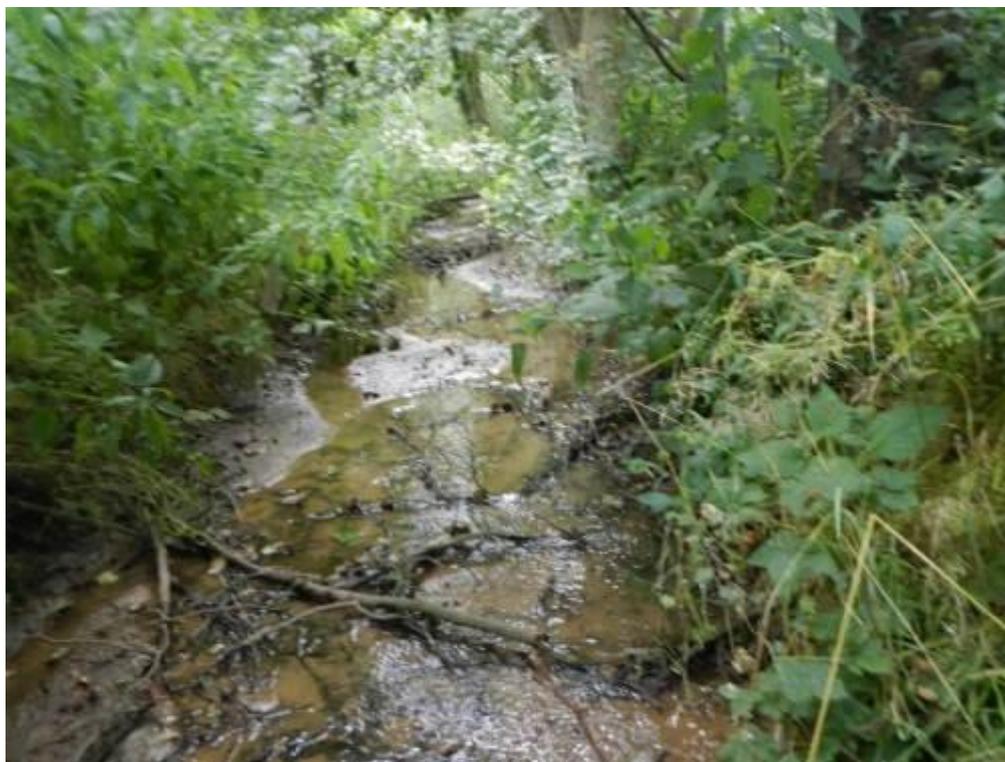
Figure 39. The second drain which poses another significant sediment source in certain flows (NGR: SE 87201 74075).

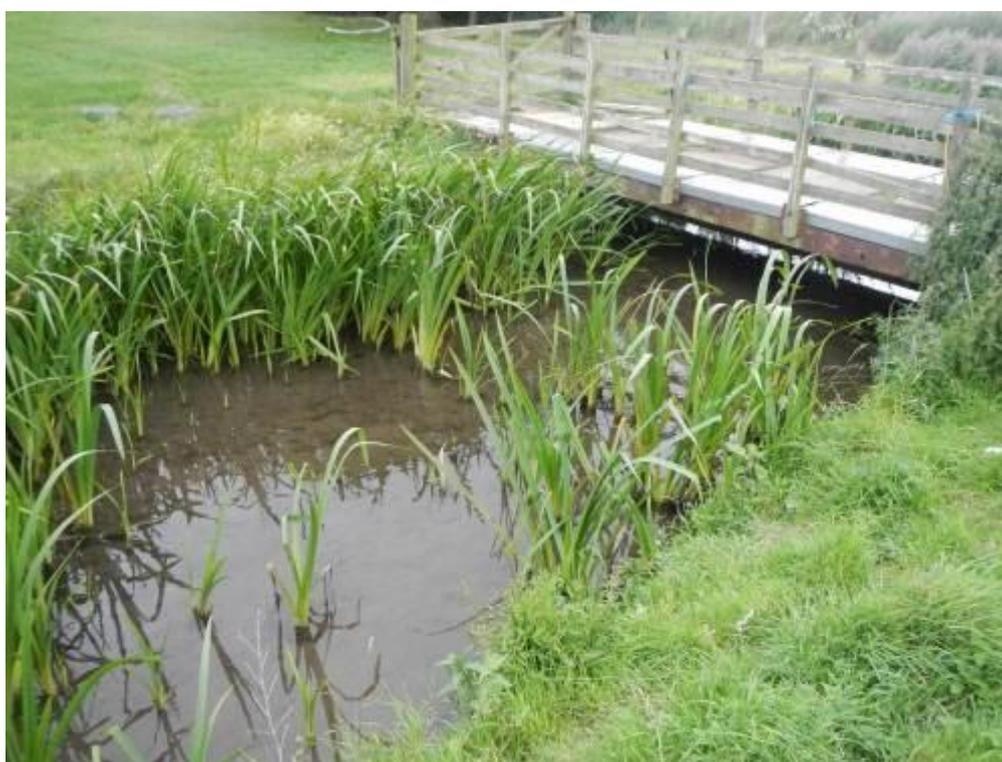
Figure 40. The leat leading off from Linton Sluice.

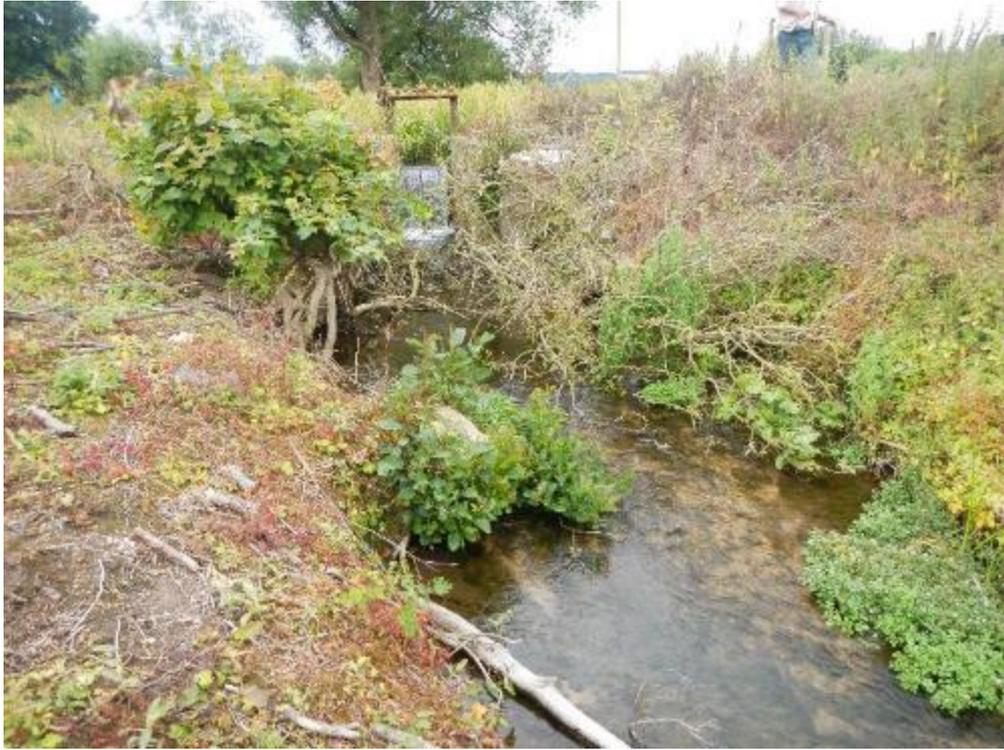
Figure 41. Linton Sluice (NGR: SE 87102 74195).

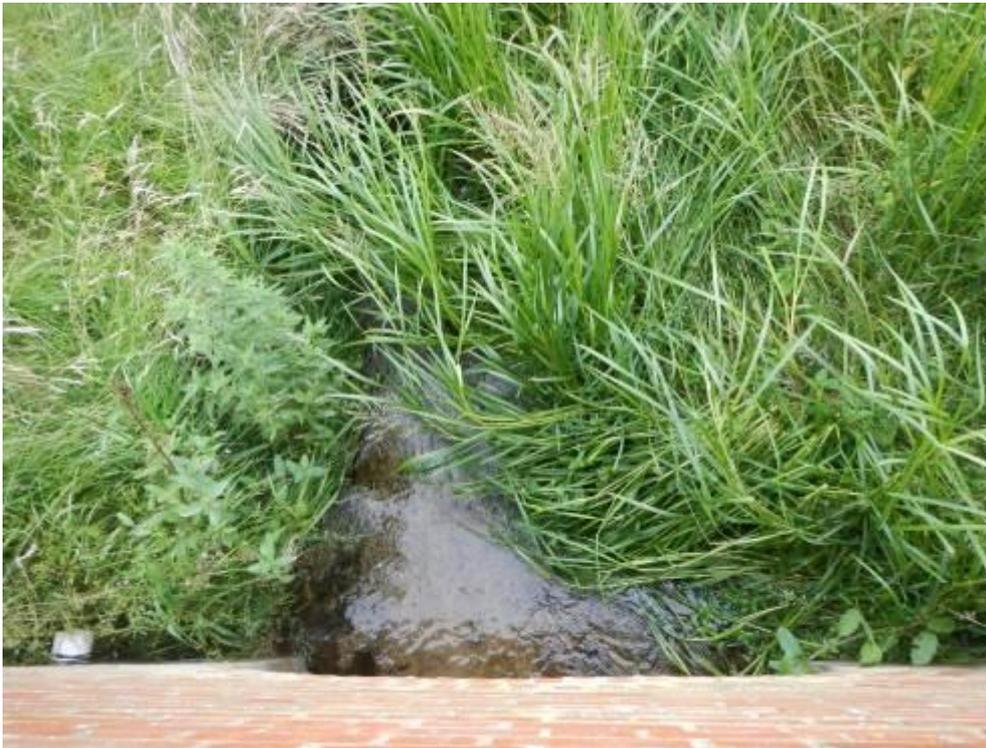
A small culvert to cater for a road crossing poses no real issue to fish or sediment passage (Fig. 42). D/s of the culvert, the Beck again enters farm land where, at the time of the visit, very light grazing appeared to be having no major impact upon erosion or sedimentation but was inhibiting the establishment of bankside trees and herbaceous vegetation. Another small culvert was also noted d/s of this one (on Google Earth) at NGR: SE 87140 74790, but this was not inspected during the visit.

Figure 42. No major issues from an adequately sized road culvert (NGR: SE 87112 74270).

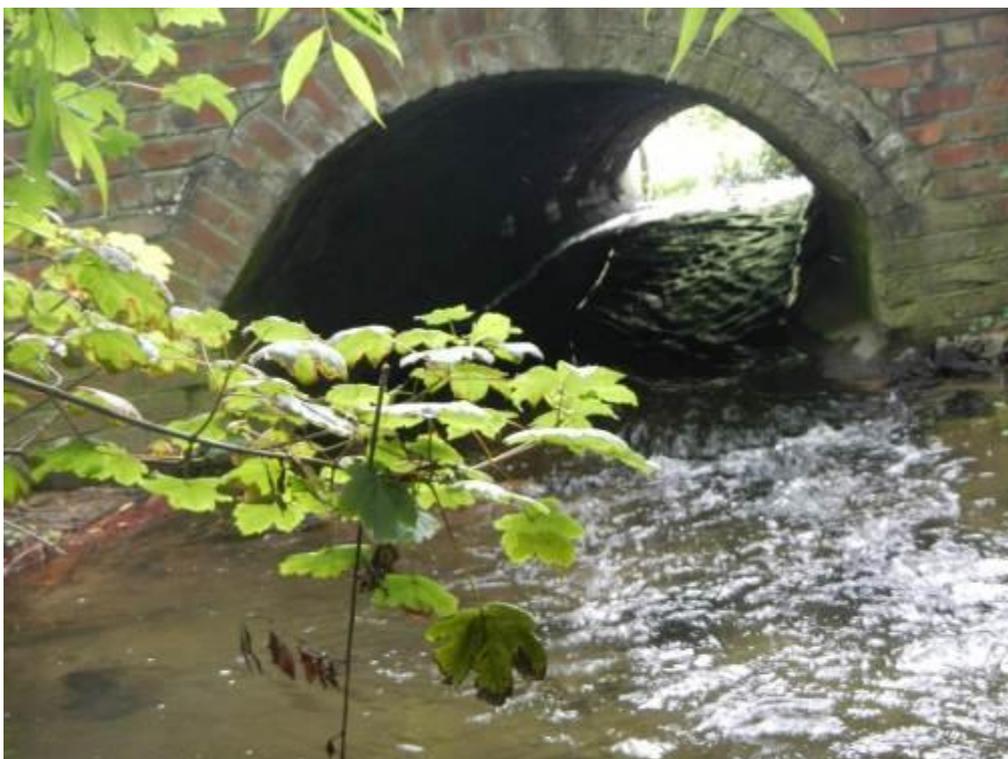
Figure 42. A64 Bridge, with a shallow flows over an inclined invert/base creates an obstacle to fish passage (NGR SE 87008 75091).

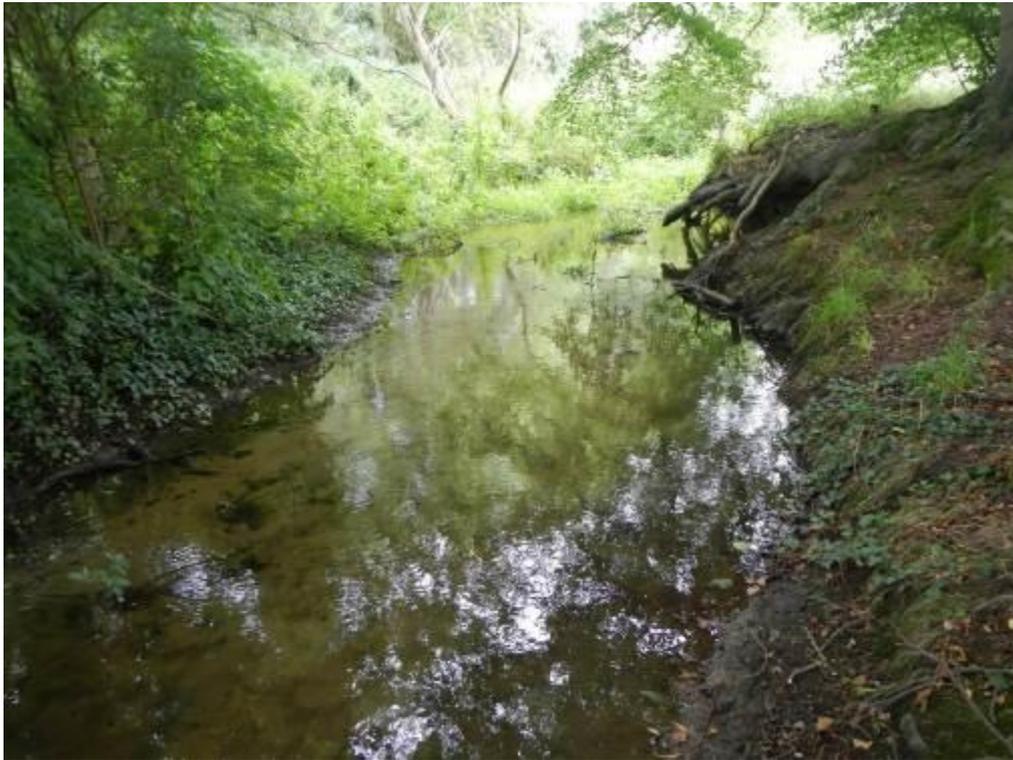
Figure 43. D/s A64, over shaded and likely dredged channel with excess sediment accumulation on the bed.

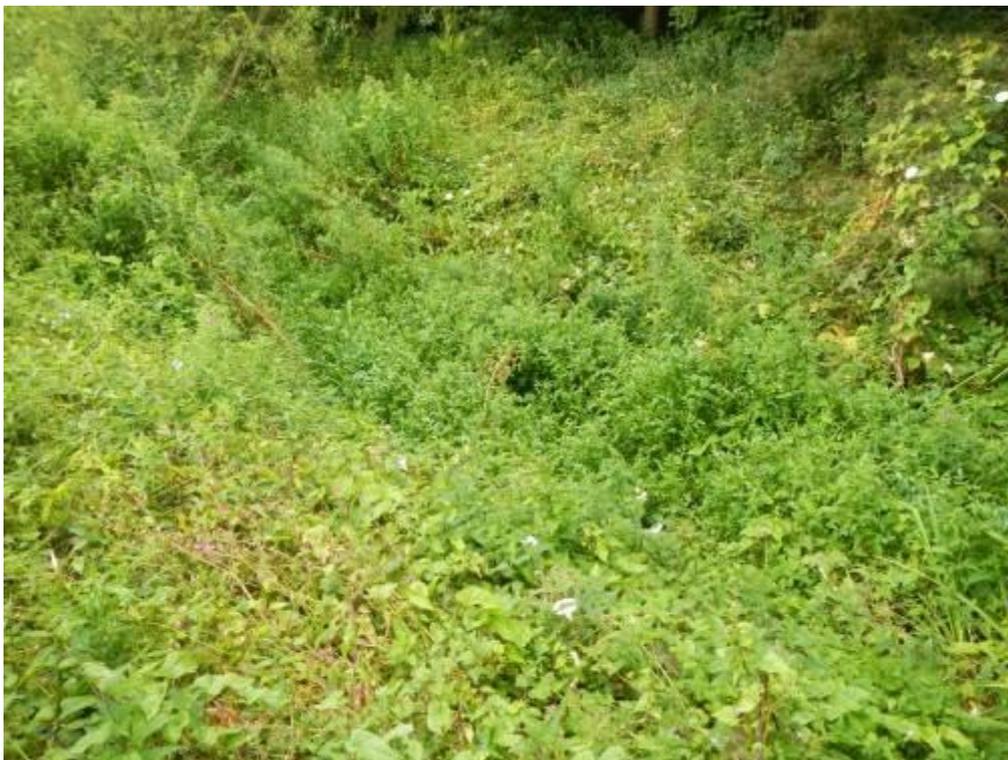
Figure 44. D/s of the tree shading, bankside vegetation envelopes the channel, the issue exacerbated by the incision of the channel.

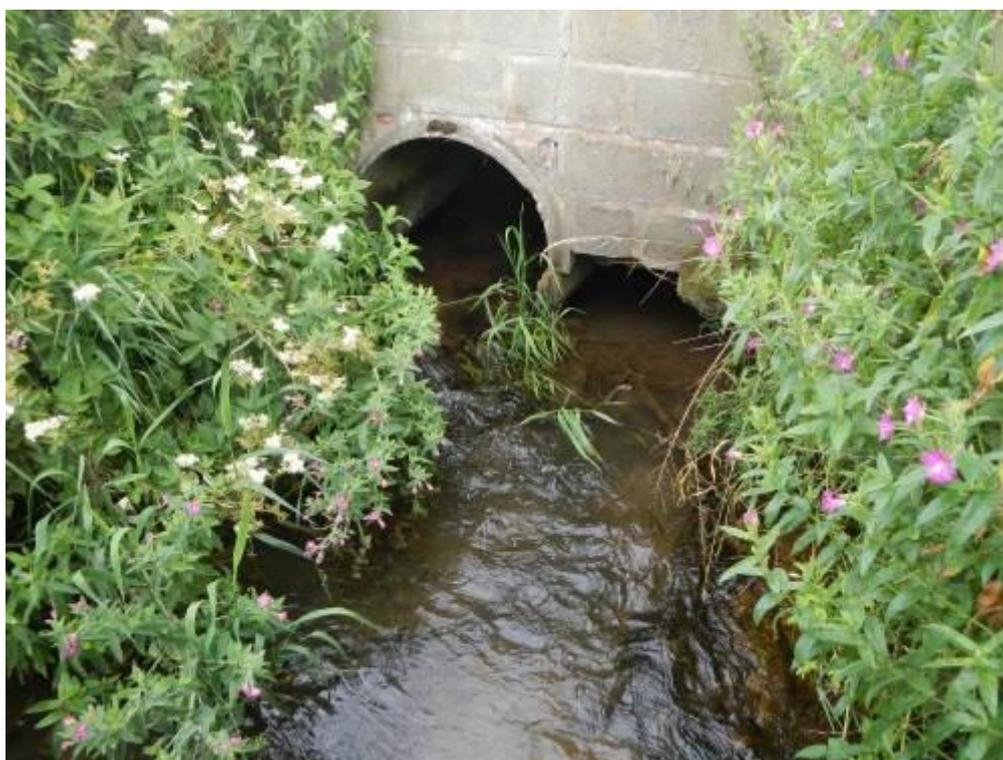
Figure 45. Small culvert which poses no major obstruction, providing it remains clear of debris (NGR: SE 86825 75367).

The small culvert observed on Google Earth at SE 87140 74790 but not inspected during the visit should be assessed for fish passage and sediment transport. The culvert towards the lower end of the section (Fig. 45; SE 86825 75367) should also be replaced with a larger, sunken culvert when it degrades to a stage that requires repair.

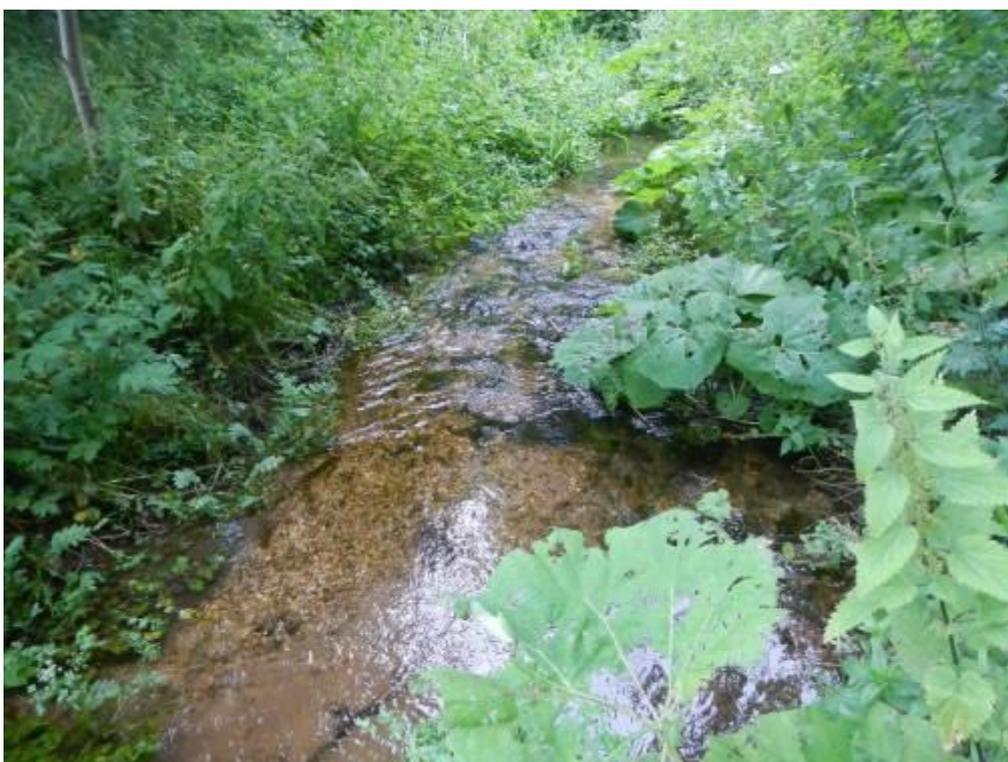
Figure 46. The channel becomes visible again as it enters the plantation.

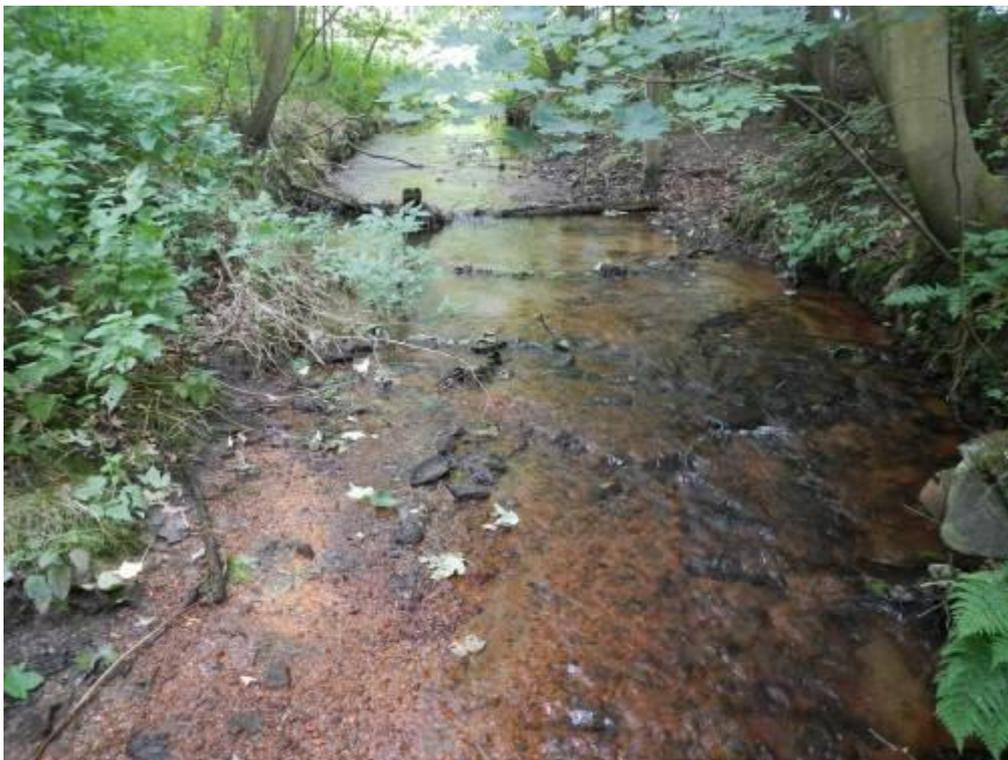
As the Beck progresses through the plantation, an influence of ochreous material becomes apparent within the substrate, staining the bed through a short section but not to an extent that is considered to be indicative of a major issue (Fig. 47). The channel is of a reasonable gradient here and a wider range of substrate sizes are present. Increased LWD would help to develop scour features and sort the substrate.

Figure 47. Some ochreous staining on a varied substrate, including some larger material. Introduction of woody material would beneficially scour and sort this into valuable habitat.

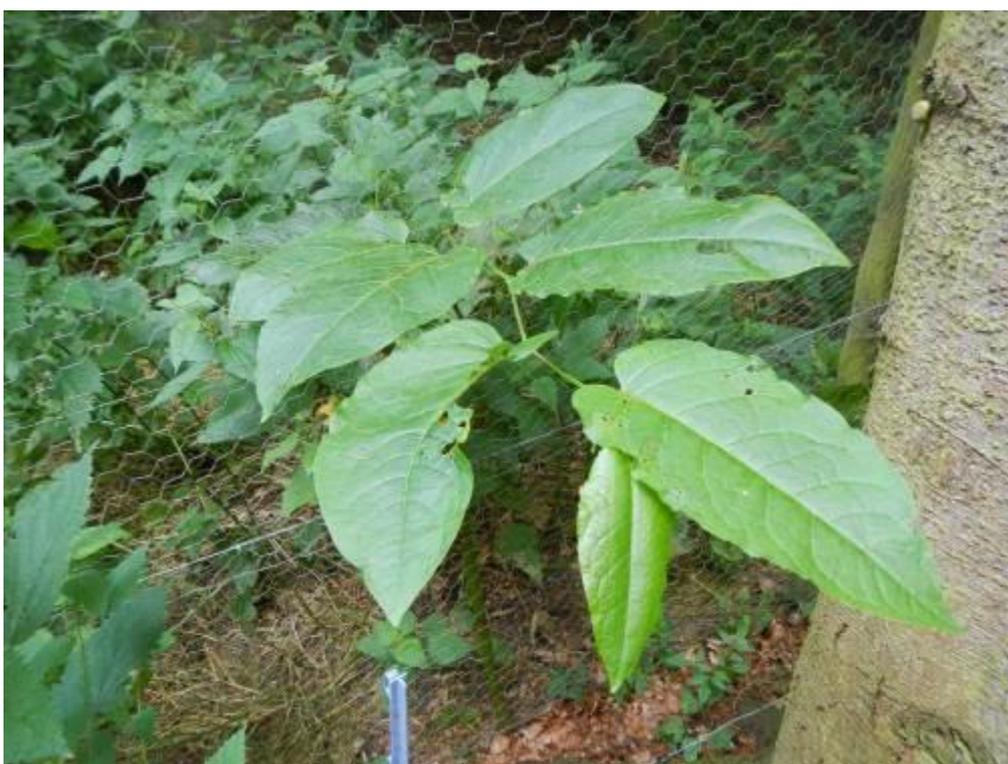
Some form of knotweed, suspected to be Himalayan knotweed *Persicaria wallichii*, was observed weed was observed along the bank and protruding from the adjoining pheasant release pen (Fig. 48).

Figure 48. Suspected Himalayan knotweed (NGR: SE8676175611).

The knotweed observed growing in and around the pheasant pen (SE 86761 75611) should be treated to prevent its spread along the watercourse.
