Scampston Beck Catchment Walkover

North Yorkshire

04/08/2015

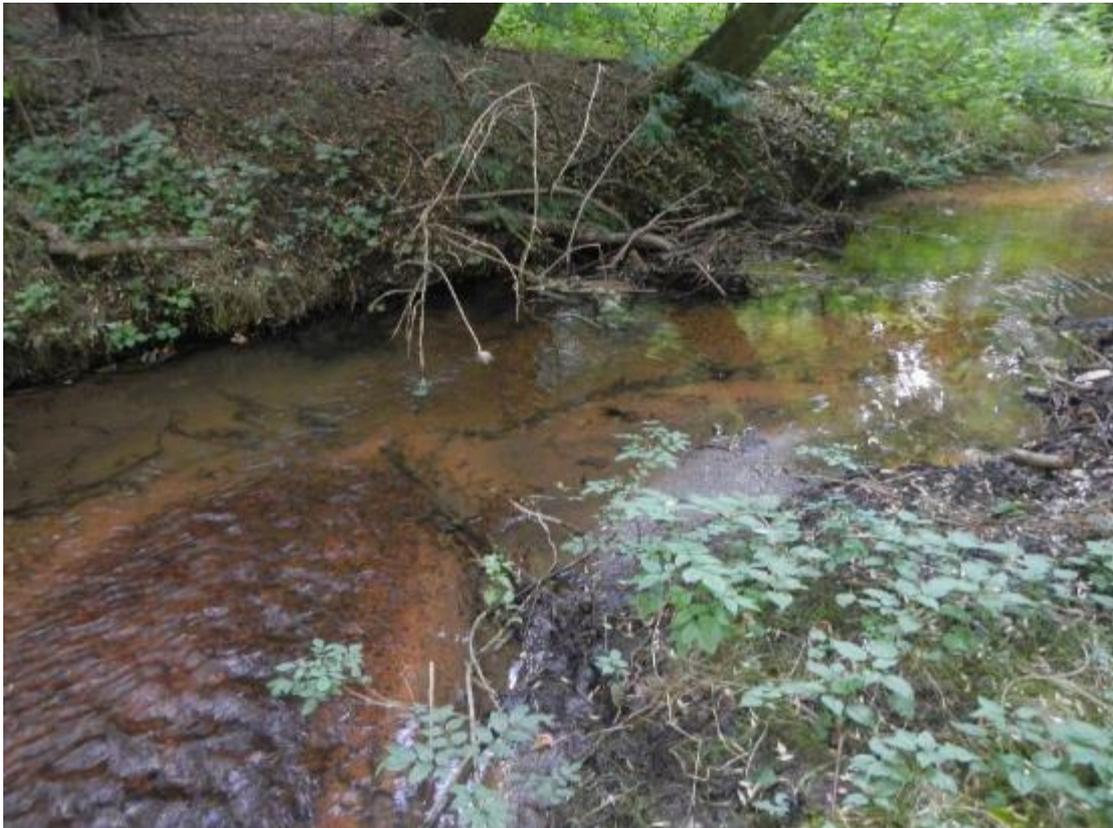
Figure 49. Tree roots and in-channel structure increase bed scour to create adult trout lies.

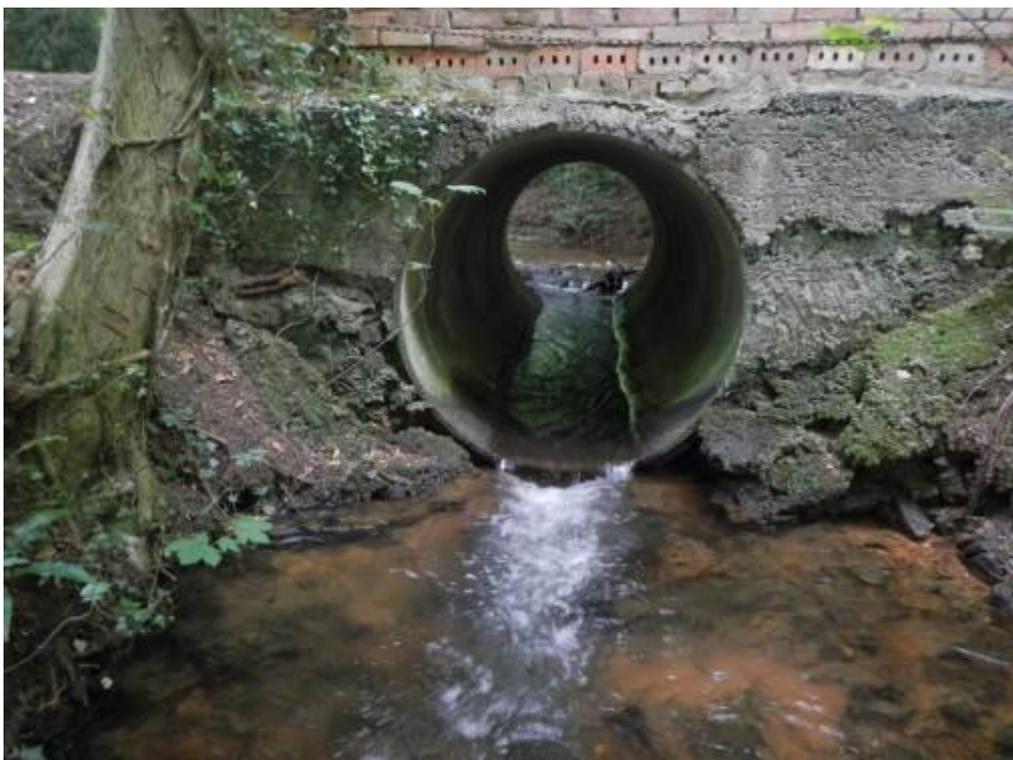
A perched (c.100mm-150mm), inclined culvert carrying an access track creates another barrier to fish movement (Fig. 49). As the structure looks old and in a poor state of repair, it is recommended that when replaced, the new culvert be larger diameter and set below the bed level (c.1/3 of its capacity).

Figure 50. Perched culvert creating an issue for fish passage (NGR: SE 86730 75700).

The culvert (Fig. 50; SE 86730 75700) should ideally be replaced with a larger structure, sunken into the bed to reduce the step and impoundment upstream. In the short-term, baffles (as described for the A64 road culvert) or, ideally, a small rock ramp, could greatly improve fish passage at the structure.

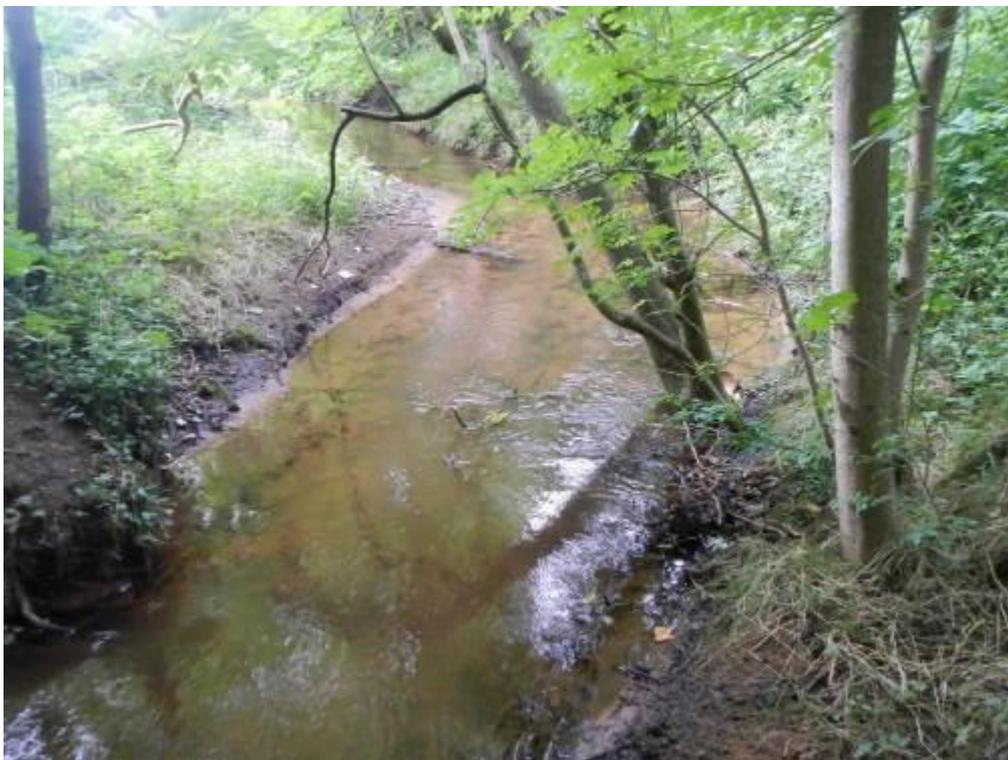
Figure 51. The plantation stops on the LB and continues for a few hundred metres on the RB. The over-capacity channel in this section has facilitated significant sediment deposition.

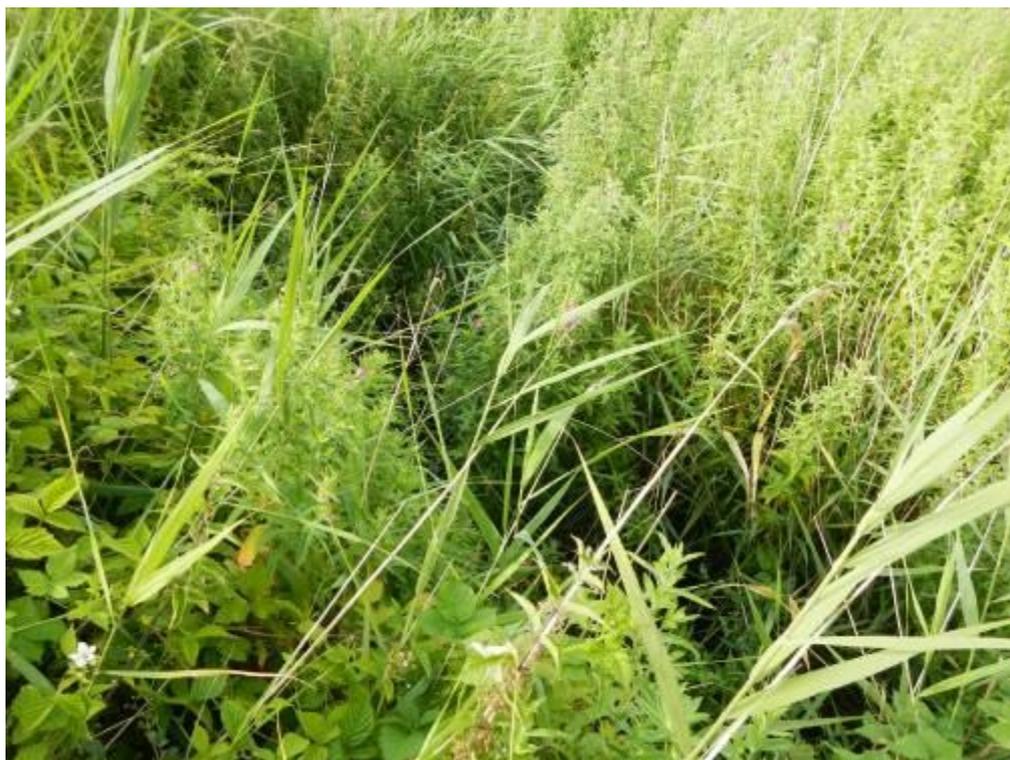
Figure 52. The typical appearance of the lower section of the Beck, overgrown and incised below arable fields.
