Walkover Habitat Survey
Scopwick Beck, Lincolnshire
November 2016

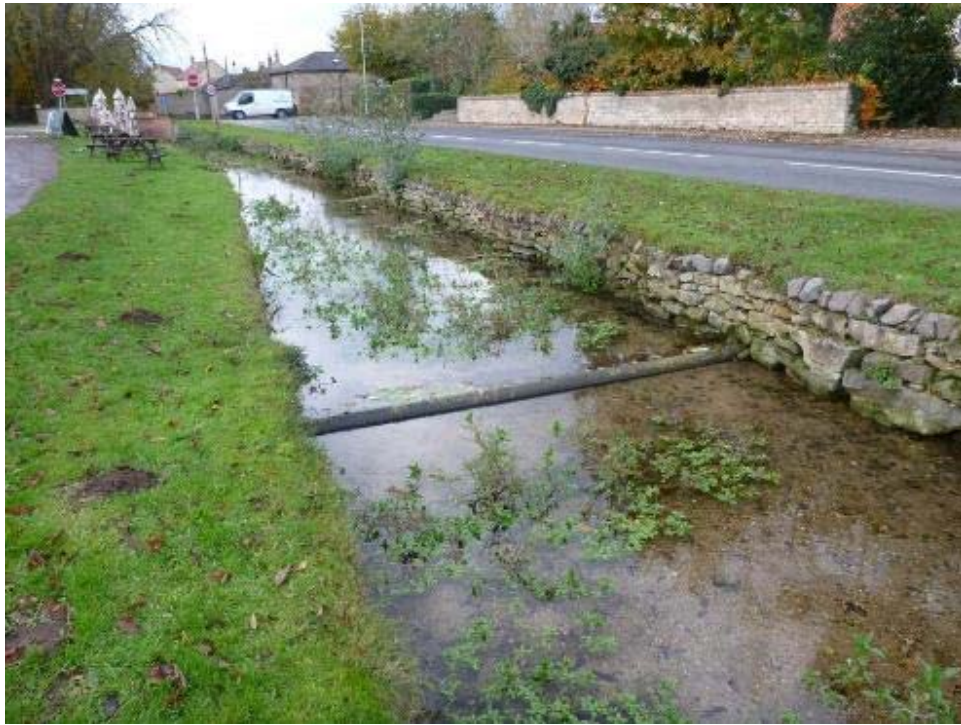
Photo 1 The beck near the crossroads in Scopwick village is characterised by a uniformity of width and depth, with stone-walled banks. Note services crossing the river bed.

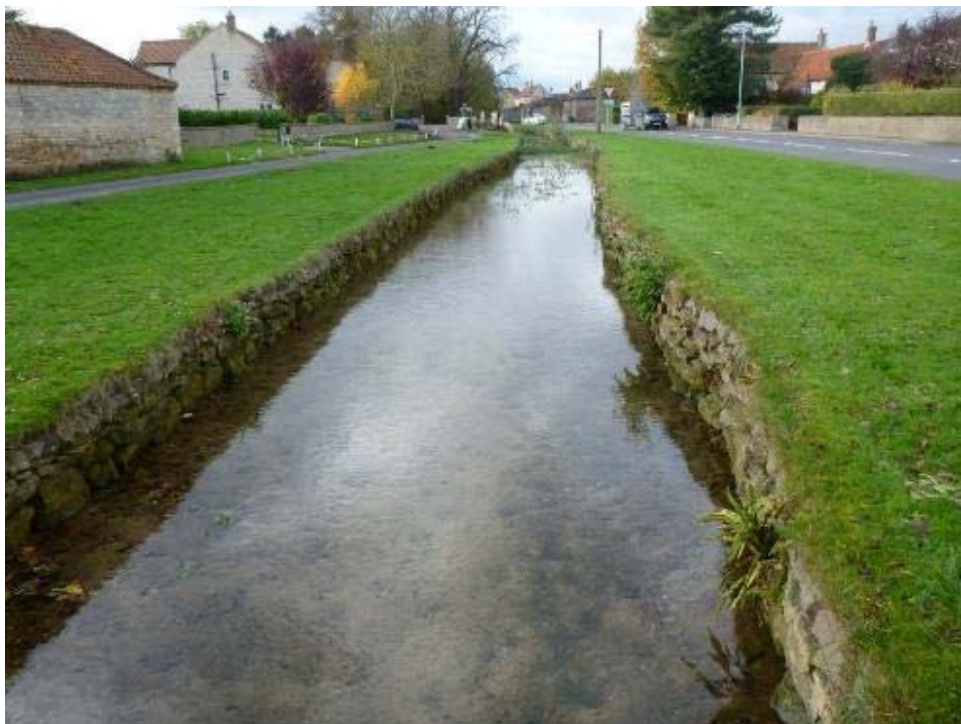
Photo 2 As above. Emergent vegetation is sparse here despite the absence of shading, suggesting it is removed.

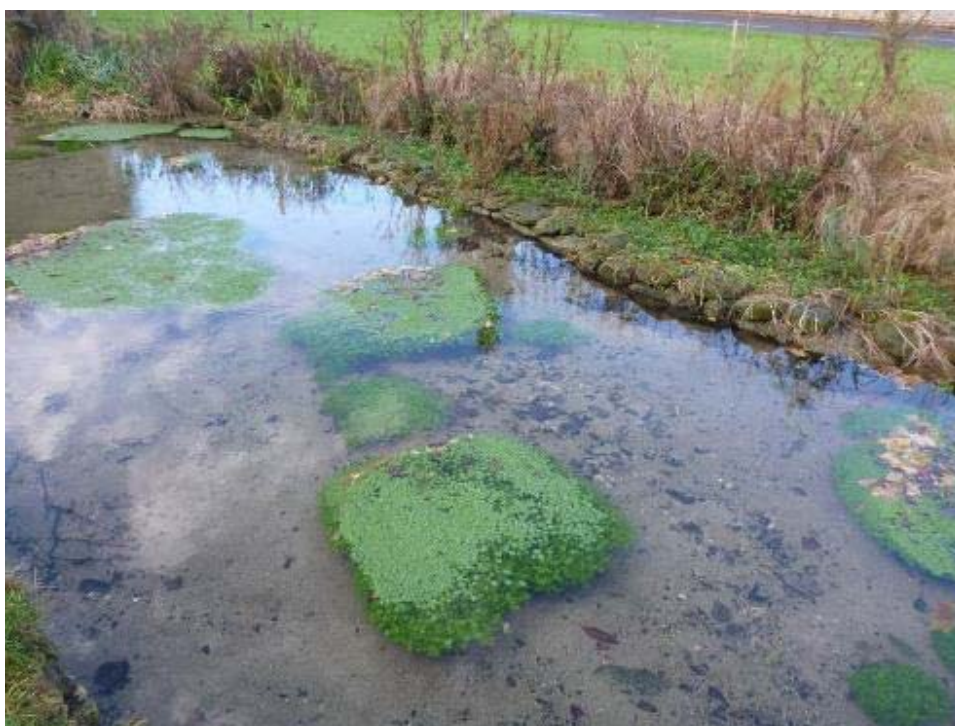
Photo 6 Near the Church, Scopwick. Low, stone shelves in the margins have colonised with aquatic vegetation providing improved marginal habitat. This effect could be enhanced and extended, possibly using softer edging materials, such as coir.

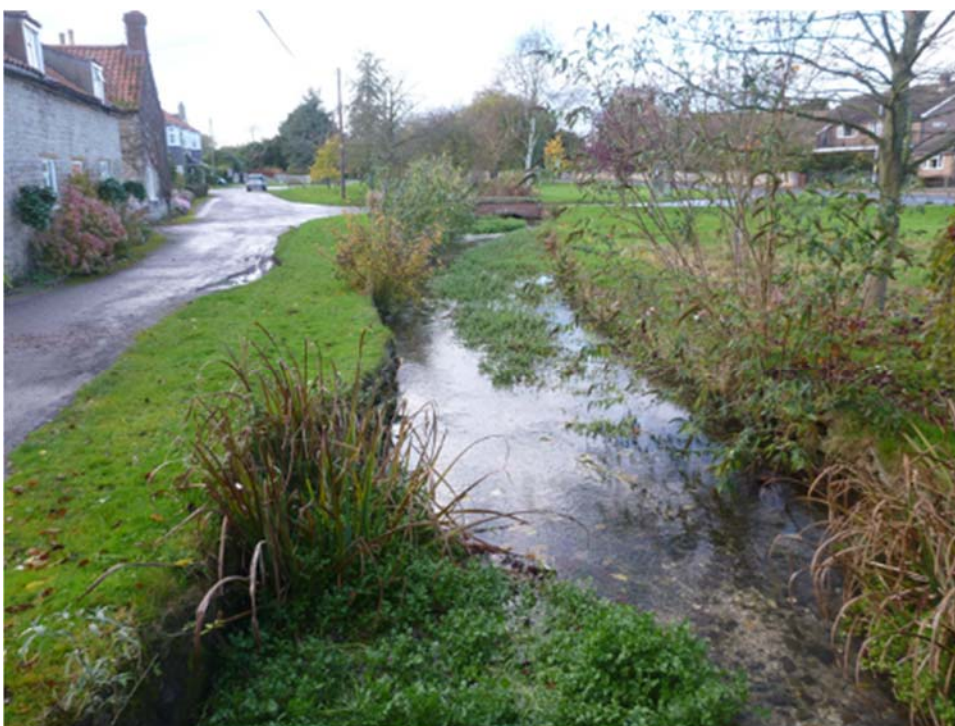
Photo 8 Upstream from the footbridge at the eastern end of Brookside. More aquatic vegetation is present, providing better habitat. This gives an indication of the types of habitat that could be introduced in a managed way further upstream.

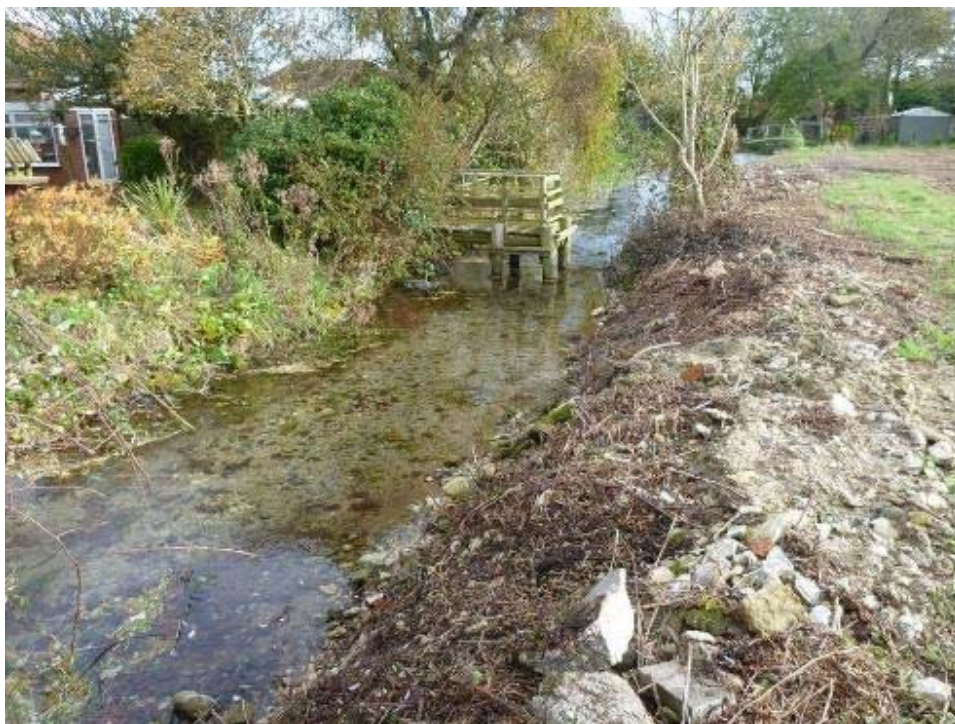
Beyond this shaded section is a reach of the beck bordered by the rear of approximately nine residential properties on the left (north) bank (Photo 11). On the right (south) bank is agricultural land owned by Mr Paul Scholey, and with progress downstream, three parcels of land owned by residential properties opposite, then a flow gauging station and weir (Photo 12). Some in-stream habitat improvement work is planned for the section of beck on Mr. Scholey's land.

Photo 11 Section on Mr. Scholey's land where improvement works are planned.

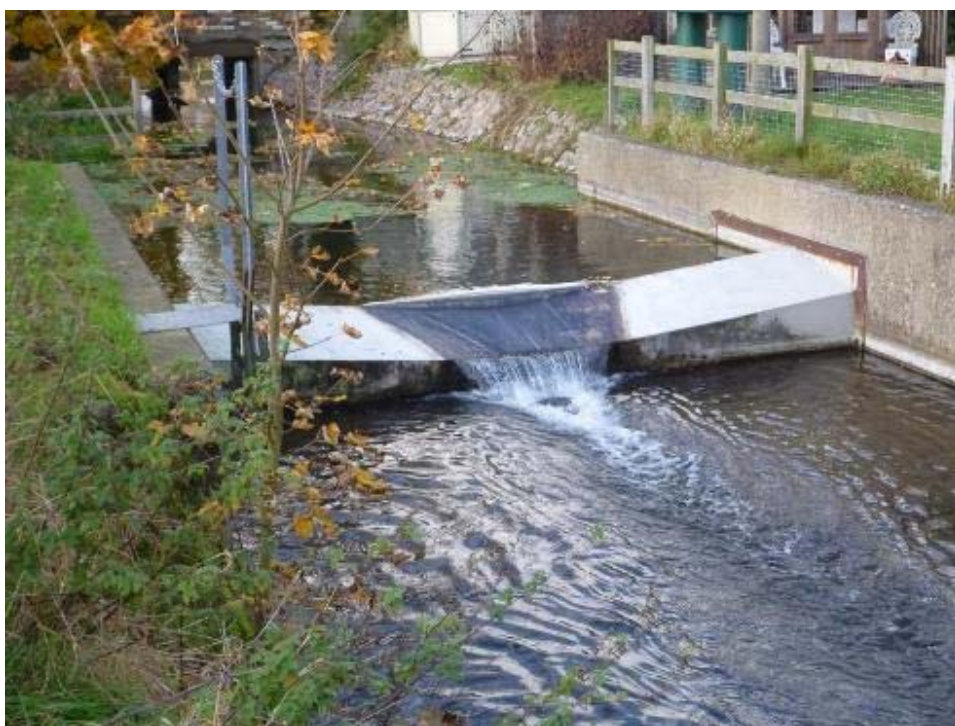
The Environment Agency flow gauging weir was apparently installed following an inquiry into the deepening of boreholes for water abstraction from the aquifer in the 1970s. Around this time the beck dried up, resulting in the death of many eels (P. Scholey, pers. comm.). The weir structure is an obstacle to free fish movement and will hinder recolonization of the beck by fish following environmental stresses such as drought or pollution. It also impounds water upstream and limits the scope for in-stream habitat improvement.

Photo 12 Environment Agency flow gauging weir (TF0743658004) which appears to be set at a higher level than necessary. It is possible downstream water levels were higher at the time of construction if stop logs were in place at the structure c.260m downstream in Photo 14.

Investigate if the flow gauge weir is set high and possibility of lowering / improving fish and eel passage.

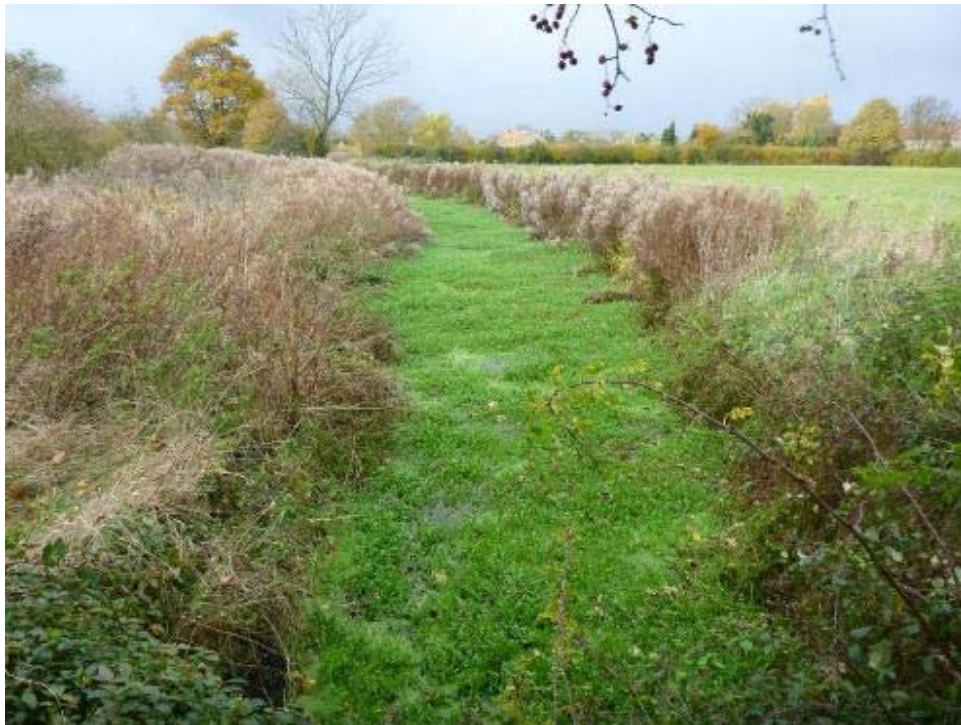
Downstream of the gauging weir is a uniformly overwide, unshaded section of channel (Photo 13), impounded above a former hatch or sluice at the site of the Old Water Mill (Photo 14). The aforementioned characteristics of the channel here result in it being choked with water cress (*Rorippa* sp.). Reducing the level of the impoundment and creating a low-flow channel within the wider bank-full channel would maintain open water and improve instream habitat here.

Photo 13 Impounded reach upstream of structure in Photo 14, choked with water cress.

Improve the instream habitat downstream of the gauge weir to the Old Water Mill, either:

- Lowering impoundment at the Water Mill and introducing habitat structures to the existing channel upstream, or
- Create a new channel, possibly on the south bank, bypassing the impoundment and rejoining the existing channel downstream of the Water Mill. Subject to further investigation and survey of levels.

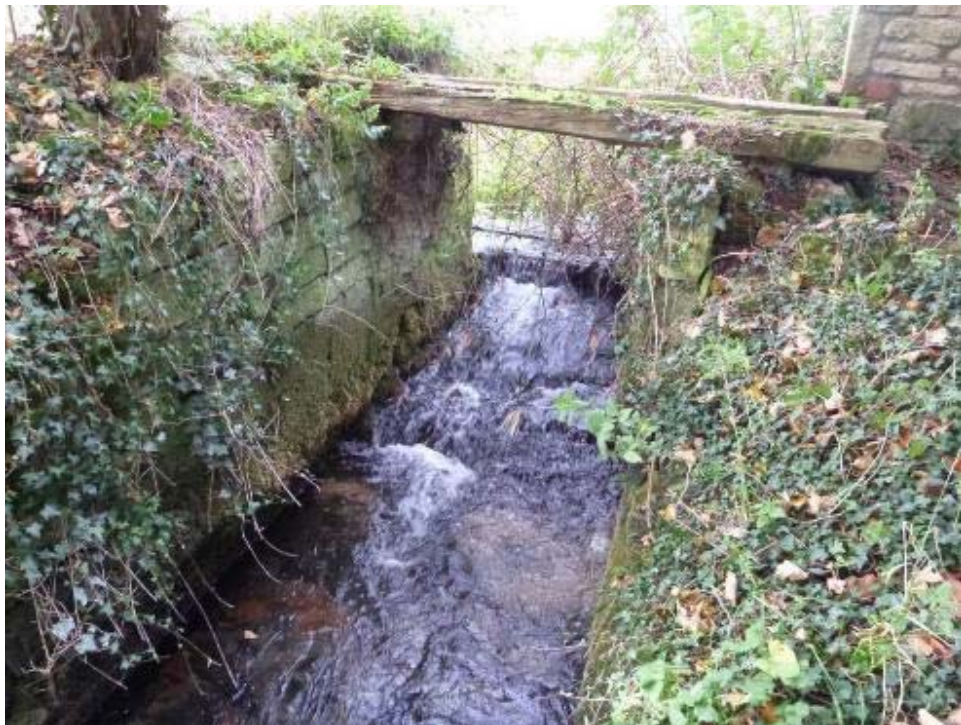
Photo 14 Former water control structure at the Old Water Mill (TF 07667 57898)

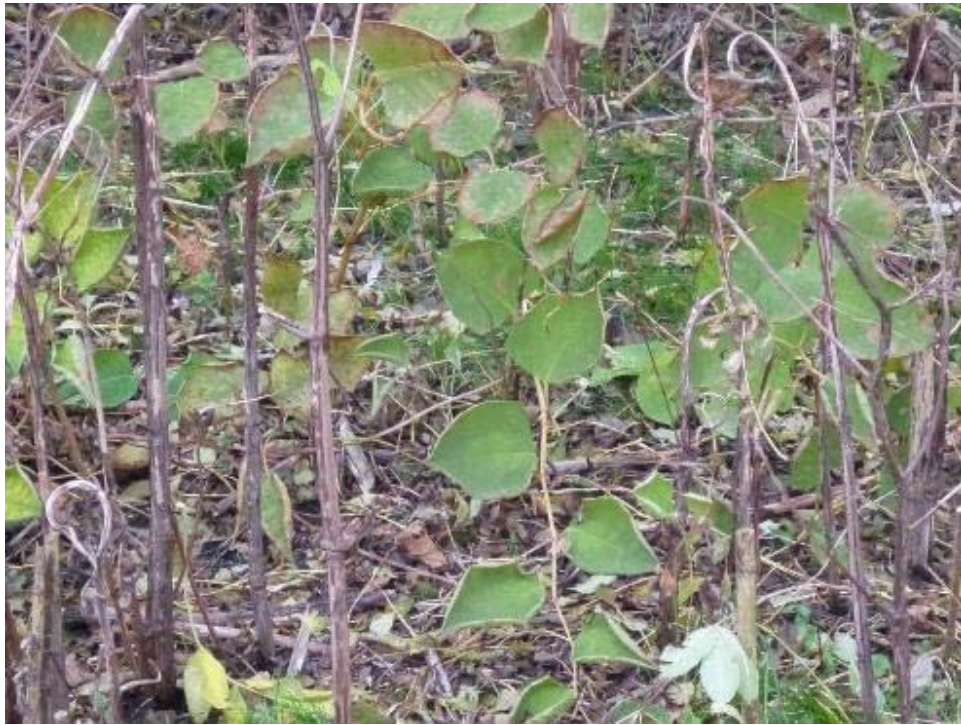
Downstream of the Old Water Mill, the channel is again over- wide and shallow, with stonework banks in the immediate vicinity of the Mill. There appears to be a small stand of Japanese knotweed (*Fallopia japonica*) on the south bank opposite the Mill building, an undesirable non-native, invasive plant (Photos 15 - 16). This should be controlled to prevent its spread, but specialist advice is required – the plants **should not** be strimmed or flailed, as it will propagate from very small pieces. Lincolnshire Rivers Trust may be able to help via their invasive species control project (contact marie.taylor@lincsivers.org.uk).

Photo 15 Japanese knotweed at TF0769257875. An invasive, non-native plant.

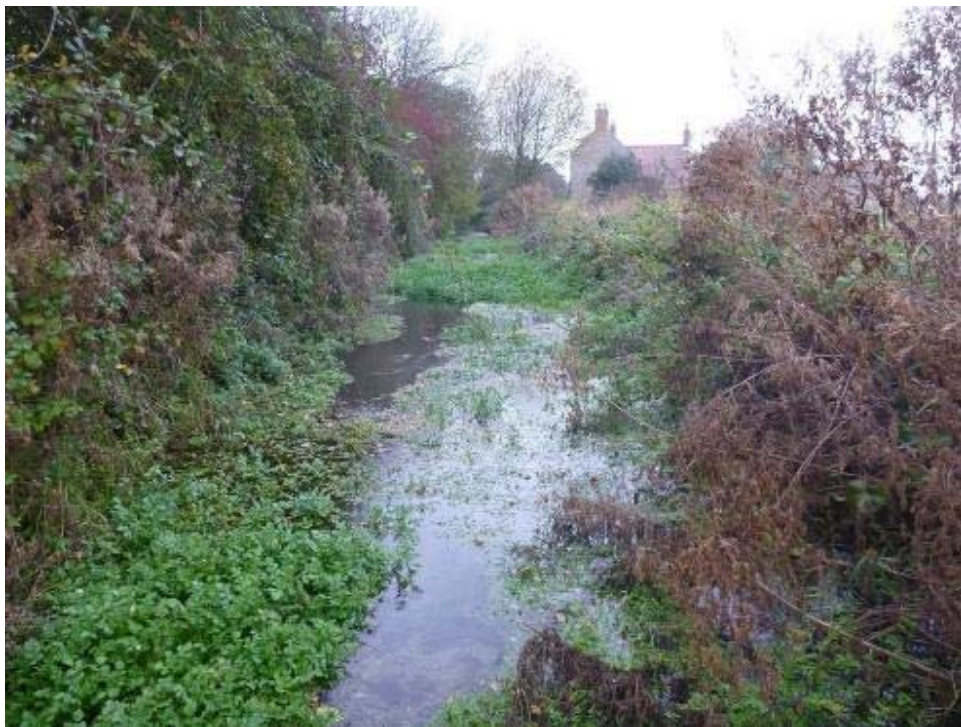
Photo 16 View upstream towards the Old Water Mill Cottage. An overwide, shallow channel, shaded on the south bank (left of picture) which has limited the extent of instream aquatic vegetation growth and maintained some open water.

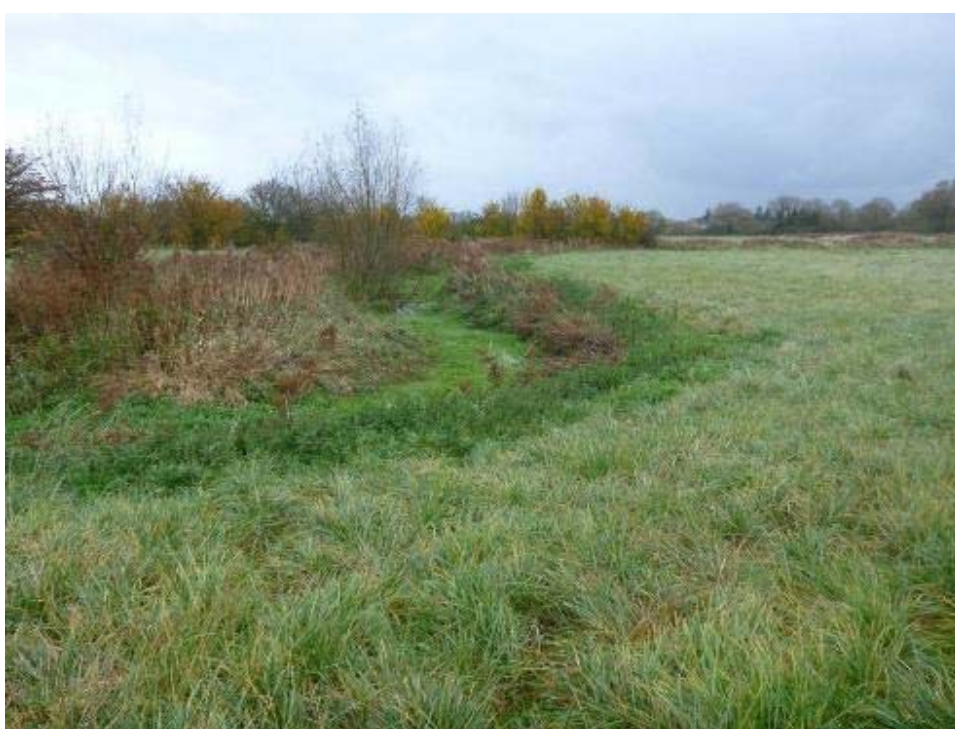
Photo 22 As per previous photo, showing channel choked with aquatic vegetation.

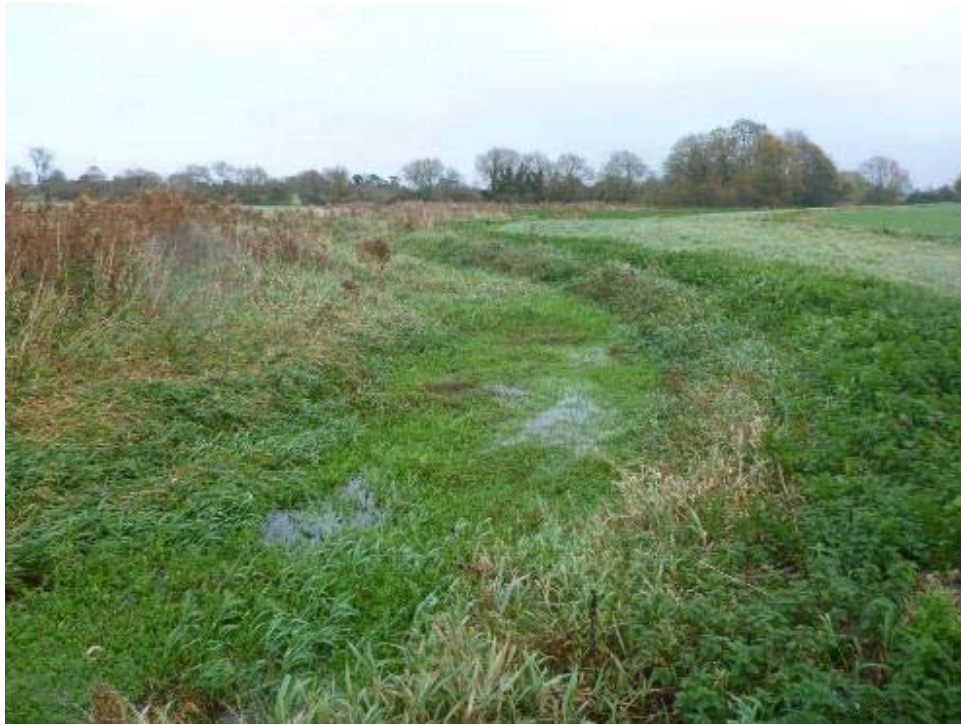
Photo 23 The trees in the background are the grounds of the former Corn Mill at Kirkby Green. The course of the beck is likely to have been altered historically in order to provide water power to the mill (see Photo 24).

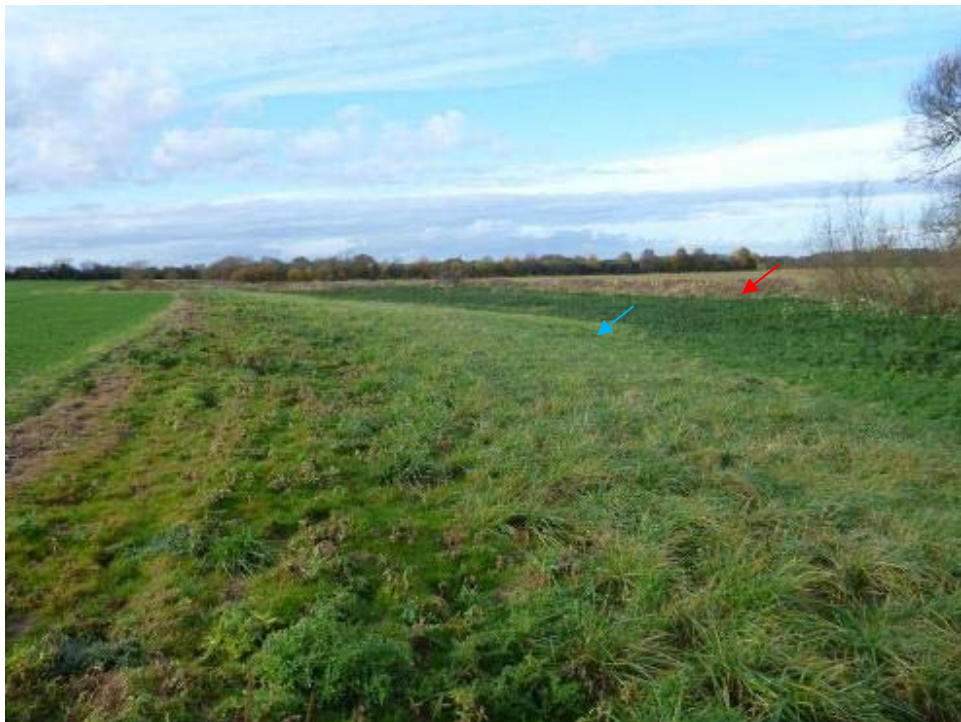
Photo 24 View upstream on the right (south) bank from the trees in Photo 23. The river channel (red arrow) is perched above the level of the land on the near bank (blue arrow), suggesting it was moved to provide a fall of water at the Corn Mill.

The impoundment at the former Corn Mill and perched channel through this reach reduces the gradient of the channel upstream, effectively to almost zero, creating a linear pond rather than a stream. Instream habitat improvements (narrowing, deflectors) on the existing channel

1. Remove the impoundment at the Corn Mill to restore energy to the reach upstream and carry out instream habitat improvements on the existing channel (narrowing, bed re-profiling, flow deflectors, etc.).
2. Realign the channel course back to the natural gradient of the longitudinal valley slope, bringing the new channel back into the existing channel downstream of the impoundment at Corn Mill.

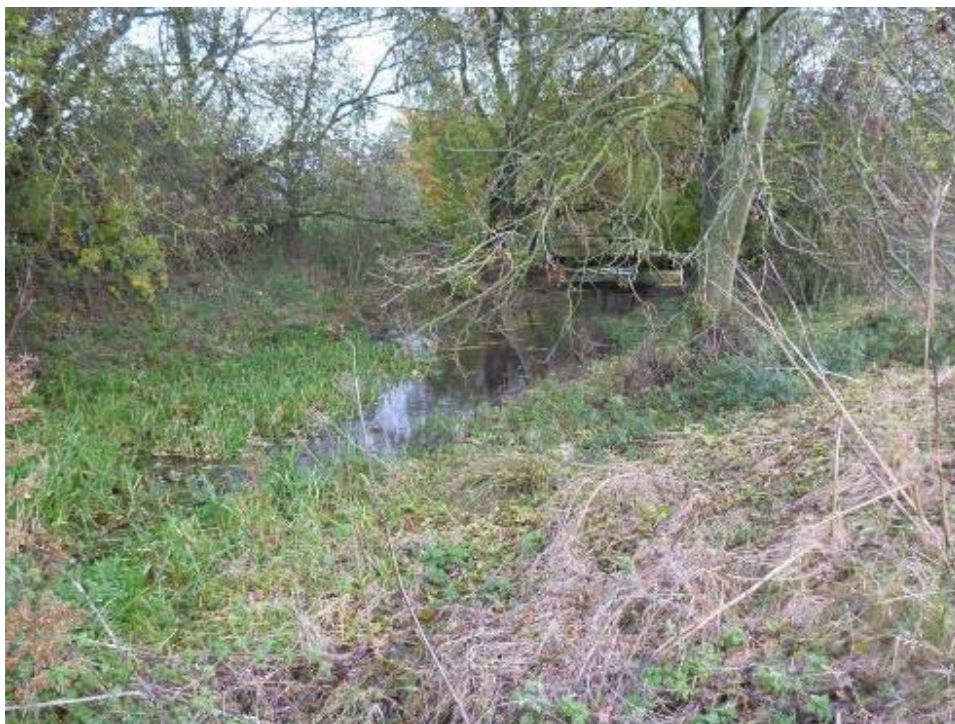
The relatively higher-gradient section of channel between the Old Water Mill and the ford quickly gives way to a sluggish, vegetation-choked channel indicating historic modification, most likely associated with the former Corn Mill at Kirkby Green, now a private residence (TF 08402 57662). It is probable that the course of the beck was moved up the valley sides to provide a fall at the Corn Mill, generating water power. Adjacent land levels (Photos 23-24) and LiDAR data support this observation (Appendix, Figure 2); LiDAR also shows a significant drop in levels within the channel at the site of the former Corn Mill, indicating the impoundment is still present (it was not possible to gain access to verify this on the day of the survey).

Photo 25 Widening of channel as it enters the grounds of the former Corn Mill at Kirkby Green. On the day of the walkover, it was not possible to access here to confirm, but LiDAR data and Google Earth suggests the beck is impounded here.

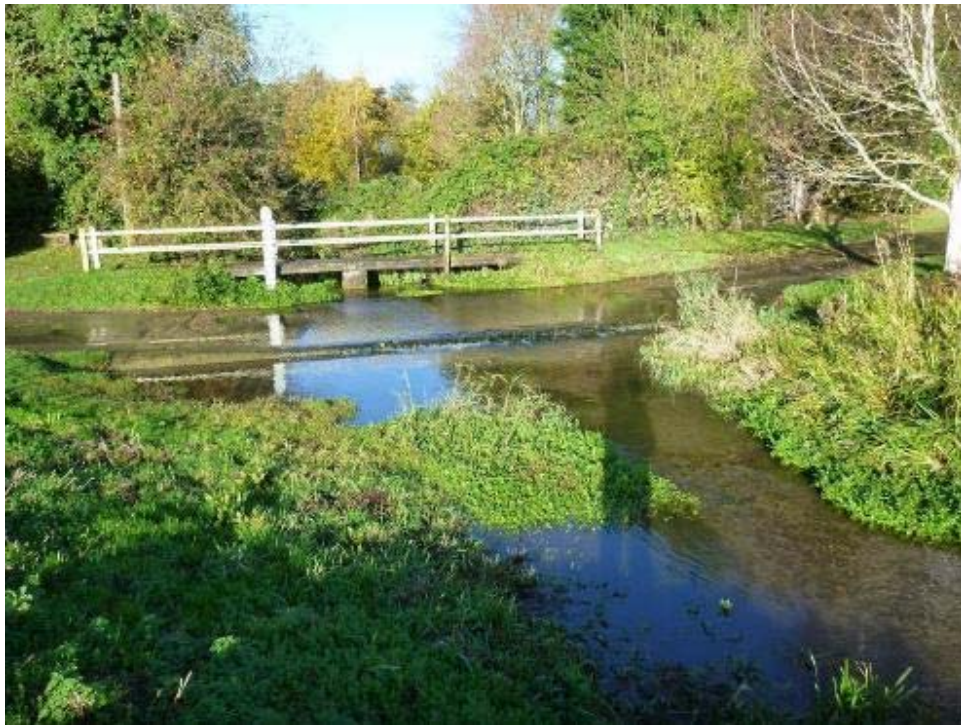
At Church Lane, Kirkby Green, the beck crosses a ford (Photo 26), which is probably a minor barrier to fish passage at low flow conditions. Downstream the river channel is over-wide and embanked, particularly on the right bank. It appears that channel maintenance (weed cutting, dredging) takes place from this bank, judging by the spoil deposited which is colonised by pioneer and nutrient-loving species like nettles and willow herb. The full (engineered) channel width at water level is approximately 5 metres, but the natural narrowing process is establishing marginal vegetated berms, leaving a low flow channel width of 1 – 2 metres (Photo 27). The beck is uniformly shallow through this reach, providing generally poor in-stream habitat for fish and wildlife (Photo 28).

Photo 26 Ford at Church Lane, Kirkby Green.

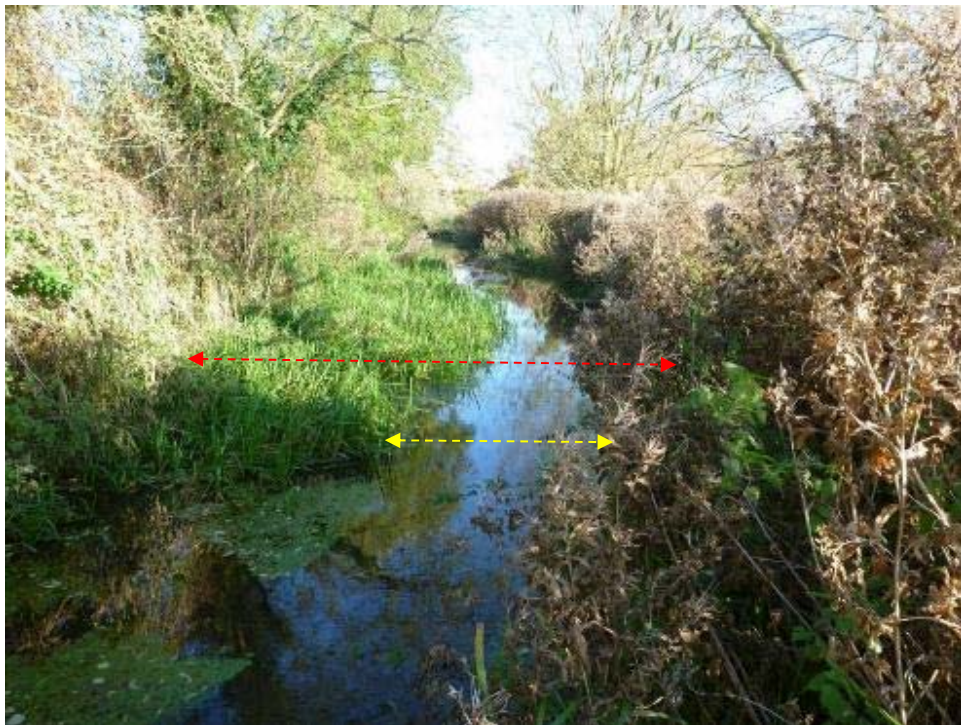
Photo 27 Engineered channel width is about 5m (red arrow), natural channel width about 1 to 2m (yellow arrow).

Creation of a low flow channel using low berms within the wider bankfull channel is feasible here, as the beck more free flowing.

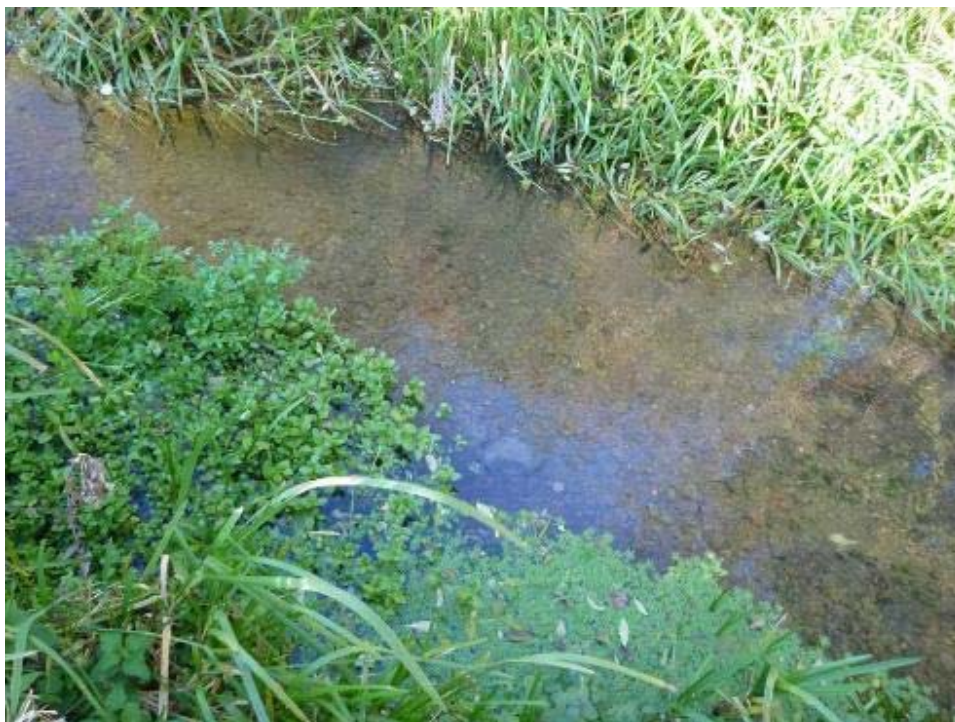
Photo 28 The beck is very shallow throughout the section downstream of Church Lane, a result of channel engineering.

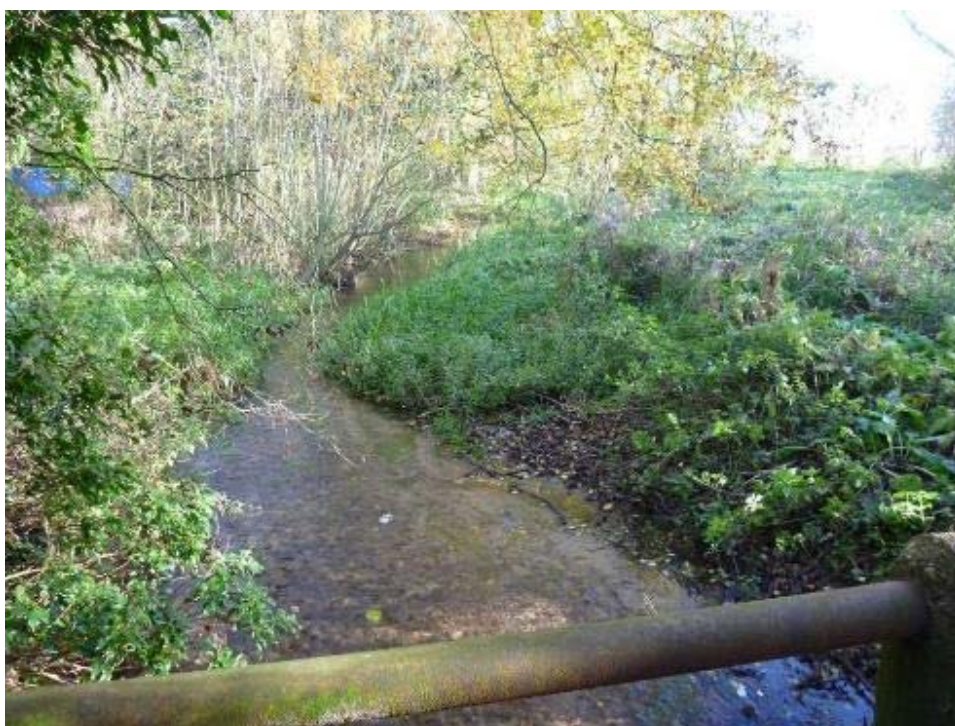
Near the right-angle bend in the main road in Kirkby Green, a footpath and footbridge crosses the beck within an area of woodland (TF 08704 57780). For a short reach here, the beck has a more natural character, embankments being absent and the river channel having more variation in width and depths (Photo 29). With downstream progress this quickly gives way to an overwide, shallow channel which is shaded by trees (hence lacks in-stream vegetation) and has a layer of silt on the bed which has accumulated above a debris dam formed by a fallen branch (Photo 30). There may be an opportunity to create a more natural meandering river course within the woodland area; a detailed survey of the area, including levels, would be required to investigate feasibility.

Photo 29 View downstream from the footbridge at TF 08704 57780. The beck has a more natural character here, although this quickly changes with downstream progress.

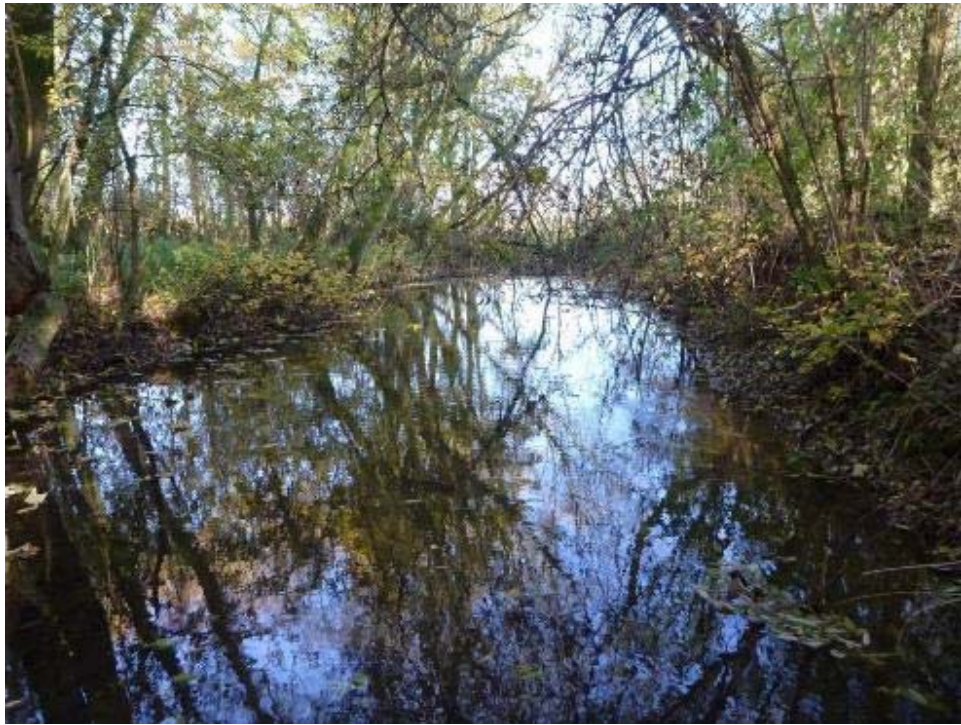
Photo 30 Wide, shaded section with deep silt on the bed at grid reference TF0877557835

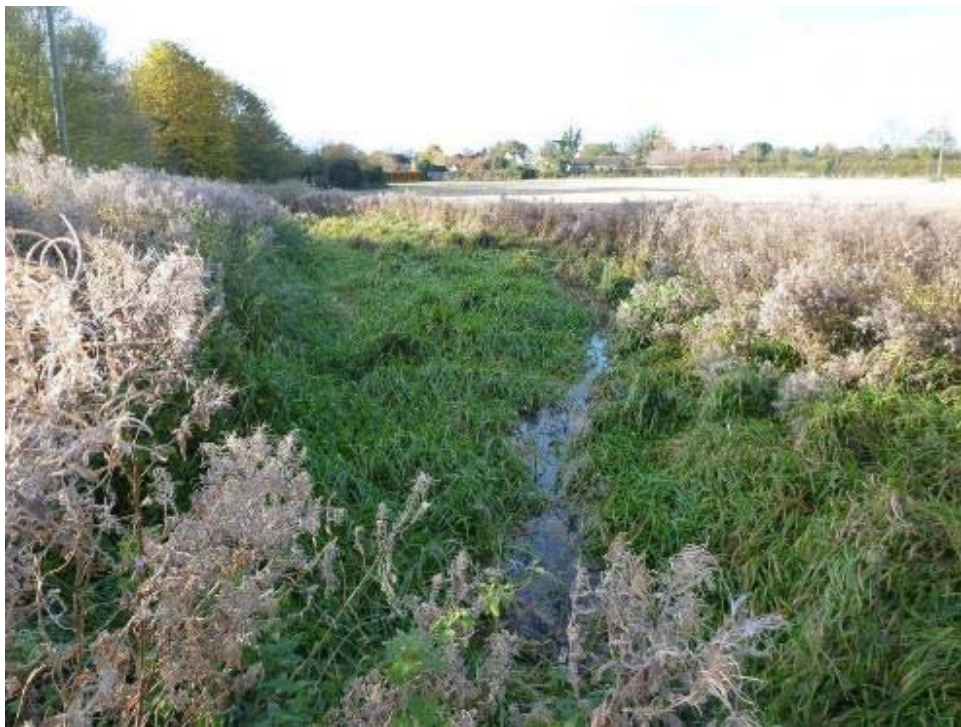
Where the beck emerges from the woodland (TF 08777 57861), the width and depth of the engineered channel increase and it is choked with emergent vegetation (Photo 31). The channel continues to become wider into an impounded mill pond within the grounds of The Mills, another former mill now private residence (Photo 32). The lack of emergent vegetation within the mill pond suggest it is regularly maintained. It was not possible to inspect the beck within the grounds of The Mills during this visit, but there is evidently a significant impoundment which is likely to be an obstruction to free fish passage.

Photo 31 Just downstream of Photo 30, the channel is widening and impounded above the mill pond at the Mills.

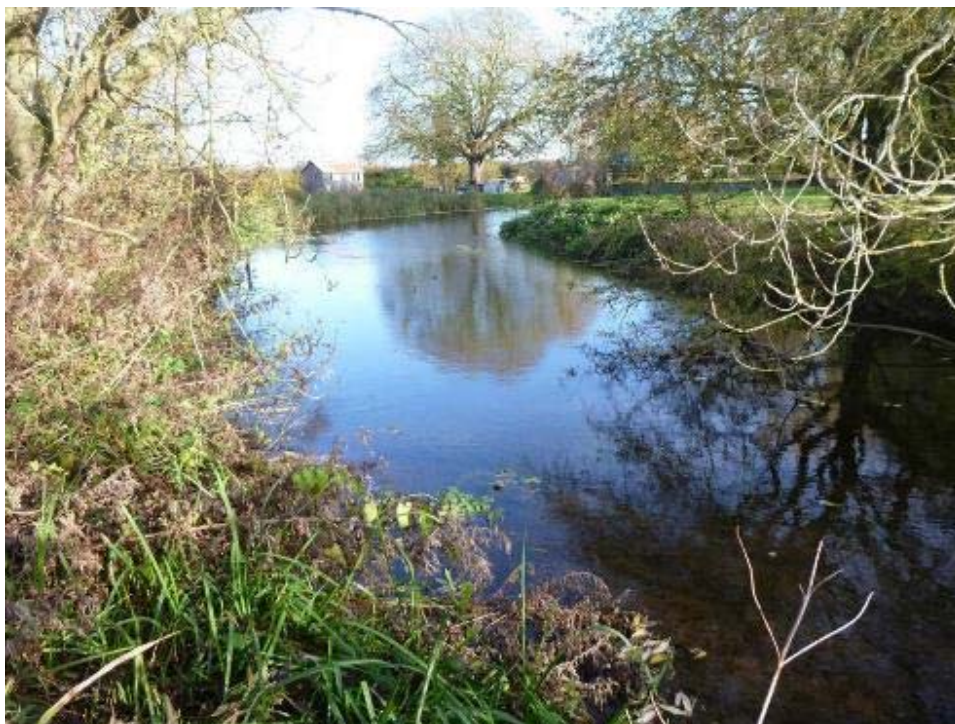
Photo 32 Impounded section of the beck at The Mills, Kirkby Green.

This section has the parcel of wood/scrubland on the right bank which potentially provides space for re-alignment and naturalisation of the beck channel, but the downstream end is affected by the impoundment at The Mills. As in the example above (Figure 1), any channel realignment would have to bypass the impoundment to provide the necessary gradient for habitat restoration. Further information on levels is required to determine feasibility. There is a public footpath through this area and a community habitat improvement project here could help enhance its amenity.
