Advisory Visit

River Sence, Leicestershire

11th September, 2008

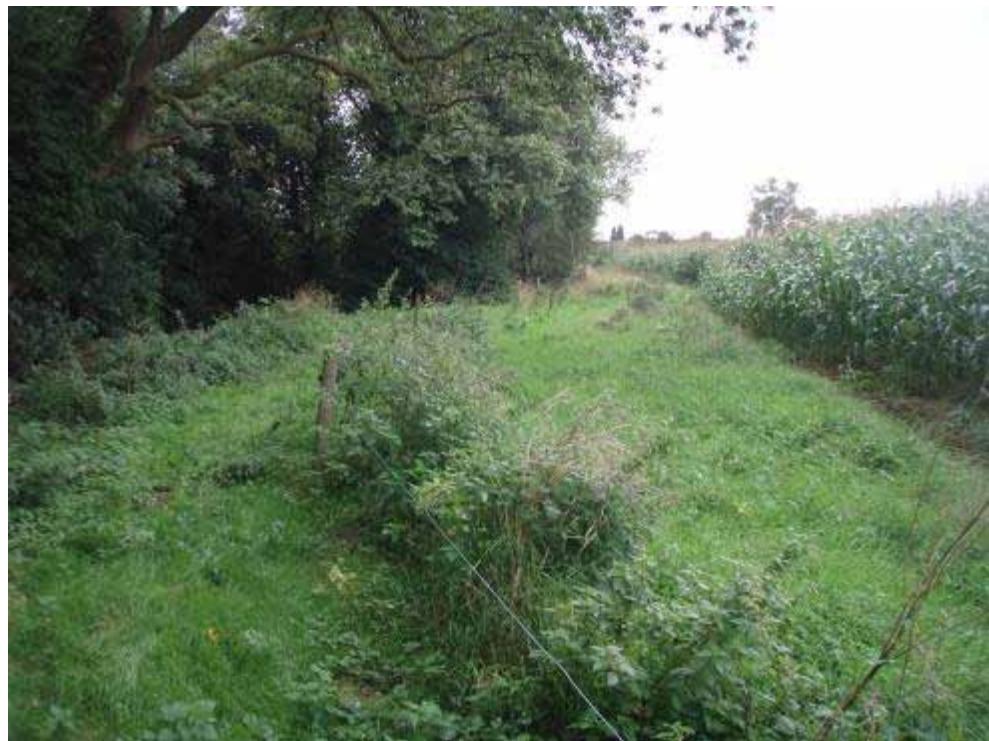
Downstream from the mill is the upstream limit of the water currently fished by Gopsall Fishing Club. The LHB is wooded, and the RHB is currently has a maize crop. Cultivation of maize can cause a problem with run-off of fine sediments from exposed soils during the winter; this can clog spawning gravels reducing the survival of trout eggs. However, there is a wide uncultivated field margin between the crop and the river in this location which should provide an adequate buffer against soil erosion (Photo 1).

Photo 1 A good margin between the maize crop and river

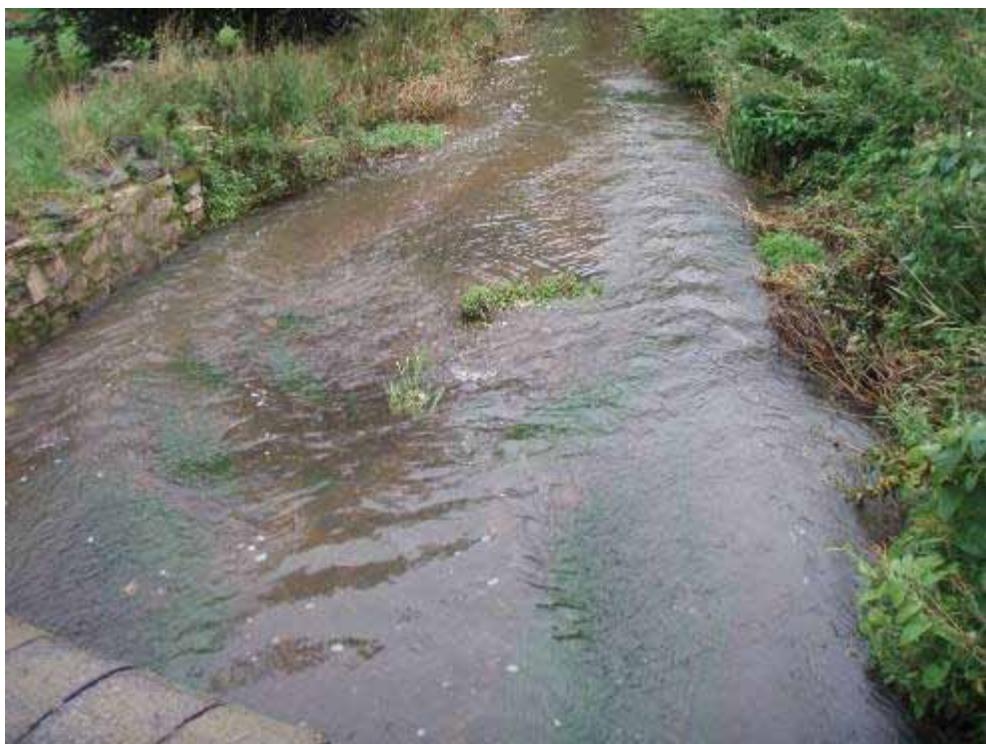
An area of shallow water with a well-sorted gravel substrate and beds of water crowfoot (*Ranunculus* sp.) is present immediately below the mill bridge (Photo 2). This is good spawning habitat and is a result of the river bed scouring caused by the narrowing of the river channel under the bridge. Just downstream of this area are other areas of less well-sorted gravel.

Photo 2 Well-sorted gravels downstream of mill bridge

- Use large woody debris (LWD) to create scour of the poorly sorted gravel substrate downstream of Help Out Mill.
- Reinforce the approaches to the ford with suitable material (ideally gravel, otherwise hardcore) to prevent trampling of the banks in these

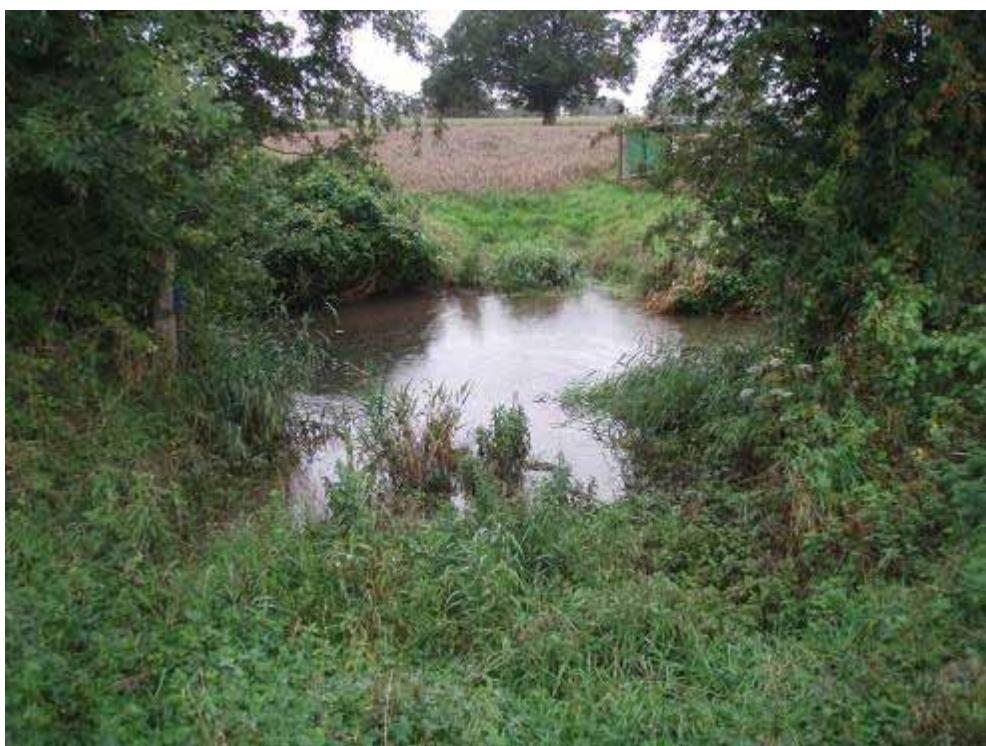
Upstream of the mill the RHB is a wheat field (which was grass last year) giving way to a wooded section, with game bird rearing pens. A ford links the wheat field to a field of grass and clover on the LHB. There is a good marginal strip alongside the river here on the LHB, fenced 4 to 5 metres away from the river. The banks are wooded with ash, hawthorn, sycamore, wych elm (larger trees dying), horse chestnut and field maple, and the canopy is heavily shading the river channel. The trees are shading out low-growing vegetation on the river banks, leaving some areas of exposed soils vulnerable to erosion potentially over-widening the channel (Photos 3-5).

Photo 3 Ford

areas by livestock, and generation of fine sediment input to the river. Create suitable barriers to guide livestock across the ford and prevent straying in the river channel.

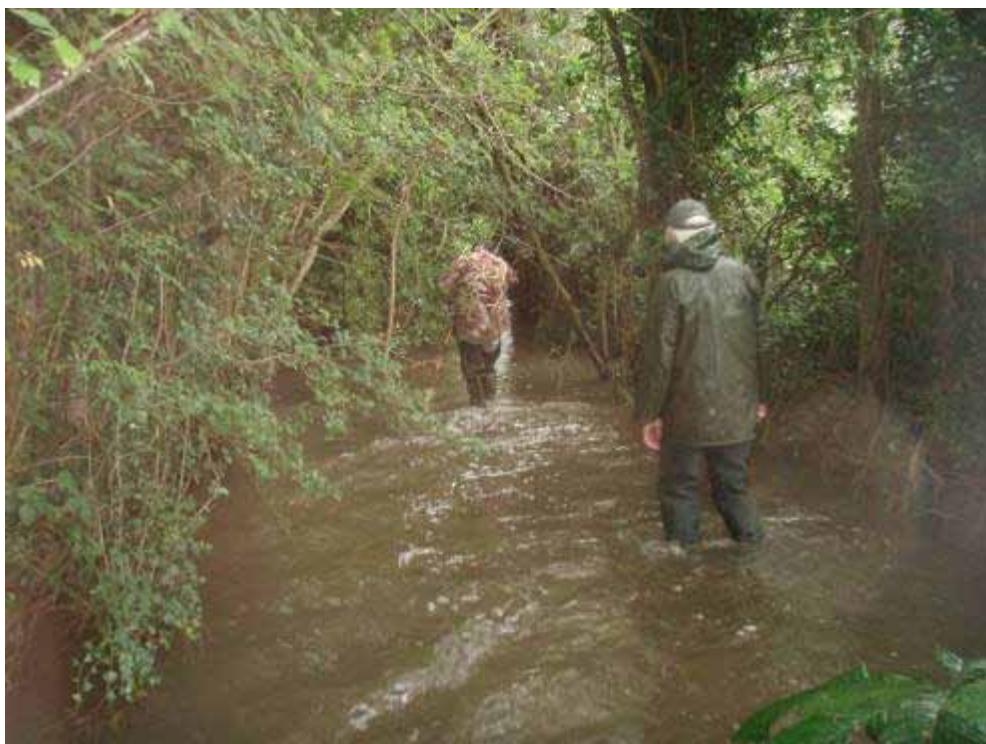
Photo 4 Heavy shading of river upstream of Help Out Mill

- Selectively thin the canopy of trees upstream of the mill, pollarding or coppicing appropriate trees on a rotational basis. Be careful to consider bats when planning tree works (large trees with cracks, crevices and ivy coverings are favoured by bats, a species with strong legal protection – if unsure seek professional help). Also leave standing any existing dead trees (Photo 7) as these are valuable habitat for invertebrates and birds (e.g. woodpeckers).
- Use the arisings from the tree management to introduce more LWD to the river channel to encourage scouring of the river bed and sorting of gravels.
- Retain and encourage low cover over the river channel, particularly where there are spawning riffles, as this will provide security for adult fish and encourage them to use these areas.

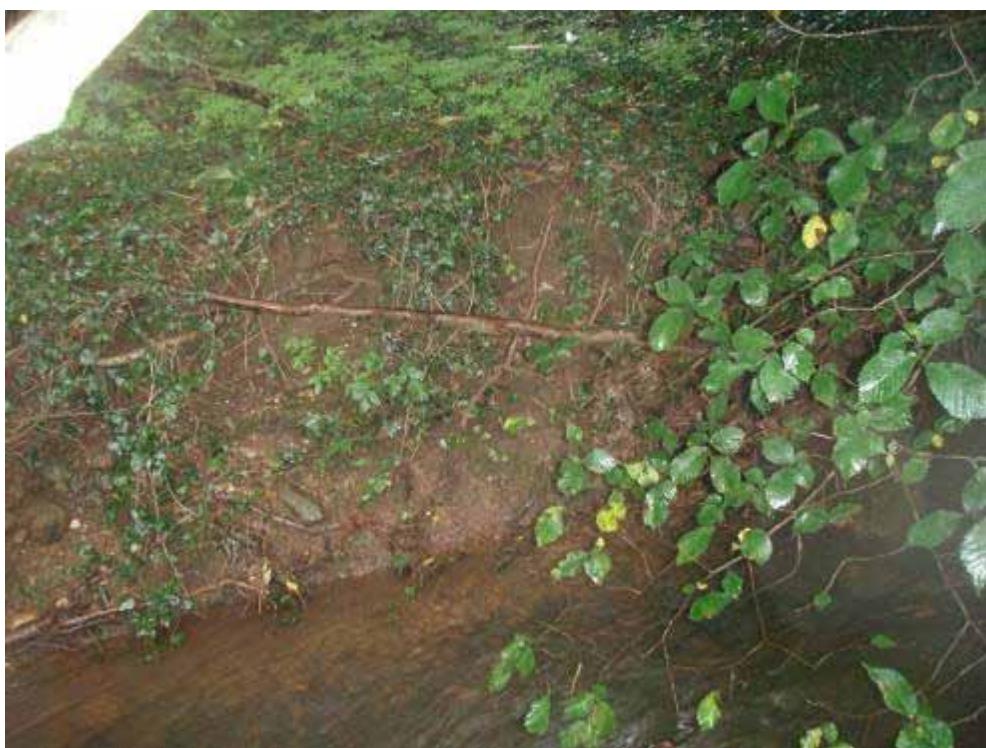
Photo 5 Exposed banks under the shady canopy

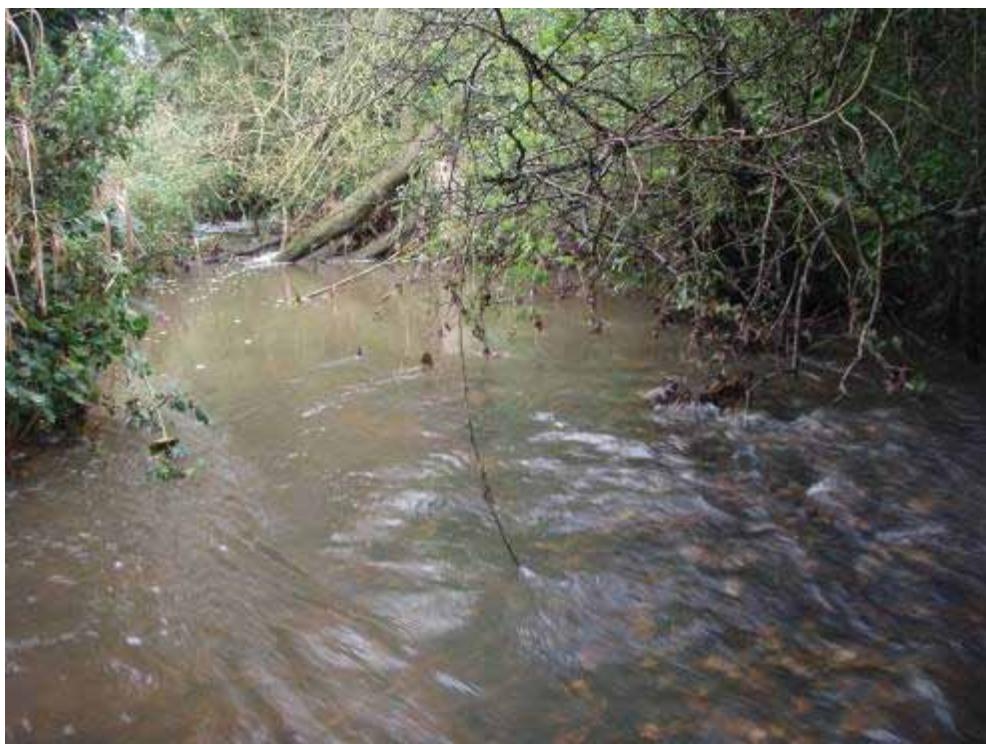
The river bed here is comprised of gravel of an ideal size for trout spawning, and there is a good bed profile with a pool/riffle sequence. The gravel is not particularly well-sorted, except in areas where LWD occurs in the channel; here bed scouring has deepened areas and thrown up banks of well-sorted gravel ideal for trout spawning (Photo 6).

Photo 6 LWD scouring a pool and throwing up well-sorted gravel

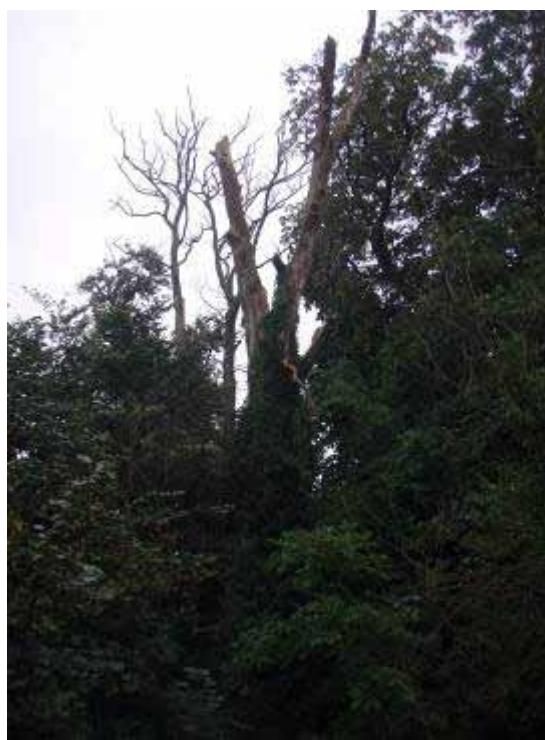
Photo 7 Leave dead trees standing

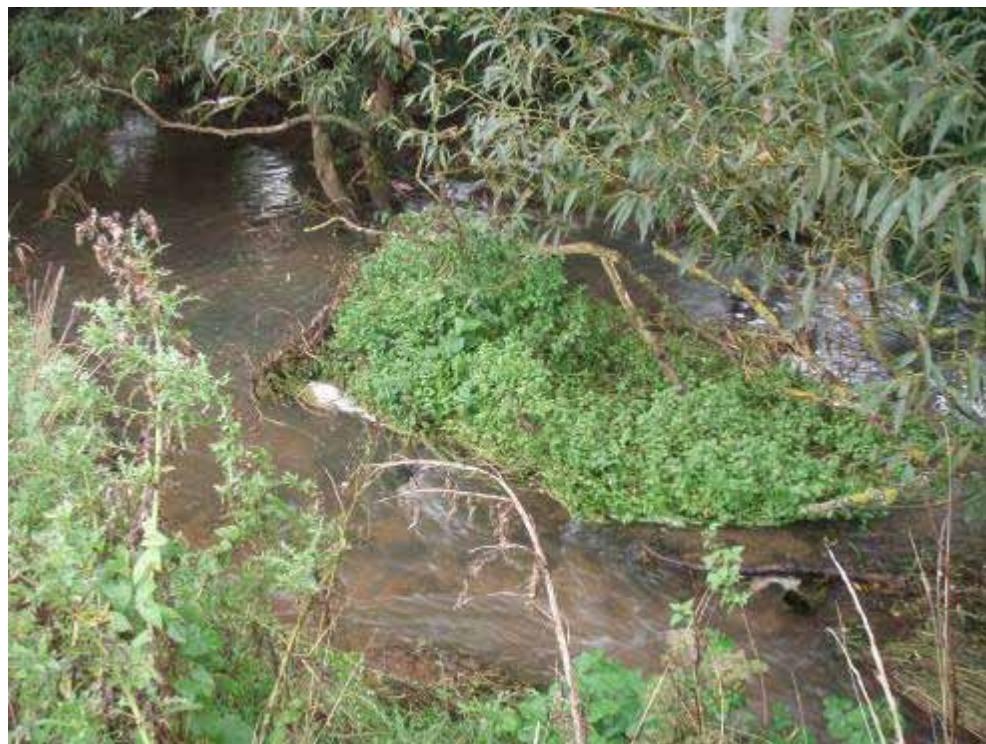
Upstream of the farm bridge the instream habitat is very good, some of the best on the River Sence. There is a pool riffle sequence, gravel substrate and good examples of LWD, including vegetated midstream islands and low cover over potential spawning riffles (Photo 8). There are plenty of opportunities on this stretch to introduce more LWD where there are willows already leaning over the river channel, and from risings from tree management (Photo 9).

Photo 8 Excellent habitat created by LWD and colonisation by vegetation

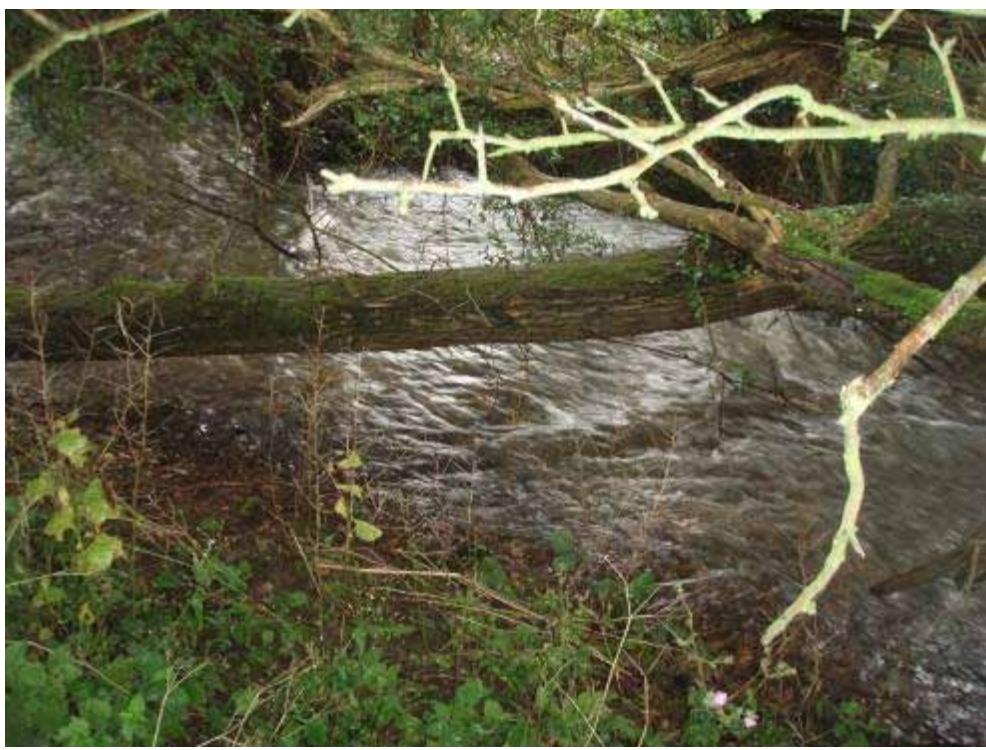
Photo 9 LWD waiting to be lowered into the river channel

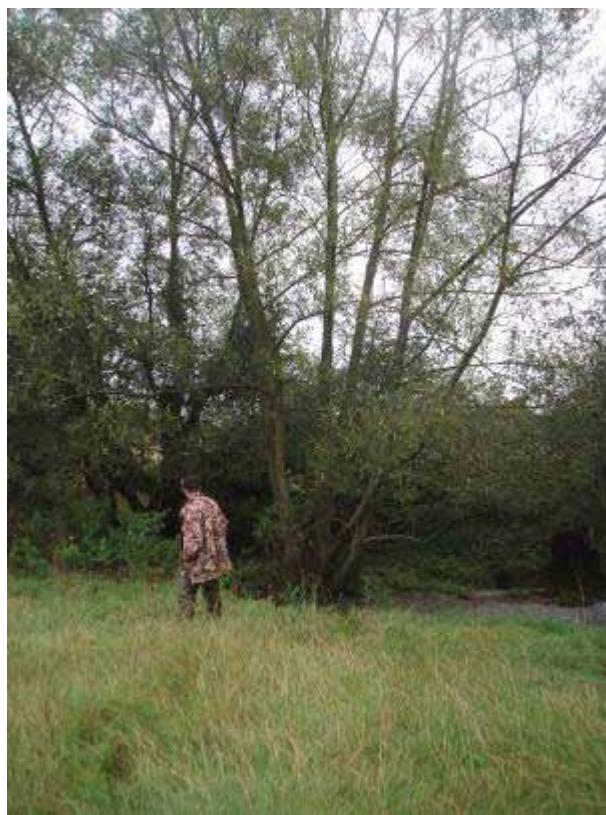
There are currently some tall willows along this section which would benefit from pollarding on a rotational basis (Photo 10). Units 2 and 4 of the SSSI (upstream of the road bridge) have an 'unfavourable recovering' status, and NE recommend scrub/hedge cutting and willow pollarding. It would make sense to liaise with NE and see if any of the works proposed for the river could be designed to help achieve favourable status for these units.

Photo 10 Larger willows would benefit from rotational pollarding

- Pollard the larger willows along this section on a rotational basis. This will reduce shading of the river channel, promoting growth of instream weed such as water crowfoot, and prevent the loss of large trees which could remove the root ball from the banks creating areas vulnerable to erosion.
- Introduce LWD to the river channel using arisings from tree management, or where there are existing opportunities in the form of leaning trunks and boughs.
- Liaise with Natural England over works which may improve the status of the SSSI.
- Keep a watching brief on plans to reinstate the water supply to the mill. This would involve impoundment of the river and may have consequences for the river habitat upstream, and free passage of fish.

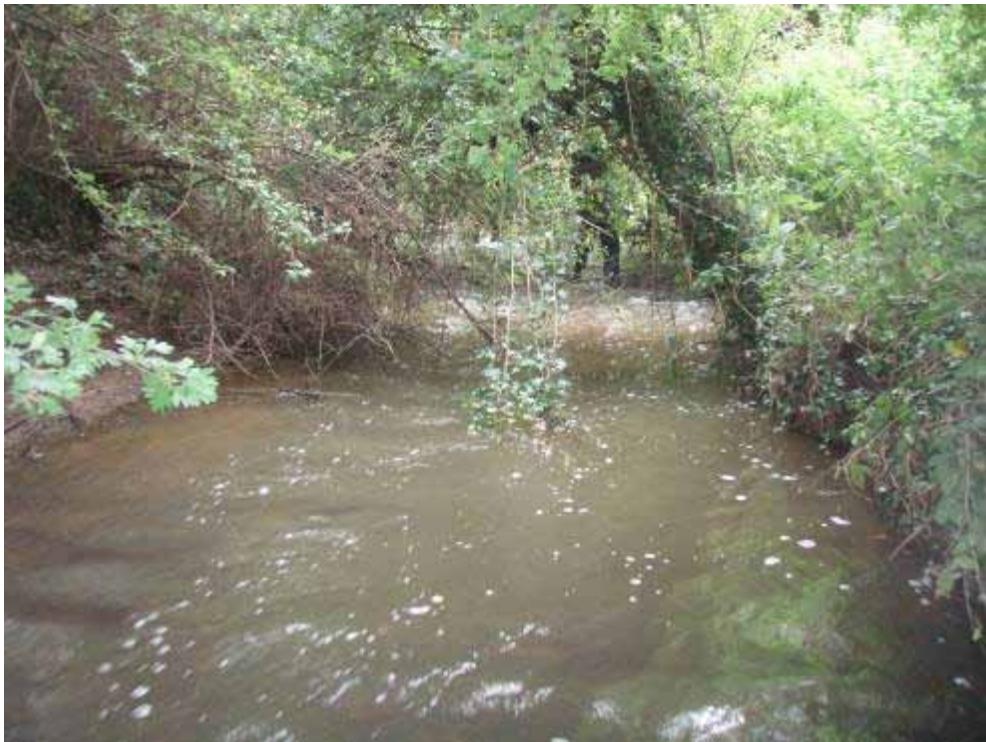
The reach is heavily shaded, mostly by hawthorn, and there is little instream vegetation (Photo 11).

Photo 11 Heavily shaded channel

- Manage bankside trees to create dappled shade along the river, and use arisings from tree management to introduce LWD to the river channel. LWD will provide good habitat for crayfish in addition to benefits to the river bed profile and substrate composition.
- Investigate the source of fine sediment inputs. Check the river during wet weather in the winter when vegetation has died back, and look for pathways for the ingress of fine sediment from fields, roads, land drains, etc.
- Ensure all equipment and clothing has been thoroughly dried or disinfected before accessing the river, to prevent the introduction of crayfish plague.

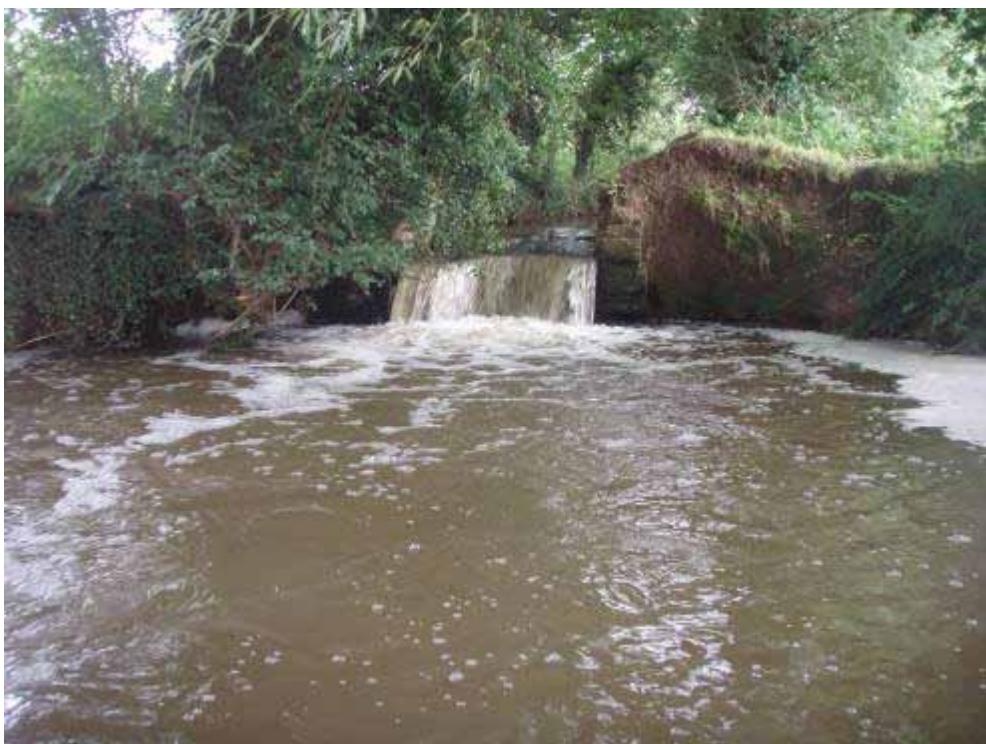
There is a weir (SK 38719 09742) with a crest height of approximately 0.6 m, and a large weir pool downstream. The weir presents a considerable obstacle to fish migration, and appears to be a redundant structure with no evident water take-off points upstream (Photo 12).

Photo 12 Weir and weirpool upstream of Tucker's Holt

- Remove the weir to facilitate free movement of fish within and between reaches of the river. Barriers to movement restrict daily and seasonal movements to access habitats for spawning, feeding and shelter and thereby limit fish populations.

Removal will require the agreement of the owner of the structure (understood to be Crown Estates), and liaison with the Environment Agency. The Water Resources department of latter will be able to advise if there are any rights of abstraction dependent upon the structure, and whether an impoundment licence is necessary for removal (contact Gill Roe). A Land Drainage consent will be required

and EA Development Control department (Sarah Mallett) should be consulted.

The presence of species with a high conservation value (native crayfish and otter) means it is essential that advice is sought on protecting these species during works, and an Environmental Impact Assessment (EIA) is likely to be required. It is recommended that EA Biodiversity staff are involved in the project at the earliest opportunity.

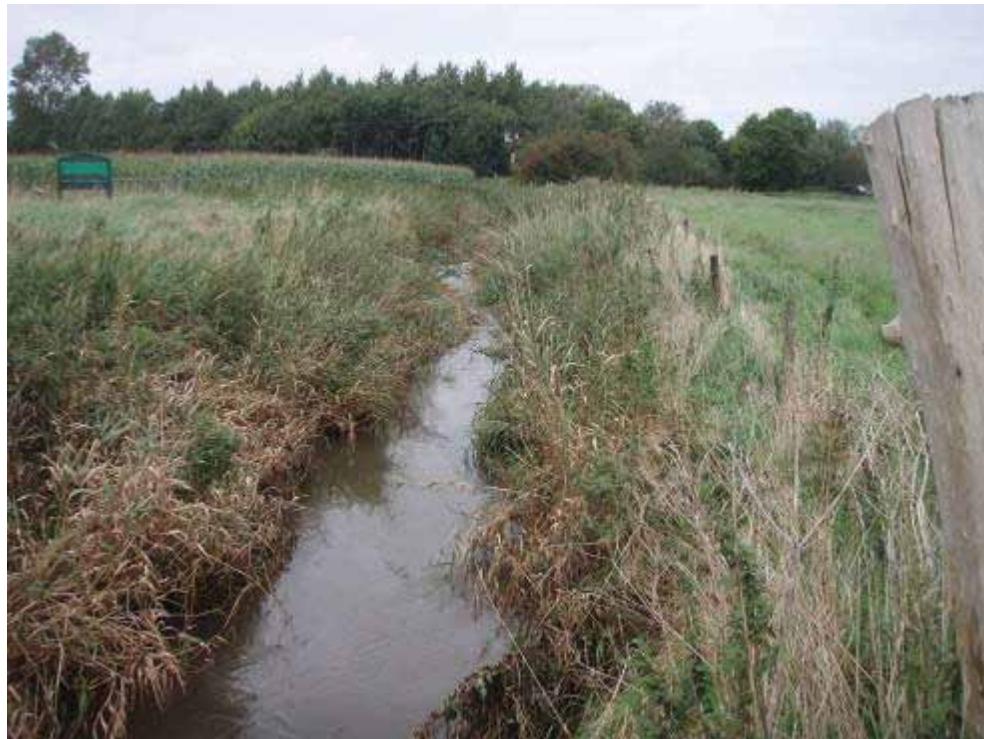
The channel here is straight and quite deeply incised suggesting past land drainage works have occurred. The channel is open, with a few hawthorn bushes and the odd small willow on the banks (Photo 13). Downstream of the grass field (LHB) there are more trees and the channel becomes more shaded. There was only one small example of LWD in this section.

The river bed here is mainly sand and silt, with very occasional areas of gravel and some exposed clay. There is little depth variation, most of the reach being about knee depth. The submerged plants present were

slow/stillwater species including Canadian pondweed (*Elodea canadensis*) and water-milfoil (*Myriophyllum* sp.). Emergent vegetation comprised bur-reed (*Sparganium erectum*), and reed canary-grass (*Phalaris arundinacea*), the latter having substantially reduced the channel width: further evidence of previous channel works creating an over wide channel.

This section of river is very poor habitat for trout, other fish species and wider biodiversity.

Photo 13 Straight, incised channel downstream of Heather Brickworks

- Ideally this section of the river needs major works to re-meander the channel, raise the bed level and reprofile the banks to reconnect the river with its floodplain. This would be a major project involving heavy machinery, the importing of large quantities of gravel and movement of large quantities of spoil.
- In the short term LWD could be introduced to promote scour of the river bed and increase depth variation.

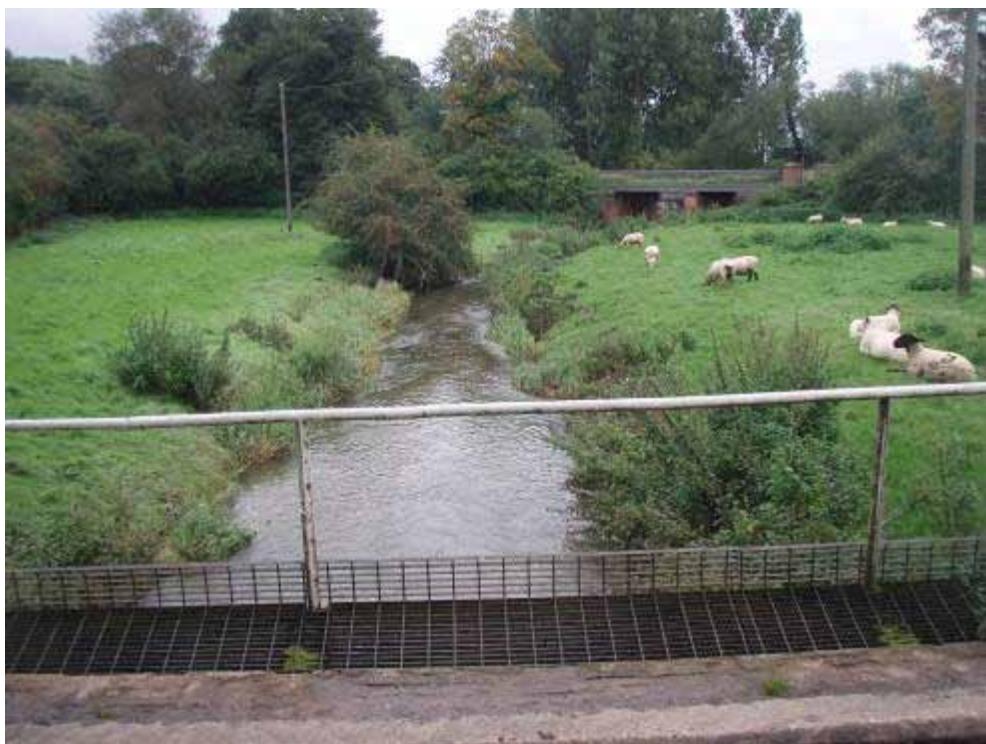
A short section of river downstream of the bridge at Shackerstone (SK 37806 06738) was inspected, between the Oaklands and Upper Cricket Field beats of Gopsall Fishing Club's waters (Photo 14). The section is open with lightly grazed fields on both banks, and beds of water crowfoot channelling the flow over some good gravels. The river flows under the canal aqueduct at the downstream end of this section. There is little need for improvement on this short section. A watching brief should be maintained on the level of livestock in the fields and their impact upon the banks, and possibly some LWD introduced on the straighter section.

Photo 14 River Sence at Shackerstone, upstream of the aqueduct

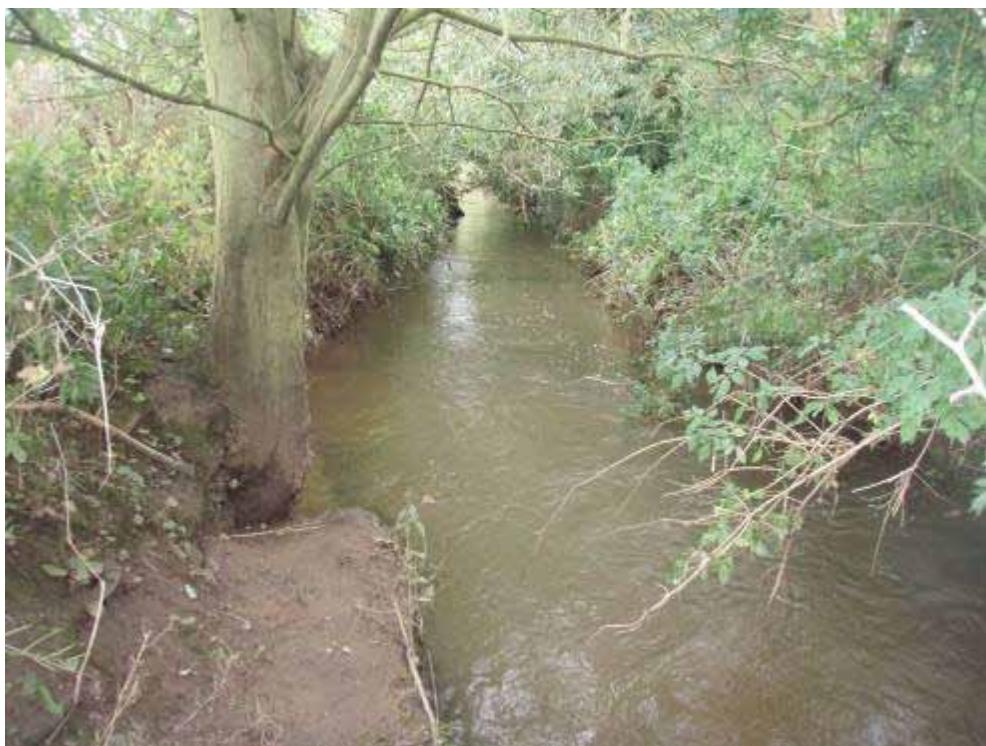
The Ibstock Brook joins the River Sence near Shackerstone at the downstream end of the Oaklands beat (SK 378 068). The brook is in a very incised channel and 60-70% shaded by trees meaning little light reaches the river bed and there is consequently an absence of instream vegetation. The absence of emergent and submerged weed and the straightened nature of the channel results in the river bed being comprised of fine, poorly sorted substrate, and a homogenous shallow depth profile. (Photo 15)

Currently the habitat in the brook is generally poor and of little value for trout. Rotational coppicing and pollarding may improve light penetration, but the incised nature of the brook could still be limiting. The introduction of gravel to raise the bed level, in combination with LWD and tree management would improve conditions and potentially create areas of spawning and juvenile trout habitat.

Photo 15 Ibstock Brook – heavily shaded, incised, straightened channel

- On the Ibstock and Bosworth Brooks, manage bankside trees to create dappled shade along the river, and use arisings from tree management to introduce LWD to the river channel. Faggot bundles and stakes should be used for channel narrowing and midstream islands, and LWD should be installed to promote bed scour. Work on the Bosworth Brook would deliver more benefit more quickly than the Ibstock Brook. The latter would also require the bed level raising by introducing gravel which would increase costs.

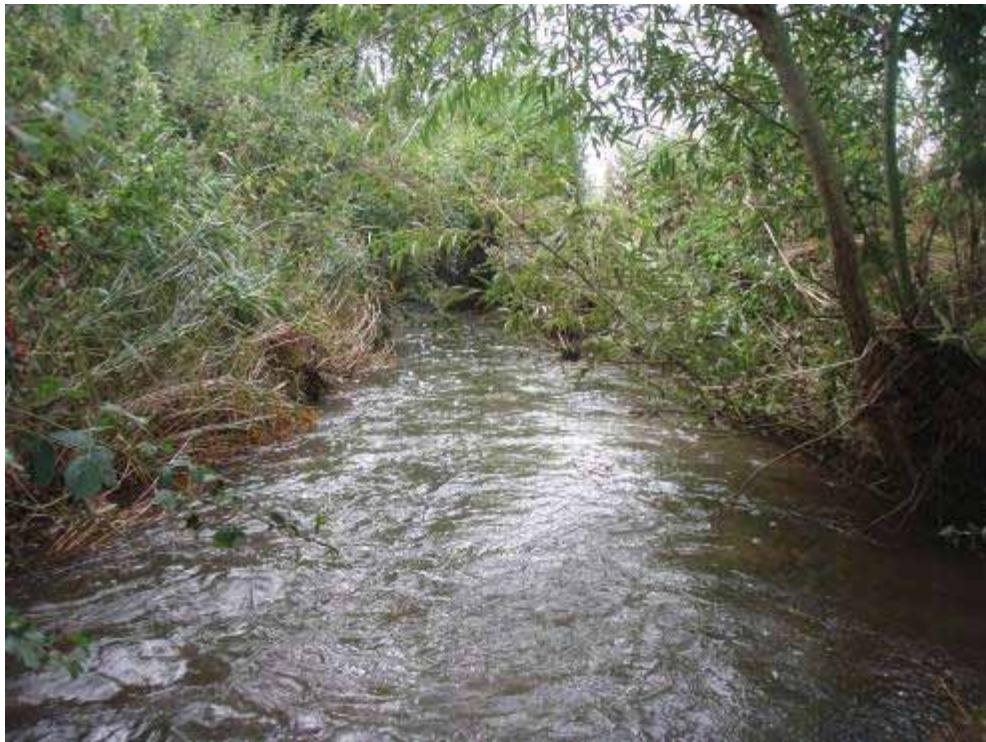
The Bosworth Brook joins the Sence downstream of Bilstone on the lower section of Gopsall Fishing Club's waters (SK363042). The brook has a better sediment profile than the Ibstock Brook, with more gravel present, and it is in a less incised channel. There is some depth variation, but the channel is very straight and examination of a parish boundary (on OS map) which followed the previous course of the brook confirms the brook has been previously straightened (Photo 16).

Photo 16 Bosworth Brook

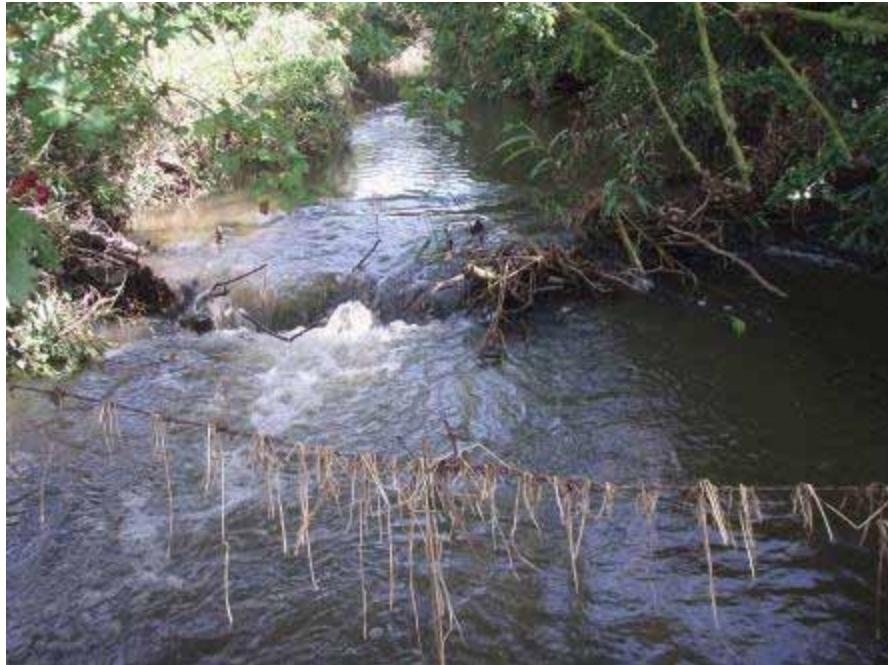
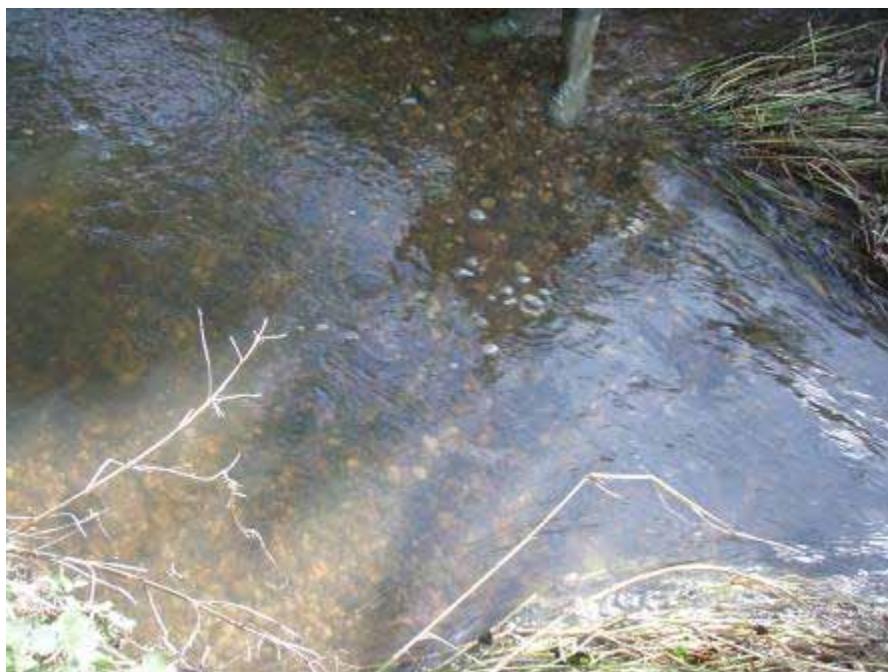
A good example of where in-channel structure has created better habitat was seen where two strands of barbed wire had been strung across the channel at a field boundary. The wire had sagged into the brook and formed a small debris 'dam' under which the flow had scoured a pool and thrown up a bank of sorted gravel downstream. Mimicking these effects with introduced structures is the key to improving trout habitat on this brook (Photos 17 and 18).

Photo 17 Debris dam caused by barbed wire...

Photo 18 ...and the gravel scoured and cleaned as a result.

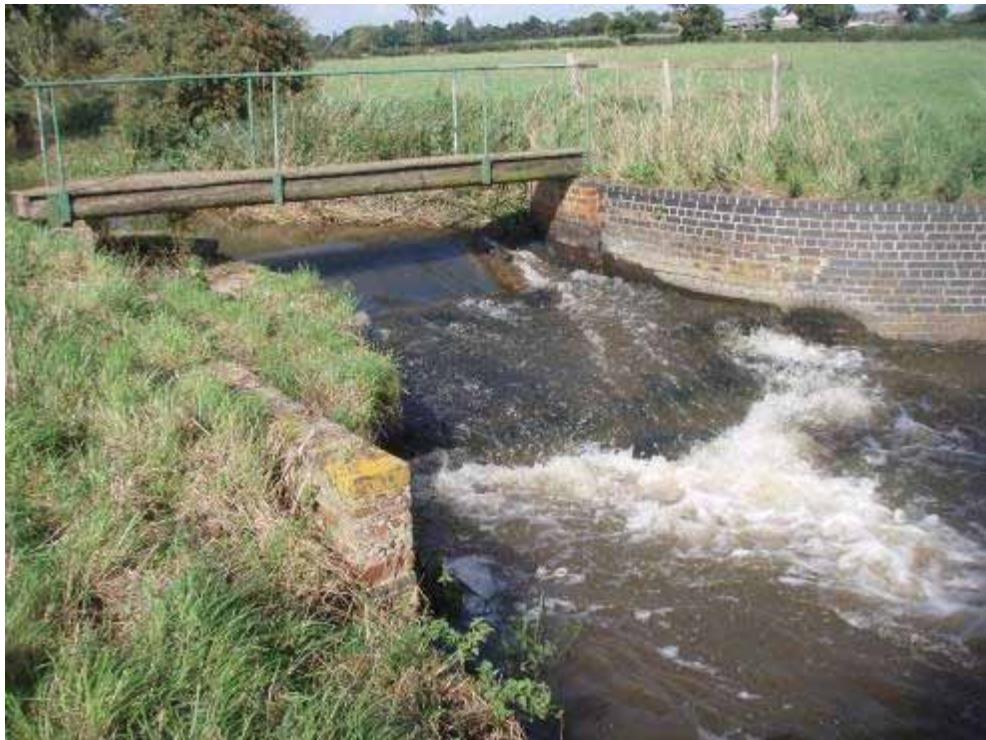
Just upstream of the Bosworth Brook – Sence confluence, on the main river, a weir was inspected (SK 36353 04412) (Photo 19). The weir has a sloping face with the facility to insert two weir boards (telegraph poles) about halfway down at a break in the gradient of the glacis; the club routinely leave the weir boards out. The weir is a considerable obstacle to the free

passage of fish, because of the fast flow of water on the sloping face. It may be possible to improve the structure in terms of fish passage with a relatively simple easement.

Photo 19 Weir on the Sence upstream of Bosworth Brook confluence

- Improve fish passage at the weir on the main river. The options and process for improving fish passage are set out in the Environment Agency's Fish Pass Manual (available from Greg Armstrong greg.armstrong@environment-agency.gov.uk). These include removing the obstacle, or constructing a fish pass, bypass channel, or easement. The latter is probably the least expensive option and requires less formal authorisations than other options.

The EA's National Fish Passage Panel (NFPP) can be consulted for advice on improving fish passage. It is recommended that more information is gathered regarding the structure (using as a template the fish pass concept form, Appendix IV of the above manual), and the NFPP's opinion sought via Greg Armstrong.
