Advisory Visit

River Sence, Sheepy Magna, Leicestershire

November, 2012

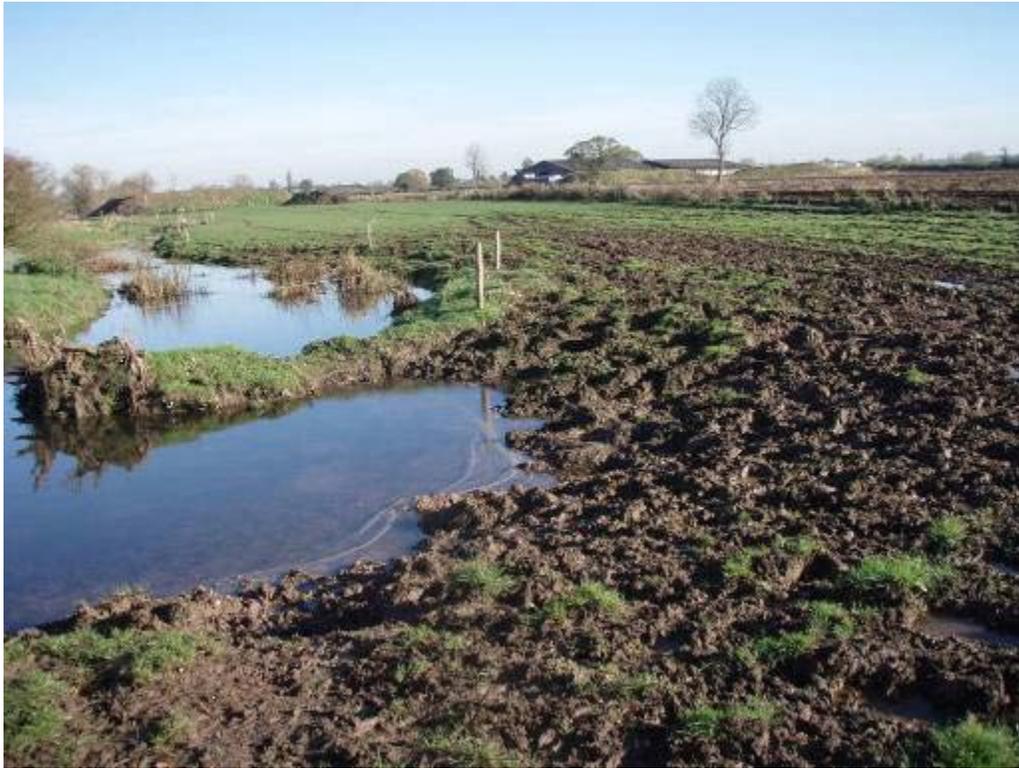
The fields downstream of the farm track are grazed and at the time of the visit were heavily trampled by cattle (Photo 1). Livestock has unrestricted access to the river bank and marginal emergent vegetation is grazed down; the poaching effect of the cattle is also causing the river channel to widen (Photo 2), which is undesirable. These fields are to become permanent grassland under the HLS agreement and overall grazing levels reduced; in addition, it is recommended that a wide margin and headlands alongside the river are further protected from grazing in a similar manner to the downstream part of this section (see below). Alternative drinking provision for livestock is desirable to avoid the situation in Photo 1.

Photo 1 Bank poaching at livestock drinking point, downstream of farm track

- Establish grassland and low-input meadows alongside the river wherever possible.
- Protect the river margins from grazing, managing them in a similar way to the lower (downstream) section of the Sence. Provide alternative livestock watering facilities if required.

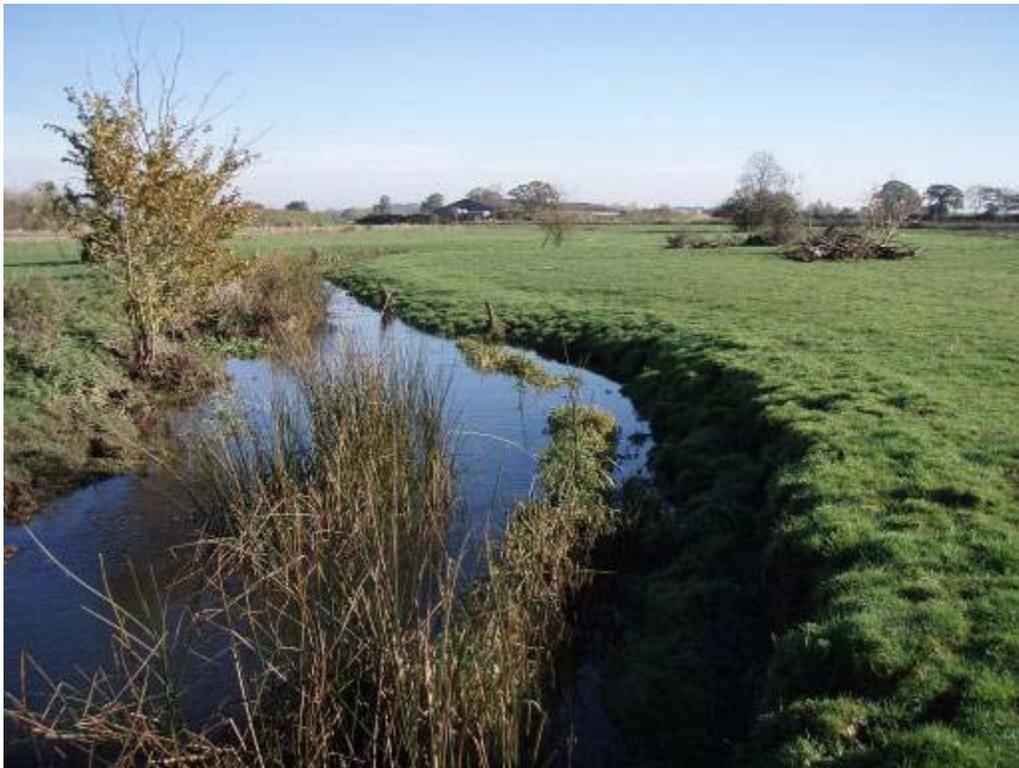
Photo 2 The channel-widening effect of grazing, where banks are trampled in and eroded and marginal emergent vegetation is grazed off.

- Re-profile the banks on inside of bends to provide a more natural channel cross-section (Photos 16, 17)
- Narrow the channel in cattle poached areas by pegging woody debris in the margins, dig out mid-river club-rush beds and place on top (Photo 17).
- Raise river bed levels in selected areas (straighter sections between pools) by introduction of gravel. It may be possible to do this in areas where club rush beds are present by digging out the vegetation, then raising the bed level with introduced gravel.

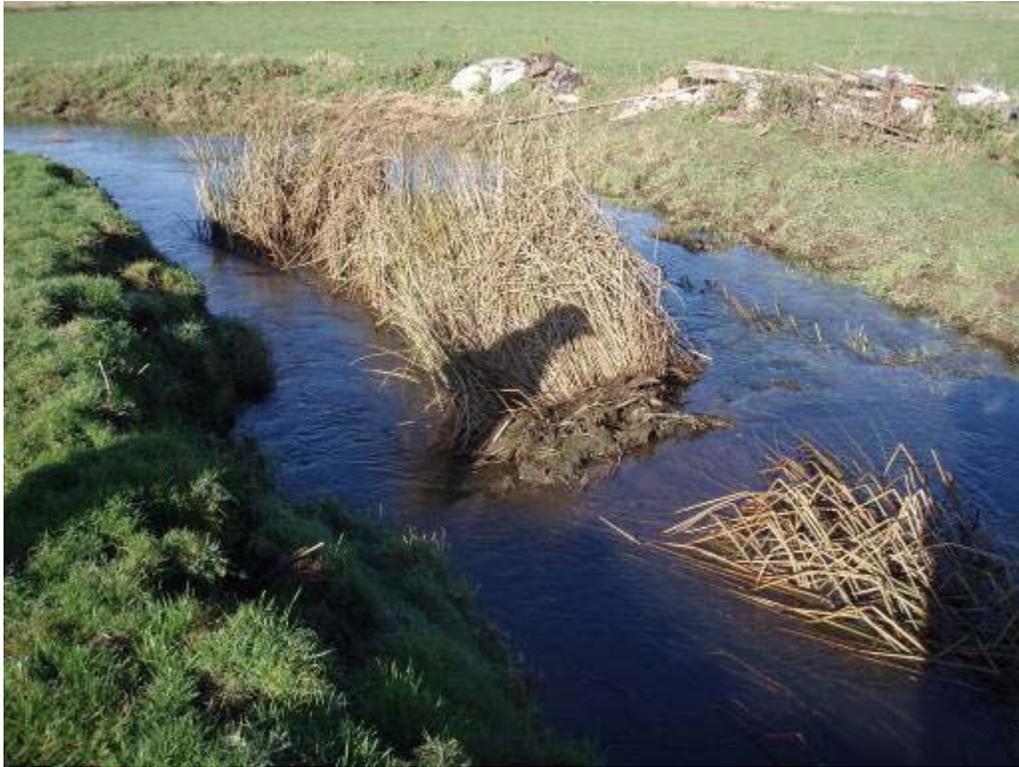
Photo 3 Stands of common club-rush in mid-channel

The above recommendations on managing the river channel should give considerable scope for tackling beds of club rush that are tending to create channel blockage. The key to sustainable management is to create the flow conditions that do not favour this species, i.e. a narrower channel with faster flows, or raising the bed level with gravel. Reducing grazing pressure and allowing the channel to narrow naturally will go a long way towards this.

Physical removal of the club rush beds in isolation is not recommended, because the channel conditions will remain the same and it will tend to grow back. Similarly, the use of herbicide (e.g. glyphosate, requiring Environment Agency consent) may get rid of club-rush in the short term, but does not change the physical conditions that favour its return.

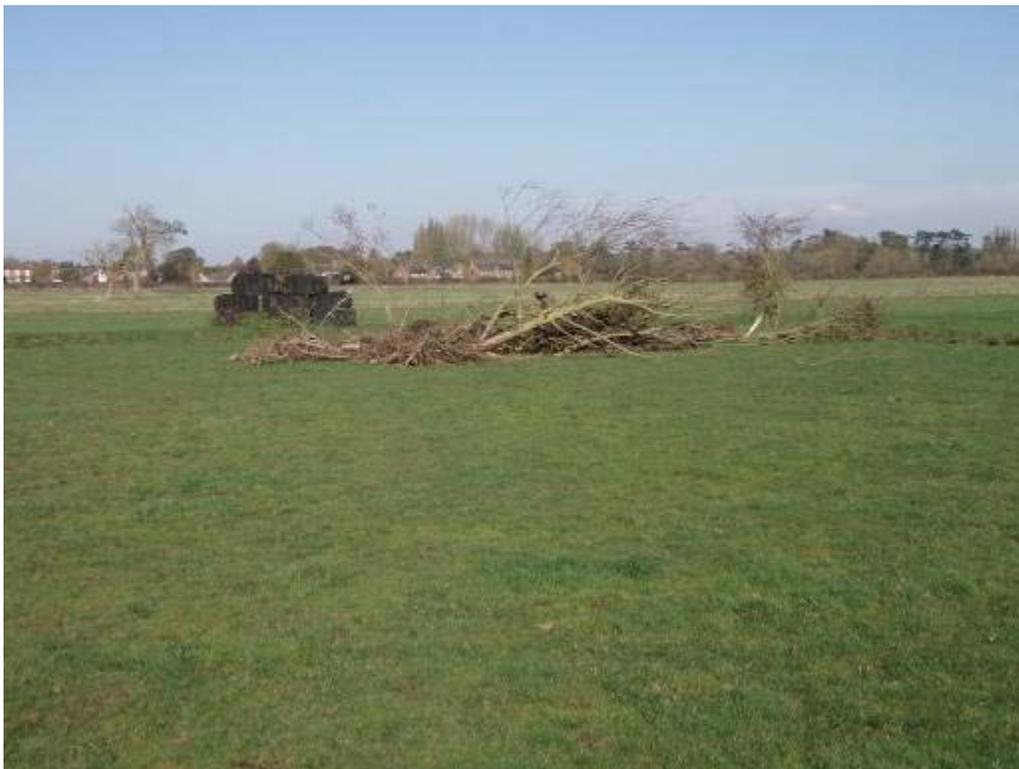
Accumulations of debris have been removed from the river recently (Photo 4). These had gathered at points where the channel is choked by beds of club-rush, leading to more impoundment and club-rush colonisation. In terms of river habitat, it is normally best practice to leave accumulations of woody debris in place because they provide refuge and feeding opportunities for fish and can help to modify the nature of the river bed and channel in beneficial ways. However, in this case the vicious circle of club-rush colonisation and channel blockage does require some intervention. Re-location of the woody debris and management techniques for club-rush are covered in the Recommendations section.

Photo 4 Woody debris recently removed from the river channel where it tends to accumulate against beds of club-rush (above).

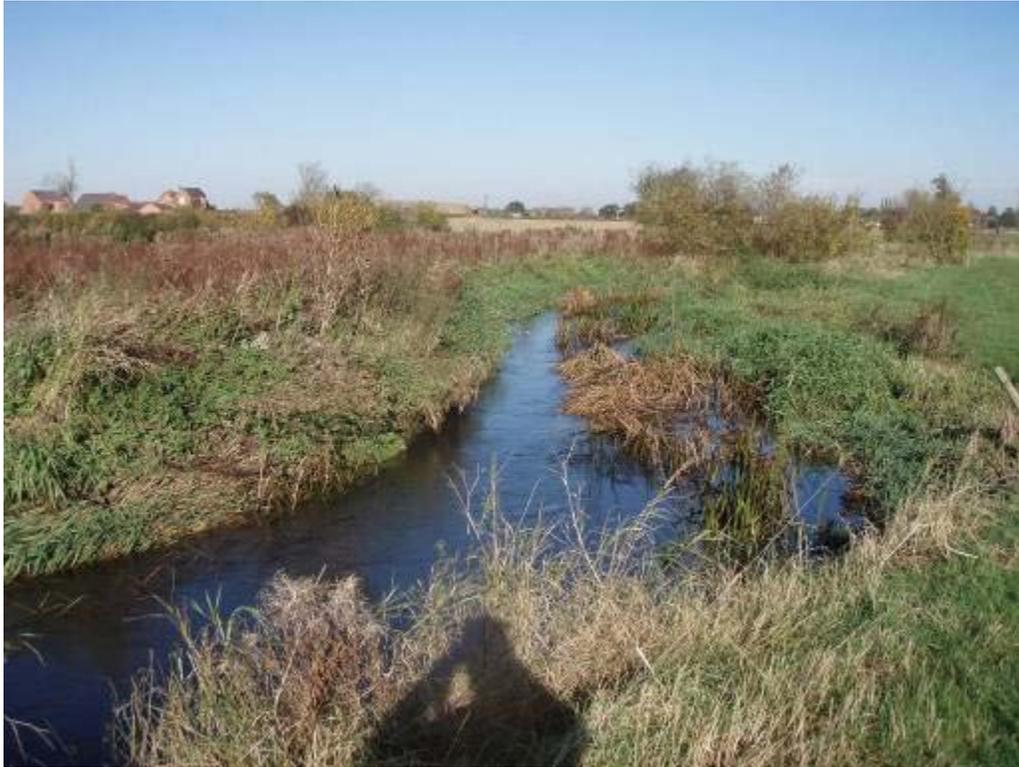
Towards the downstream end of this section, grazing pressure is lighter and some headlands between meanders have been electric-fenced, creating rougher vegetation (Photo 5). This is of great benefit to the river because the margins have colonised with vegetation and the river channel has narrowed; the shaggy, over-hanging vegetation and bushes also provide excellent cover for fish (Photo 6). This management also seems to benefit birds as several snipe and wild grey partridge were seen in this area.

Photo 5 Fenced margins and headlands on the lower section provide much better habitat alongside the river. Note the narrower channel compared to Photos 1 and 2.

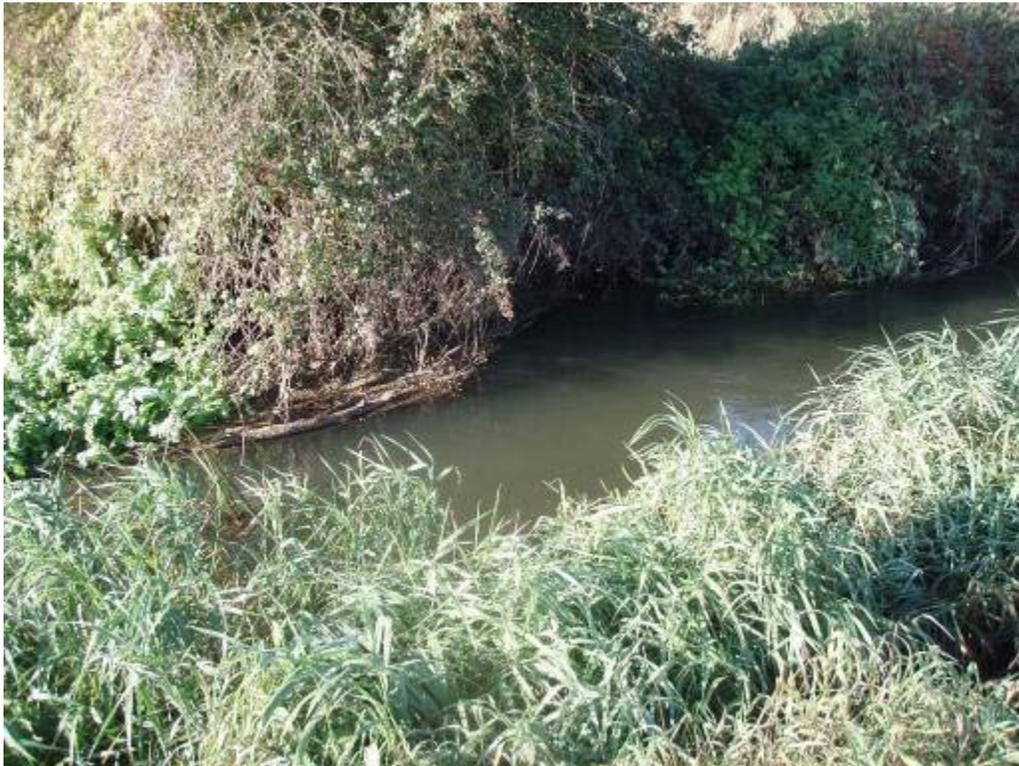
Photo 6 Over-hanging bushes and shaggy marginal vegetation – superb riparian habitat.

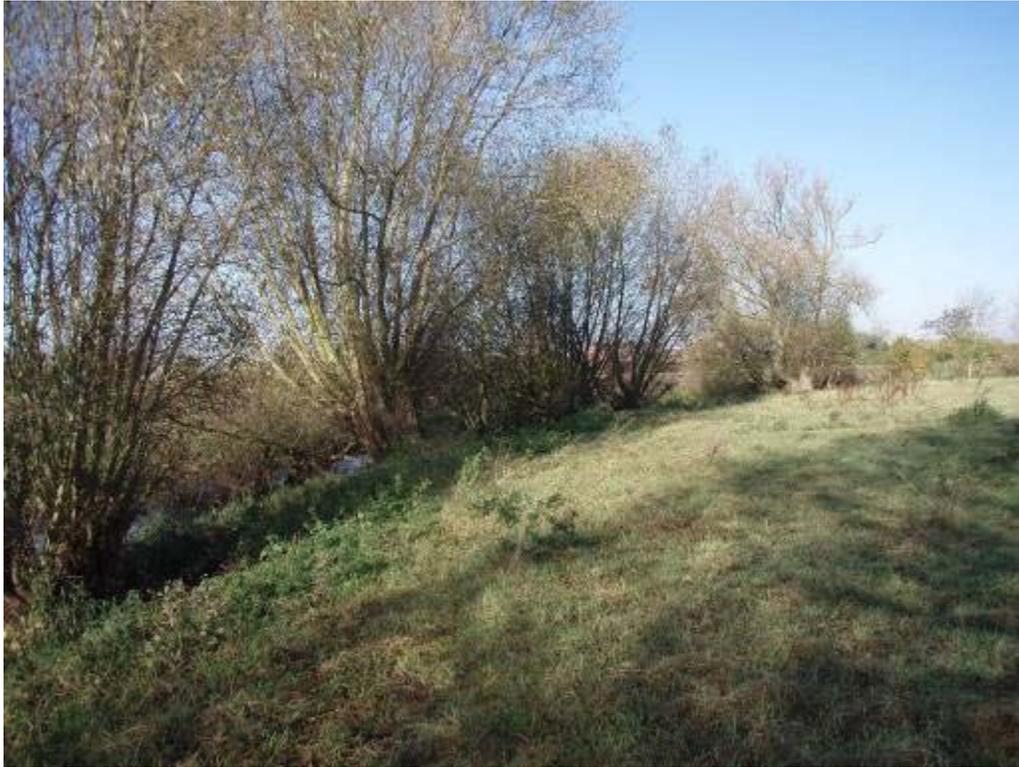
Trees are more common on the river bank here, the majority being crack willow (*Salix fragilis*); many of these have been previously pollarded and most are now reaching the stage where this is again necessary (Photo 7). Some limbs have cracked and fallen into the river, creating good habitat in some areas (Photo 8). However, the tendency for crack willow to take root and grow vigorously means frequent management is required to prevent channel blockage. Establishing different native tree species along the river (in all sections) is highly desirable; this would provide a diversity of habitat and a future supply of woody debris in the river that would require less frequent maintenance. Desirable species include alder, sallows, hazel, blackthorn, hawthorn, oak and ash (subject to current concerns over ash die-back).

Photo 7 Crack willows reaching the stage where pollarding is required.

- Coppice crack willows on a rotational basis, doing a proportion during each year of the HLS agreement.
- Retain trailing and submerged branches, pruning the minimum required to prevent channel blockage.
- Establish a greater diversity of native trees alongside the river, using HLS options if possible.

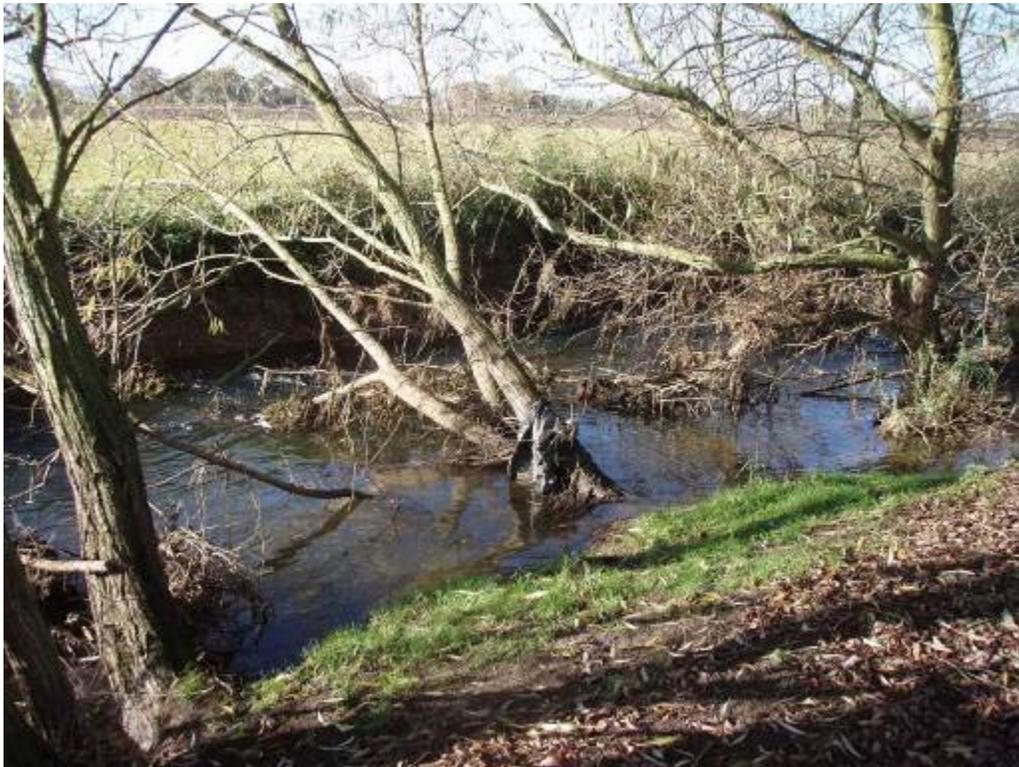
Photo 8 The cover and flow diversity provided by these trailing branches and trunks is excellent, but being crack willow this will take root and grow. Rather than removal all in one go, cutting back a small proportion each year and leaving some low and submerged branches over half the channel width is recommended.

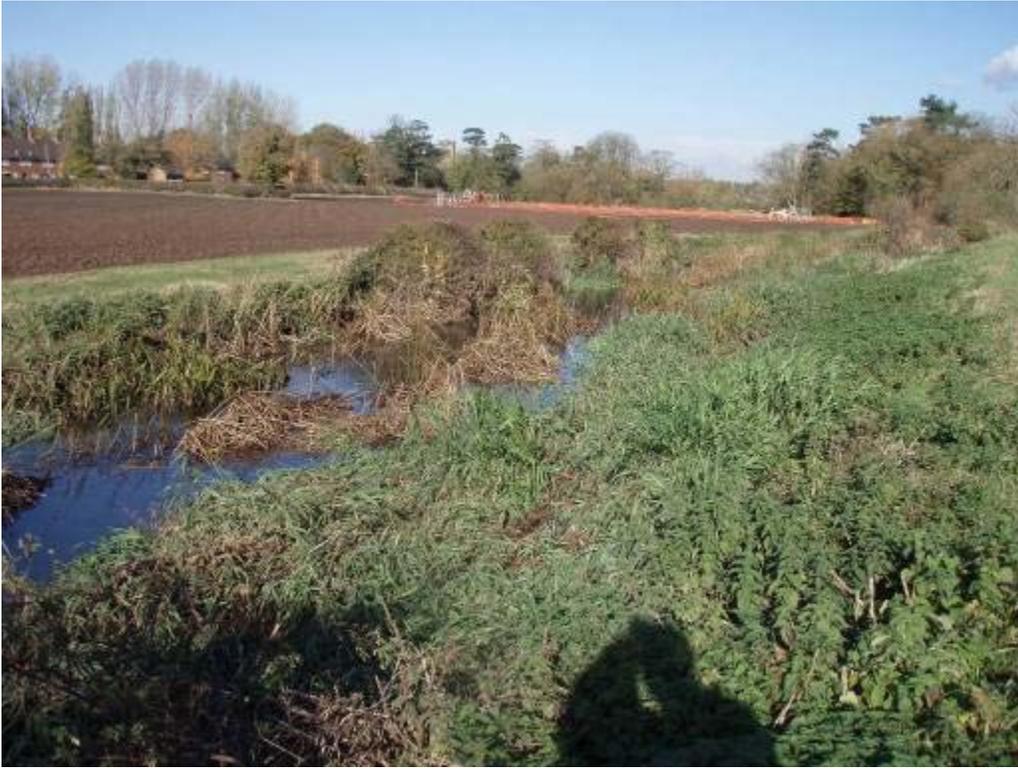
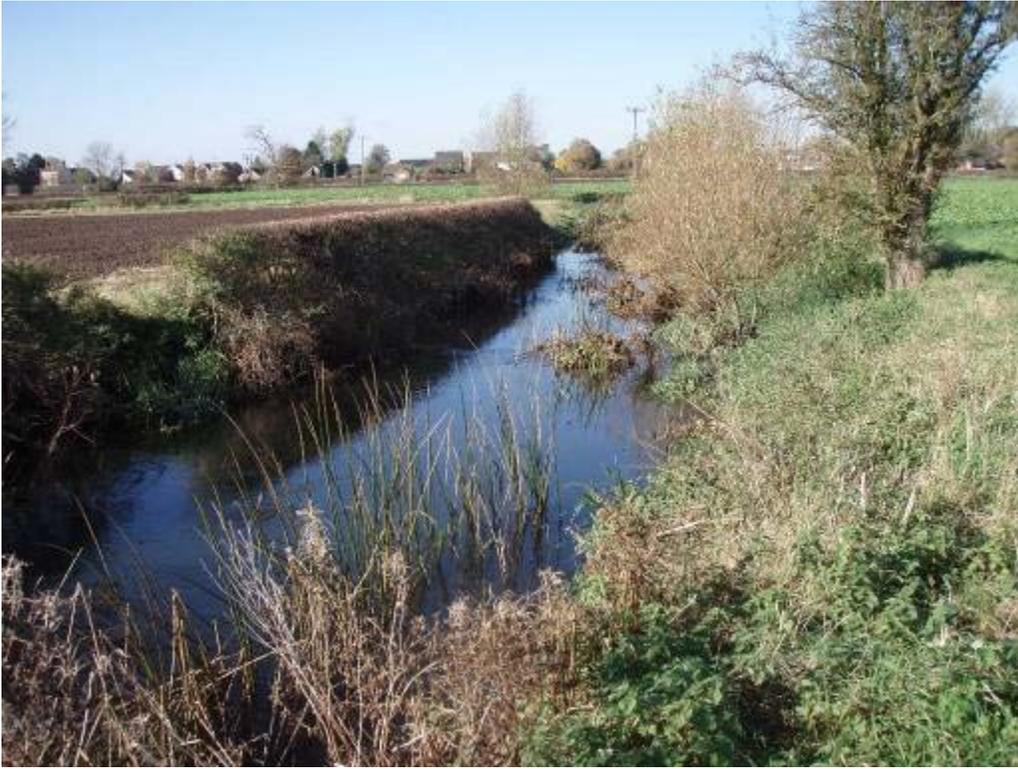
In contrast to the previous section, this reach of river appears artificially straight with few meanders. Inspection of historic maps (www.old-maps.co.uk) shows that the river was in its present course in the 1880s. The river channel is over-wide, particularly on the upstream part, probably as a result of works to alleviate flooding in the village. At the time of the visit, the channel was heavily encroached with emergent vegetation and it seems no channel maintenance has been carried out recently (Photos 9, 10).

Photo 9 Upstream reach towards Sheepy Magna village – over-wide channel choked with emergent vegetation

Photo 10 As above

The straight, over-wide channel is generally poor habitat for fish. It would benefit from the creation of a two-stage channel comprising a low-flow channel (with a natural base-width) between low berms within the wider flood conveyance channel. Given the proximity to the village, such work would need to be carefully planned and modelled, but should be achievable without increasing flood risk. It may be possible to improve the flood risk situation given propensity for the existing channel to become silted and choked with vegetation.

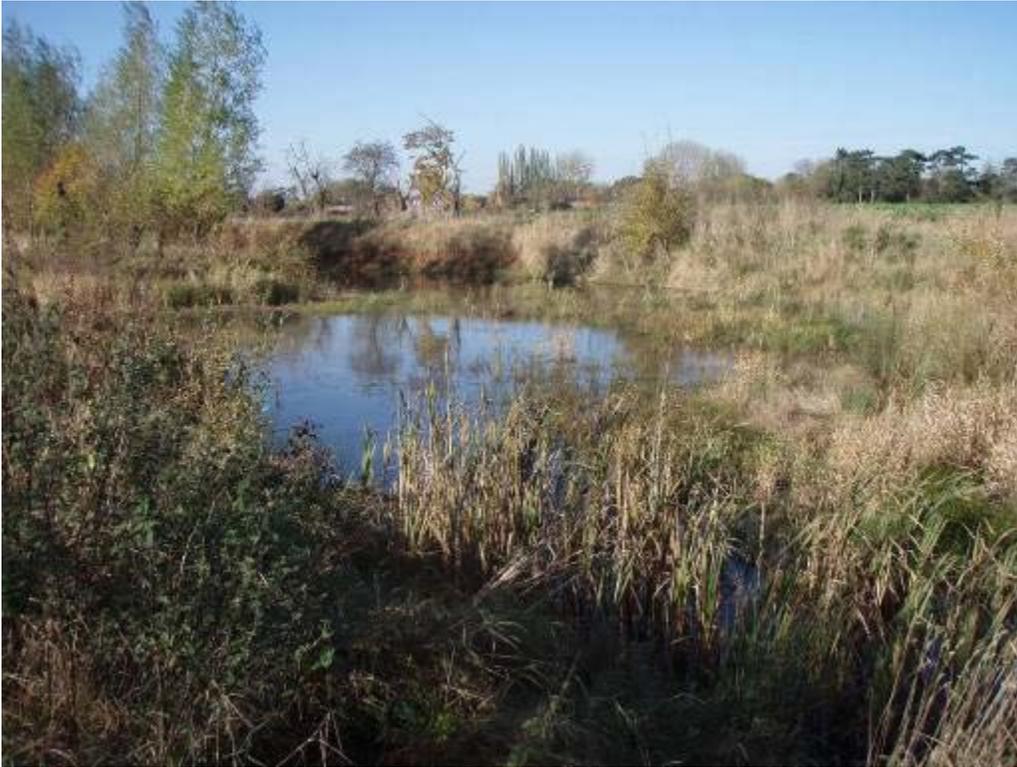
At the downstream end of this section a wildlife pond has been created on the left bank. The spoil from this forms a higher bank alongside the river here, and there are more trees present (Photos 11, 12).

Photo 11 Wildlife pond

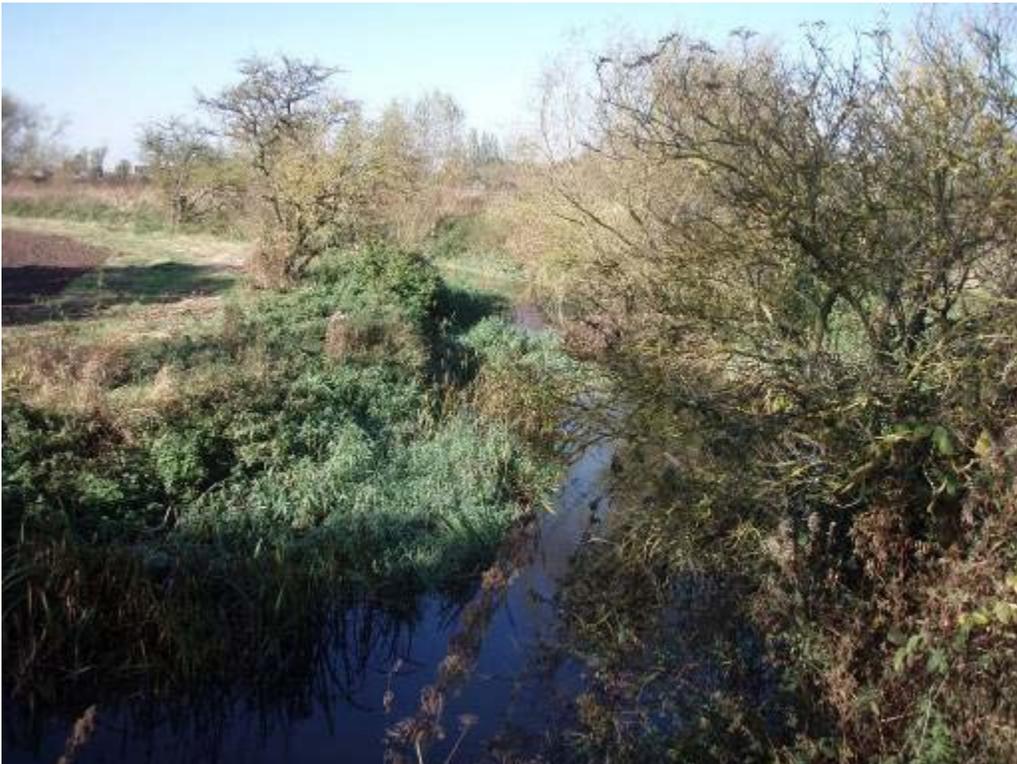
Photo 12 River alongside pond, with raised left bank (right of picture) and better riparian habitat including bushes, trees and coarse vegetation.

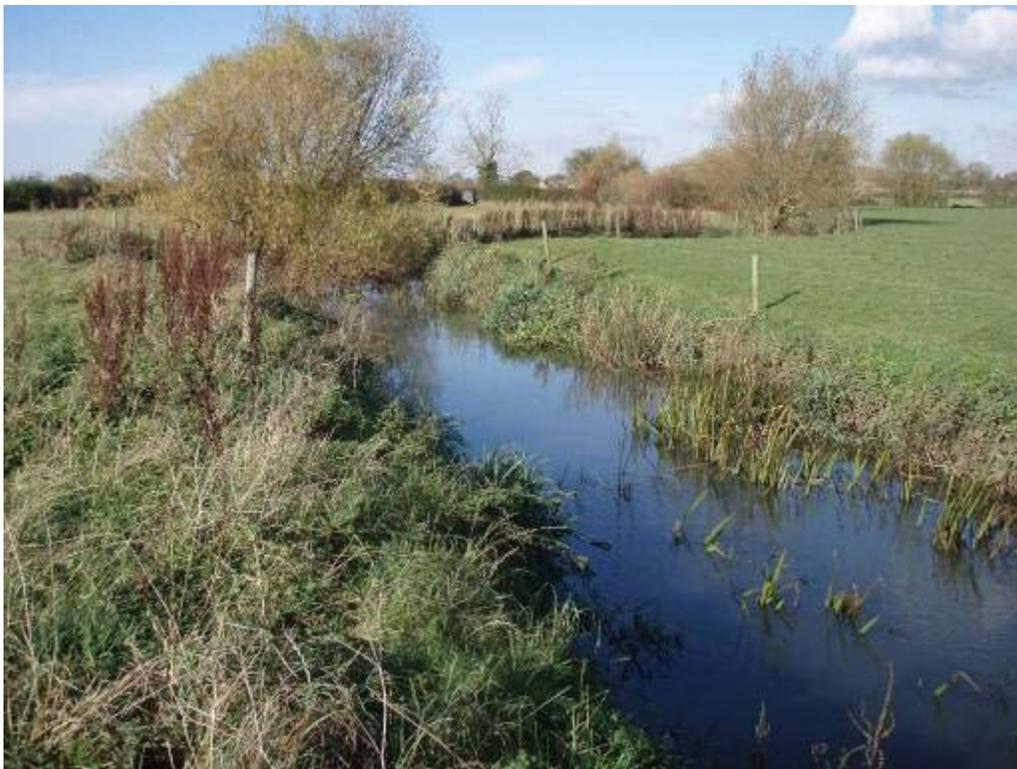
Photo 13

The Sibson Brook has a meandering plan-form but its in-stream habitat has been adversely affected by past land drainage works (bed lowering), with the same impacts as described above (Photo 13). Mr Calcott owns the right bank here.

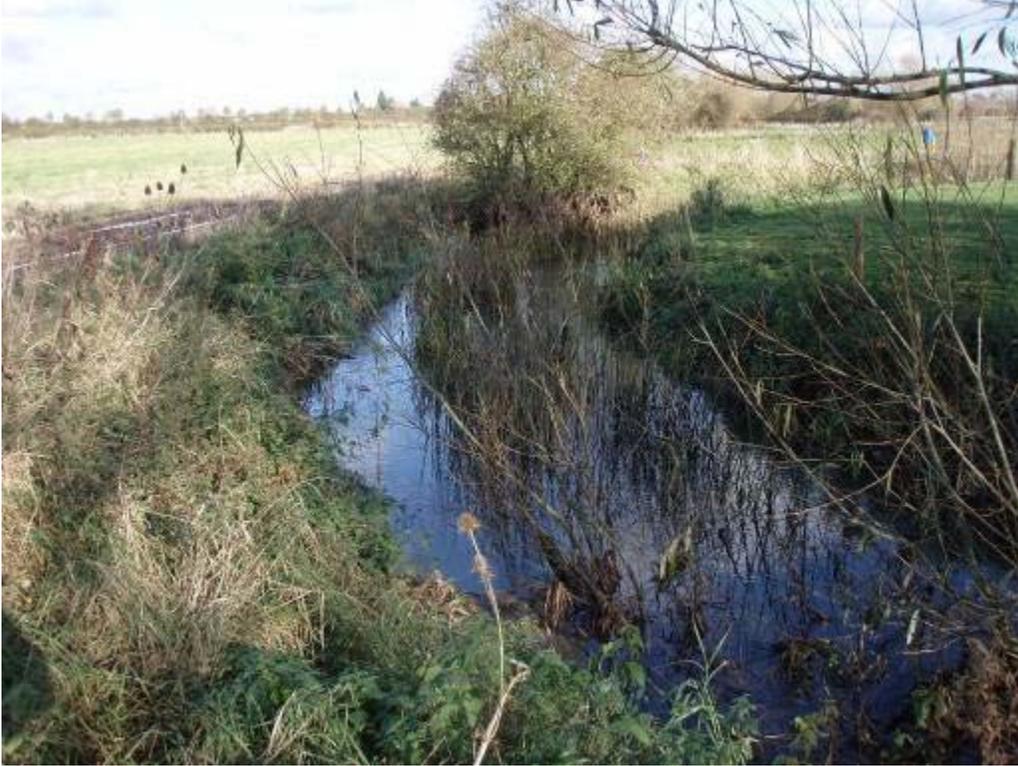
Photo 14

Riparian habitat is generally good, with a shaggy margin and overhanging bushes and trees present. Club-rush stands are present in the more open sections but are absent where the channel is shaded (Photo 14).

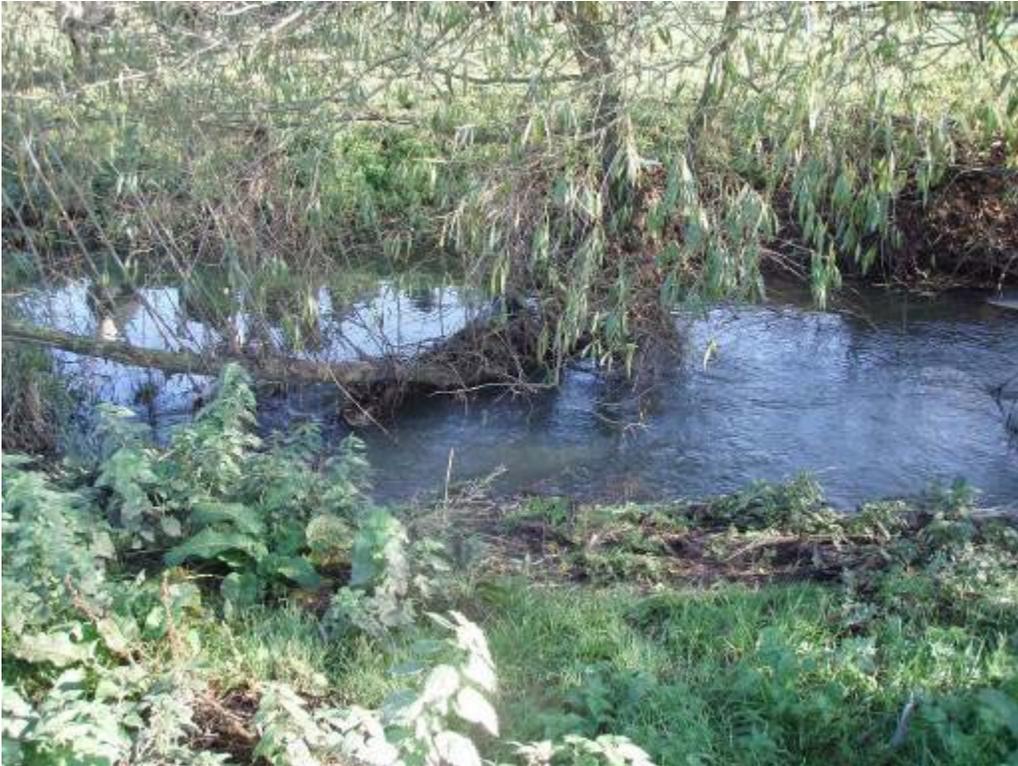
Crack willows are common, particularly along the lower field. Most of these would benefit from pollarding and it is recommended that this is done on a rotational basis, with a proportion done each year of the HLS agreement. Trailing and submerged branches should be retained where possible (Photo 15).

Photo 15 Retain overhanging and submerged branches wherever possible
