Advisory Visit
Settrington Beck
04/11/2015

1.0 Introduction

This report is the output of a site visit to Settrington Beck, at the request of East Yorkshire Rivers Trust. The purpose of the visit was to assess habitat and make recommendations for habitat improvements that could be undertaken on the beck.

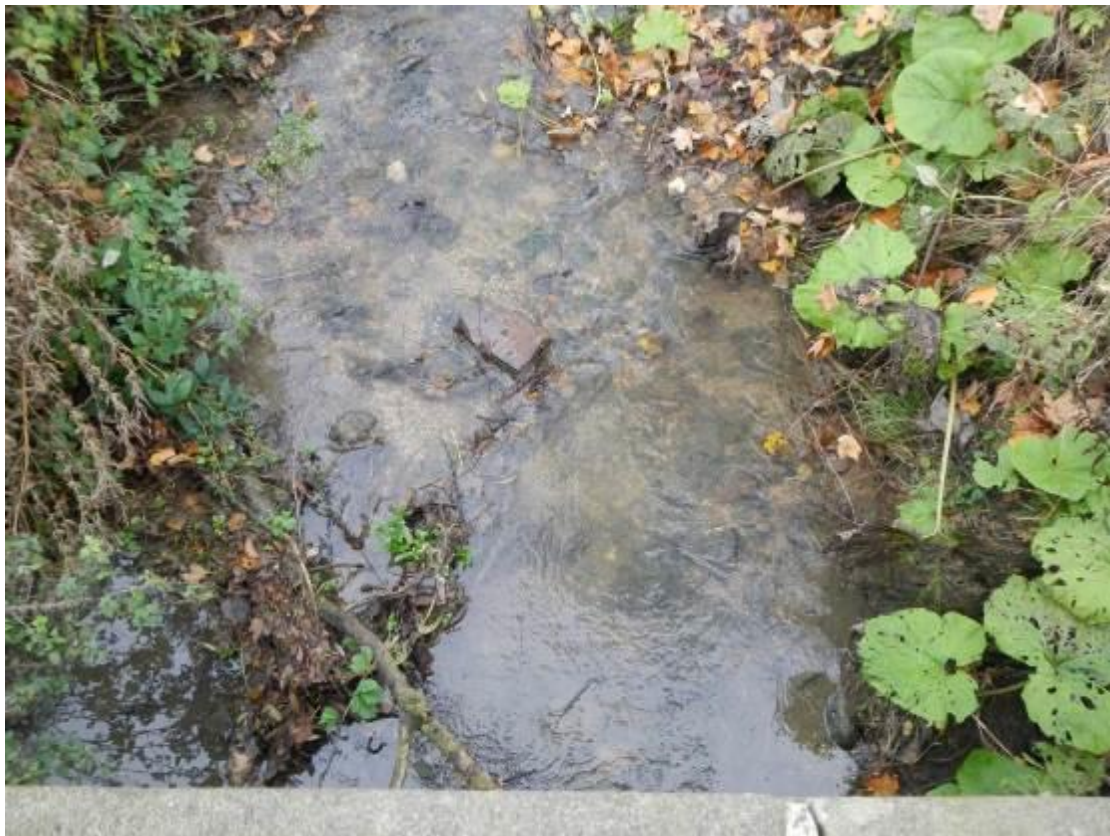
The beck was inspected from an u/s limit at North Grimston, at which point fine sediment loading within the water column and on the bed indicated potential issues with diffuse pollution further u/s (Fig. 1). While the visit was following rain, a chalk aquifer system should not naturally experience such issues. Observations made for the area u/s (Google Maps) suggest that the beck is subject to significant habitat degradation from straightening (evident by the current course and adjacent paleo-channel), and erosion resulting from livestock grazing/access to the banks. D/s of the village, the beck is better protected by a wooded area but a tributary joining it there is still providing sediment input resulting from livestock poaching (Fig. 2).

Figure 1. Cloudy water and fine sediment deposition on the beck bed.

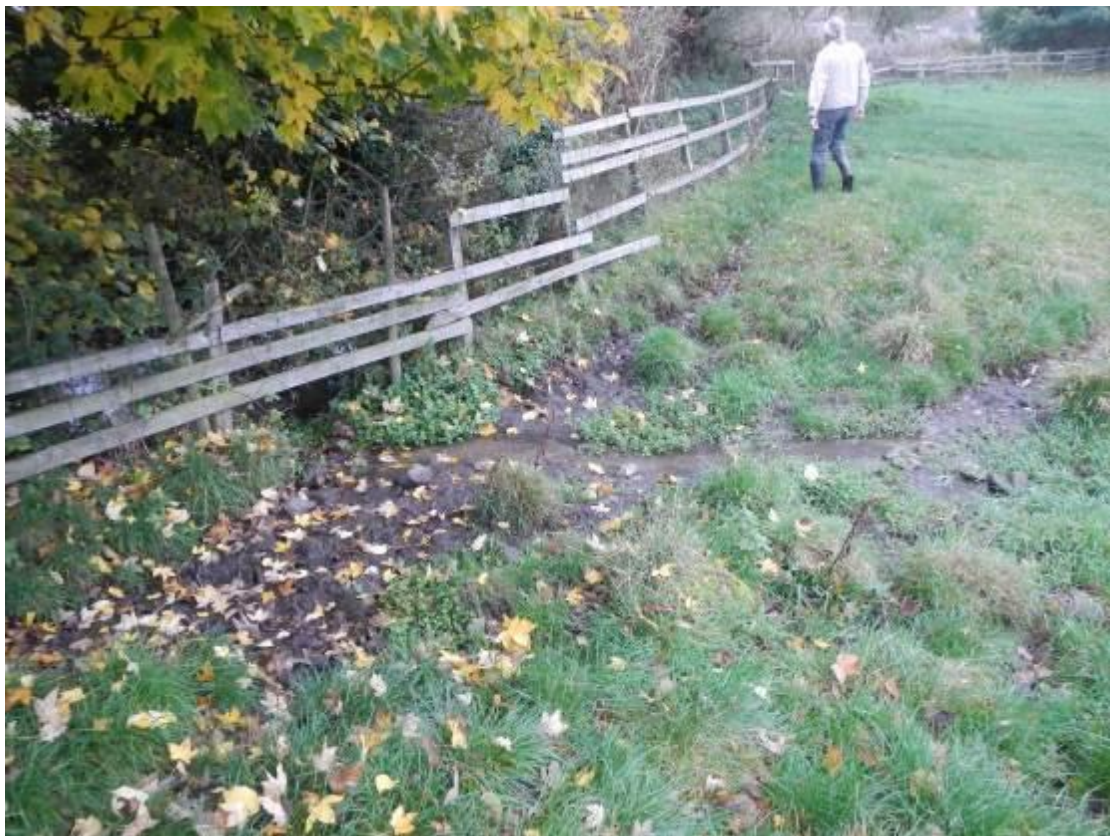
Figure 2. Livestock access to a tributary provides a good demonstration of the source of fine sediment inputs impacting upon the beck.

As one of the major impacts upon Settrington Beck is fine sediments, it is recommended that wherever livestock have access to the watercourse, buffer fencing is installed to exclude them. Negotiations regarding the fencing will have to be undertaken with the tenant farmers, but if the benefits to their land livestock management are promoted, and they are helped to understand the major impact that grazing is having upon the watercourse, they should be supportive. Incentives may also be required through Countryside Stewardship to mitigate the loss of grazing land.

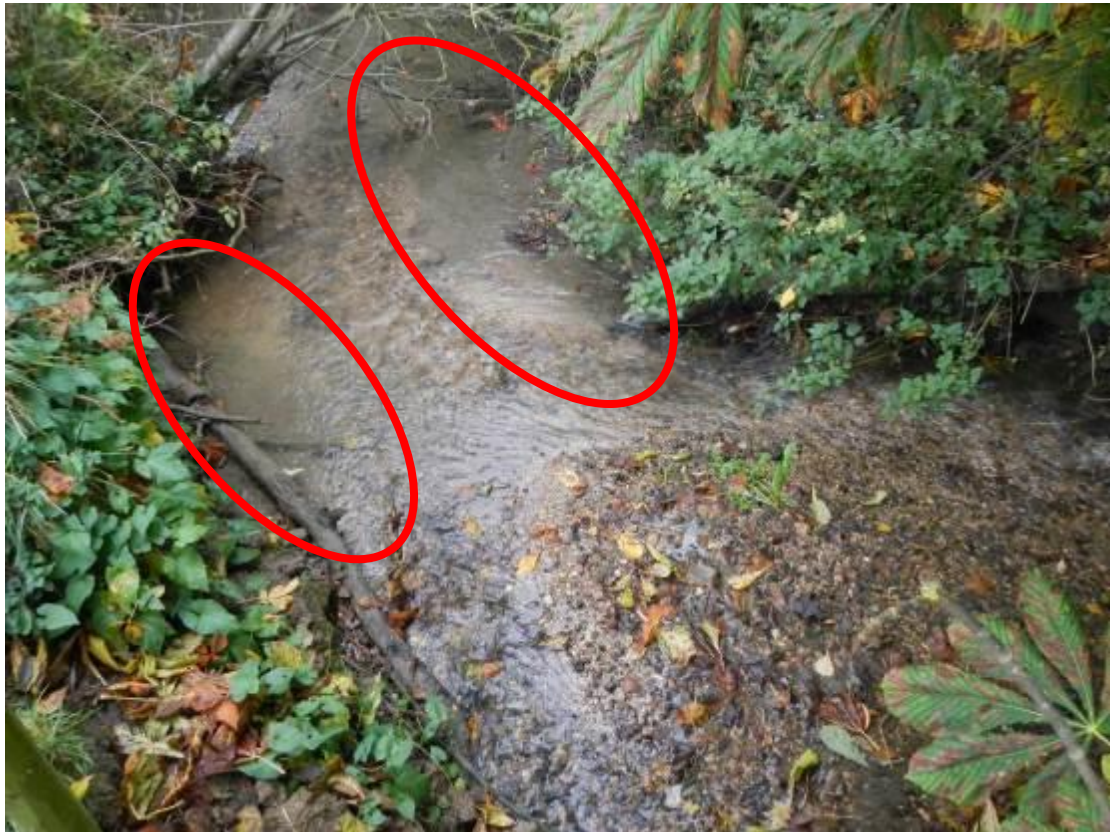
Within the wooded area, the channel is relatively natural and geomorphologically active with erosional and depositional features providing a range of habitats. Fine sediment deposition in slower flow areas again highlight issues u/s (Fig.3). Whitestone Beck enters Settrington Beck and provides another potential sediment source that is worth further investigation.

Figure 3. Areas of scour and deposition provide some important habitat features but excessive fine sediment deposition (red ovals) identifies issues u/s.

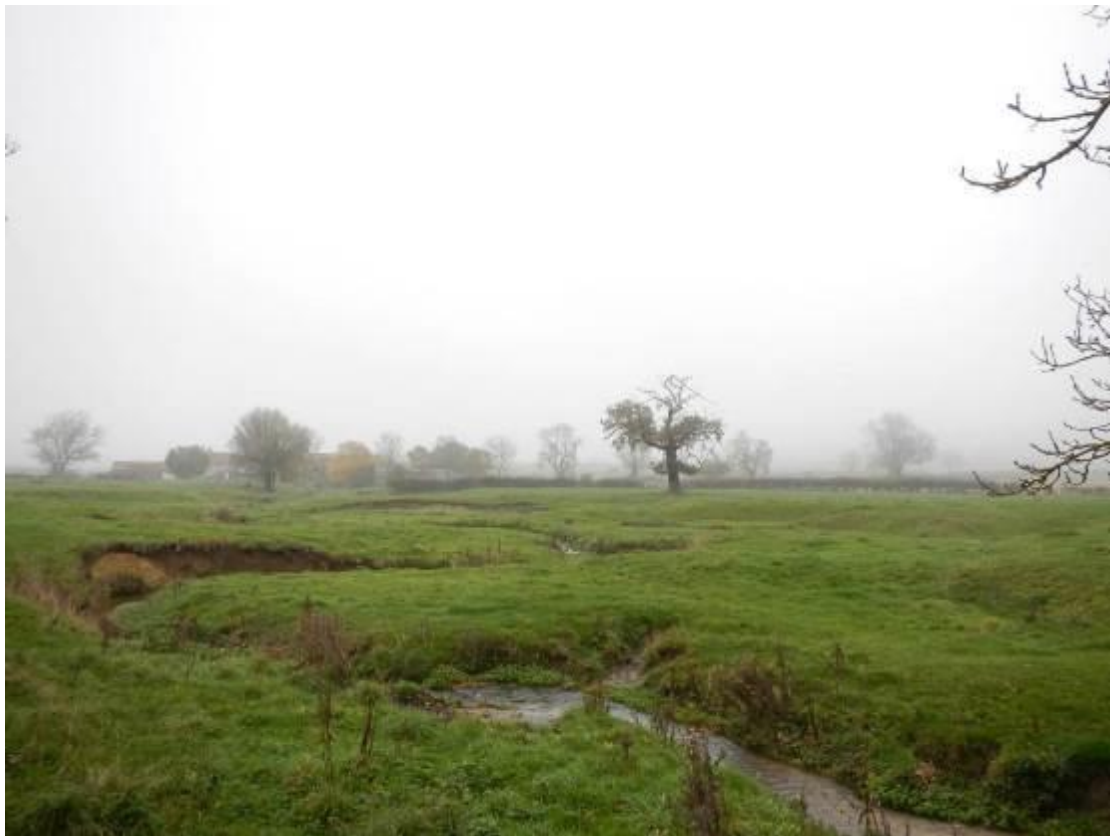
D/s of the wooded area, the beck meanders across grazing land and exhibits a natural planform, as it should be without the impact of straightening (Fig. 4). Natural erosion is a beneficial source of coarse sediment that provides important substrate for invertebrates and salmonid spawning (Fig. 5). However, grazing is accelerating the rate of bank erosion in many areas, beyond that which would naturally occur. This is resulting in further fine sediment input as evident by agitating the bed (Fig. 6), and deposits within and upon the marginal vegetation (Fig. 7).

Figure 4. A good example of the natural, meandering planform the beck should conform to.

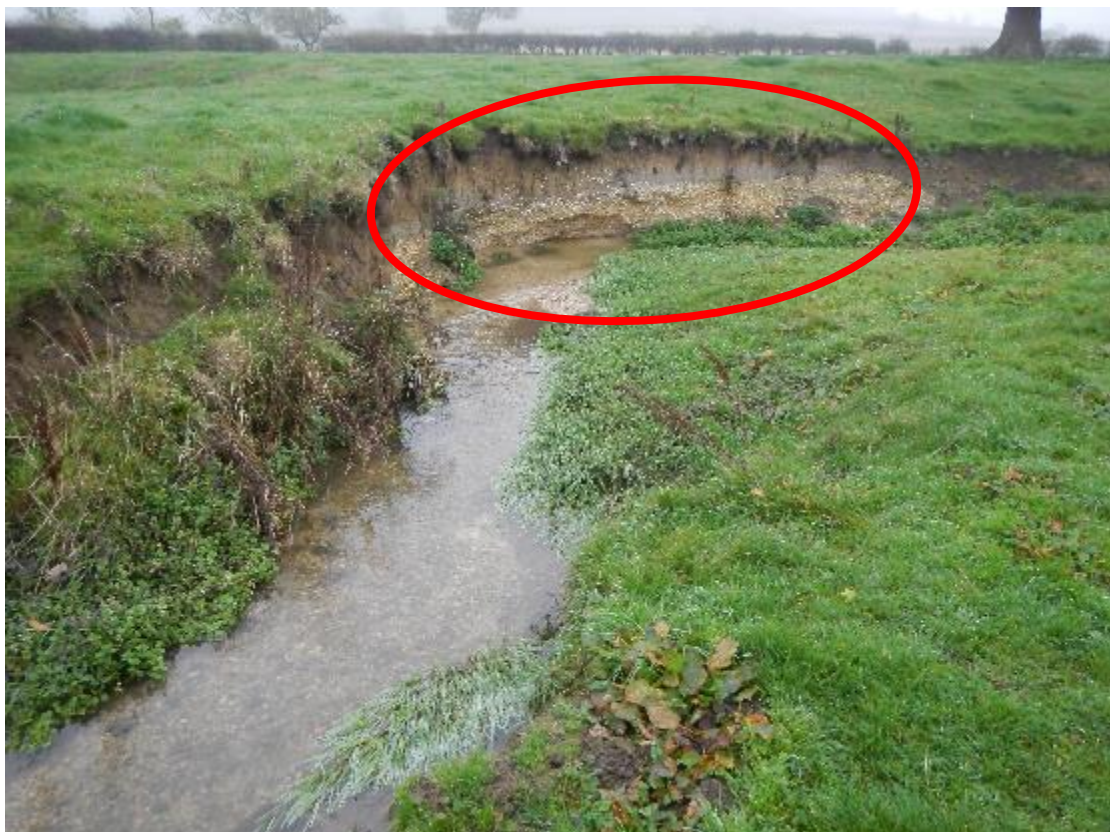
Figure 5. Some beneficial coarse sediment input to the beck (red circle)

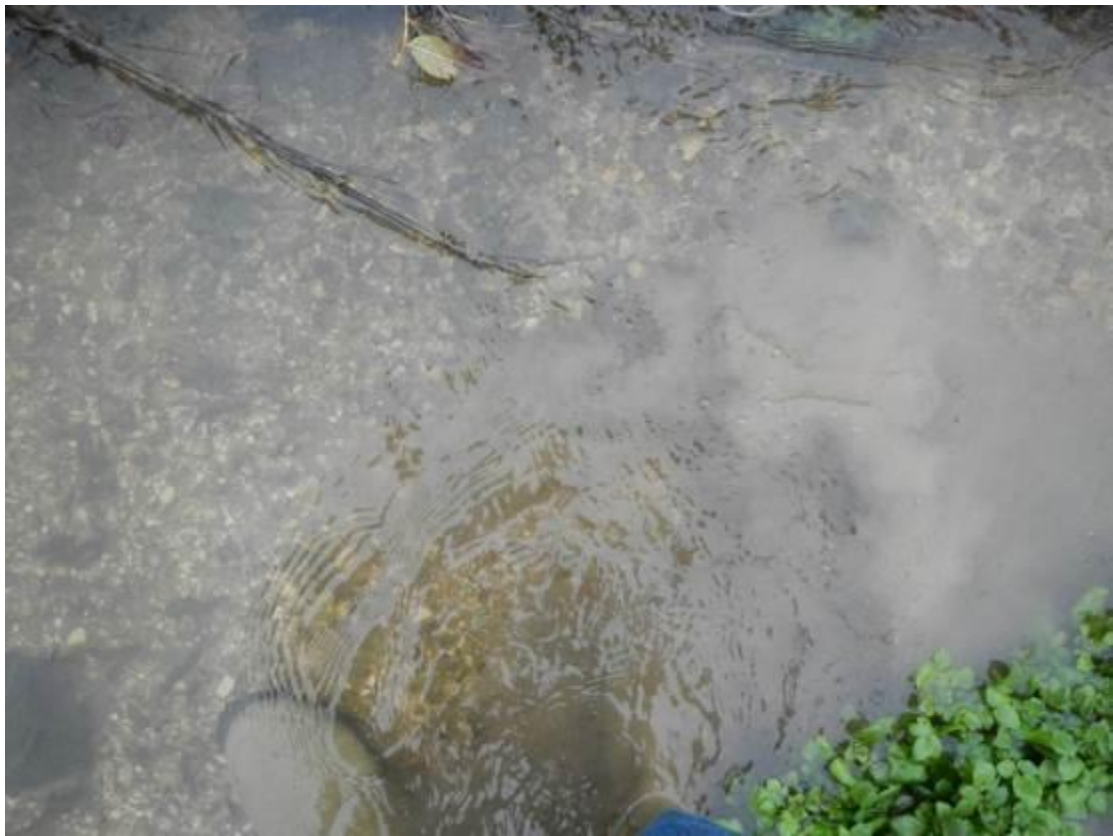
Figure 6. Agitating the bed liberates a volume of fine sediment.

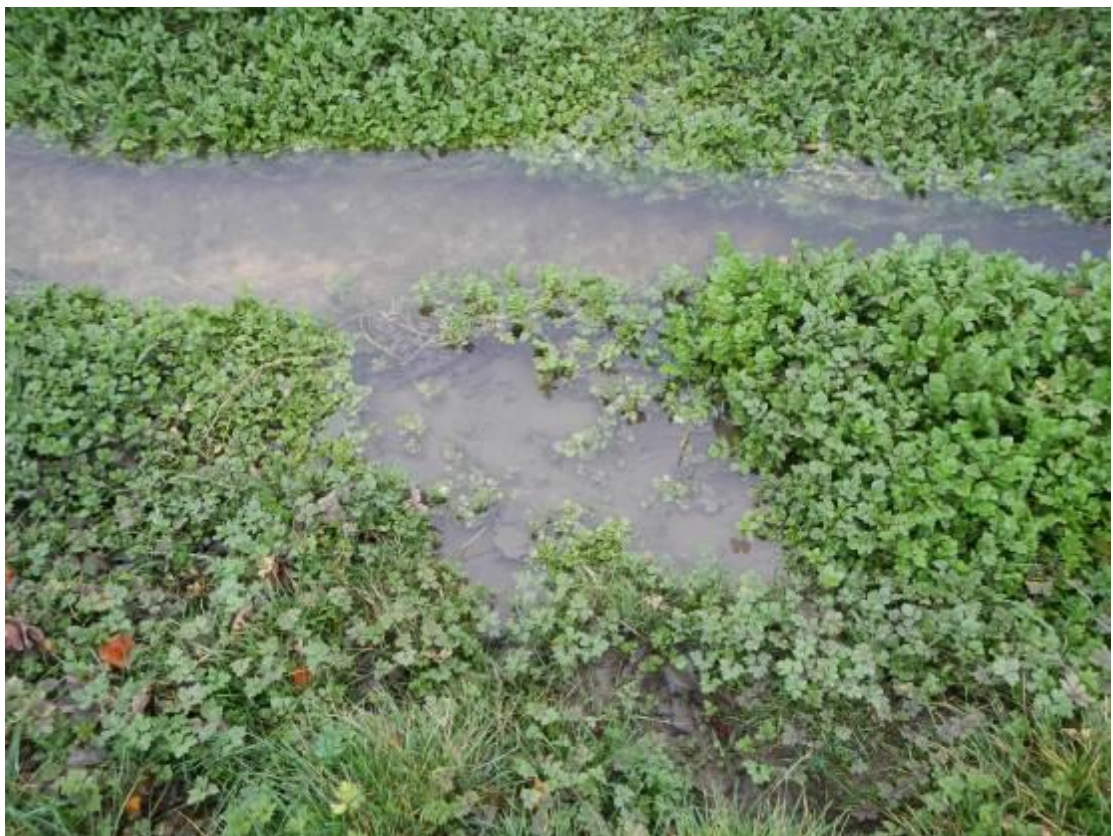
Figure 7. Fine sediment trapped between and coating (deposited as flows subside) the marginal vegetation.

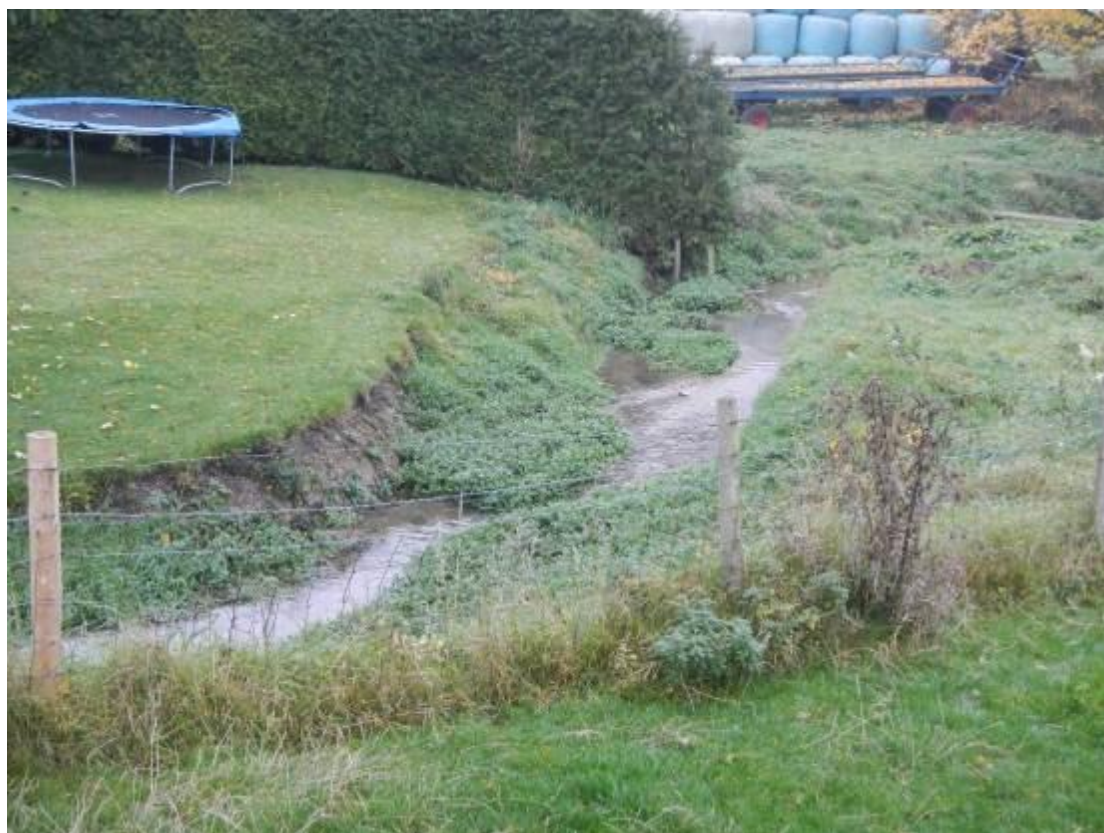
Around Bellmanear Farm, the exclusion of livestock has allowed a greater diversity of bankside vegetation to establish and, correspondingly, the banks are more stable. However, where the grass has been mowed, the reduction in vegetation diversity and root structure within the bank has resulted in increased erosion, replicating the conditions and issues commonly associated with grazing (Fig. 8).

Figure 8. Where diverse vegetation has established (protected from grazing pressure) the banks become much more stable; however, where mowing of the grass occurs, it replicates the conditions created by grazing and similar erosion occurs.

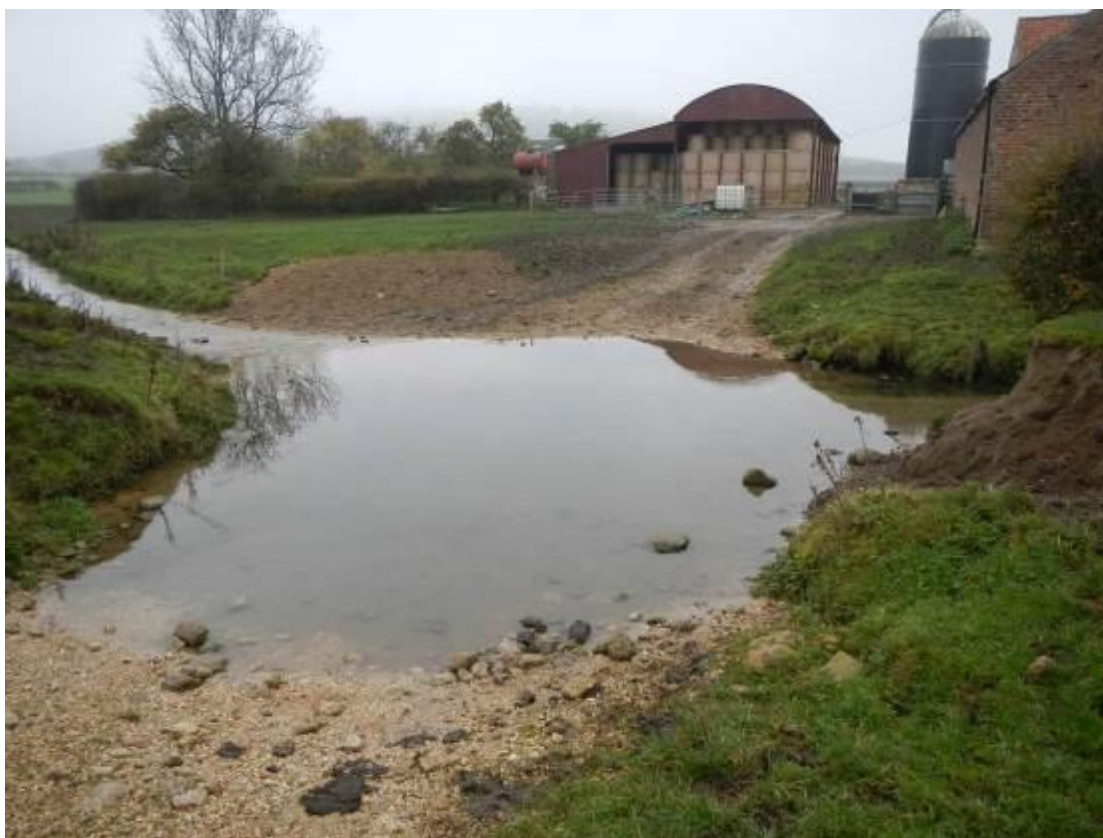
D/s of Bellmanear Farm (SE 84339 68447), two fording points create major sediment inputs to the beck and act as conduits for surface flows carrying polluting materials to the beck from further away (Figs. 9 & 10). Attempts have been made to create a harder base to the upper of the two fords but it is insufficient to counteract the poaching by cattle (Fig. 9), particularly on the banks at either side of the track. Fencing off of the beck and railings to guide livestock through the centre of the ford would help mitigate the problem.

Figure 9. Attempts have been made to protect the bed and banks of the ford immediately adjacent to Bellmanear Farm but it remains a major source of fine sediment input and pollution to the watercourse. Restricting livestock to the hard-standing area of the crossing would be beneficial.

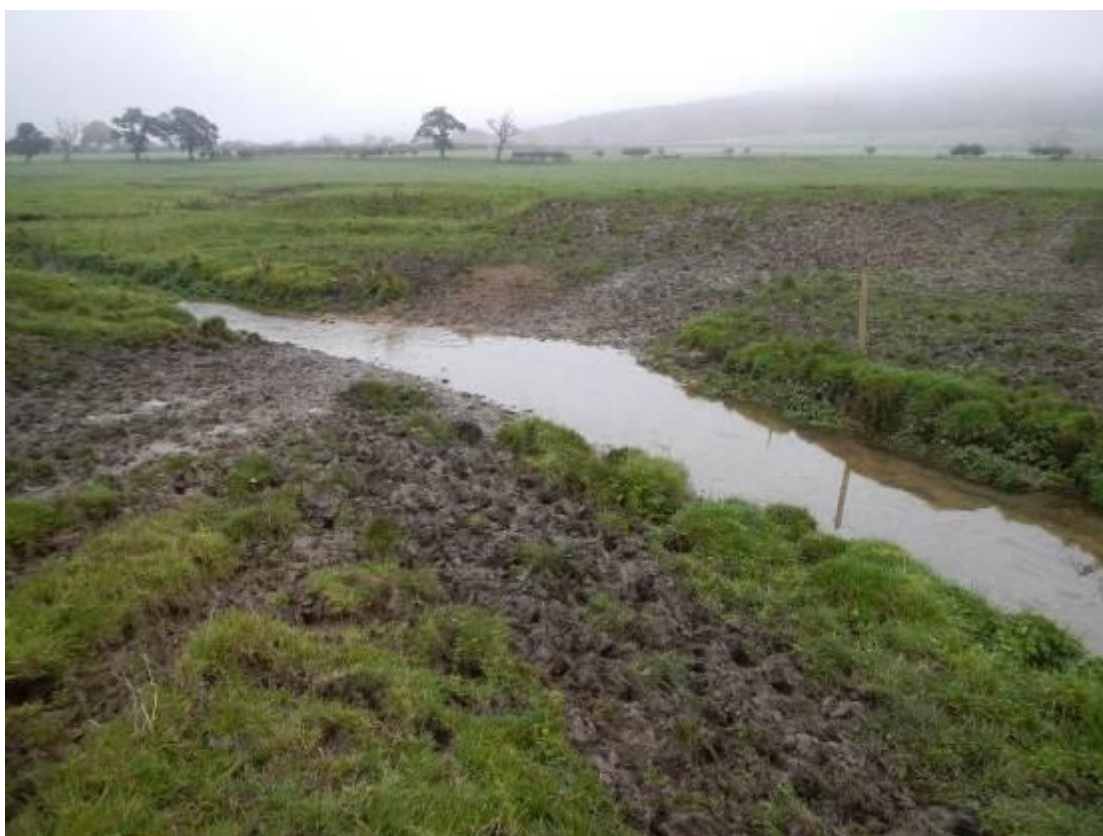
Figure 10. The second fording point d/s of Bellmanear Farm represents an even greater source of fine sediment input to the beck.

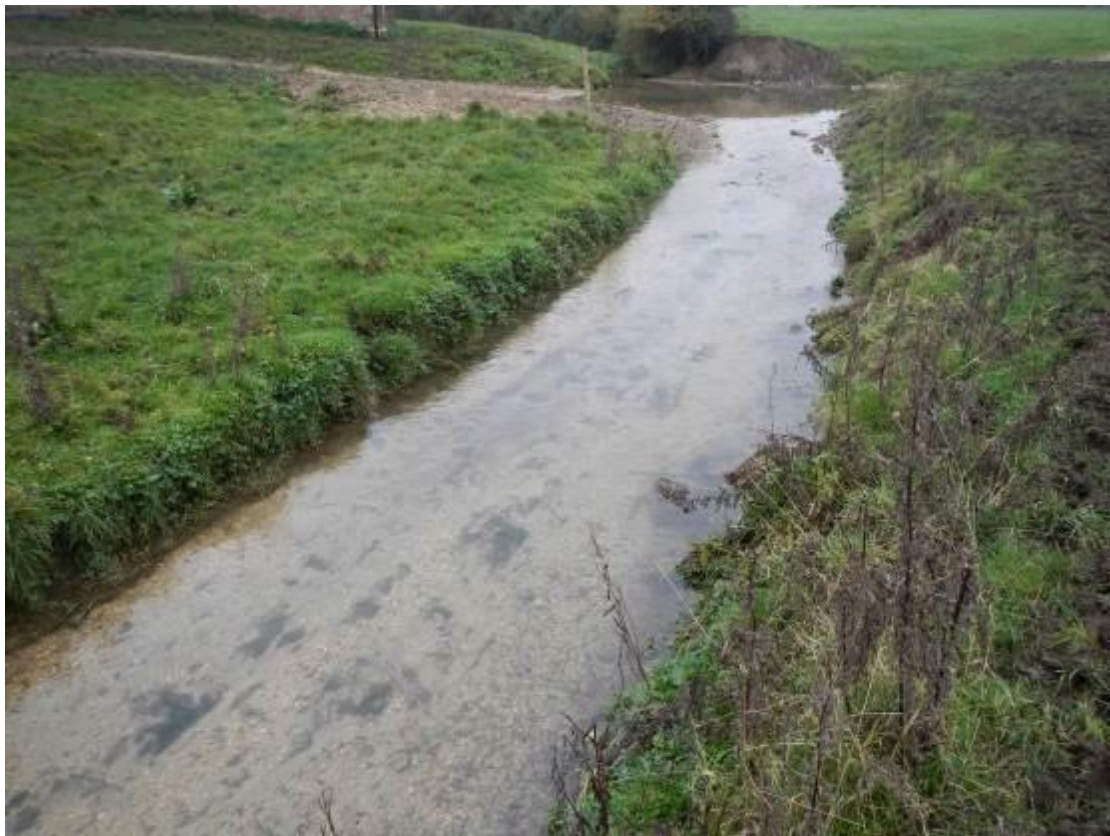
Within the same field, the impact of dredging, creating an over-capacity (Fig. 11) and straightened (Fig. 12) channel, and erosion associated with grazing and cattle poaching severely impact upon the watercourse (Fig. 13). Obvious signs of the paleo-channel remain at either side of the current, straightened channel offering some potential for restoration of the beck's natural course (Fig. 14).

Figure 11. Straightened, over-capacity section between the two fords. Note the fine sediment composition of the substrate.

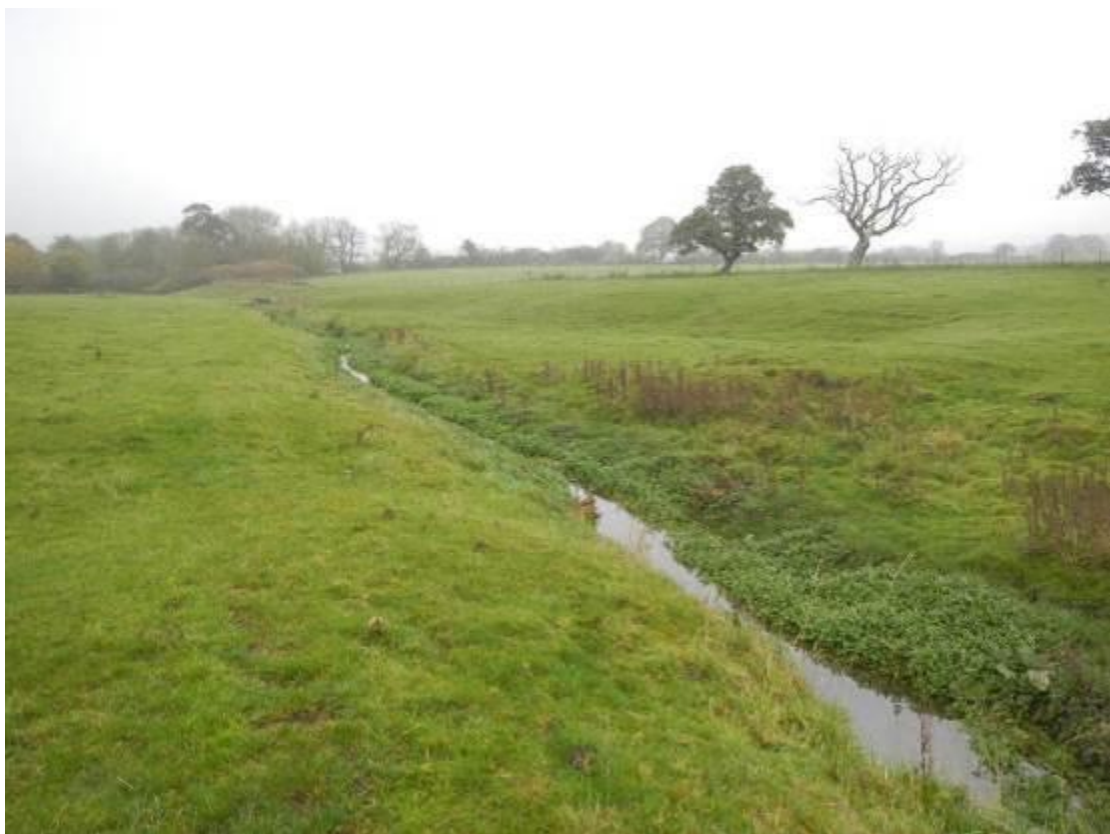
Figure 12. Straightened and over-capacity channel that has begun to narrow through encroachment of emergent vegetation.

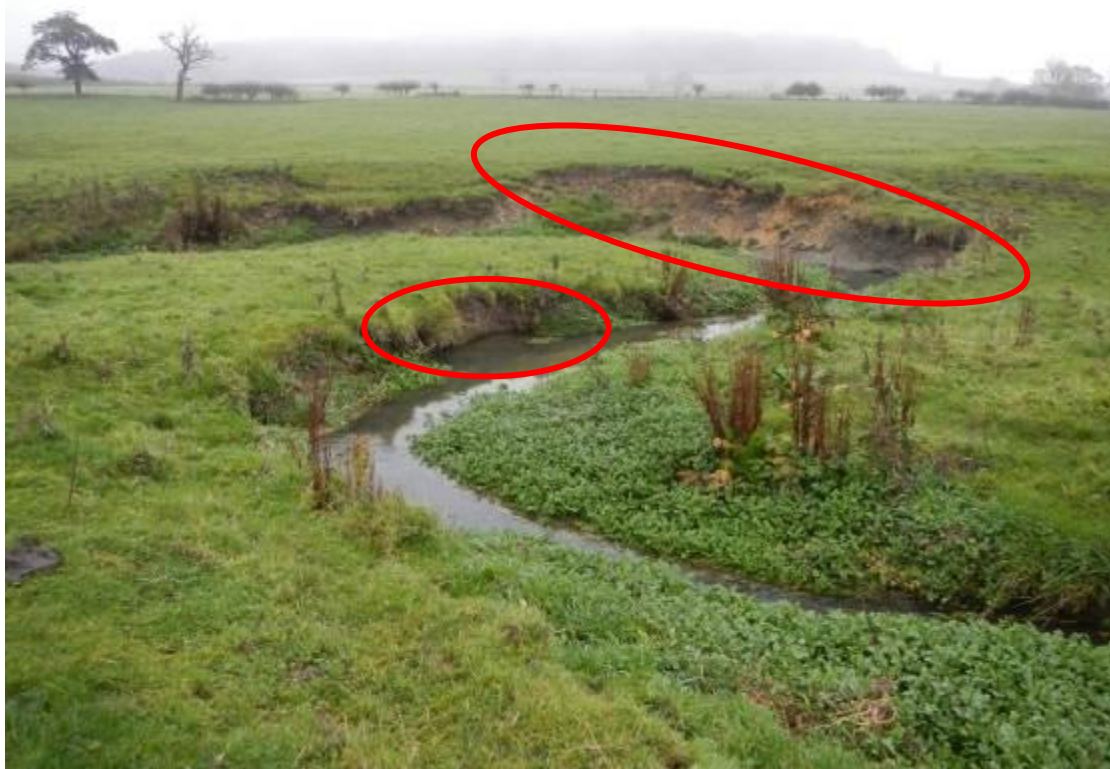
Figure 13. Where the more sinuous channel remains, the impact of grazing and associated erosion is evident (red ovals).

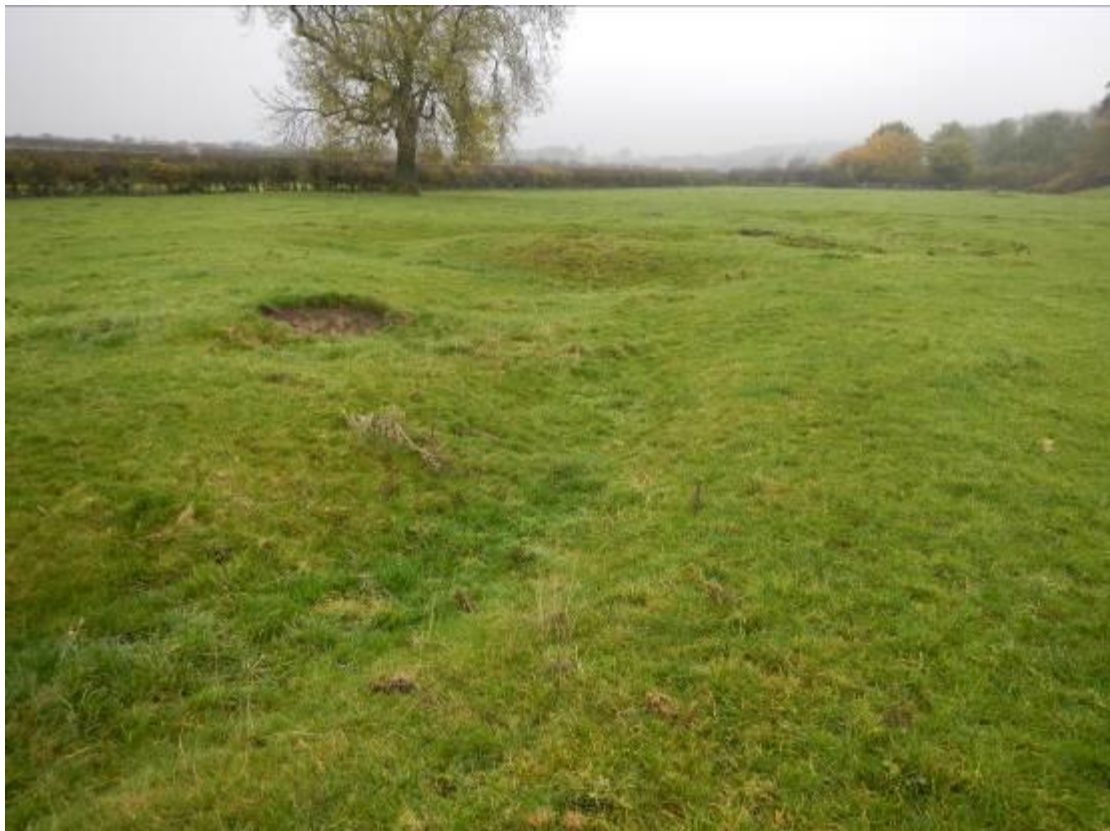
Figure 14. One of the many paleo-channels which lies alongside the beck's current straightened course.

Table 4. Re-meandering			
Straightened beck channel d/s Bellmanear Farm	Fig. 14	With sufficient funding it may be possible to undertake a river restoration project to reinstate the beck's paleo-channel.	SE 84403 68658
Straightened sections d/s of A64 d/s (Nr. Carpvale)	Figs. 42 & 44	With sufficient funding it may be possible to undertake a river restoration projects to reinstate the beck's paleo-channel.	Around SE 82640 72742

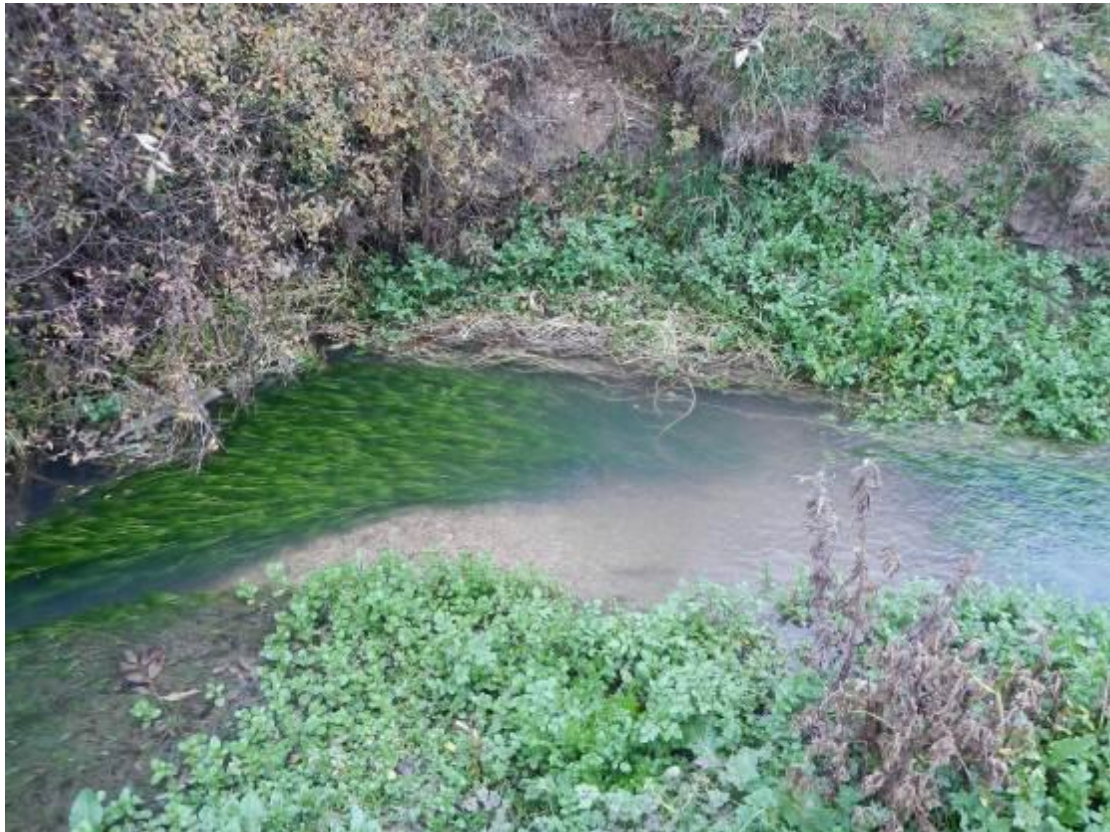
Where the channel has a more natural morphology and vegetation has narrowed the channel to a more natural width, areas of sorted (relatively silt-free) gravels suitable for salmonid spawning are present. These areas, combined with the water crowfoot (*Ranunculus* spp.) and other aquatic and marginal vegetation, also represent greatly improved habitat for invertebrates. However, where the channel is of greater capacity and flows are correspondingly slower, fine sediment deposition threatens the health of the aquatic vegetation and habitat quality.

Figure 15. Where the channel has a more natural morphology and aquatic vegetation has established, some higher quality substrate habitat is present.

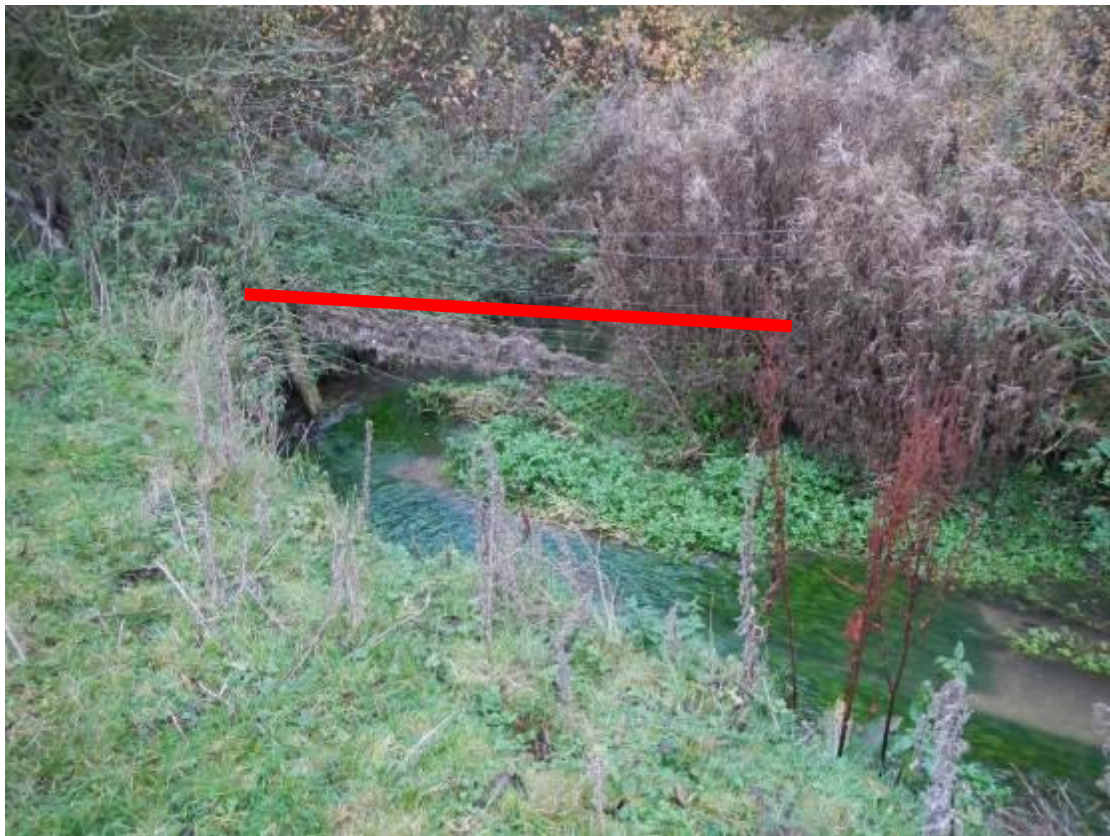
Where the beck enters a small woodland at the d/s end of the field, flood debris on the field boundary fence offers an indication of the high-water mark (Fig. 16). While some floods will inevitably reach higher than this, it offers an indication that most high flow events would be unlikely to jeopardise a buffer fence if it were set back from the bank top.

Figure 16. Flood debris on the field boundary fence provides an indication of the high-water level (red).

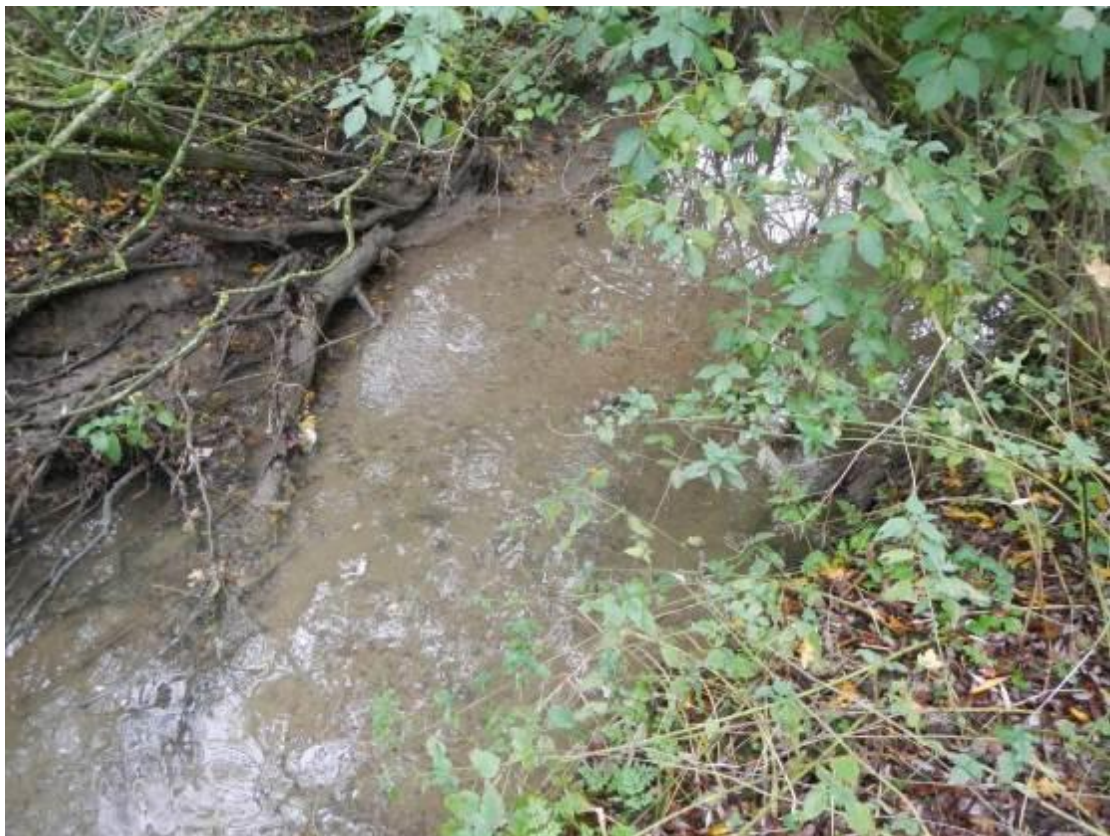
Within the wood, shading prevents vegetation growth and the channel, being subject to historic maintenance and over-capacity, has become smothered by fine sediment, thereby degrading habitat quality (Fig. 17). This serves to highlight the considerable volume of fine sediment entering the beck u/s.

Figure 17. Excessive fine sediment on the bed.

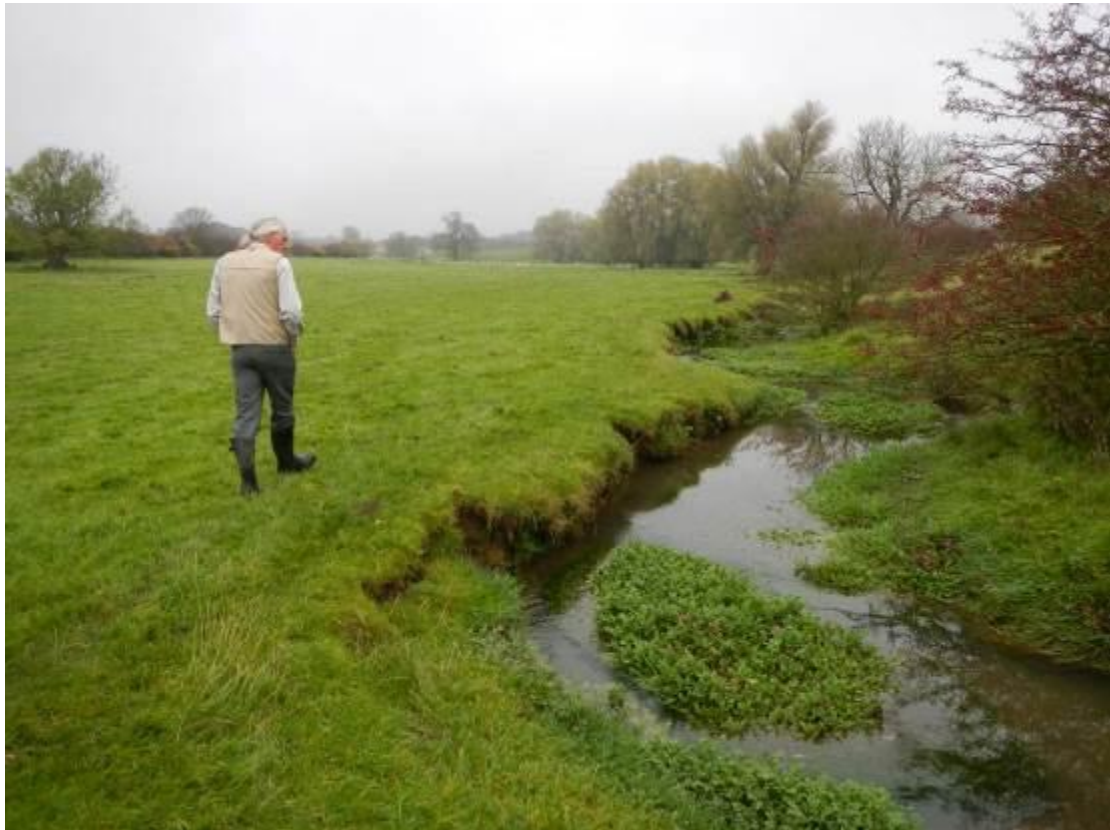
The field d/s of the wood appears to be used primarily for sheep grazing which, although resulting in less physical poaching damage than cattle grazing, can lead to equal habitat degradation through the close cropping of bankside vegetation and the associated impact upon root structures within the bank (Fig. 18). Consequently, bank erosion remains a major issue.

Figure 18. Sheep grazed field d/s of the wood - less poaching issues than cattle grazing but similar impact upon bank stability and erosion rates.

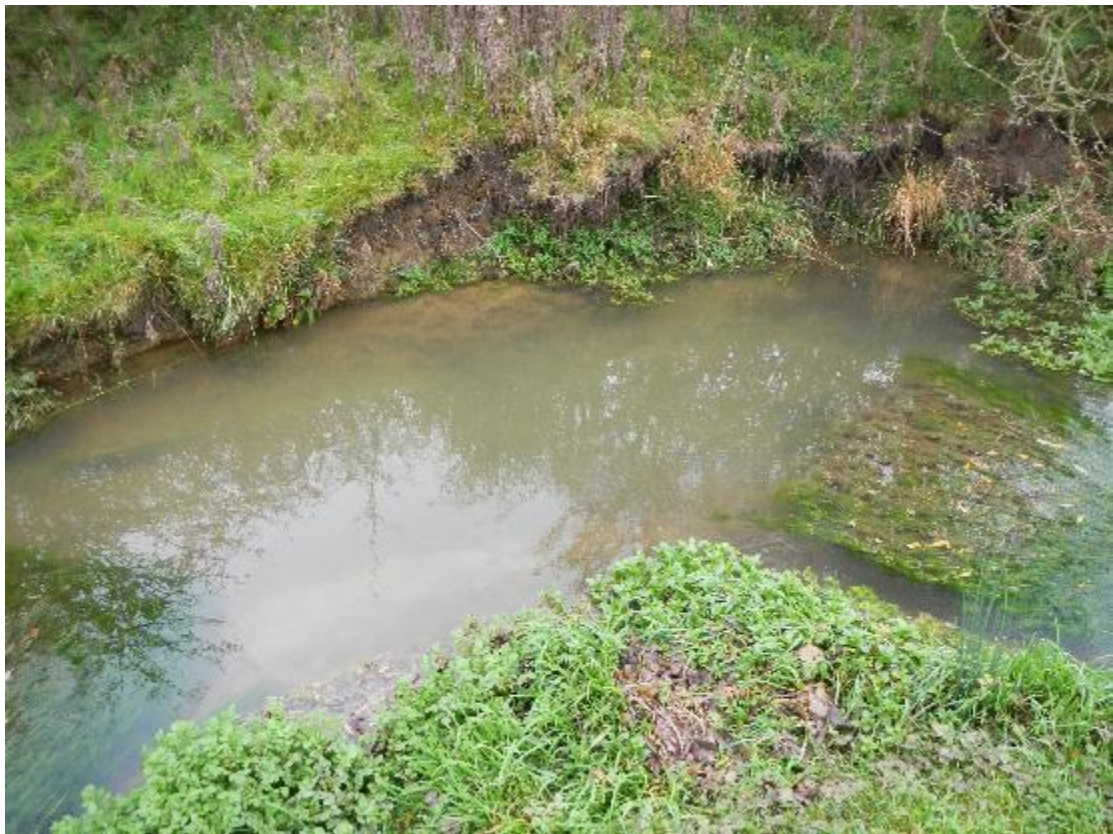
The cumulative effect of fine sediment input to the beck is evident within deeper pool areas where the poor water clarity is more apparent and the slower flows allow deposition upon the aquatic vegetation (Fig. 19). Where in-channel features pinch the channel width, the accelerated flows achieve some substrate sorting; however, the channel has to be pinched to an unnaturally narrow width for the size of the beck to mitigate against the impact (Fig. 20).

Figure 19. Poor water clarity within deeper pools and fine sediment deposition amongst the aquatic vegetation highlight the cumulative impact of high sediment input.

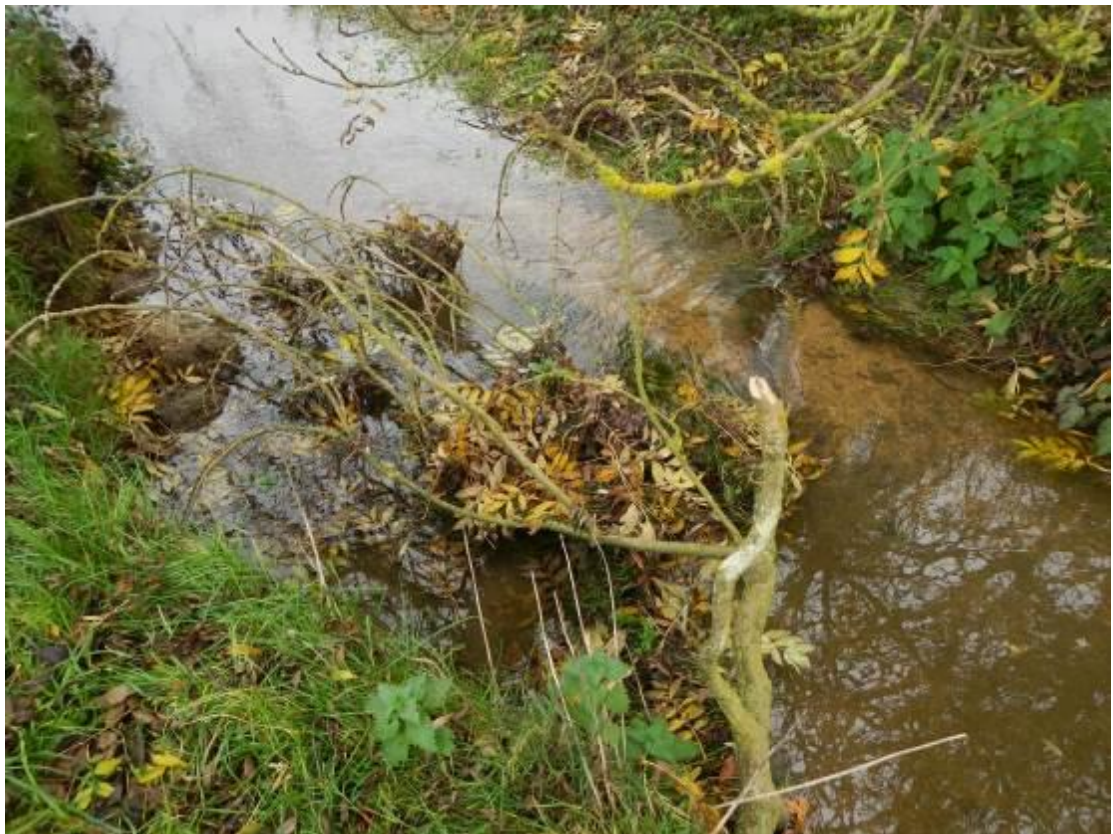
Figure 20. It is not until the channel is significantly narrowed that flows reach a velocity capable of beginning to clean and sort the gravel. Even then, the fine sediment impact is notable.

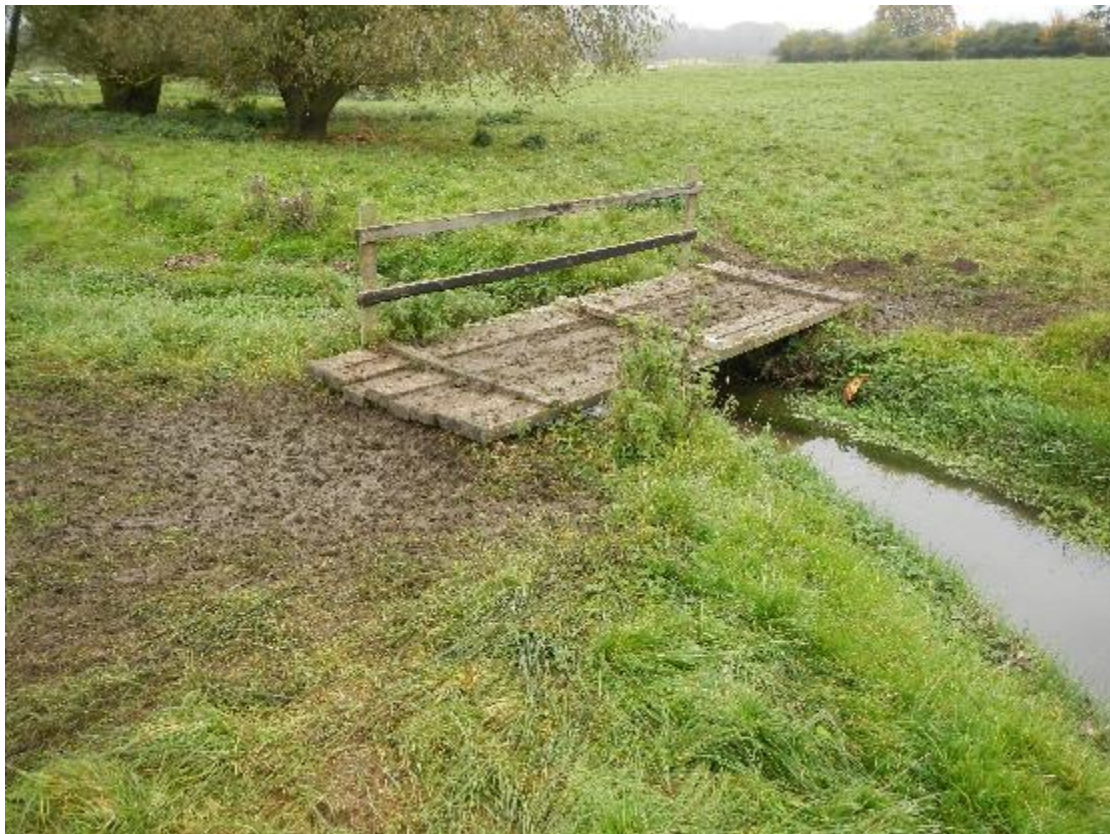
Small bridges already present within the field offer the potential for installing buffer fencing along the beck without restricting grazing access to the fields (Fig. 21). Excluding sheep from the undercut, unstable banks would reduce the risk of sheep being injured or lost into the beck, as well as reducing the rate of future erosion. The addition of hard-standing to protect the ground in the area of access to the bridge would be beneficial.

Figure 21. Small bridges already present would allow access even if both banks of the beck were buffer fenced.

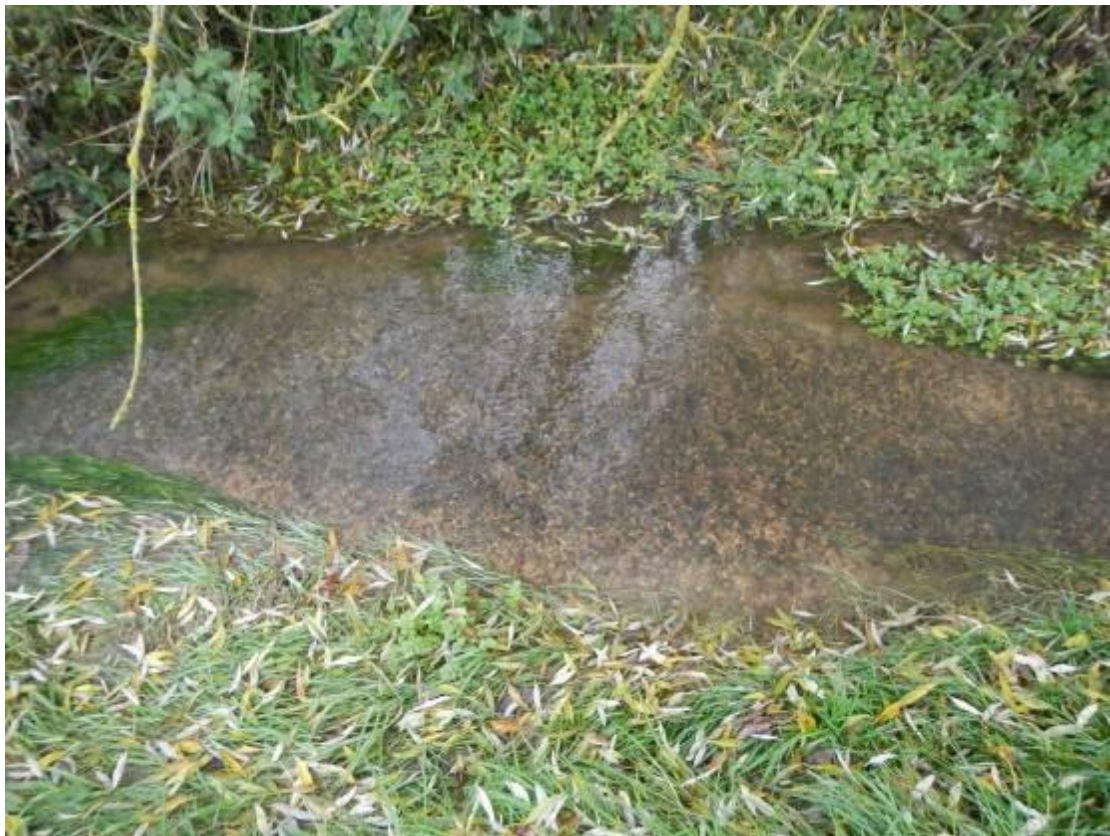
Moving d/s, habitats with potential for salmonid spawning, as well as for invertebrates and smaller fish species, become increasingly impacted by the fine sediment and are severely degraded. In many cases these habitats are unlikely to support those natural functions (Fig. 22).

Figure 22. Heavily silted gravels that would otherwise provide high quality spawning and invertebrate habitat.
