Advisory Visit
Settrington Beck
04/11/2015

1.0 Introduction

This report is the output of a site visit to Settrington Beck, at the request of East Yorkshire Rivers Trust. The purpose of the visit was to assess habitat and make recommendations for habitat improvements that could be undertaken on the beck.

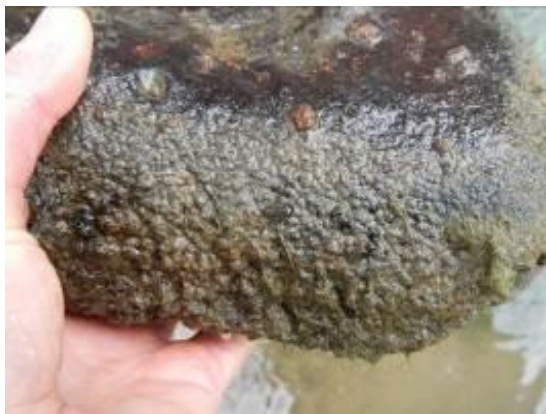
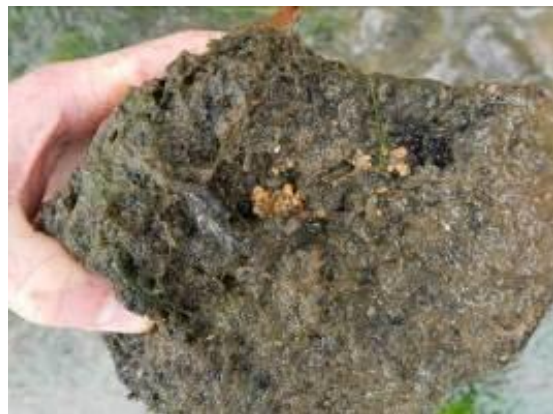
Stone turning revealed some of the expected invertebrate assemblages, but at severely impoverished densities. (Fig. 23a & b). Tufa (calcium carbonate precipitate) was also noted on some of the substrate in this area, indicating high calcium carbonate within the water; however, the tufa appeared to be inactive. This is another symptom of the sedimentation and eutrophication of the beck as they can both inhibit growth of the biofilms which produce tufa.

Figure 23a. Only one ephemerid was found through turning of numerous stones.

Figure 23b. A few cased caddis were observed.

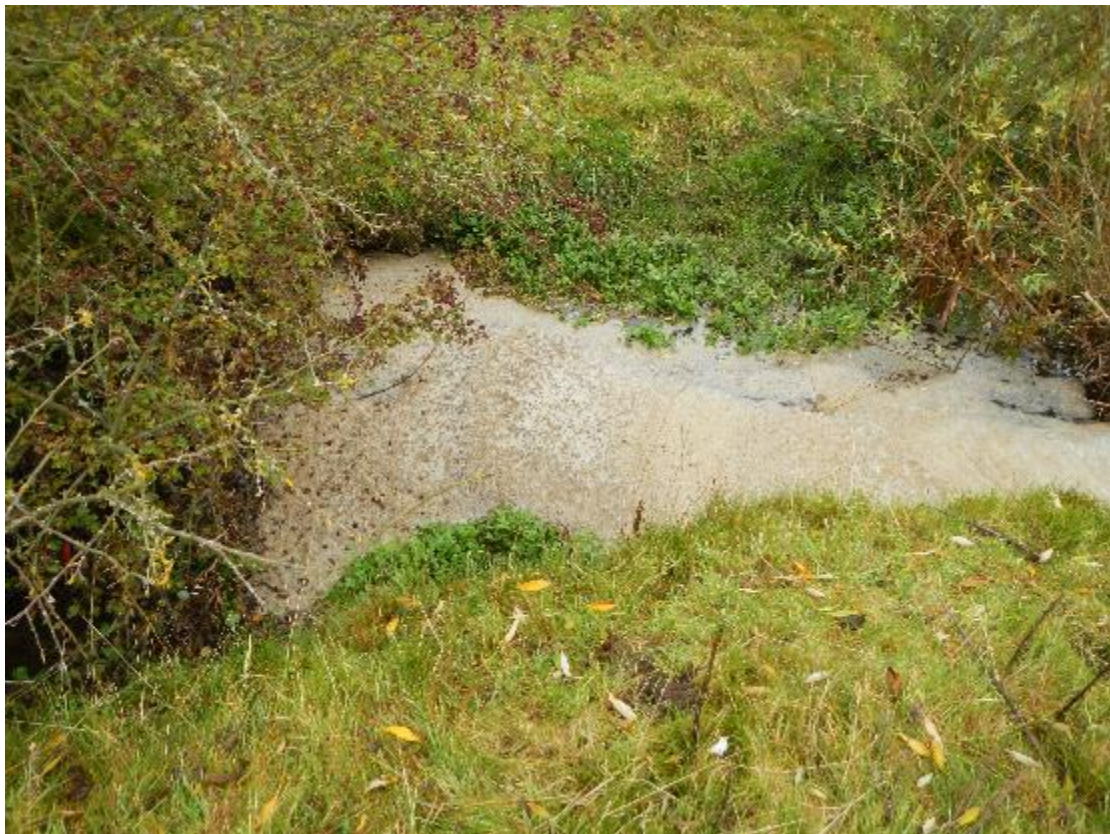
Where a fallen hawthorn (*Crataegus monogyna*) shrub impounds the flow, foam has collected on the water surface (Fig. 24). While some foam can occur on watercourses naturally as a result of decaying matter, in this instance it is likely another sign of enrichment.

Figure 24. Foam on the water surface is another potential sign of nutrient enrichment.

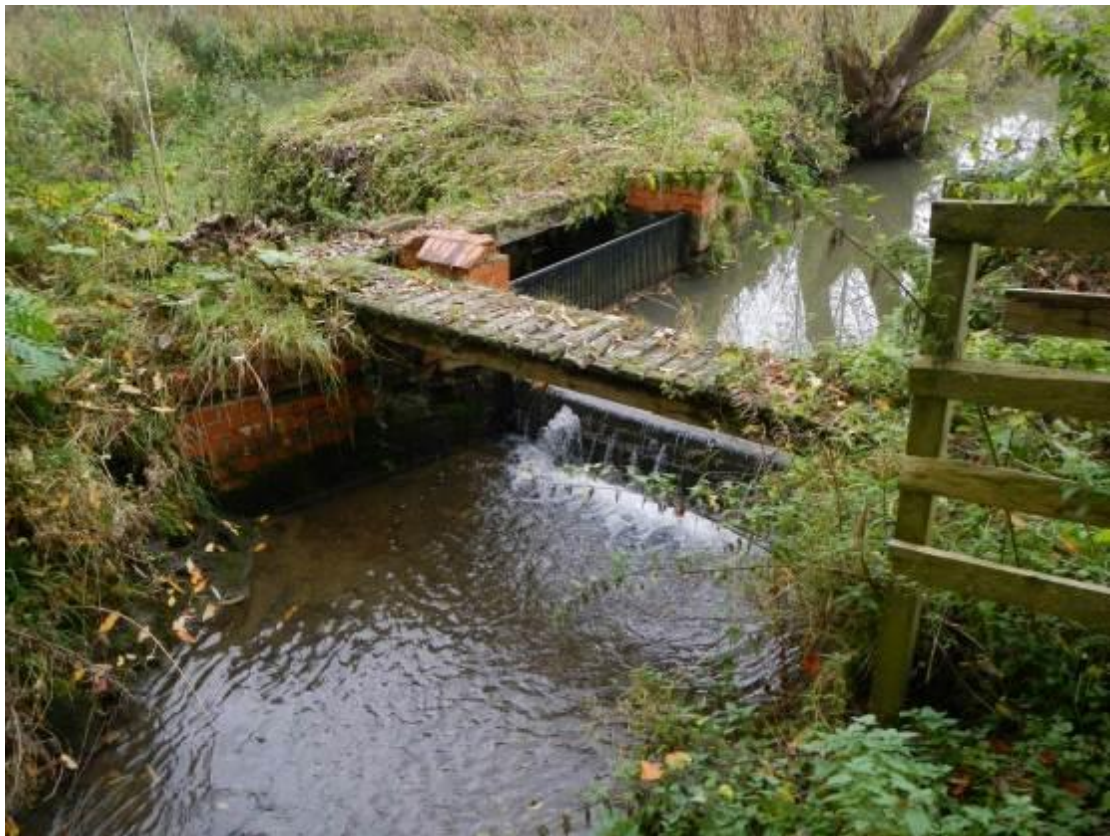
At the inlet to Settrington mill pond, a board weir poses a major obstruction to fish passage and impounds the channel u/s (Fig. 25). It is suspected that the weir is used to counteract the partial blocking of the pond inlet screen, as the beds of each appear to be the same height. It may now be possible to remove the screen and the weir, allowing a simple overspill that favours flow to the beck.

Figure 25. Weir/water feed to Settrington mill pond – a major barrier to fish passage and impoundment to beck flows.

Investigate ways to maintain a sufficient feed of water to the pond, without the use of weir boards, to maintain free fish passage in that area. It may be possible to remove the weir and operate a simple screened overspill to feed the pond when the beck has sufficient flow. This would completely remove the weir board barrier leaving only the raised rock armoured bed that protects the weir base for fish to ascend. Removal of the boards would also greatly reduce the length of beck that is impounded u/s.

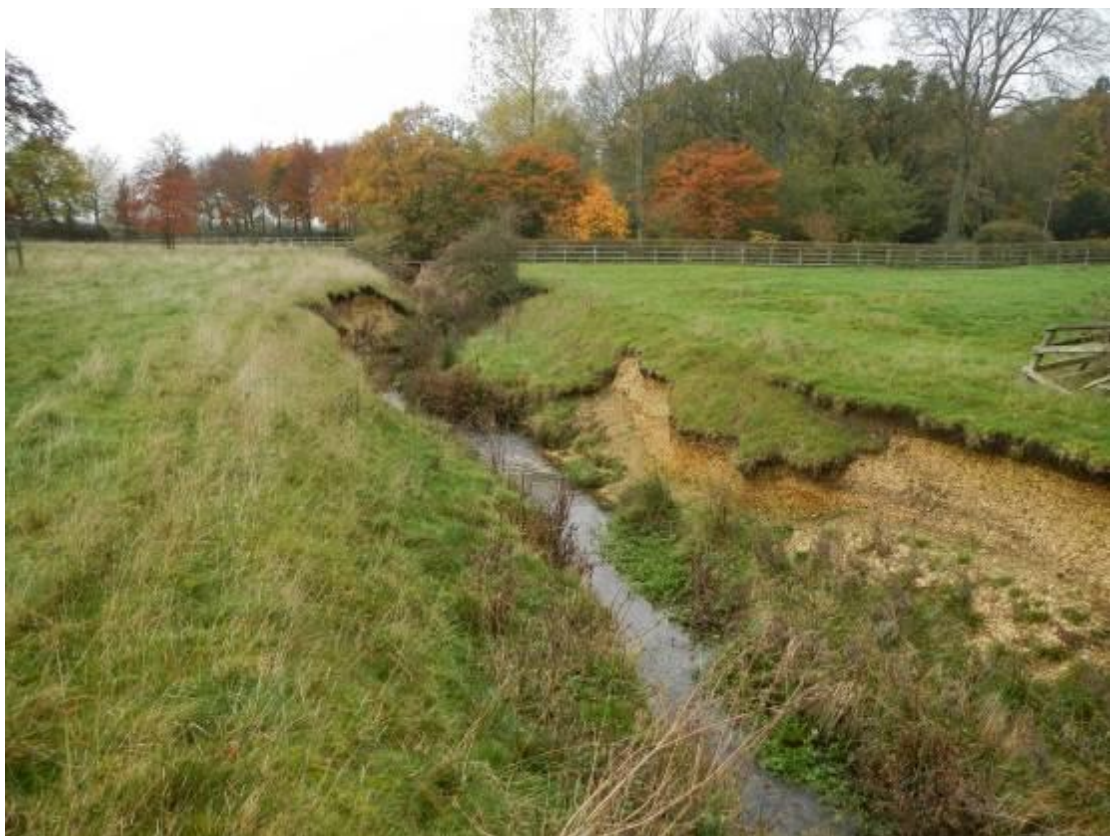
Looking at the surrounding land and the straightened, steep gradient channel d/s on the beck, it is suspected that the original channel course lies somewhere beneath the pond, with the current channel being a bypass cut through the base of the valley side on the LB (Fig. 26). Although the channel is eroding and slumping quite significantly here, it is recommended that these processes are allowed to progress and develop as they will ultimately lead to improved in-channel habitat. At some point in the future, it would then be beneficial to install fencing to allow the bank to stabilise and slow the currently accelerated sediment input to the channel.

Figure 26. The straightened and, correspondingly, steeper low habitat quality bypass channel alongside the mill pond.

The issue of fluming flows through the uniform, artificial channel section could be reduced through the installation of flow baffles. This technique is often undertaken within culverts using concrete baffles (often kerb stones). However, in this case it may be more in-keeping with the garden and more acceptable to the owner to use rock/boulder clusters within the channel to create resting areas for fish in a more aesthetically pleasing manner (see Fig. 51 below). The rock clusters could be employed to meander the flows within the channel and create areas of slower water where fish can rest as they attempt to ascend the channel.

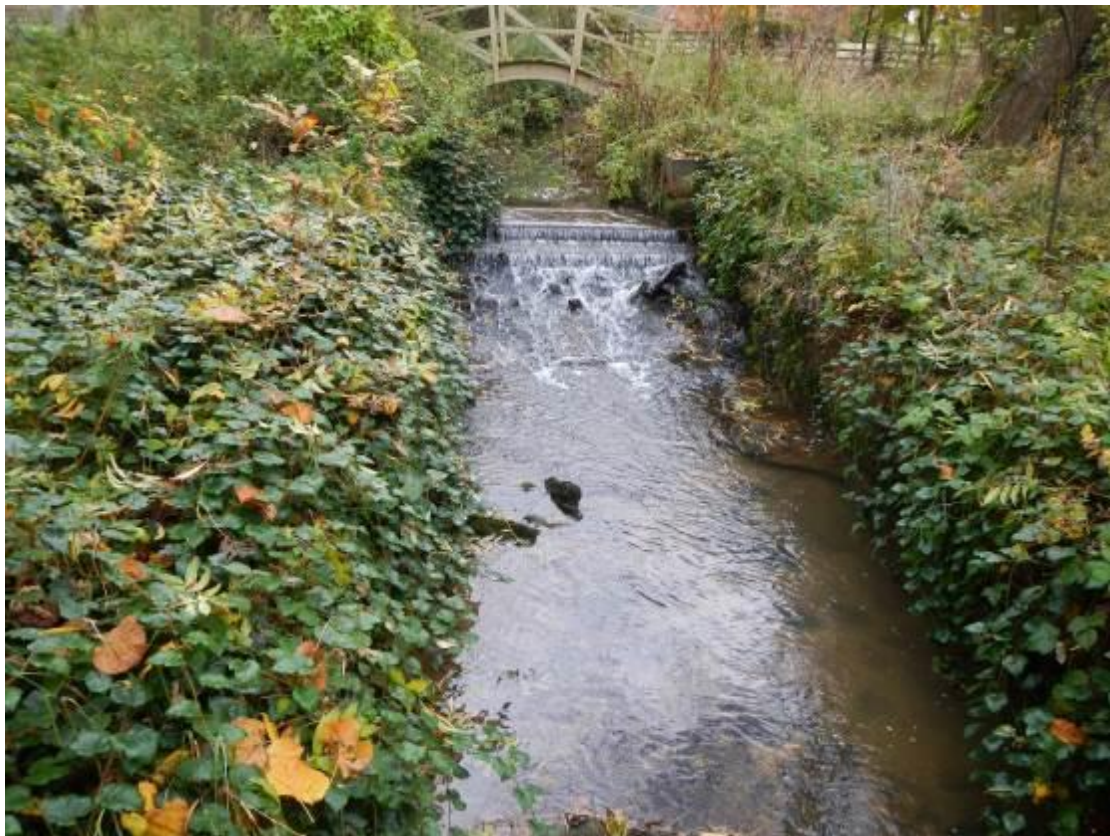
Figure 27. An ornamental weir located near the d/s end of the mill pond; an obstacle to fish passage.

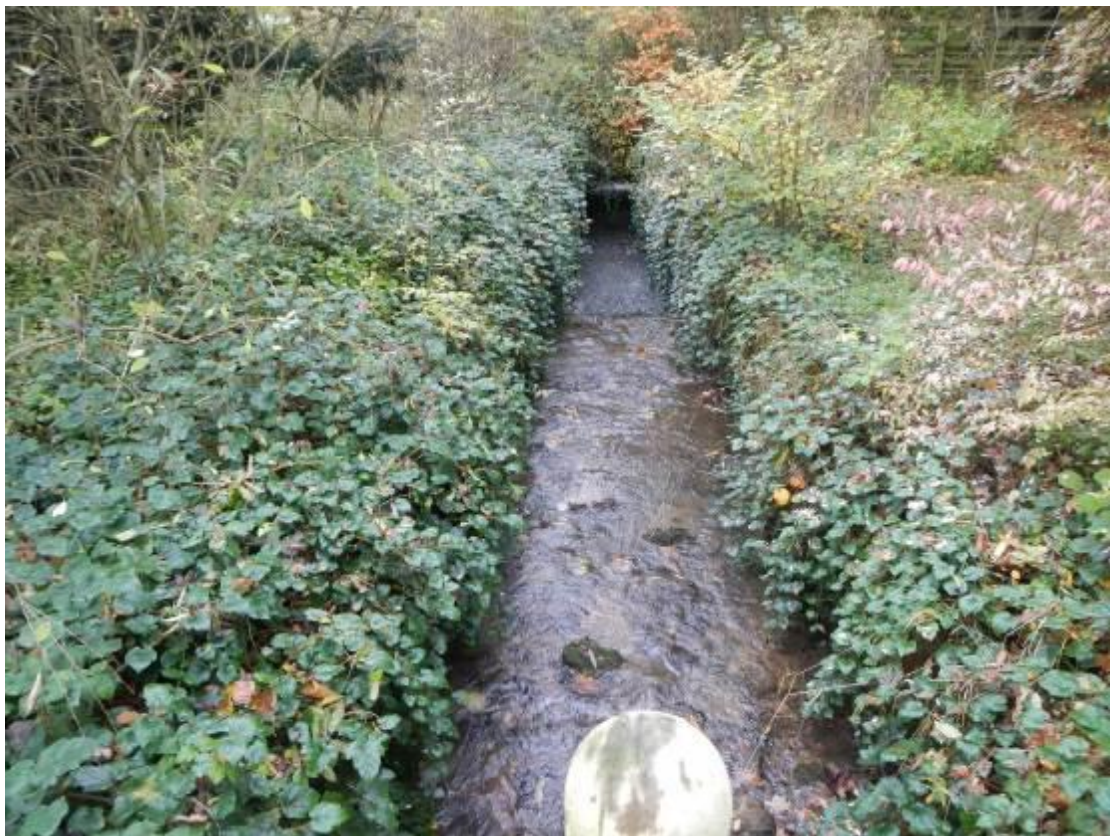
As well as degrading the channel quality, this also maintains the beck elevation above the valley bottom. D/s of the pond, the beck returns to the natural valley bottom via a steep, artificial channel section that includes a weir (Fig. 27) and road culvert (Fig. 28), both which provide poor passability for fish, and armouring d/s of the culvert (Fig. 29) which assists fish passage somewhat.

Figure 28. Poor passage for fish created by the straight, steep channel flowing down into the concrete-lined road culvert.

Within the actual road and railway culverts, a simple concrete baffle array could be employed using kerb stones or similar, as shown in Fig. 52a & b. This would create increased deposition within the channel, slow the flow making it easier to ascend, and create slack water where fish can rest as they pass through.

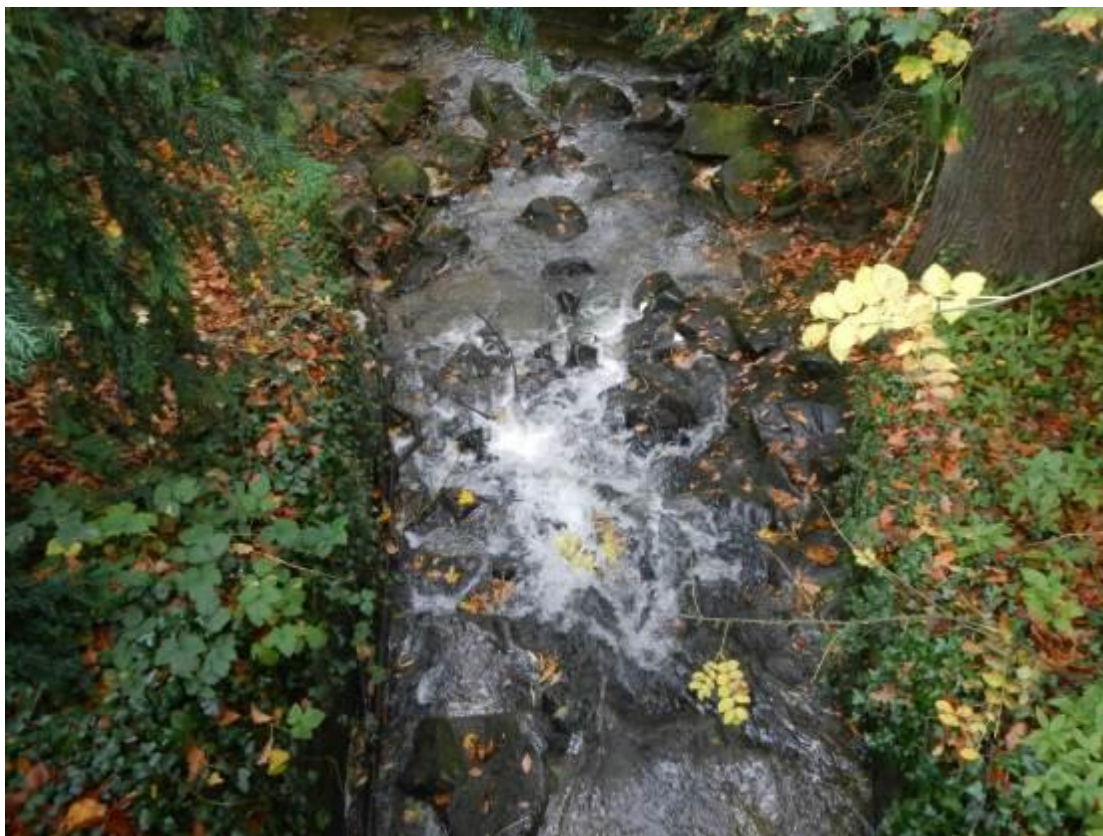
Figure 29. Rock armouring on the d/s side of the road culvert. This was likely installed as scour protection for the bed but does provide some improvement to fish passage, rather than a sheer drop or concrete lined channel.

Access to road culvert access at d/s end of Settrington mill pond	Fig. 29	Additional rip rap to create an enhanced rock ramp.	SE 83818 70046
>3m high weir that impounds water to feed the now disused fish farm and carp lakes	Fig. 43	Identify whether the feed to the lakes is still required. 1. If not - Remove weir 2. If so – Investigate options for a bypass channel, possibly using a paleo-channel	SE 82640 72742
Railway culvert that impedes fish passage	Figs. 47 & 48	1. Install baffles on culvert base to slow flows and increase water depth. 2. Improve rock ramp access to culvert

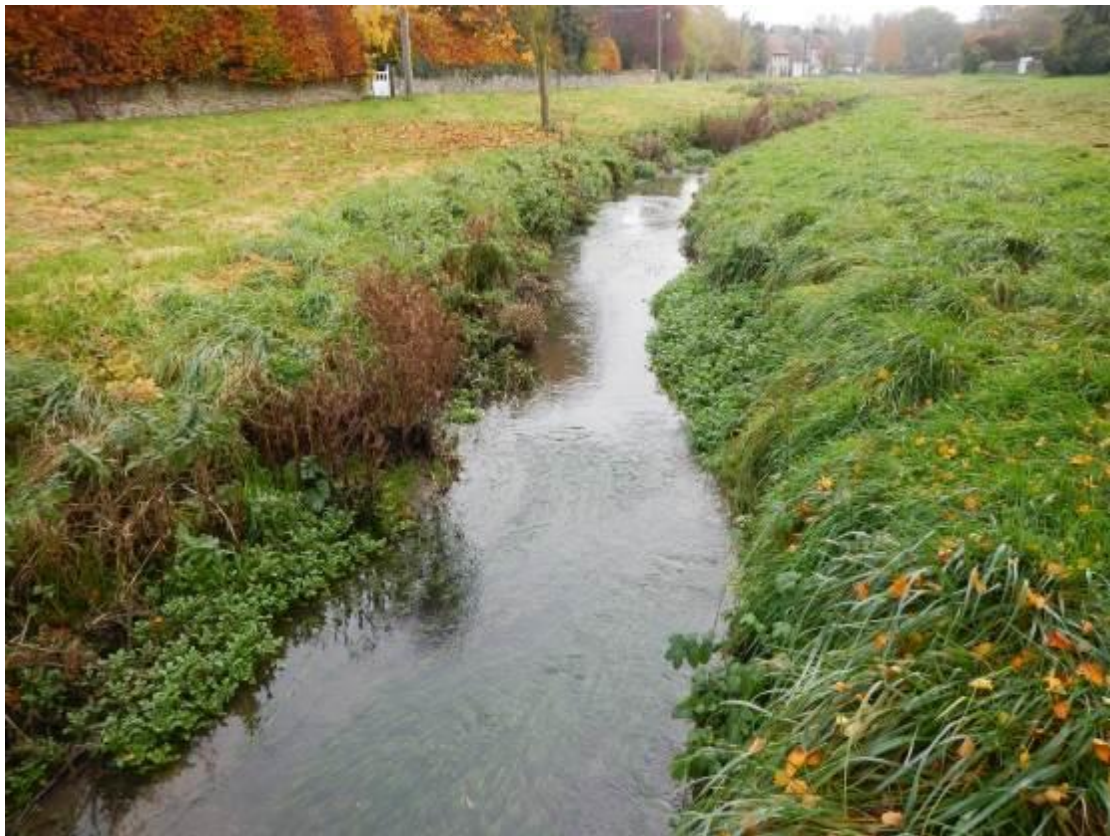
Through the centre of the village, the channel appears to have been straightened and lacks deeper pool areas but, in the absence of grazing, has naturalised and supports some beneficial features. Although the land adjacent is mowed, a reasonable buffer strip of unmown land is provided along the beck which has allowed some herbaceous vegetation to establish (Fig. 30). It is suspected, however, that mowing/cutting closer to the beck has been undertaken relatively recently as a greater diversity of herbaceous vegetation and shrubs would be expected. The bed of the beck remains heavily impacted by sediment (Fig. 31).

Figure 30. Straightened channel though Settrington Village.

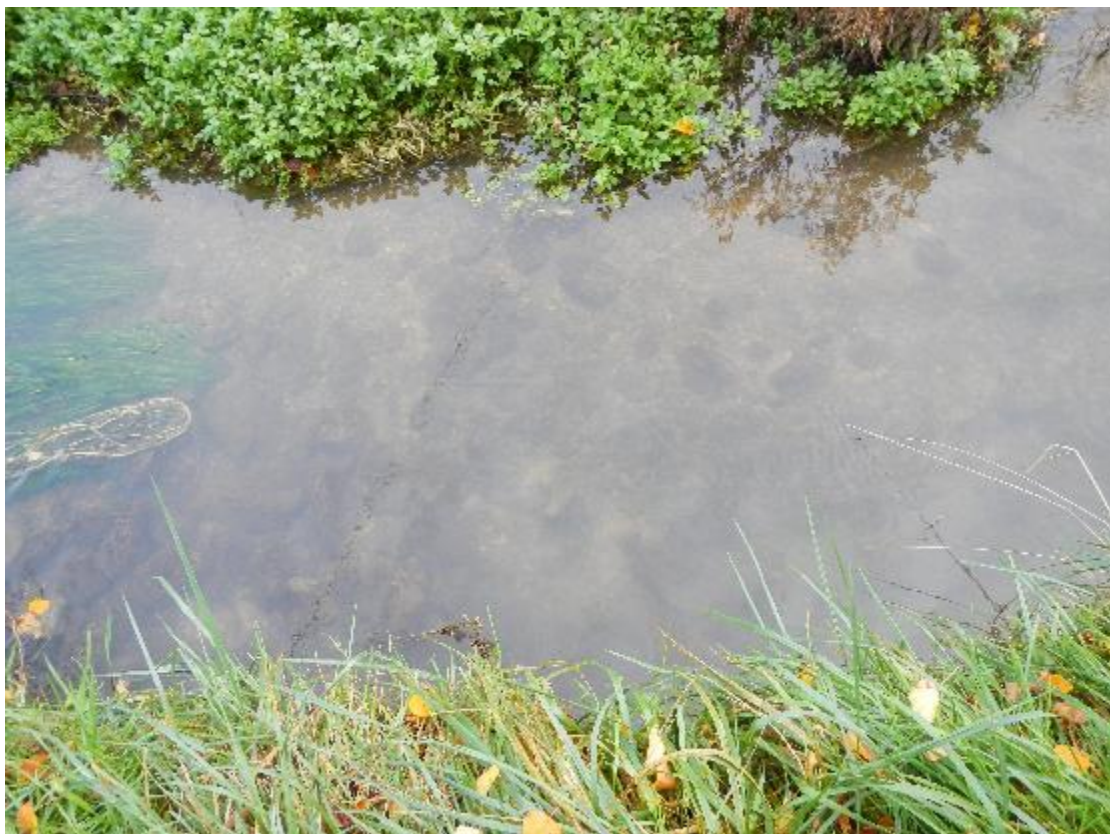
Figure 31. Poor habitat quality - armoured substrate resulting from excess sediment input u/s and potentially impacted by and interruption of gravel supply.

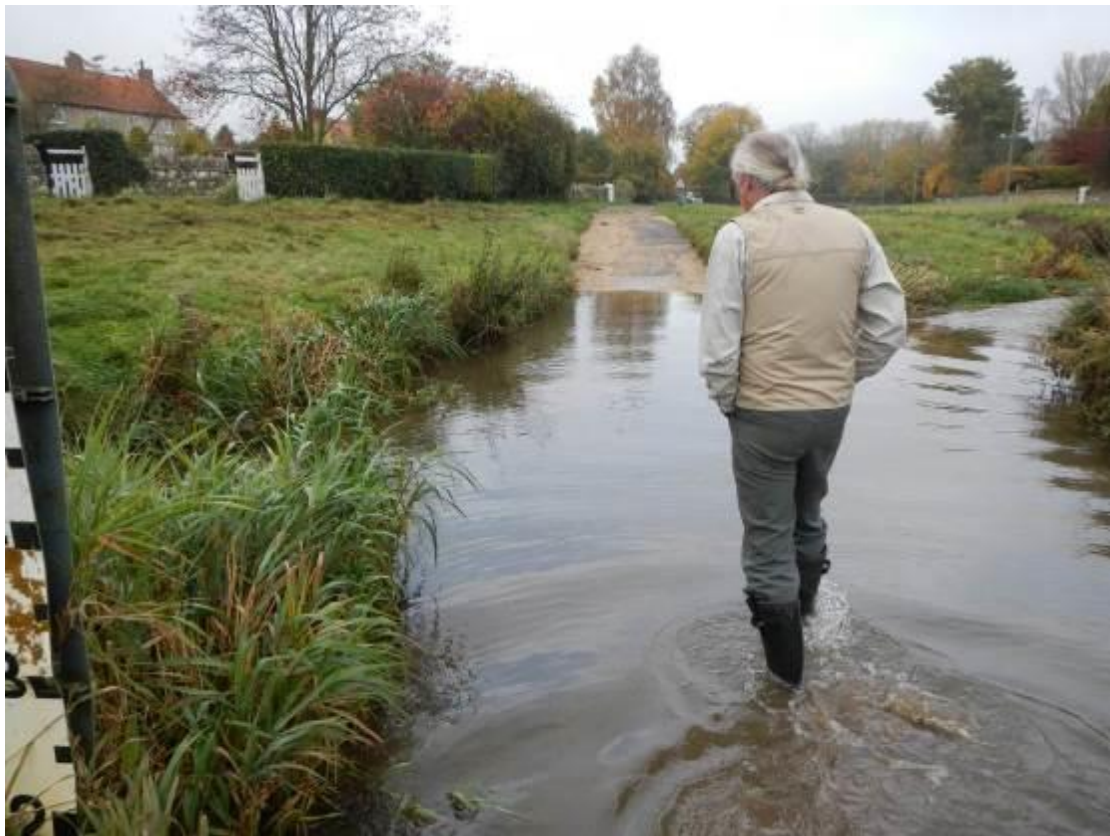
Several fords cross the beck within the village; these areas are over-wide and likely to accumulate substrate supplied from u/s (Fig. 32). It is suspected these are dredged and the material removed. While this might maintain access, it denudes the channel of important gravel substrate and may explain the coarse, armoured nature of the bed d/s that lacks gravel (Fig. 31). At one of the fords, a water vole may have been spotted, supported by the presence of numerous suspected burrows (Fig. 34); however, no latrines were observed.

Figure 33. Massively over-capacity ford area where it is suspected that dredging/gravel removal is undertaken, as evident by the trail of gravel leading out of the ford at either side (likely to be washout from the removal vessel as it ascends the slope).

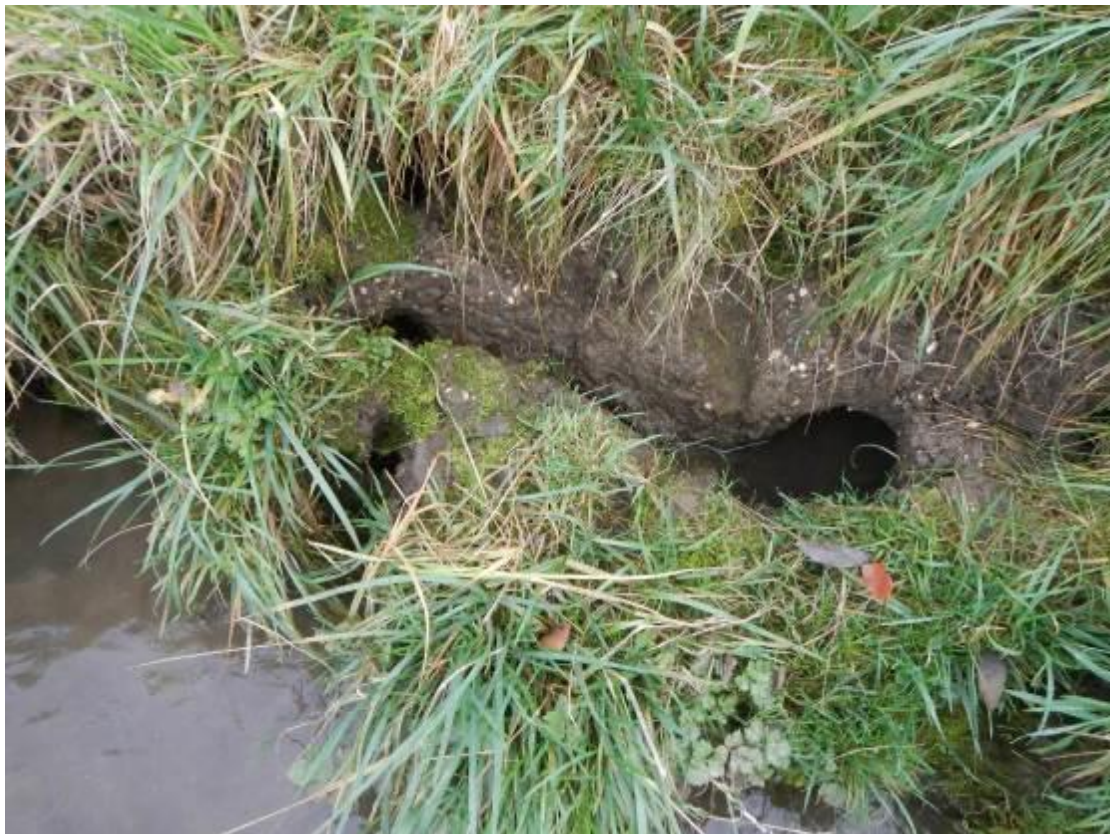
Figure 34. Suspected water vole burrows within the bank around the ford.

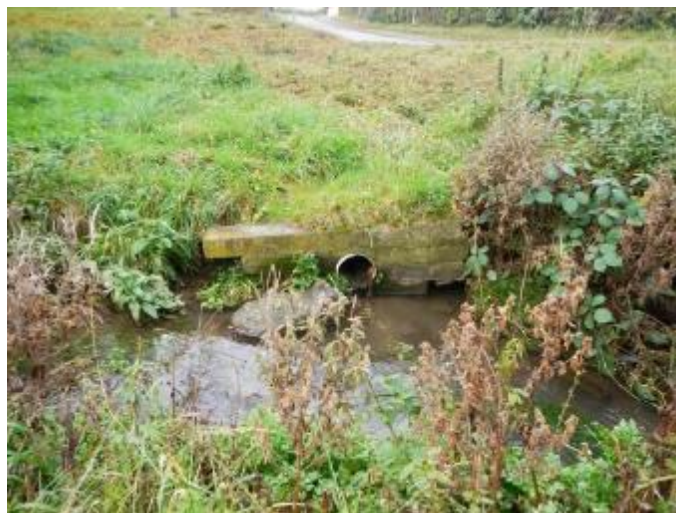
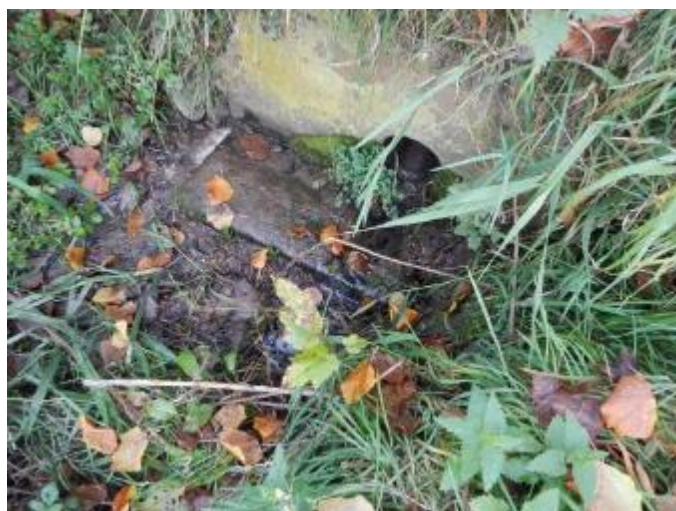
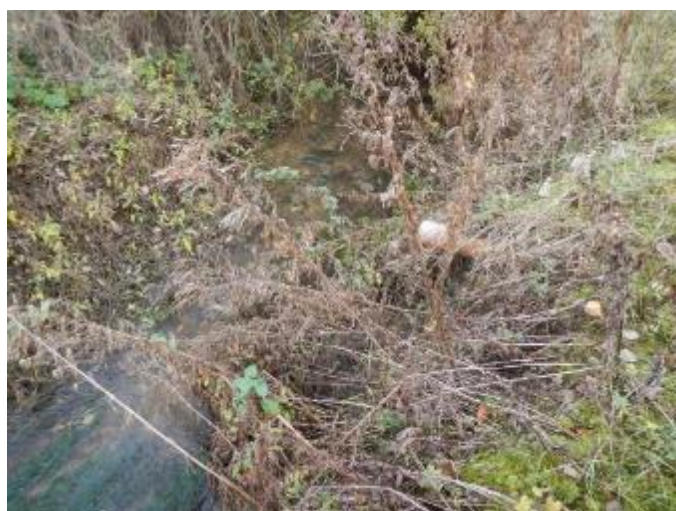
Several outfalls were observed to be discharging into the beck around the village (Figs. 35a, b & c). Inspection of these revealed no signs of any malodorous or obviously polluting substances and it is therefore assumed that these are surface water outfalls.

Figures 35a, b & c. Suspected surface water outfalls

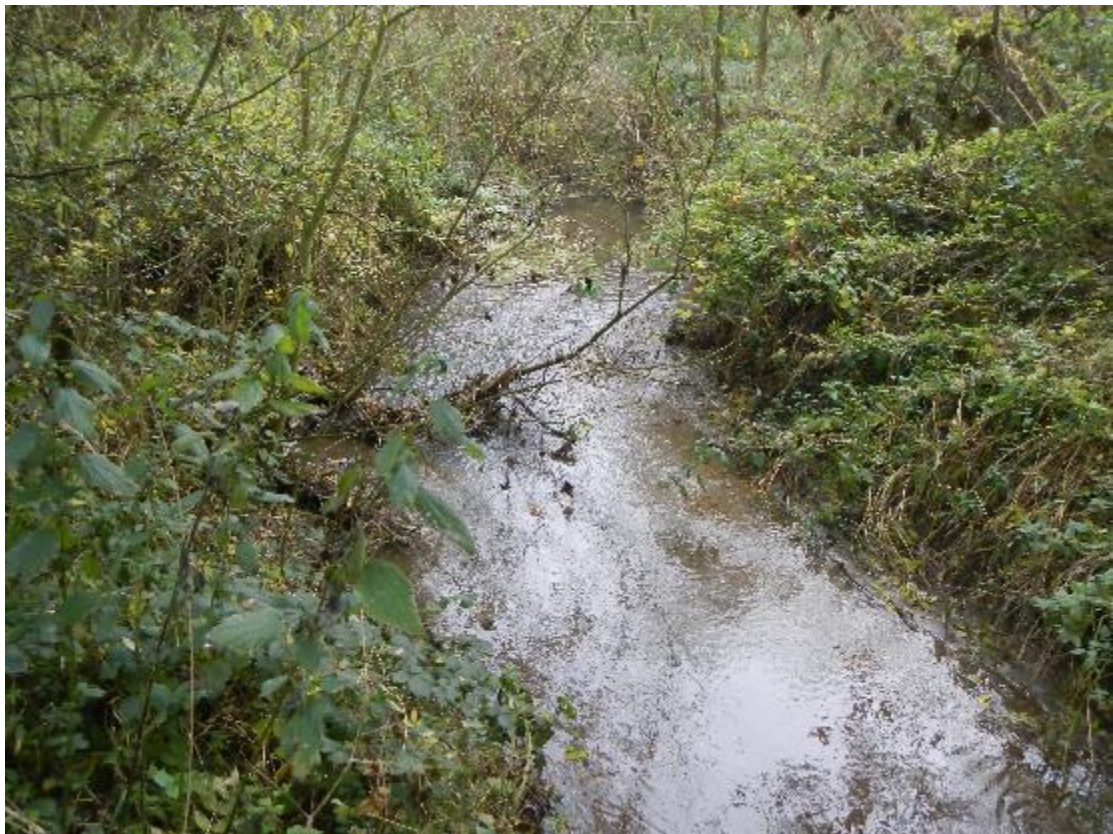
Figure 36. Good quality, naturalised habitat within the wooded buffer.

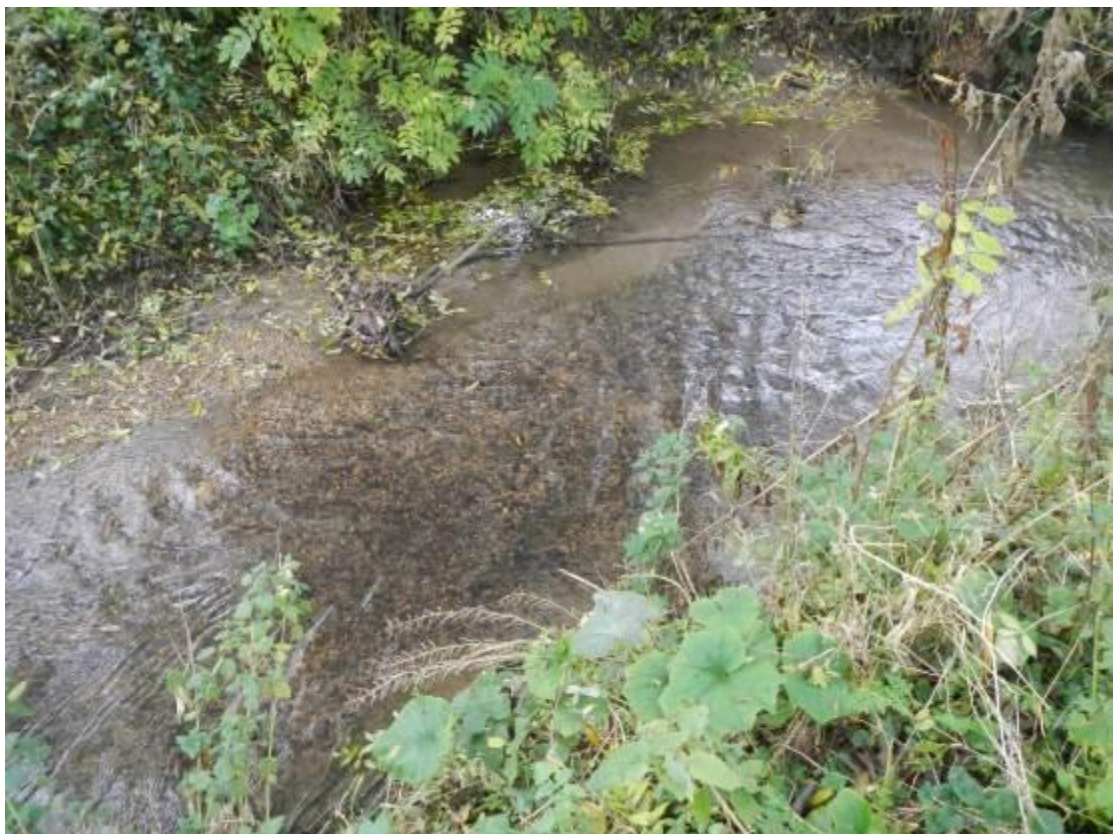
Figure 37. The substrate habitat quality remains severely compromised by fine sediment.

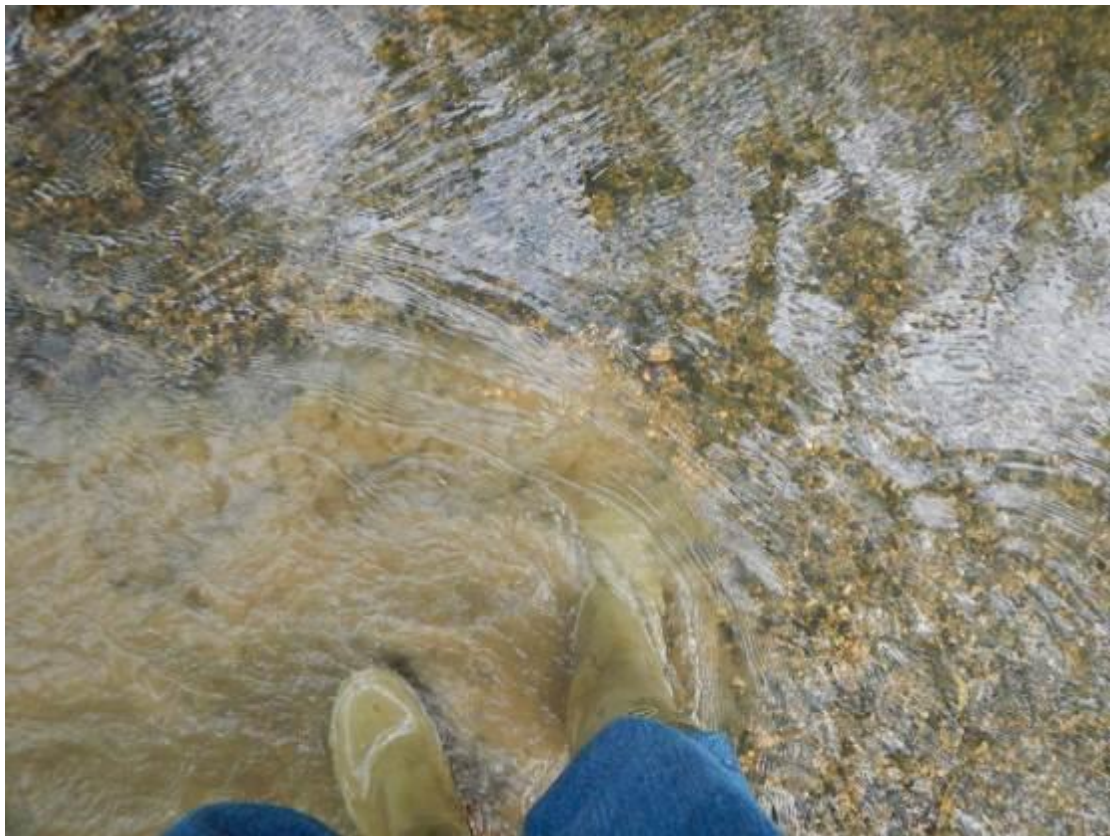
Figure 38. Agitation of the bed displaces large plumes of fine sediment.

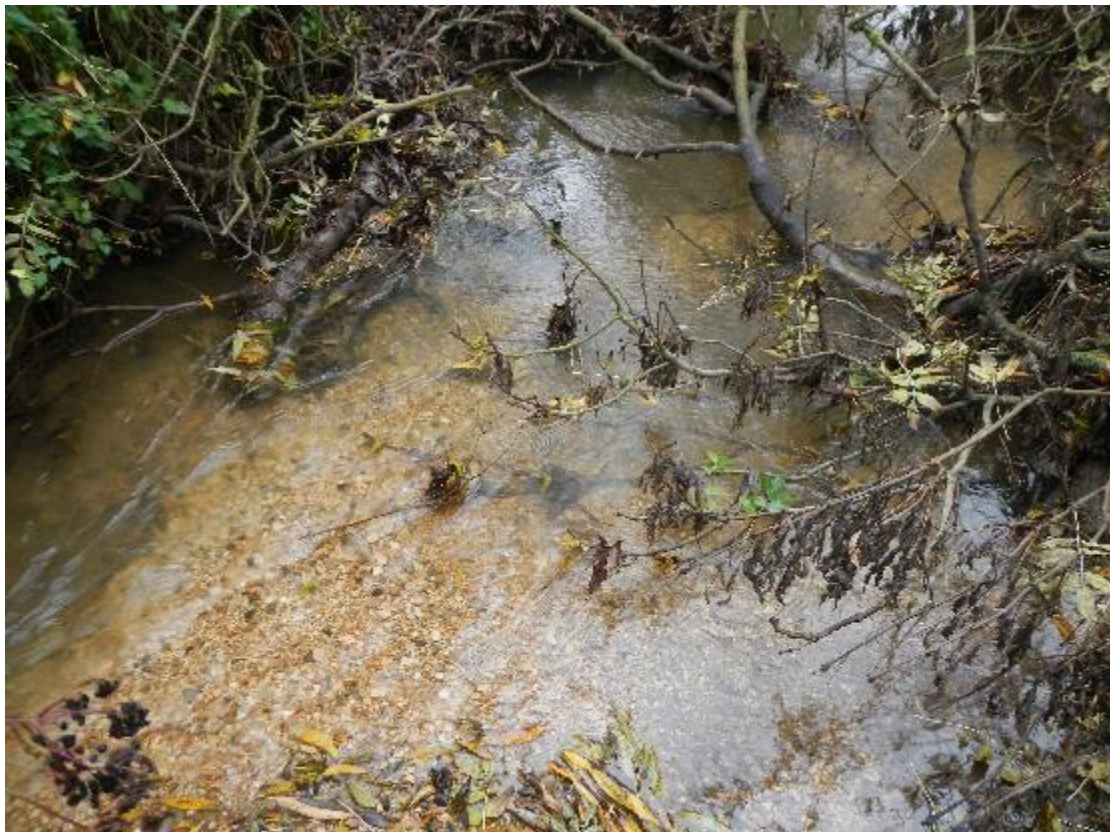
Figure 39. Where woody material constricts the flow and scours the bed, some higher quality gravels are present.

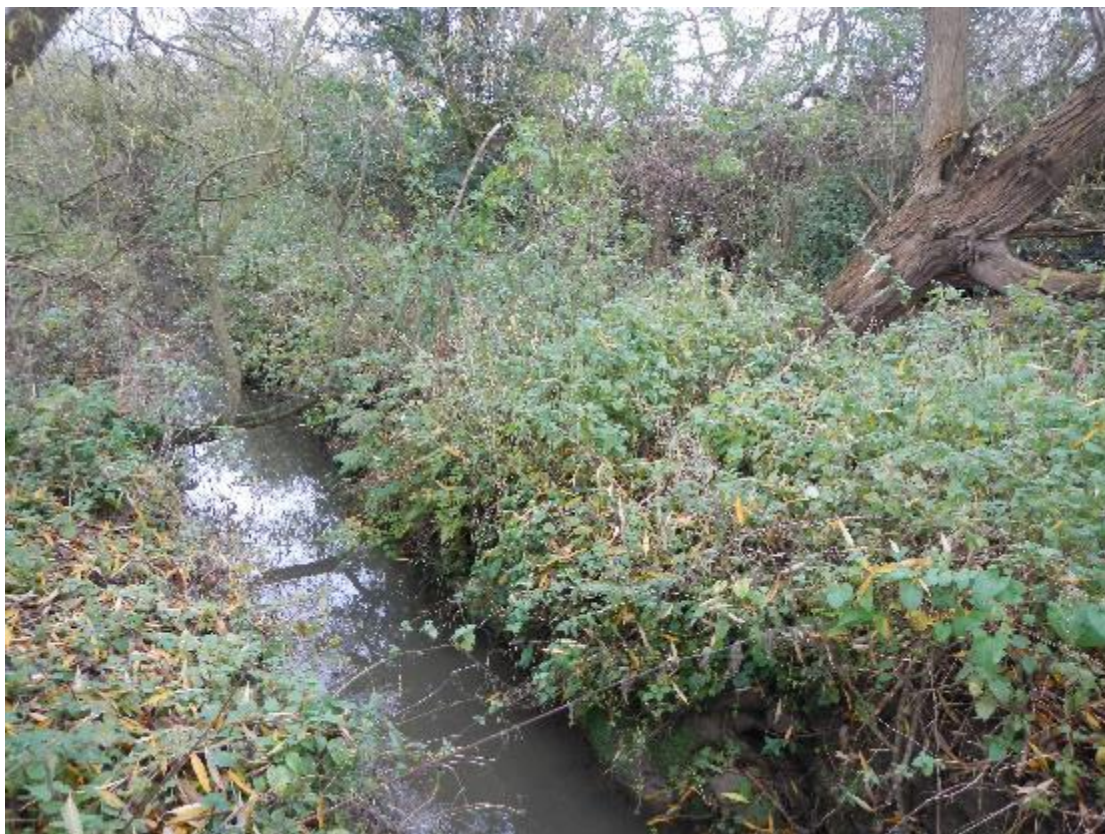
However, the channel immediately adjacent to the sewage works has been more recently straightened, presumably in response to the erosion of the RB (alongside the works) which was threatening to undermine the boundary fence. As in other areas, the straightening and re-sectioning has left the channel over-capacity and with poor quality habitat (Fig. 40). The only outlet observed for the sewage works appeared to be discharging relatively clean water, with no significant odour or signs of sewage fungus (Fig. 41).

Figure 40. The straightened channel alongside the sewage works.

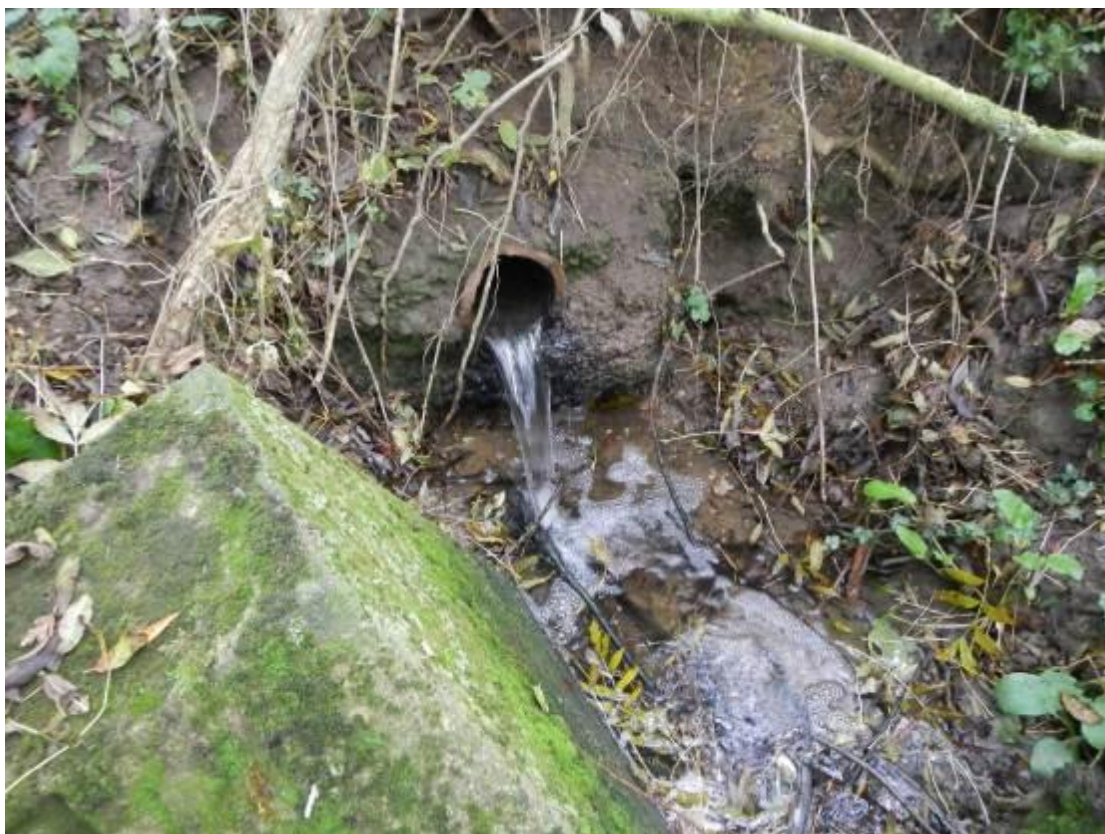
Figure 41. The only outfall observed for the sewage works.

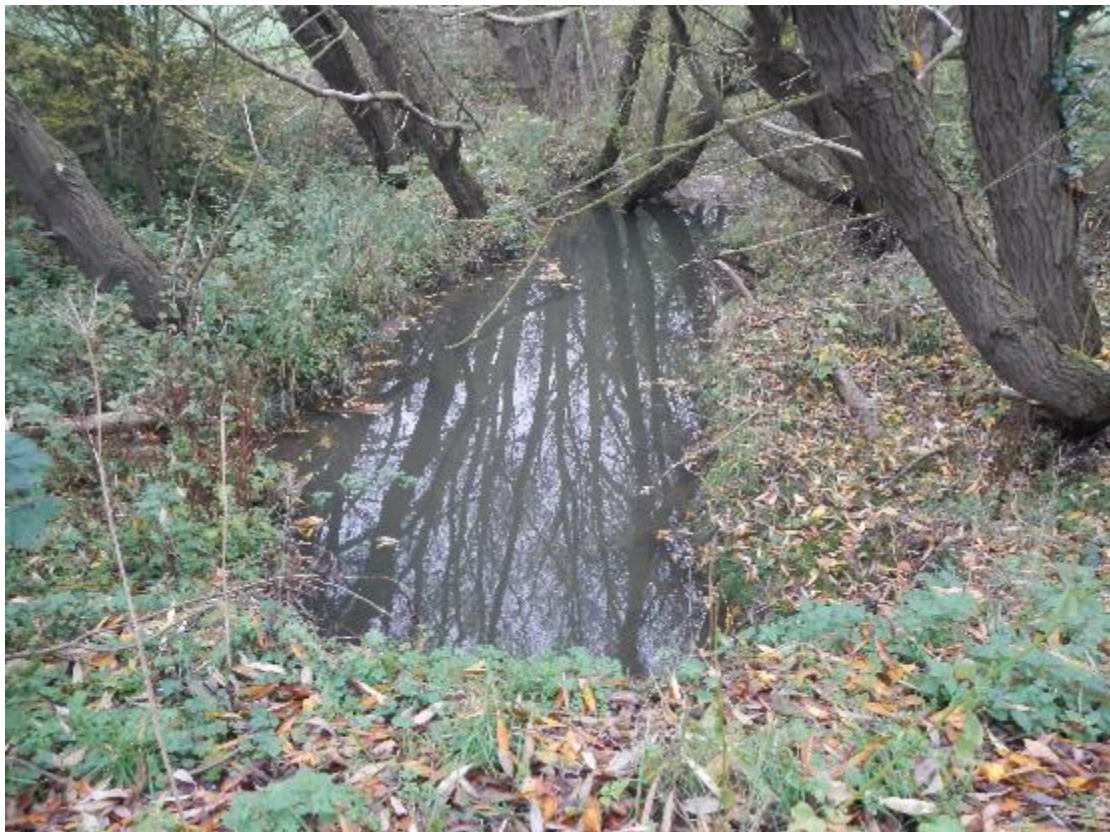
A brief look u/s of the A64 road bridge revealed that the flow was greatly impounded and the habitat resembled that of a stillwater (Fig. 42). These conditions continue for >200m d/s, to a 3-m weir at SE 82640 72742 that impounds water as a feed for the disused fish farm and adjacent carp lakes (Carpvaley).

Figure 42. The beck is impounded for several hundred metres, with the influence of the d/s weir extending well upstream of the A64.

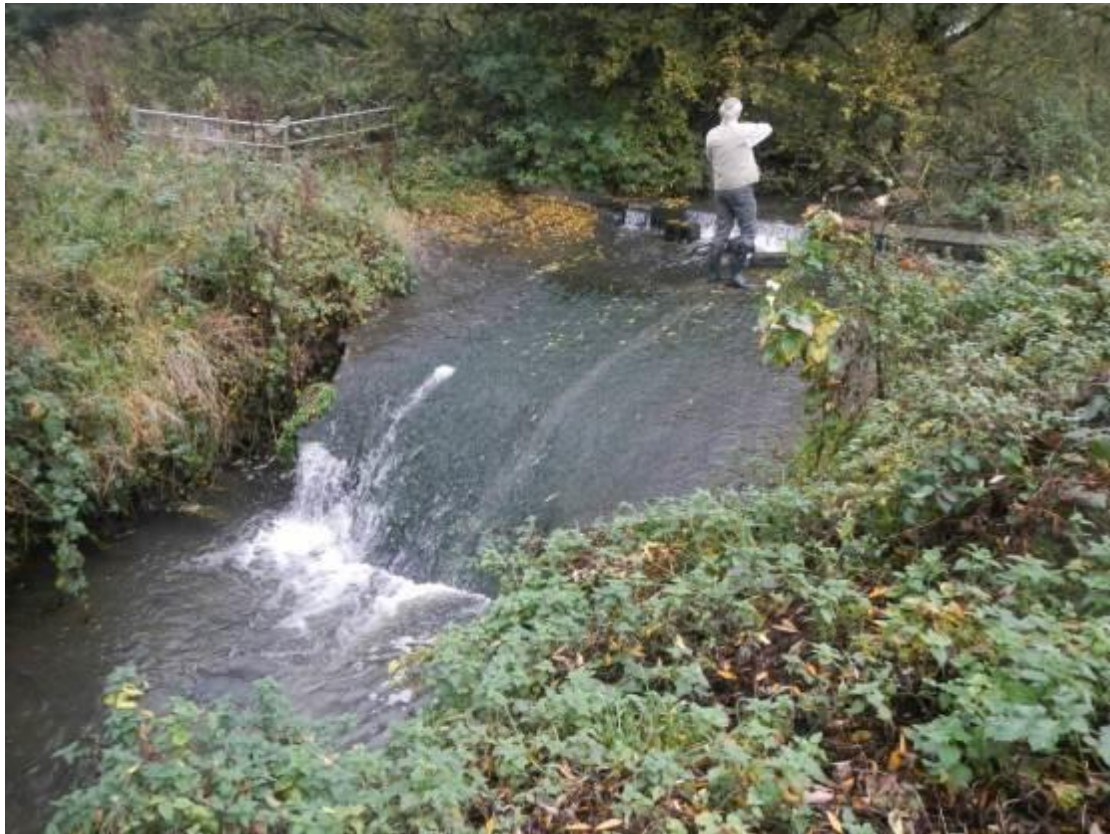
The weir poses a complete barrier to u/s fish migration (Fig. 43). Paleo-channels within the wood provide an indication of the natural, more sinuous course (Fig. 44) and may provide some potential for a river restoration project or, at least, creating a bypass channel around the weir if it cannot be removed; this could be the case if it is still required to maintain water levels within the carp fishery. Habitat within the straightened sections is of very low quality (Fig. 45).

Figure 43. >3m high weir that impounds several hundred metres of the beck and poses a completely impassable barrier to the u/s migration of fish.

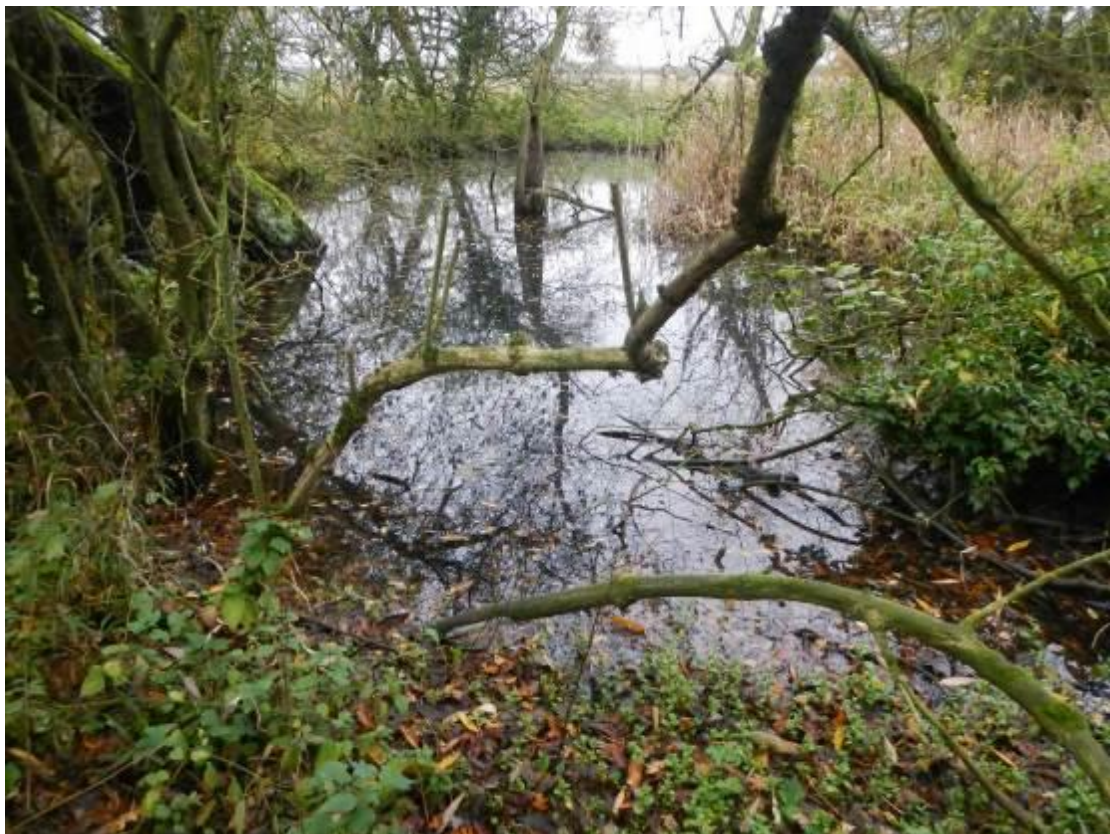
Figure 44. One of the redundant paleo-channels alongside the carp fishery.

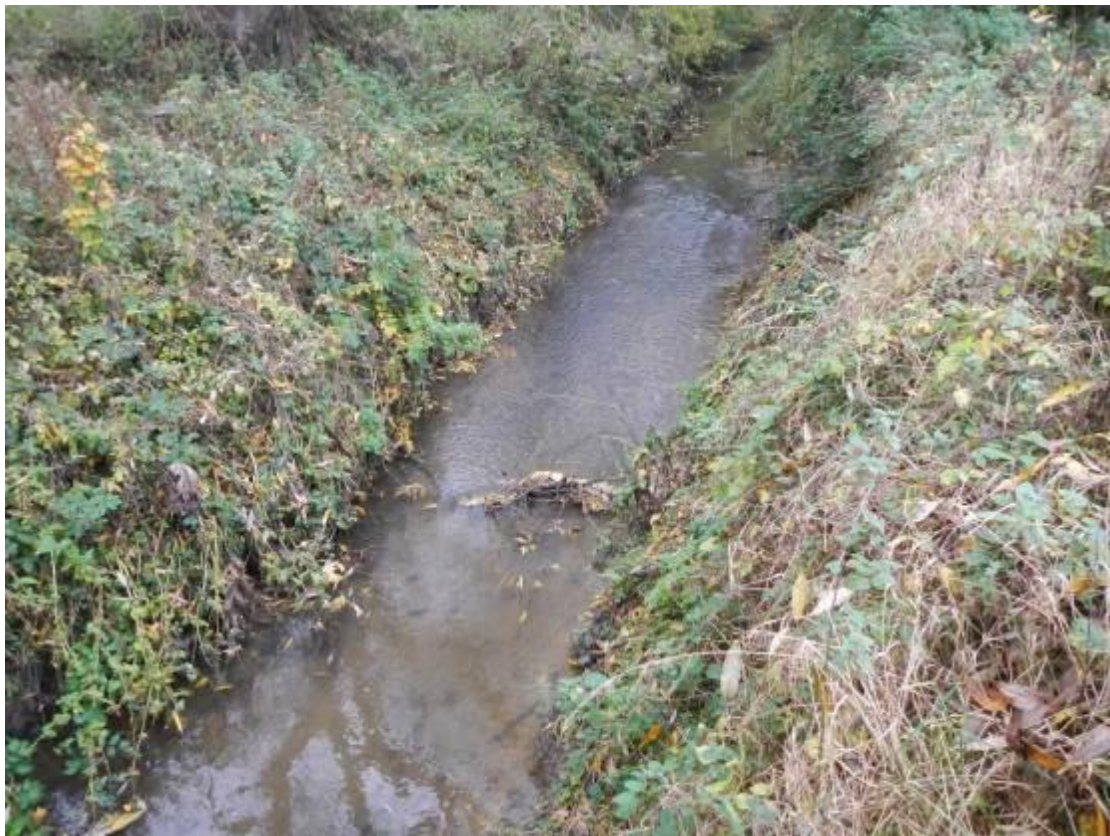
Figure 45. Very low habitat quality within the straightened channel.
