Advisory Visit
Settrington Beck
04/11/2015

1.0 Introduction

This report is the output of a site visit to Settrington Beck, at the request of East Yorkshire Rivers Trust. The purpose of the visit was to assess habitat and make recommendations for habitat improvements that could be undertaken on the beck.

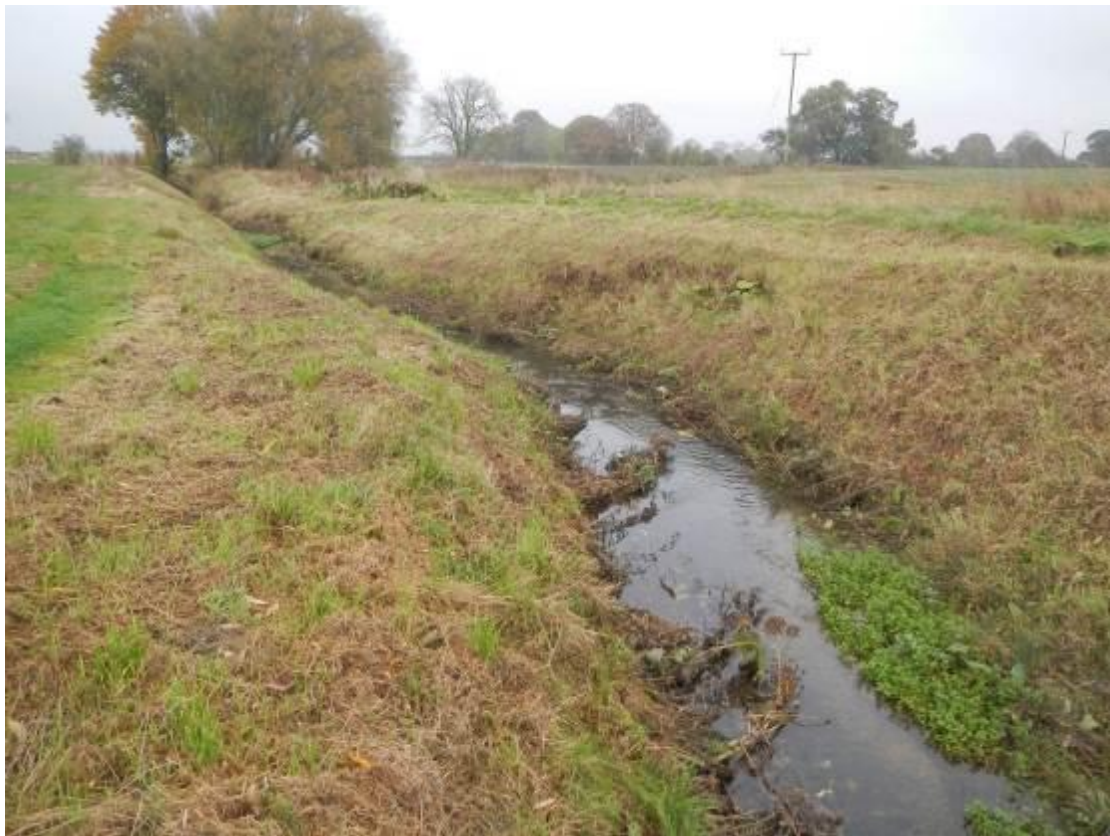
The past dredging and realignment remains a significant impact for the remainder of the watercourse d/s to the Derwent, with further sections of paleo-channel evident. Around Marr House (SE 82406 73448) maintenance of bankside vegetation has been undertaken. It is not clear as to the purpose but it may be an attempt to adopt it as garden or simply to reduce perceived flood risk (Fig. 46). The result is a further negative impact upon the already poor quality habitat.

Figure 46. Maintenance of bankside vegetation around Marr House.

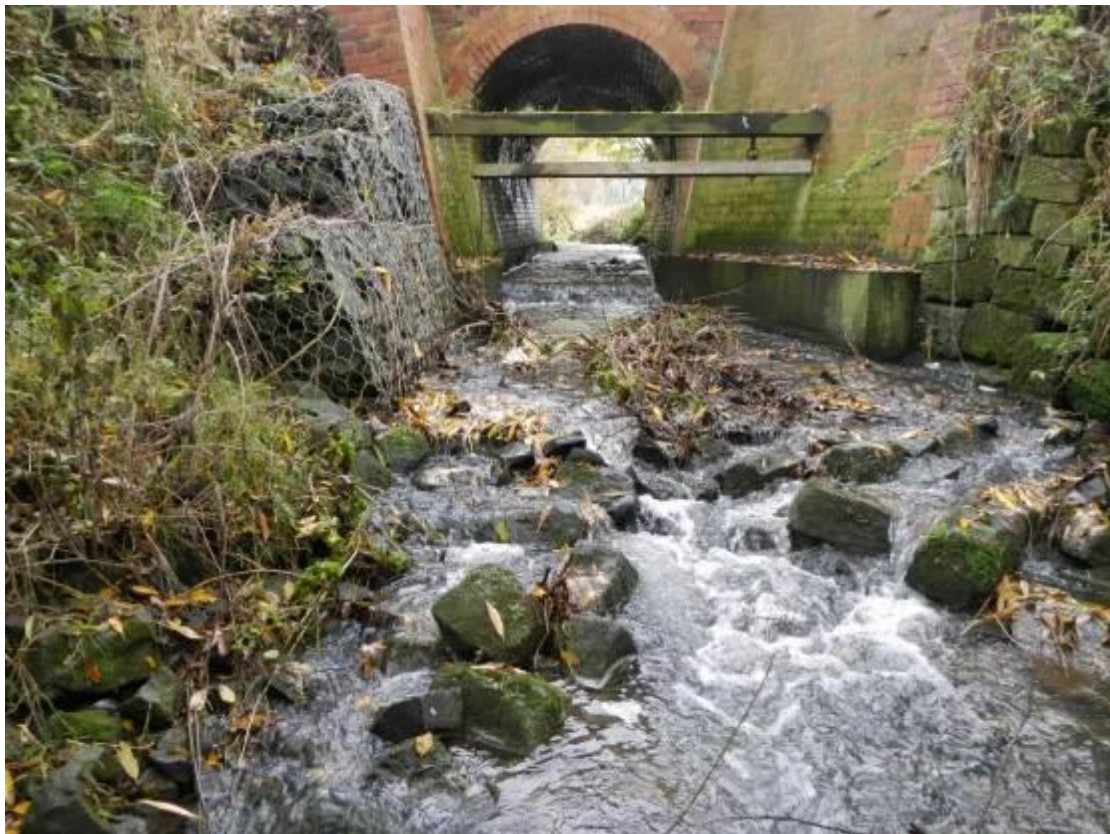
D/s of the house, the beck flows through a perched, cobble-lined railway culvert that poses another obstacle for fish (Figs. 47 & 48). Stone rip rap employed to reduce the impact of scour on the d/s side of the structure aids fish passage somewhat but it remains a major barrier, exacerbated by the fluming effect of the culvert. Fish passage between the culvert and the Derwent is inhibited.

Figure 47. Railway culvert – rip rap at the d/s entrance improves fish passage somewhat, but it remains a major obstacle.

Within the actual road and railway culverts, a simple concrete baffle array could be employed using kerb stones or similar, as shown in Fig. 52a & b. This would create increased deposition within the channel, slow the flow making it easier to ascend, and create slack water where fish can rest as they pass through.

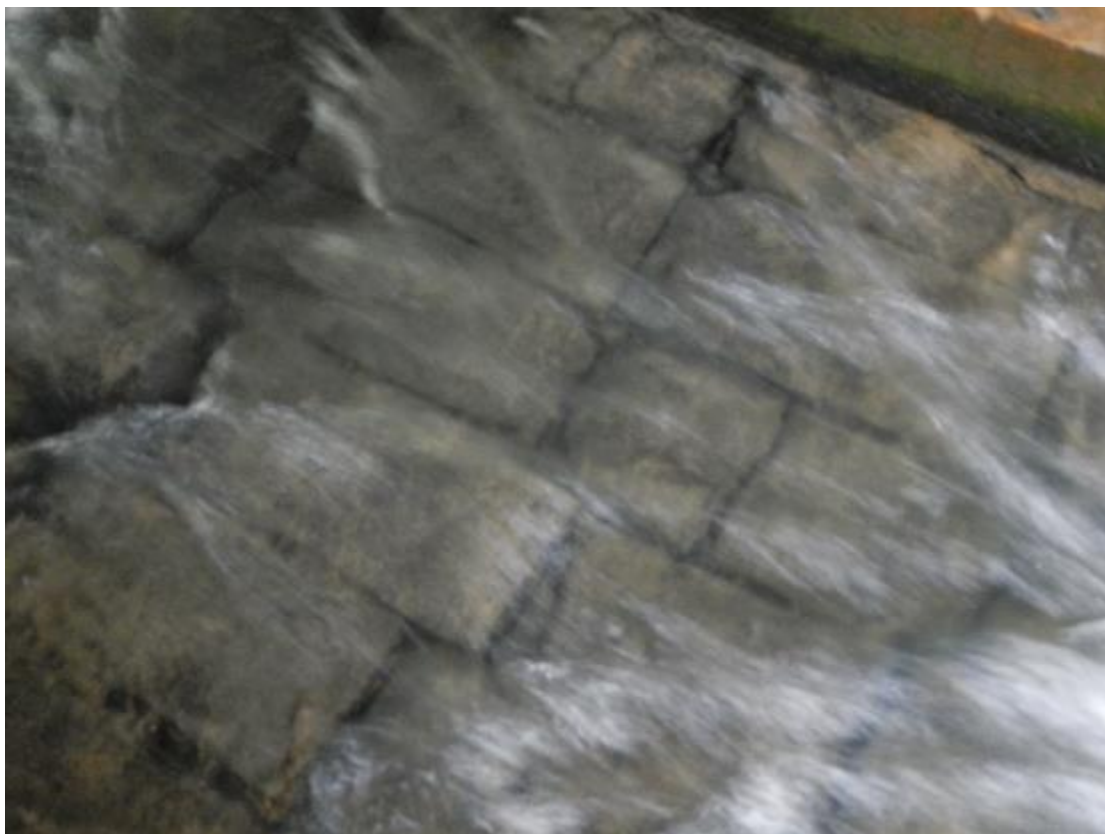
Figure 48. The swift flow over the relatively smooth and flat bed further impedes the passage of any fish making it into the culvert.

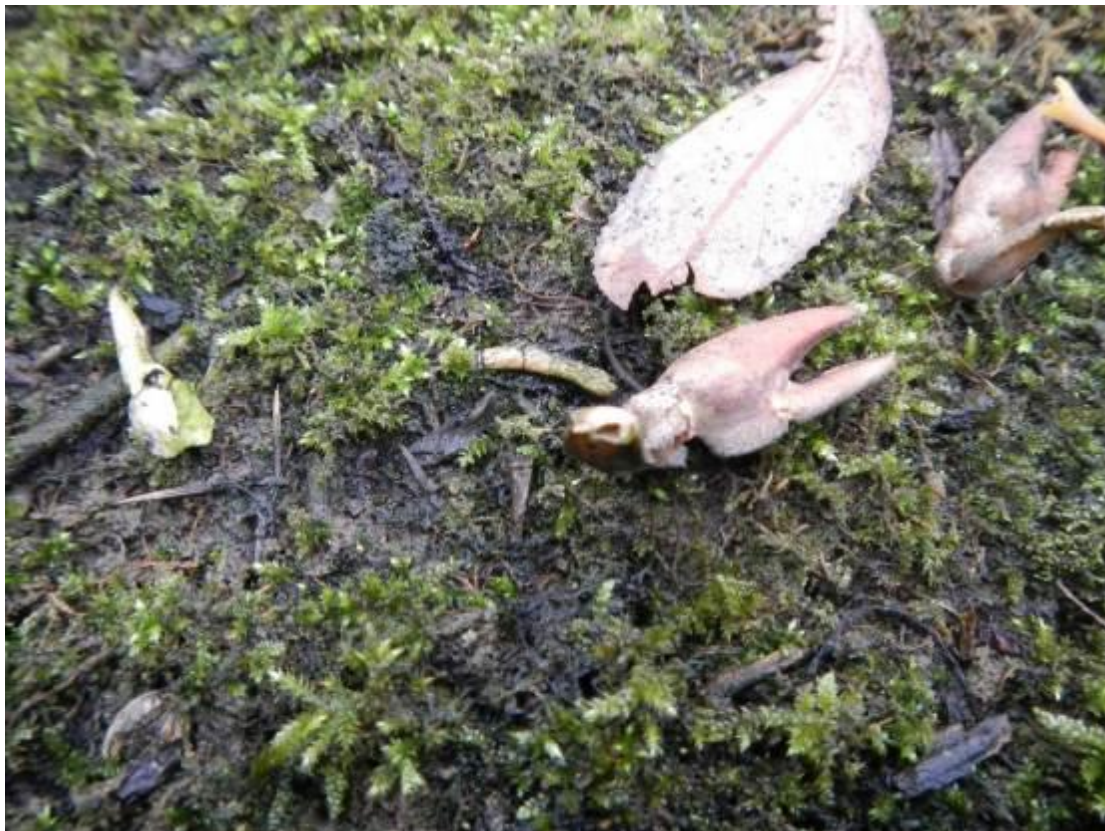
Signal crayfish (*Pacifastacus leniusculus*) remains were also found at the culvert (Fig. 49). These invasive crayfish are the legacy of an historic grant programme for their cultivation available from the then Ministry of Agriculture Fisheries and Farming (MAFF) in the 1980s.

Figure 49. Remains of a signal crayfish.

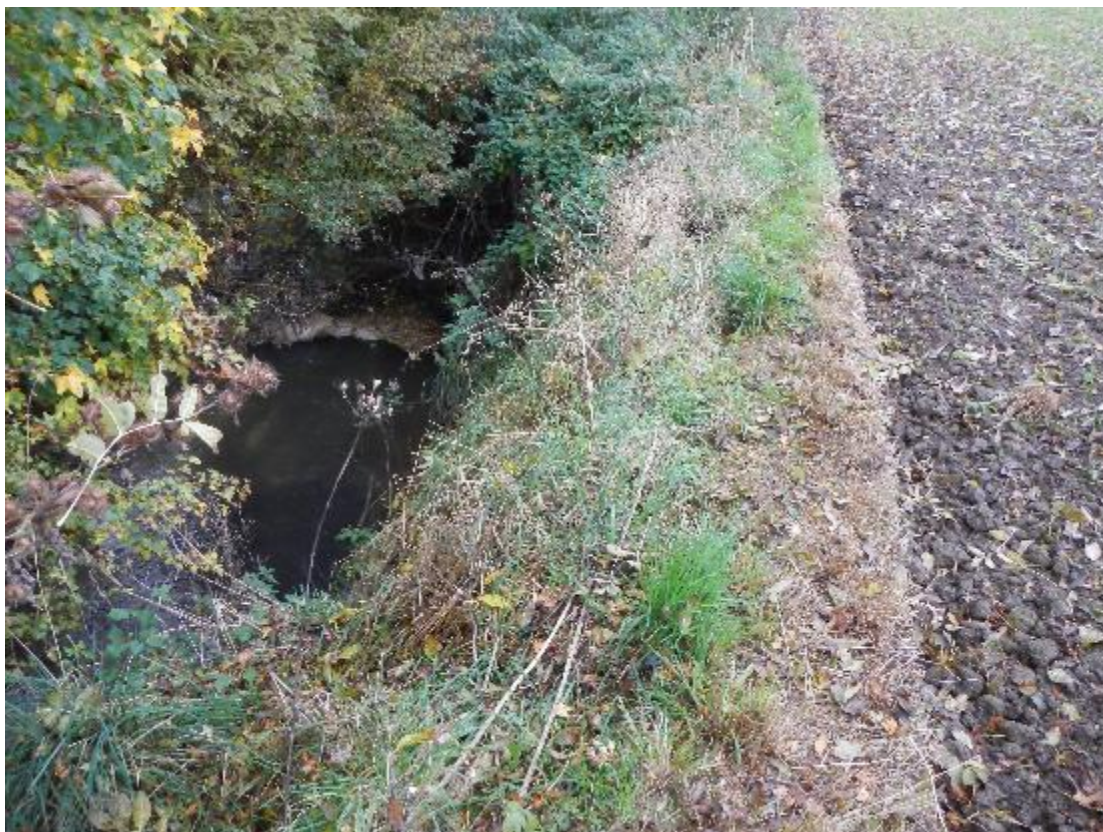
The buffer strip in the field where the beck meets the Derwent is much smaller than in other sections. This creates an issue where the bank is eroding towards the field and could lead to more serious erosion if it reaches the unconsolidated ground (Fig. 50).

Figure 50. One of the few areas of the arable land use adjacent to the beck where the buffer strip is not large enough.

Table 3. Bank erosion			
Description	Fig. #	Solution	Location
Any grazed bank sections without buffer fencing. Particularly prevalent on Bellmanear Farm and the fields d/s		Install buffer fencing as far back from the watercourse as can be agreed with the landowner/tenant.	Particularly (SE 84292 68088 - SE 84067 69629)
Eroding garden at Bellmanear Farm.	8	Leave a larger buffer of unmown grass and allow the bank to regrade naturally.	SE 84317 68314
Erosion and cattle poaching at Bellmanear Farm Fords.	9 & 10	1. Ideally the ford should be replaced with a clear-span bridge or oversized, sunken culvert (possibly in a slightly different location). It should also be ensured that the farm tracks have drainage points that discharge to soak-away areas in rough vegetation, rather than directly down the track to the watercourse.	SE 84339 68447
Cultivation too close to the beck	50	Increase size of the buffer strip	SE 82160 73738
