Shalbourne Stream – Mill House

**An Advisory Visit by Nick Lawrence on behalf of the Wild Trout Trust
September 2019**

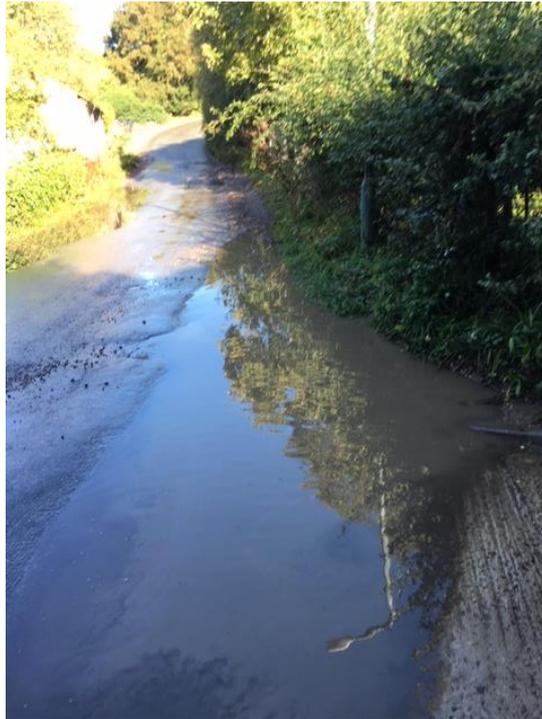
In the section downstream of the Mill House, notable fine sediment pollution from road run off was pouring directly into the river (Photo 1). This sediment can smother gravels which fish spawn in, reducing natural recruitment within the reach. It can also be damaging to invertebrates which will have a knock-on effect upon fish populations.

Photo 1 Massive amounts of sediment washed down the road directly into the river. (SU 31629 63648)

With no fish visible in this channel, it is possible that the culvert under the road in photo 1, where both channels meet, is impassable to fish. This couldn't be

It would be worthwhile contacting Action for the river Kennet (ARK) as they have an app that they use to record point source pollution issues within the Kennet

catchment (Called Muddy Walks). Once the issue has been logged a plan can be made to reduce the sediment running directly into the stream.

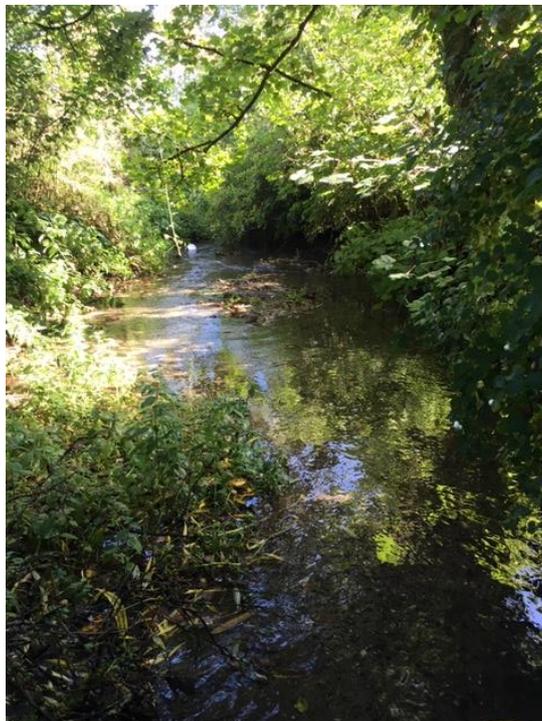
Photo 2 Downstream of road bridge: quality varied habitat with dappled light, in-channel bars and a riffle and pool formation.

Photo 2 is a prime example of the type of varied habitat that trout favor. In the picture, encroaching marginal vegetation is providing cover for fish and pinching the flow. Downstream is an island where the channel splits before a high-quality riffle that flumes into a pool, where the white bucket is visible.

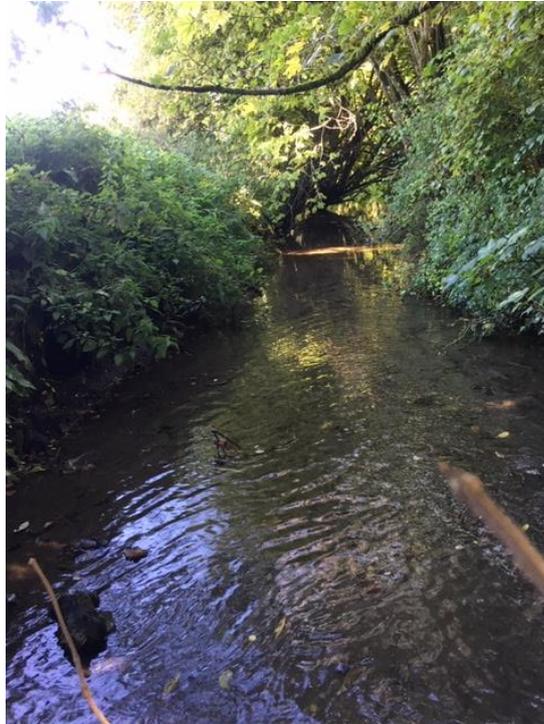
Photo 3 Near the bottom boundary the stream becomes more uniform, overwide, heavily shaded with lots of siltation.

Towards the downstream boundary, the stream is suffering from an overwide uniform channel (Photo 3) which is allowing the sediment from the road run off to settle across the bed. There is no flow diversity here and the shading is suppressing marginal plant growth; plants that could otherwise help to collect the silt in the margins and assist in pinching the channel to keep gravels clean.

The habitat shown in photos 2 and 3 appears capable of supporting brown trout and just because no fish were seen on the visit, does not mean they aren't there. Investigations downstream after the visit found no impoundments and reasonable habitat, which means that even if trout aren't here, once the habitat is right, they should be able to re-colonize it. These areas could do with some skylighting of the channel and, using the locally won timber, some strategic woody deflectors could be used to pinch the channel to scour and clean the gravels.

- **Explore possibilities of adding woody material, tree limbs or brushwood mattresses in the lower section to encourage variation in flow and depth. This can be done in conjunction with some coppicing in the heavily shaded areas of woodland to generate the material for the structures and add light to the channel in the right places. Approximately 3-4 structures could change this reach and drastically improve it. Photos 9, 10 & 11 show some examples of the type of structures that could be installed.**

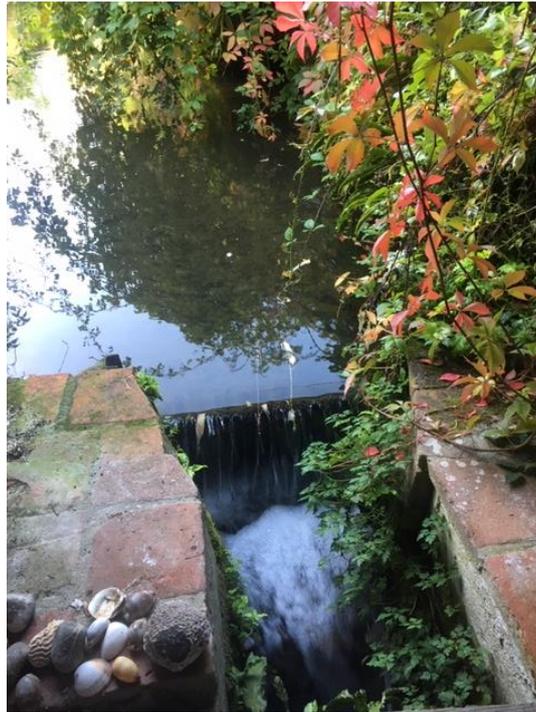
Photo 4 Boards in the old mill race, impounding the flow and impeding fish passage.

The old mill structure in photo 4 has led to a devastating loss of habitat upstream, impounding the river for at least 70 metres, where it can only really be described as a slow flowing canal. The river has been robbed of its natural flow diversity, greatly impeding natural geomorphic processes. Consequently, sediment has been deposited on the bed in large quantities, smothering the gravels and restricting the natural processes of the river. The thick layer of fine silt is also impeding the growth of aquatic plants, most notably water crowfoot (a very important weed in the chalkstream environment), which will lead to a subsequent reduction in the suitability of the habitat for fish and invertebrates.

This weir is also an impassable barrier to fish passage. Fish need to migrate within a river for many reasons such as spawning and to find better places to feed. This barrier is stopping that migration. It will affect local populations of brown trout, grayling and bullheads within this reach and the broader river system.

The first issue that needs to be addressed is the weir. If the weir was lowered or removed, the habitat upstream of it would change dramatically.

The mill house weir (photo 4) should be removed to assist fish passage for any fish that venture through the culvert under the road into the reach upstream. This in turn will improve the habitat directly upstream of the house, reduce sedimentation of the channel and provide more favourable conditions for in stream weed. As a minimum the boards should be left out during the critical period October- April when fish are migrating, and flows are high, but a more aspirational project to restore the watercourse back to a functioning stream should be the primary goal.

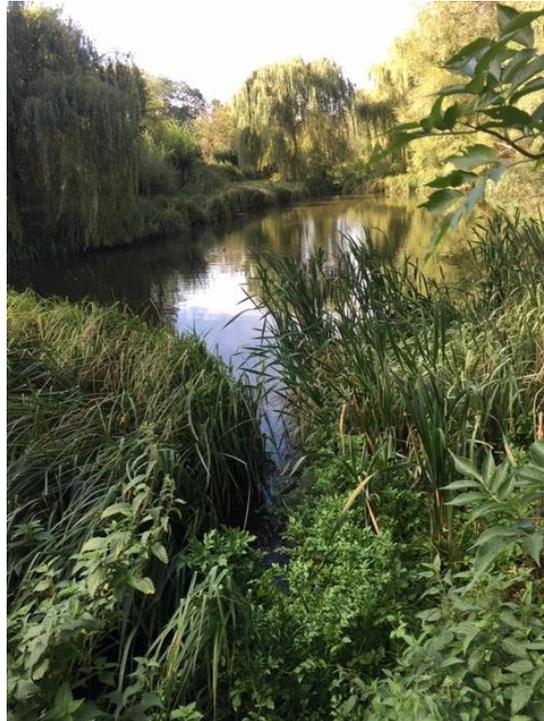
The mill race is also stranded by 2 online lakes upstream of it, which again inhibits fish movements. These lakes (photo 5) are shallow, and if fish were to venture into them, they would find it hard to navigate the maze of channels.

Photo 5 Top of the mill leat looking onto online lake.

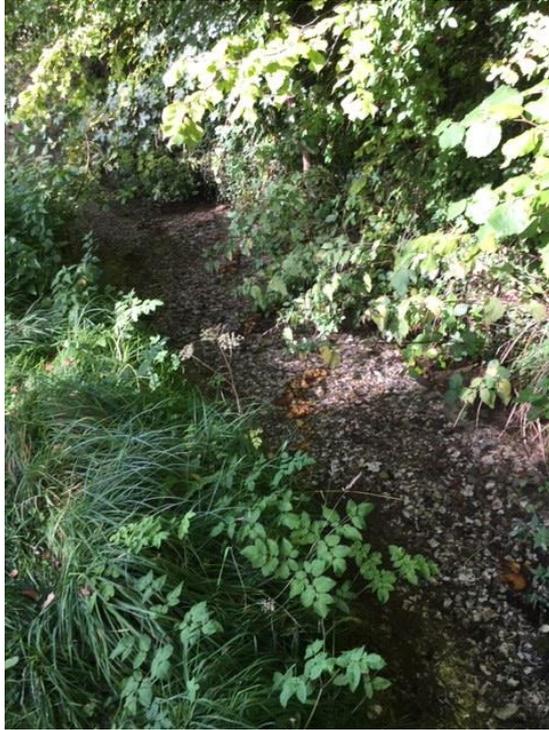
The more valuable un-impounded habitat seems to be available in the bypass stream (photo 6) that flows alongside the lakes and around the mill leat, although the unknown is still what happens to it under the road culvert. This stream looks like prime trout habitat, with pristine gravels, a likely spot for trout spawning if they can get there.

Photo 6 Bypass channel: pristine headwater habitat.

The side stream has the more valuable habitat for fish and although unproven probably has better potential for fish to migrate into the reach, discussions should be had with neighbours as to the state of this stream where it goes under the road and whether there are any other structures impeding fish passage. A collaborative effort could be engineered into a project to restore this.

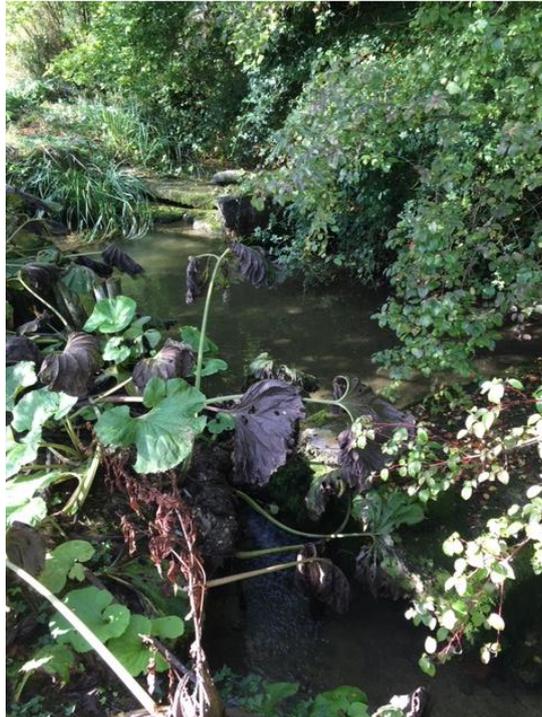
Photo 7 Two old derelict weirs, impeding fish passage and natural processes.

The side stream does have 2 impounding structures (Photo 7) that were possibly used historically to build a head of water to power the mill. With their purpose now obsolete, they have fallen into disrepair and all they are doing now is impeding passage of fish (debatable whether fish would go above here as 50 yards away the river was dry) and the natural transportation of silt and gravel downstream.

The two other 2 small impoundments that were seen during the visit were caused by concrete structures (Photo 7). These are again stopping fish passage and hindering the natural processes of the stream and the winterbourne section upstream. The ideal would be to remove them. Removal of these weirs would see an improvement to the appearance of the gravel bed, which would likely be clean and clear of silt.

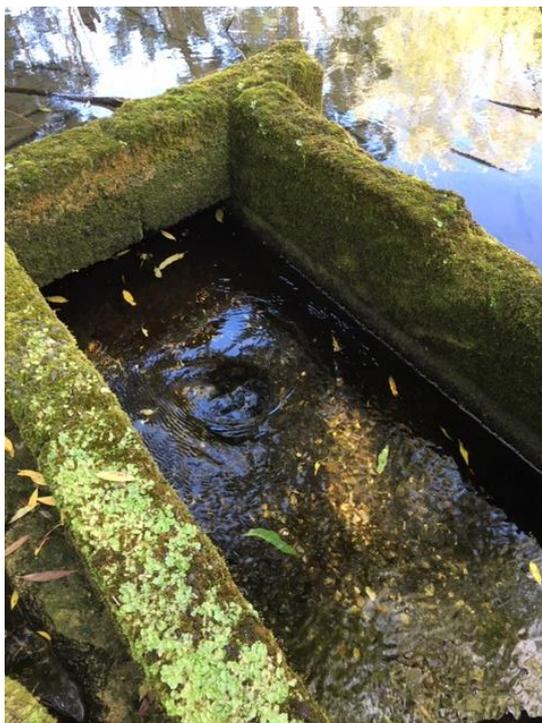
Note that 50 – 100 yards upstream of photo 7 the stream is dry as it seems to be fed from an artesian well (photo 8) that was spewing water out at the most upstream section of the site. This well was used in the past to feed watercress beds and the channel would have been manipulated to accommodate the cress farm. The derelict cress beds are now acting as a good quality shallow wetland habitat, perfect for wildfowl, of which many different species were spotted on the visit.

Photo 8 Artesian well, the perennial head of the Shalbourne Stream

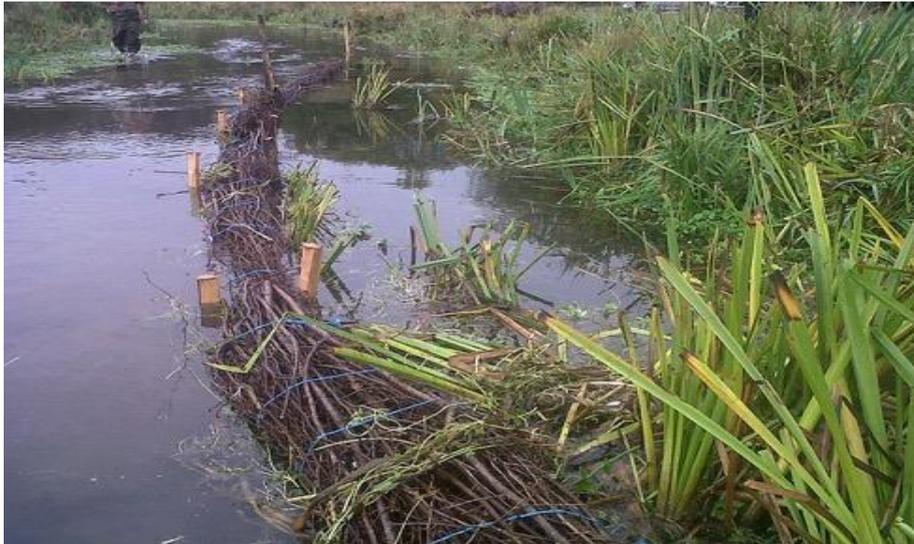
Photo 9. Faggots on the Upper Itchen used to narrow the river to help establish a margin.

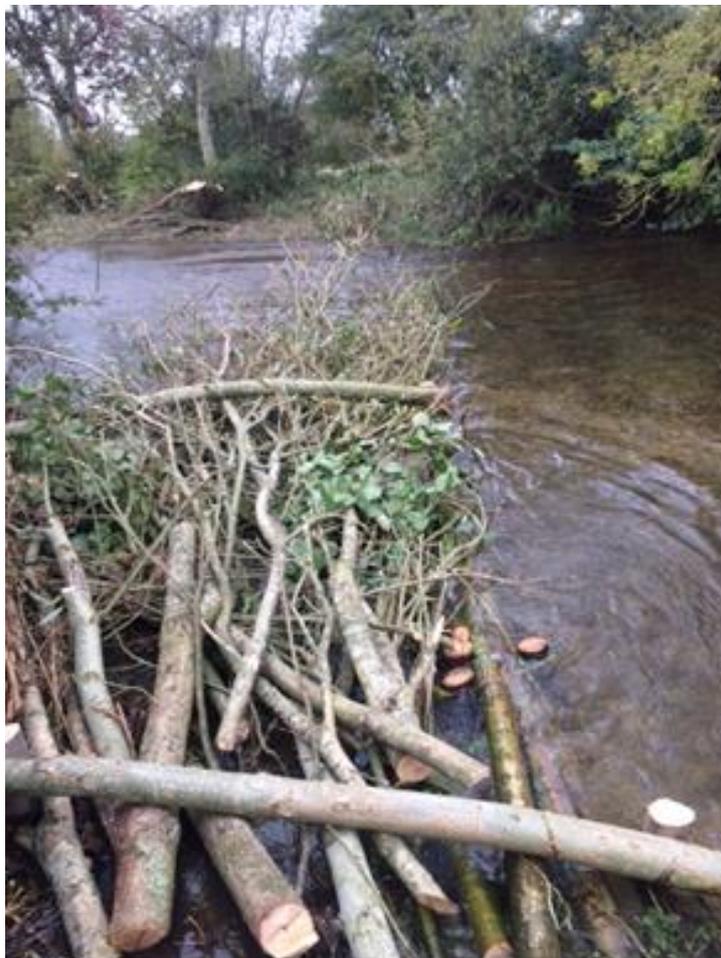
Photo 10. Brushwood mattress constructed with coppiced willow.

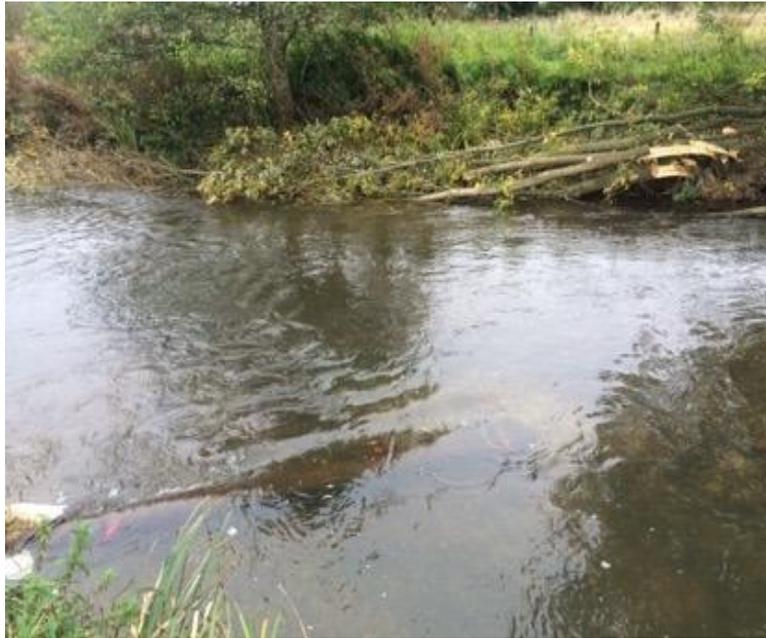
Photo 11. Log deflector combined with folded willow.
