Advisory Visit

Shelf Brook, Glossop, Derbyshire

March 2019

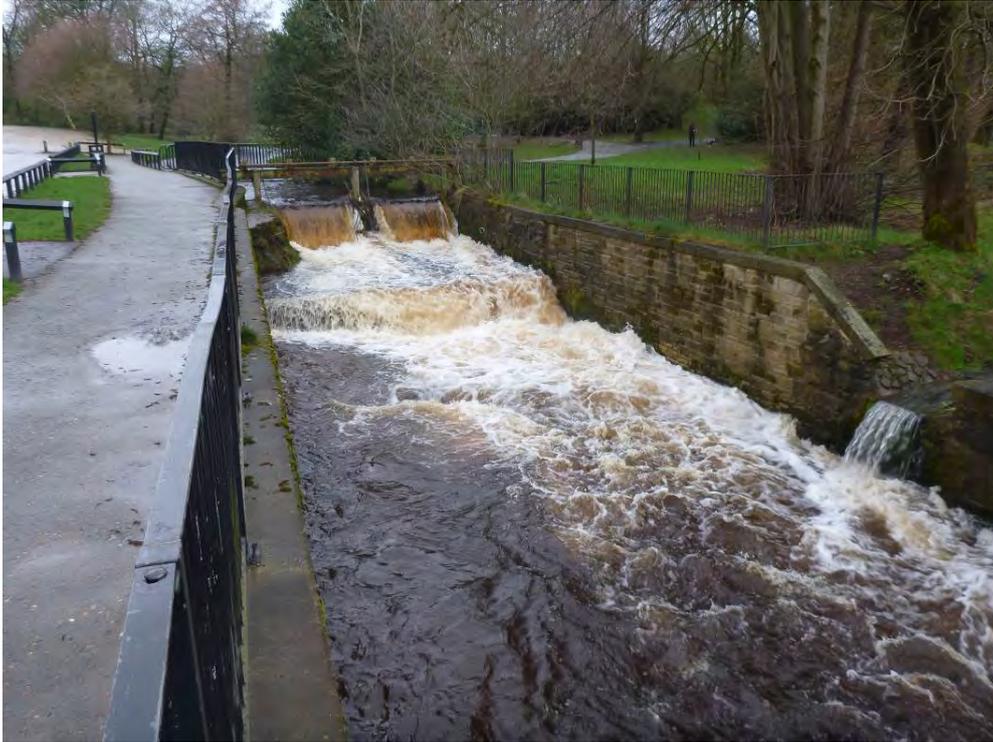
Photo 1 Weir in Manor Park, Glossop.

The weir consists of a concrete step with two sluice gates on top. There is a man-hole cover in the pavement on the true right bank upstream of the weir which reportedly contains a flow control for a feed of water from upstream of the weir into the mill reservoir to the south of High Street East (Figure 1). The reservoir has been empty and disused for many years and the flow closed off; a small flow into and out of it was observed on the day of the visit, possibly surface water drainage due to the wet weather.

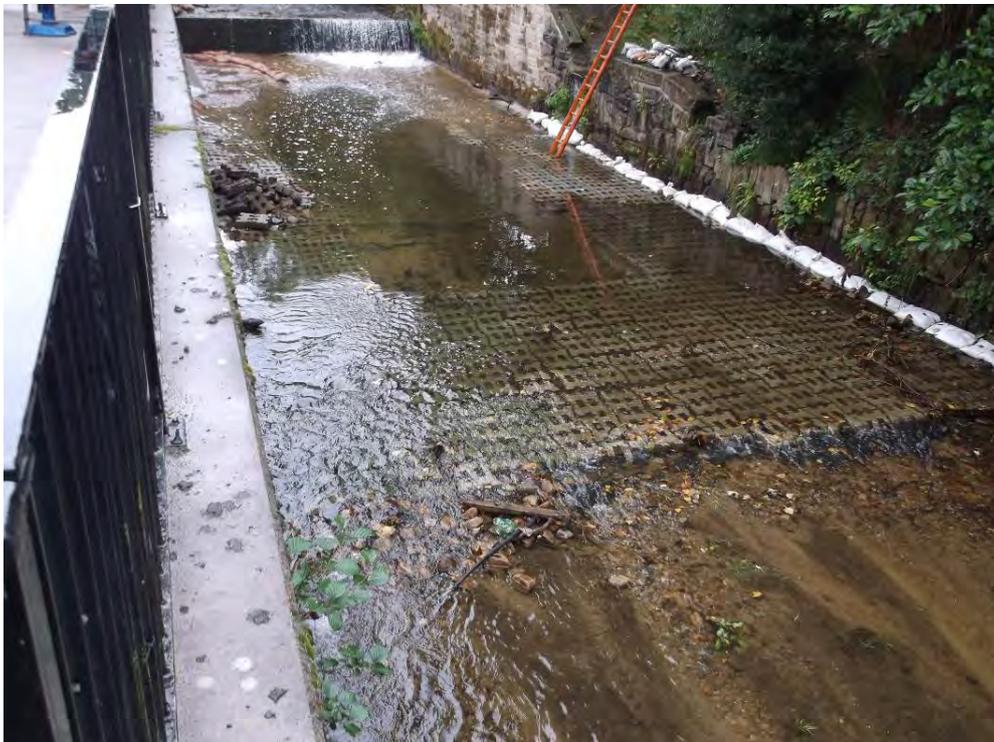
- the in-filling of deeper areas of the channel downstream of the weir with stone. It is not clear if this was imported stone, or accumulated river sediment which was removed from upstream of the weir
- following wash-out of the stone in-fill, the bed was lined with interlocking concrete blocks, creating an extended shallow apron downstream of the weir structure (Photo 2). Presumably the aim of this is to prevent bed scour and the undermining of the retaining walls. However, the high flows at the time of the visit demonstrated the concentration of energy below the weir and it was evident that the interlocking blocks were becoming dislodged by the current.

Photo 2 Concrete blockwork on the river bed (Photo: Geoff Hulmes).

There is no doubt that the works described above have had a detrimental impact on the in-stream habitat downstream of the weir and the present situation is a sterile environment for fish. The wider habitat on the Shelf Brook (from the limited reach inspected) is sub-optimal for trout; the channel is much-modified in this urban environment and lacks natural features like pools and riffles. In this context, the removal of the deeper water areas below the weir is likely to have had a more significant detrimental effect than would have been the case in a less modified river.

The apparently recurring issue of the bed scour protection failure and the ongoing problem of zero fish migration past this site have a common cause: the presence of the weir and its concentration of flow energy. The erosion issues are further exacerbated by the interruption of sediment transport by the weir, and other weirs in the vicinity. Given the apparent redundancy of the weir for supplying water to the mill reservoir, the weir could be completely or partially removed to solve or lessen both problems.

Aim to remove the weir. If removal is not feasible, reduce its height as much as possible. Use the above techniques to dissipate flow energy and improve fish passage. Those same techniques could also be employed to make the upstream weir passable while retaining the feed to the duck pond, should it be required. This is not a foregone conclusion as many ponds can function quite adequately as enclosed systems, without the requirement for an inflow and outflow, which often discharges elevated nutrient water to a potentially sensitive watercourse. If it can be ascertained that the feed to the pond is not required, the weir upstream and feed to the duck pond could also be fully removed.

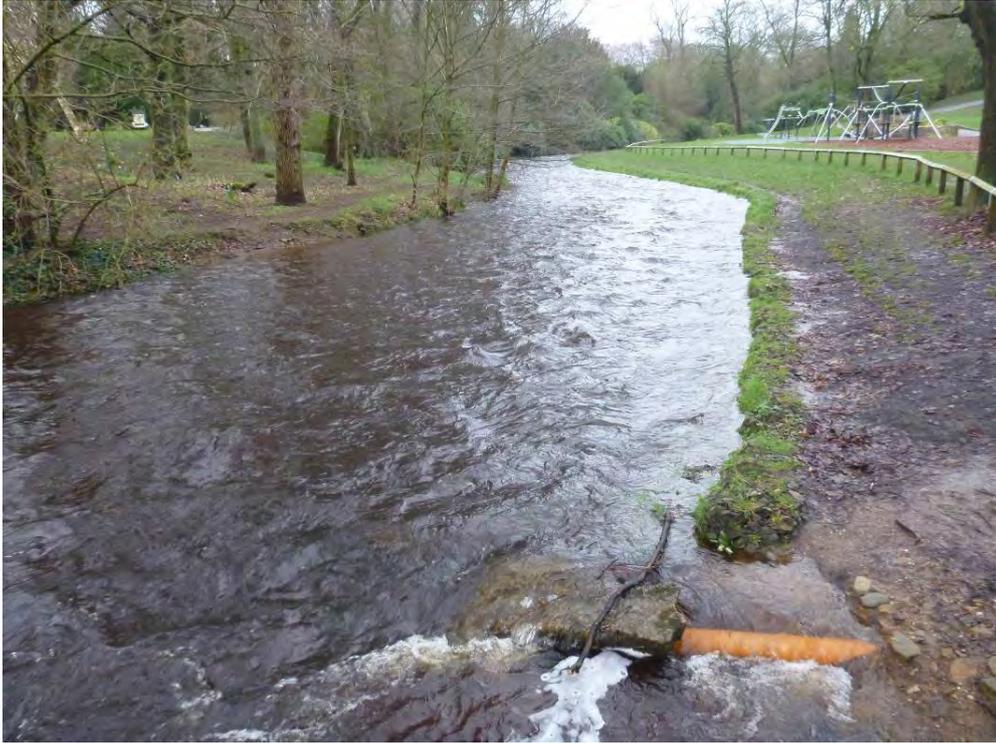
Partial or total weir removal would cause the river bed upstream to re-grade, as sediment (cobbles, gravels and finer materials) which has accumulated above the impoundment is re-distributed (Photo 3). A 'knick point' would form which would gradually migrate upstream until the river bed stabilised at a new lower level; some bank slumping/erosion may initially occur as part of this process but could be stabilised if required. It is recommended that a survey by a fluvial geomorphologist is carried out to predict the extent of this effect and whether there would be any impact upon the upstream weir structure which provides a feed of water into the duck pond (Photo 4). The sluices could be opened as an initial trial.

Photo 3 River upstream of the weir. The river bed here would re-grade to a lower level following removal of the weir downstream. Note the existing bank reinforcement provided by rock rolls; these could be repositioned at a lower level if required following weir removal.

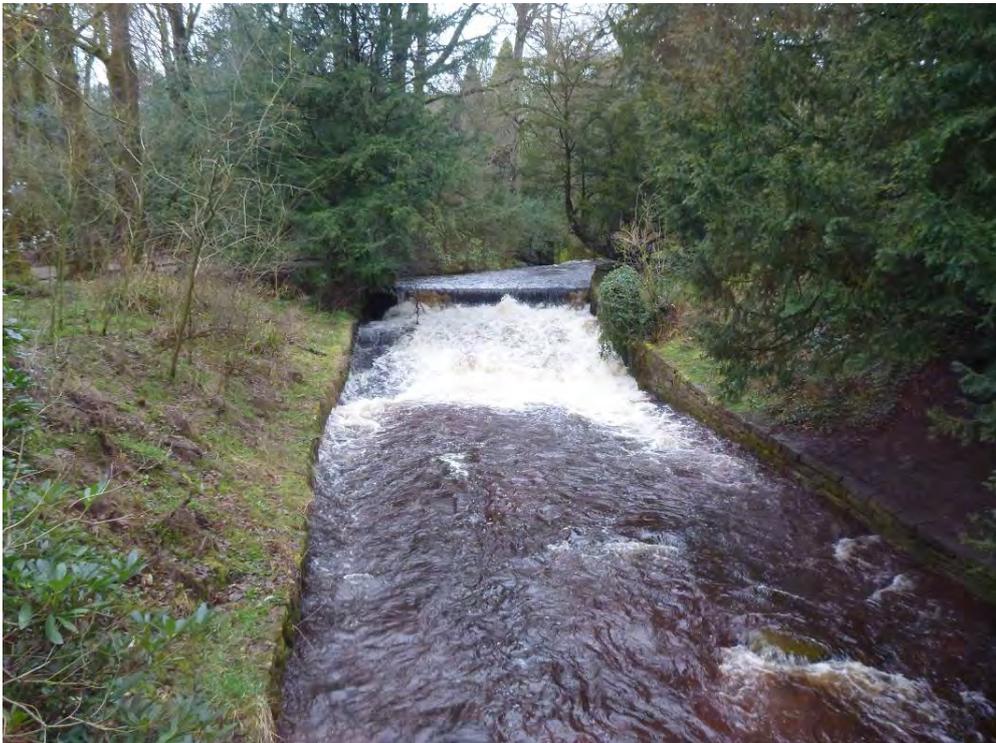
Photo 4 Upstream weir (at NGR SK 03952 94591), providing head of water to the duck pond.

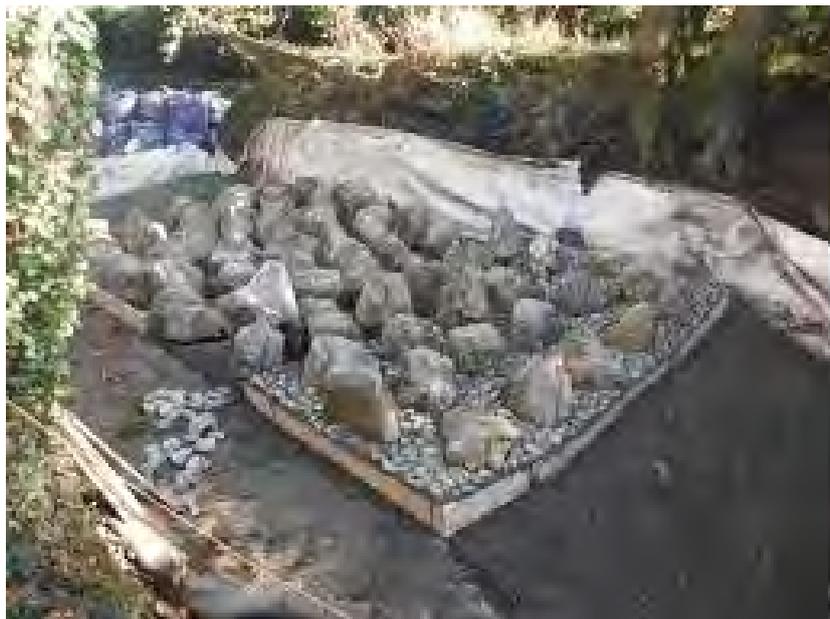
Photo 5 Rock ramp during construction.

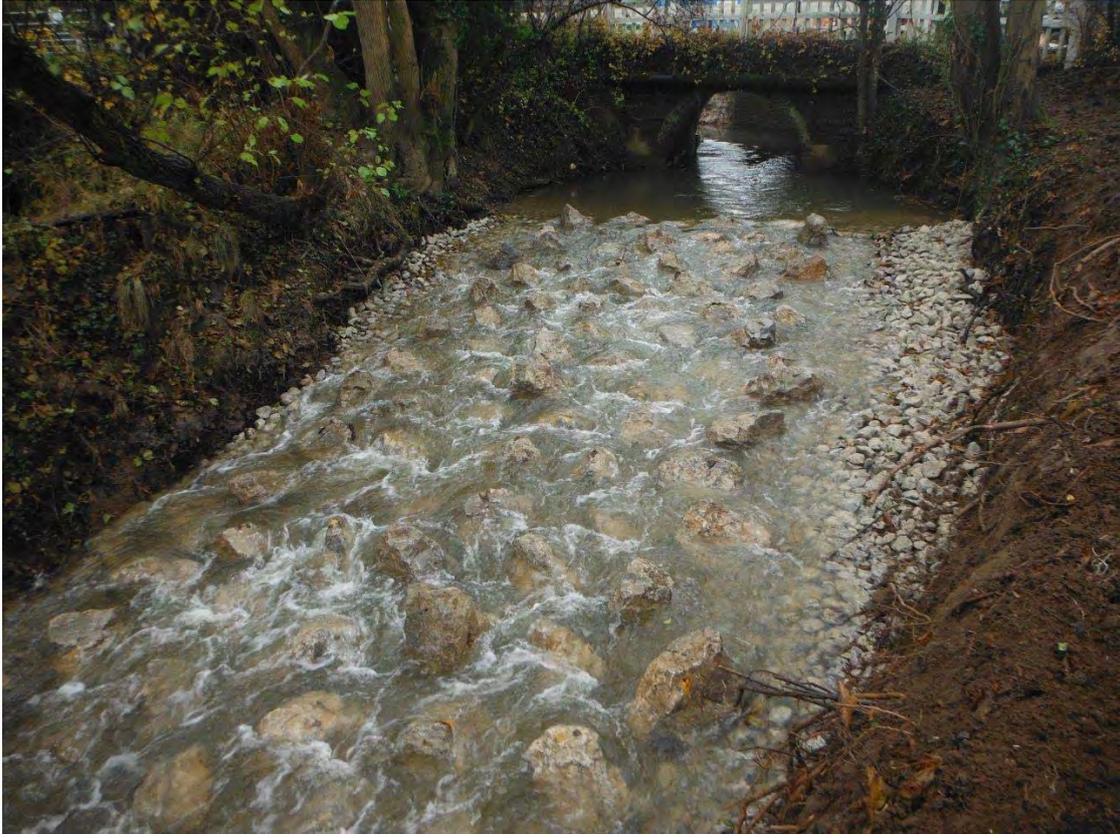
Photo 6 Completed rock ramp, spreading out the head loss and flow energy, reducing scour and facilitating fish passage

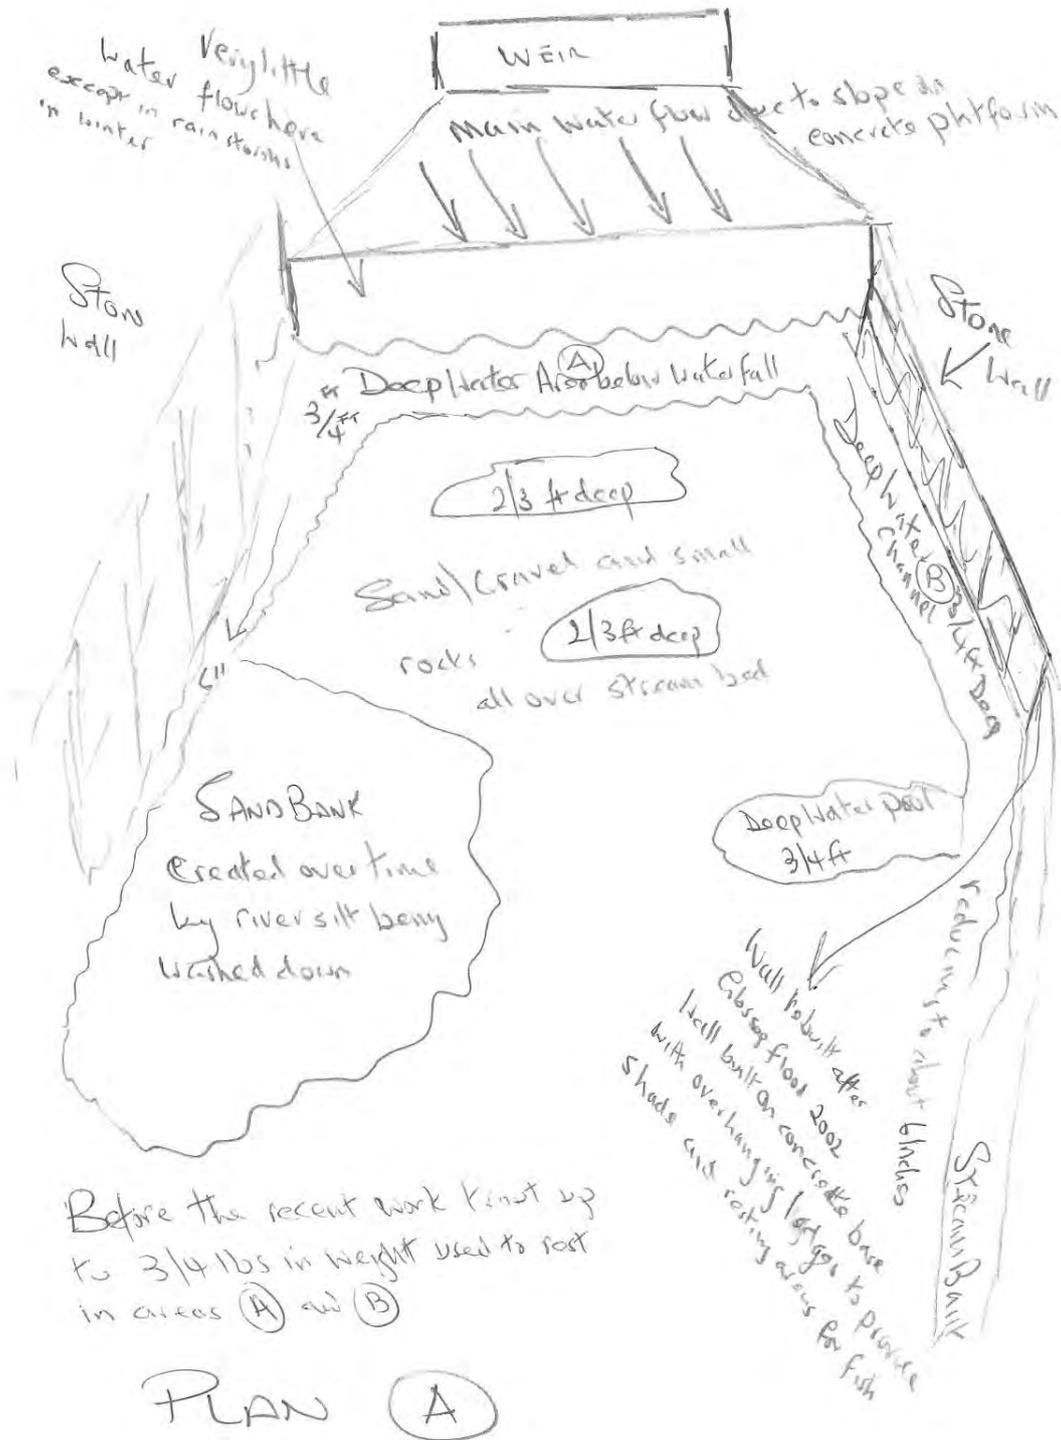
Appendix 1 shows a sketch supplied by Mr Hulmes indicating the situation prior to the works to the river channel downstream of the weir. The works involved:

Figure 2 Sketch of pre-works situation downstream of the weir, Manor Park, Glossop (by Geoff Hulmes).

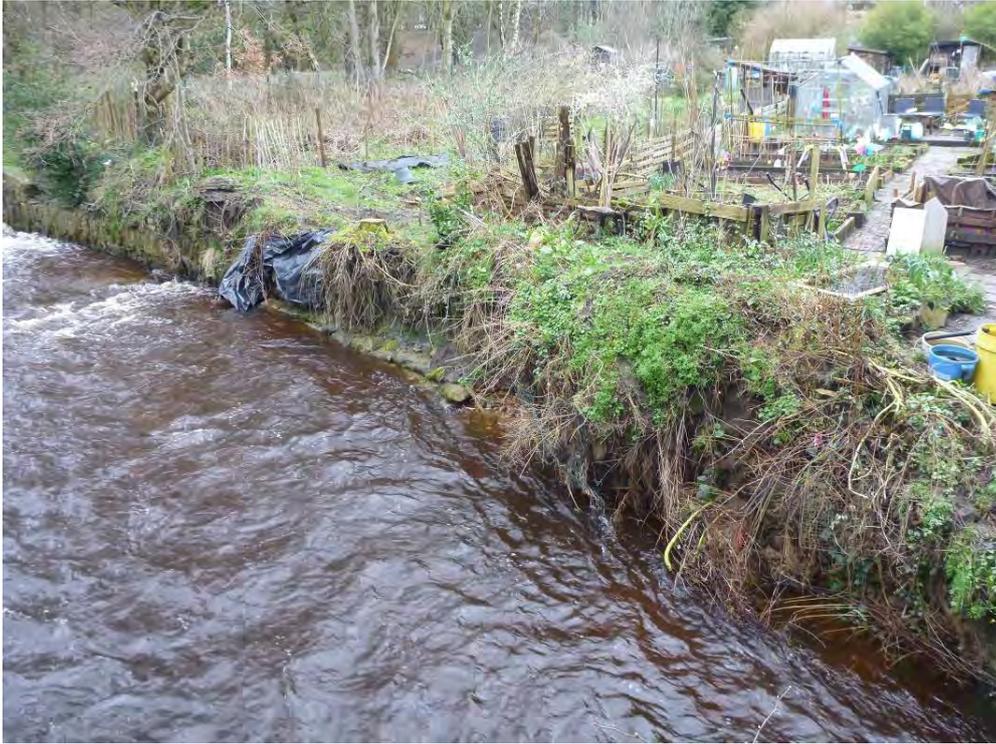
Photo 7 Allotments on LH bank downstream of the weir; some bank erosion is occurring here.

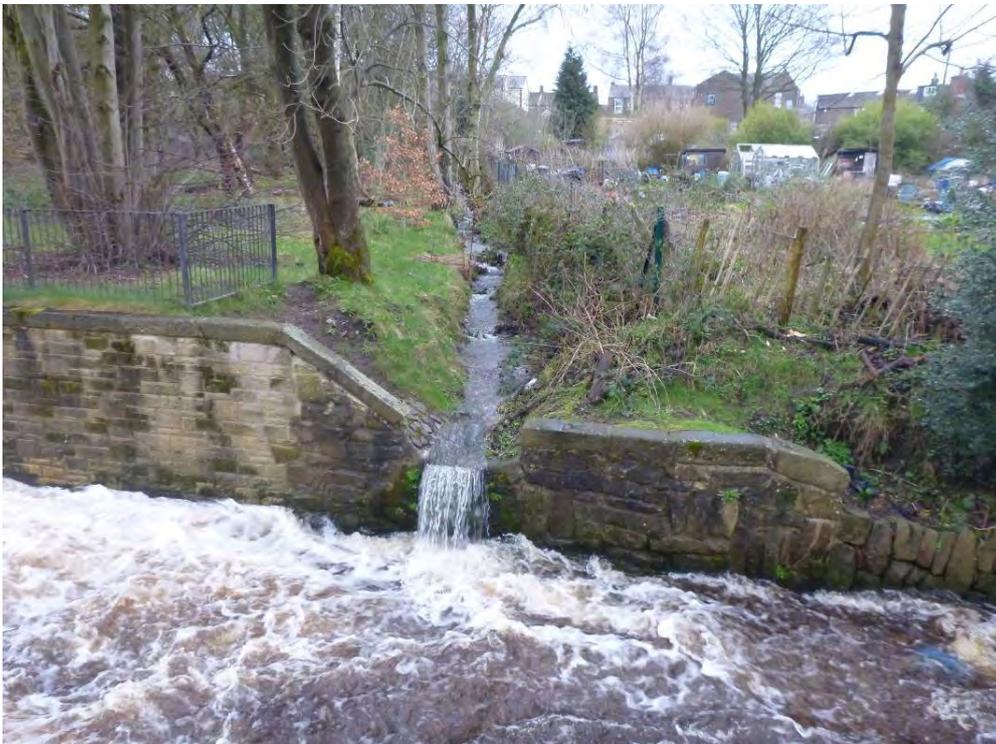
Photo 8 Small stream or drain entering on the left bank just downstream of the weir.

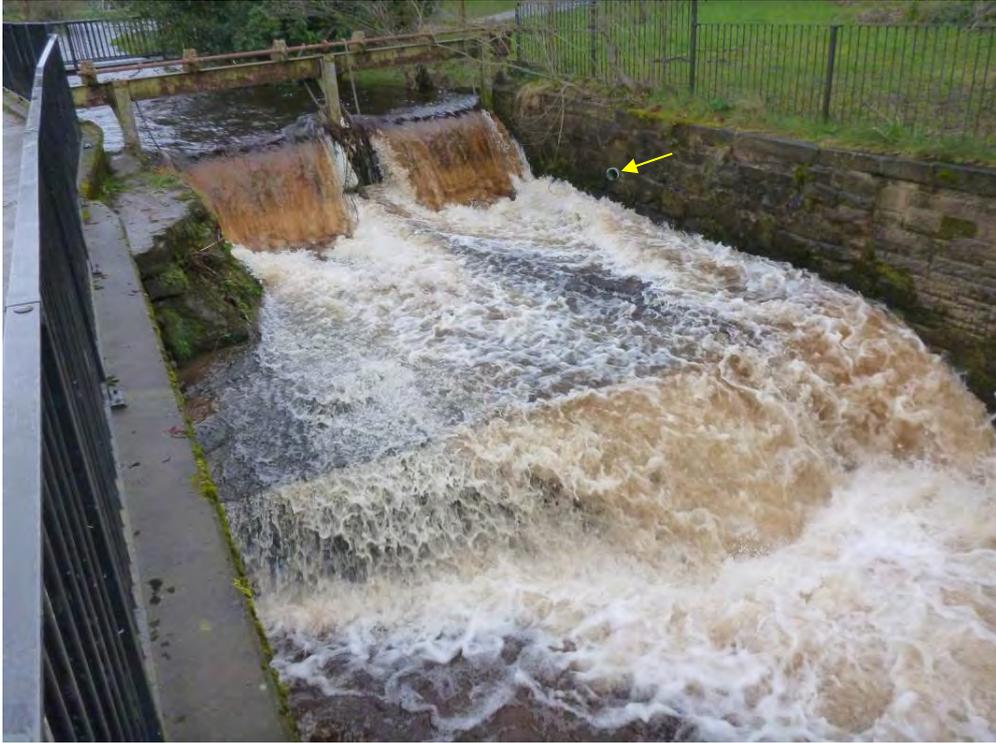
Photo 9 Weir and sluice structure. Note land drain (arrow).

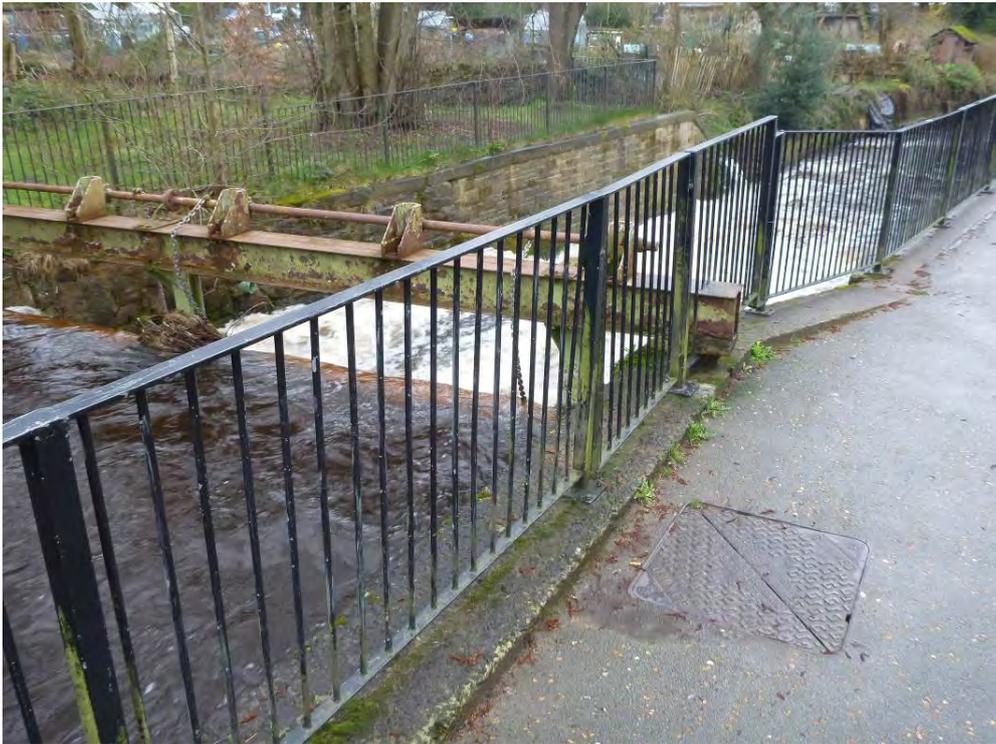
Photo 10 Man-hole containing water offtake control.

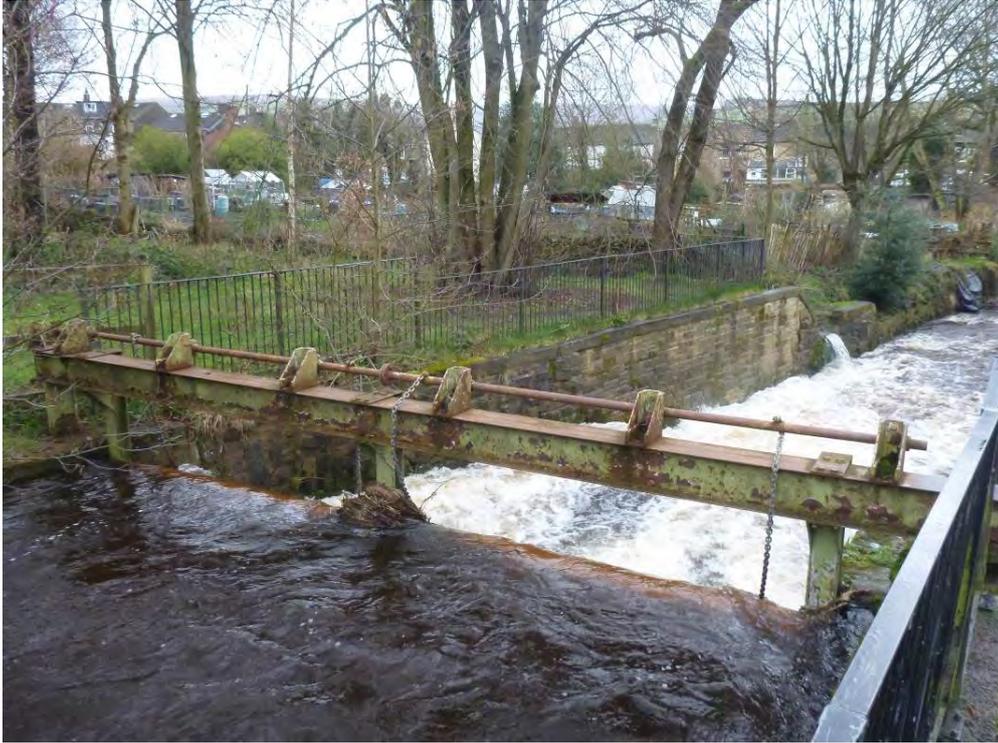
Photo 11 Sluice gate structure

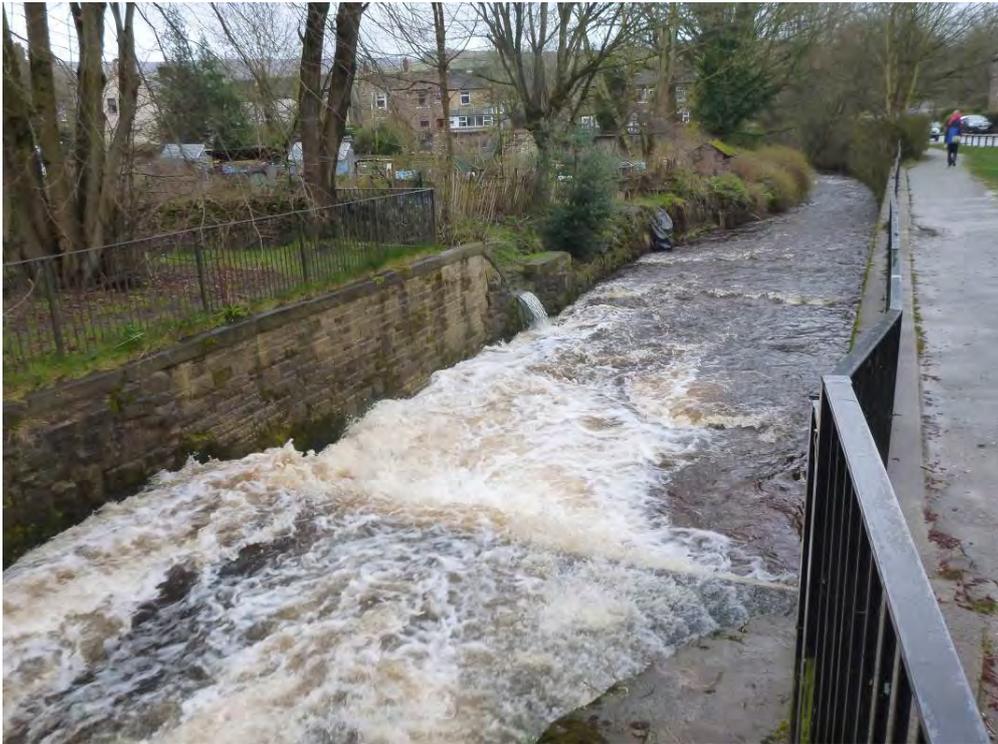
Photo 12 Downstream view from the weir

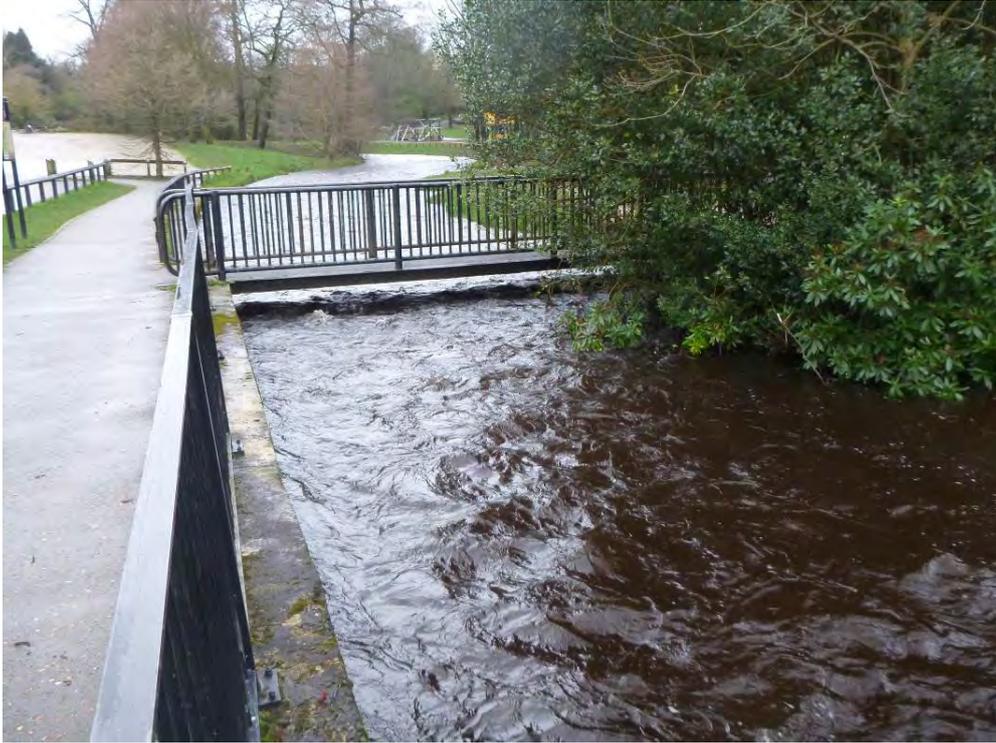
Photo 13 Footbridge a short distance upstream of the weir

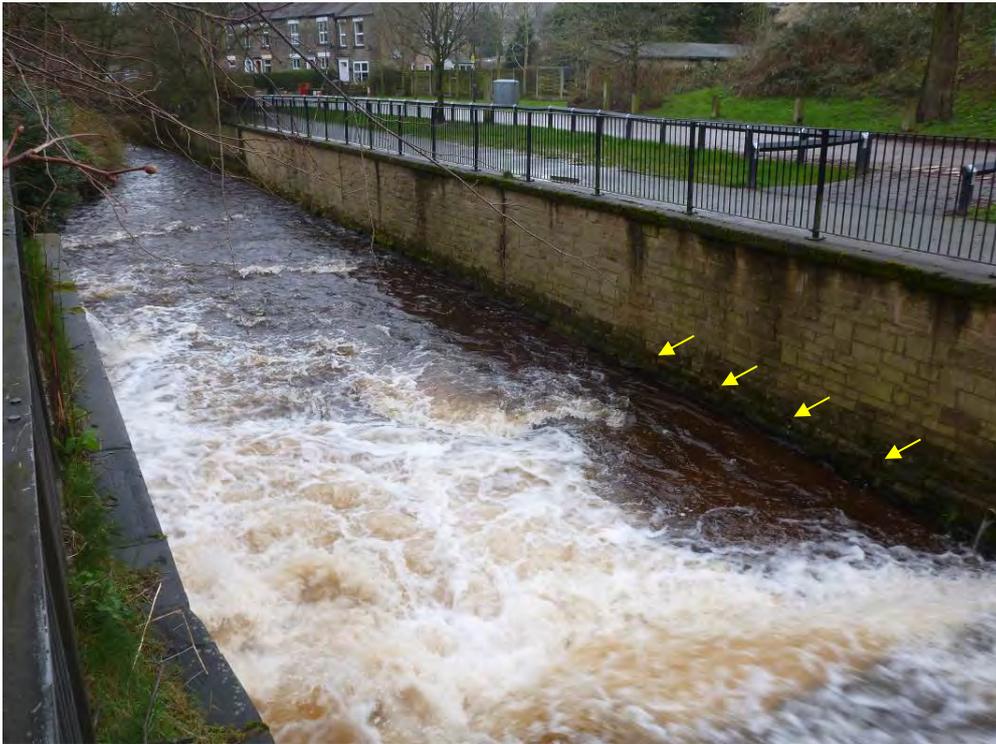
Photo 14 View from left bank. Note drainage outlets at the base of the wall (arrows)

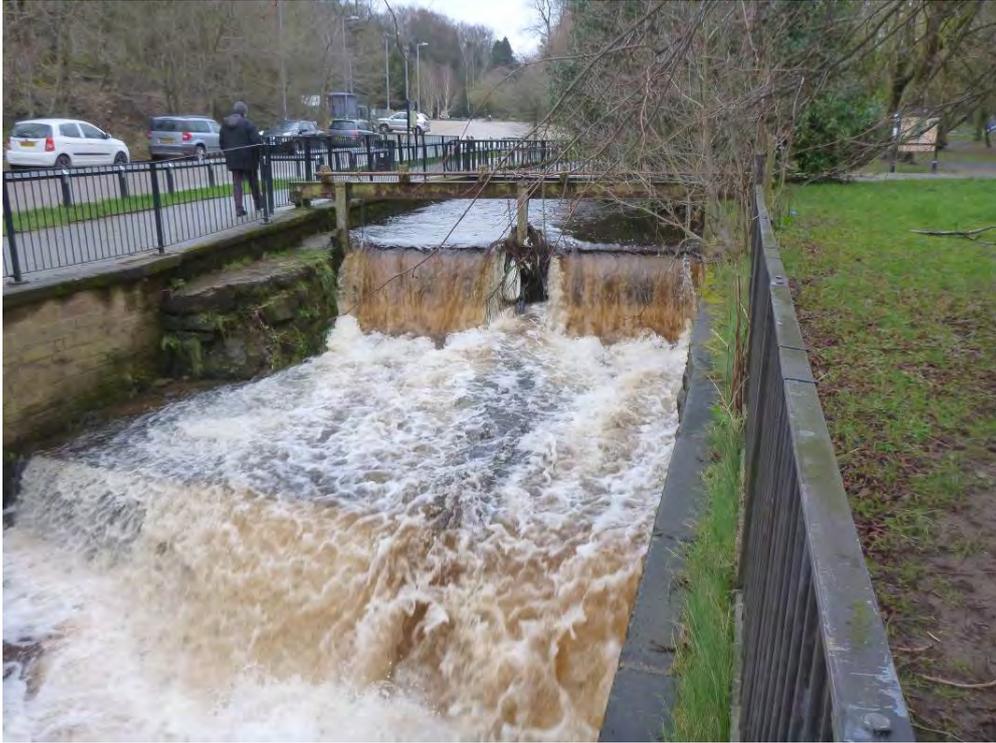
Photo 15 View of weir from LH bank

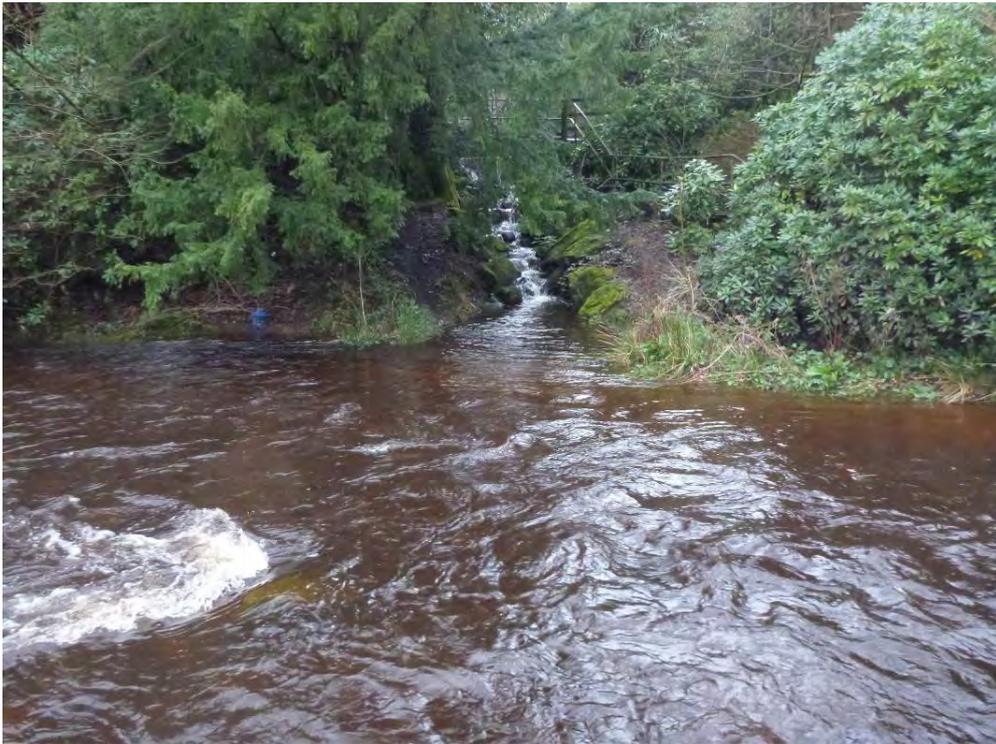
Photo 16 Outlet from duck pond into brook upstream of the weir

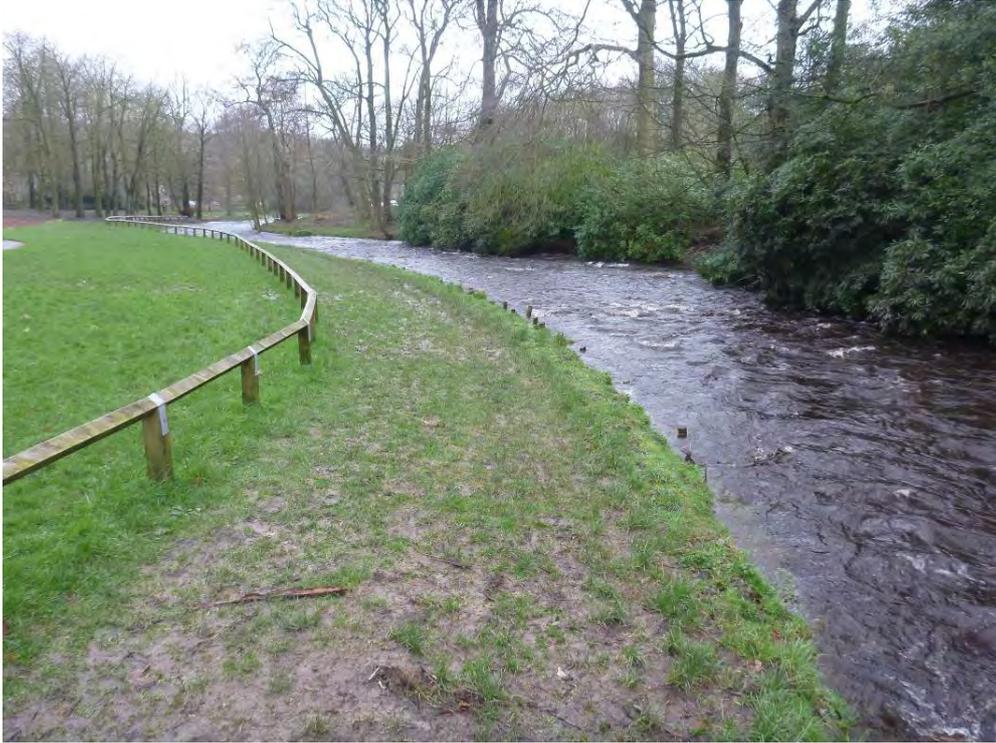
Photo 17 View of brook looking downstream towards the weir from alongside the children's play area.
