**Advisory Visit**

**Shimna River, Co. Down**

**15<sup>th</sup> and 16<sup>th</sup> May, 2012**

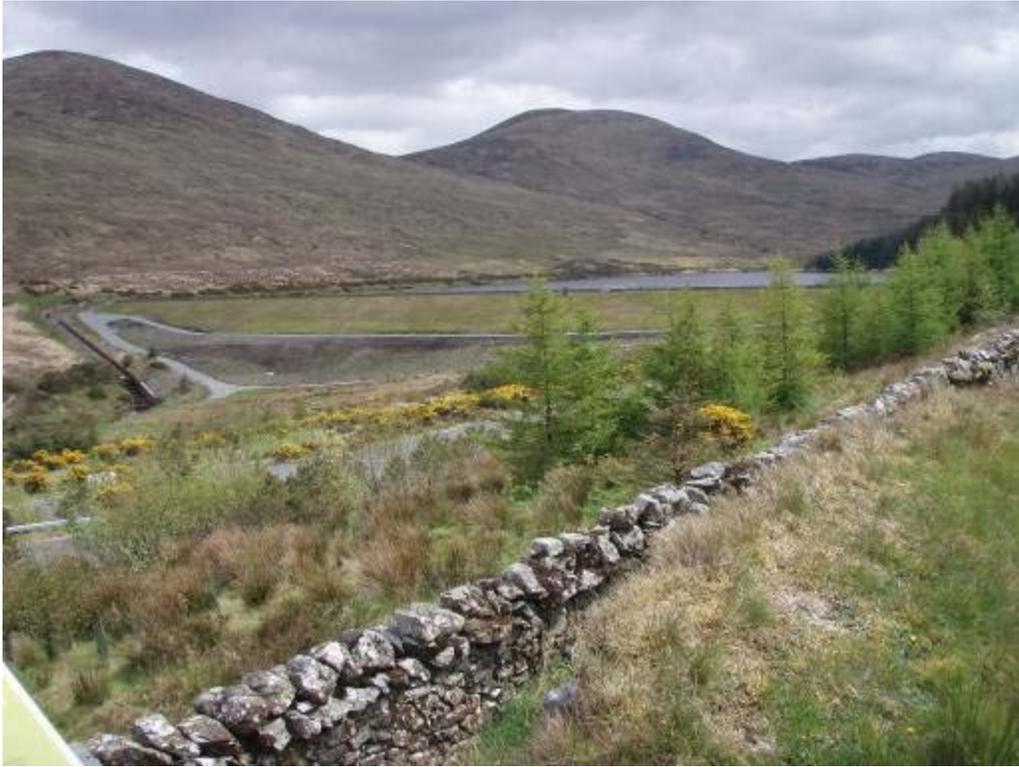
The Shimna is dammed close to its source by the Fofanny Dam, a public water supply reservoir managed by Northern Ireland Water (NIW). The Fofanny Water Treatment Works (WTW) is located a short distance below the dam and was built in 2008, replacing an existing WTW and allowing water to be supplied for treatment by gravity rather than pumping. The dam was constructed in the 1920s and enlarged in the 1950s and there is reportedly a release of compensation water 2.28 MI/D (about 26 litres per second) into the Shimna (NIEA 2009c); hence the river reach downstream of the reservoir has severely depleted flows until the confluences of tributaries draining Slieve Meelmore (J 293298) and the Trassey River (J 309313). The in-stream habitat within the depleted reach is reasonably good but the densities of fish are likely to be very low, limited by the low baseline flows (Photos 1 - 3). Sediment supply may also be limited by the dam, restricting the availability of suitable salmonid spawning substrate.

**Photo 1 Fofanny dam in the headwaters of the Shimna River**

- Fofanny reservoir and compensation flows. As described above, the reservoir impacts upon flows in the upper catchment and is likely to be having a detrimental impact upon numbers of juvenile salmonids in this reach. Further investigation is required into the impact of regulated flows on the availability of in-stream habitat, compared to a natural flow regime.

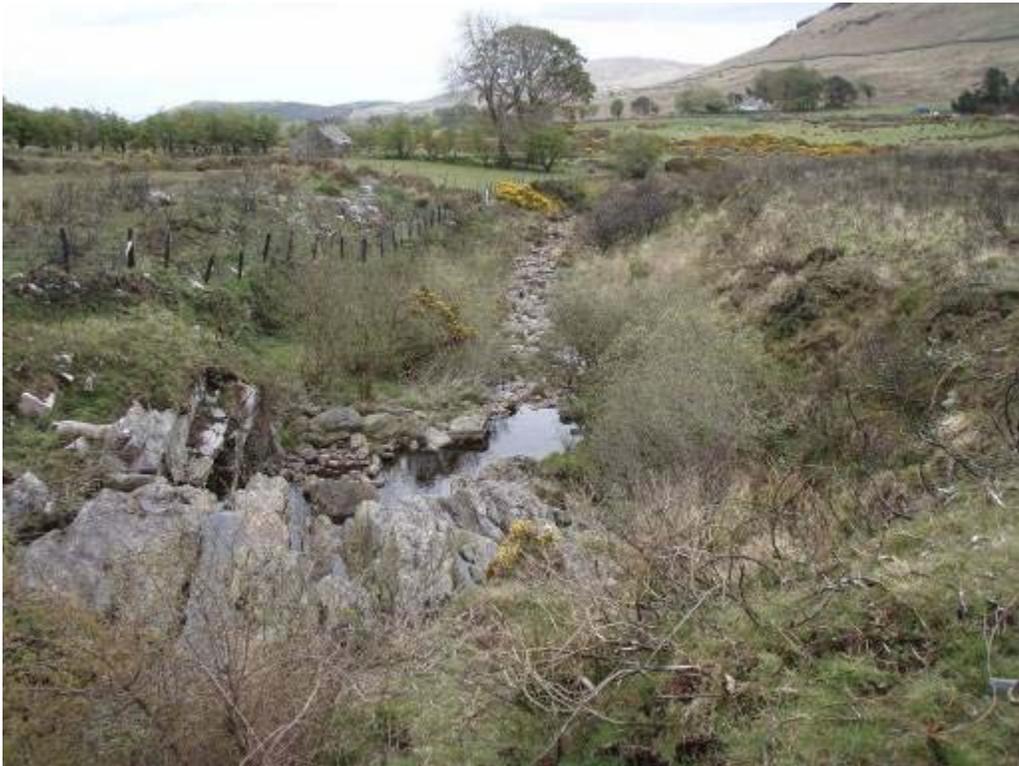
The depletion of flows in the upper Shimna is at odds with its designation as an ASSI and a reason for the failure of the waterbody to reach good ecological potential. The situation warrants study to determine the impact upon the ecology of the river, including its salmonid fish community. There

**Photo 2 Very low flows in the river downstream of the dam**

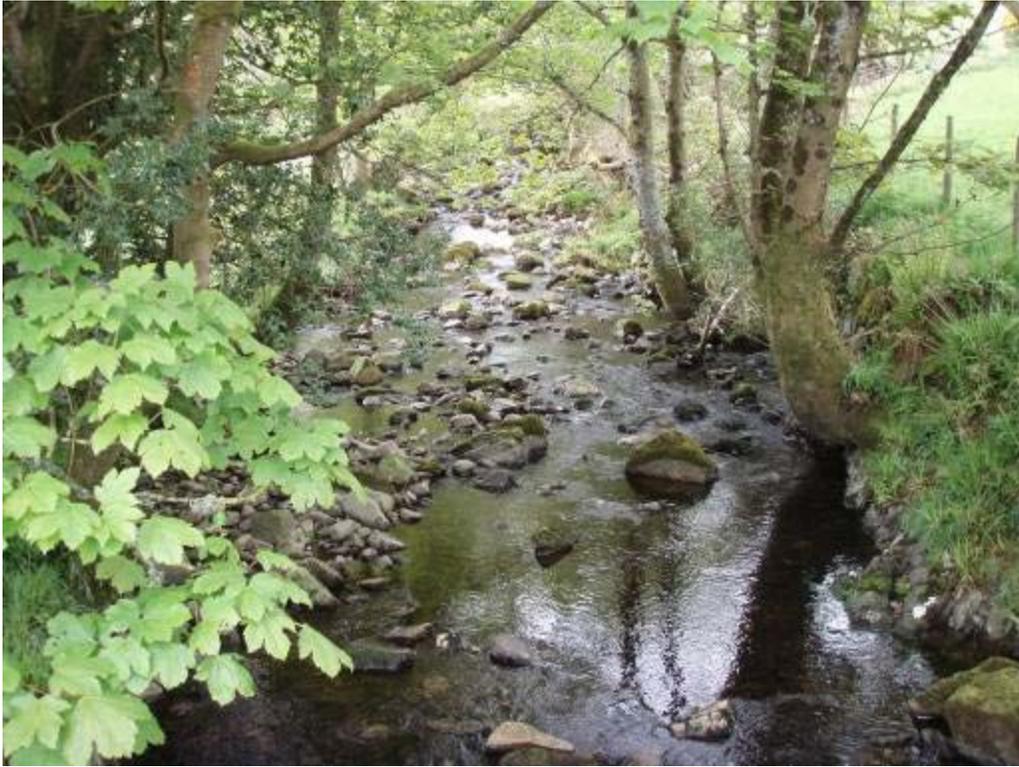
**Photo 3** The Shimna upstream of the Trassey confluence – good in-stream habitat but possibly still impacted by low flows. Grid reference J301305.

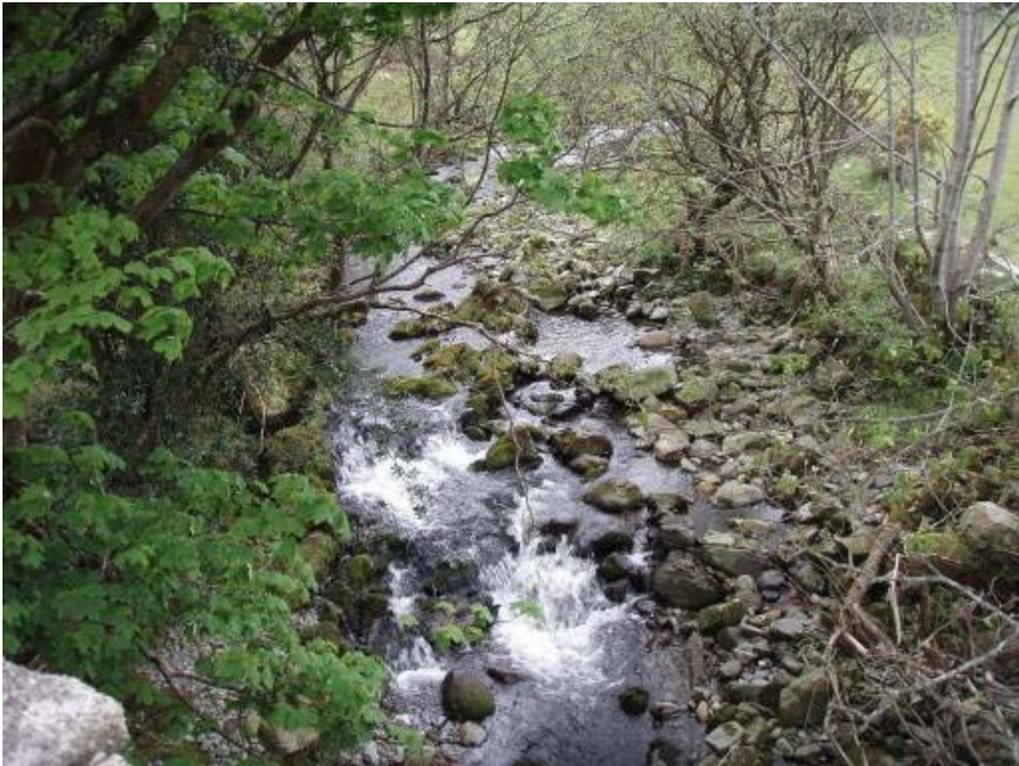
**Photo 4** Shimna at Clonachullion Bridge (J313317), with greater flows because of the input from the Trassey River.

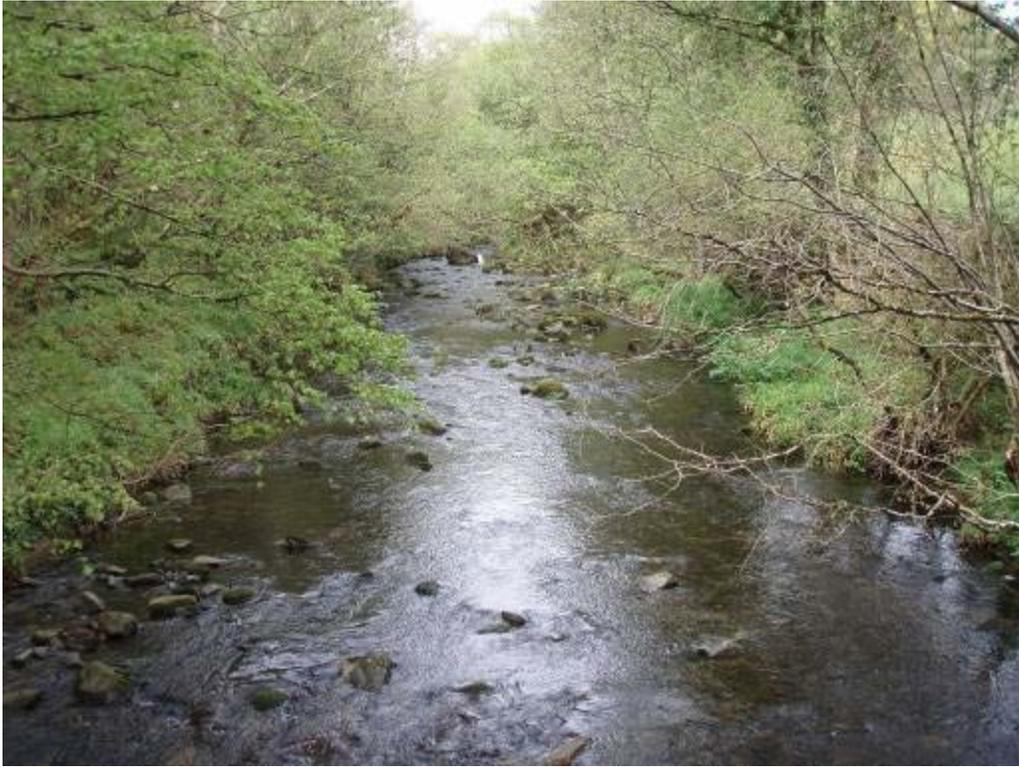
**Photo 5 Shimna looking upstream from western boundary of Tollymore Forest Park**

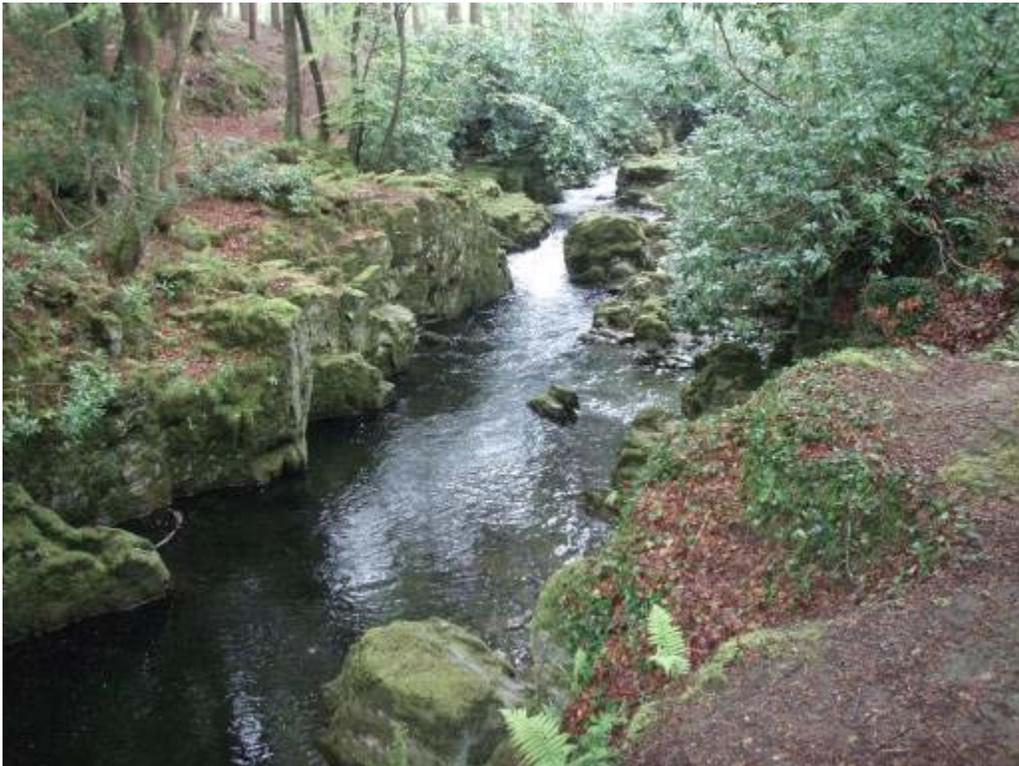
Within the forest park the Shimna is an exceptionally beautiful, natural, upland river with good in-stream habitat for salmonids. The overall gradient of the river is steep, but varies between reaches. In the lower gradient sections the river tends to be shallow with a mixed substrate of bedrock outcrops, boulders and finer bed materials (cobbles – gravel)(Photo 5); in the steeper sections there are spectacular bedrock cascades and gorges, with deep pools ideal for holding adult salmonids (Photo 6).

**Photo 6 A cascade and deep pool in the bedrock gorge within Tollymore Forest Park**

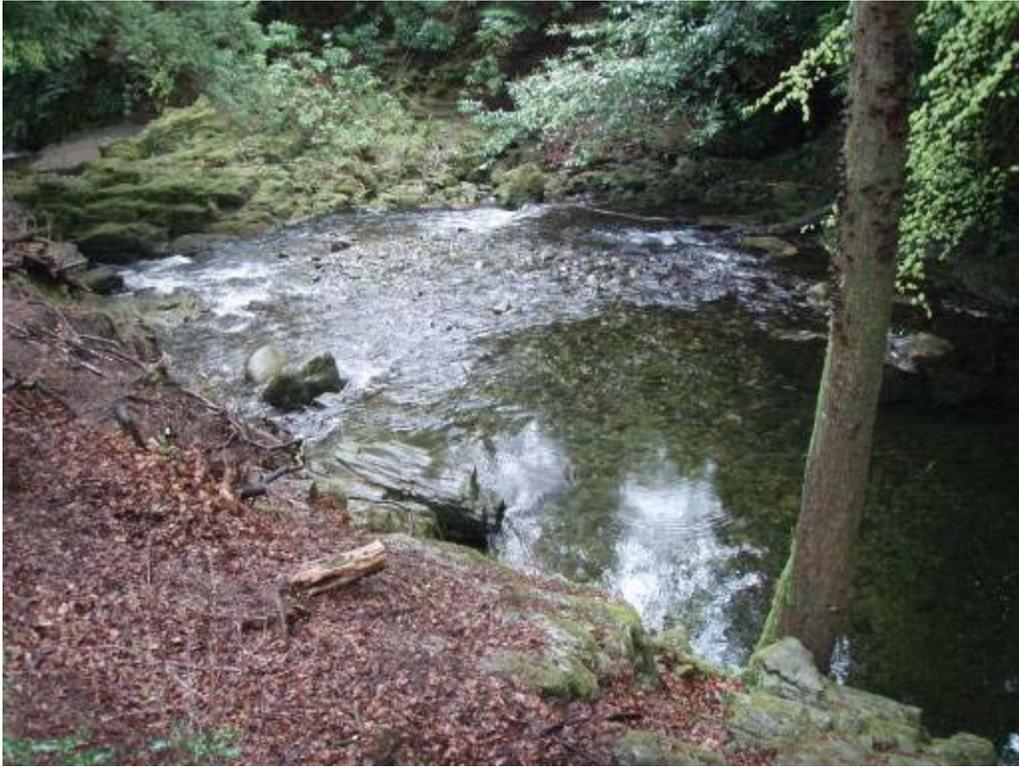
The tails of the deep pools tend to have accumulations of gravel which looks ideal spawning medium for salmon and sea trout (Photo 7). The river is reported to move a great deal of its bed load downstream during spates, and

large accumulations of gravel were observed in the lower river (e.g. downstream of Mile Bridge). Club members reported that overcutting of redds takes place in the Tollymore Park section of the river, indicating spawning habitat may be a limiting factor here. The transport of large volumes of bed load material is a natural function of the steep gradient and spate nature of the river; however the hydrology is likely to be influenced by land use practices and associated drainage (e.g. commercial forestry) which can increase peak flows. It is recommended that dialogue is started with the forestry authority to determine the extent of this effect and possible mitigation measures (for example Pont Bren project, WTT Upland Habitat Manual – supplied during visit). Reduction in peak flows is also of benefit for flood risk management.

**Photo 7 Accumulation of gravel at the tail of a pool**

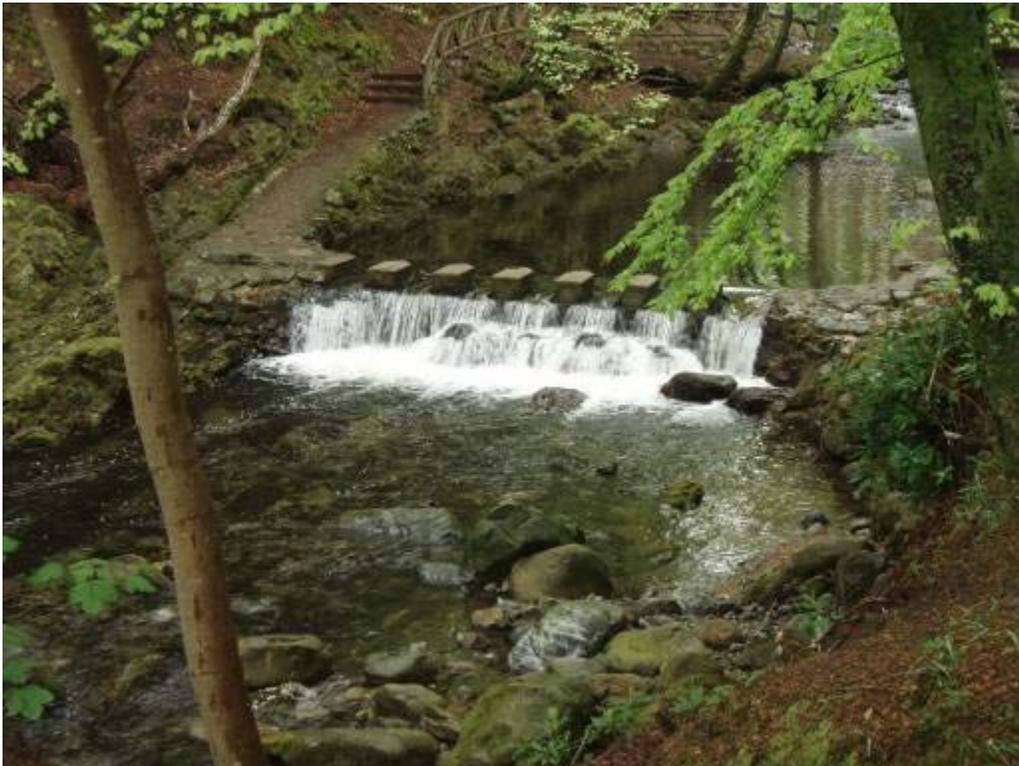
There are three stepping stone weirs across the river within Tollymore Park (Photo 8), one of which was breached. The two structures in good repair are barriers to upstream migration of adult salmon and sea trout (in all but high flows) because of the shallow spread of water across the crest and lack of deep water downstream to assist leaping. A deeper notch between one or two of the stepping stones, with a laminar (non-turbulent) flow into the downstream pool would be adequate to allow fish to use burst-speed swimming to cross the weir.

**Photo 8 Stepping stone weir which will impede the migration of salmon and sea trout.**

- Fish passage. The stepping stone weirs within the forest park should be modified to facilitate fish migration.

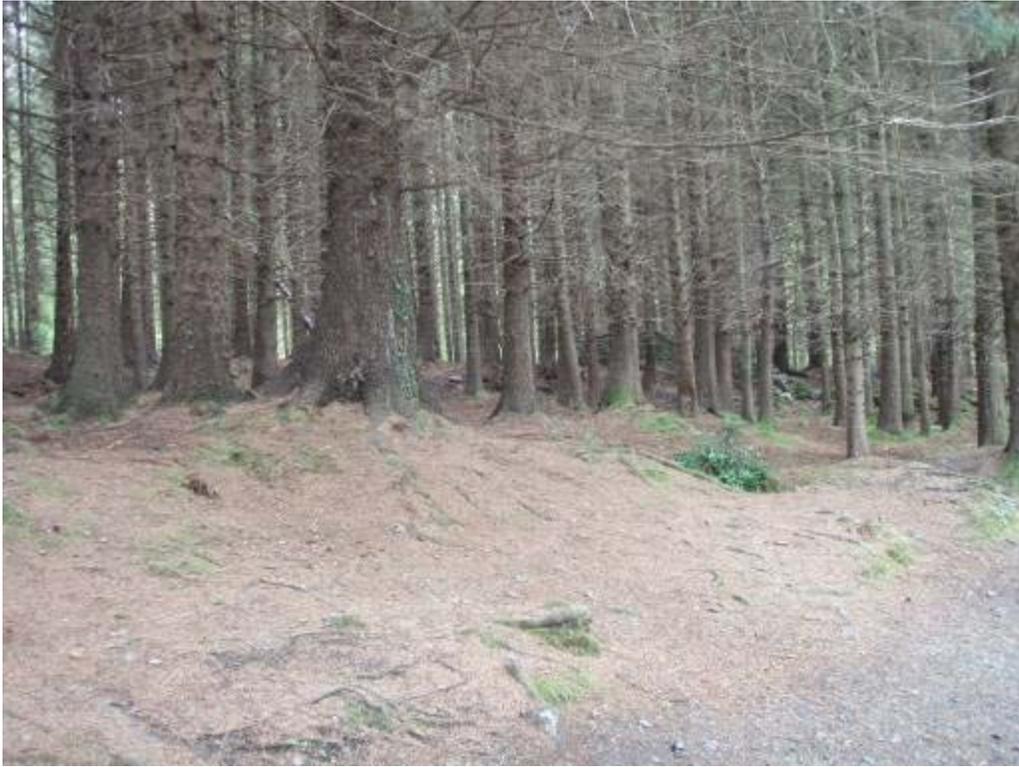
The forest park contains a mixture of stands of coniferous trees and mixed deciduous woodland. Some of the conifers have been recently felled, but there are some areas where stands are sited immediately alongside the river (Photo 9). It is recommended that the club talk to the forestry authority to find out about the management plan for the forest. From the perspective of river management, this should ideally be replacement of coniferous forestry with mixed native deciduous tree species. If coniferous forestry is continued it should be according to best practice and have a buffer zone of native deciduous species alongside watercourses, without through drains to the river.

**Photo 9 Coniferous forestry close to the river**

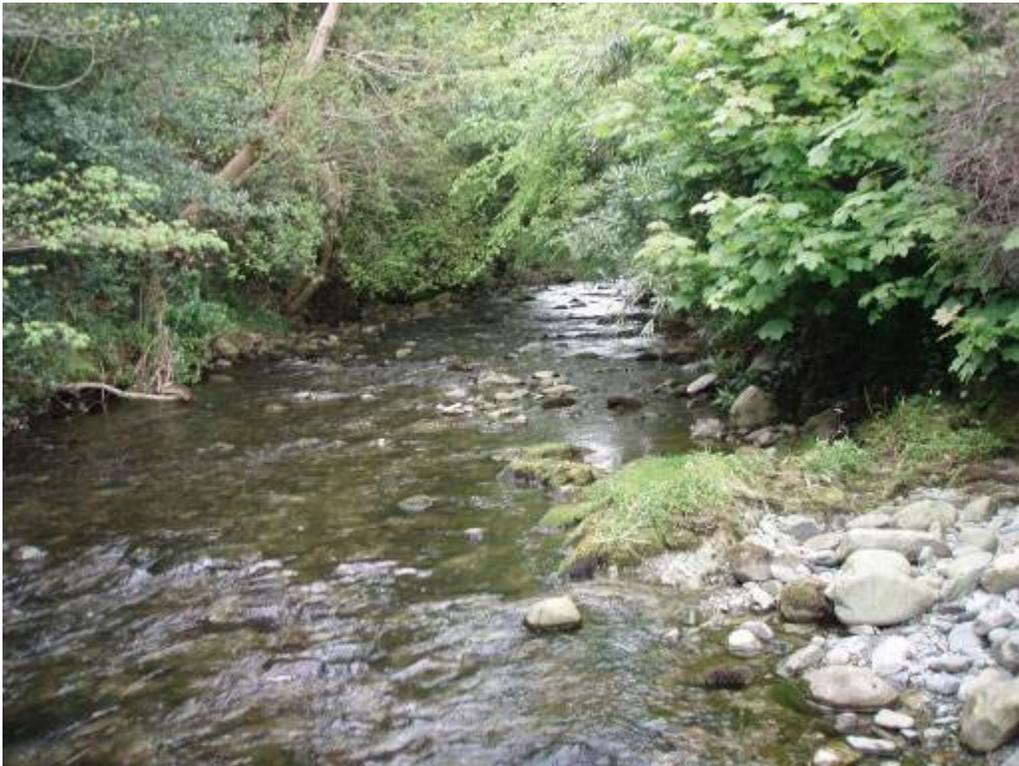
Downstream of the forest park, past the Enniskeen Hotel, the gradient of the river lessens. The river has excellent in-stream habitat with a pool, riffle and glide sequence, very good bed substrate ranging from small boulders down to gravel and a healthy, wooded riparian zone (Photo 10). Similar conditions persist with progress downstream past the Scout Camp (Photo 11) and fish counter to Mile Bridge. The excellent juvenile salmonid

**Photo 10 Shimna at Enniskeen Hotel – excellent in-stream habitat for juvenile salmonids**

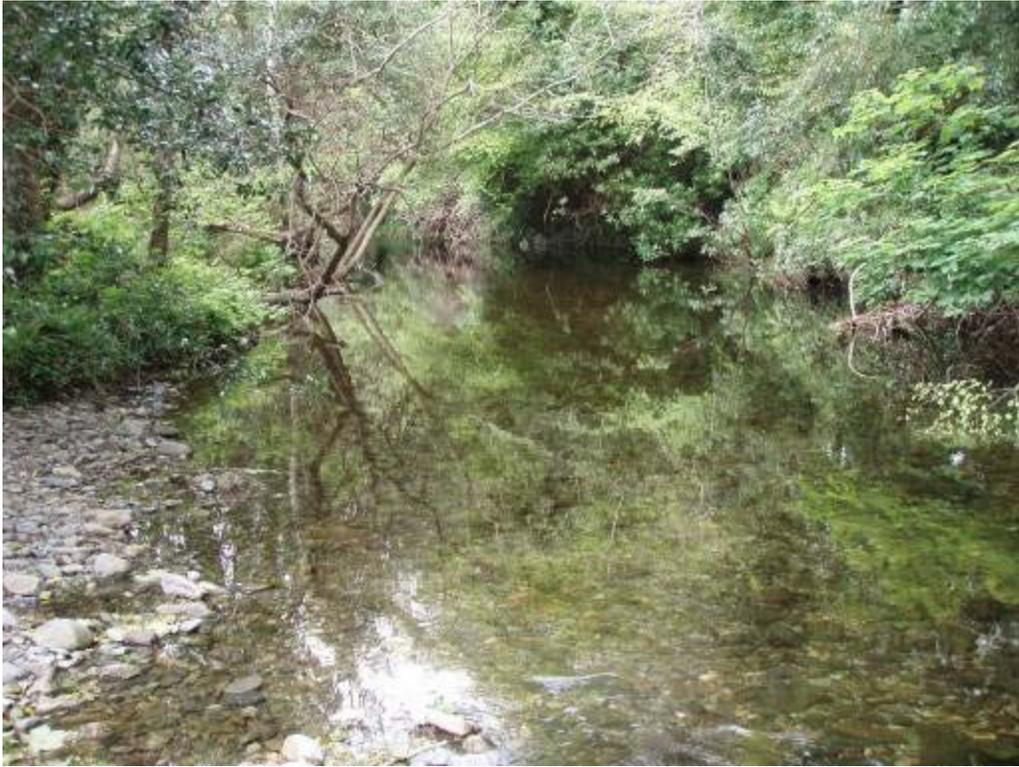
densities recorded at the Scout Camp survey site (Photo 11) reflect the very good habitat for spawning and juveniles. Some good examples of woody debris and bankside cover were observed (Photos 12, 13).

**Photo 11** Electric fishing survey site at Scout Camp. Note the good low cover over the water along the true left bank (right of picture).

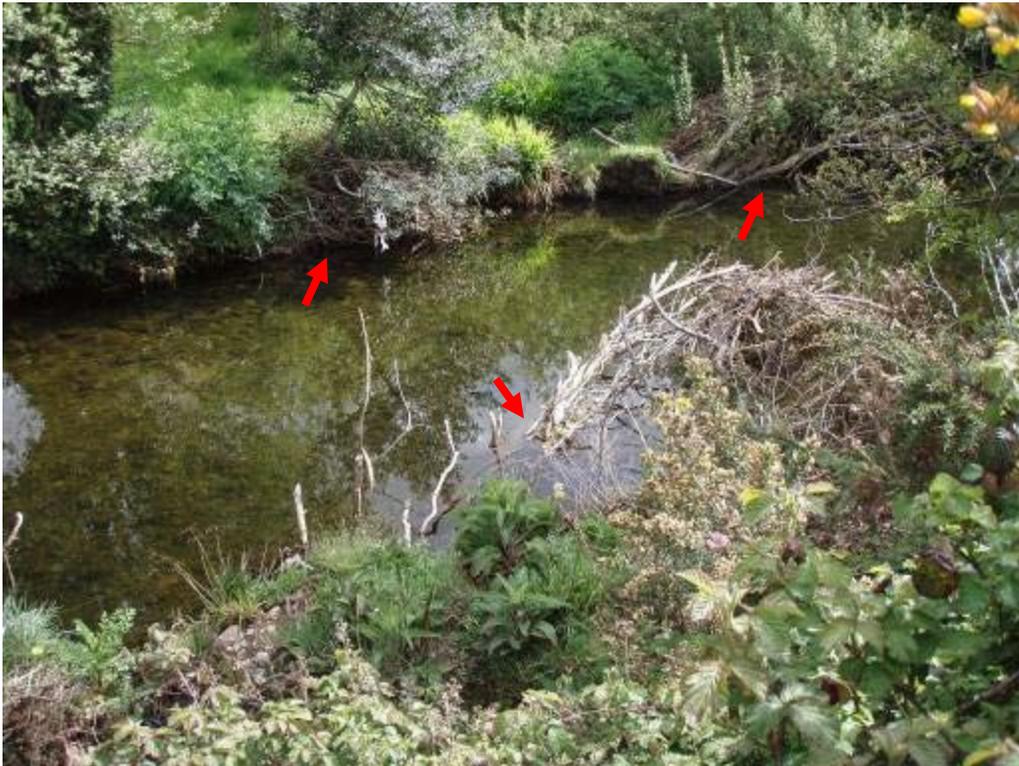
**Photo 12** Woody debris in the channel and low cover along the bank providing superb in-stream habitat for juvenile salmonids. More of this = more smolts heading to sea.

- Management of woody debris within the channel. Woody debris in the river channel is a very important habitat for salmonids, providing shelter and food, creating variety in water depth and grading gravel, making it favourable for spawning. Routine removal of woody debris is bad practice for river habitats and should be avoided if at all possible. Further guidance on managing woody debris is given in the WTT Upland Rivers Habitat Manual.

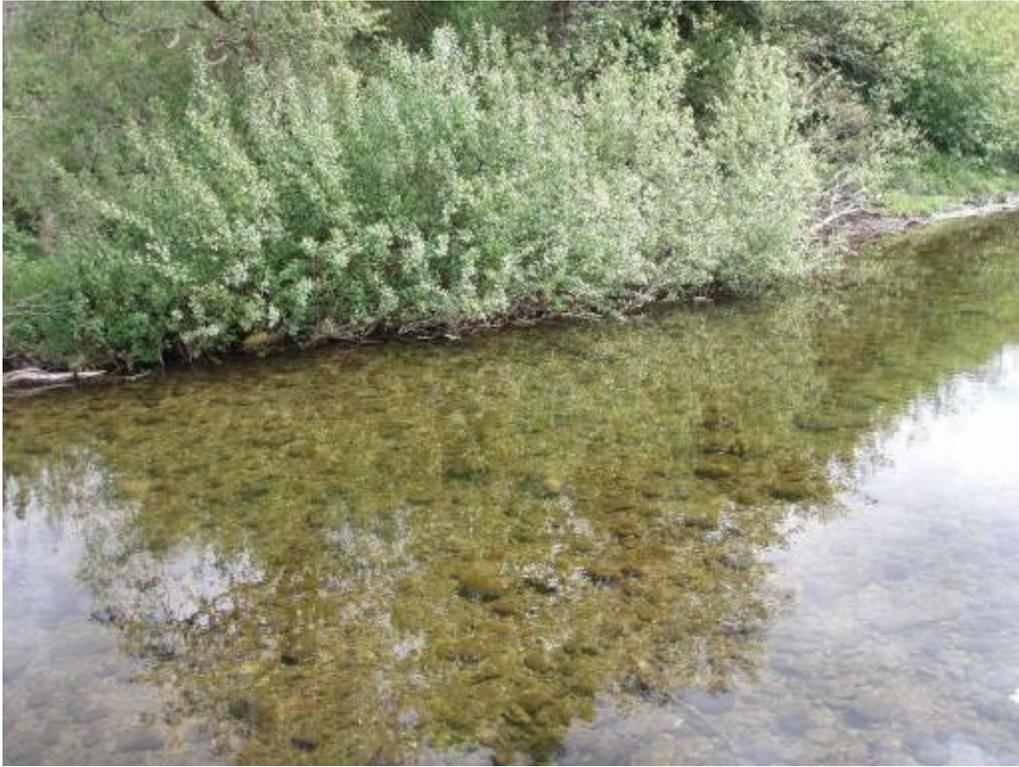
**Photo 13** Low, bushy growth alongside and otherwise open, shallow glide. Managing the margins to encourage this type of cover will improve the carrying capacity for juvenile salmonids in these sections.

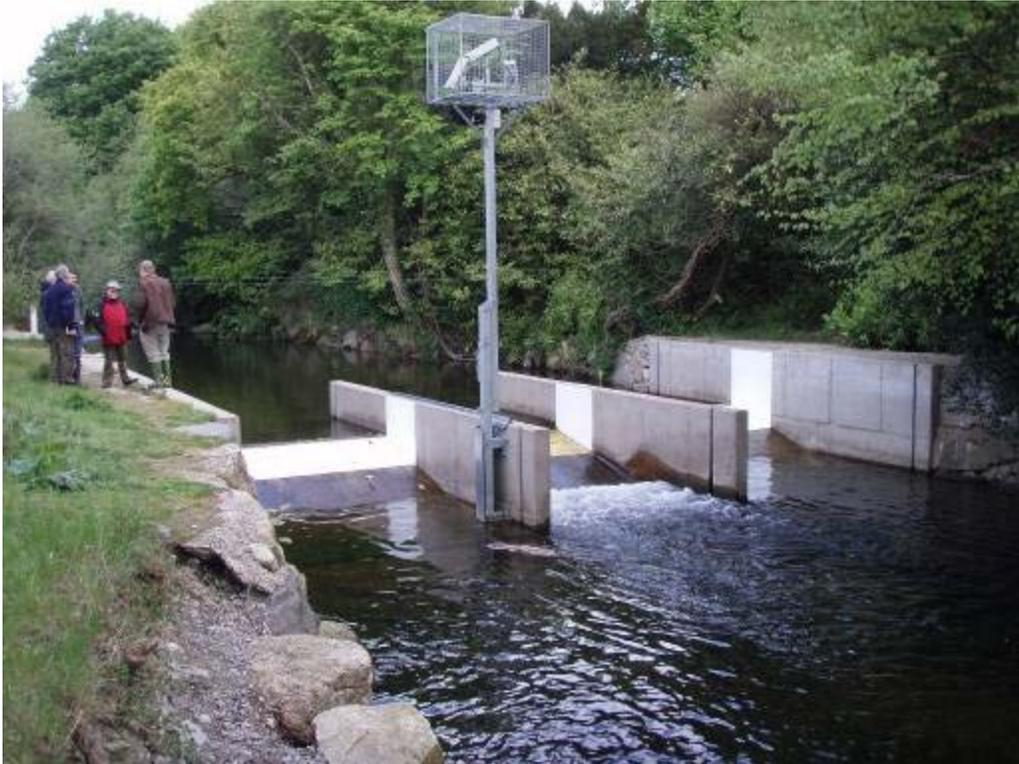
**Photo 14** Recently constructed resistivity fish counter

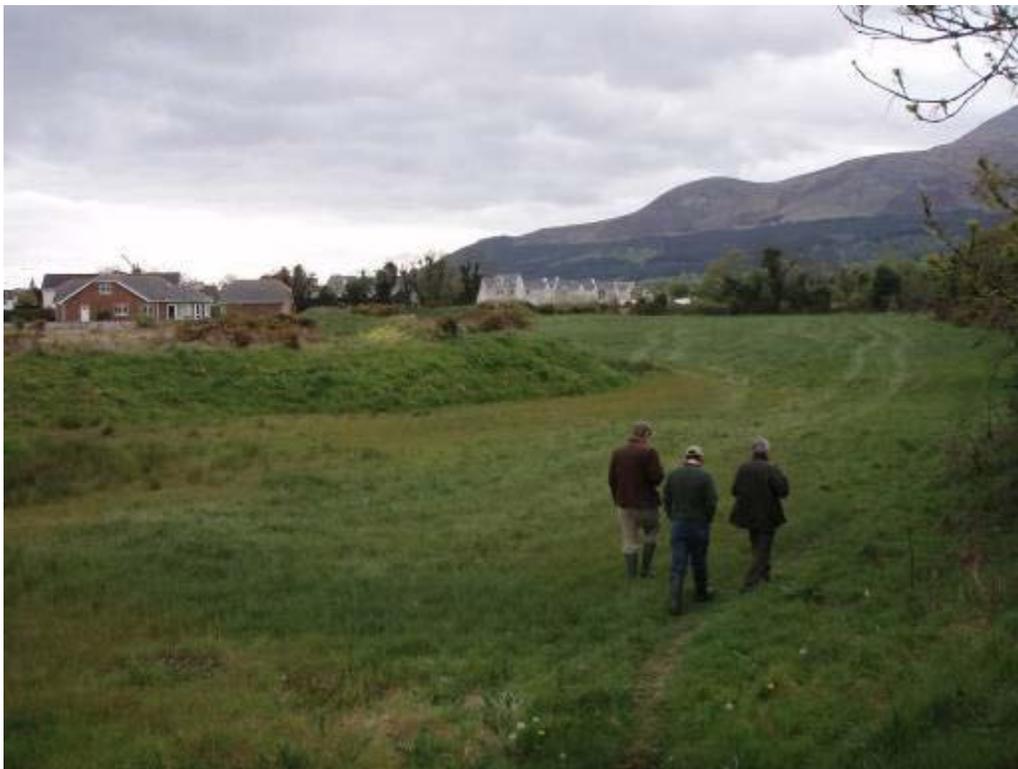
Downstream of the gauging station, the Burren has been straightened and canalised (Photo 16). There is an embankment on the left bank and in 2008 a secondary floodbank was constructed set back from the river; new housing development is ongoing behind the secondary floodbank (Photo 15).

**Photo 15** Field on left bank of the Burren downstream of the flow gauging station (J 373329). The new flood bank is on the left of the picture and the river channel follows the line of trees on the right of the picture.

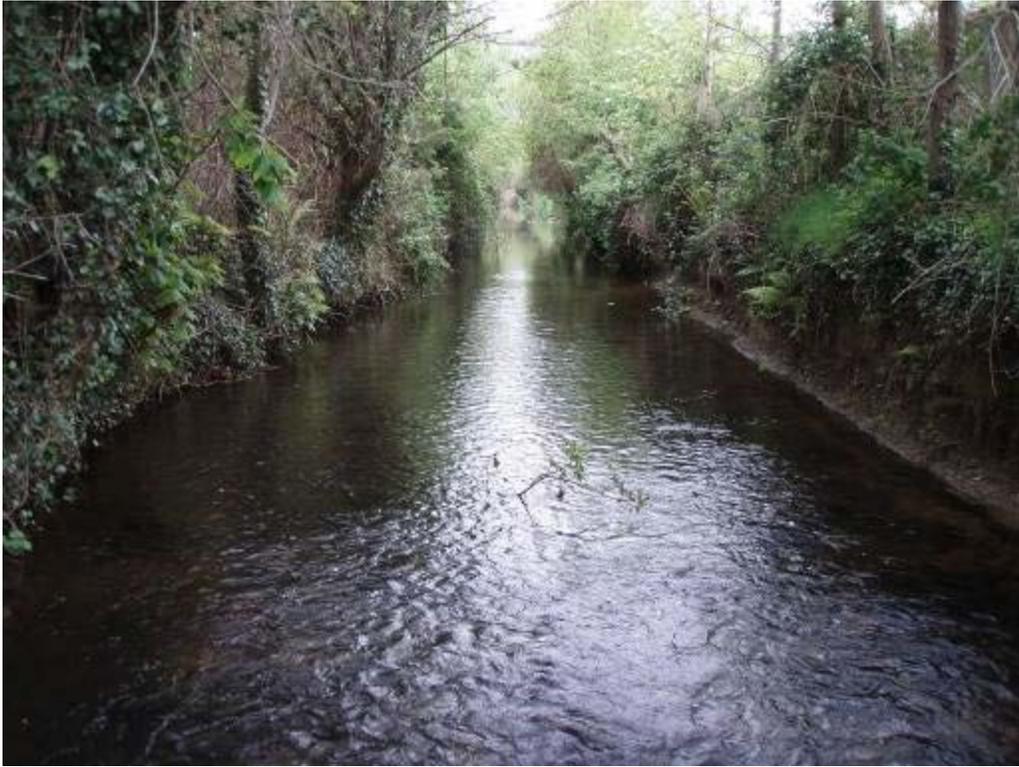
**Photo 16 Straightened channel of the Burren**

It is recommended that a conceptual design for re-naturalising the course of the straightened section of the Burren is produced by a qualified fluvial geomorphologist. There appears to be adequate space alongside the existing channel downstream of the gauging station to create a meandering channel and restore connectivity between the river and its floodplain. The advantages of such a scheme include:

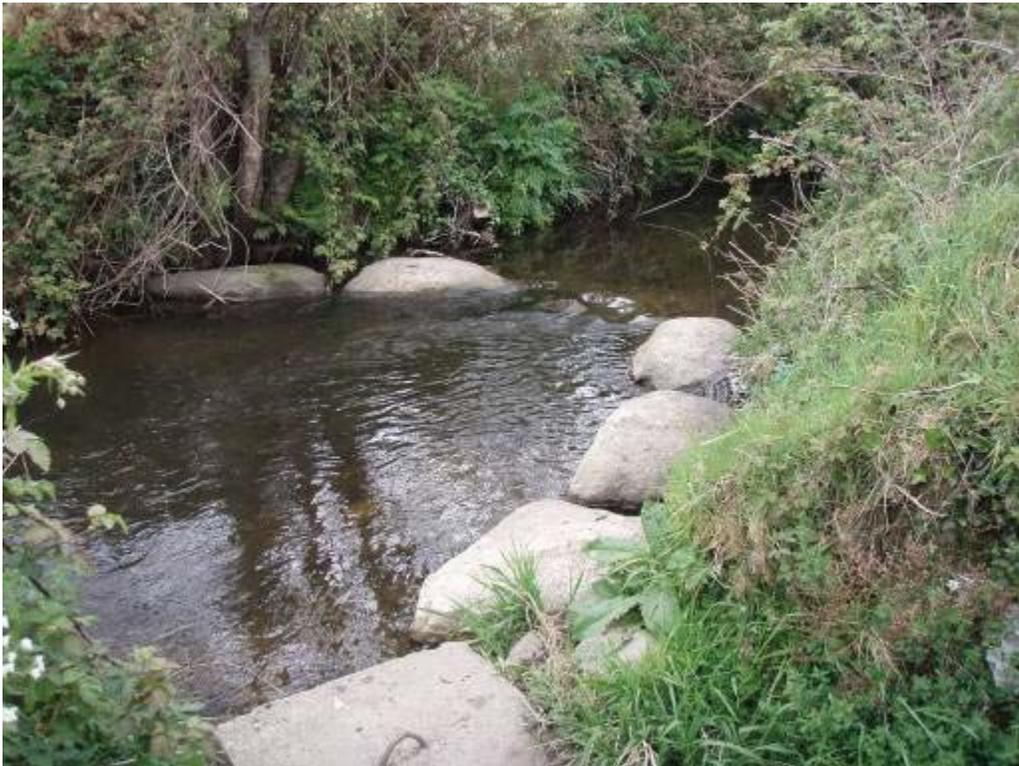
Some habitat enhancement work was carried out on the straightened channel by the Rivers Agency in 2008, including installation of boulder horseshoe weirs, gravel introduction, gravel retaining logs and random boulder placement (Photos 17 – 21). The banks of the channel are well-vegetated and provide reasonably good low cover. Electric fishing results from this part of the Burren show reasonable numbers of fry but relatively poor numbers of parr, probably reflecting the lack of depth variation (pool habitat) in the straightened channel.

**Photo 17 Horseshoe boulder weir, creating pool habitat**

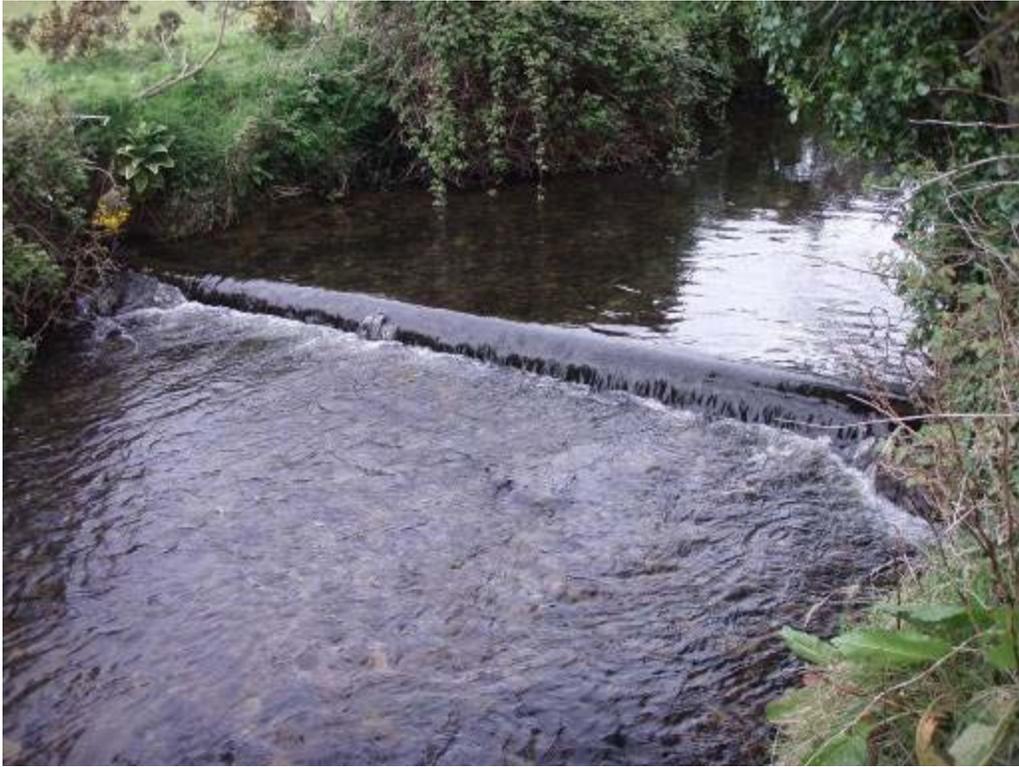
**Photo 18** Cross-channel log with the intention of retaining gravel.

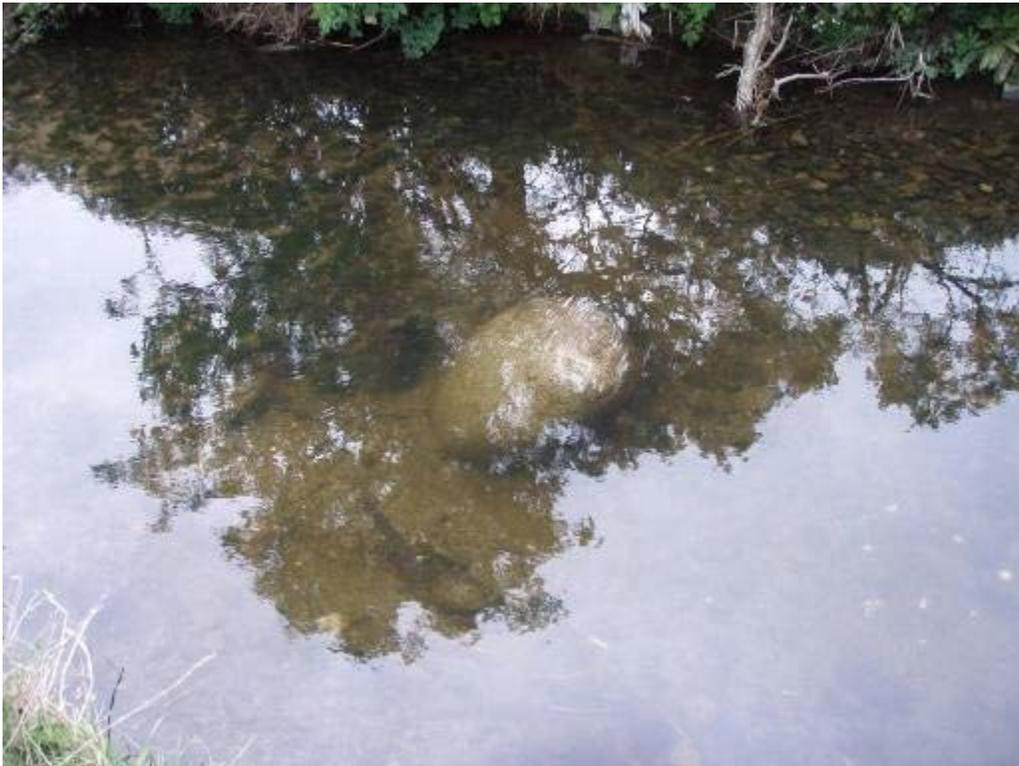
**Photo 19** Boulder placed in mid-channel

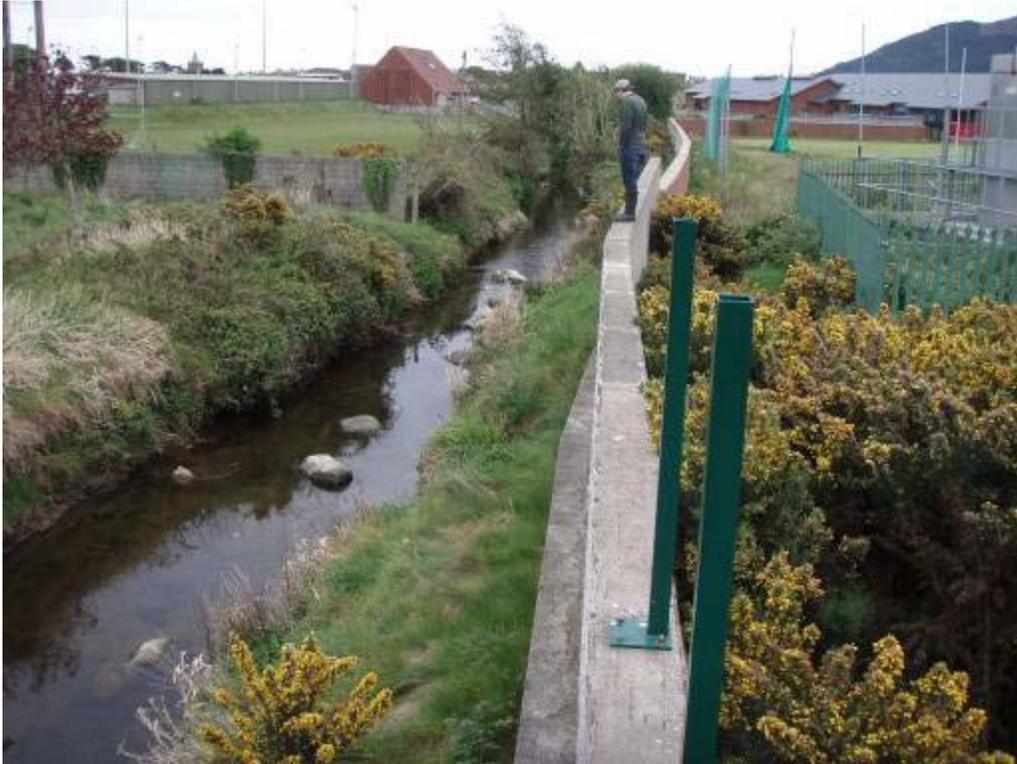
Further downstream is a sewage pumping station (Photo 20) which has caused several pollutions and fish kills in recent years when storm tanks have overflowed with inadequate flows in the river to provide dilution. Fish Legal is acting on behalf of the club in negotiations with NIW over this issue

and it is of paramount importance that the risk of future incidents is eliminated.

**Photo 20** Burren alongside the sewage pumping station which has caused numerous pollutions via the storm overflow when the river has been insufficiently high to provide dilution.

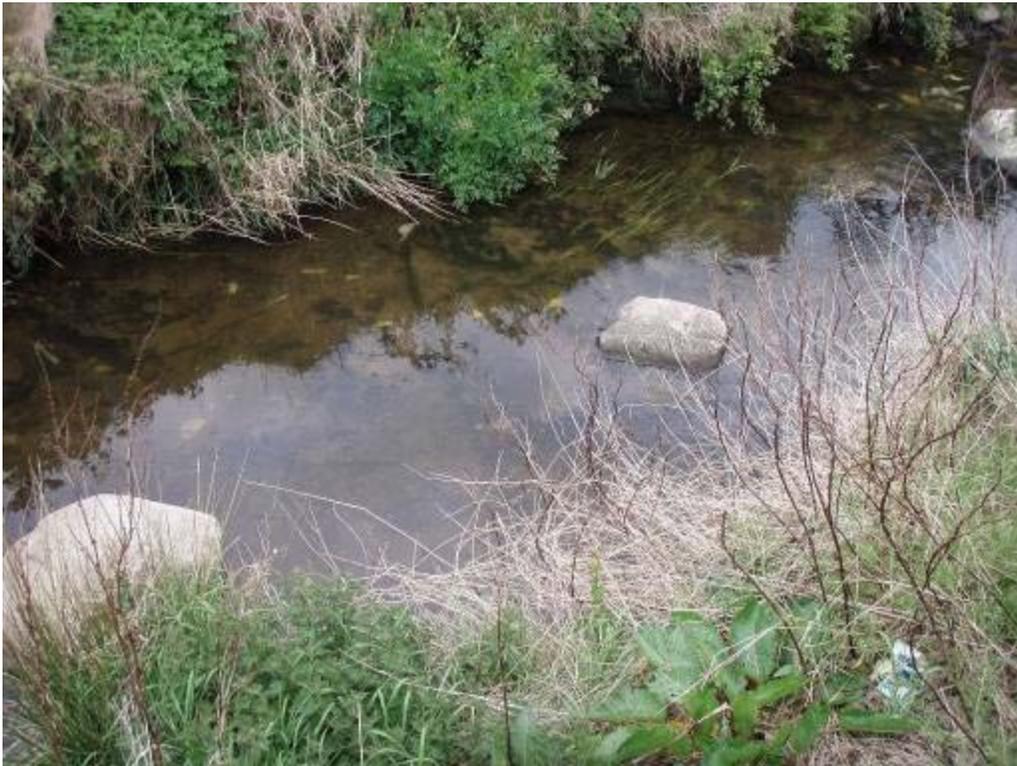
On the lower Burren (in the park) a new flood wall has been constructed on the left bank and an earth embankment set back from the river on the right bank. The in-river habitat continues to be poor, comprising a trapezoidal cross-section, relatively shallow depth and fine sediment bed; however trout numbers appeared to be reasonably good judging by the numbers of rising fish. The riparian vegetation on the left bank was reasonably good, with overhanging willow, gorse and broom providing some low cover over the water; this has apparently grown since the construction of the flood wall. On the right bank the vegetation appears more frequently managed, although long grass and a few willow shoots have been allowed to develop. The club should liaise with the council over vegetation maintenance alongside the channel to achieve better levels of low cover without compromising the flood capacity. Planting of low growing willow species and cutting on a rotational basis is recommended.

**Photo 21** Poor quality habitat in the lower Burren – lack of depth variation and accumulated fine sediment. Boulders have been placed as part of habitat improvement scheme.

In the meantime, further enhancements to the existing straight channel could be carried out. These could include:

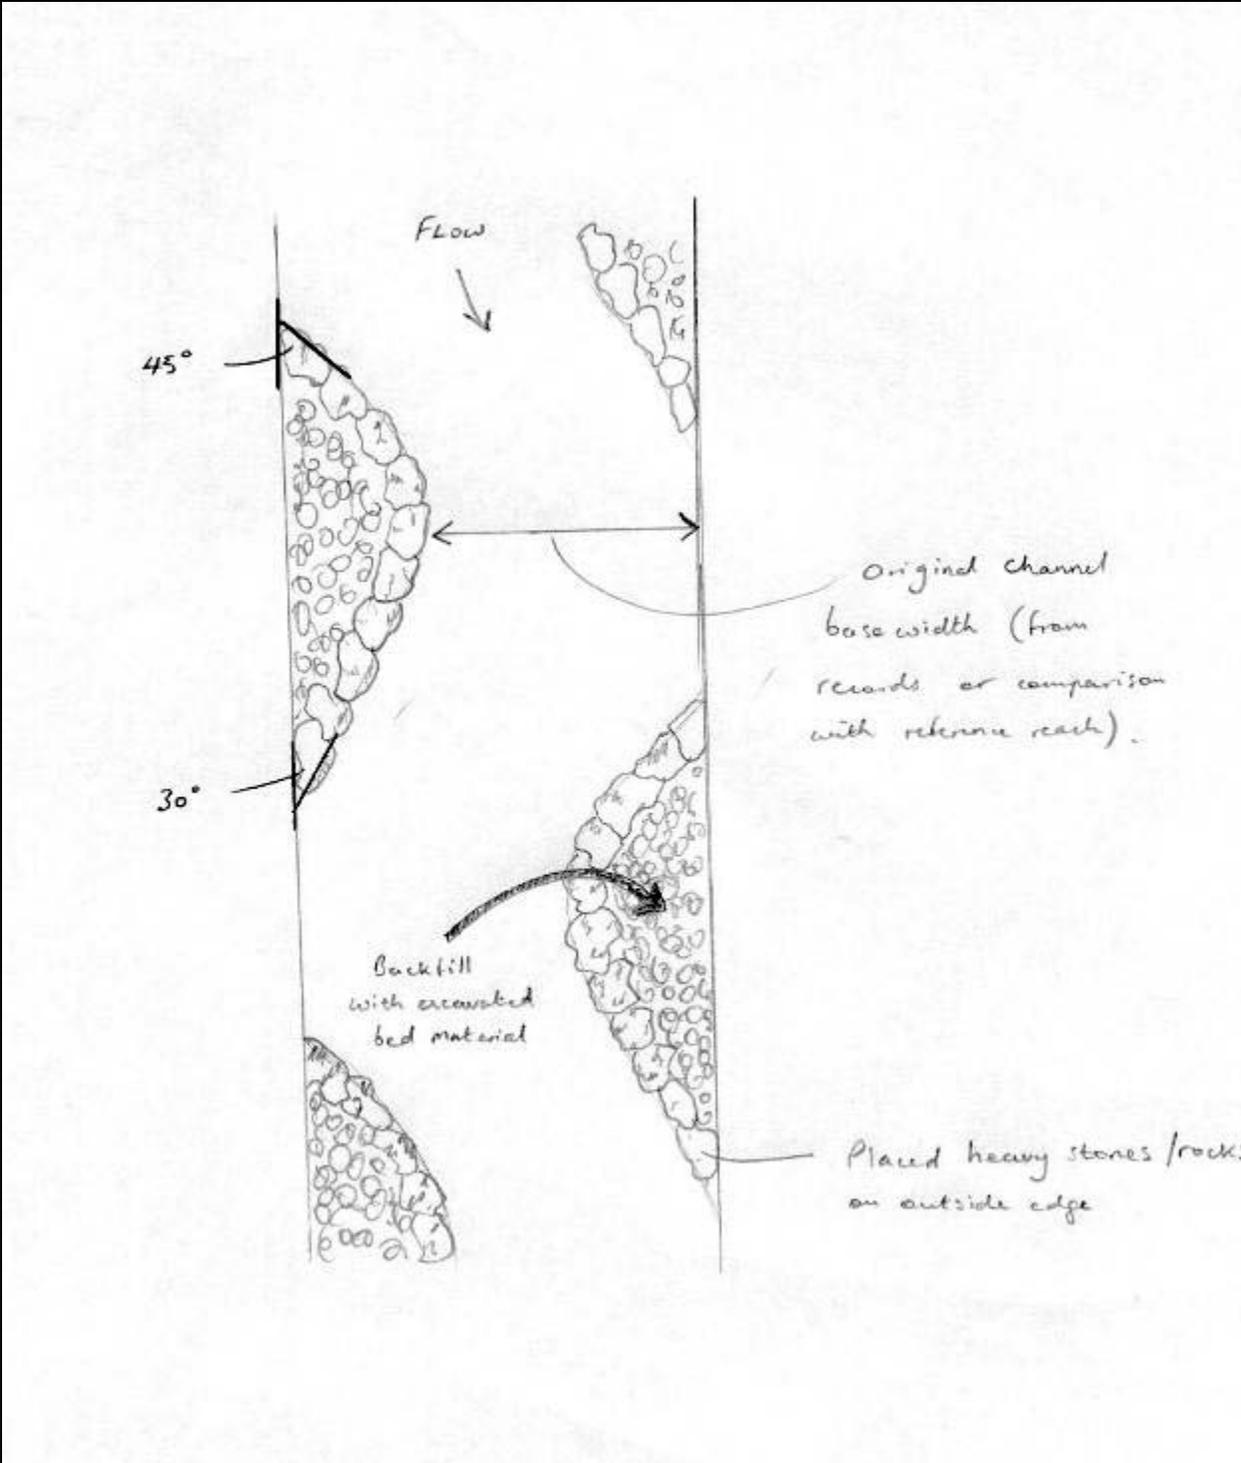
Figure 2 Alternating low-level deflectors to restore natural channel basewidth (from O'Grady, 2006).

- Create a two-stage channel by constructing a series of low-level, alternating deflectors (Figure 2, Photo 22). These should aim to re-create natural channel width based upon river engineering records or a suitable unaltered reference reach (O'Grady, 2006). The river channel has a relatively low gradient through the section downstream of the flow gauging station and for this reason, further boulder weirs are not recommended because of their impounding effect upstream of the structure.
- Hinge some bankside trees by partially cutting through the trunk and laying the tree in the margins to provide bushy cover (Photo 23)

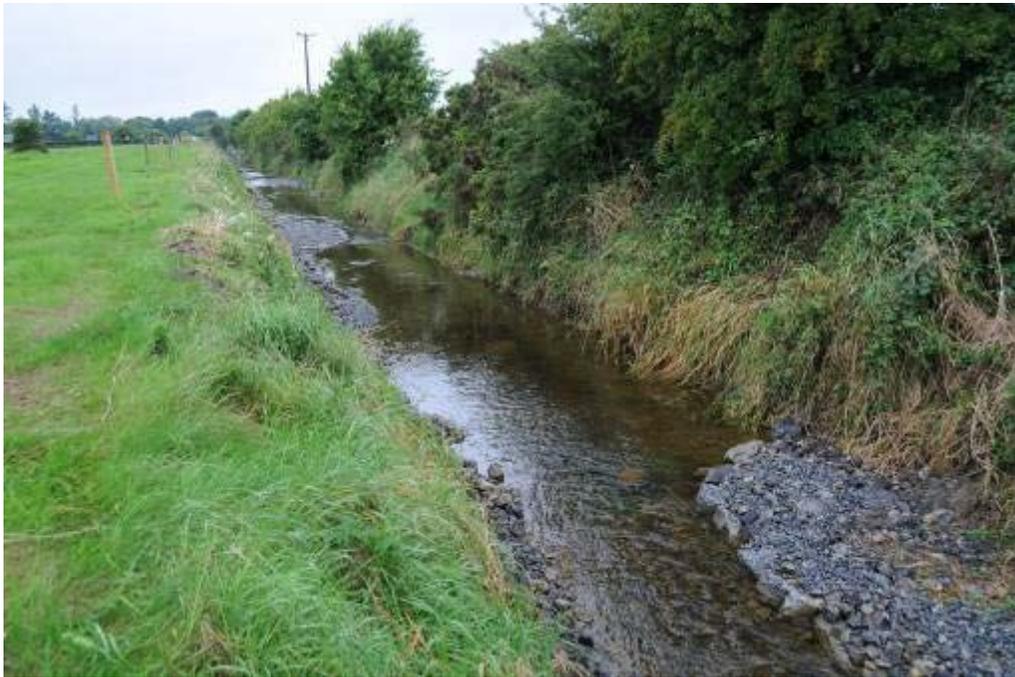
**Photo 22 Recently completed low-level deflectors in the Dawros River (Co. Galway)**

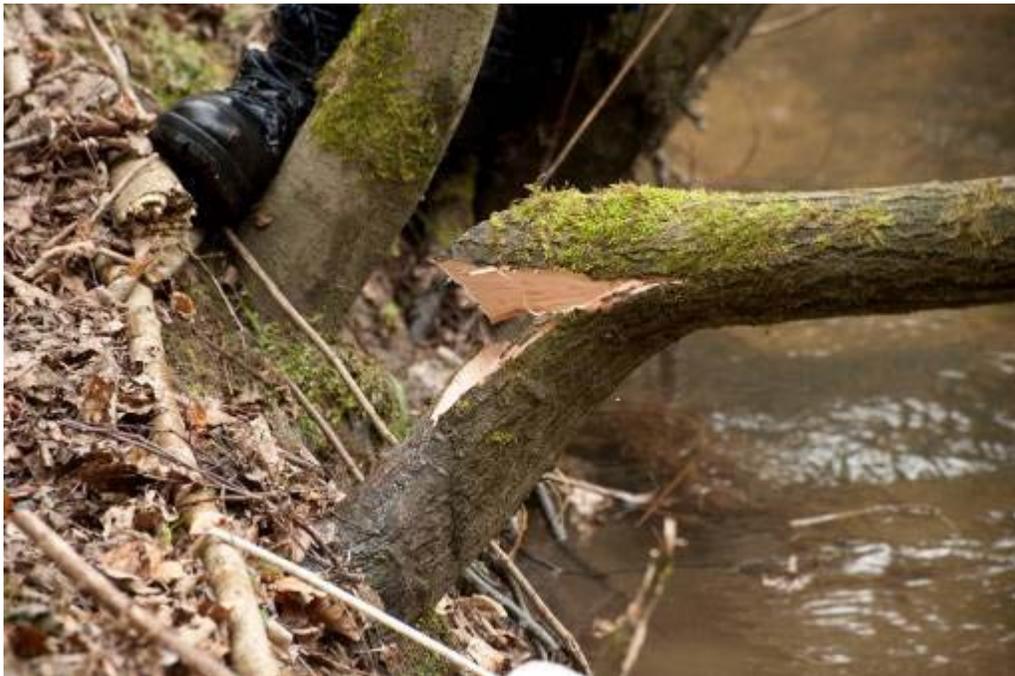
**Photo 23 Hinging trees to provide marginal cover.**
