Advisory Visit
River Aire, Skipton Angling Association
August 2016

1.0 Introduction

This report is the output of several site visits to the River Aire, N. Yorkshire, undertaken by Jon Grey of the Wild Trout Trust. The visit was requested by Graeme Waterfall (Chairman) of Skipton Angling Association (SAA), who accompanied Jon (with Dave Martin, Bailiff) on the initial walkover in June, 2016. Jon re-walked further sections in early August, 2016. The main report will deal with those sections visited that are exclusively fished by SAA; an appendix covers additional waters shared with Bradford City Angling Association – see Fig 1.

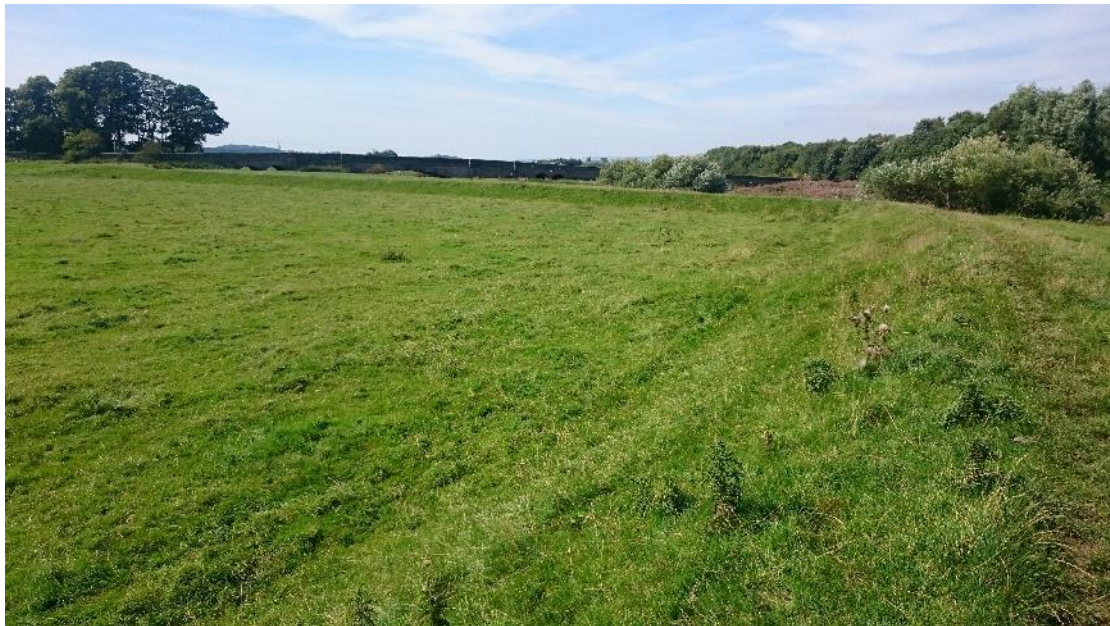
Historically, the river has been straightened or moved to accommodate road and rail infrastructure, increase conveyance of spate flows, and probably also to create more coherent parcels of land for agriculture. Such interference is always detrimental; a shortening of the channel and hence a steepening of the gradient resulting in increased erosion and leaving the river heavily incised with incredibly steep banks. It appears also to have been dredged to provide material for the earthen bunds evident in the adjacent fields (Fig 2).

Fig 2. The bunding around the pasture edge, immediately d/s of Carleton Stone Bridge which is just visible in the background. The bunds are evident on the map in Fig 1.

The bunds are an attempt to constrain the flow within the channel with the misguided notion of increasing conveyance of spate flow d/s and hence reduce local flooding. All they serve to do is increase the likelihood of flooding further d/s and increase the downward erosion within the channel (further incision) instead of allowing spate energy to dissipate across the floodplain. Fine sediments are retained within the confines of the channel so that as the water level recedes and energy abates, the silt drops out and smothers the cobbles and gravels. Much of this rich sediment should have been deposited onto the flood plain and enhance production there. Hence, the river is effectively dis-connected from its floodplain.

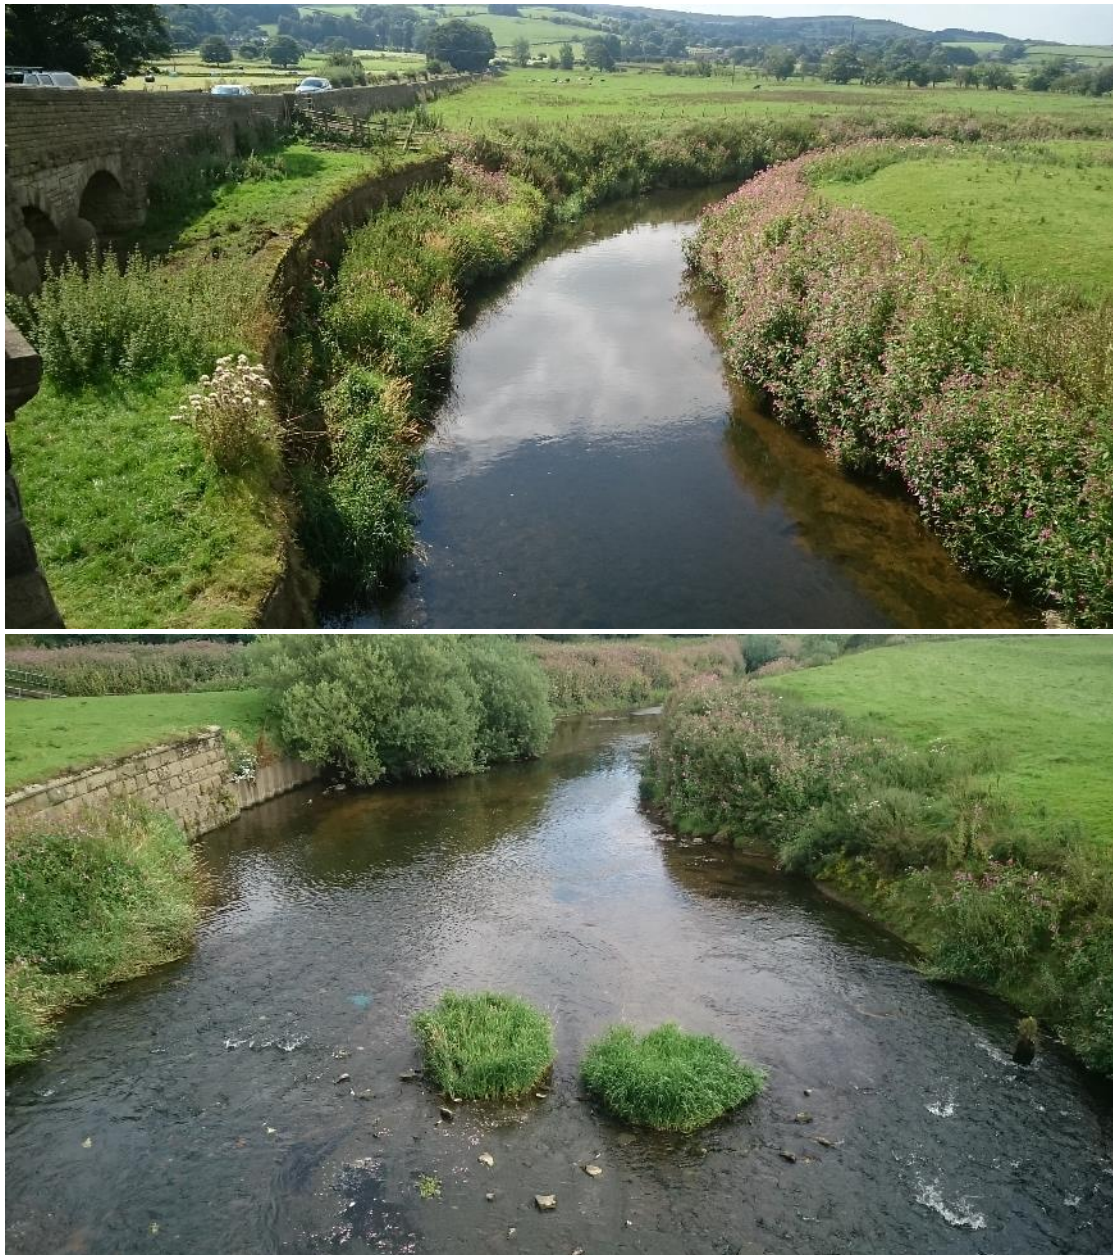
The starting point for the walkover was Carleton Stone bridge at SD9833750082 (Fig 3). There are considerable bank reinforcements both immediately u/s and d/s to ensure that the Aire is passed

through the bridge rather than meandering naturally across the wide floodplain. Fortunately the footings of the bridge are sufficiently deep and retain a natural substrate so that fish passage is not an issue. Immediately d/s of the bridge, the river is wider and shallower because of the eddying effect of higher flows around the hard infrastructure. However, there is notable development of sediment bars (some with pioneer vegetation) and retention of suitable-sized (10-40mm) well-aerated gravels that may be used for spawning; indeed, the diversity of structure and weed growth, even with a shallow depth of water is good habitat for juvenile fish (Fig 3).

Fig 3. Looking u/s (upper panel) and d/s (lower panel) from Carleton Stone Bridge. Note the considerable stone reinforcement of banks to force flow through bridge arches. There is a deeper pool d/s of the vegetated bars with a tail of sorted gravels, and the mix of depths and flow velocities provide good habitat for juvenile fish.

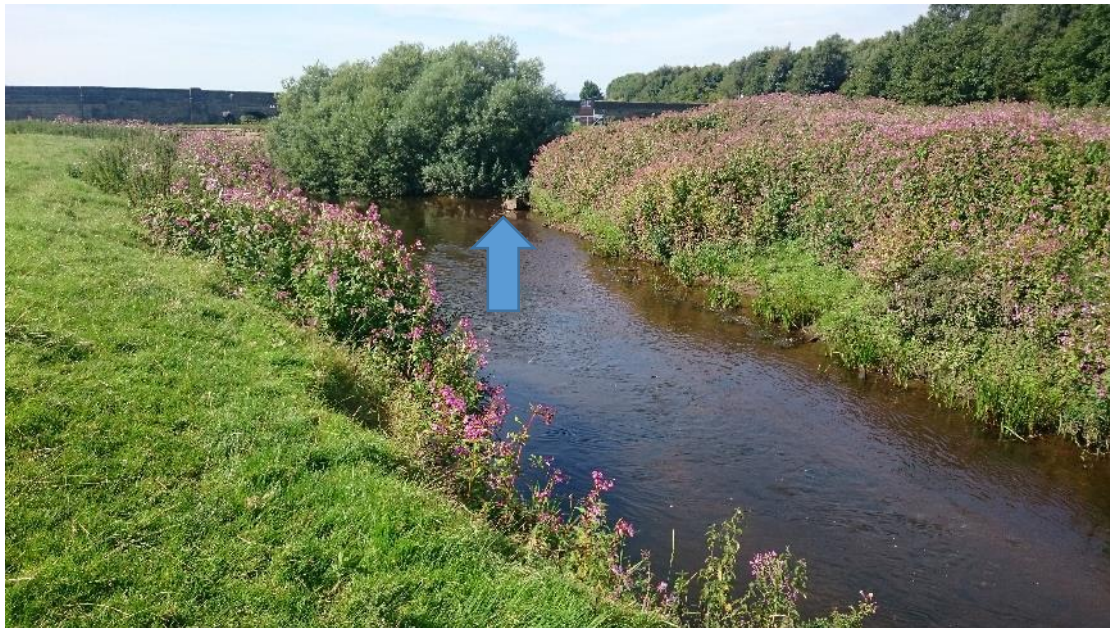
Dense stands of the invasive non-native species, Himalayan balsam (*Impatiens glandulifera*), are evident on both banks and especially immediately below the confluence of Eller Beck which joins the mainstem Aire on the LB ~100m below Carleton Stone Bridge (Fig 4). Balsam is an annual, relying upon enormous production of seeds each year to recolonise areas. It has little in the way of root structure and rapid tall growth means that it tends to readily outcompete native plants. As a consequence, when it dies back in autumn, there is no understory and no root matrix within the soils of the banks to provide physical resilience to erosion during spates.

Fig 4. Looking u/s to the mouth of Eller Beck (blue arrow) almost hidden beneath a stand of willow. Note the dense beds of Himalayan balsam on both banks, partially controlled by grazing on the RB.

Himalayan balsam was the only invasive plant observed but it is extensive. It appears to increase in density ~2km u/s at Inghey Bridge where a small tributary enters from near Skipton Auction Mart. Eller Beck is clearly a different source. Eradication is difficult without a coordinated approach from the u/s end. The club should engage with any initiatives to try and control its growth and future spread. Anglers should be encouraged to follow simple biosecurity protocols to ensure they are not transporting propagules u/s; consider installing a warning sign on the access gate.

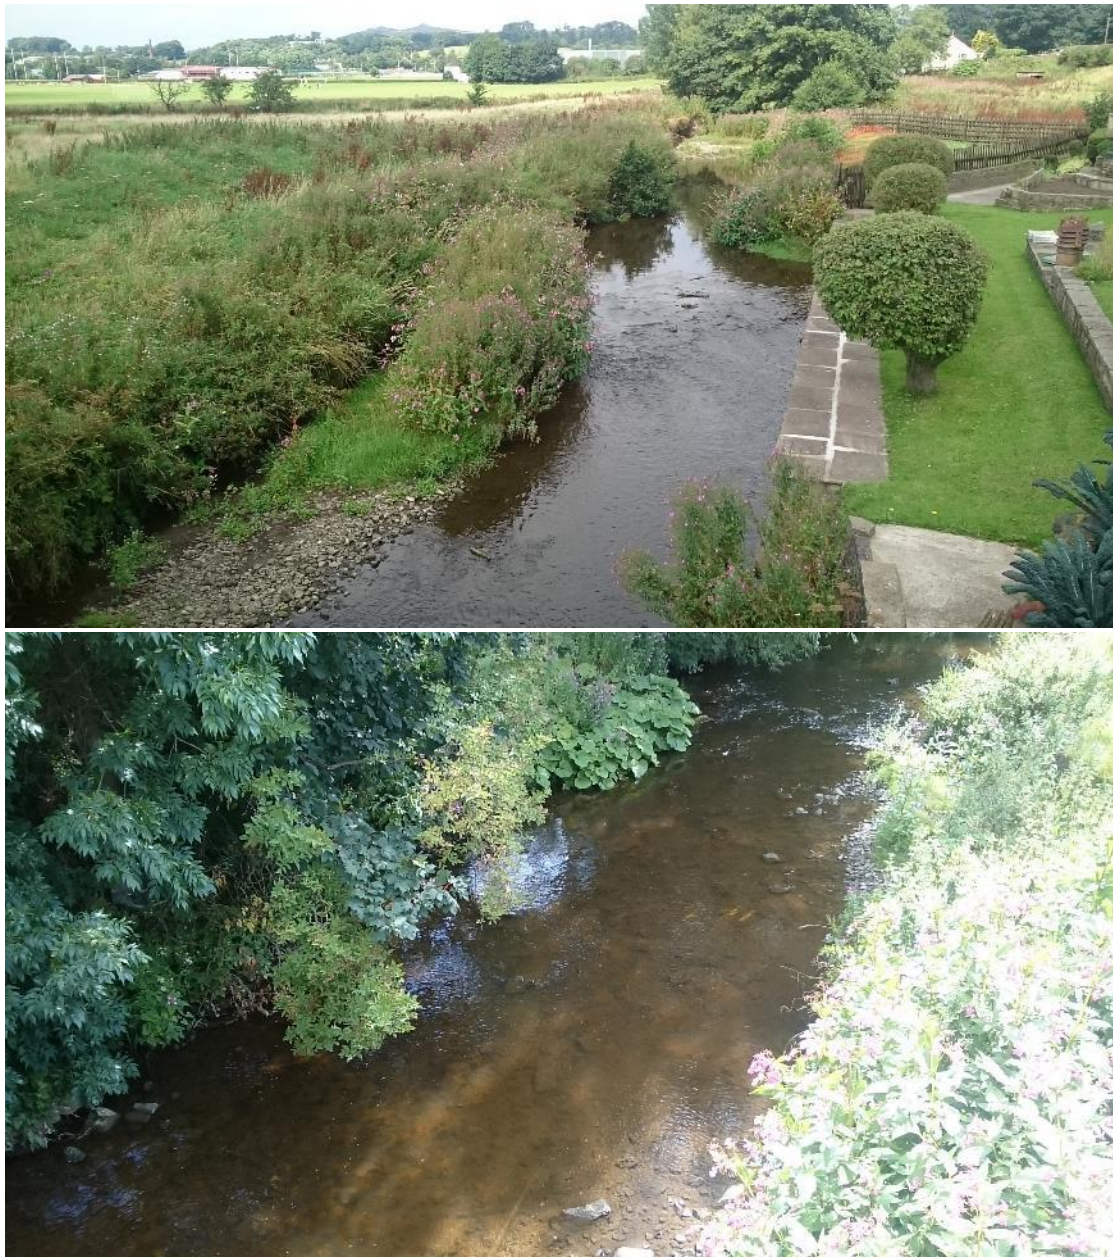
Despite Eller Beck flowing through the town of Skipton, it is formed from a multitude of smaller tributaries, some of which have very high water quality and good riparian habitat, and hence provide a network of spawning streams. Limited natural channel characteristics were evident where the beck is allowed to meander and braid (see Fig 5), but as can be seen from the map (Fig 1), it has been straightened and over-widened for much of its lower reaches and hence excess erosion, grazing to the bank edge and livestock access are all contributing to a higher than natural sediment load which is smothering the bed.

Fig 5. Looking u/s from the highest spot check point, the road bridge over Eller Beck (upper panel) where, despite the walling and formalised true LB, the beck is meandering and braiding around deposition bars. Lower panel: straightened, over-wide section looking d/s from same road bridge and highlighting excess sediment in the channel. Good low cover on the true LB.

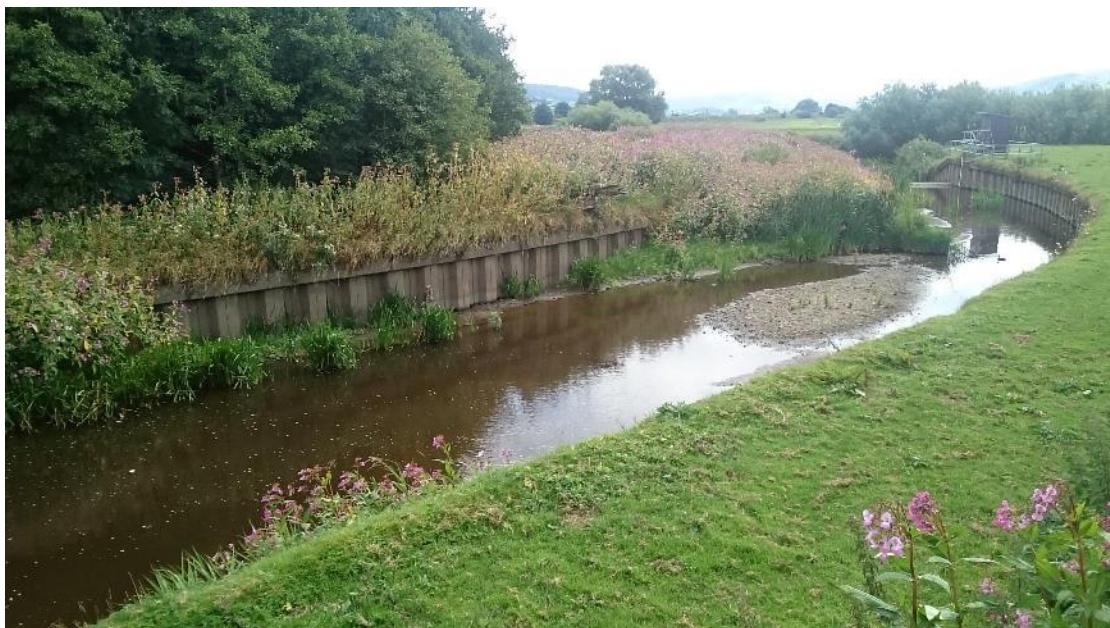
Connectance is a major issue. There are two considerable obstacles to free fish passage (and geomorphological process, the natural supply of gravels to the main river); an Environment Agency gauging weir ~25m u/s of the confluence (Fig 6), and a further step weir ~250m further u/s (Fig 7). Weirs alter the free flowing character of the beck u/s by impoundment and prevent free transport of substrate, thereby impacting upon geomorphology d/s. Channels tend to be overly wide and homogenous in depth and character - see a WTT video outlining key impacts, here:

Fig 6. Highly modified channel walls (and hence lack of low cover) to constrain the course of the beck over the gauging weir just visible (top right). Note, as the channel is overly wide, and the weir impounds the beck for ~50m u/s, there is marked deposition of substrate.

There are no fish passage issues on the sections of the mainstem Aire that were examined for this report, but access to the tributaries is hindered in many cases, especially at Eller Beck. As noted in the Habitat Assessment section, angling clubs should not overlook the importance of small tributaries to wild fish production in their waters. The Environment Agency gauging weir near the mouth of Eller Beck is a considerable obstruction, and is still functional as a gauge for the water level monitoring network. However, as has been recently demonstrated at Eshton Beck, u/s near Gargrave, gauging weirs can be made passable to fish, and so options for Eller Beck gauge should be explored and pursued. With regard to the stepped weir at SD9848550304, Paul Gaskell (WTT) reported to Aire Rivers Trust in 2012 that: *Removal of this structure would be a significant and costly undertaking – but would bring huge benefits to both in-channel habitat and connectivity. This is certainly a case where a gradual approach (i.e. removal in at least 3 separate phases) and an assessment of the response of the upstream watercourse to the*

removal of each part of the structure over at least 6 months before proceeding with the next phase. An alternative, and less radical approach, would be to install pre-barrage easements that could be bolted to the stepped face of the weir. This approach could be coupled with a more moderate notching (i.e. partial removal) of the structure. This notching could provide at least a proportion of the habitat quality benefits associated with increased flow velocities upstream of the barrier. Alternatively, the apparent "perched" nature of the channel on the left hand bank may offer an opportunity to cut a bypass channel through the meadow. This may be perceived as a benefit by the landowner as it would be likely to reduce the attractiveness of the weir pool to trespassing anglers that are currently causing a nuisance.

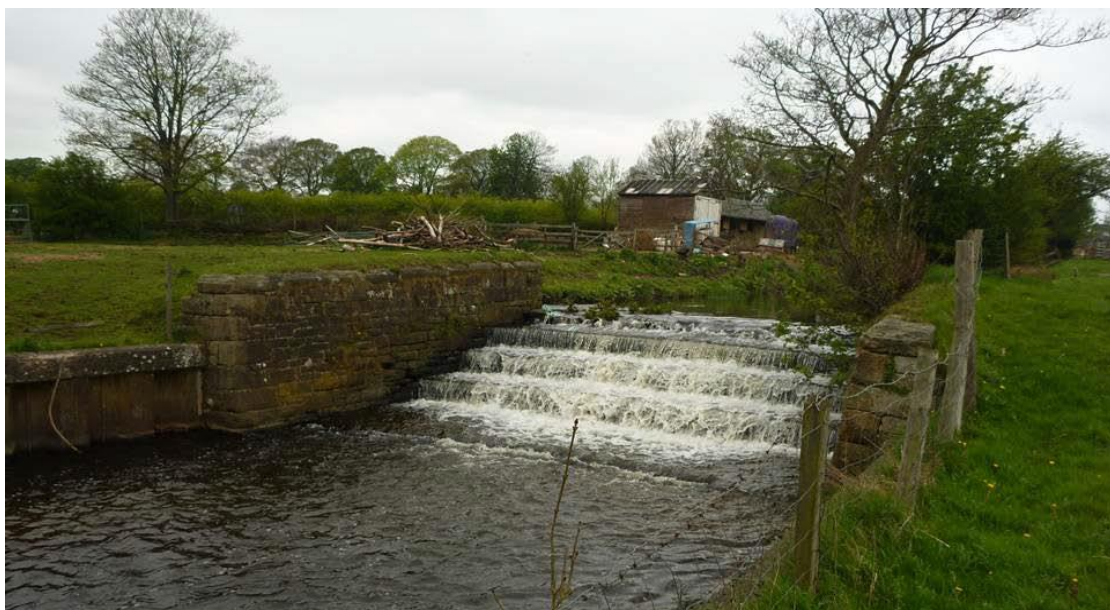
Fig 7. Step weir at SD9848550304. Image taken from P. Gaskell's 2012 report for Aire Rivers Trust.

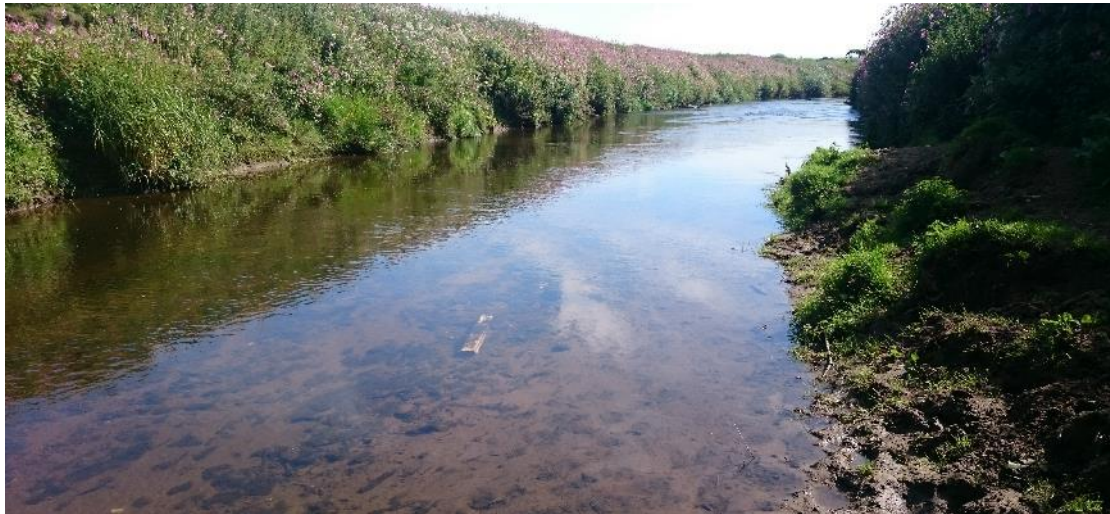
Below the confluence with Eller Beck, the Aire is forced to the right by stone walling at the foot of the bank, and remains constrained by bunding on both banks for over 1km to the railway bridge. For the uppermost ~200m, the river is generally shallow with limited riffles and pools attempting to form in an overly wide, straightened, engineered channel (Fig 8). Anecdotal evidence suggests that the area quality of clean gravels has recently declined and silt now smothers a greater extent. Several mature willows (*Salix caprea* and *S. fragilis* – goat and crack willow, respectively) are well established and where they are close to the water line, provide some low cover

Fig 8. Straightened shallow section demonstrating incised, trapezoidal channel caused by dredging and bunding. Silt is evident at the edges but riffles in the distance maintain clean gravels.

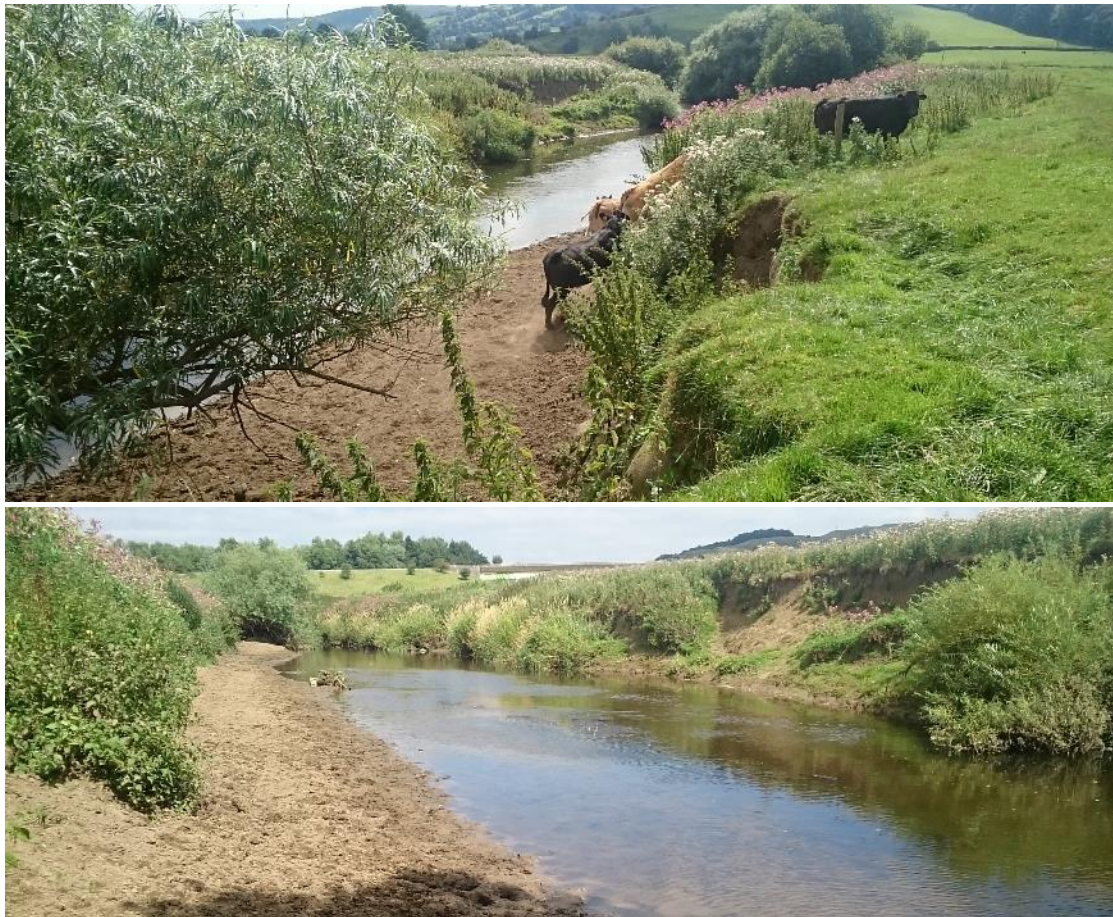
However, they also attract the attention of cattle for shade, as browse, and as access points to the river (Fig 9). The continual poaching (trampling) of the banks is a double-edged sword. In such an engineered channel, the gradual re-profiling of the banks allows some better, if limited connection between the river and its floodplain. However, these focal points also cause considerable soil ingress, especially during high rainfall events as they form gutters into the river. There is also the introduction of excess nutrients via faecal matter which contributes to the proliferation of nuisance algae and an oxygen demand from bacterial metabolism in the water.

Fig 9. Upper panel: cattle accessing the river bed especially around mature willow trees. Lower panel: cattle access the full length of bank toe here; a positive aspect is that there is sufficient space for the low-flow channel to meander within the confines of the bunded banks.

It might be beneficial in this situation, where the channel is so incised, to continue to allow cattle access to the water's edge but lay some of the mature willow trunks thereby preventing the cattle from walking along the bank foot. There is sufficient room to get the river path meandering again at low-flows within the constraints of the engineered, trapezoidal channel – see Fig 9, lower panel; this may be achieved using low cost interventions under the exemptions of the new Environmental Permit Regulations – see Recommendations.

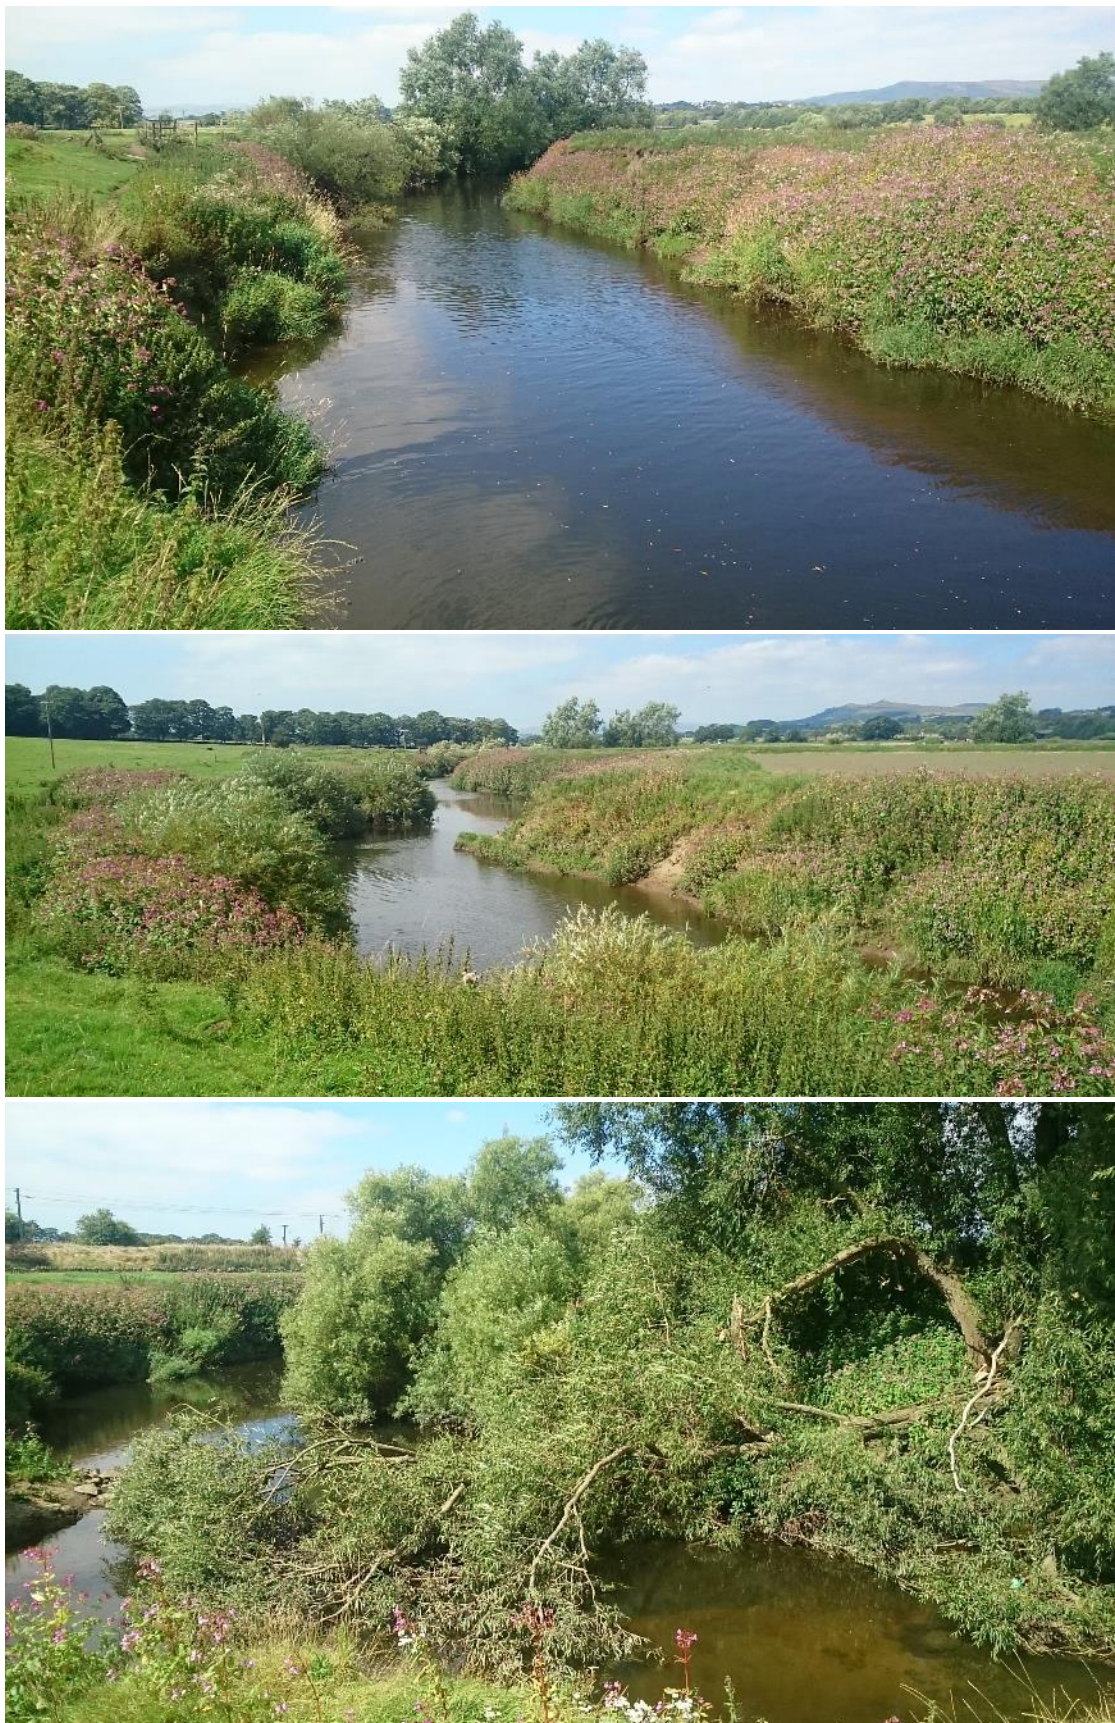
The ~800m section above the railway bridge, and indeed for many hundreds of metres d/s of that bridge are so deeply incised by dredging and bunding that flow is barely discernible (Fig 10). There are incredibly deep holes in the bed where the boulder clay has been gouged into during spates because the flow energy is constrained within the bunds. These holes may be deep also because the river is being starved of cobble and gravel substrate as geomorphological process is strangled upstream; all the weirs on the system may be preventing the natural resupply of material down-river, post-dredging. The only habitat features of note are the sporadic stands of mature willow. As most of these comprise multiple trees or multiple trunks, some could be laid parallel to the bank, i.e. along the channel, to encourage deposition of finer sediments in their lee, and introduce some further flow diversity under low-flow conditions. The idea is to emulate natural tree fall, as can be seen in the lower panel of Fig 10. As the name suggests, crack willows naturally crack and lay under their own weight, but generally remain alive and will reinforce the sediments where they fall via adventitious roots. There were three sizeable brown trout holding station around this one branch, whereas none had been seen in the 800m u/s.

Fig 10. Upper & mid panels: the almost canal-like sections with barely discernible flow above the railway bridge. Lower panel: a cracking crack willow branch that is still viable, and introducing much needed habitat and flow variability in an otherwise uniform channel.

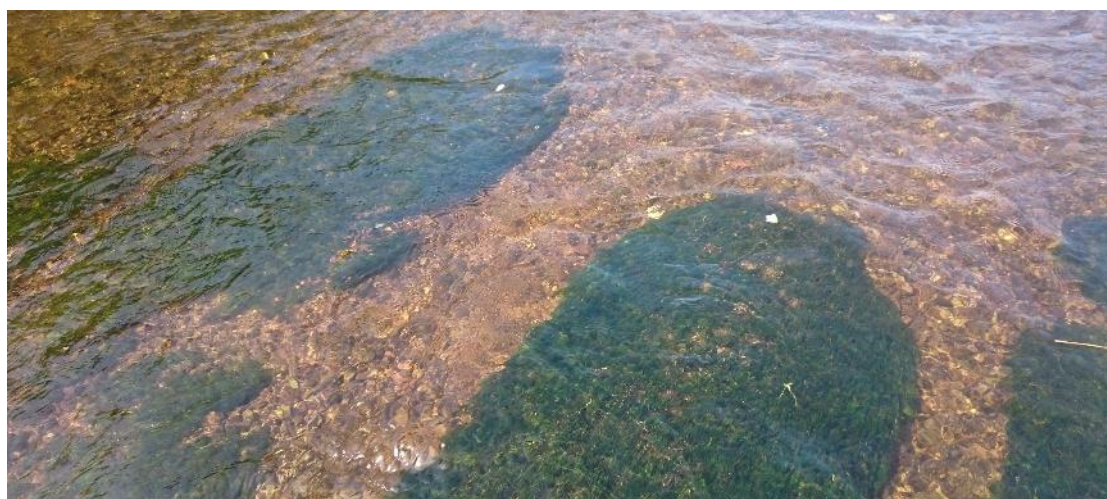
Through historic straightening and dredging, the channel has become trapezoidal in cross-section. This results in the uniform distribution of bed materials, an unsorted 'cake-mix' which is typically low quality habitat for invertebrates as well as lacking in structure required for spawning substrate. The saving grace for the majority of the upper reach is the growth of macrophytes such as *Ranunculus* spp. (water crowfoot) which forces the water around the plant mass, thereby concentrating flow into narrow channels which removes the finer silts and effectively cleans the gravels in between (Fig A). Swan grazing is reducing this valuable function in some stretches.

Fig A. Water crowfoot (*Ranunculus* spp.) stands pushing the flow about and keeping gravels clean. Note the close cropping of the plant by mute swans (*Cygnus olor*).

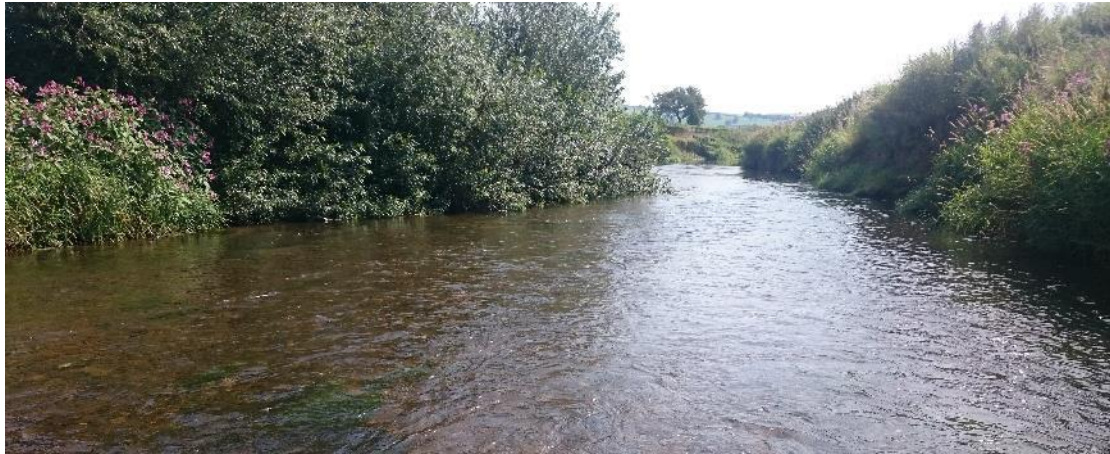
There is also sporadic introduction of habitat diversity from small clumps of mostly goat willow (*Salix caprea*); some of these trees are rooted at the toe of the bank and thus provide vital low cover via trailing branches, which also help to diversify flow by pinching the

channel and create scour holes underneath which are excellent holding spots for larger fish (Fig B). It is important also to consider the role these trees play as focal points for mating swarms of aquatic insects, thereby keeping the insects close to the banks and providing cover for them during inclement weather before they lay their eggs back in the river.

Fig B. An example of excellent quality habitat provided by goat willow. The root mass will provide physical structure to stabilise the bank, and the low growing and trailing branches not only provide cover but diversify flow and depth by 'pinching' the channel width.

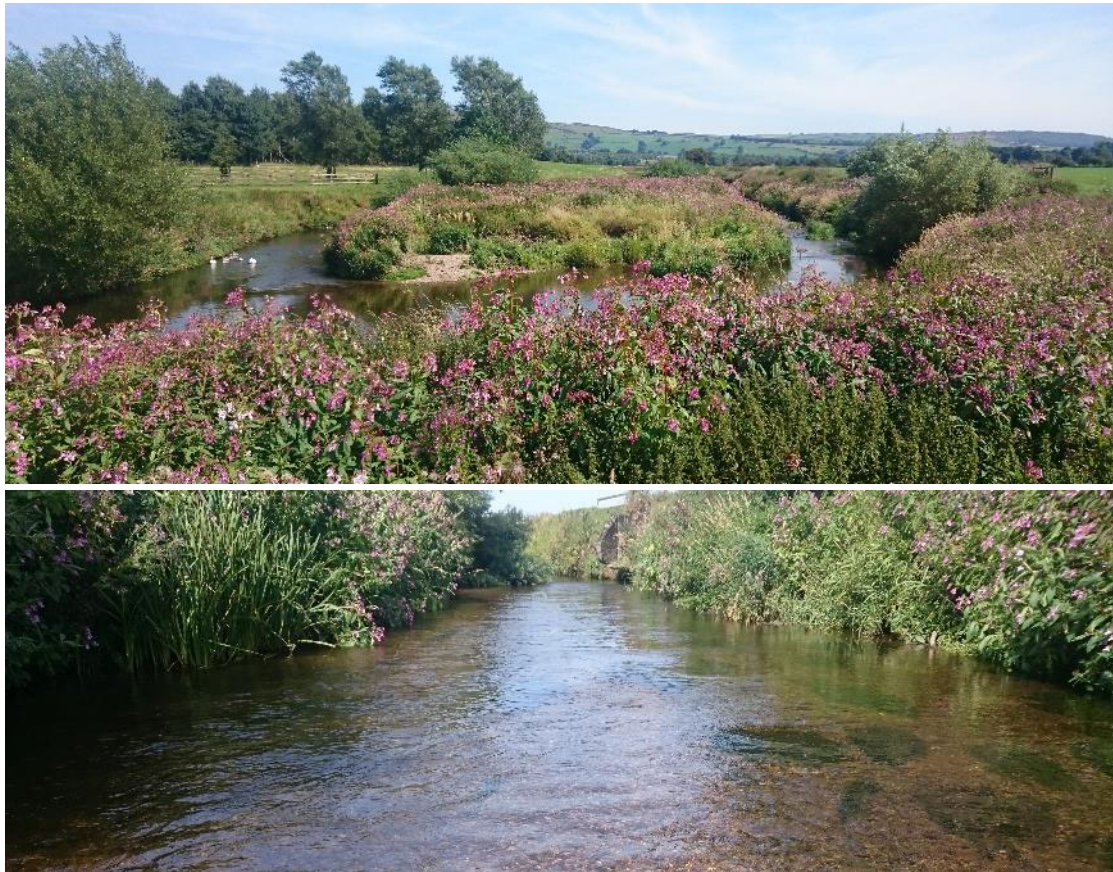
The downstream impacts of a pinch-point are exemplified by the footbridge at SD9739450464 where the Aire is essentially forced into a narrow aperture, and 'blows out' a pool immediately below. The material scoured from the pool has deposited to form an island, ramps of well-sorted substrate and effectively braiding the channel into two separate paths which are formed of clean, bright gravel beds (Fig C). The island is now well vegetated, helping to consolidate its structure. While flow is stronger in the channel to the LB and presents more classic river habitat, the slower flow in the channel to the RB is a useful refuge area for juvenile fish, especially during spate flows.

Fig C. Upper panel: the island (braiding) within the channel immediately below the pinch-point introduced by the footbridge from Carleton to Ings Lane. Lower panel: looking u/s from near the foot of the island along the channel hugging the true LB. Note clean gravels, water crowfoot growth and cover from shaggy bankside vegetation, although also note presence of Himalayan balsam.

Thus, the presence of submerged aquatic plants, the bridge, and the few willows are the only 'hard' features which create resistance to the flow in the trapezoidal channel and produce depth and flow diversity in an otherwise uniform environment. To create better, diverse habitat, it is these features and functions which need to be emulated or reintroduced where appropriate, especially in the straighter sections.

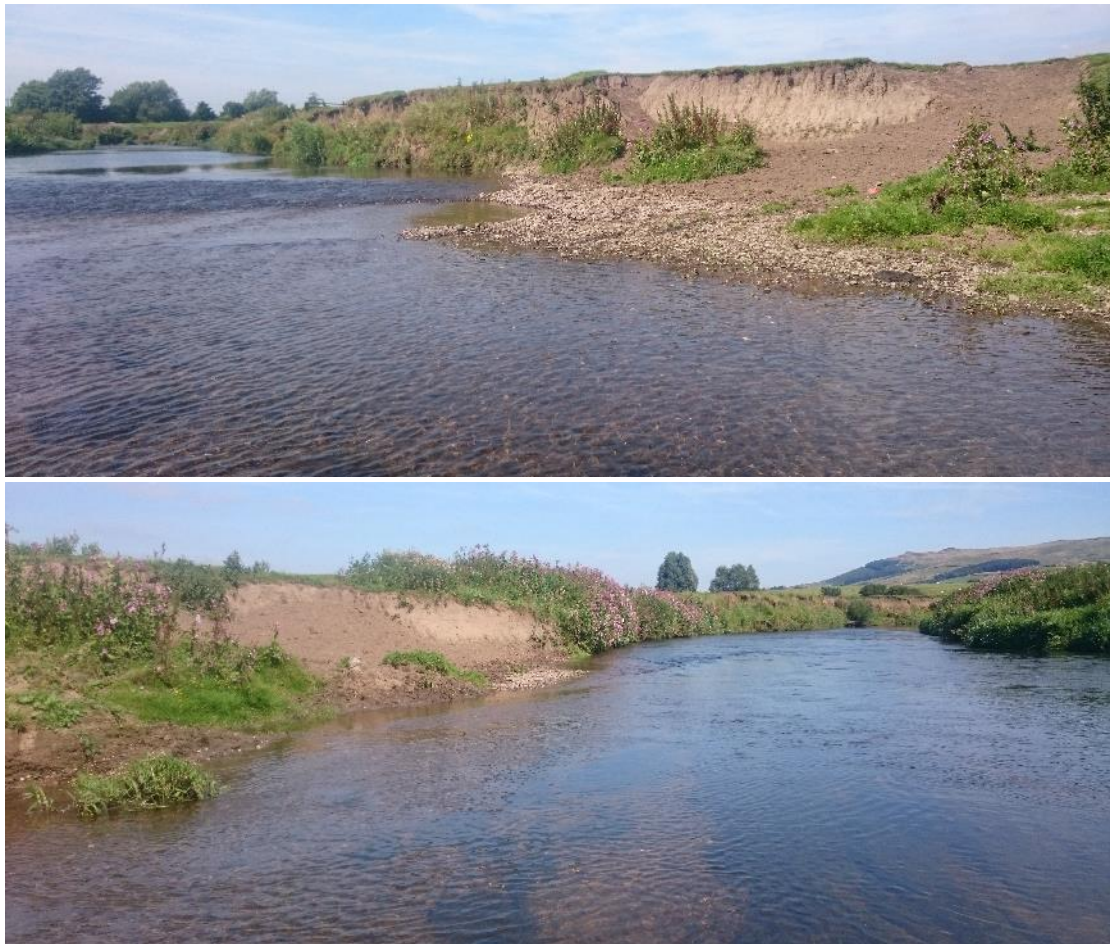
At several points, livestock has accessed the river bed and caused considerable erosion of the LB (Fig D). While this trampling and poaching introduces fine soil and nutrients, viewed in the context of an increasingly constrained and incised channel, the localised widening and connection point for the river to its floodplain is actually beneficial. One way to nullify some of the negative aspects of such access points would be to introduce a pinch-point via paired log-deflectors or by laying of willow trunks (if present); this should focus the flow through the gap and also provide a nearby depositional environment (in the lee of the deflector) where the fines may accumulate and eventually consolidate.

Fig D. Looking u/s (upper) and d/s (lower) from mid-river at a cattle access point on the LB. Note the considerable growth of aquatic plants in the wider, shallow channel.

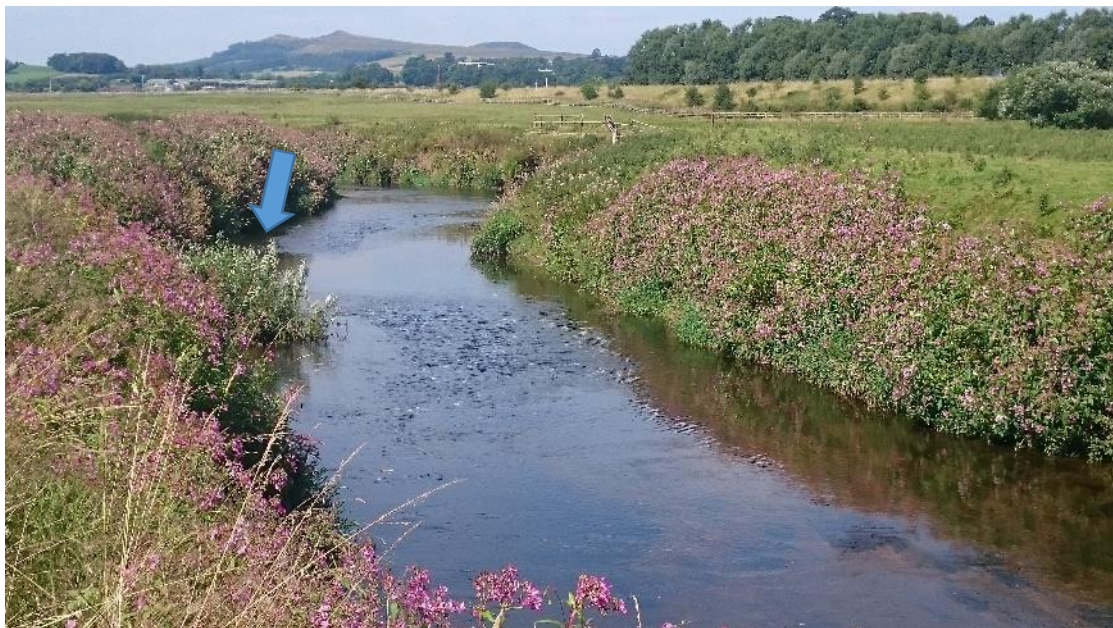
The channel becomes more incised with distance d/s; the banks are much higher and steeper by Carleton Stone Bridge and access to the riverbed is tricky. This does mean that the vegetation is largely unhindered by livestock grazing, even on the unfenced section, and hence the plants at the waterline create a shaggy margin, ideal for fish cover (Fig E). However, it also means that because spate energy rarely overtops the banks and dissipates onto the floodplain, erosion continues downwards and exacerbates the incision, and as a consequence, the lower reaches are typically deeper and slower flowing. It is especially important to retain even relatively small features near to the toe of the bank to provide some heterogeneity in the channel, e.g. the retention of a long-dead tree trunk (in Fig F) provides sufficient flow deflection to allow the consolidation of a vegetated bar immediately d/s.

Fig E. Looking u/s from near Carleton Stone Bridge at the heavily incised channel. Note the slight pinch from a willow (blue arrow) on the RB has caused variation in the depth and flow immediately d/s.

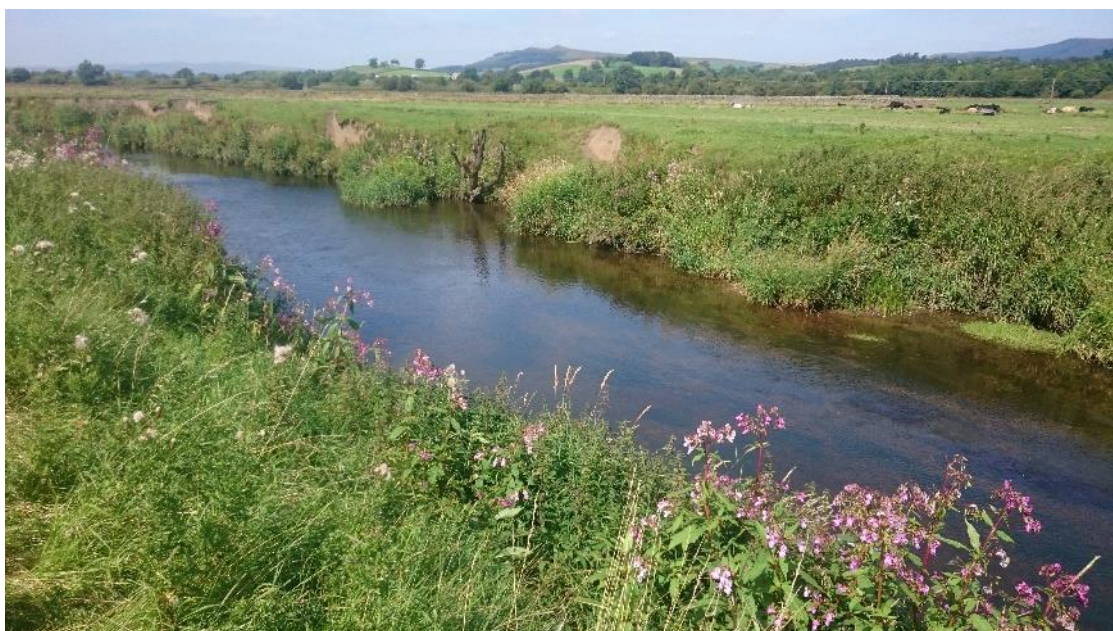
Fig F. Retention of the dead trunk has protected the LB immediately d/s and created a vegetated bar.
