## Advisory Visit

River Slea, Sleaford, Lincolnshire

February 2015

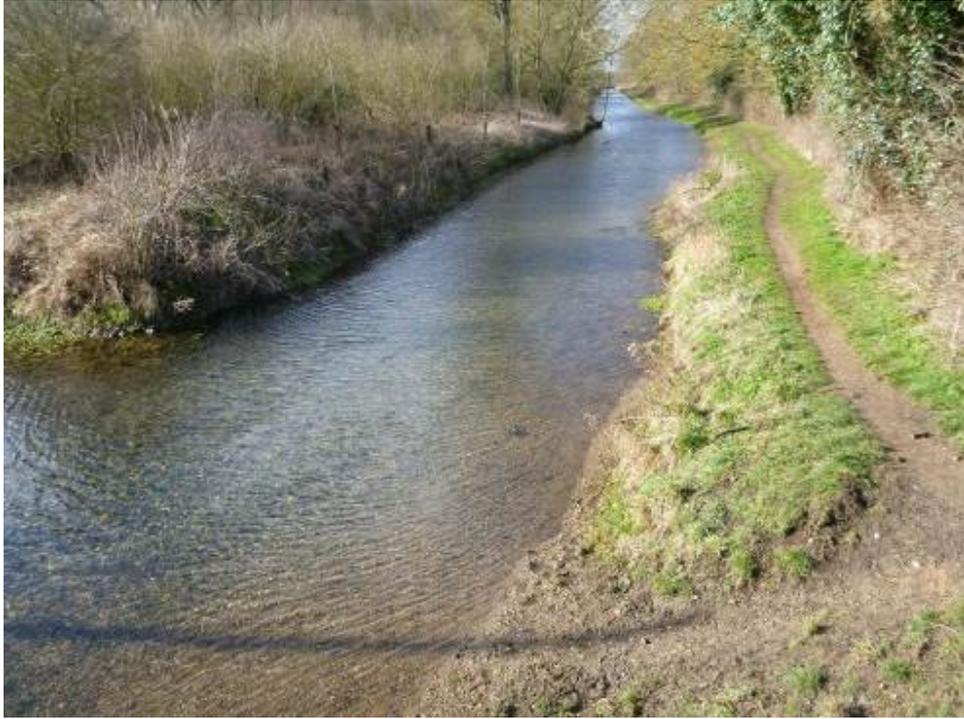
From Drove Lane to the railway bridge (TF0592445933) the river has a uniform width and uniform shallow depth. The channel is canalised and has no natural flow features (such as pools and riffles). The river bed substrate is poorly sorted and dominated by finer sediment (sand and small gravel). Upstream of Drove Lane there are few aquatic plants evident, whereas downstream mare's tail (*Hippuris vulgaris*), starwort (*Callitriche*) and forget-me-not (*Mysotis*) are present. This probably reflects the fact that the channel upstream of Drove Lane dries out regularly and is more shaded than

**Photo 1 View upstream from Drove Lane – note lack of in-stream vegetation, probably because of shading and intermittent flows**

Use an excavator to re-shape the river bed, a technique pioneered by the late Nigel Holmes. A thalweg (continuous deep line of flow) is excavated in the river bed and the arising material used to form berms (benches) in the margins of the river. An example is shown in Photo 19.

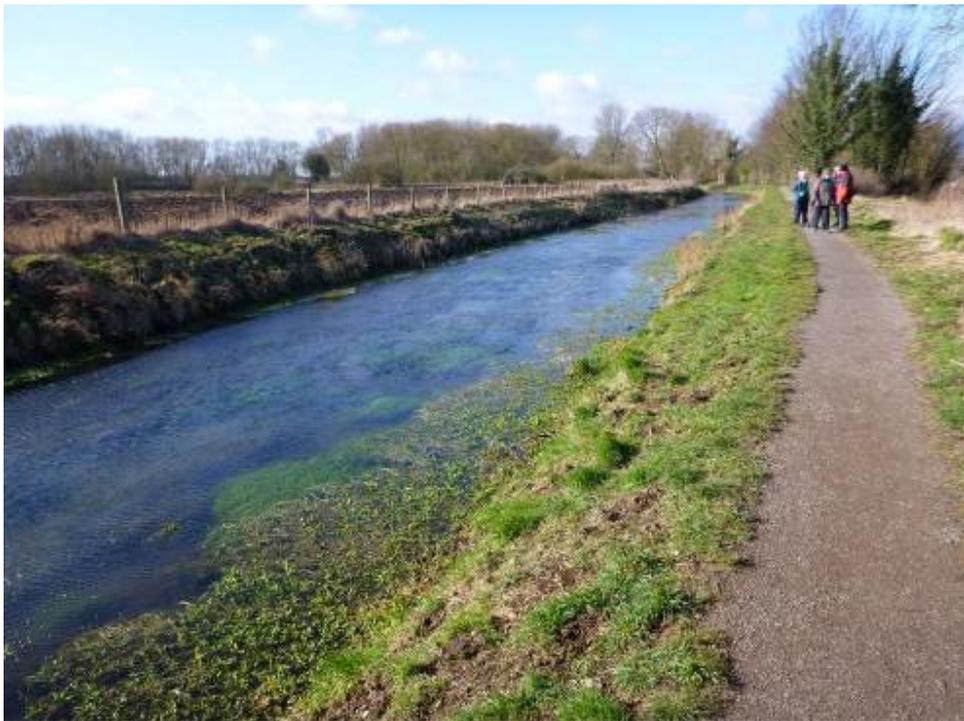
the section downstream. The latter appears to have had mature trees removed from the right (south) bank recently (they are evident on Google maps aerial photographs), which may have reduced shading and stimulated aquatic plant growth.

**Photo 2 Downstream of Drove Lane – more instream vegetation present.**

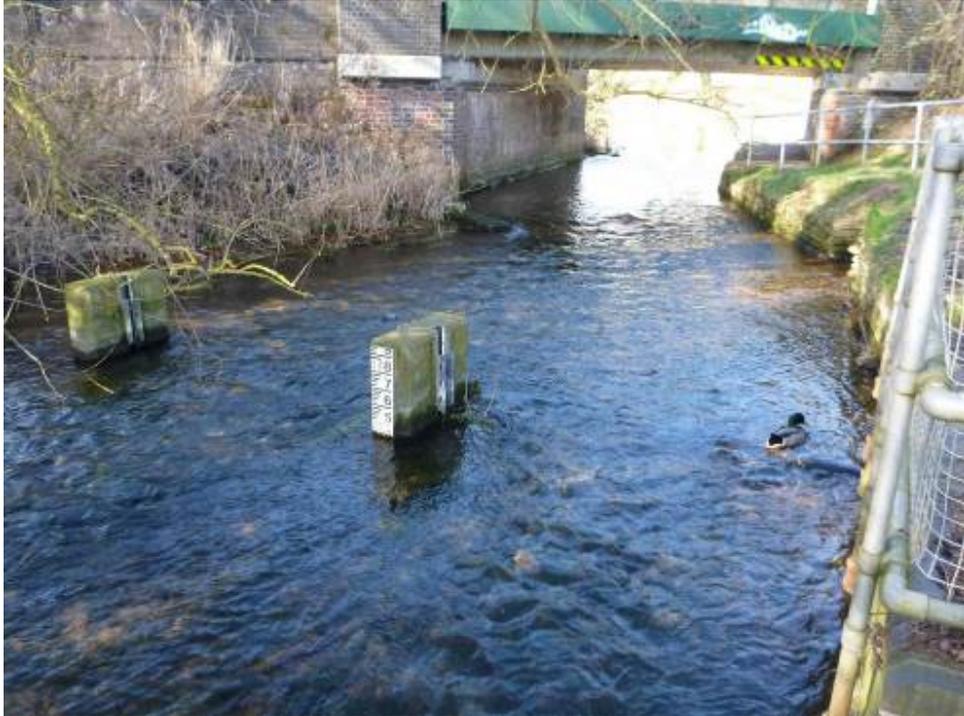
At the railway bridge the channel narrows and steepens through the bridge, speeding up the flow. The river bed substrate here is coarser gravel and there was evidence of trout spawning here. There are uprights in the river bed with slots for weir boards, apparently used in the past to retain water during periods of low flow but unused in recent years since the flow augmentation scheme began.

**Photo 3 Railway bridge. Some evidence of trout spawning was seen here.**

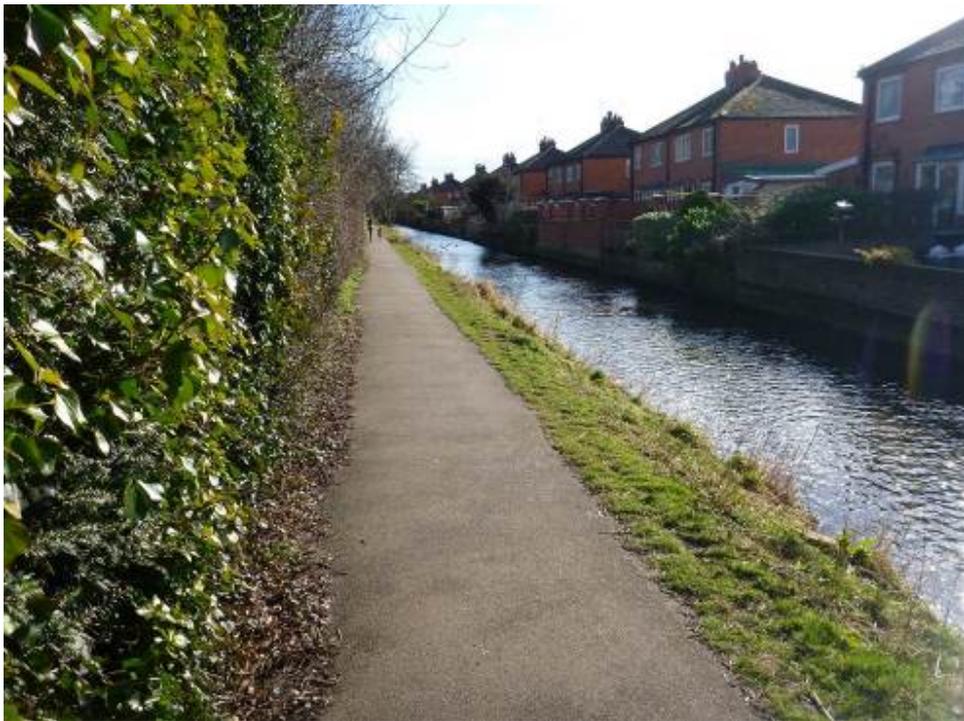
Downstream of the railway bridge (TF0592445933) the flow augmentation enters the river on the left bank. Downstream of this point the river enters the urban area of Sleaford, with houses (Electric Station Road) along the right bank. The left bank footpath continues, being tarmacked from this point.

**Photo 4 Downstream of the flow augmentation point (Electric Station Road houses on opposite bank).**

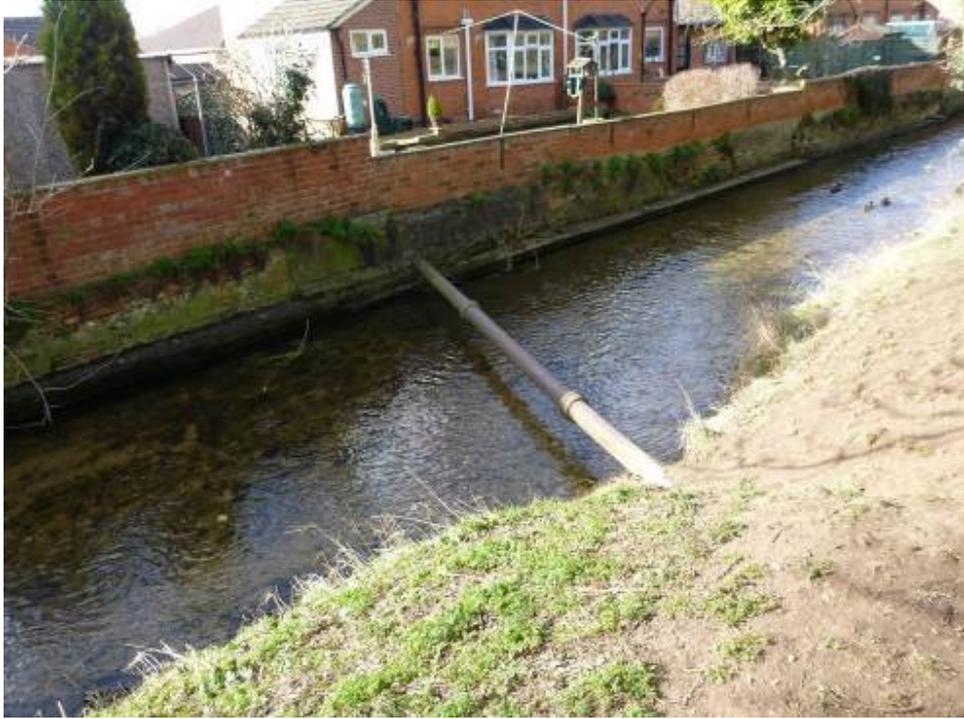
The river has hard, vertical banks (walled) on the right bank and an earth left bank, downstream as far as Castle Causeway. The channel has uniform shallow depth, width and no variation in flow characteristics (smooth glide); the substrate is a poorly sorted mixture of gravel and finer sediments. There is little aquatic vegetation evident, possibly because of the shading by the wall and houses along the right (south) bank. Service pipes cross the channel at a low level in some places.

**Photo 5 Service pipes crossing the river not far above water level**

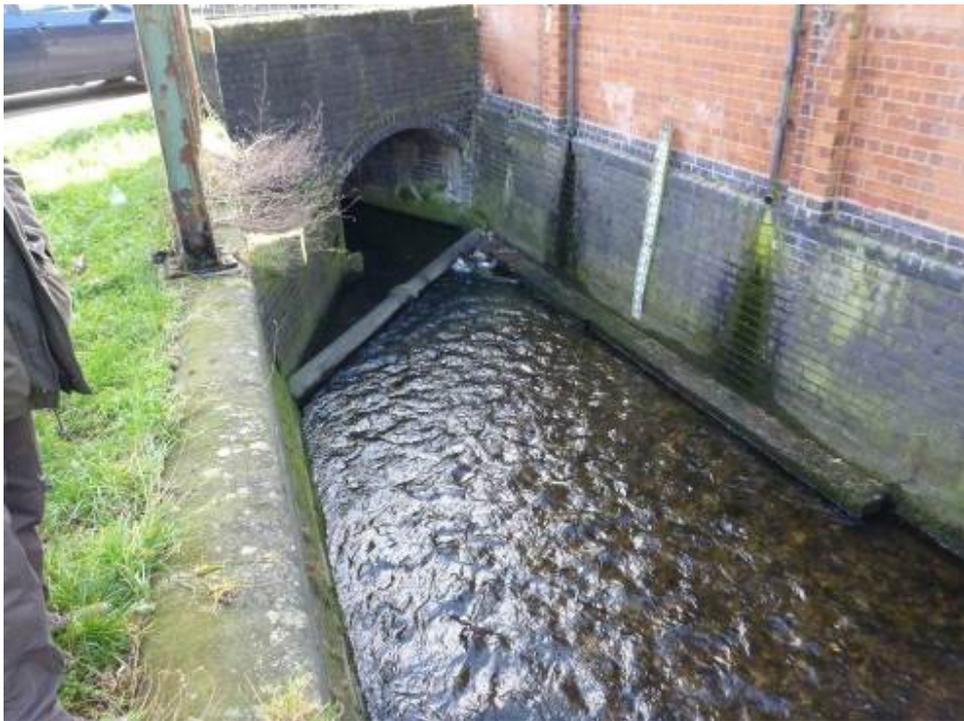
**Photo 6 Castle Causeway culvert**

The river flows through a culvert underneath Castle Causeway (TF0635545741) emerging to run alongside West Banks road towards Sainsburys supermarket. The channel narrows and steepens through the culvert, creating a faster flow and maintaining a bed substrate of coarser gravels which are more suited to trout spawning; indeed a large trout redd was evident just downstream of the culvert. A small number of brown trout were observed in this section of the river in a range of sizes from juvenile fish (1-year olds) through to adult fish of 45cm plus.

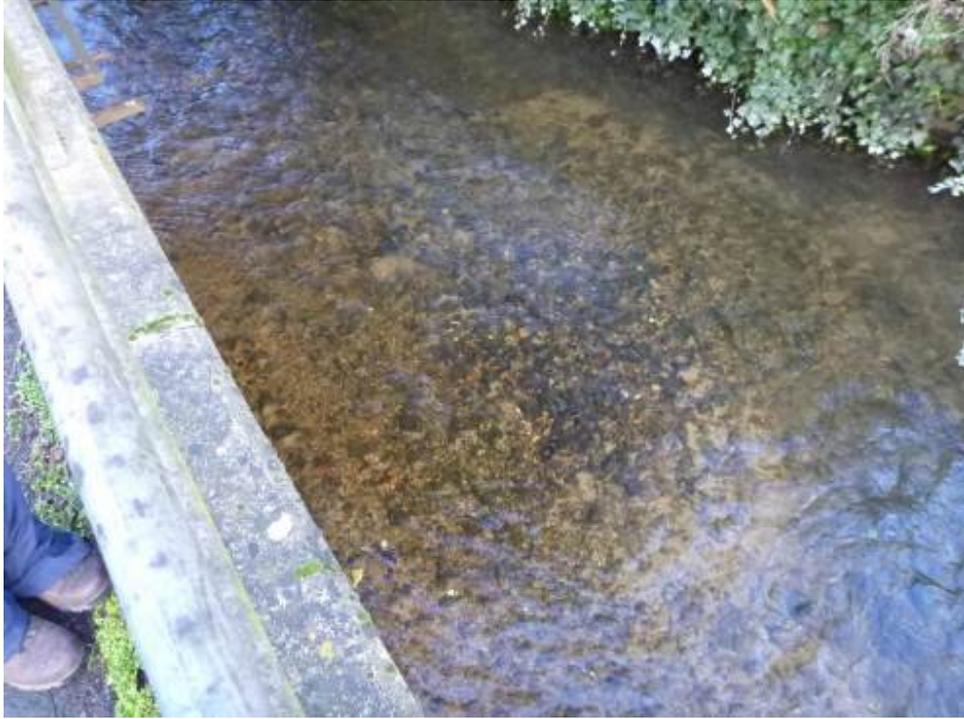
**Photo 7 A large trout redd (spawning site) in gravels immediately downstream of Castle Causeway culvert.**

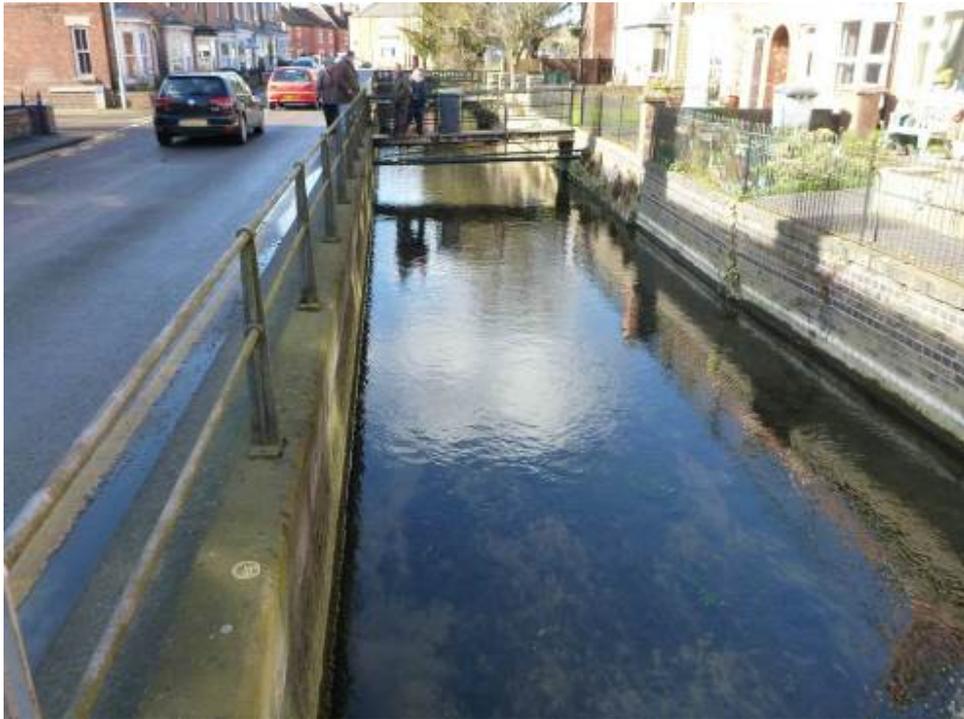
Both banks of the river here are vertical brick walls and there are multiple bridges for vehicle access to properties on the left bank. Further downstream from the culvert, the flow returns to a steady glide and the bed substrate is dominated by fine sediment, with occasional aquatic plants evident. There is little variation in depth apart from one area where a semi-submerged service pipe has caused some undershot scour and a deeper area; three trout were occupying this area.

**Photo 8 The river alongside West Banks**

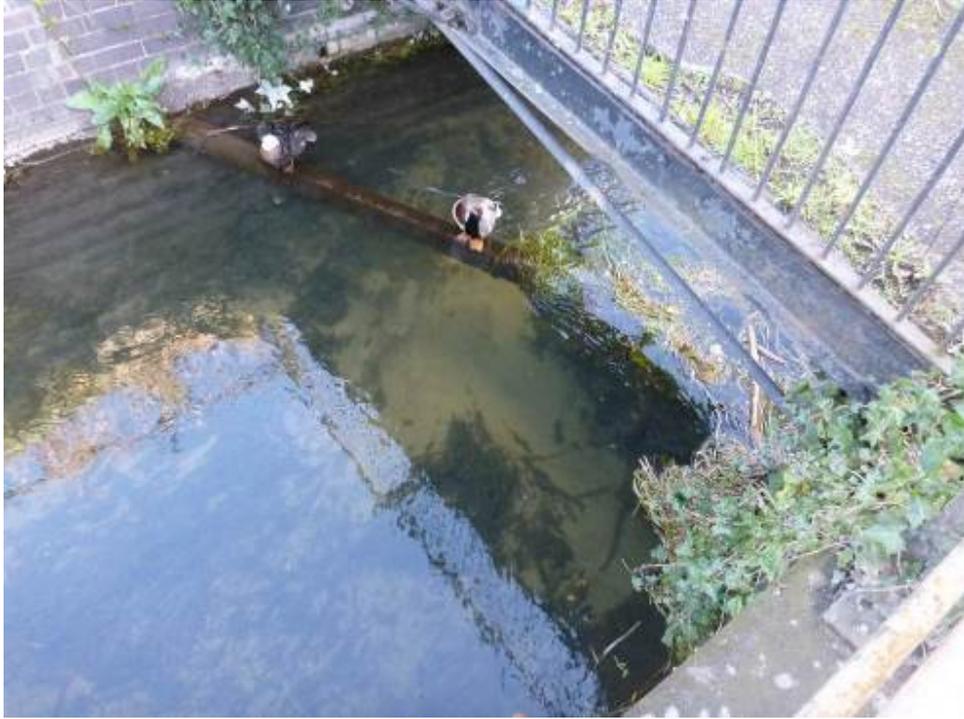
**Photo 9 A pipe causing undershot scour and a deeper area occupied by several trout**

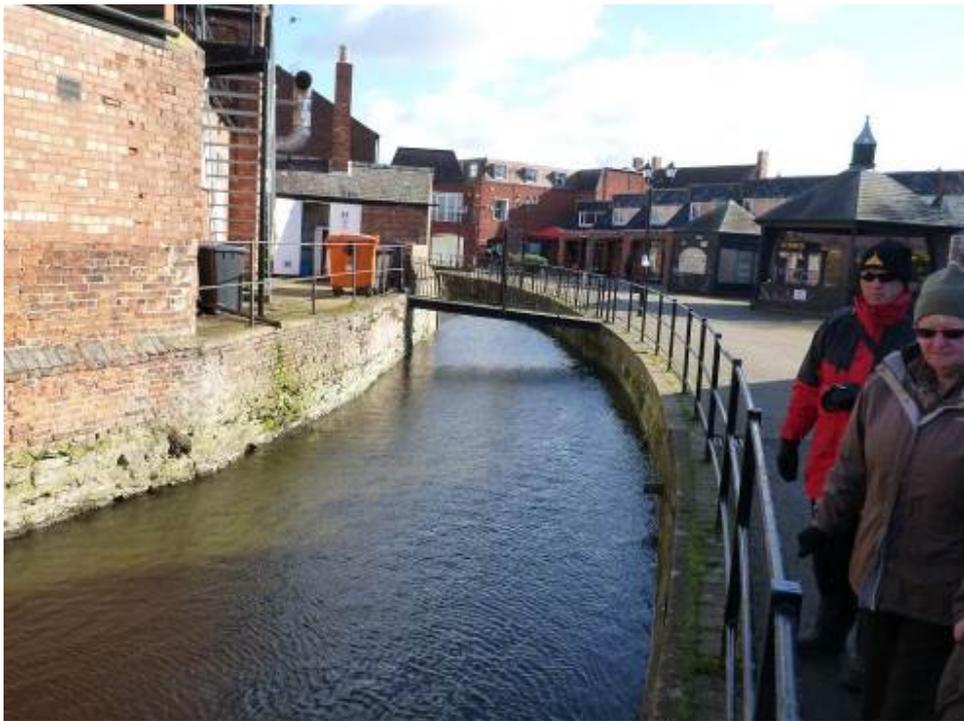
Back on the River Slea, the river flows under Water Gate (TF0671845775) and through a pedestrianised shopping area towards another two culverts under a building and then under South Gate. Again the banks are vertical brick walls and the channel a uniform width and depth. An interpretation board is located in the pedestrian area which would benefit from renovation, both physically and in the nature of the information provided.

**Photo 10 Pedestrianised area downstream of Water Gate**

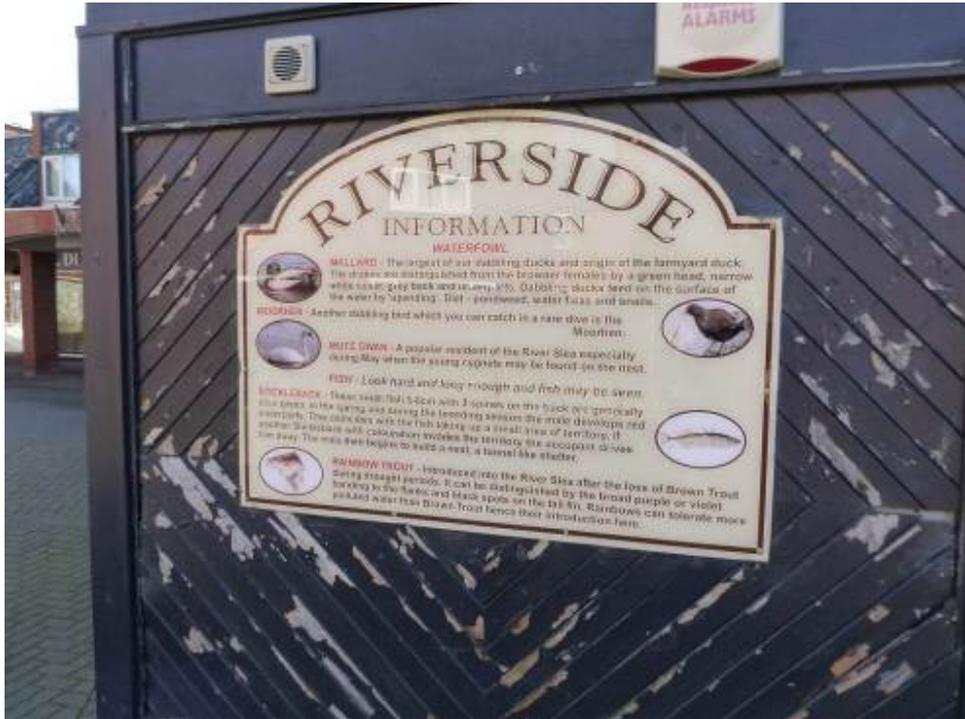
Photo 11 Interpretation board in need of updating. No rainbow trout (a non-native species) were seen during the visit, only brown trout.

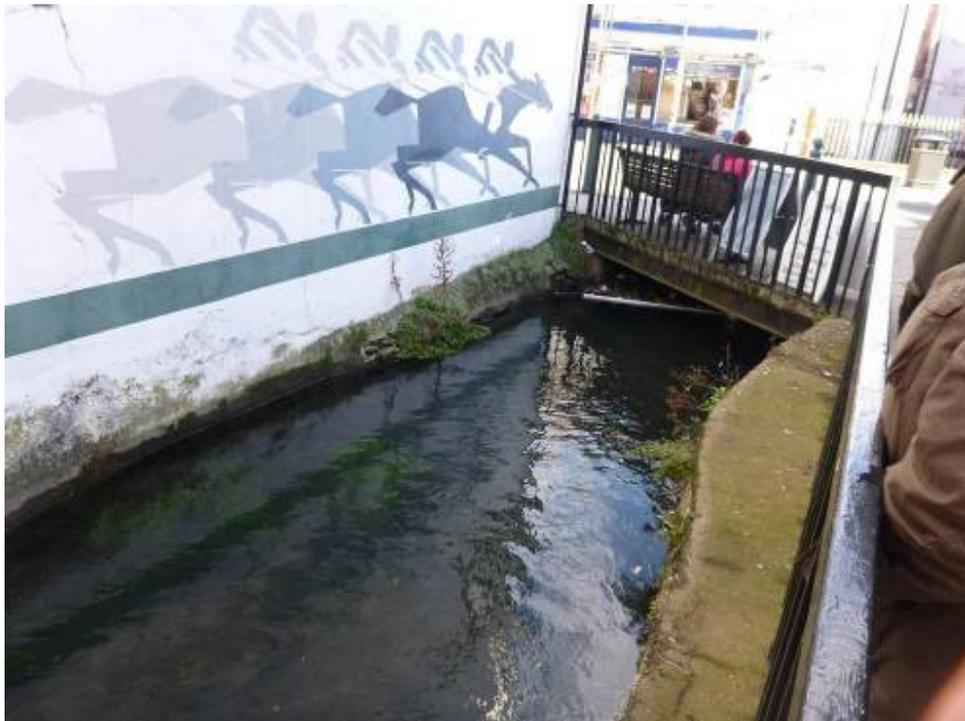
The culvert under South Gate is reported to be narrow (approximately 1.7 metres diameter) and there was little clearance between water level and the top of the culvert on the downstream side, reflecting the generally low flood risk on the Slea. Downstream from South Gate the river has buildings immediately adjacent to the channel on both banks.

Photo 12 The narrow culvert under South Gate

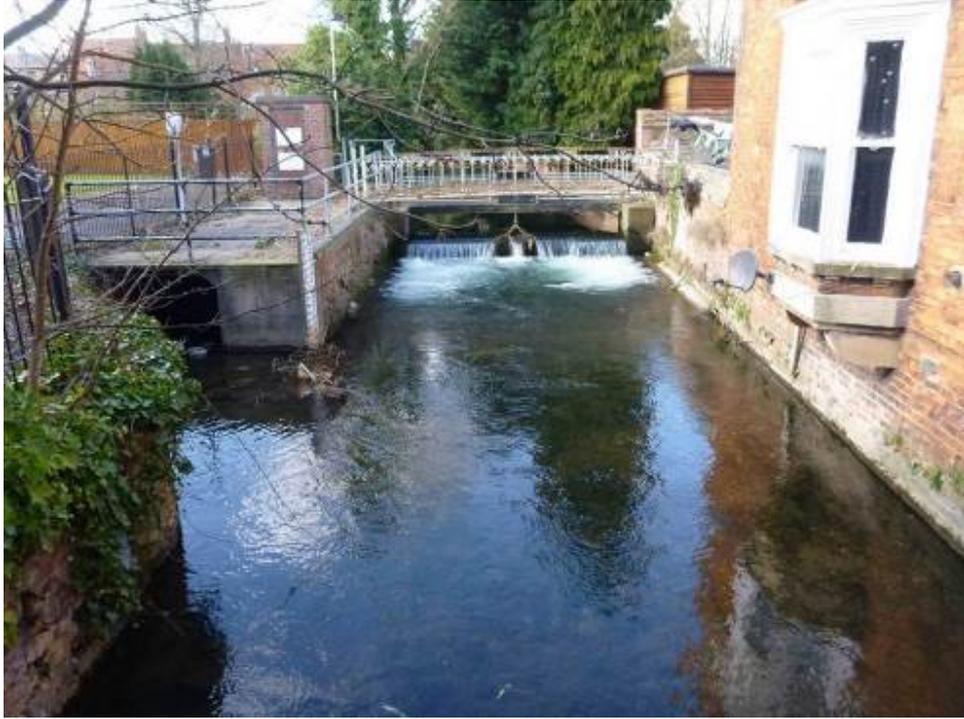
**Photo 13**

Just upstream of Carre Bridge (TF0692045760) is an EA flow gauging station with a weir (Photo 13), which is located just downstream of the confluence with the Nine-foot river. The gauging weir is passable by adult trout moving upstream, but is a barrier to smaller trout and other species. The EA have a prioritised programme of addressing gauging station weirs for fish passage; enquiries should be made regarding this structure.

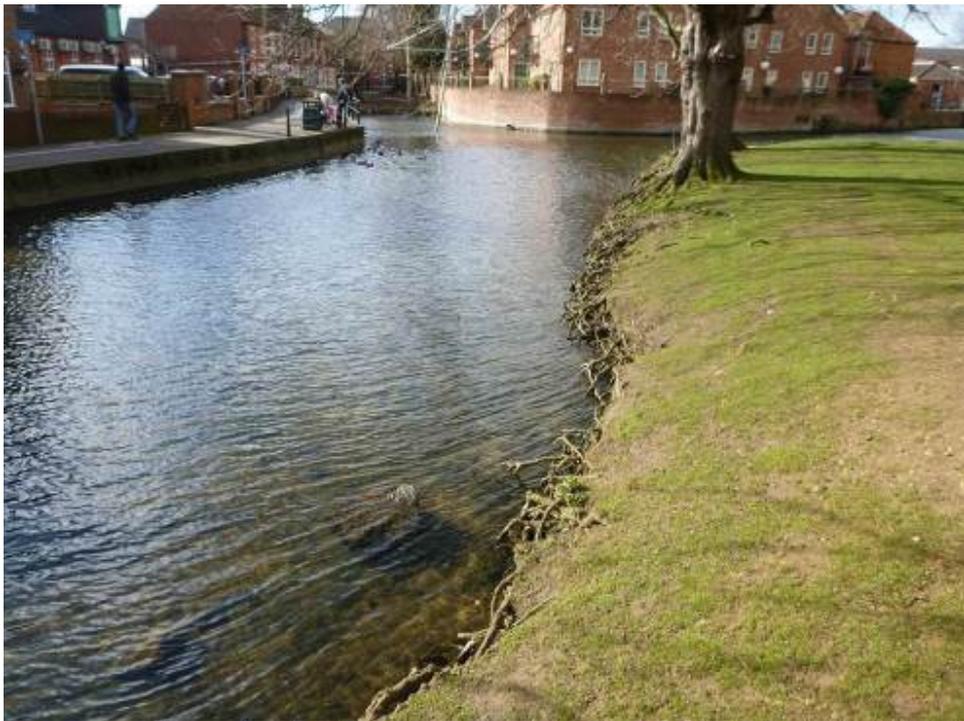
**Photo 14**

Below Carre Bridge is the beginning of the historic navigation on the Slea and the river bed is owned by the Slea Navigation Trust. The river widens out into a basin in front of the historic navigation company building and there is an in-filled channel branching from the right bank (former access for boat turning). This area has been re-developed and includes a slipway and a lifting bridge (TF0708845750). The banks are mainly hard engineered (concrete, steel pilings) apart from an area on the left bank with mature trees; the bank here is heavily eroded by waterfowl, exposing the tree roots at water level (Photo 14).

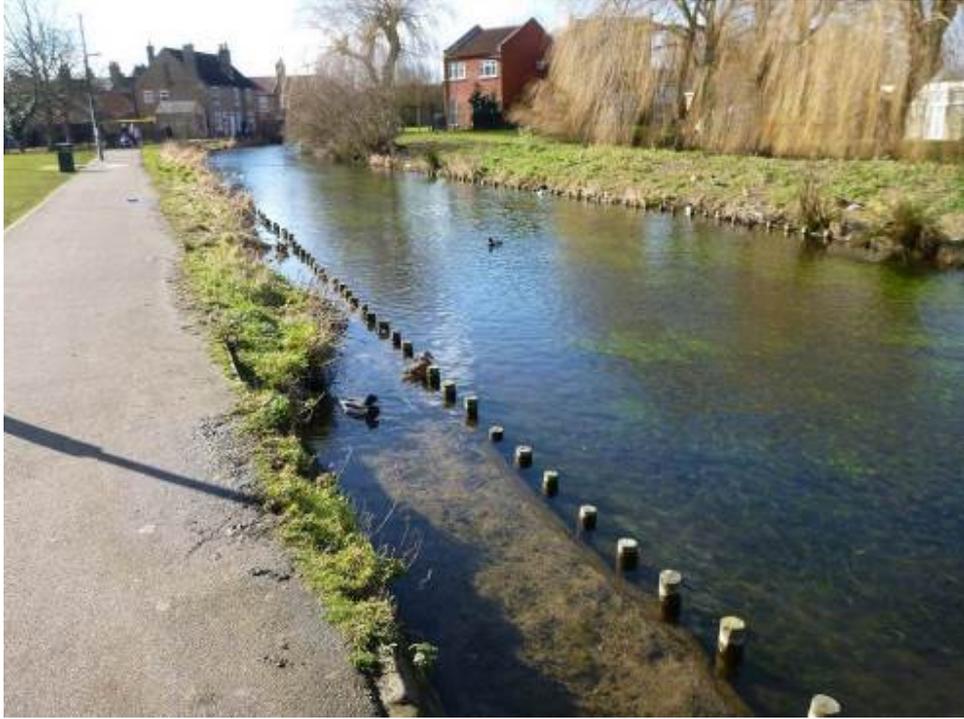
Photo 15

Downstream of the lifting bridge, the river channel is maintained artificially wide reflecting its use as a navigation. It is uniformly shallow with aquatic plant growth prolific on the river bed (Photo 15). With progress downstream, past the footbridge near the council offices and leisure centre (TF0722245879), the channel becomes perched above the surrounding land until the level control structure (a tilting weir) is reached at Coggleford Mill (TF0744846116). The Old River Slea leaves the higher level channel through a sluice on the right bank just downstream of the leisure centre bridge.

Between the lifting bridge and Coggleford Mill, a past project to introduce soft, vegetated margins to the river has been attempted which involved driving in lines of wooden posts to support a geotextile membrane, then backfilling with gravel and planting (Photo 15). This has only been partially successful, with long sections of posts now exposed, with no marginal vegetation present. The left bank appears to have colonised much more successfully than the right, possibly because of its south-facing aspect. There are large numbers of waterfowl in this area, encouraged by public feeding, which will exert considerable grazing pressure and make establishing new planting a challenge

The marginal habitat of this lower section has been attempted previously with mixed results. This could be tried again, given that the wooden posts are still in place. The crucial consideration if these margins are re-planted is protection from the abundant waterfowl; this would involve physical barriers (mesh, cages, etc.) which would have to be in place for two growing seasons and may be considered unsightly and prone to interference.

Restoration of the failed marginal habitat improvement could be attempted, but the limiting factor is protection from waterfowl. More detailed costings could be provided on request. **Acknowledgement**

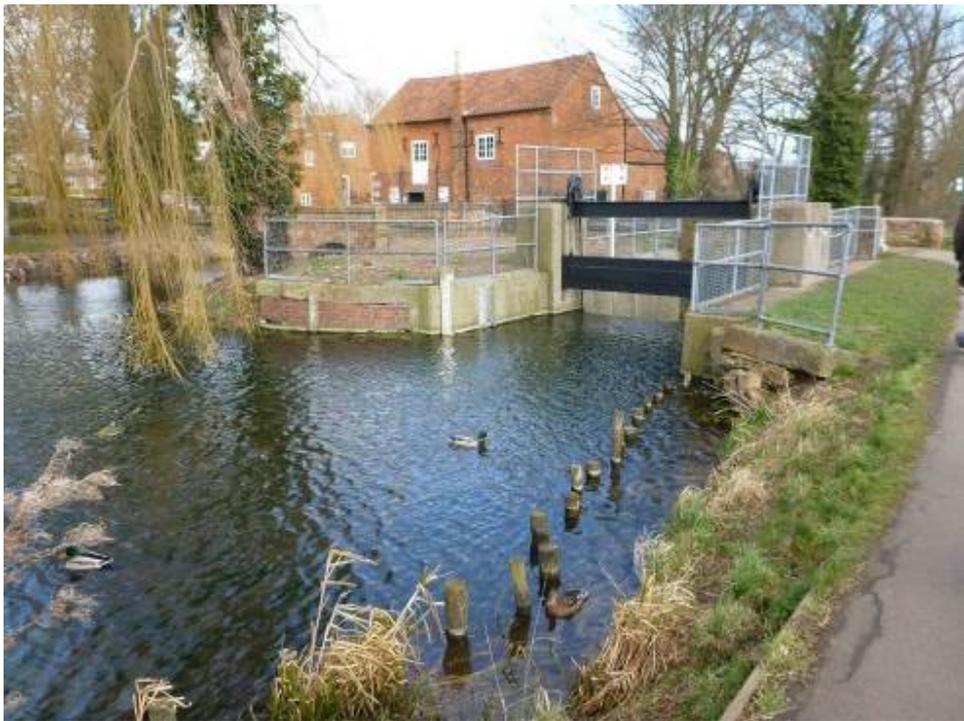
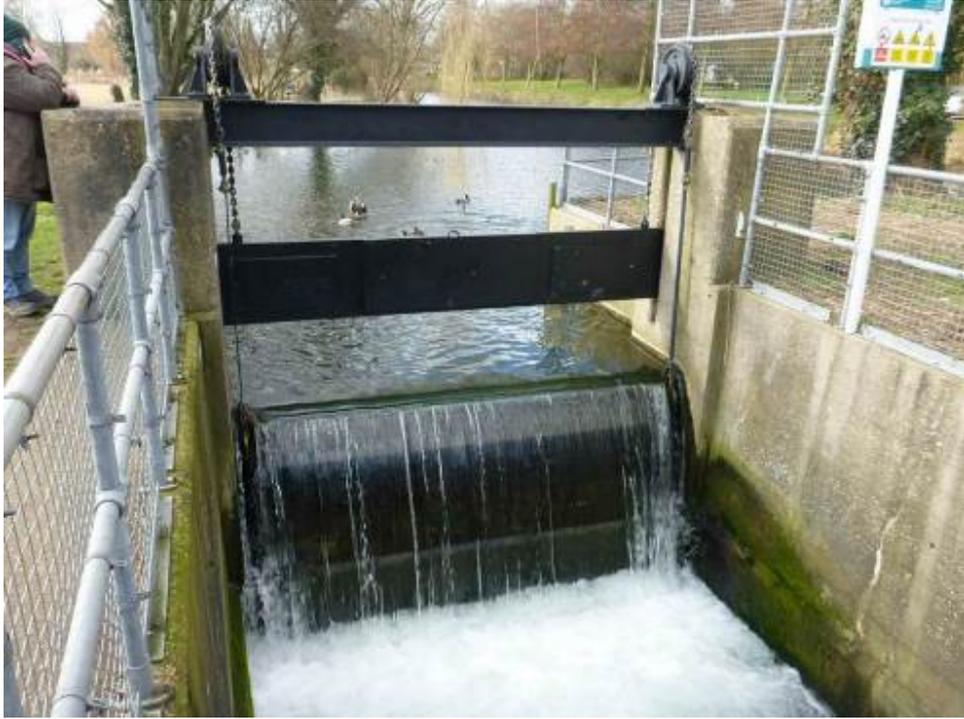
Photo 16 The tilting weir and Coggleford Mill (background)

**Photo 17 The tilting weir**

The tilting weir at Coggleford Mill is located in the former lock structure and has a head difference of around 1.5 metres (Photos 16, 17). The channel upstream has recently been cleared of emergent vegetation to improve the water flow to the mill (a tourist attraction). The weir is a barrier to fish movements, preventing fish from moving freely between the reaches upstream and downstream of the mill. Making fish passage possible would greatly improve the resilience of fish populations in the Slea by connecting different habitats used for spawning, feeding and over-wintering and making it easier for fish to naturally recolonise following pollution incidents. If plans are being considered to renovate the lock structure, serious consideration should be given to installing a fish pass in this location. The mill bypass channel may provide a route (Photo 18), although a professional appraisal should be conducted to determine the best option.

On the lower section of river (between Carre Road and Coggleford Mill) the opportunities for habitat improvement are limited because of the impounded nature of the river. Changing the dimensions of the channel or introducing in-stream structures would not have the desired result (increased localised scour to change depths and sort bed substrate) because of the low energy of the impounded reach; they would also potentially conflict with the use of the channel as a navigation. If works at Coggleford lock are carried out in the future, it would be of benefit to the river to incorporate a multi-species fish pass for the reasons noted above.

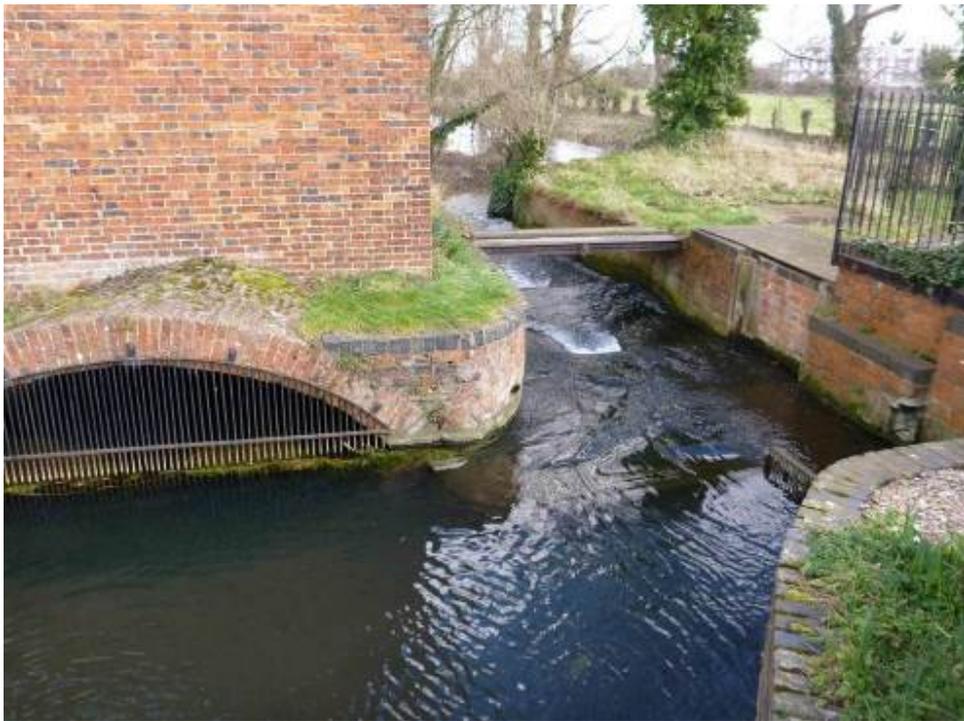
**Photo 18 Cogleford Mill bypass**
